DRAFT COAL ASH IMPOUNDMENT SITE ASSESSMENT REPORT

MONTROSE GENERATING STATION
KANSAS CITY POWER & LIGHT
MONTROSE, MISSOURI

March 2011

Were assessed on March 1, 2011

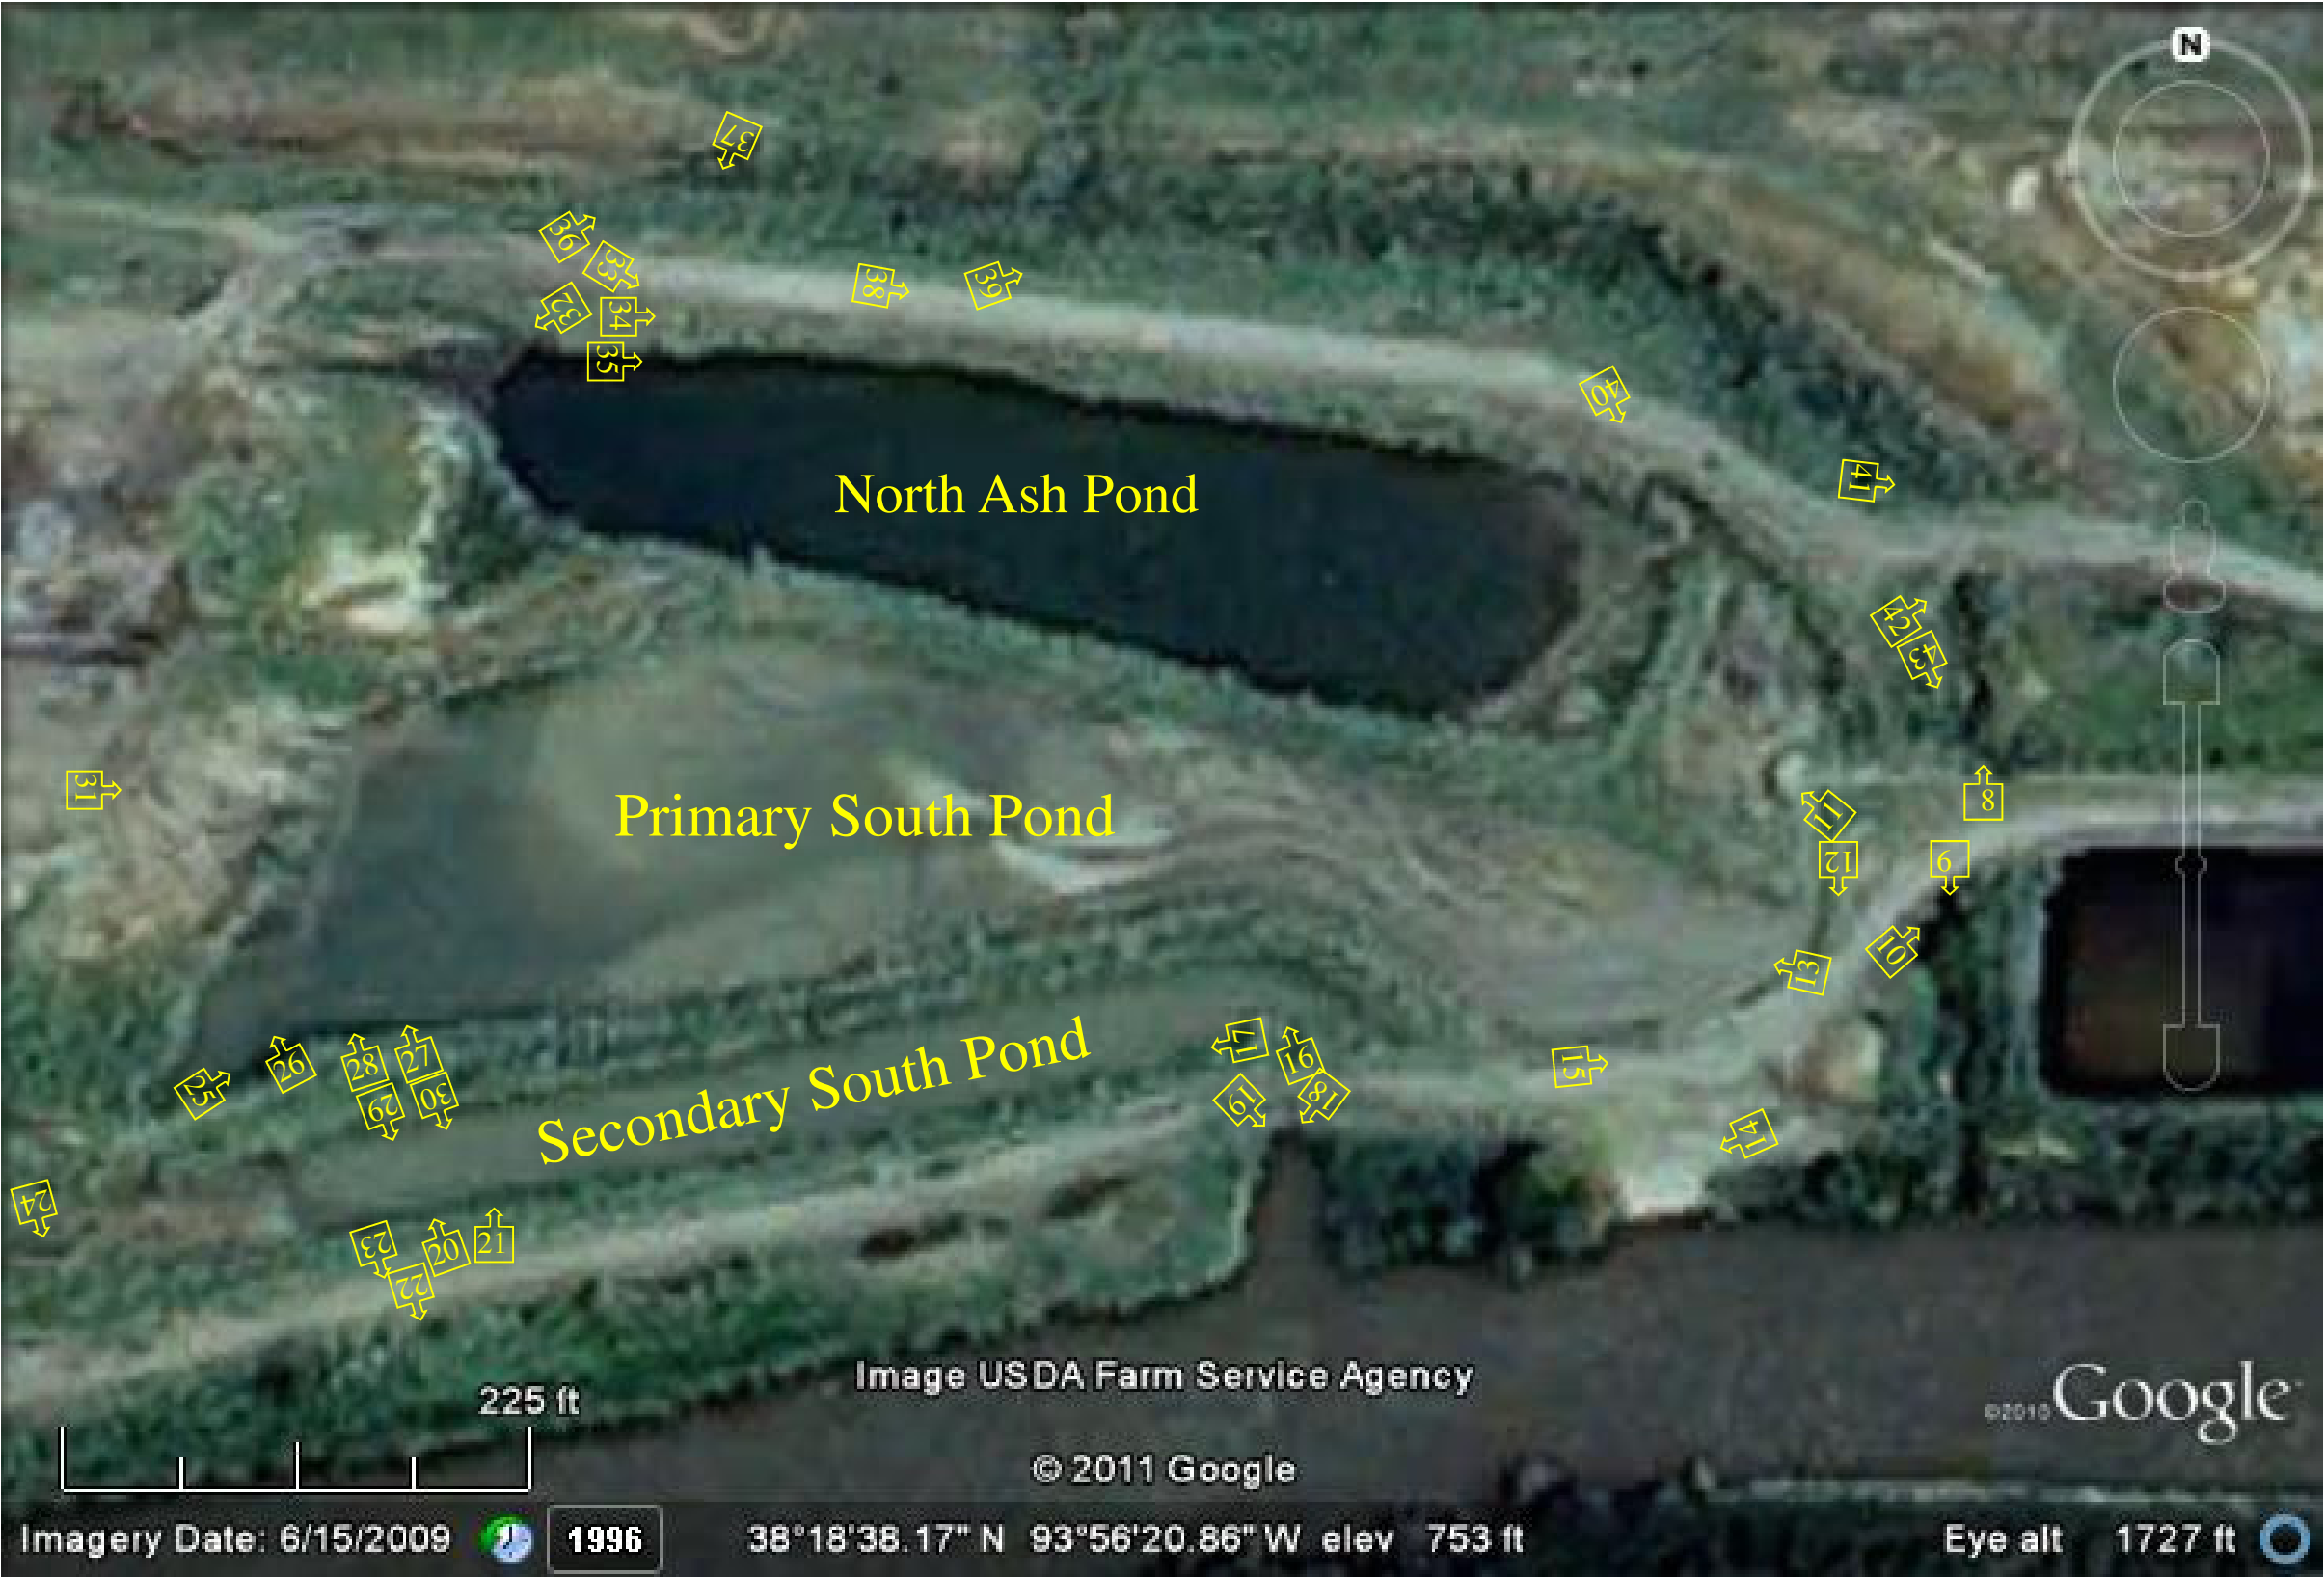
PLATE
5

- Notes:
- 1) Photographs 1 through 7 and 44 were taken near the power generating plant and not shown on this map.
 - 2) Photograph locations are approximate and may not coincide with the coordinates shown on the photo.

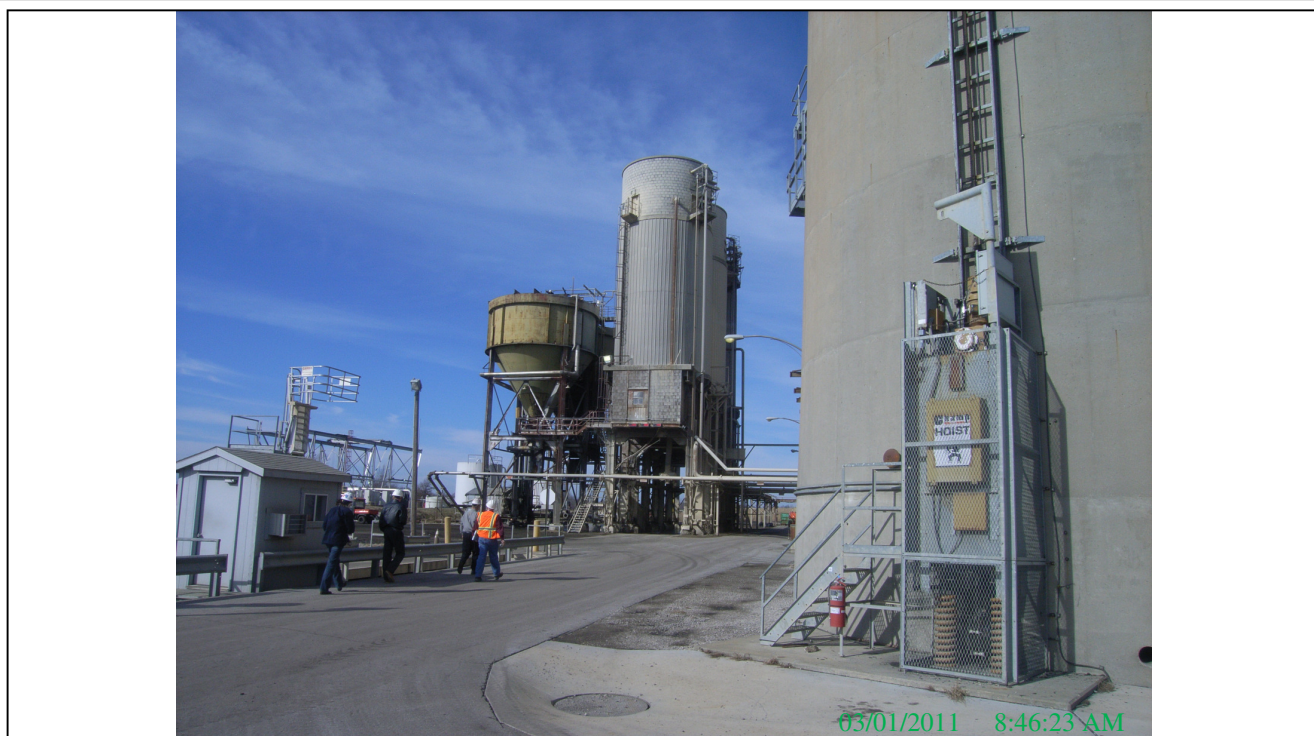
1-Bottom Ash and Fly Ash Silos Looking West

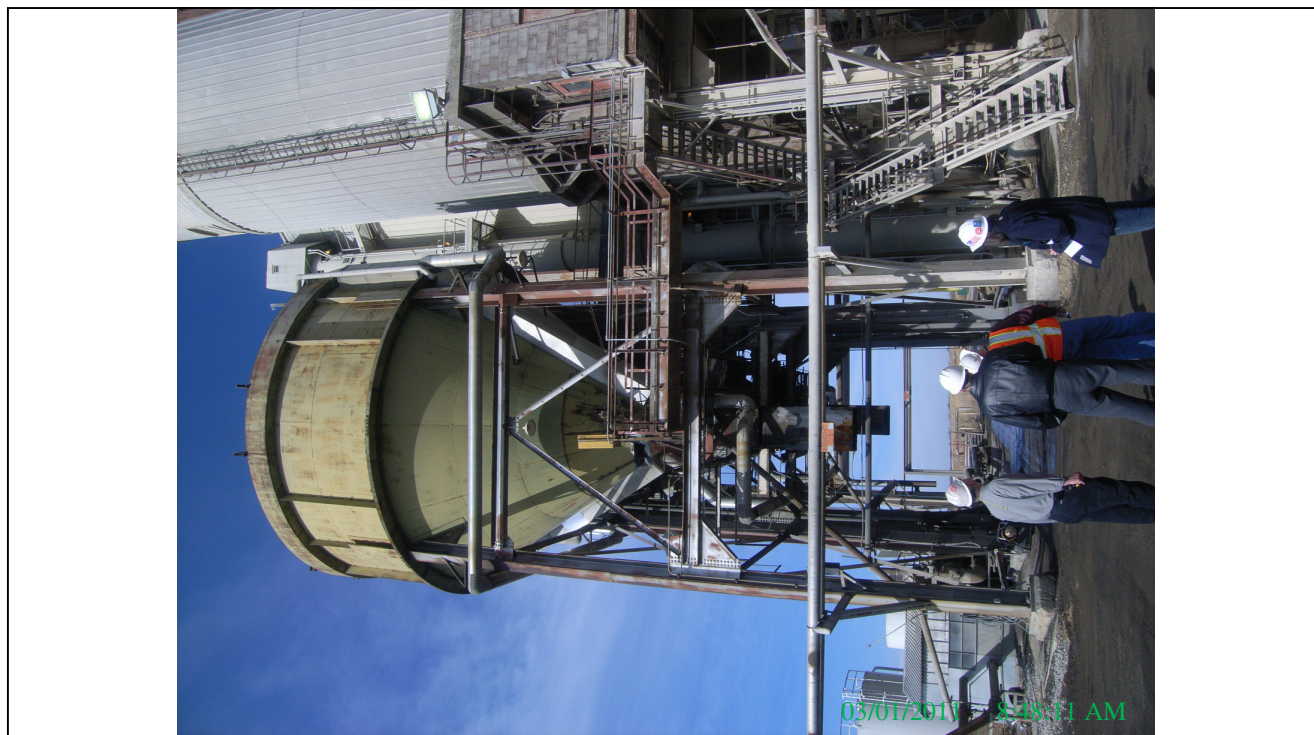
2-Bottom Ash Silo Looking West

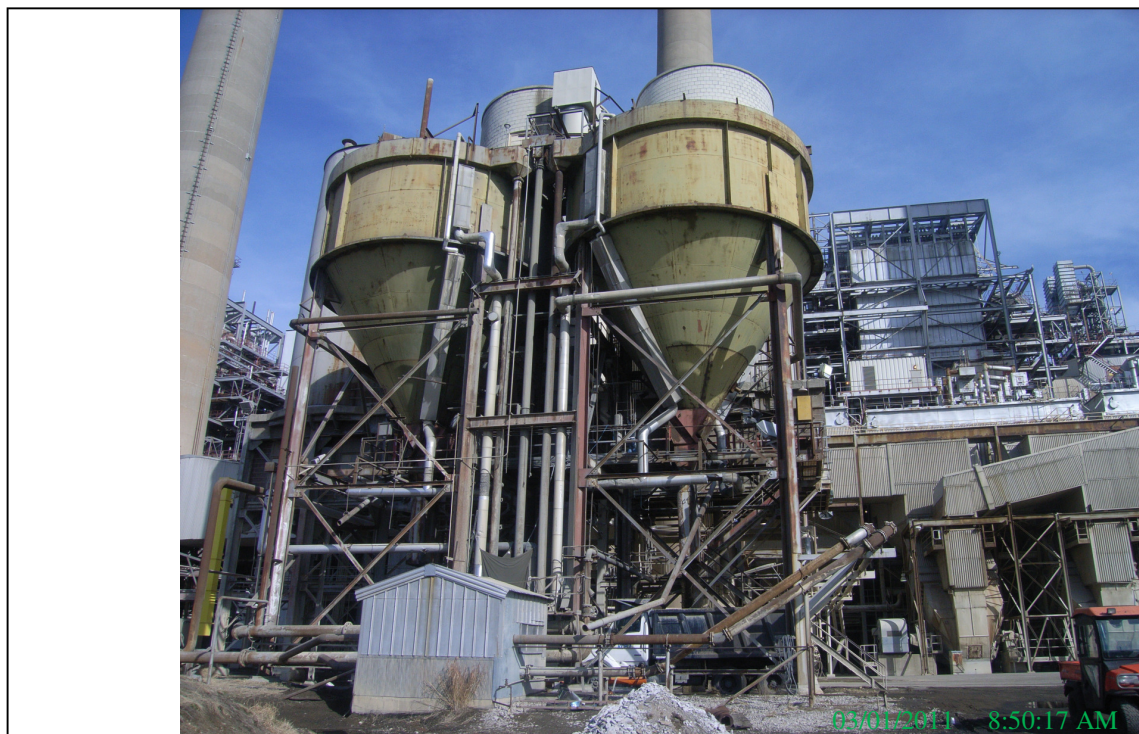
3-Bottom Ash Silo Looking North

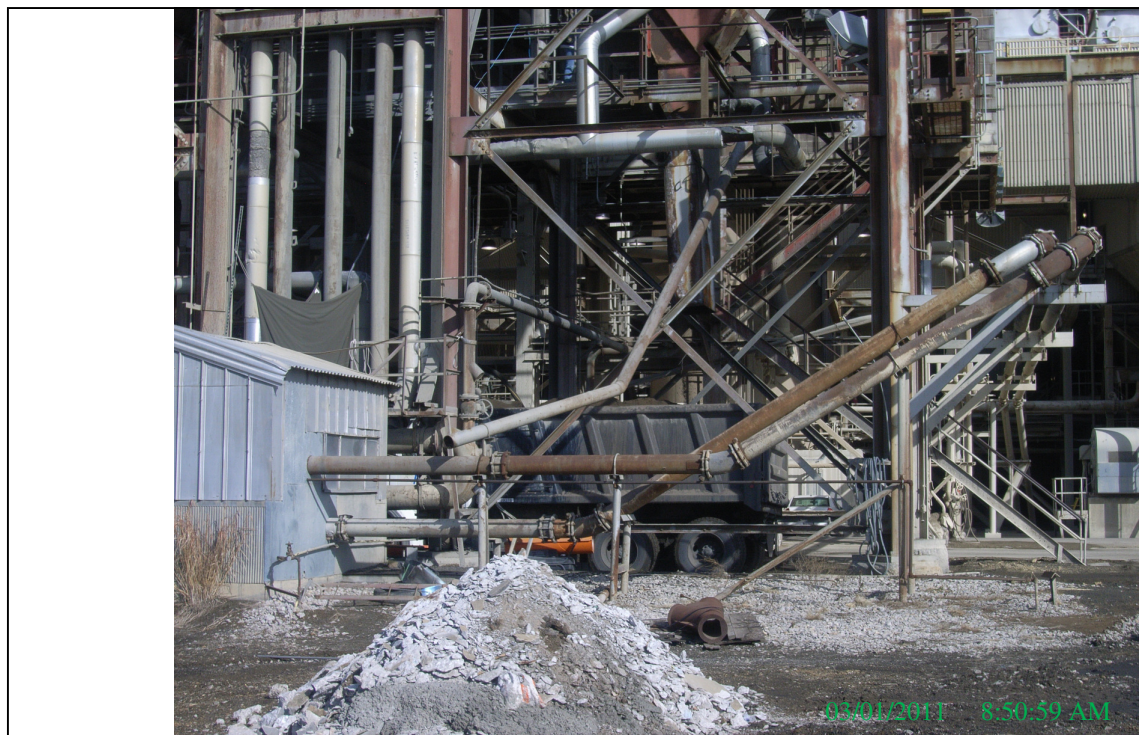
4-Bottom Ash Silo Filling Truck

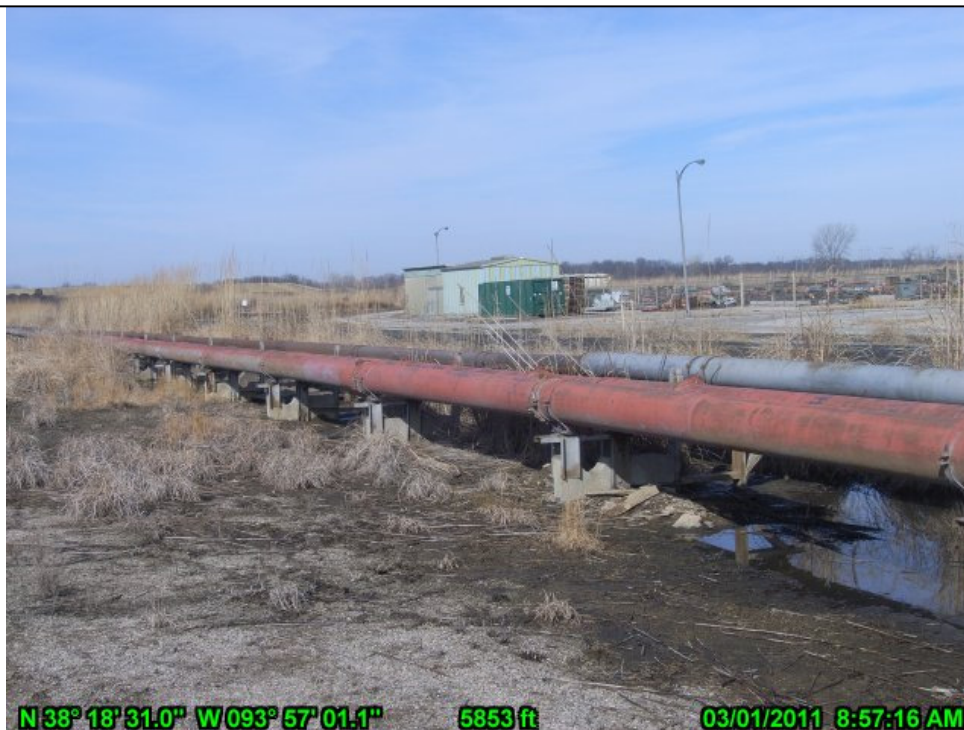
5-Sluice Pipes Looking Northwest

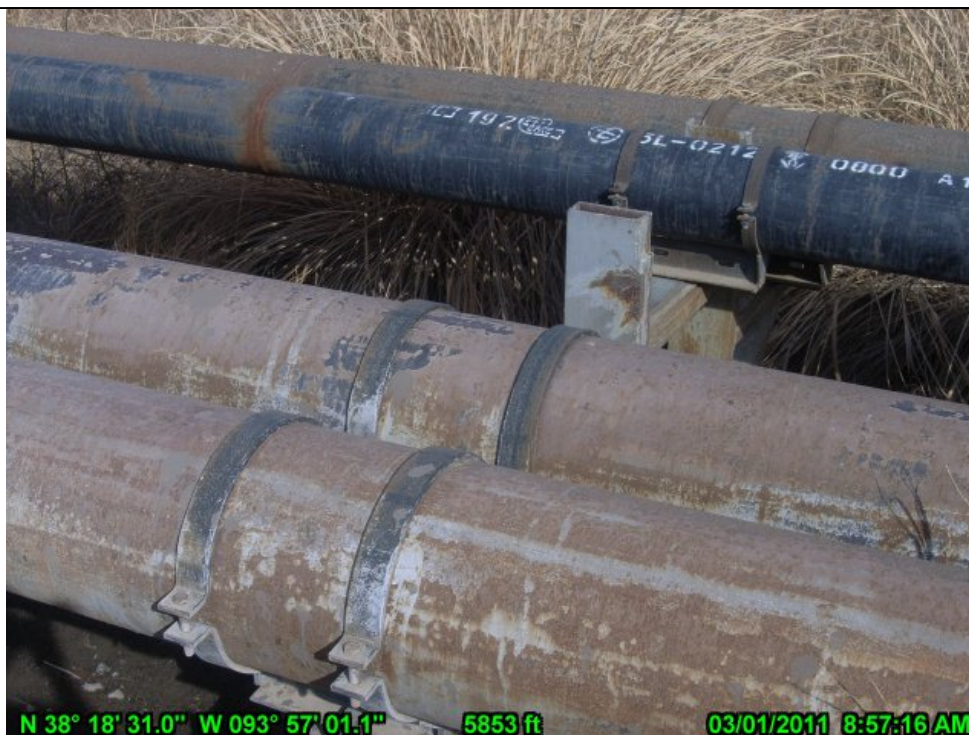
6-12" and 18" Sluice Pipes

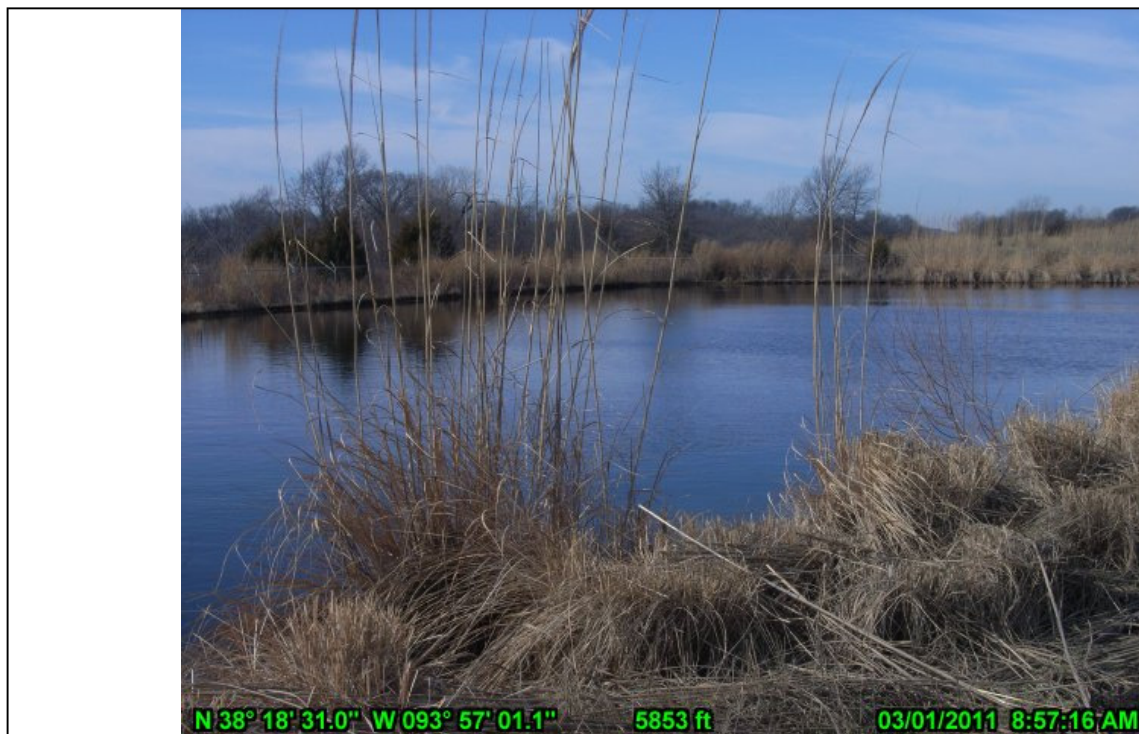
7-Metal Washing Discharge Pond

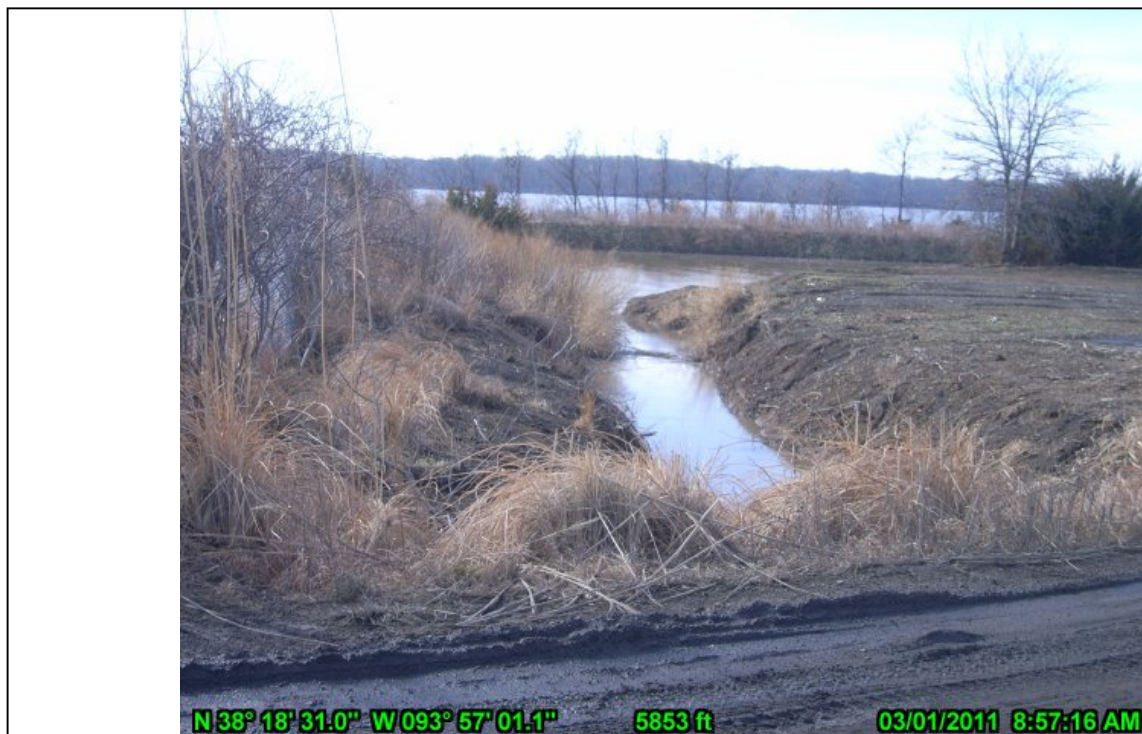
9-Drainage Ditch from North Pond Flowing to Discharge Canal

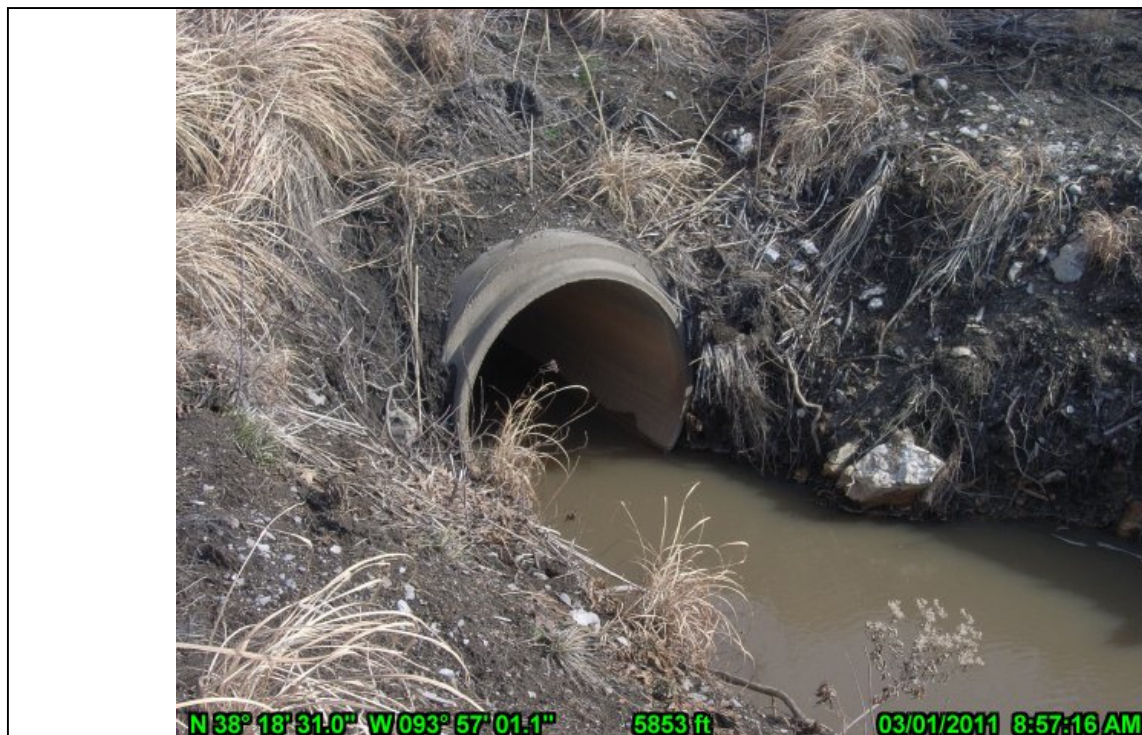
10-Drainage Ditch Culvert Looking Upstream

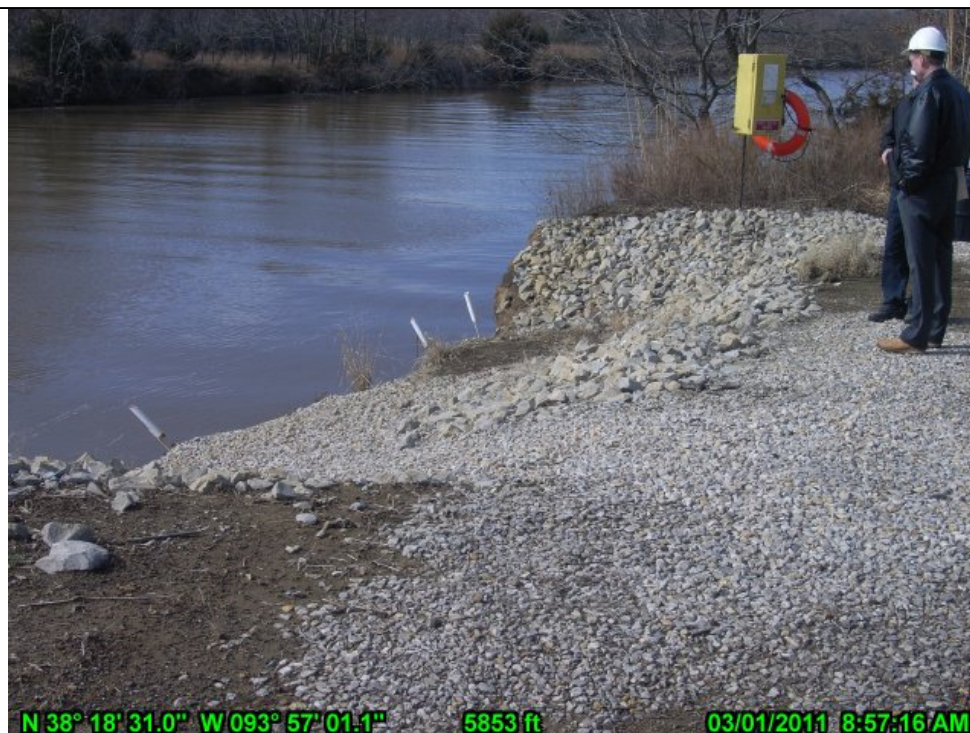
14-"Employee Fishing Area" Adjacent to Discharge Canal

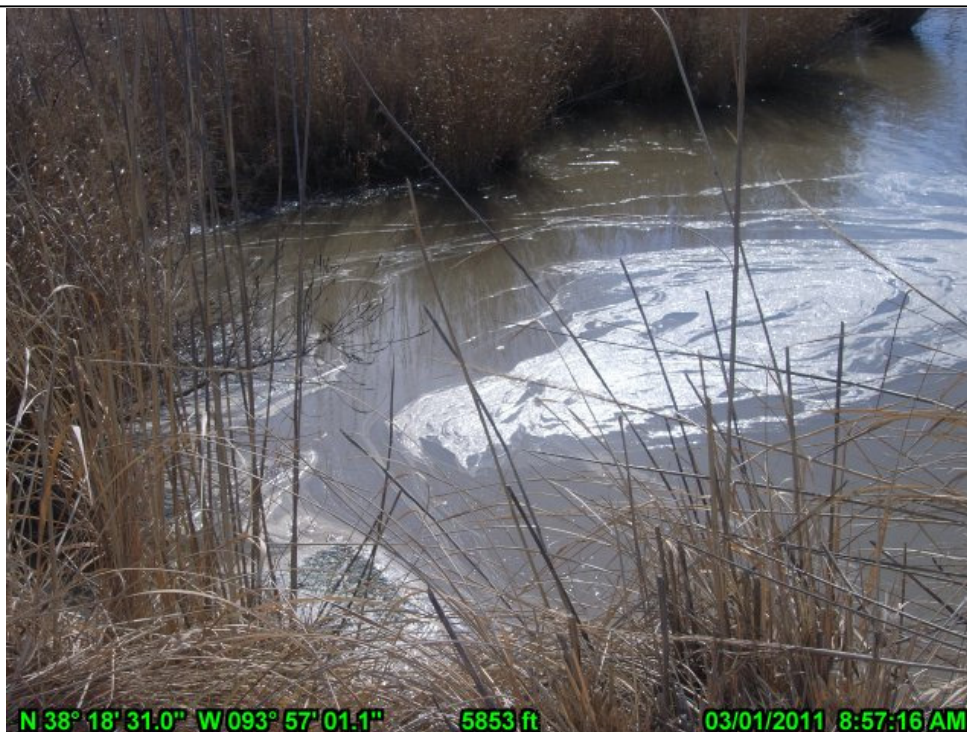
19-Outlet of South Pond Outfall

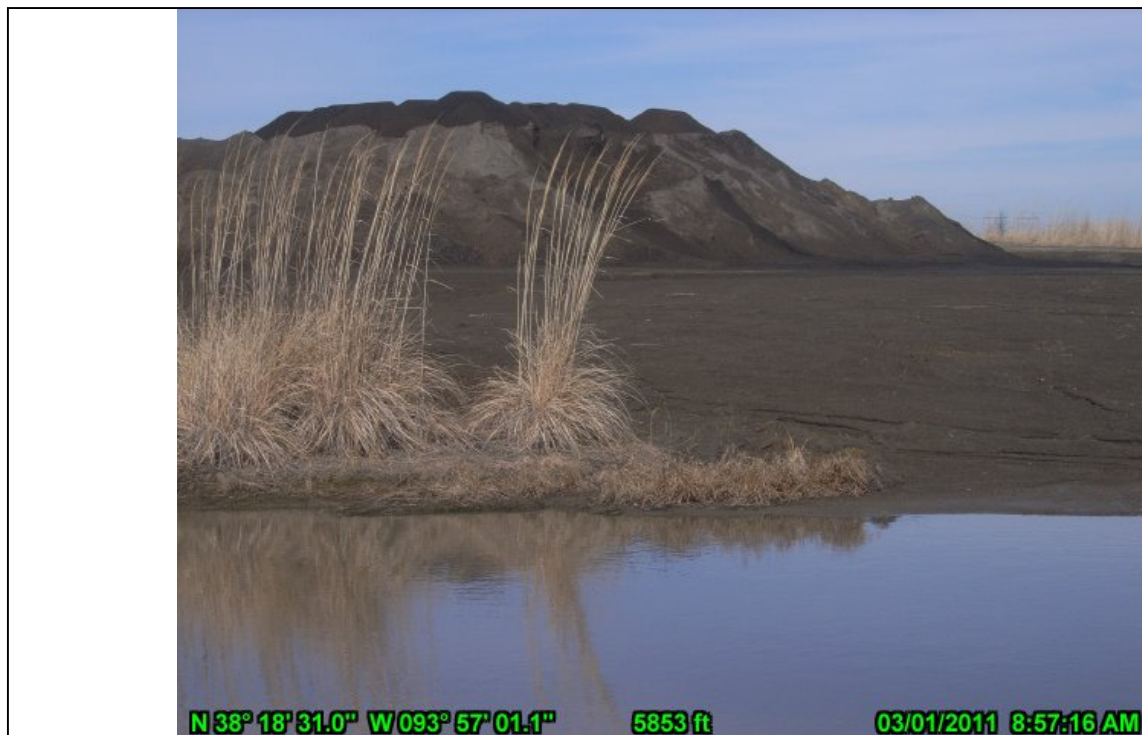
26-Primary South Pond Looking Northwest

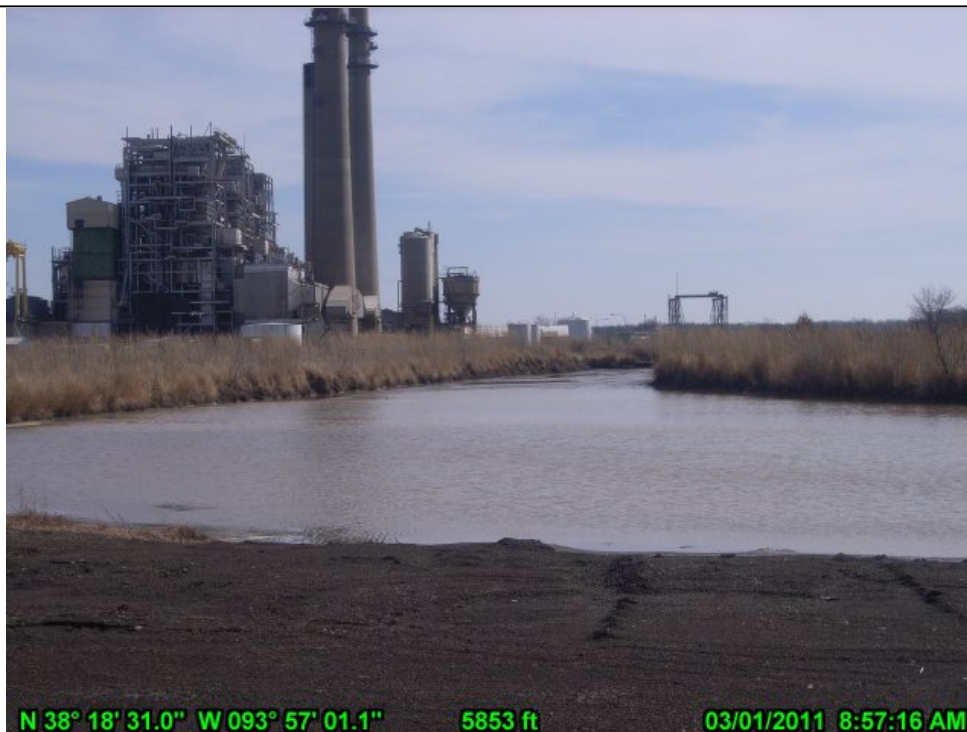
31-Primary South Pond Looking East

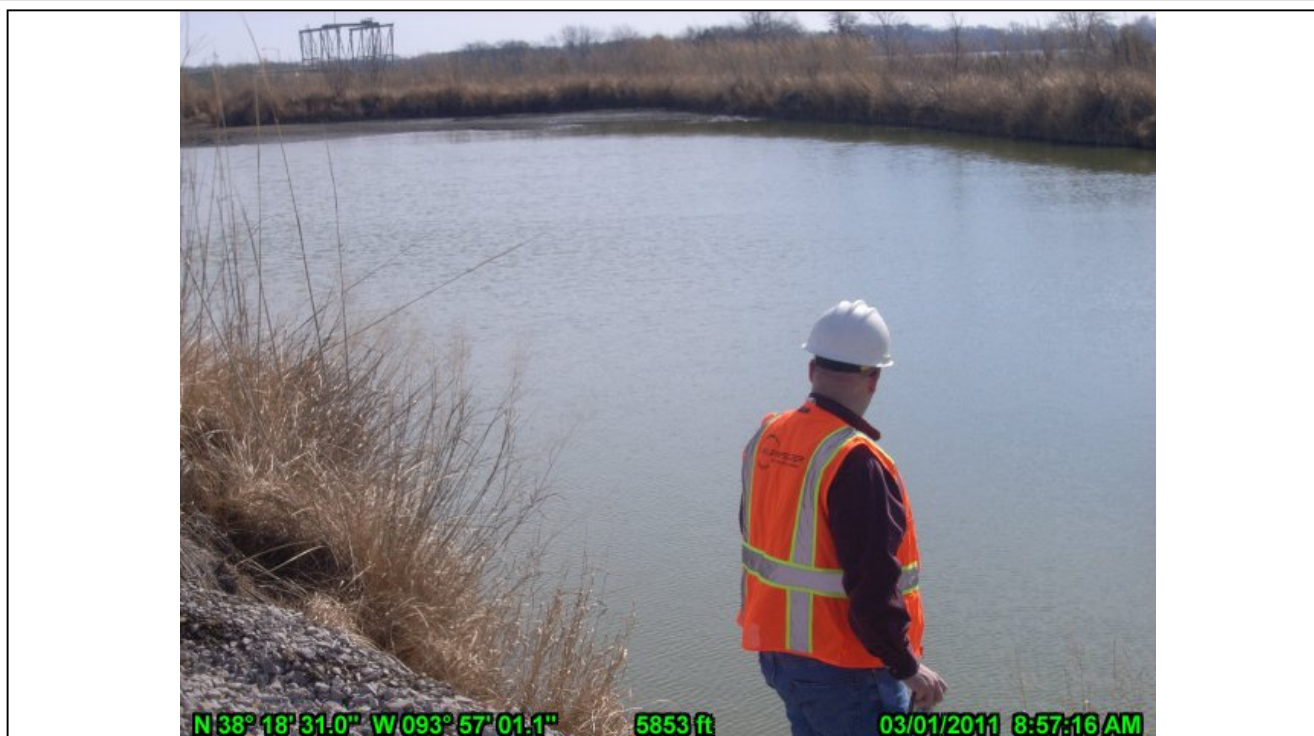
33-North Pond Looking Southeast

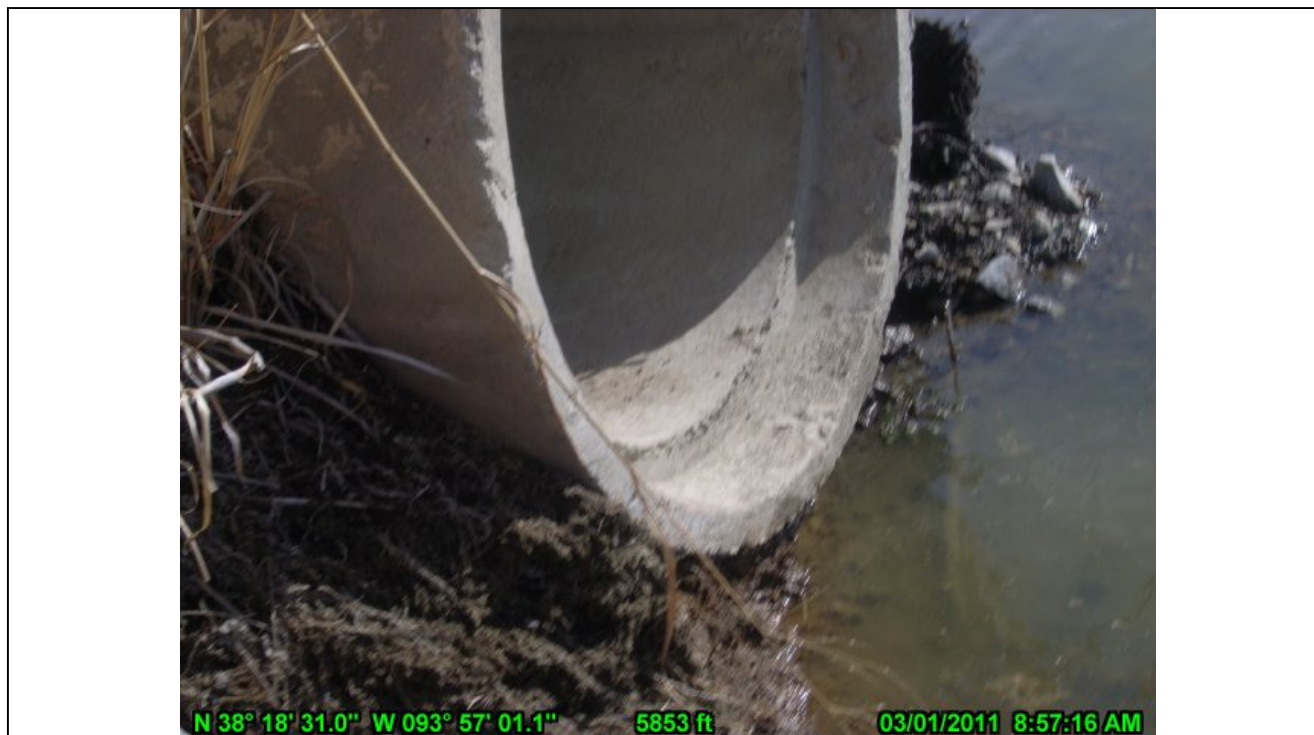
34-Inlet to North Pond Outfall

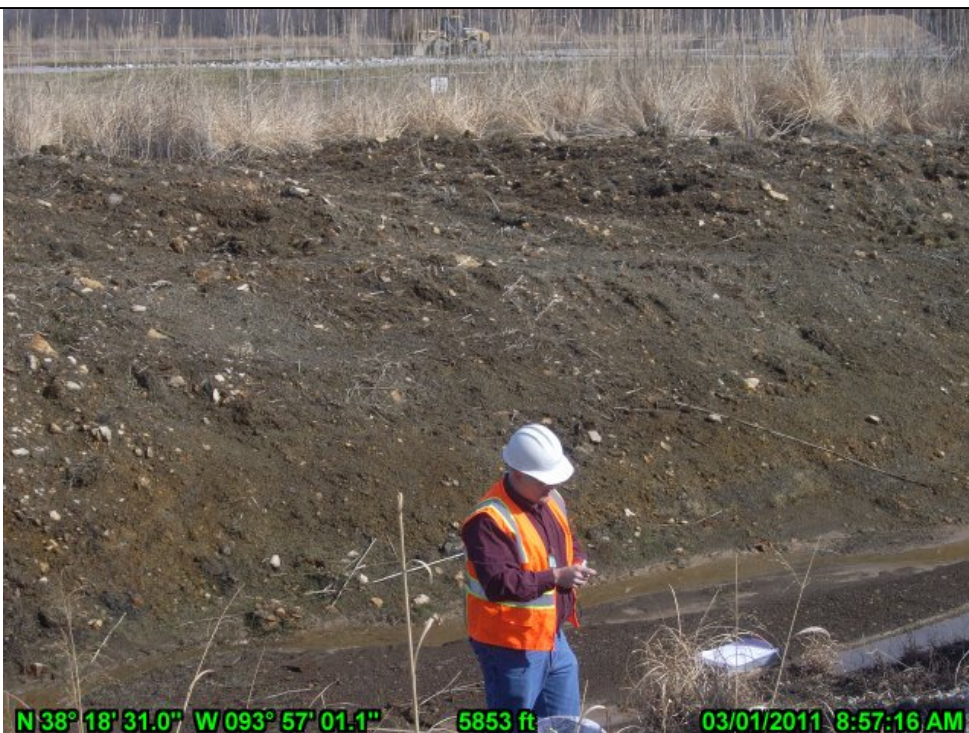
36-South Pond Outfall Discharge Area and Ditch

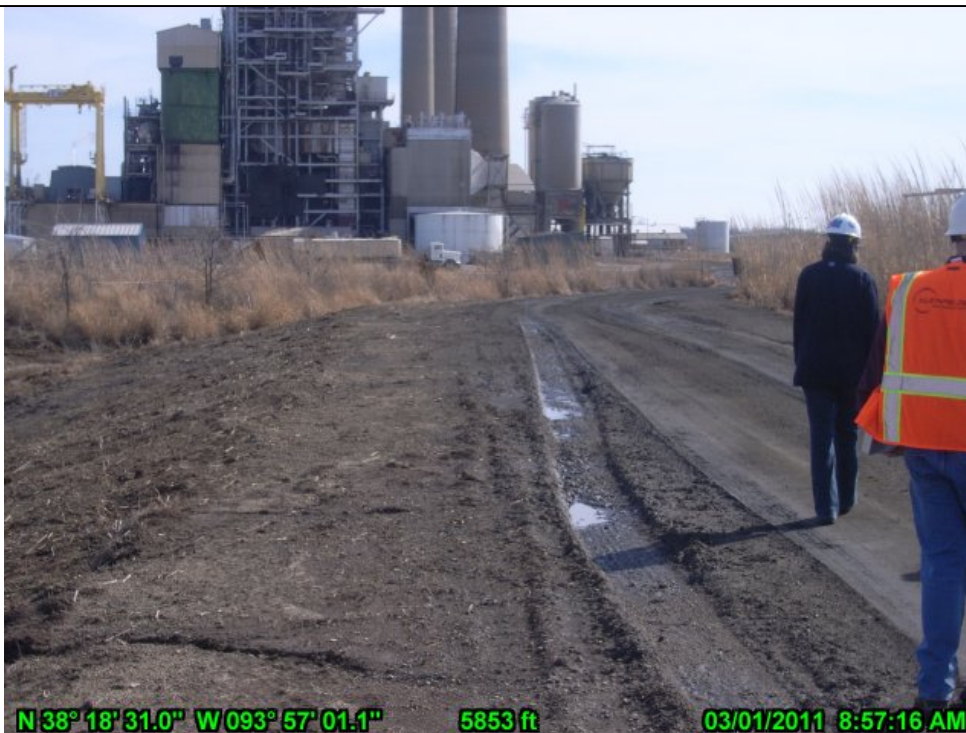
38-North Pond North Embankment Looking East

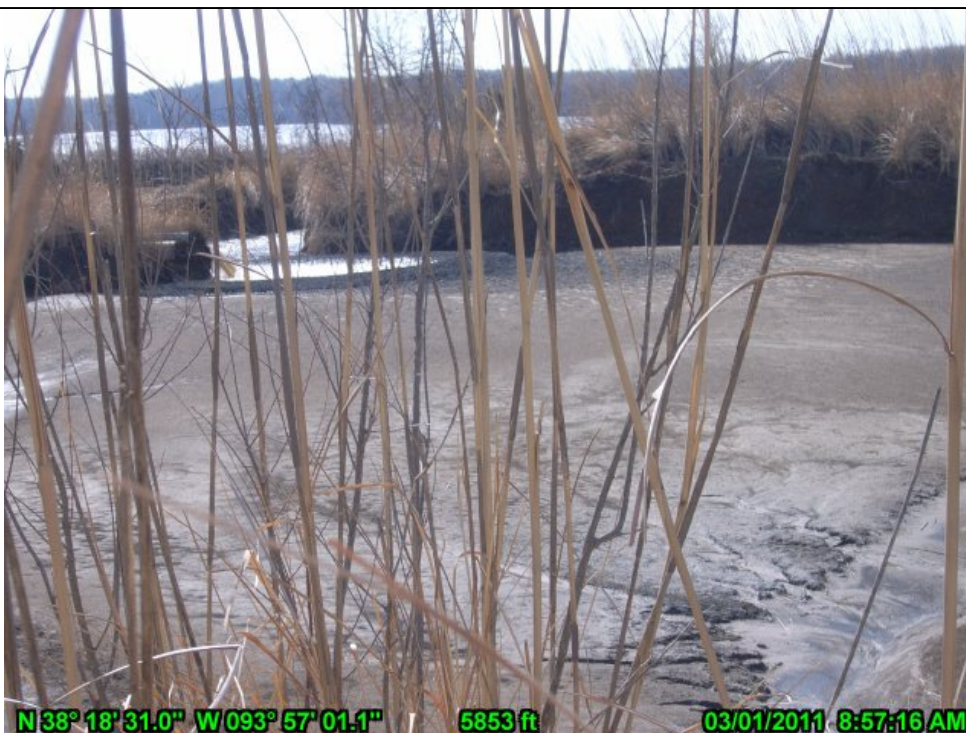
40-Inlet Area of North Pond Looking Southeast

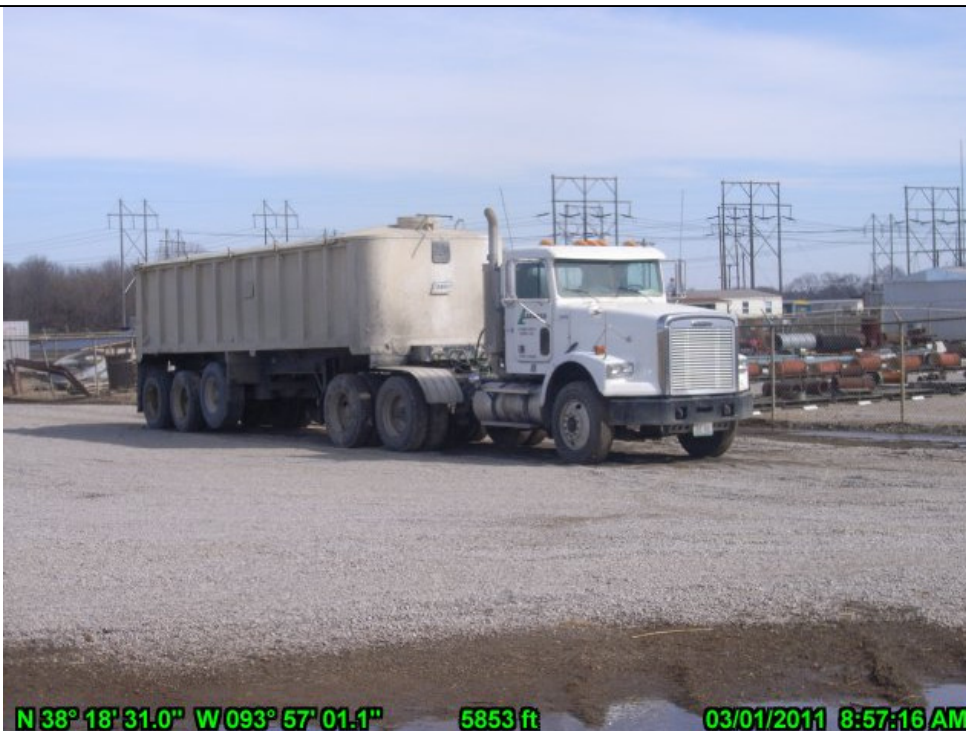
44-LaFarge Fly Ash Haul Truck
