Report of Geotechnical Investigation  
Dam Safety Assessment of Coal Combustion  
Surface Impoundments  
Kentucky Utilities, a Subsidiary of E.ON U.S.  
Green River Station, Central City, KY

AMEC Project No. 3-2106-0177-0002

September 2010

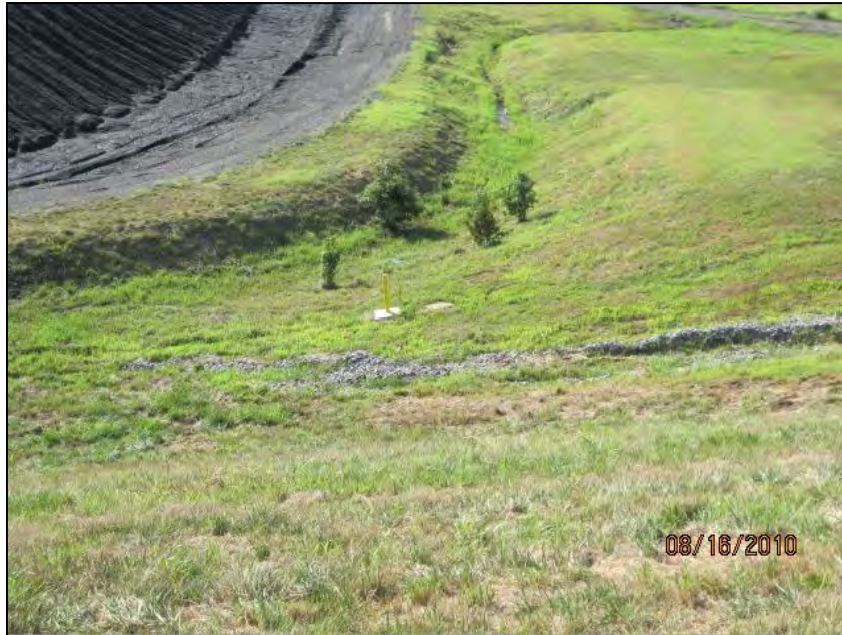
**M-7**

**LOOKING S FROM WEST PORTION OF SOUTH DIKE -  
CREST, NEW PZ BEYOND TOE, EDGE OF COAL PILE**

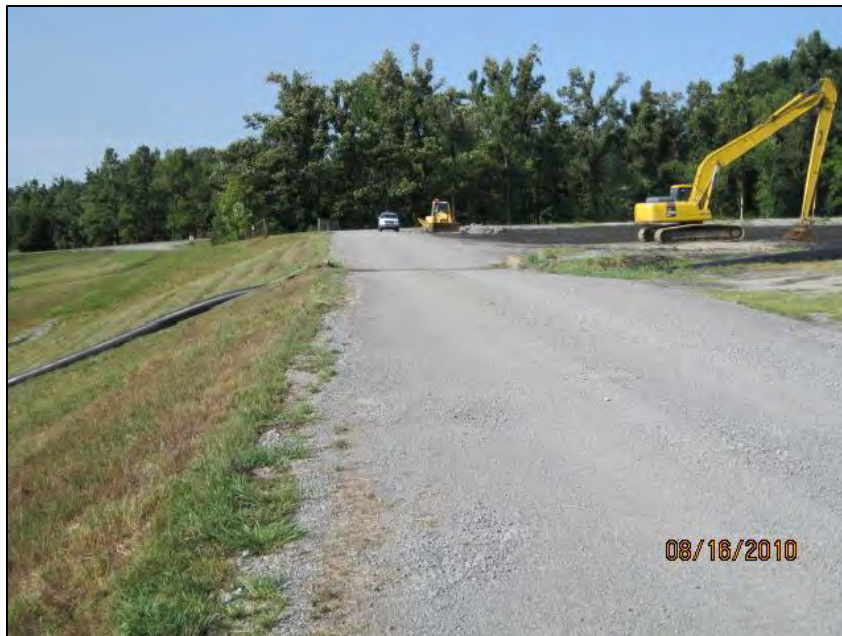
**M-8**

**LOOKING W FROM WEST PORTION OF SOUTH DIKE - SLUICE PIPES CROSSING  
EMBANKMENT, ASH STACKED TO NEAR CREST OF SOUTH DIKE**

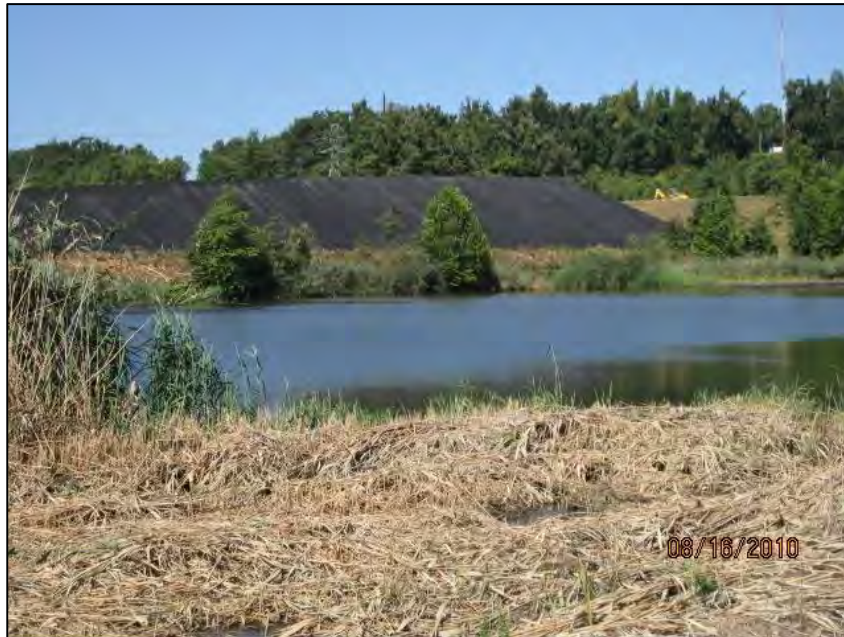
### CR-5

LOOKING W FROM EAST DIKE, POND INTERIOR AT NORTH END, WEST BERM AT COAL PILE

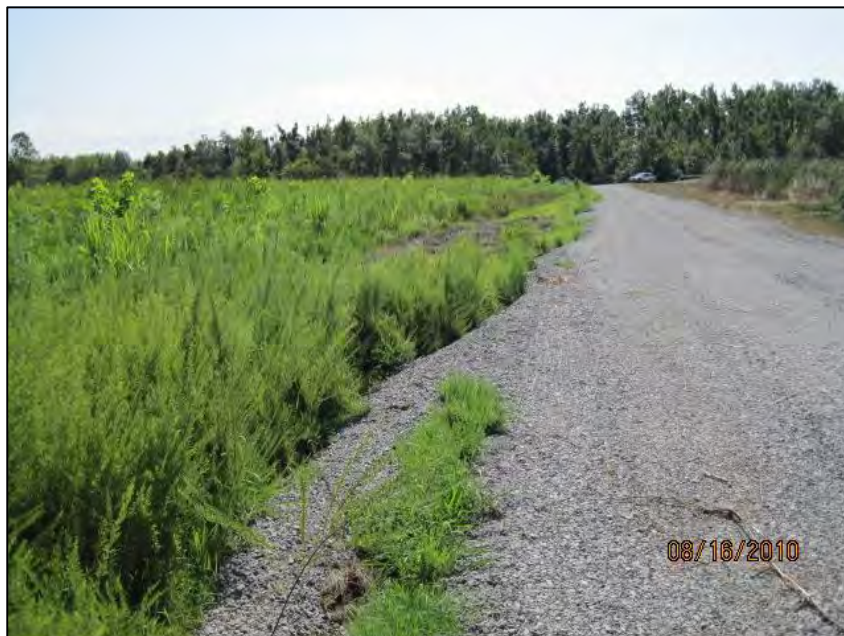
### CR-6

LOOKING S FROM NORTH END OF EAST DIKE (COMMON WITH ASH POND 2),  
DOWNSTREAM SLOPE (=UPSTREAM SLOPE AP 2)

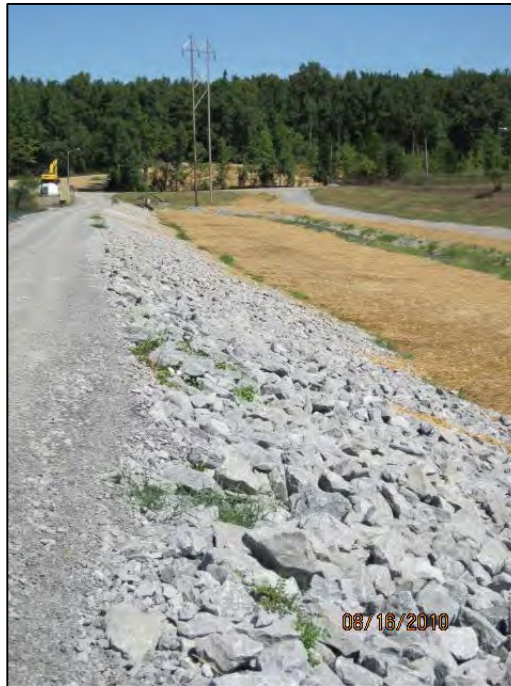
**2-9**

**LOOKING N AT DOWNSTREAM SLOPE OF EAST DIKE**

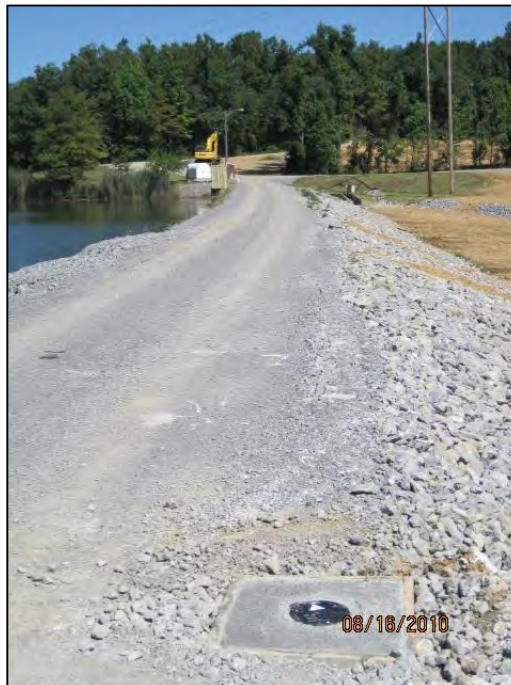
**2-10**

**LOOKING N AT CREST OF EAST DIKE, FOREGROUND: NEW PZ IN ROAD  
BACKGROUND: OUTLET WORKS AND TIE-IN TO NATURAL GROUND**

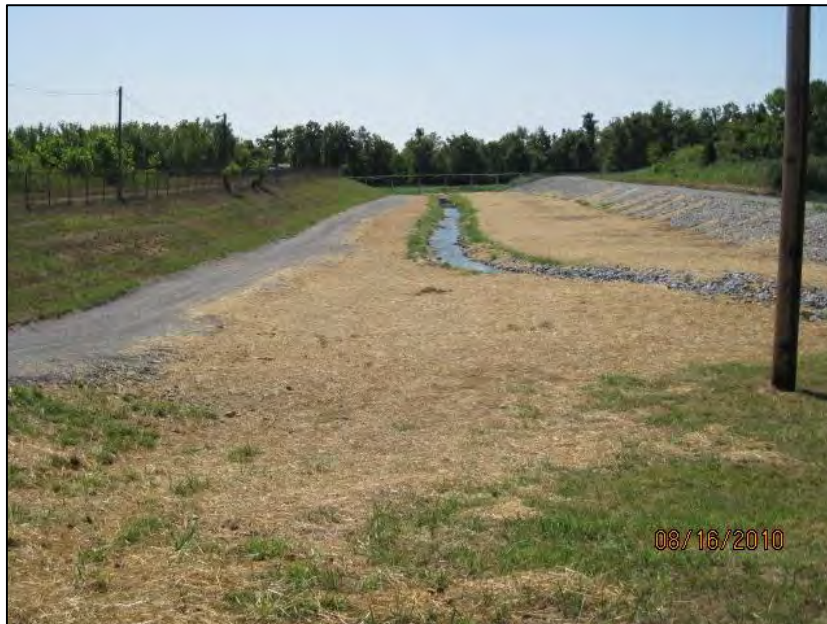
**2-16**

**LOOKING SOUTH AT LEFT: DOWNSTREAM SLOPE WEST DIKE SCRUBBER POND, CENTER: SITE OUTLET DITCH, RIGHT: DOWNSTREAM SLOPE EAST DIKE ASH POND 2**

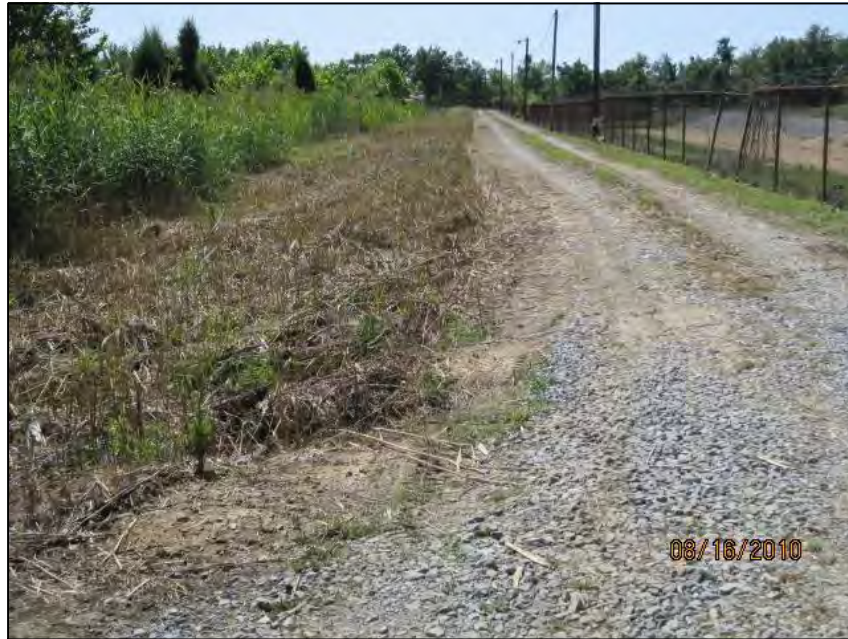
**SP-1**

**LOOKING S AT CREST AND UPSTREAM SLOPE OF WEST DIKE, HEIGHT OF INTERIOR AREAS OF ASH UP TO WITHIN 1-FOOT OF CREST**

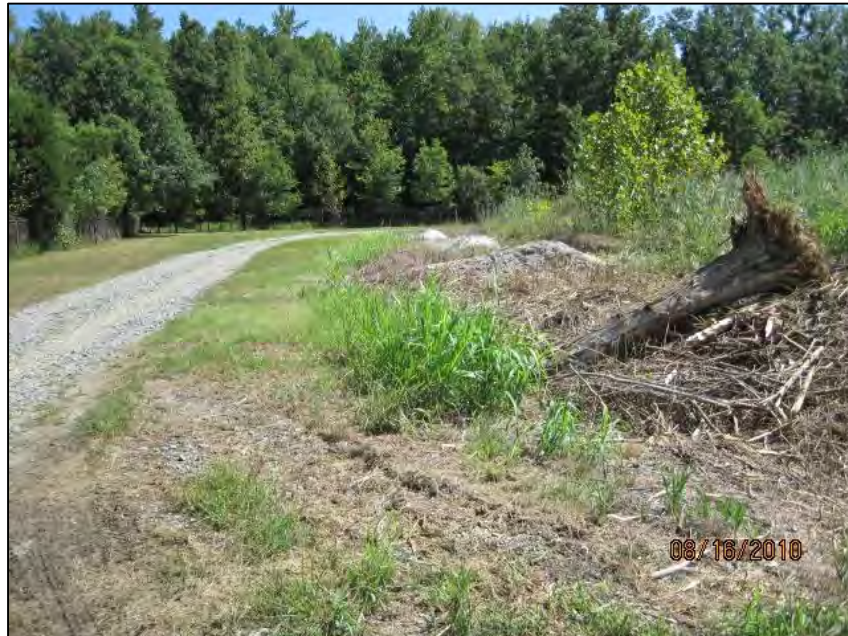
**SP-2**

**LOOKING W AT CREST AND UPSTREAM SLOPE OF NORTH DIKE, INTERIOR AREAS OF ASH AND PILED MATERIAL ABOVE CREST**
