Report of  
Dam Safety Assessment of Coal Combustion  
Surface Impoundments

Kentucky Utilities,  
a wholly owned subsidiary of  
LG&E and KU Energy LLC

Green River Station, Central City, KY

AMEC Project No. 3-2106-0177-0002

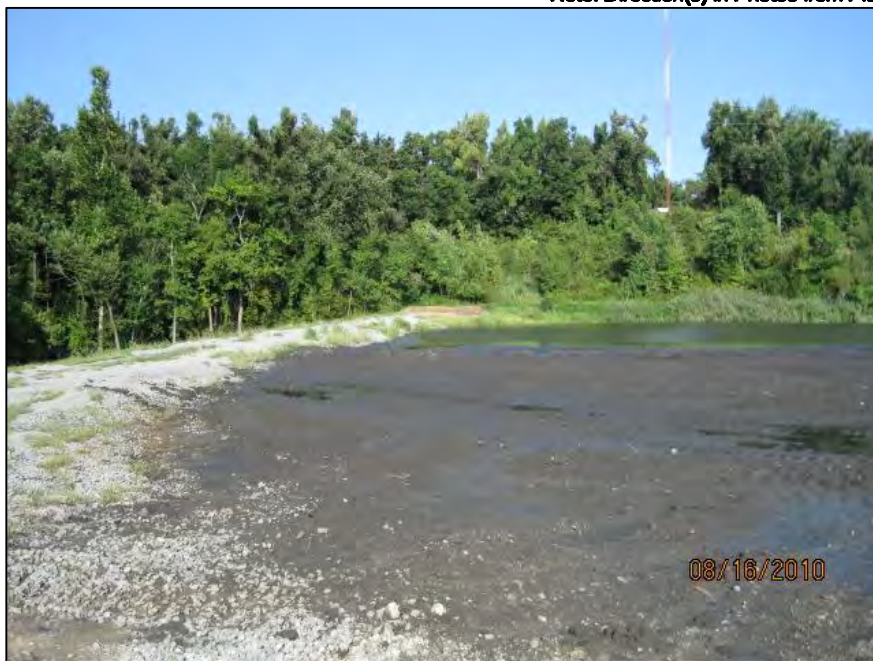
**M-1**

**LOOKING NW AT WEST DIKE - CREST, UPSTREAM SLOPE, POND INTERIOR**

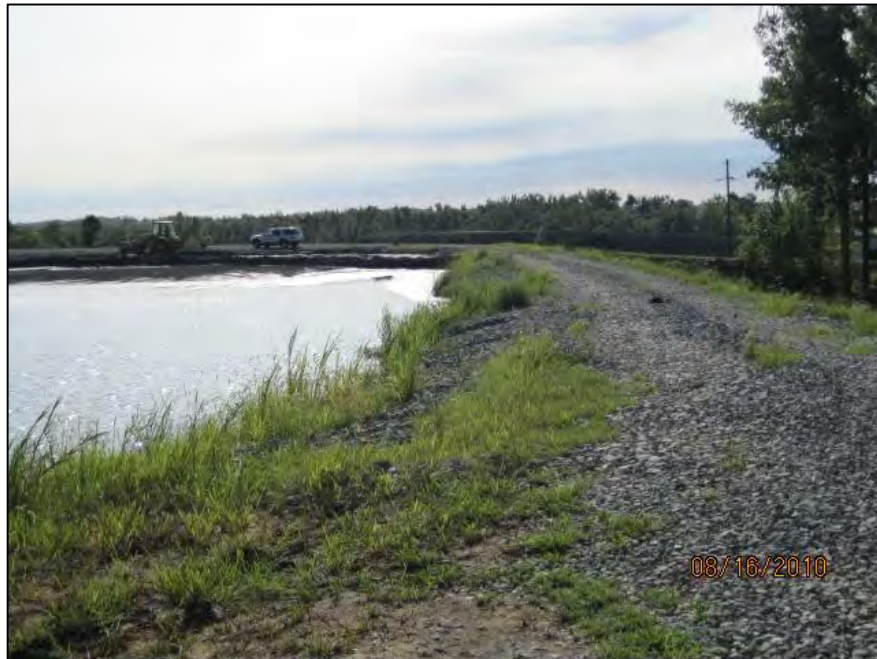
**M-4**

**LOOKING S AT WEST DIKE - CREST AND UPSTREAM SLOPE**

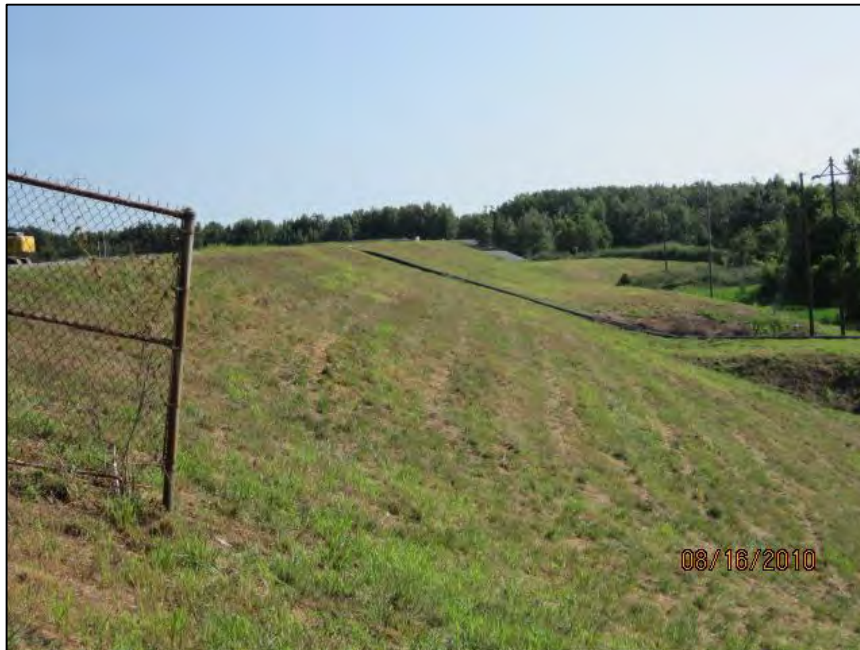
**M-5**

**LOOKING E FROM WEST END OF SOUTH DIKE - DOWNSTREAM SLOPE**

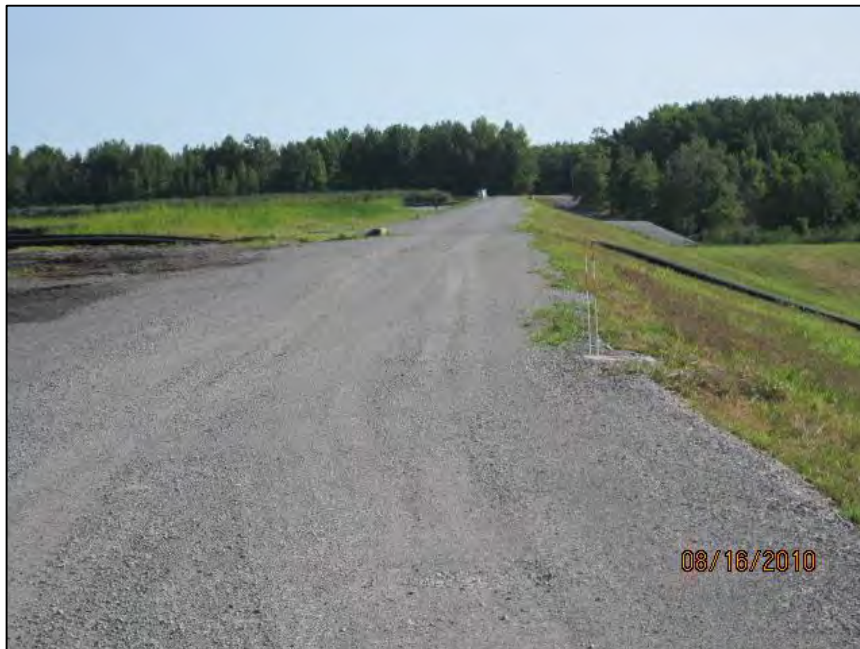
**M-6**

**LOOKING E FROM WEST PORTION OF SOUTH DIKE -  
CREST, NEW PZ-P3A ON SOUTH EDGE OF ROAD**

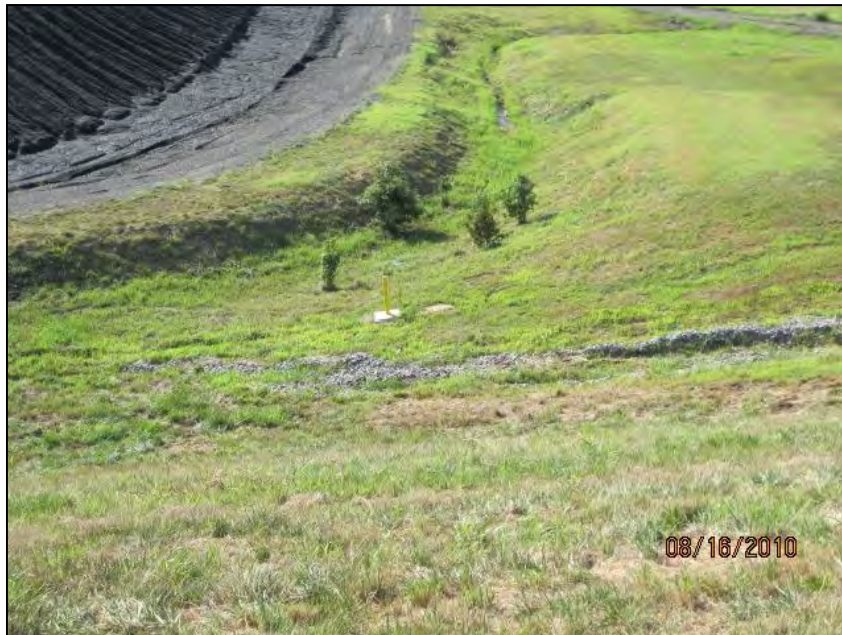
**M-7**

**LOOKING S FROM WEST PORTION OF SOUTH DIKE -  
CREST, NEW PZ BEYOND TOE, EDGE OF COAL PILE**

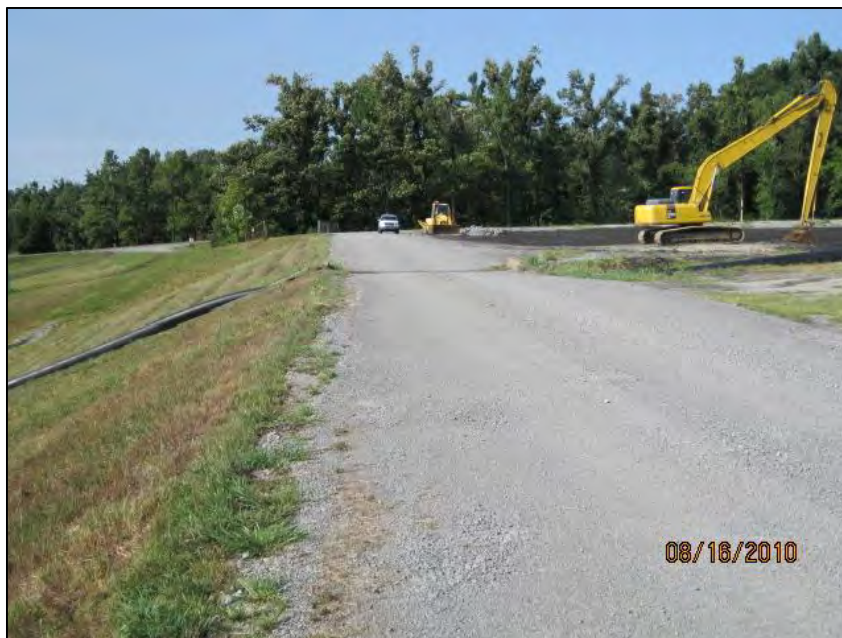
**M-8**

**LOOKING W FROM WEST PORTION OF SOUTH DIKE - SLUICE PIPES CROSSING  
EMBANMENT, ASH STACKED TO NEAR CREST OF SOUTH DIKE**

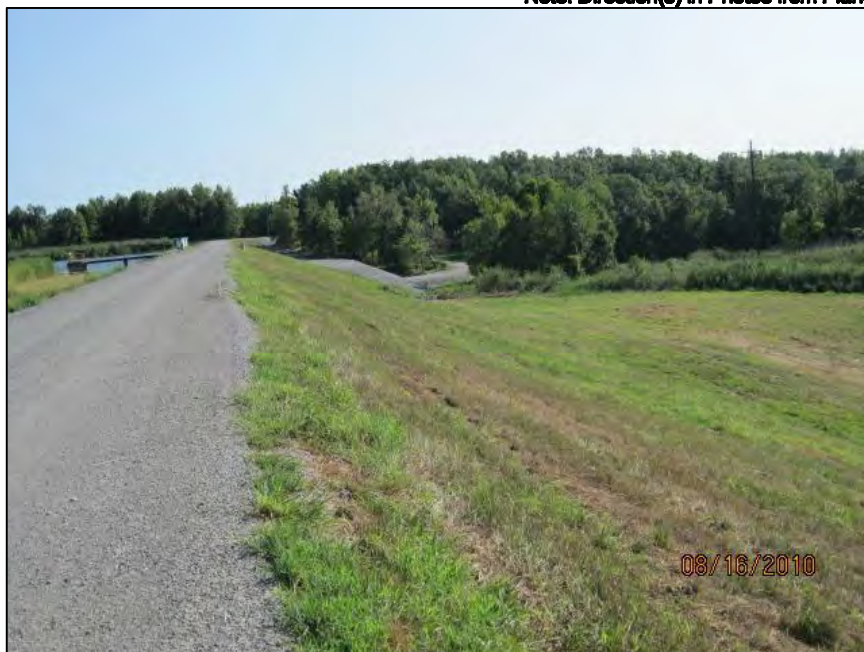
**M-11**

**LOOKING E FROM SOUTH DIKE - DOWNSTREAM SLOPE**

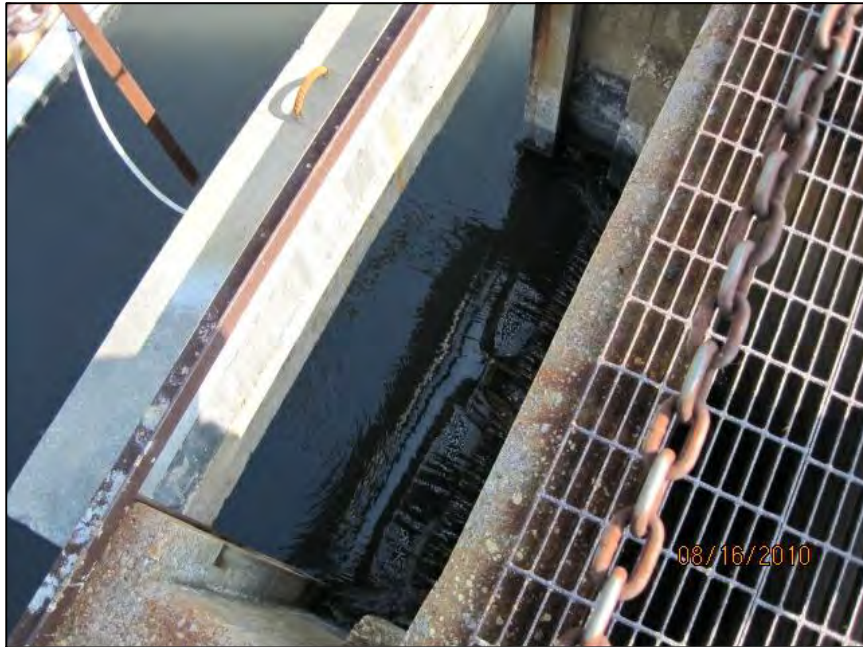
**M-14**

**LOOKING DOWN INTO INLET OF OUTLET STRUCTURE**

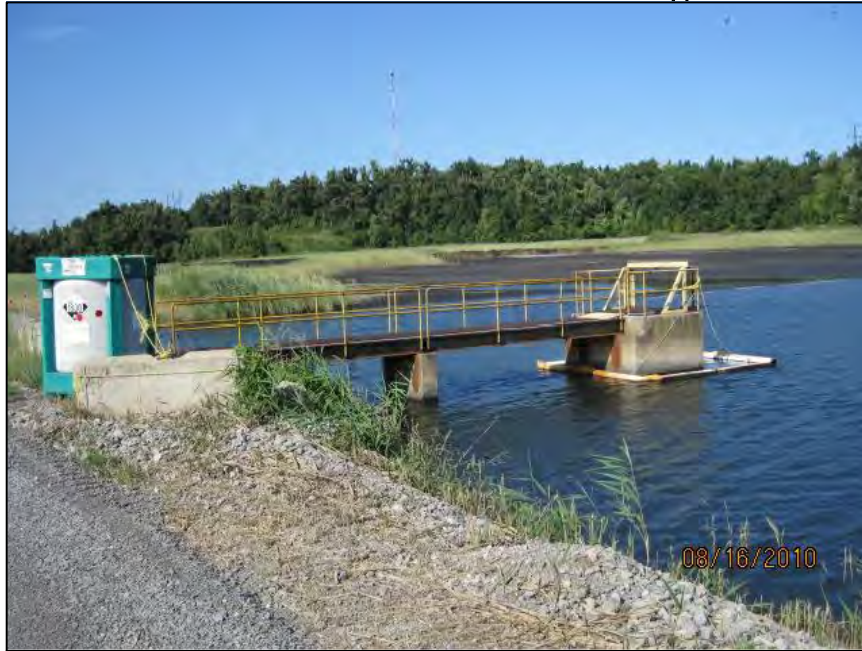
**M-15**

LOOKING NW AT OUTLET STRUCTURE, PERIMETER SKIMMER AND POND INTERIOR TO NATURAL HILLSIDE IN BACKGROUND. STACK OF CONCRETE STOP LOGS IN FOREGROUND

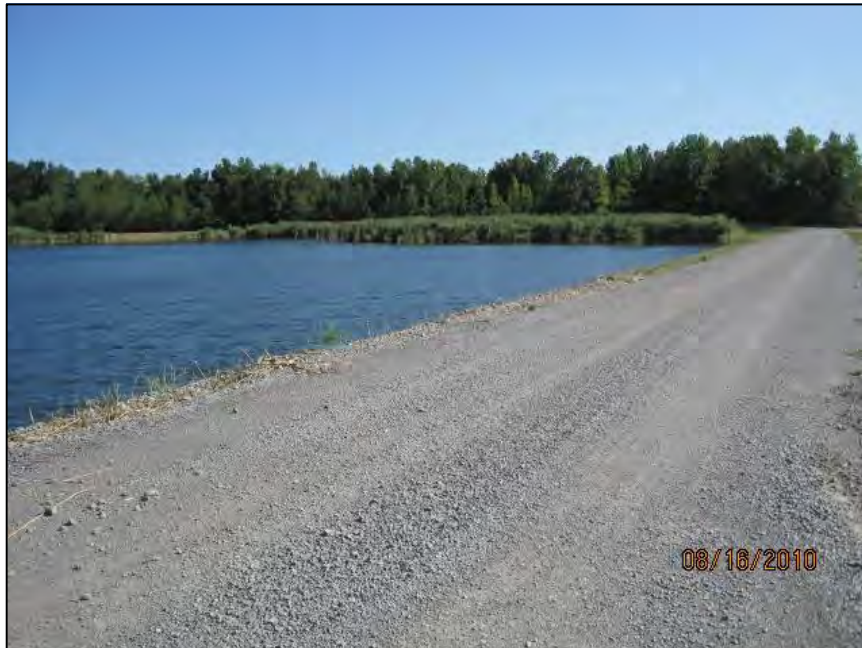
**M-16**

LOOKING NE AT EAST END OF SOUTH DIKE AND POND INTERIOR, NATURAL GROUND IN BACKGROUND

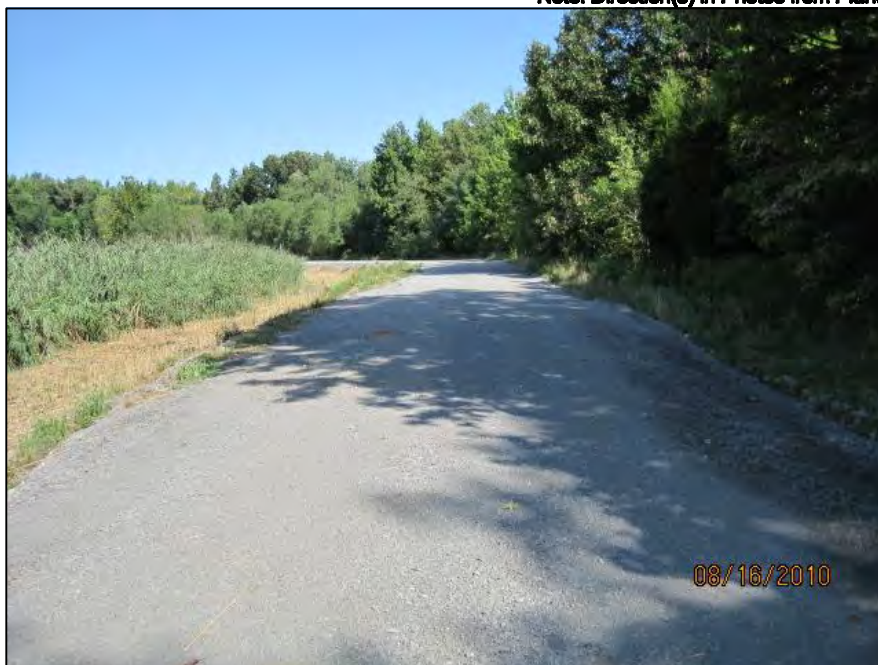
**M-17**

**LOOKING N AT EAST DIKE, PRIMARILY ORIGINAL GROUND ON EAST SIDE**

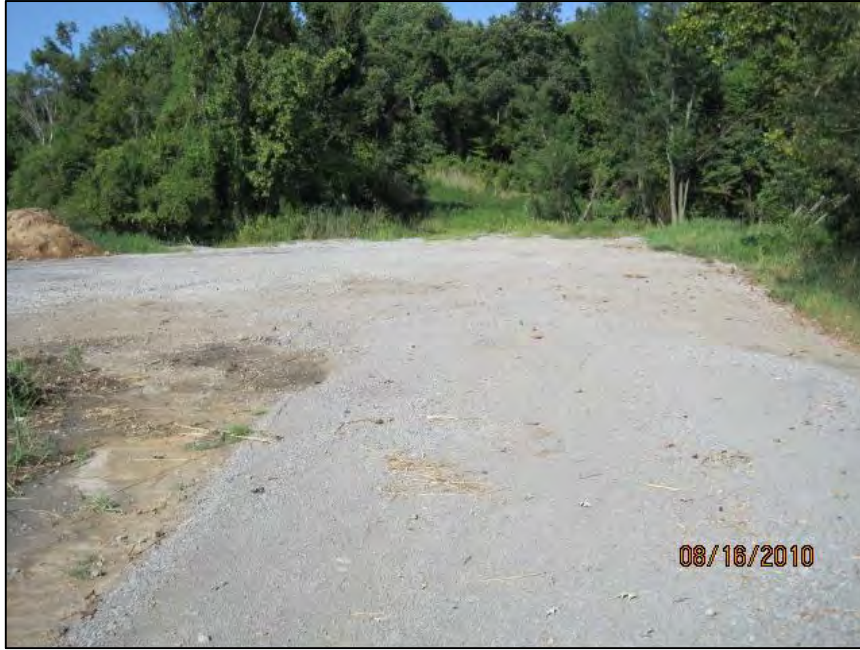
**M-19**

**TIE-IN OF NORTH END OF EAST DIKE TO ORIGINAL GROUND**

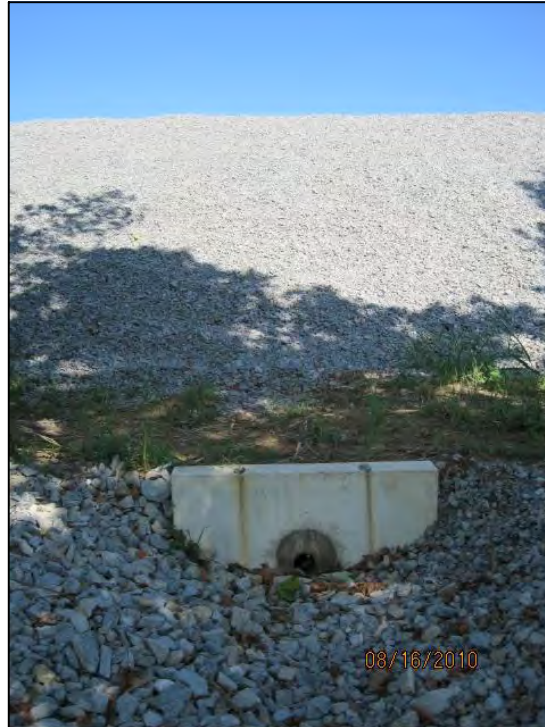
**M-21**

**EAST BUTTRESS AND DRAIN OUTLET ON SOUTH DIKE**

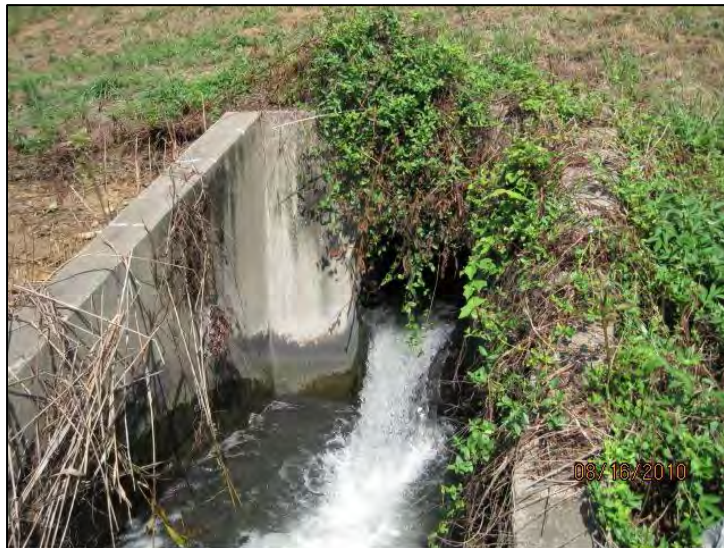
**M-22**

**PRINCIPAL OUTFALL AT TOE OF SOUTH DIKE,  
SOME EROSION ON OUTSIDE SIDEWALLS**

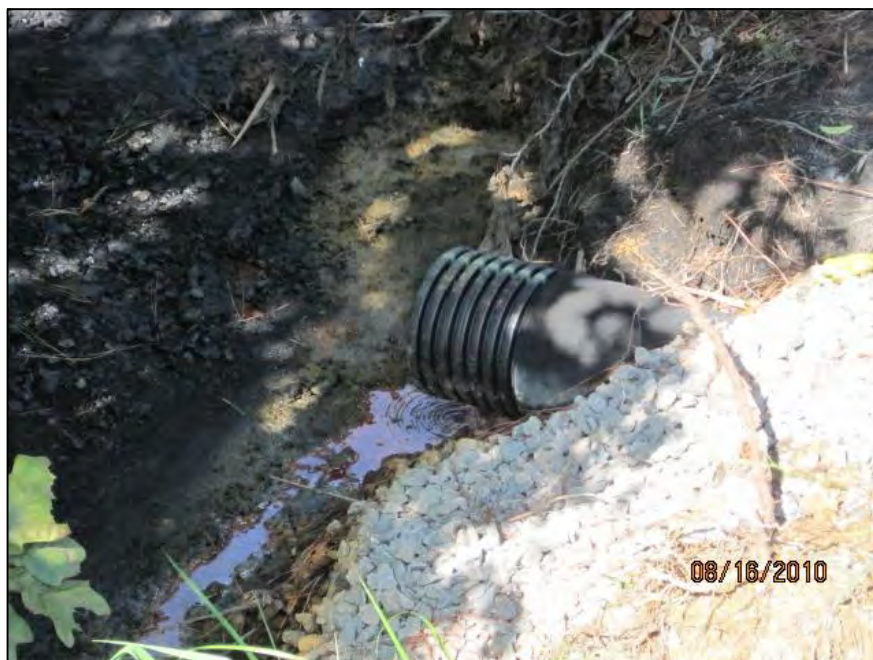
**M-24**

**TOE DRAIN OUTLET FOR WEST BUTTRESS ON SOUTH DIKE**

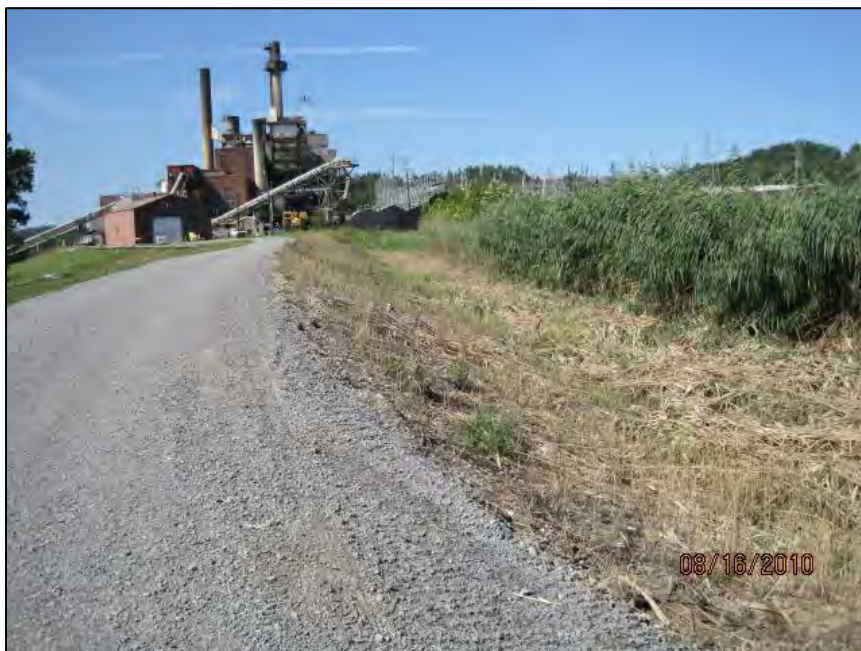
**CR-2**

**LOOKING W AT SOUTH DIKE (ROAD), CREST AND UPSTREAM SLOPE**

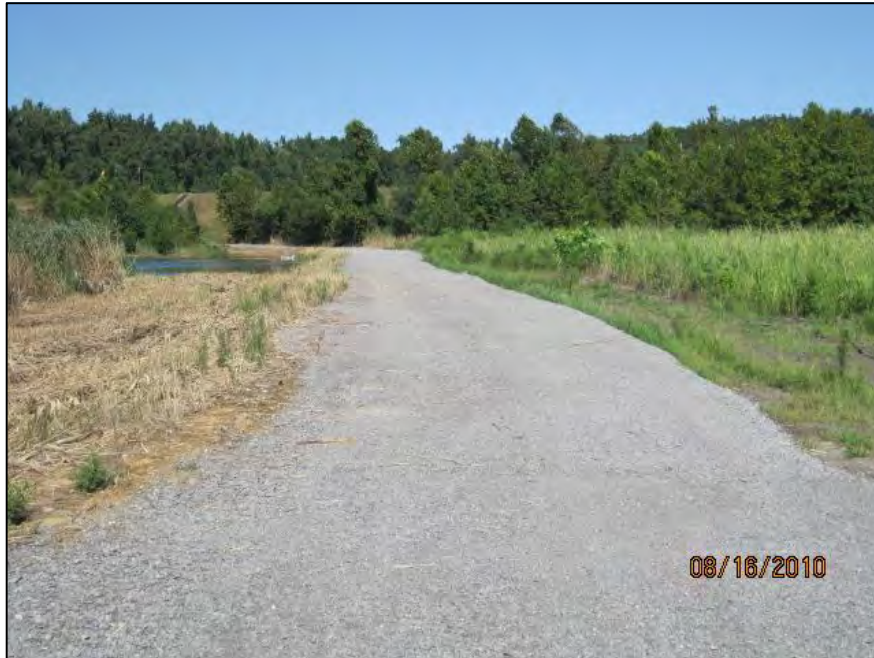
**CR-3**

**LOOKING N AT EAST DIKE (COMMON WITH ASH POND 2)**

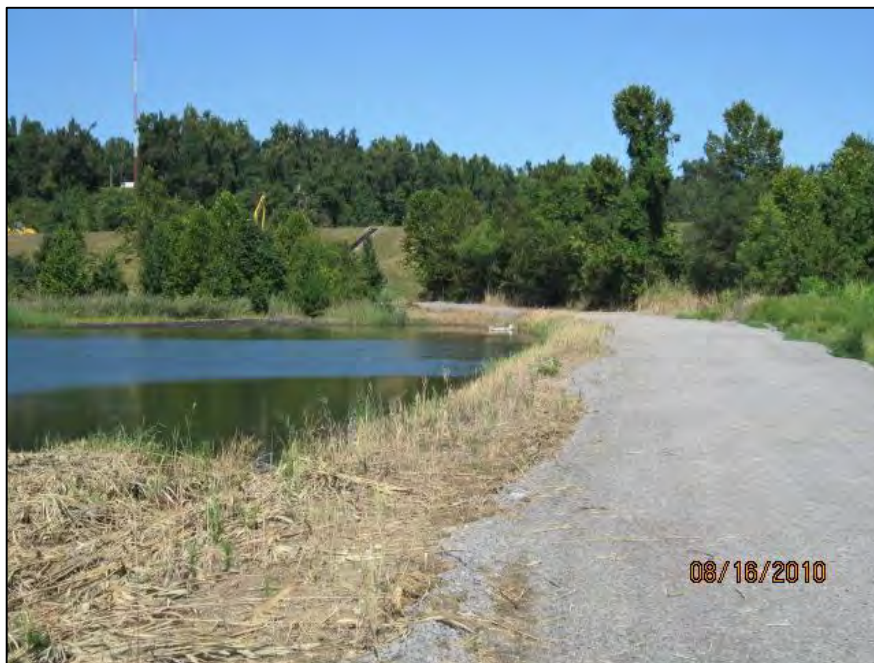
**CR-4**

**LOOKING NW ON EAST DIKE, POND INTERIOR AND TIE-IN IN BACKGROUND**

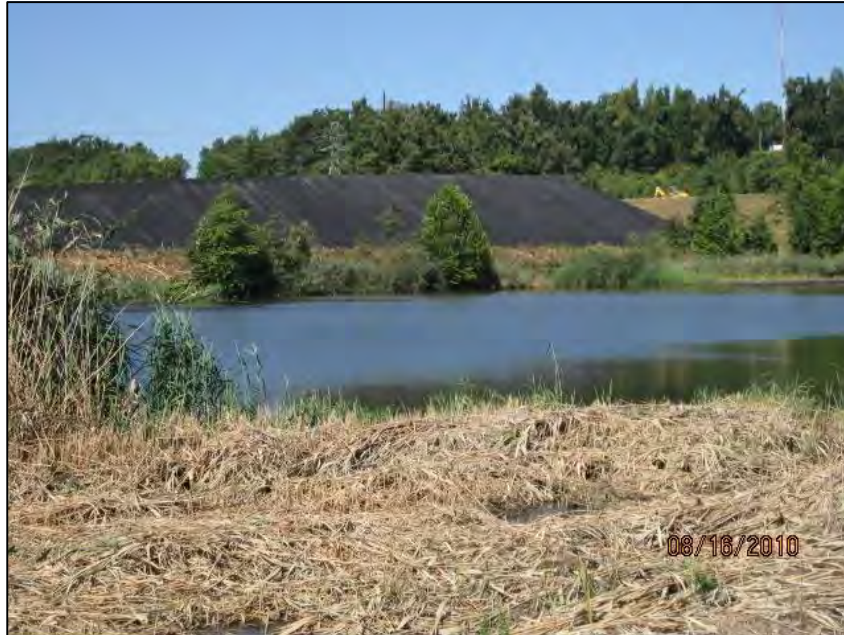
**CR-5**

LOOKING W FROM EAST DIKE, POND INTERIOR AT NORTH END, WEST BERM AT COAL PILE

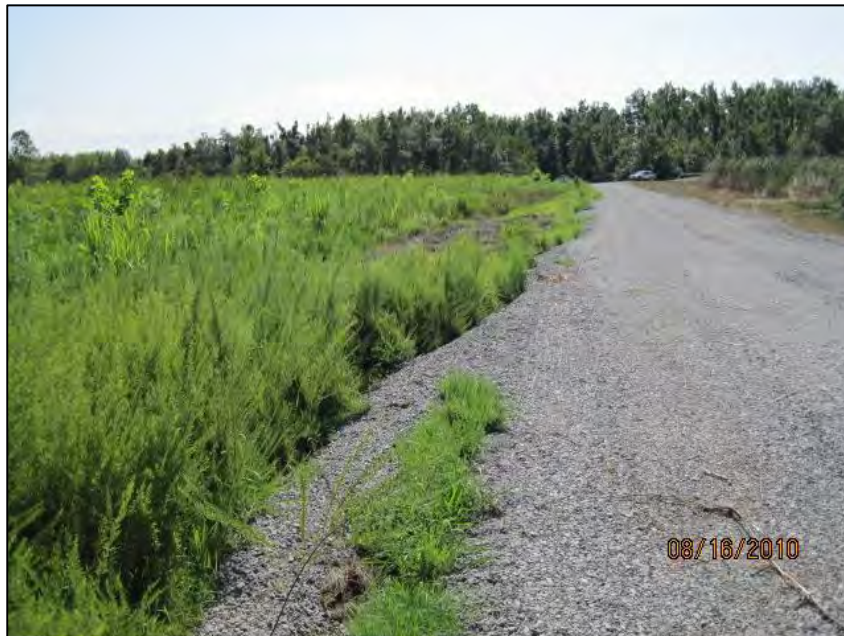
**CR-6**

LOOKING S FROM NORTH END OF EAST DIKE (COMMON WITH ASH POND 2),  
DOWNSTREAM SLOPE (=UPSTREAM SLOPE AP 2)

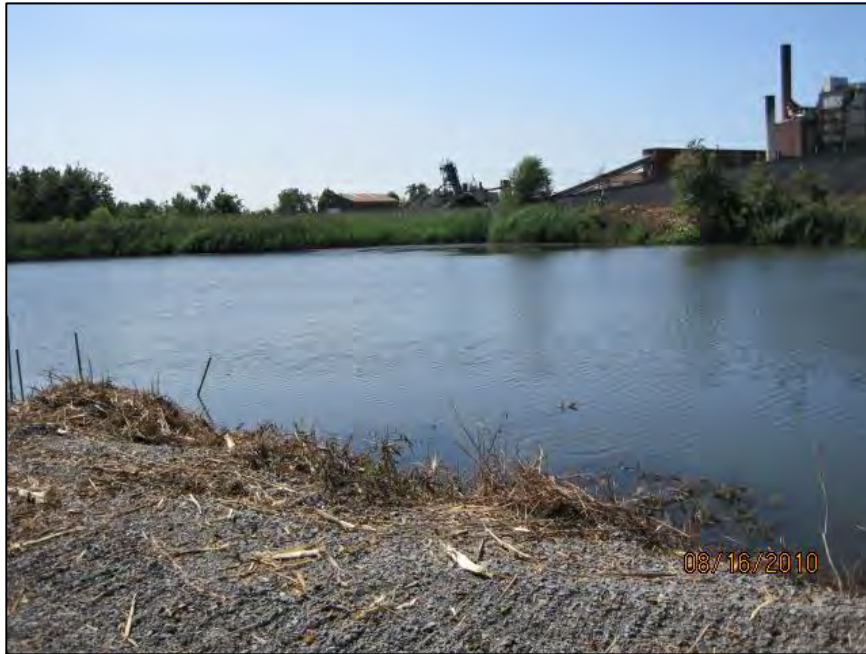
**CR-9**

**LOOKING SW FROM EAST DIKE AT POND INTERIOR (ABOUT 50% WATER)**

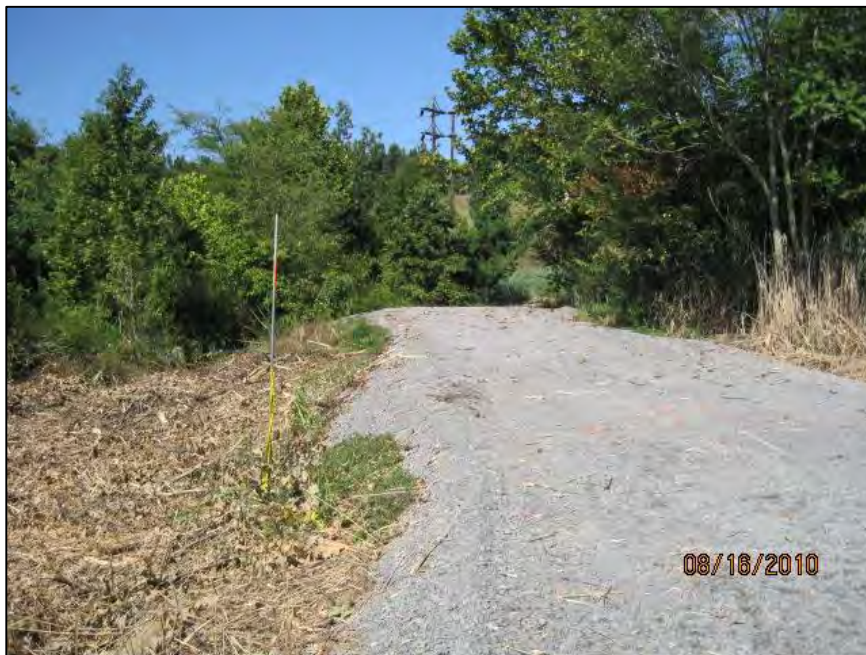
**CR-10**

**LOOKING N FROM EAST DIKE AT TIE-IN**

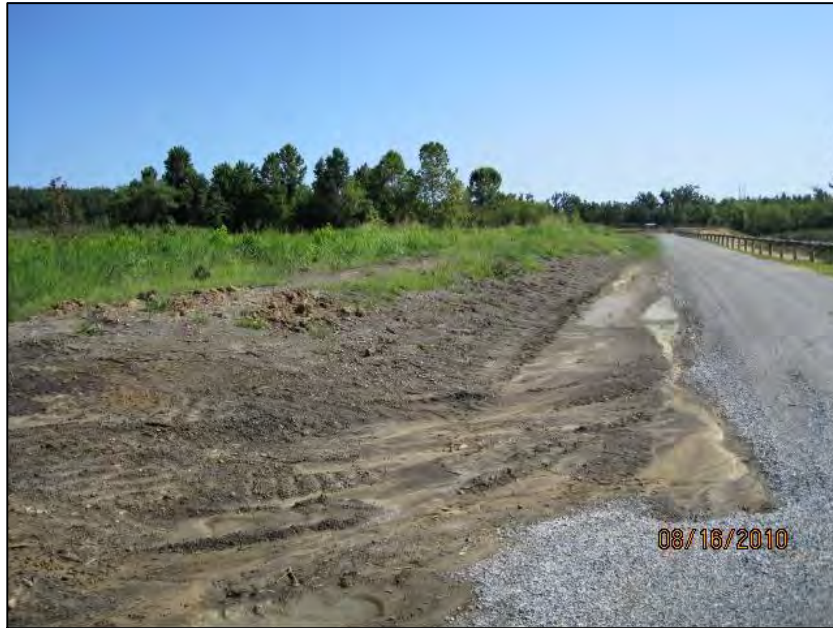
**2-1**

The outlet structure for Ash Treatment Basin #2 consists of a concrete riser structure located on the north end of the east dike. The riser structure supports a floating metal pipe and rubber perimeter skimmer and an adjustable stop log unit that facilitates water level adjustment as needed, based on plant operations (photos 2-11 and 2-12). A 30-inch diameter culvert pipe empties the riser into a concrete box that is located beyond the toe of the downstream embankment. The concrete box contains a fixed overflow weir, most likely used as a flow measurement device for the permitted NPDES discharge location 001 (photos 2-13 and 2-14). The flow then enters a rock lined channel that ultimately discharges to Green River (photos 2-6 and 2-16). KU representatives present during the field visit indicated the roadway was the south embankment for the Coal Pile Runoff Pond and Ash Pond 2. A distinct drop in elevation was observed on the south dike/road at Ash Treatment Basin #2 (photo 2-4). An interior mound of ash located north of the south dike appeared to carry the same top of dike elevation from the Coal Pile Runoff Pond (photos 2-1, 2-2, 2-3, and 2-4). If the road is the dike, the interior mound of ash is above the dike elevation.

**LOOKING E FROM WEST CORNER AT SOUTH DIKE (ROAD?), UPSTREAM SLOPE AND CREST, MOUND TO NORTH**

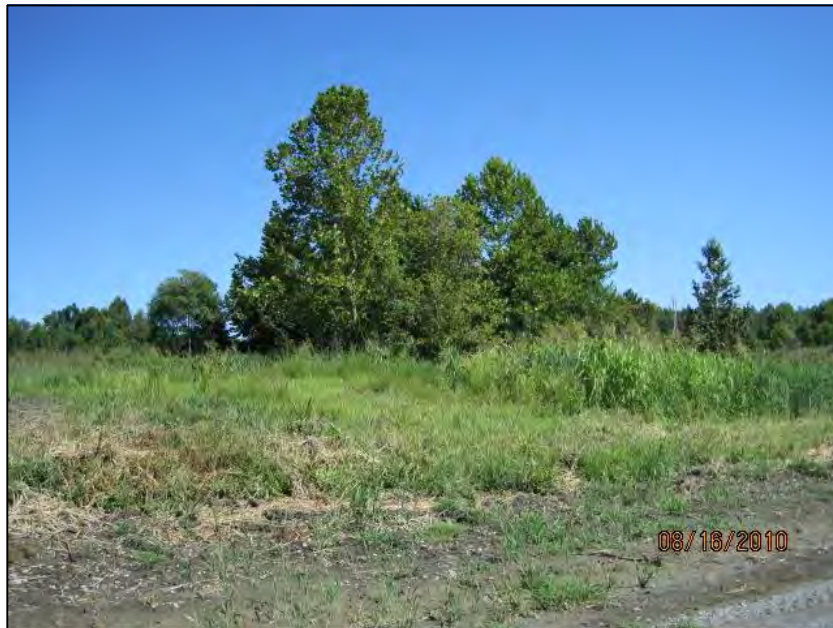
**2-2**

**LOOKING NE ON SOUTH DIKE, ASH ABOVE LEVEL OF ROAD, TREES IN INTERIOR**

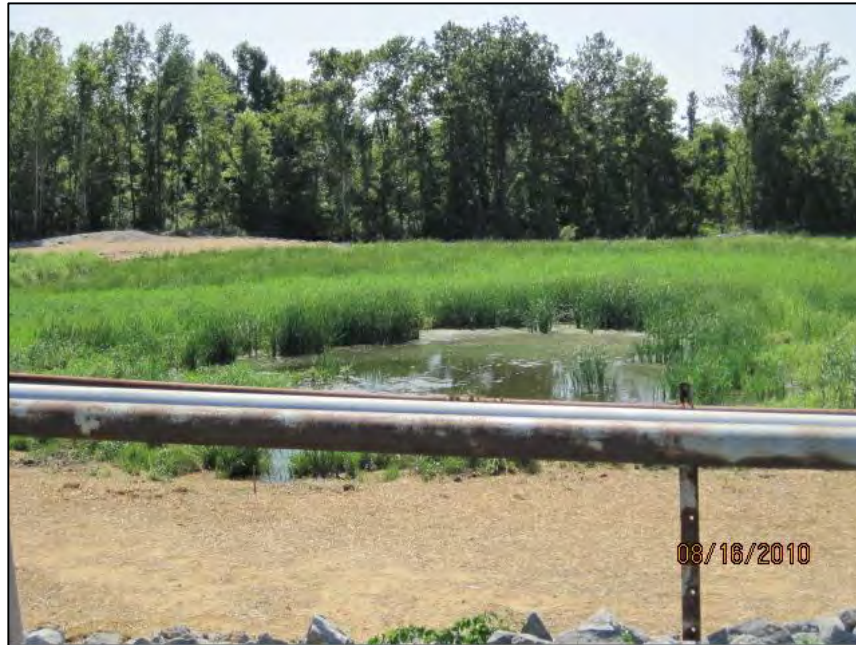
**2-7**

**LOOKING S FROM PHOTO 2-6 AT FORMER ASH POND 3**

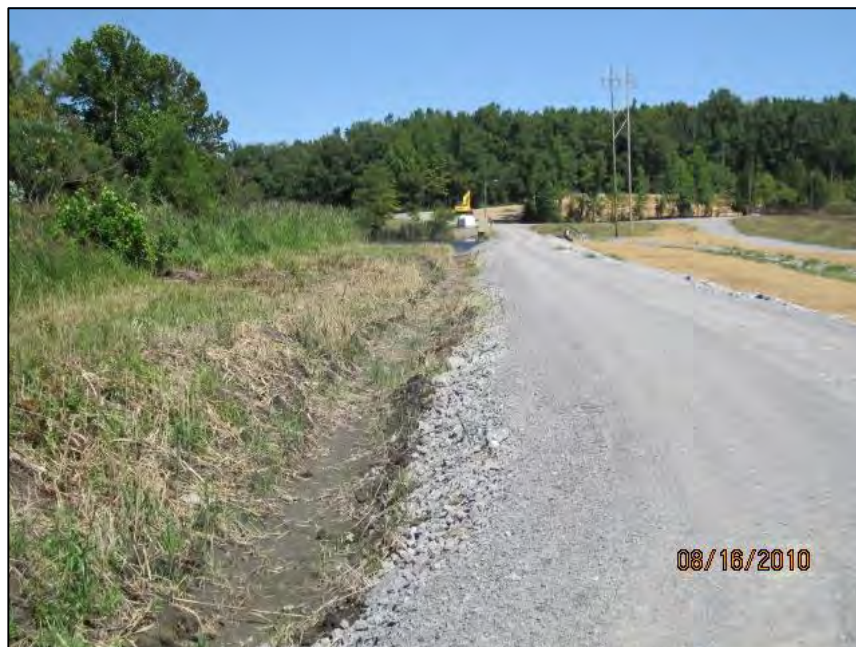
**2-8**

**LOOKING N AT CREST AND UPSTREAM SLOPE OF EAST DIKE**

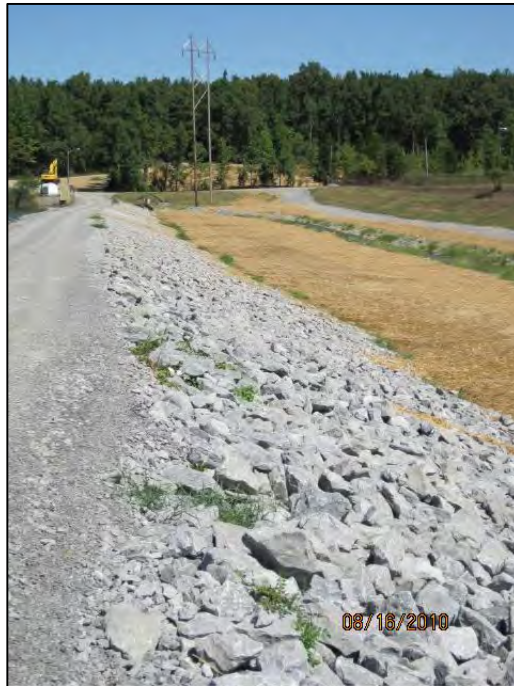
**2-9**

**LOOKING N AT DOWNSTREAM SLOPE OF EAST DIKE**

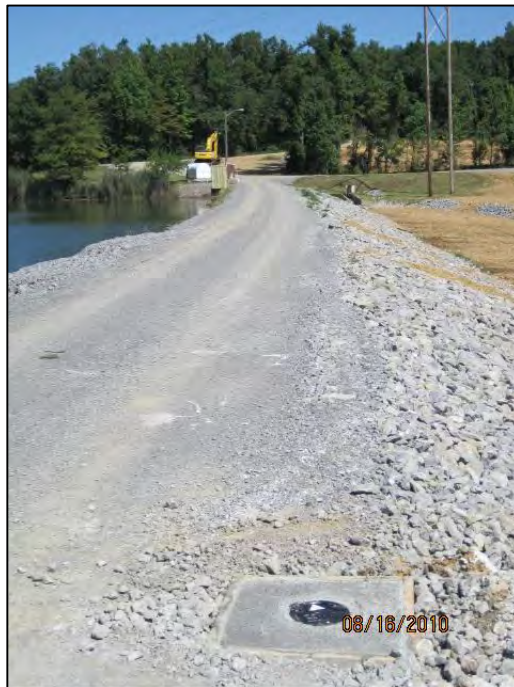
**2-10**

**LOOKING N AT CREST OF EAST DIKE, FOREGROUND: NEW PZ IN ROAD  
BACKGROUND: OUTLET WORKS AND TIE-IN TO NATURAL GROUND**

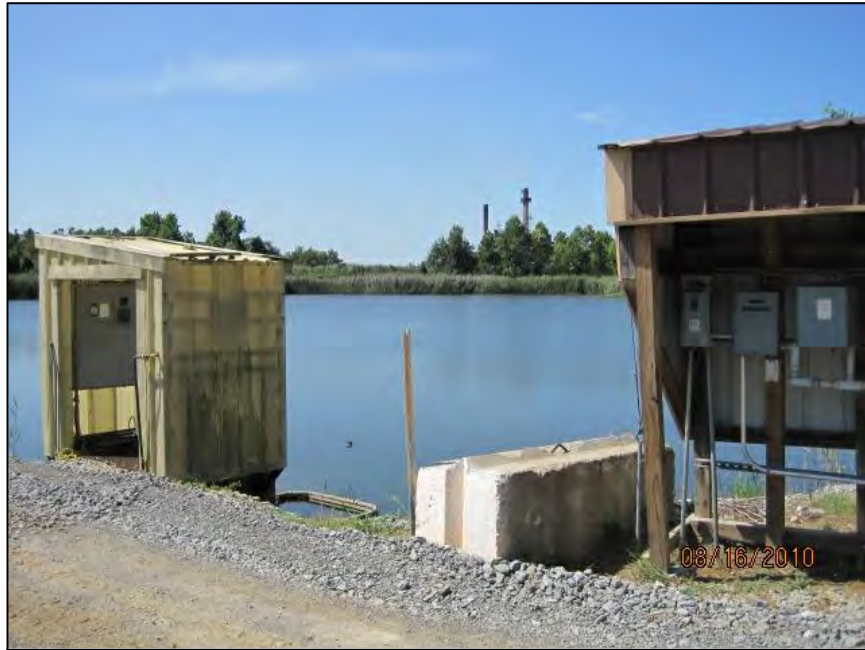
**2-11**

**LOOKING SW FROM NORTHEAST CORNER OF POND AT OUTLET STRUCTURE, CONTROLS AND POND INTERIOR**

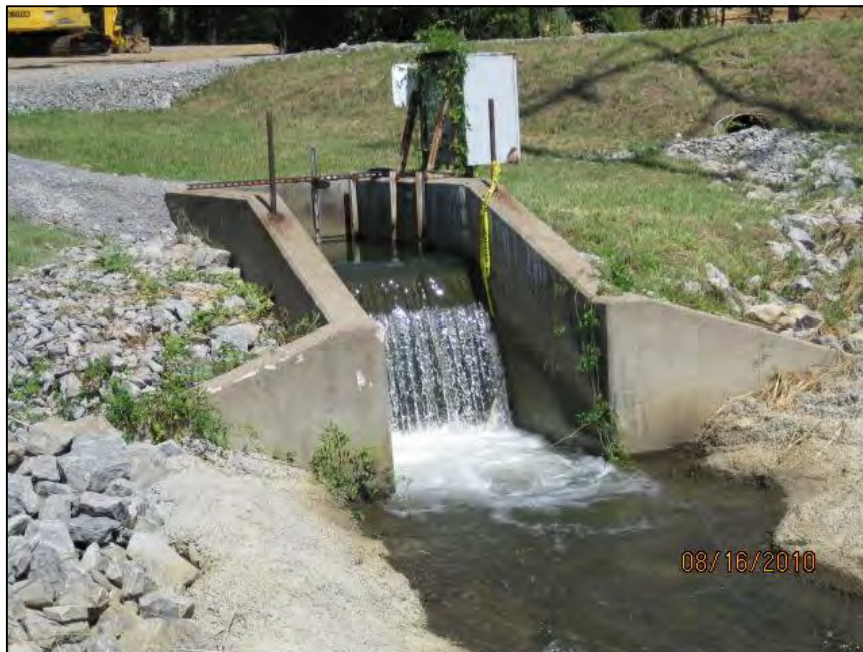
**2-14**

**LOOKING NE AT NPDES OUTFALL 001, OVERFLOW AND GROUDED CHANNEL**

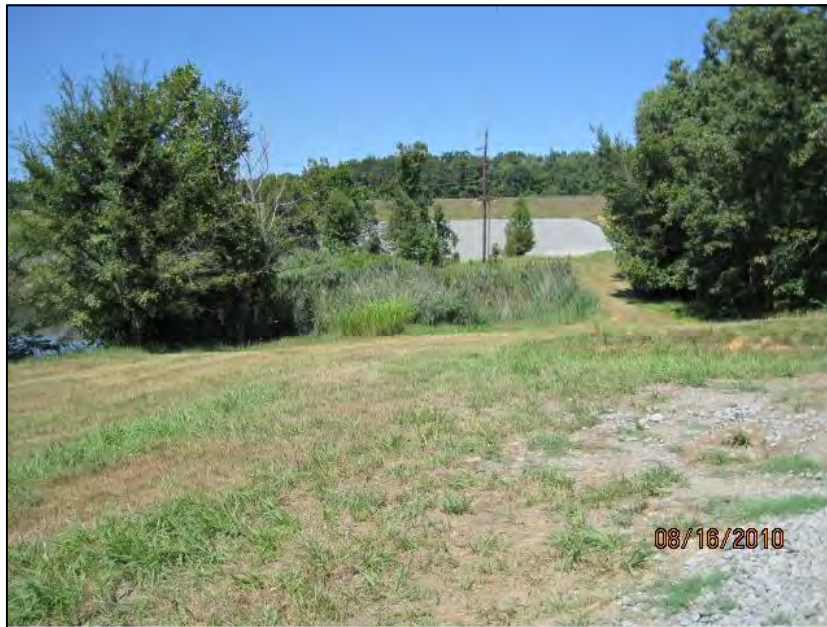
**2-15**

**LOOKING N AT EAST TIE-IN TO NATURAL GROUND, BACKGROUND: EAST BUTTRESS ON MAIN POND SOUTH DIKE**

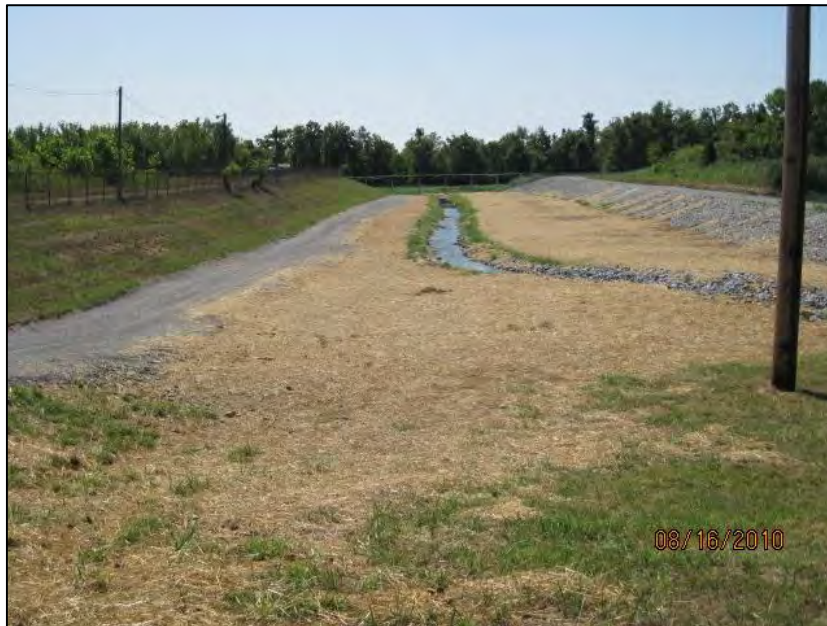
**2-16**

**LOOKING SOUTH AT LEFT: DOWNSTREAM SLOPE WEST DIKE SCRUBBER POND, CENTER: SITE OUTLET DITCH, RIGHT: DOWNSTREAM SLOPE EAST DIKE ASH POND 2**

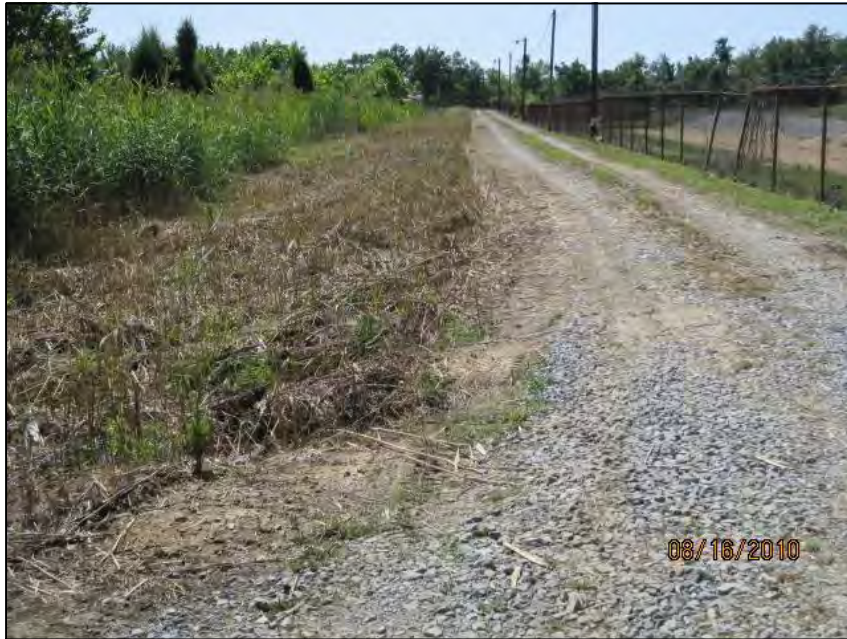
**SP-1**

**LOOKING S AT CREST AND UPSTREAM SLOPE OF WEST DIKE, HEIGHT OF INTERIOR AREAS OF ASH UP TO WITHIN 1-FOOT OF CREST**

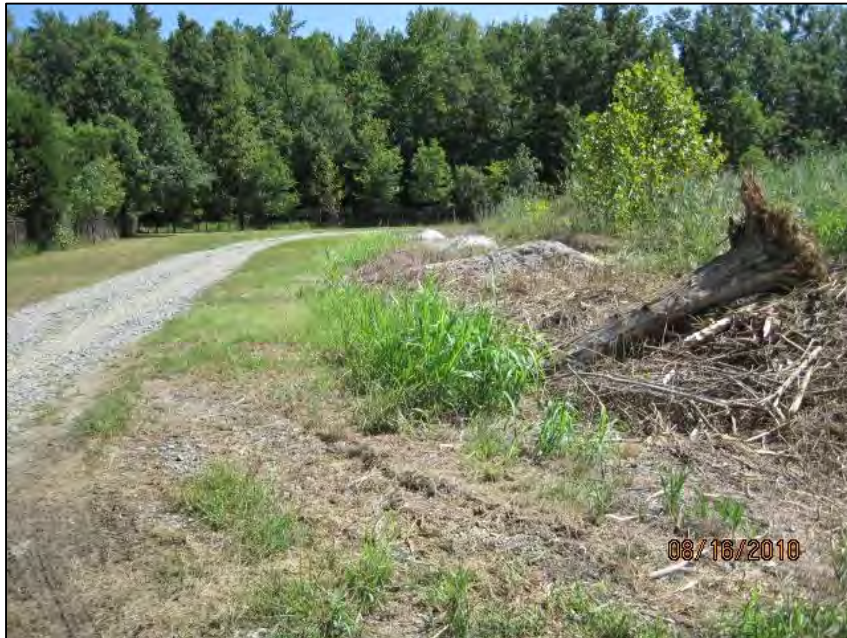
**SP-2**

**LOOKING W AT CREST AND UPSTREAM SLOPE OF NORTH DIKE, INTERIOR AREAS OF ASH AND PILED MATERIAL ABOVE CREST**

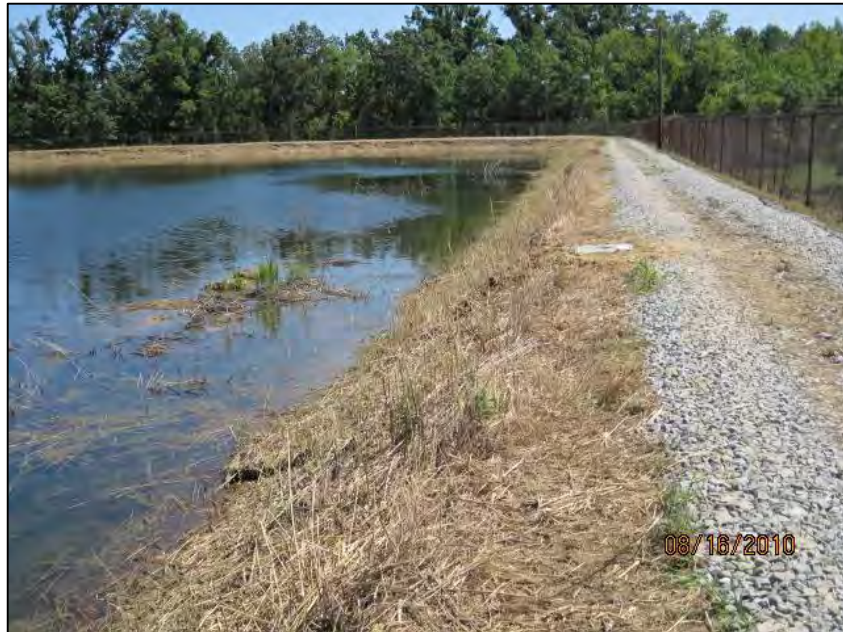
**SP-5**

**LOOKING E AT CREST AND UPSTREAM SLOPE OF SOUTH DIKE, NEW PZ IN CREST, AREAS WITH UNEVEN TO NEAR VERTICAL SLOPES ON UPSTREAM SLOPE ON SOUTH AND EAST DIKE**

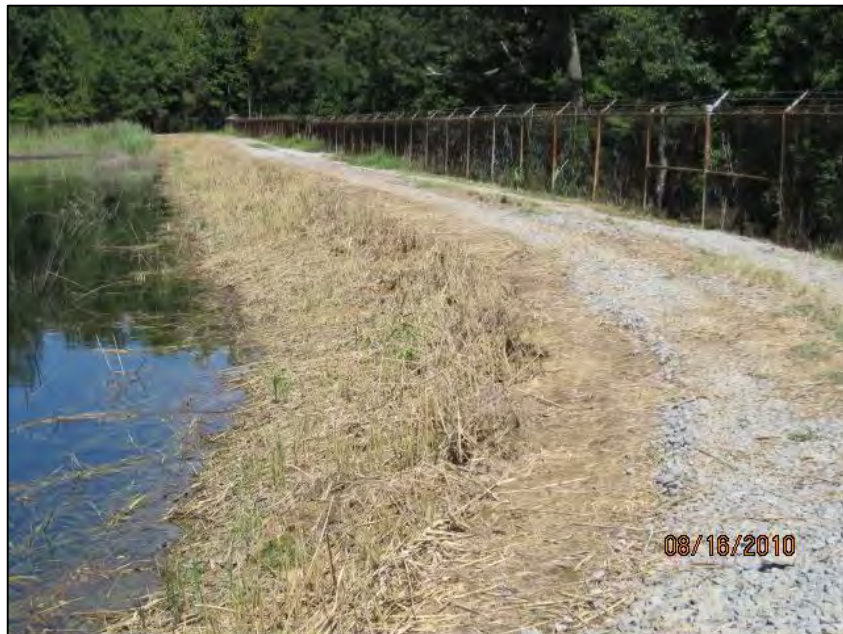
**SP-6**

**LOOKING N FROM SOUTHEAST CORNER AT CREST AND UPSTREAM SLOPE OF EAST DIKE, AREAS WITH UNEVEN TO NEAR VERTICAL SLOPES ON UPSTREAM SLOPE**

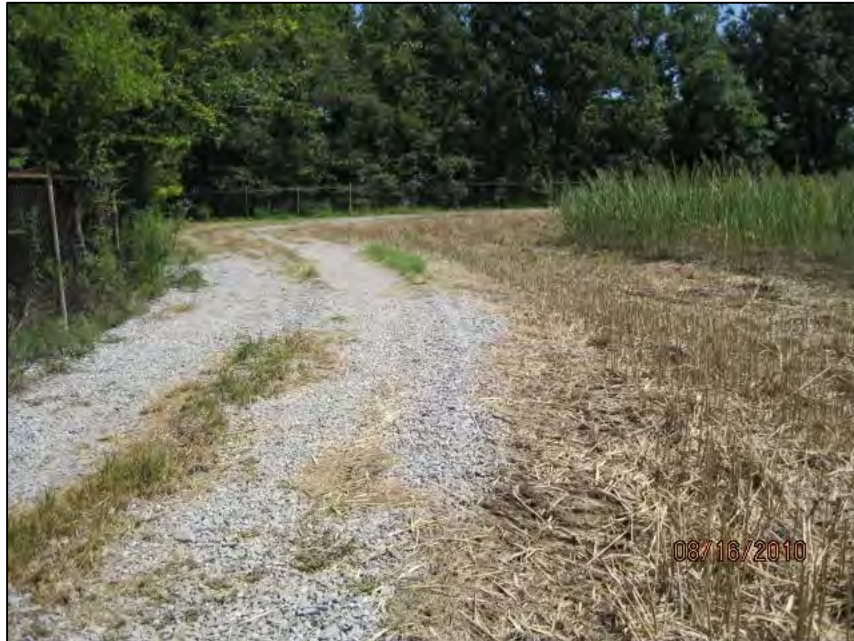
**SP-7**

LOOKING W FROM NORTH DIKE AT NORTHWEST CORNER OF POND, NATURAL GROUND ON DOWNSTREAM SIDE

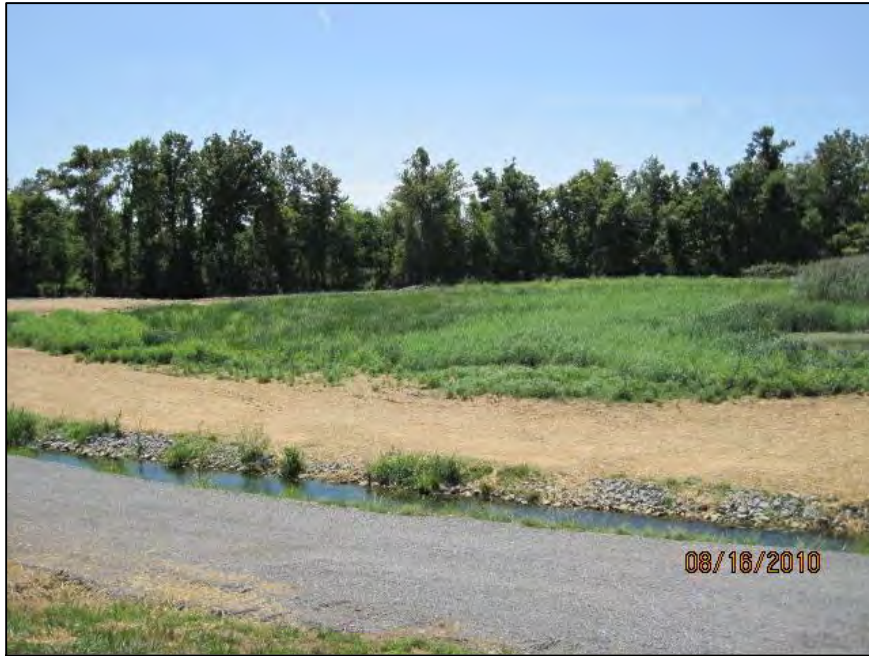
**SP-9**

**LOOKING SOUTH FROM NEAR SOUTHEAST CORNER TOWARD FORMER ASH POND 3**

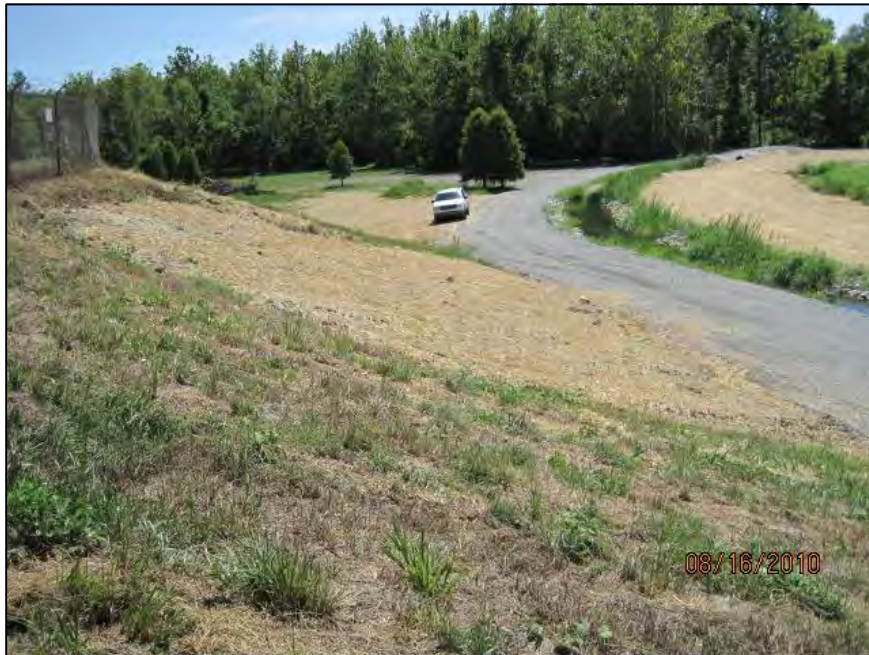
**SP-10**

**LOOKING SE AT SOUTHWEST CORNER DOWNSTREAM SLOPE, SHALLOW SURFACE SLIDE REPAIR**

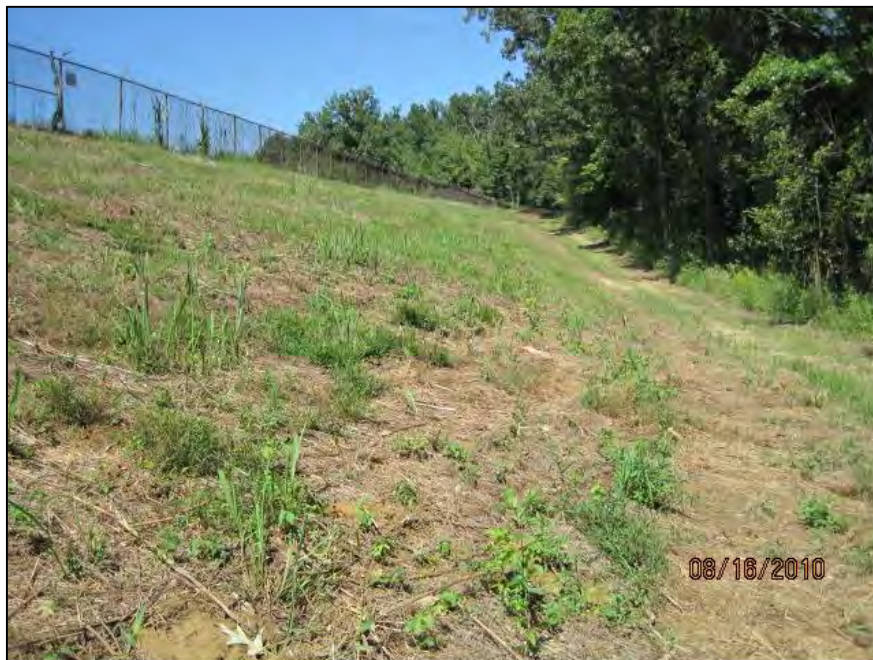
**SP-12**

**LOOKING NE AT DOWNSTREAM SLOPE OF SOUTH DIKE, STEEP SLOPE, SPARSE GRASS**
