Report of  
Dam Safety Assessment of Coal Combustion  
Surface Impoundments

Kentucky Utilities,  
a wholly owned subsidiary of  
LG&E and KU Energy LLC

Green River Station, Central City, KY

AMEC Project No. 3-2106-0177-0002

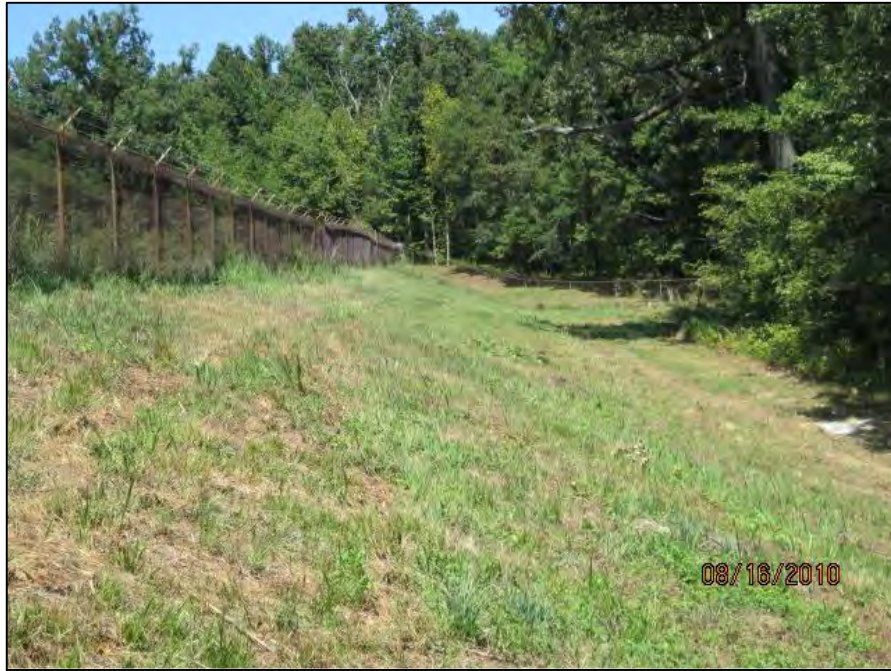
**SP-13**

**LOOKING N AT DOWNSTREAM SLOPE EAST DIKE, STEEP SLOPE, AREAS OF SPARSE GRASS, TIE INTO ORIGINAL IN BACKGROUND**

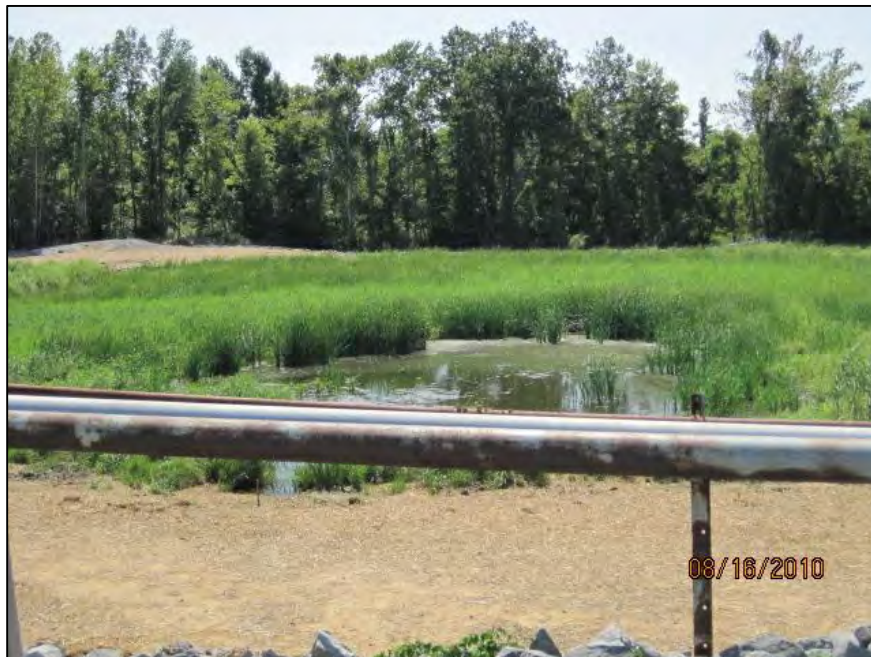
**3-2**

**LOOKING S FROM PHOTO 2-6 AT ASH POND 3**

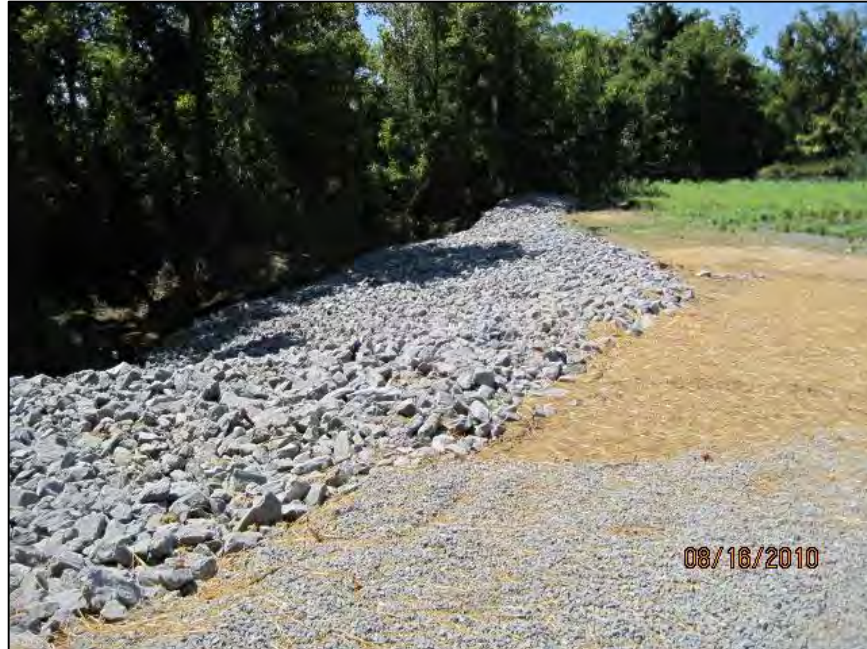
**3-3**

**REGRADED AND RIP-RAP ARMORED SOUTH AND ONLY DIKE OF ASH POND 3**
