Comment on Draft Report – Kentucky Utilities – Tyrone Generating Station

**Re: Kentucky Utilities' Comments for  
*DRAFT Report of Geotechnical Investigation Dam Safety Assessment of Coal Combustion Surface  
Impoundments Kentucky Utilities, a Subsidiary of E.ON U.S. Tyrone Generating Station, Tyrone, Kentucky***

TYRONE ASH POND PHOTOS  
January 7, 2011

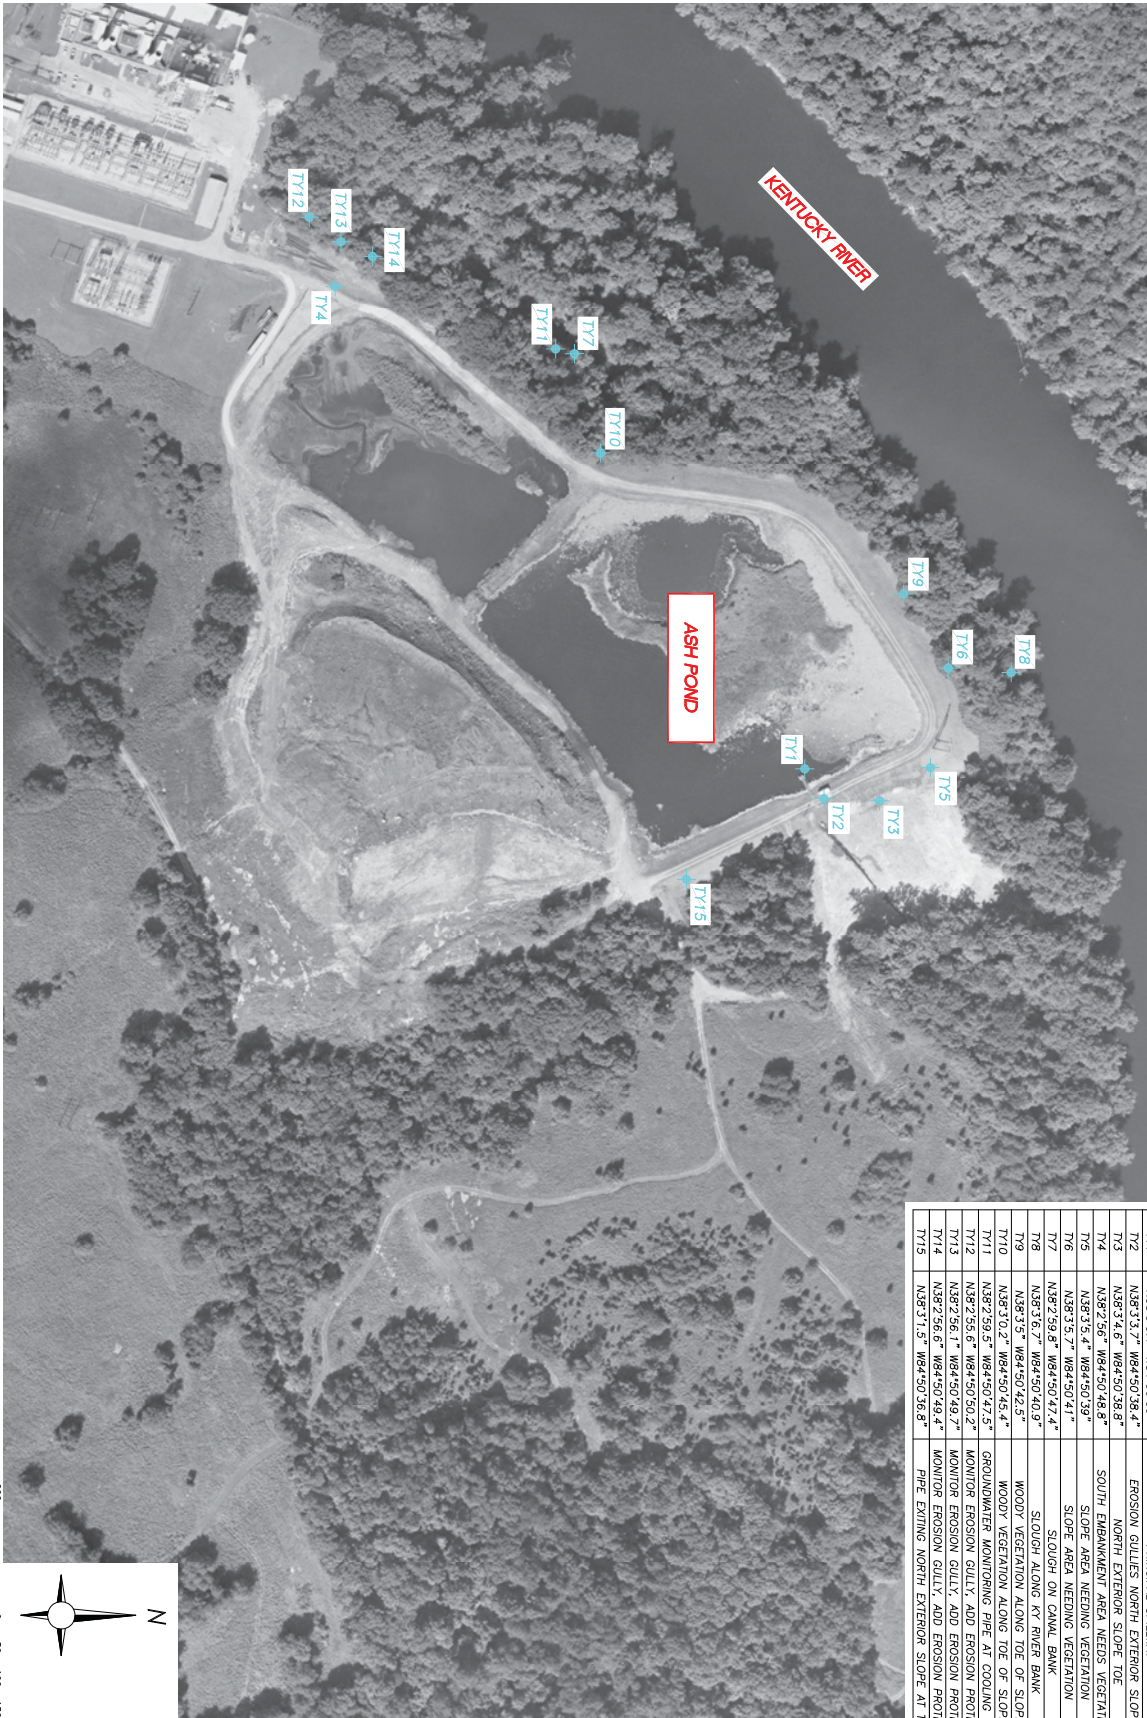
GPS PT	COORDINATES	DESCRIPTION
TY1	N38°3.4' W84°50'39.4"	PRINCIPAL SPILLWAY
TY2	N38°3.7' W84°50'38.4"	EROSION GULLES NORTH EXTERIOR SLOPE
TY3	N38°3.4' W84°50'38.8"	NORTH EXTERIOR SLOPE TOE
TY4	N38°2'56" W84°50'48.8"	SOUTH EMBANKMENT AREA WEEDS VEGETATION
TY5	N38°3.5' W84°50'39"	SLOPE AREA NEEDING VEGETATION
TY6	N38°3.5' W84°50'41"	SLOPE AREA NEEDING VEGETATION
TY7	N38°2'59.8" W84°50'47.4"	SLOUGH ON CANAL BANK
TY8	N38°3'6.7" W84°50'40.9"	SLOUGH ALONG KY RIVER BANK
TY9	N38°3'5" W84°50'42.5"	WOODY VEGETATION ALONG TOE OF SLOPE
TY10	N38°3'0.2" W84°50'45.4"	WOODY VEGETATION ALONG TOE OF SLOPE
TY11	N38°2'59.5" W84°50'47.5"	GROUNDWATER MONITORING PIPE AT COOLING CANAL
TY12	N38°2'55.6" W84°50'50.2"	MONITOR EROSION GULLY ADD EROSION PROTECTION
TY13	N38°2'56.1" W84°50'49.7"	MONITOR EROSION GULLY ADD EROSION PROTECTION
TY14	N38°2'56.6" W84°50'49.4"	MONITOR EROSION GULLY ADD EROSION PROTECTION
TY15	N38°3'1.5" W84°50'36.8"	PIPE EXITING NORTH EXTERIOR SLOPE AT TOE
