Assessment of Dam Safety of Coal Combustion Surface Impoundments

Sam Seymour - Fayette Power Project Station

Lower Colorado River Authority

April 18, 2011

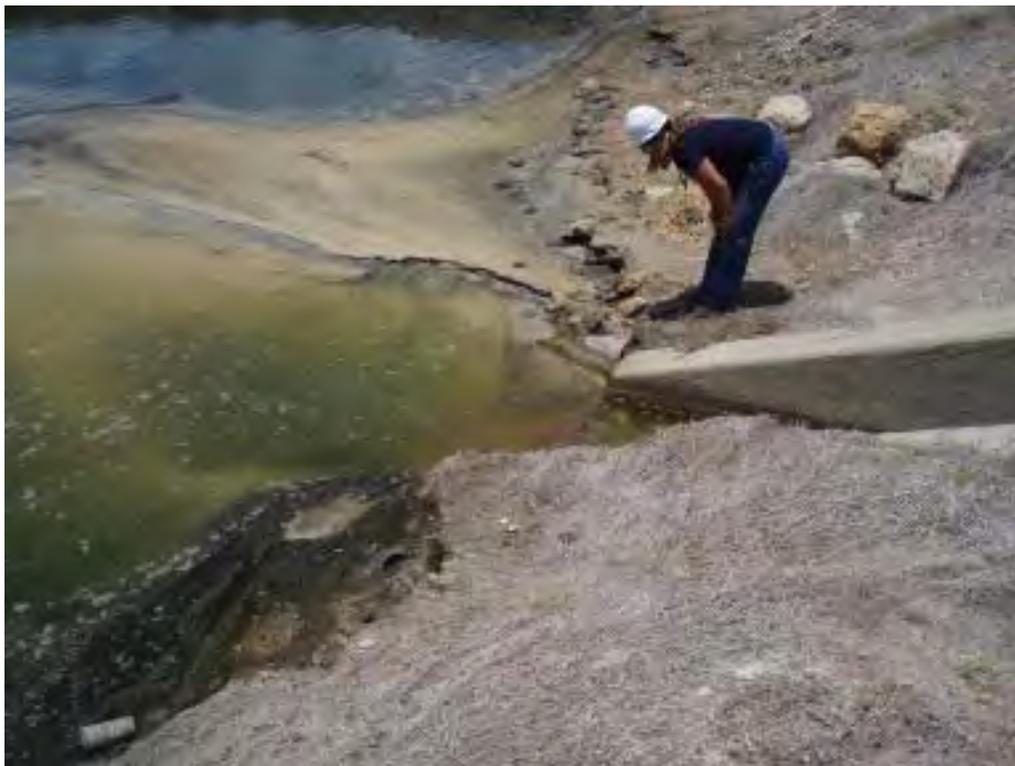
Photo No. 1: Reclaim Pond - Overview of waste drain trench outlet at the north embankment interior slope.

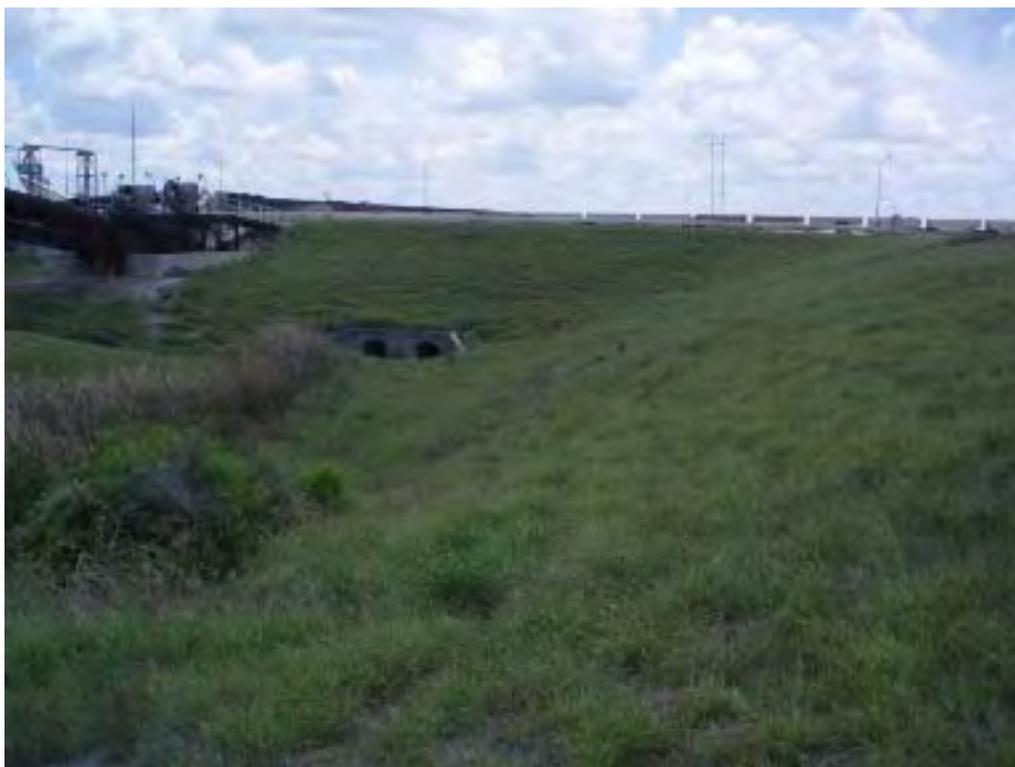
The exterior slope on the north appears to be in fair condition (Photos 2, 27, 34, 37, 38, 39, 40, 41, and 42). The grass on the north embankment ranged from 12 to 36 inches in height. Some minor brush and huisache bushes were observed on the slope. Brush and trees were observed at the toe of the slope in the drainage ditch. Desiccation cracks up to a ½ inch wide and eight (8) inches deep were observed at various locations on the slope.

Photo No. 2: Reclaim Pond - North embankment exterior slope, looking east.

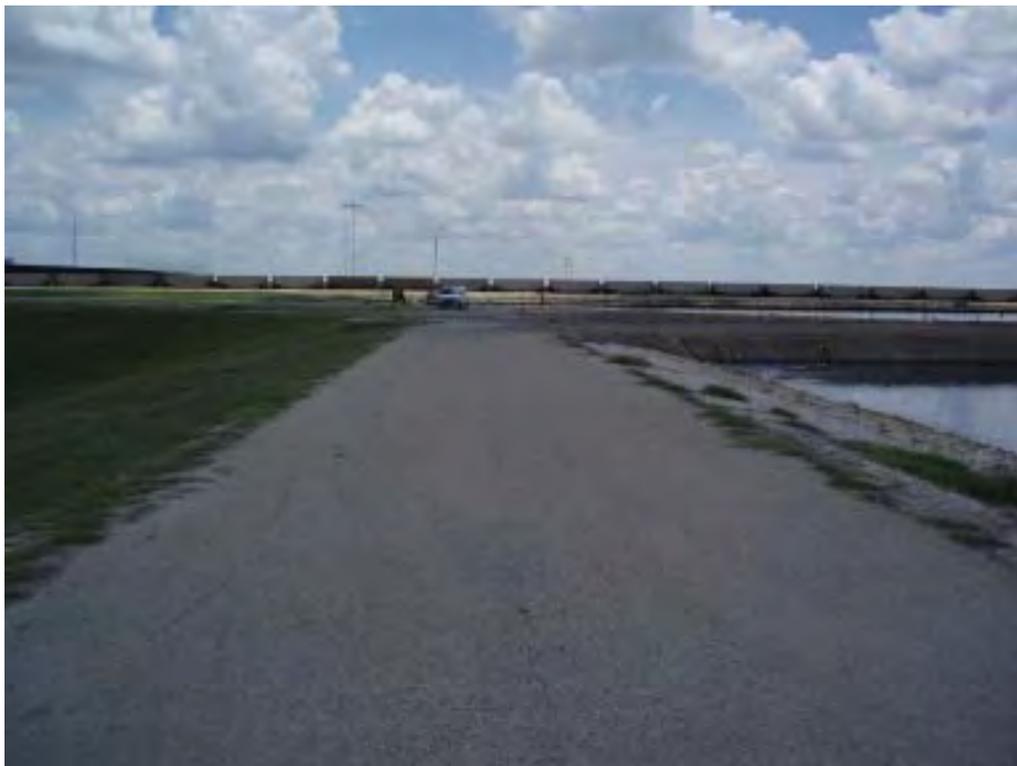
Photo No. 3: Reclaim Pond - North embankment crest, looking east

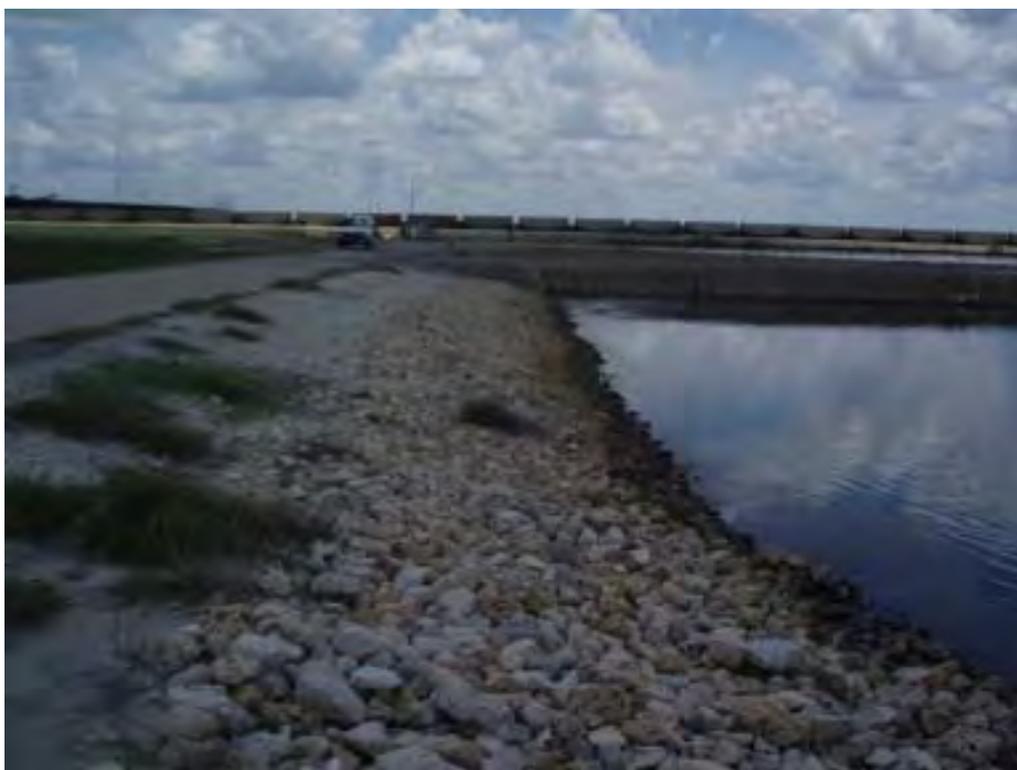
Photo No. 4: Reclaim Pond - North embankment interior slope, looking east

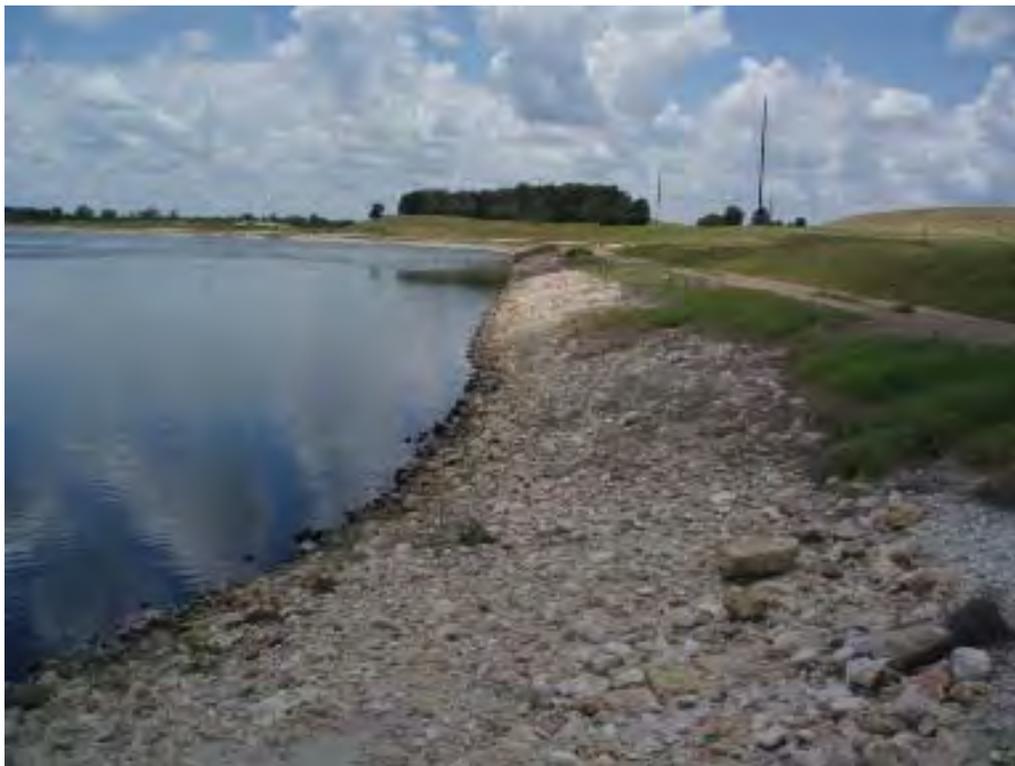
Photo No. 5: Reclaim Pond - West embankment interior slope, looking south.

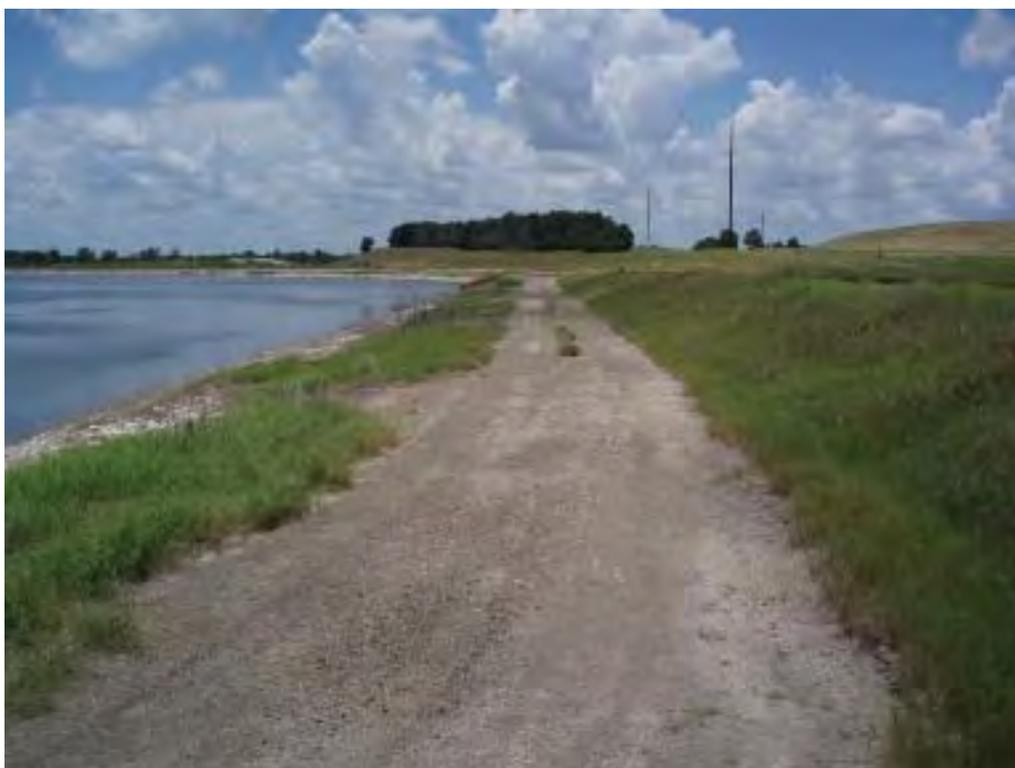
Photo No. 6: Reclaim Pond - West embankment crest, looking south.

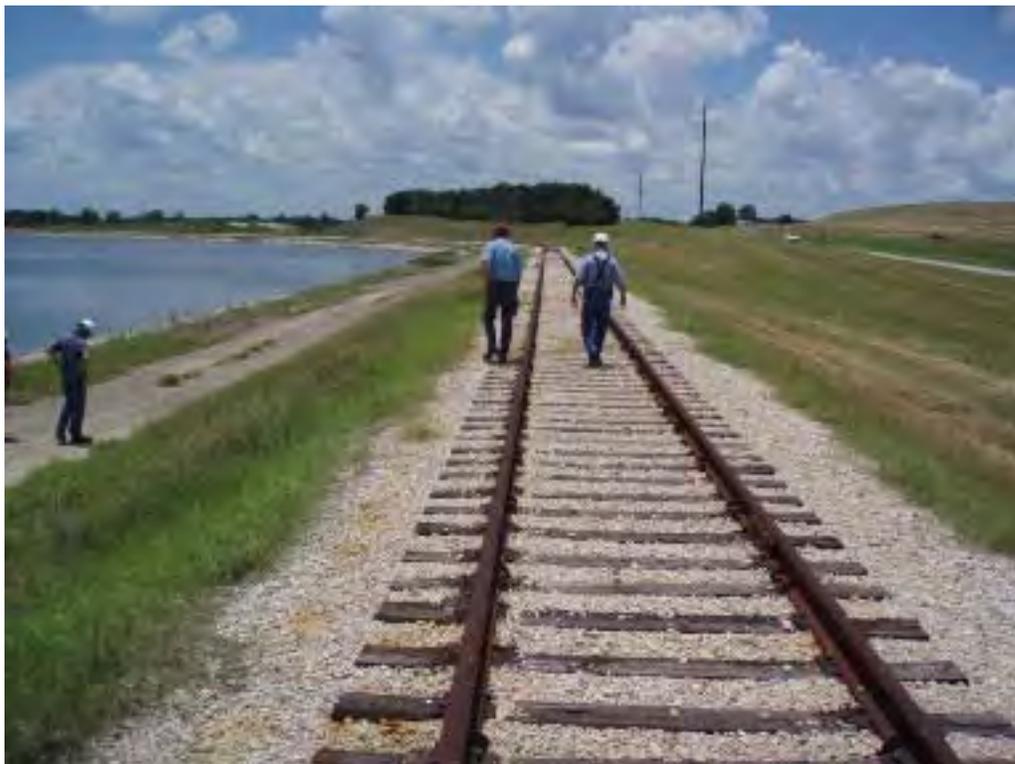
Photo No. 7: Reclaim Pond - Overview of west embankment from railroad spur, looking south.

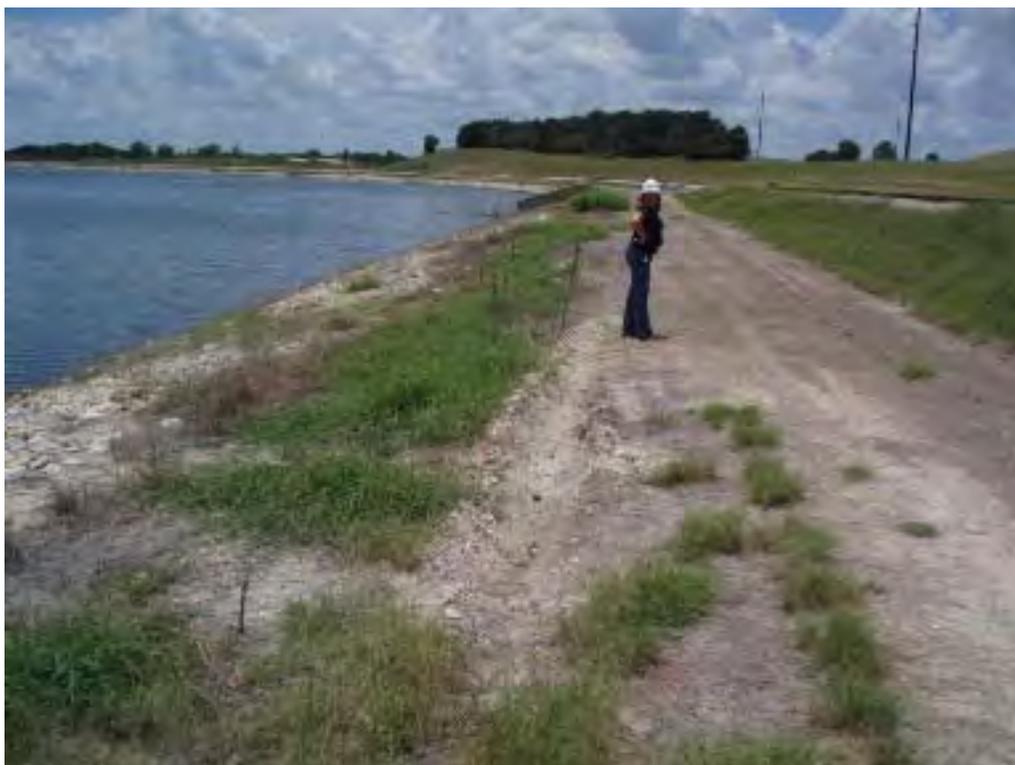
Photo No. 8: Reclaim Pond - West embankment, looking south at typical bare spots and tractor ruts on crest and interior slope.

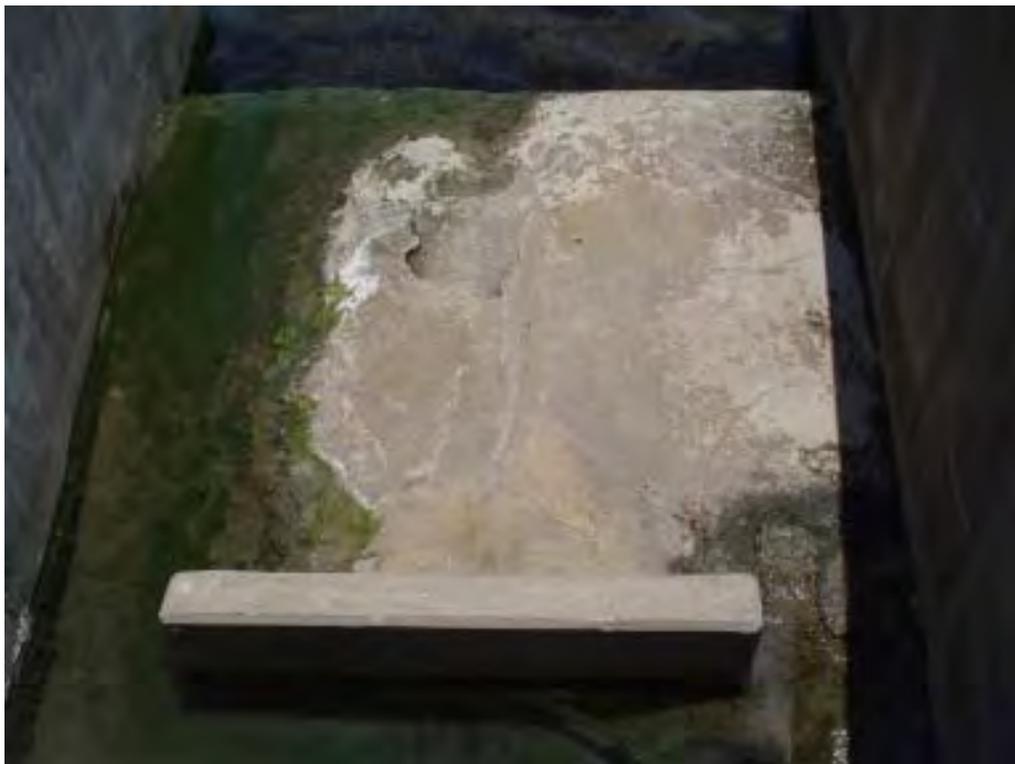
Photo No. 9: Reclaim Pond – Overview of stormwater outlet structure on west embankment interior slope. Stormwater is from FGD residue silos and truck wash area.

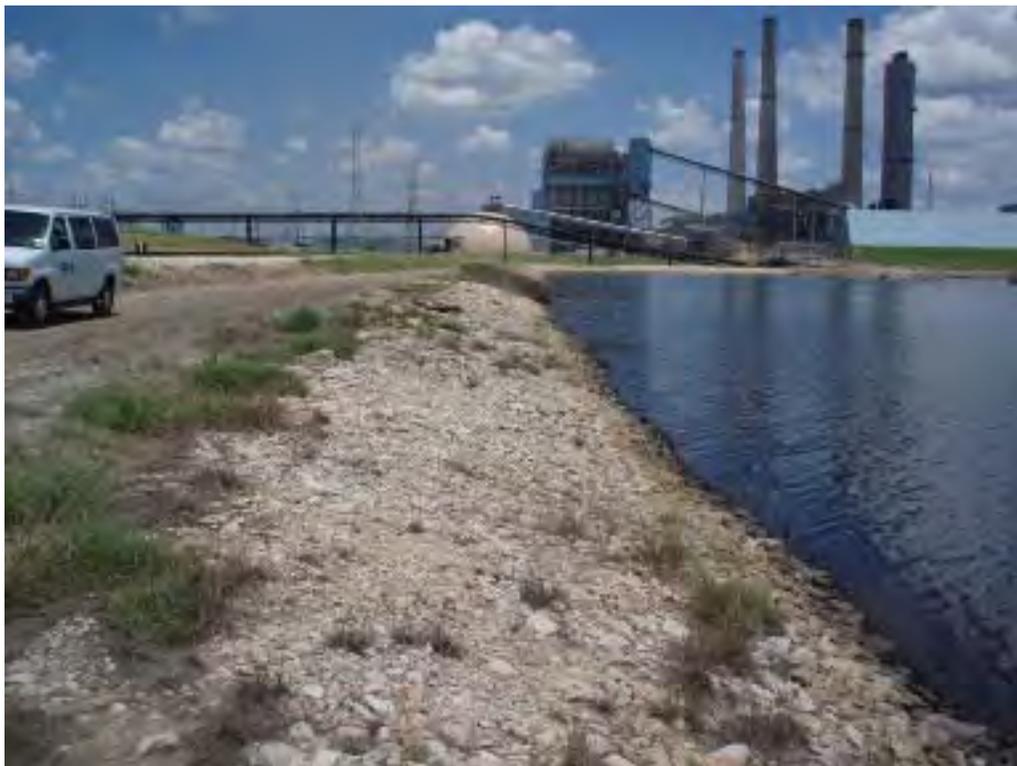
Photo No. 11: Reclaim Pond - West embankment interior slope, looking north.

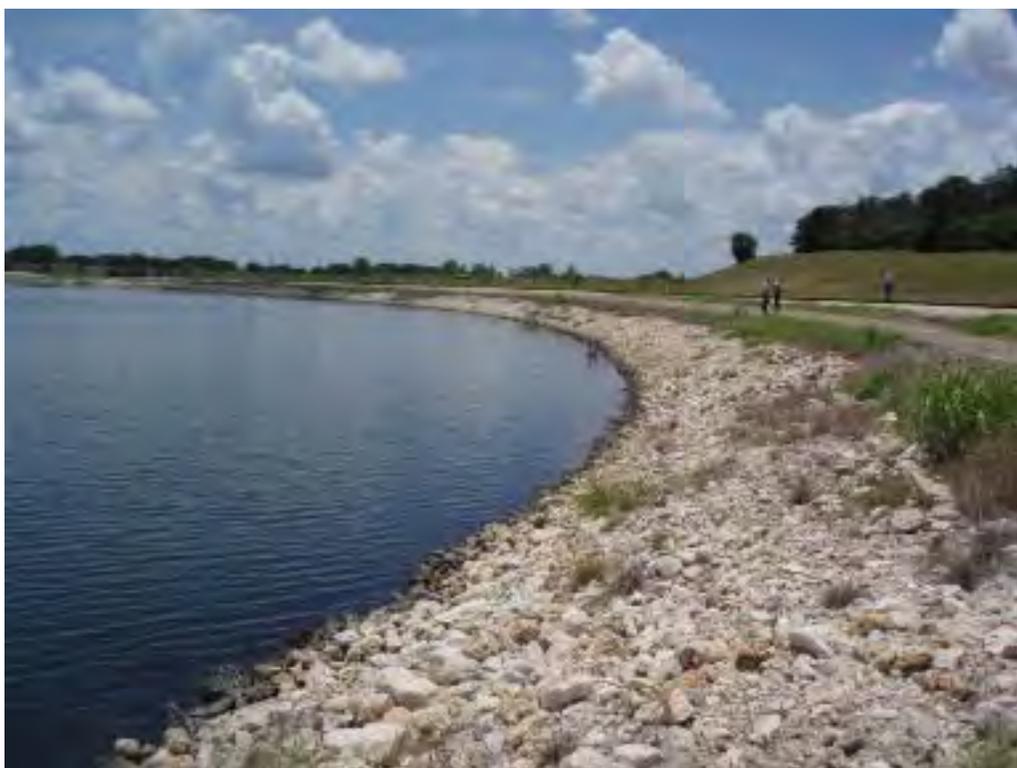
Photo No. 12: Reclaim Pond - South embankment interior slope, looking southeast

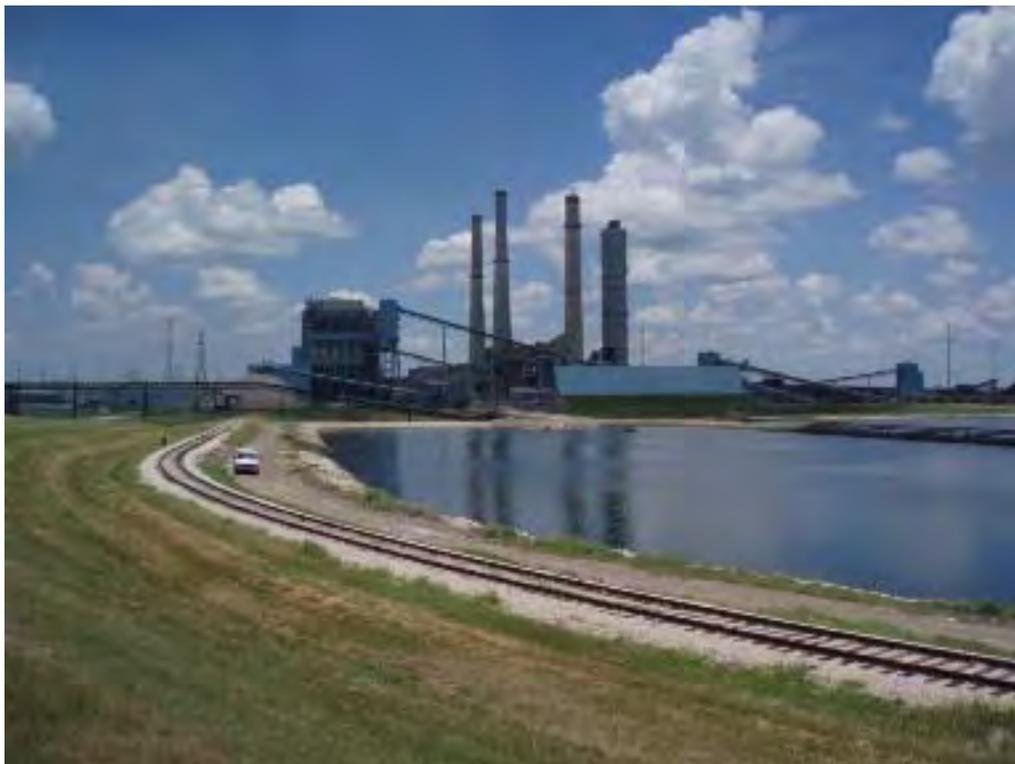
Photo No. 13: Reclaim Pond - Overview of western portion of impoundment, looking north.

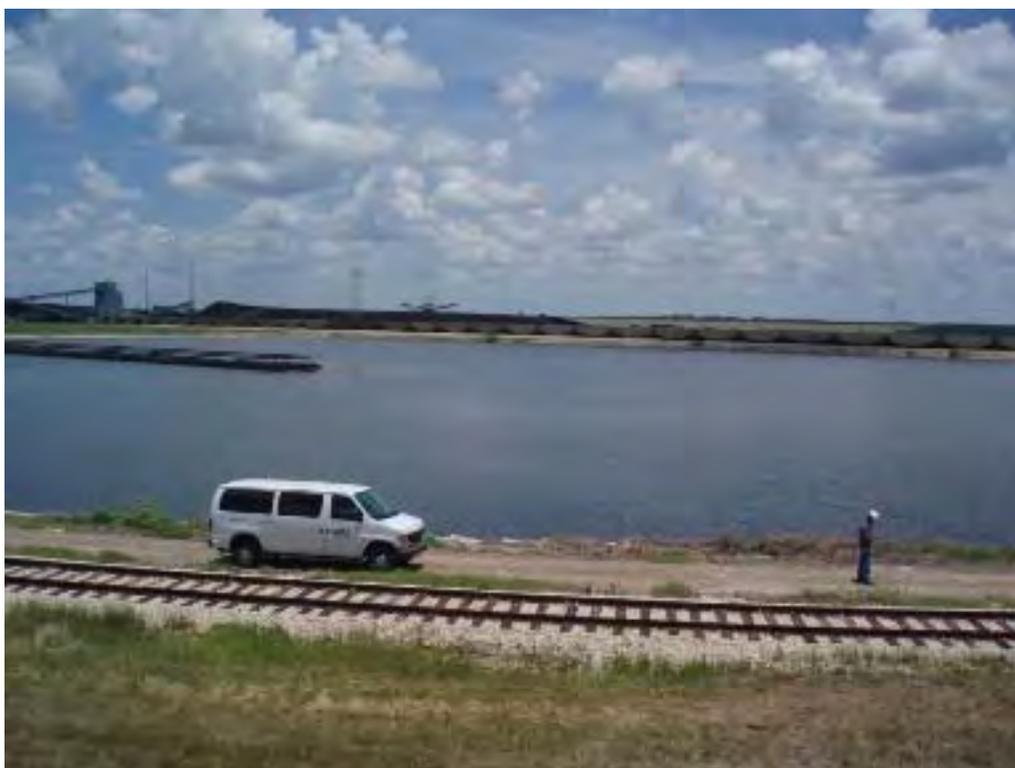
Photo No. 14: Reclaim Pond - Overview of impoundment, looking northeast.

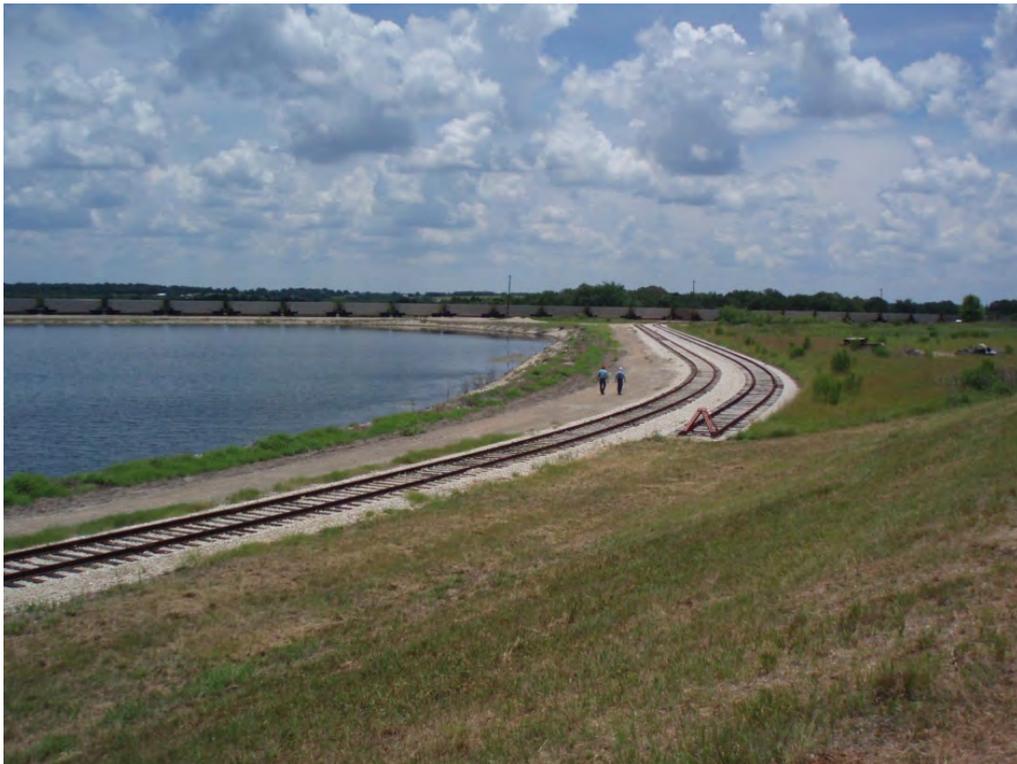
Photo No. 15: Reclaim Pond - Overview of south embankment, looking southeast.

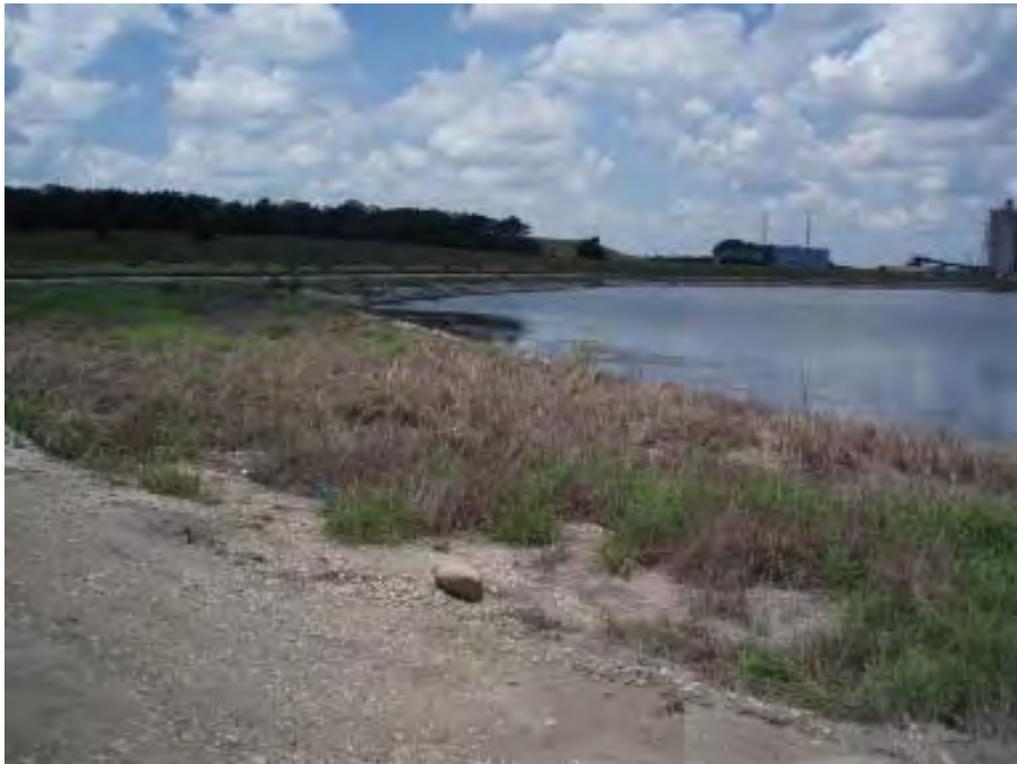
Photo No. 17: Reclaim Pond - Overview of south embankment, looking northwest.

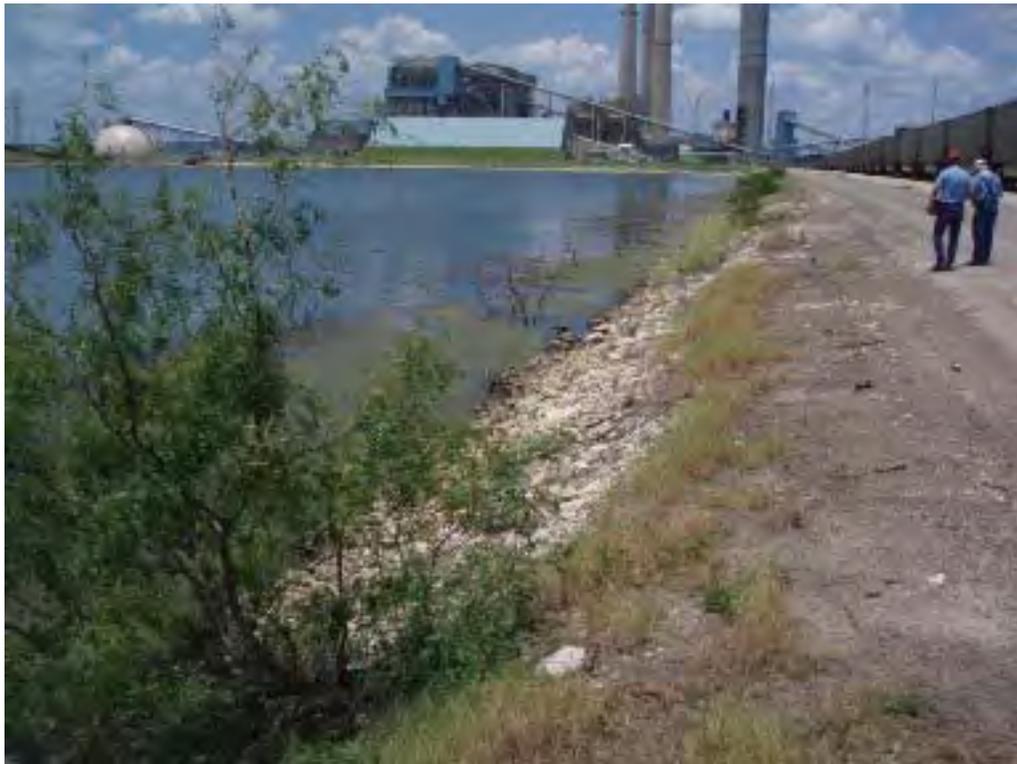
Photo No. 19: Reclaim Pond - East embankment interior slope, looking at a 4-inch-diameter mesquite tree and brush. Note some minor surface erosion near crest.

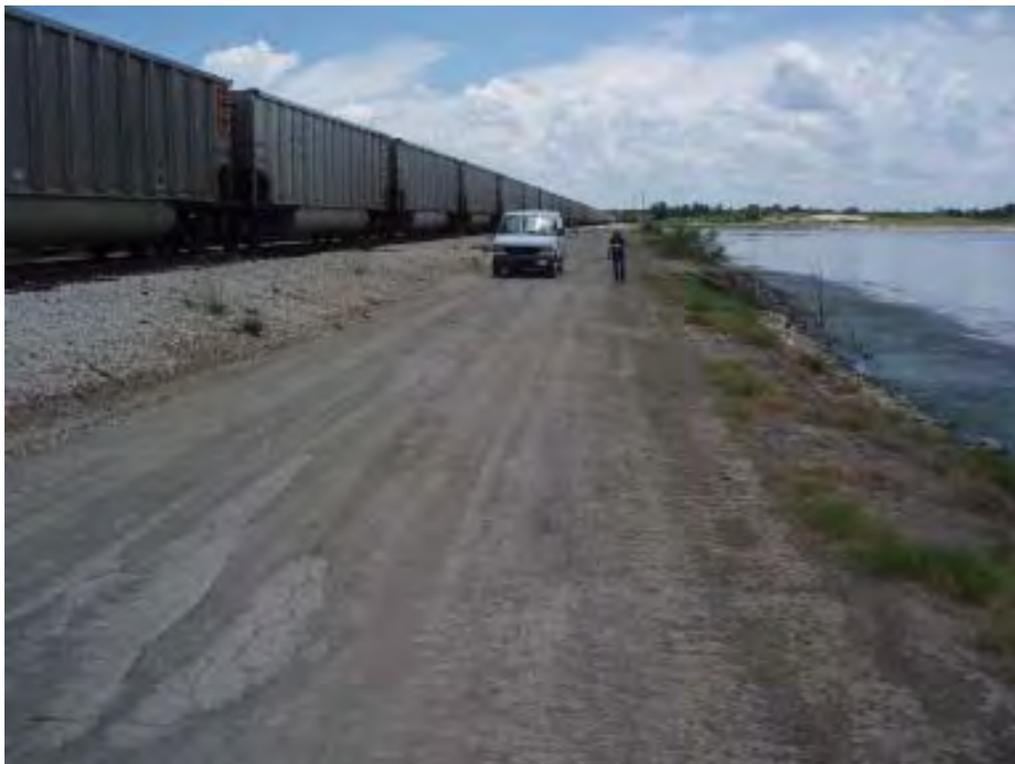
Photo No. 23: Reclaim Pond - East embankment crest, looking south.

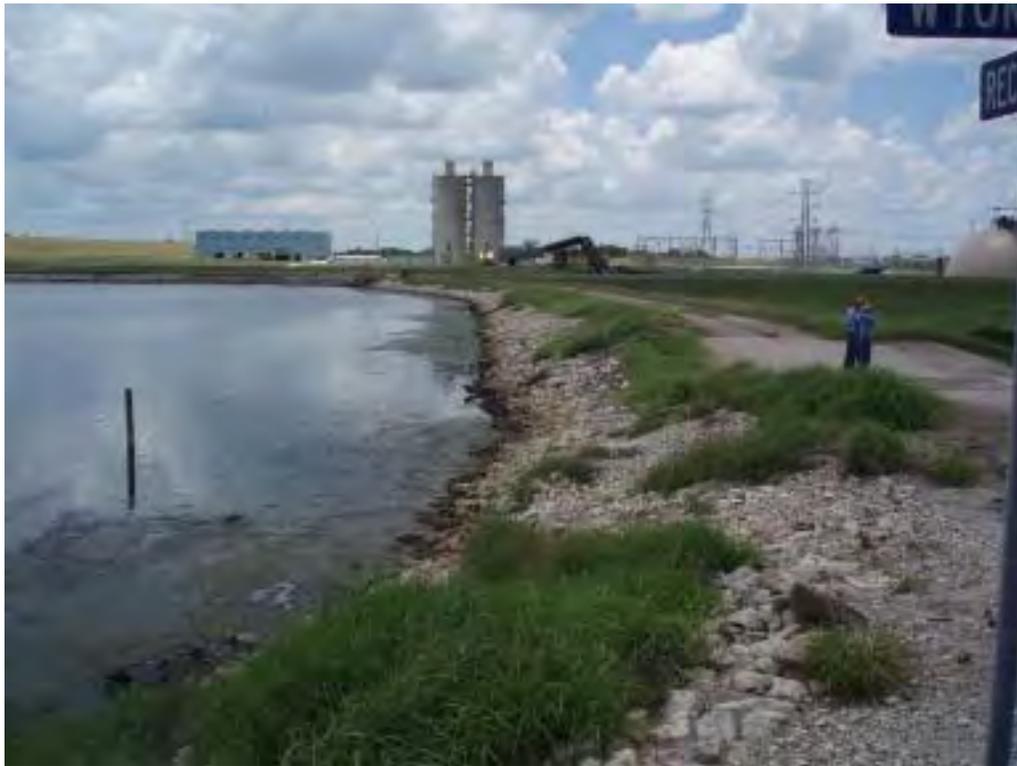
Photo No. 25: Reclaim Pond - North embankment interior slope, looking west.

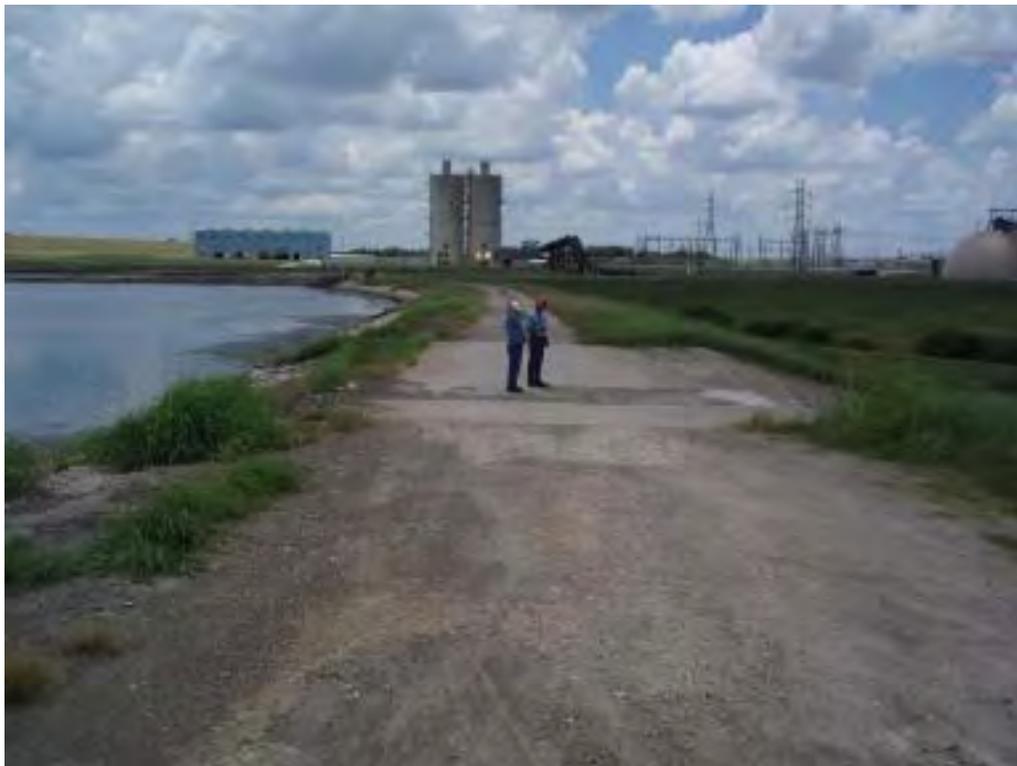
Photo No. 26: Reclaim Pond - North embankment crest, looking west.

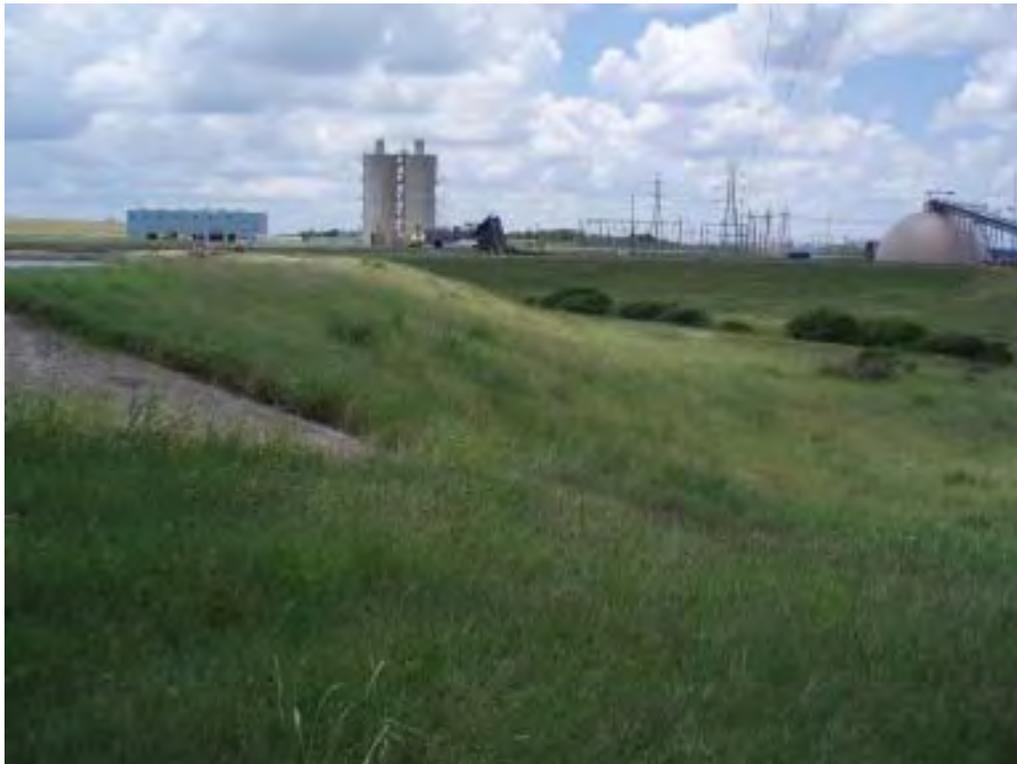
Photo No. 27: Reclaim Pond - North embankment exterior slope, looking west.

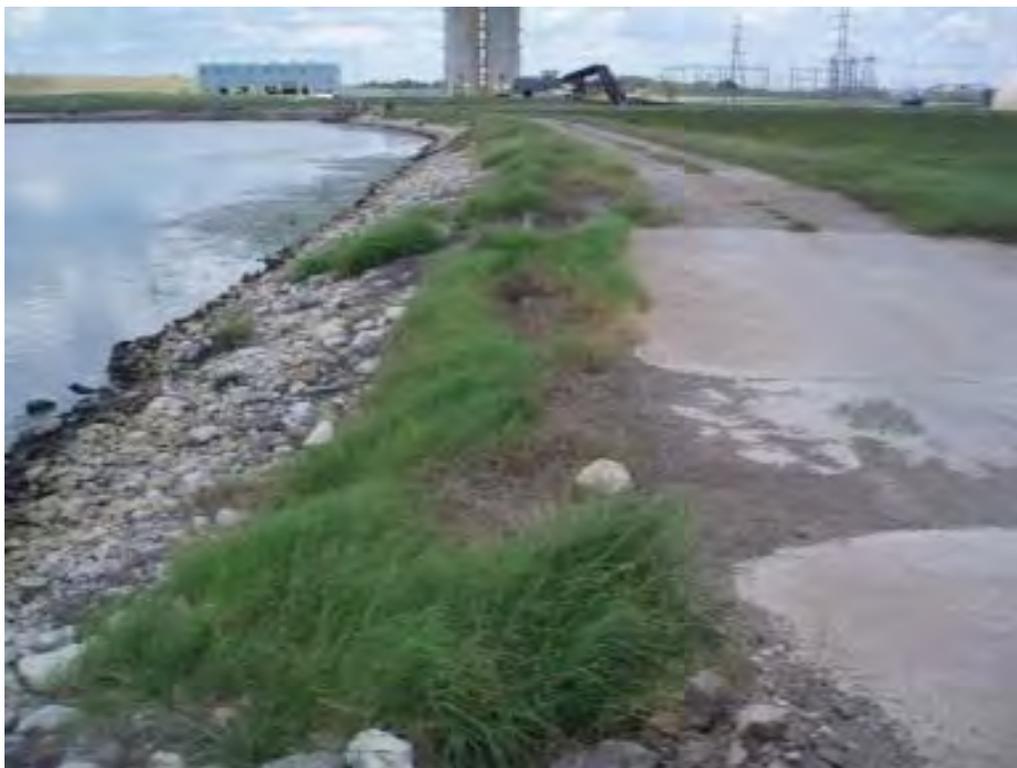
The emergency spillway appeared to be in fair condition (Photos 28, 29, 30, 31, and 41). The concrete lining was in good condition. The spillway discharge channel had some minor grass growing in the channel. The entrance to the spillway channel had excessive vegetation and there was missing riprap. There was also excessive vegetation in the outlet channel.

Photo No. 28: Reclaim Pond - North embankment, looking at emergency spillway channel entrance.

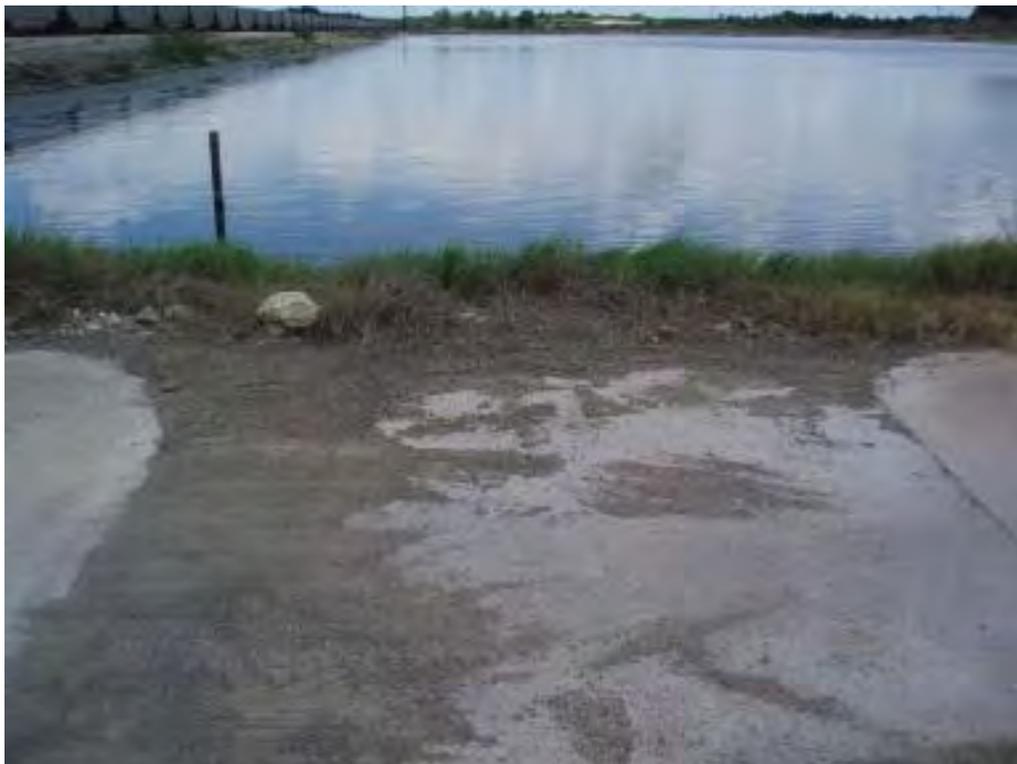
Photo No. 29: Reclaim Pond - North embankment, looking south at spillway channel entrance.

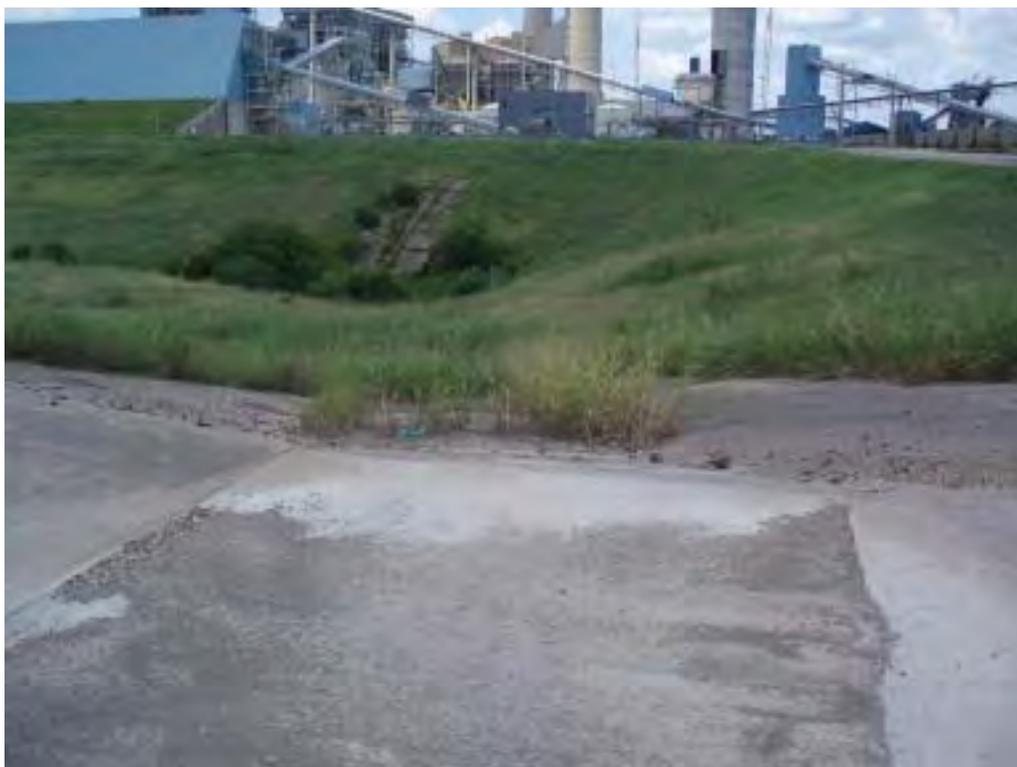
Photo No. 30: Reclaim Pond - North embankment, looking north at spillway discharge channel.

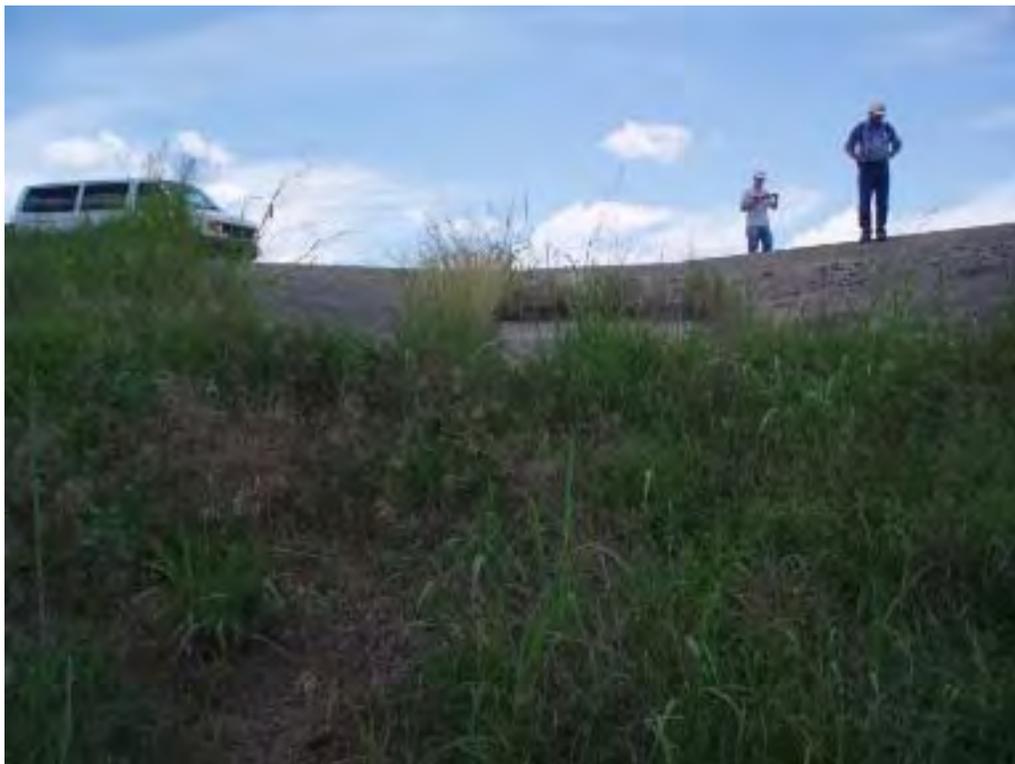
Photo No. 31: Reclaim Pond - North embankment exterior slope, looking south at spillway discharge channel.

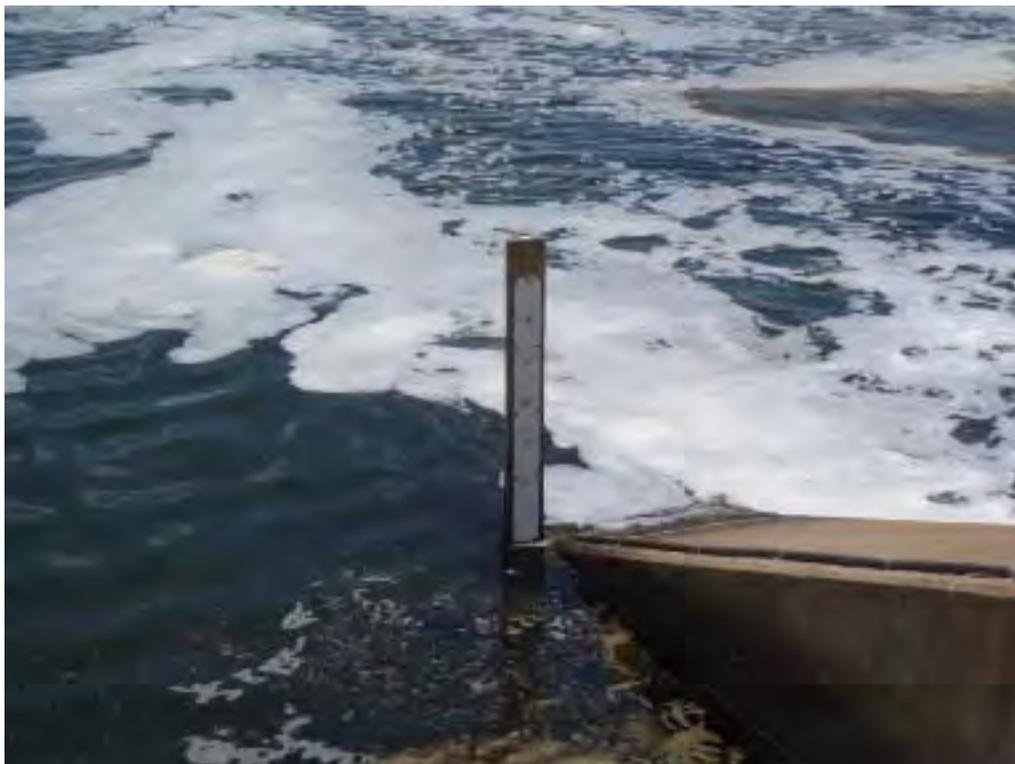
Photo No. 33: Reclaim Pond - North embankment interior slope, looking at staff gage at reclaim pump station

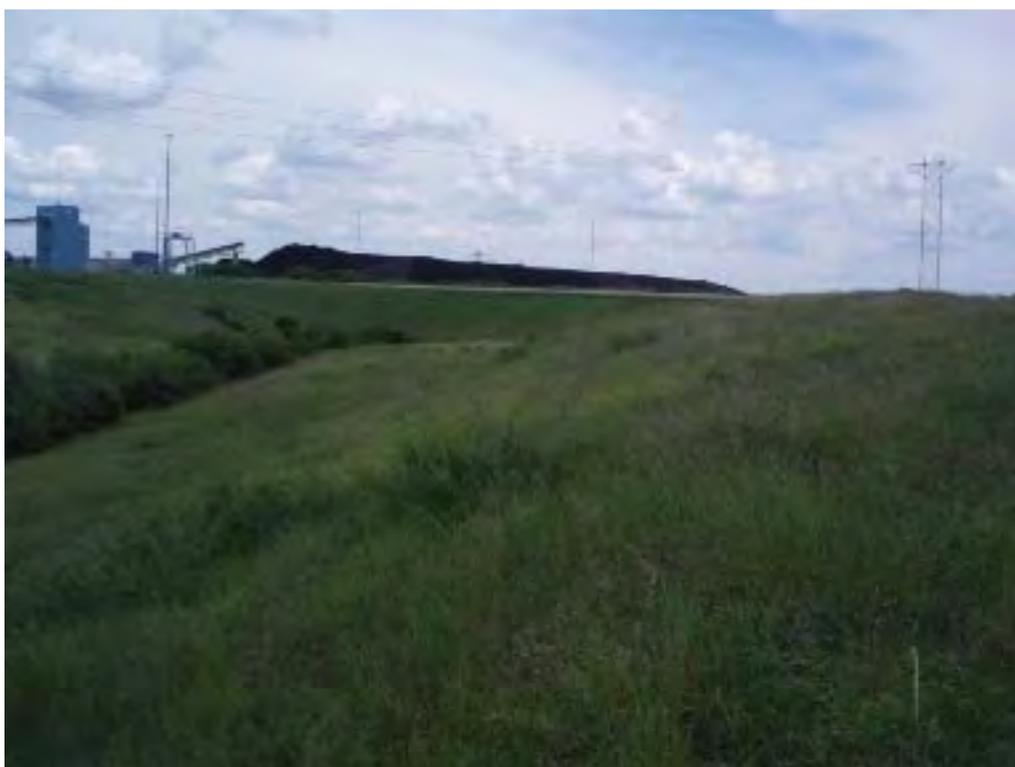
Photo No. 34: Reclaim Pond - North embankment exterior slope, looking east.

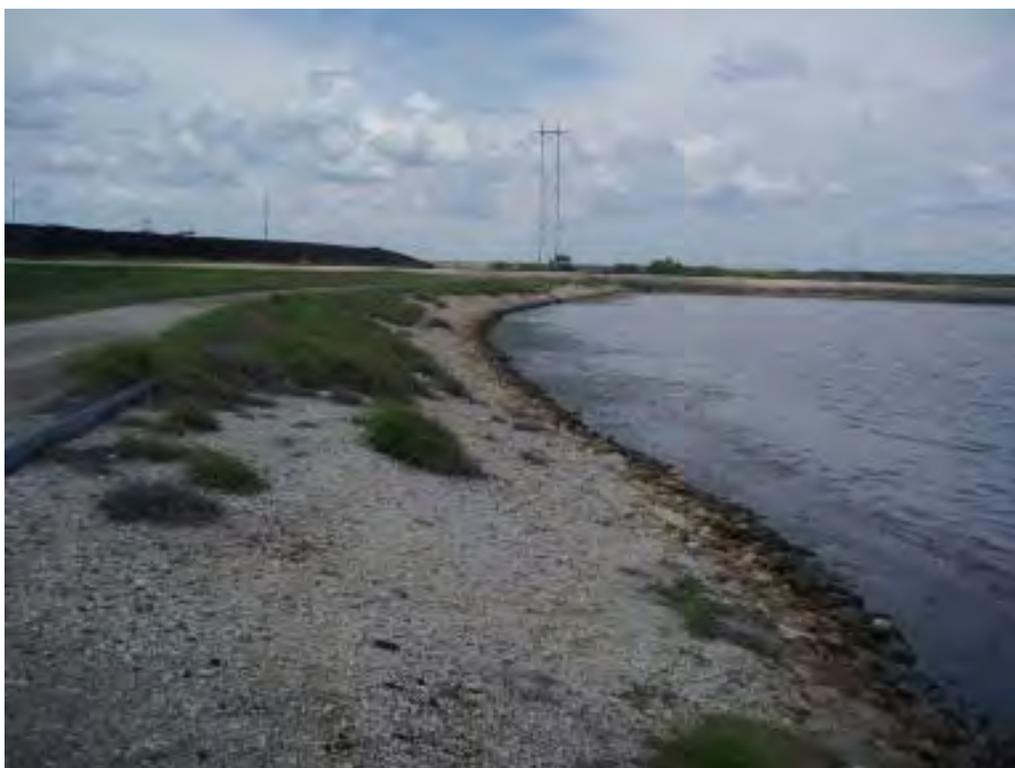
Photo No. 36: Reclaim Pond - North embankment interior Slope, looking east. Note 6-inch-diameter HDPE pipe from the CADP on left side of photo.

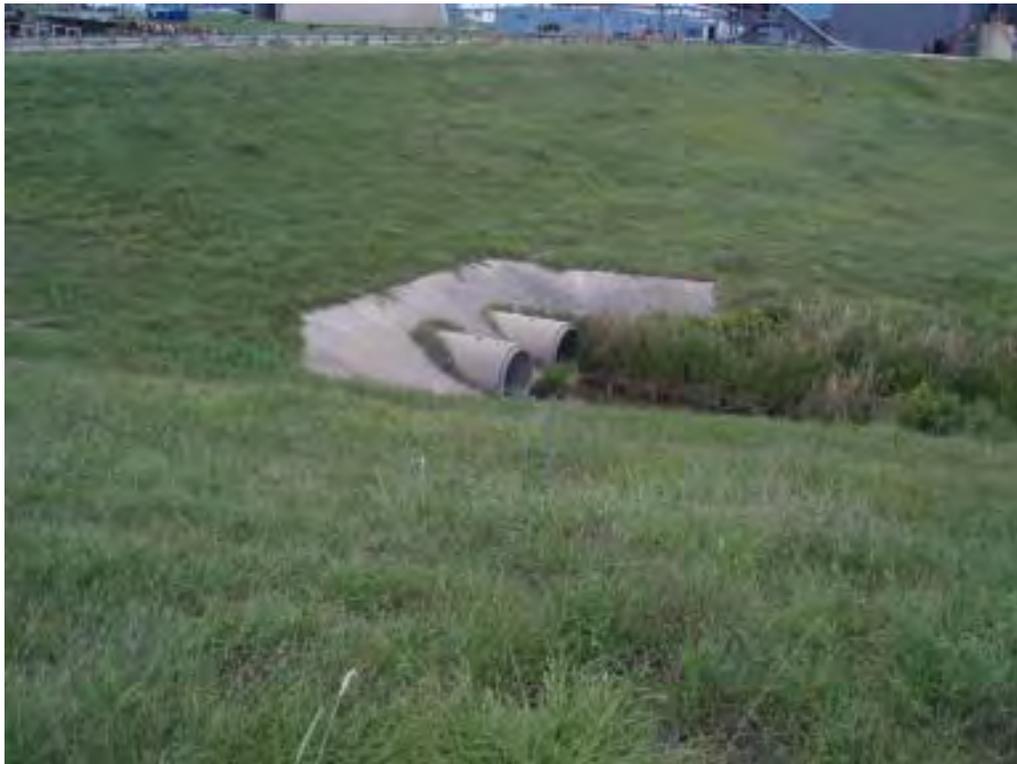
Photo No. 37: Reclaim Pond - North embankment exterior slope, looking north at two 8-foot-diameter drainage pipes at toe of slope.
