Assessment of Dam Safety of Coal Combustion Surface Impoundments

Sam Seymour - Fayette Power Project Station

Lower Colorado River Authority

April 18, 2011

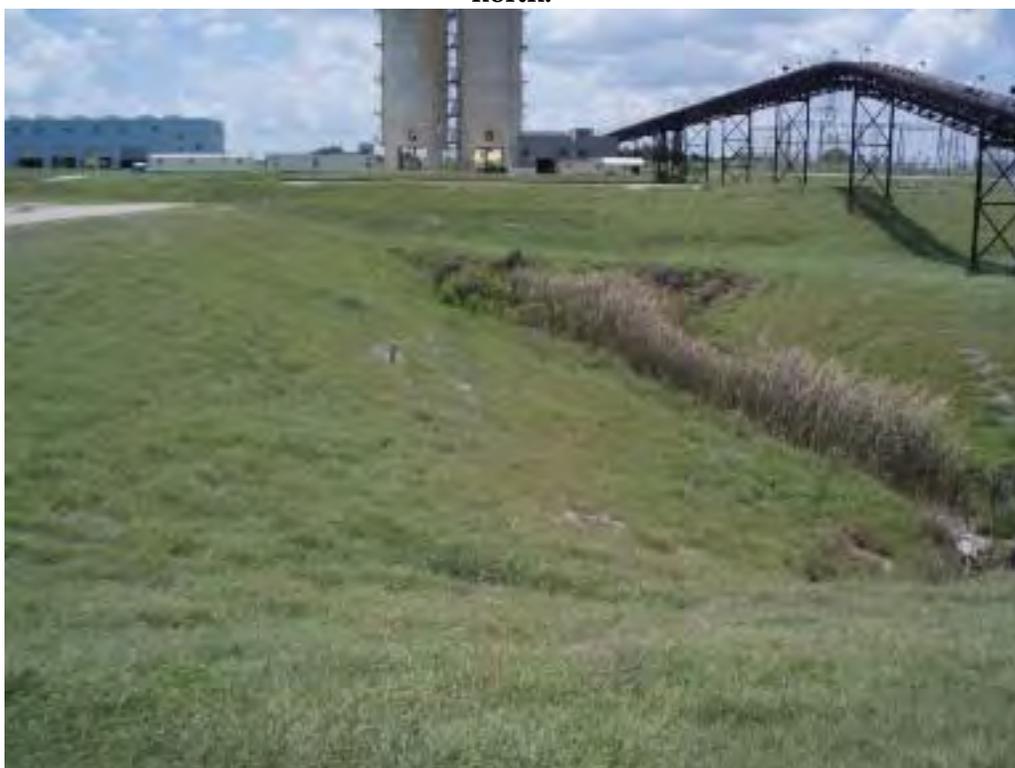
Photo No. 40: Reclaim Pond - Overview of north embankment exterior slope and downstream area, looking west

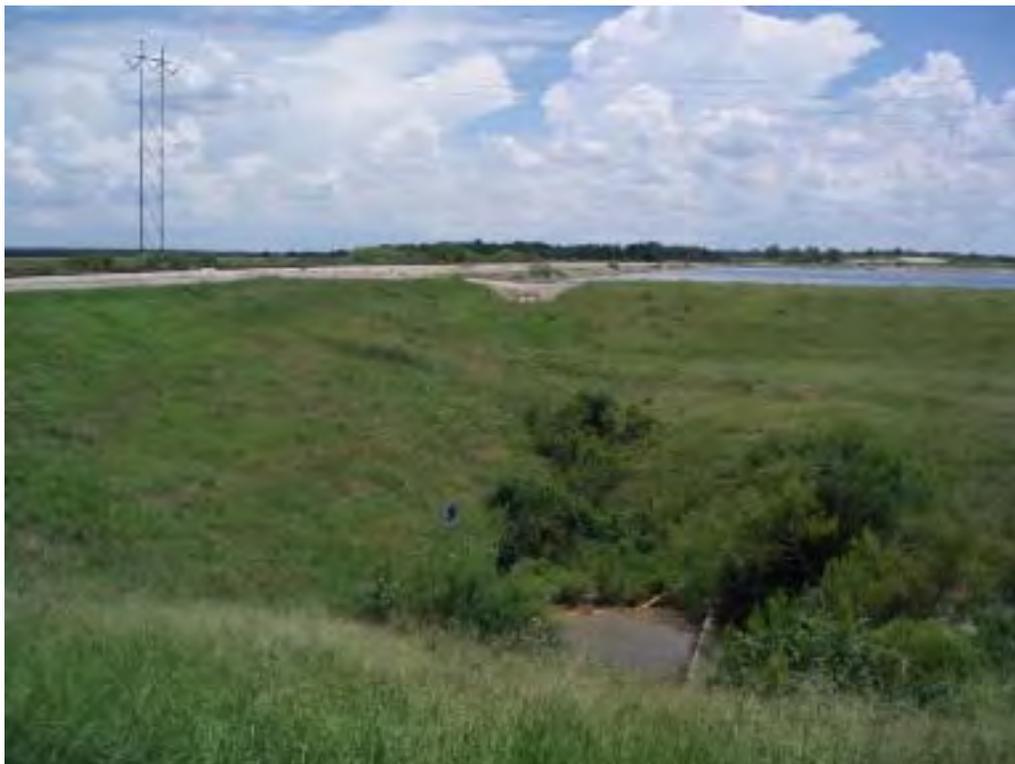
Photo No. 41: Reclaim Pond - Overview of north embankment spillway and railroad embankment, looking south. Note small trees growing at the toe in the drainage ditch.

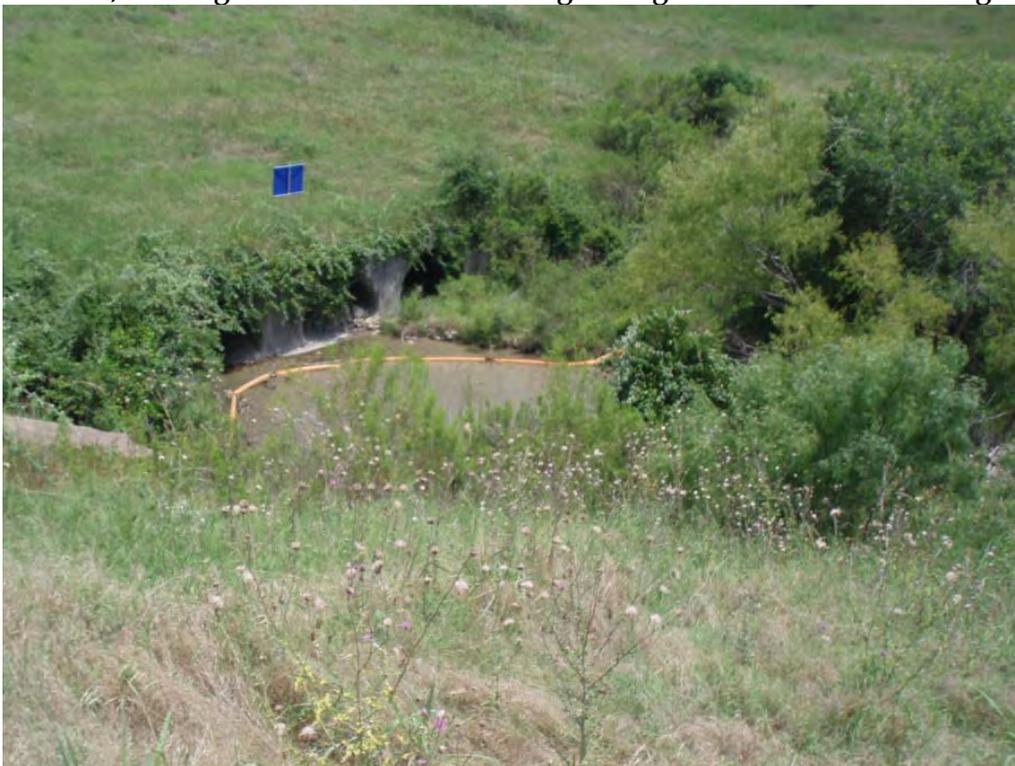
Photo No. 42: Reclaim Pond - Overview of triple arch culverts under railroad embankment. Note small trees and vegetation in the drainage ditch and debris in the arch culverts.

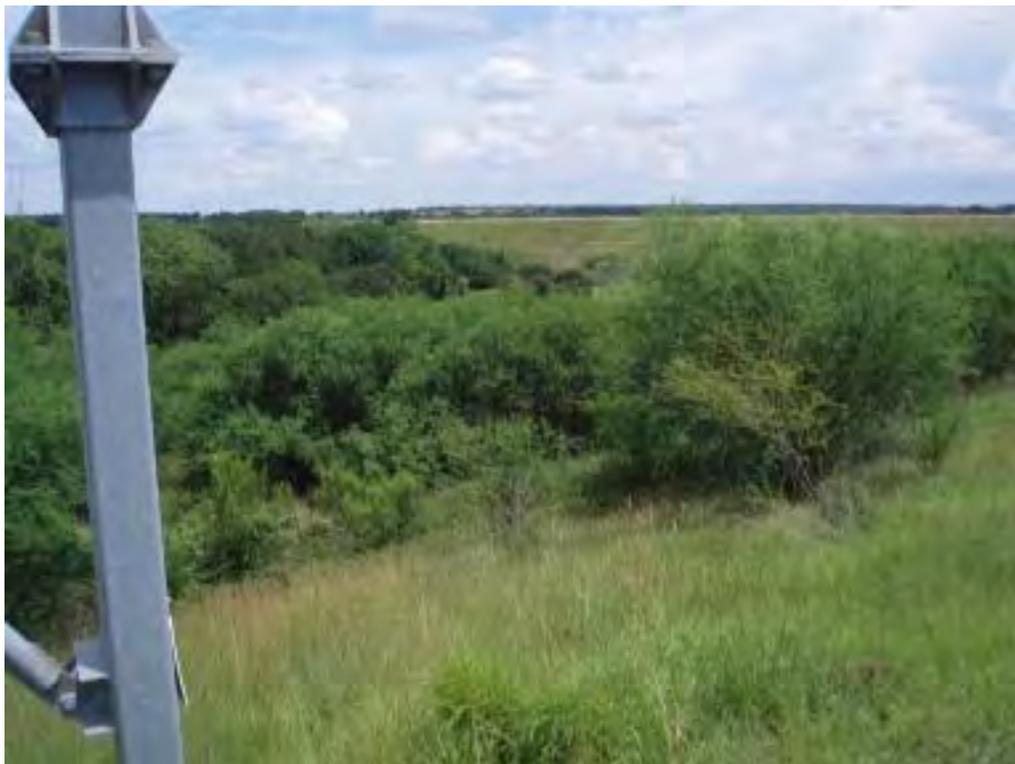
The exterior slope on the east embankment is generally poor (Photos 43, 44, 46, 47, 48, 50, and 51). The grass on the east embankment ranged from 12 to 36 inches in height. Brush and mesquite trees, including one large diameter tree, were observed on the embankment, although most trees were smaller in diameter. Desiccation cracks up to a ½ inch wide and 8 inches deep were observed at various locations on the embankment. A fly ash surfaced access road was observed on the exterior slope of the embankment (Photos 48 and 50).

Photo No. 43: Reclaim Pond - East embankment downstream area, looking southeast.

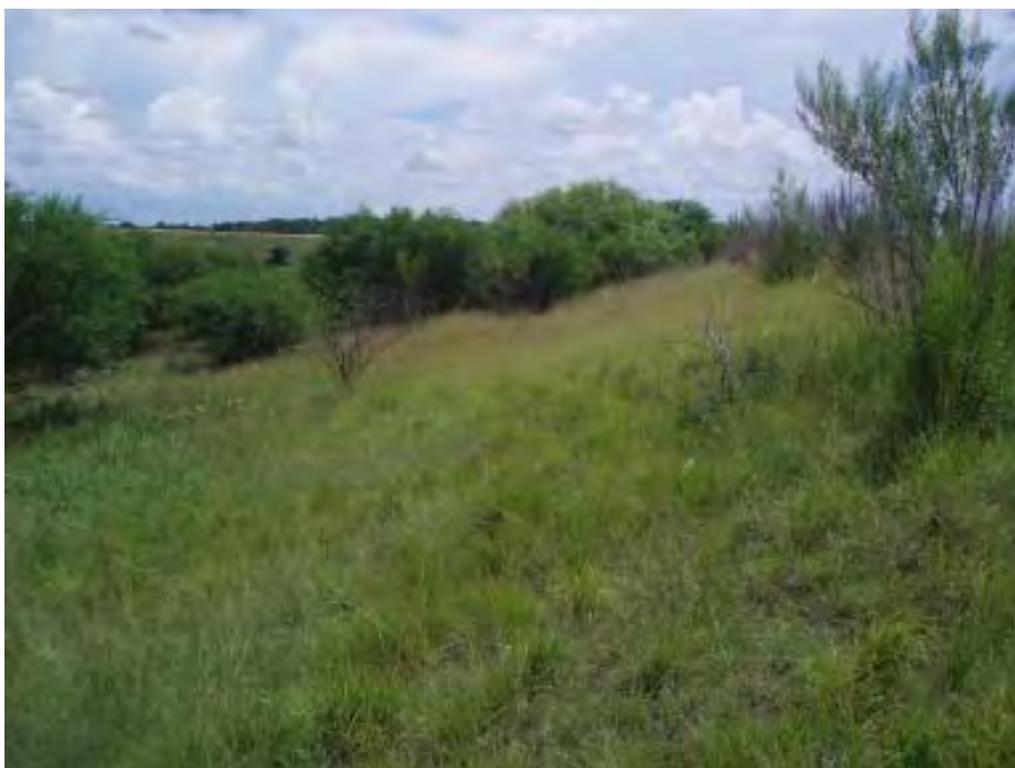
Photo No. 44: Reclaim Pond - East embankment exterior slope, looking south.

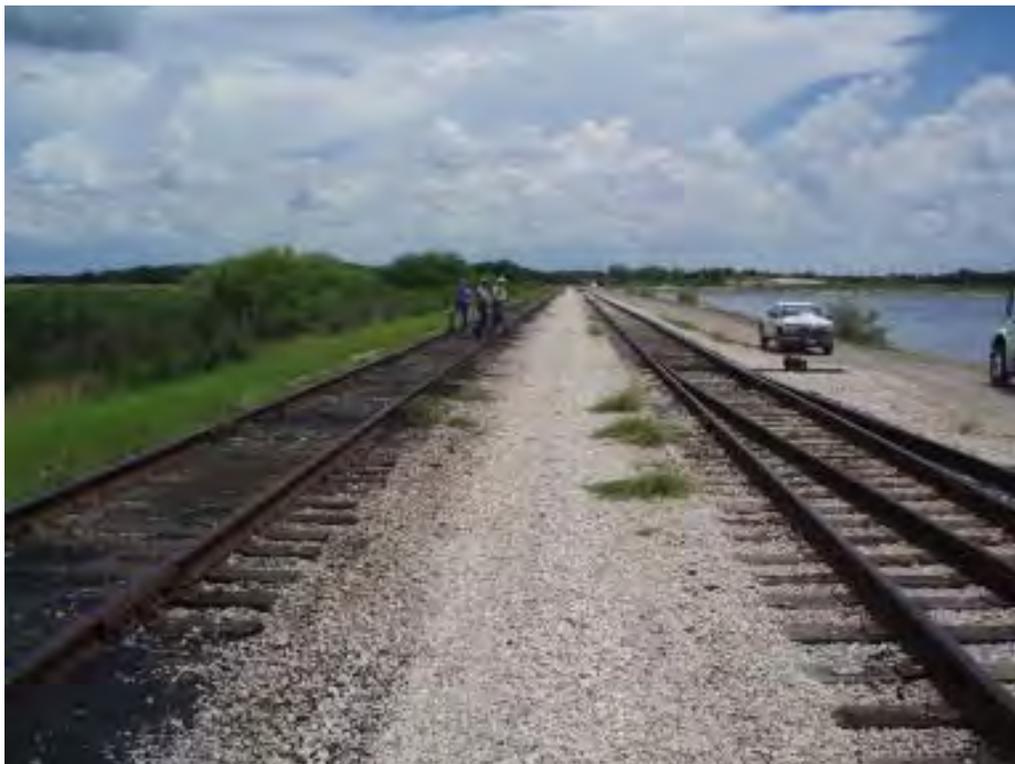
Photo No. 45: Reclaim Pond - East embankment crest, looking south. Note crest has two railroad spurs and an access road.

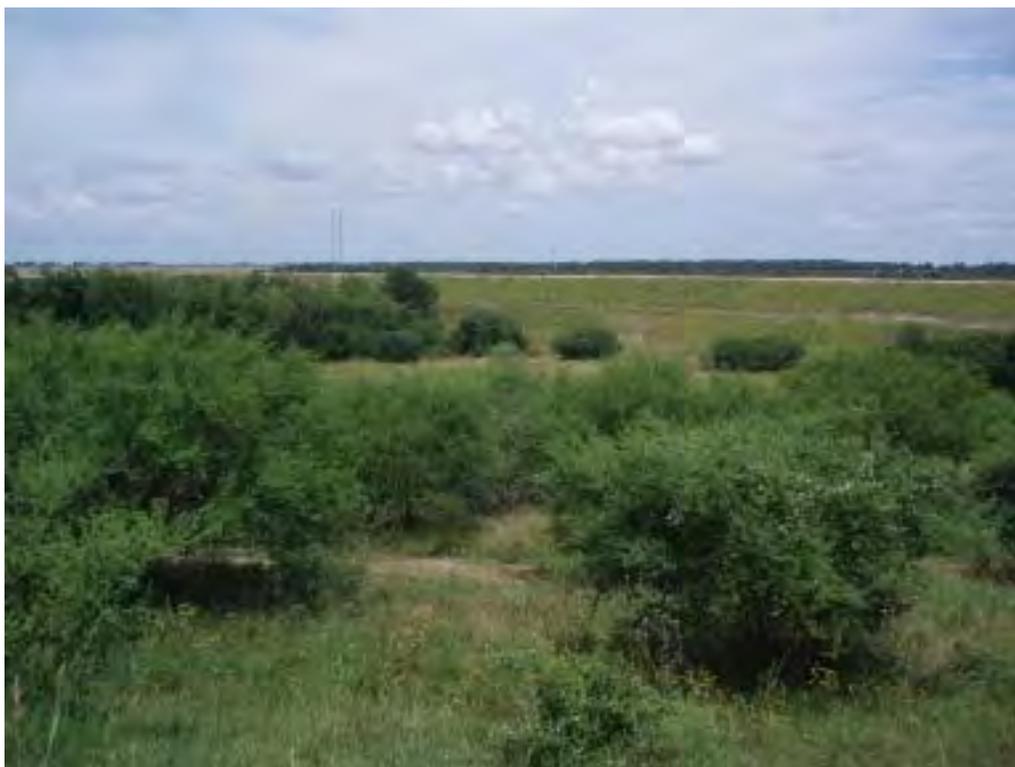
Photo No. 46: Reclaim Pond - East embankment exterior slope, looking east at downstream area. Note railroad embankment in background.

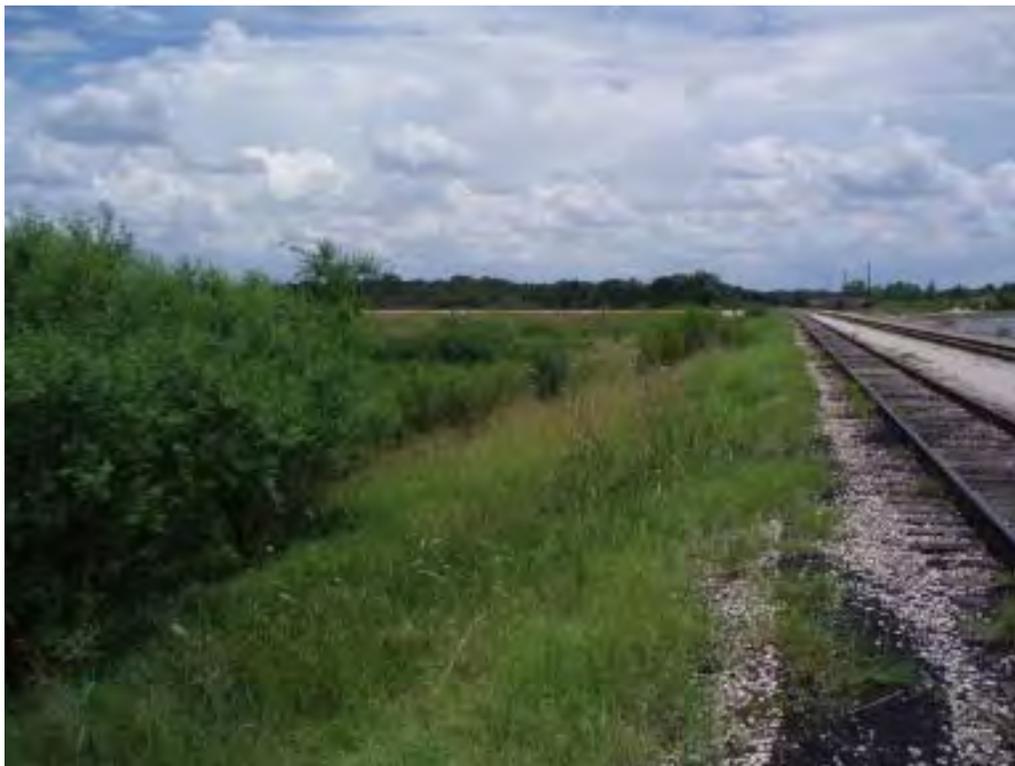
Photo No. 47: Reclaim Pond - East embankment exterior slope, looking south.

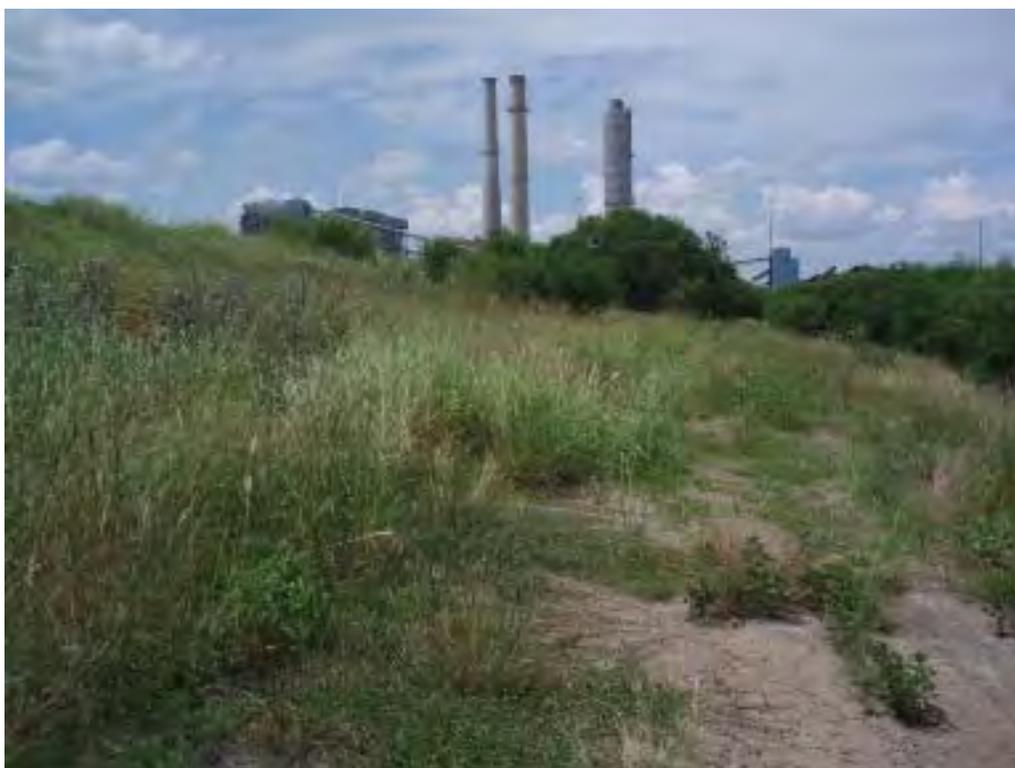
Photo No. 48: Reclaim Pond - East embankment exterior slope, looking north.

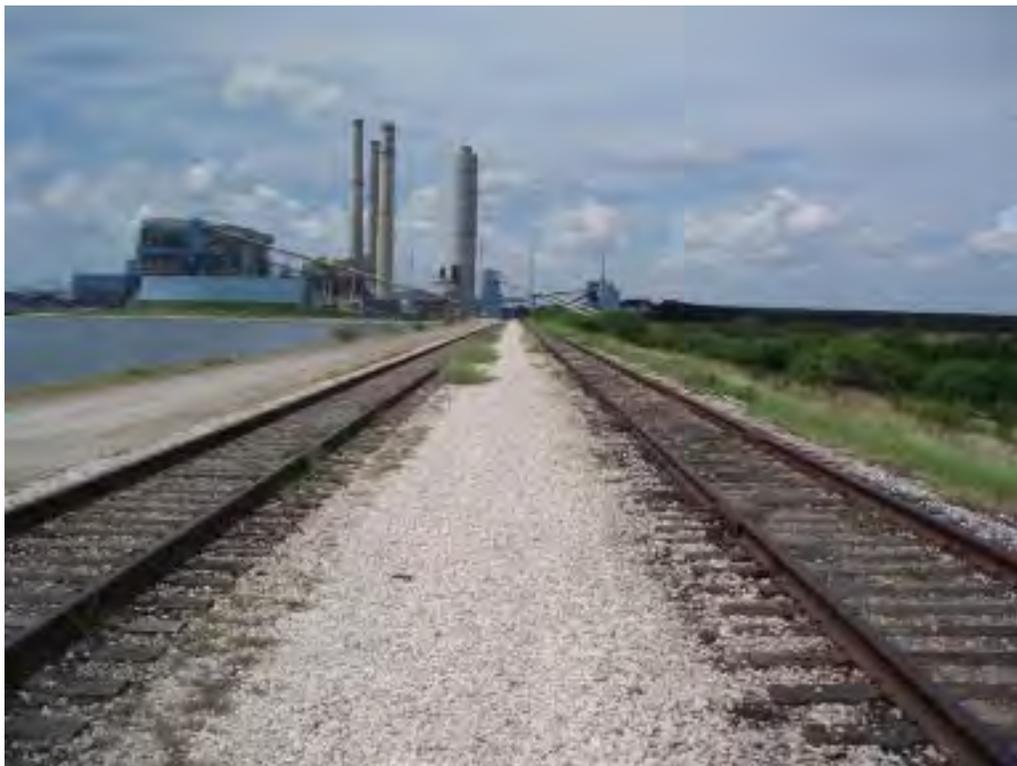
Photo No. 49: Reclaim Pond - East embankment crest, looking north.

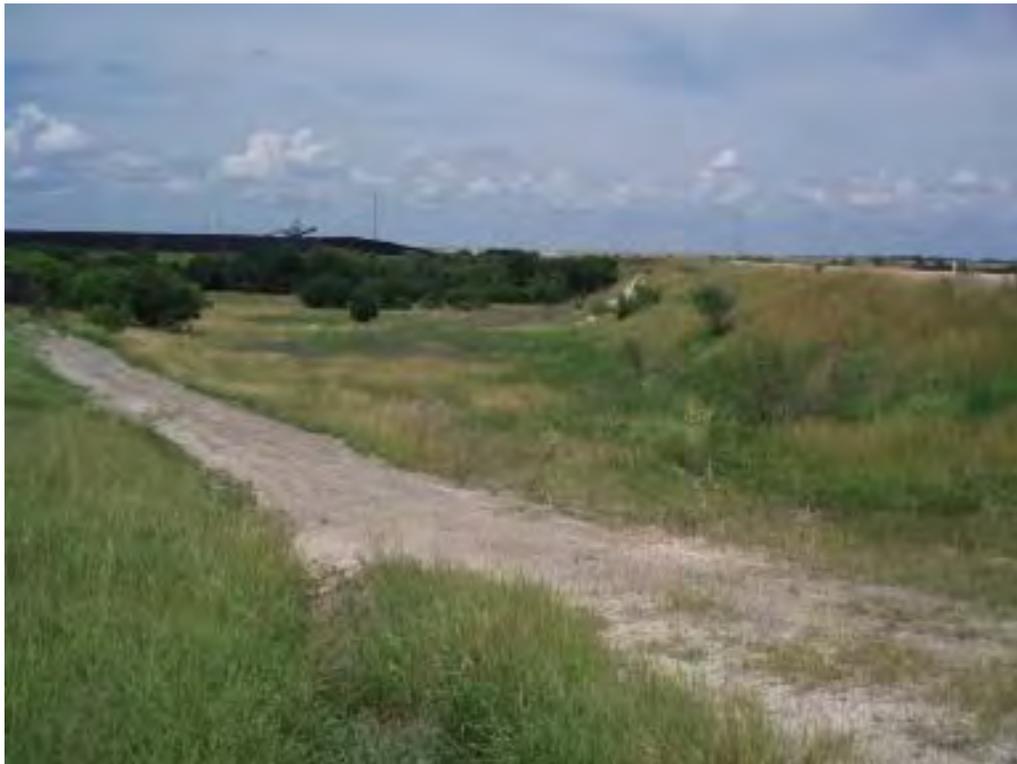
Photo No. 51: Reclaim Pond - Overview of east embankment downstream area. Note railroad embankment to the right side of photo.

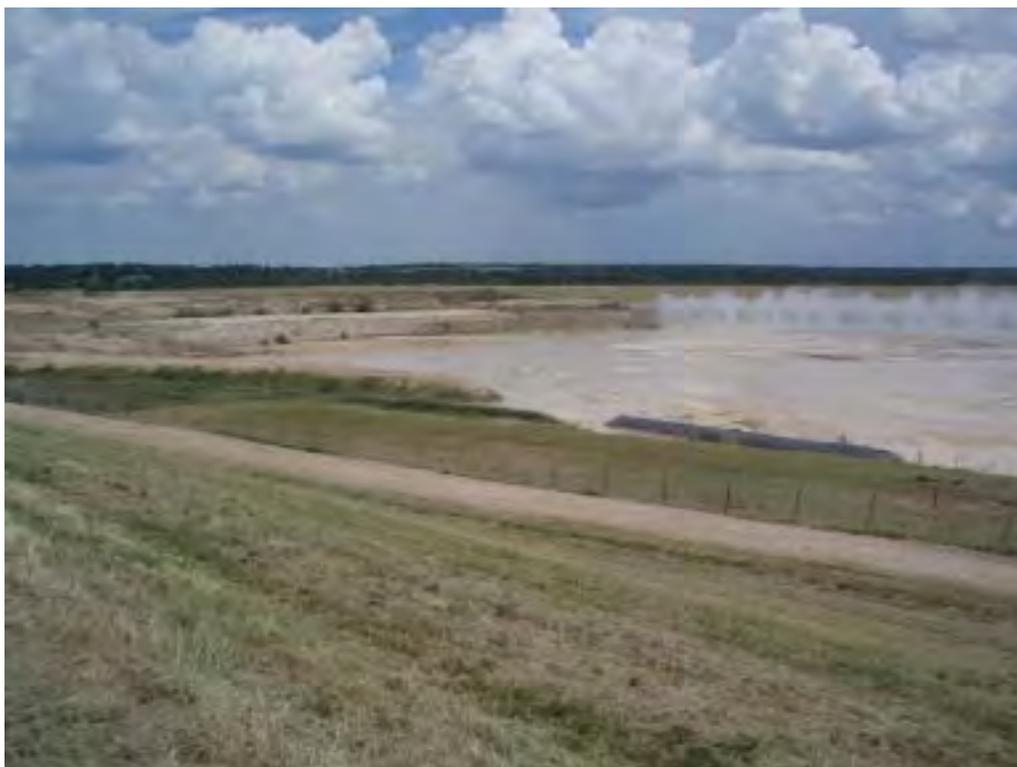
Photo No. 52: CADP - Overview of final settling basin, looking southeast. Note evaporation spray system on the right.

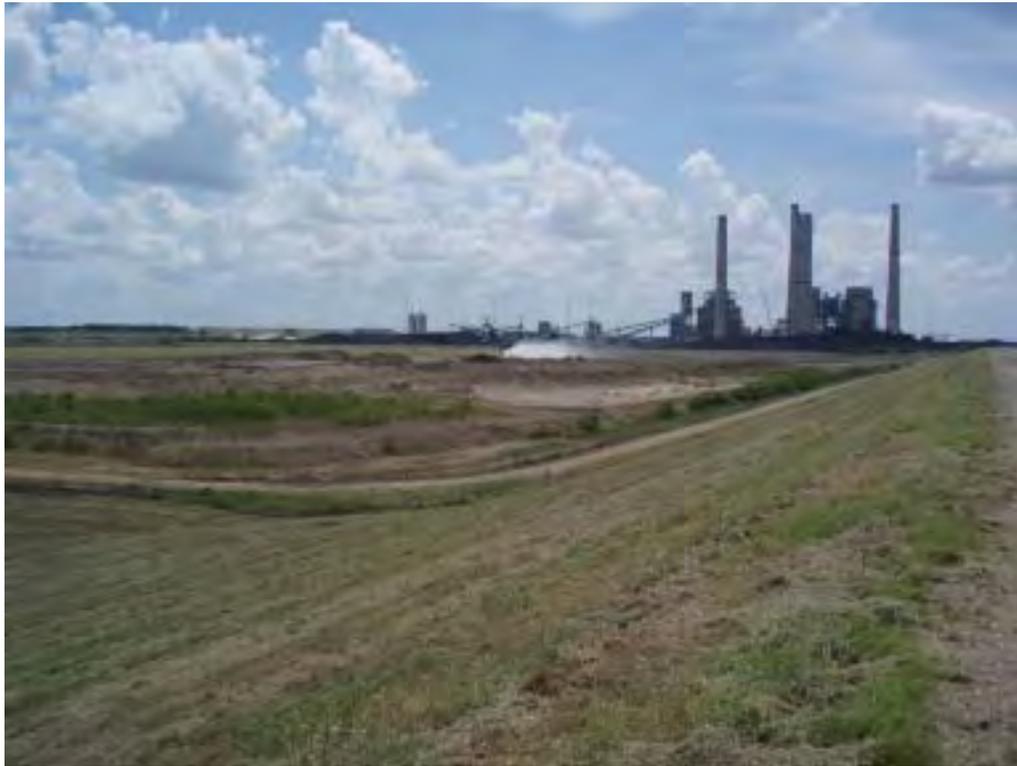
The CADP is incised on the north and west embankments. The south and east exterior slopes appear to be generally in fair condition (Photos 53, 54, 55, 57, 58, 60, 61, 62, 67, 68, 69, 71, 73, 74, 77, 78, and 85). The grass on the embankment was approximately 8 to 12 inches tall and was recently mowed. Trees and brush up to 6 inches in diameter were observed at the toe of the south embankment in the Coal Pile Run-off Pond. There were some bare spots near the middle of the south embankment exterior slope (Photo 81).

The crest of the CADP appeared to be generally in fair condition (Photos 53, 56, 59, 72, 75, 86, 89, 90, 91, 99, 100, 101, 102, 103, and 104). The crest surface consisted of gravel road base material and was used as an access road. Some minor rutting and depressions were observed on the east and west embankment crest. A tension crack in the previously raised portion of the crest was observed on the north embankment (Photo 99). The chain link fence and posts appeared to be holding the raised section of the crest preventing it from sloughing. The water level was at about El. 355 and there was approximately seven (7) feet of freeboard at the time of the site visit.

Photo No. 53: CADP - Overview of active portion of impoundment, looking southwest.

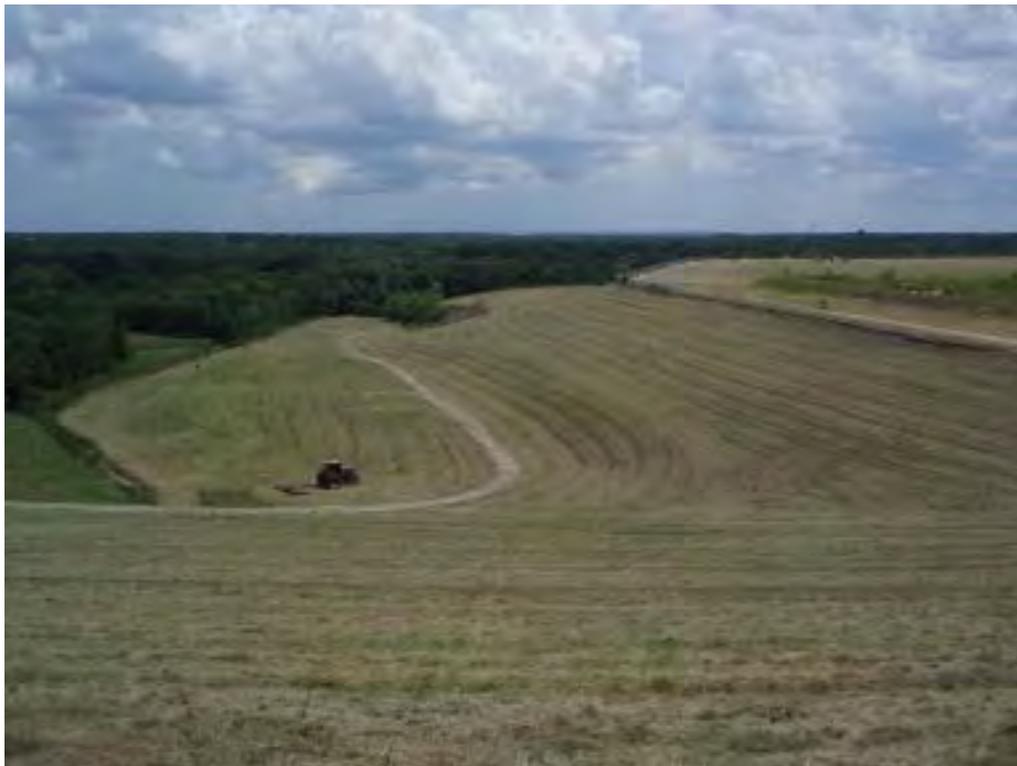
Photo No. 54: CADP - Overview of east embankment and downstream area, looking south.

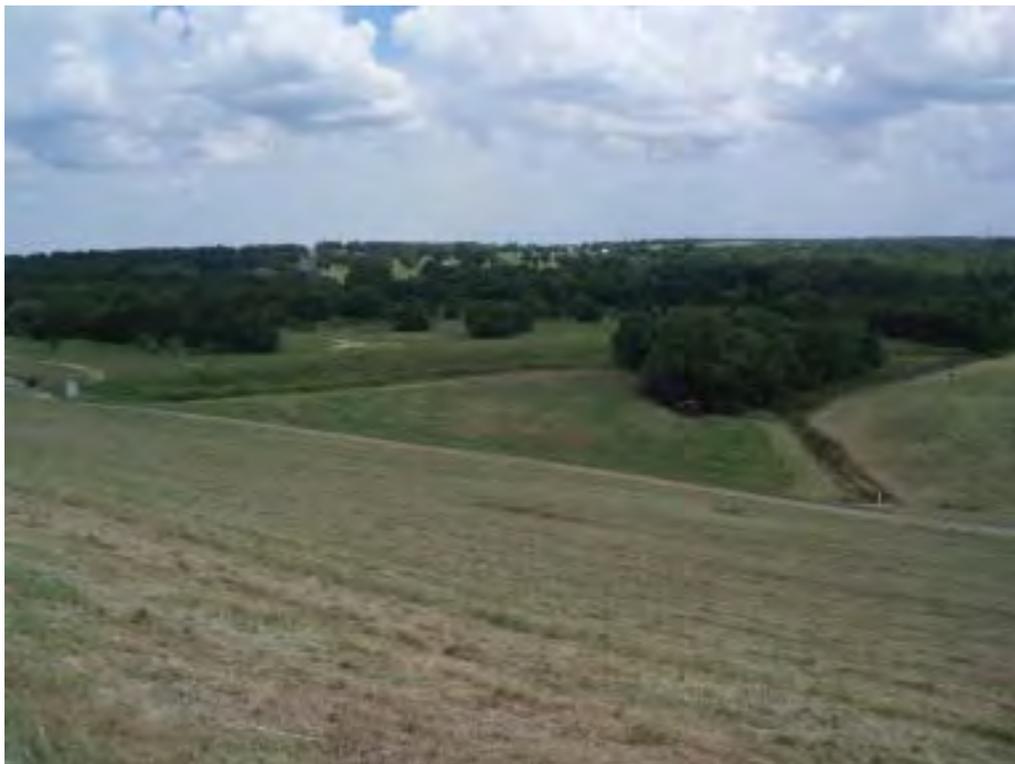
Photo No. 55: CADP - Overview of east embankment downstream area, looking southeast.

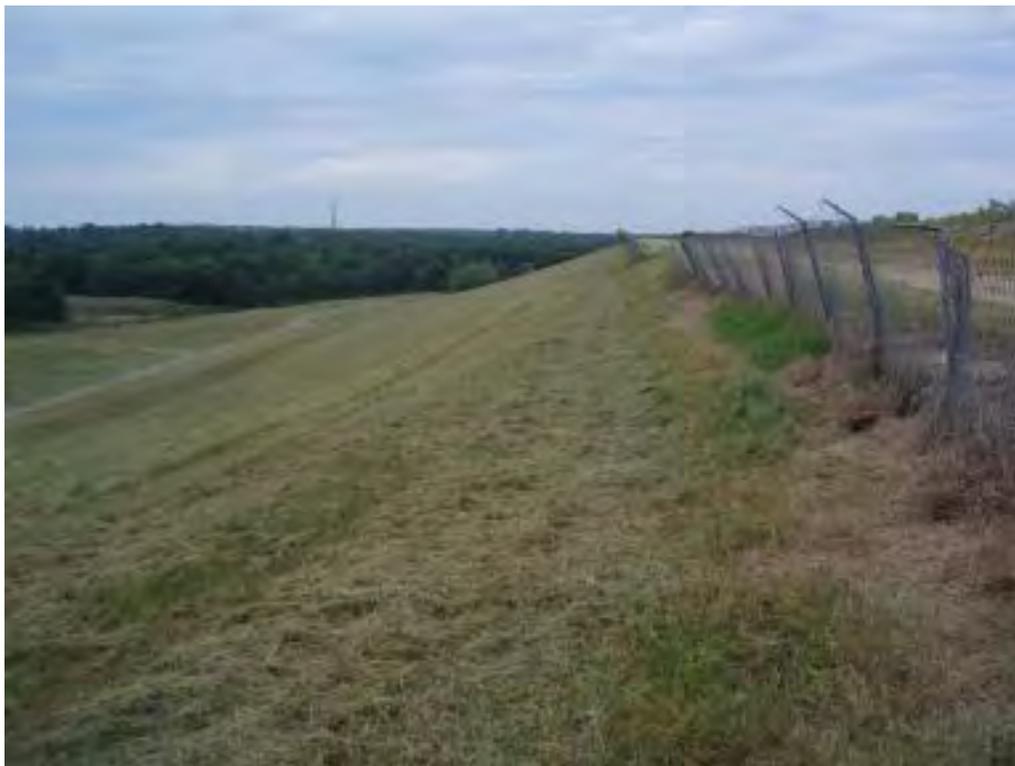
Photo No. 57: CADP - East embankment exterior slope, looking south.

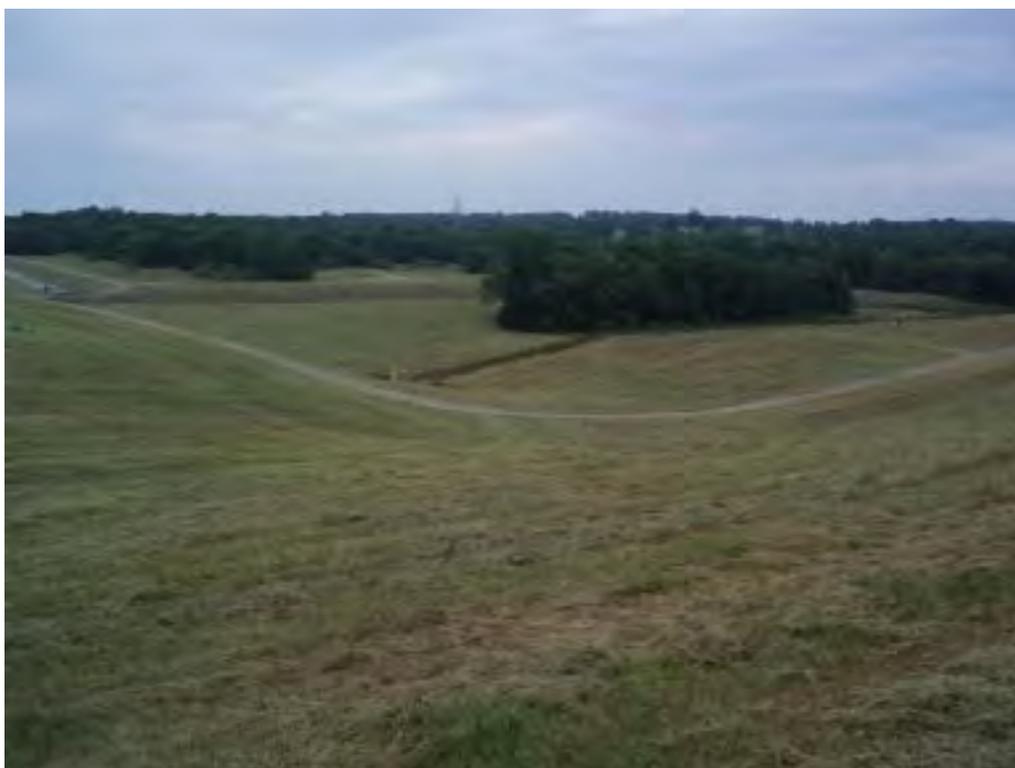
Photo No. 58: CADP - East embankment exterior slope, looking southeast at groin with Cedar Creek Dam.

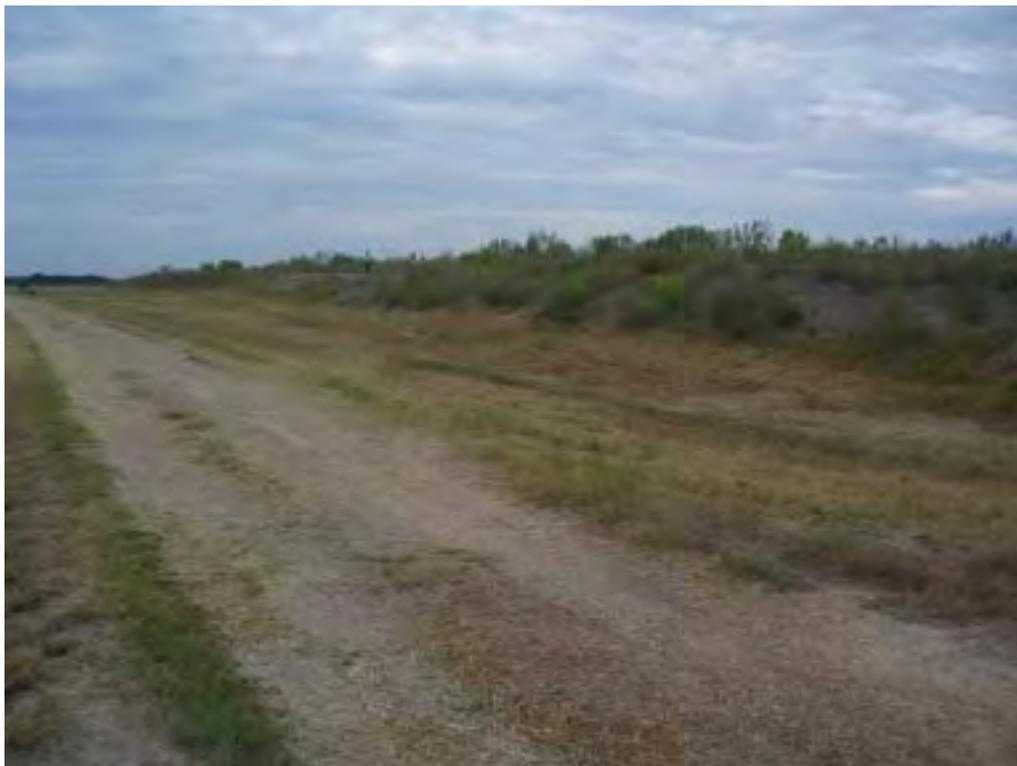
Photo No. 59: CADP - East embankment interior slope, looking southwest.

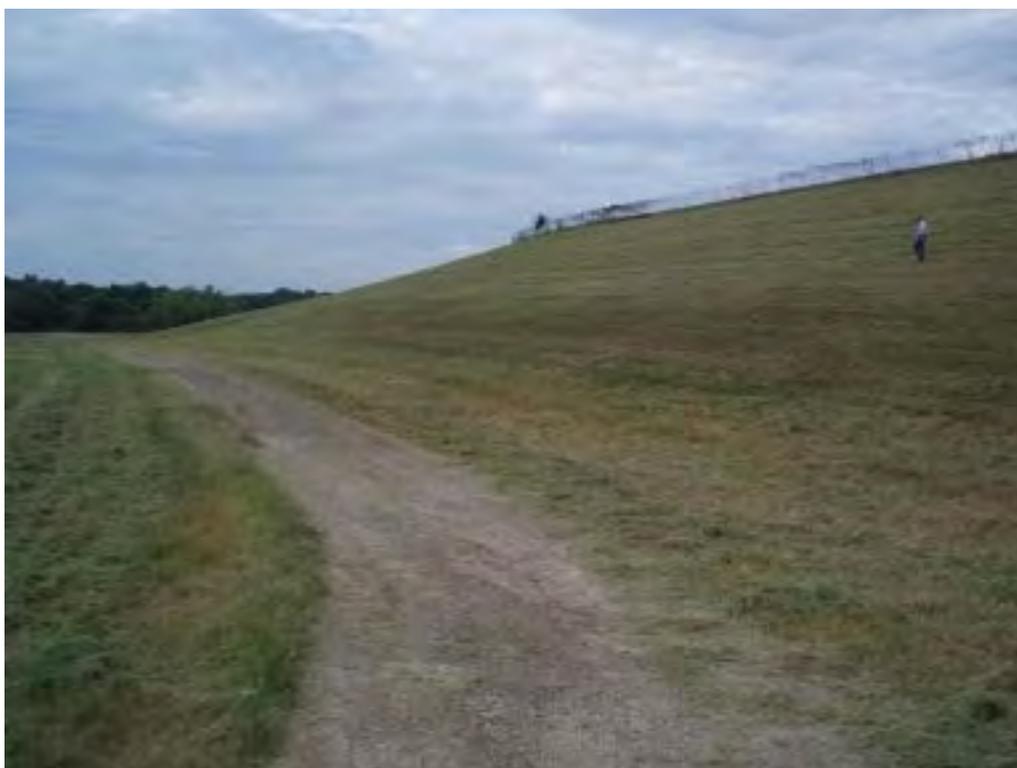
Photo No. 60: CADP - East embankment exterior slope looking southwest.

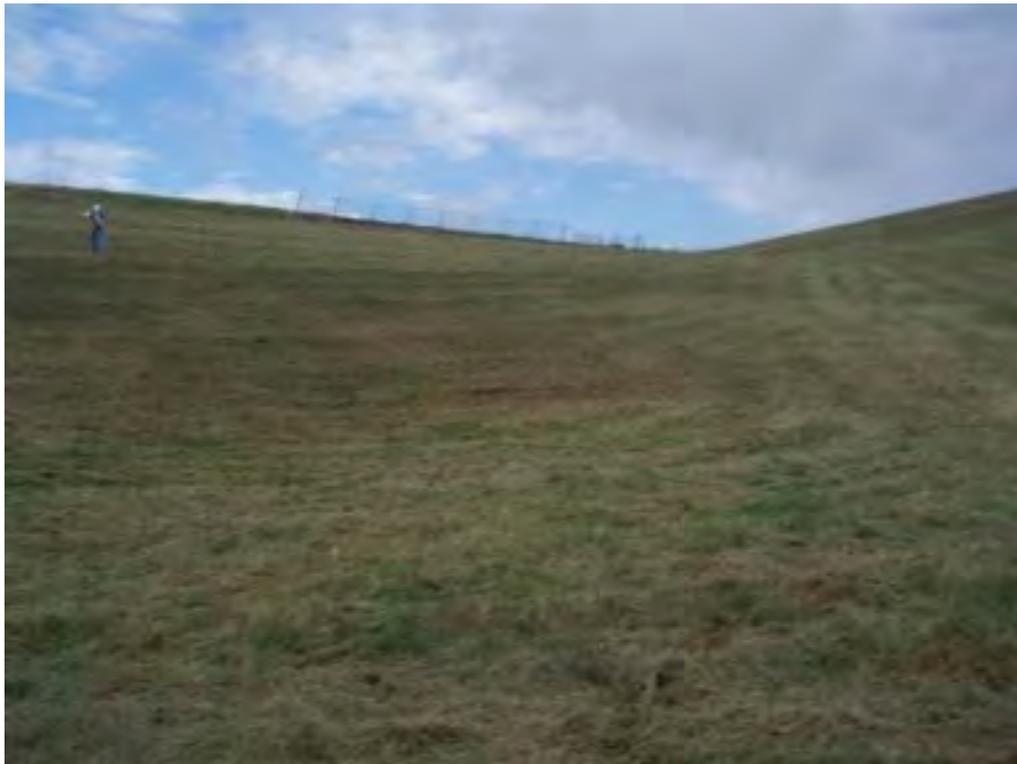
Photo No. 61: CADD - East embankment exterior slope, looking northwest at groin with Cedar Creek Dam.

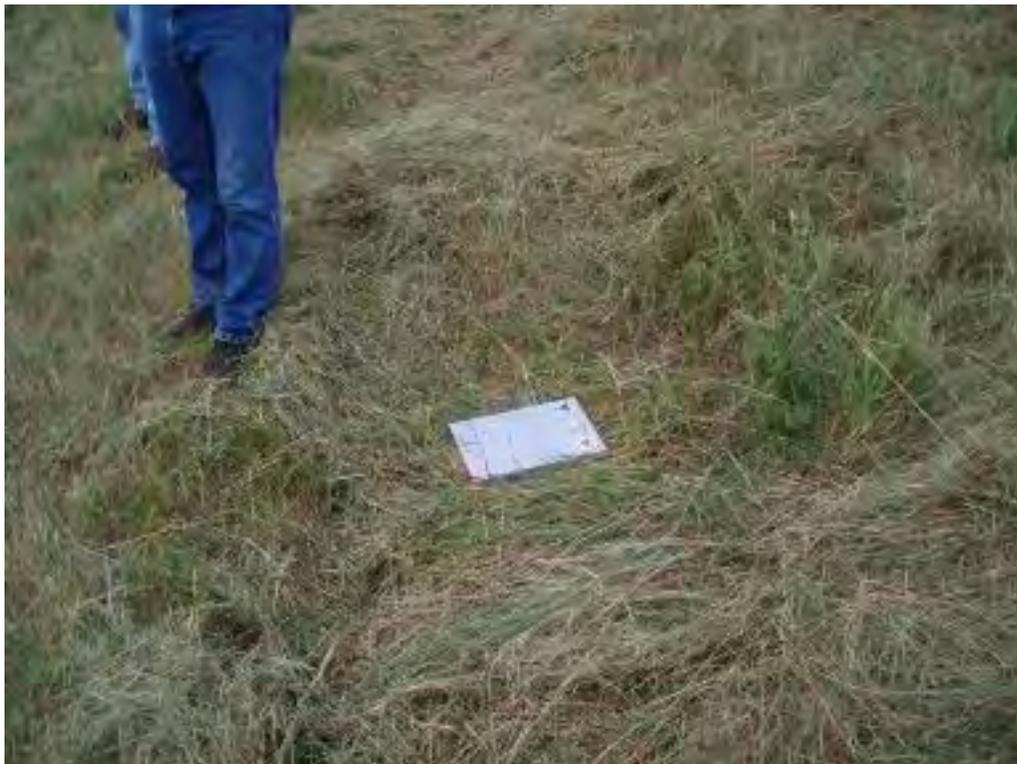
CDM observed 16 rodent holes, reportedly made by armadillos, on the east embankment exterior slope. The holes ranged in size from 4 to 8 inches in diameter (Photos 63 and 65). There were also multiple surface depressions that were likely rodent holes that collapsed, possibly as a result of mowing operations (Photos 62, 79, 80, and 84).

Photo No. 62: CADD - East embankment exterior slope, looking at 3'Wx3'Lx1'D depression. Possible collapsed rodent burrow.

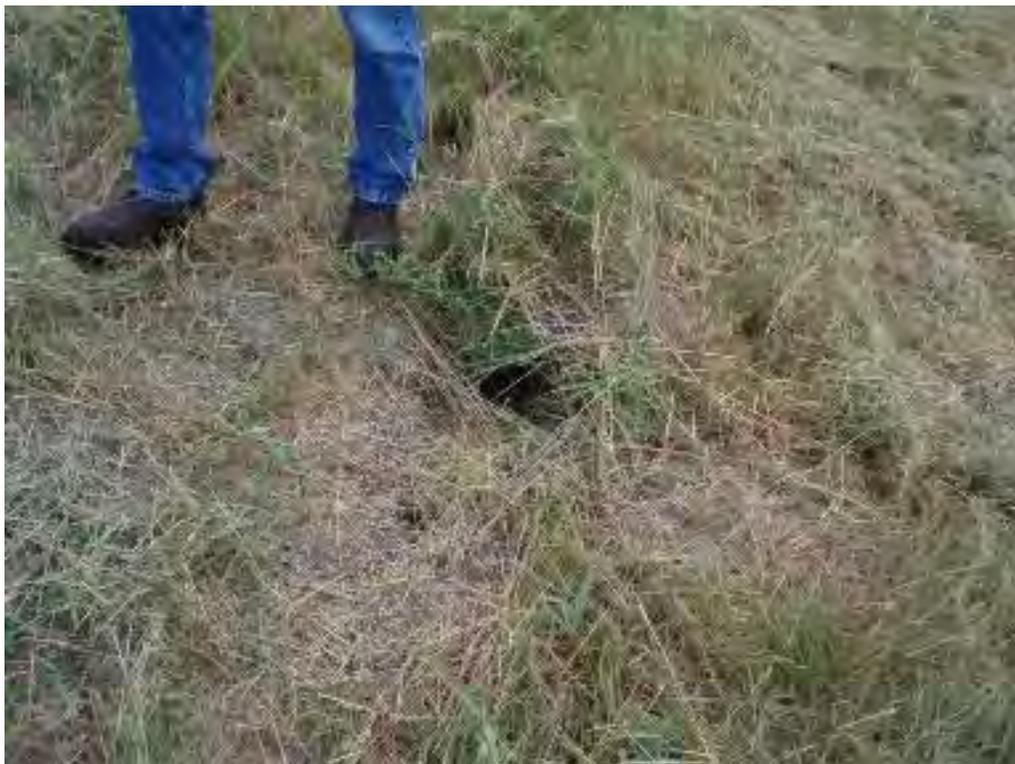
Photo No. 63: CADP - East embankment exterior slope, looking at a 6-inch-diameter rodent hole.

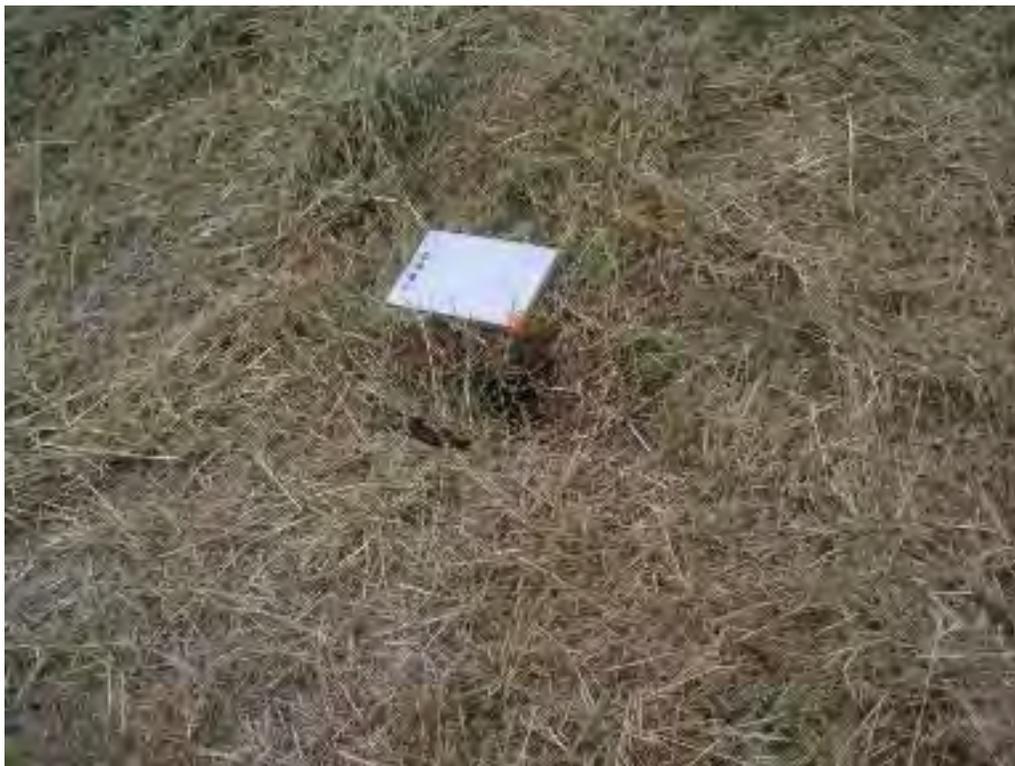
Photo No. 65: CADP - East embankment exterior slope, looking at an 8-inch-diameter rodent hole.

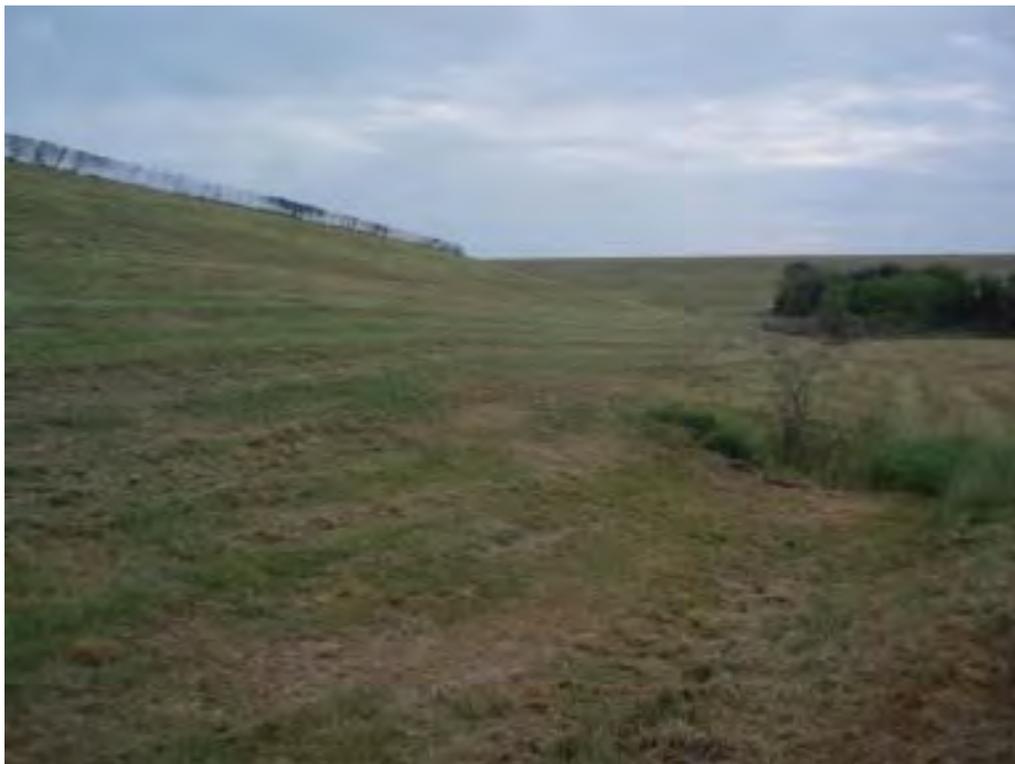
Photo No. 67: CADP - East embankment exterior slope, looking north.

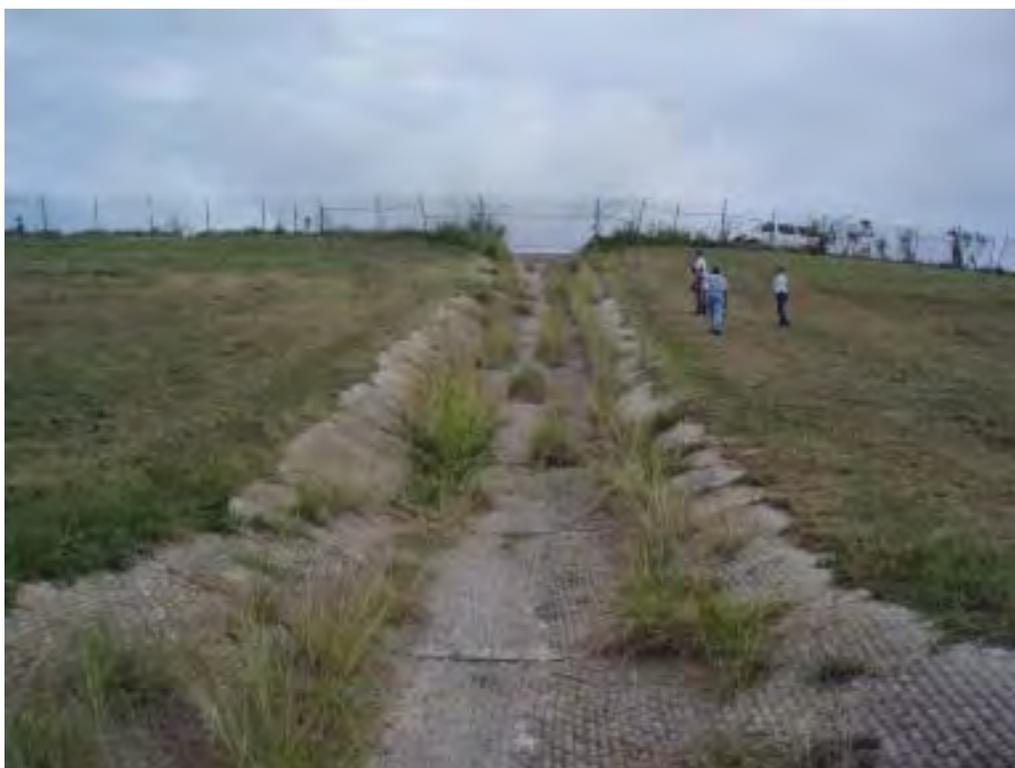
Photo No. 68: CADP - East embankment exterior slope, looking west at stormwater discharge channel from capped portion of the impoundment.

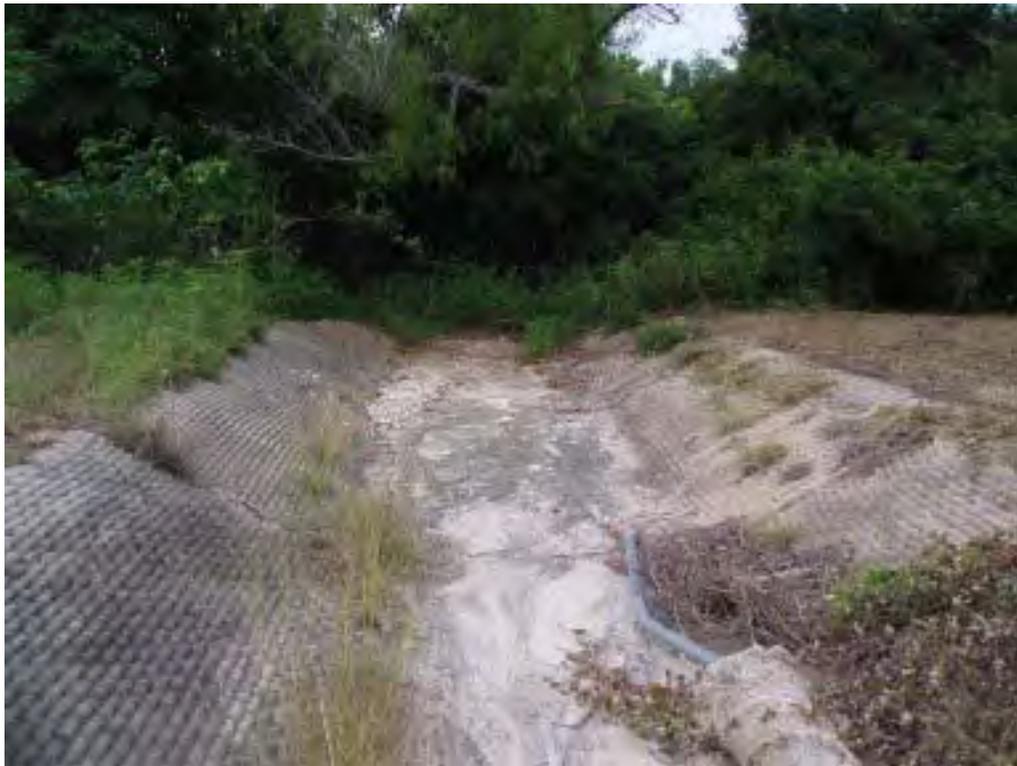
Photo No. 69: CADP - East embankment exterior slope, looking south at stormwater discharge channel from capped portion of the impoundment.

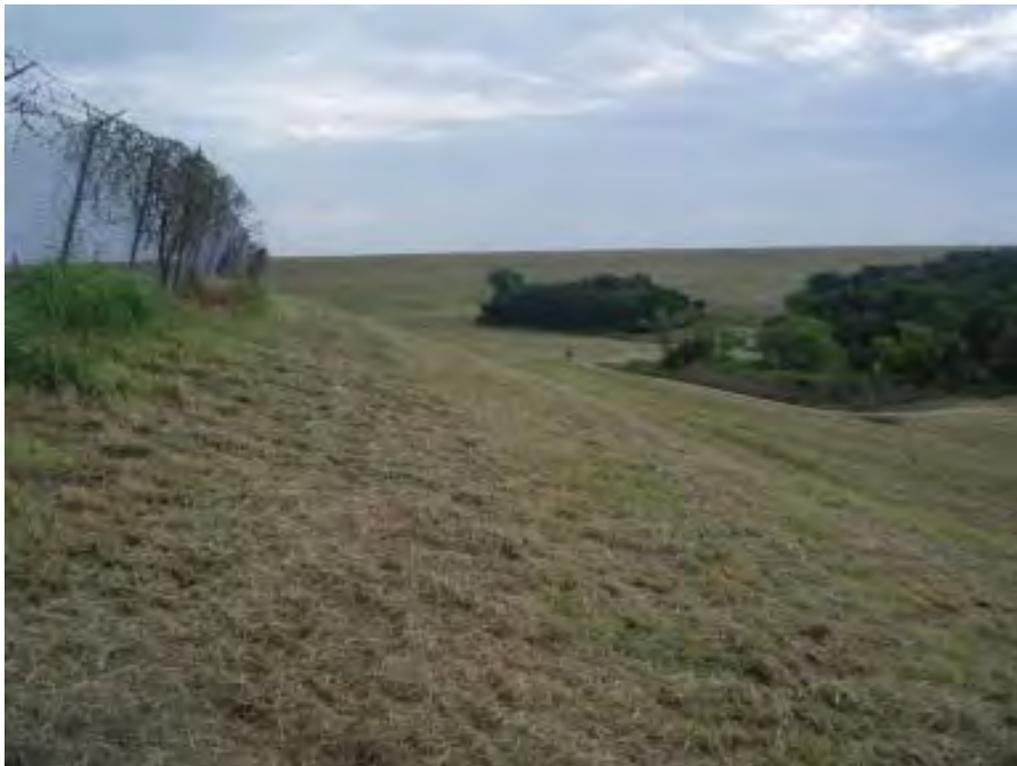
Photo No. 70: CADP - East embankment exterior slope, looking north.
