Assessment of Dam Safety of Coal Combustion Surface Impoundments

Sam Seymour - Fayette Power Project Station

Lower Colorado River Authority

April 18, 2011

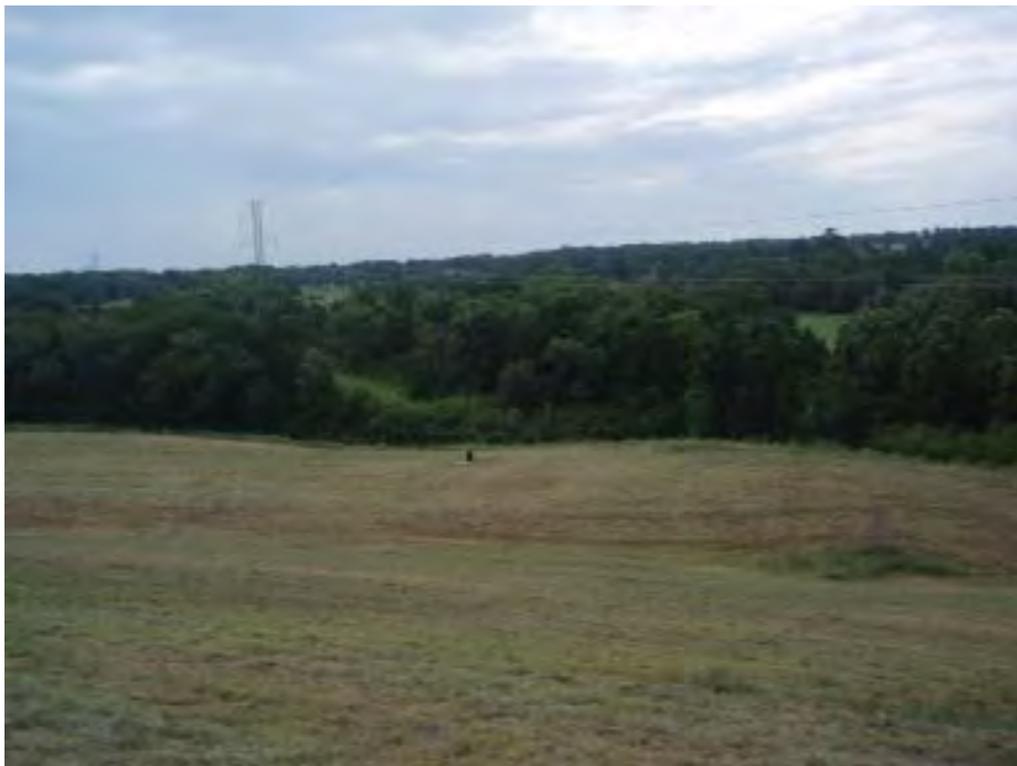
The CADP is incised on the north and west embankments. The south and east exterior slopes appear to be generally in fair condition (Photos 53, 54, 55, 57, 58, 60, 61, 62, 67, 68, 69, 71, 73, 74, 77, 78, and 85). The grass on the embankment was approximately 8 to 12 inches tall and was recently mowed. Trees and brush up to 6 inches in diameter were observed at the toe of the south embankment in the Coal Pile Run-off Pond. There were some bare spots near the middle of the south embankment exterior slope (Photo 81).

Photo No. 71: CADP - Overview of east embankment downstream area, looking east.

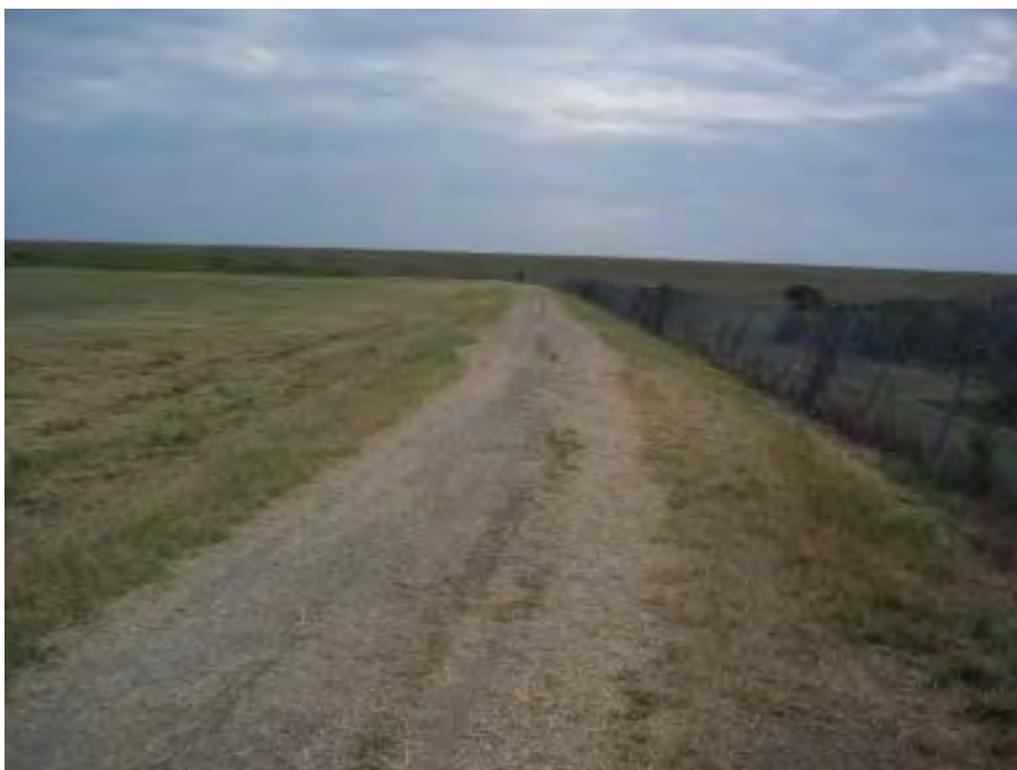
The crest of the CADP appeared to be generally in fair condition (Photos 53, 56, 59, 72, 75, 86, 89, 90, 91, 99, 100, 101, 102, 103, and 104). The crest surface consisted of gravel road base material and was used as an access road. Some minor rutting and depressions were observed on the east and west embankment crest. A tension crack in the previously raised portion of the crest was observed on the north embankment (Photo 99). The chain link fence and posts appeared to be holding the raised section of the crest preventing it from sloughing. The water level was at about El. 355 and there was approximately seven (7) feet of freeboard at the time of the site visit.

Photo No. 72: CADP - East embankment crest, looking north.

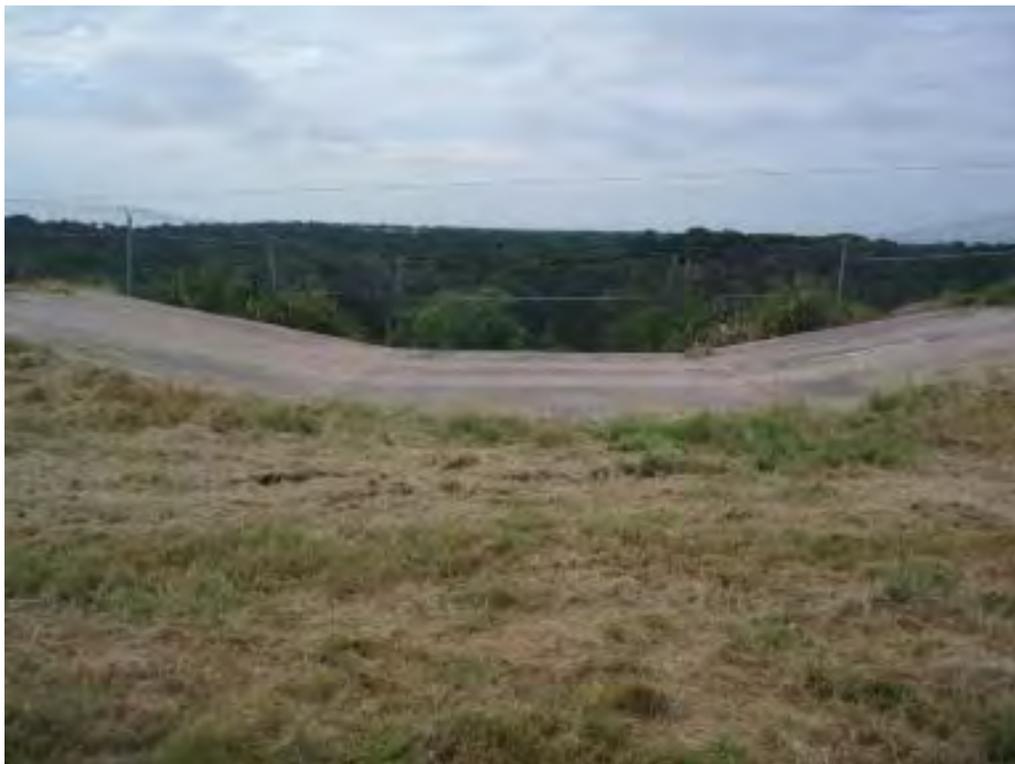
Photo No. 73: CADP - East embankment, looking south at approach to discharge channel inlet control section from capped portion of the impoundment.

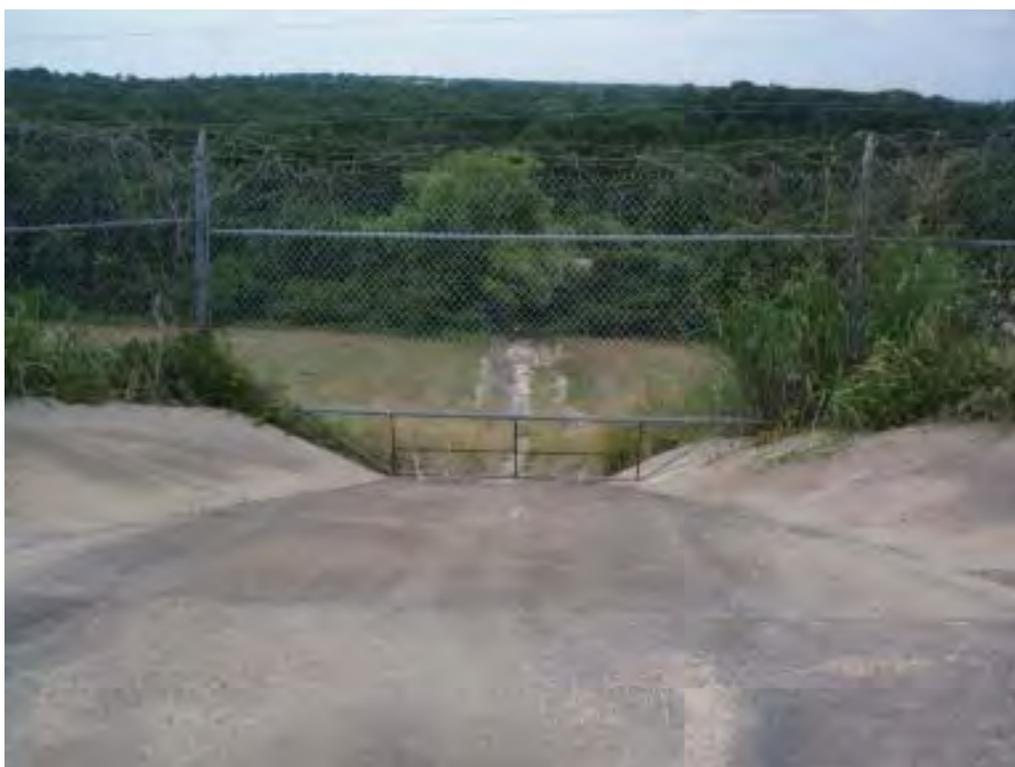
Photo No. 74: CADP - East embankment, looking south at stormwater control section outlet from capped portion of the impoundment.

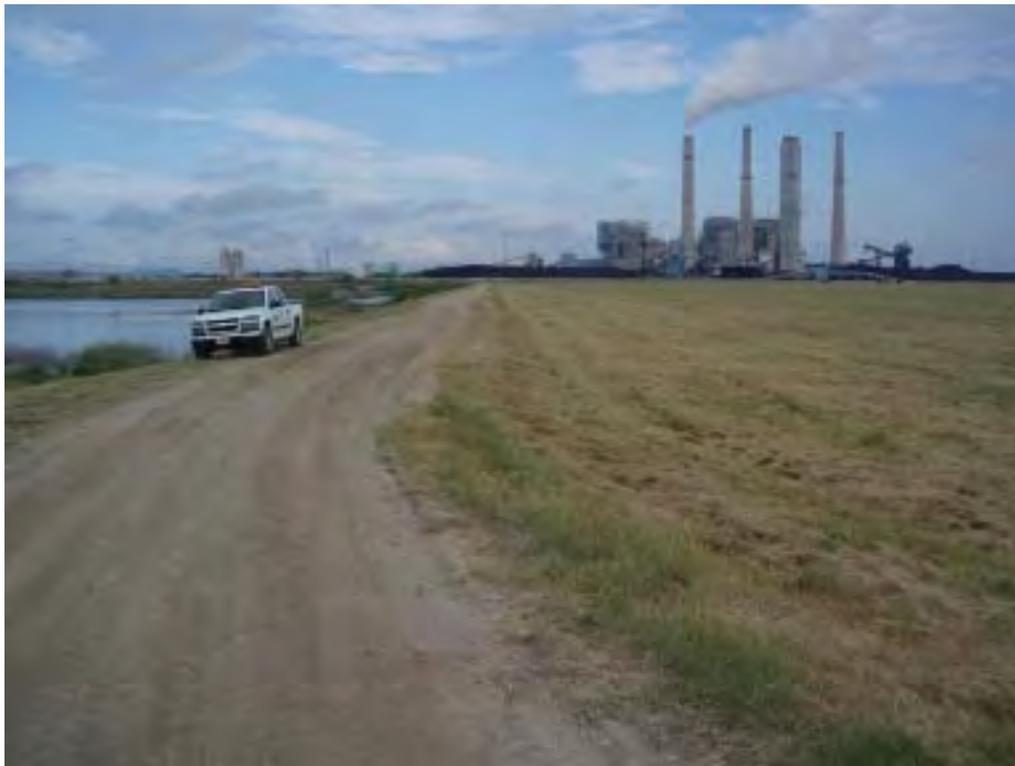
Photo No. 75: CADP - South embankment crest and capped area, looking west.

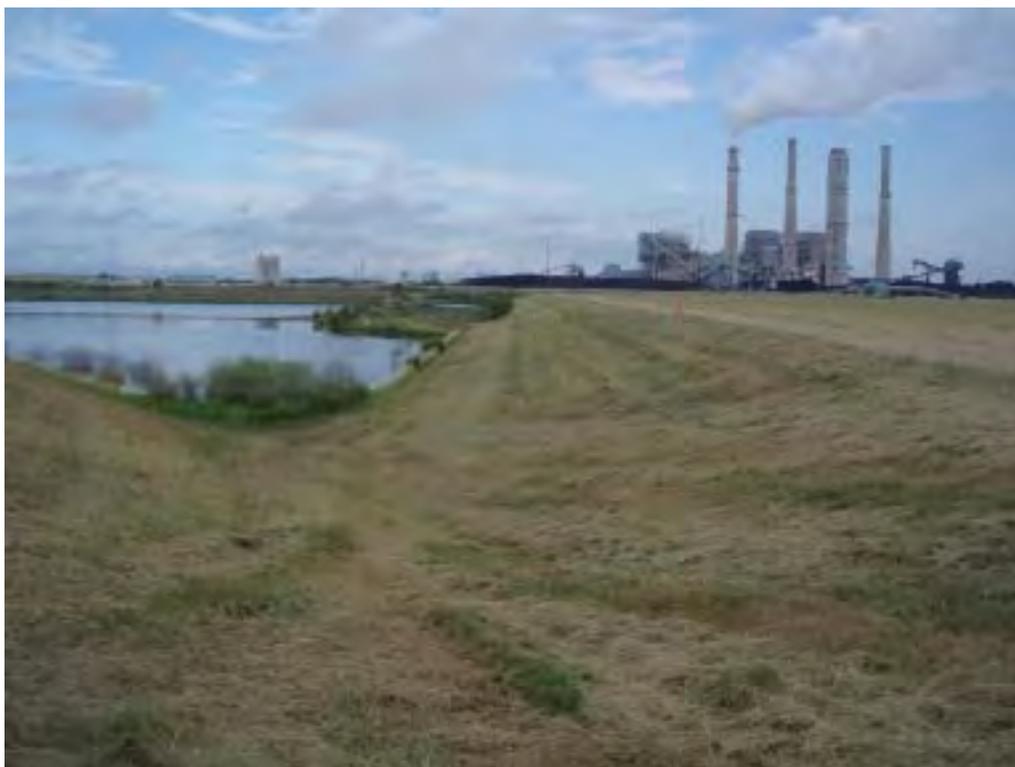
Photo No. 76: CADP - Groin of south embankment exterior slope and Coal Pile Run-off Pond interior slope, looking west. Note water, brush and small trees at toe of slope.

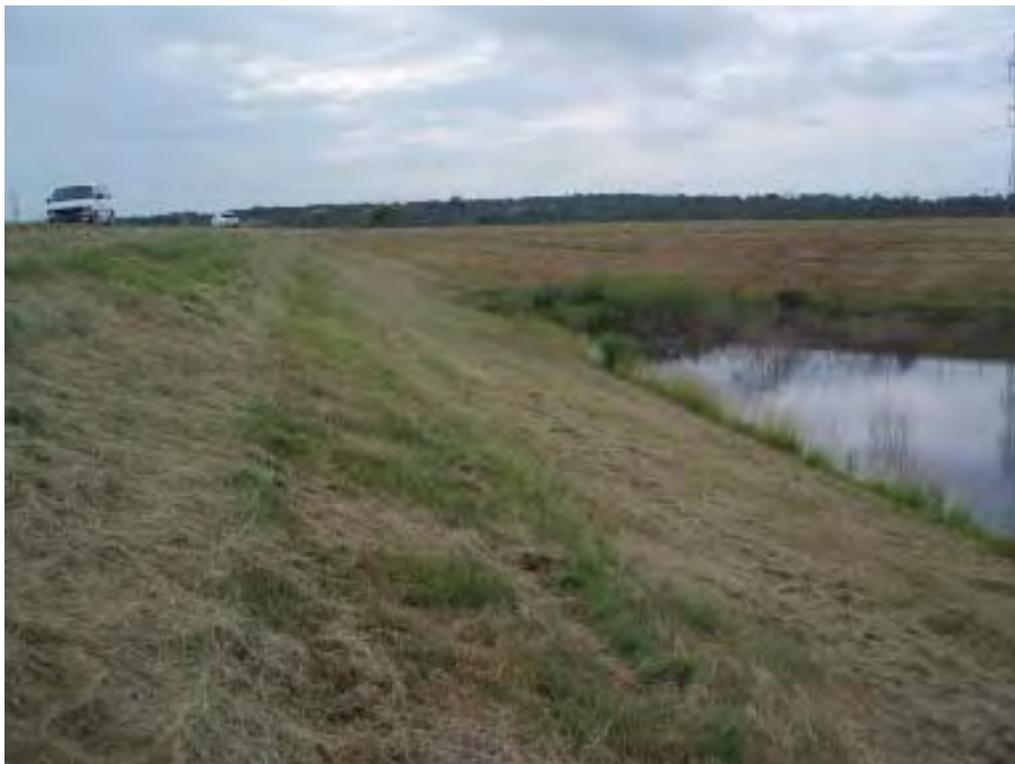
Photo No. 77: CADP - South embankment exterior slope, looking east at groin with Coal Pile Run-off Pond. Note water, brush and small trees at toe of slope.

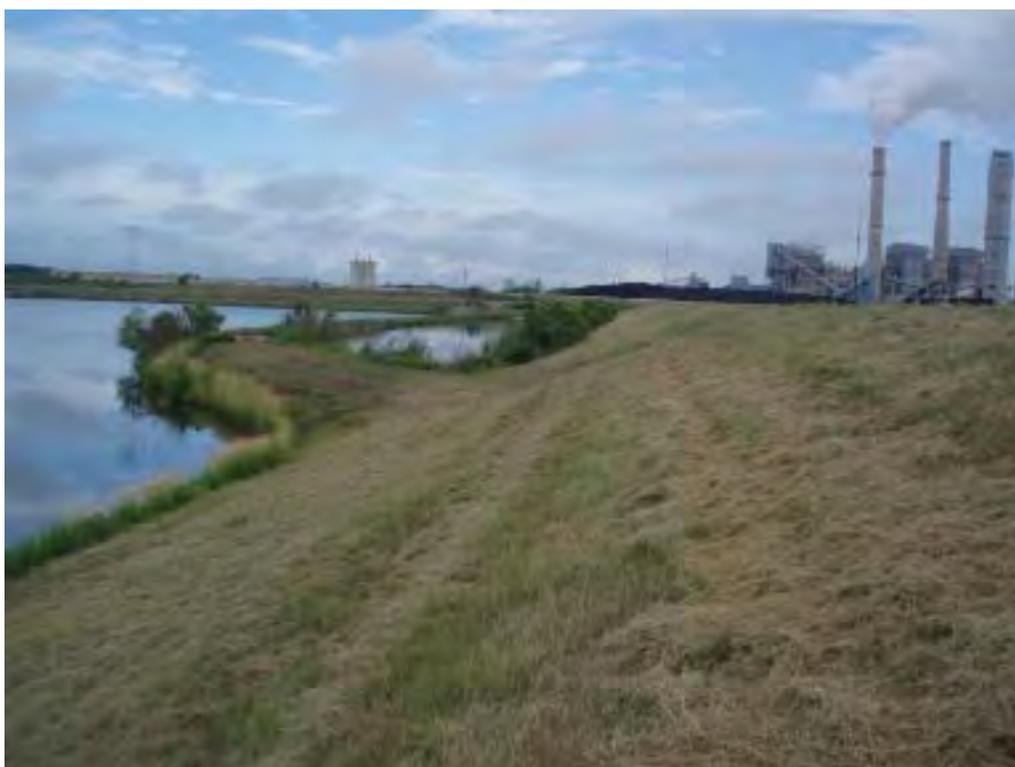
Photo No. 78: CADP - South embankment exterior slope, looking west.

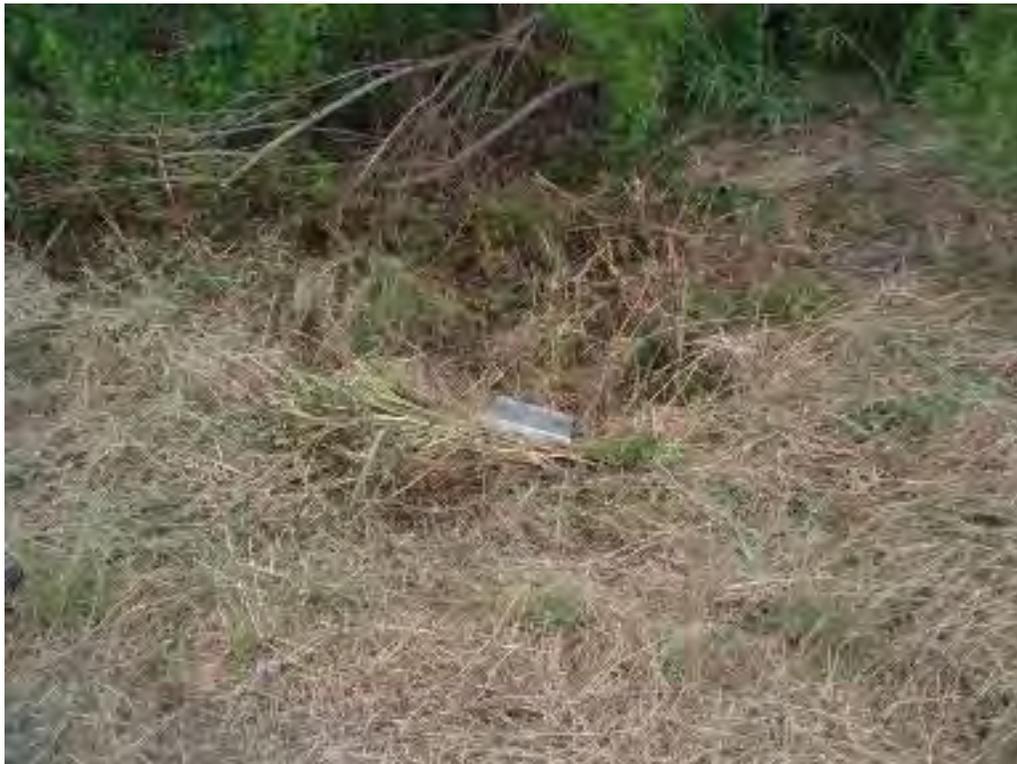
Photo No. 79: CADP - South embankment exterior slope, looking at 3'Wx4'Lx2'D depression at toe of slope. Possible collapsed rodent burrow

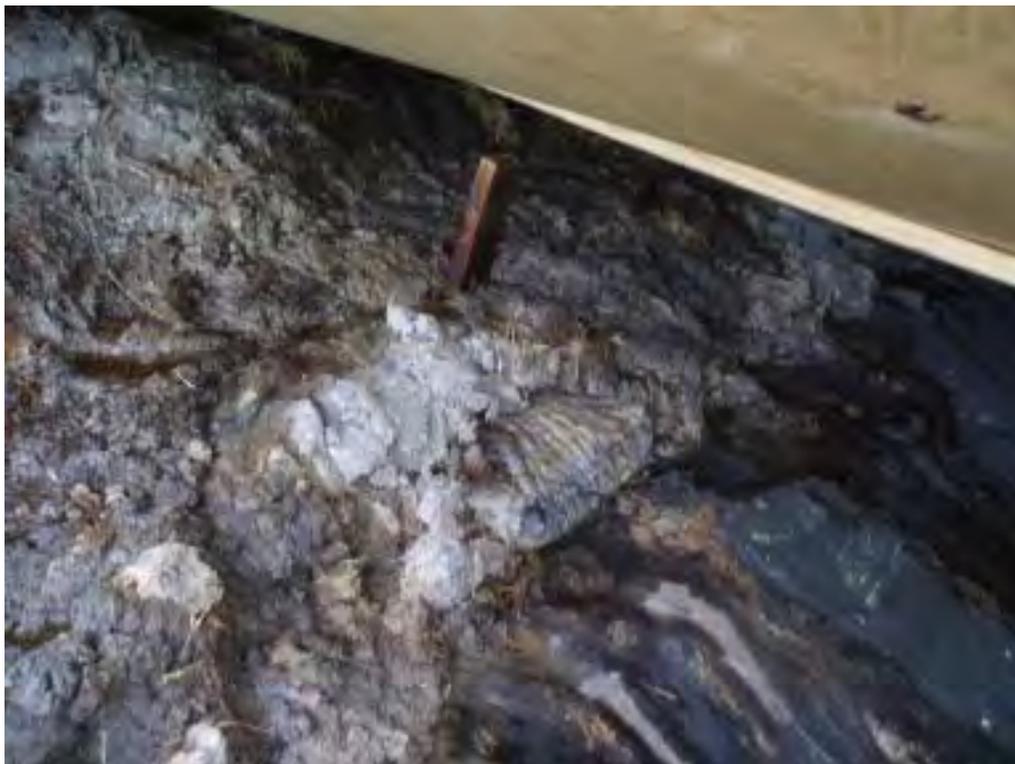
21.	Minor seepage collected in toe drain system of east embankment and discharges into sump pit. No flow observed during site visit. One isolated seep on exterior of south embankment, Qavg ~10 gal/day based on data provided.

Photo No. 83: CADP - South embankment exterior slope, looking at seep. Note liner down slope of seep to collect water. Flow ~8 gallons per day.

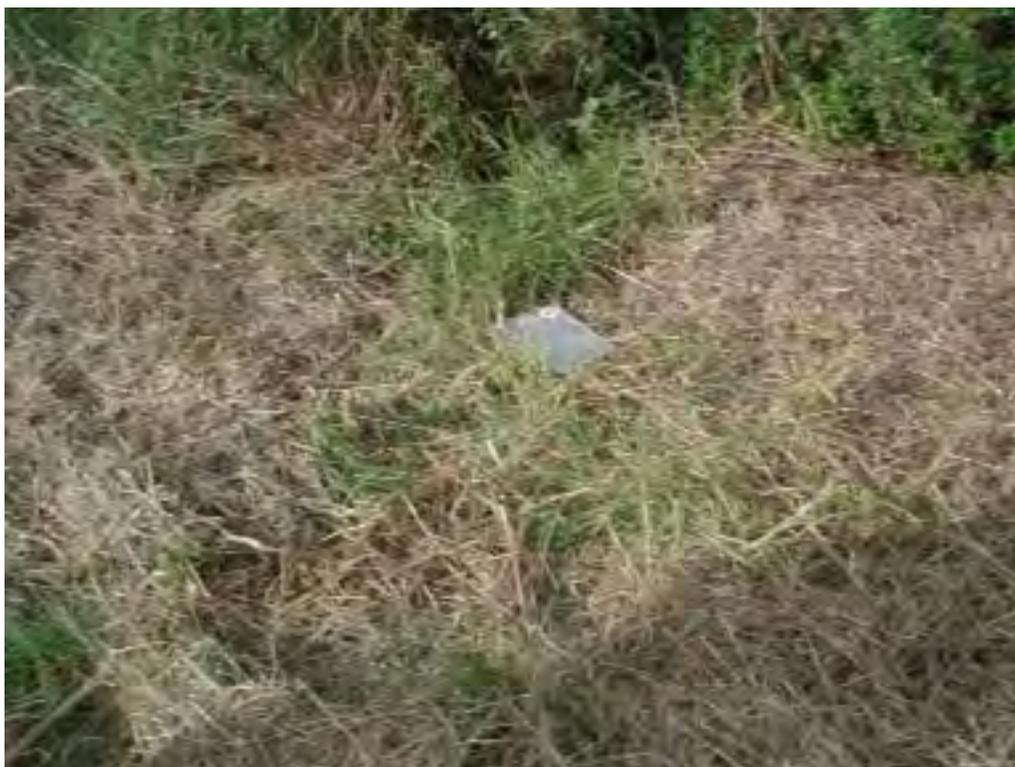
Photo No. 84: CADP - South embankment exterior slope, looking at 2'Wx4'Lx1'D depression at toe of slope. Possible collapsed rodent burrow.

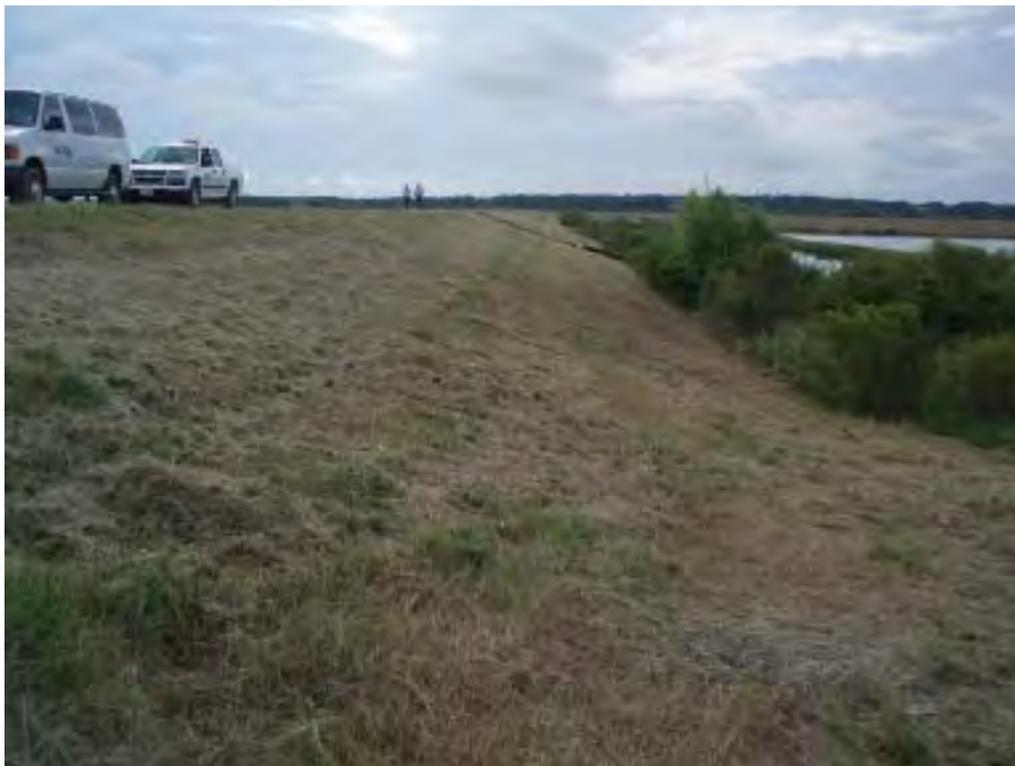
Photo No. 85: CADP - South embankment exterior slope, looking east.

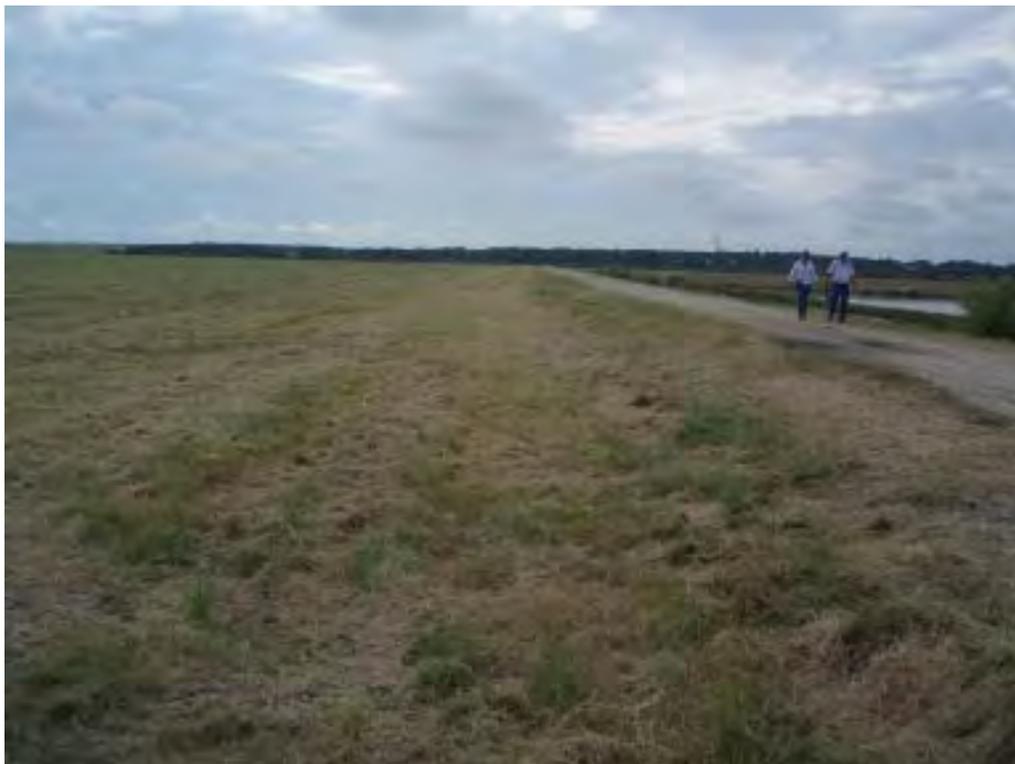
Photo No. 87: CADP - South embankment, looking east at capped portion of impoundment.

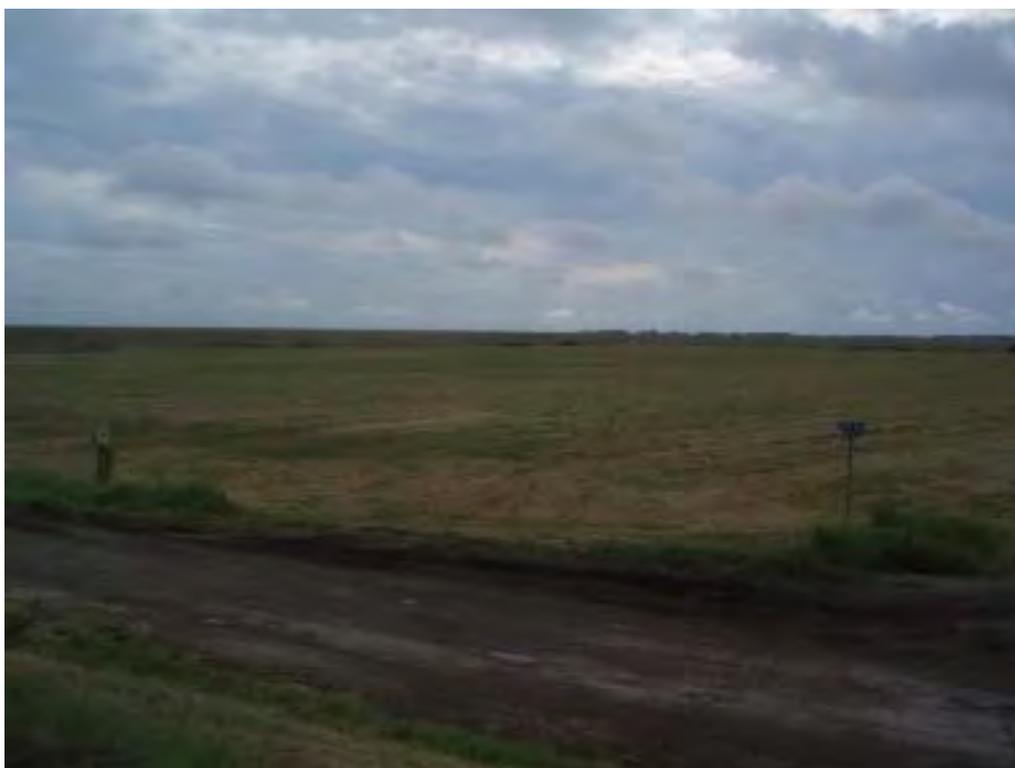
Photo No. 88: CADP - Overview of capped area, looking northeast from southwest corner of impoundment.

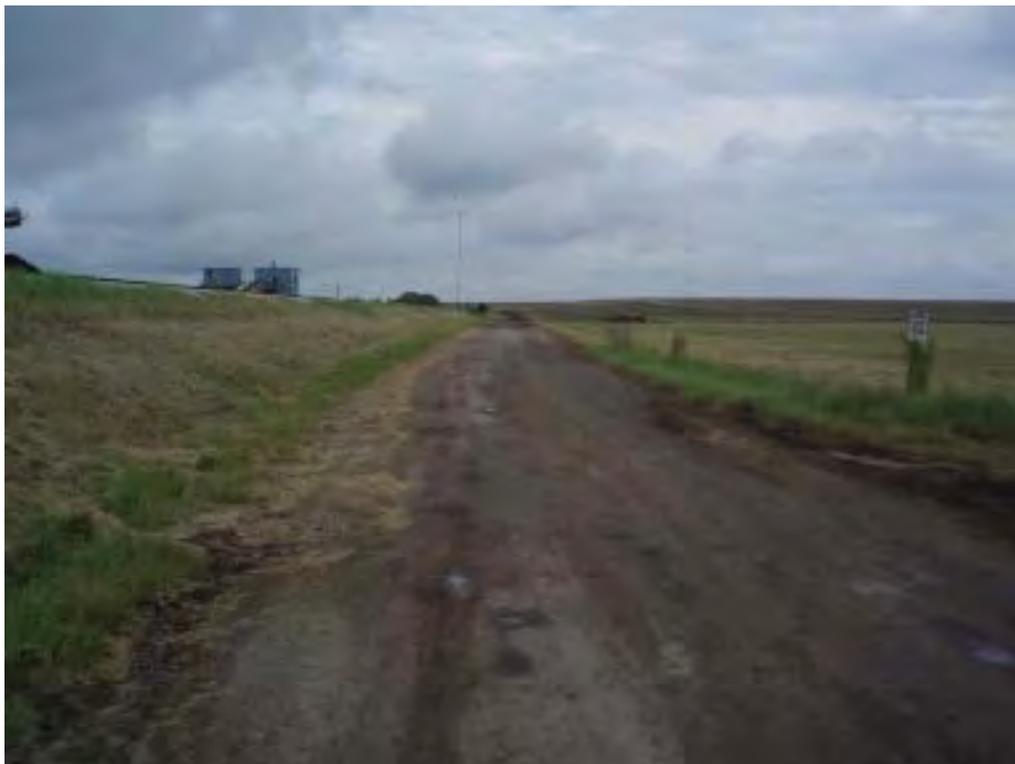
Photo No. 89: CADP - West embankment crest, looking north.

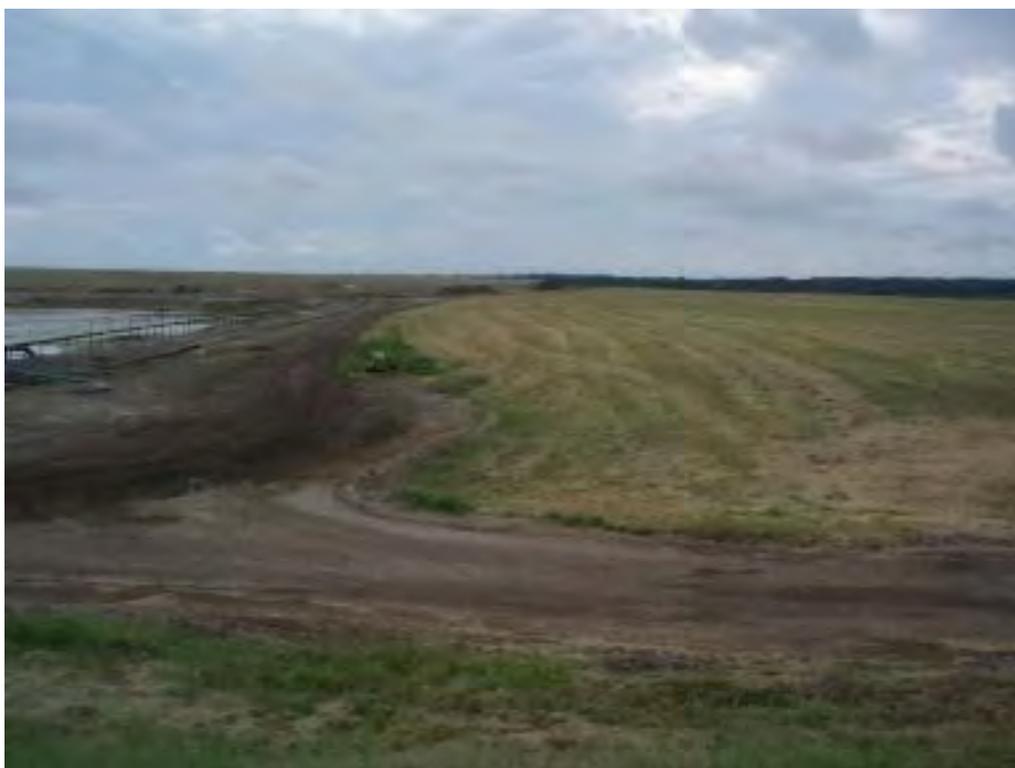
Photo No. 90: CADP - overview of transition between the active and the capped portion of the impoundment, looking east.

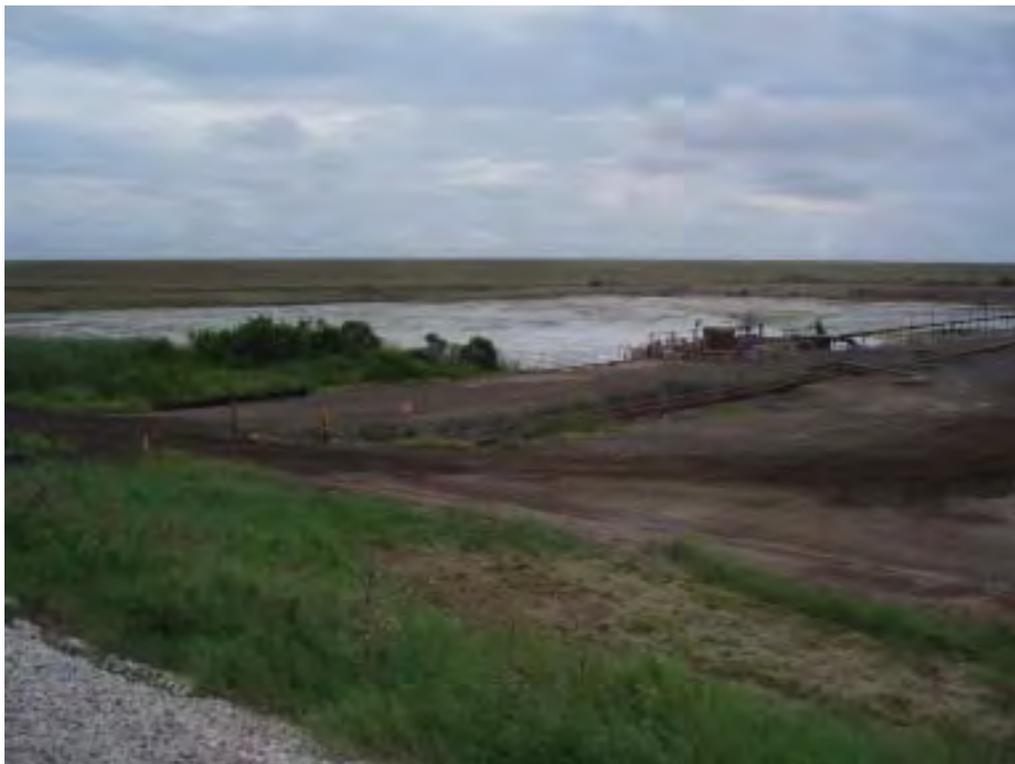
Photo No. 91: CADP - Overview of the active portion of the impoundment, looking northeast.

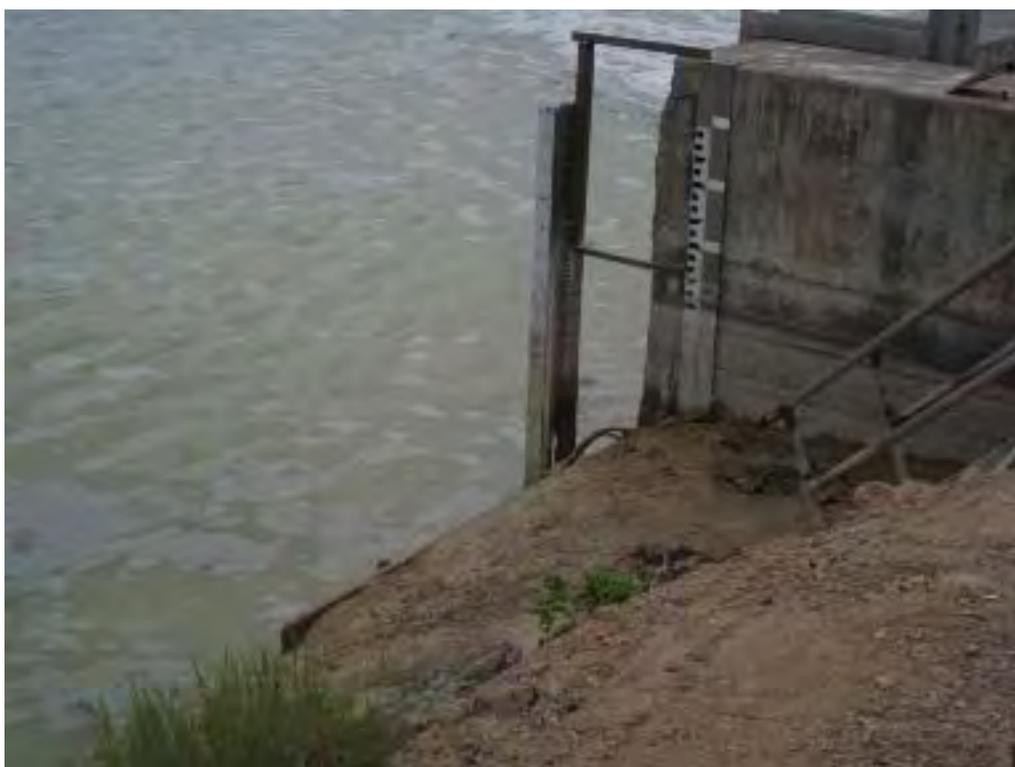
On the northwest corner of the intake structure there are two manual staff gauges in the CADP (Photos 92 and 93). The pond water levels are recorded twice a day and reported in a daily status report that is electronically mailed to pertinent staff.

Photo No. 92: CADP - West embankment interior slope, looking at staff gage on intake structure.

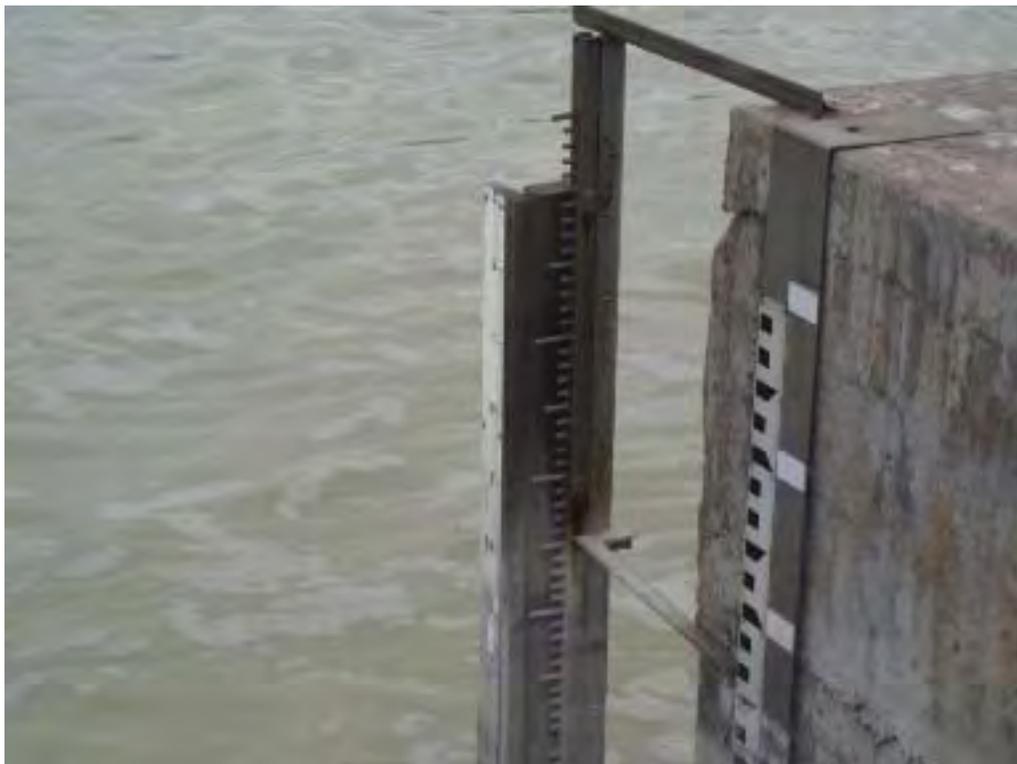
Photo No. 93: CADP - West embankment interior slope, close up of staff gage on intake structure.

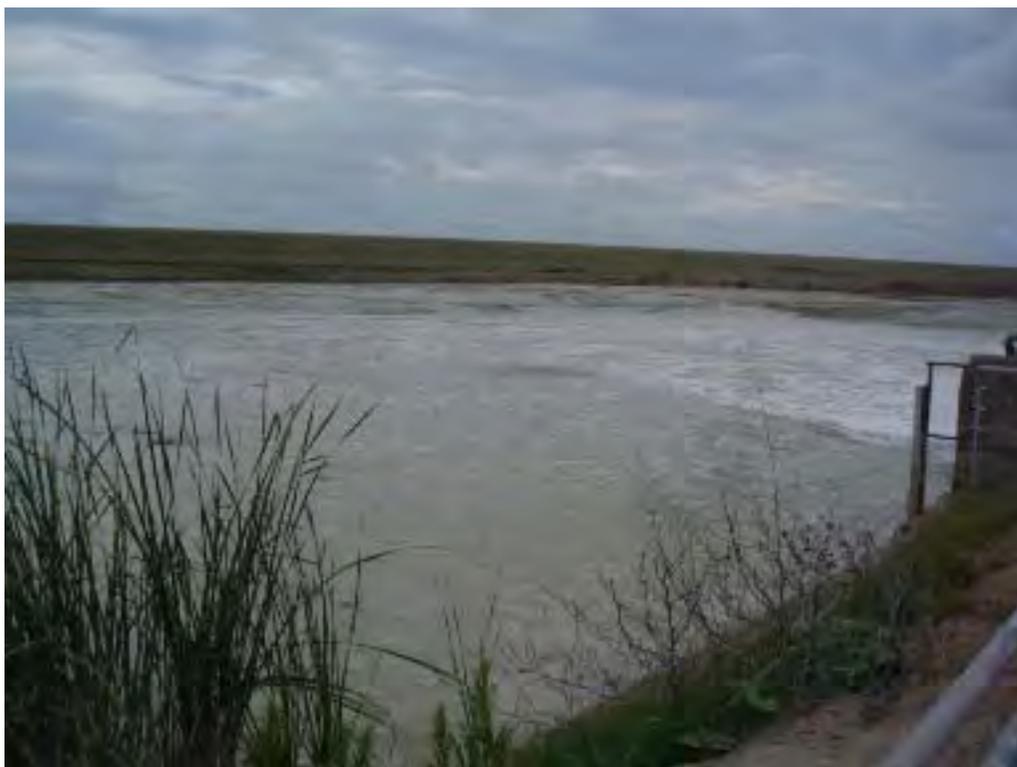
Photo No. 94: CADP - Overview of final settling basin area, looking northeast.

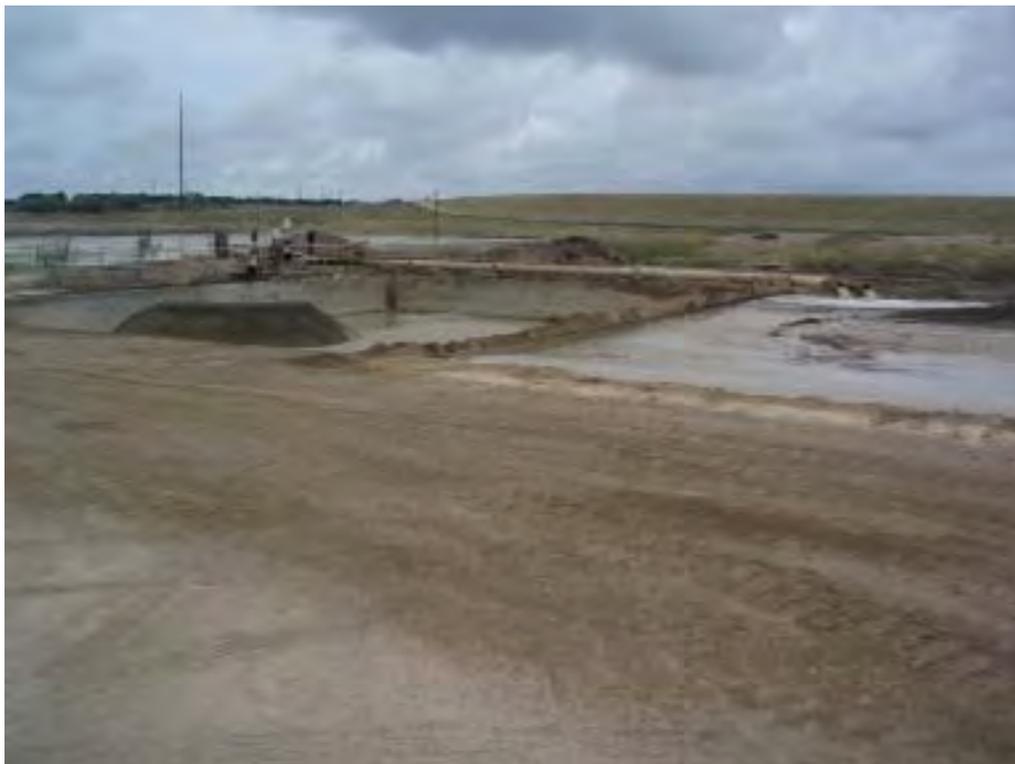
Photo No. 95: CADP - Overview of two primary settling basins where CCW is sluiced into the impoundment. Settling basins are alternated and cleaned out when full.

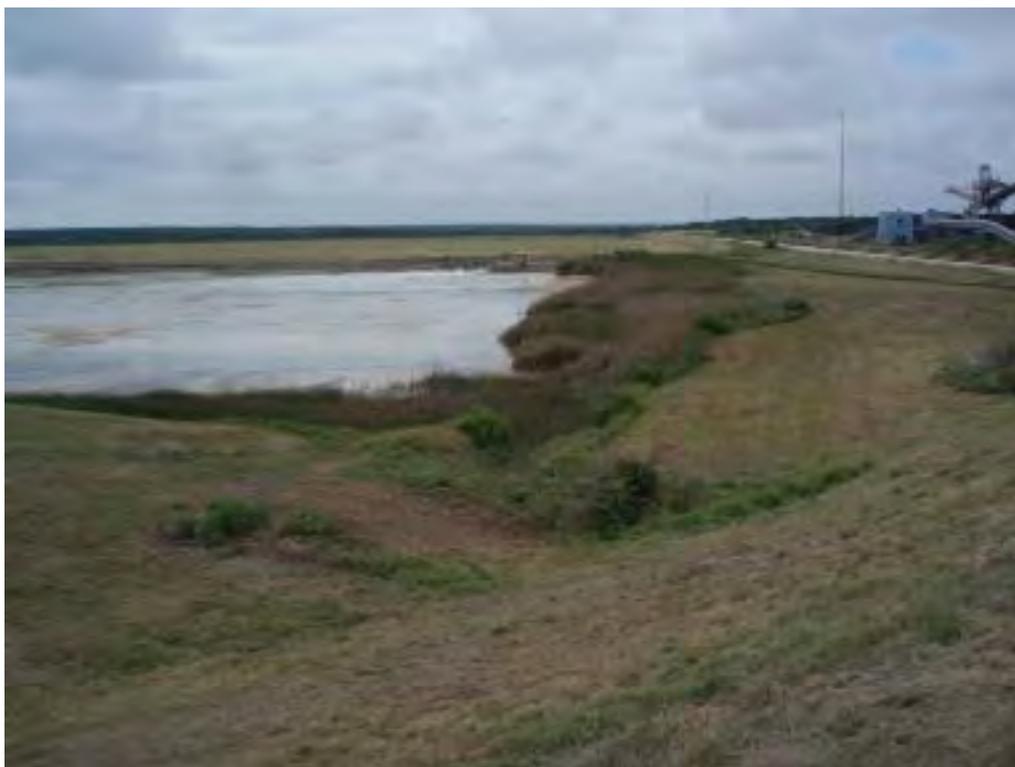
Photo No. 96: CADP - West embankment interior slope, looking south.

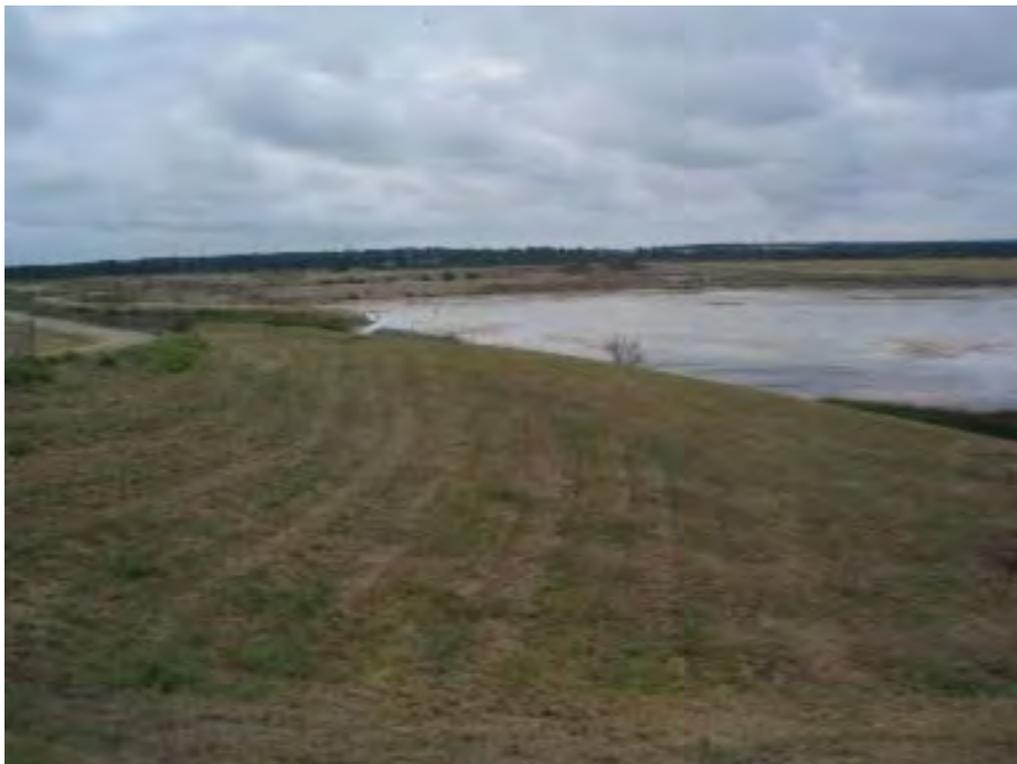
Photo No. 97: CADP - Overview of active portion of impoundment, looking southeast.

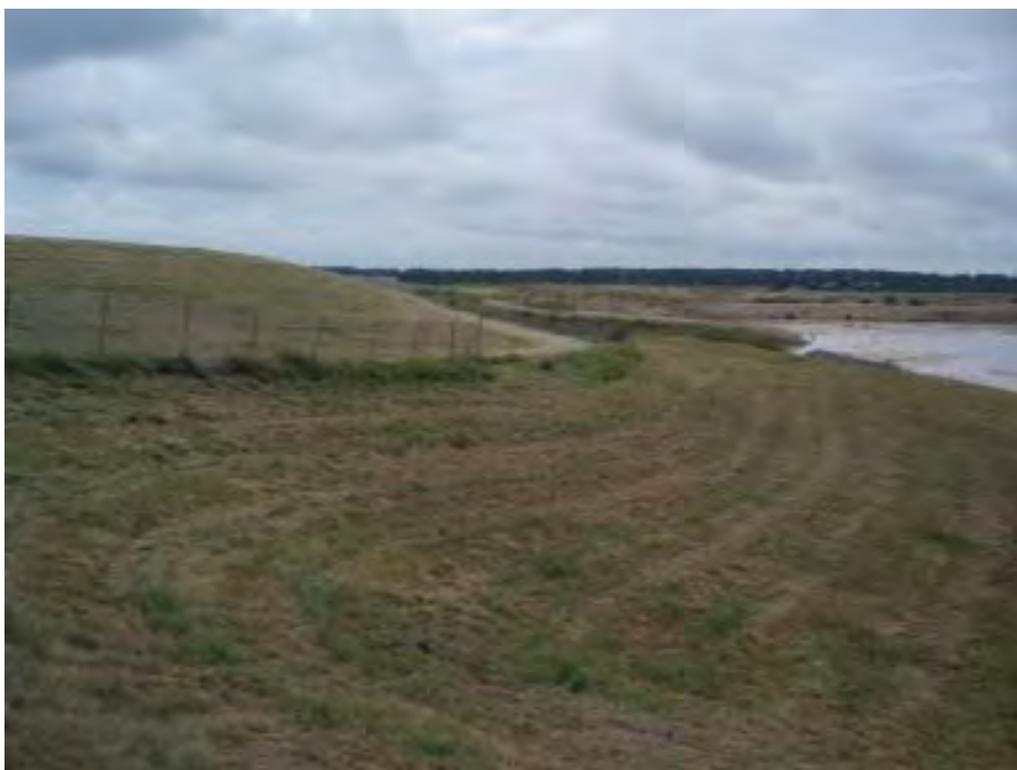
Photo No. 98: CADP - North embankment interior slope, looking east. Note Cedar Creek Dam on left side of photo.

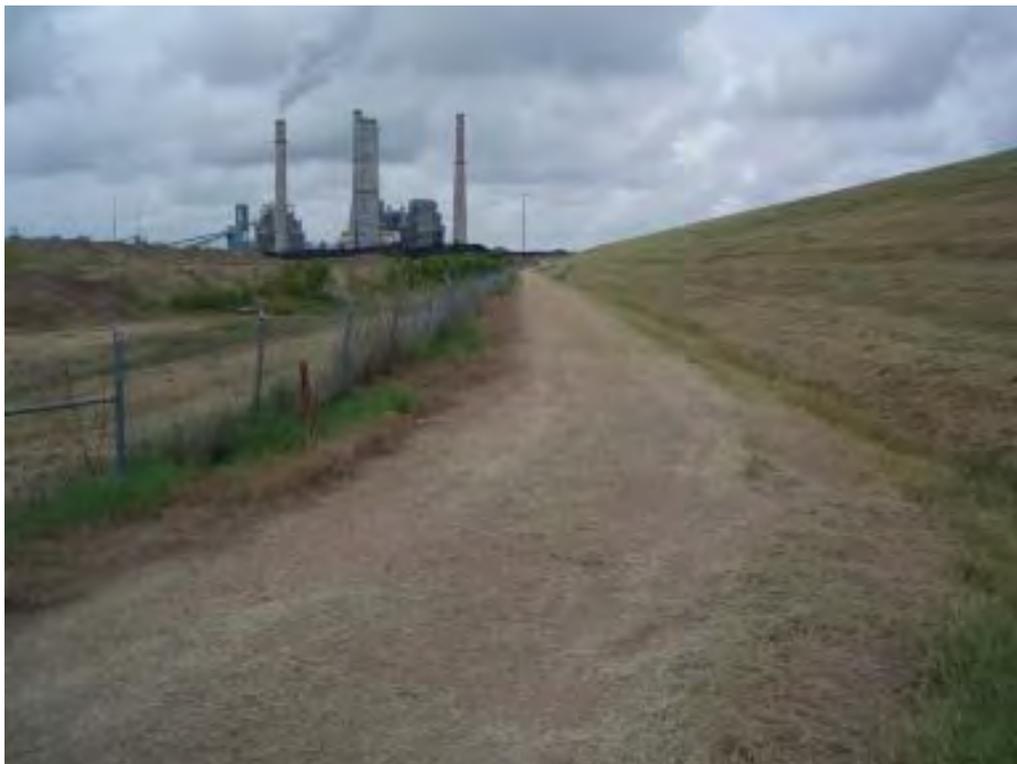
Photo No. 101: CADP - North embankment crest, looking west.

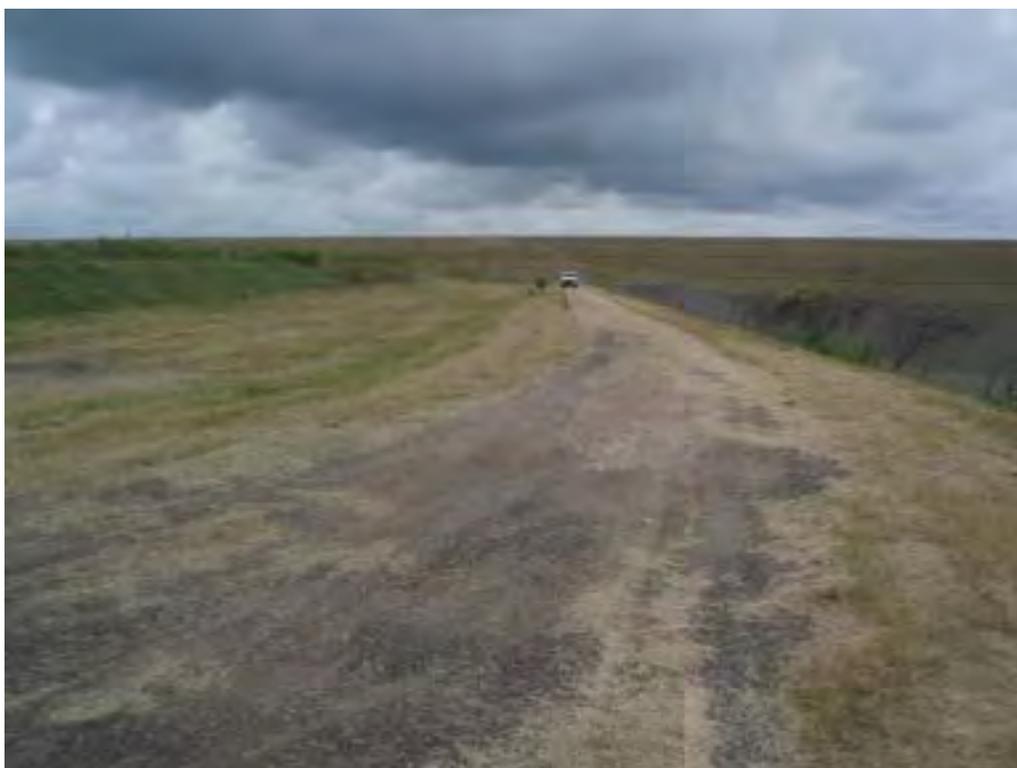
Photo No. 102: CADP - East embankment crest, looking north.

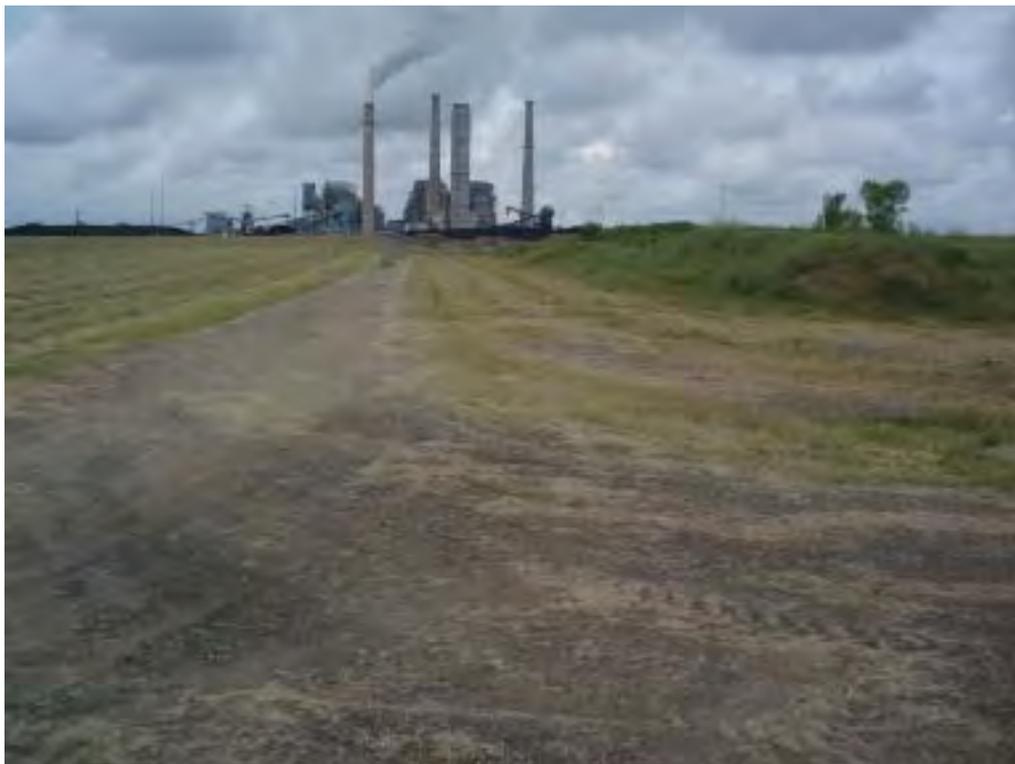
Photo No. 103: CADP - Looking west at transition from active portion to capped portion of impoundment from east embankment crest.

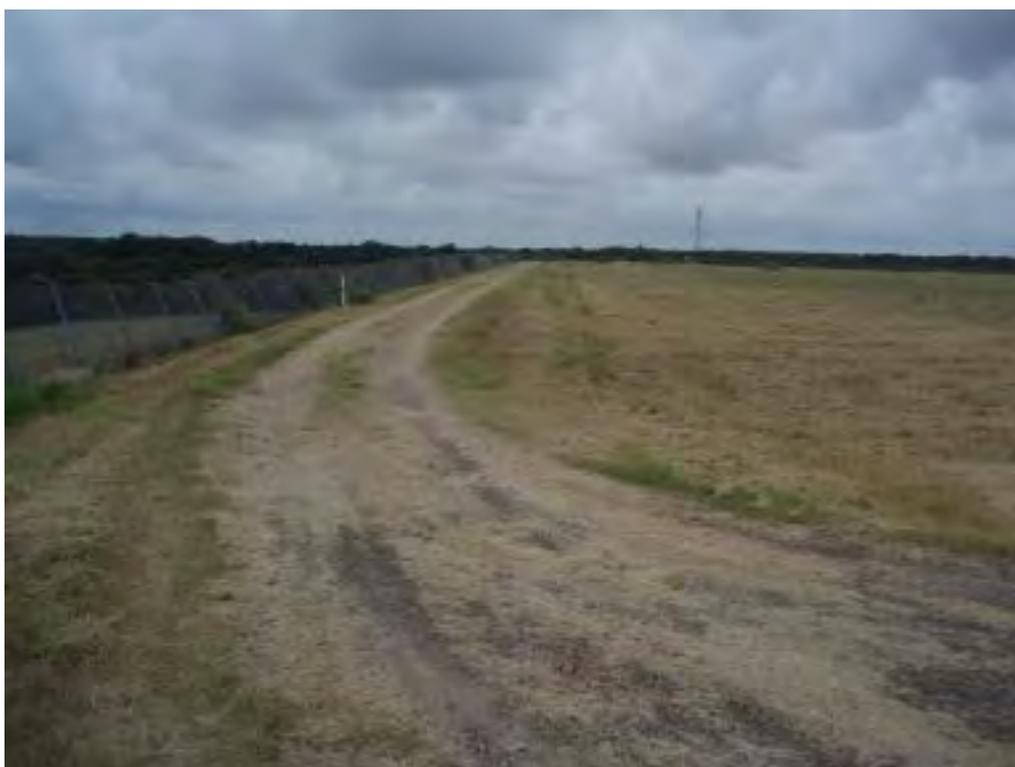
Photo No. 104: CADP - East embankment crest, looking south.
