Assessment of Dam Safety of Coal Combustion Surface Impoundments

Sam Seymour - Fayette Power Project Station

Lower Colorado River Authority

April 18, 2011

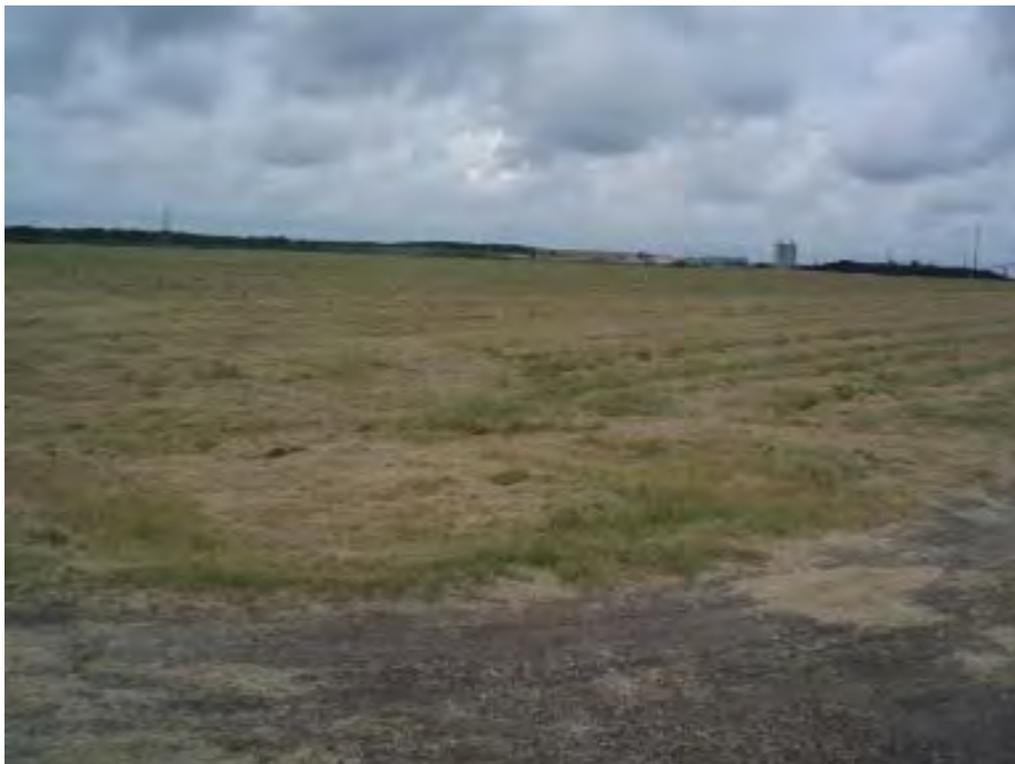
Photo No. 105: CADD - Overview of capped portion of impoundment from northeast corner, looking southwest.
