Coal Combustion Waste Impoundment

Round 7 - Dam Assessment Report

George Neal North Energy Center

MidAmerican Energy
Sergeant Bluff, Iowa

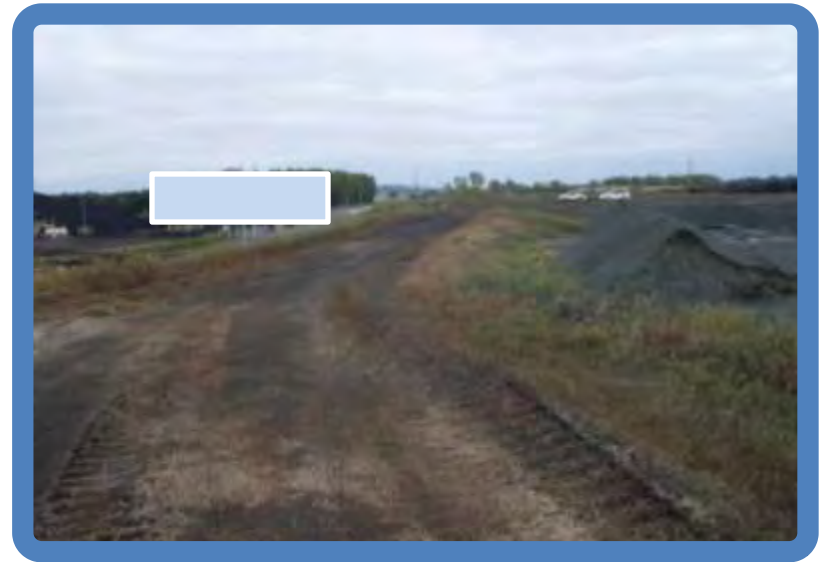
Photo 1.1

Pond 1 discharge of bottom ash (only 1.5 hr/day inflow)

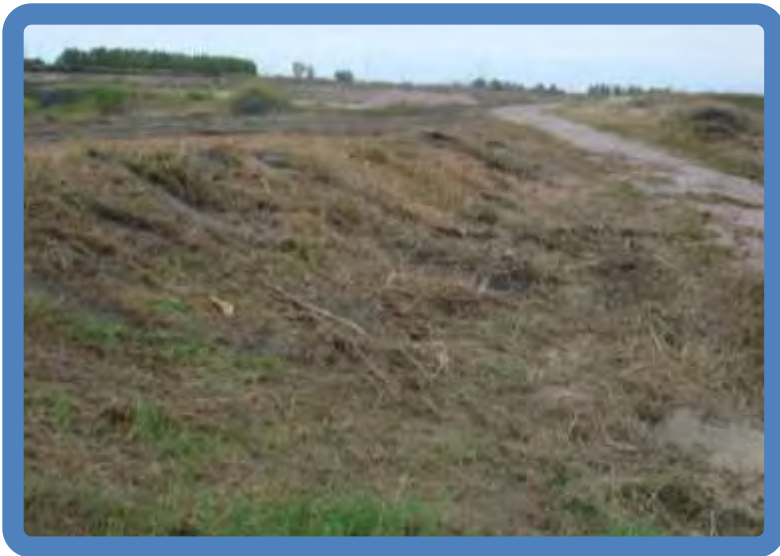
Photo 1.10

Pond 1 dike outside slope (SW side viewed NE)-note berm

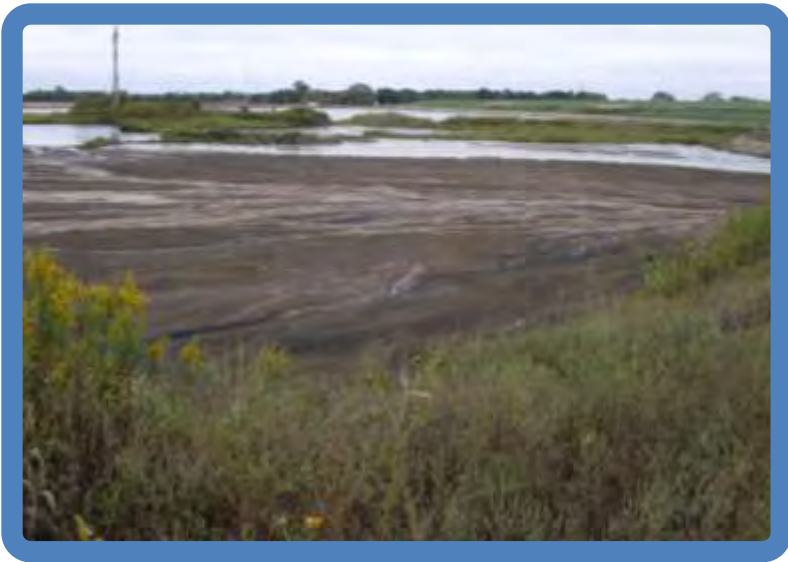
The inside slopes of Pond 2 are generally buried with ash deposits. The majority of the Pond 2 area was observed to be dry; the southeast half was in the process of being excavated to restore storage volume and will receive effluent in the future. Only the upper third (northwest part) has effluent inflow (see Photos 2.2, 2.4, 2.15). The fly ash deposits in the area of the effluent discharge pipes were observed to be solidified into sedimentary rock-like layers (see Photo 2.16). An interior access road was observed inside the northwest side of the pond (see Photo 2.1); this road leads to the current location of the northeast cross dike. Water discharges through culverts under the northeast cross dike (see Photo 2.14) to the northeast area of Pond 2 (see Photo 2.13) and on through the discontinuous former northeast cross dike to Pond 3A.

Photo 2.13
Pond 2 northeast area (viewed SE)

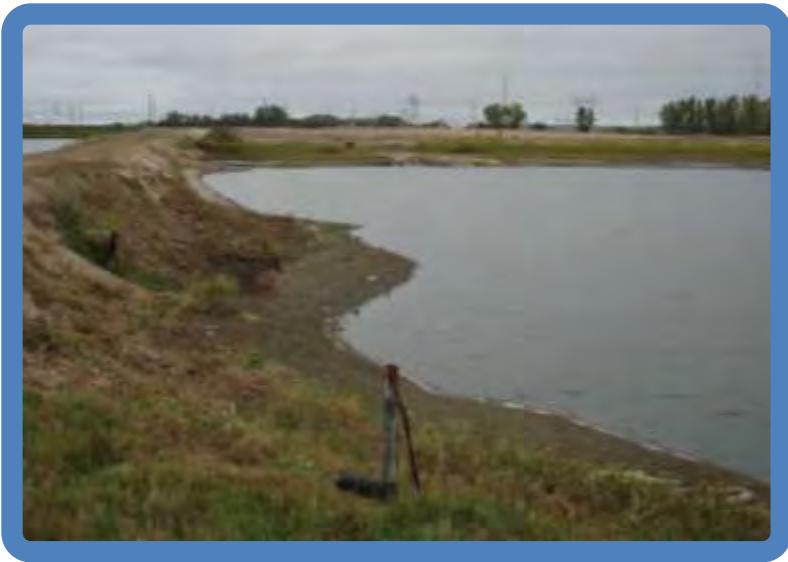
Photo 3.1

There is one 24-inch diameter CIP culvert that discharges through the northeast cross dike into Pond 3B South, located within about 30 feet of the Pond 3B South outfall structure (Photo 3.1). In addition, there is a temporary outlet pipe through the very bottom of the southwest-side offset perimeter dike segment that has a valve operator at the inside edge of the crest. MidAmerican staff indicated that a temporary permit had been obtained to discharge from Pond 3A directly to the outlet channel, apparently to drop the water level in Pond 3A as low as possible during grading work on the inside slope along the south side of the pond. The visible parts of the pipes appeared sound.

Ash Pond 3B North discharges through a 24-inch diameter CIP culvert through the southeast cross dike into Ash Pond 3B South (discharge end visible in far cross dike in Photo 3.1). This operational pipe was not viewed closely.

Pond 3B South, which serves as a “polishing pond,” was observed to have a recently lowered pool of water. The pool of water occupies practically all of the basin area (see Photos 3.1 and 3.5) even at the lowered level. Thus, the lower part of the inside slopes of Pond 3B South is normally below water level in the pond. The exposed upper part of the inside slopes above the former higher water level around the pond was observed to have a generally sparse vegetative cover (see Photos 3.1, 3.6, and 3.7). A blanket of small stone was observed on the inside slope in the vicinity of the access bridge to the new stop-log structure and onto a low spot on the crest (see Photo 3.2).

No slumps, slides, or other signs of shear failure were observed in the visible parts of the slopes above the water level. No significant erosion was noted, although some minor wave erosion was noted along the previous higher operating water level; in addition, the inside slope surface of the southwest-side cross dike is locally eroded where the culvert discharges into Pond 3B South from Pond 3A (see Photo 3.1).

Pond 3B South cross dike inside slope (SW side viewed NW)

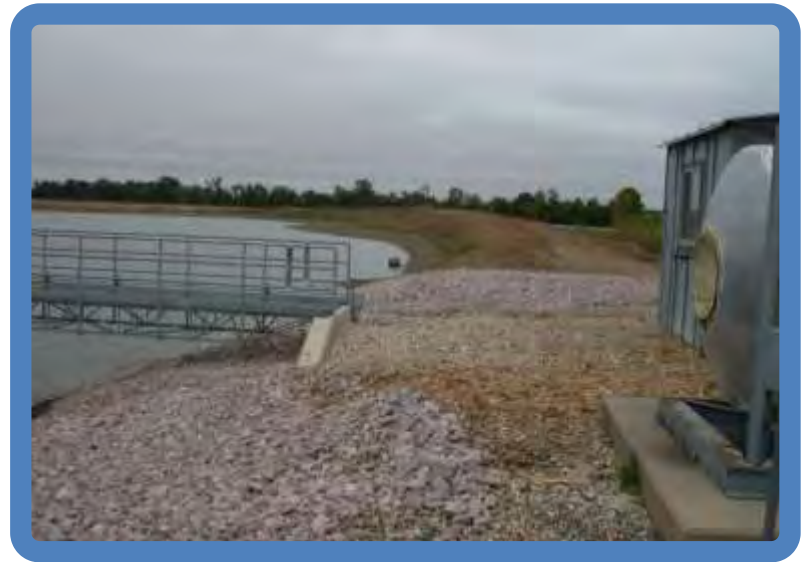
Photo 3.2

Pond 3B South dike crest and inside slope (S side viewed NE)

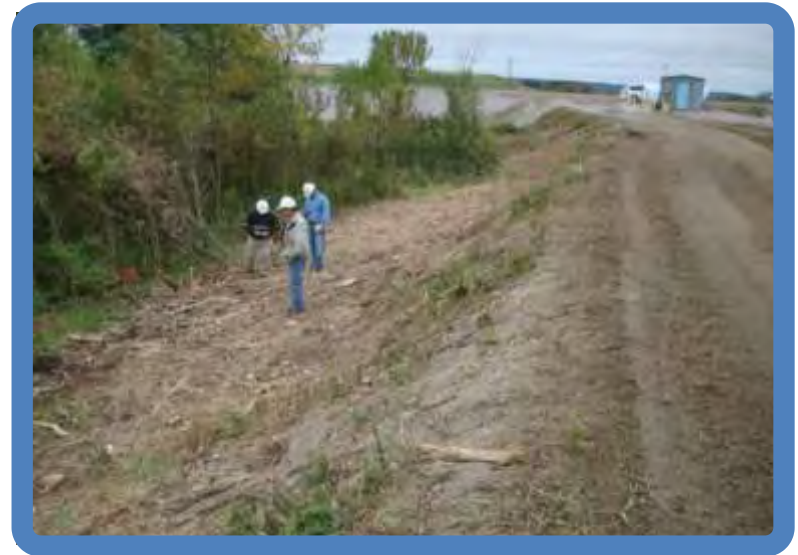
Photo 3.4

The outside slope and toe area along the south-side perimeter dike was observed to have sparse or spotty vegetation, apparently due to recent clearing operations (see Photo 3.4). A good grass cover was observed on the outside slope and toe area of the northeast-side perimeter dike (see Photo 3.9).

Pond 3B South dike crest and outside slope (S side viewed SW)

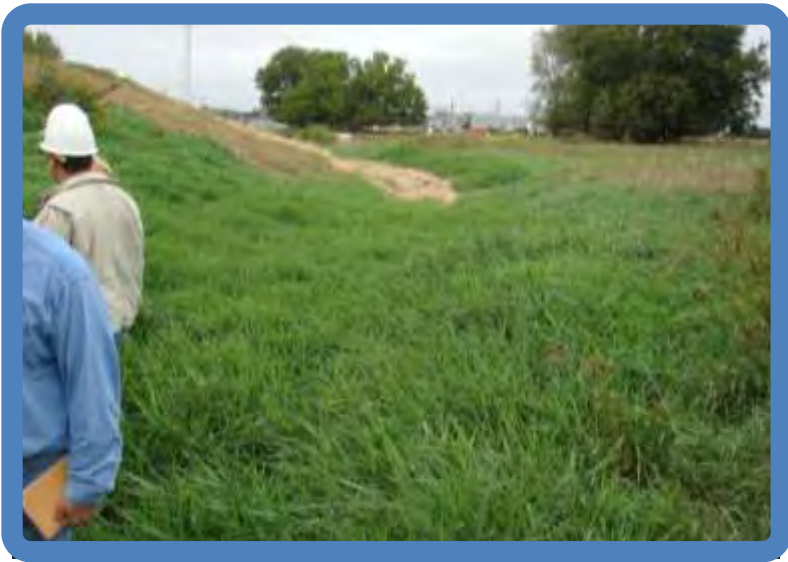
Photo 3.9

Pond 3B South dike outside slope (NE side viewed NW)

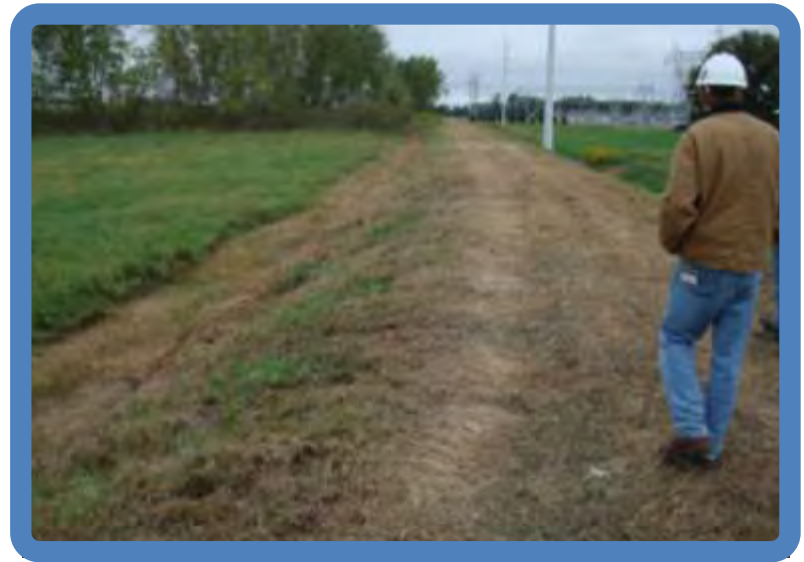
Photo 3.10

In the visible parts of the inside slopes above ash level no obvious signs of slumps, slides, bulges, tension cracks, or animal holes were observed (see Photos 3.10 through 3.13). No significant erosion was observed.

Pond 3B North dike crest and inside slope (NE side viewed NW)

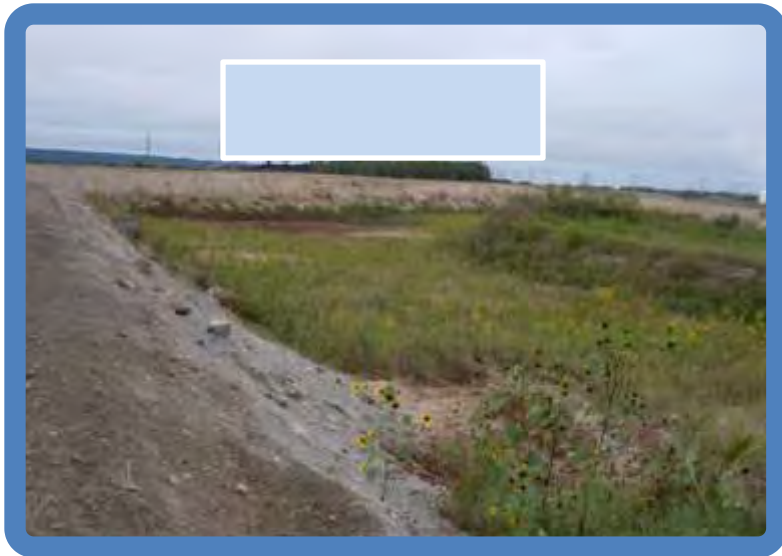
Photo 3.11

Pond 3B North crest and cross dike inside slope
(SE side viewed SW)

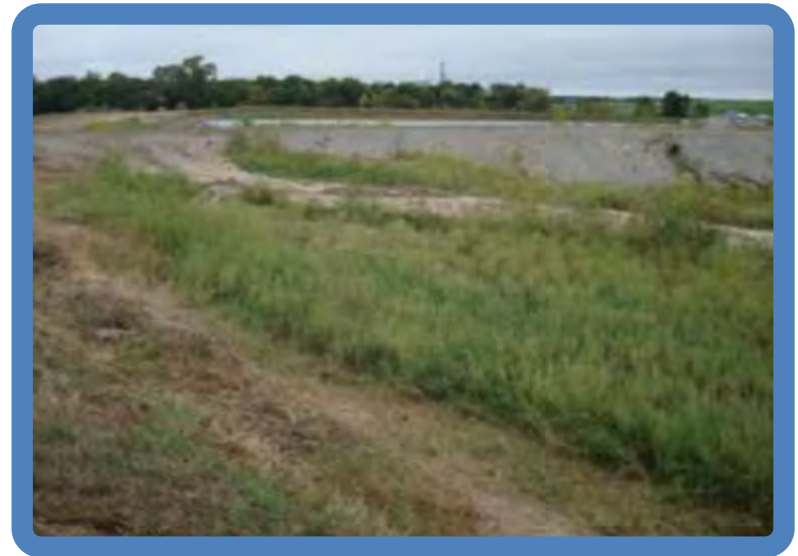
Photo 3.12

Pond 3B North cross dike inside slope (SE side viewed S)

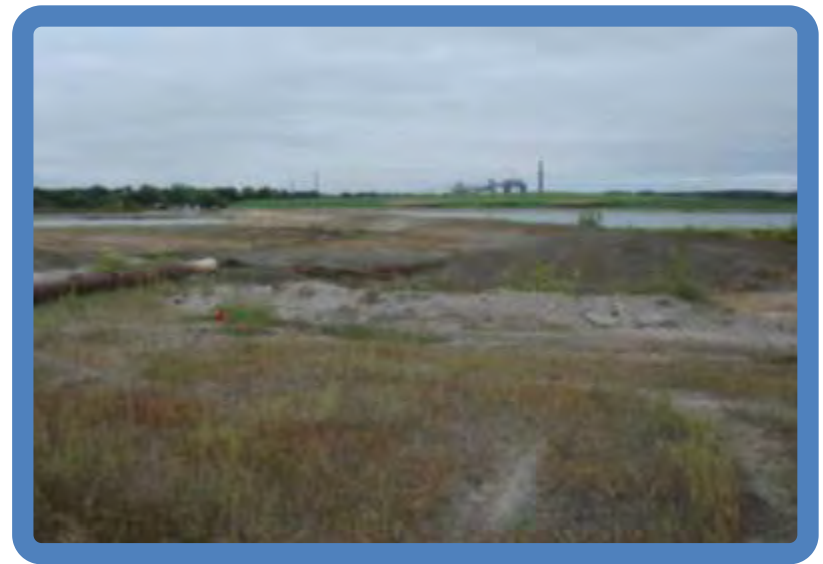
Photo 3.18

Pond 3B North is the northerly half of Pond 3 B. The southwest part (less than half) of Pond 3B North currently receives sluiced ash from Boiler Unit 3; the sluice water ponds at the lower, southeast end and the ash builds up at the northwest end, where ash is discharged into the pond (see Photo 3.18). The northeast part of Pond 3B North is currently diked off and in the process of being excavated to restore storage volume; the southeast end of this part has been excavated, and vegetation is becoming established on the bottom (see Photo 3.11). A buffer of 50 or 60 feet has been maintained between the excavation and the perimeter dike where apparent seepage erosion holes were observed in the outside slope.

Pond 3B North pond area and discharge pipe (viewed SE)

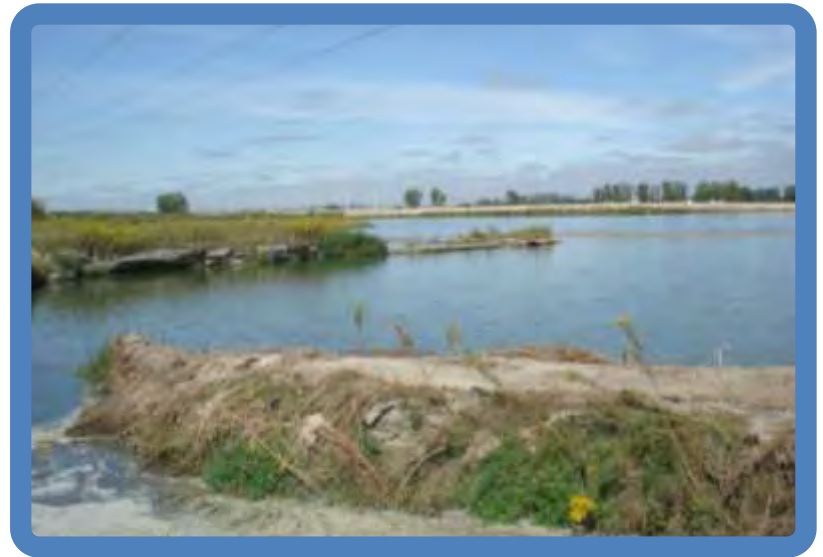
Pond 3A was observed to have the largest pool of water of all the ash ponds at NNEC. The pool of water occupies most of the basin area (see Photos 3.24 and 3.30), except in the northwest part where ash deposits have accumulated and where ash formerly was mounded along the inside edge of the northwest-side crest above the crest elevation (see Photos 3.19 through 3.22). Thus, the inside slopes of Pond 3A are generally covered with water or buried with ash deposits. The ash deposits were observed to contain some C-stone fragments (see Photo 3.31). In addition to the sluiced discharge received from Pond 2, Pond 3A occasionally receives discharge from an ash sluice pipe located over the northwest side (see Photo 3.32), near juncture with northeast part of Pond 2. The exposed upper part of the inside slope above water level on the south side was observed to have been recently graded and was generally bare with no vegetative cover at the time of the site visit (see Photo 3.25).

Photo 3.24
Pond 3A pond area (viewed NE)
-note solidified fly ash

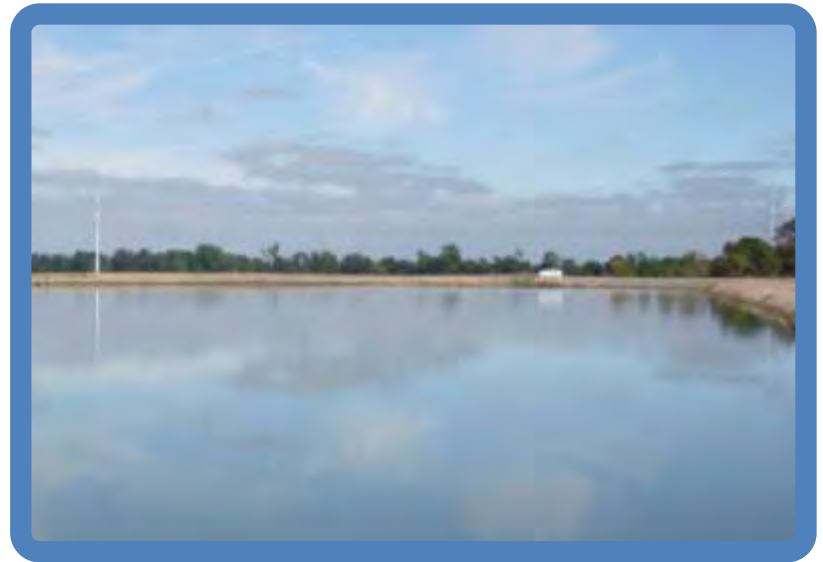
Southwest cross dike embankment: no photo (partly visible to far left in Photo 3.30)

Photo 3.30
Pond 3A pond area viewed E toward NE cross dike

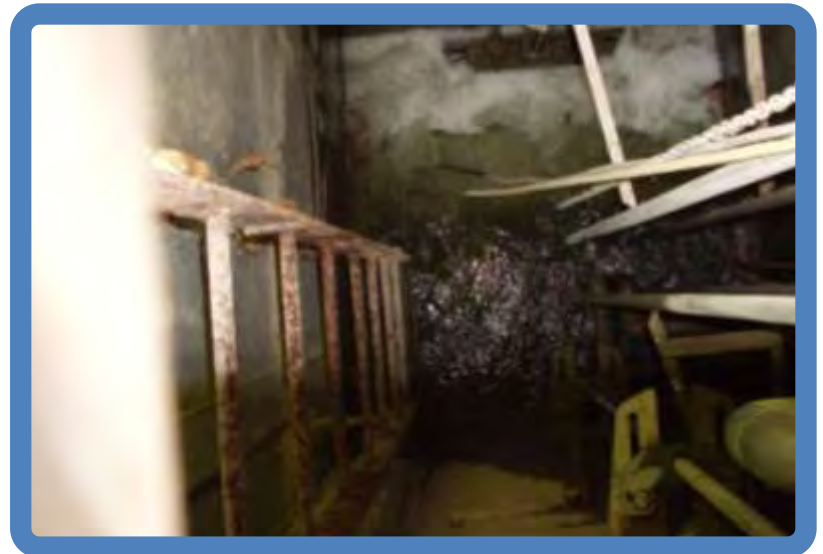
The outfall path from Pond 3B South starts at the new stop-log structure shown in Photo 4.1. A skimmer box surrounds the overflow section and is fitted with a staff gauge (see Photo 4.2). From an adjustable 4-foot wide stop-log weir (see Photo 4.3) flow enters the structure and discharges through a 24-inch RCP pipe in the bottom of the structure to a wet well (see Photo 4.4, interior view) at the crest of the dike.

The overflow structure is the new stop-log structure located at the southwest corner of Pond 3B South (see Photos 4.1 through 4.3); the overflow structure and access bridge were observed to be in very good visual condition and appeared sound and serviceable. The wet well located at the south-side perimeter dike crest was in good visual condition (see Photo 4.4). MidAmerican staff explained that CO₂ is added to the discharge water at the wet well to maintain a pH value near 8.0.

Photo 4.4
Pond 3B South Wet Well Structure CO₂ applied

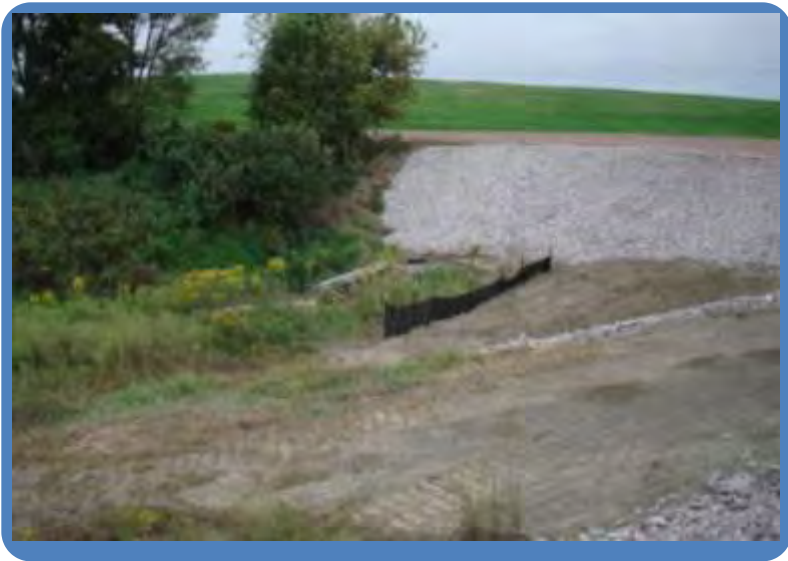
From the wet well the water discharges through another 24-inch RCP, which connects underground to a 48-inch diameter RCP (see Photo 4.5 for general location). The 48-inch pipe also receives drainage from a channel from the oxbow lake (see Photo 4.6). The inlet and outlet ends of the 1,650-foot long, 48-inch culvert were observed to be in good visual condition and appeared to be in sound condition (see Photos 4.7 through 4.10). Then the discharge from the 48-inch culvert daylights into the 1,200-foot long swale (see Photos 4.9 and 4.12), including a 50-foot section where the water is channeled through a 48-inch aluminum CMP (see Photo 4.11), then to the final outfall structure (see Photo 4.12) that discharges into the Missouri River (see Photos 4.12 through 4.14). At the final outfall structure, water flows over a 3-foot wide rectangular weir (see Photo 4.13), then into a 48-inch RCP culvert (see Photo 4.14) discharging into the Missouri River. The discharge channel was observed to be open and free-flowing with no obstructions or bank failures. The visible parts of aluminum culvert and the final outfall structure were observed to be in good visual condition and appeared sound and serviceable.

Outlet Pipe connects underground to 48" RCP, next to landfill

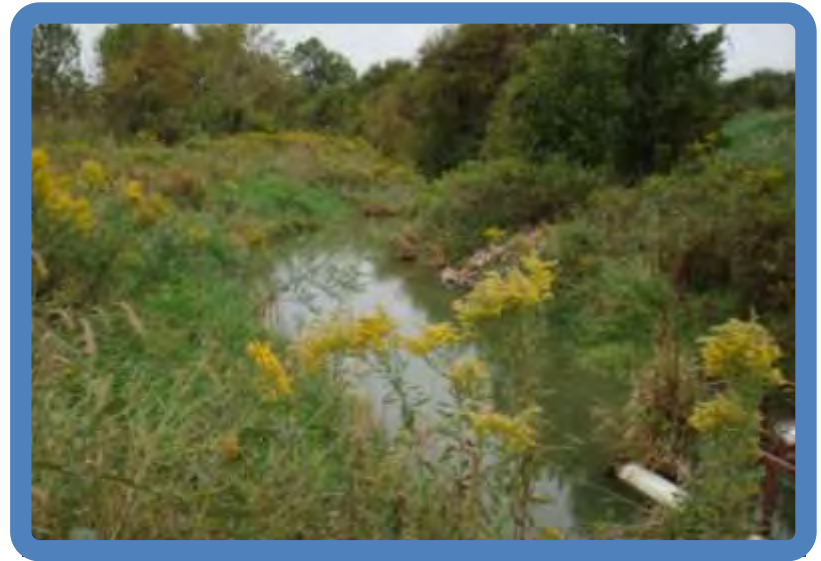
Photo 4.6

Channel from oxbow lake to Inlet End of 48" RCP Culvert

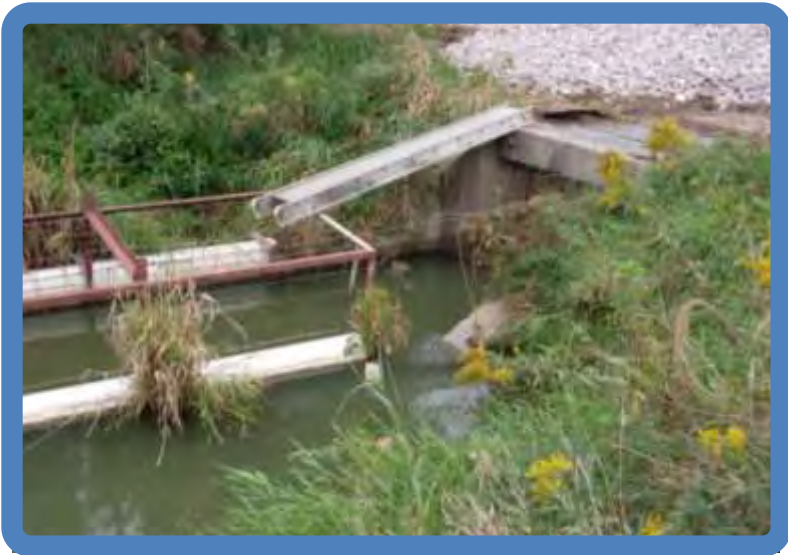
Photo 4.7

Inlet End of 48" RCP Culvert
-cage to stop beaver activity

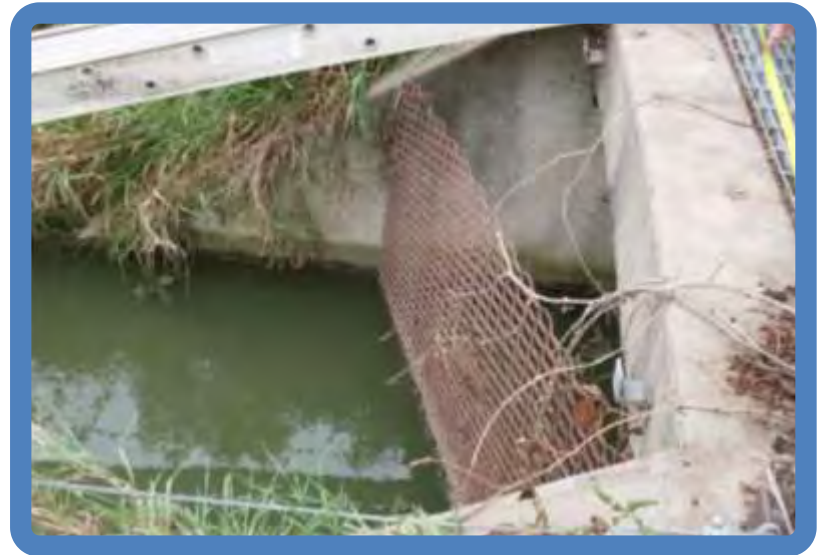
Photo 4.8

Inlet End of 48" RCP Culvert
-screen to block animals and debris
