Coal Combustion Waste Impoundment

Round 7 - Dam Assessment Report

George Neal North Energy Center

MidAmerican Energy
Sergeant Bluff, Iowa

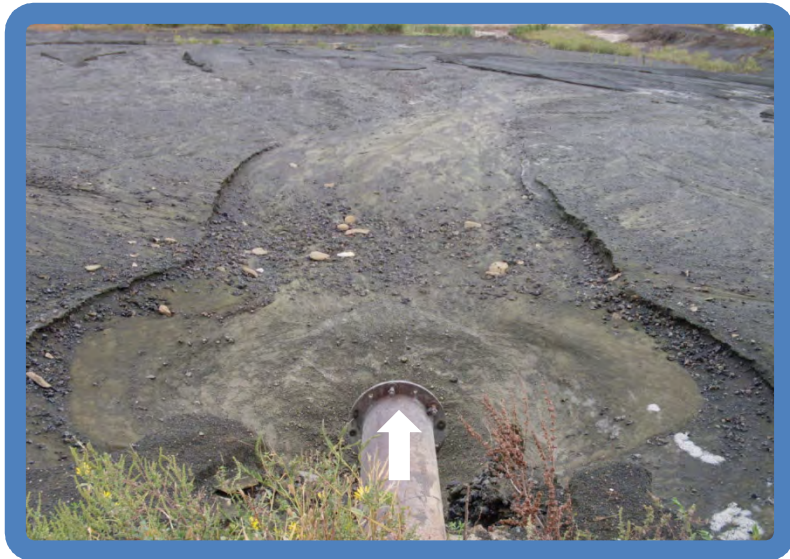
Photo 1.1
Pond 1 discharge of bottom ash (only 1.5 hr/day inflow)

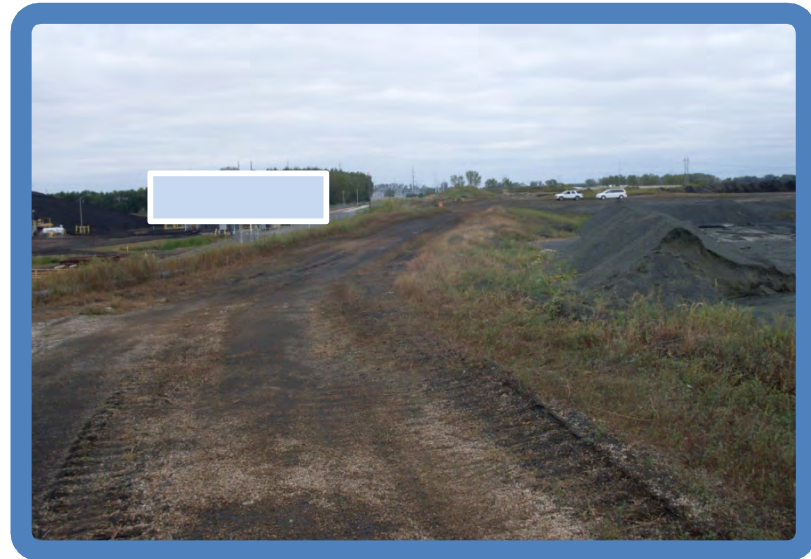
Photo 1.2
Pond 1 dike crest and inside slope (NW side viewed NE)

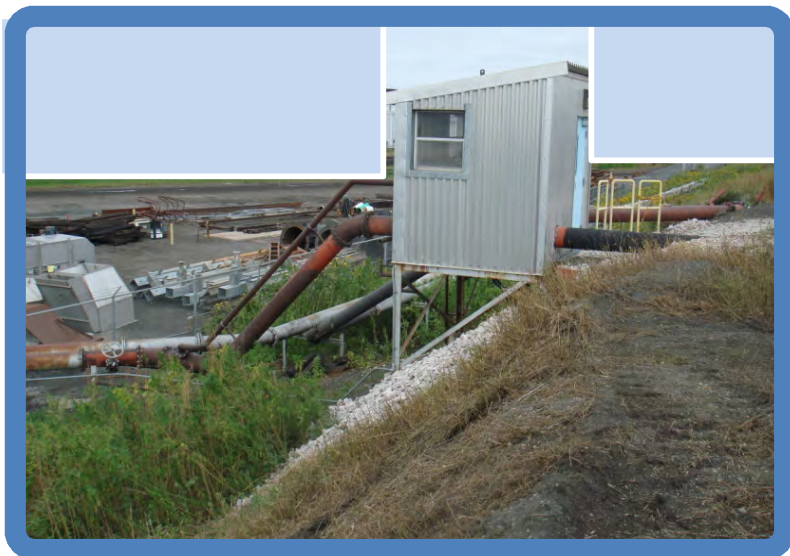
Photo 1.3
Pond 1 dike outside slope (NW side viewed N) and
flow splitting structure to Pond 1 and Pond 2

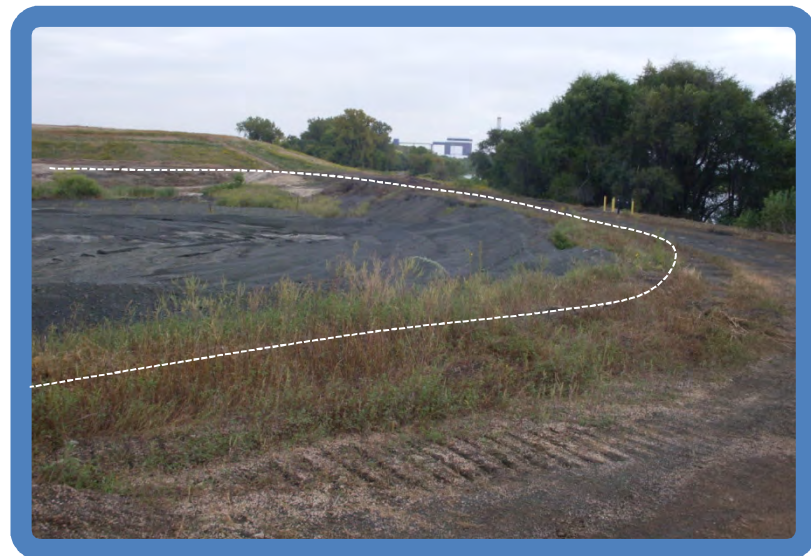
Photo 1.4
Pond 1 dike inside slope (SW side viewed SE)
-mounded ash is in area of former erosion

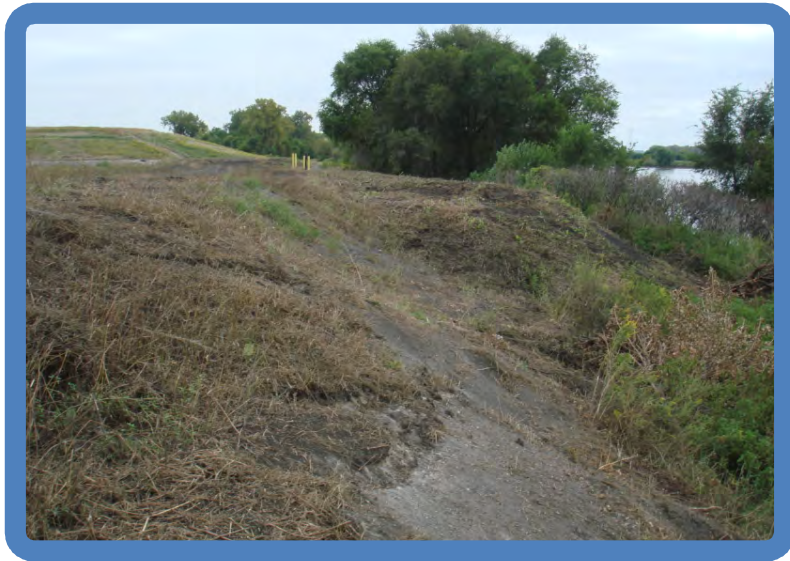
Photo 1.5
Pond 1 dike outside slope (SW side viewed SE)-note berm

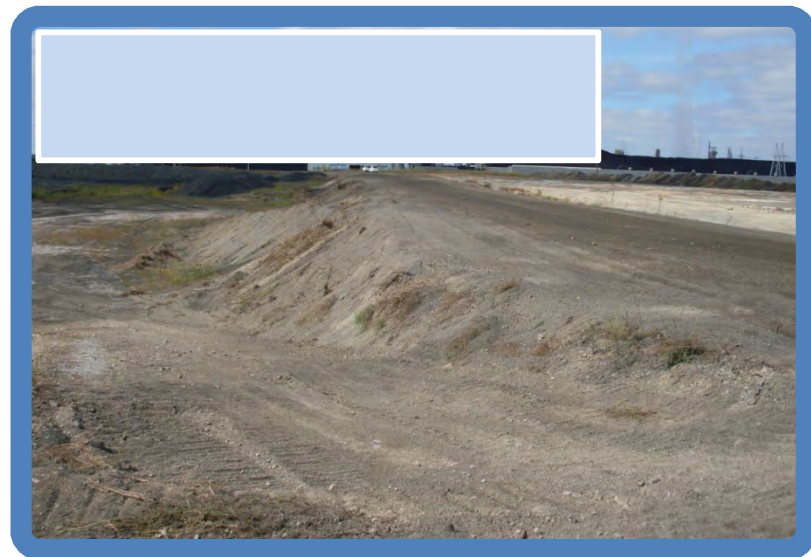
The perimeter dike around Pond 1 does not tie-in to natural abutments but continues on to bound the northwest and southeast sides of Pond 2. Thus, the perimeter dike has no abutments and the only groins at Pond 1 are those formed where the northeast cross dike ties-in to the perimeter dike at each end of the cross dike. The groins at each end are buried with CCW, although an access ramp into Pond 1 exists in the groin area at the southeast end of the cross dike (see Photo 1.16).

Photo 1.16
Pond 1 cross dike inside slope and crest (NE side viewed N)

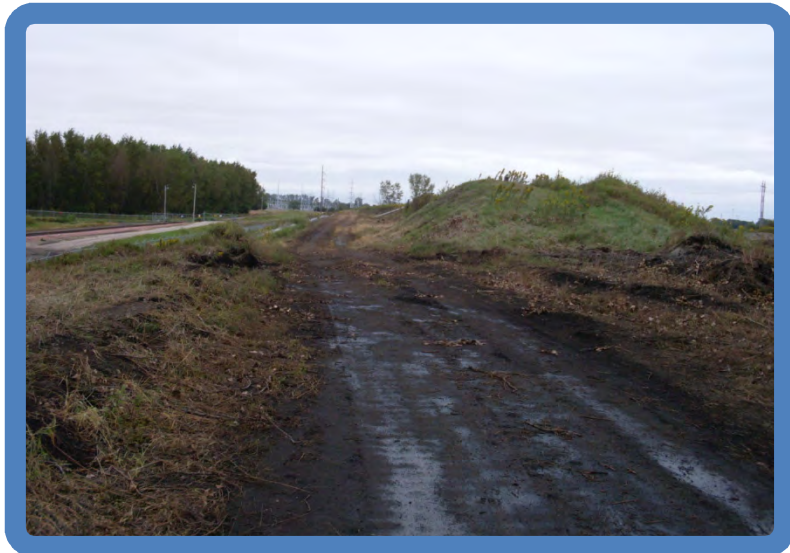
Ash material was observed to have been piled up along the inside edge of the crest on the northwest side of Pond 2 (and Pond 3) giving the appearance of a higher berm (see Photo 2.3).

Photo 2.3
Pond 2 dike crest (NW side viewed NE)

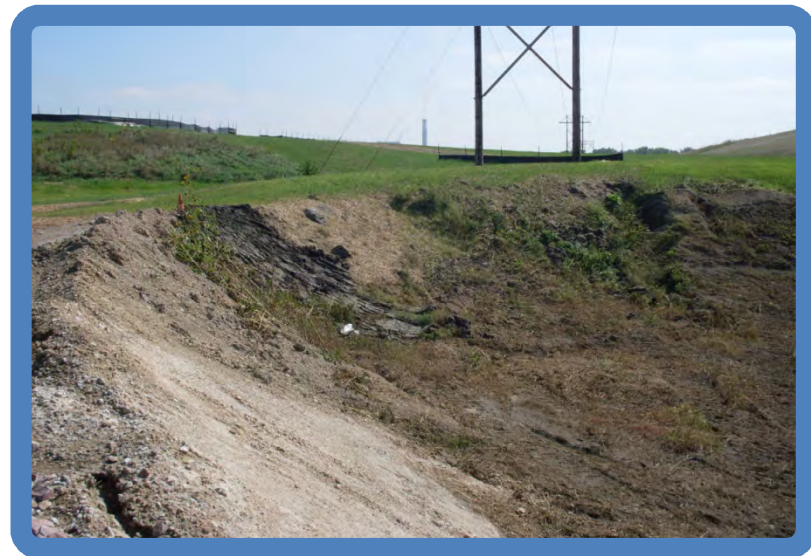
No obvious signs of slumps, slides, bulges, tension cracks, seepage, or animal holes were observed in the outside slope. Trees, brush, and other woody vegetation appeared to have recently been removed from the outside slope and toe area along the southwest-side offset perimeter dike segment. No major erosion was observed. One minor erosion gully in the slope was observed to have recently been repaired with clay fill (see Photo 2.12).

Photo 2.12
Pond 3A dike outside slope (SW segment viewed SE)
-note erosion repair area

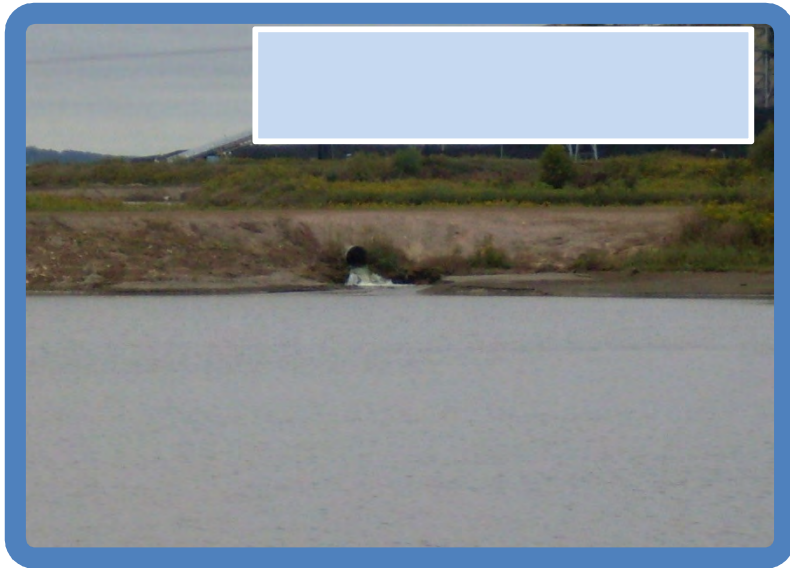
Photo 3.1

There is one 24-inch diameter CIP culvert that discharges through the northeast cross dike into Pond 3B South, located 100 to 150 feet from the Pond 3B South outfall structure (see Photo 3.1). In addition, there is a temporary outlet pipe through the very bottom of the southwest-side offset perimeter dike segment that has a valve operator at the inside edge of the crest. MidAmerican staff indicated that a temporary permit had been obtained to discharge from Pond 3A directly to the outlet channel, apparently to drop the water level in Pond 3A as low as possible during grading work on the inside slope along the south side of the pond. The visible parts of the pipes appeared sound.

Ash Pond 3B North discharges through a 24-inch diameter CIP culvert through the southeast cross dike into Ash Pond 3B South (discharge end visible in far cross dike in Photo 3.1). This operational pipe was not viewed closely.

No slumps, slides, or other signs of shear failure were observed in the visible parts of the slopes above the water level. No significant erosion was noted, although some minor wave erosion was noted along the previous higher operating water level; in addition, the inside slope surface of the southwest-side cross dike is locally eroded where the culvert discharges into Pond 3B South from Pond 3A (see Photo 3.1).

Pond 3B South cross dike inside slope and outfall from Pond 3A (SW side viewed SW)

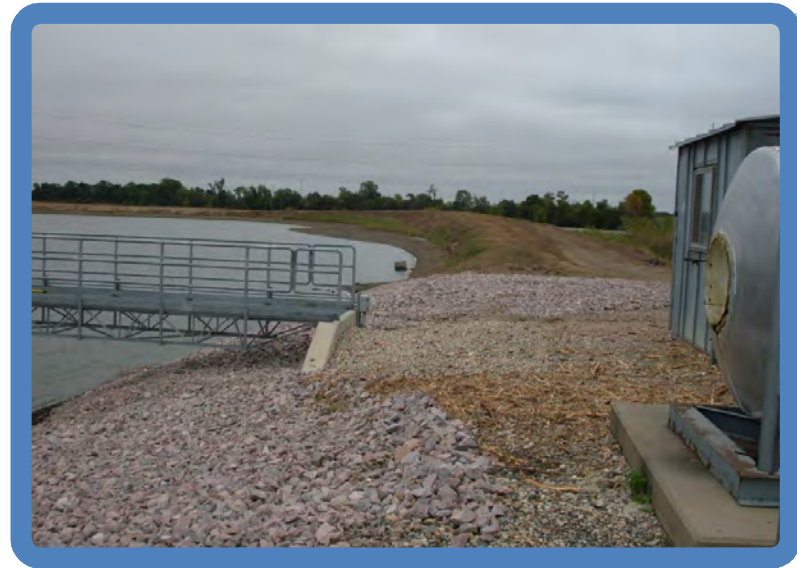
Photo 3.2

Pond 3B South, which serves as a “polishing pond,” was observed to have a recently lowered pool of water. The pool of water occupies practically all of the basin area (see Photos 3.1 and 3.5) even at the lowered level. Thus, the lower part of the inside slopes of Pond 3B South is normally below water level in the pond. The exposed upper part of the inside slopes above the former higher water level around the pond was observed to have a generally sparse vegetative cover (see Photos 3.1, 3.6, and 3.7). A blanket of small stone was observed on the inside slope in the vicinity of the access bridge to the new stop-log structure and onto a low spot on the crest (see Photo 3.2).

Pond 3B South dike crest and inside slope (S side viewed NE)

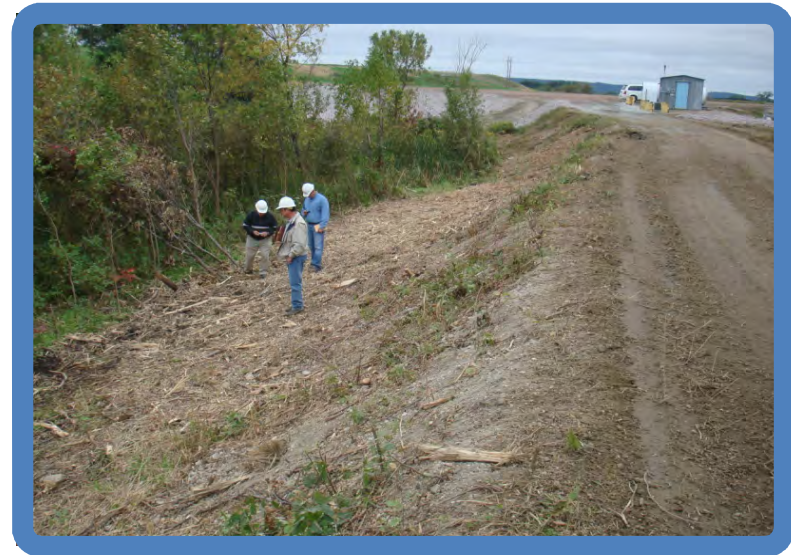
Photo 3.4

The outside slope and toe area along the south-side perimeter dike was observed to have sparse or spotty vegetation, apparently due to recent clearing operations (see Photo 3.4). A good grass cover was observed on the outside slope and toe area of the northeast-side perimeter dike (see Photo 3.9).

Pond 3B South dike crest and outside slope (S side viewed SW)

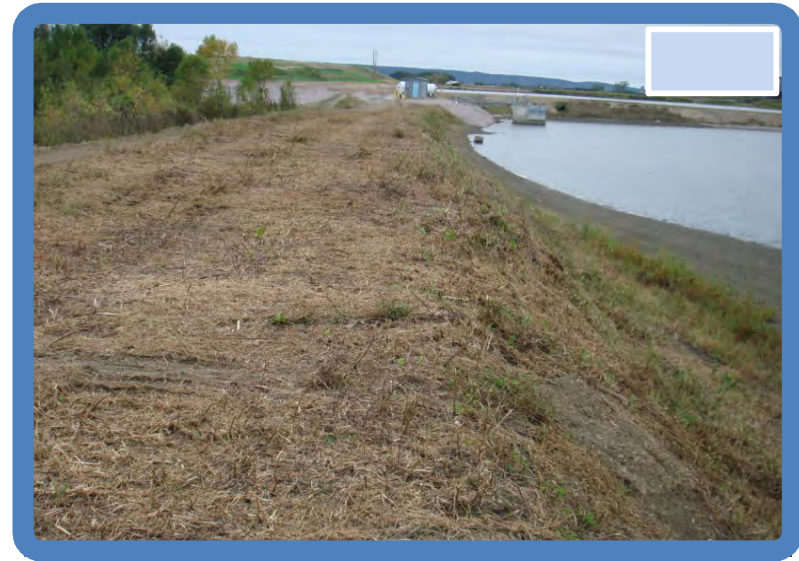
Photo 3.6

Pond 3B South dike crest and inside slope (S side viewed SW)

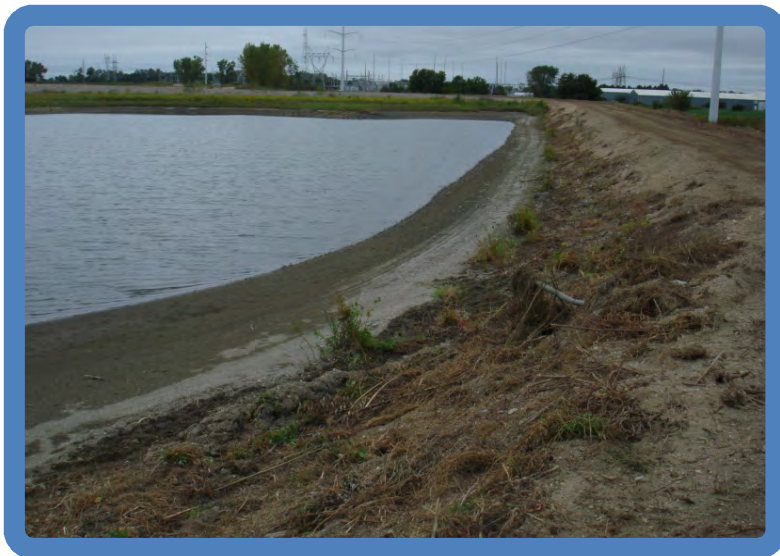
Photo 3.7

Pond 3B South dike inside slope (NE side viewed N)

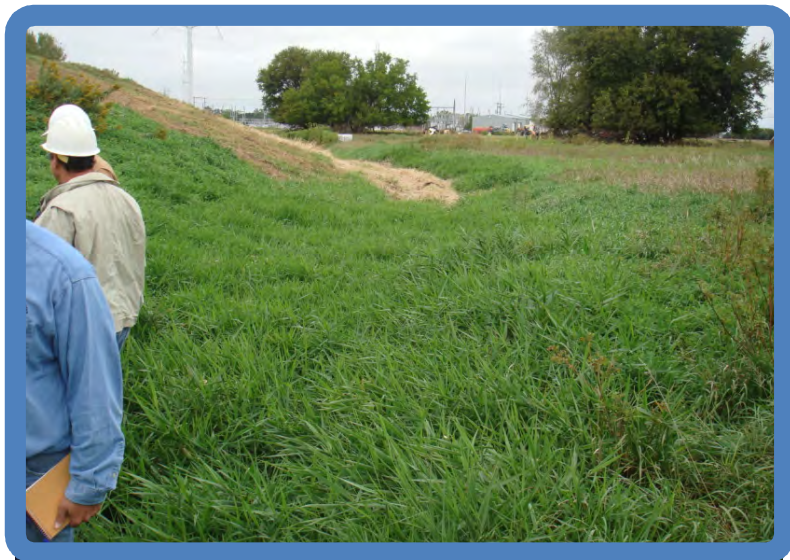
Photo 3.8

No obvious signs of slumps, slides, bulges, tension cracks, or animal holes were observed in the outside slope. However, holes were observed in the outside slope surface several feet (vertically) below the crest in the area of suspected seepage erosion through the northeast-side perimeter dike (see Photo 3.8). An animal hole was noted in the ash mound above crest level on the northwest side. No major surface erosion was observed.

Pond 3B North is the northerly half of Pond 3 B. The southwest part (less than half) of Pond 3B North currently receives sluiced ash from Boiler Unit 3; the sluice water ponds at the lower, southeast end and the ash builds up at the northwest end, where ash is discharged into the pond (see Photo 3.18). The northeast part of Pond 3B North is currently diked off and in the process of being excavated to restore storage volume; the southeast end of this part has been excavated, and vegetation is becoming established on the bottom (see Photo 3.11). A buffer of 50 or 60 feet has been maintained between the excavation and the perimeter dike where apparent seepage erosion holes were observed in the outside slope.

Pond 3B North dike outside slope (NE side viewed SE)
-note erosion holes

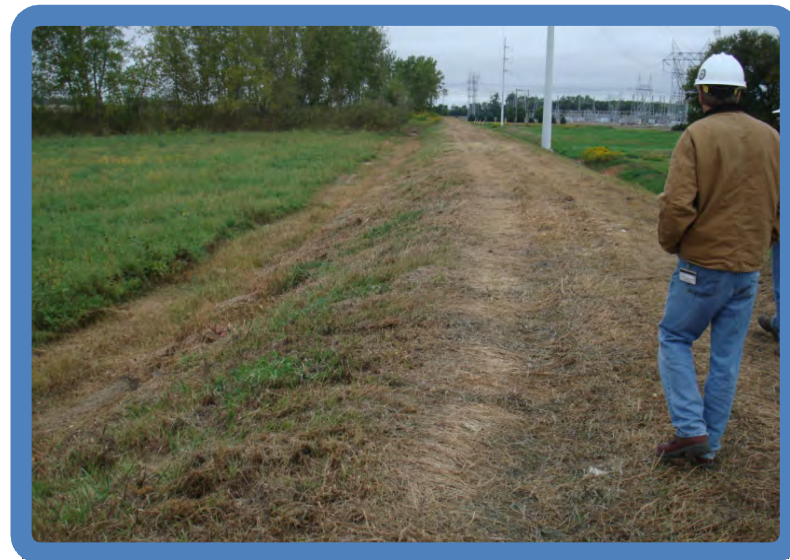
Photo 3.9
Pond 3B South dike outside slope (NE side viewed NW)

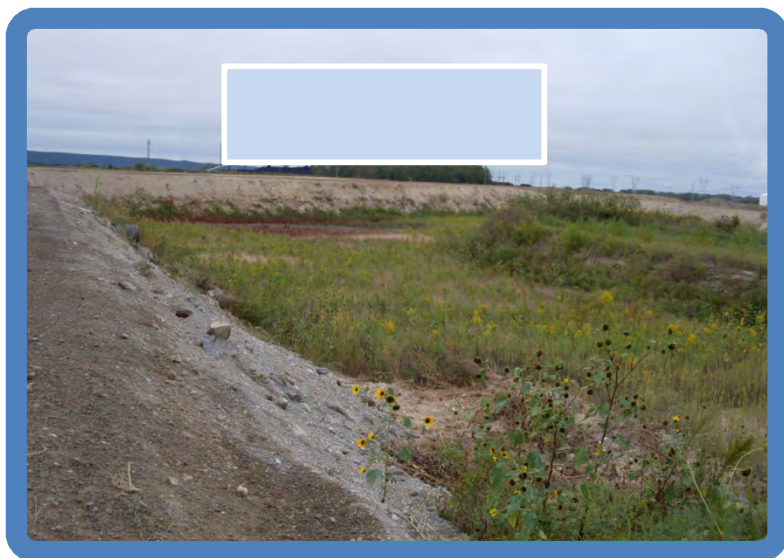
In the visible parts of the inside slopes above ash level no obvious signs of slumps, slides, bulges, tension cracks, or animal holes were observed (see Photos 3.10 through 3.13). No significant erosion was observed.

Photo 3.10
Pond 3B North dike crest and inside slope (NE side viewed NW)

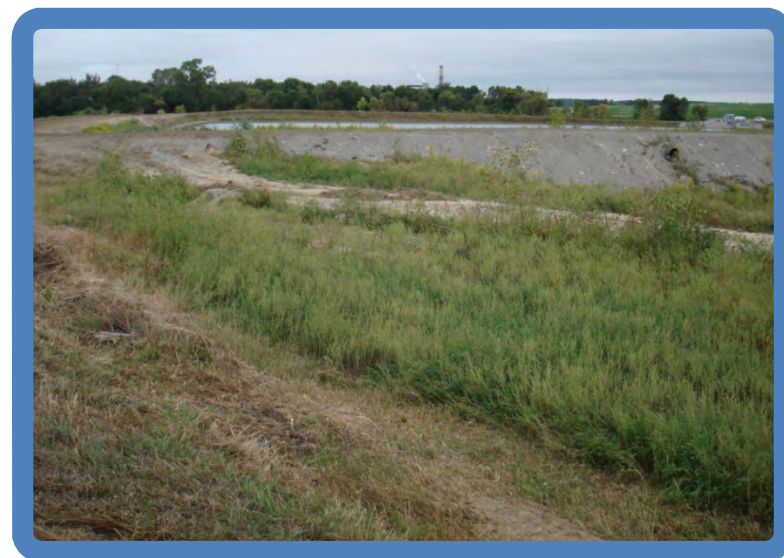
Photo 3.11
Pond 3B North crest and cross dike inside slope
(SE side viewed SW)

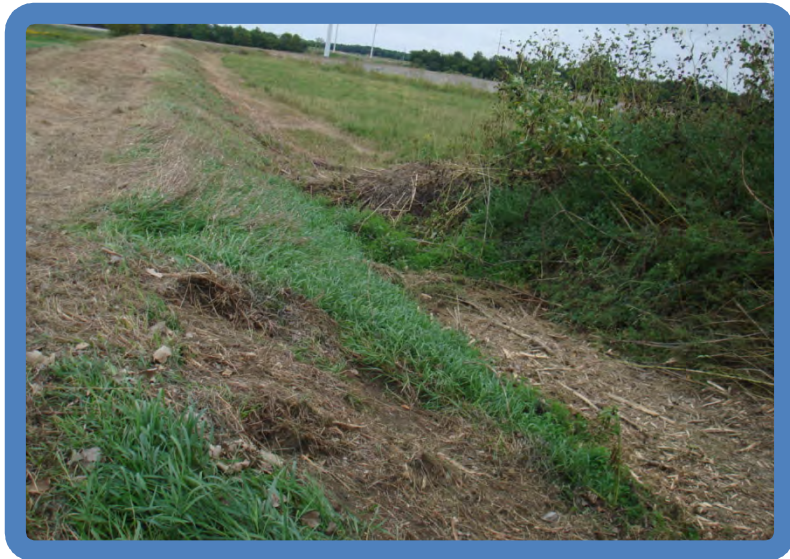
Photo 3.12
Pond 3B North cross dike inside slope (SE side viewed S)

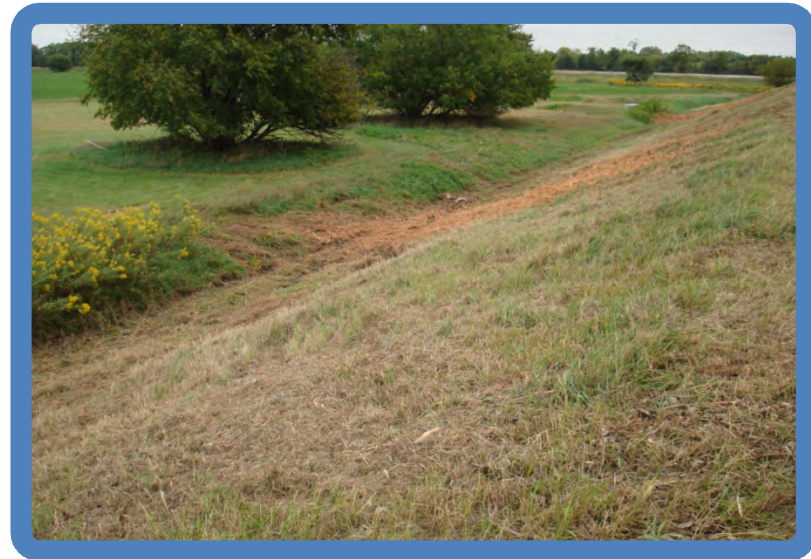
Photo 3.13
Pond 3B North dike inside slope (NE side viewed SE)

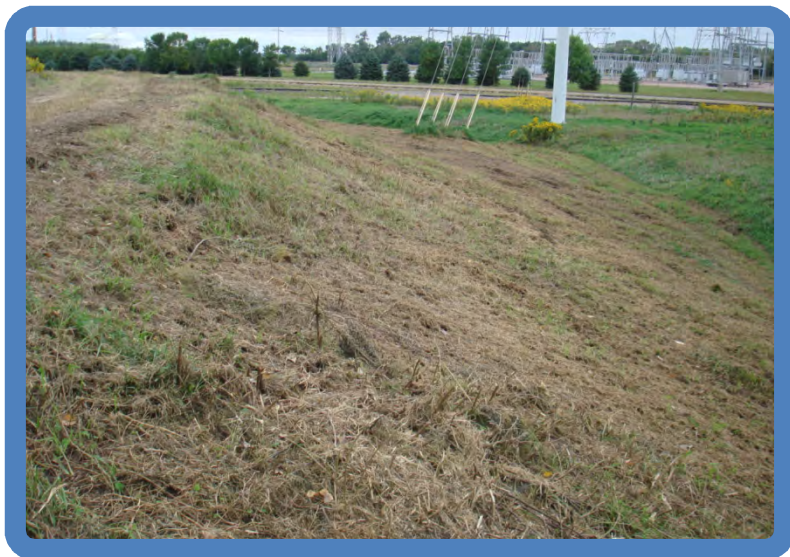
The outside slope and toe area along the northwest-side and northeast-side perimeter dike was observed to have a well-maintained grass cover (see Photos 3.14 through 3.16).

Photo 3.14
Pond 3B North dike outside slope (NE side viewed SE)

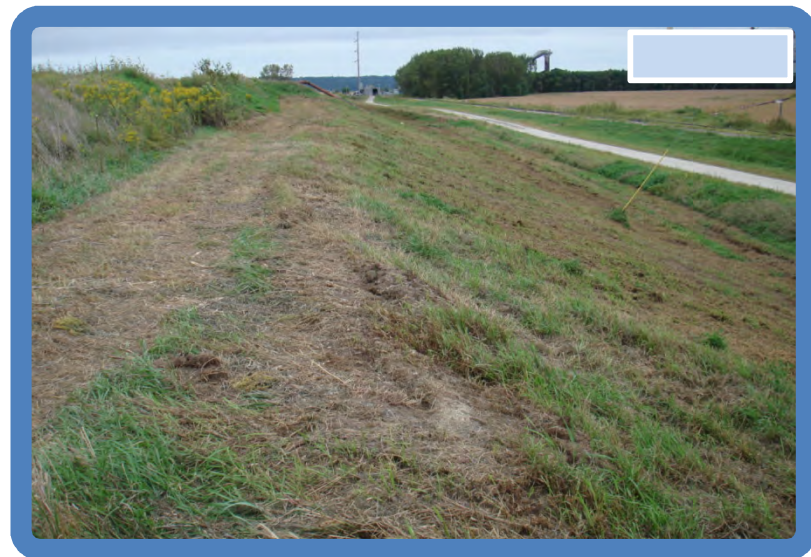
Photo 3.15
Pond 3B North dike outside slope (NE side viewed NW)

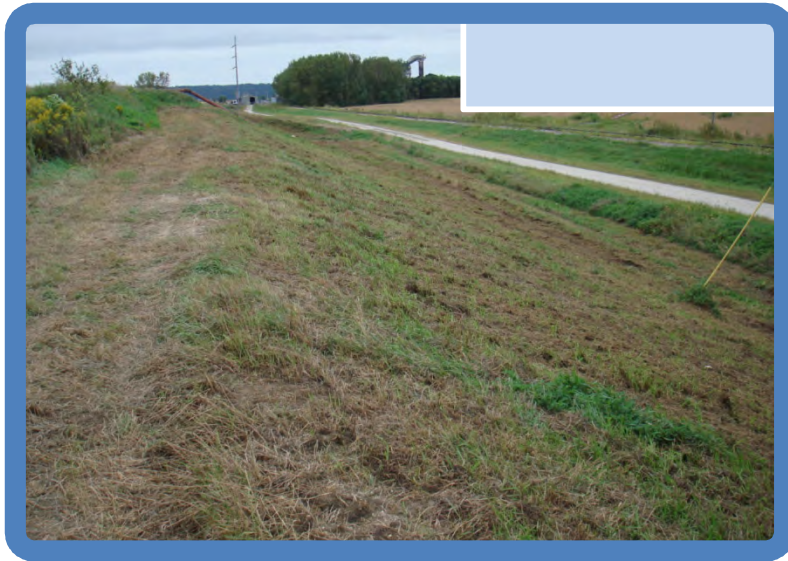
The perimeter dike inside slope is generally buried with ash deposits, except along the southeast part of the perimeter dike on the northeast side, which is partially exposed above ash level in the pond. There is a linear mound of ash material up to 10 feet high above the dike crest elevation along the inside edge of the perimeter dike crest on the northwest side (see Photos 3.16 and 3.19) and partly on the northeast side, northwest end.

Photo 3.16
Pond 3B North dike outside slope (NW side viewed SW)

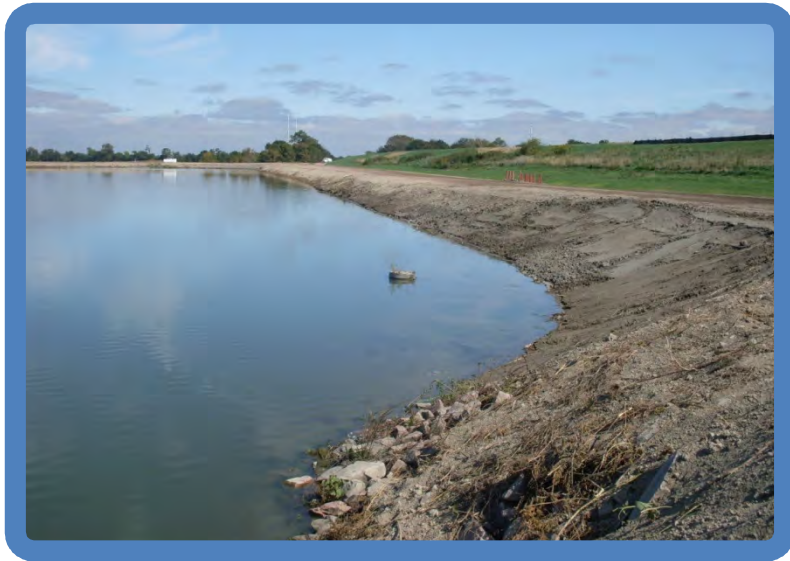
Pond 3A was observed to have the largest pool of water of all the ash ponds at NNEC. The pool of water occupies most of the basin area (see Photos 3.24 and 3.30), except in the northwest part where ash deposits have accumulated and where ash formerly was mounded along the inside edge of the northwest-side crest above the crest elevation (see Photos 3.19 through 3.22). Thus, the inside slopes of Pond 3A are generally covered with water or buried with ash deposits. The ash deposits were observed to contain some C-stone fragments (see Photo 3.31). In addition to the sluiced discharge received from Pond 2, Pond 3A occasionally receives discharge from an ash sluice pipe located over the northwest side (see Photo 3.32), near juncture with northeast part of Pond 2. The exposed upper part of the inside slope above water level on the south side was observed to have been recently graded and was generally bare with no vegetative cover at the time of the site visit (see Photo 3.25).

Photo 3.24
Pond 3A pond area (viewed NE)
-note solidified fly ash

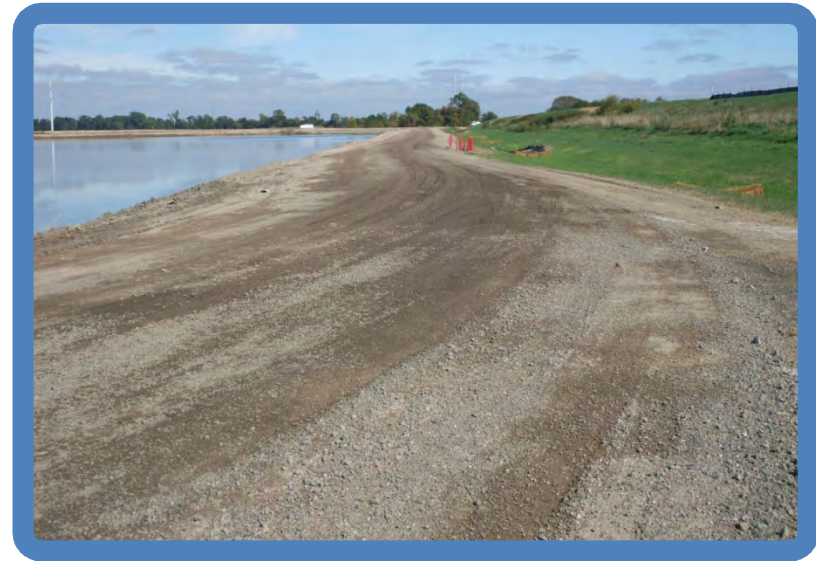
Photo 3.25
Pond 3A dike inside slope (S side viewed E)

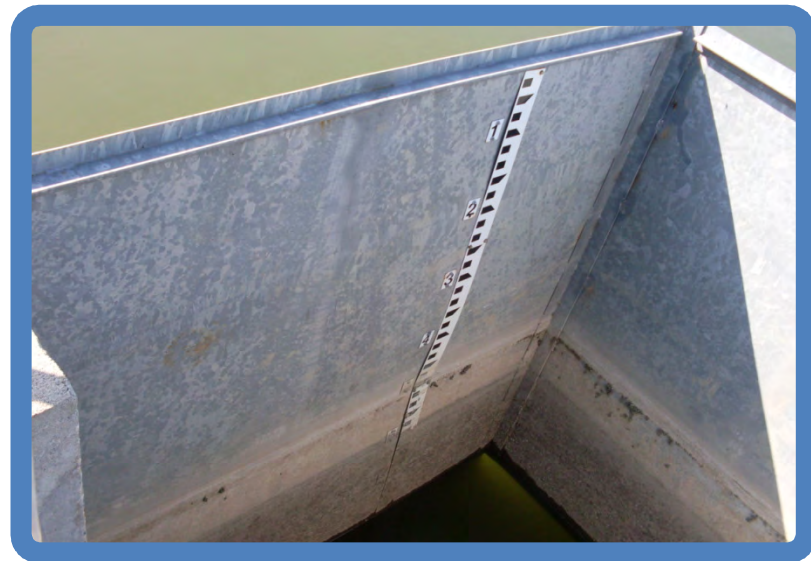
The outfall path from Pond 3B South starts at the new stop-log structure shown in Photo 4.1. A skimmer box surrounds the overflow section and is fitted with a staff gauge (see Photo 4.2). From an adjustable 4-foot wide stop-log weir (see Photo 4.3) flow enters the structure and discharges through a 24-inch RCP pipe in the bottom of the structure to a wet well (see Photo 4.4, interior view) at the crest of the dike.

The overflow structure is the new stop-log structure located at the southwest corner of Pond 3B South (see Photos 4.1 through 4.3); the overflow structure and access bridge were observed to be in very good visual condition and appeared sound and serviceable. The wet well located at the south-side perimeter dike crest was in good visual condition (see Photo 4.4). MidAmerican staff explained that CO₂ is added to the discharge water at the wet well to maintain a pH value near 8.0.

Photo 4.1
Pond 3B South Stop-log Structure

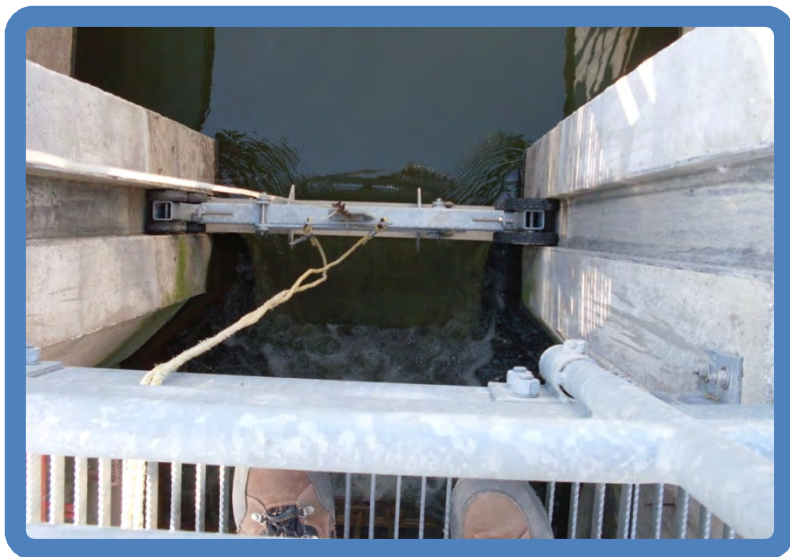
Photo 4.2
Pond 3B South Skimmer Box with staff gauge

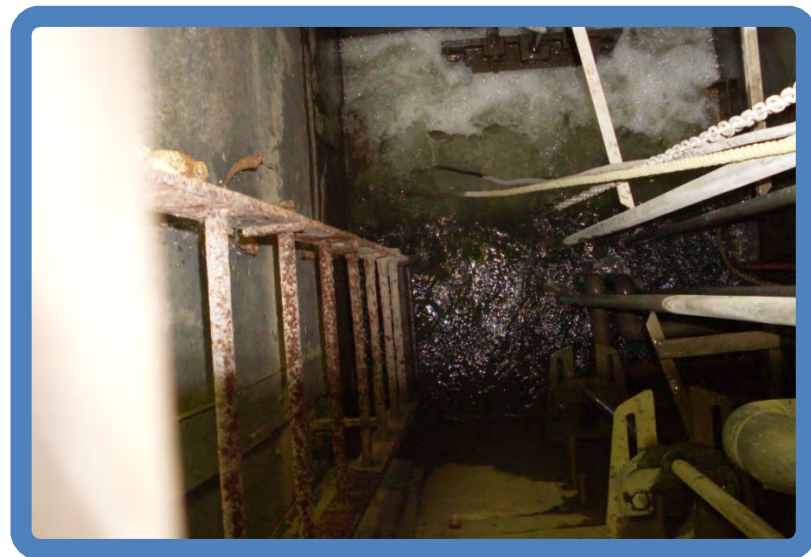
Photo 4.3
Pond 3B South Stop-log Structure adjustable weir

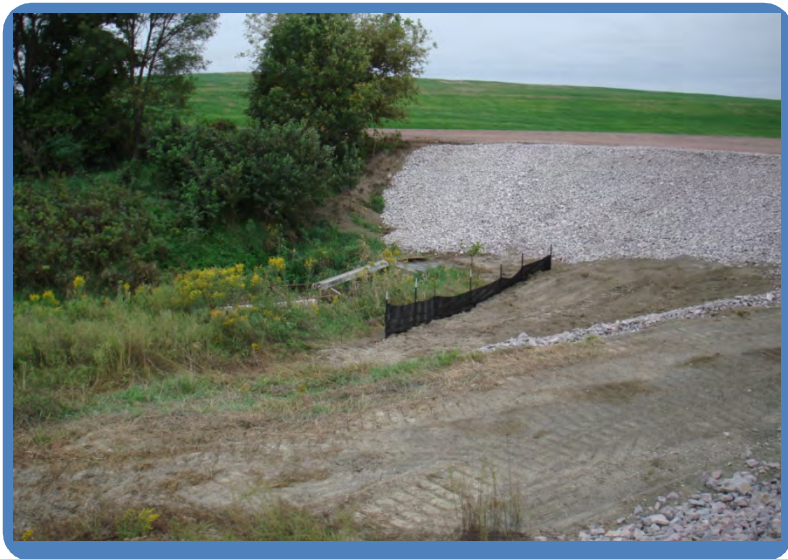
Photo 4.4
Pond 3B South Wet Well Structure CO₂ applied

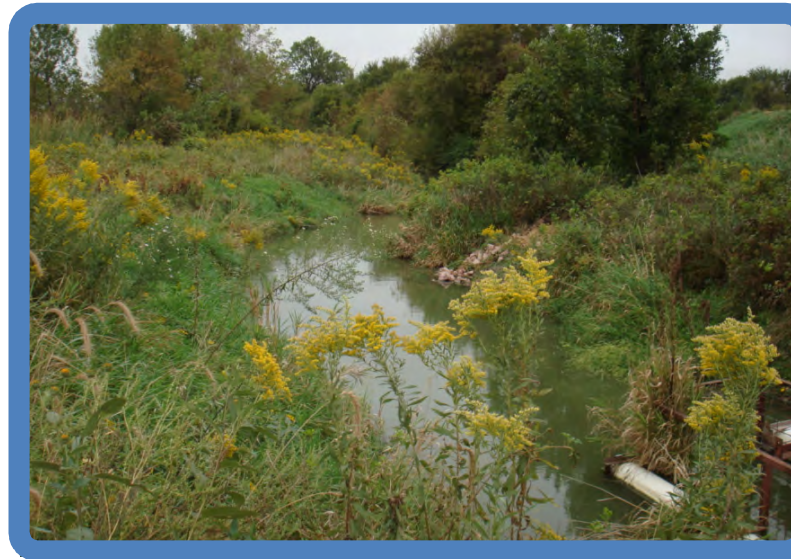
From the wet well the water discharges through another 24-inch RCP, which connects underground to a 48-inch diameter RCP (see Photo 4.5 for general location). The 48-inch pipe also receives drainage from a channel from the oxbow lake (see Photo 4.6). The inlet and outlet ends of the 1,650-foot long, 48-inch culvert were observed to be in good visual condition and appeared to be in sound condition (see Photos 4.7 through 4.10). Then the discharge from the 48-inch culvert daylights into the 1,200-foot long swale (see Photos 4.9 and 4.12), including a 50-foot section where the water is channeled through a 48-inch aluminum CMP (see Photo 4.11), then to the final outfall structure (see Photo 4.12) that discharges into the Missouri River (see Photos 4.12 through 4.14). At the final outfall structure, water flows over a 3-foot wide rectangular weir (see Photo 4.13), then into a 48-inch RCP culvert (see Photo 4.14) discharging into the Missouri River. The discharge channel was observed to be open and free-flowing with no obstructions or bank failures. The visible parts of aluminum culvert and the final outfall structure were observed to be in good visual condition and appeared sound and serviceable.

Photo 4.5
Outlet Pipe connects underground to 48" RCP, next to landfill

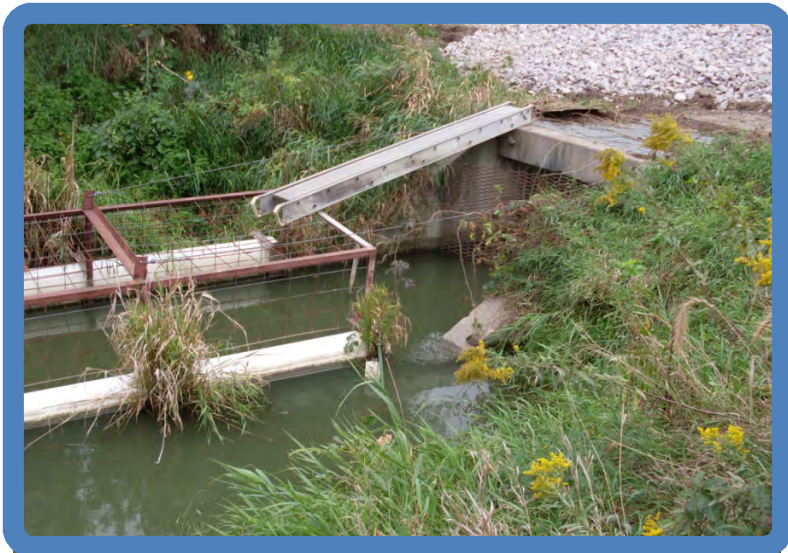
Photo 4.6
Channel from oxbow lake to Inlet End of 48" RCP Culvert
