**CAROLINA POWER & LIGHT  
MAYO ELECTRIC GENERATING PLANT**

**MAYO CREEK DAM  
ASH POND DAM  
PERSON COUNTY, NORTH CAROLINA**

**FIVE-YEAR INDEPENDENT CONSULTANT INSPECTION  
AS REQUIRED BY  
NORTH CAROLINA UTILITIES COMMISSION**

**December 22, 1999**

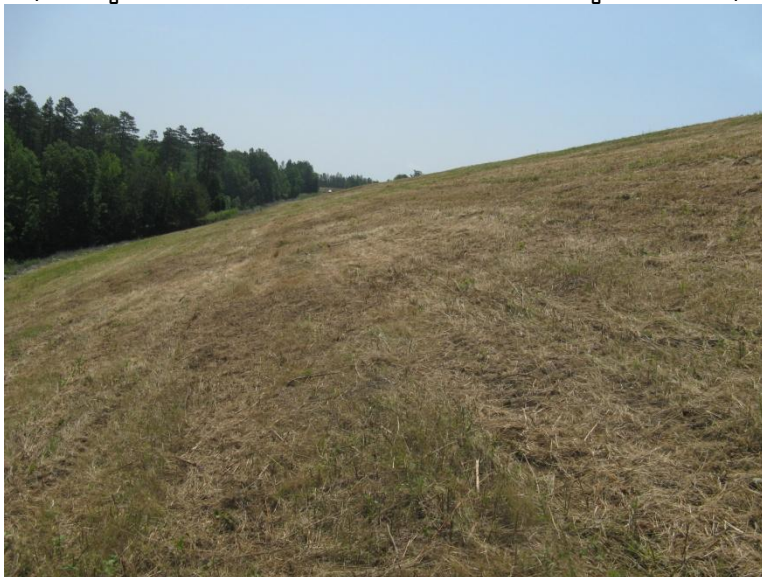
Photo 5: Embankment Looking to Right Abutment, Downstream Embankment, Photo: 036, 6/3/09  
(Note right and left are referenced from observer facing downstream)

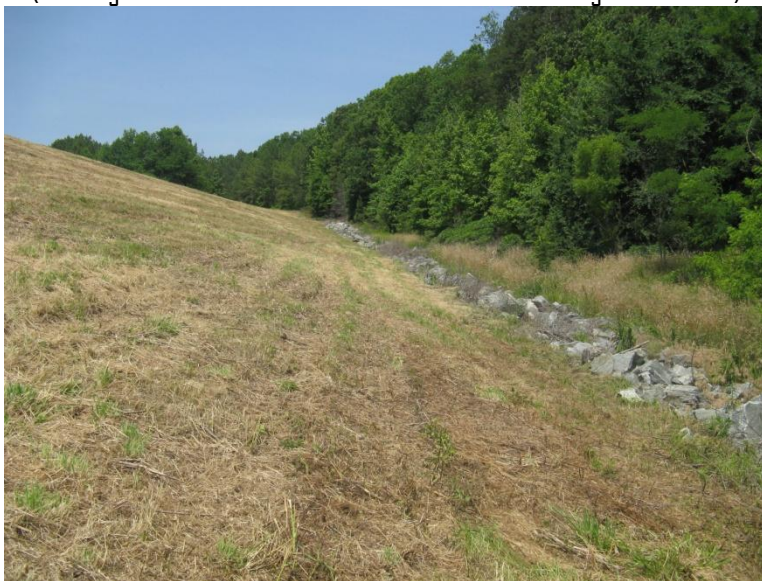
Photo 6: View of Left Groin and Embankment, Left Groin, Photo: 032, 6/3/09  
(Note right and left are referenced from observer facing downstream)

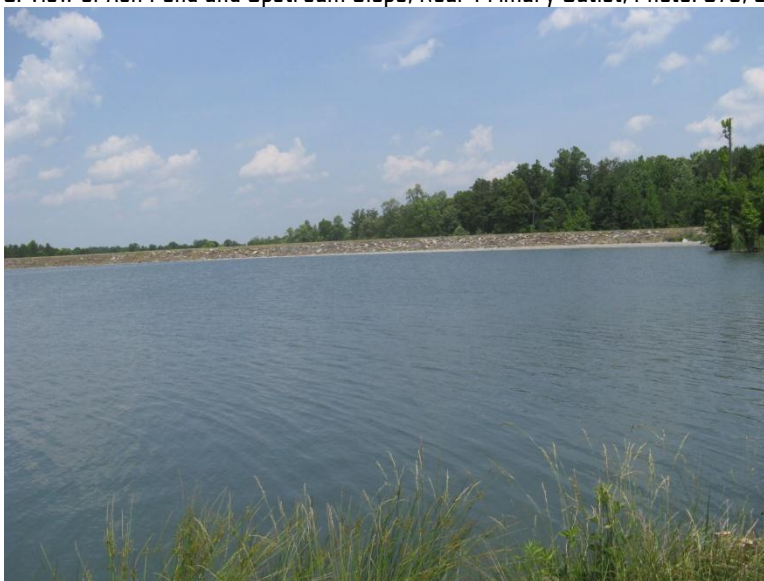
Photo 8: View of Ash Pond and Upstream Slope, Near Primary Outlet, Photo: 075, 6/3/09

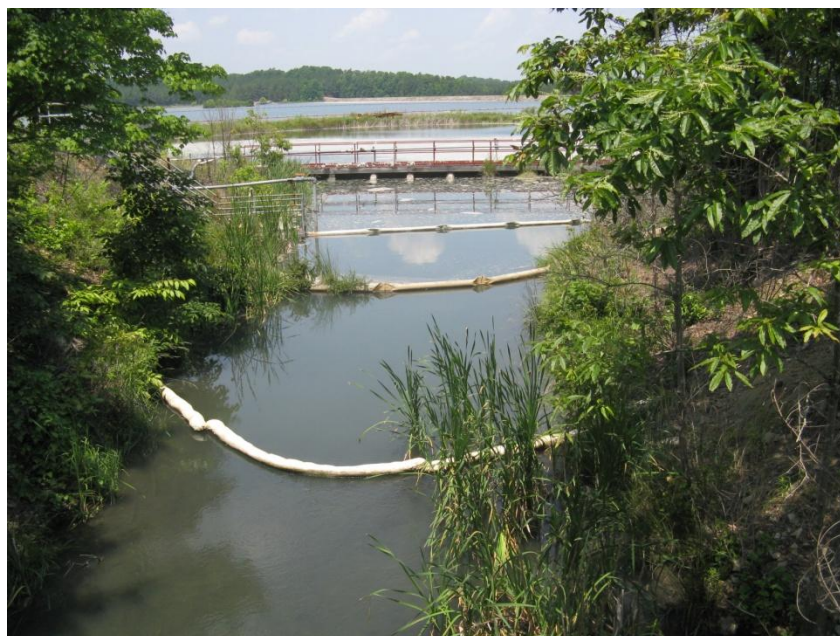
Photo 12: Downstream channel looking upstream at stilling pool with embankment dam in background, Photo: 069, 6/3/09
