**Assessment of Dam Safety of Coal Combustion  
Surface Impoundments**

**Northern Indiana Public Service Company**

**R.M. Schahfer Generating Station**

*Draft Report*

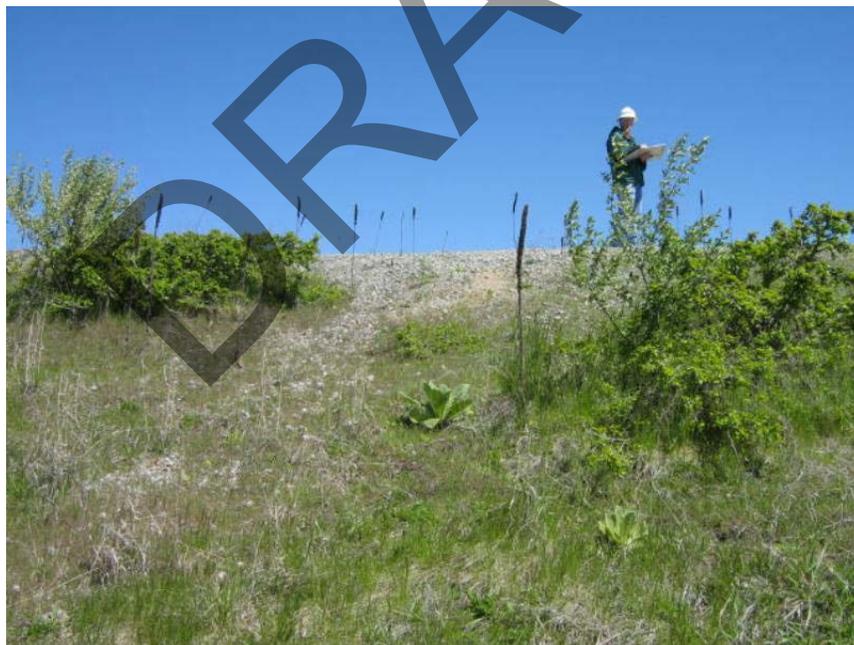
- 17,18,19. Depressions, minor erosion rills, surface erosion, localized failures, and soft soils noted along west embankment exterior slope. Surface erosion (approximately 1-2') and rodent burrows noted along southwest embankment exterior slope. Depression at intake pipe along the southwest embankment exterior slope. Riprap slide along the east embankment interior slope. Surface erosion noted at the north embankment exterior slope (east edge).

6. Final Settling Basin - Erosion rill west embankment exterior slope

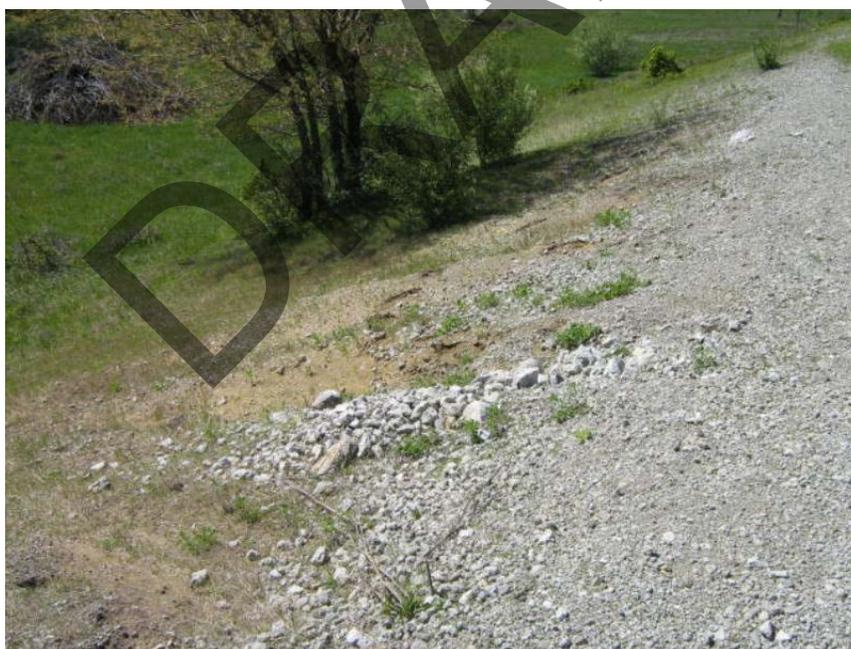
8. Final Settling Basin - Erosion rills on south embankment exterior slope

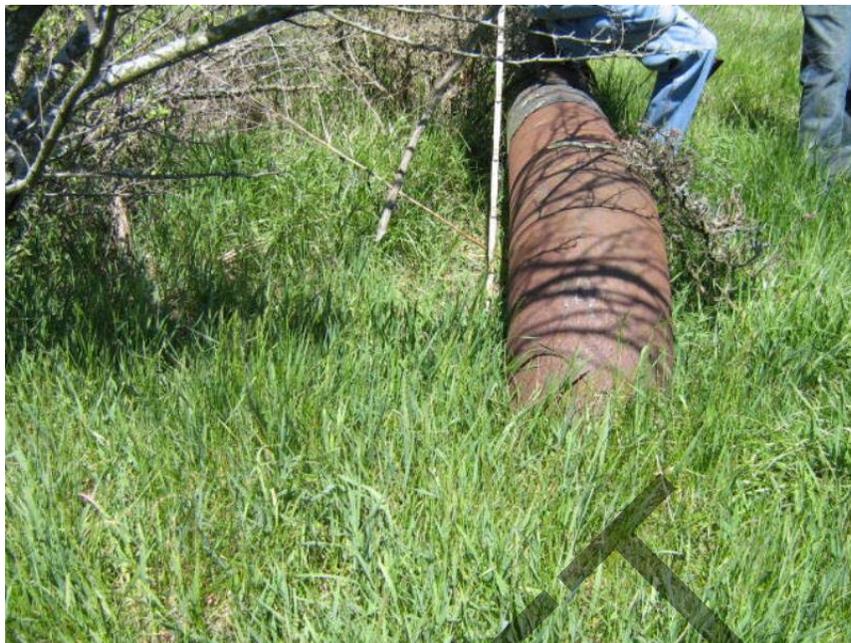
9. Final Settling Basin - Depression at intake pipe (10 inch diameter metal) on south embankment exterior slope

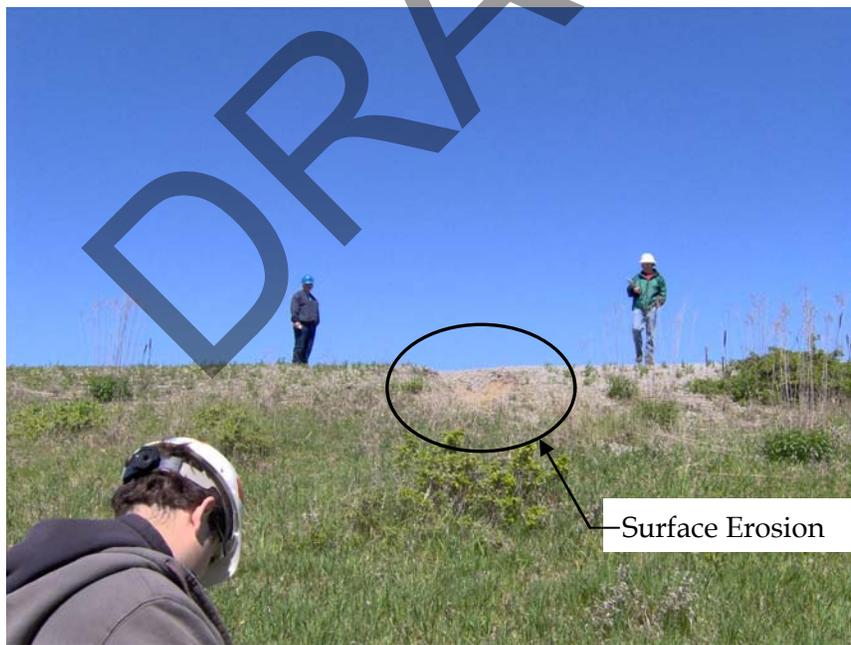
12. Final Settling Basin - Surface erosion located on south embankment exterior slope

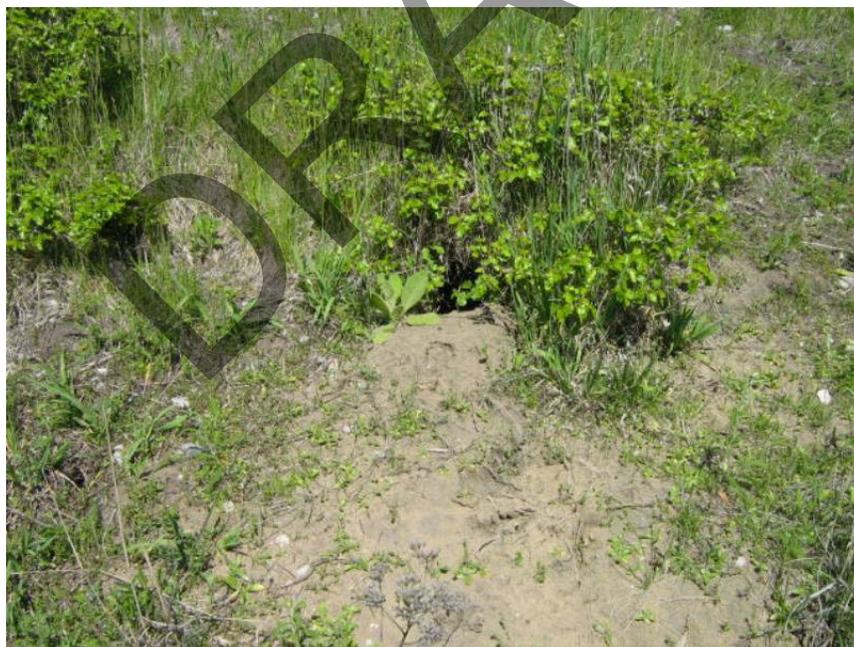
14. Final Settling Basin - Rodent burrow on south embankment exterior slope

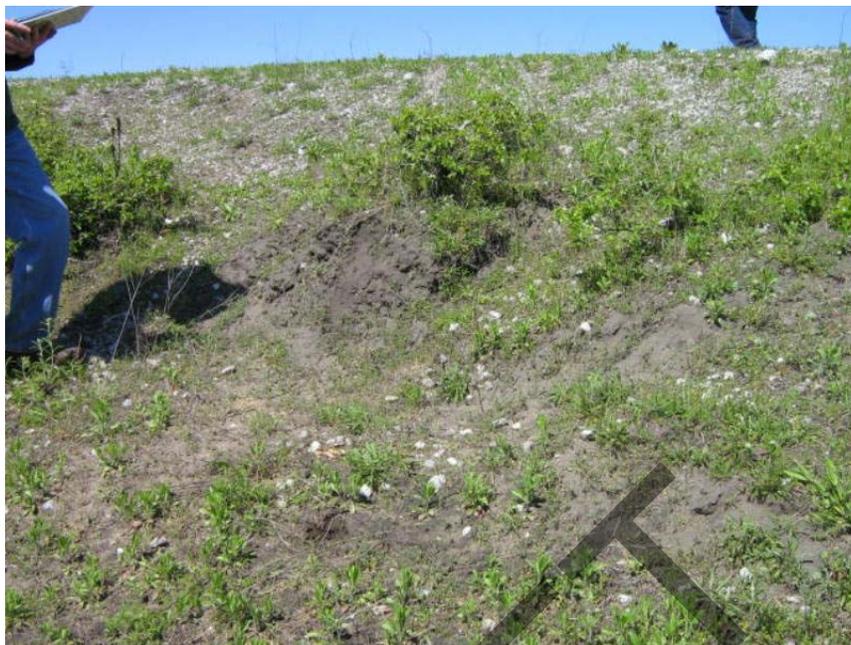
15. Final Settling Basin - Scarp on south embankment exterior slope

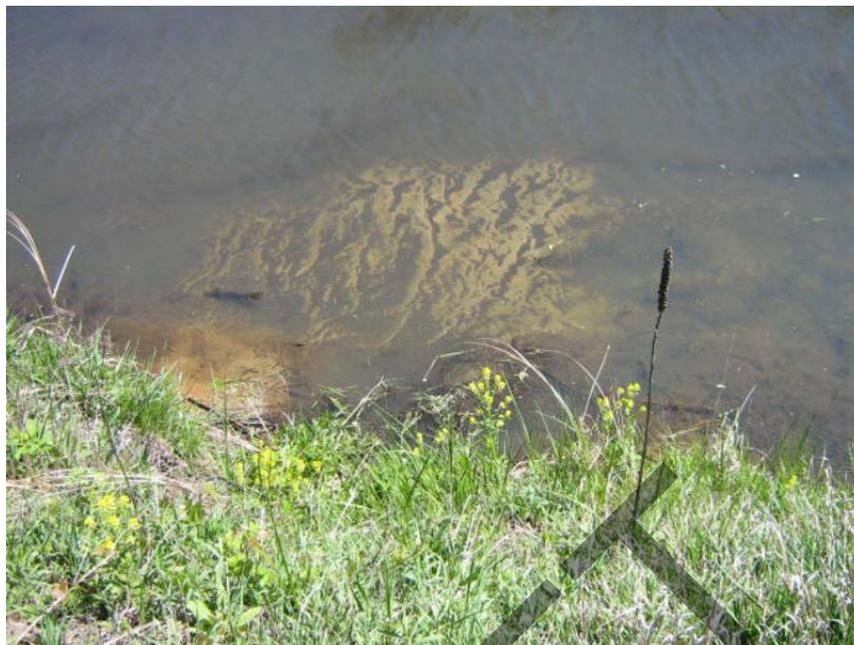
19. Final Settling Basin - Possible seepage into drainage ditch

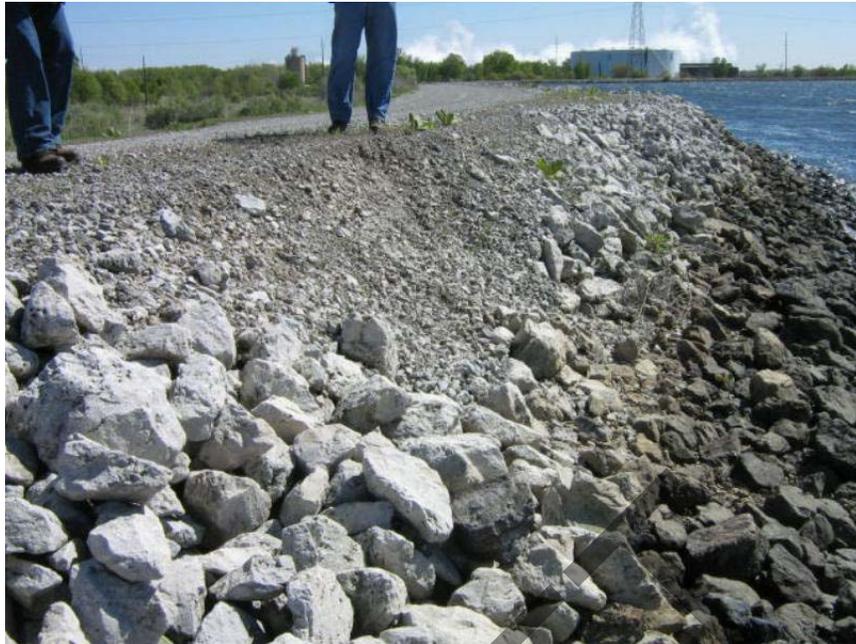
21. Final Settling Basin - Riprap slide on east embankment interior slope

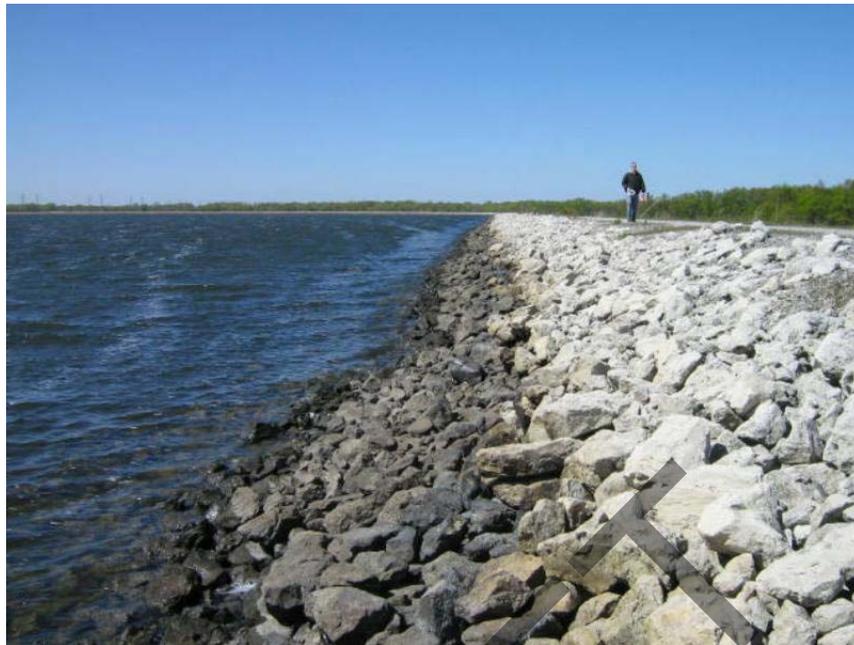
23. Final Settling Basin - East embankment interior slope, riprap erosion

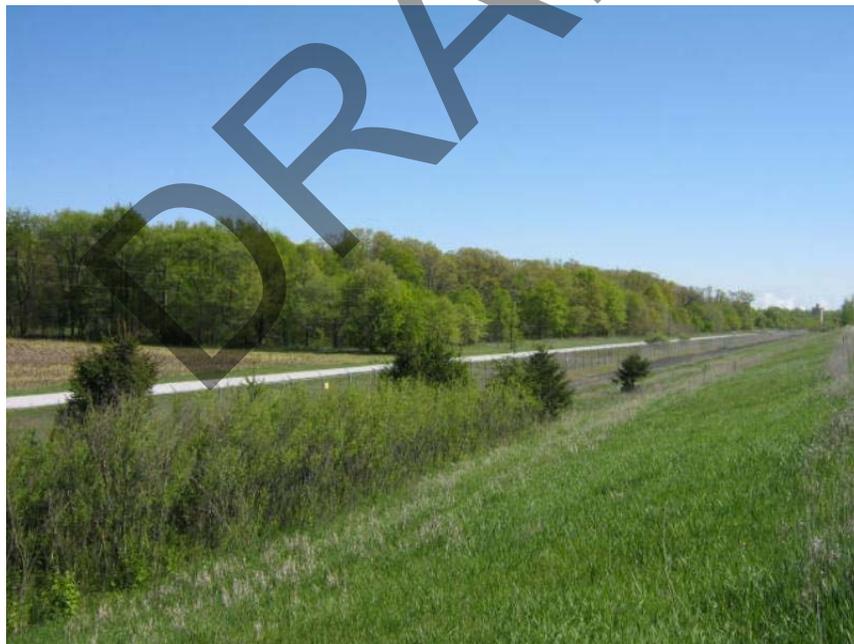
24. Final Settling Basin - Shrubs and brush at exterior slope at toe of east embankment

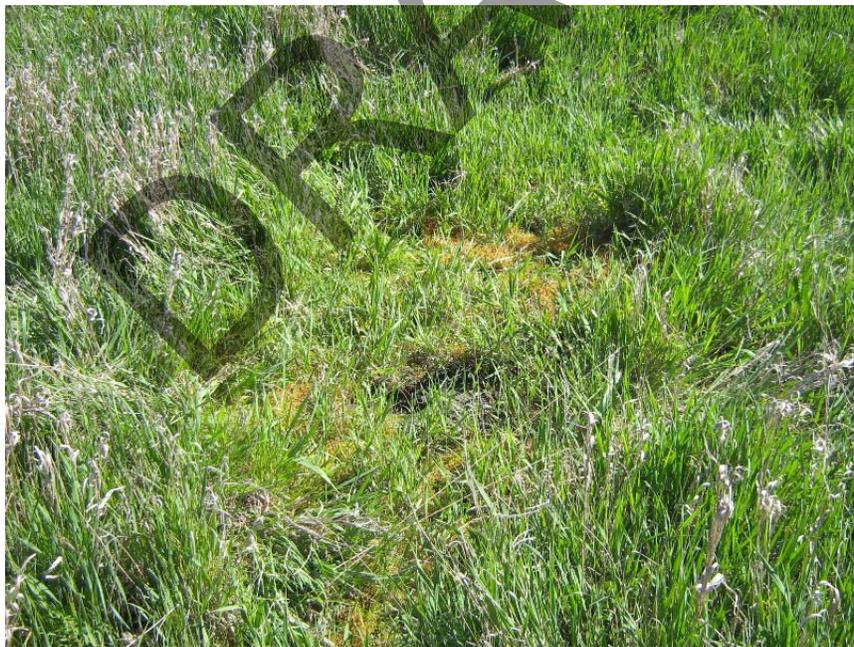
- 20. There are no decant pipes. Outlet controlled by overflow weir and Pump Station.
- 21. Possible historic seepage area located along the north embankment exterior slope. The area is currently dry, however moss indicates moisture.

30. Final Settling Basin - North embankment exterior slope, possible seepage area, moss covered

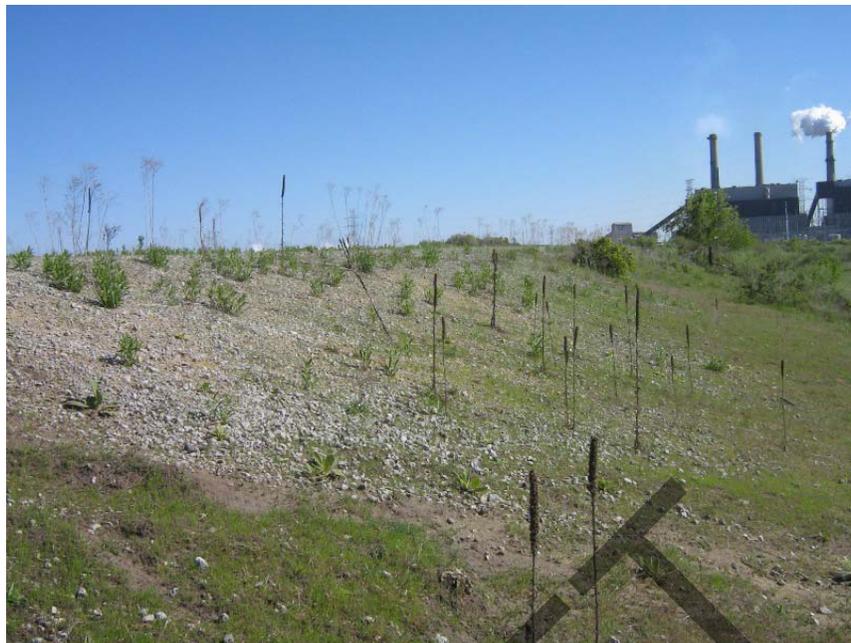
33. Final Settling Basin - West embankment exterior slope, sparse vegetation

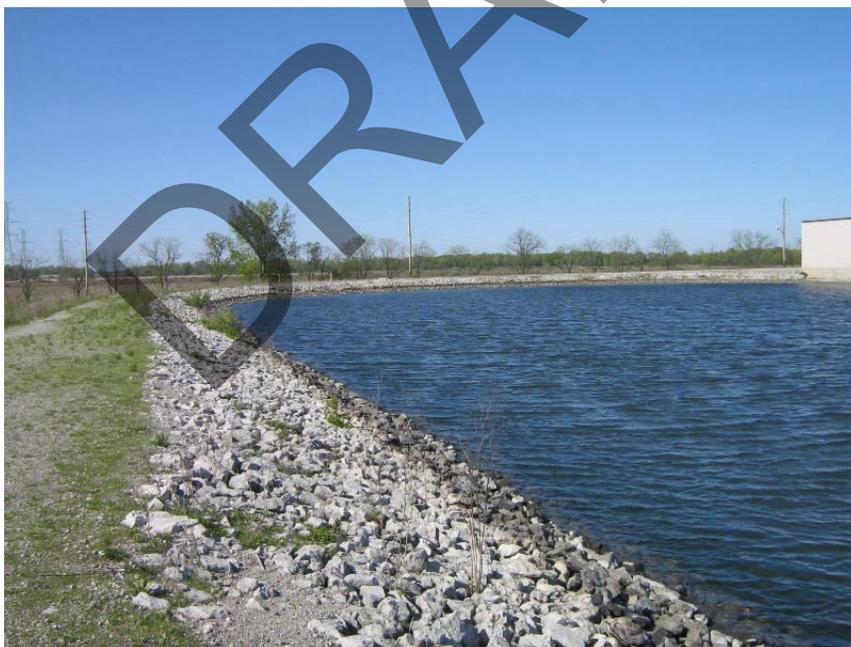
34. Final Settling Basin - West embankment interior slope

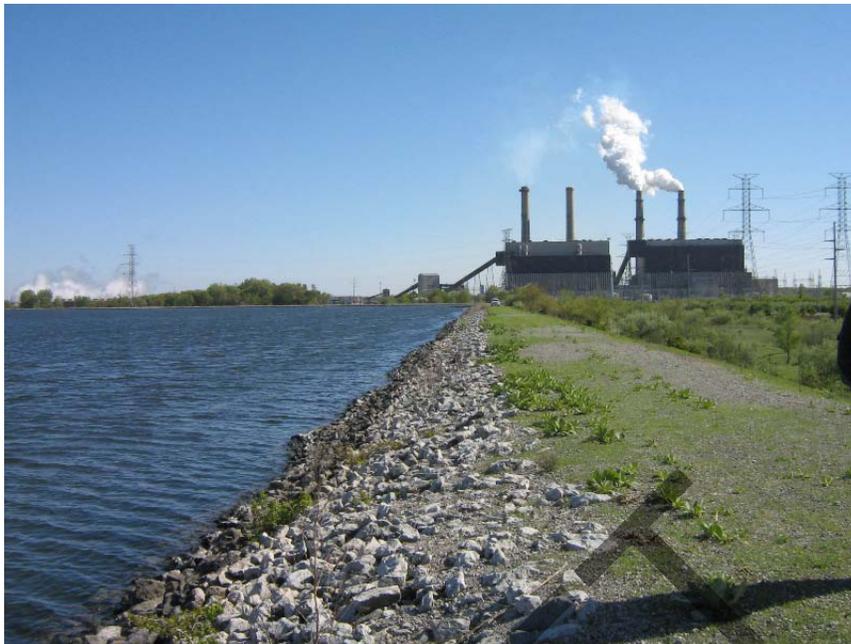
35. Final Settling Basin - West embankment crest and interior slope

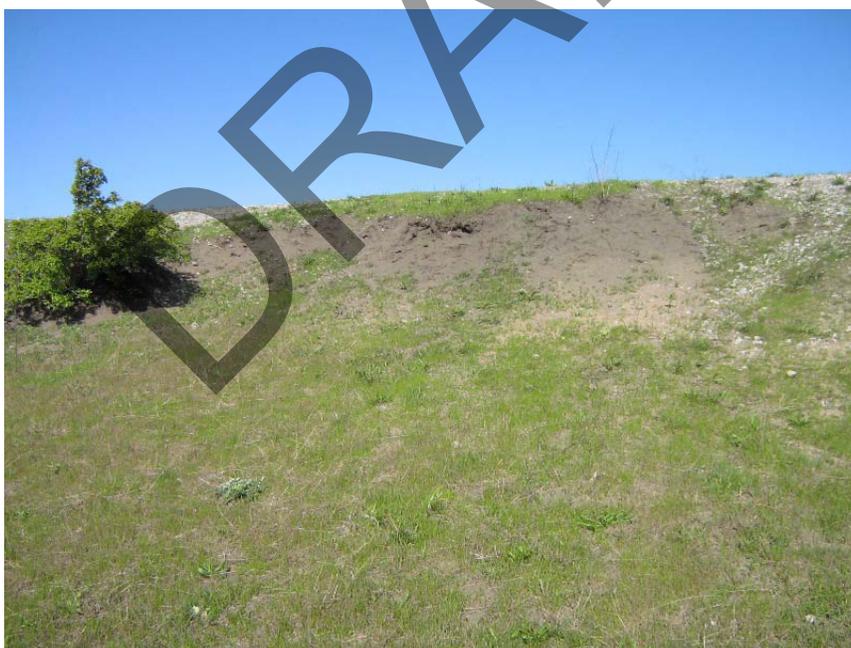
36. Final Settling Basin - Active scarp on west embankment exterior slope (approximately 32 feet in length)

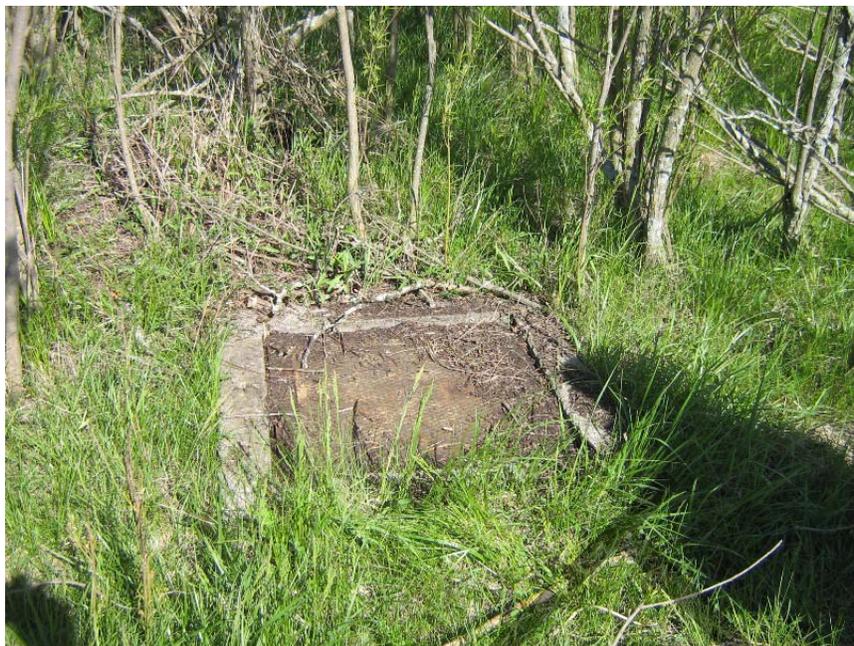
37. Final Settling Basin - Manhole located on west embankment exterior slope

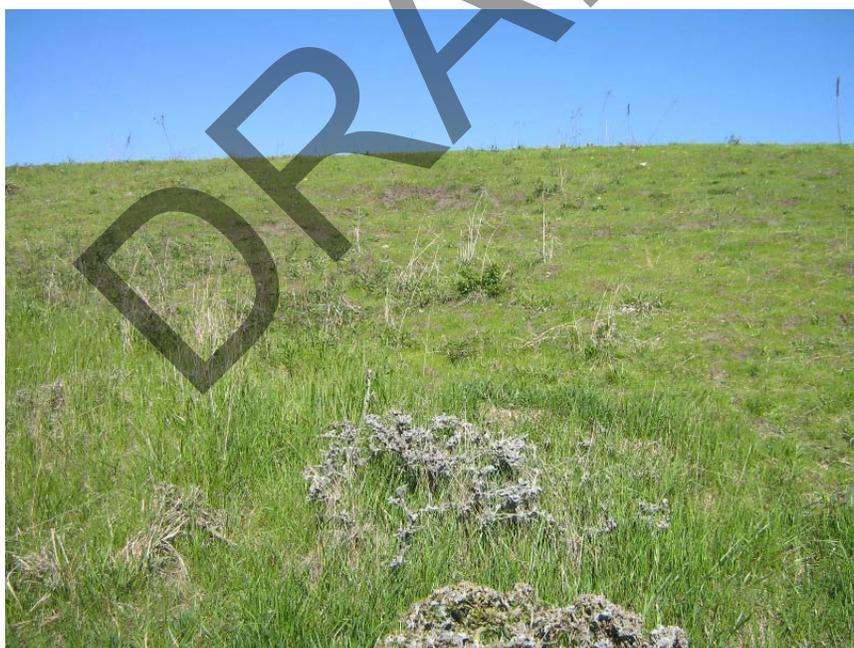
38. Final Settling Basin - Scarp on west embankment exterior slope

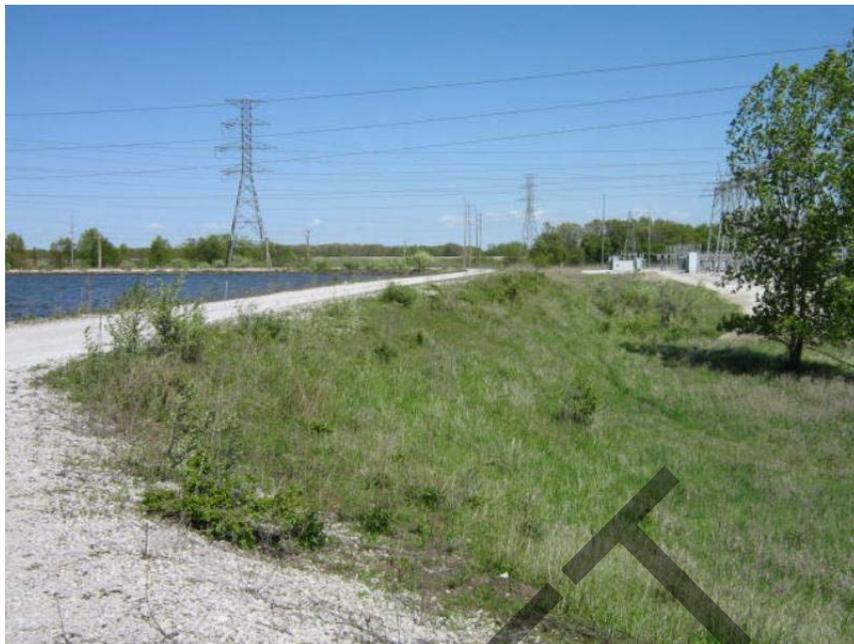
41. Intake Settling Basin - South embankment exterior slope, tree near slope toe

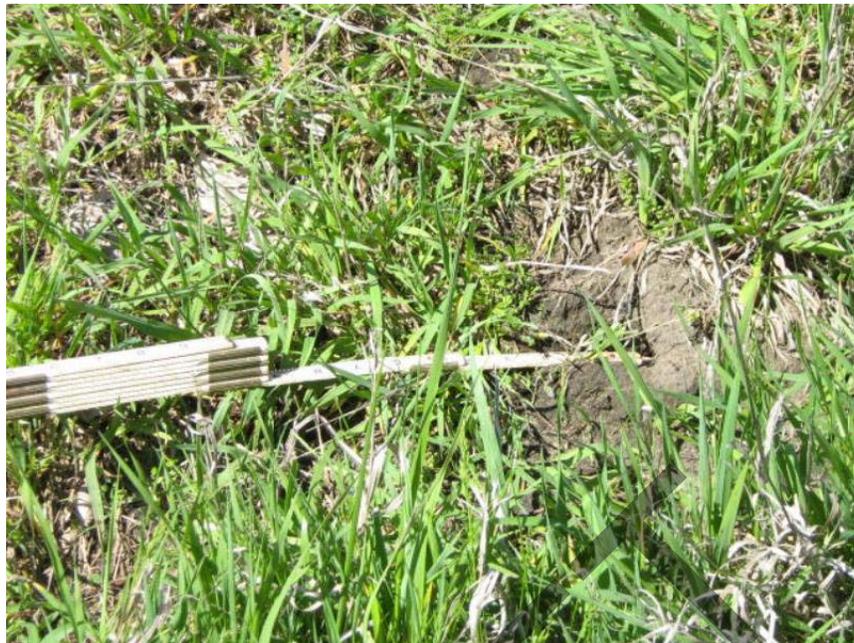
43. Intake Settling Basin - Rodent burrow on south embankment exterior slope

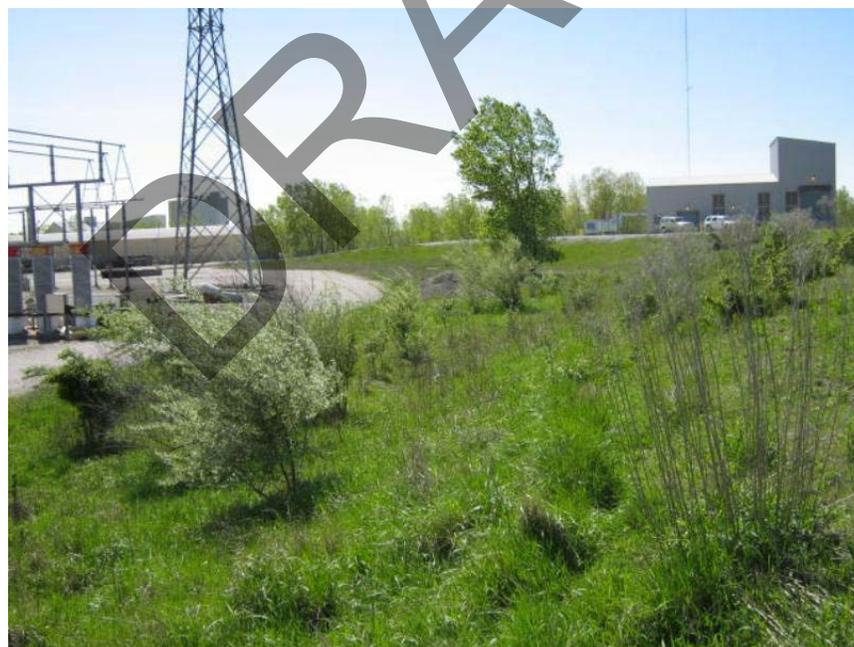
44. Intake Settling Basin - South embankment exterior slope, vegetation

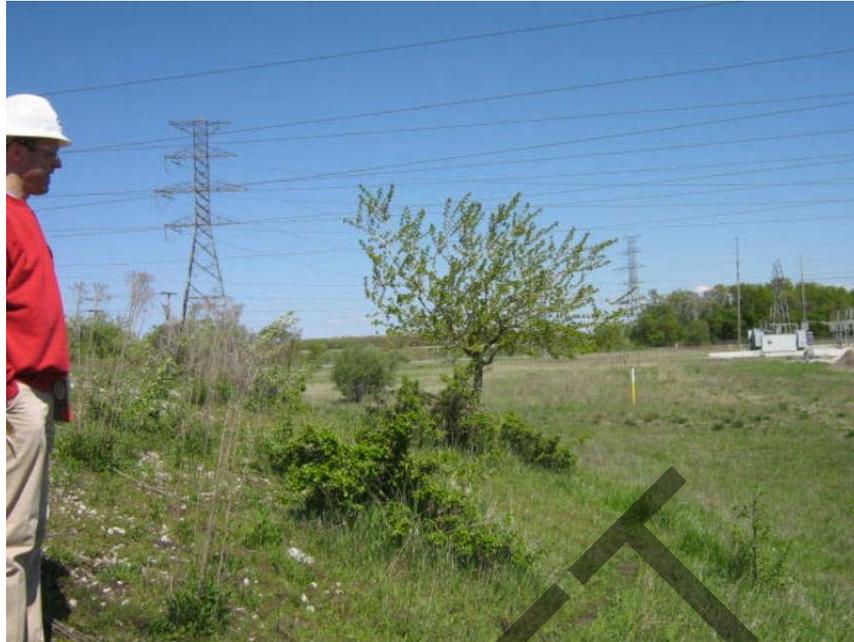
45. Intake Settling Basin - South embankment exterior slope

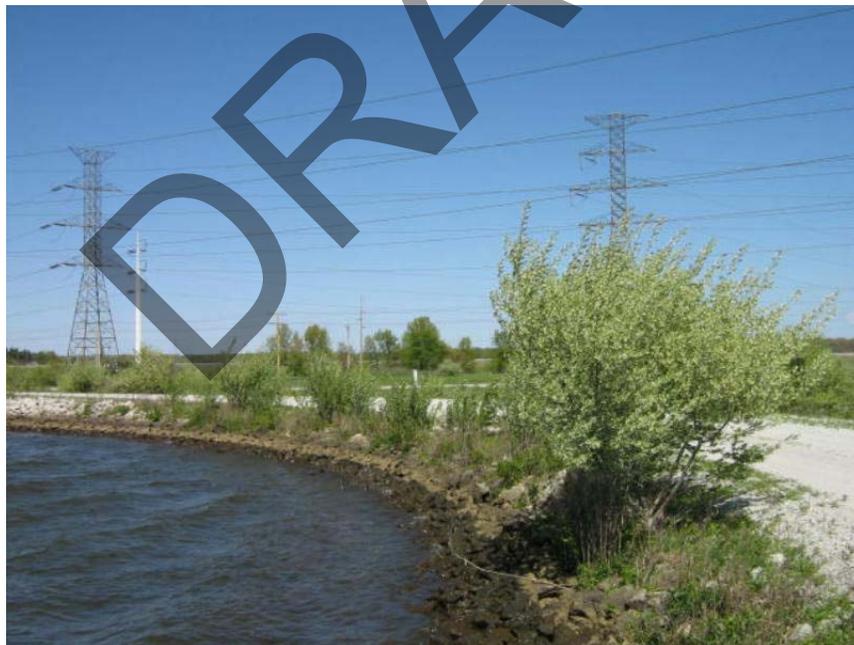
46. Intake Settling Basin - South embankment interior slope, vegetation

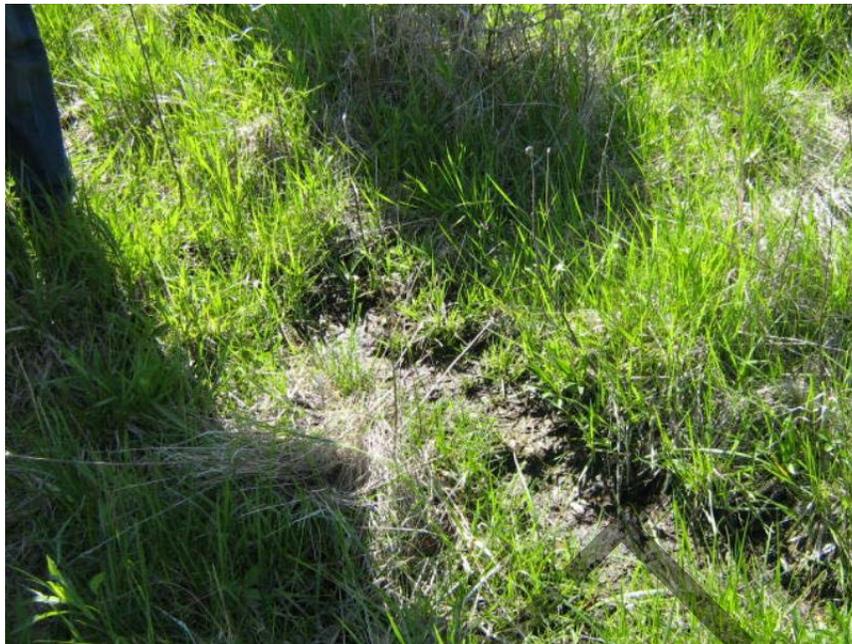
47. Intake Settling Basin - Saturated area located on east embankment exterior slope

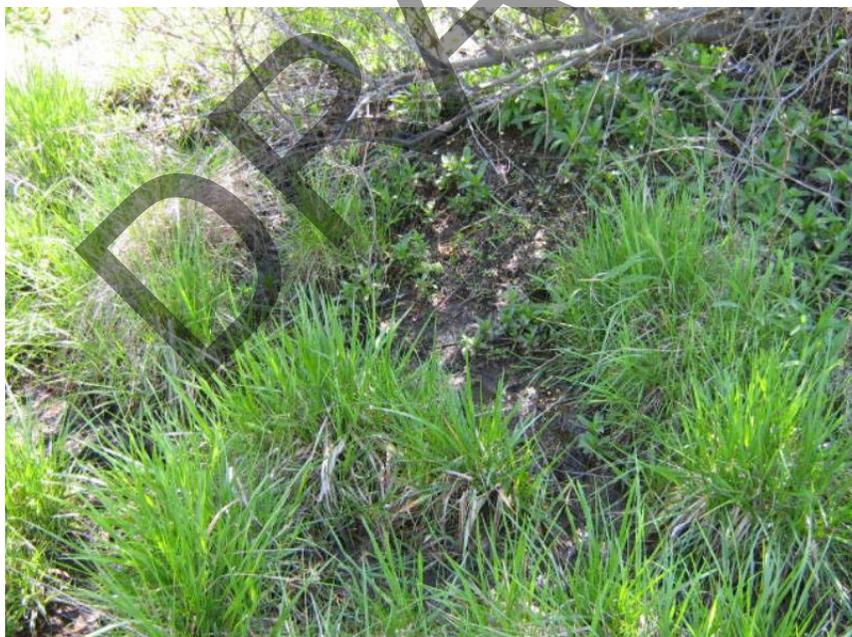
48. Intake Settling Basin - Saturated area located on east embankment exterior slope

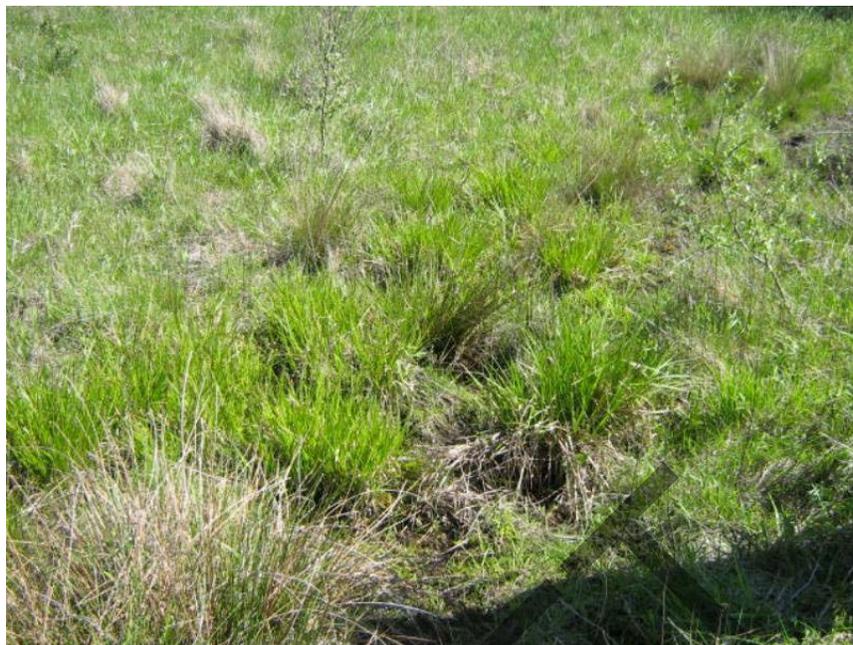
49. Intake Settling Basin - Saturated area located on east embankment exterior slope

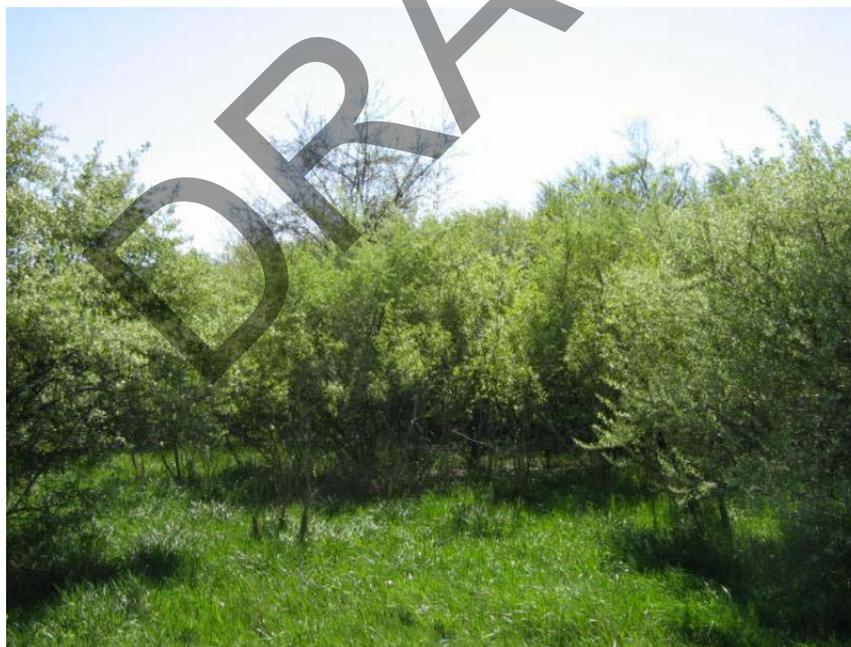
50. Intake Settling Basin - Vegetation and trees on base of east embankment exterior slope toe

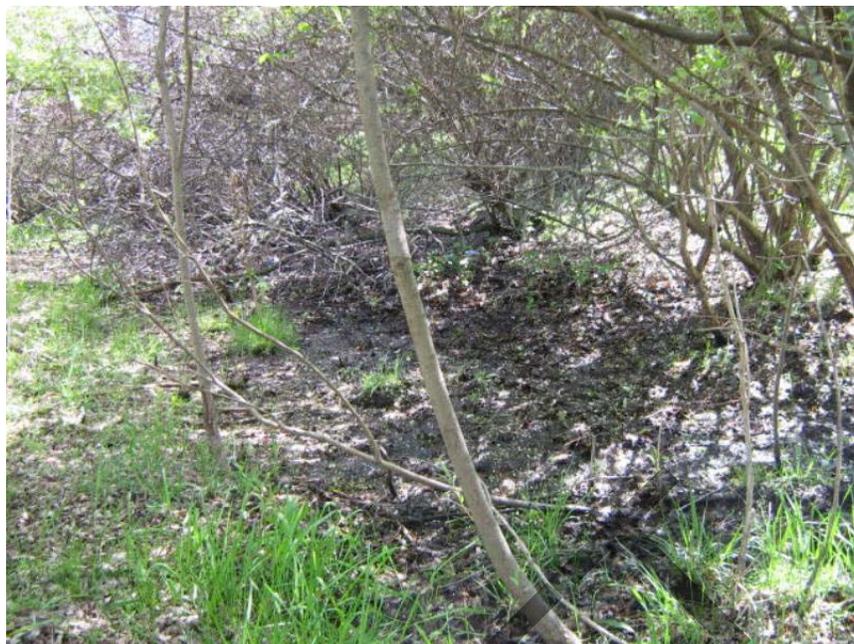
51. Intake Settling Basin - Brush on east embankment exterior slope

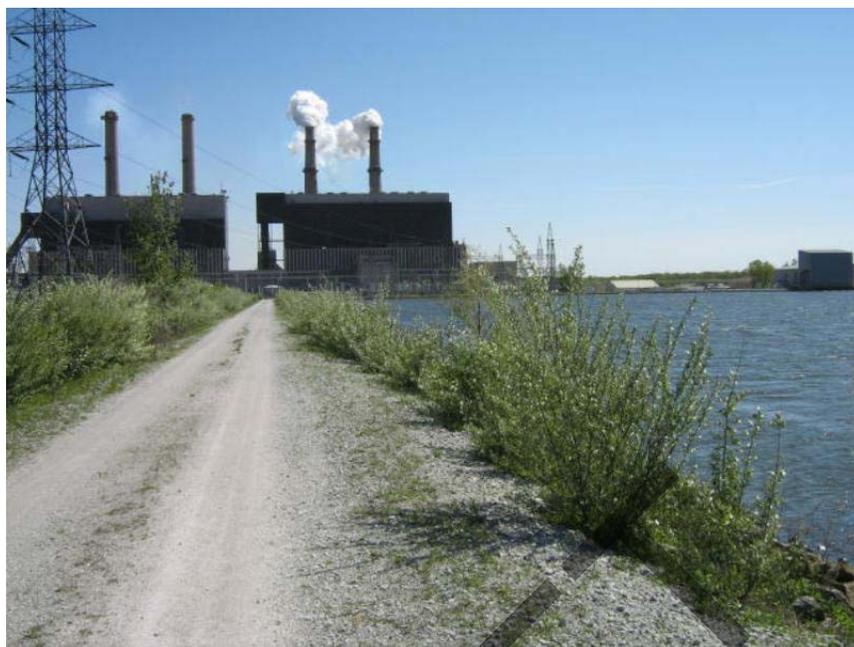
53. Intake Settling Basin - East embankment crest

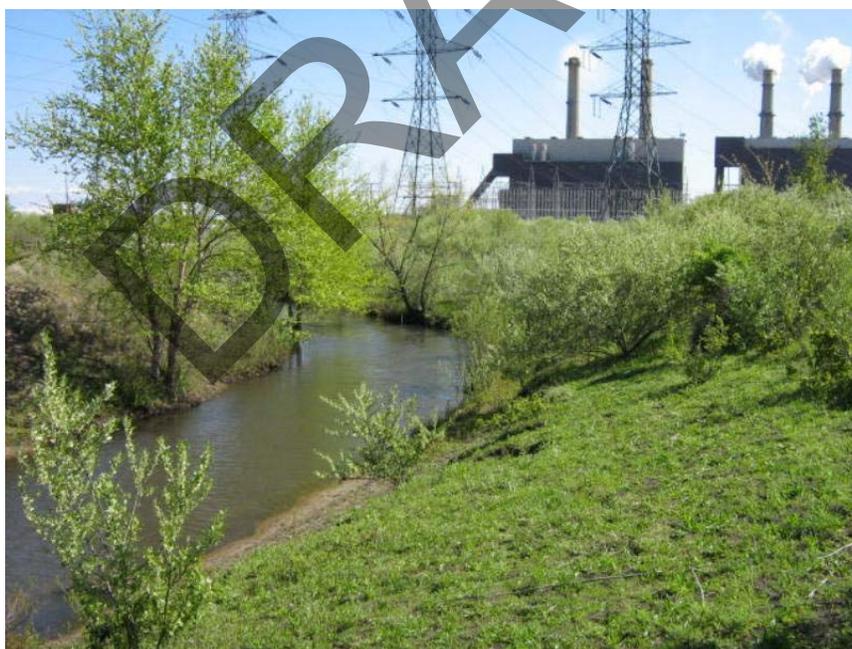
54. Intake Settling Basin - Drainage ditch at east embankment exterior slope toe

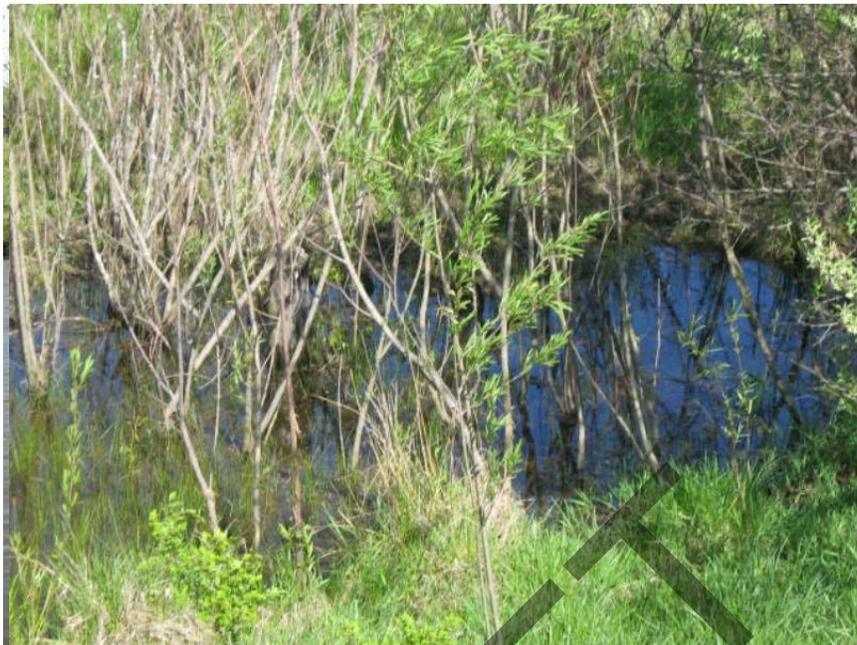
55. Intake Settling Basin - Standing water on east embankment exterior slope toe

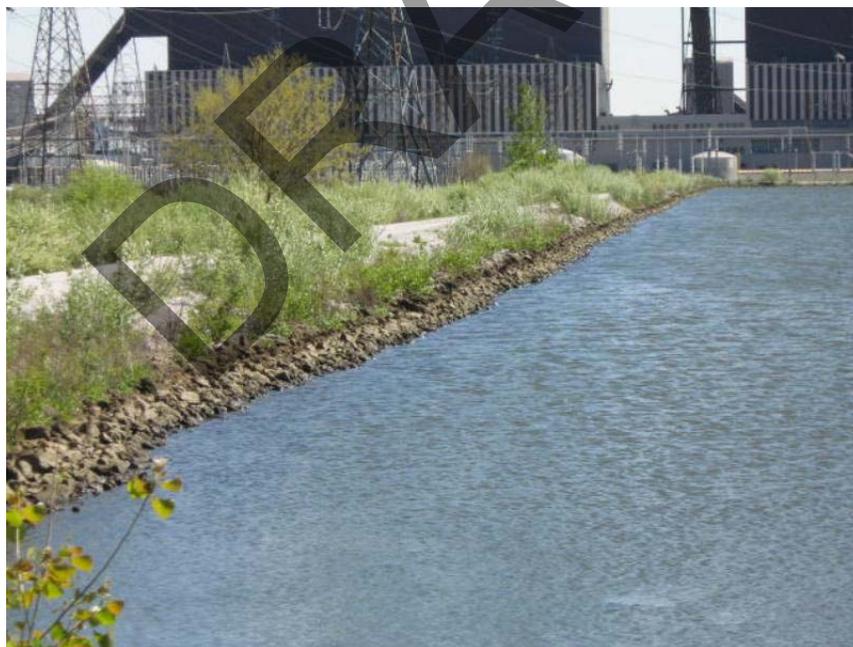
56. Intake Settling Basin - East embankment interior slope

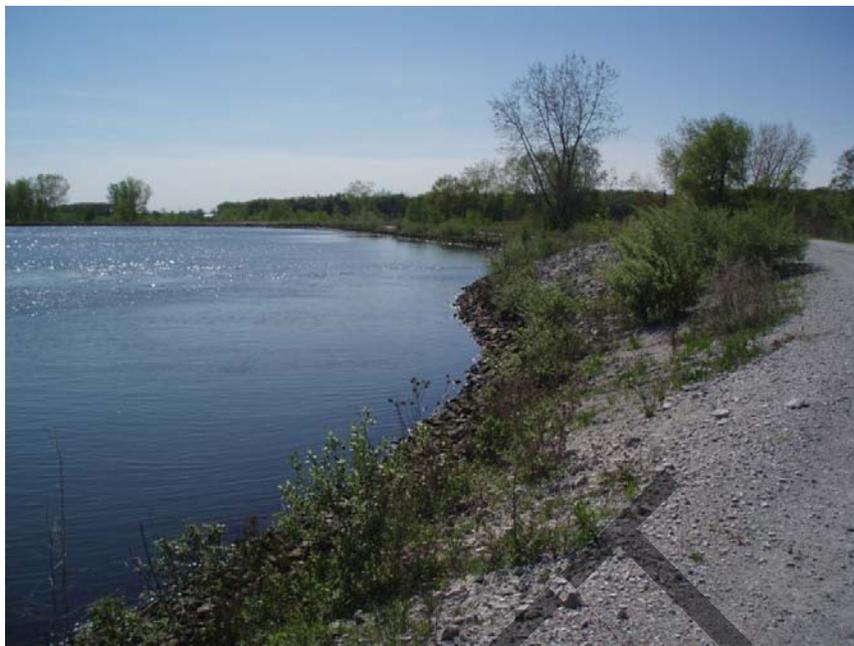
57. Intake Settling Basin - North embankment interior slope

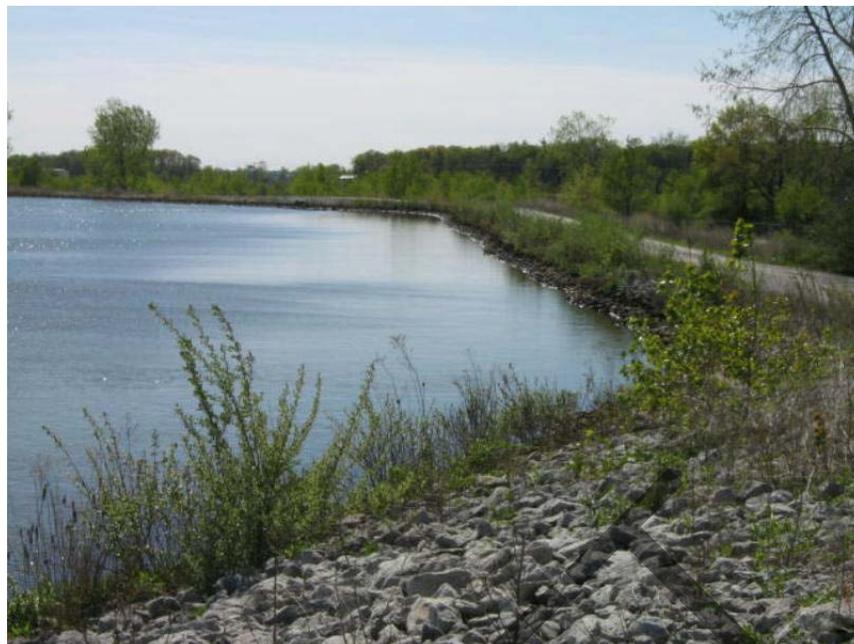
59. Intake Settling Basin - North embankment interior slope

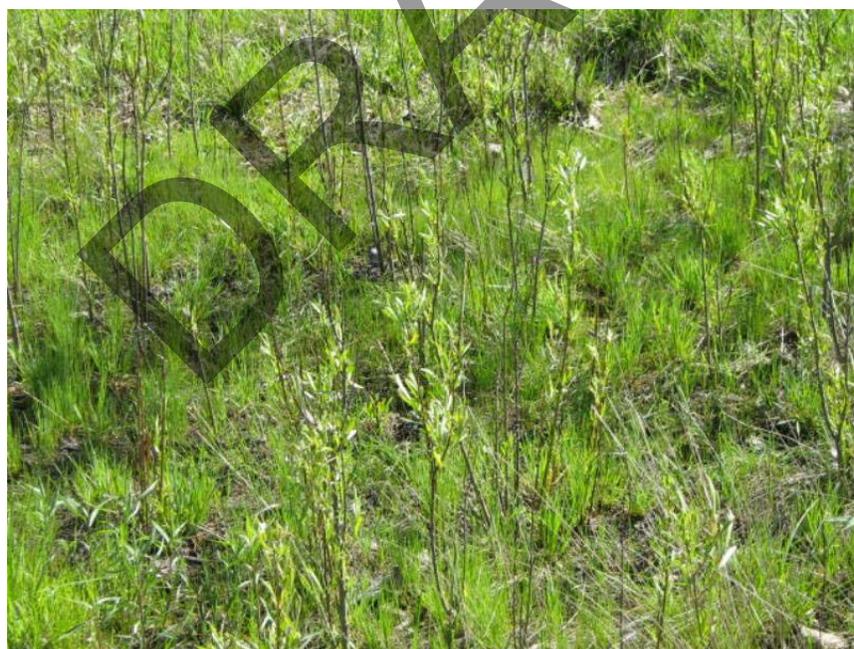
60. Intake Settling Basin - Saturated area on north embankment exterior slope (approximately 25 feet long by 8 feet wide)

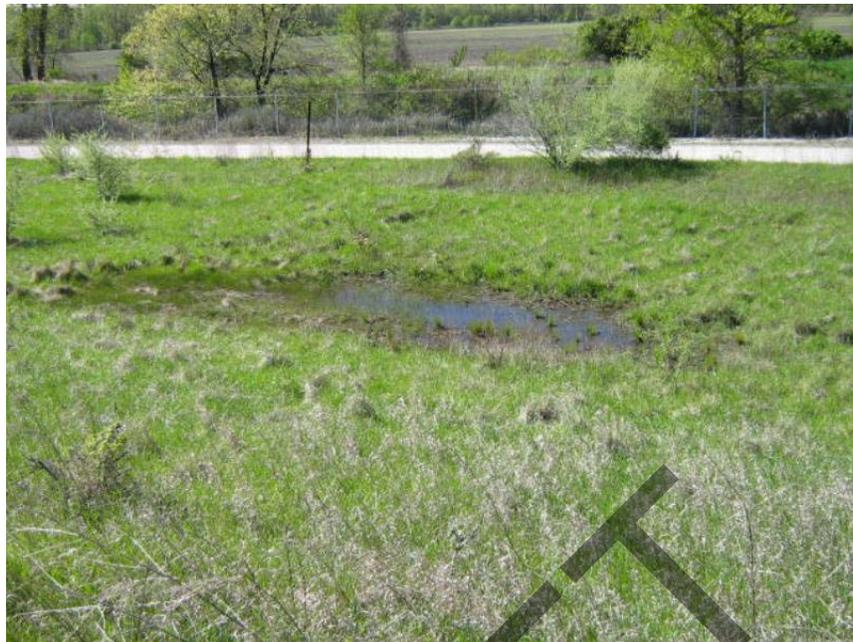
61. Intake Settling Basin - Standing water at slope toe of north embankment exterior slope

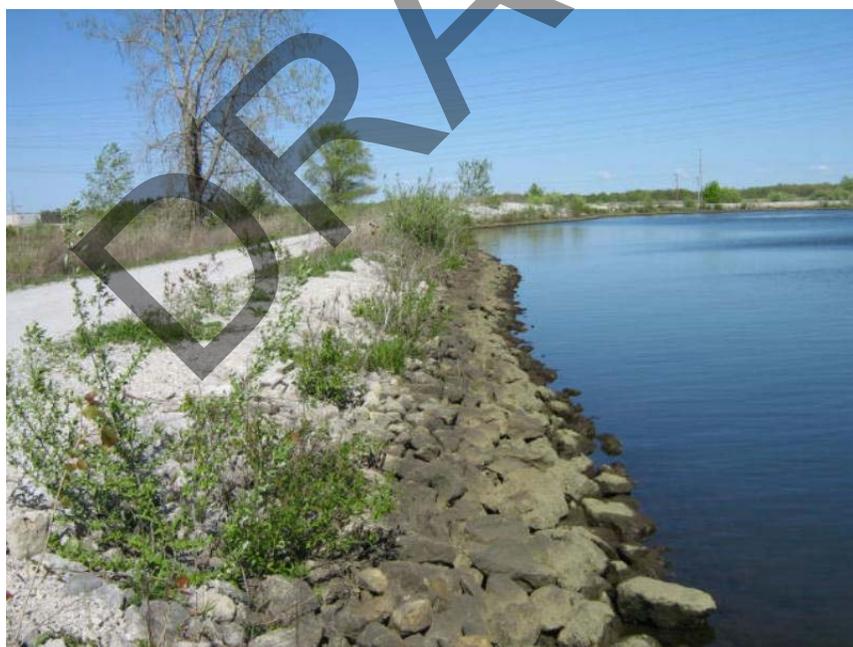
62. Intake Settling Basin - North embankment interior slope, high water line

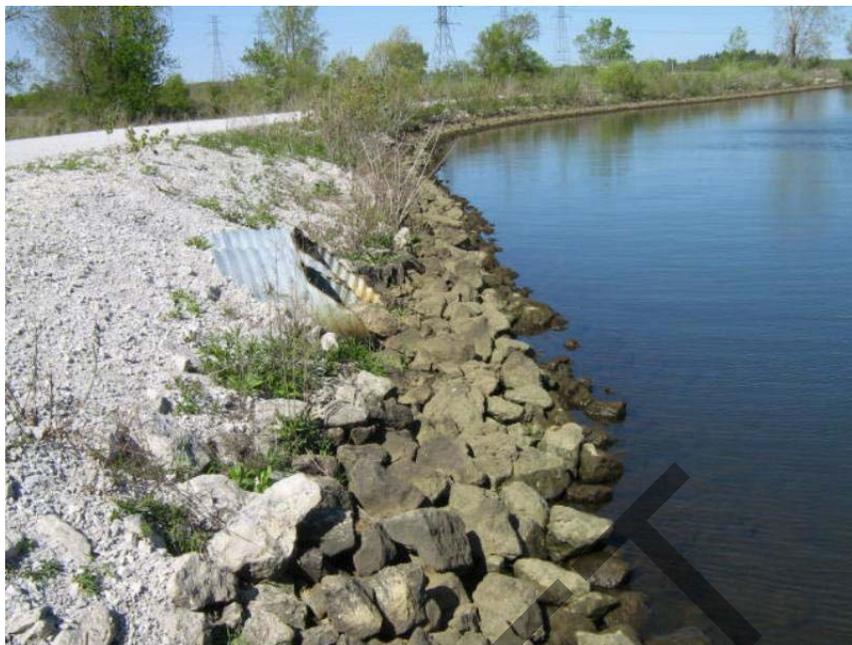
63. Intake Settling Basin - North embankment interior slope, two (2) 24-inch-diameter CMP overflow pipes

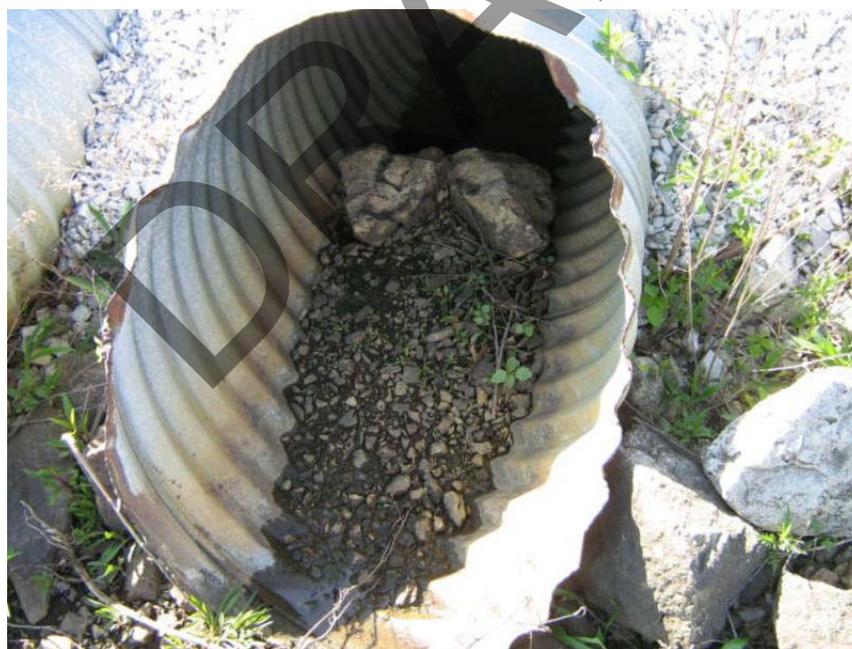
64. Intake Settling Basin - North embankment interior slope, overflow pipe, sedimentation

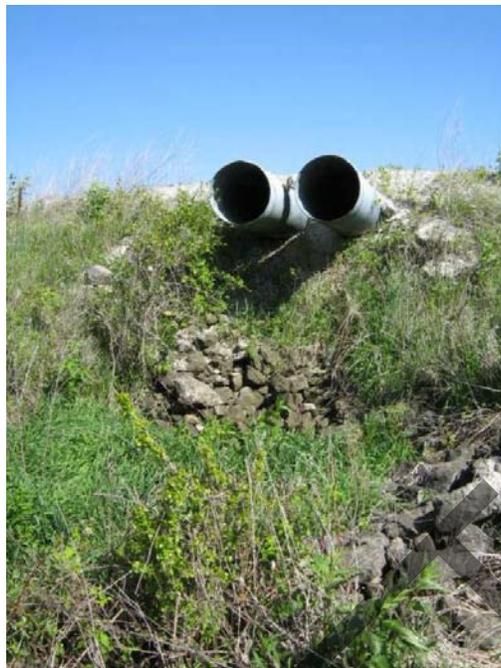
65. Intake Settling Basin - North embankment exterior slopes, overflow pipe discharge

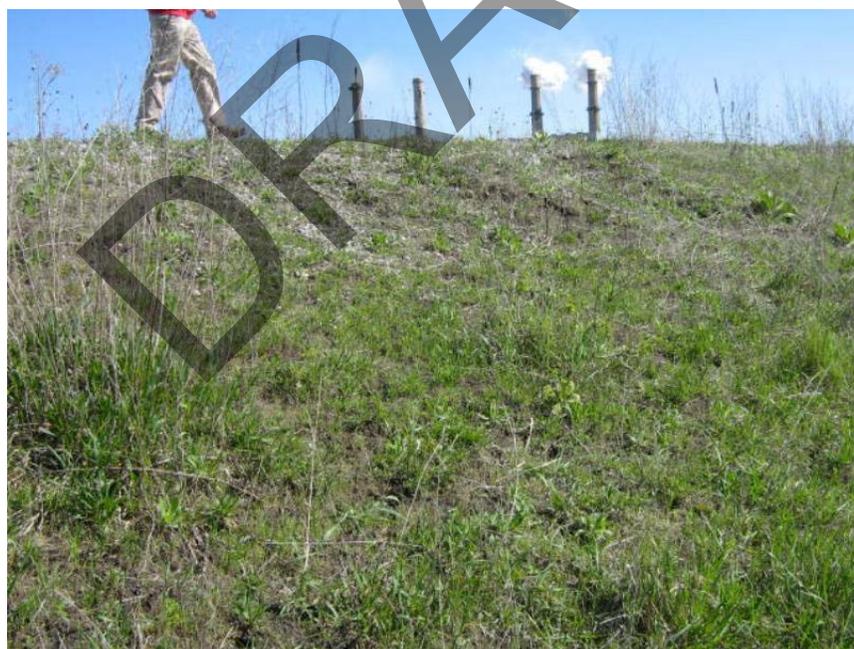
66. Intake Settling Basin - Erosion rills on west embankment exterior slope
