**Assessment of Dam Safety of Coal Combustion  
Surface Impoundments**

**Northern Indiana Public Service Company**

**R.M. Schahfer Generating Station**

*Draft Report*

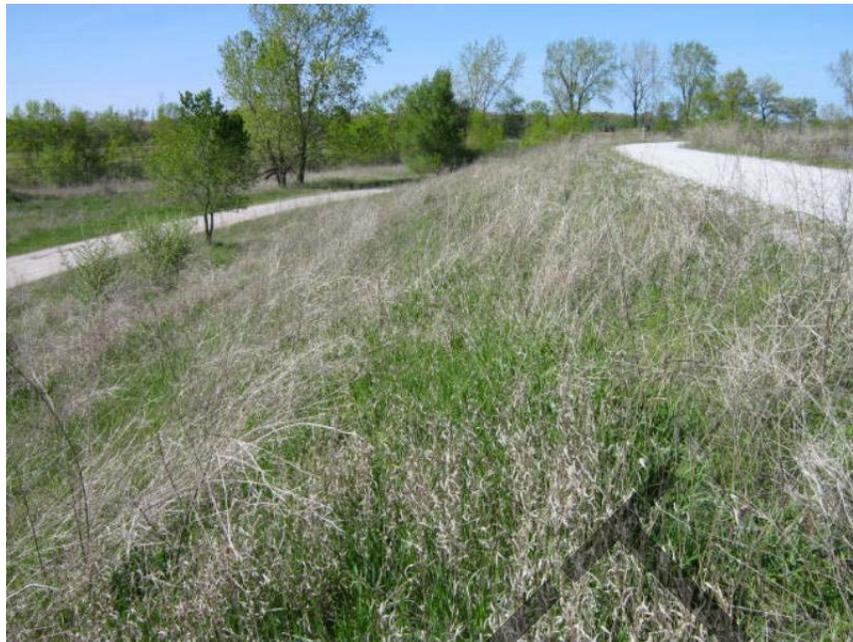
67. Intake Settling Basin - West embankment exterior slope, vegetation

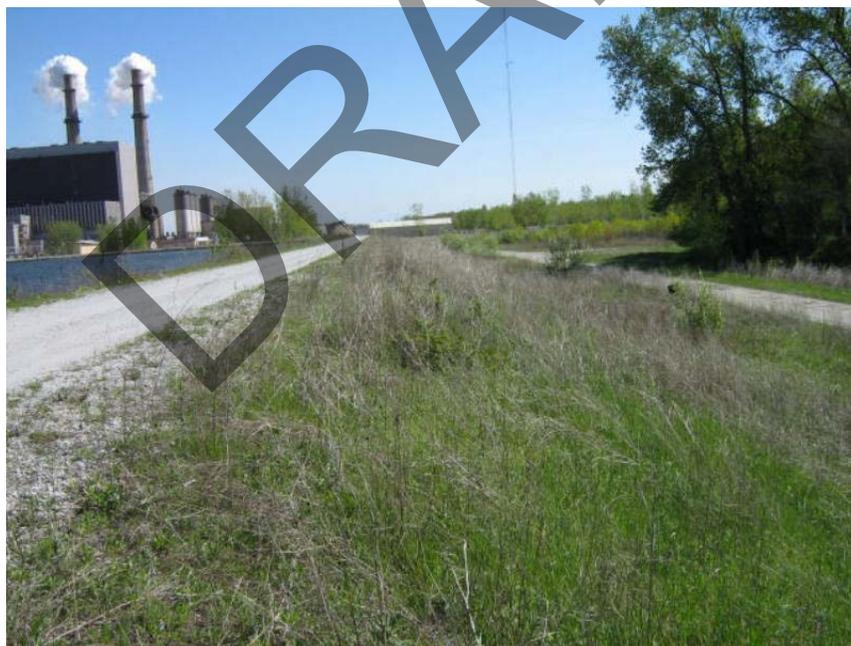
68. Intake Settling Basin - West embankment exterior slope

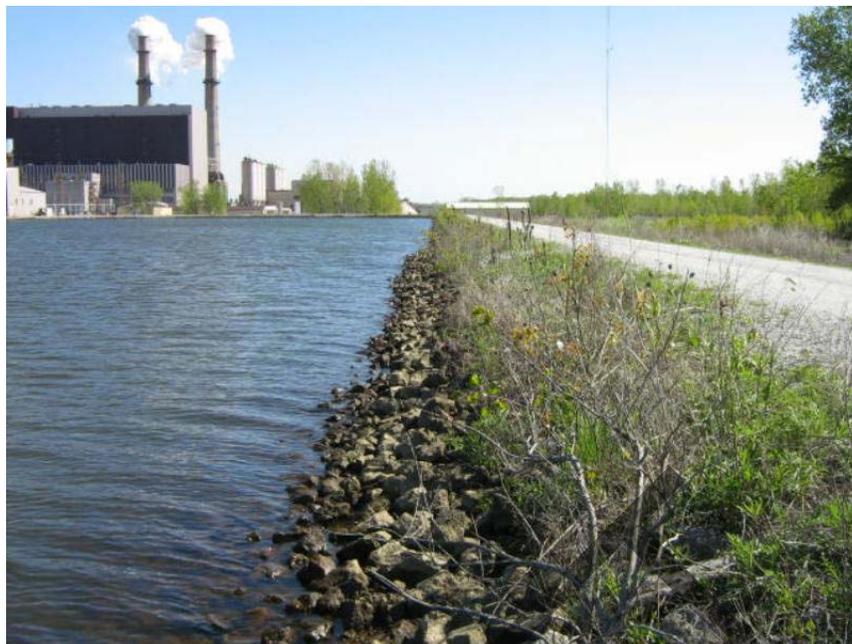
69. Intake Settling Basin - West embankment interior slope, vegetation and saplings

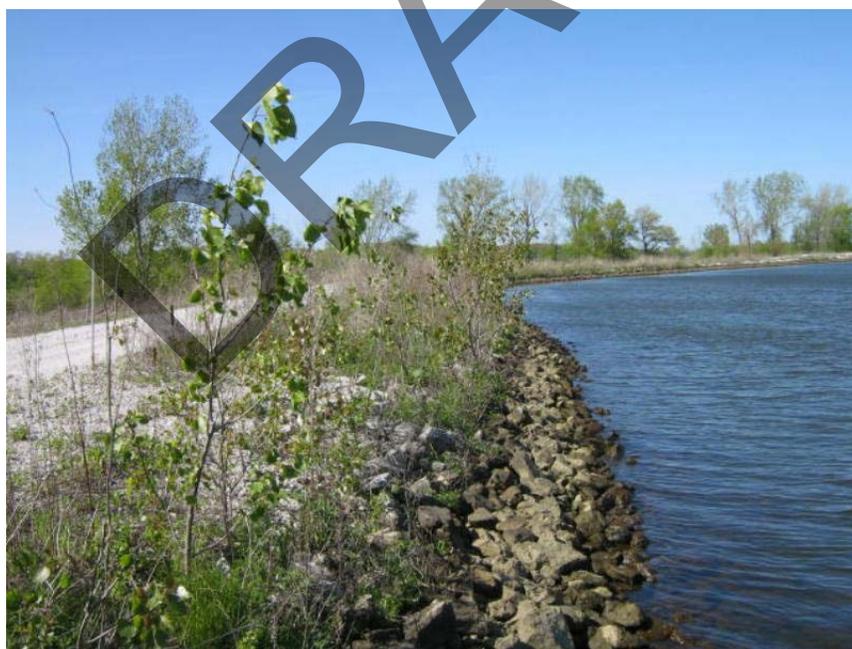
70. Intake Settling Basin - West embankment interior slope, vegetation, brush, and saplings

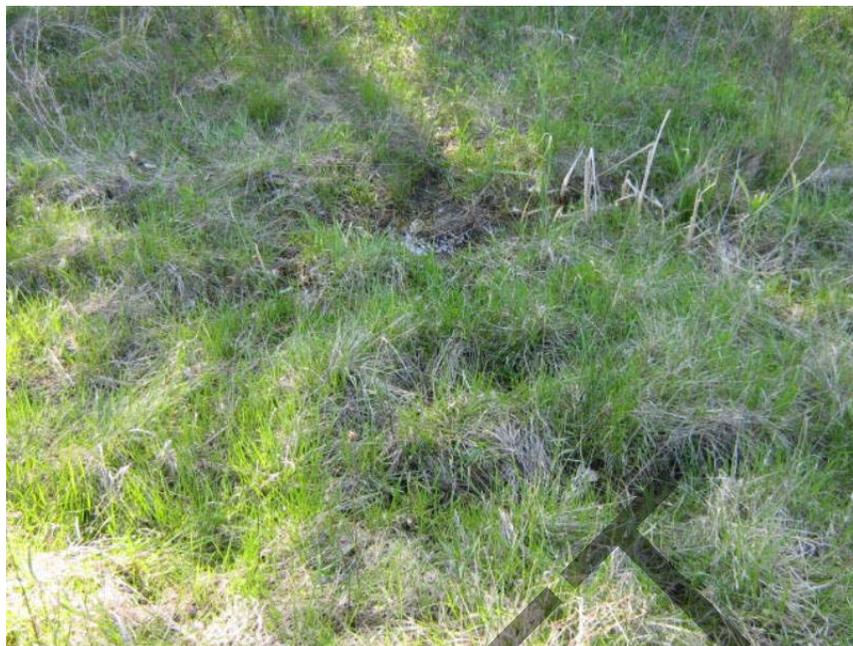
71. Intake Settling Basin - Saturated area on west embankment exterior slope (approximately 40 feet wide by 7 feet in length)

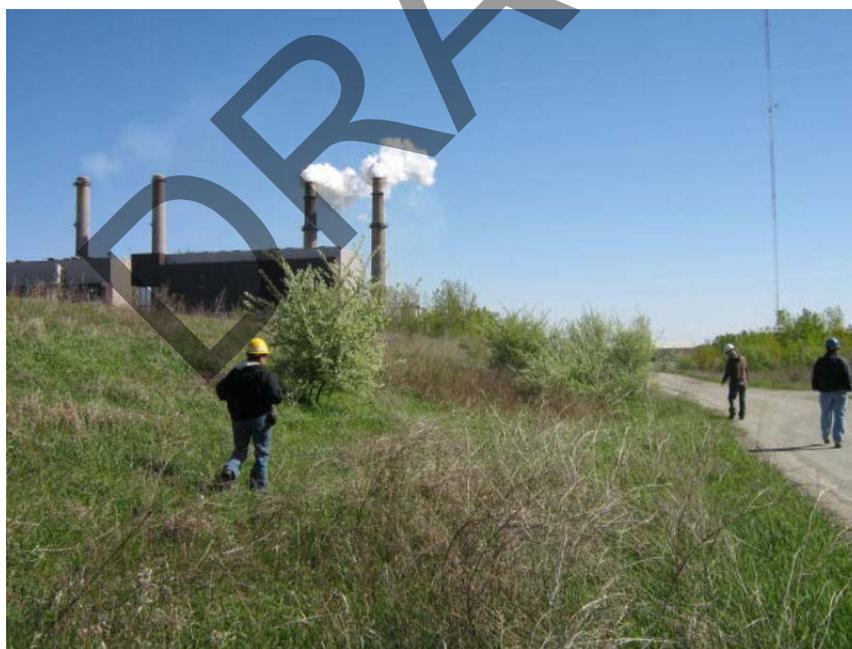
72. Intake Settling Basin - Vegetation on west embankment exterior slope, vegetation, brush, and small trees

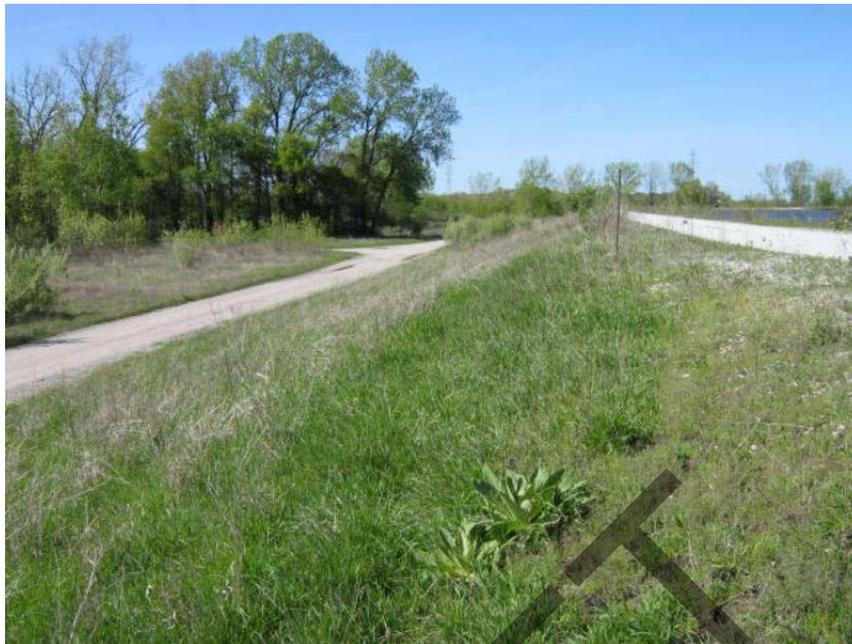
73. Intake Settling Basin - West embankment exterior slope

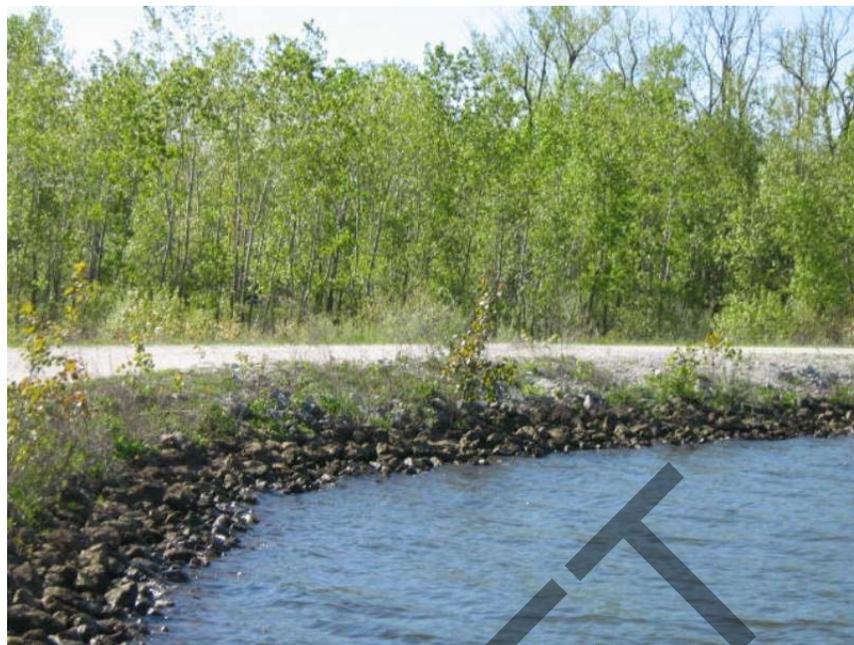
75. Intake Settling Basin - South embankment interior slope

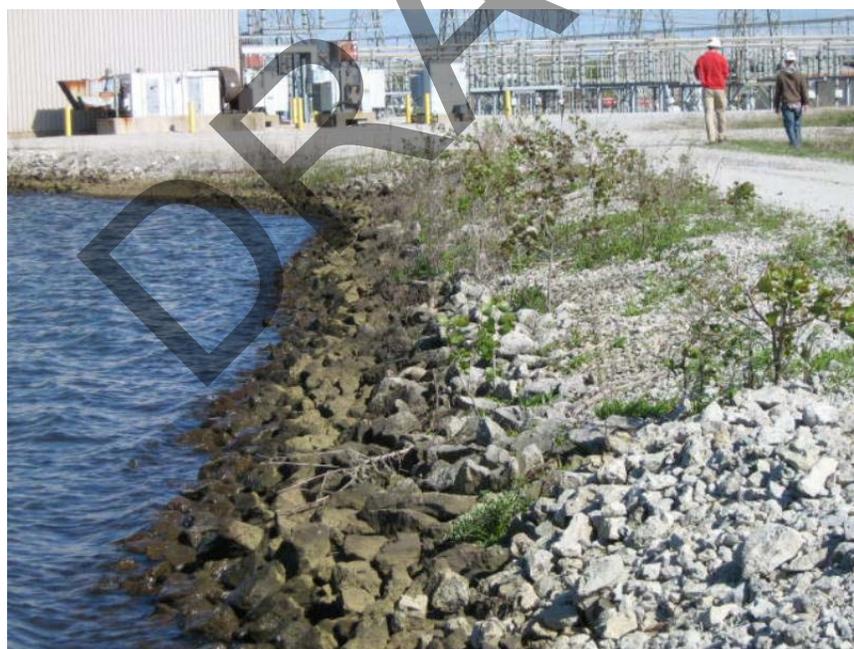
76. Intake Settling Basin - South embankment exterior slope

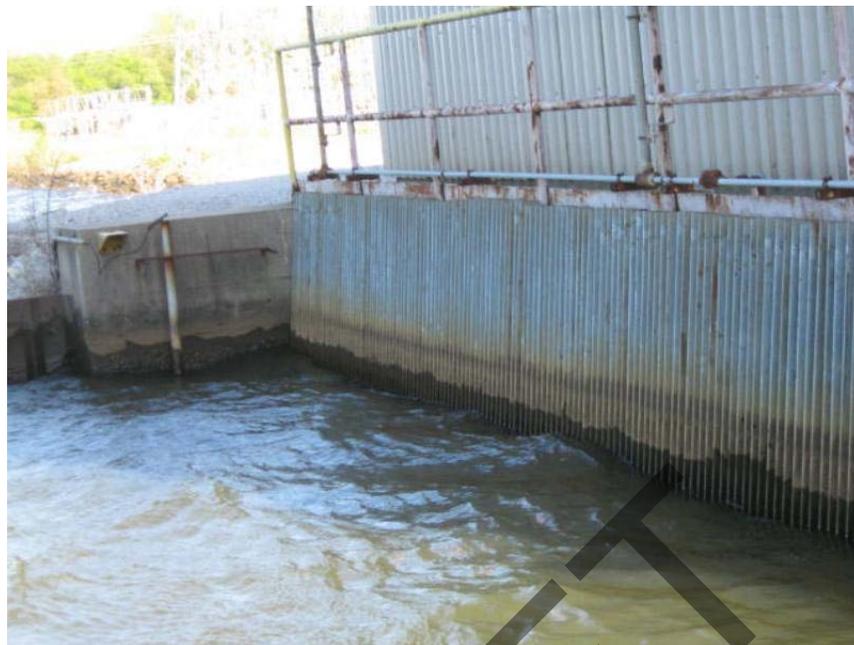
77. Intake Settling Basin - Pump station bar screen

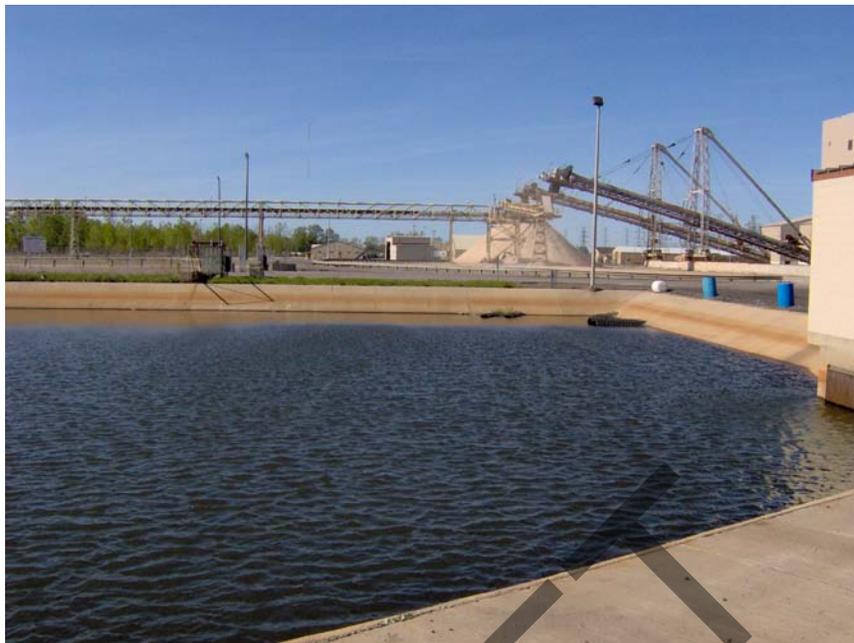
78. Retention Pond - Pump station, looking north

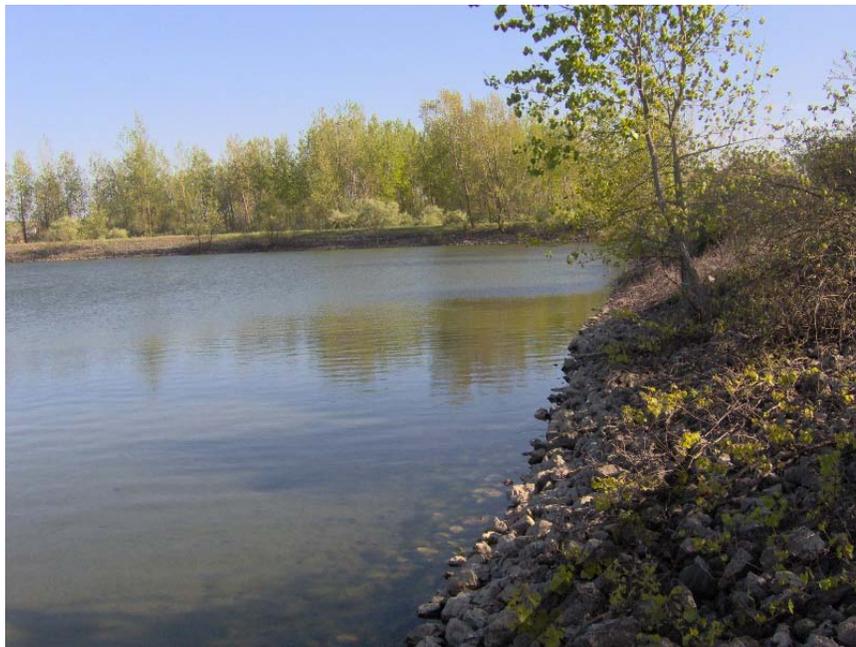
85. FGD Landfill Runoff Pond - West embankment interior slope, vegetation, tree and brush

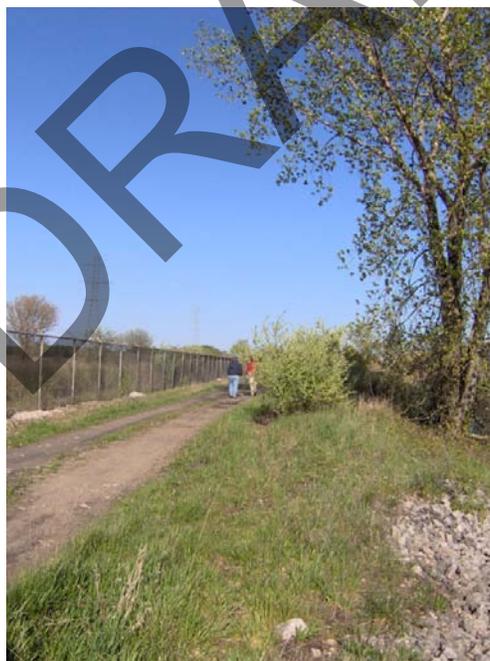
86. FGD Landfill Runoff Pond - Large tree located on north embankment interior slope

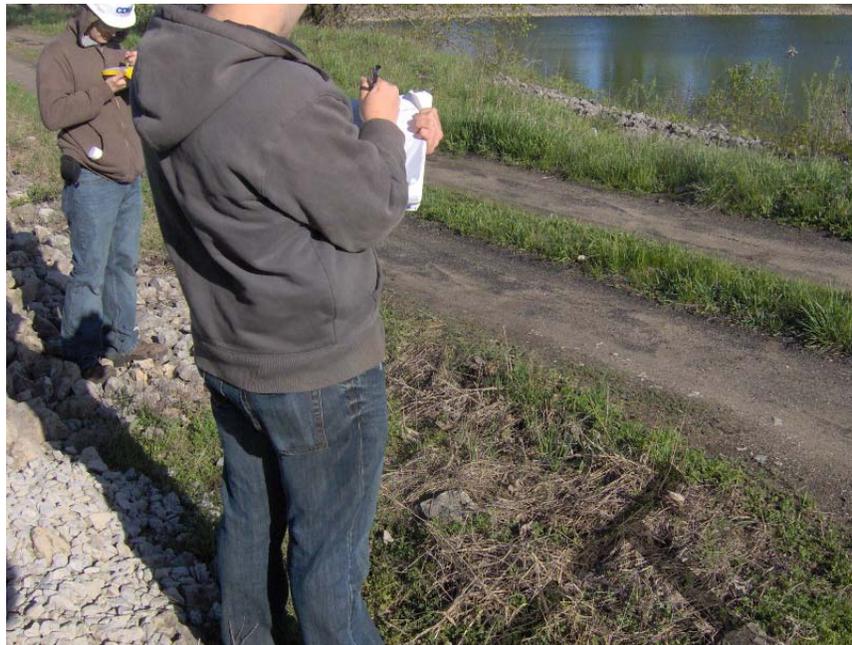
87. FGD Landfill Runoff Pond - North embankment crest

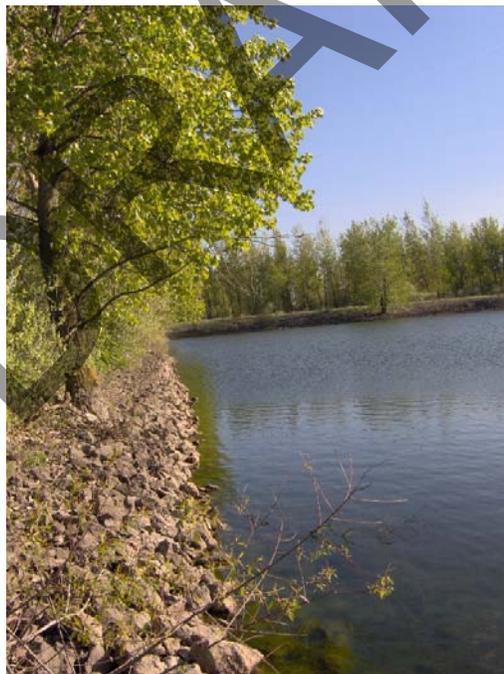
88. FGD Landfill Runoff Pond - East embankment interior slope, vegetation, brush, and trees

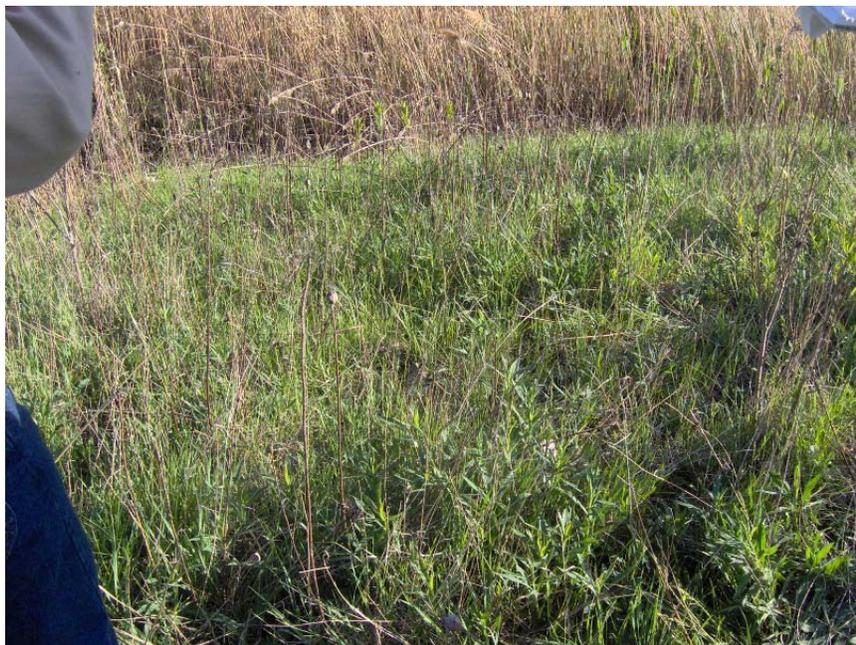
89. FGD Landfill Runoff Pond - Inlet into pond on east embankment crest

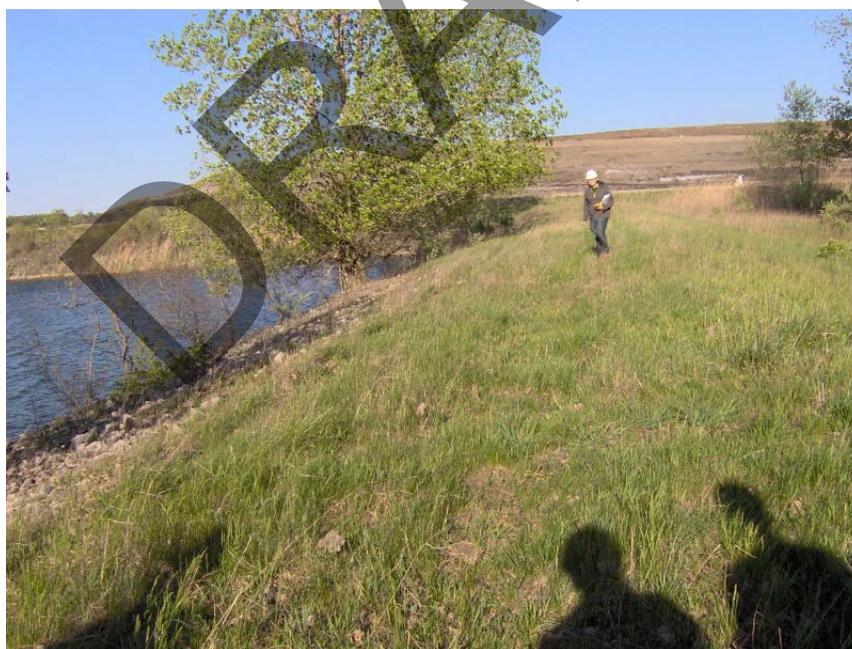
92. FGD Landfill Runoff Pond - South embankment crest, looking west, trees on interior and exterior slopes

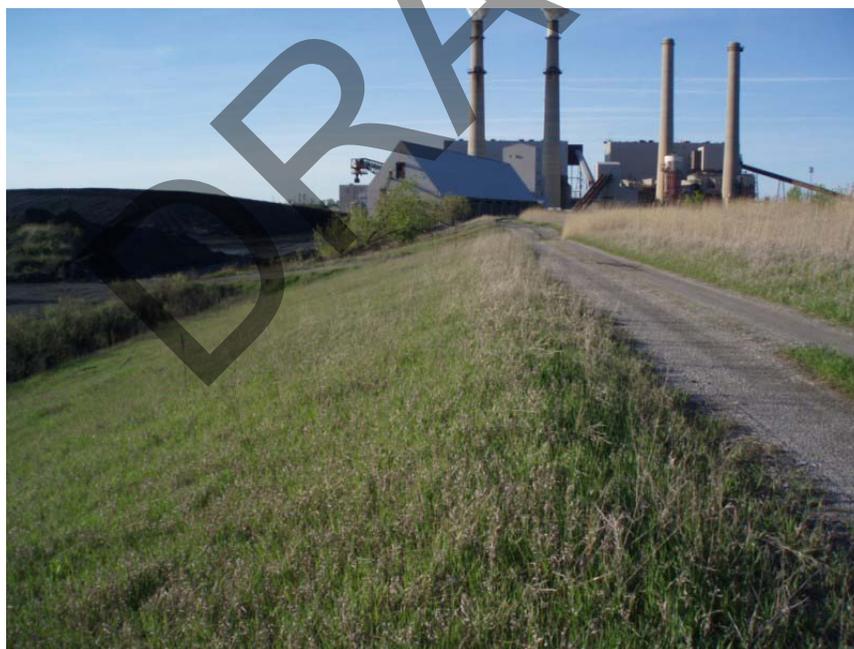
97. Gypsum Storage Area (Units 14&15) A - West embankment exterior slope

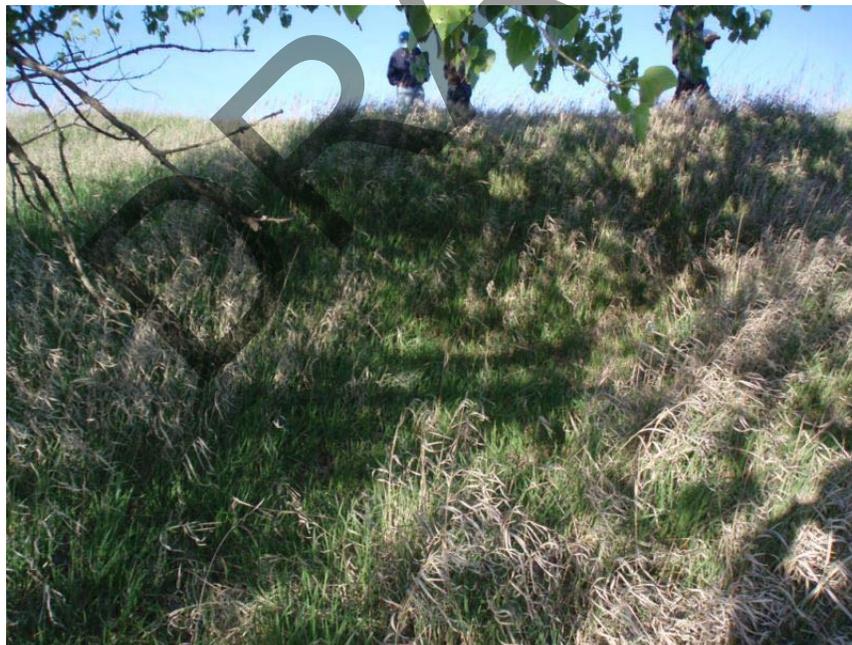
99. Gypsum Storage Area (Units 14&15) A - Scarp on west embankment exterior slope

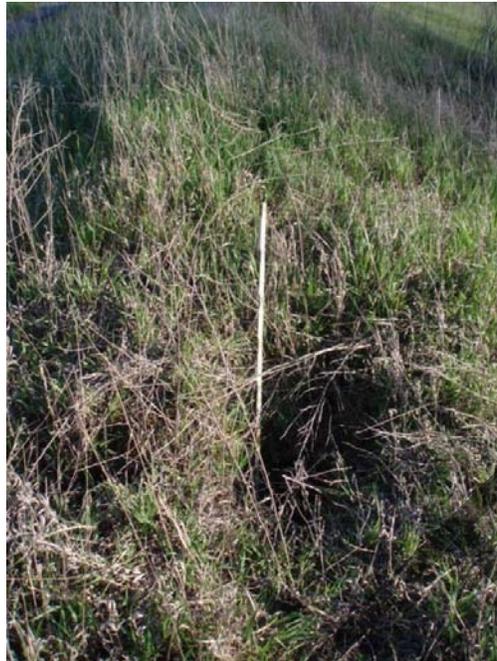
100. Gypsum Storage Area (Units 14&15) A - Slough on west embankment exterior slope (approximately 2 feet Deep)

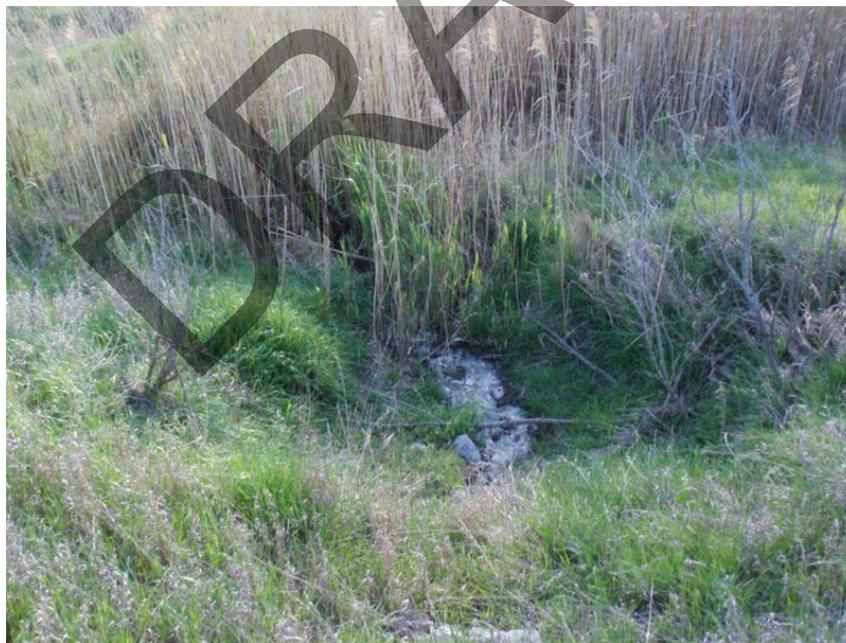
101. Gypsum Storage Area (Units 14&15) A - Very steep slope on west embankment exterior Slope, seepage

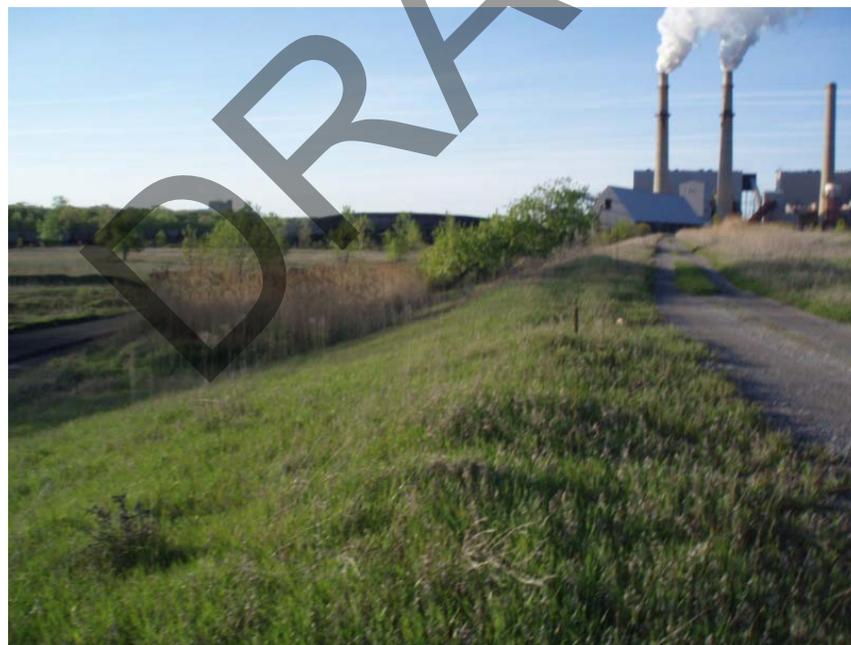
103. Gypsum Storage Area (Units 14&15) A - West embankment exterior slope

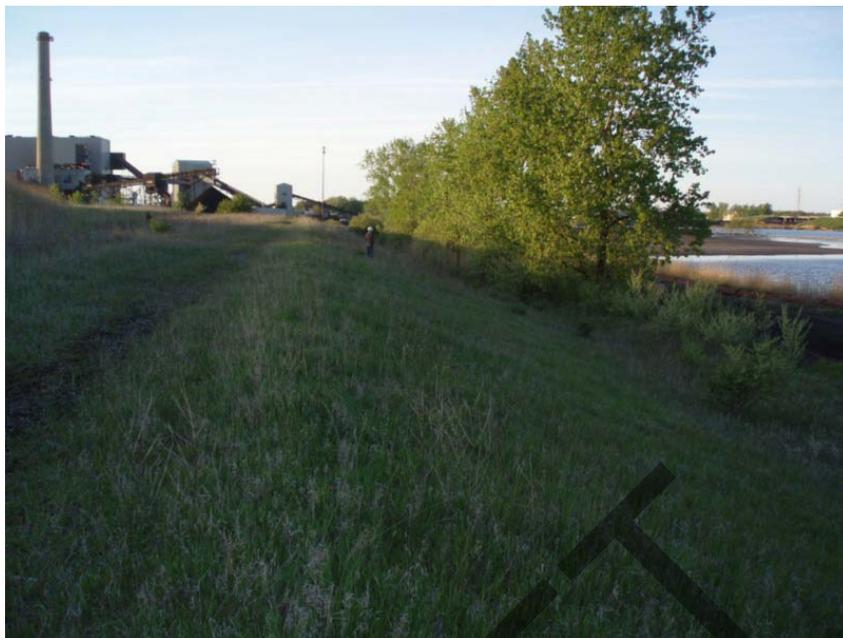
106. Gypsum Storage Area (Units 14&15) A - East embankment crest

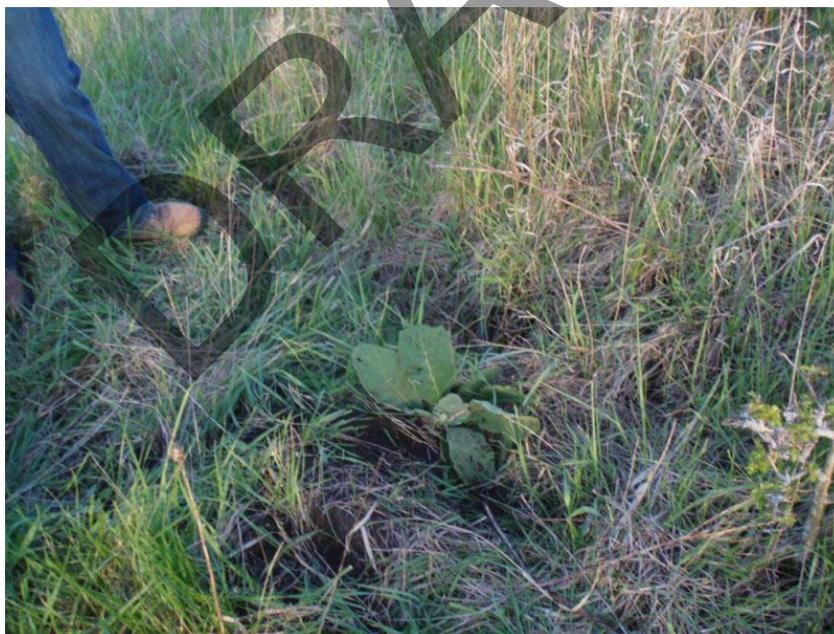
109. Gypsum Storage Area (Units 14&15) A - Abandoned rodent burrow on north embankment exterior slope

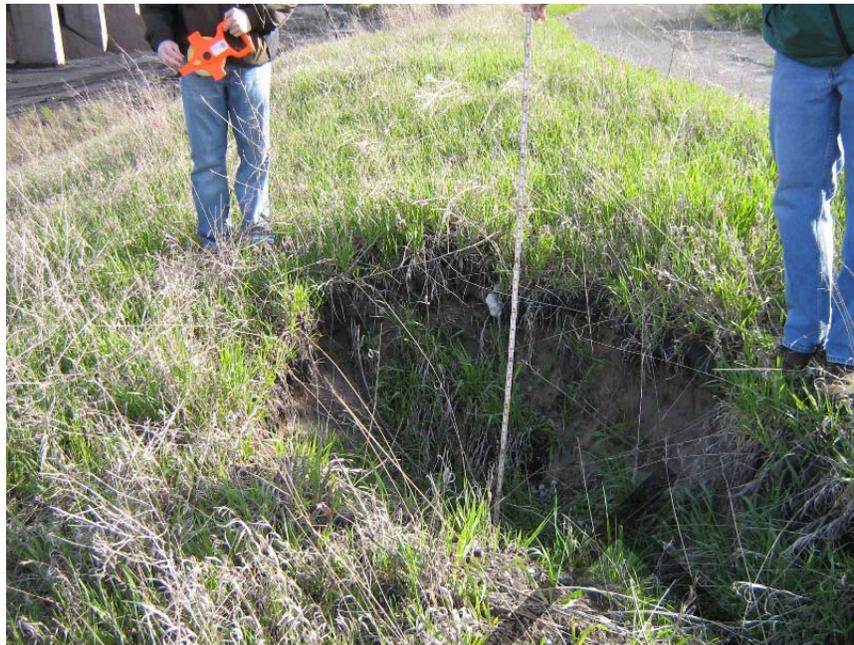
116. Gypsum Storage Area (Units 14&15) A - West embankment exterior slope, erosion rill (approximately 3 feet deep)

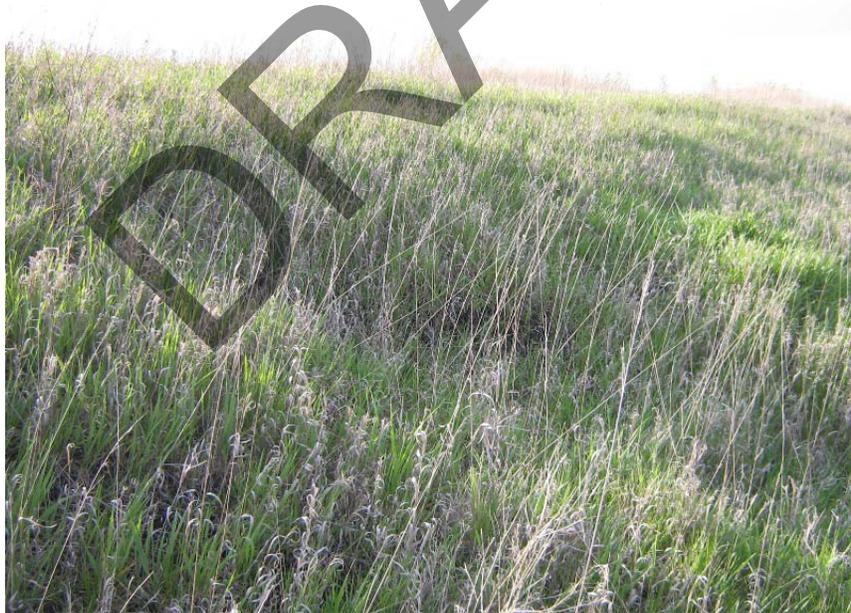
117. Gypsum Storage Area (Units 14&15) A - Slough on west embankment exterior slope

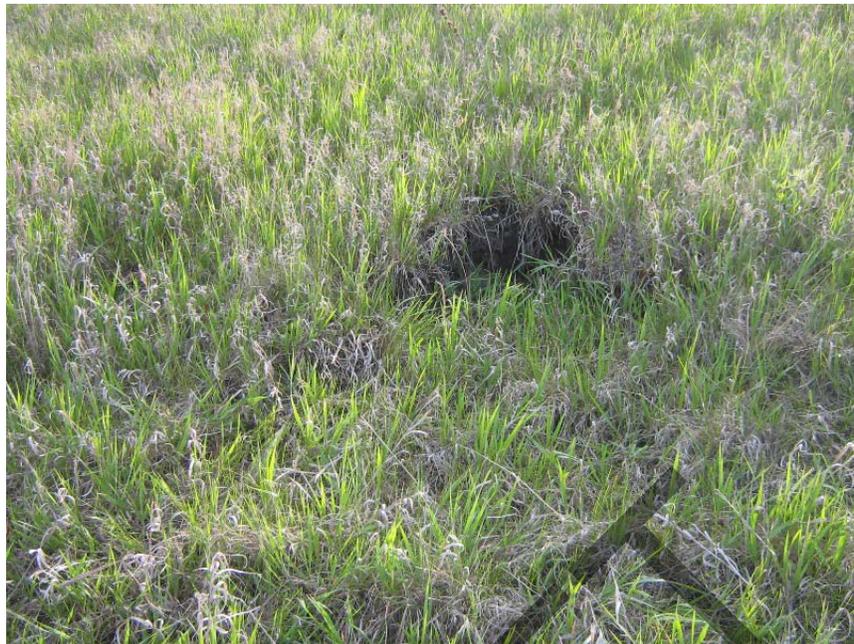
118. Gypsum Storage Area (Units 14&15) A - Slough on west embankment exterior slope (approximately 2 feet deep)

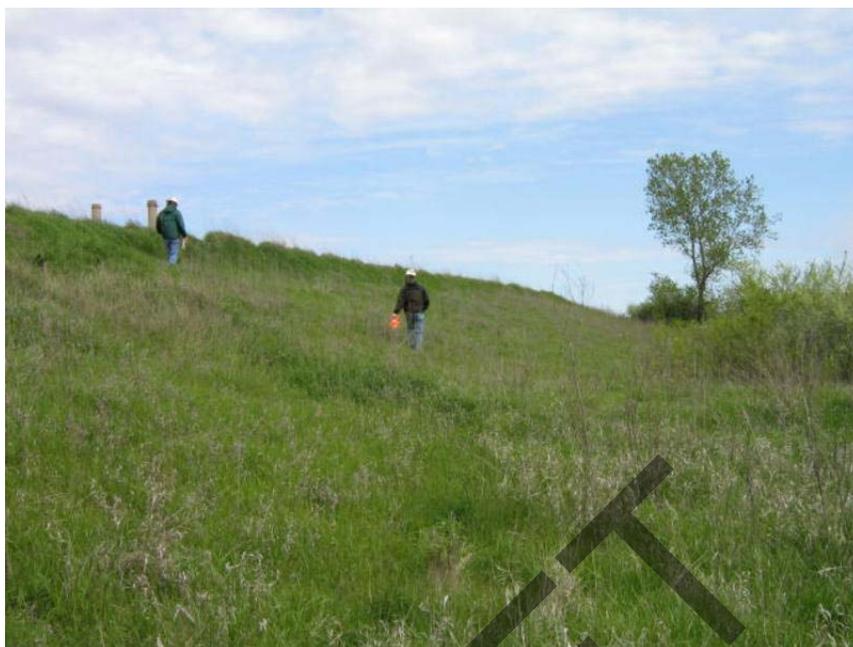
119. Gypsum Storage Area (Units 14&15) B - East embankment exterior slope, looking north

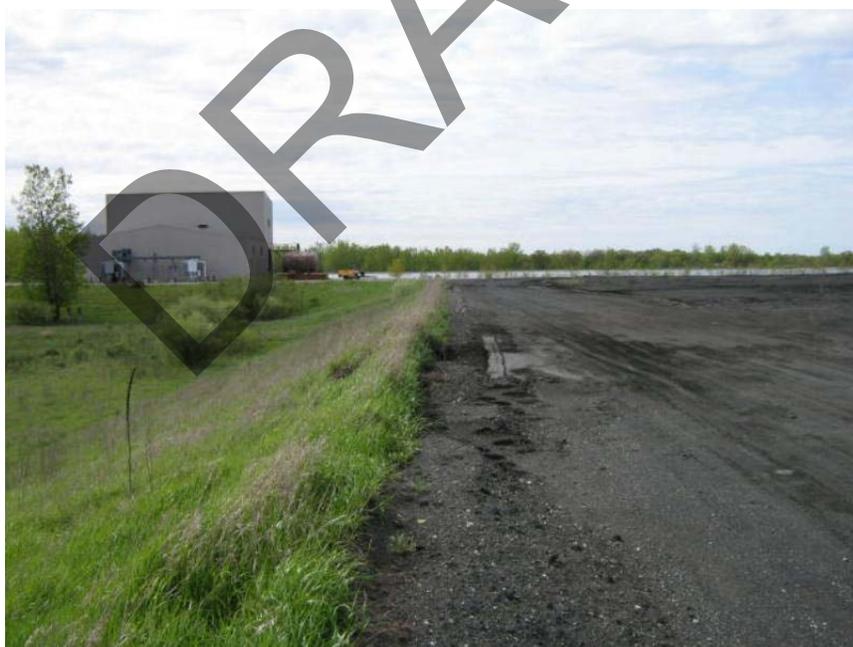
120. Gypsum Storage Area (Units 14&15) B - East embankment crest and exterior slope, looking south

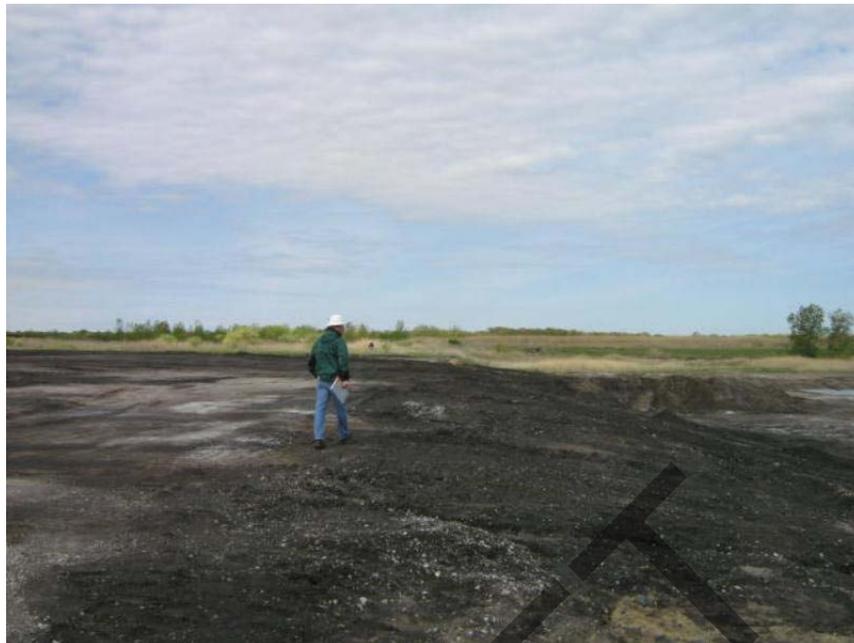
121. Gypsum Storage Area (Units 14&15) B - North embankment crest, looking west

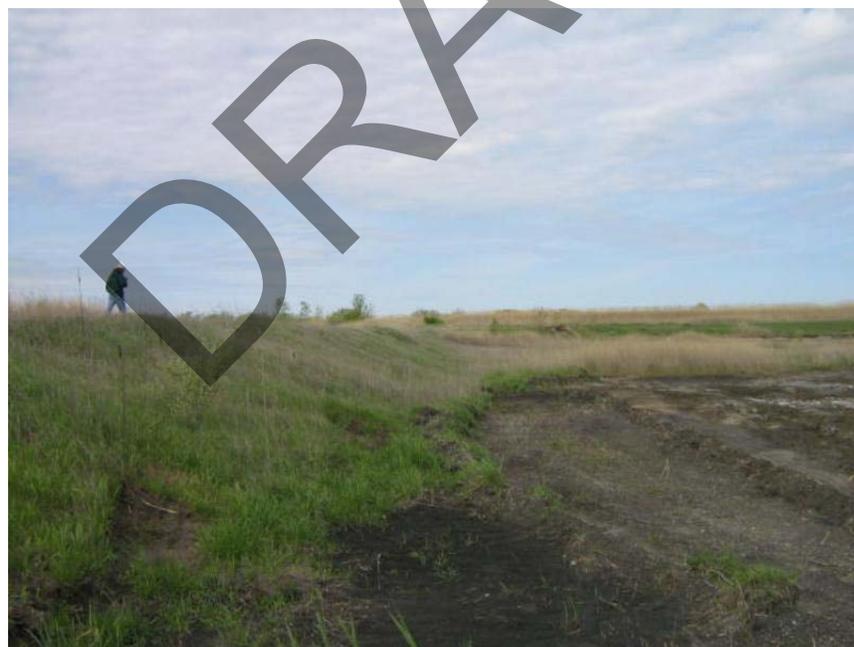
122. Gypsum Storage Area (Units 14&15) B - North embankment exterior slope, looking west

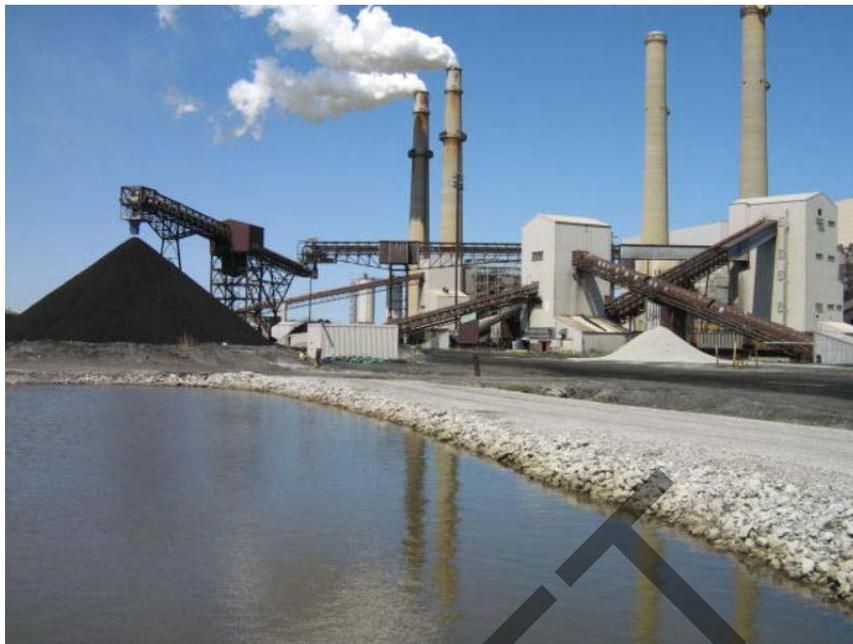
123. Material Storage Runoff Basin - North embankment interior slope

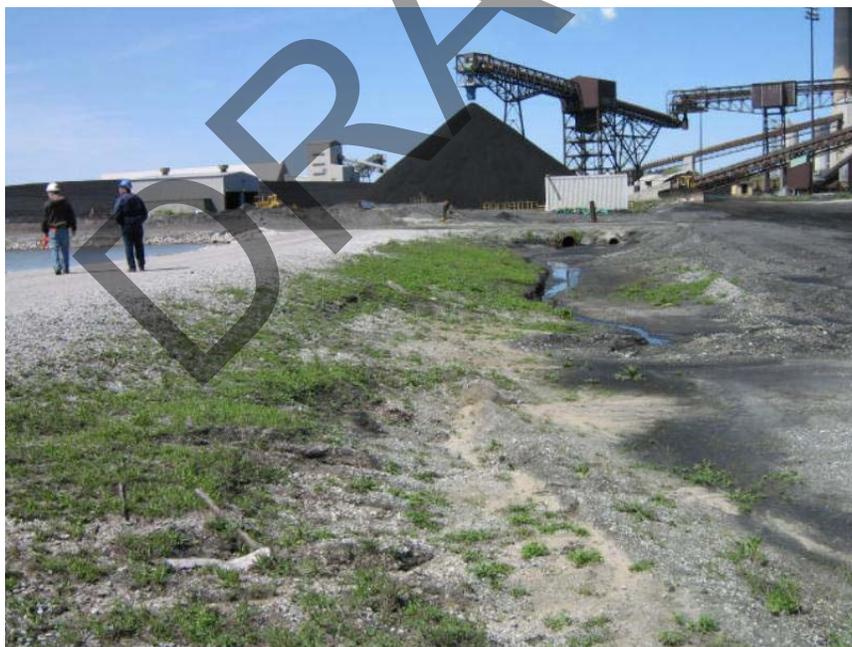
124. Material Storage Runoff Basin - North embankment exterior slope

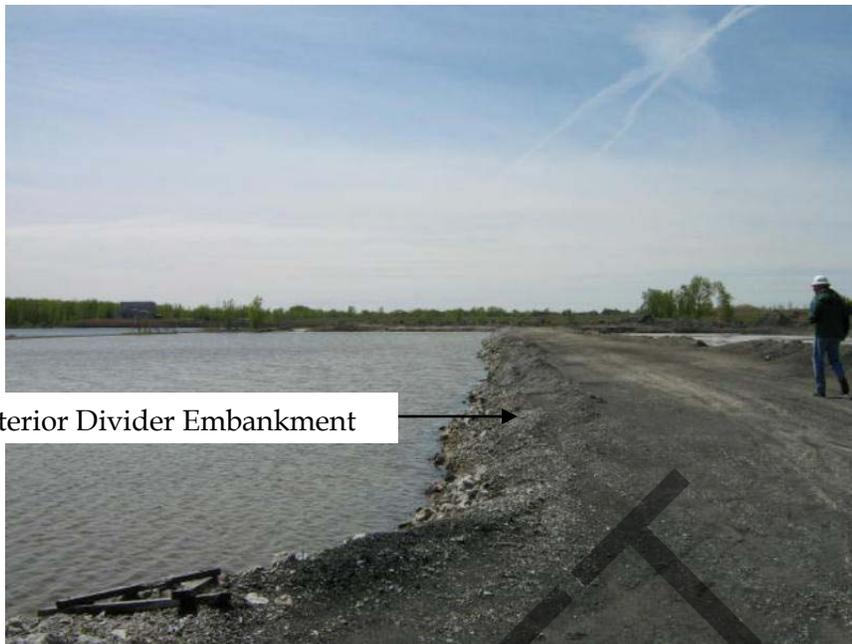
Interior Divider Embankment

125. Material Storage Runoff Basin - Interior divider embankment constructed within Material Storage Runoff Basin

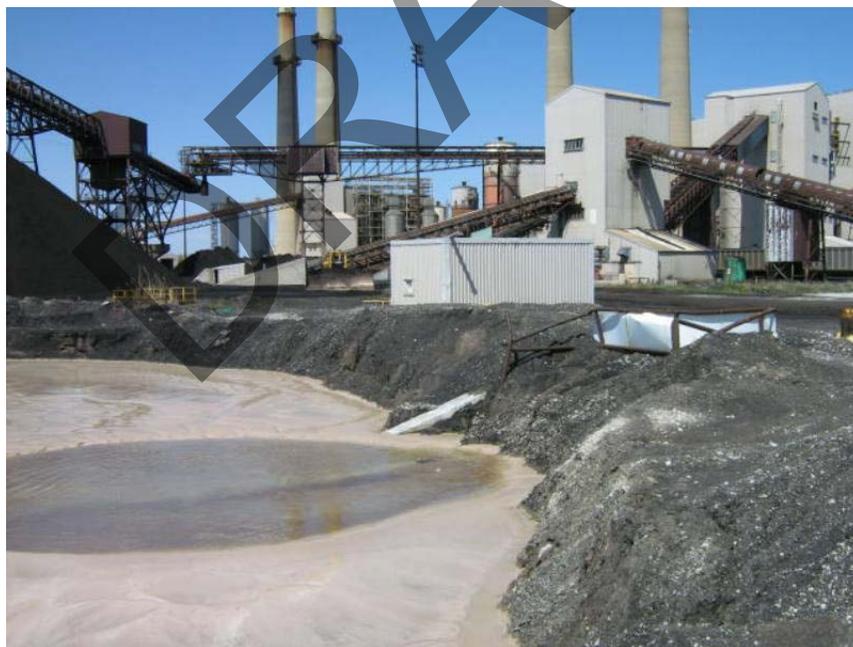
126. Material Storage Runoff Basin - North embankment interior slope, looking west at inflow pipes

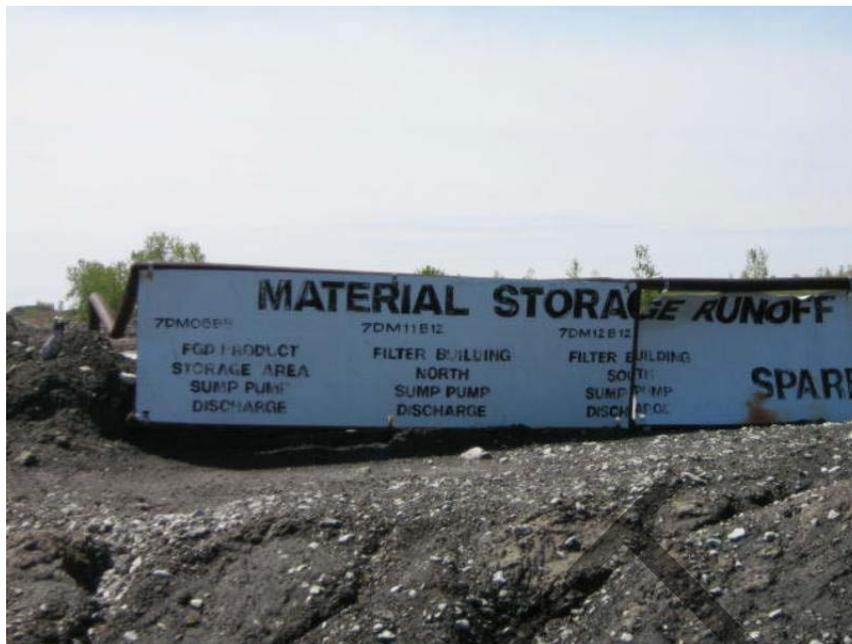
127. Material Storage Runoff Basin - North embankment crest, sluice line identification

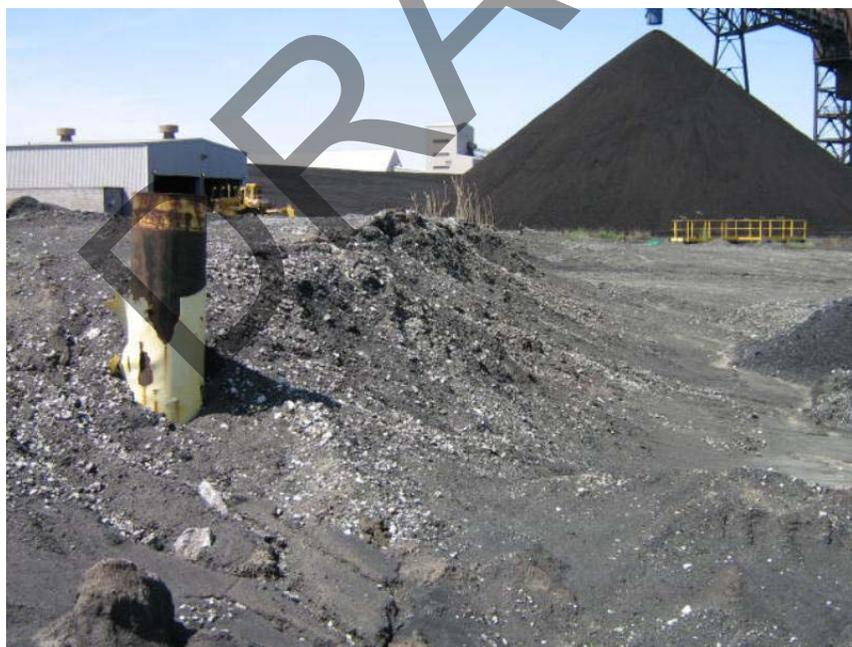
128. Material Storage Runoff Basin - North embankment exterior slope, looking west

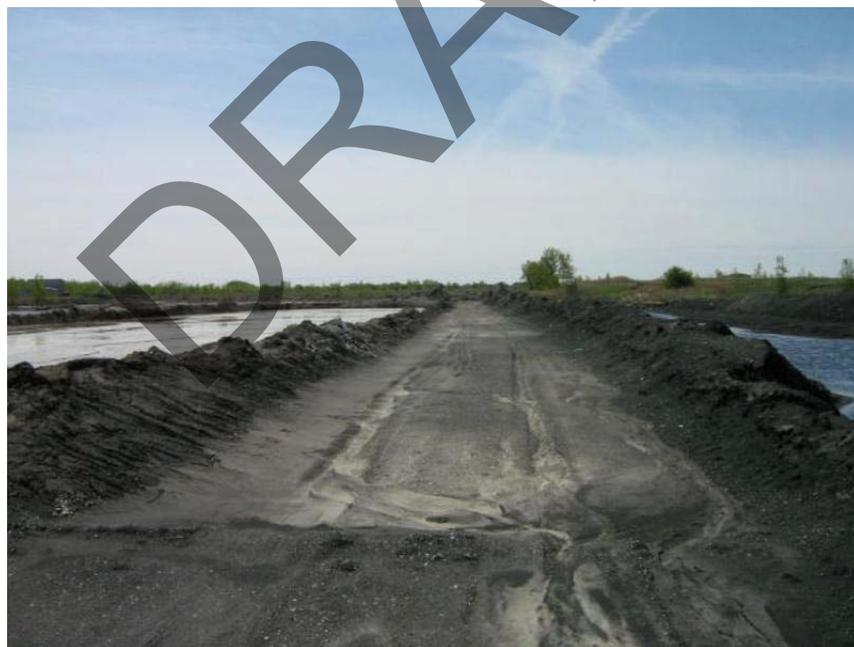
130. Material Storage Runoff Basin - Interior divider embankments constructed to create center and west cells, looking south

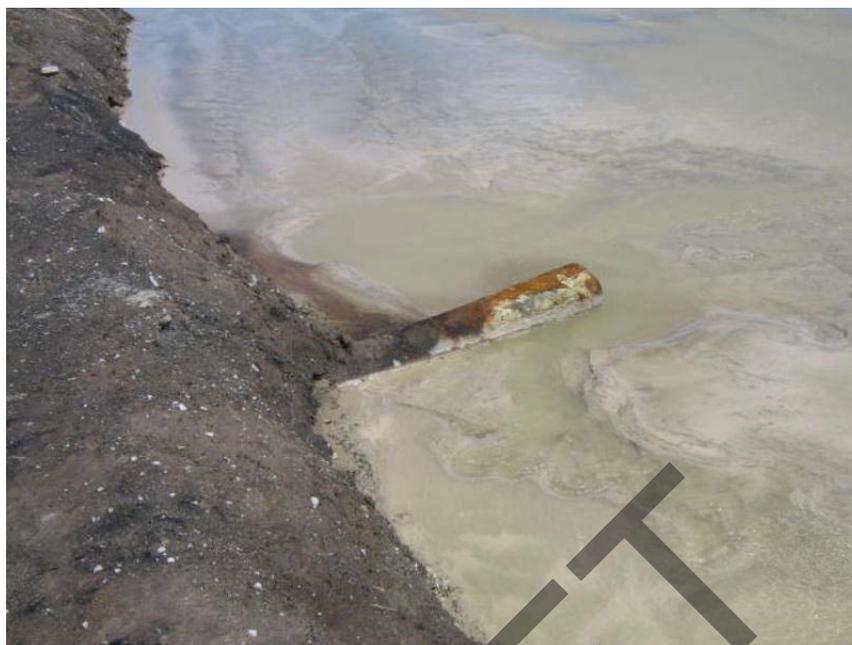
131. Material Storage Runoff Basin - East embankment interior slope, 6-inch-diameter steel outlet pipe

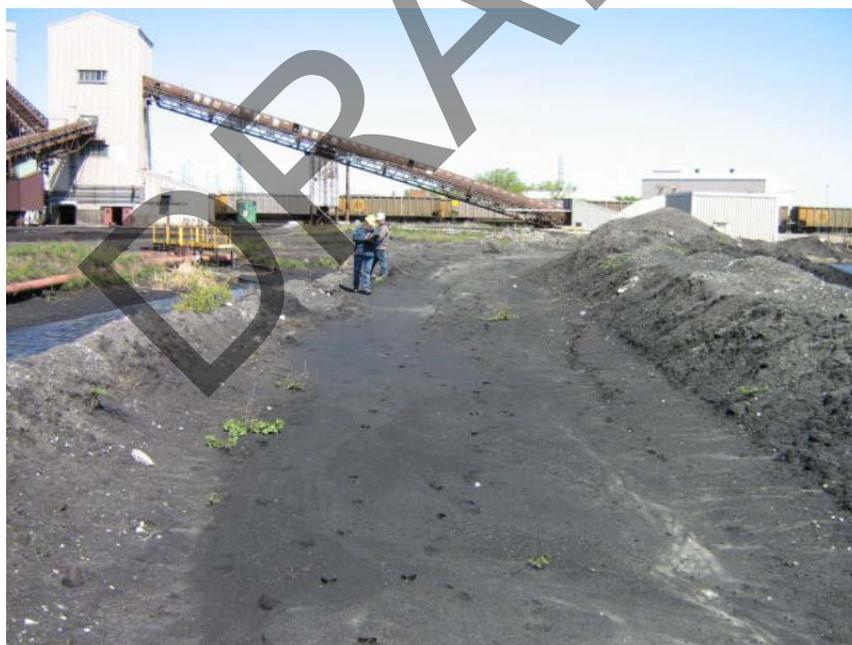
132. Material Storage Runoff Basin - West embankment crest, looking south

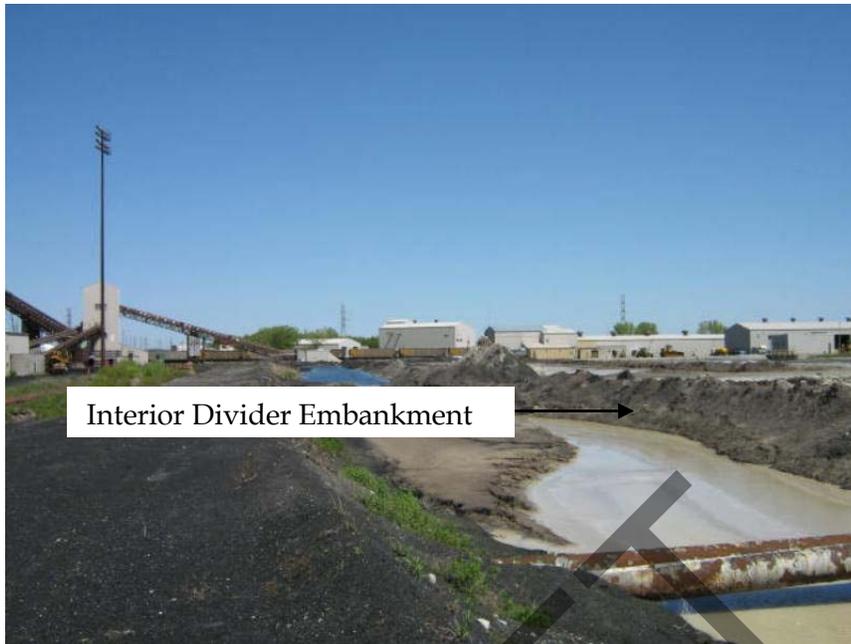
133. Material Storage Runoff Basin – West embankment crest and interior slope, looking north, showing overview of divider embankment constructed within Material Storage Runoff Basin
