**Assessment of Dam Safety of Coal Combustion  
Surface Impoundments**

**Northern Indiana Public Service Company**

**R.M. Schahfer Generating Station**

*Draft Report*

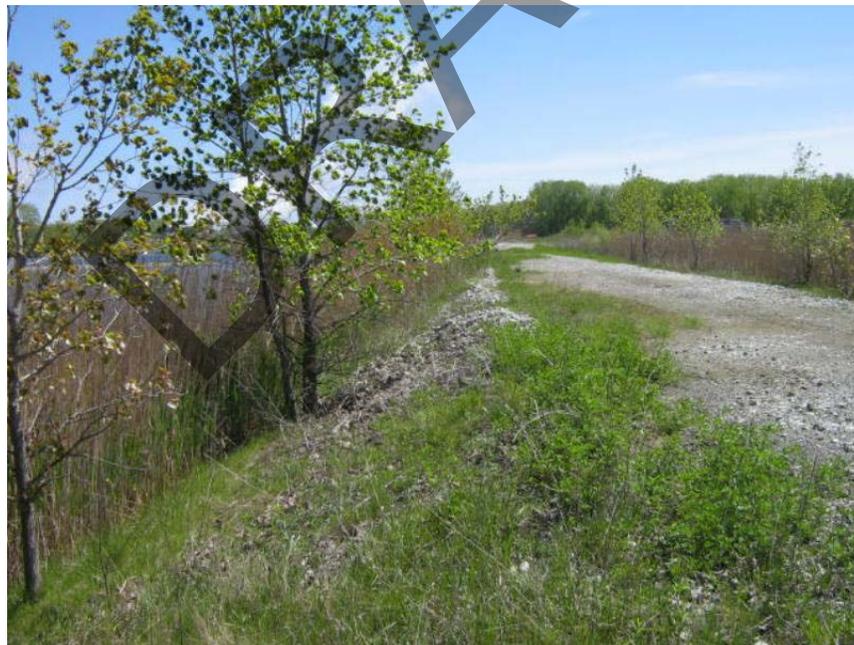
134. Material Storage Runoff Basin - South embankment crest and interior slope, looking east

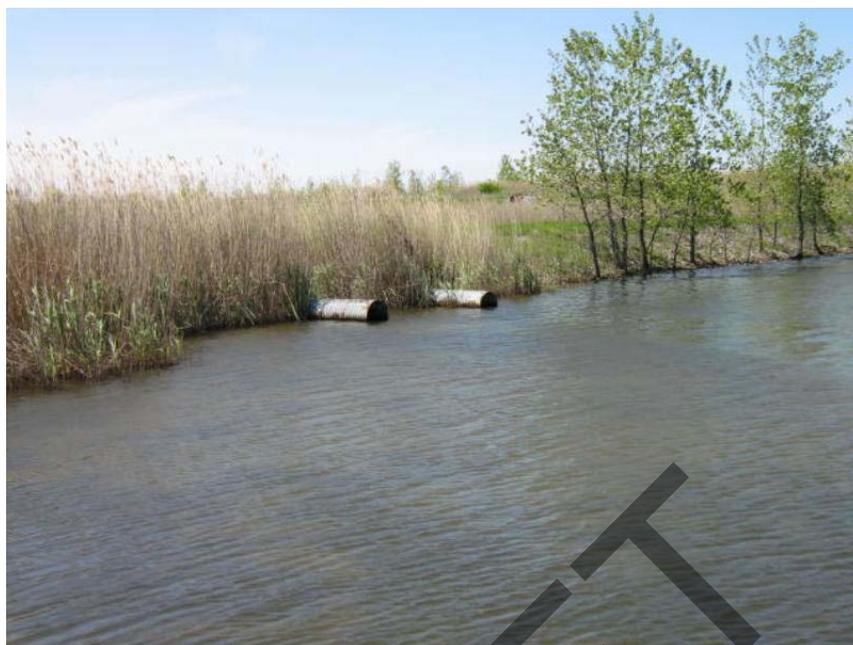
135. Material Storage Runoff Basin - South embankment interior slope looking at two (2) 24-inch-diameter CMP outlets

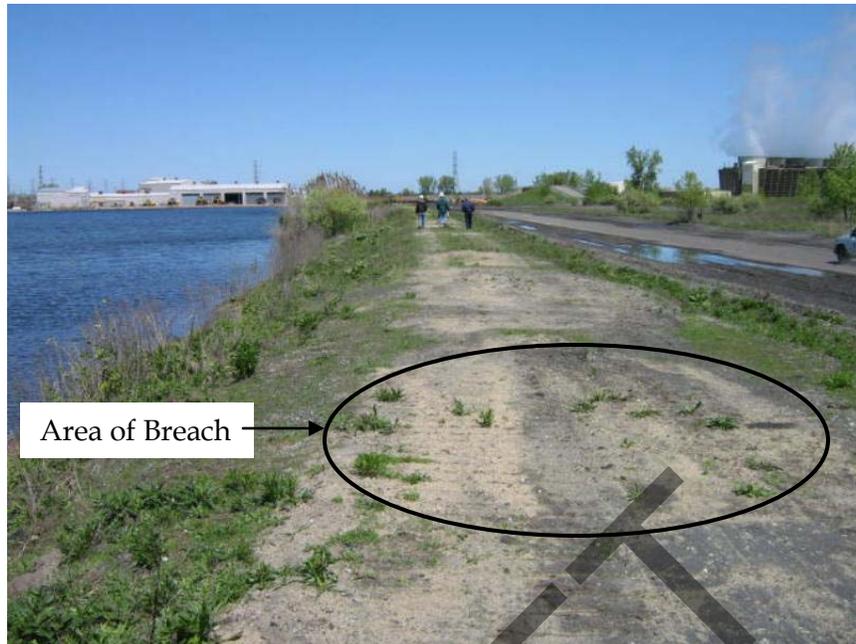
139. Metal Cleaning Water Basin - East embankment crest, looking north, depression (area of breach)

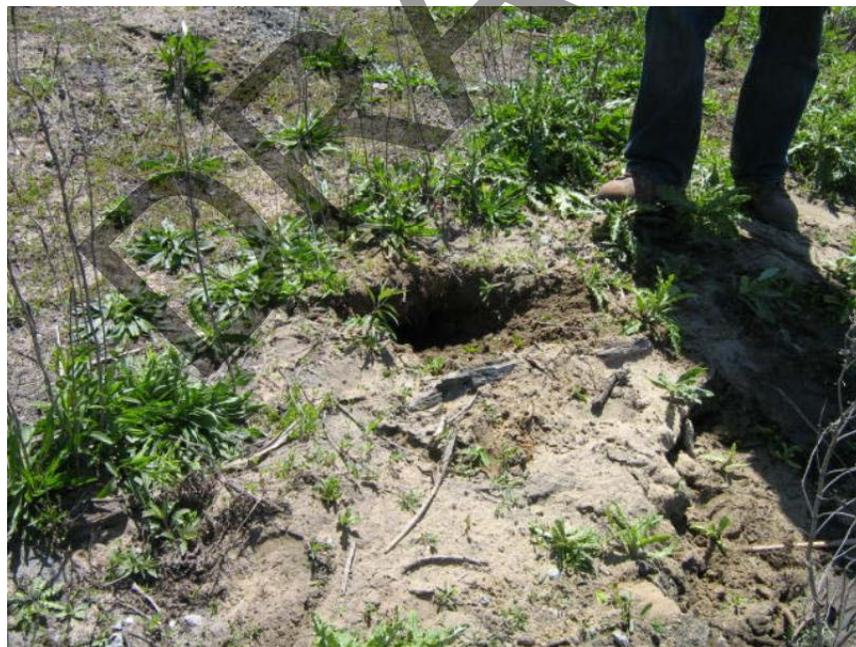
140. Metal Cleaning Water Basin - East embankment interior slope, possible start of rodent burrow (approximately 2 feet in length, 1 foot deep)

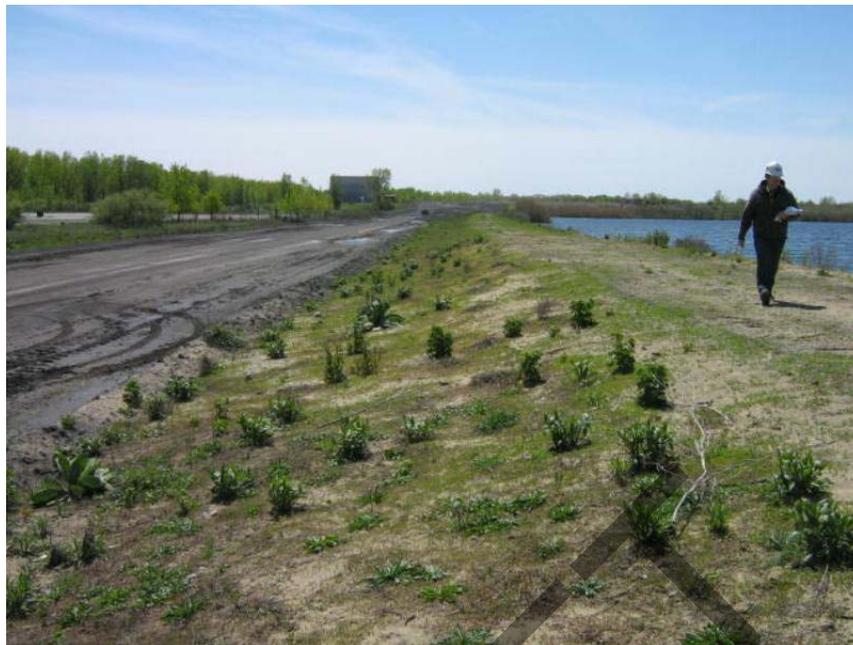
141. Metal Cleaning Water Basin - East embankment exterior slope, looking south, sparse vegetation

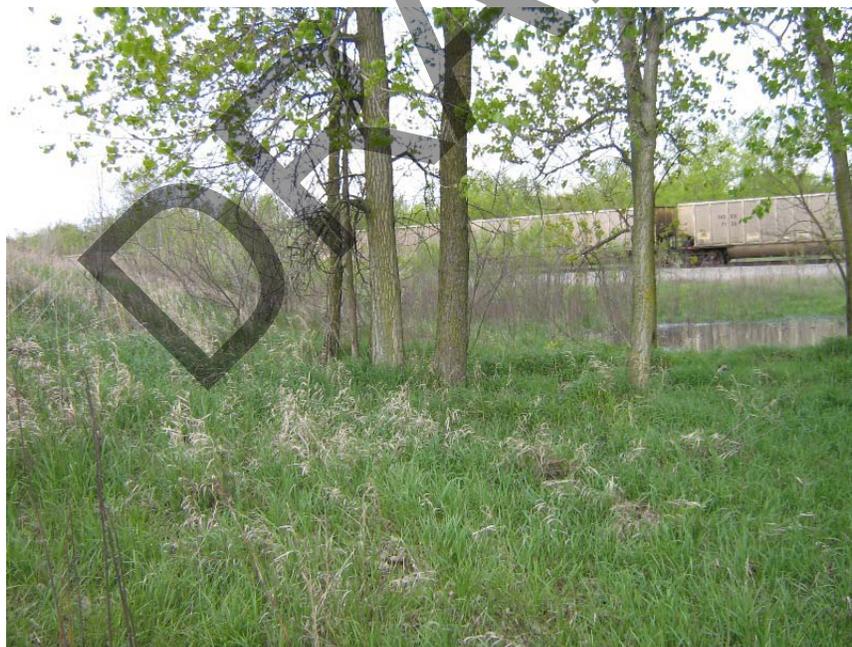
151. Waste Disposal Area - West embankment exterior slope, trees at toe of slope

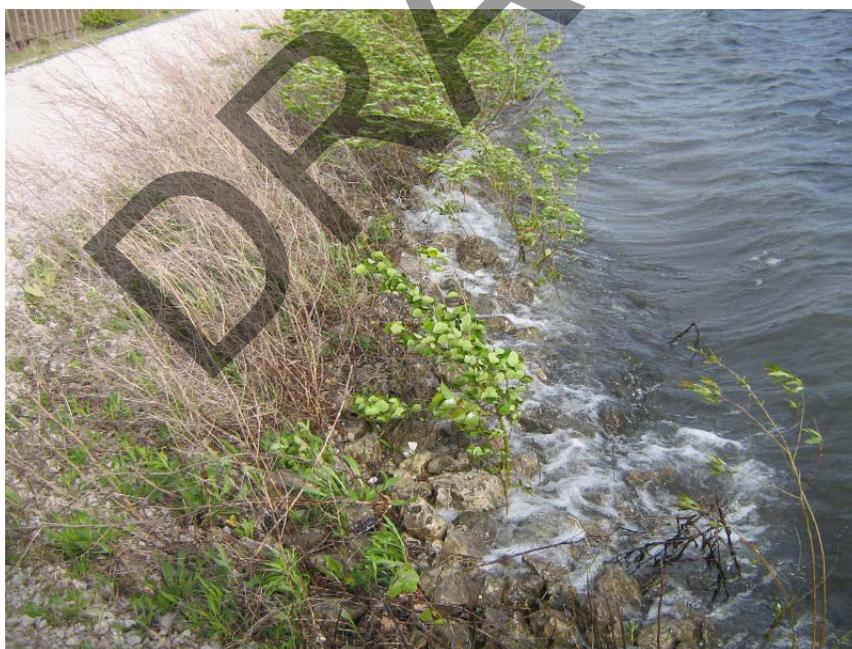
161. Waste Disposal Area - Wave action at south embankment interior slope

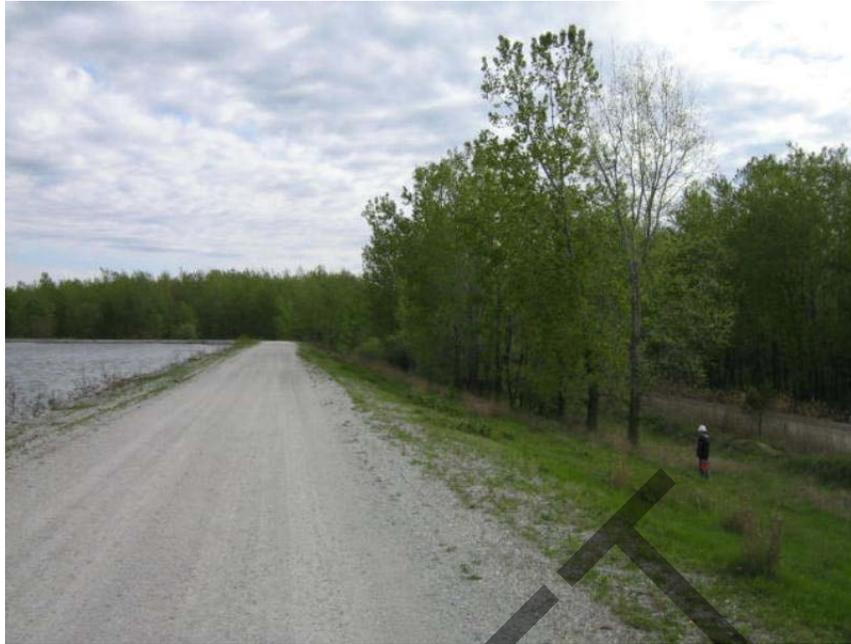
170. Recycle Settling Basin - South embankment crest and exterior slope, looking east, trees at toe

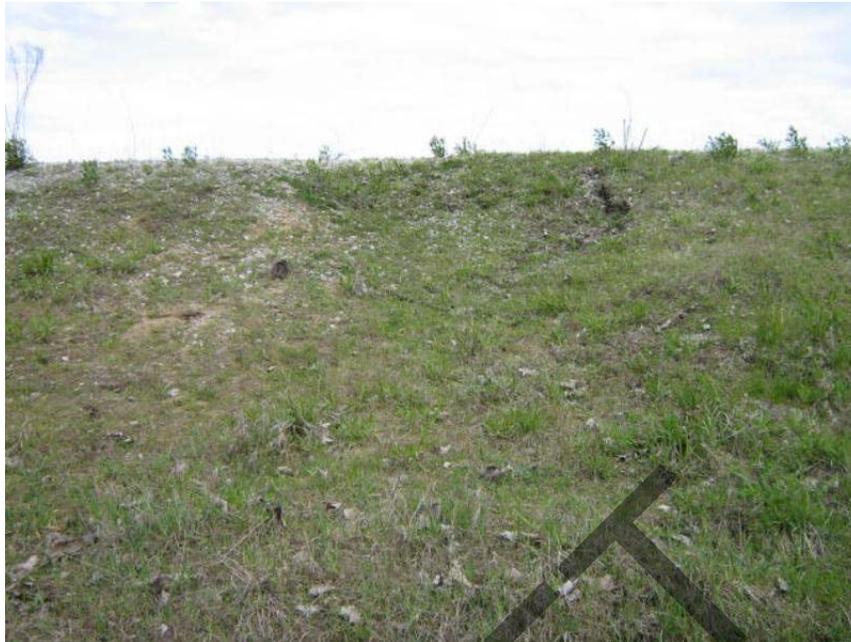
174. Recycle Settling Basin – Erosion feature on southeast embankment exterior slope

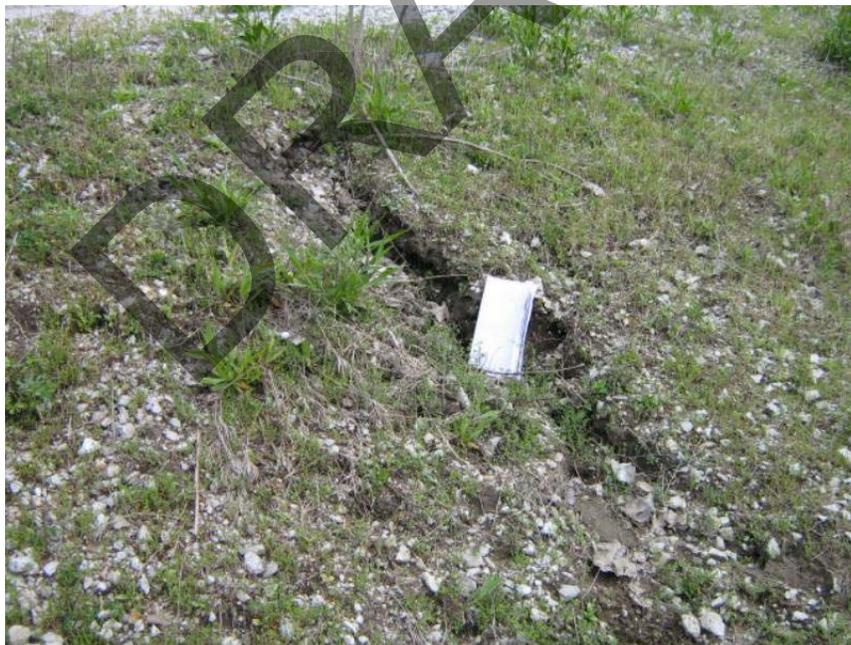
175. Recycle Settling Basin - Erosion rill on southeast embankment exterior slope

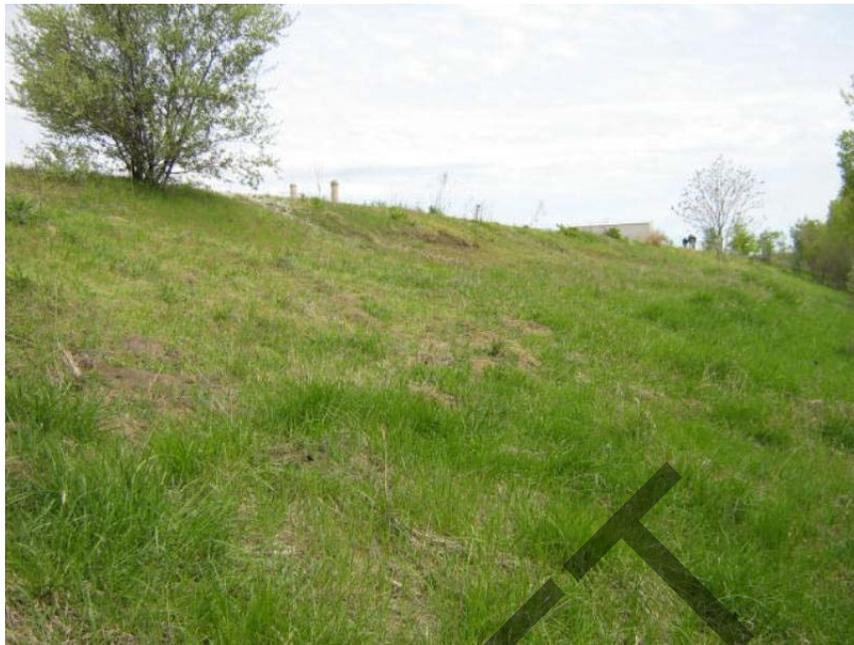
176. Recycle Settling Basin - Sloughing on east embankment exterior slope (approximately 80 feet in length)

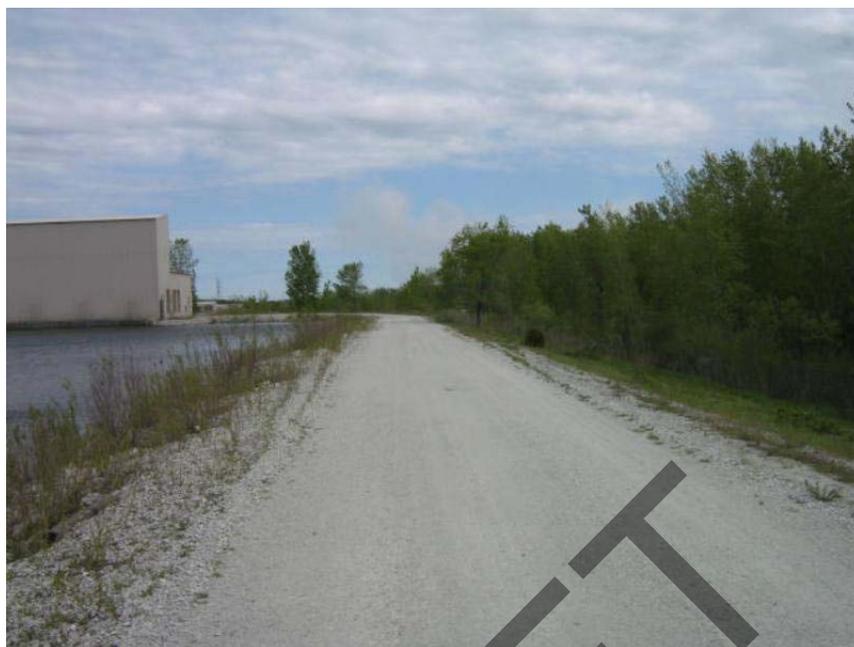
178. Recycle Settling Basin - East embankment crest, looking north

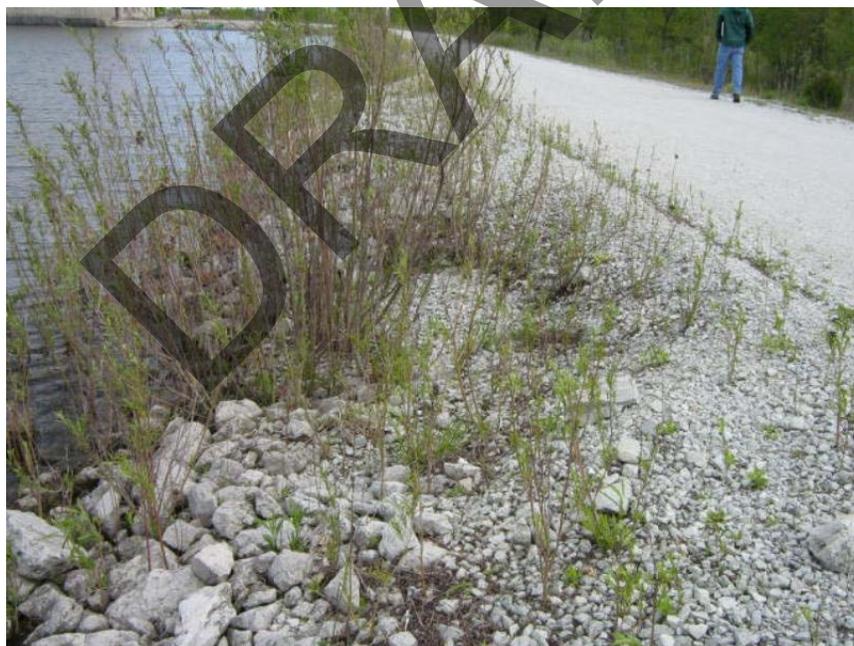
179. Recycle Settling Basin - East embankment interior slope, vegetation and minor erosion of riprap armoring

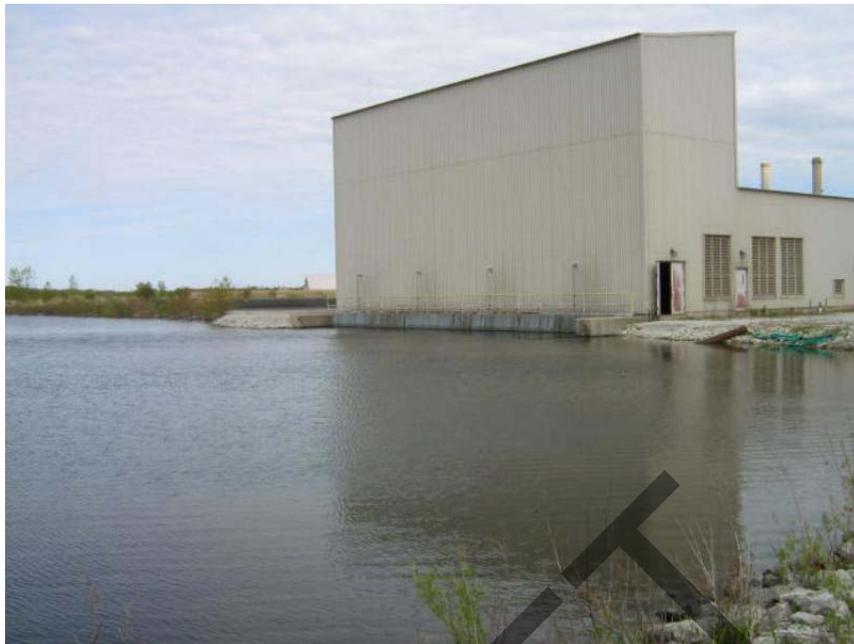
180. Recycle Settling Basin - Intake structure on north embankment

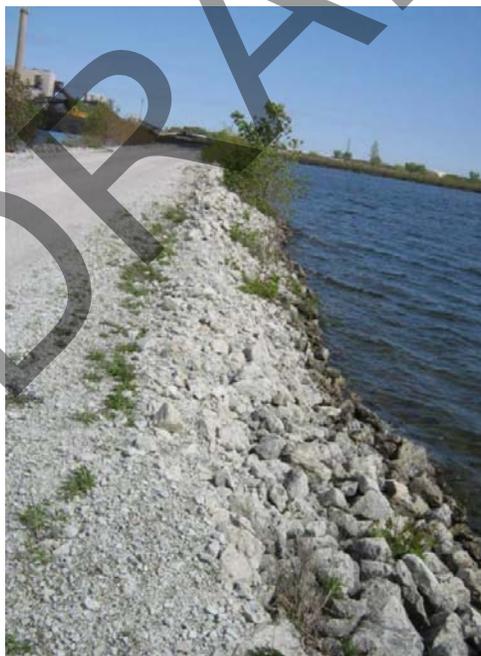
181. Recycle Settling Basin - Riprap erosion on west embankment interior slope
