Assessment of Dam Safety of Coal Combustion Surface Impoundments

Northern Indiana Public Service Company

R.M. Schahfer Generating Station

November 19, 2010

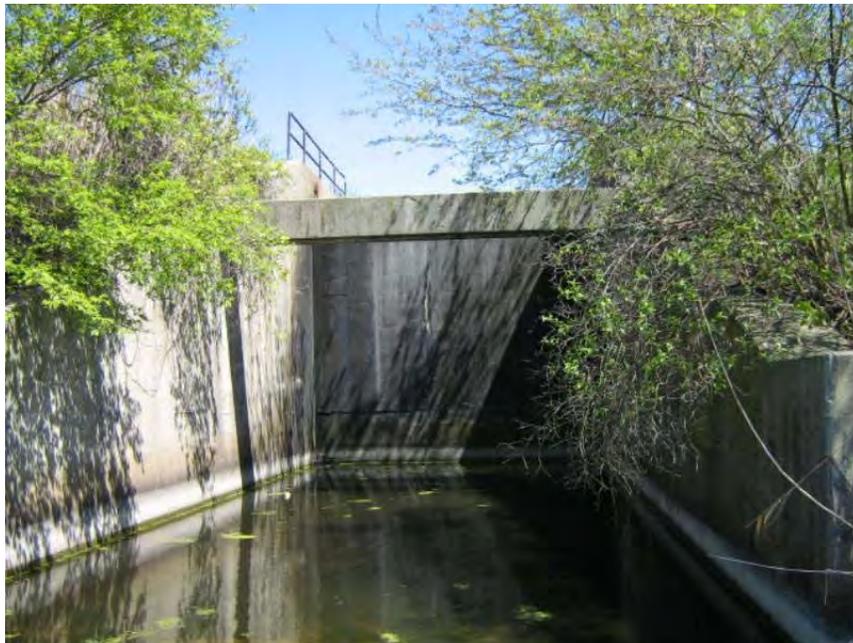
1. Final Settling Basin - Overflow Weir on West Embankment, Looking East

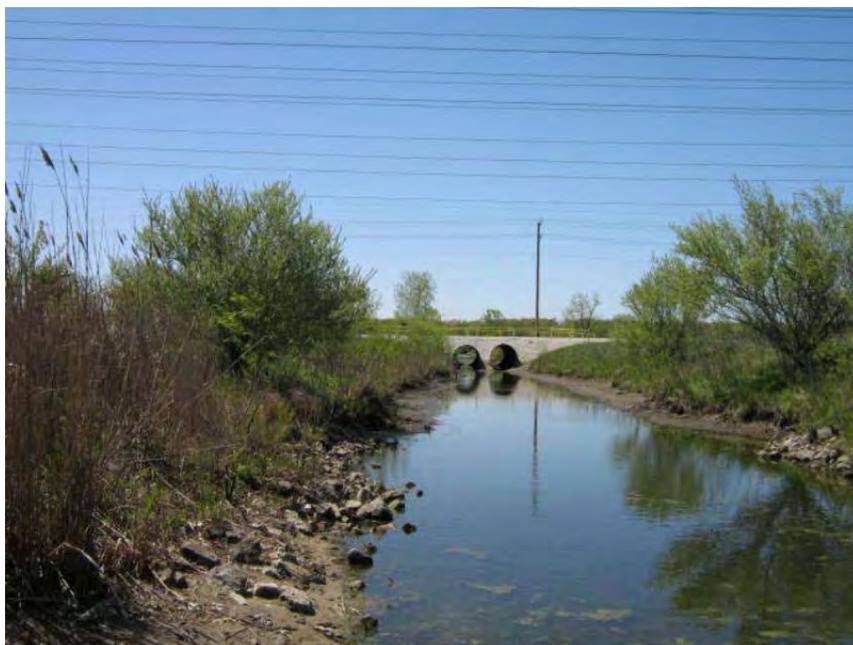
2. Final Settling Basin - Outlet Channel, Looking West from Overflow Weir

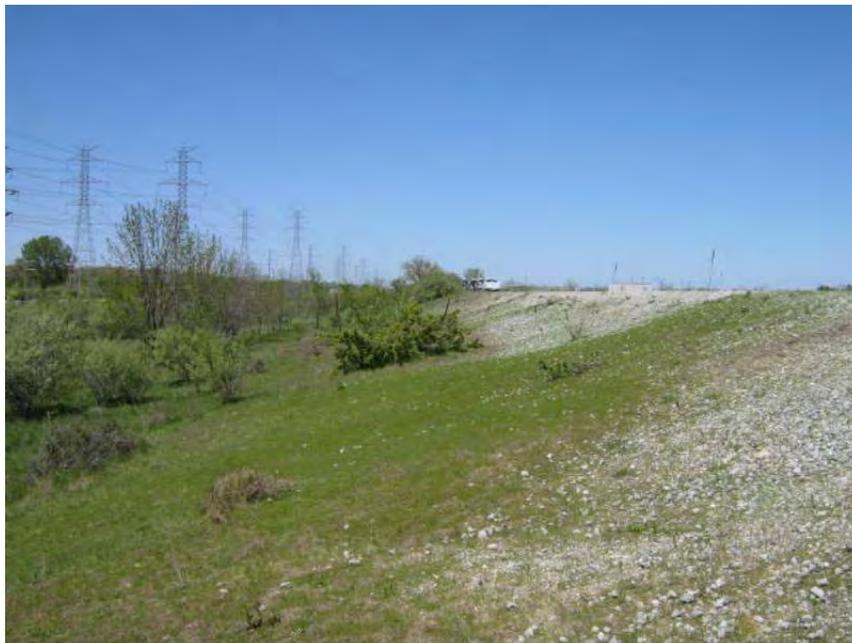
5. Final Settling Basin - West Embankment Exterior Slope, Looking North

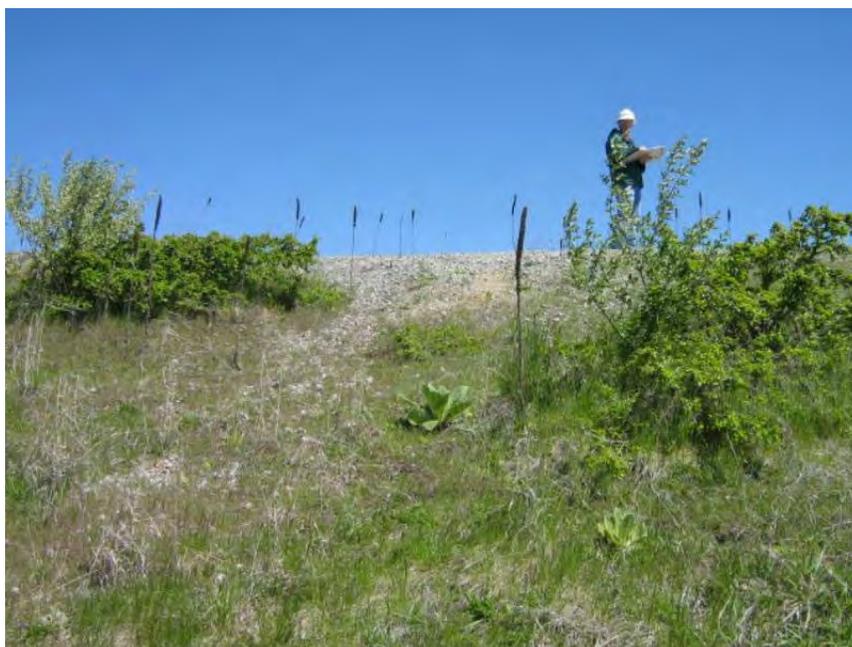
- 12. No trash racks. Bar screens installed at pump station.
- 17,18,19. Depressions, minor erosion rills, surface erosion, localized failures, and soft soils noted along west embankment exterior slope. Surface erosion (approximately 1-2') and rodent burrows noted along southwest embankment exterior slope. Depression at intake pipe along the southwest embankment exterior slope. Riprap slide along the east embankment interior slope. Surface erosion noted at the north embankment exterior slope (east edge).

6. Final Settling Basin - Erosion Rill West Embankment Exterior Slope

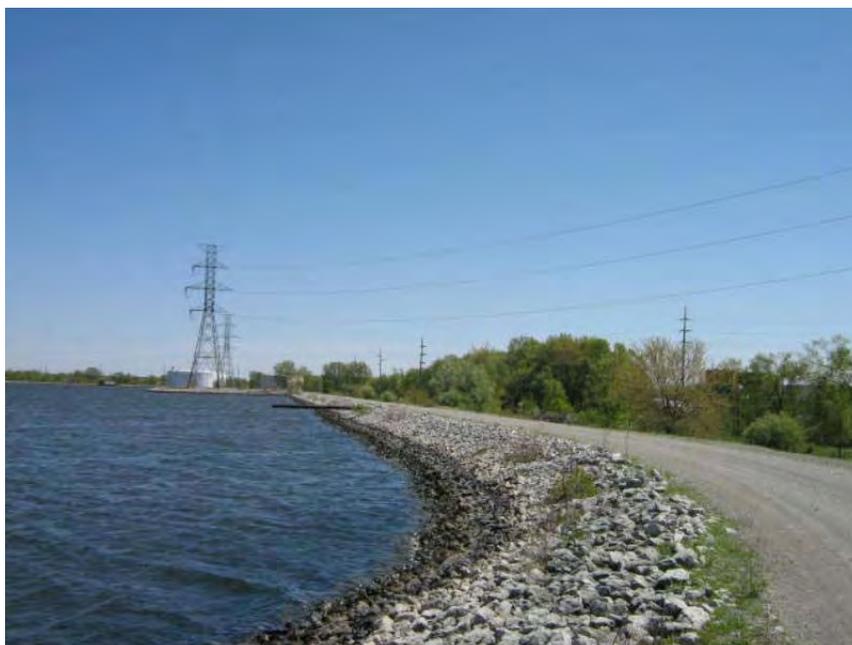
7. Final Settling Basin - South Embankment Interior Slope, Looking Southeast

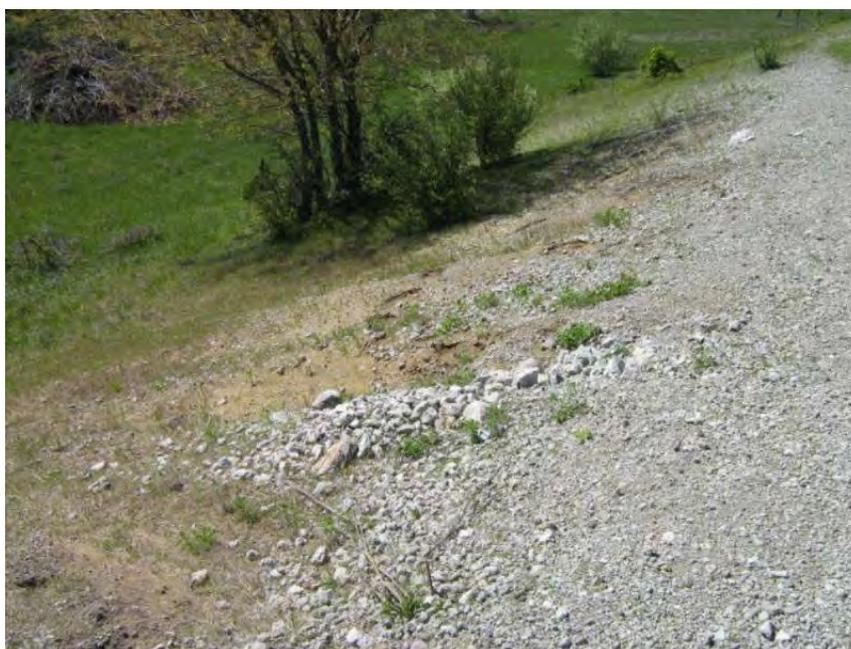
8. Final Settling Basin - Erosion Rills on South Embankment Exterior Slope

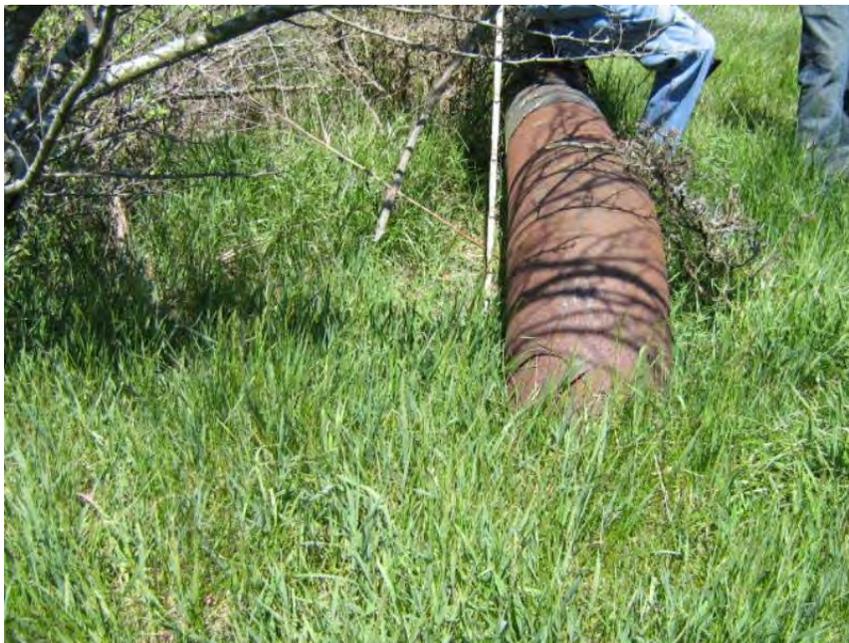
9. Final Settling Basin - Depression at Intake Pipe (10 inch diameter Metal) on South Embankment Exterior Slope

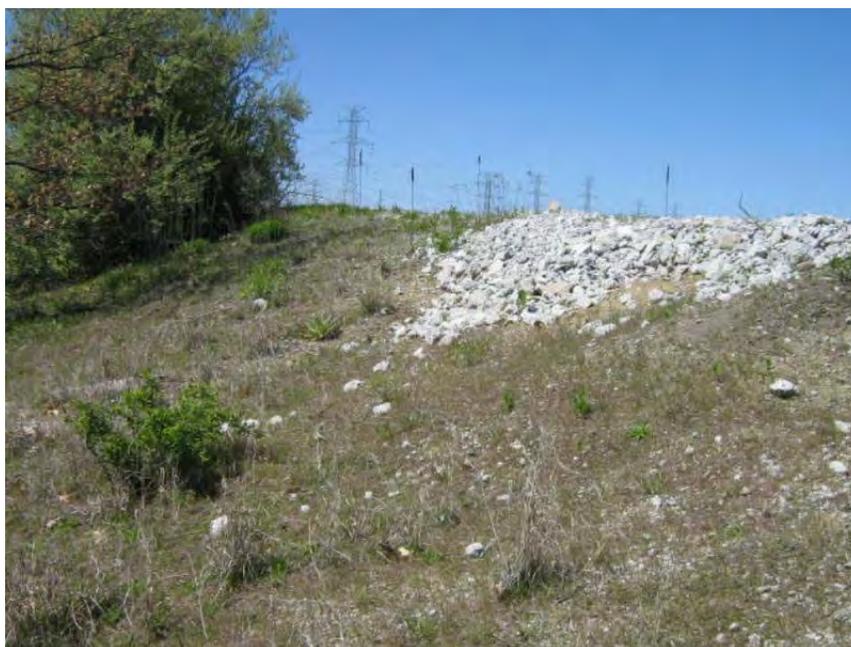
10. Final Settling Basin - South Embankment Exterior Slope

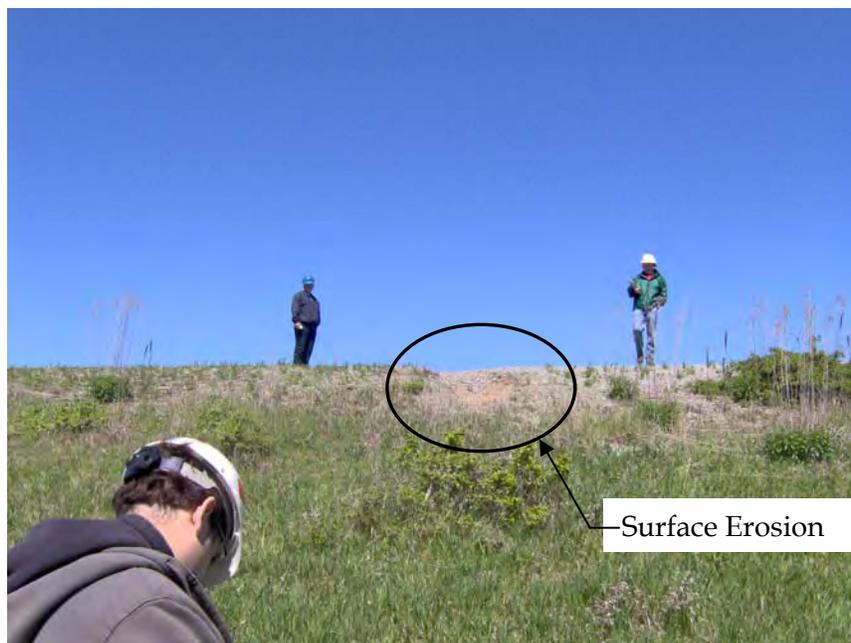
12. Final Settling Basin - Surface Erosion Located on South Embankment Exterior Slope

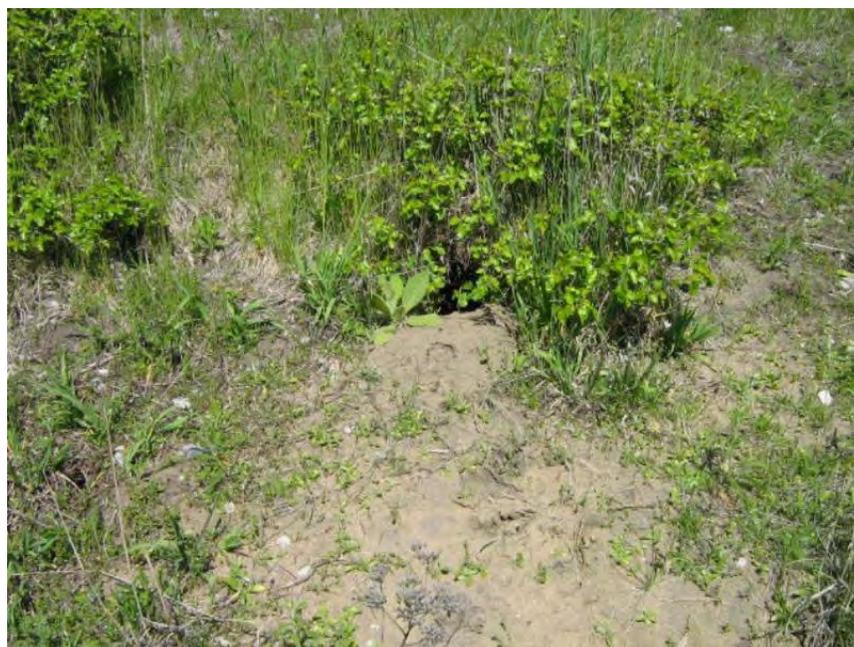
14. Final Settling Basin - Rodent Burrow on South Embankment Exterior Slope

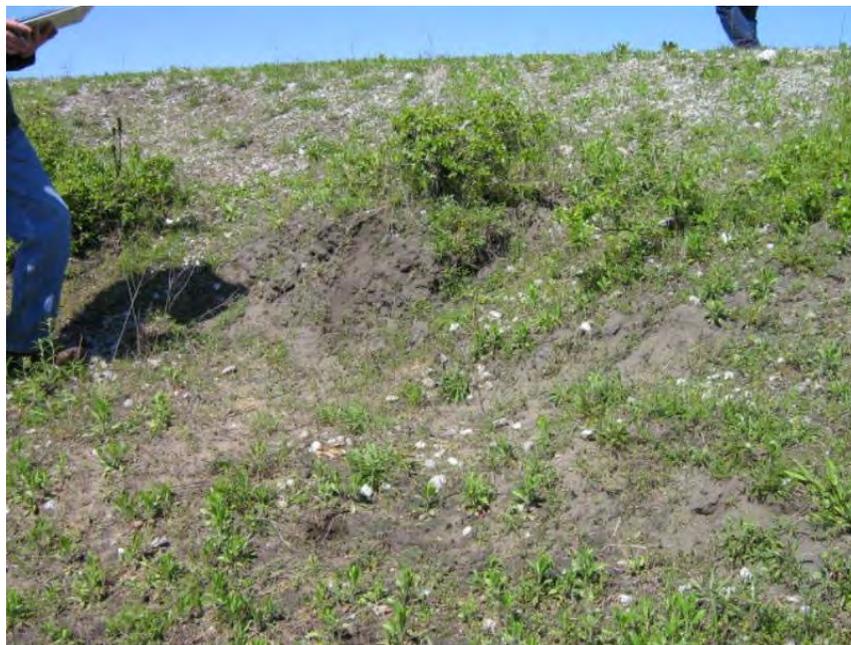
15. Final Settling Basin - Scarp on South Embankment Exterior Slope

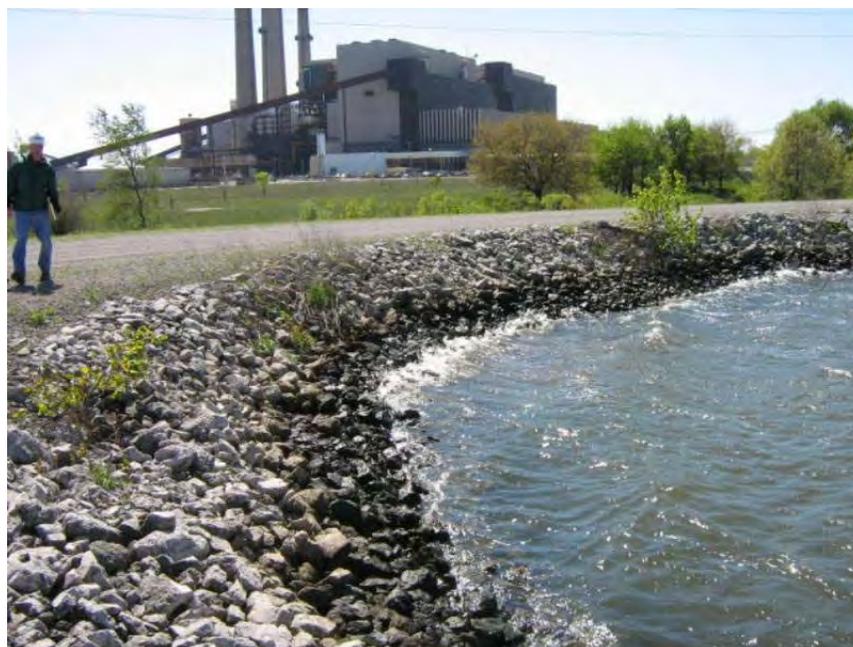
16. Final Settling Basin - Erosion on South Embankment Interior Slope

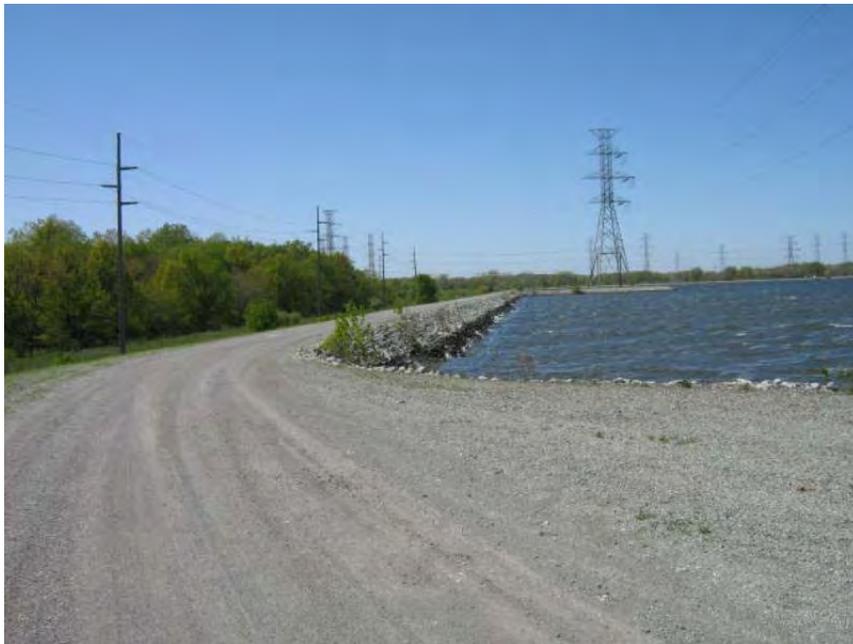
17. Final Settling Basin – South Embankment Crest

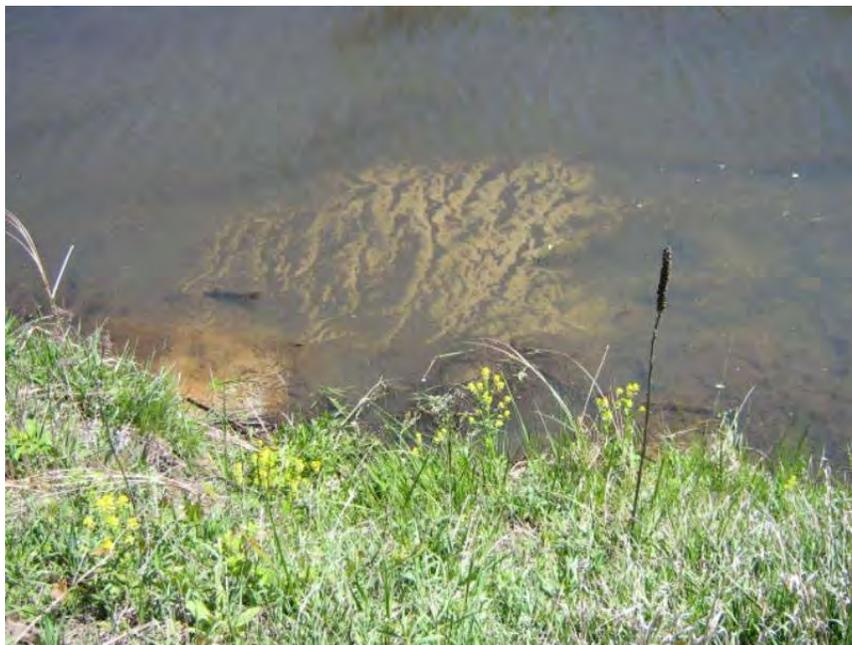
19. Final Settling Basin - Possible Seepage into Drainage Ditch

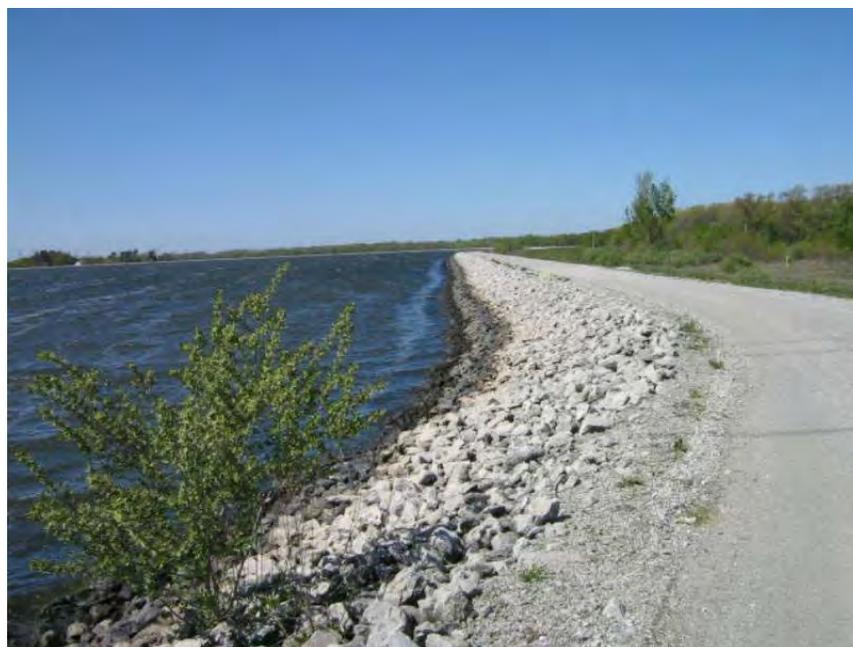
20. Final Settling Basin - East Embankment Crest and Interior Slope

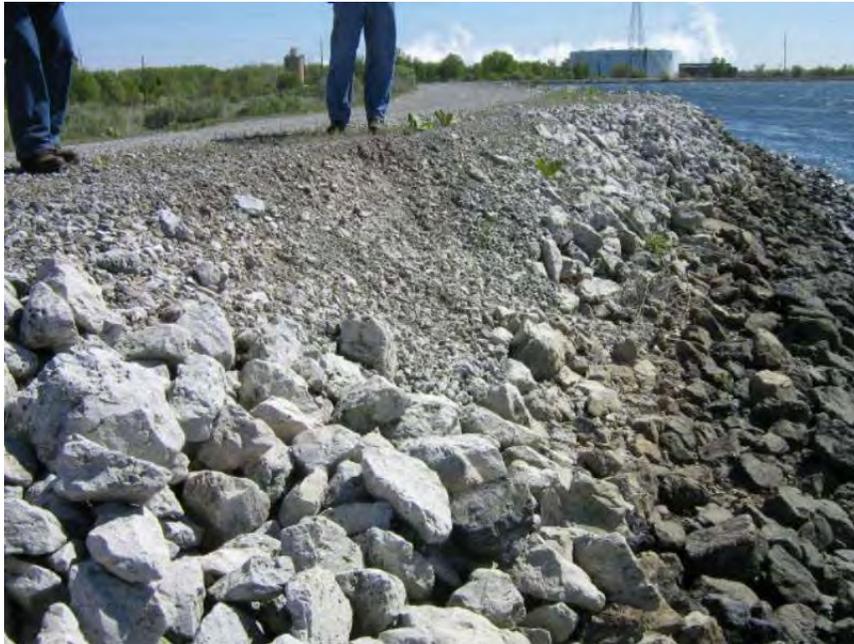
21. Final Settling Basin - Riprap Slide on East Embankment Interior Slope

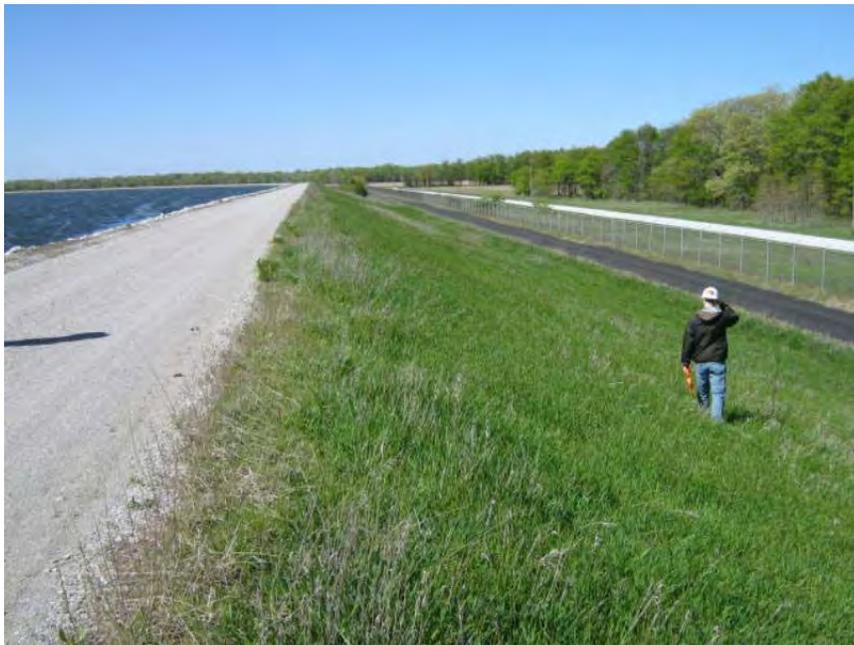
22. Final Settling Basin - East Embankment Exterior Slope, Well Established Vegetation

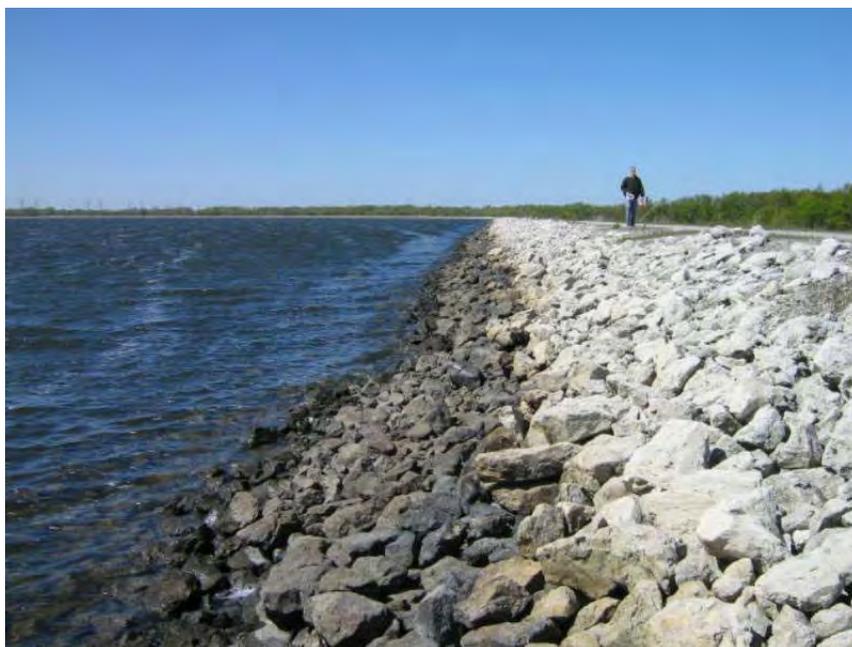
23. Final Settling Basin - East Embankment Interior Slope, Riprap Erosion

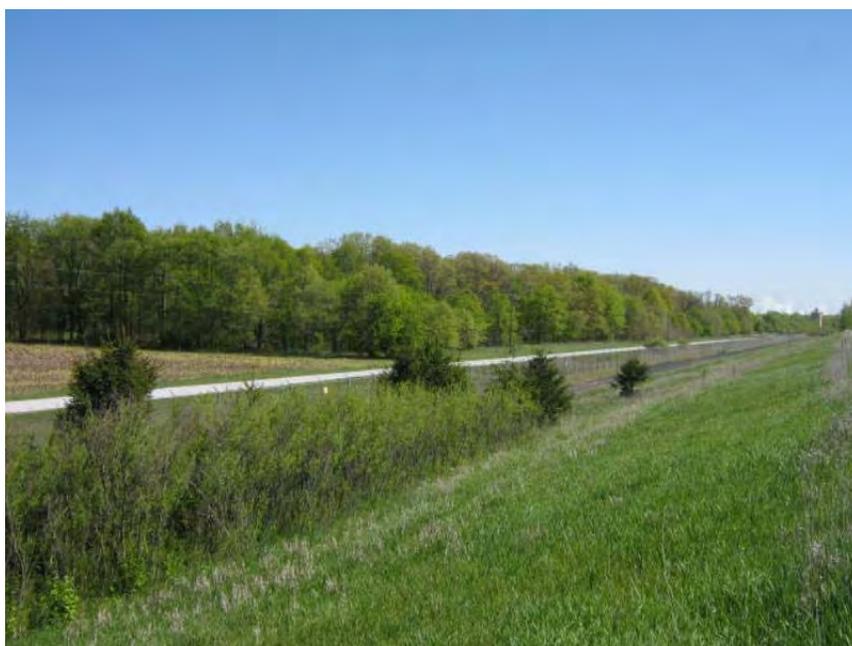
24. Final Settling Basin - Shrubs and Brush at Exterior Slope at Toe of East Embankment

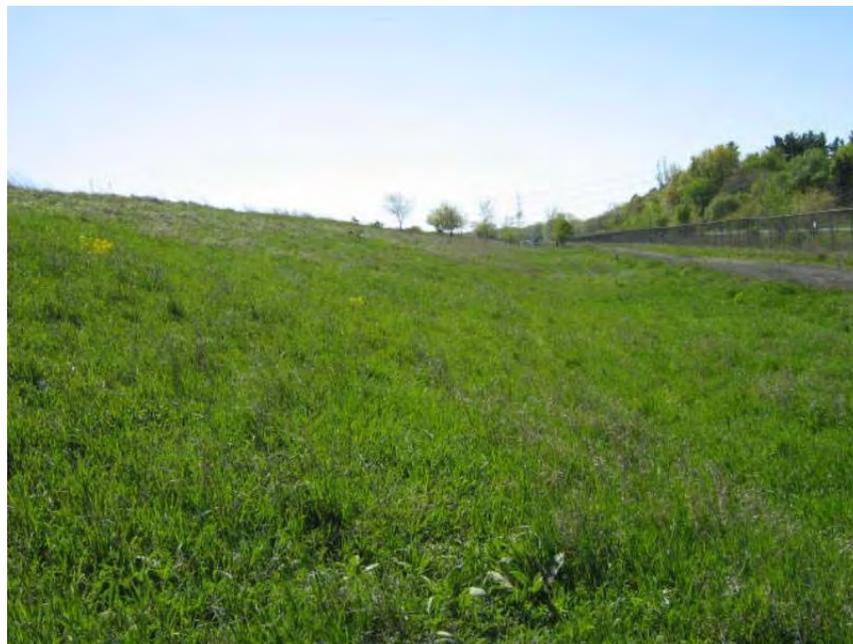
25. Final Settling Basin - North Embankment Exterior Slope,
Looking West

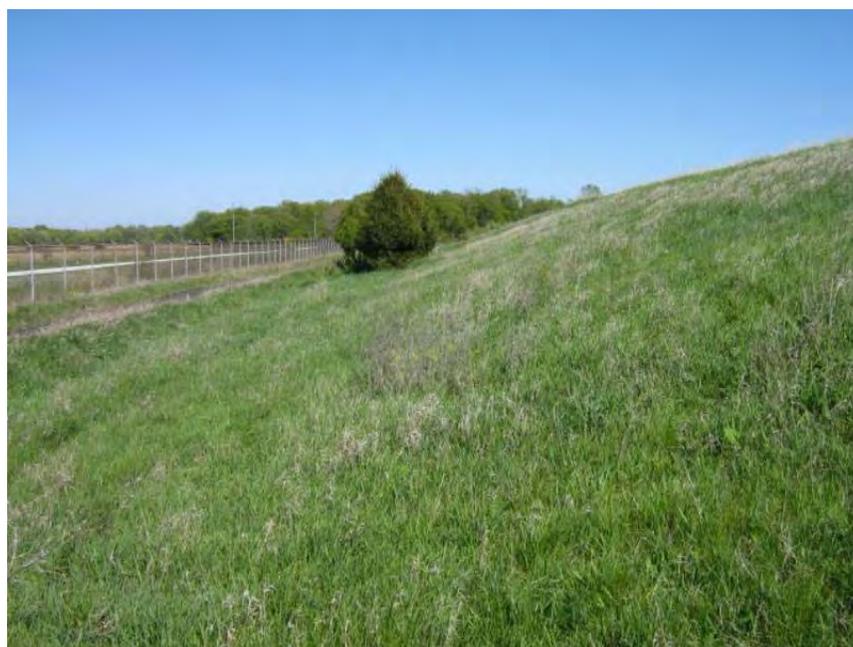
26. Final Settling Basin - North Embankment Exterior Slope,
Looking East

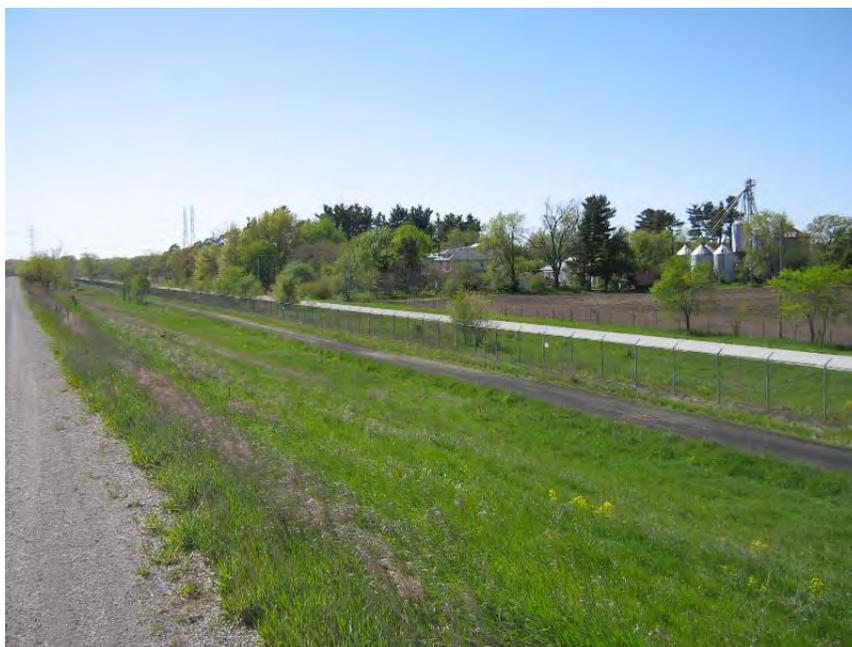
27. Final Settling Basin - North Embankment Exterior Slope, Private Residence in Background

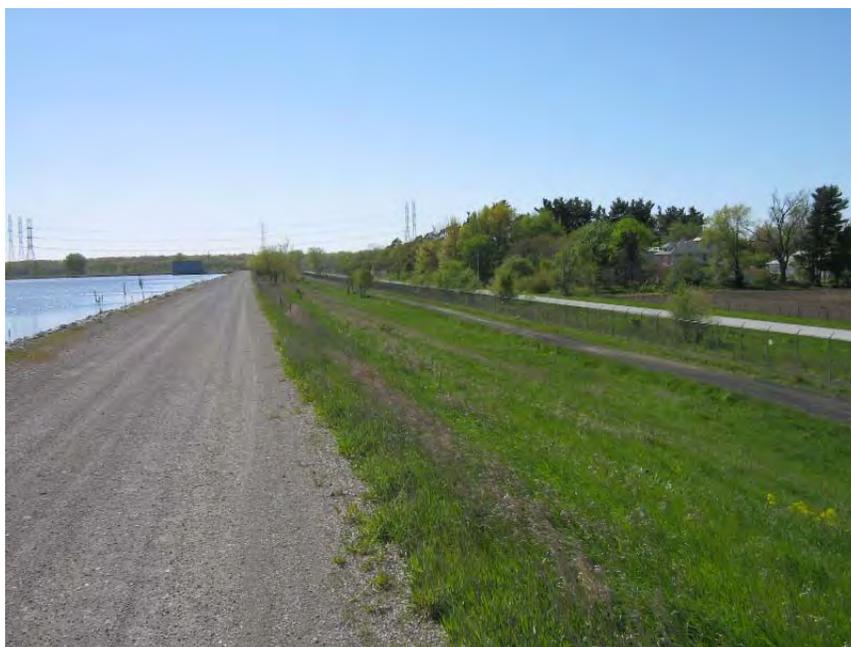
28. Final Settling Basin - North Embankment Crest and Exterior Slope

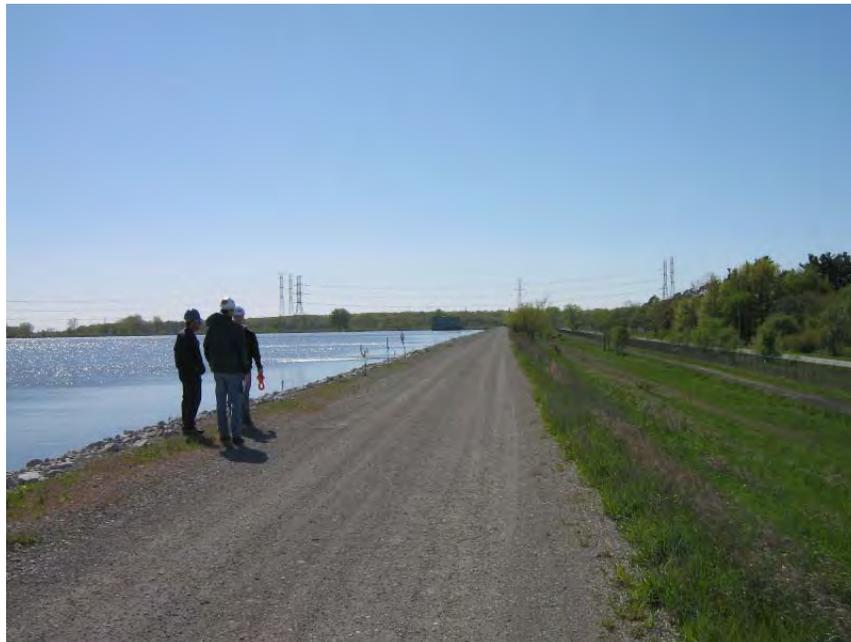
29. Final Settling Basin – North Embankment Crest Looking West

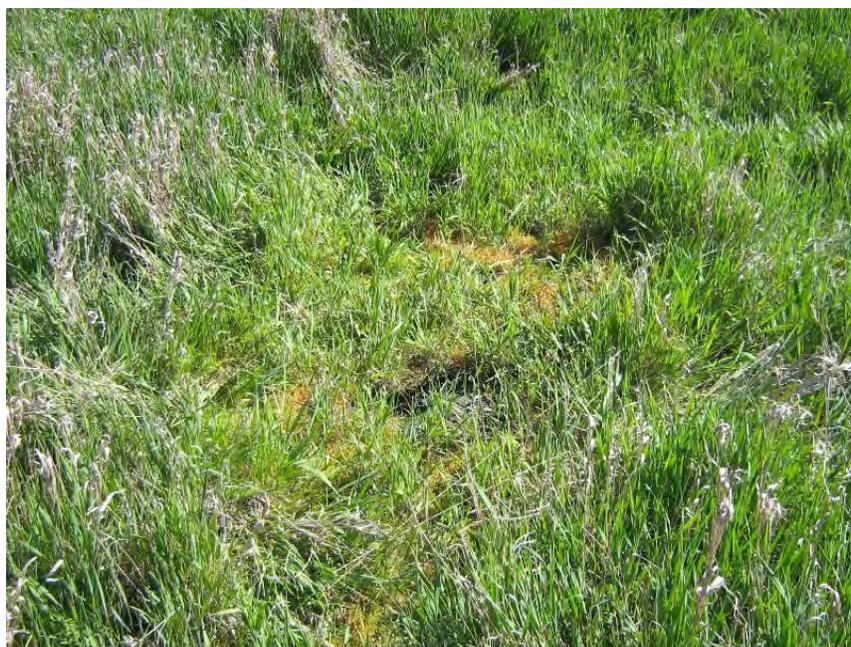
- 20. There are no decant pipes. Outlet controlled by overflow weir and Pump Station.
- 21. Possible historic seepage area located along the north embankment exterior slope. The area is currently dry, however moss indicates moisture.

30. Final Settling Basin – North Embankment Exterior Slope, Possible Seepage Area, Currently with Moss

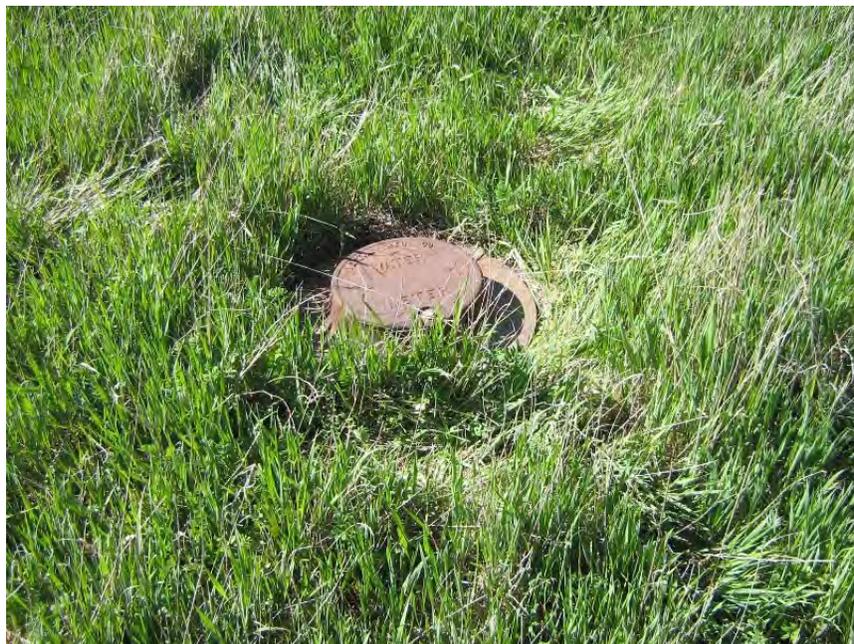
31. Final Settling Basin - Water Meter on North Embankment
Exterior Slope

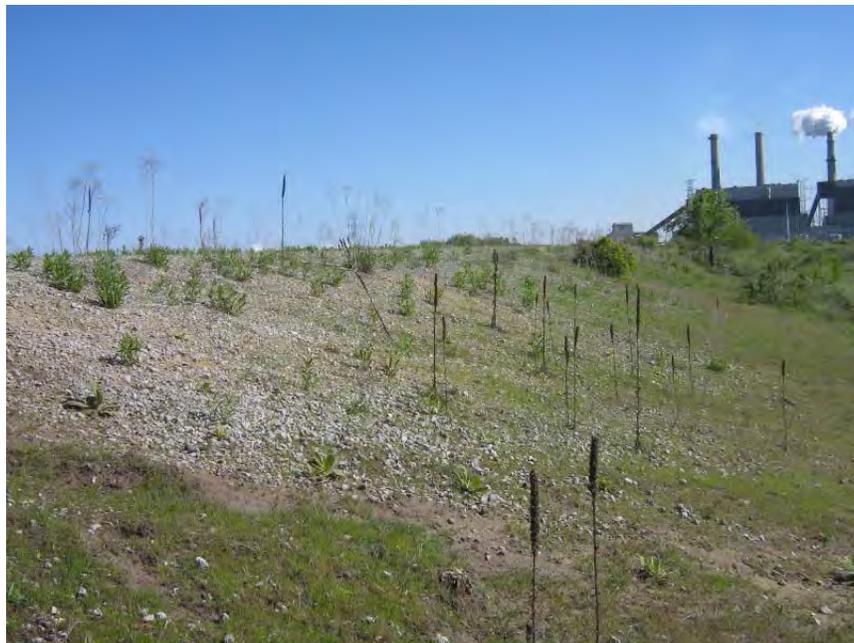
33. Final Settling Basin - West Embankment Exterior Slope, Sparse Vegetation

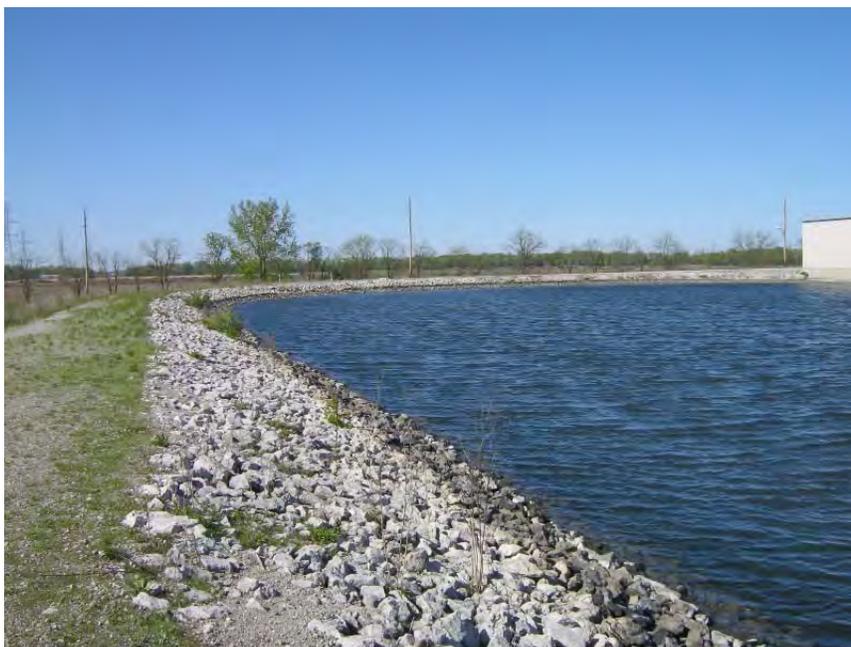
34. Final Settling Basin - West Embankment Interior Slope

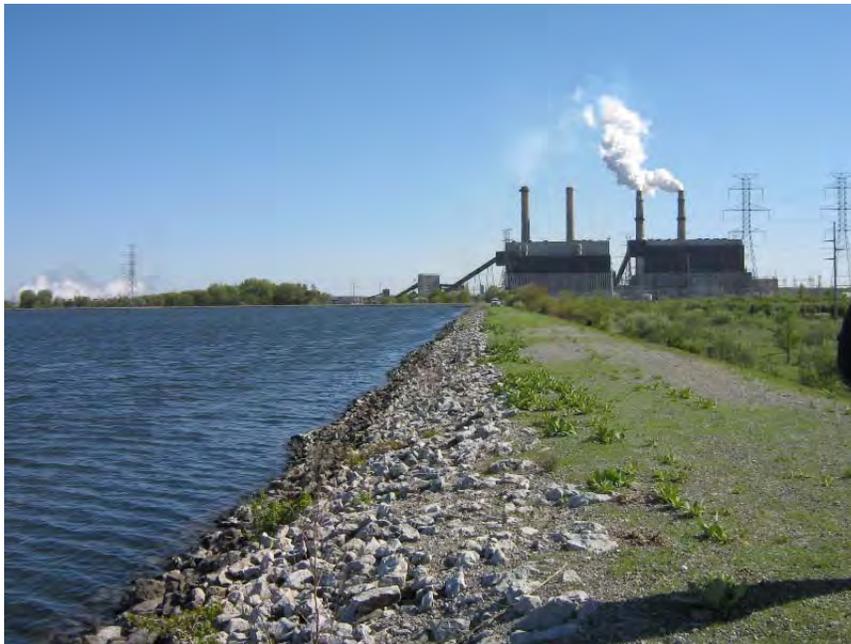
35. Final Settling Basin - West Embankment Crest and Interior Slope

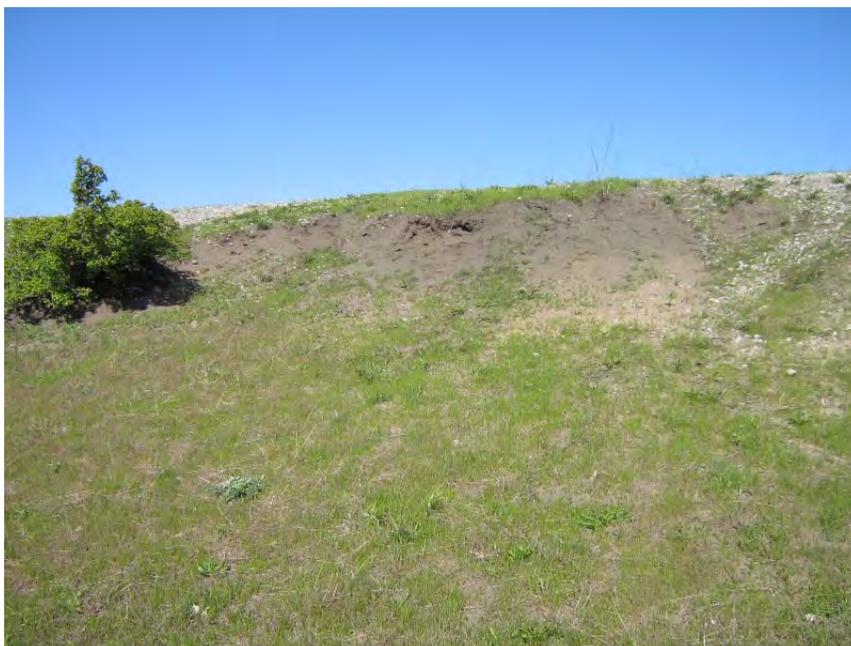
36. Final Settling Basin - Active Scarp on West Embankment Exterior Slope (Approximately 32 feet in Length)

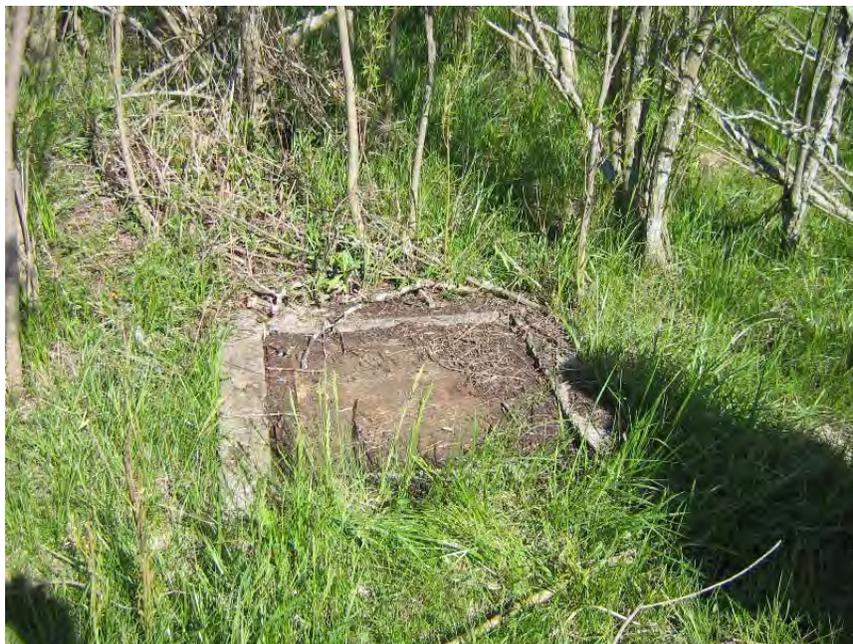
37. Final Settling Basin - Manhole Located on West Embankment Exterior Slope

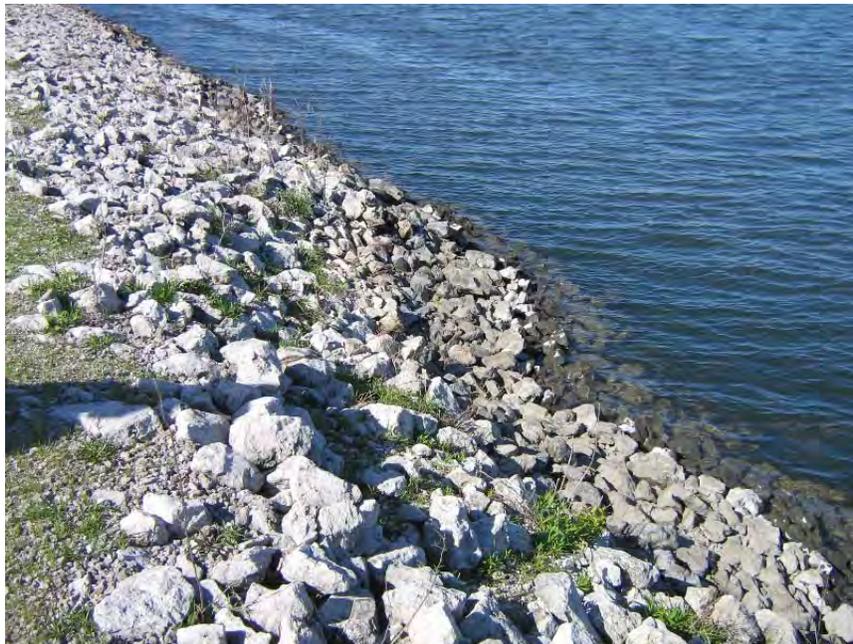
39. Final Settling Basin - Riprap Erosion on West Embankment Interior Slope

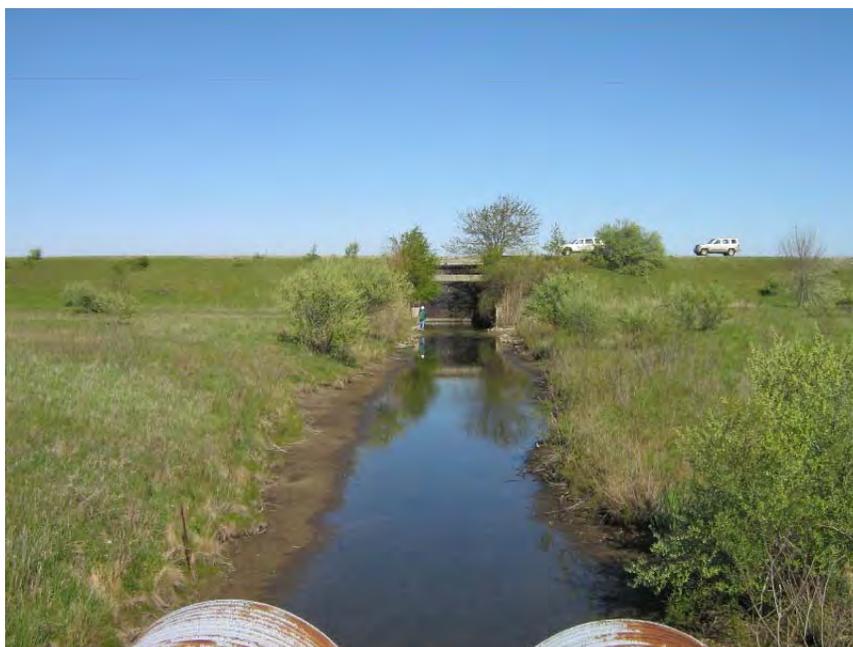
40. Final Settling Basin - Drainage Ditch

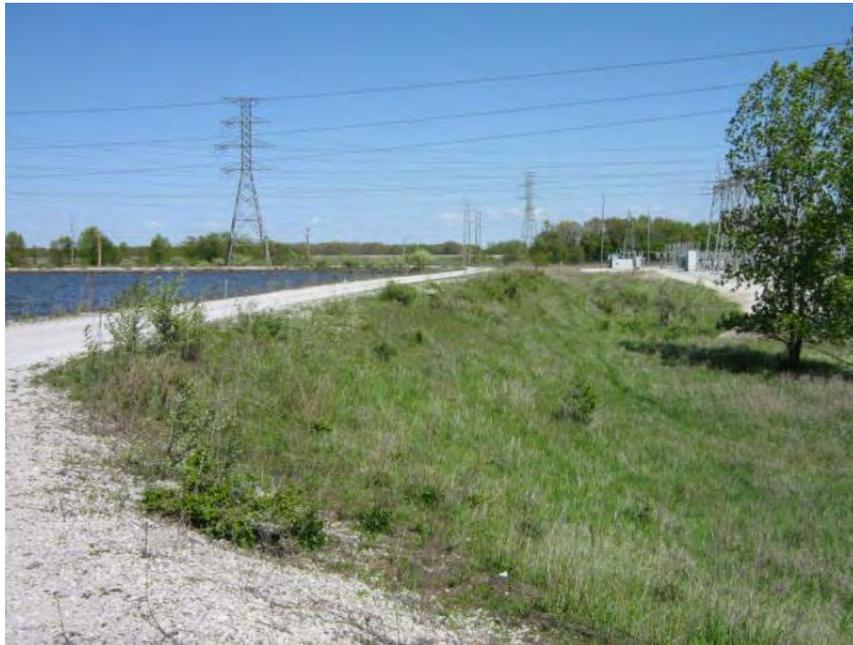
41. Intake Settling Basin - South Embankment Exterior Slope, Tree near Slope Toe

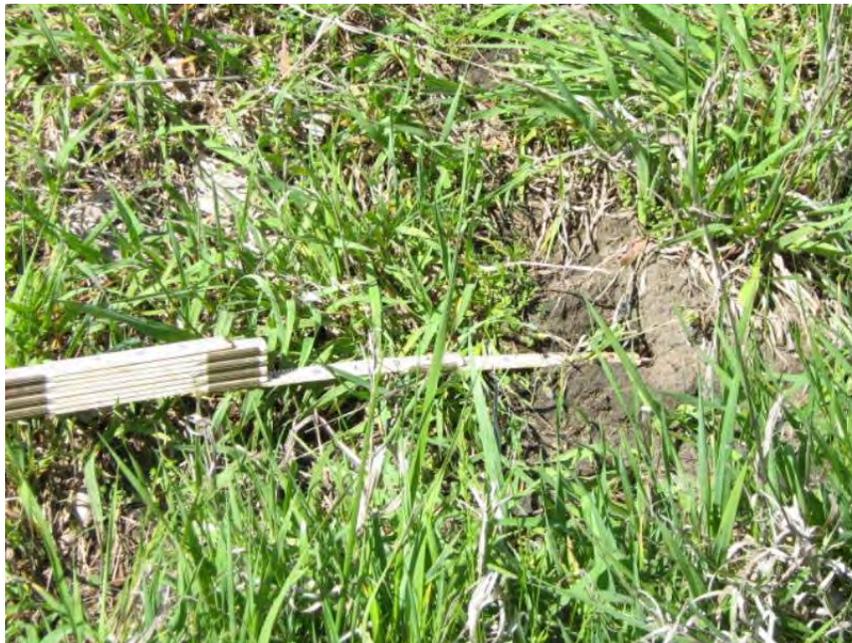
43. Intake Settling Basin - Rodent Burrow on South Embankment Exterior Slope

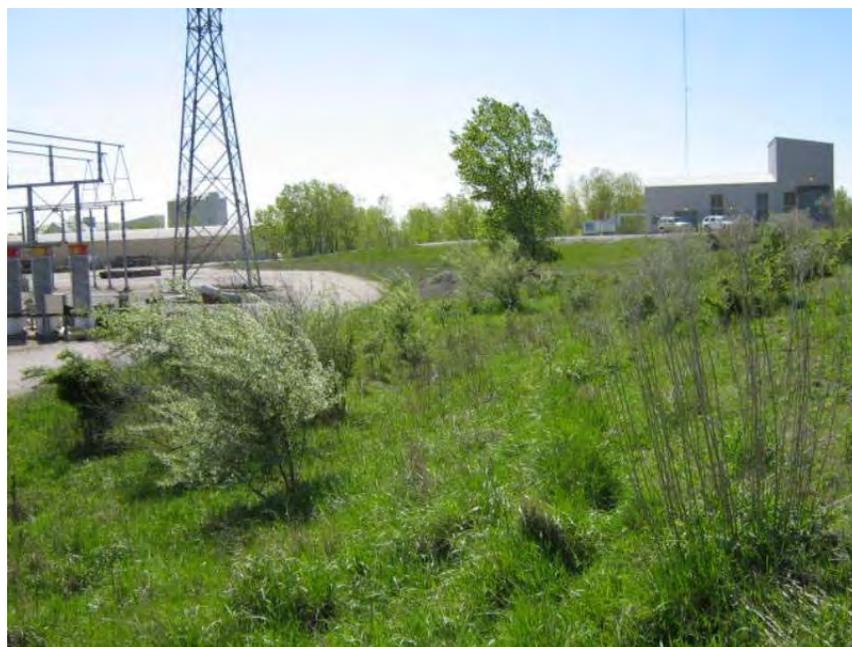
44. Intake Settling Basin - South Embankment Exterior Slope, Vegetation

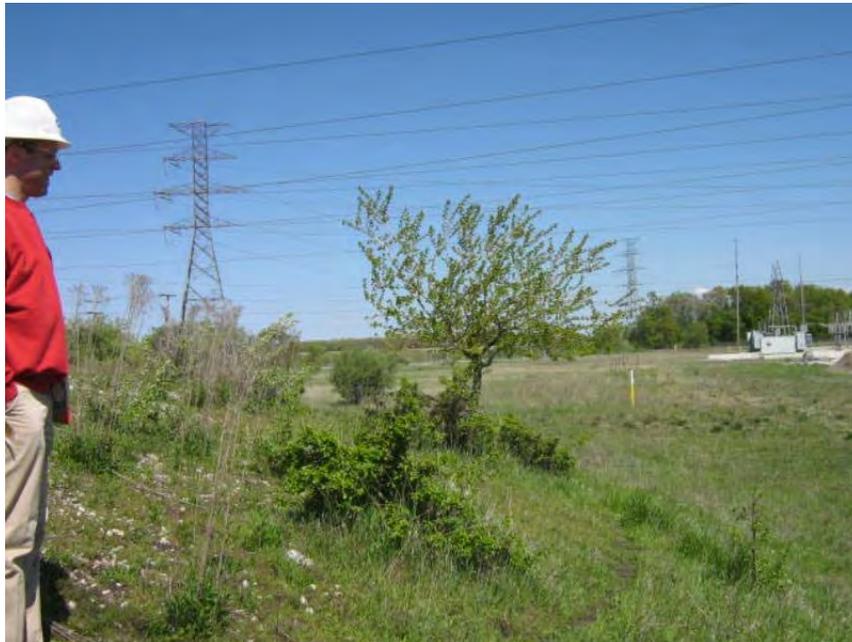
45. Intake Settling Basin - South Embankment Exterior Slope

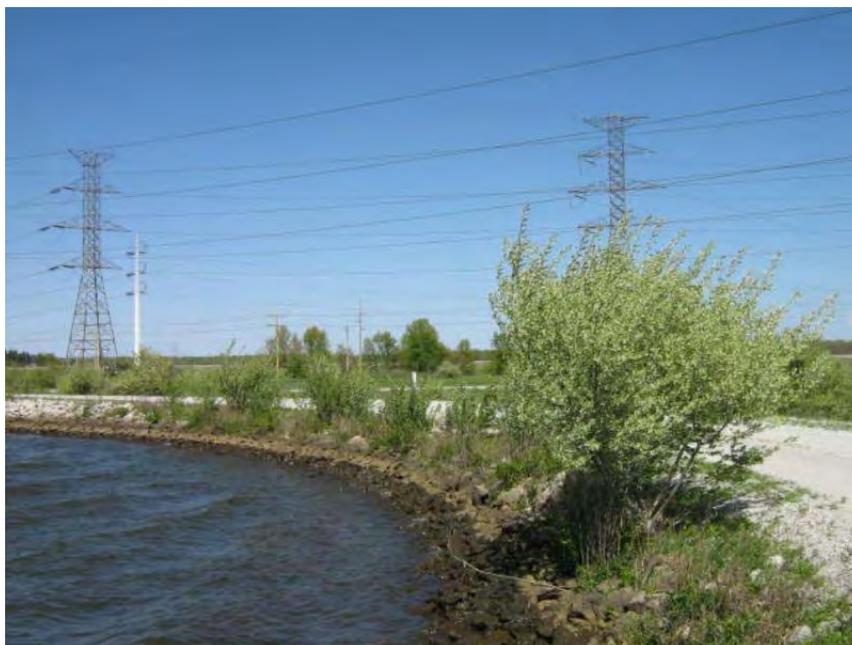
46. Intake Settling Basin - South Embankment Interior Slope,
Vegetation

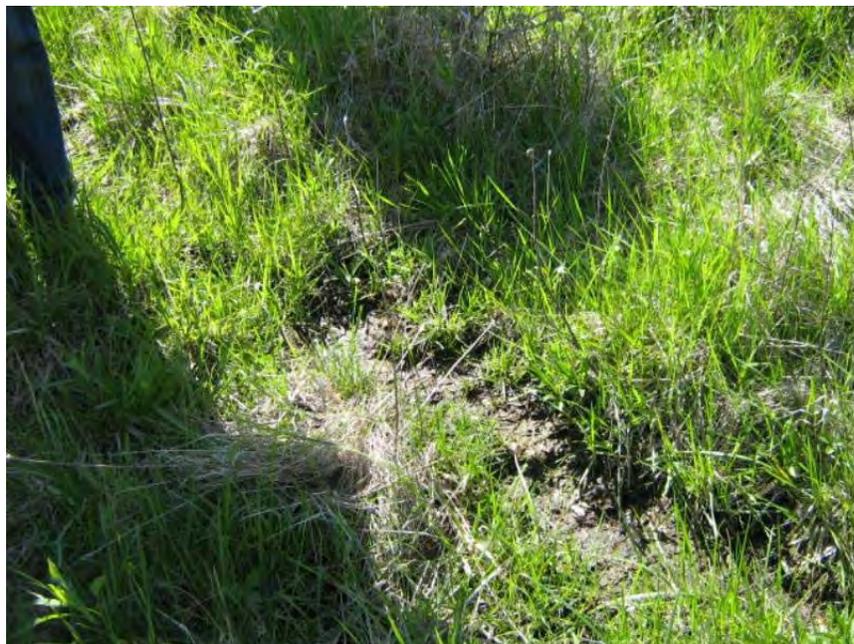
47. Intake Settling Basin - Saturated Area Located on East Embankment Exterior Slope

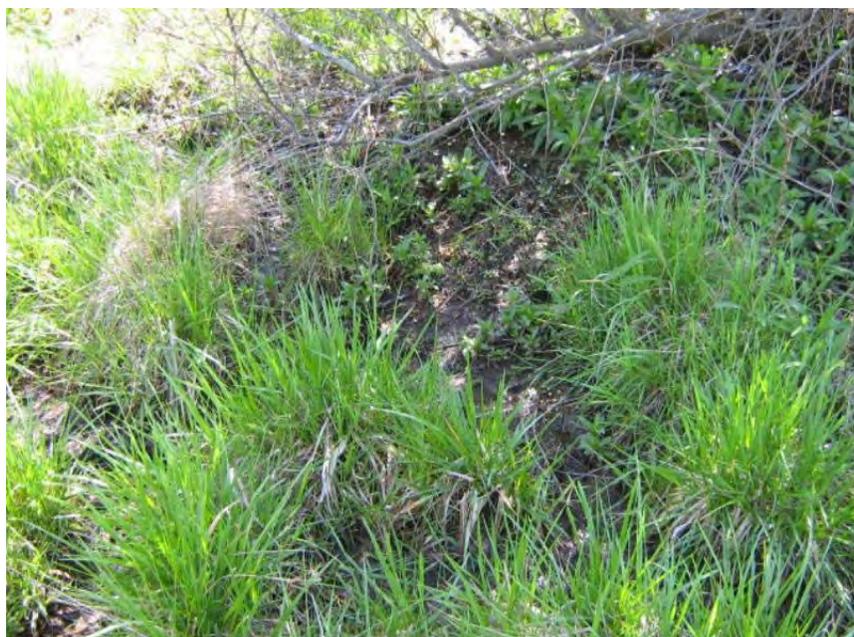
48. Intake Settling Basin - Saturated Area Located on East Embankment Exterior Slope
