Assessment of Dam Safety of Coal Combustion Surface Impoundments

Northern Indiana Public Service Company

R.M. Schahfer Generating Station

November 19, 2010

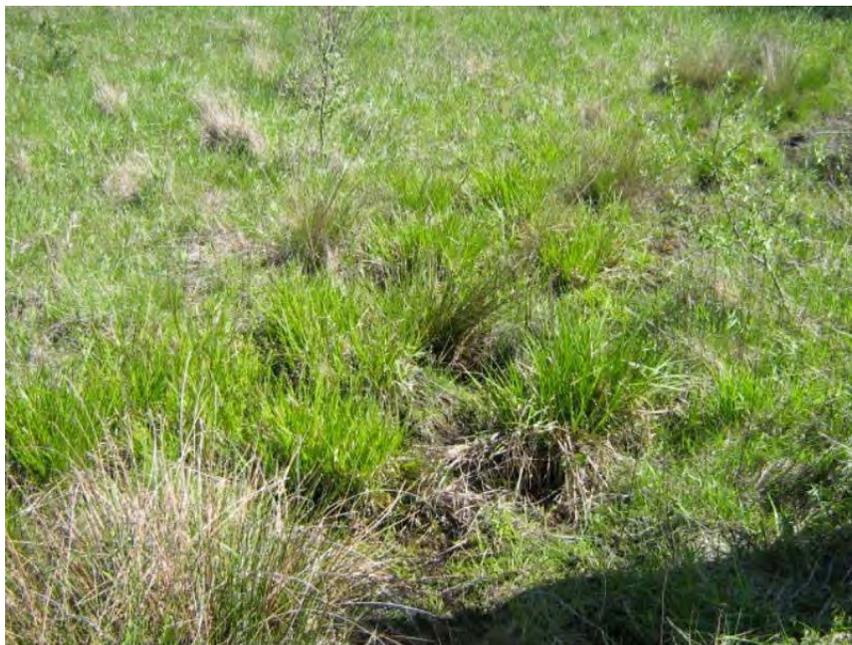
49. Intake Settling Basin - Saturated Area Located on East Embankment Exterior Slope

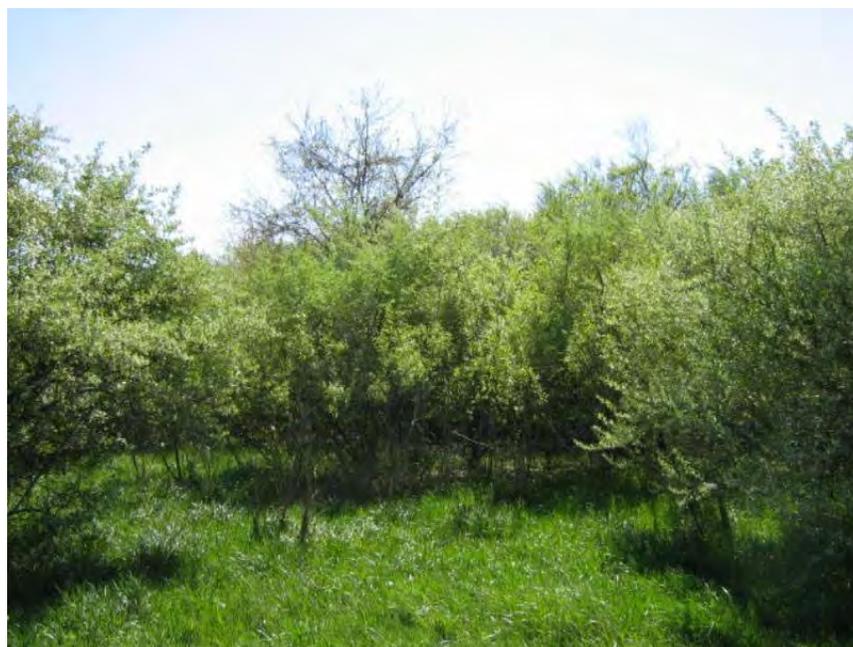
50. Intake Settling Basin - Vegetation and Trees on Base of East Embankment Exterior Slope Toe

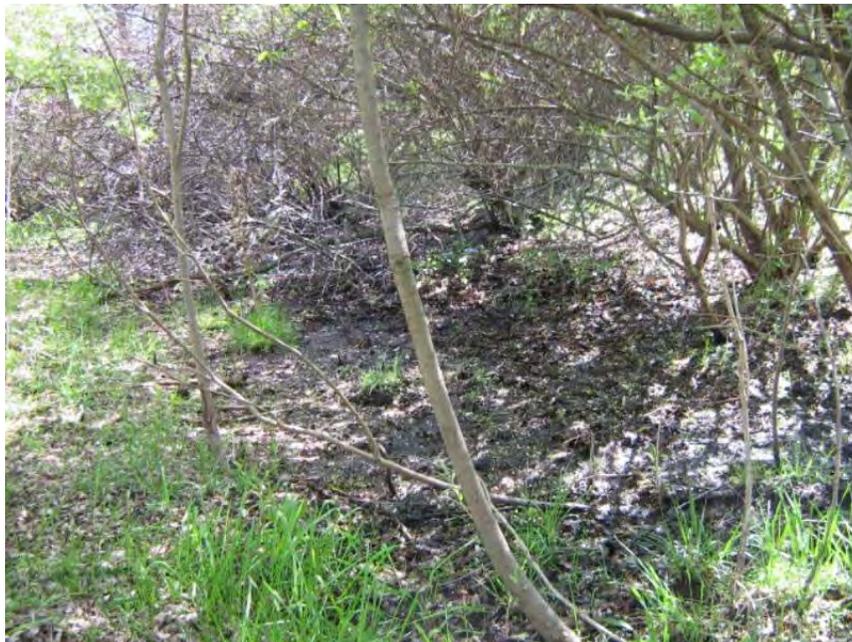
51. Intake Settling Basin - Brush on East Embankment Exterior Slope

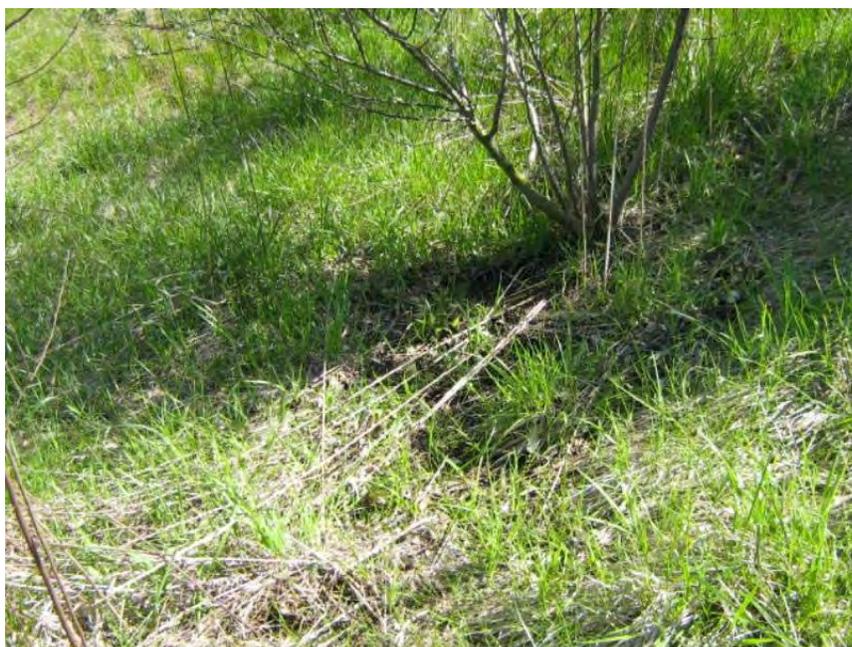
52. Intake Settling Basin - Saturated Area in Brush on East Embankment Exterior Slope

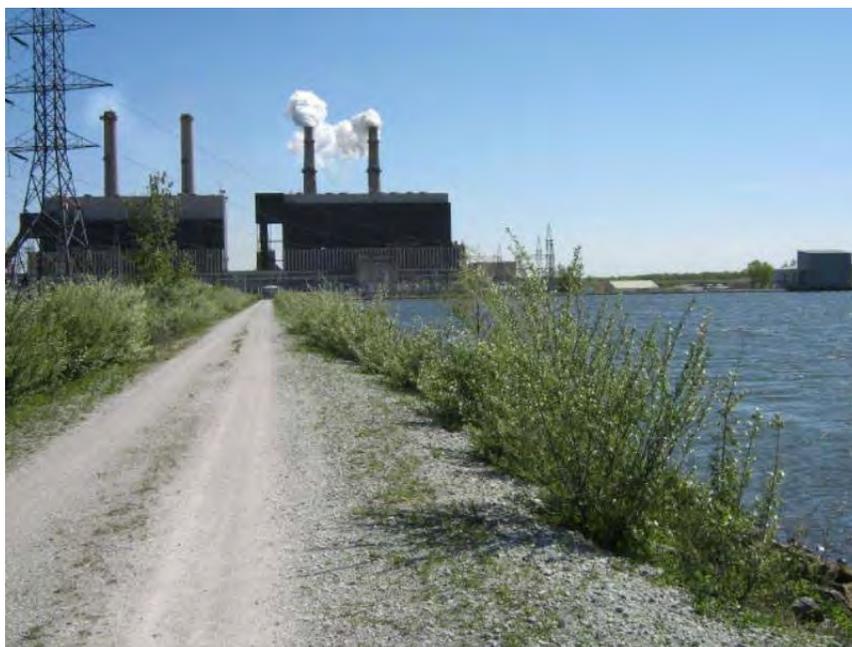
53. Intake Settling Basin - East Embankment Crest

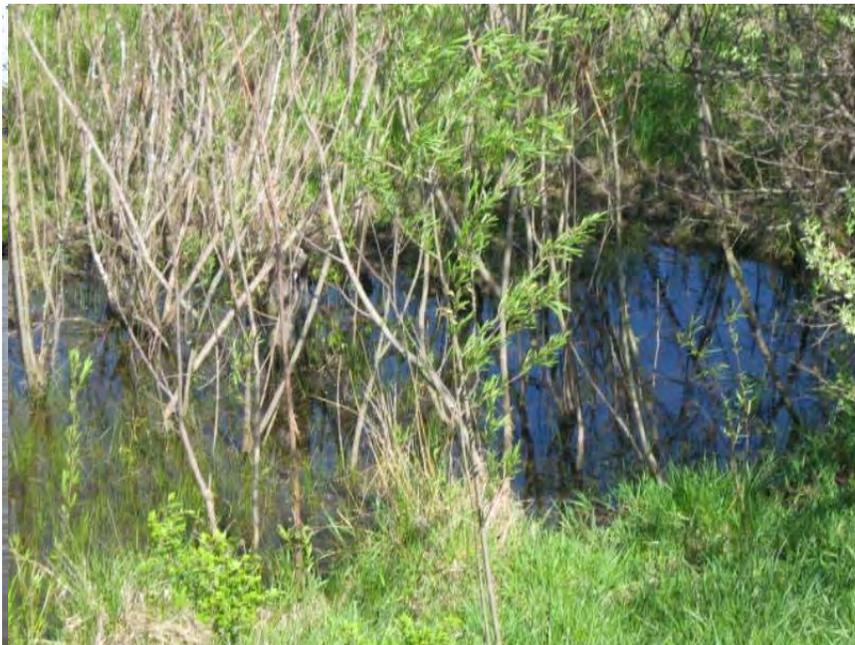
55. Intake Settling Basin – Standing Water on East Embankment
Exterior Slope Toe

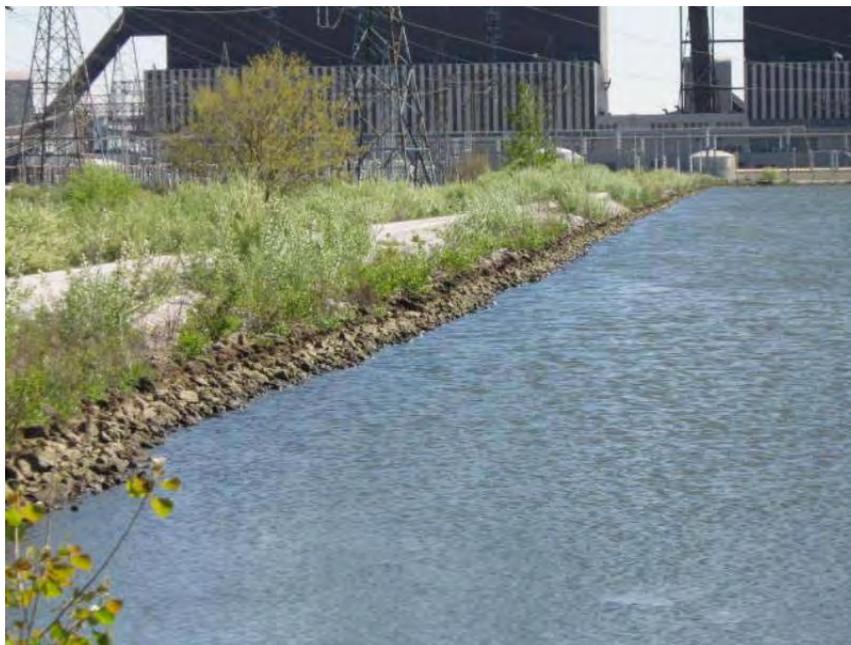
56. Intake Settling Basin - East Embankment Interior Slope

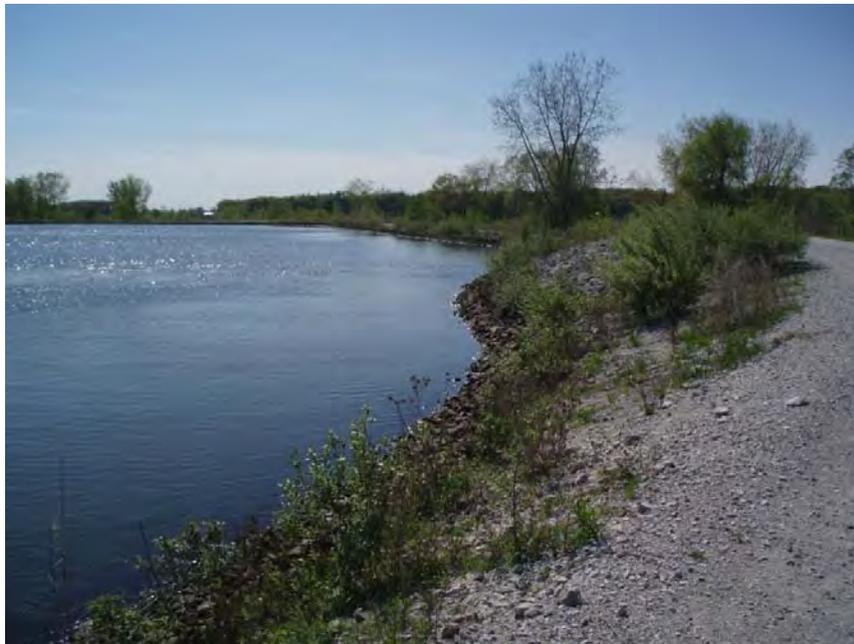
57. Intake Settling Basin - North Embankment Interior Slope

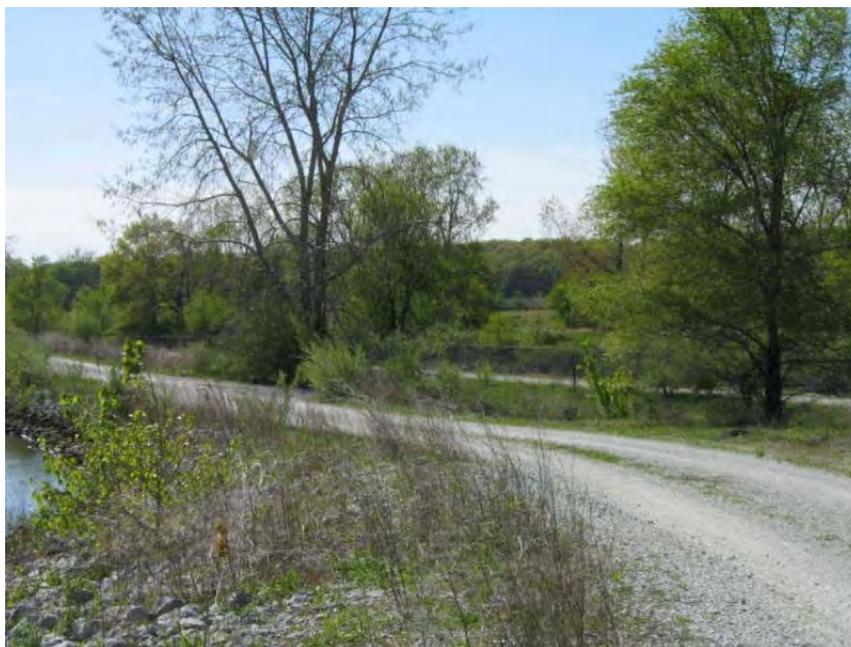
58. Intake Settling Basin - North Embankment Crest and Interior Slope

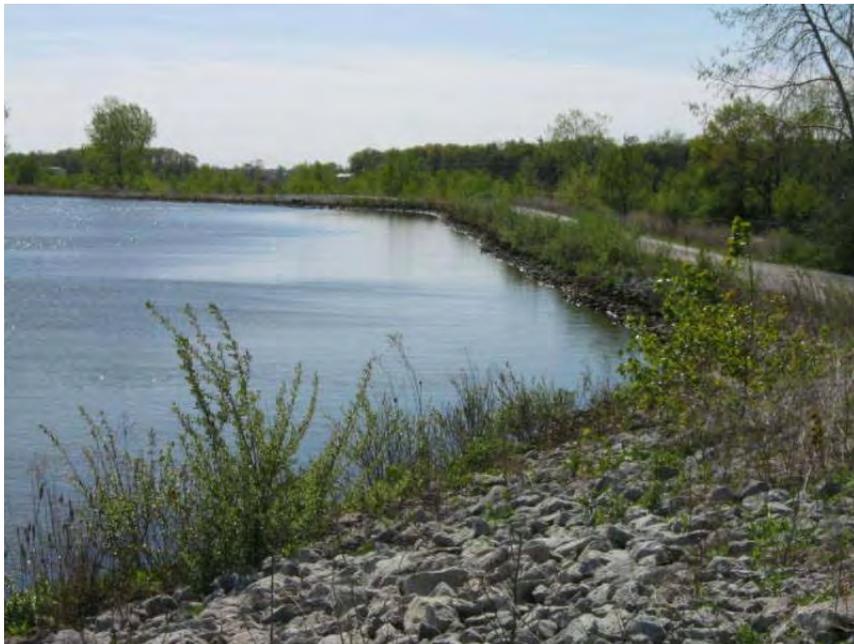
59. Intake Settling Basin - North Embankment Interior Slope

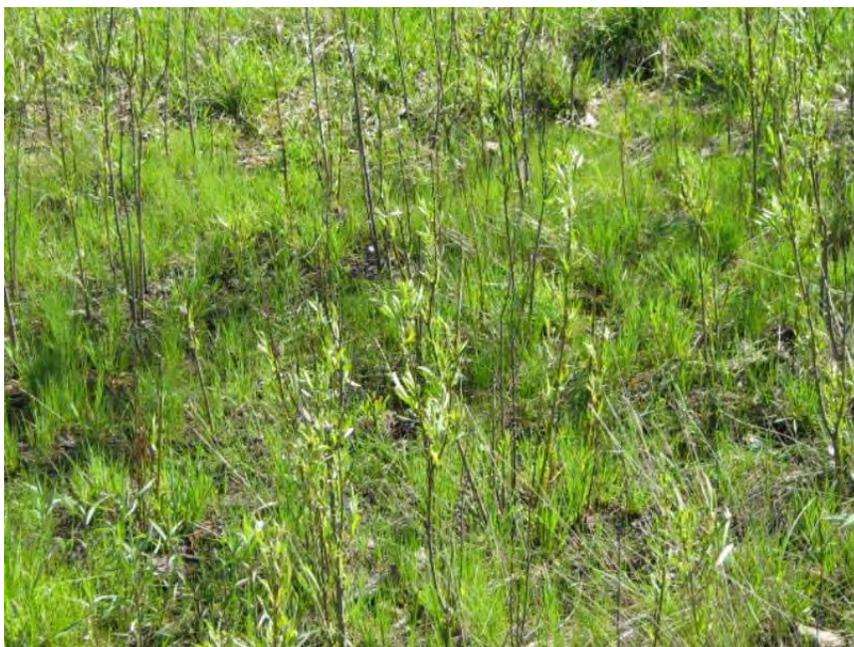
60. Intake Settling Basin - Saturated Area on North Embankment Exterior Slope (Approximately 25 feet long by 8 feet wide)

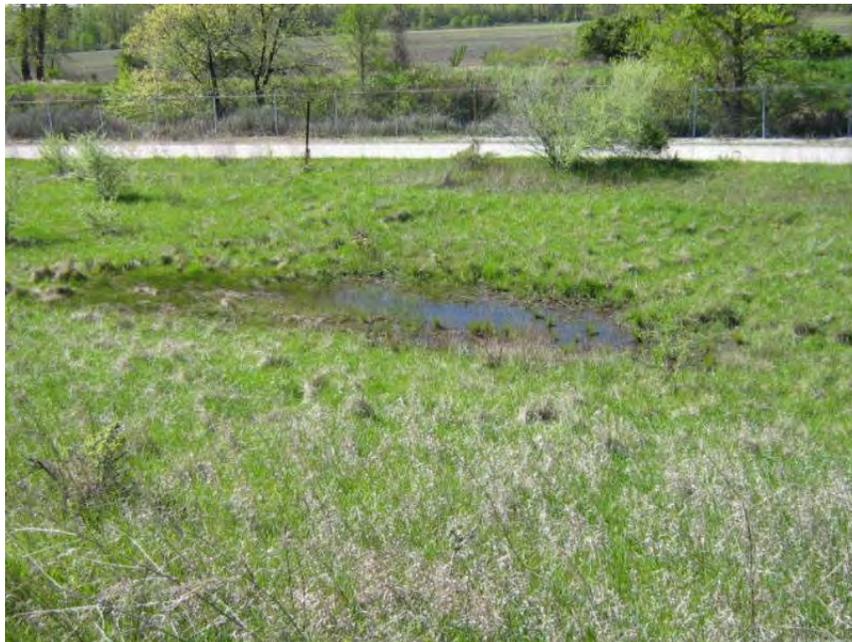
61. Intake Settling Basin - Standing Water at Slope Toe of North Embankment Exterior Slope

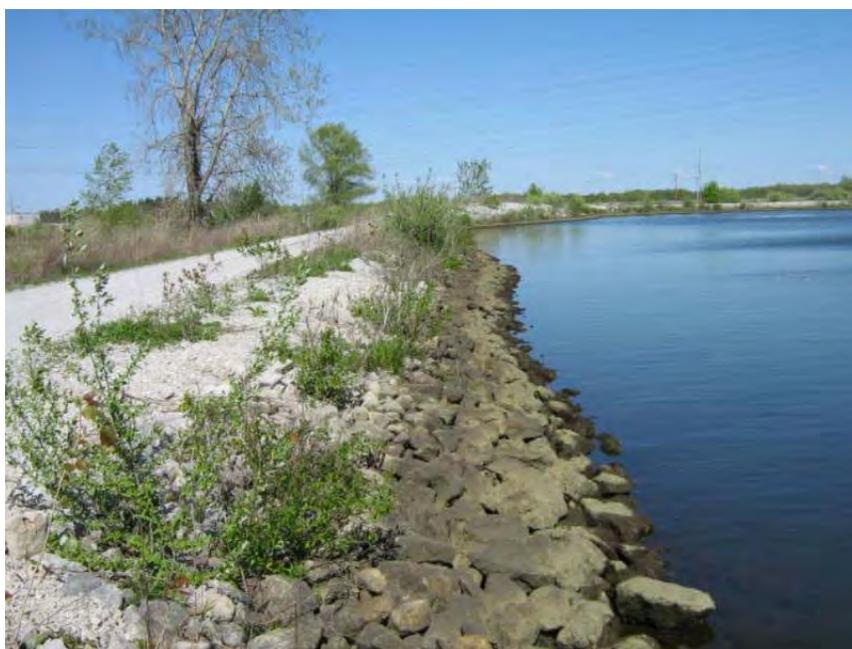
62. Intake Settling Basin - North Embankment Interior Slope, High Water Line

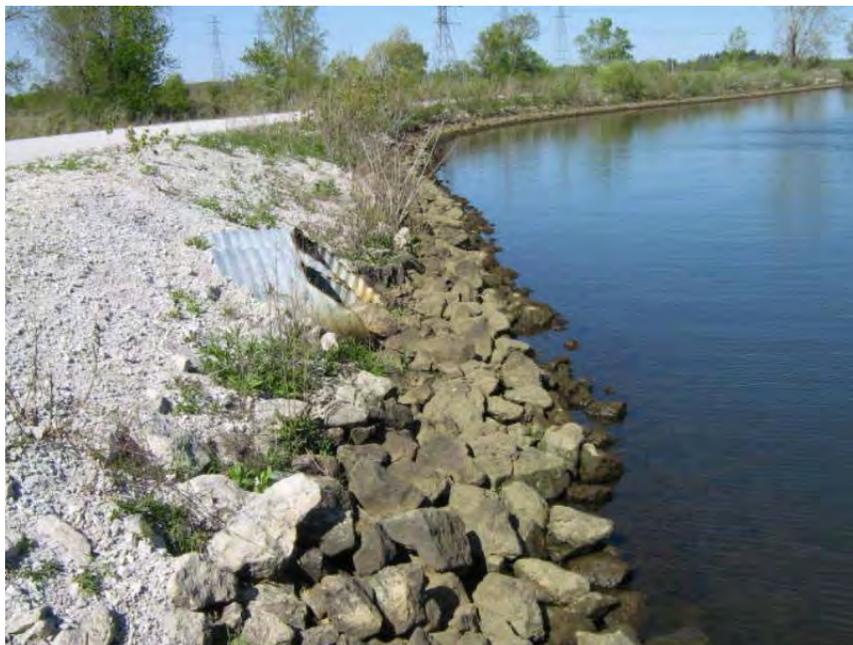
63. Intake Settling Basin - North Embankment Interior Slope, Two (2) 24-inch-diameter CMP Overflow Pipes

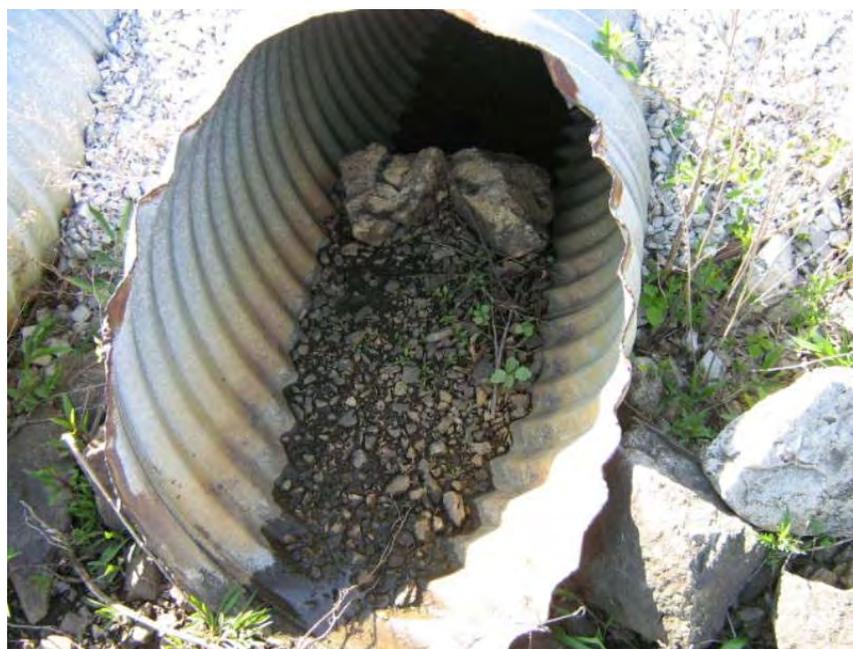
64. Intake Settling Basin - North Embankment Interior Slope, Overflow Pipe, Sedimentation

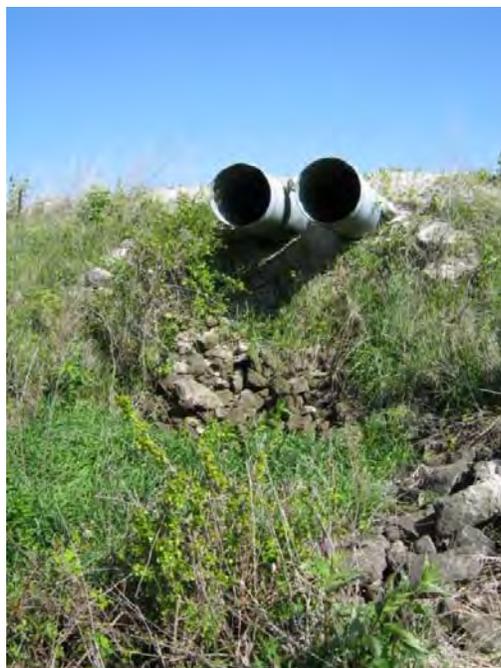
65. Intake Settling Basin - North Embankment Exterior Slopes,
Overflow Pipe Discharge

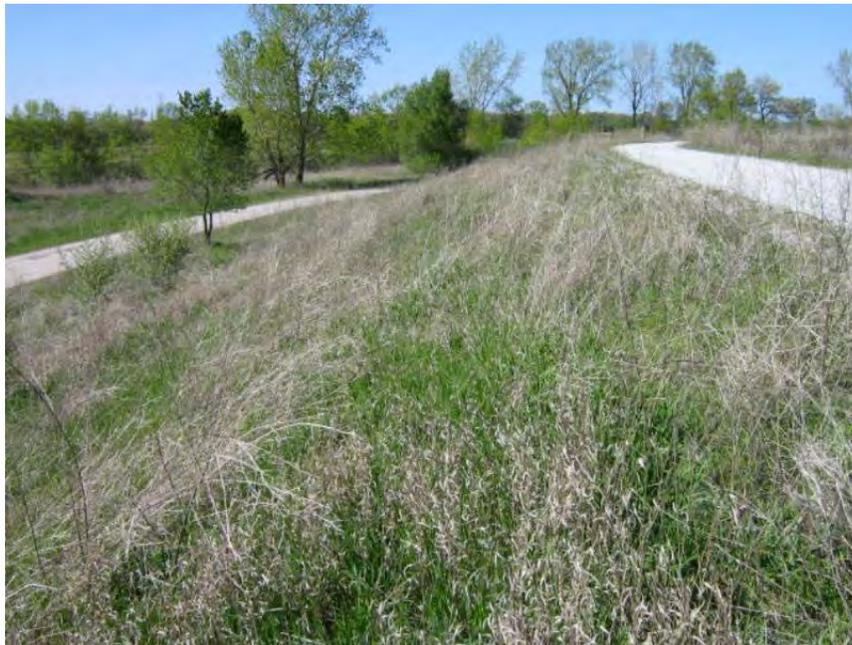
67. Intake Settling Basin - West Embankment Exterior Slope, Vegetation

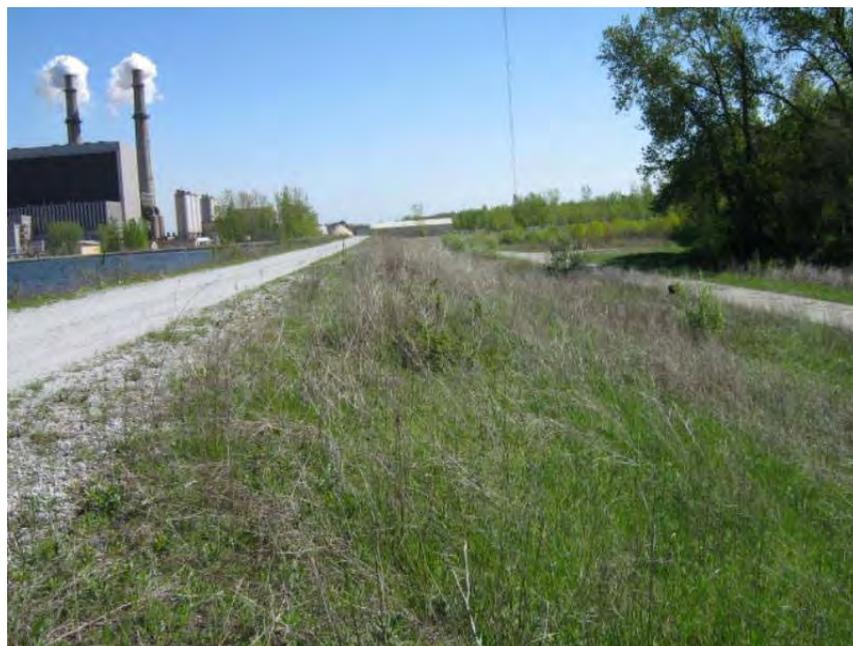
68. Intake Settling Basin - West Embankment Exterior Slope

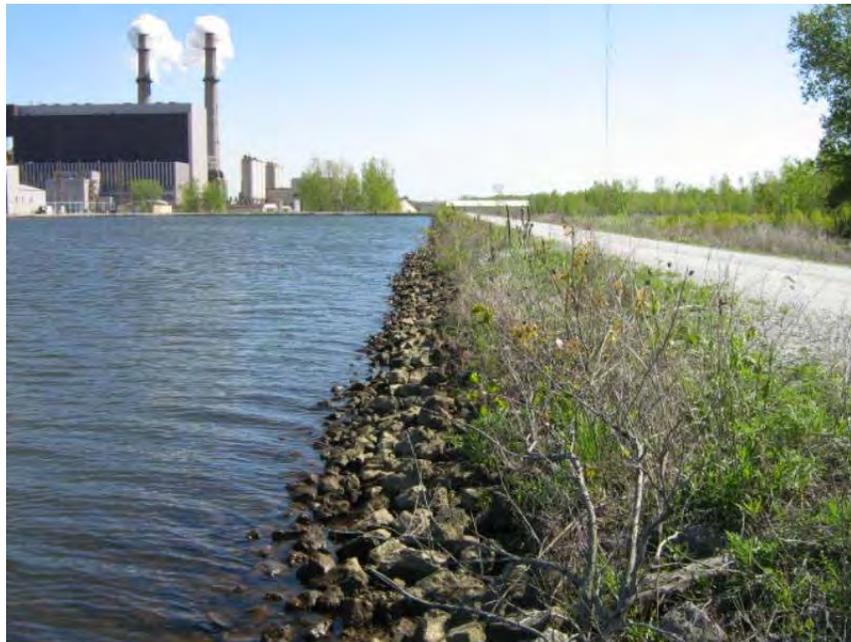
69. Intake Settling Basin - West Embankment Interior Slope,
Vegetation and Saplings

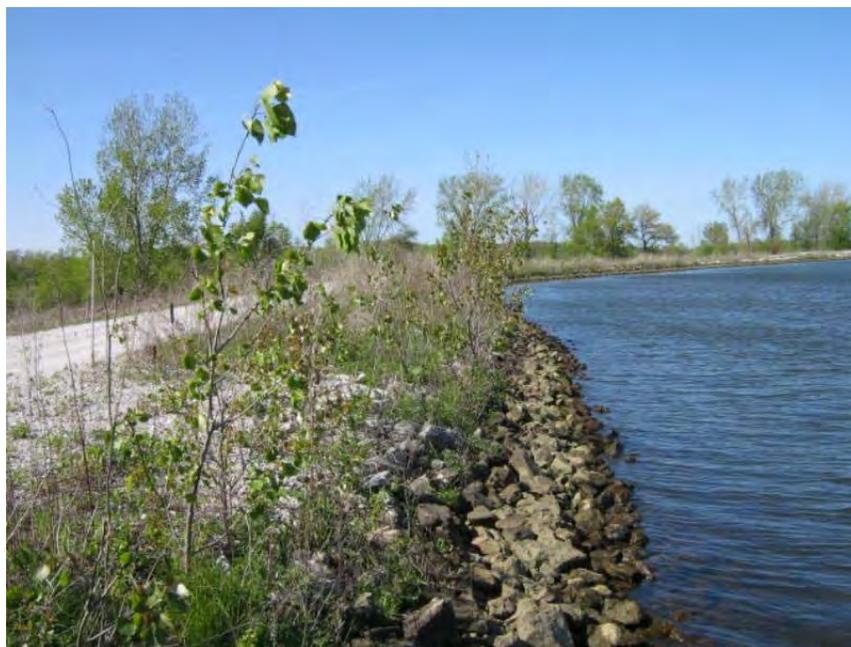
70. Intake Settling Basin - West Embankment Interior Slope,
Vegetation, Brush, and Saplings

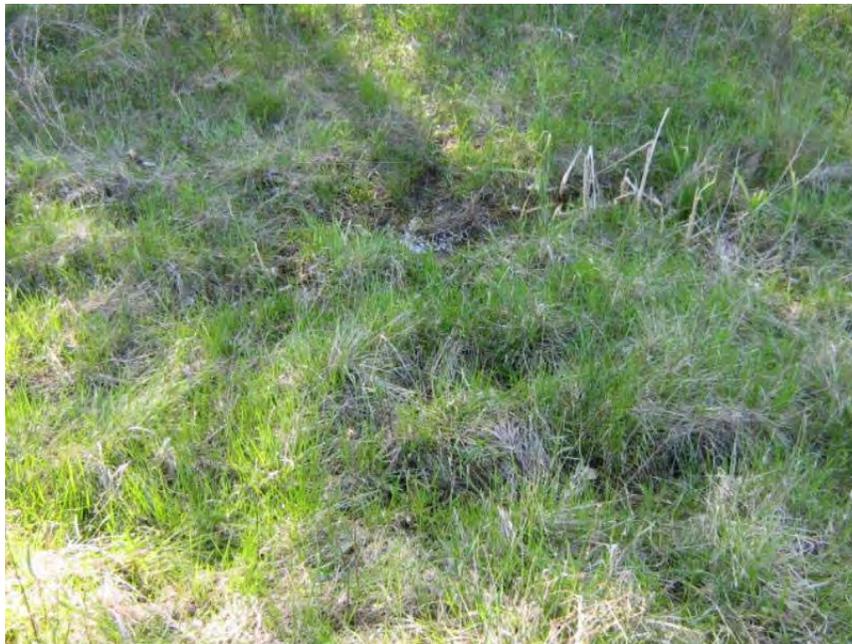
71. Intake Settling Basin - Saturated Area on West Embankment Exterior Slope (Approximately 40 feet wide by 7 feet in length)

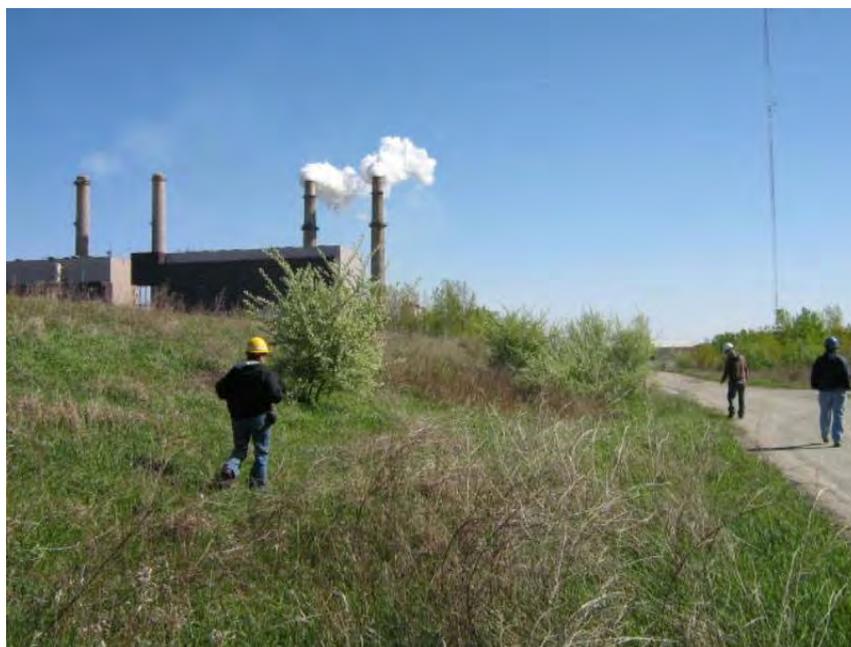
72. Intake Settling Basin - Vegetation on West Embankment Exterior Slope, Vegetation, Brush, and Small Trees

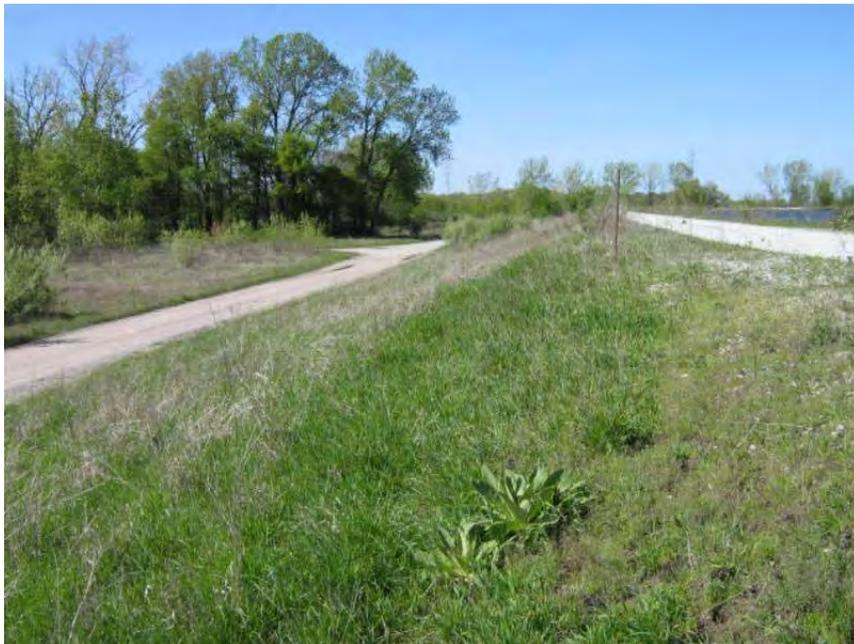
73. Intake Settling Basin - West Embankment Exterior Slope

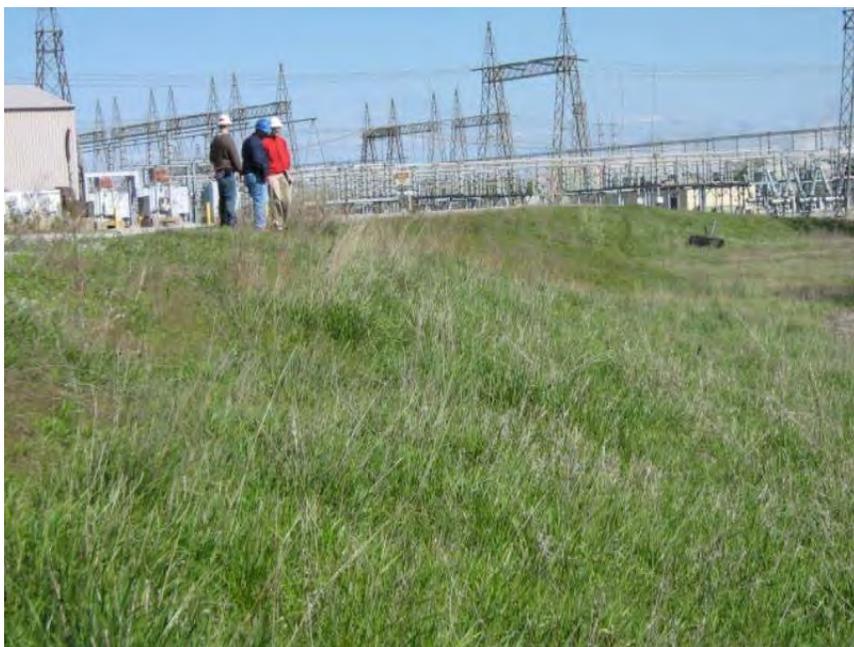
74. Intake Settling Basin - South Embankment Exterior Slope

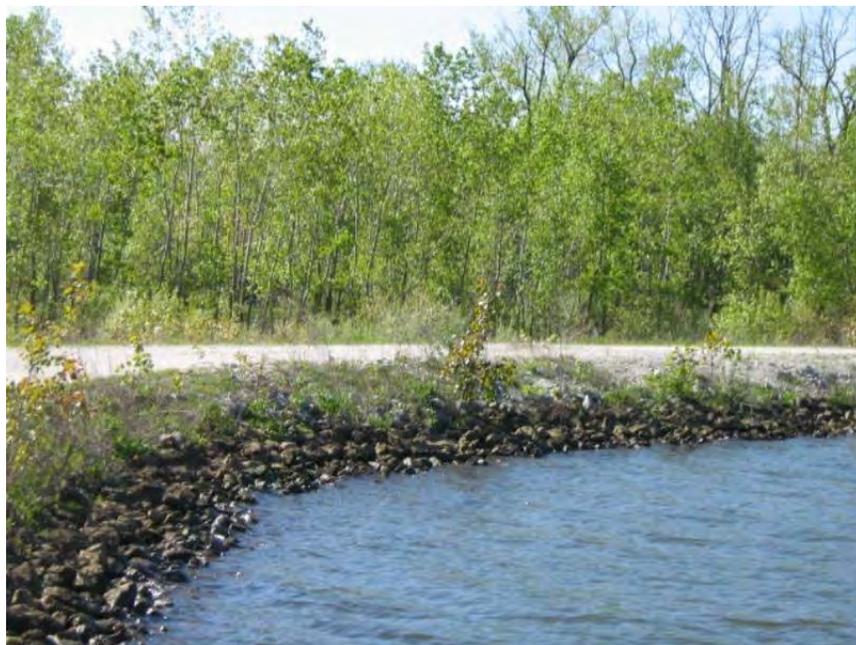
75. Intake Settling Basin - South Embankment Interior Slope

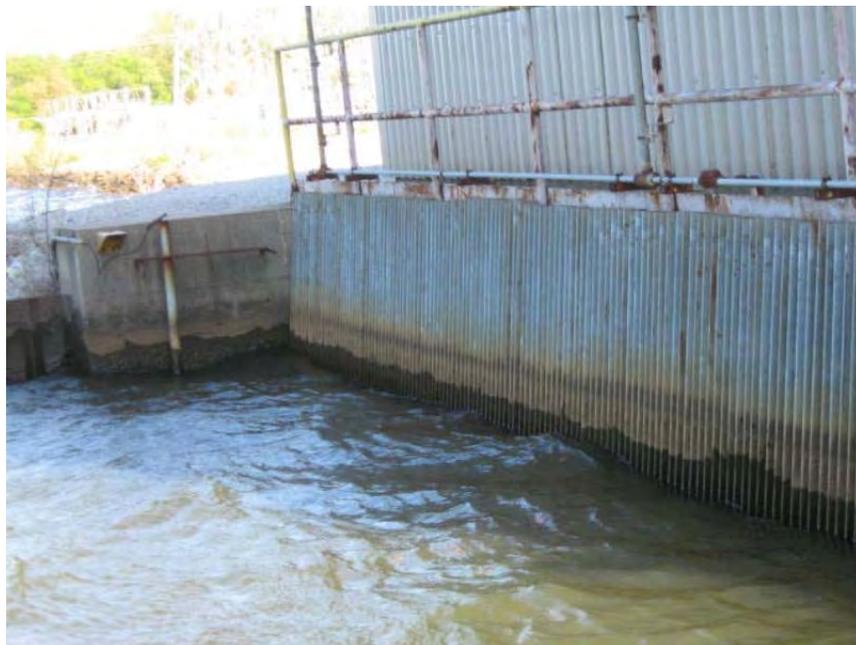
77. Intake Settling Basin - Pump Station Trash Racks

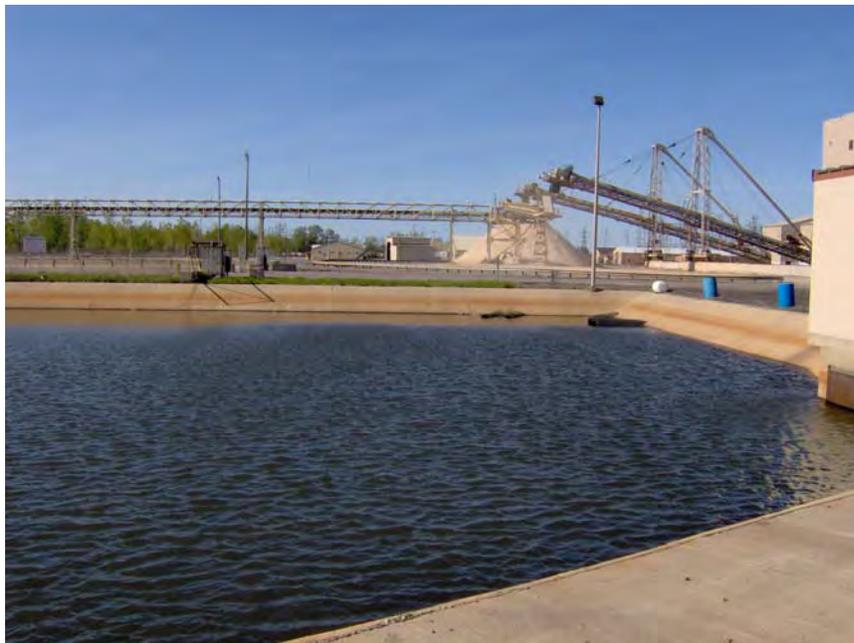
78. Retention Pond - Pump Station, looking North

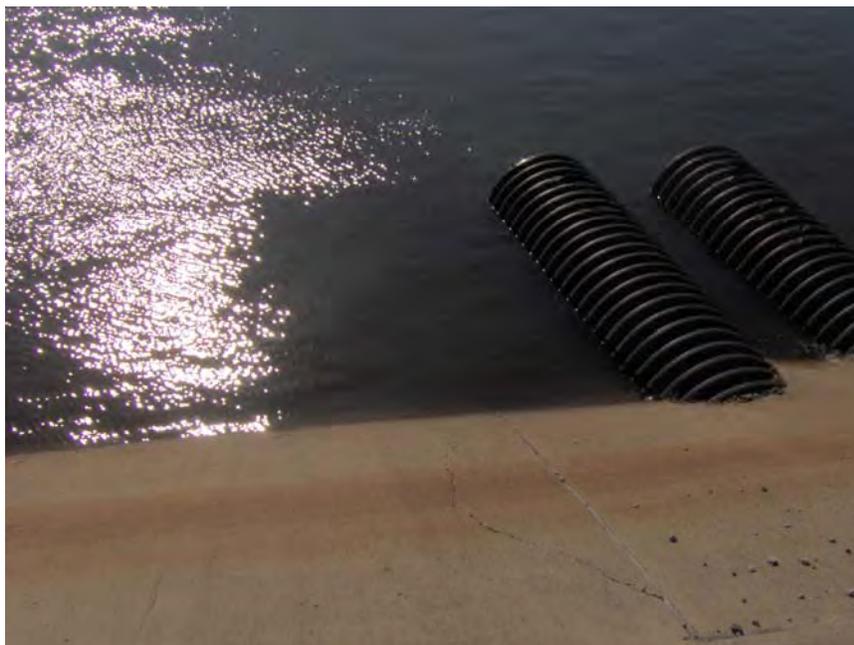
79. Retention Pond - Pond Inlets

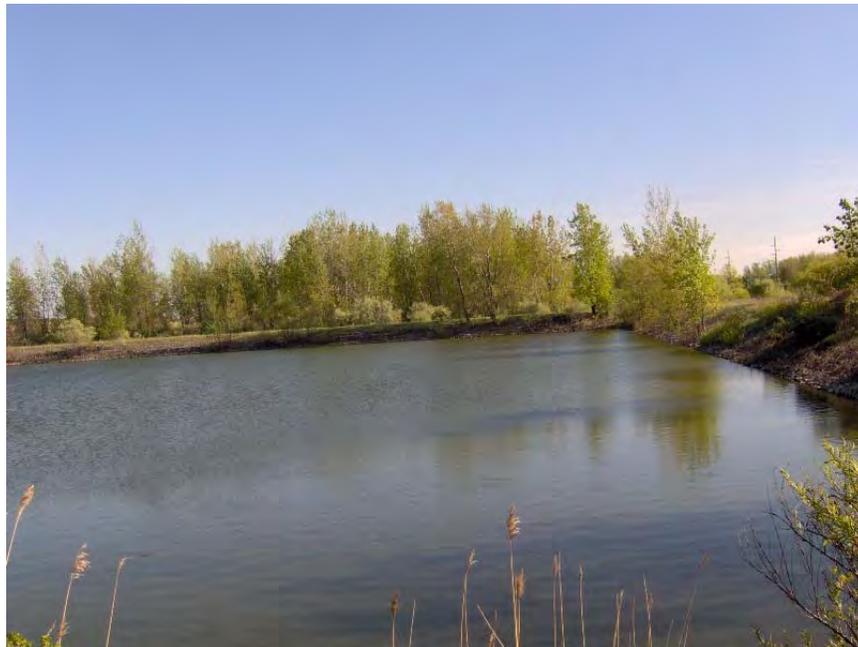
83. FGD Landfill Runoff Pond - West Embankment Interior Slope,
Looking South

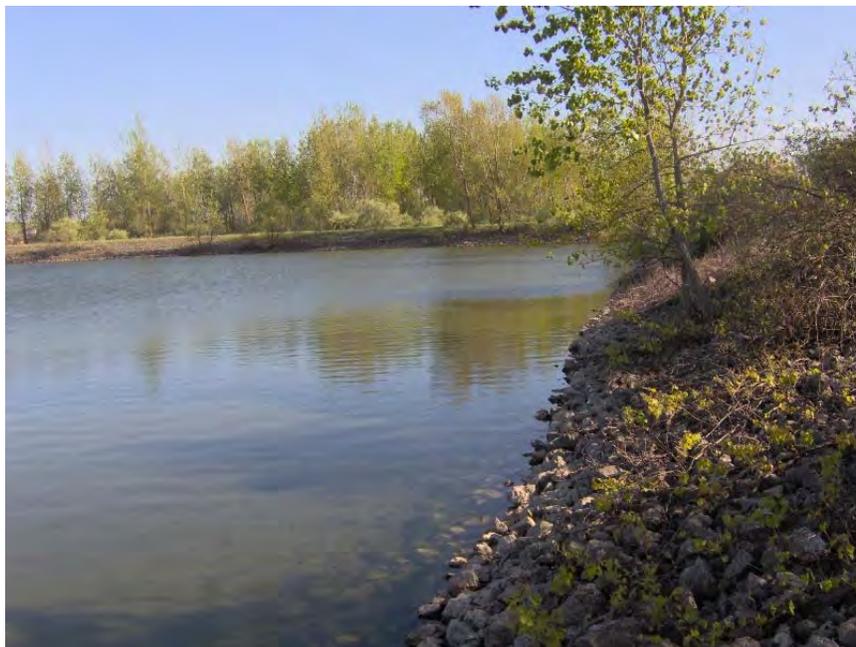
85. FGD Landfill Runoff Pond - West Embankment Interior Slope, Vegetation, Tree and Brush

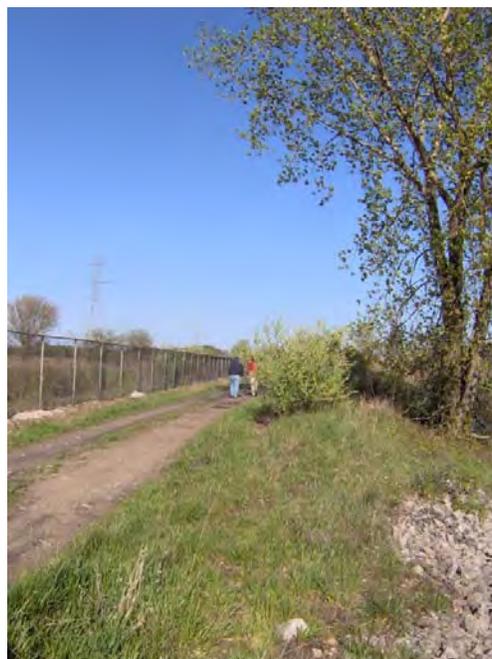
86. FGD Landfill Runoff Pond - Large Tree Located on North Embankment Interior Slope

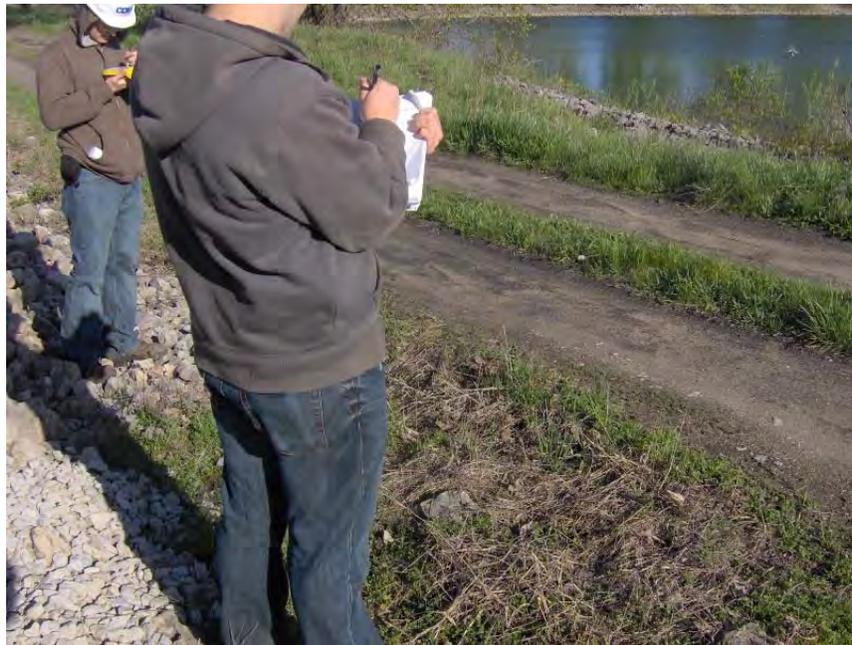
87. FGD Landfill Runoff Pond - North Embankment Crest

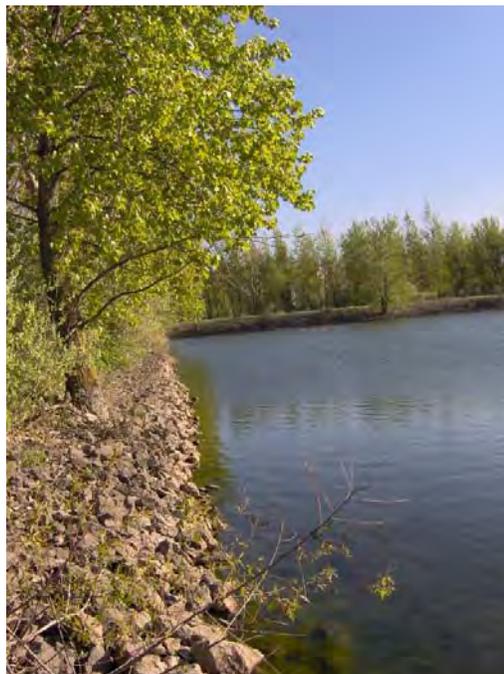
88. FGD Landfill Runoff Pond - East Embankment Interior Slope, Vegetation, Brush, and Trees

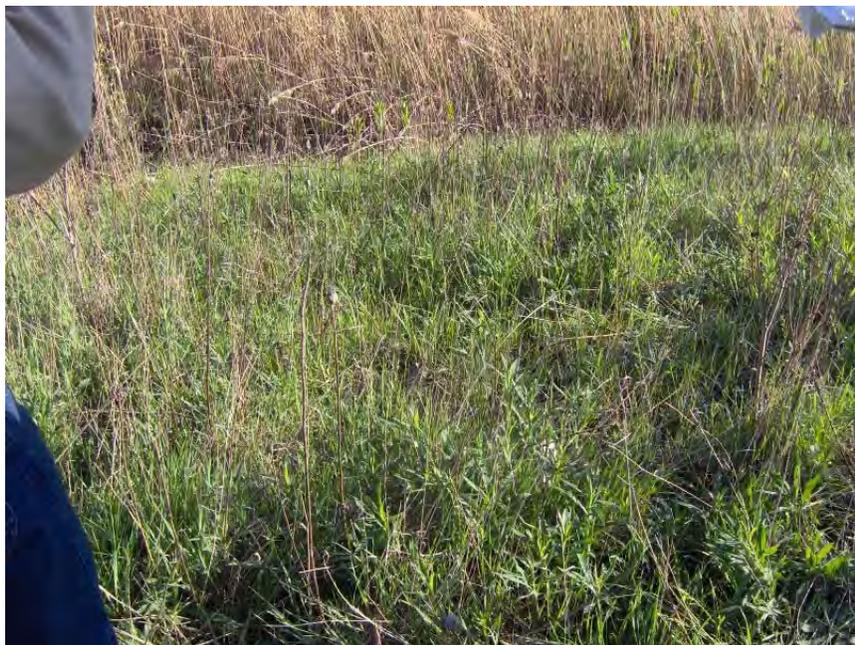
89. FGD Landfill Runoff Pond - Inlet into Pond on East Embankment Crest

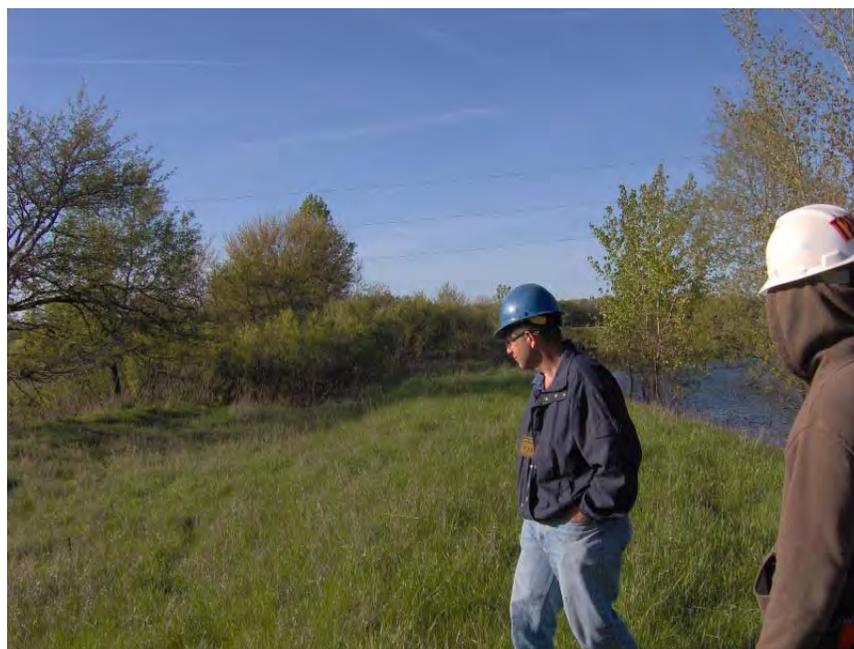
94. FGD Landfill Runoff Pond - West Crest

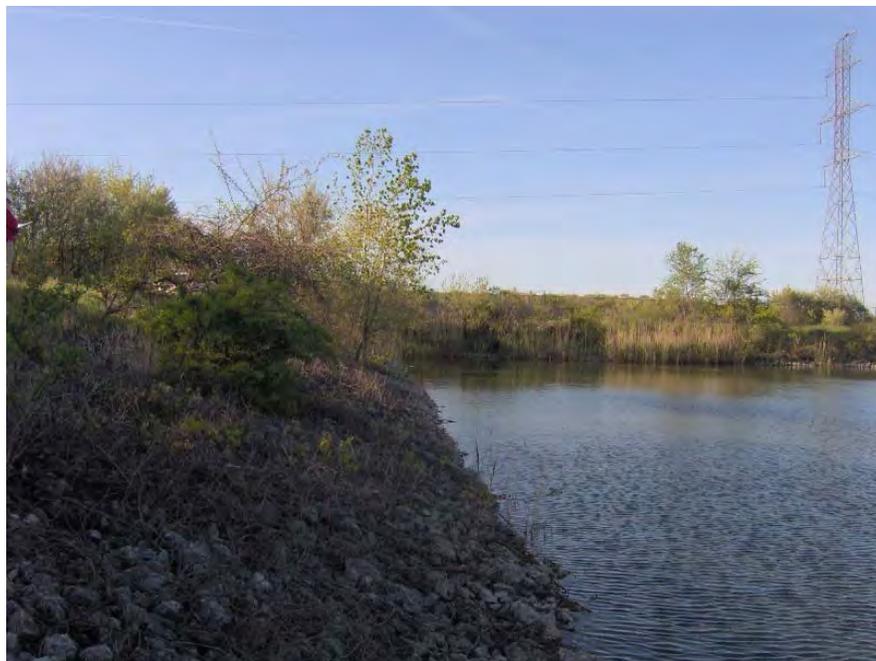
95. FGD Landfill Runoff Pond - West Embankment Interior Slope

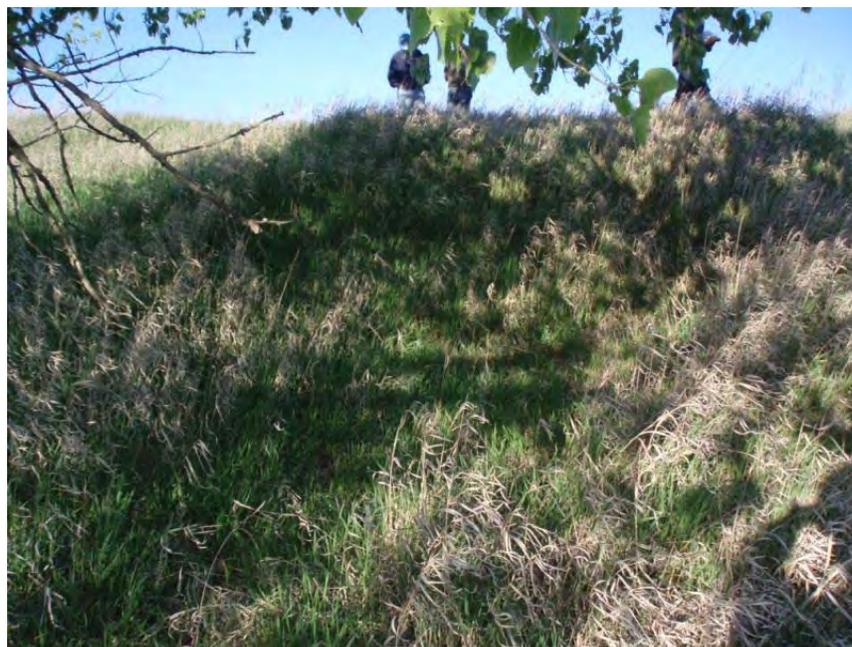
99. Retired Waste Disposal Area - Scarp on West Embankment Exterior Slope

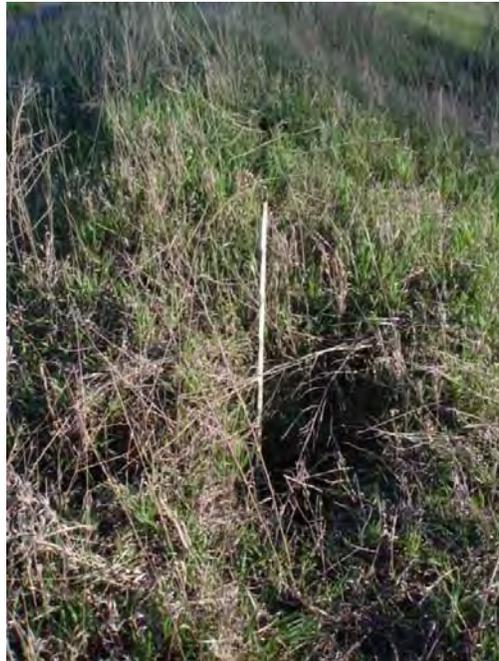
100. Retired Waste Disposal Area - Slough on West Embankment Exterior Slope (Approximately 2 feet Deep)

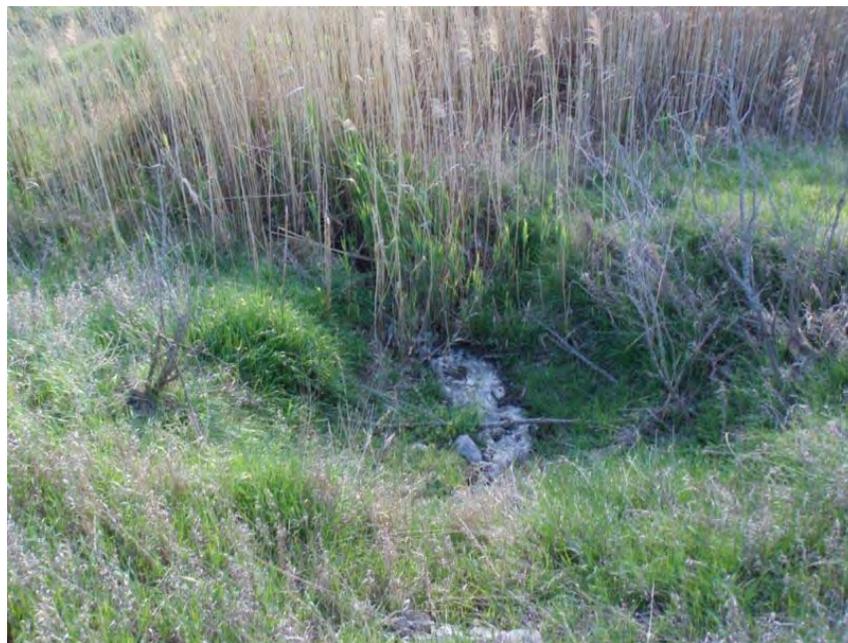
101. Retired Waste Disposal Area - Very Steep Slope on West Embankment Exterior Slope, Seepage

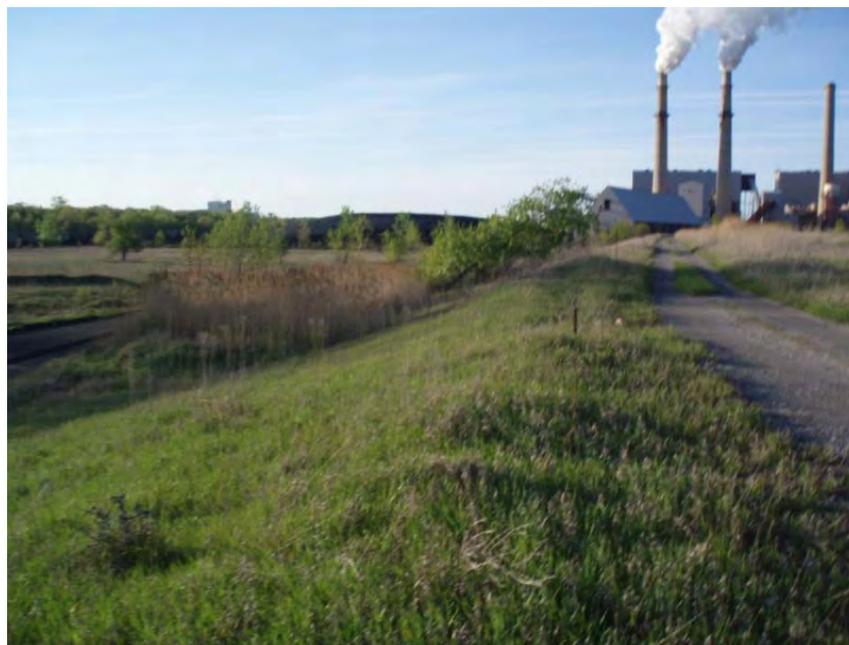
103. Retired Waste Disposal Area - West Embankment Exterior Slope

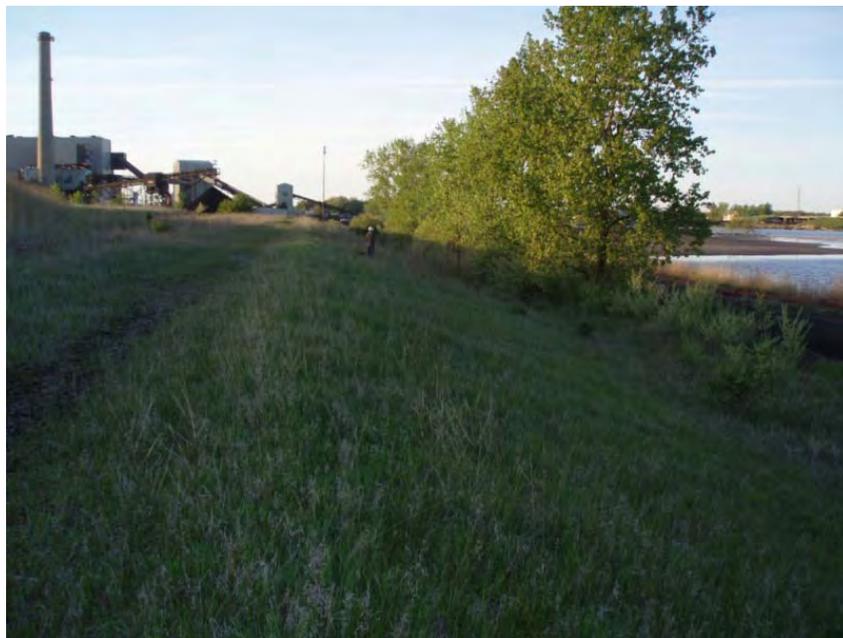
106. Retired Waste Disposal Area - East Embankment Crest

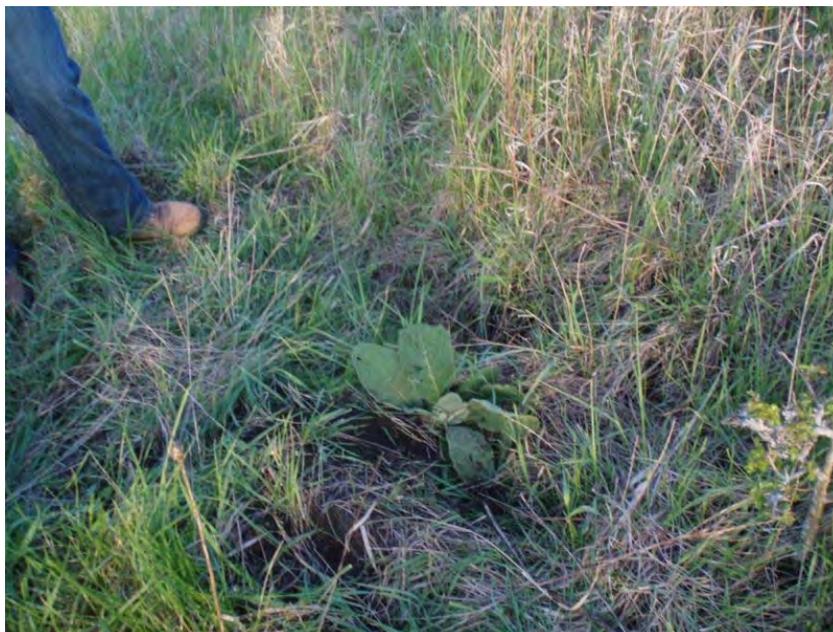
109. Retired Waste Disposal Area - Abandoned Rodent Burrow on North Embankment Exterior Slope
