Assessment of Dam Safety of Coal Combustion Surface Impoundments

Northern Indiana Public Service Company

R.M. Schahfer Generating Station

November 19, 2010

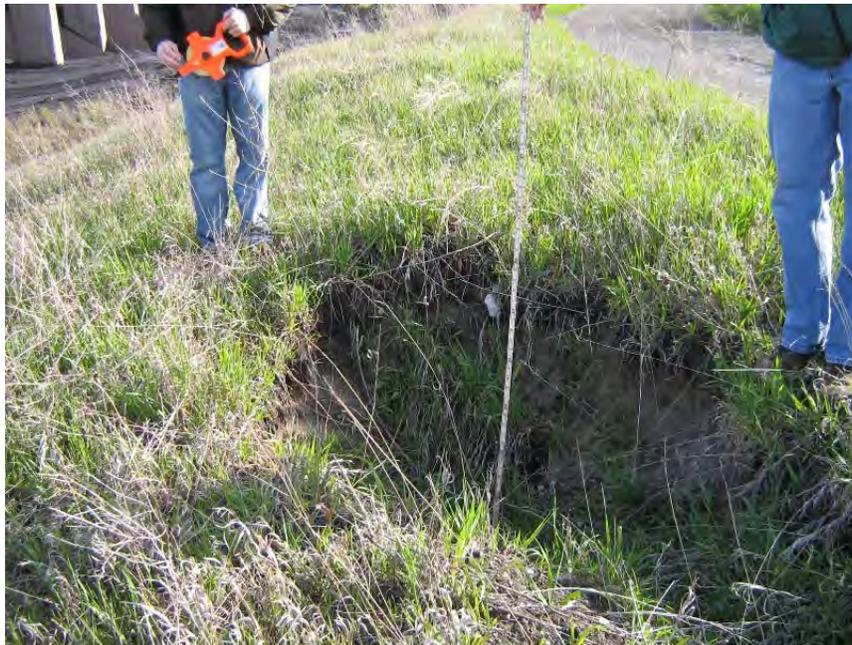
116. Retired Waste Disposal Area - West Embankment Exterior Slope, Erosion Rill (Approximately 3 feet Deep)

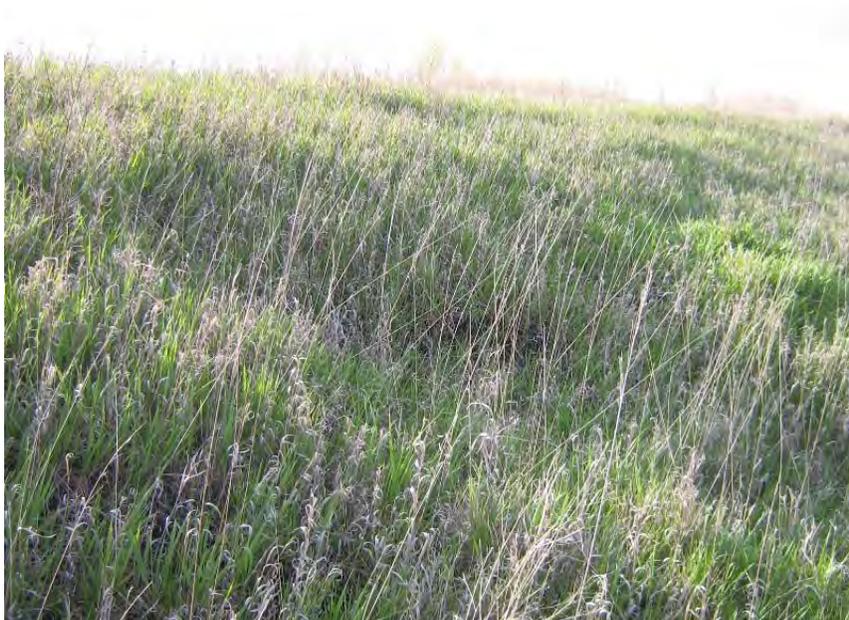
117. Retired Waste Disposal Area - Slough on West Embankment Exterior Slope

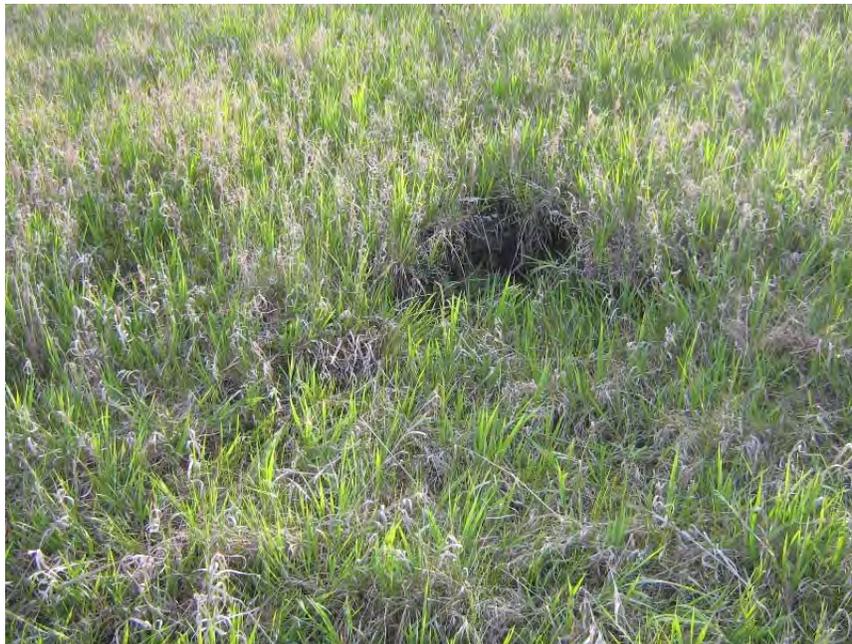
118. Retired Waste Disposal Area - Slough on West Embankment
Exterior Slope (Approximately 2 feet Deep)

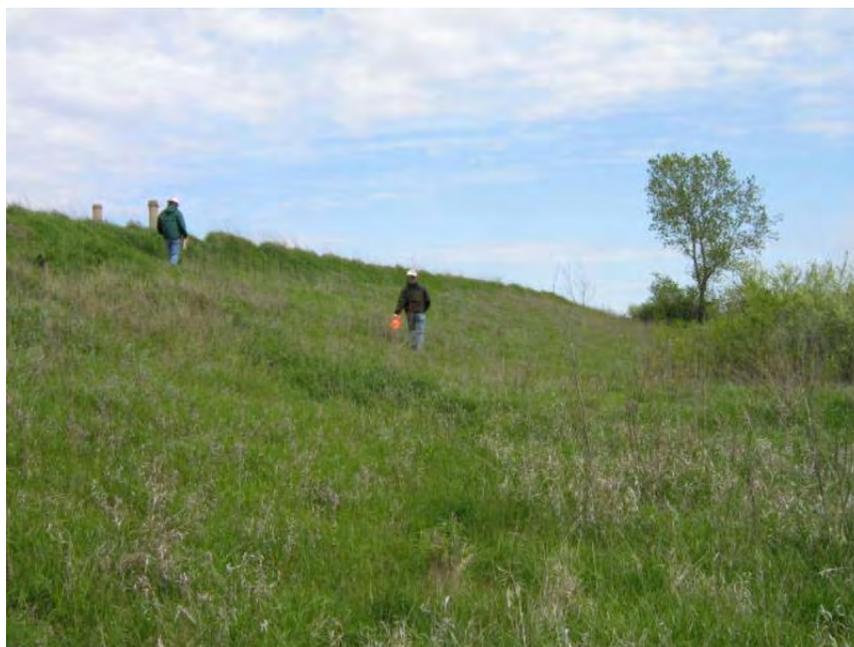
119. Retired Waste Disposal Area - East Embankment Exterior Slope, Looking North

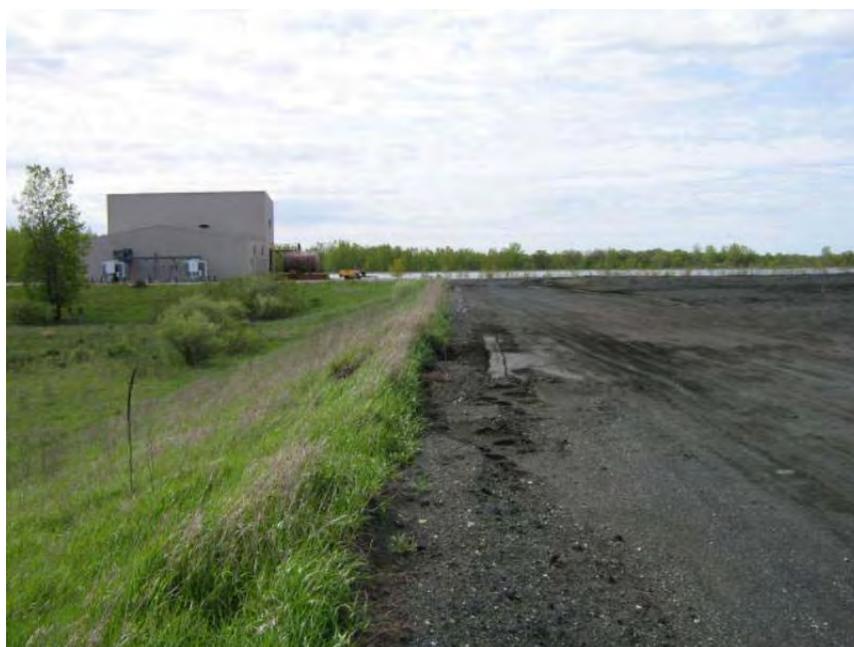
120. Retired Waste Disposal Area - East Embankment Crest and Exterior Slope, Looking South

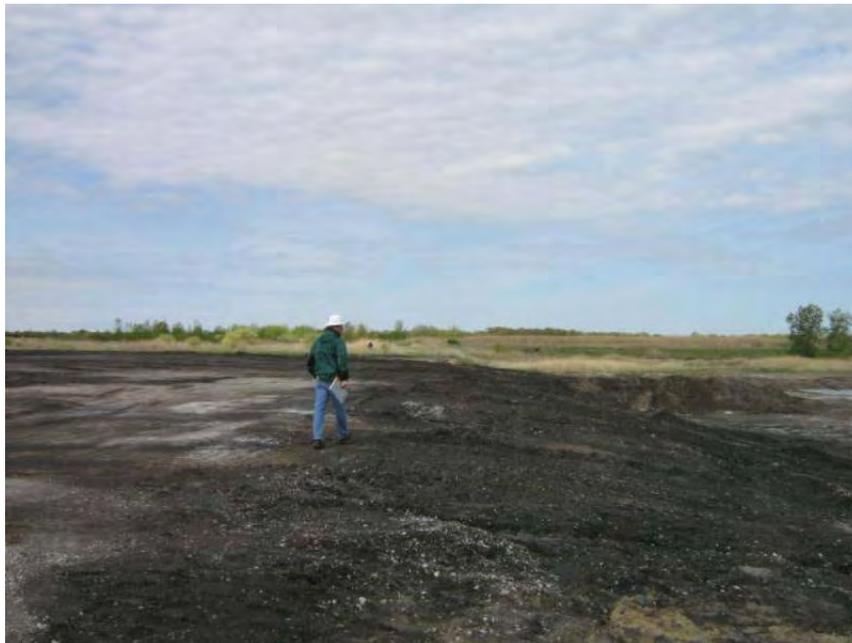
121. Retired Waste Disposal Area - North Embankment Crest, Looking West

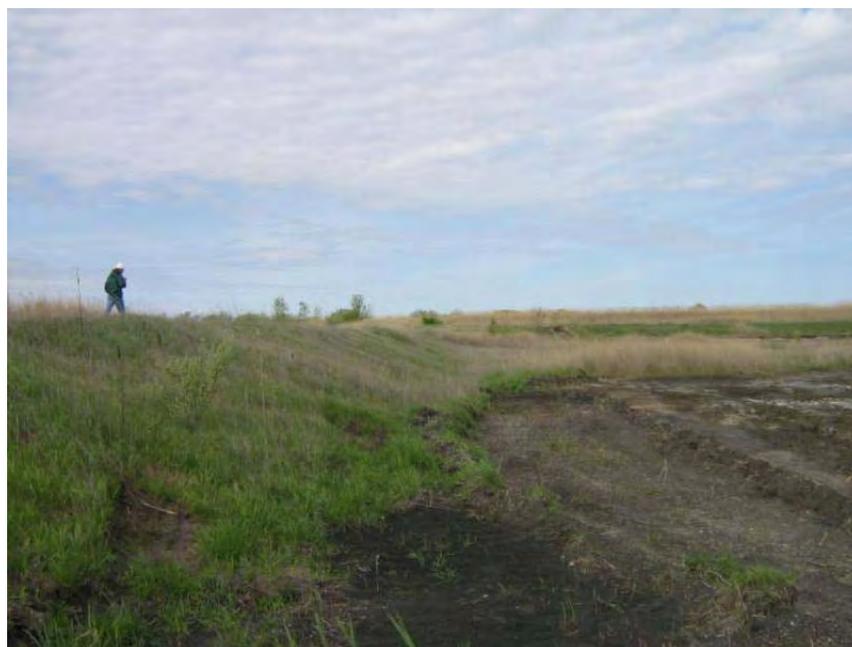
122. Retired Waste Disposal Area - North Embankment Exterior Slope, Looking West

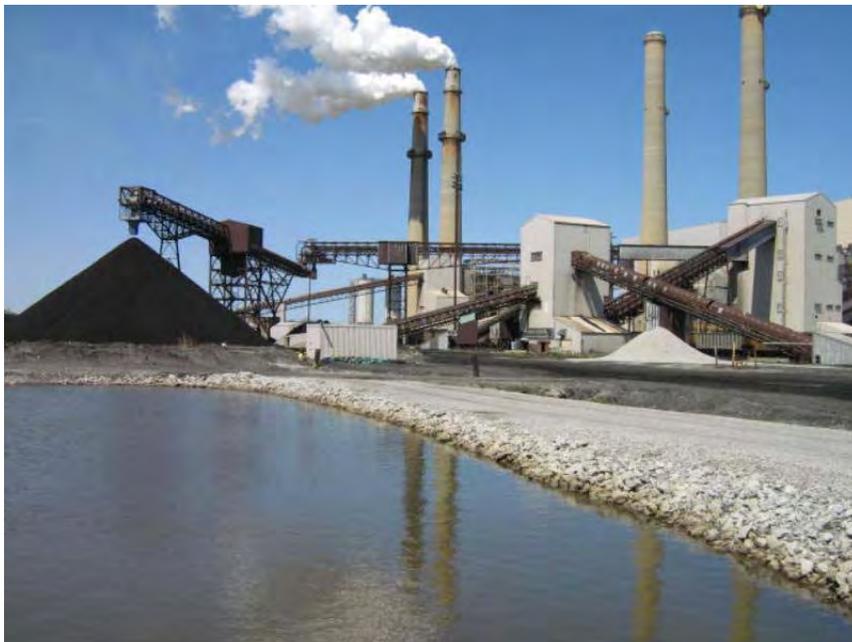
123. Material Storage Runoff Basin - North Embankment Interior Slope

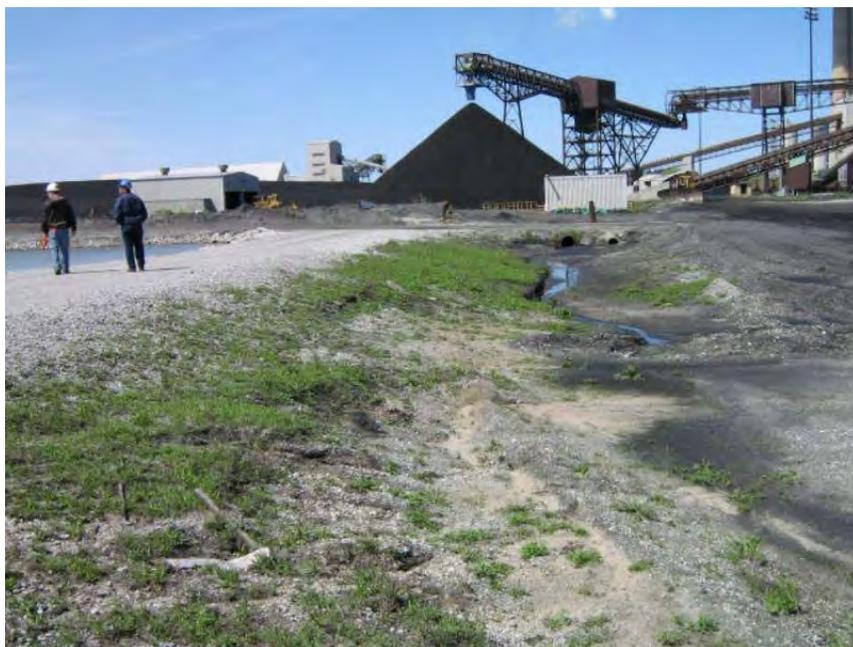
124. Material Storage Runoff Basin - North Embankment Exterior Slope

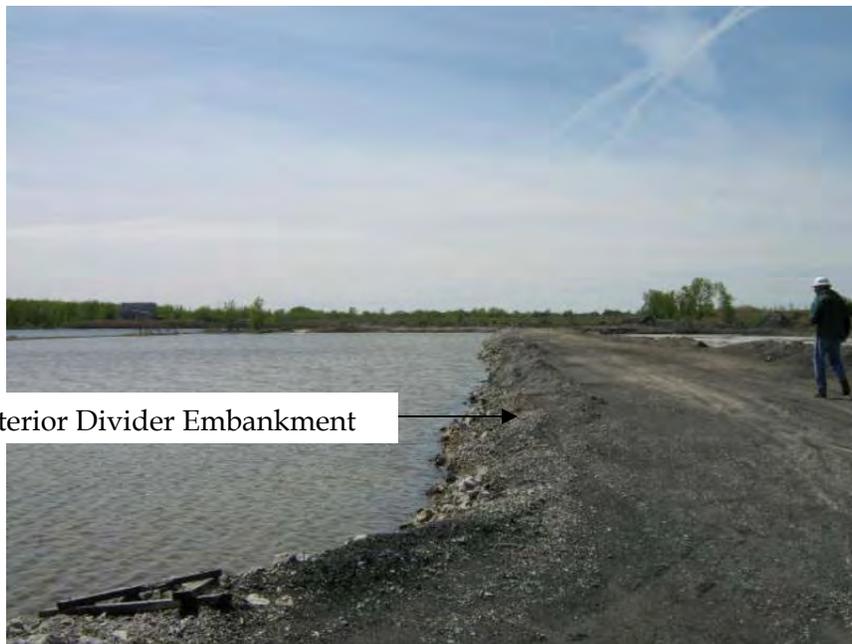
125. Material Storage Runoff Basin - Interior Divider Embankment
Constructed within Material Storage Runoff Basin

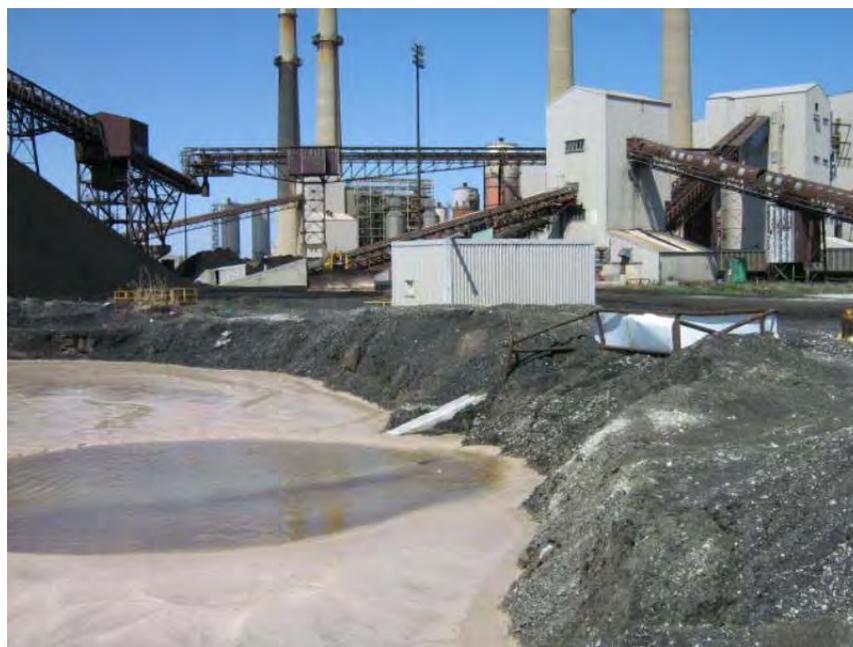
126. Material Storage Runoff Basin - North Embankment Interior
Slope, Looking west at Inflow Pipes

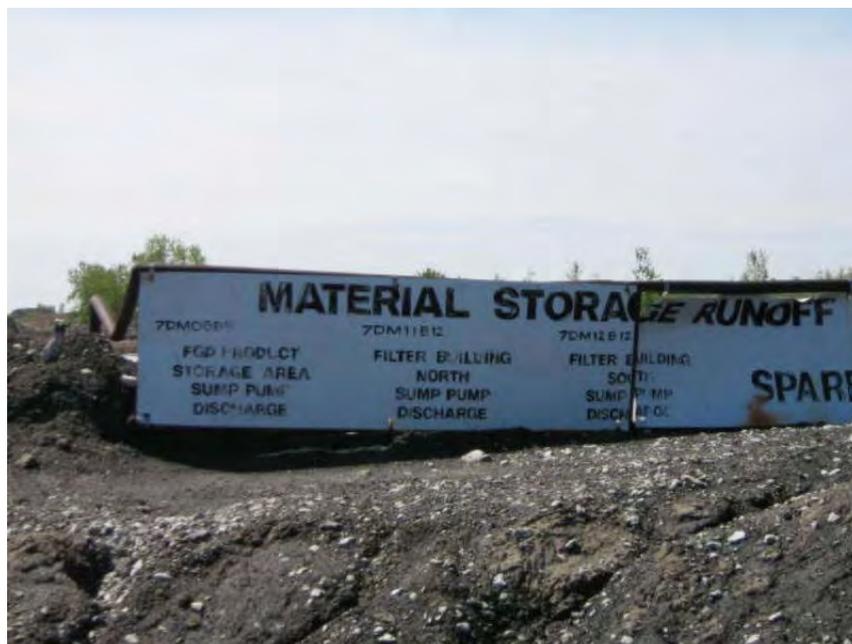
127. Material Storage Runoff Basin - North Embankment Crest, Sluice Line Identification

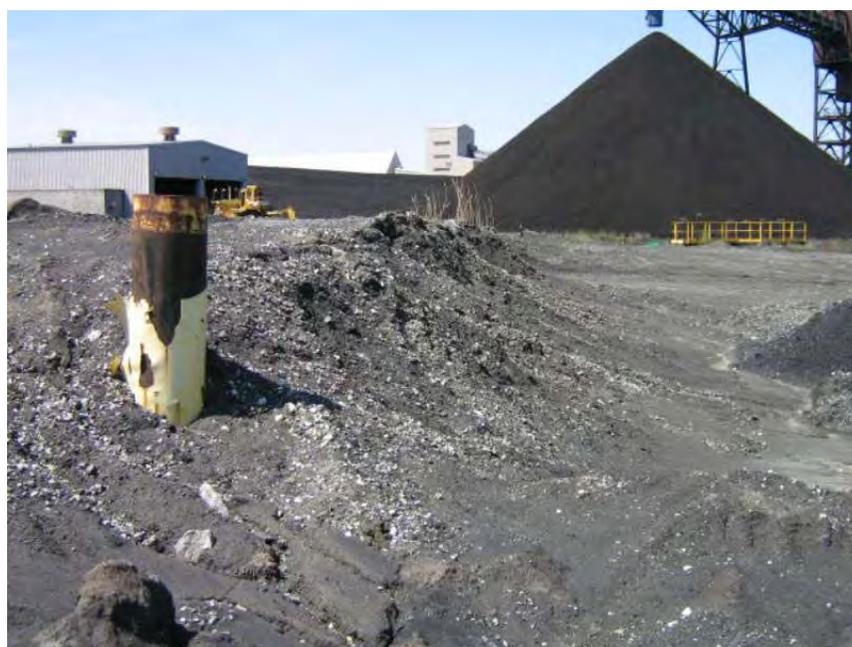
128. Material Storage Runoff Basin - North Embankment Exterior Slope, Looking West

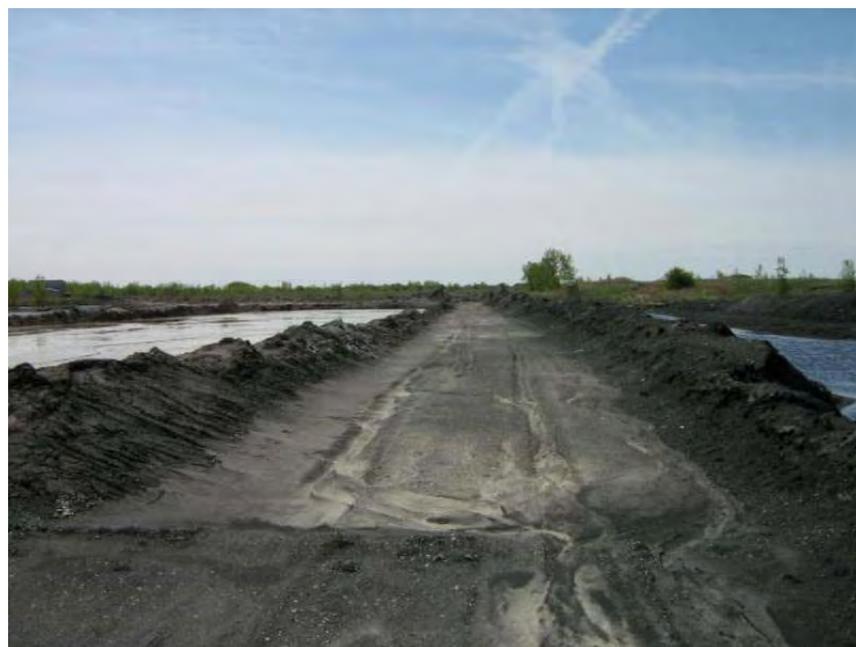
130. Material Storage Runoff Basin - Interior Divider Embankments Constructed to Create Center and Western Compartments, Looking South

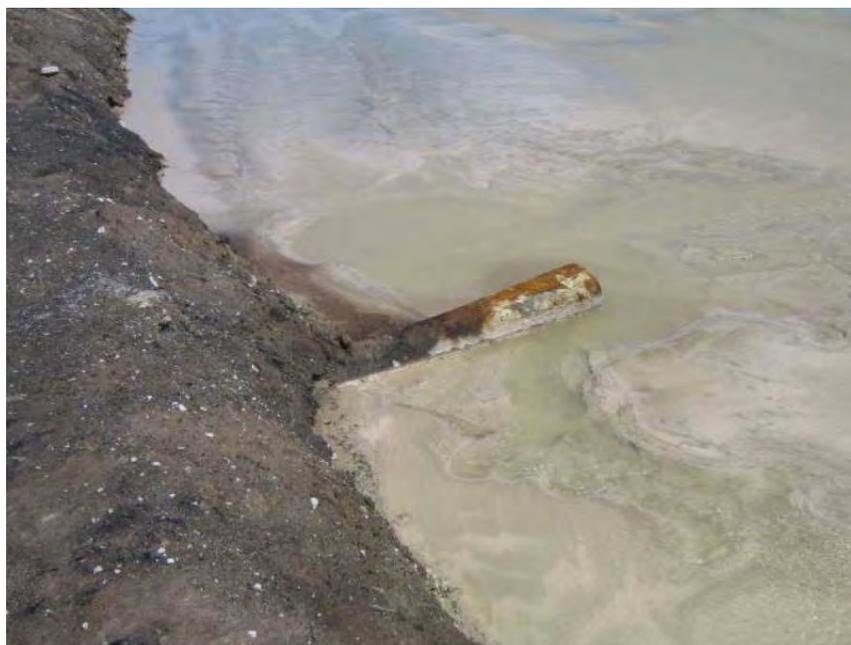
131. Material Storage Runoff Basin - East Embankment Interior Slope, 6-inch-diameter Steel Outlet Pipe

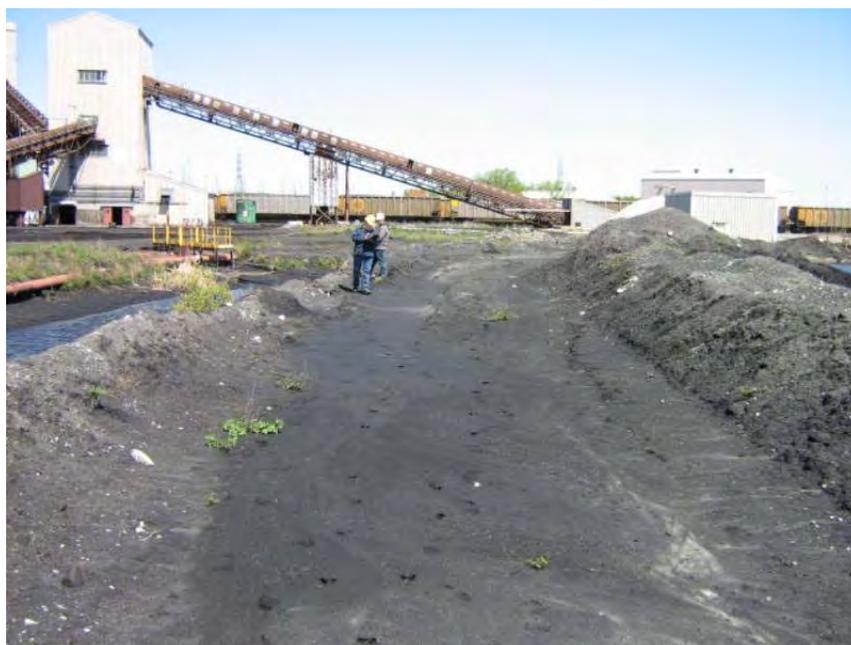
132. Material Storage Runoff Basin - West Embankment Crest, Looking South

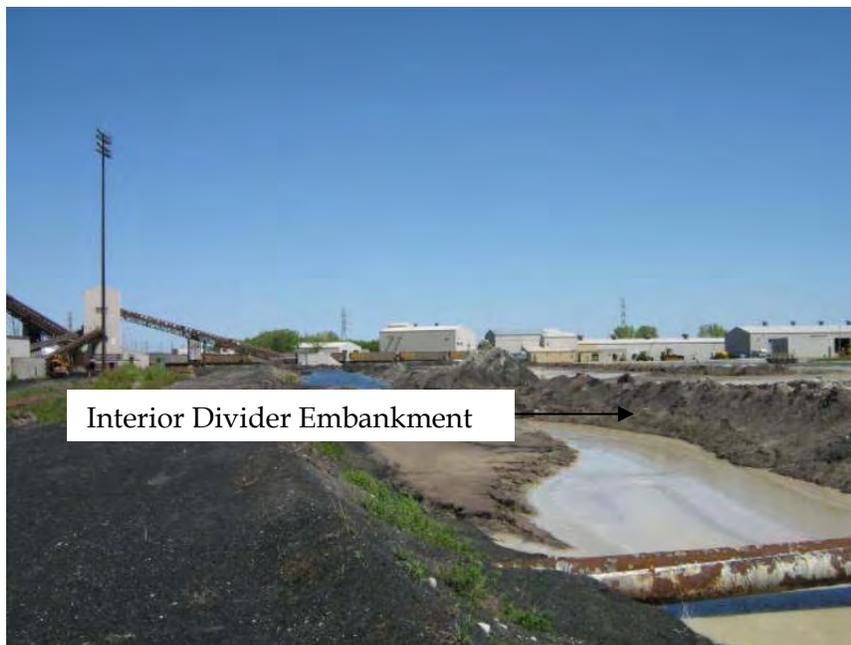
133. Material Storage Runoff Basin – West Embankment Crest and Interior Slope, Looking North, Showing Overview of Divider Embankment Constructed Within Material Storage Runoff Basin

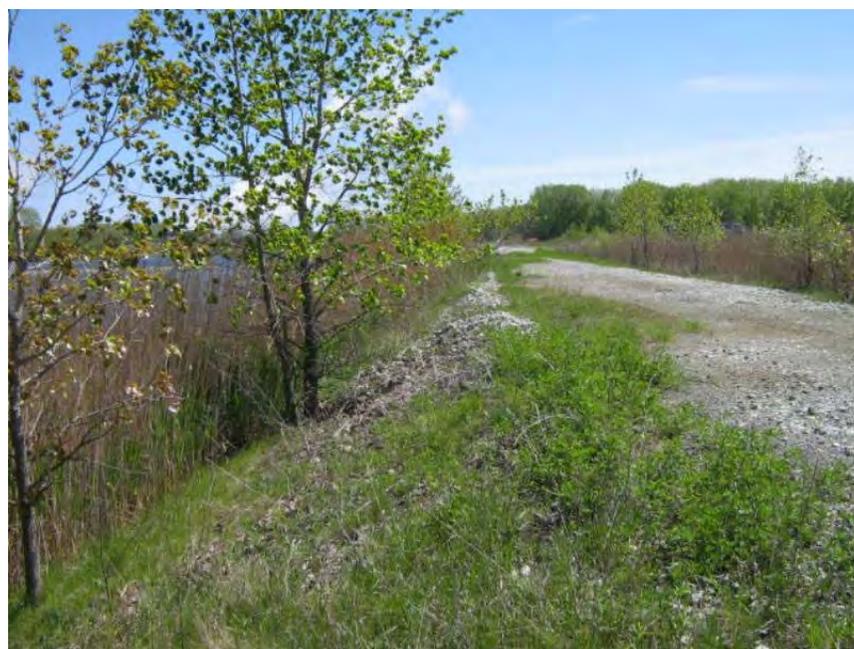
134. Material Storage Runoff Basin - South Embankment Crest and Interior Slope, Looking East

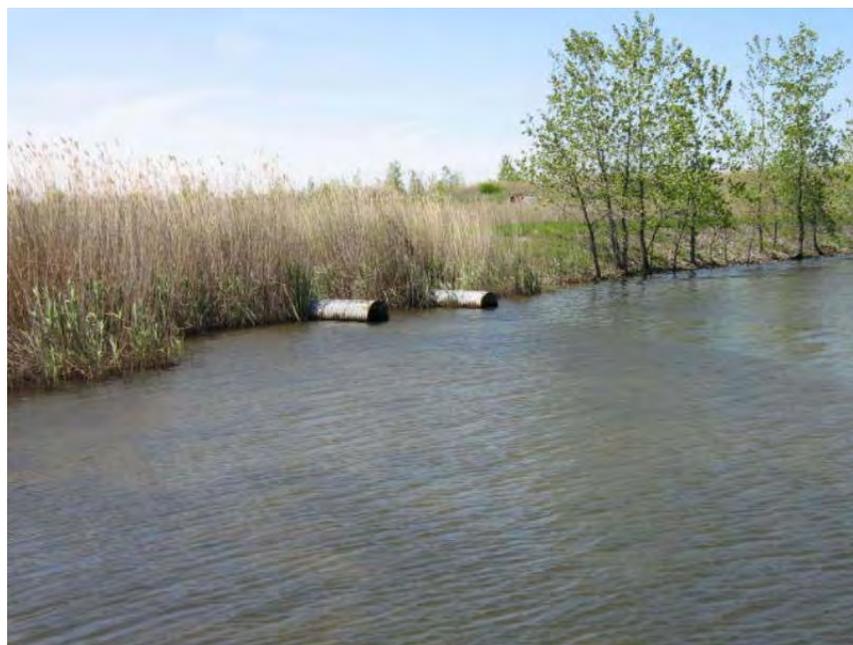
135. Material Storage Runoff Basin – South Embankment Interior Slope Looking at Two (2) 24-inch-diameter CMP Outlets

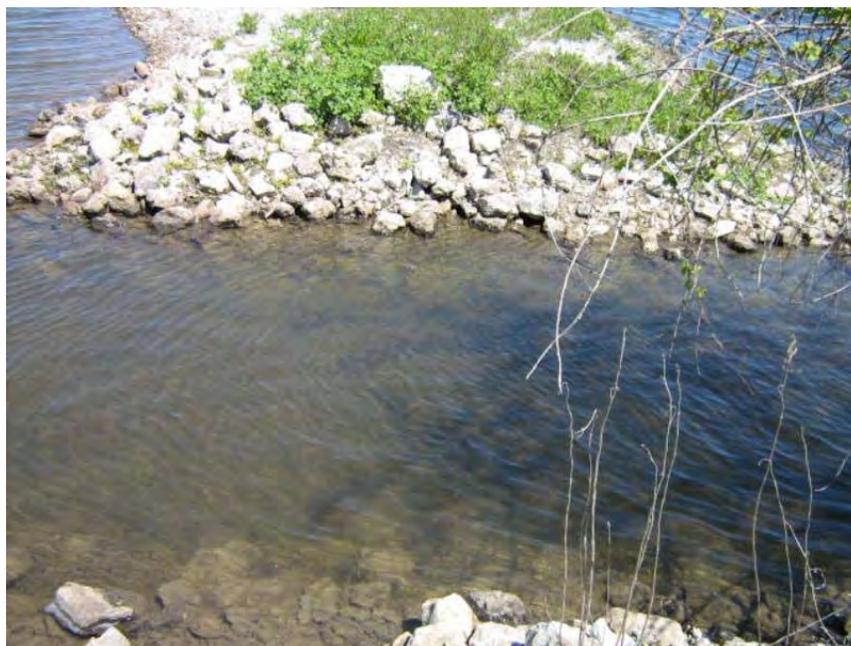
136. Material Storage Runoff Basin - Channel between Material Storage Runoff Basin and Metal Cleaning Basin, Looking North

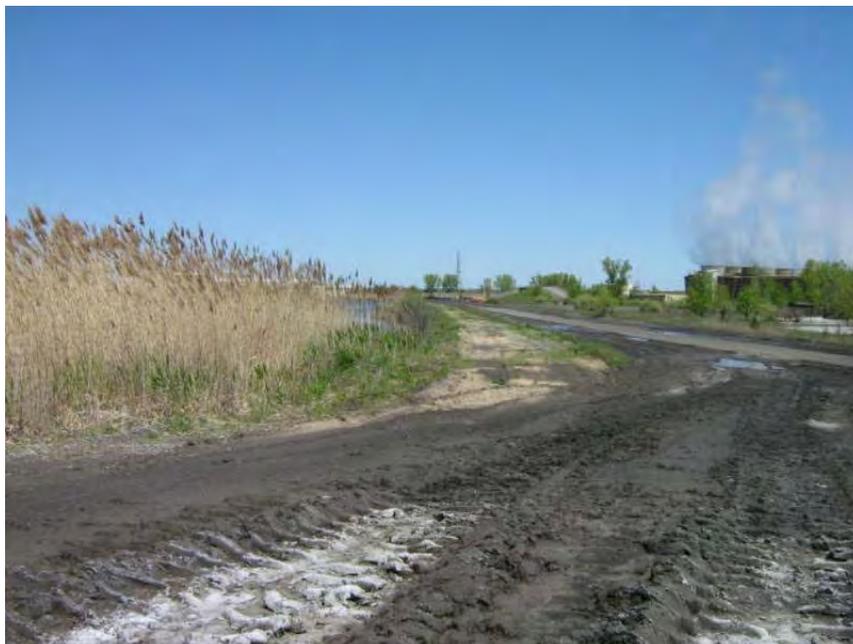
137. Metal Cleaning Waste Basin - East Embankment Crest,
Looking North

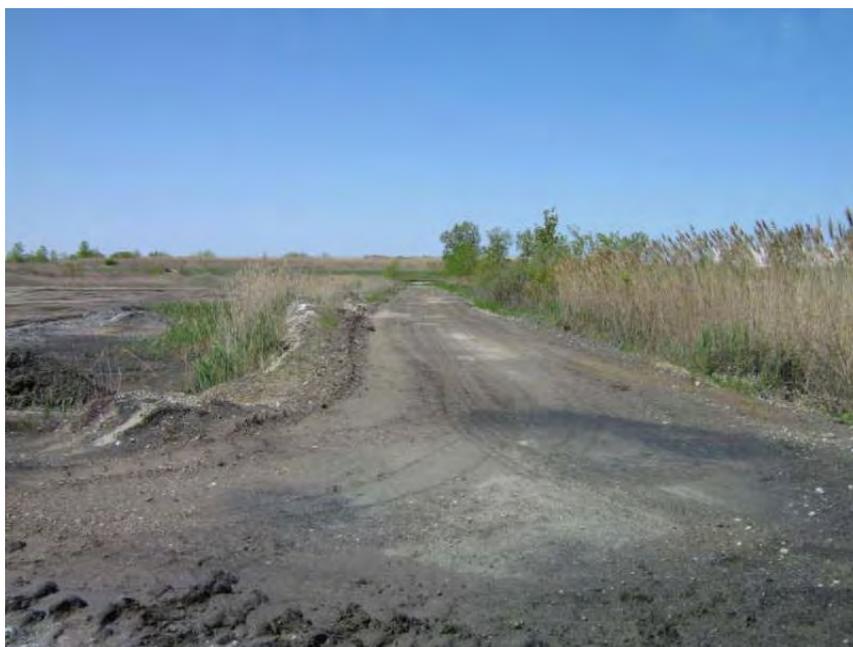
138. Metal Cleaning Waste Basin - South Embankment Crest,
Looking West

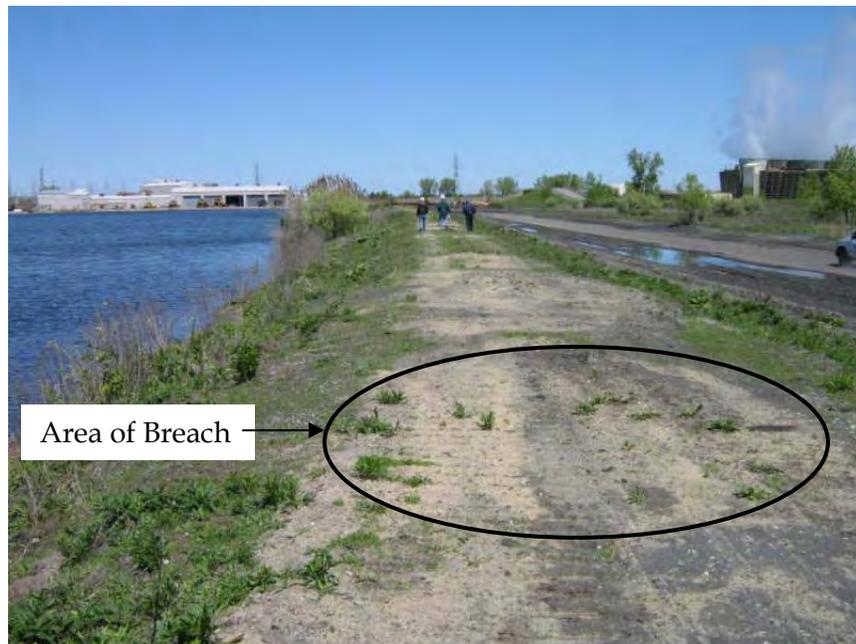
139. Metal Cleaning Waste Basin - East Embankment Crest, Looking North, Depression (Area of Breach)

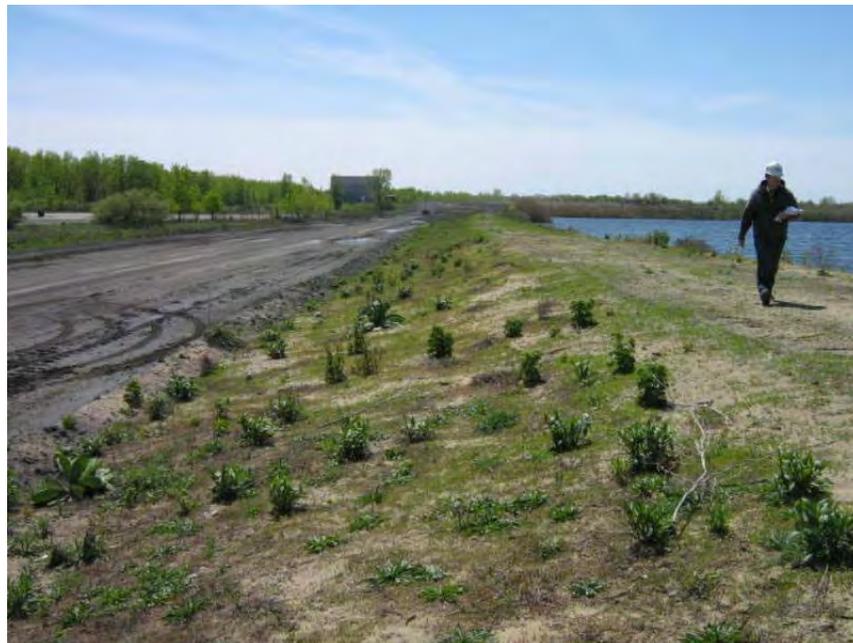
141. Metal Cleaning Waste Basin - East Embankment Exterior Slope,
Looking South, Sparse Vegetation

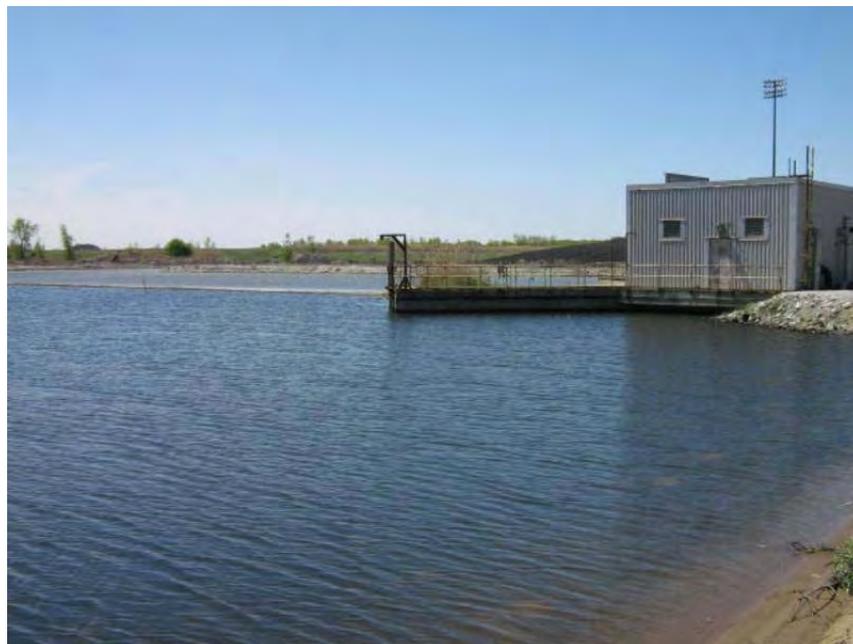
142. Metal Cleaning Waste Basin - Pump Station at Northwestern
Corner of Pond

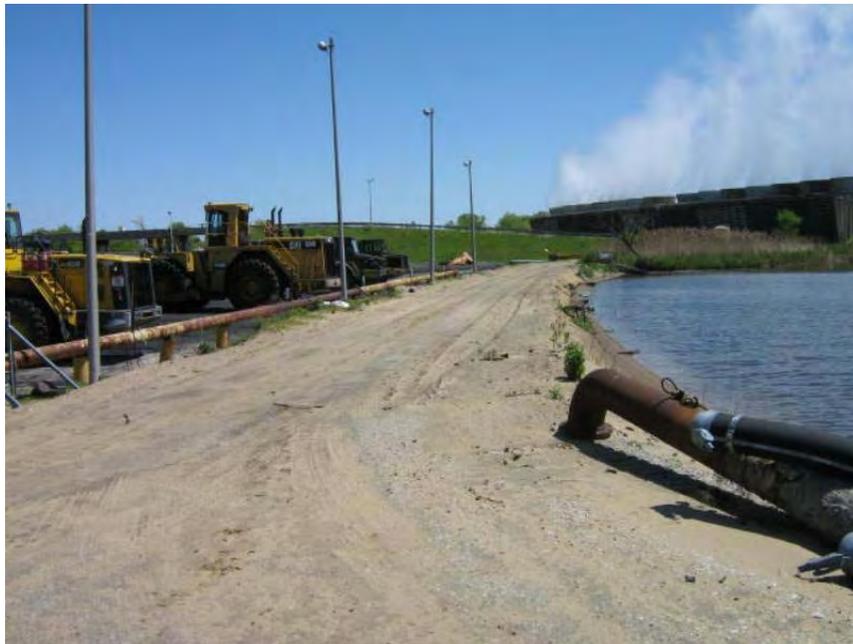
143. Metal Cleaning Waste Basin - North Embankment Crest,
Looking East

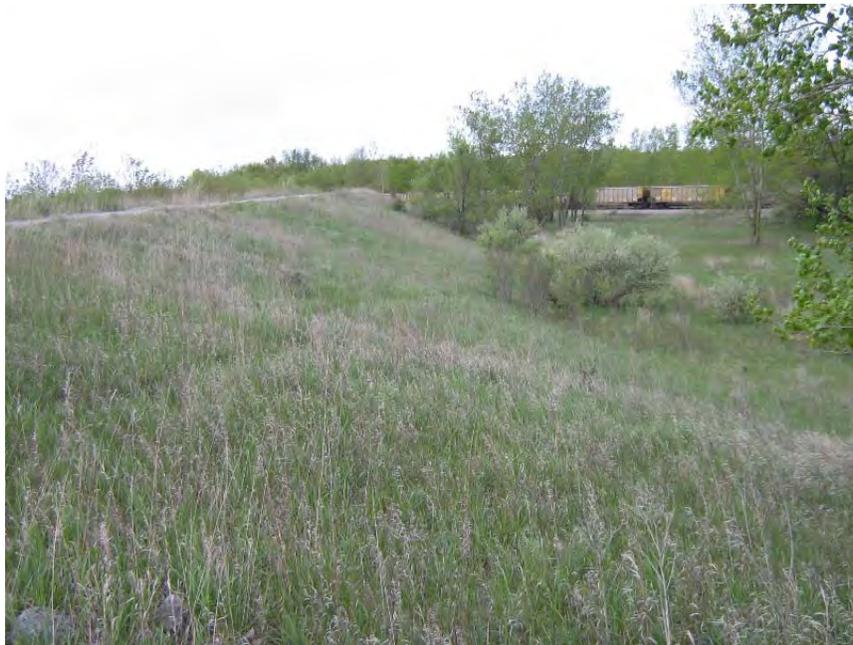
144. Waste Disposal Area - West Embankment Exterior Slope, Looking South

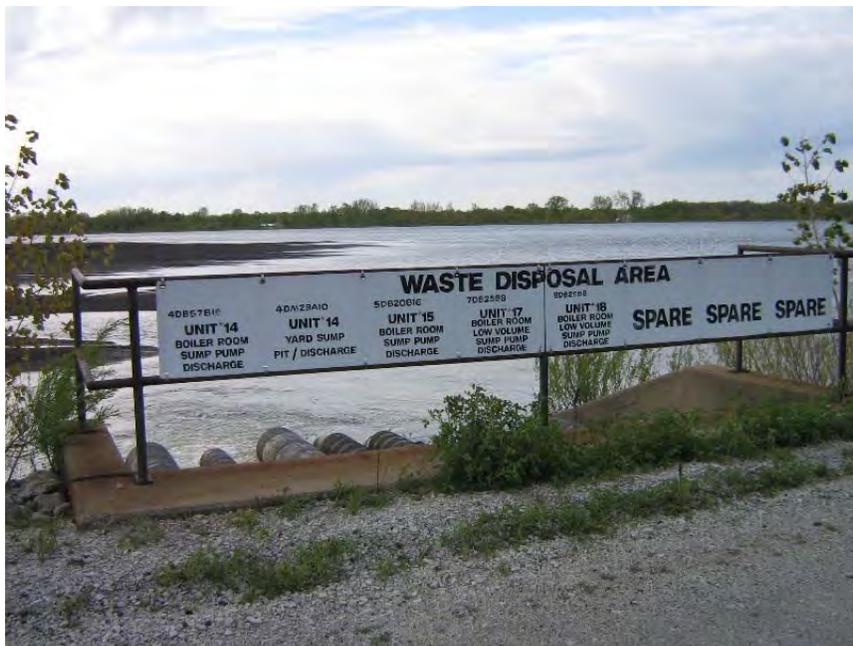
145. Waste Disposal Area - Northwest Embankment Crest, Sluice Line Identification

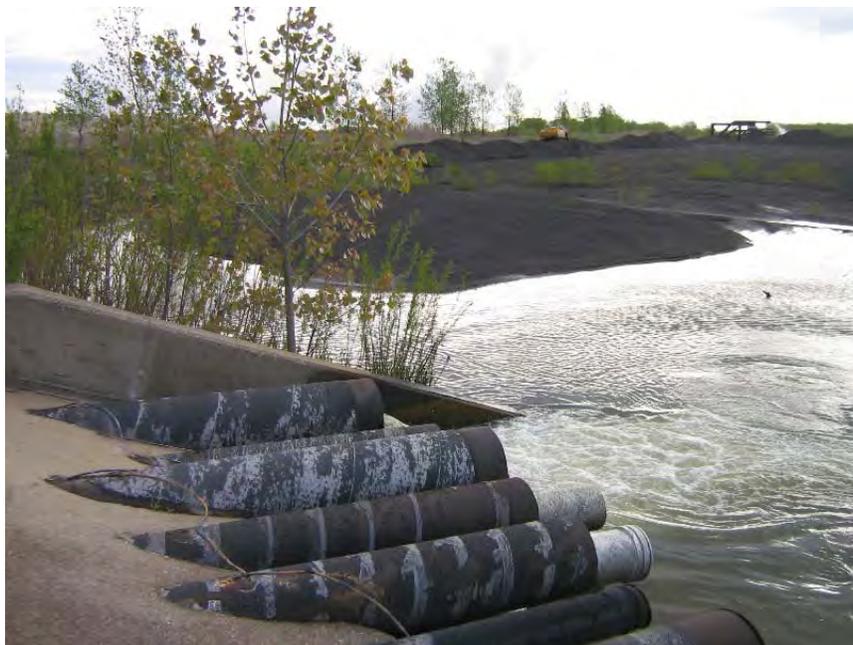
146. Waste Disposal Area - Northwest Embankment Interior Slope
Inlet Pipes

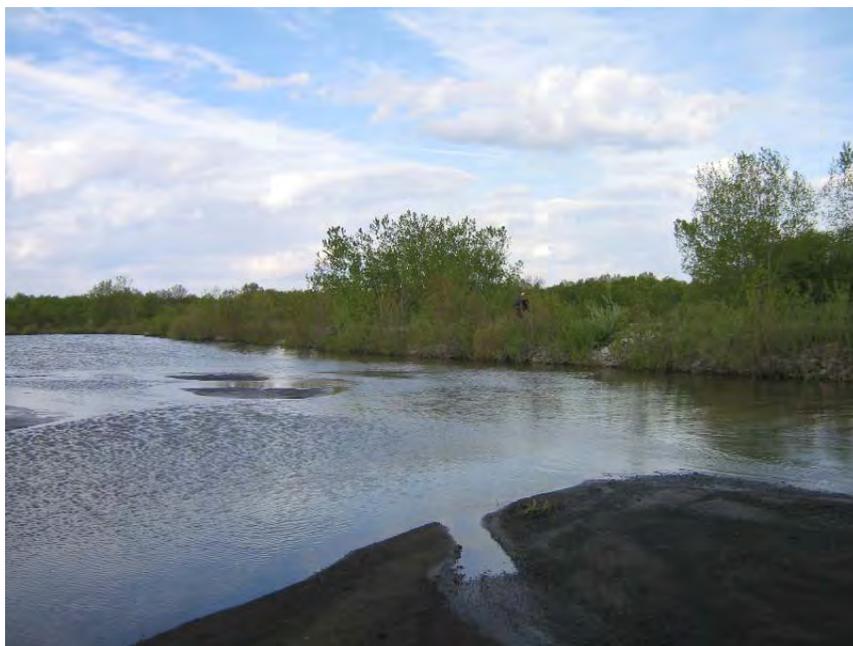
147. Waste Disposal Area - West Embankment Interior Slope,
Looking West

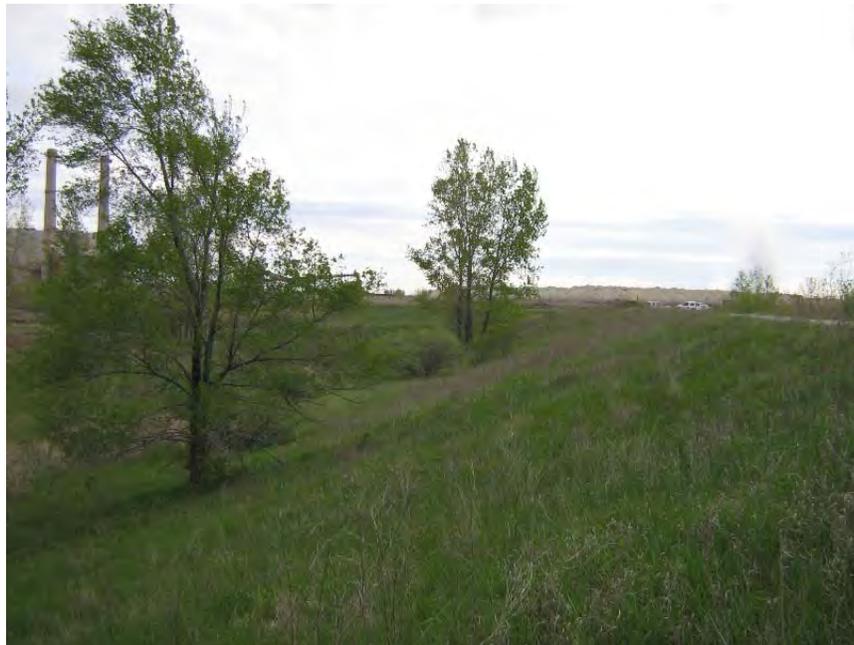
148. Waste Disposal Area - West Embankment Exterior Slope, Looking North

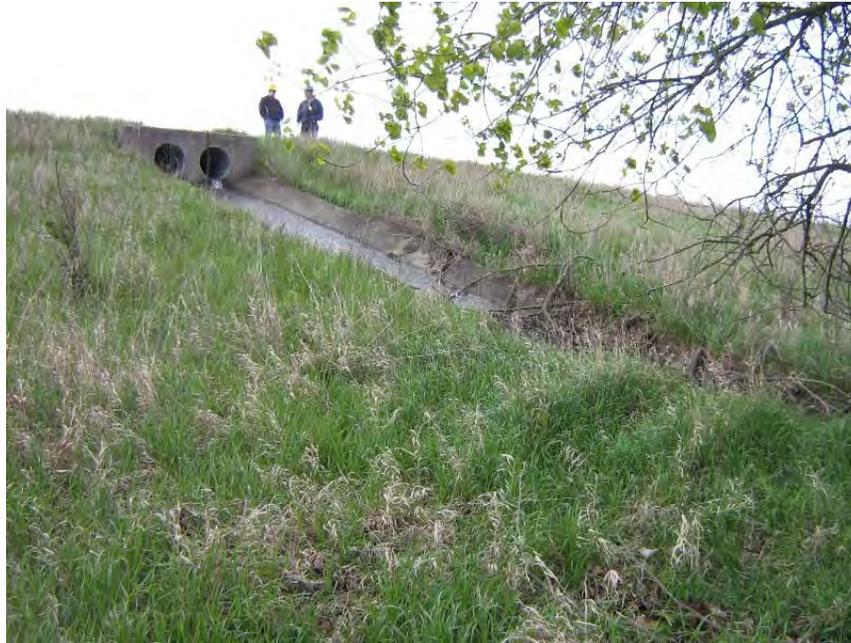
150. Waste Disposal Area - West Embankment Exterior Slope, Discharge Pipes and Channel

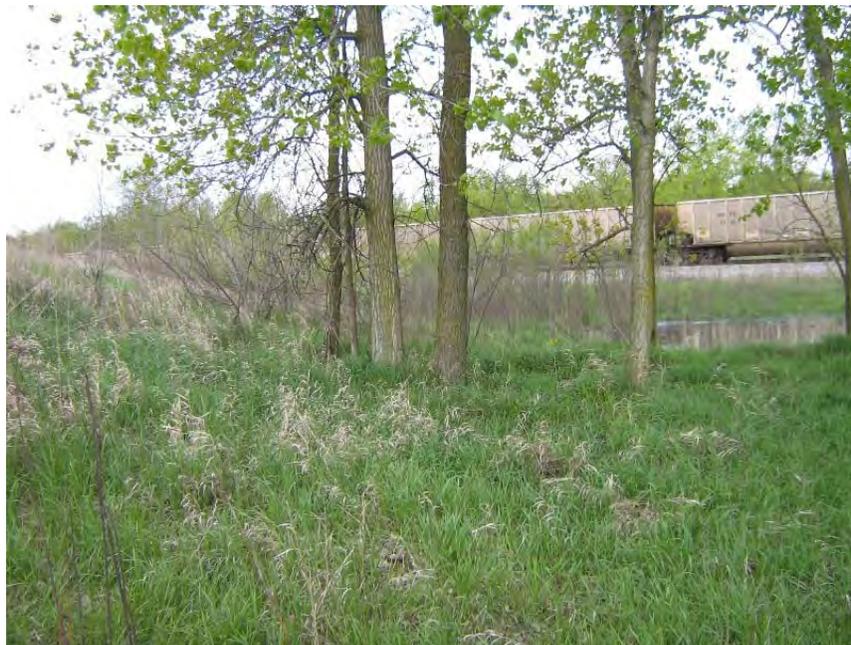
151. Waste Disposal Area - West Embankment Exterior Slope, Trees at Toe of Slope

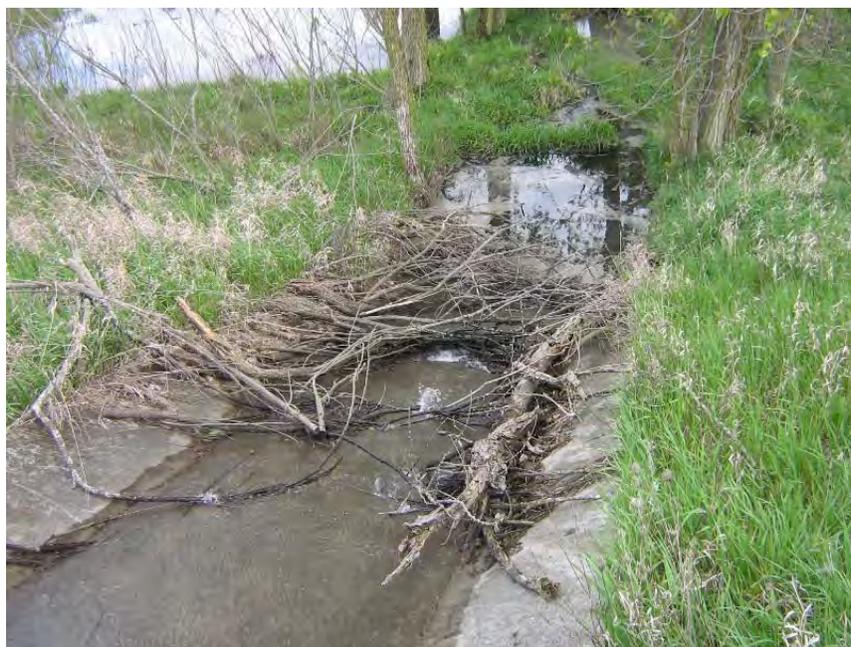
152. Waste Disposal Area - Outlet Channel on West Embankment Exterior Slope

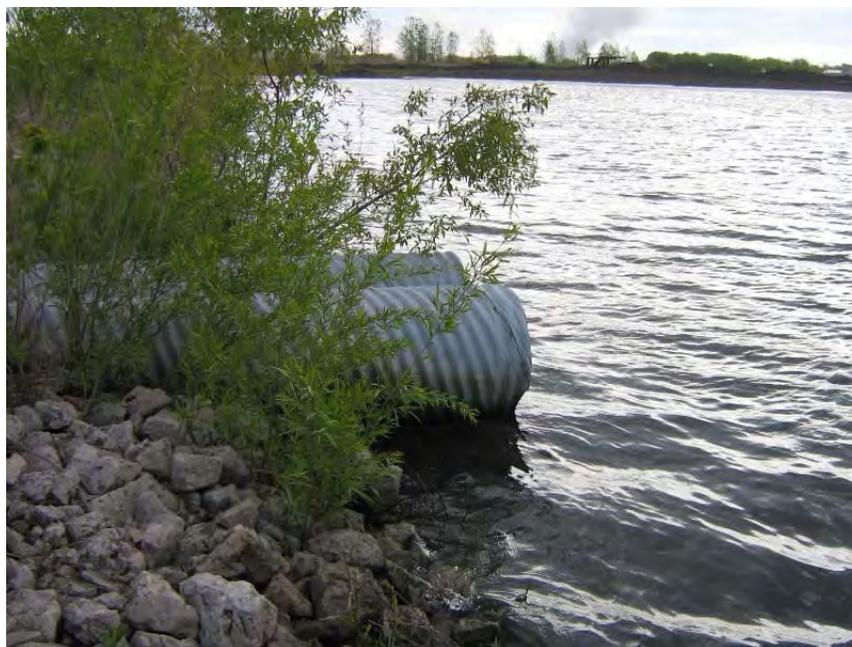
153. Waste Disposal Area - West Embankment Interior Slope, Two (2) 3-inch-diameter CMP Outlets

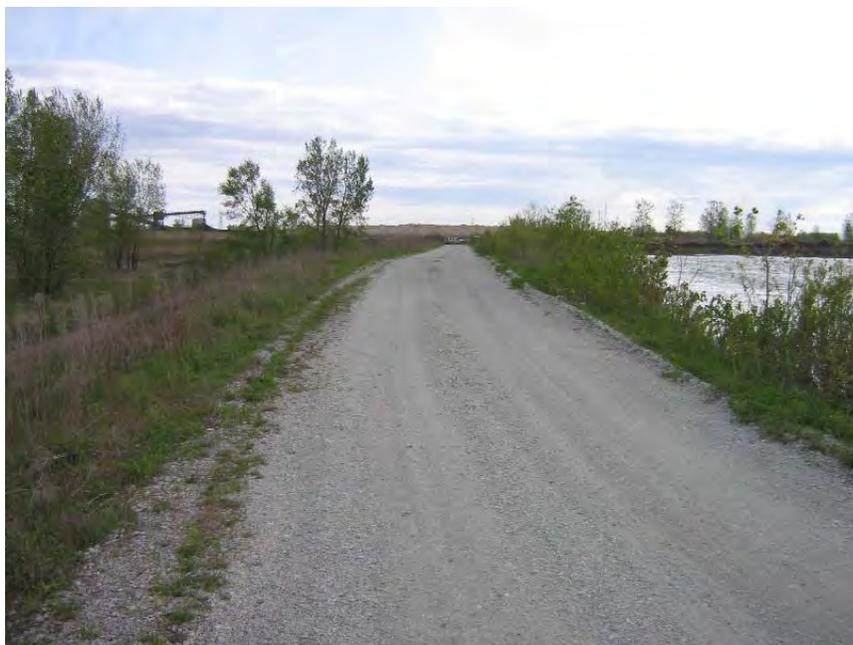
154. Waste Disposal Area - West Embankment Crest, Looking North

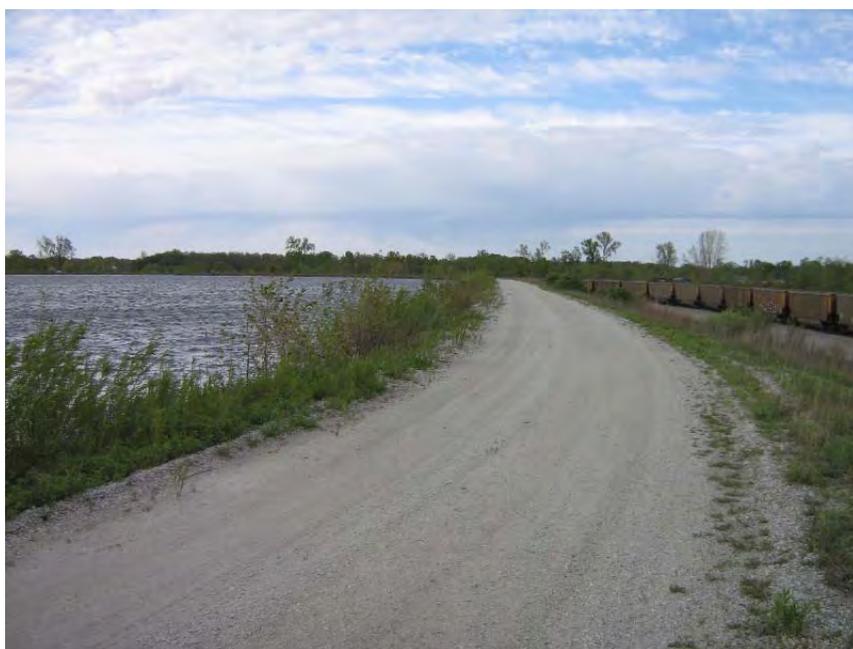
155. Waste Disposal Area - West Embankment Crest, Looking South

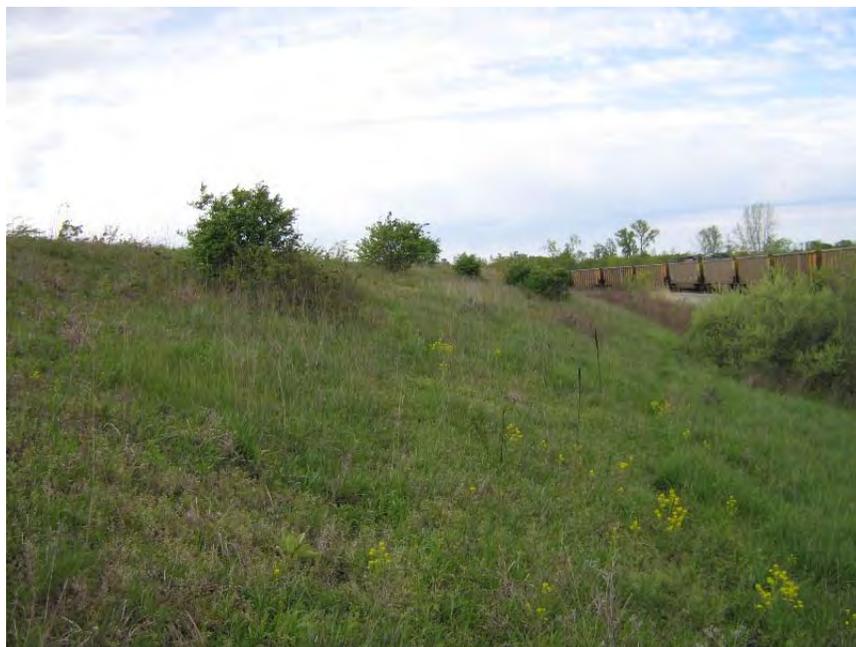
156. Waste Disposal Area - West Embankment Exterior Slope,
Looking South

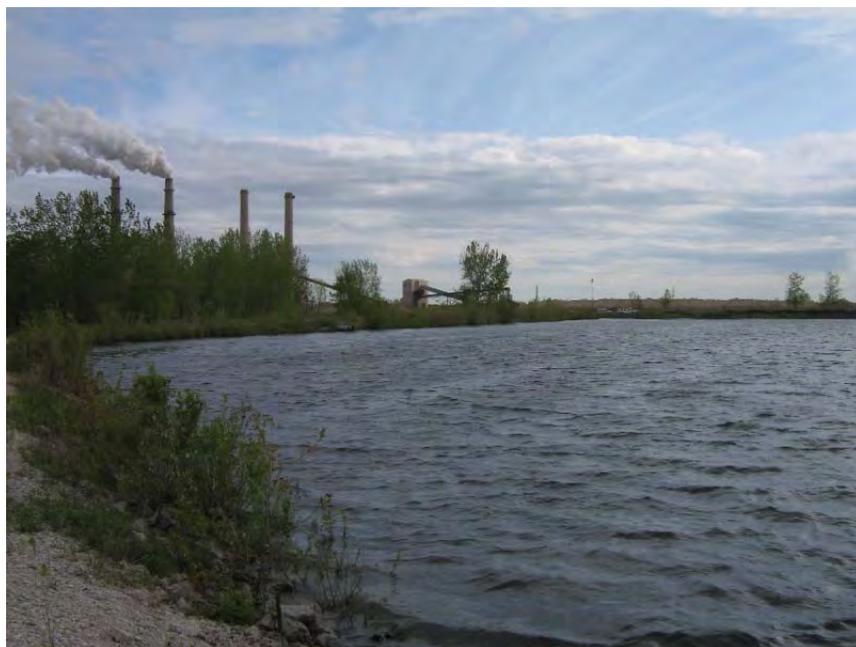
157. Waste Disposal Area - West Embankment Interior Slope,
Looking North

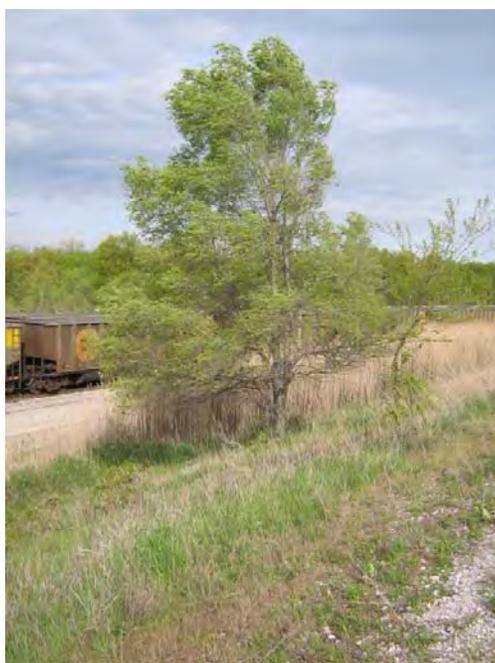
159. Waste Disposal Area - West Embankment Exterior Slope

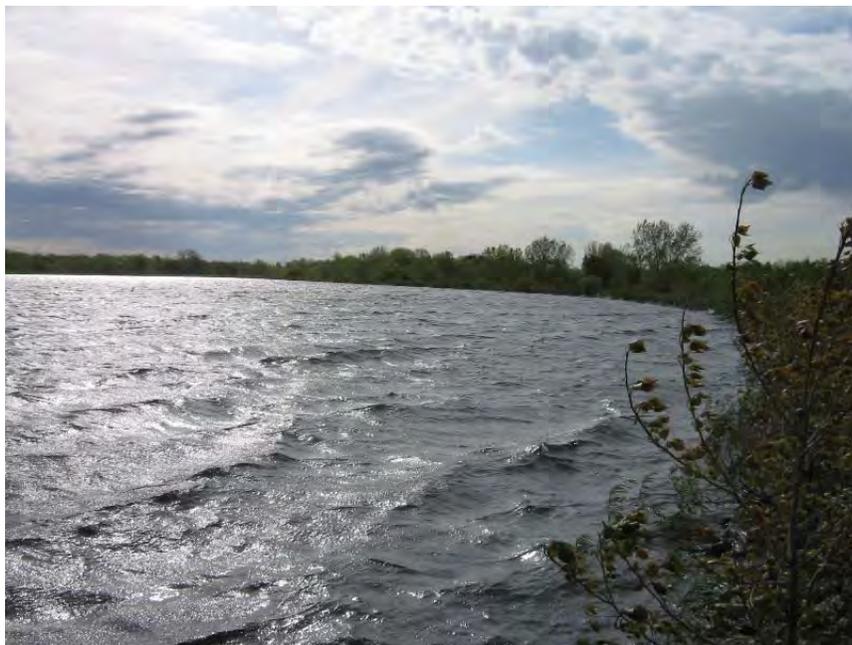
160. Waste Disposal Area - South Embankment Interior Slope,
Looking East
