Assessment of Dam Safety of Coal Combustion Surface Impoundments

Northern Indiana Public Service Company

R.M. Schahfer Generating Station

November 19, 2010

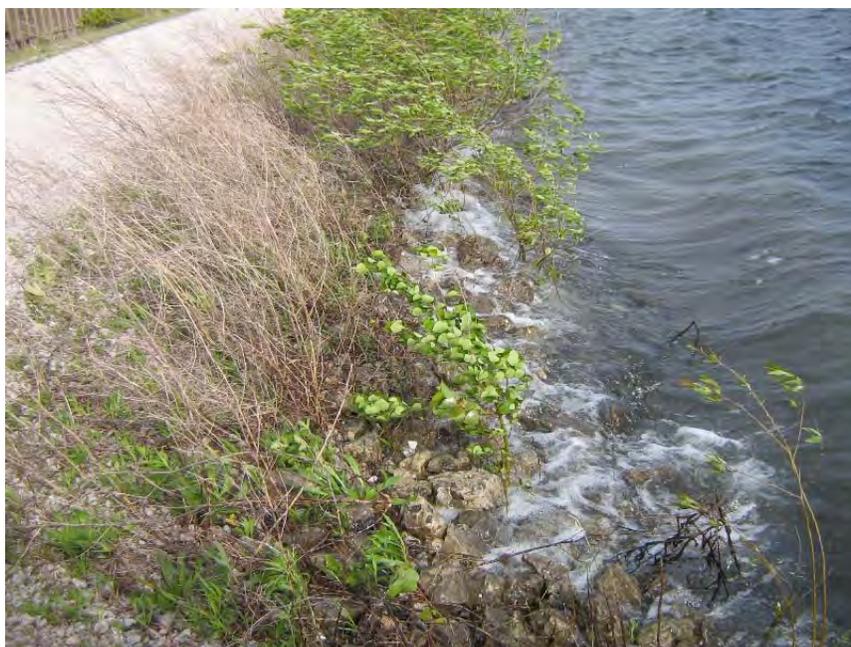
161. Waste Disposal Area - Wave Action at South Embankment
Interior Slope

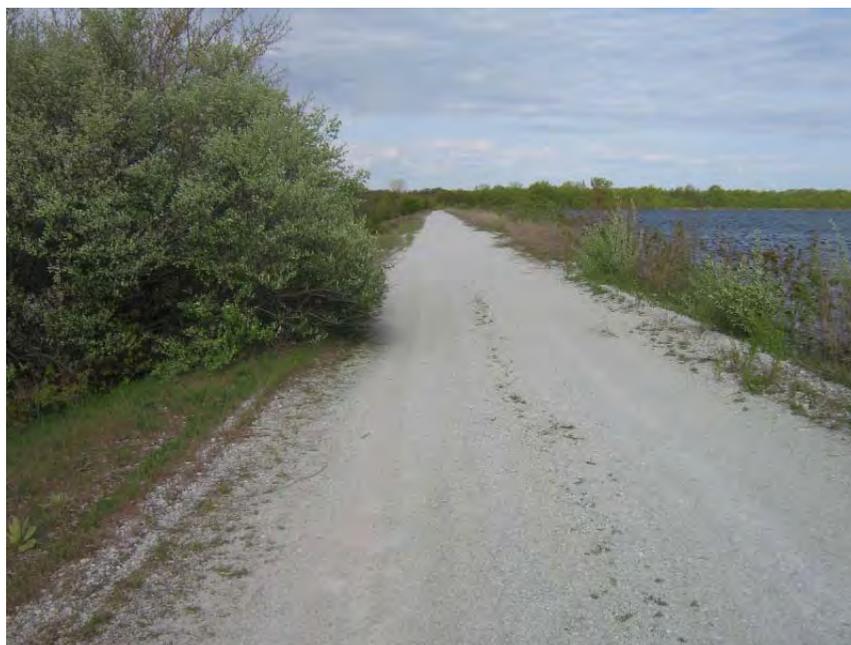
162. Waste Disposal Area - South Embankment Crest, Looking West

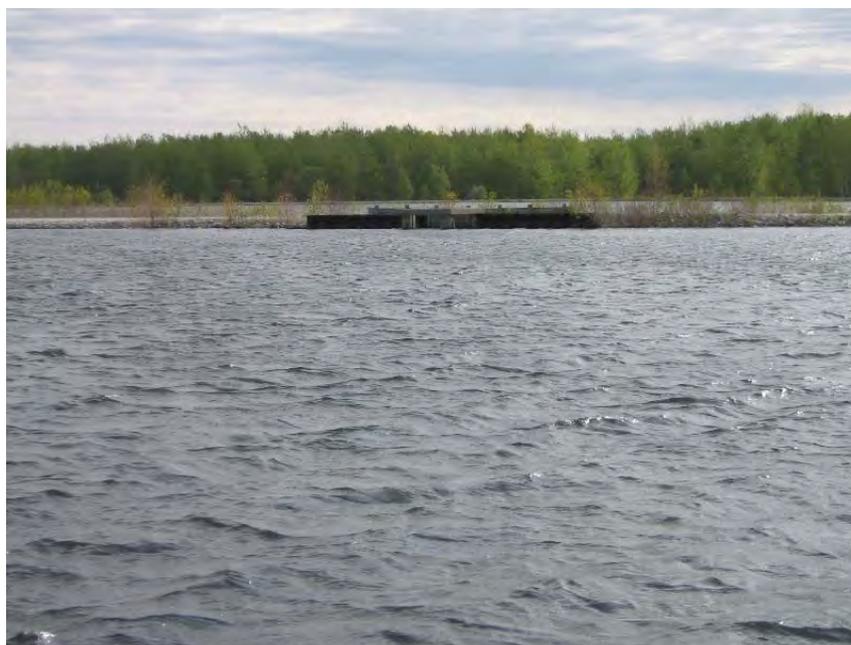
163. Waste Disposal Area - East Embankment Interior Slope, Outlet Structure

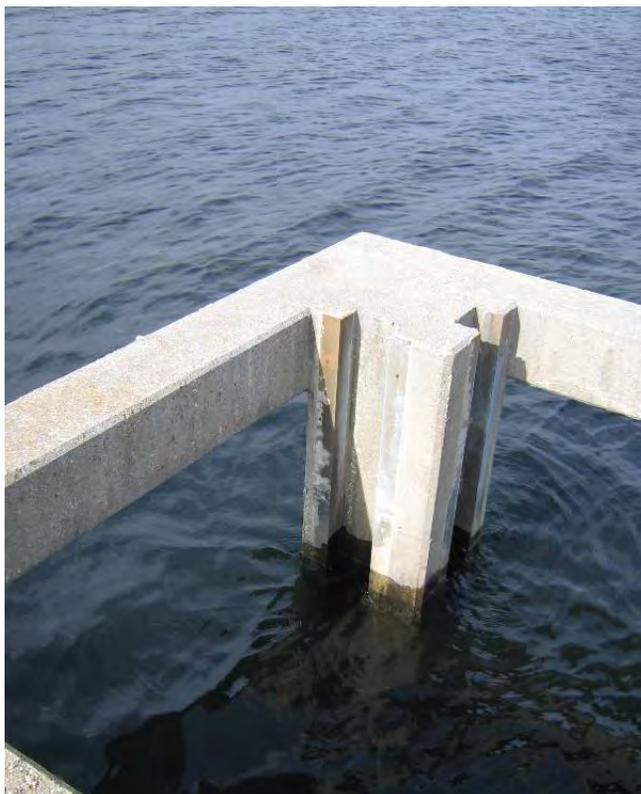
164. Waste Disposal Area - East Embankment Outlet Structure,
Slots for Stoplogs

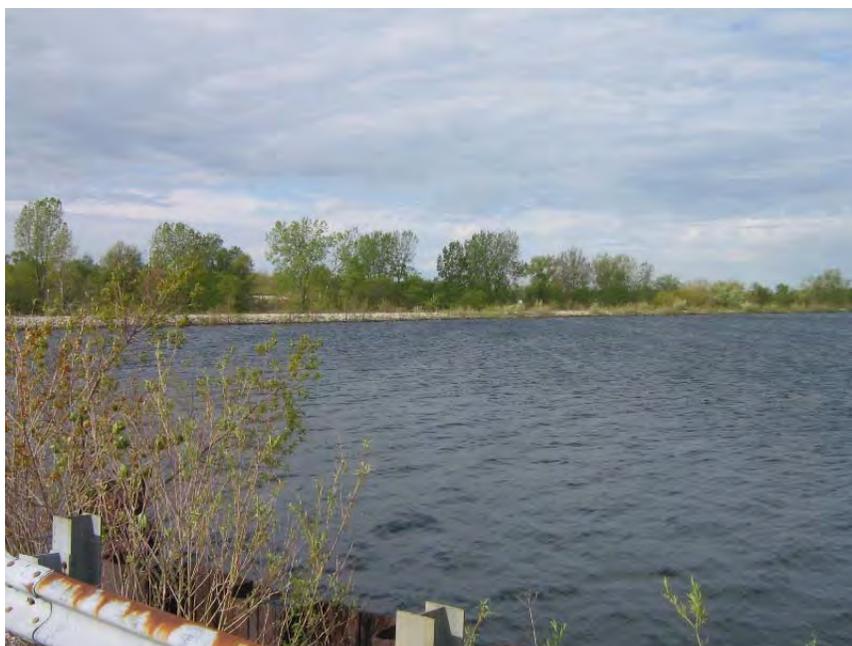
165. Waste Disposal Area - South Embankment Interior Slope,
Looking South

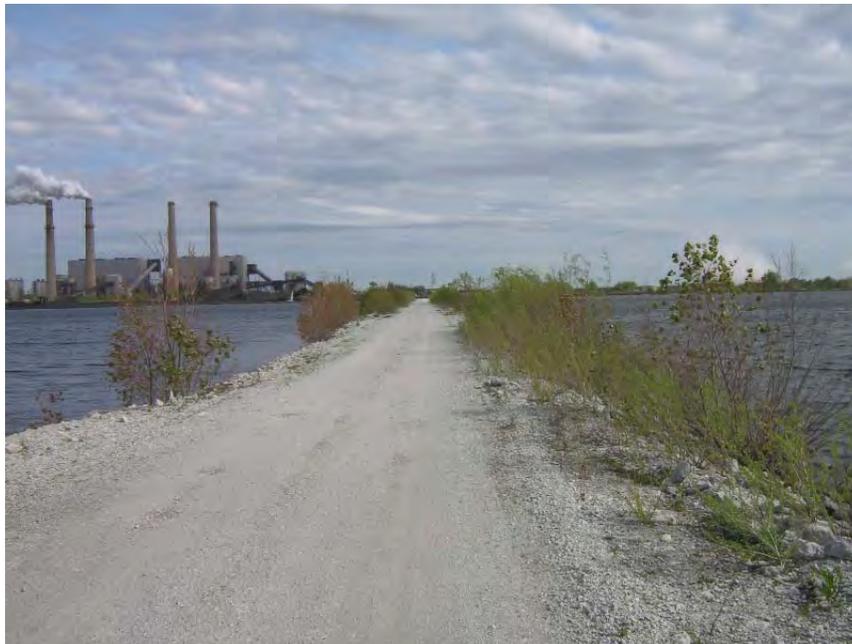
166. Waste Disposal Area - East Embankment Crest, Looking North

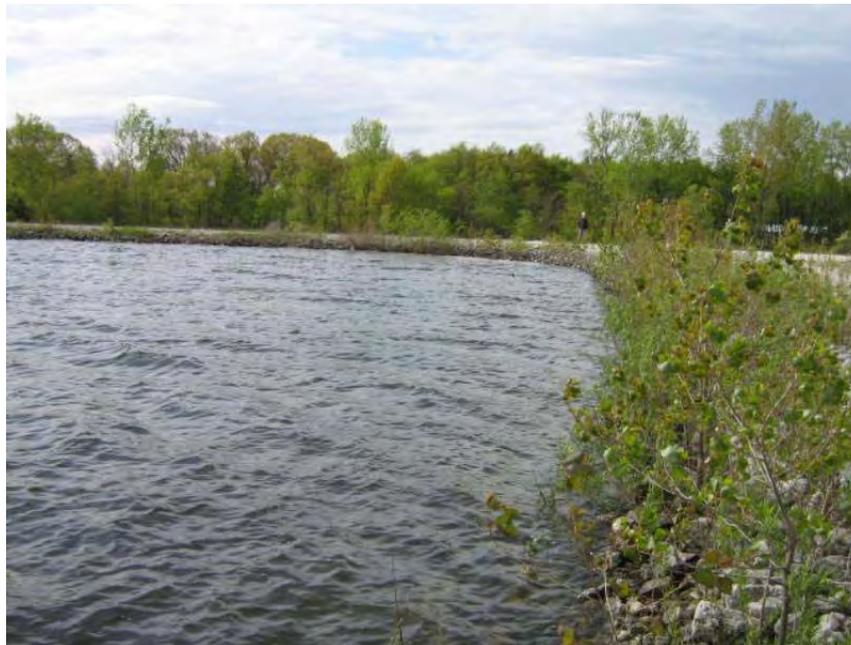
168. Recycle Basin - West Embankment Interior Slope, Looking South

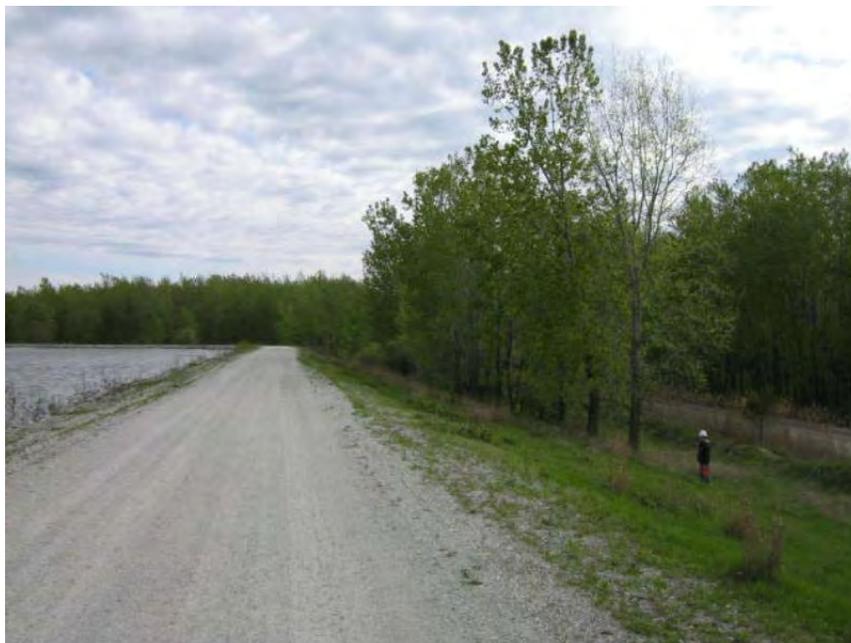
170. Recycle Basin - South Embankment Crest and Exterior Slope, Looking East, Trees at Toe

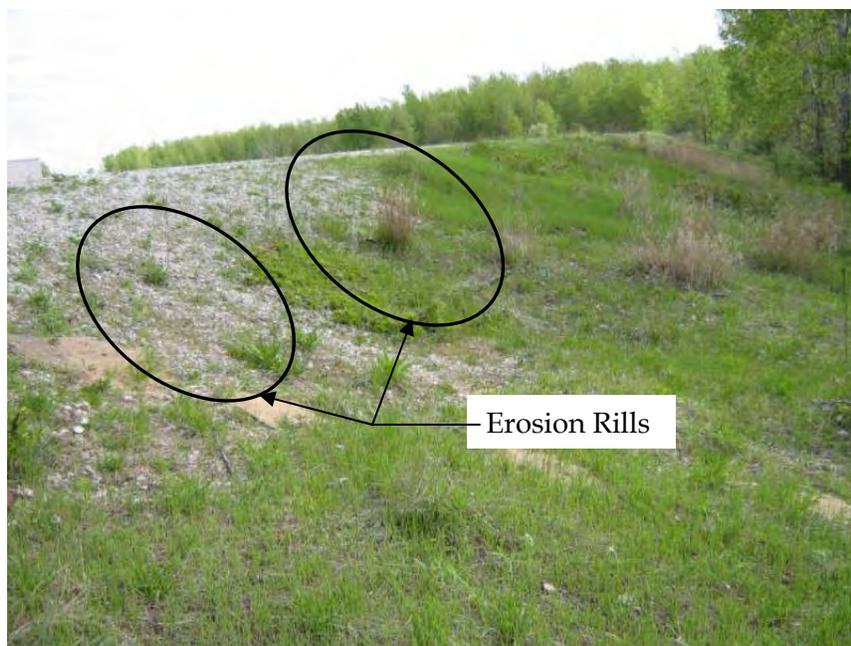
171. Recycle Basin - Erosion Rills on Southeast Embankment Exterior Slope

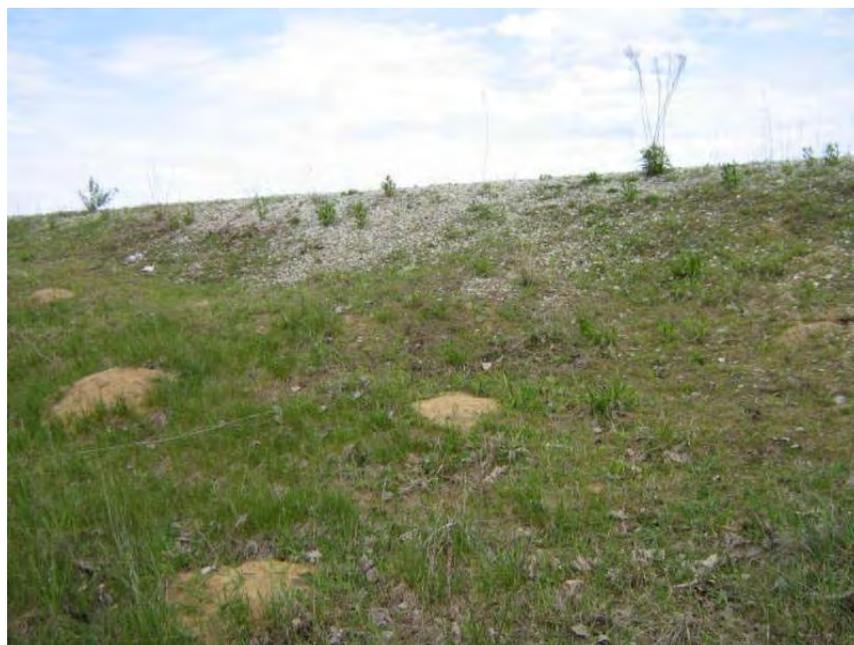
172. Recycle Basin - Southeast Embankment Exterior Slope

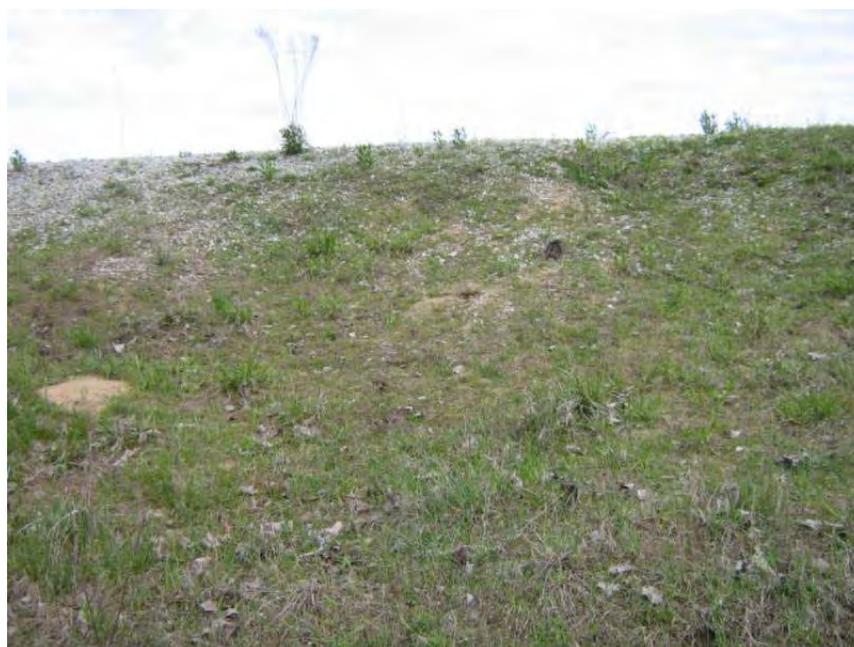
173. Recycle Basin - Southeast Embankment Exterior Slope

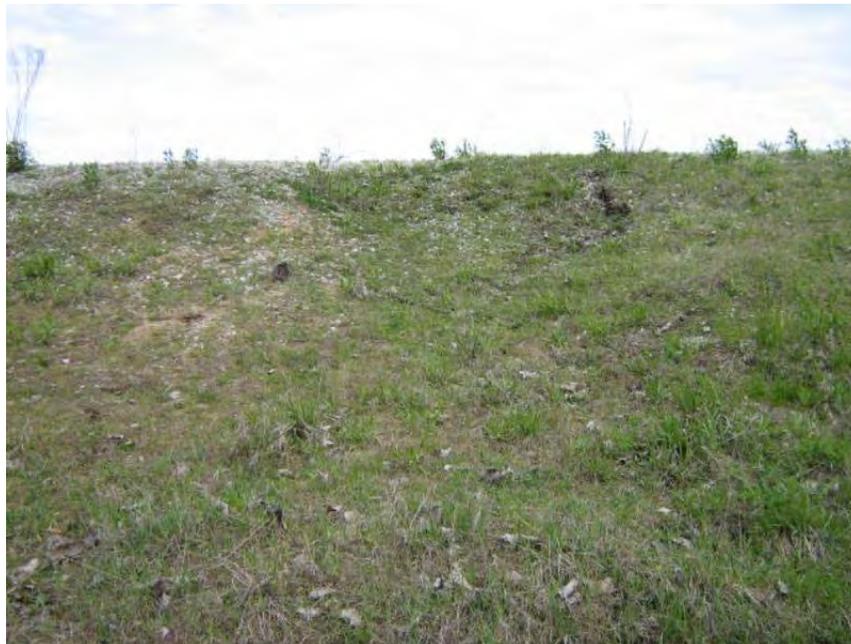
174. Recycle Basin - Erosion Feature on Southeast Embankment Exterior Slope

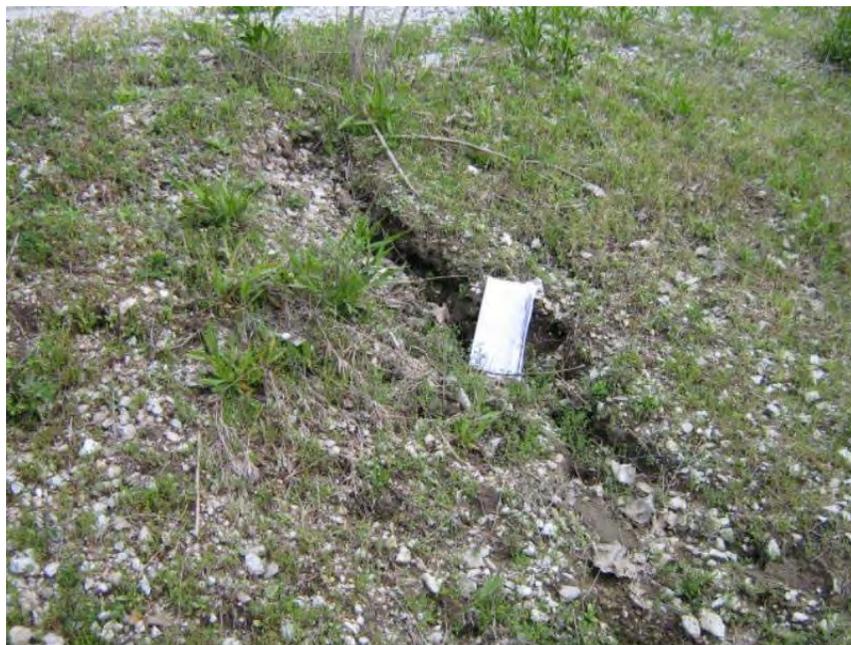
175. Recycle Basin - Erosion Rill on Southeast Embankment Exterior Slope

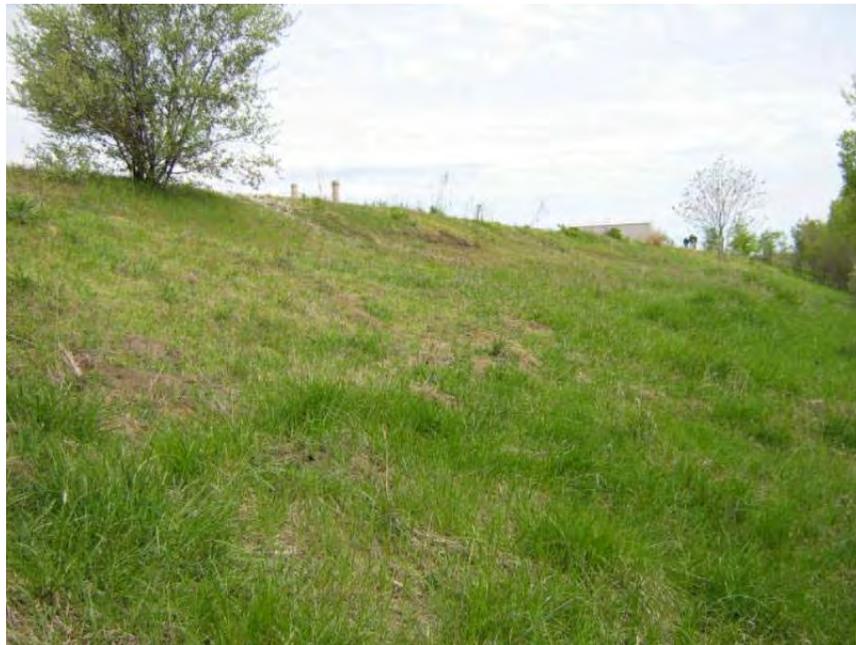
176. Recycle Basin - Sloughing on East Embankment Exterior Slope
(Approximately 80 feet in length)

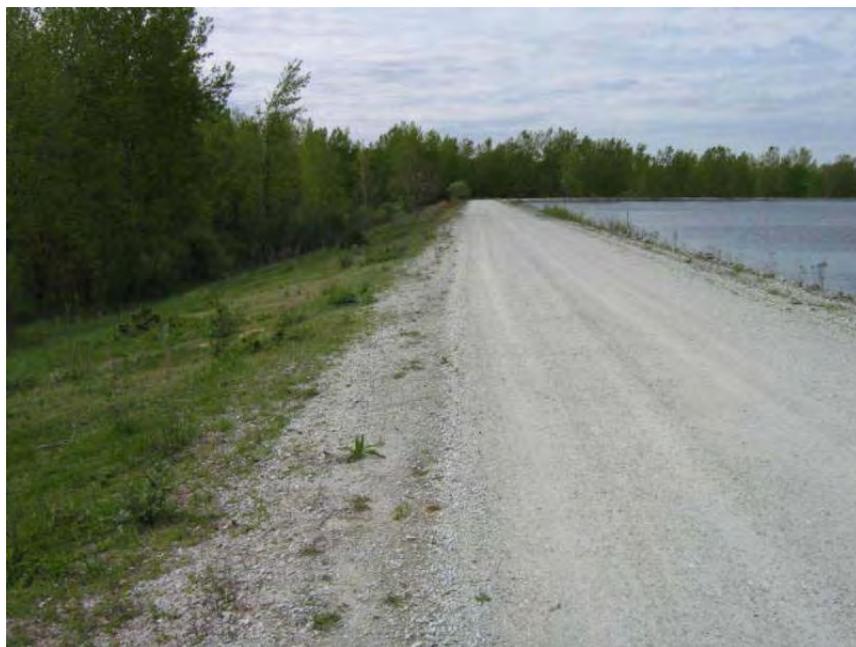
177. Recycle Basin - East Embankment Crest, Looking South

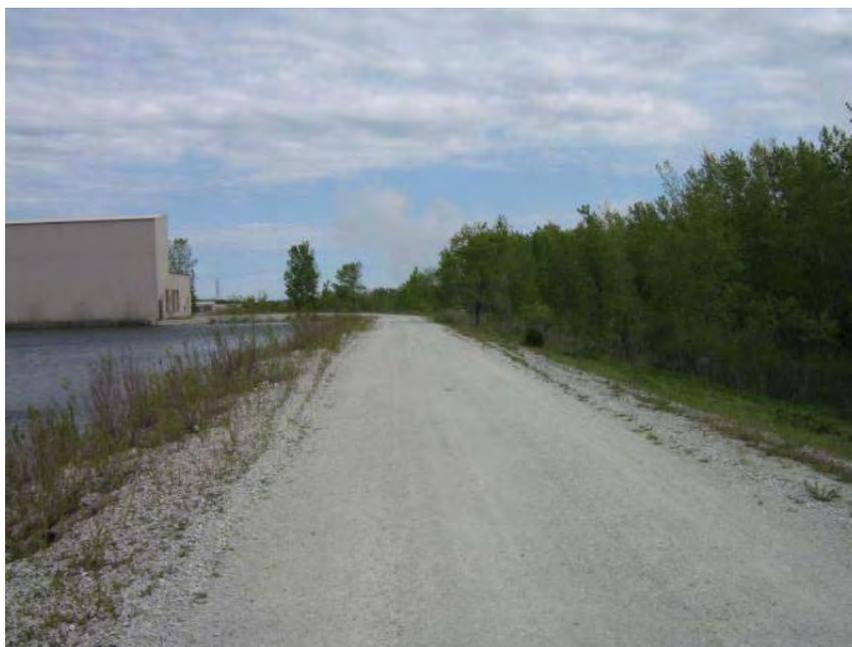
178. Recycle Basin - East Embankment Crest, Looking North

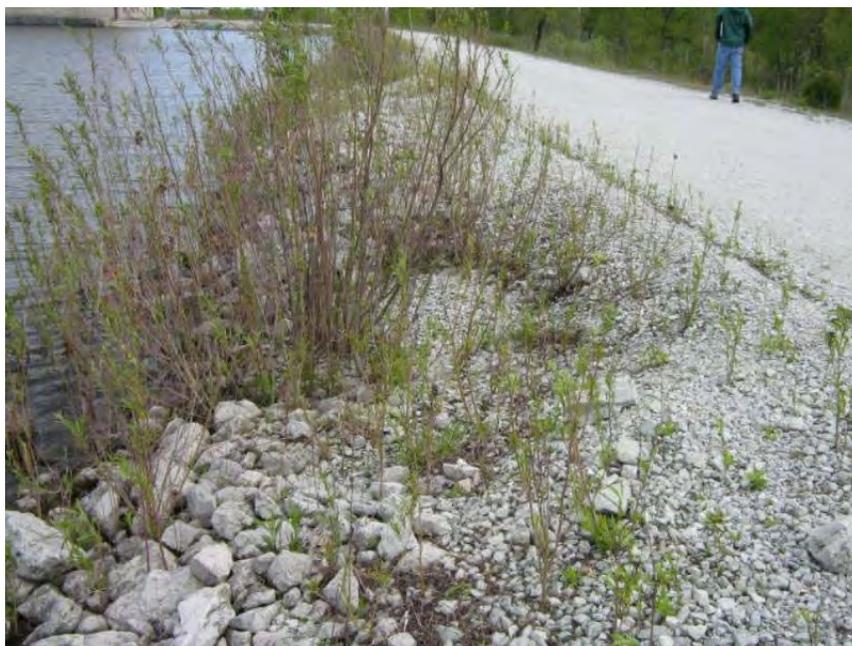
179. Recycle Basin - East Embankment Interior Slope, Vegetation and Minor Erosion of Riprap Armorment

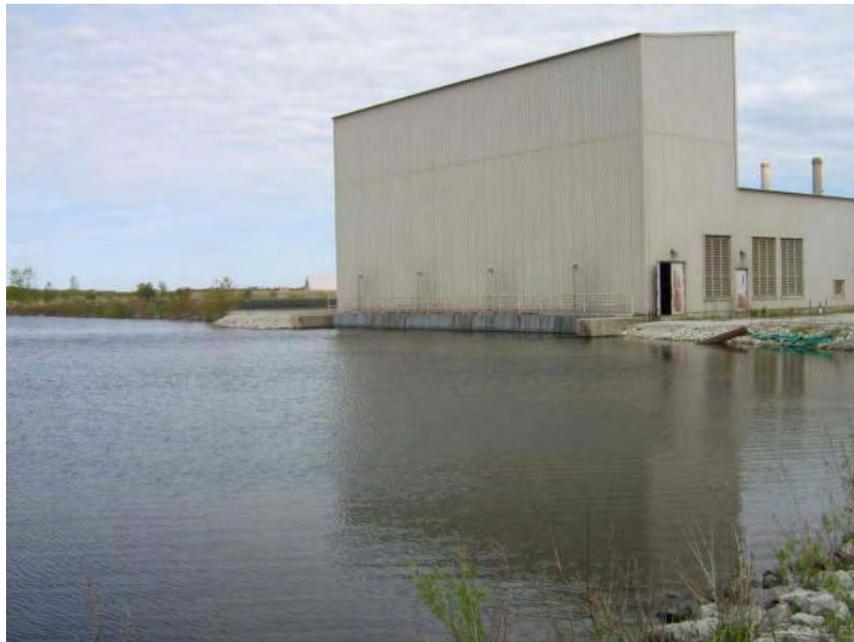
180. Recycle Basin - Intake Structure on North Embankment

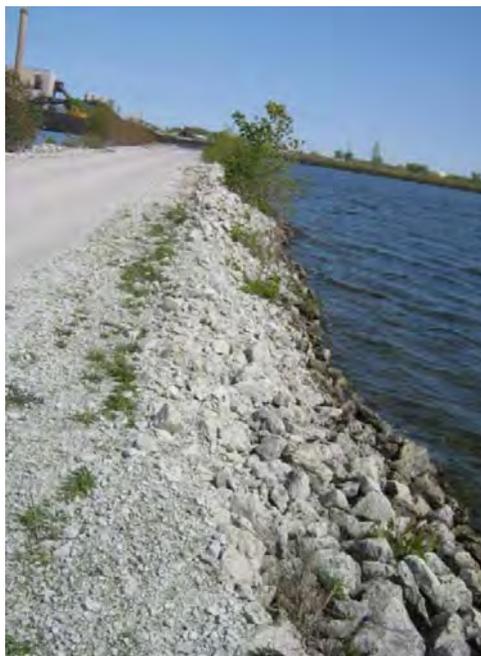
181. Recycle Basin - Riprap Erosion on West Embankment Interior Slope
