Report of Dam Safety Assessment of Coal Combustion
Surface Impoundments
NRG Energy
Huntley Generating Station
Tonawanda, NY

AMEC Project No. 3-2106-0194

September 2011

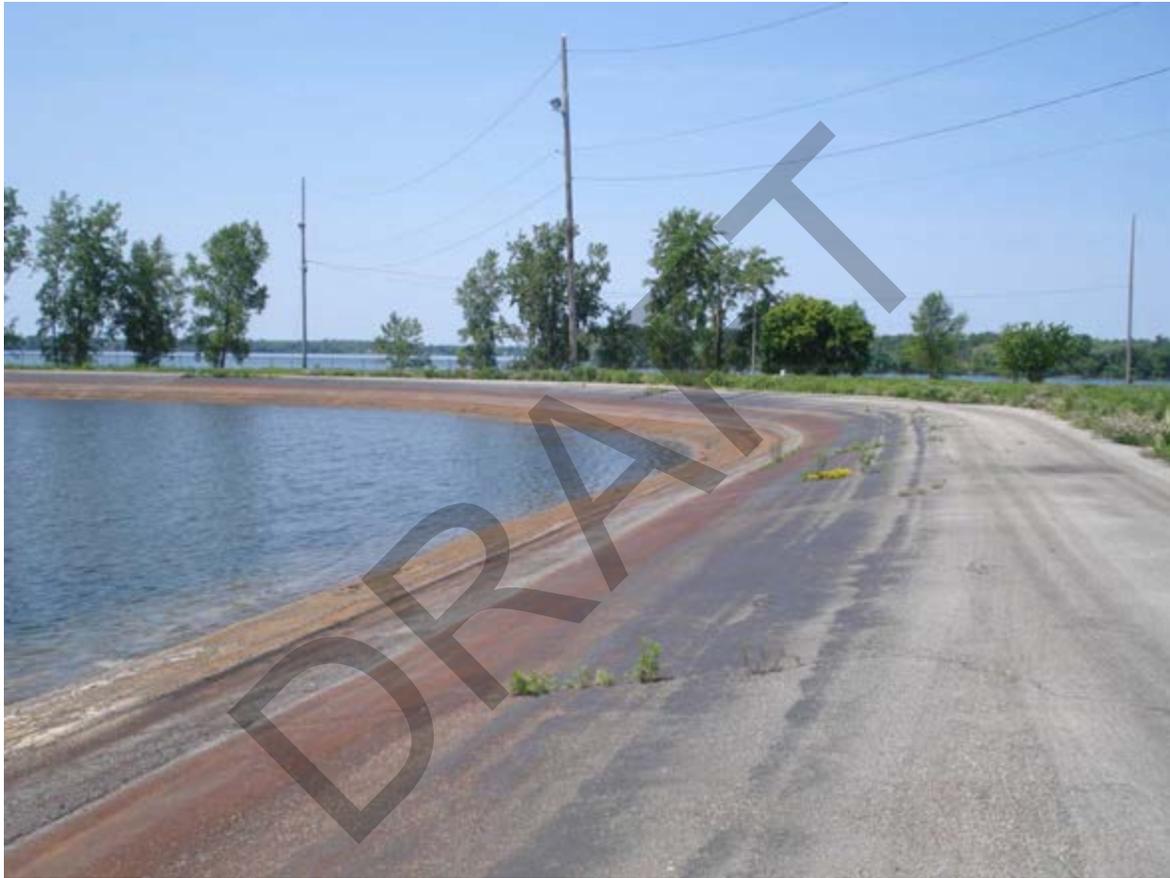
upstream slopes, crest and portions of the downstream slopes have an asphalt liner. The liner is shown to consist of 2-inches of binder and 2-inches of surface for a total 4-inch asphalt cover. The lined slopes and crest appeared to be in fair condition with red staining on the lower sections of the upstream slopes and areas of cracks with or without protruding vegetation in several locations (Photos NEQ-1 through NEQ-6). The downstream slopes, especially on the west dike appeared to be in poor to fair condition with more degradation of the asphalt liner as evidenced by more protruding vegetation (Photo NEQ-4 and NEQ-7). As you proceed south along the west dike, the North Basin is located approximately 185 feet to 110 feet from the edge of the bank of the Niagara River. The following photo presented as NEQ-3 in Appendix B presents a view of the crest and the upstream and downstream slopes of the basin.

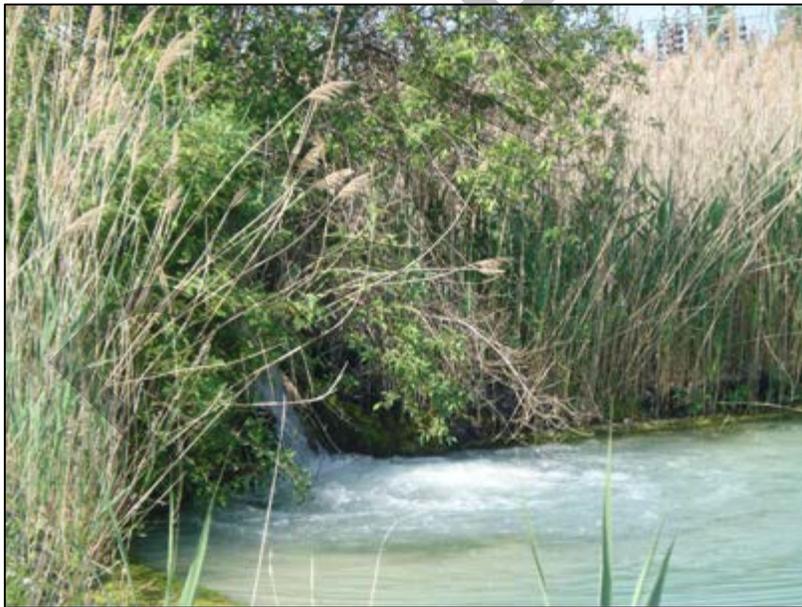
1-4

LOOKING WEST AT INLET PIPE FROM
PLANT TO POND 1, HIGH VEGETATION

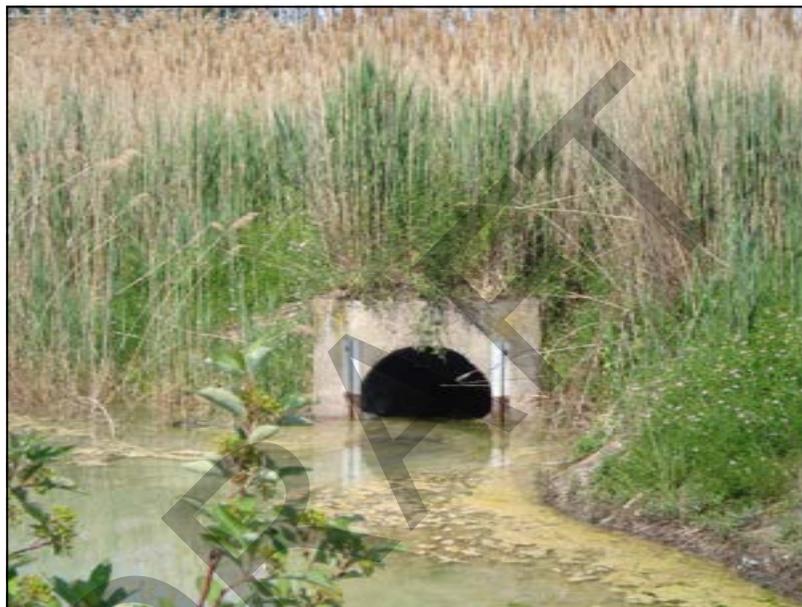
1-5

LOOKING WEST POND 1 AND OUTLET PIPE TO POND 2, HIGH VEGETATION

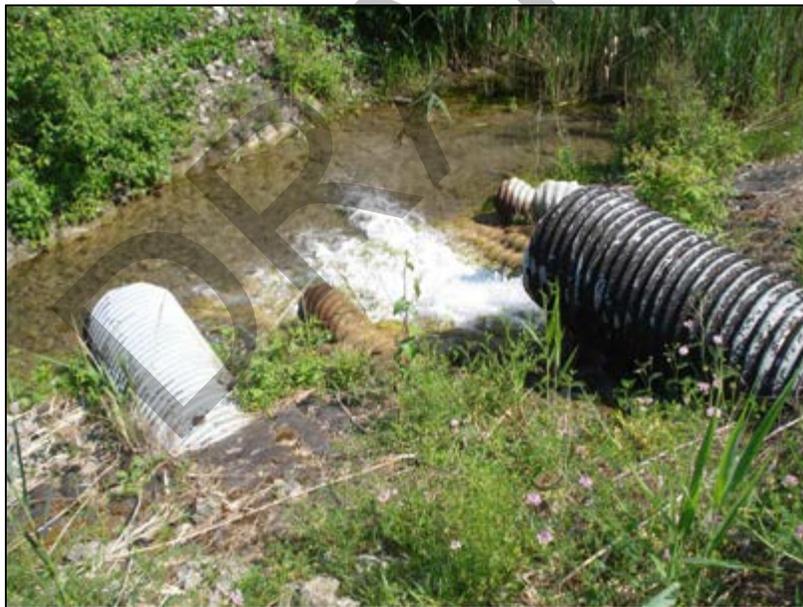
2-4

LOOKING NORTH AT OUTFALL TO DITCH FROM POND 2

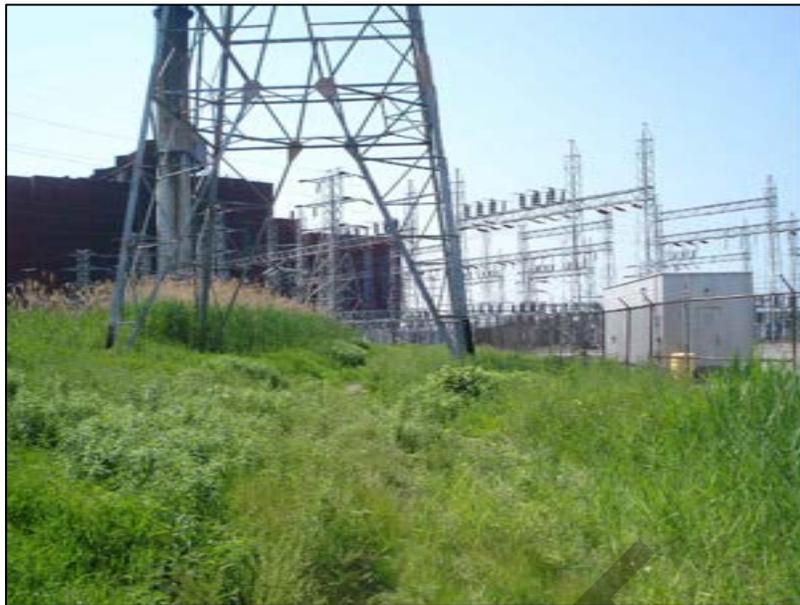
2-5

LOOKING SOUTHWEST AT NORTHWEST DOWNSTREAM EMBANKMENT OF POND 2, HIGH VEGETATION

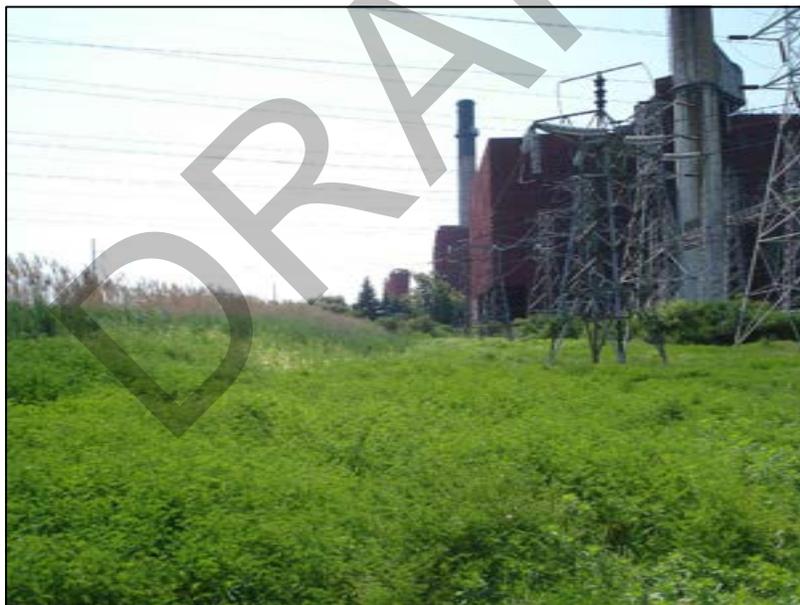
2-6

LOOKING SOUTH AT SOUTHWEST DOWNSTREAM EMBANKMENT OF POND 2, HIGH VEGETATION

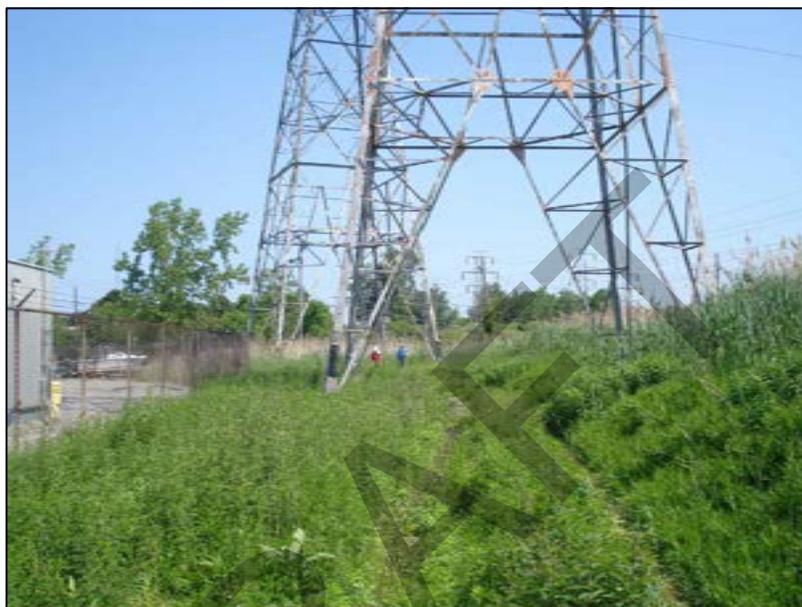
2-7

LOOKING NORTH AT NORTHWEST DOWNSTREAM EMBANKMENT OF POND 2

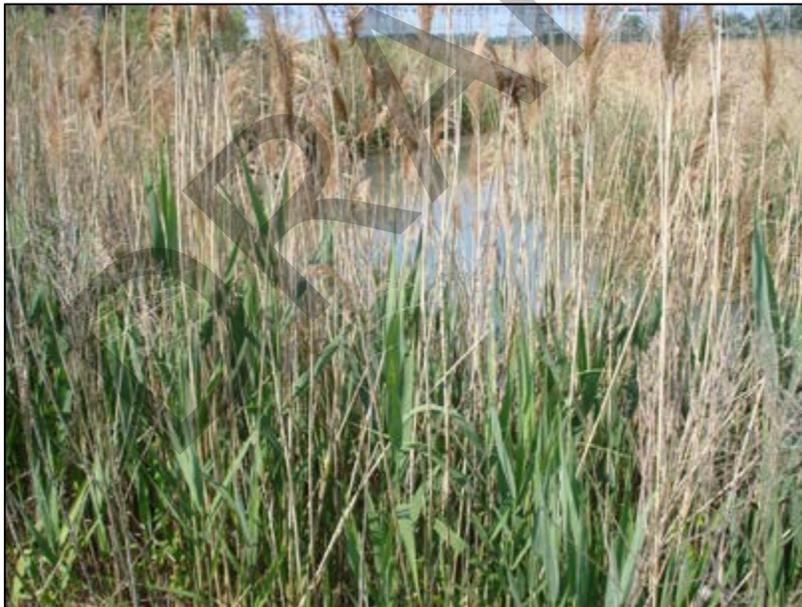
3-2

LOOKING WEST AT SOUTH END OF POND 3, HIGH VEGETATION

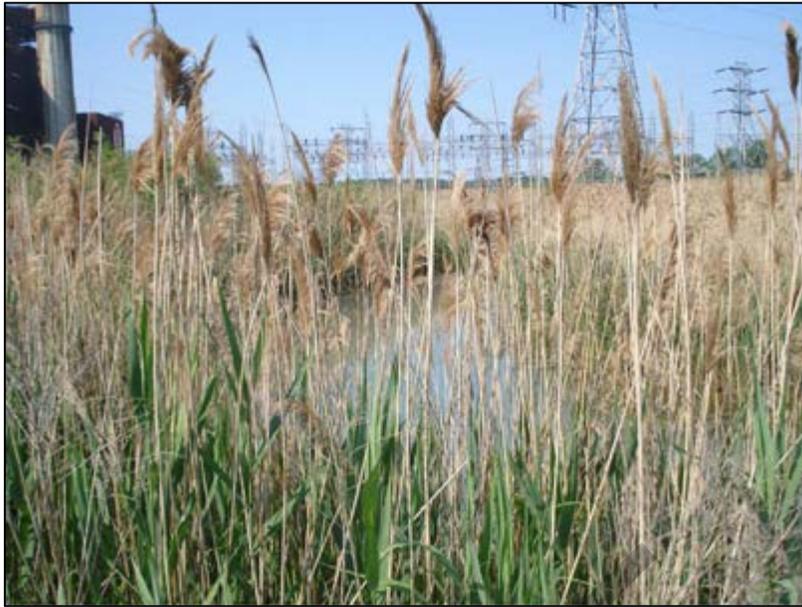
3-3

LOOKING WEST AT NORTH END OF POND 3, HIGH VEGETATION

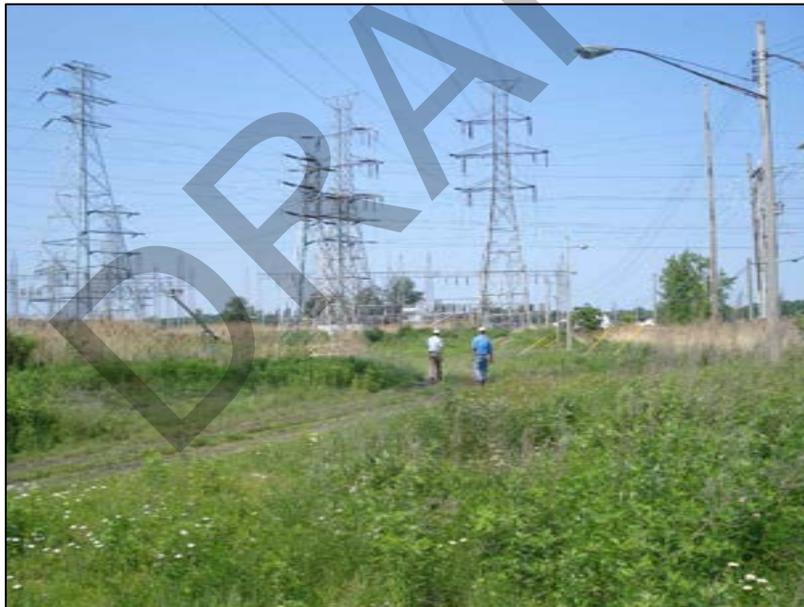
3-8

LOOKING WEST AT NORTH END OF POND 3 (FOREGROUND)
AND POND 2 (MOUND IN BACKGROUND)

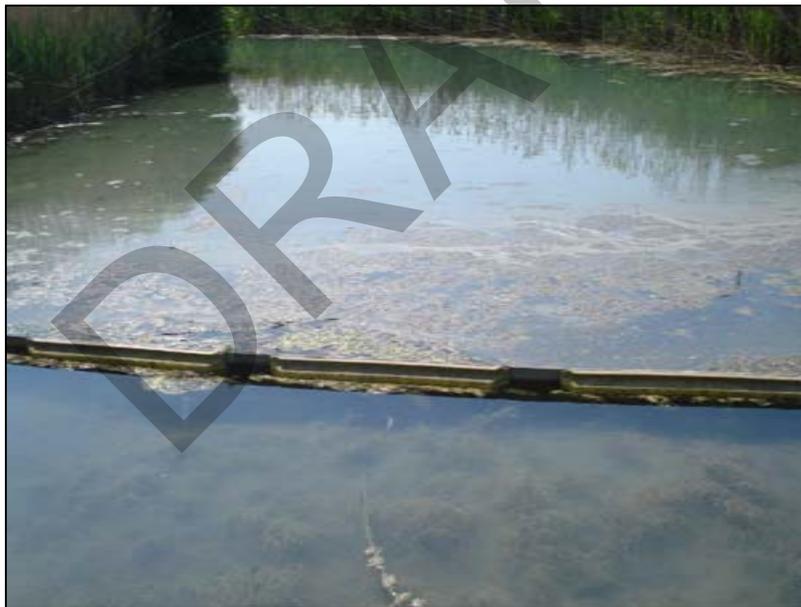
3-10

LOOKING SOUTH AT SKIMMER
ABOVE OUTLET PIPE FROM POND 3

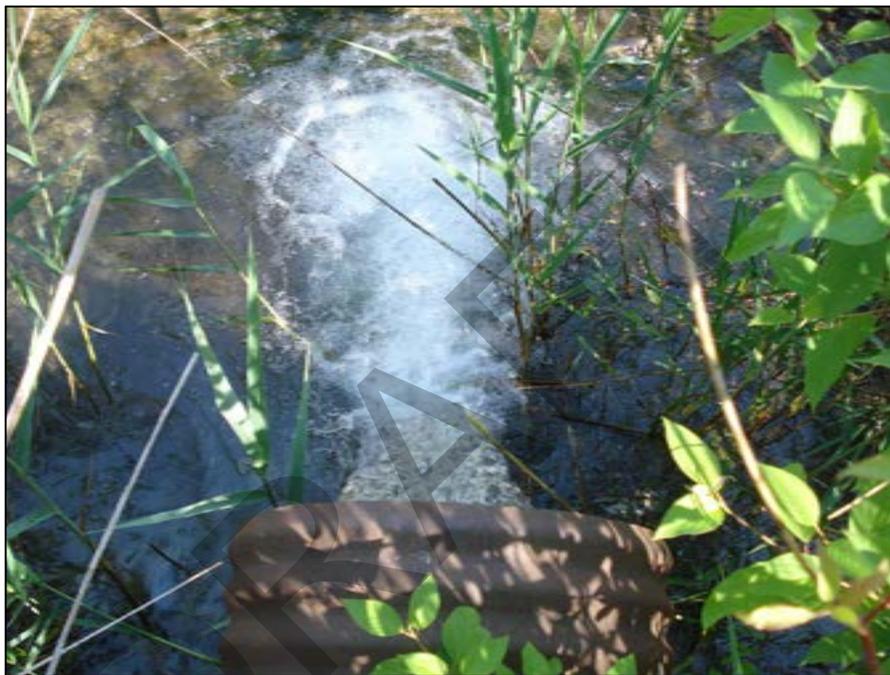
3-11

LOOKING NORTH AT OUTLET TO
DITCH FROM POND 3

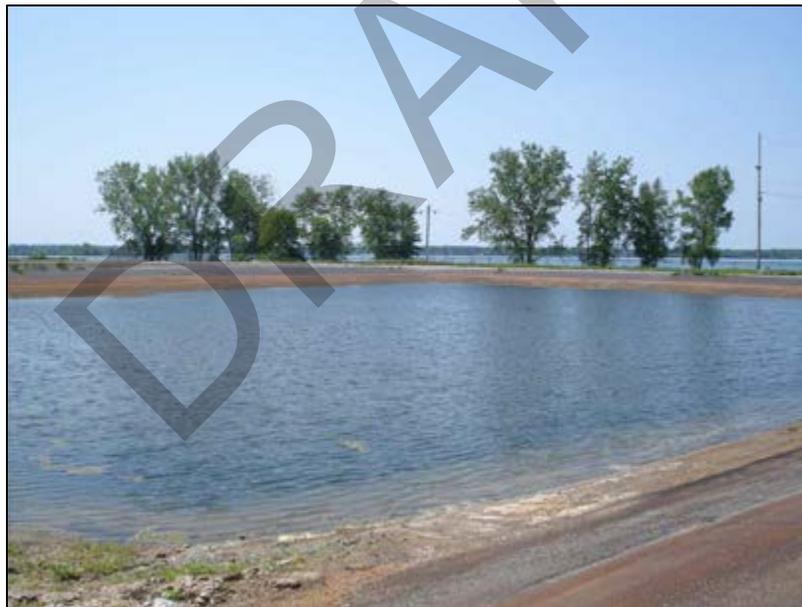
NEQ-2

LOOKING SOUTHWEST ACROSS NORTH EQUALIZATION BASIN, NIAGARA RIVER IN BACKGROUND

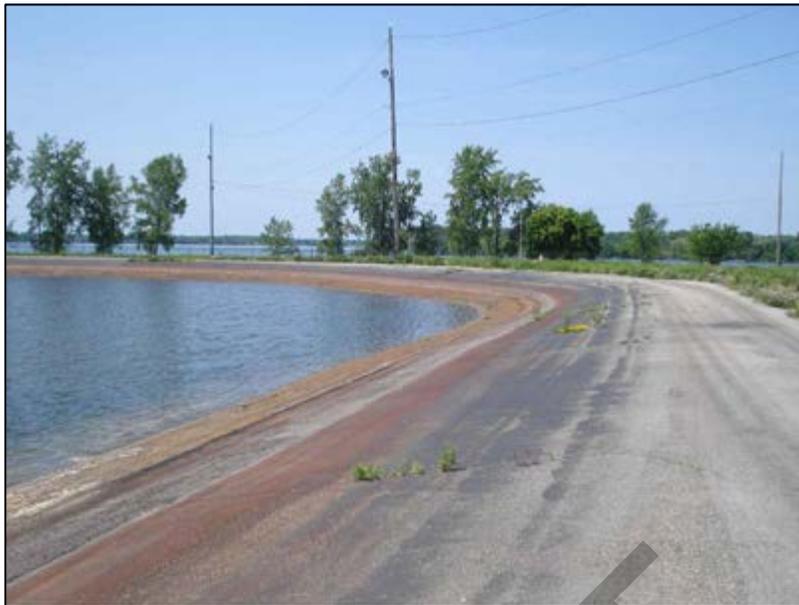
NEQ-3
 LOOKING WEST AT NORTHWEST
 CORNER OF NORTH EQUALIZATION BASIN

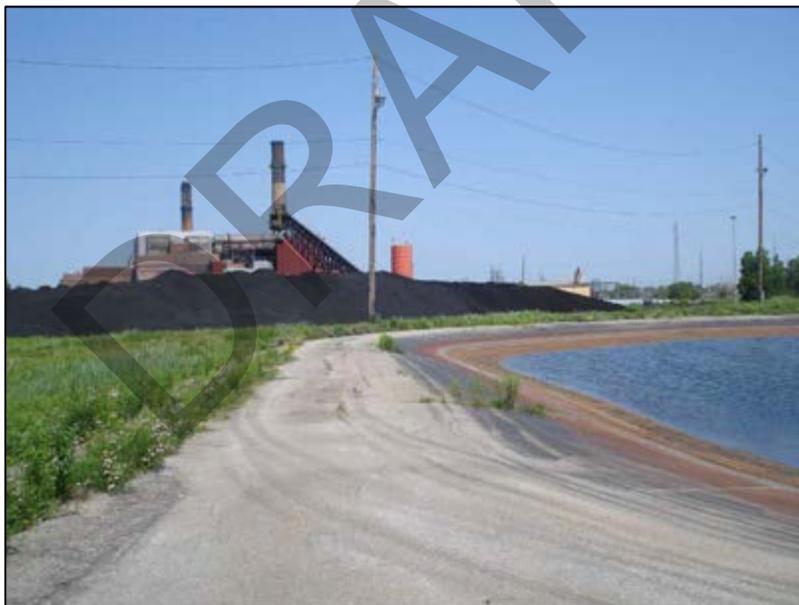
NEQ-4
 BETWEEN EQ PONDS LOOKING NORTH AT
 WEST END OF NORTH EQUALIZATION BASIN

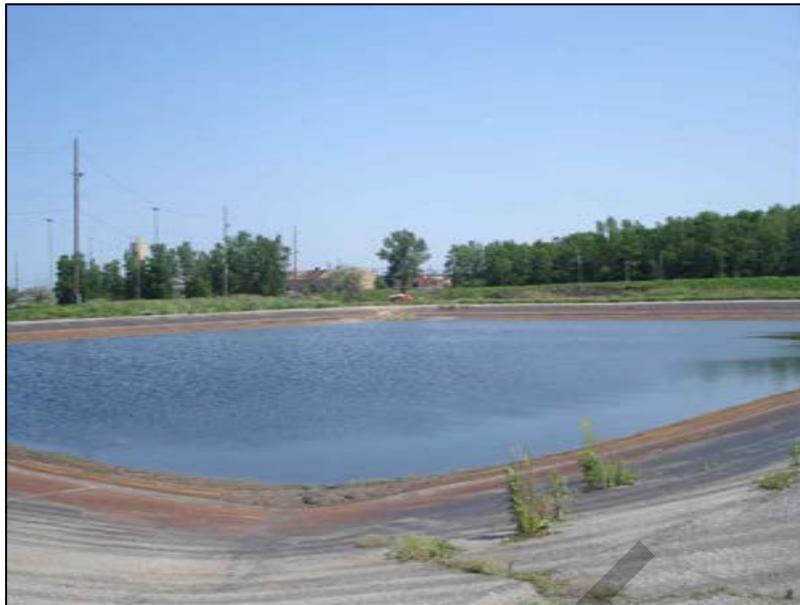
NEQ-5
 BETWEEN EQ PONDS LOOKING NORTHEAST AT
 INTERIOR OF NORTH EQUALIZATION BASIN

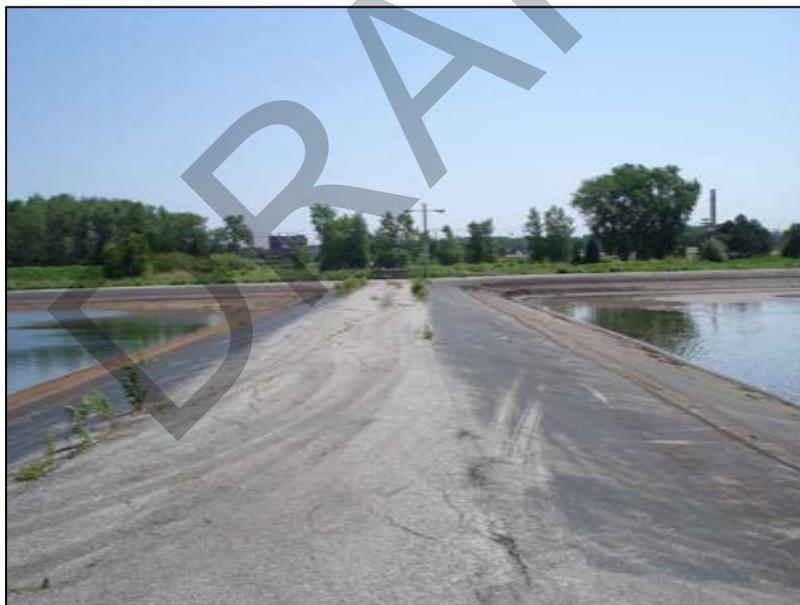
NEQ-6
 BETWEEN EQ PONDS LOOKING EAST AT CREST
 BETWEEN NORTH AND SOUTH EQUALIZATION BASIN

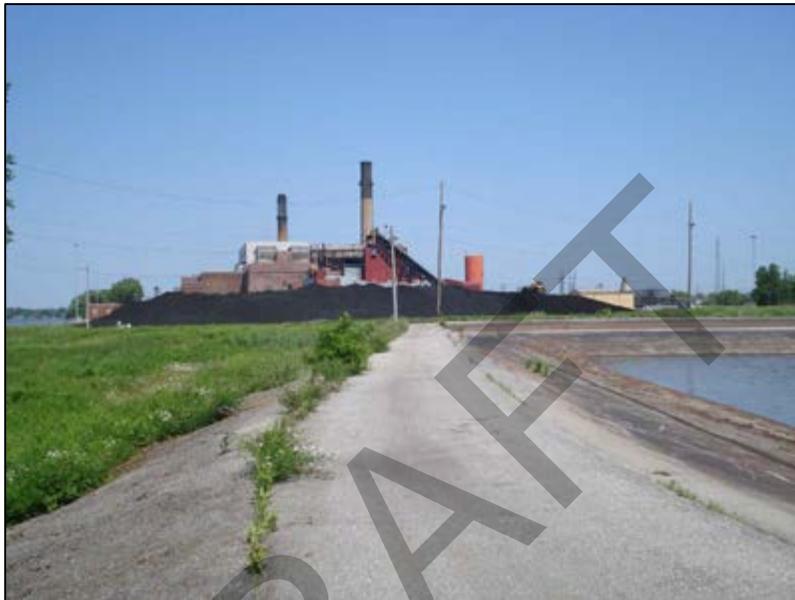
NEQ-7

SOUTHWEST CORNER OF SOUTH EQUALIZATION BASIN LOOKING NORTH AT WEST DIKE OF SOUTH EQUALIZATION BASIN (FOREGROUND) AND NORTH EQUALIZATION BASIN (BACKGROUND)

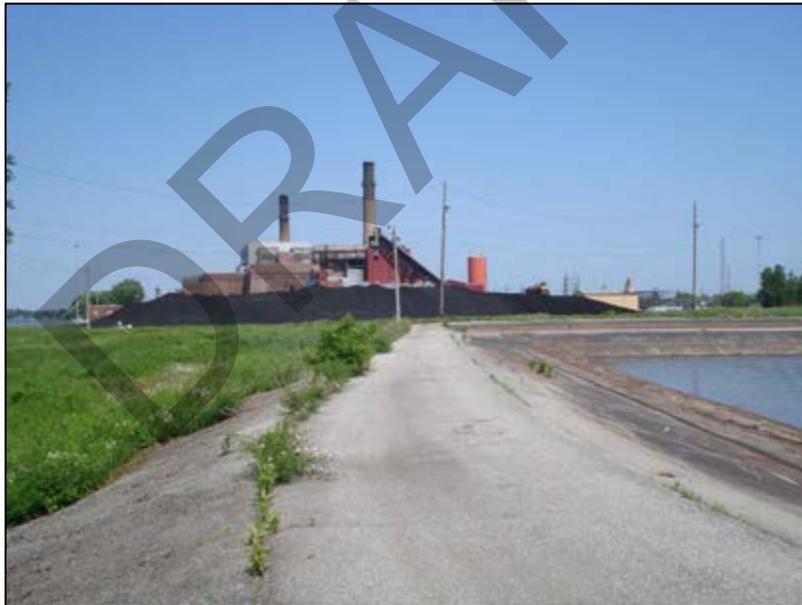
SEQ-4

SOUTHWEST CORNER OF SOUTH EQUALIZATION BASIN LOOKING NORTH

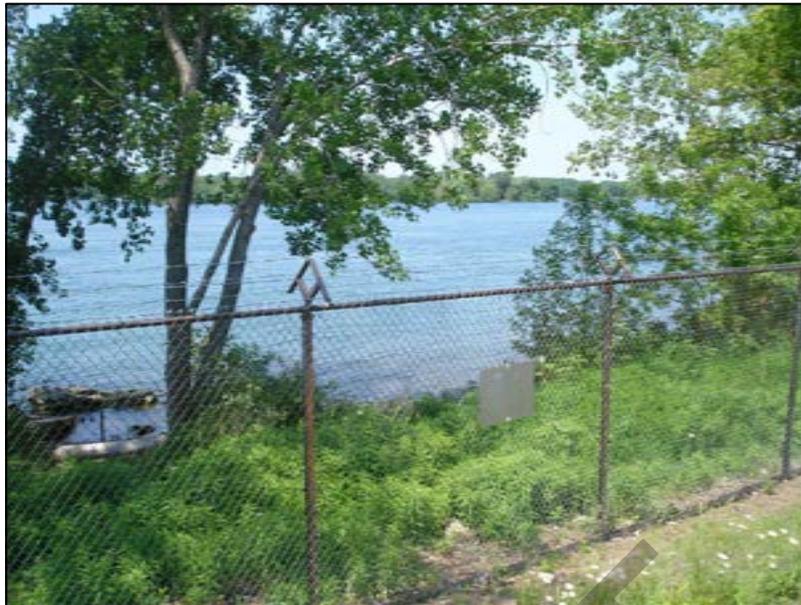
SEQ-5

SOUTHWEST CORNER OF SOUTH EQUALIZATION BASIN LOOKING WEST AT TOE OF DOWNSTREAM SLOPE/BANK OF NIAGARA RIVER

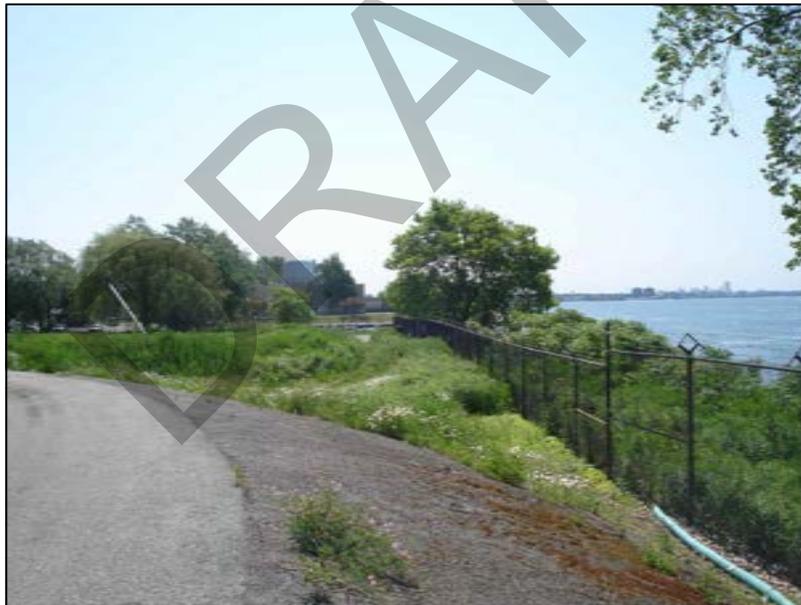
SEQ-6

SOUTHWEST CORNER OF SOUTH EQUALIZATION BASIN LOOKING SOUTH AT DOWNSTREAM SLOPE, SOUTH POND OUTLET IN BACKGROUND.

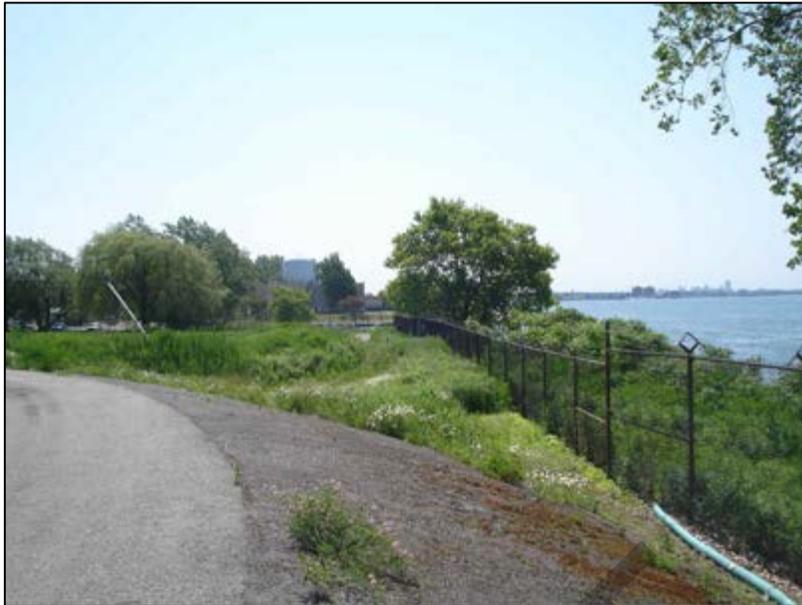
S-3

LOOKING SOUTH TOWARD AREA AT SOUTHWEST END OF SOUTH POND AND OUTLET, SOUTH POND OUTLET PIPE EXPOSED IN BACKGROUND

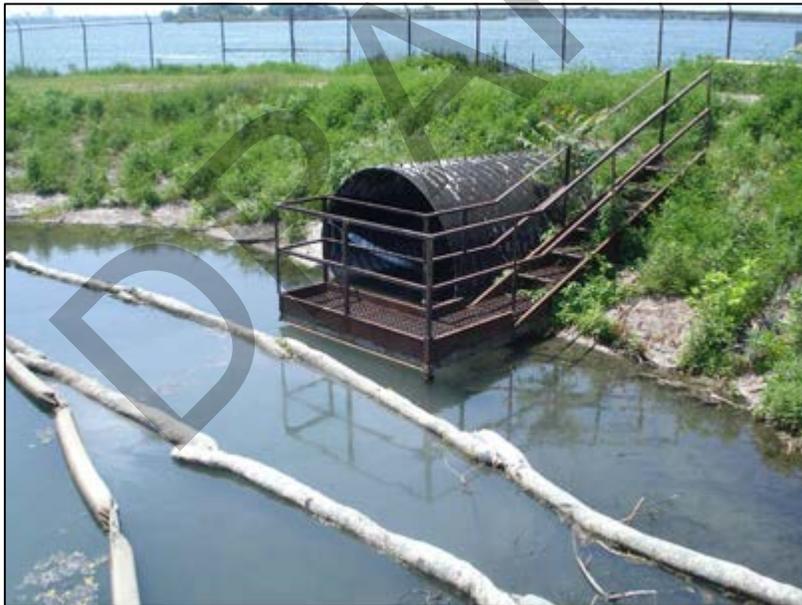
S-4

INLET OF OUTLET PIPE AT SOUTH POND, SKIMMER BOOMS UPSTREAM FROM OUTLET.

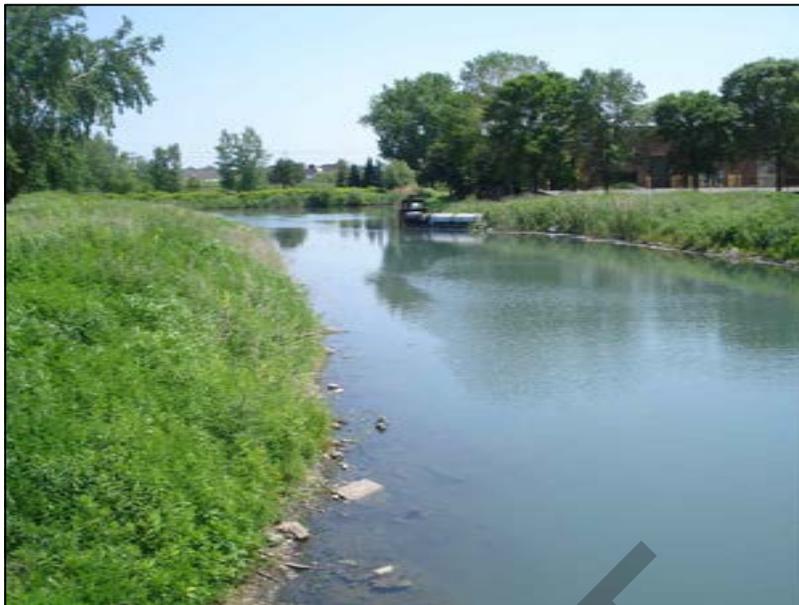
S-5
NEAR SOUTH POND OUTLET LOOKING EAST
AT INTERIOR OF POND, HIGH VEGETATION

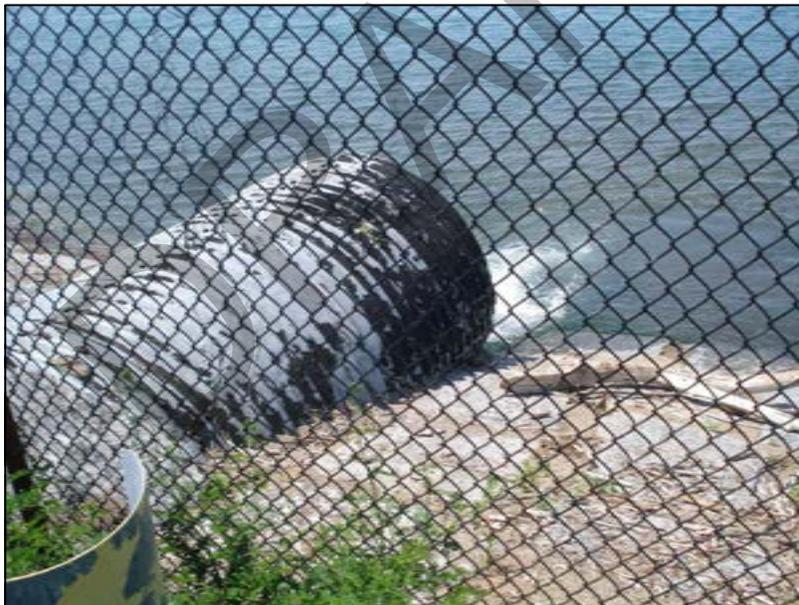
S-6
OUTLET OF SOUTH POND TO NIAGARA RIVER

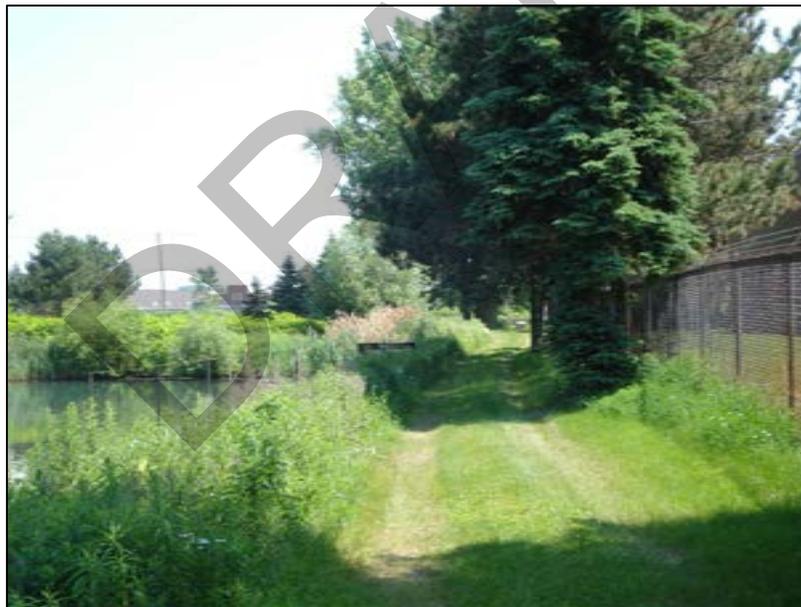
S-10

FROM SOUTH DIKE LOOKING EAST AT SOUTHEAST CORNER OF POND, SOUTH US SLOPES AND CREST, HIGH VEGETATION
