Coal Combustion Residue Impoundment

Round 9 - Dam Assessment Report

L.V. Sutton Steam Electric Plant

Ash Ponds

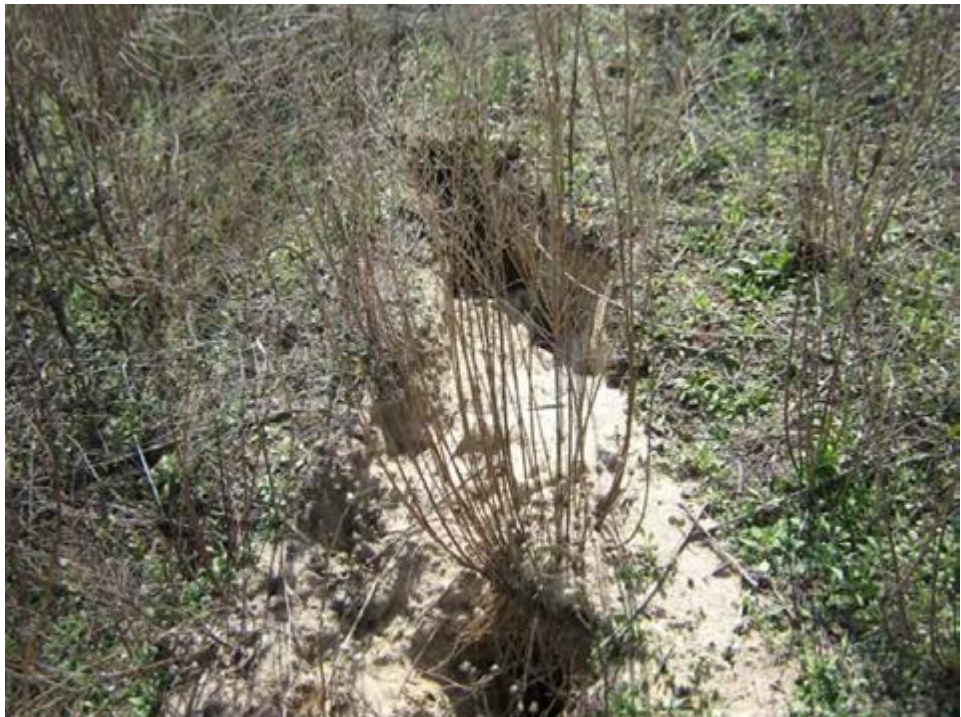
There were no signs of surficial sloughing along the downstream slope. Rill erosion and animal burrows were found in multiple places along the embankment. There were also areas that were bare and need to be seeded.

Animal burrows along downstream slope, 1984 Ash Pond

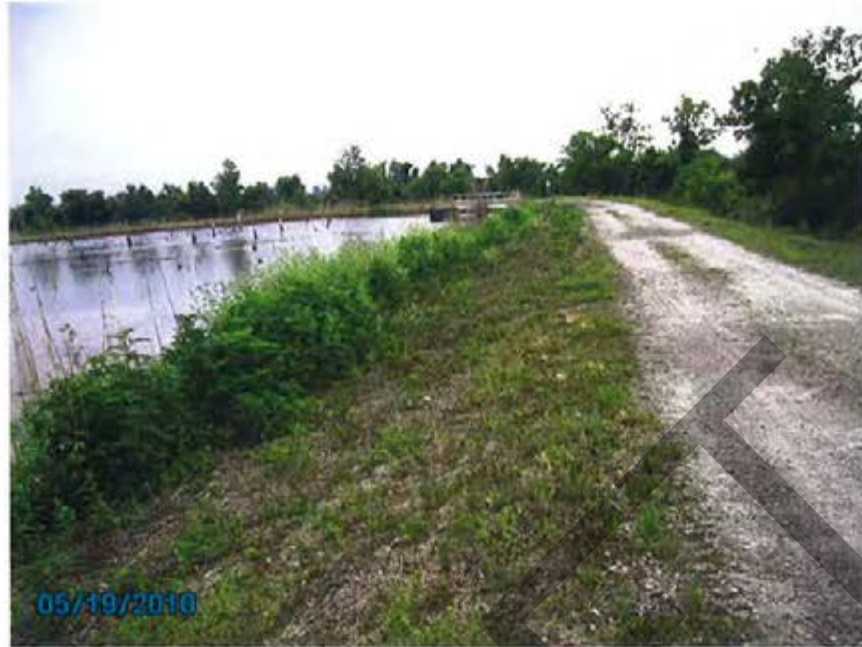
1. 1983/1971 Ash Pond – View of interior slope for west dike looking toward discharge structure.

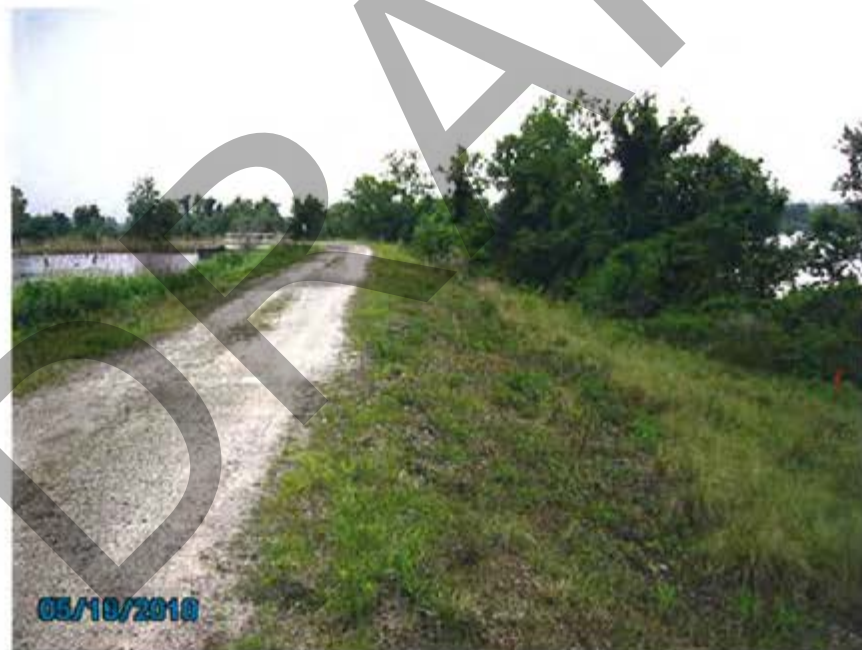
2. 1983/1971 Ash Pond – View of exterior slope for west dike looking toward discharge structure.

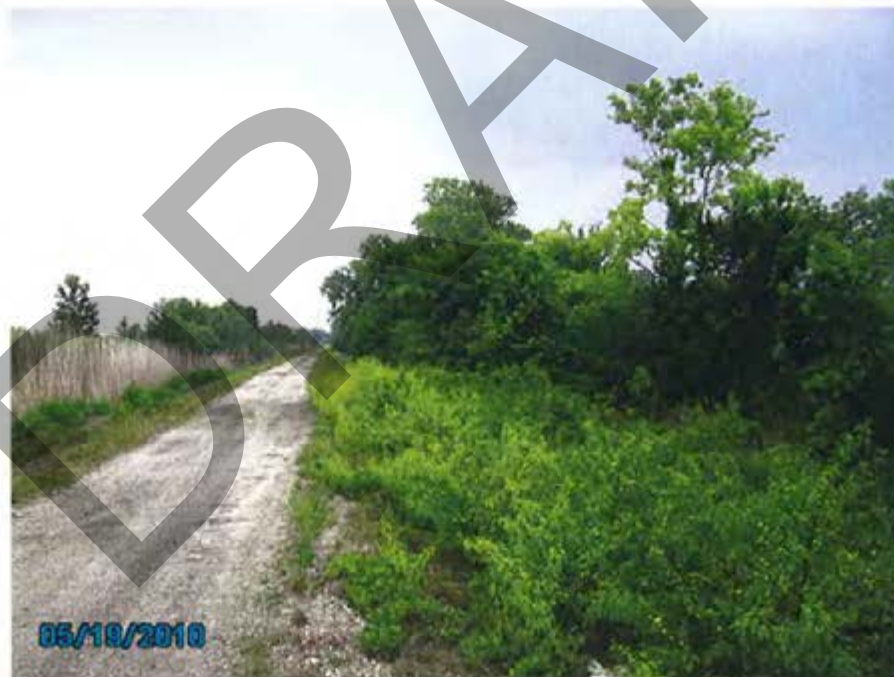
4. 1983/1971 Ash Pond – View of exterior slope for south dike.

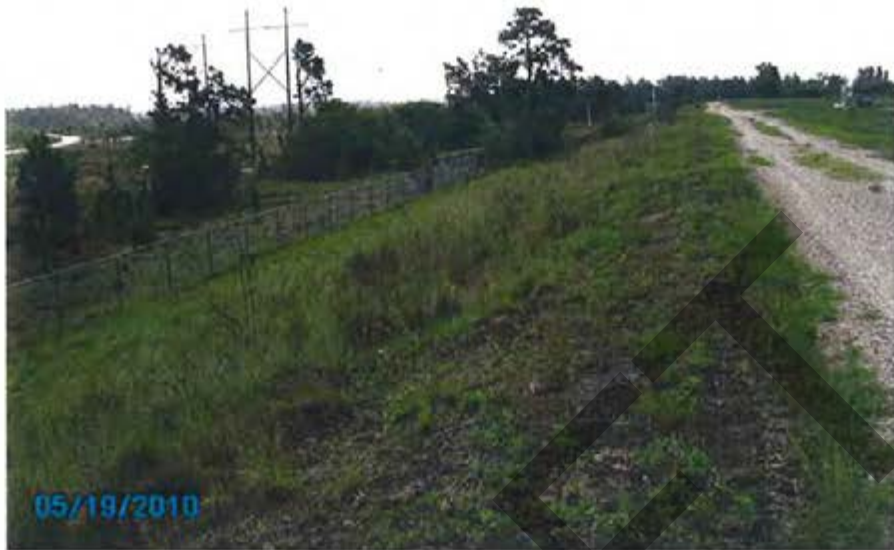
5. 1984 Ash Pond - View of exterior slope for east dike looking south.

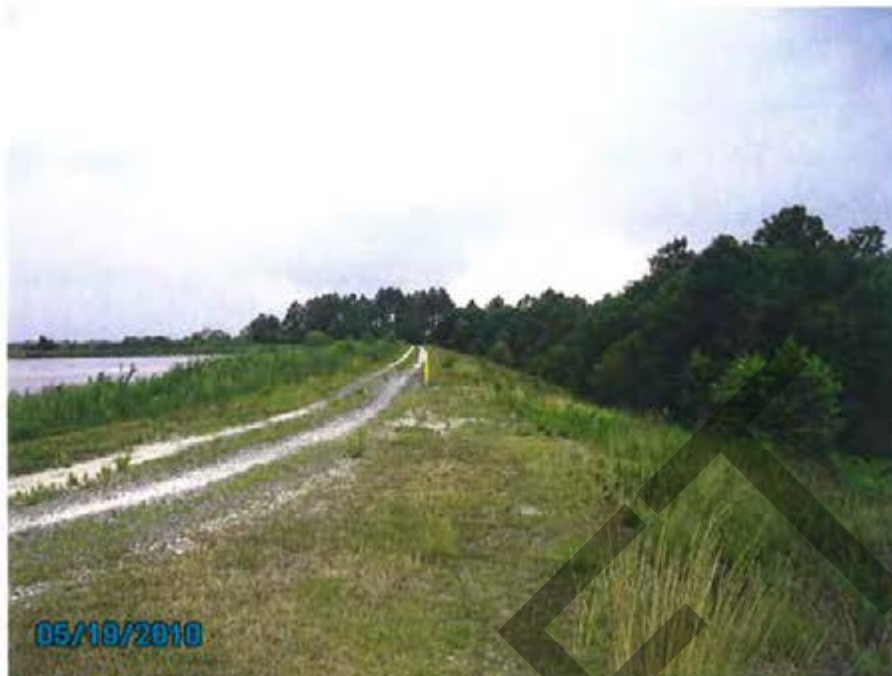
9. 1984 Ash Pond – View of exterior slope for south dike looking west (at northeast corner).

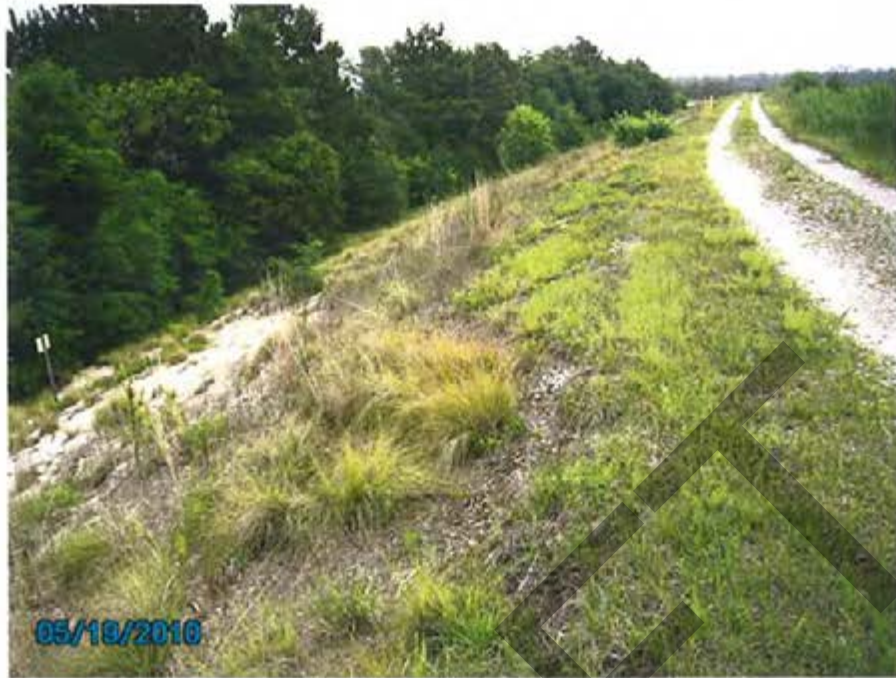
11. 1984 Ash Pond – View of exterior slope for south dike looking toward east (at northwest corner).

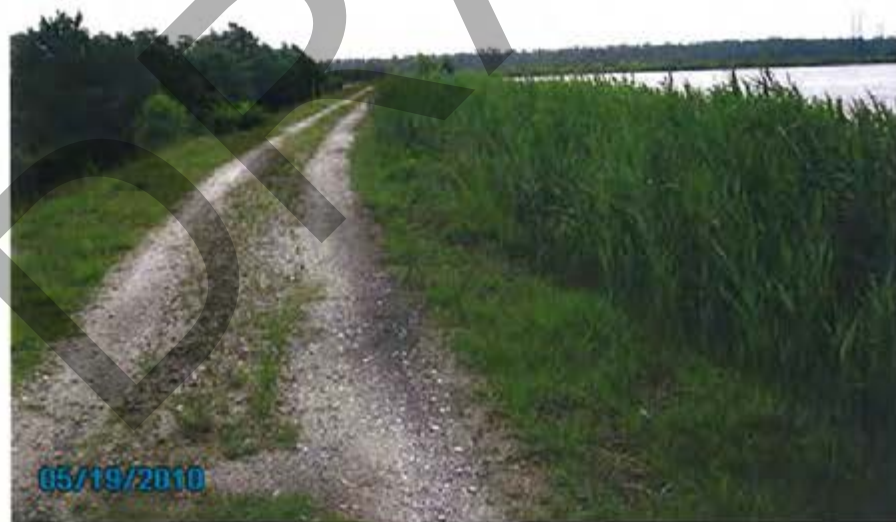
12. 1984 Ash Pond – View of exterior slope for south dike looking east (at northwest corner).

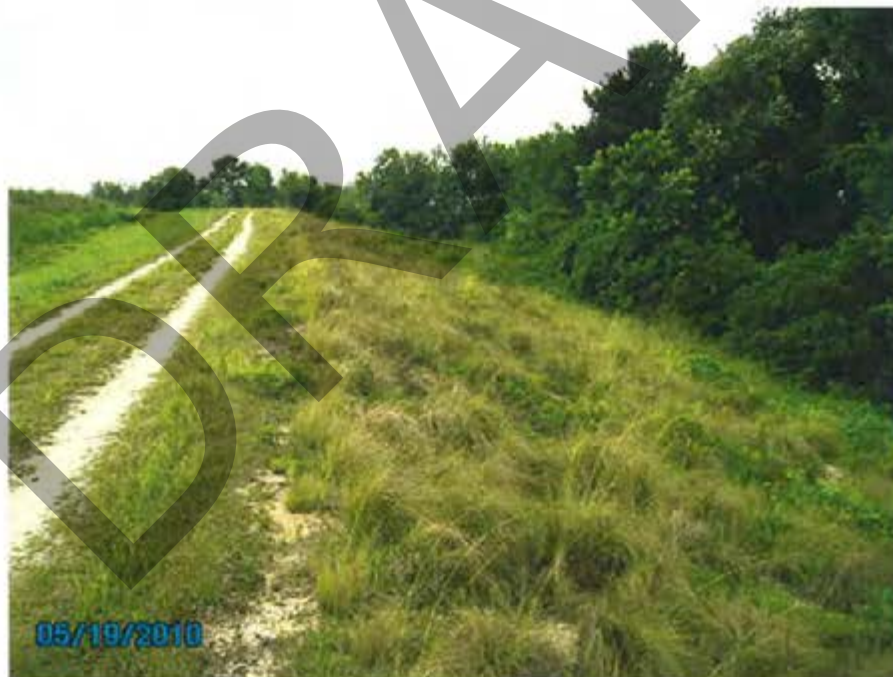
16. 1984 Ash Pond – View of exterior slope for west dike looking south.

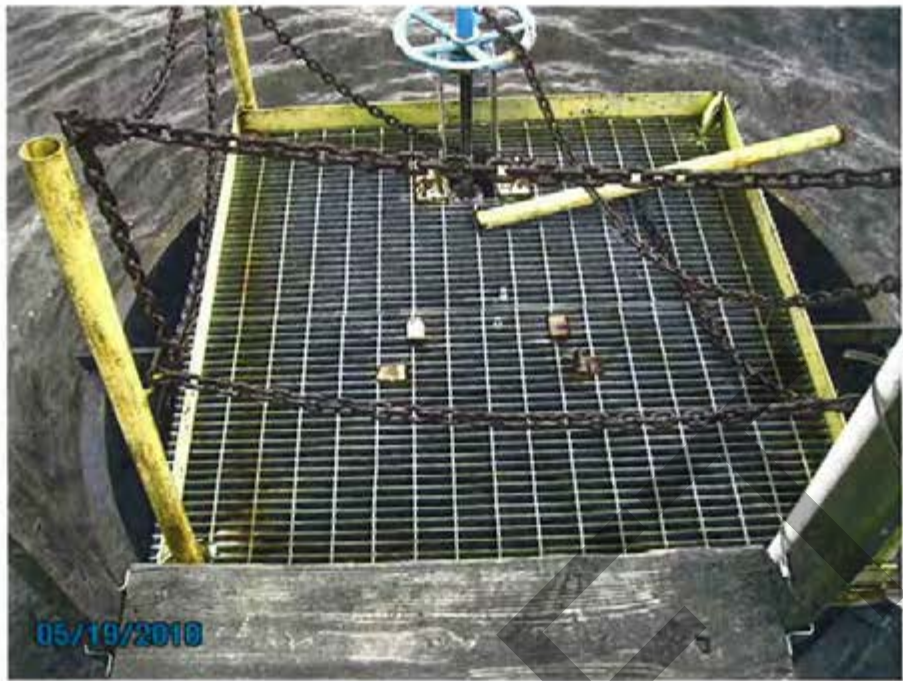
19. 1984 Ash Pond – View at top of platform mounted on skimmer for discharge structure.

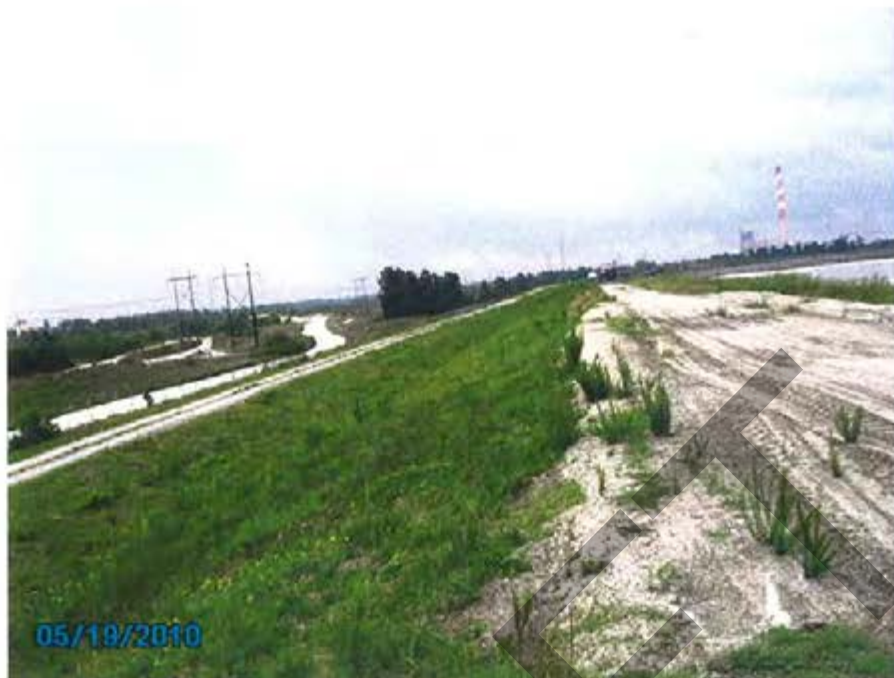
21. 1984 Ash Pond/Interior Storage – View of exterior slope for containment dike looking south.

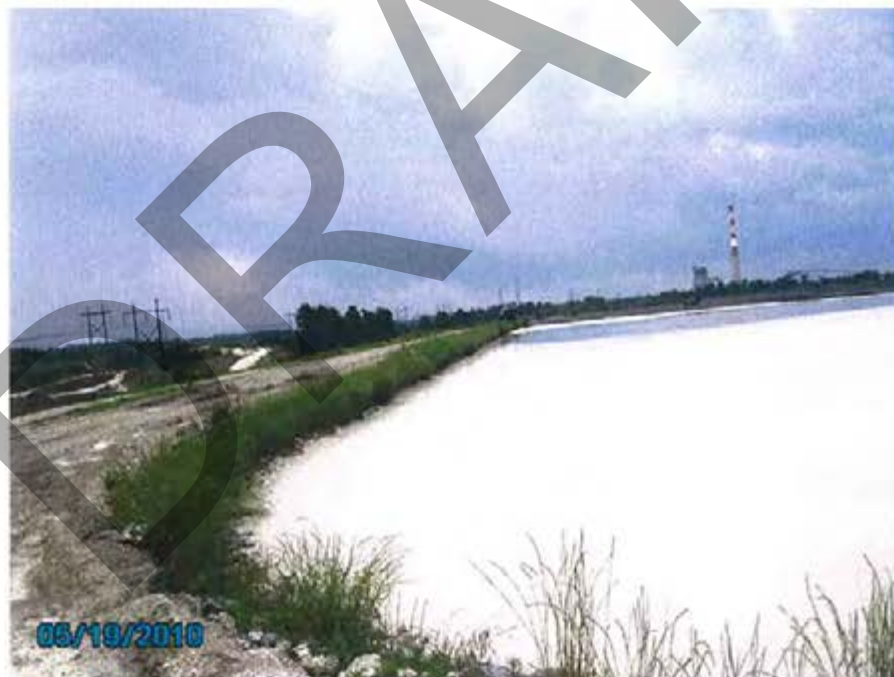
22. 1984 Ash Pond/Interior Storage – View of interior slope for containment dike looking south.

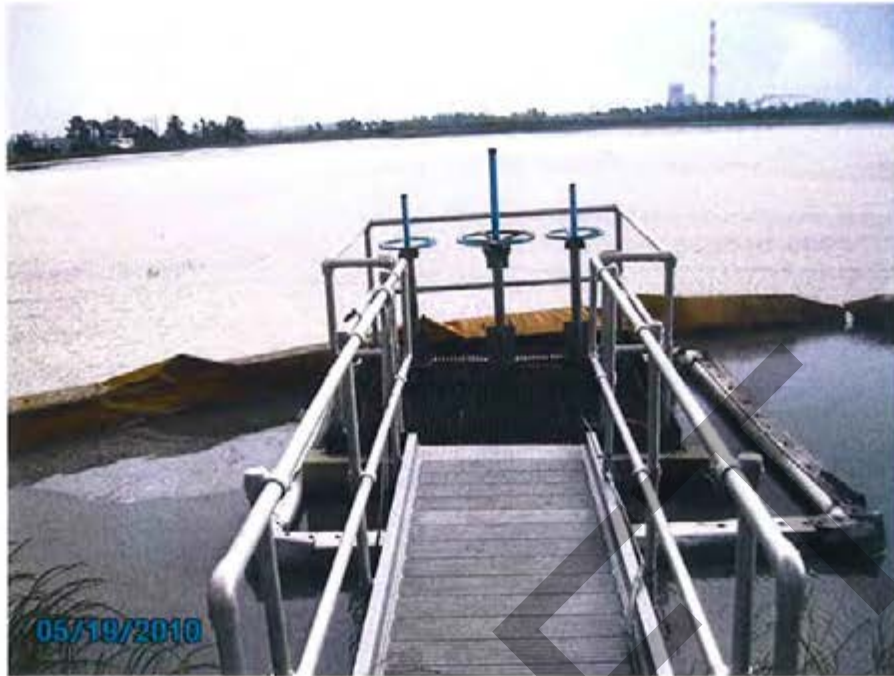
25. 1984 Ash Pond/Interior Storage – View of discharge structure from access platform.
