US EPA ARCHIVE DOCUMENT

| Site Name: <u>Progress Energy Asheville</u> | Date: <u>29 MAY 2009</u> |
| Unit Name: <u>1964 POND</u> | Operator's Name: <u>PROGRESS ENERGY</u> |

PHOTOGRAPH LOCATION PLAN  
ASH PONDS - PROGRESS ENERGY  
ASHEVILLE STEAM ELECTRIC PLANT  
SKYLAND, NORTH CAROLINA

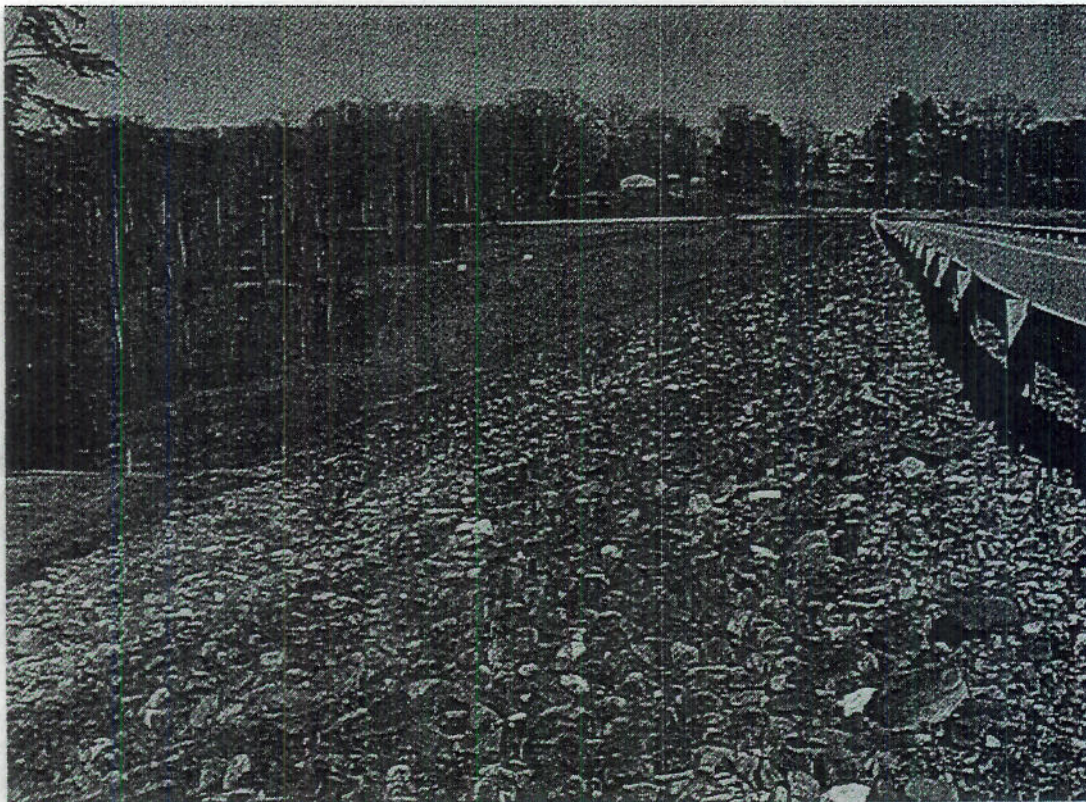
Photograph 2: Cooling Lake Dam – downstream slope looking north.

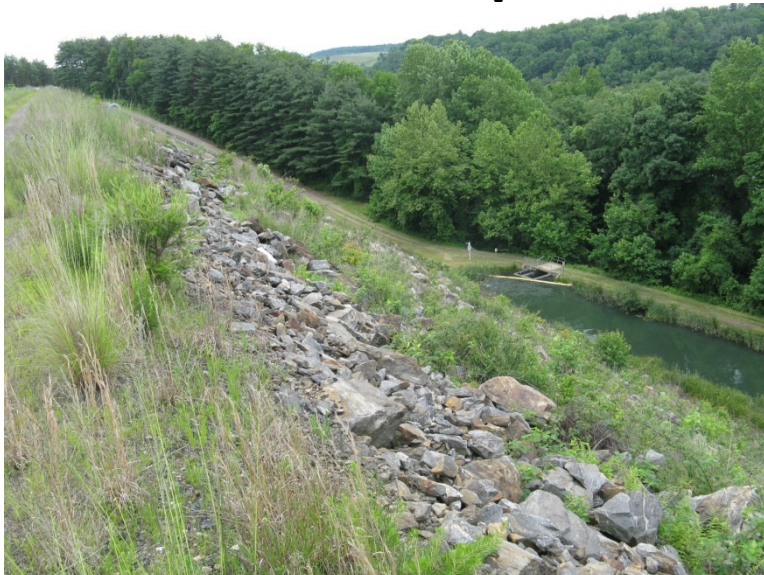
Photo 1: 1964 Dam - Downstream Embankment and Stilling Pond, Crest, Photo: 051, 5/29/09

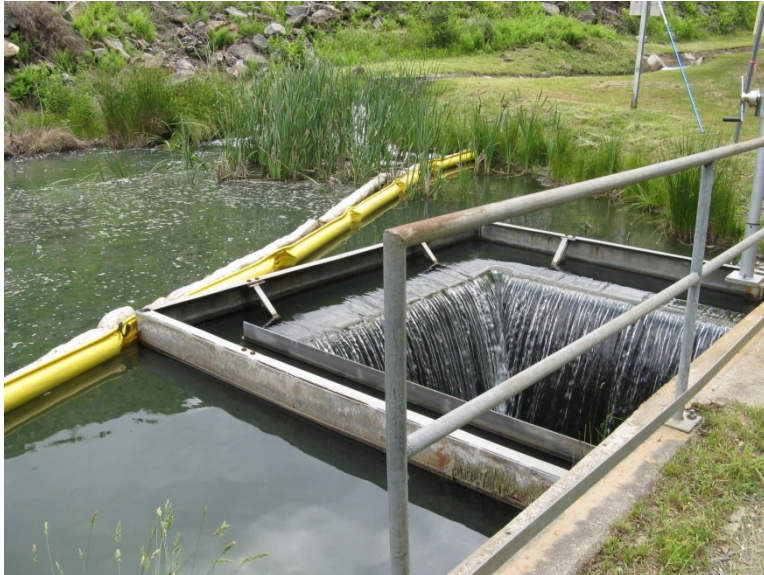
Photo 3: 1964 Dam - Stilling Pond Outlet, Toe, Photo: 070, 5/29/09

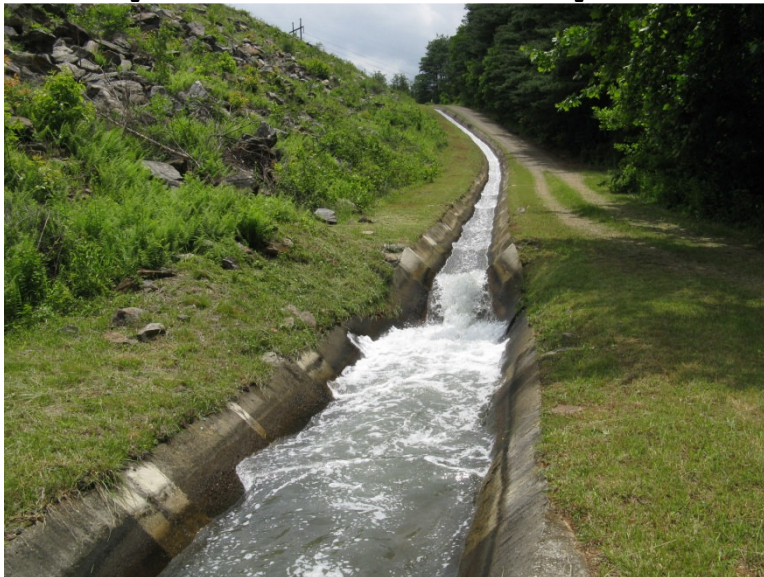
Photo 4: 1964 Dam - Concrete Flume, Right Groin, Photo: 083, 5/29/09  
(note: right and left are based on the observer facing downstream)

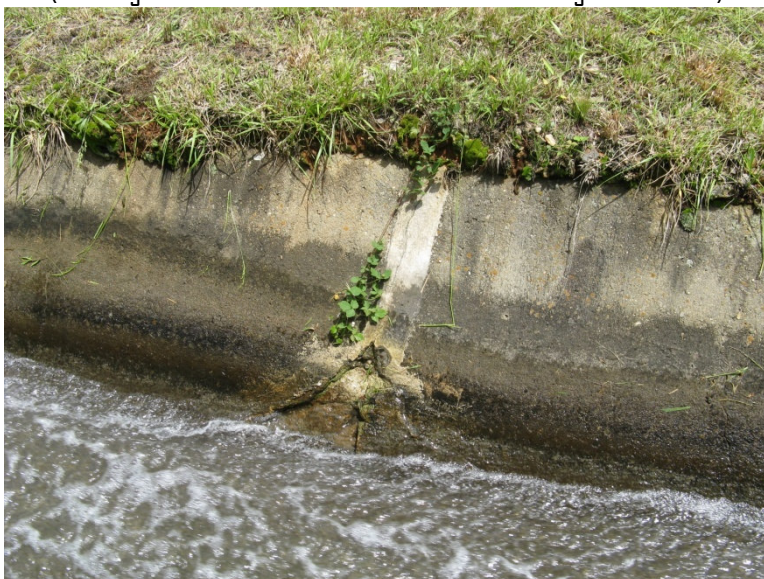
Photo 7: 1964 Dam - Stilling Pond Outfall, Toe, Photo: 086, 5/29/09

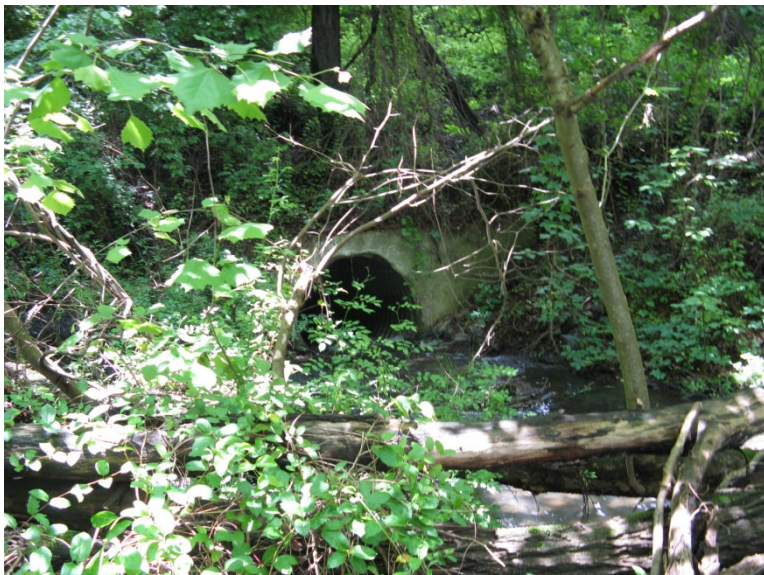
Photo 9: 1964 Dam – Internal Drain, Toe, Photo: 081, 5/29/09

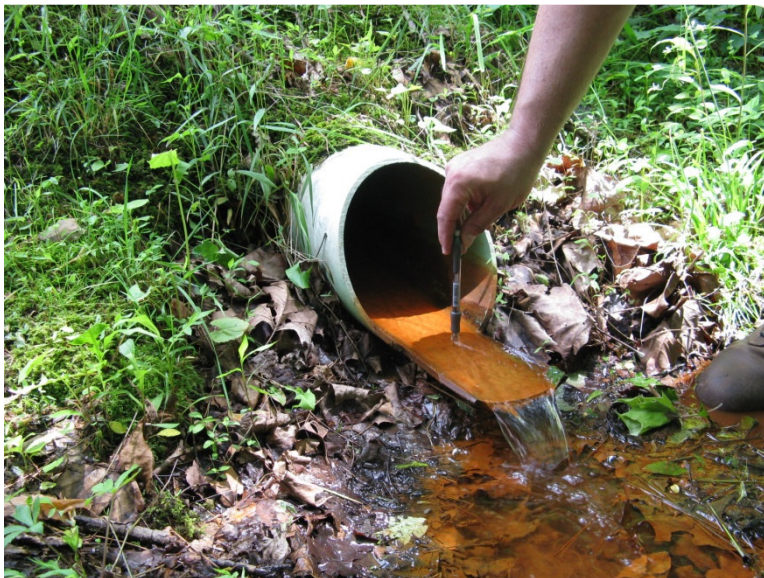
Photo 10: 1982 Dam - Weir Outlet for Internal Drain, Toe, Photo: 006, 5/29/09

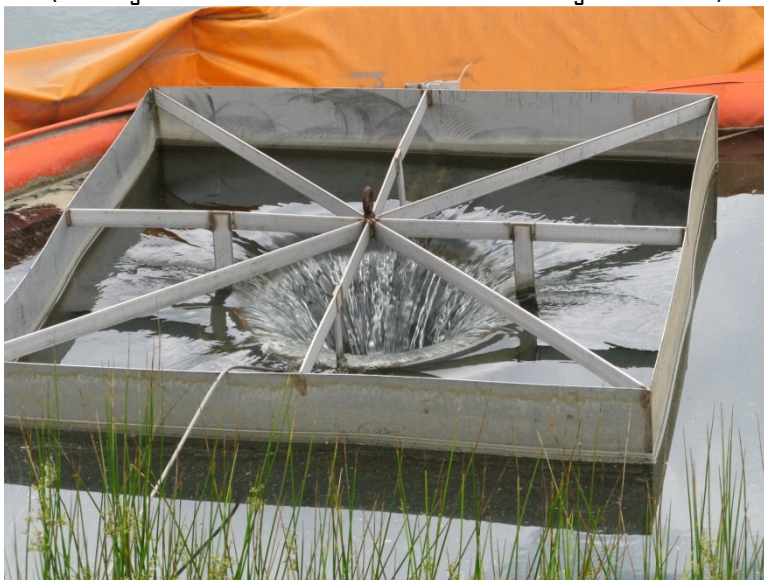
Photo 13: 1982 Dam - Primary Outlet, Right Abutment, Photo: 099, 5/29/09  
(note: right and left are based on the observer facing downstream)

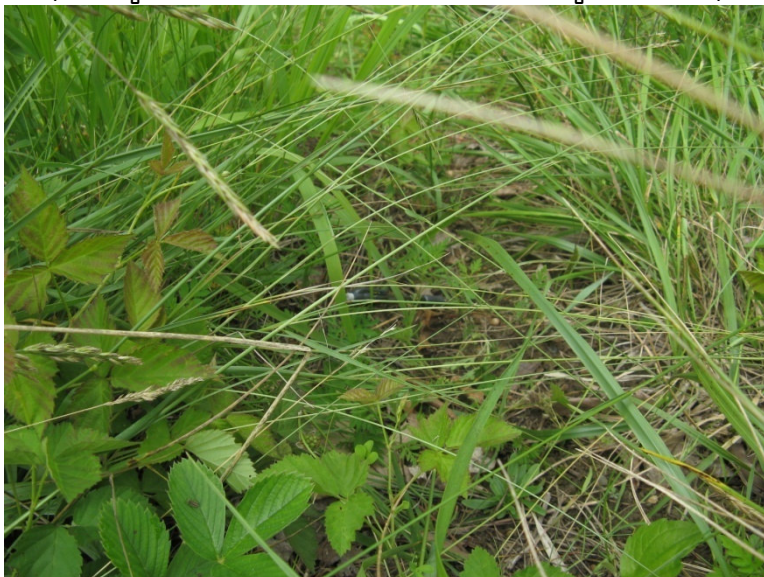
Photo 14: 1982 Dam - Animal Burrow, Downstream Embankment 50' Right of Piezometer, Photo: 028, 5/29/09  
(note: right and left are based on the observer facing downstream)

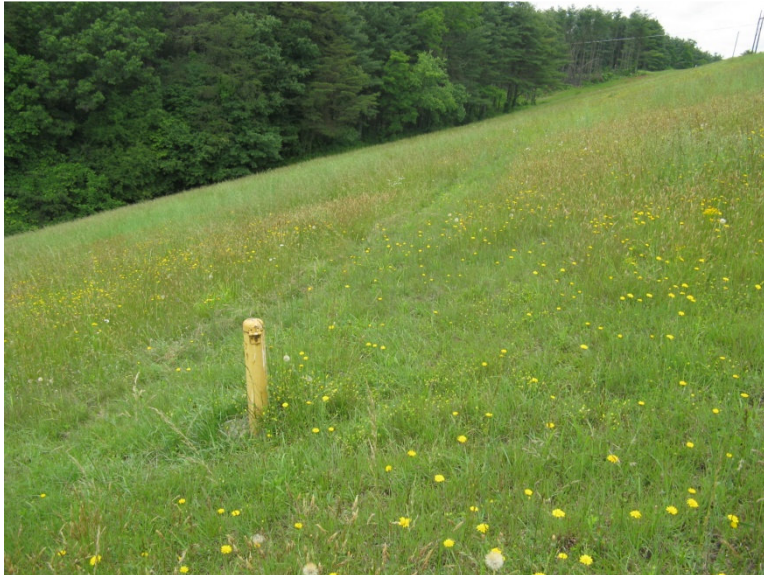
Photo 15: 1982 Dam - Midsection of Downstream Slope, Downstream Embankment, Photo: 030, 5/29/09

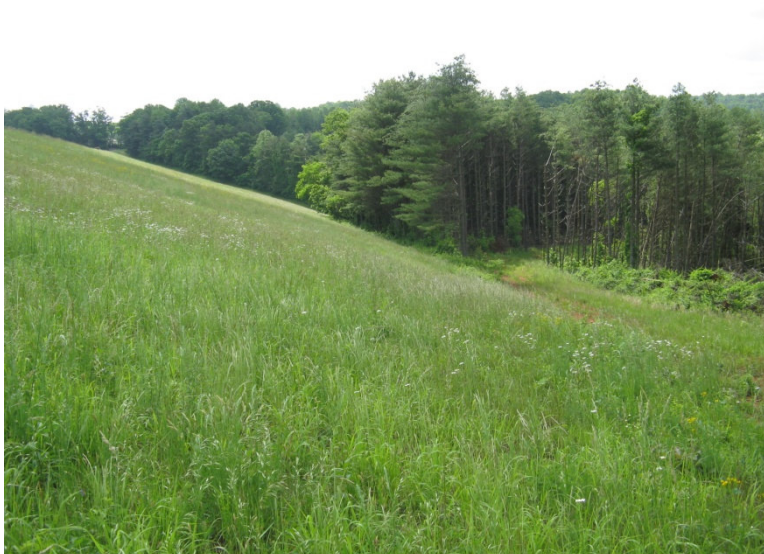
Photo 16: 1982 Dam - View of Right Groin, Right Abutment, Photo: 016, 5/29/09  
(note: right and left are based on the observer facing downstream)

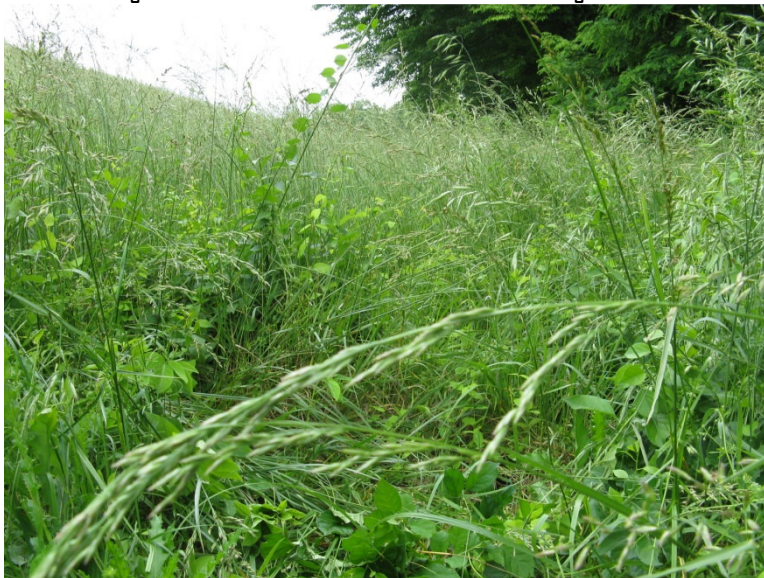
Photo 17: 1982 Dam – Tall Vegetation, Left Groin, Photo: 037, 5/29/09  
(note: right and left are based on the observer facing downstream)
