# Assessment of Dam Safety Coal Combustion Surface Impoundments Draft Report

Progress Energy  
Carolinas  
Cape Fear Plant

Moncure, North Carolina

July 17, 2009

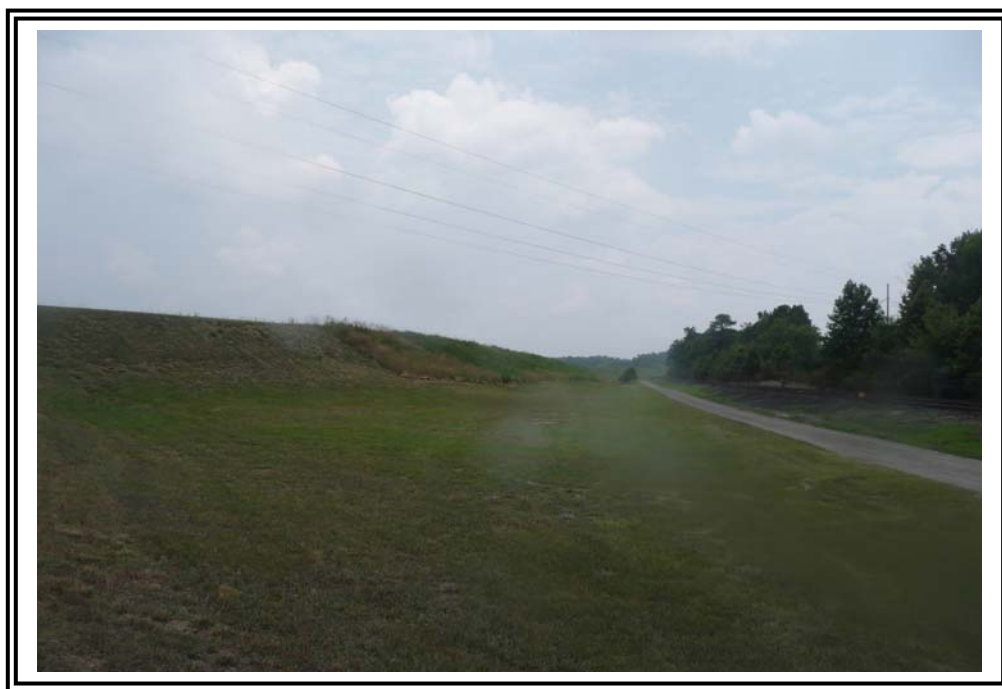
1

Northwest end of 1985 Ash Pond West Dike, looking southeast.

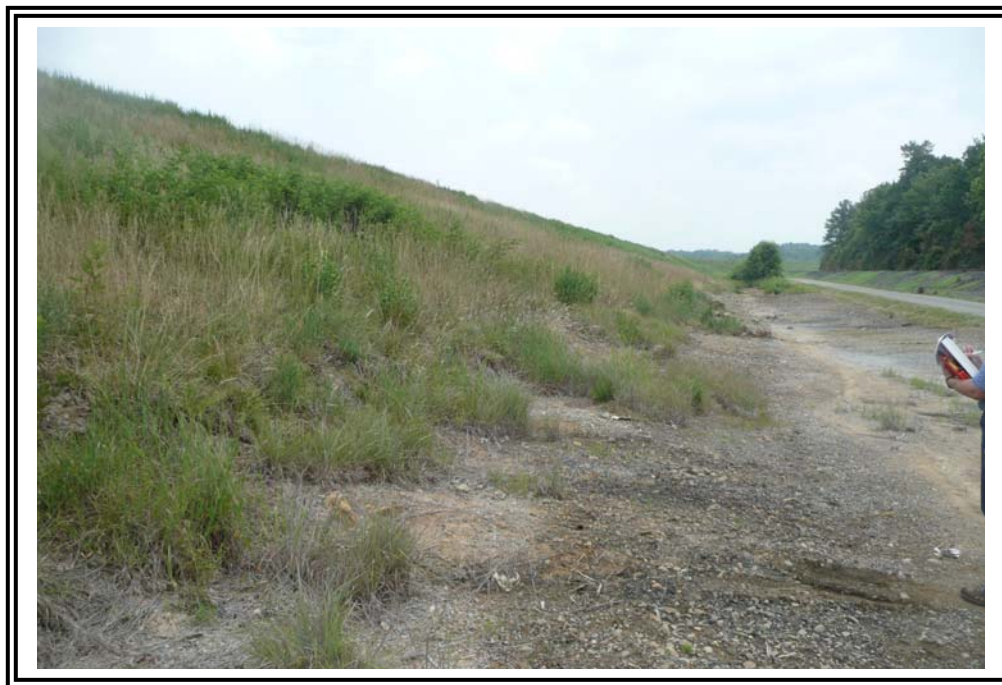
2

1985 Ash Pond West Dike toe along the northern portion of Dike.

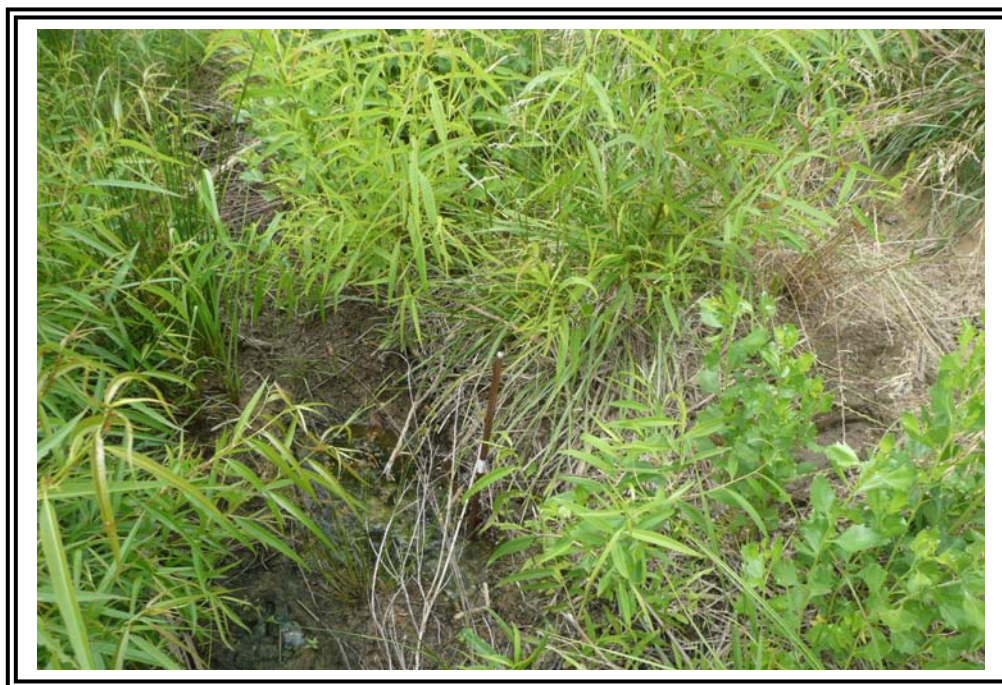
Soft soil at the toe of the 1985 Ash Pond West Dike. Probe pushed into the ground about 2 feet.

Along the west dike of the 1985 Ash Pond, an area of ponded water occurs between the toe of the dike and the access road. While there is a twin culvert extending below the access road and railroad tracks, it appears from evidence of the depth of ponding and erosion from this ponding observed in during CHA's visit, that the capacity and or pitch of these culverts is inadequate to drain the area. The result of the standing water is not only the softening exhibited in Photos 8 and 9 but beaching erosion resulting in toe loss as shown in Photo 3.

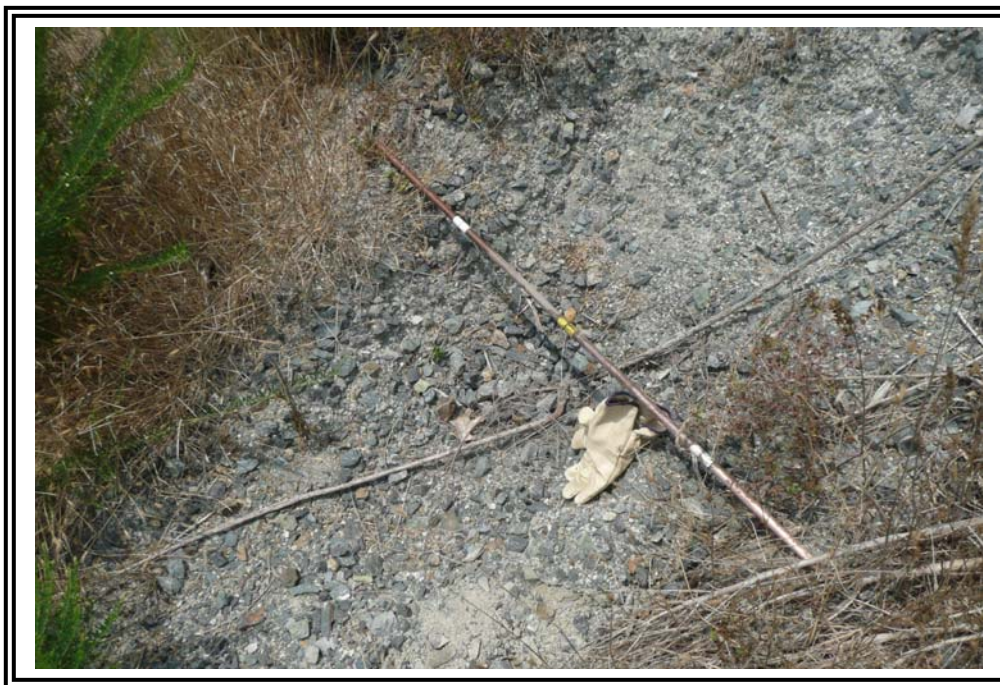
Along the west dike, many voids were observed in the upper portion of the downstream slope. Progress Energy personnel indicated that these were rodent holes that were filled with gravel fill during routine maintenance. Photo 10 shows an area of this stone fill. Photo 12 shows an open void.

Stone filled erosion and /or abandoned rodent hole on the 1985 Ash Pond West Dike.  
Progress Energy reports filling rodent holes and erosion features with gravel.

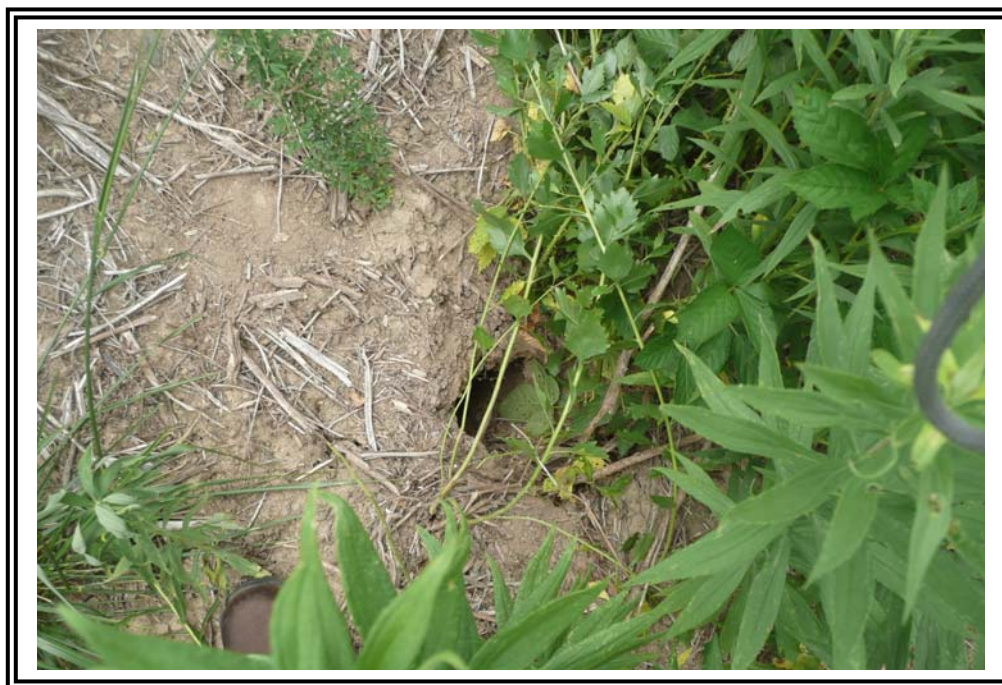
12

Rodent hole on the 1985 Ash Pond West Dike.

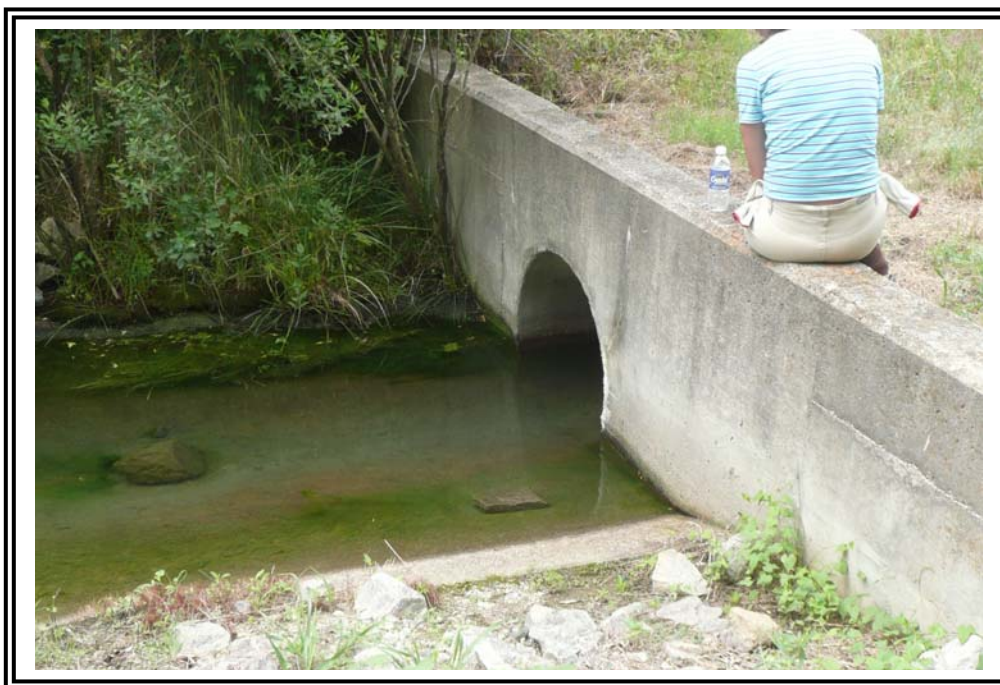
14

Culvert under the access road at the toe of the 1985 Ash Pond West Dike outlet channel.

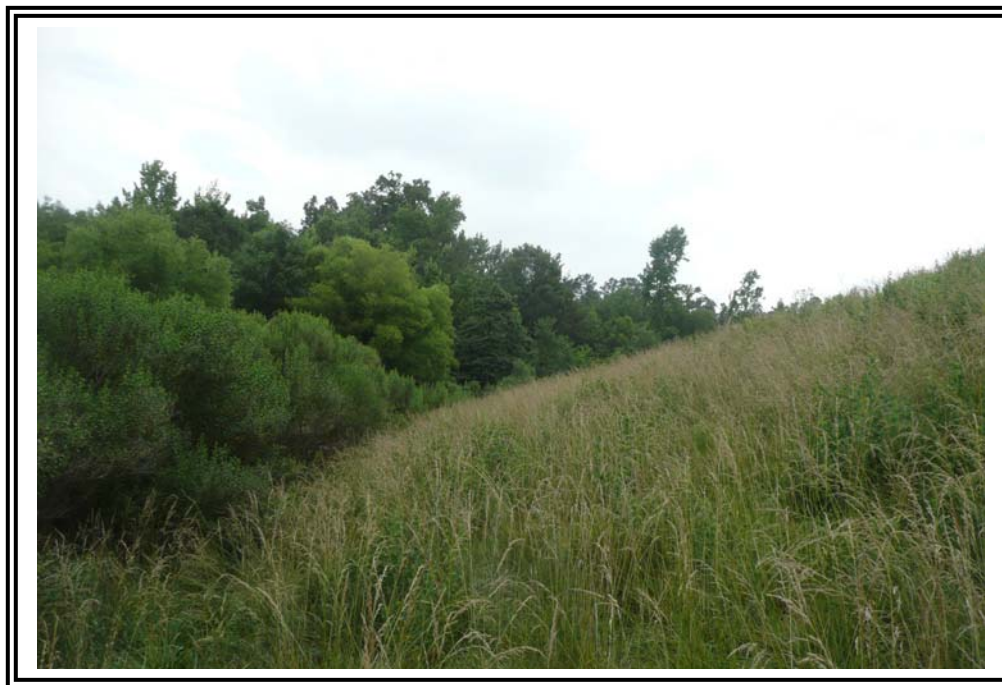
16

Southeast corner of the 1985 Ash Pond Dike, looking southwest.

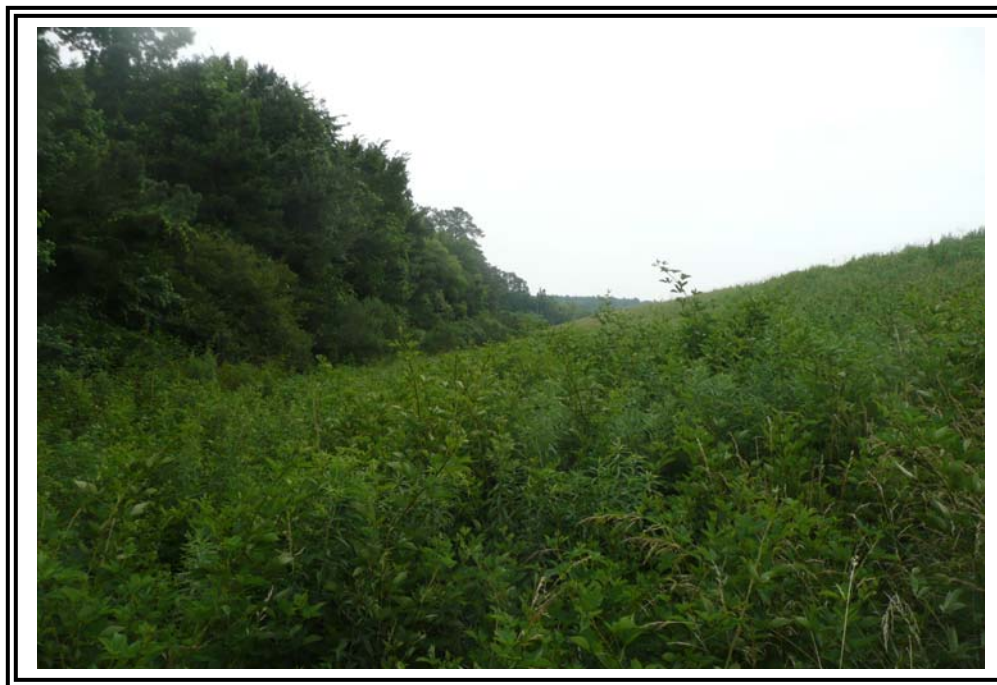
18

East Dike of the 1985 Ash Pond, looking south.

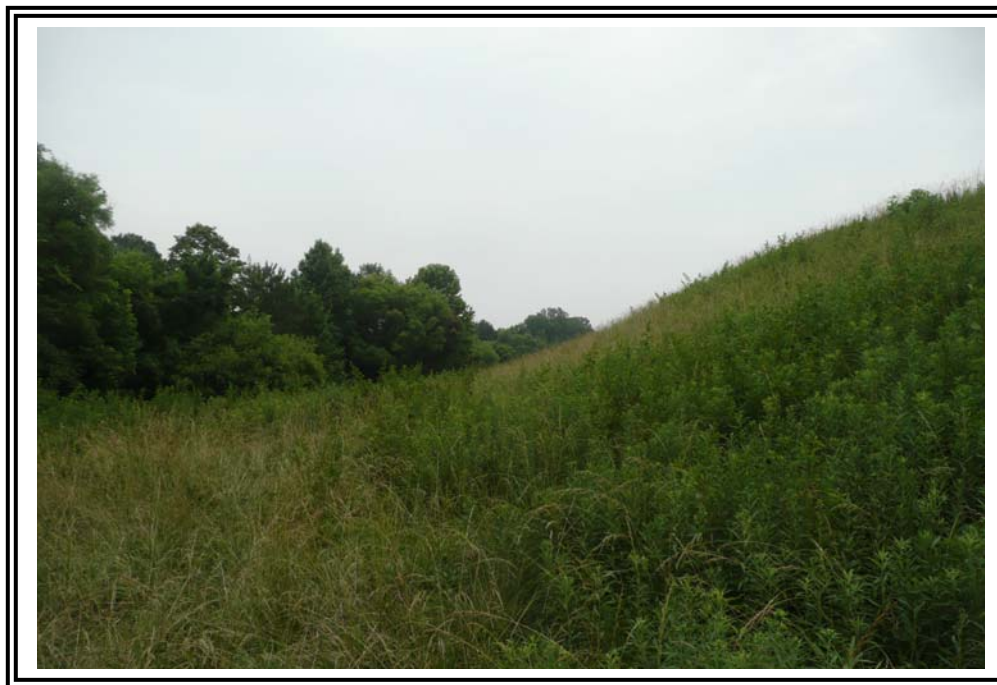
20

Corner at the north and northeast Dike of the 1985 Ash Pond, looking east.

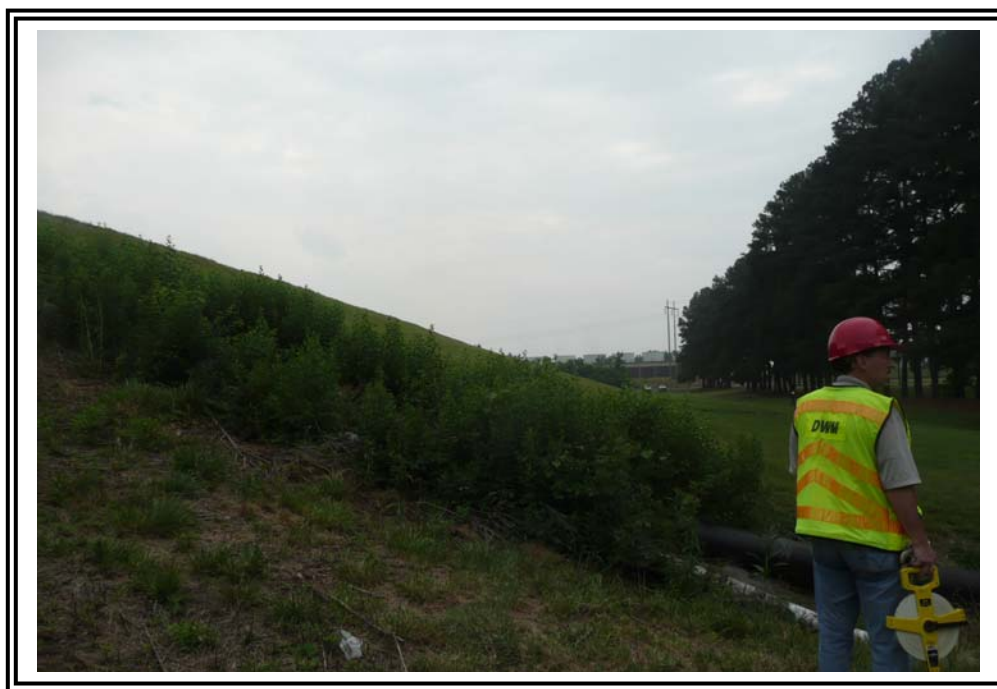
21

North Dike of the 1985 Ash Pond, looking southwest.

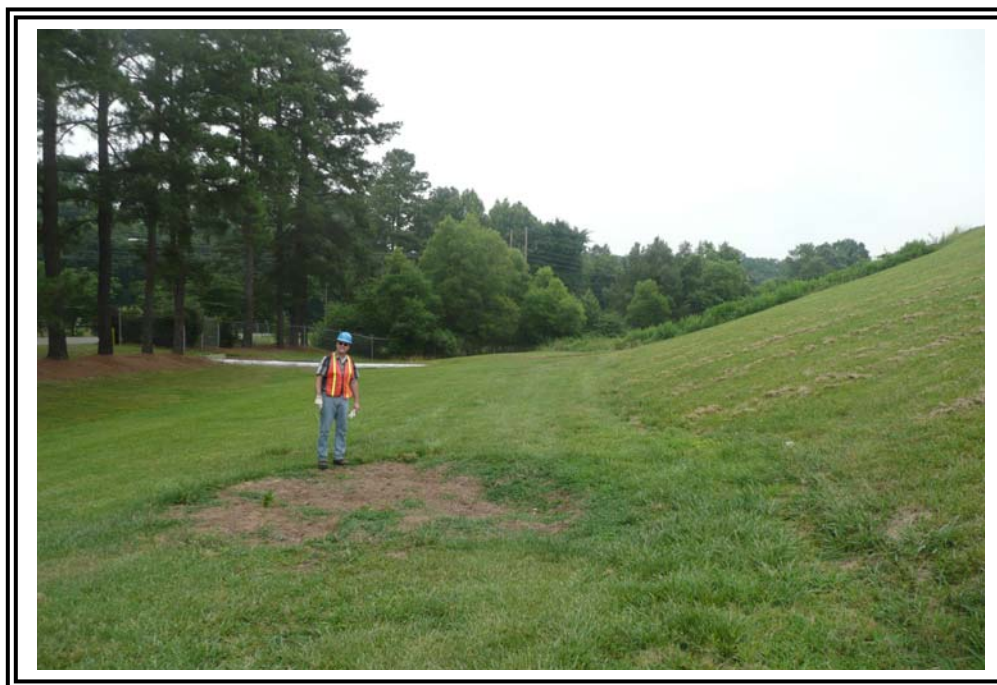
22

The downstream slope along the north dike is mowed, appropriate grass vegetation as shown in Photo 23. In this area, the downstream slope appeared uniform. A bare patch was observed just beyond the toe of the north dike as shown in Photo 22. Progress Energy personnel indicated that they had recently observed this area and that they did not know of something having been placed in this area to cause that might have caused the grass to die off.

Toe of the North Dike of the 1985 Ash Pond, looking northeast.  
Note: Bare patch at the toe of the Dike

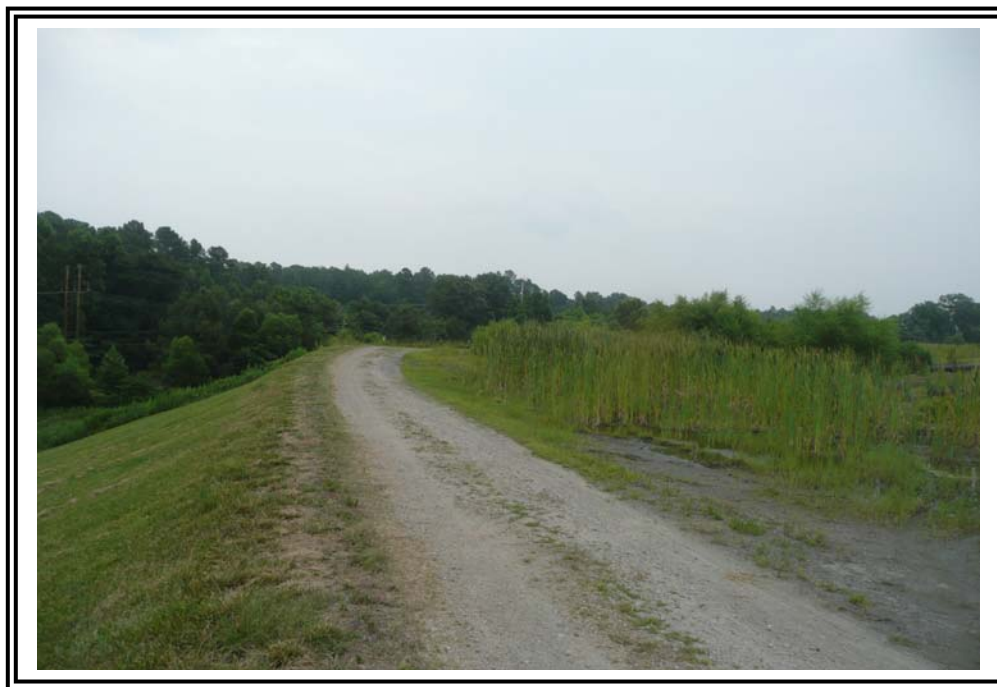
25

North Dike crest of the 1985 Ash Pond, looking northeast.  
Note: Ash level is approximately at the crest of the Dike.

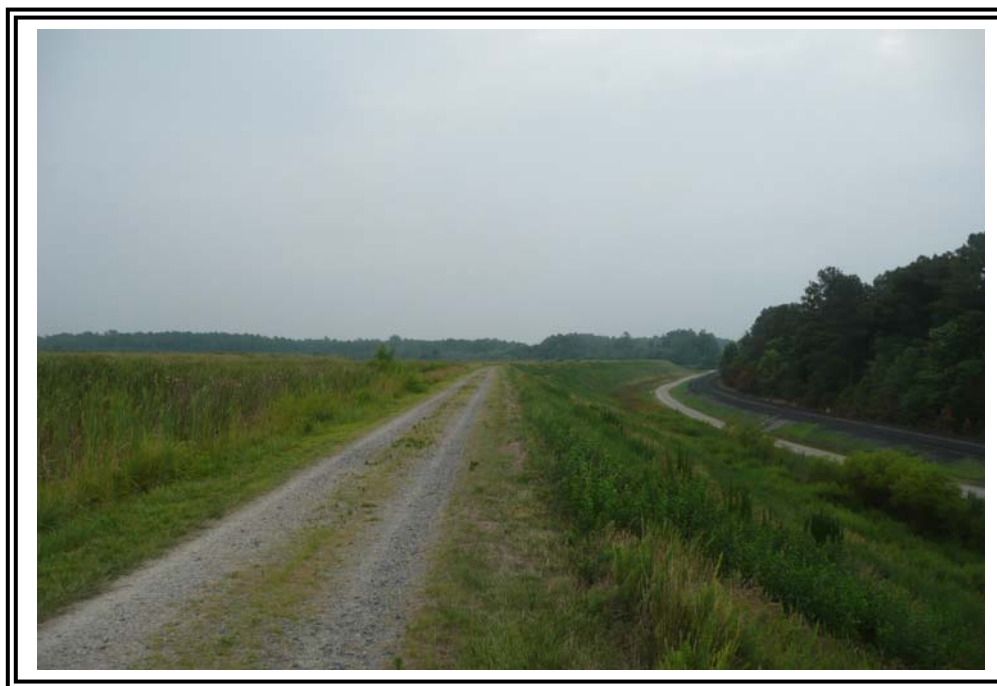
26

West Dike crest of the 1985 Ash Pond, looking southeast. Note: "Pond within a pond" to the upstream side of the crest. Ash in 1985 Ash Pond approximately at the crest of the dike.

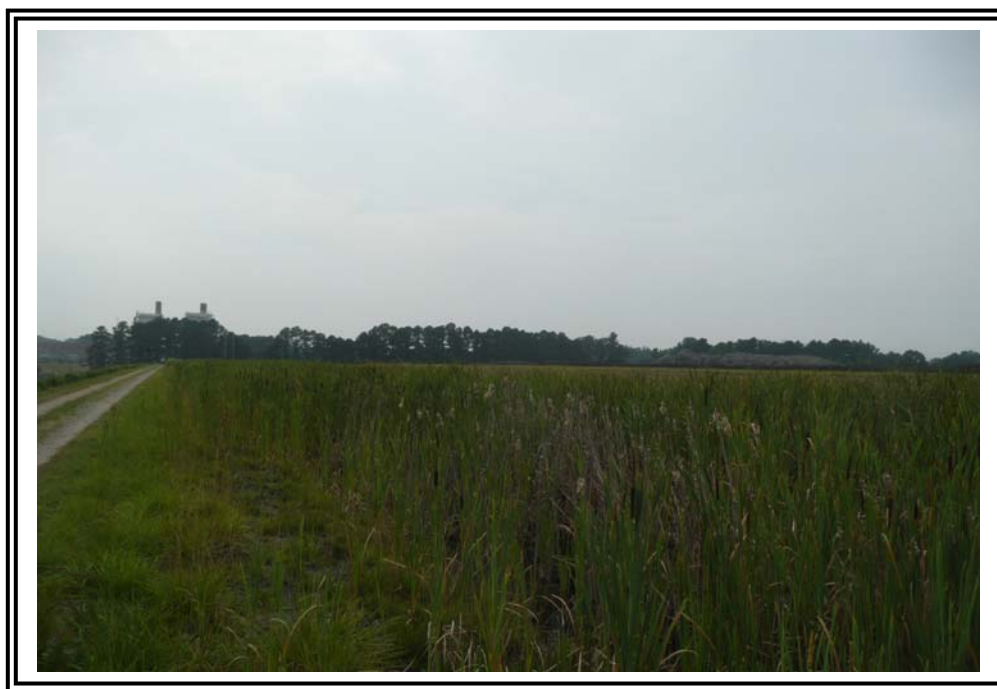
27

1985 Ash Pond, looking north.  
Note: stacked ash in the "Pond within a pond".

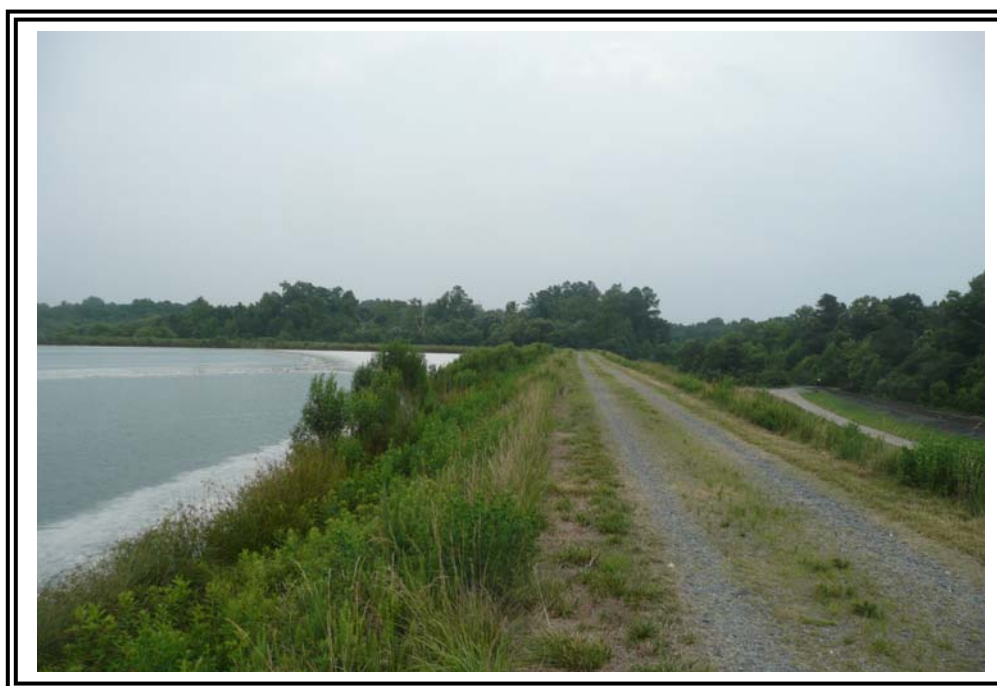
28

South end of west Dike crest at the 1985 Ash Pond, looking southeast.

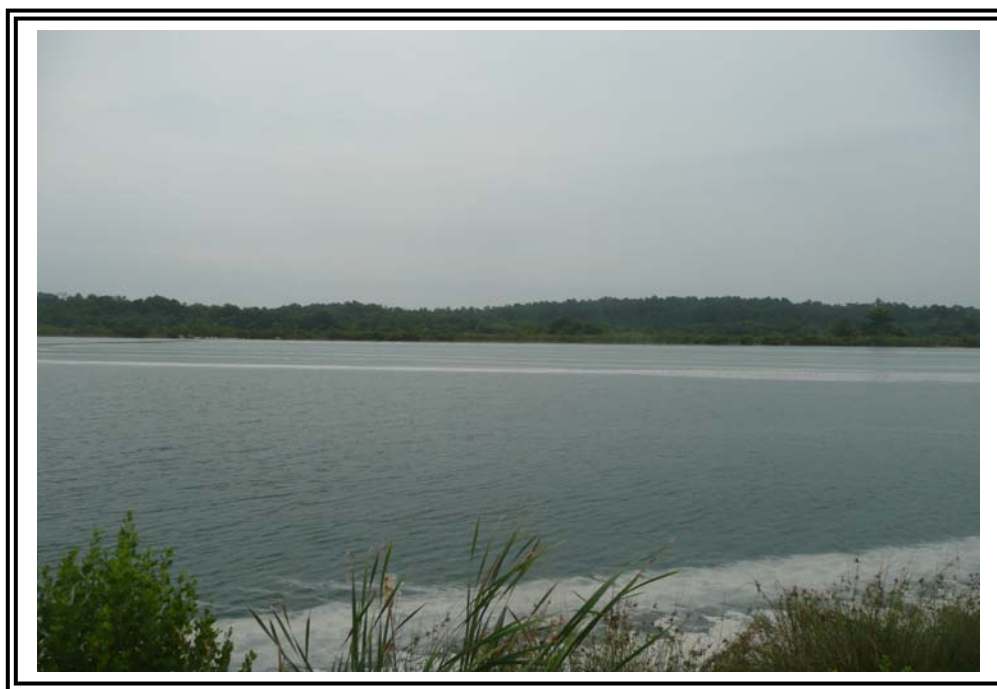
29

Looking east across the 1985 Ash Pond at the east Dike.

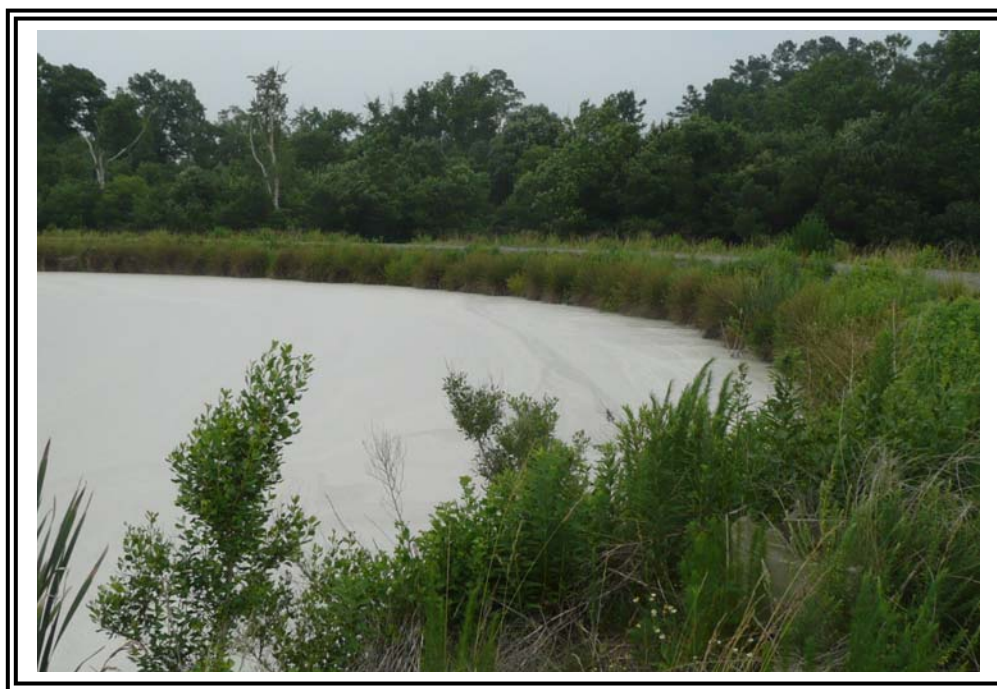
31

South end of the 1985 Ash Pond, looking southeast.

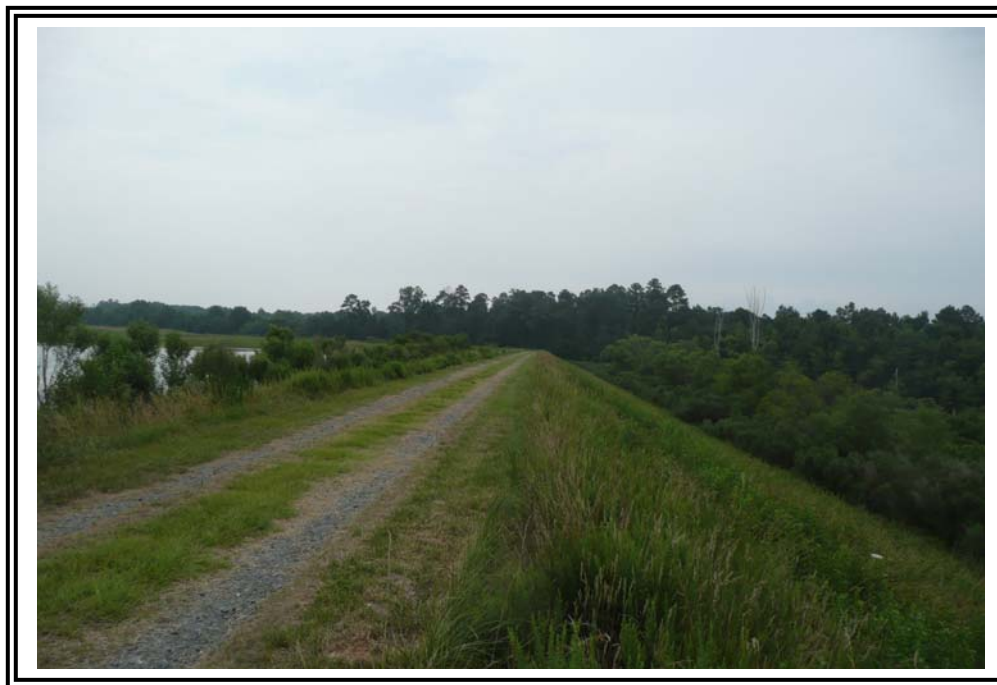
32

Crest of the east Dike of the 1985 Ash Pond, looking north.

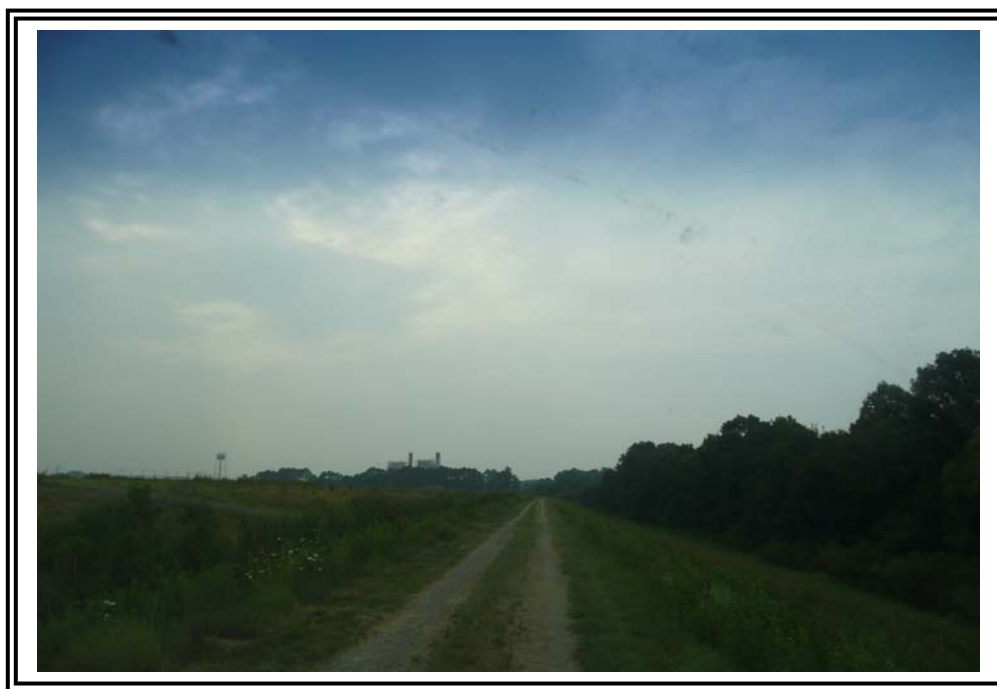
33

Northeast Dike crest of the 1985 Ash Pond, looking west.

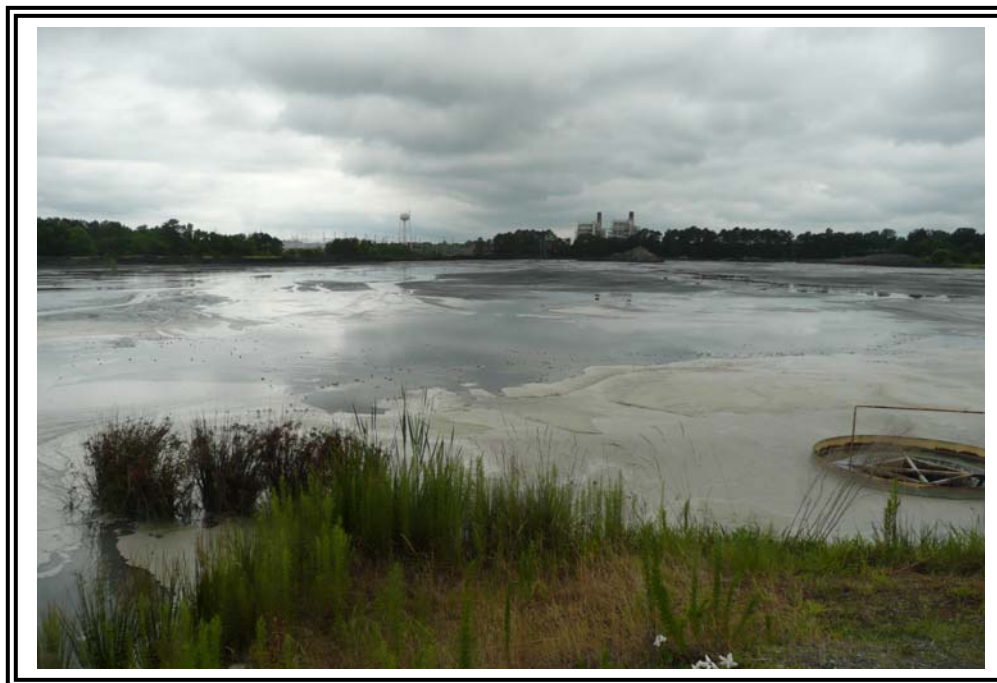
34

Current ash disposal in a "Pond within a pond". Pond was constructed with earthen dikes placed on top of ash in 1985 Pond, looking northwest.

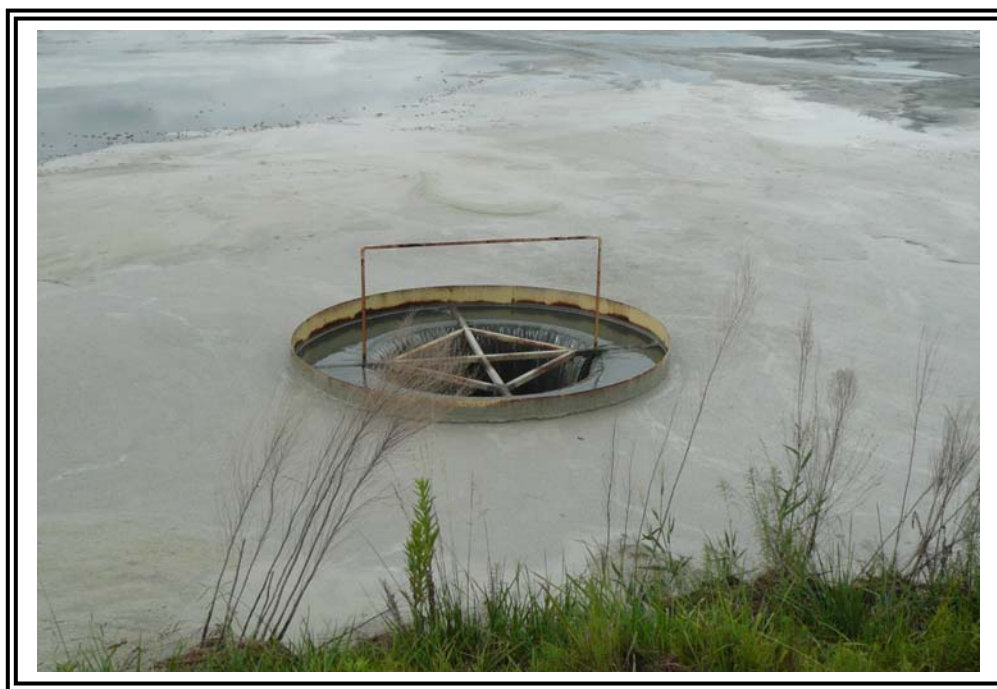
35

Close up of the outlet control structure in "Pond within a pond".

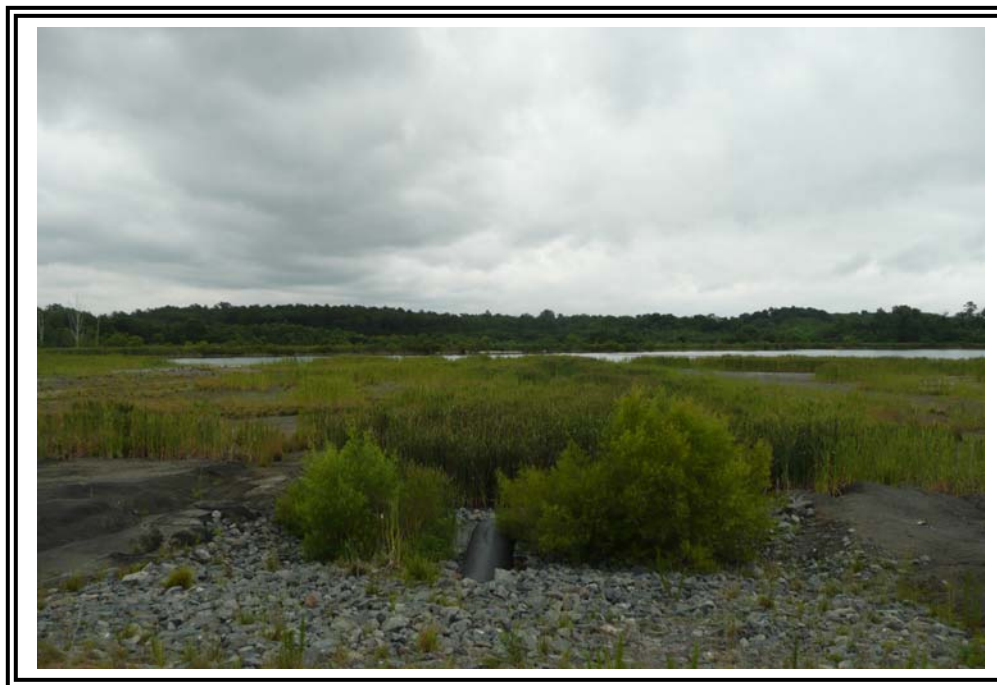
36

Outlet of "Pond within a Pond" into 1985 Ash Pond, looking southeast. Notice ash stockpiles within the pond.

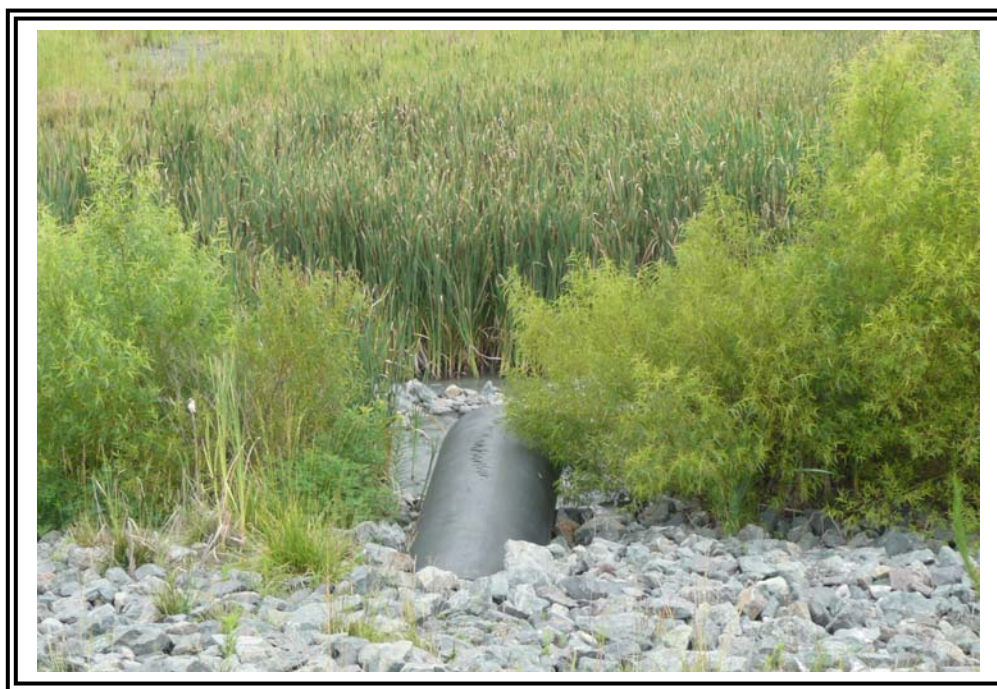
37

Close up of "Pond within a Pond" outlet.

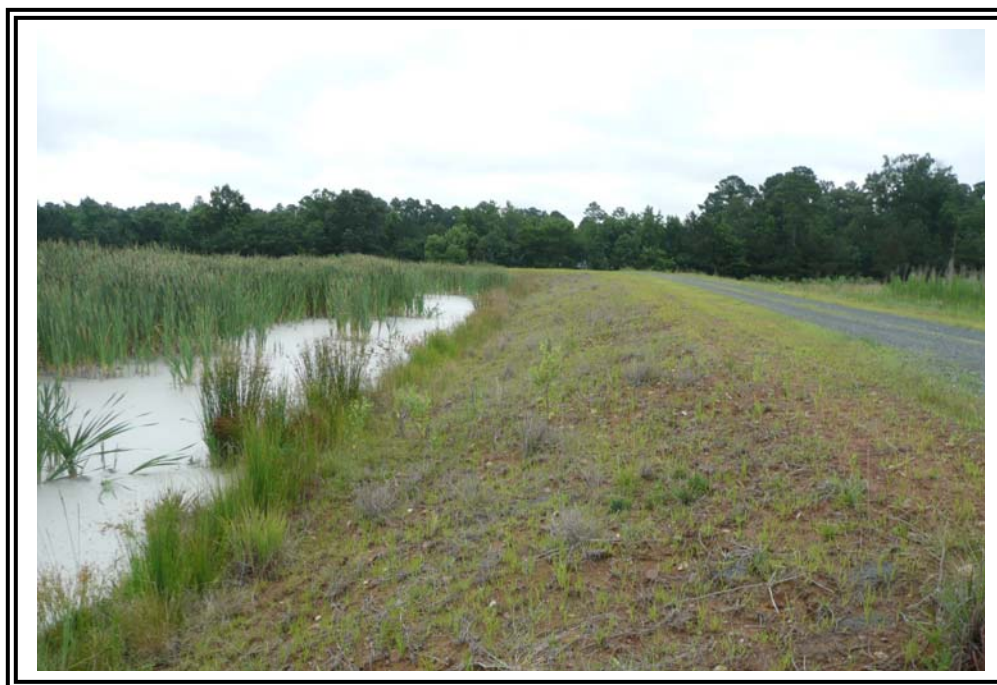
38

East Dike of "Pond within a Pond" upstream slope, looking northeast.

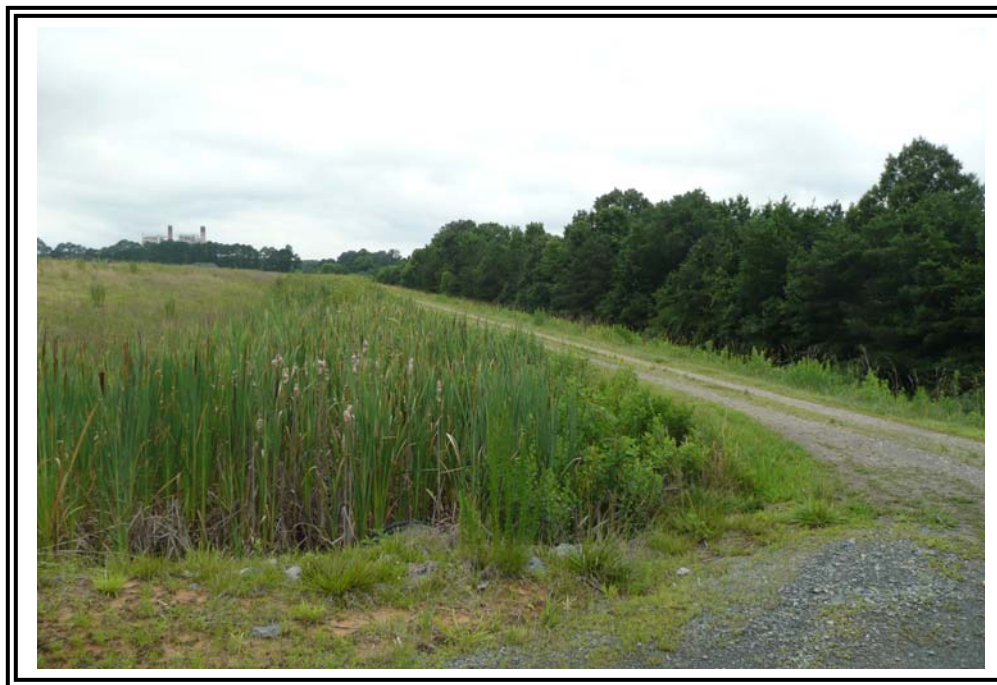
40

Space between "Pond within a pond" north Dike and 1985 Ash Pond northeast Dike, looking northwest.

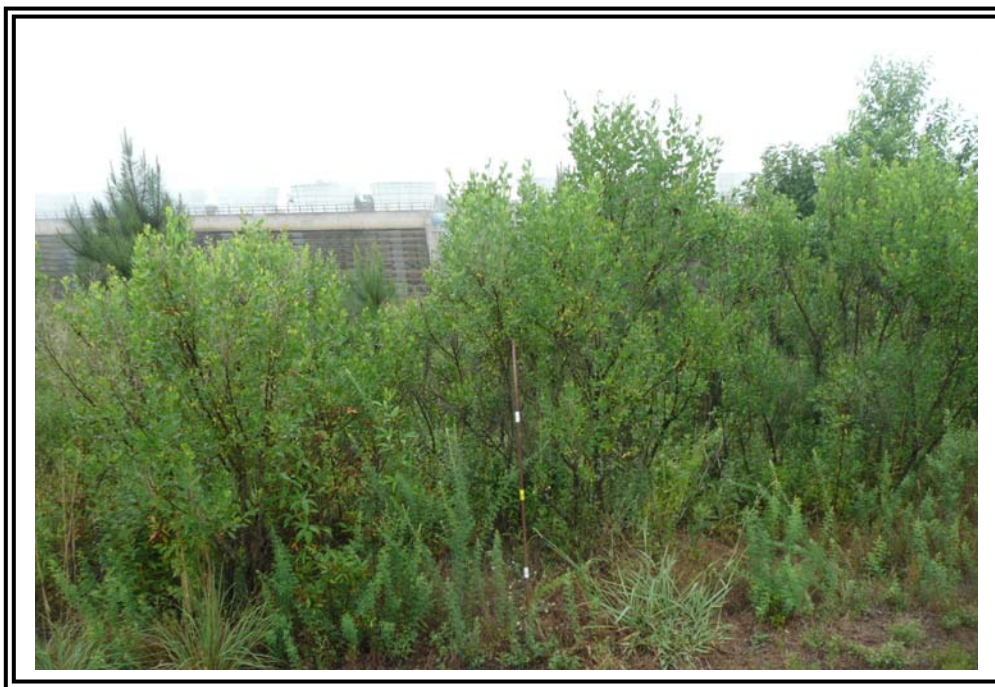
41

North end of 1978 Ash Pond Dike, downstream slope is covered with large brush.

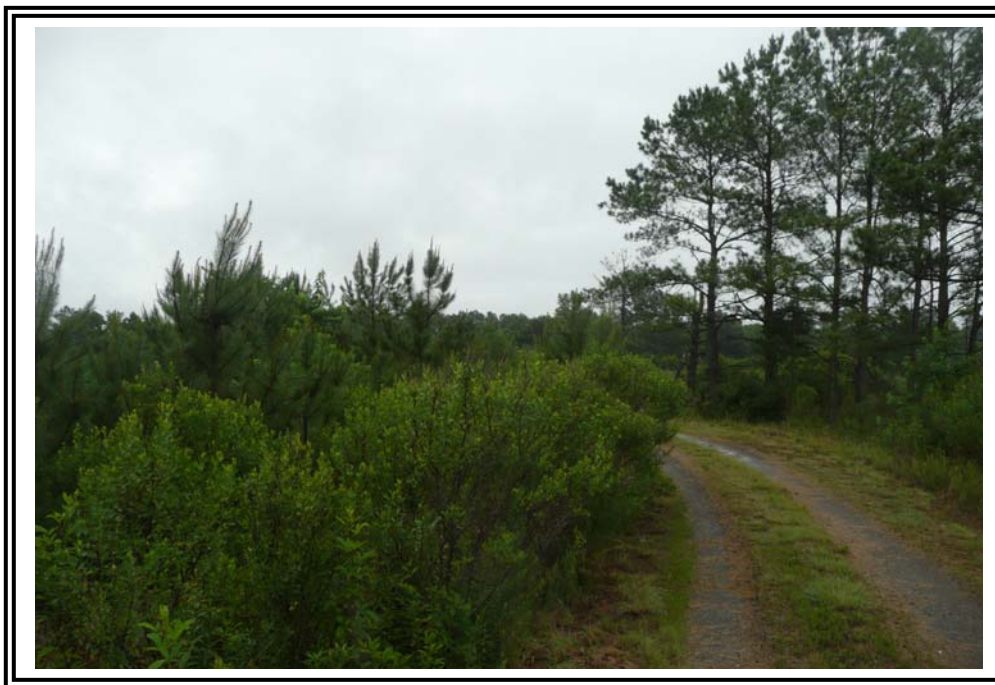
42

North end of 1978 Ash Pond Dike crest. Brush and small Pine trees are in the left of the photo and are on the downstream slope. Tall Pine trees on the right of the photo are in deposited ash within the pond.

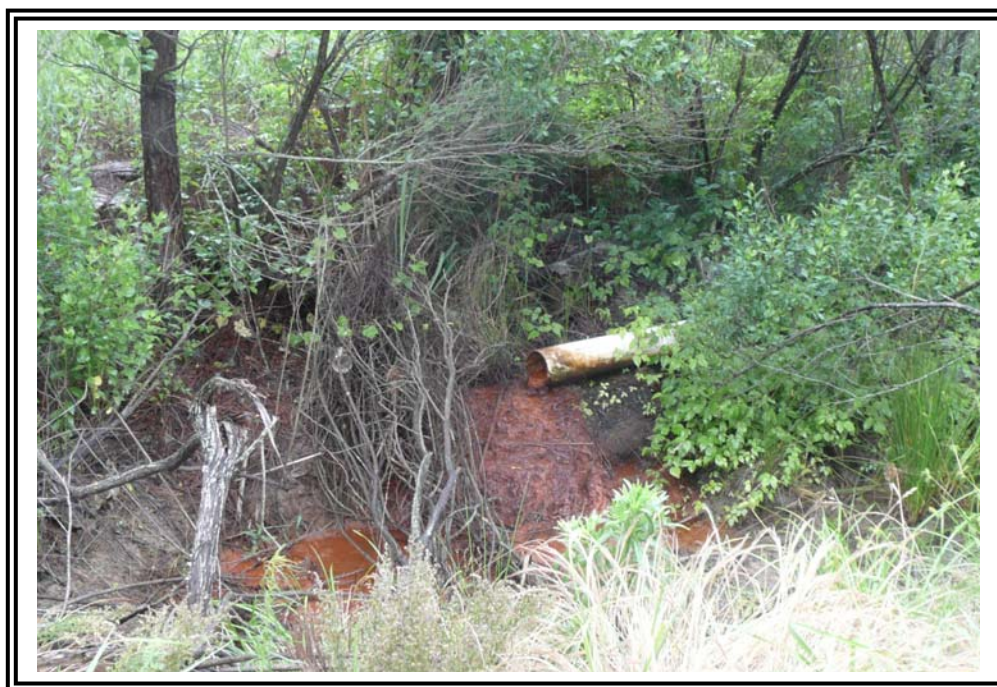
43

Apparent trench/field drain outlet at north dike toe on 1978 pond adjacent to cooling towers

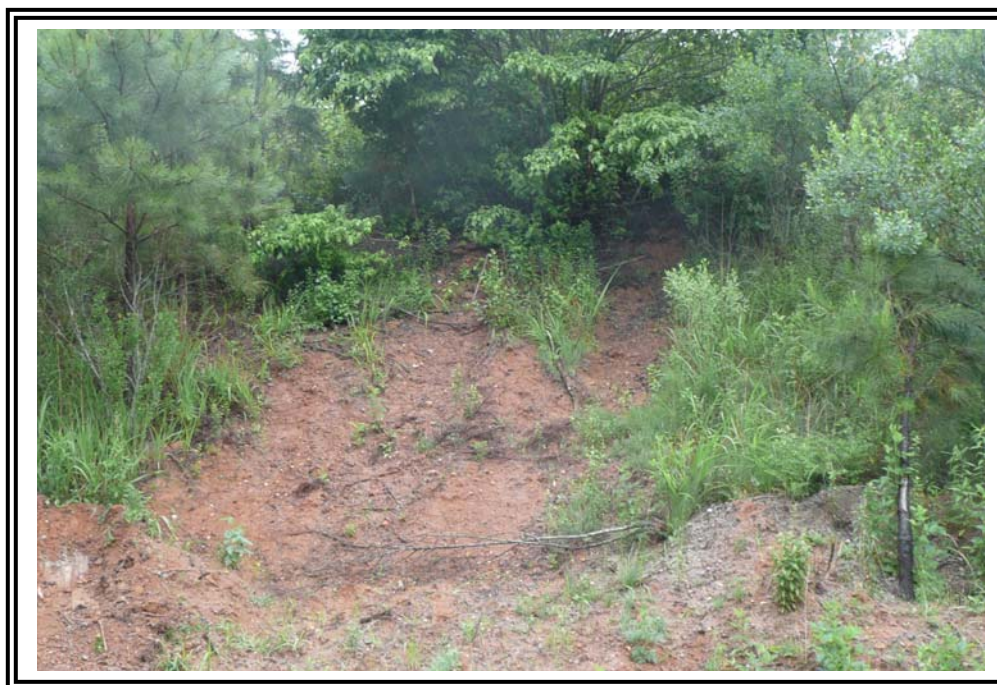
44

Example of poor vegetative cover, erosion, and probable human activity on the downstream slope of the 1978 Ash Pond Dike.

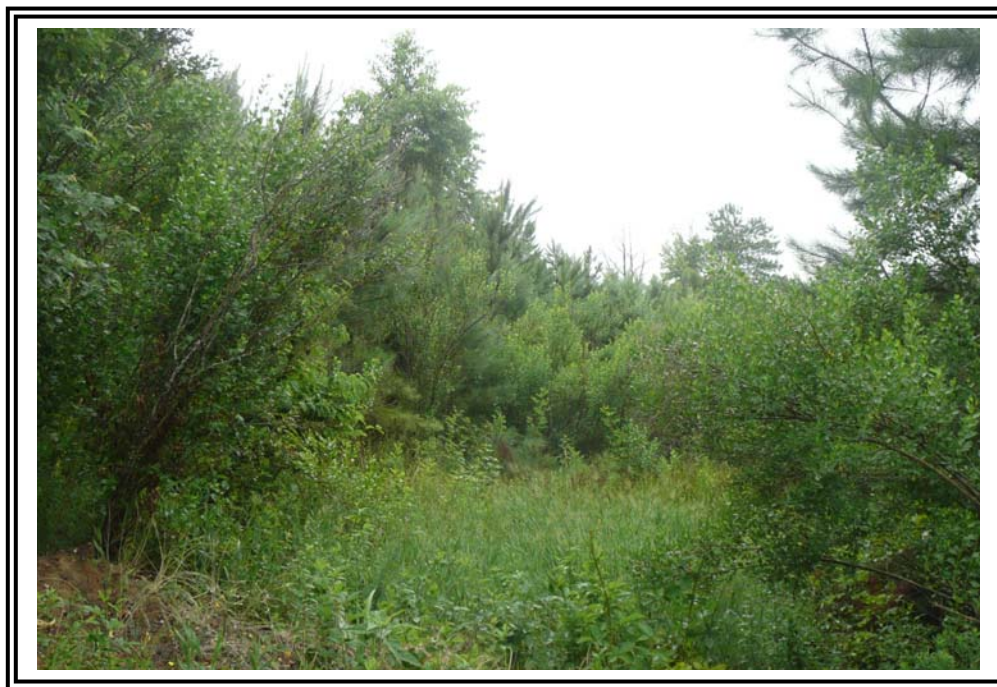
45

General vegetation conditions on the north end of the 1978 Ash Pond Dike downstream slope.

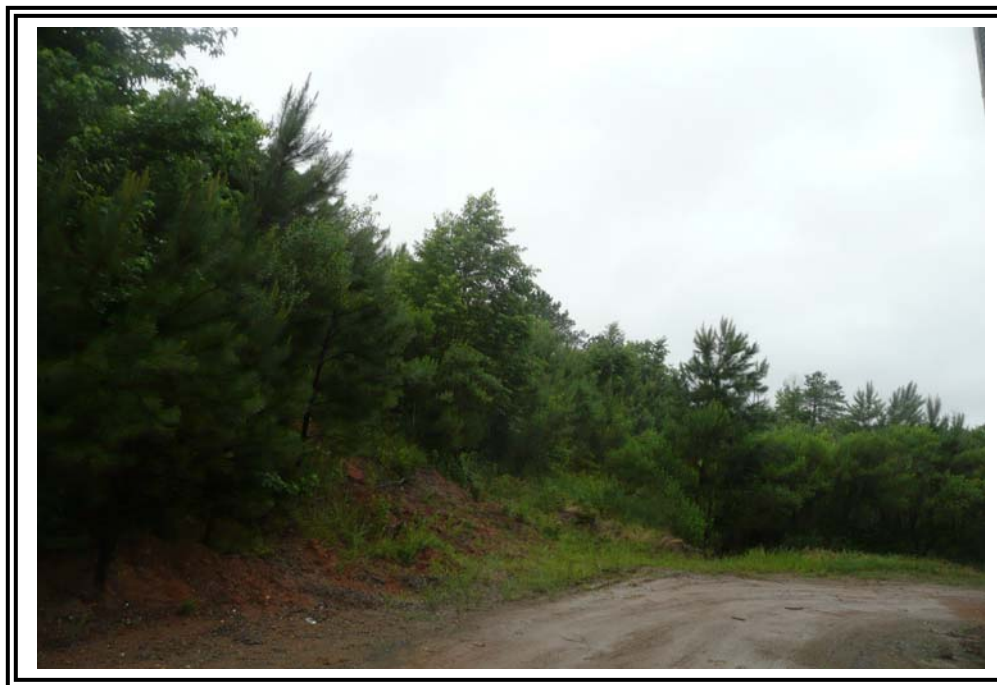
46

Toe of the 1978 Ash Pond Dike at the north corner, looking west.

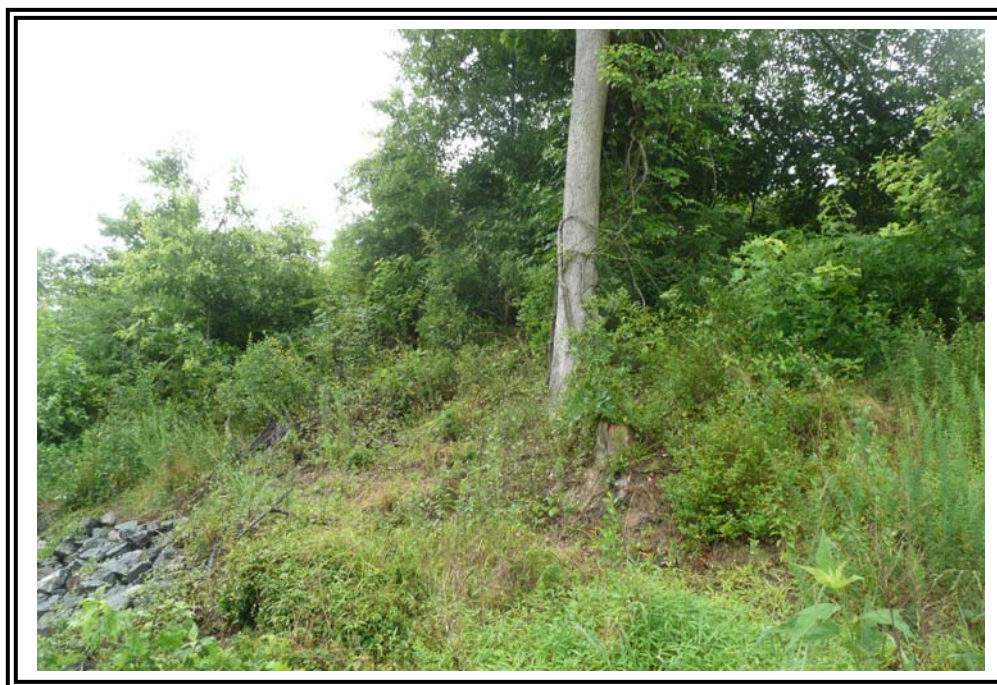
48

Erosion/surface sloughing around the tree stump on the 1978 Ash Pond Dike.
