# Assessment of Dam Safety Coal Combustion Surface Impoundments Draft Report

Progress Energy  
Carolinas  
Cape Fear Plant

Moncure, North Carolina

July 17, 2009

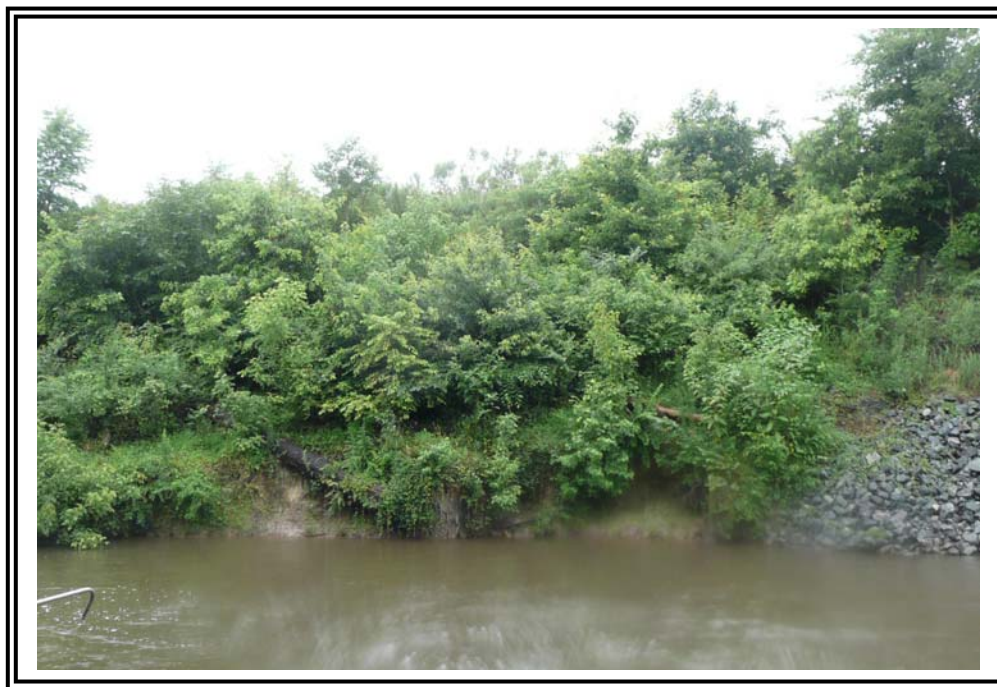
49

Erosion at the toe of the 1978 Ash Pond at discharge canal. Also note the fallen tree.

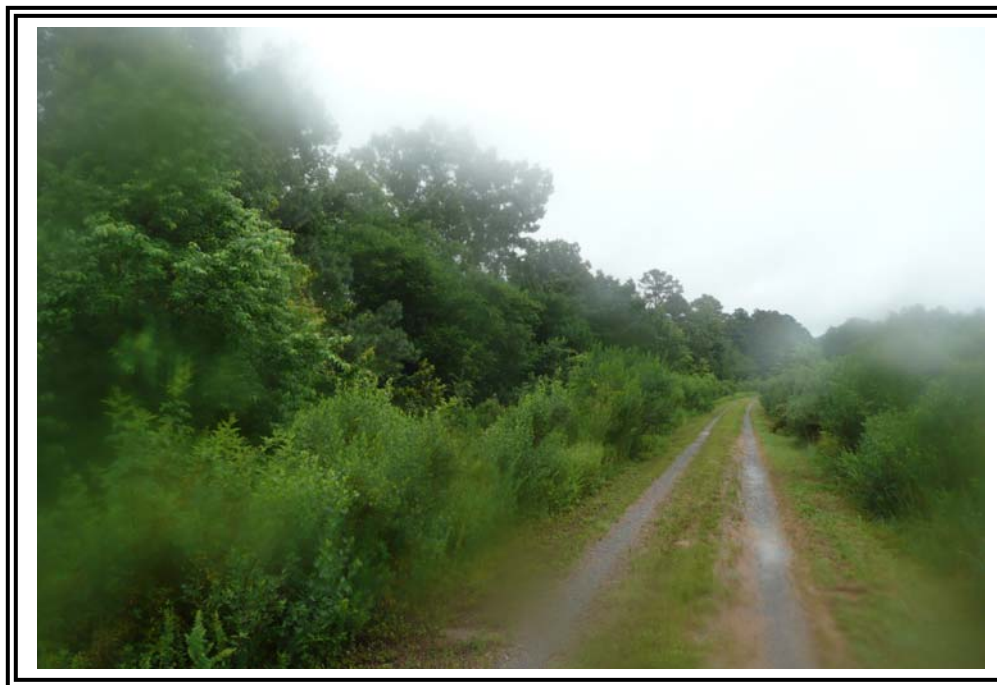
50

Crest of the 1978 Ash Pond Dike approaching the east corner of the Dike, looking south. Note: Taller trees are on the downstream slope in the left of the photo and shorter brush is on the upstream slope in right of the photo.

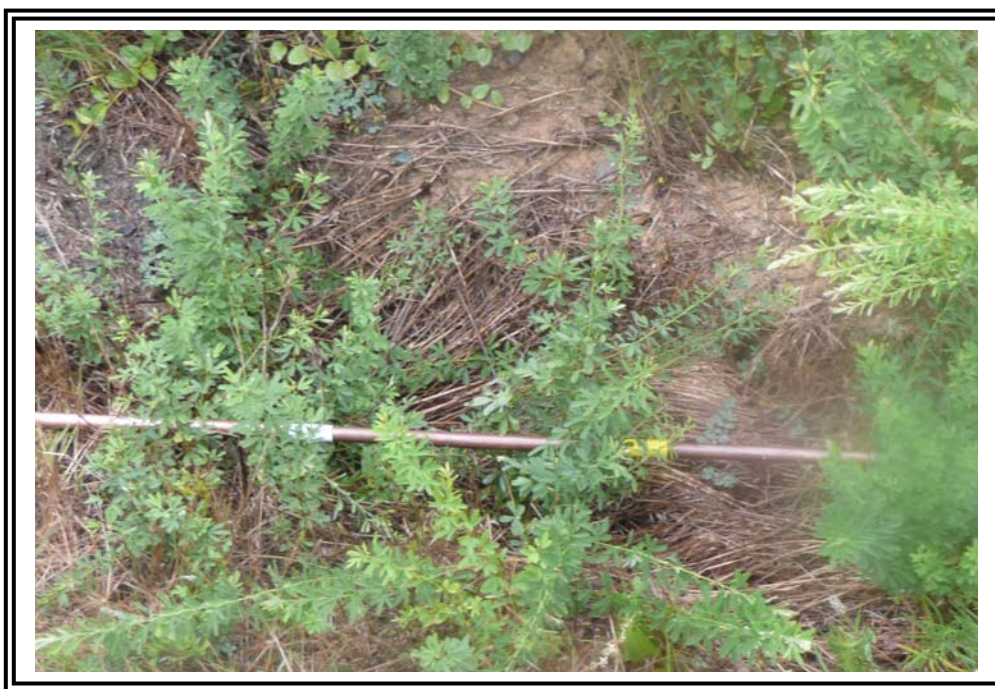
51

Irregular ground surface on the downstream slope at the east side of the 1978 Ash Pond Dike.

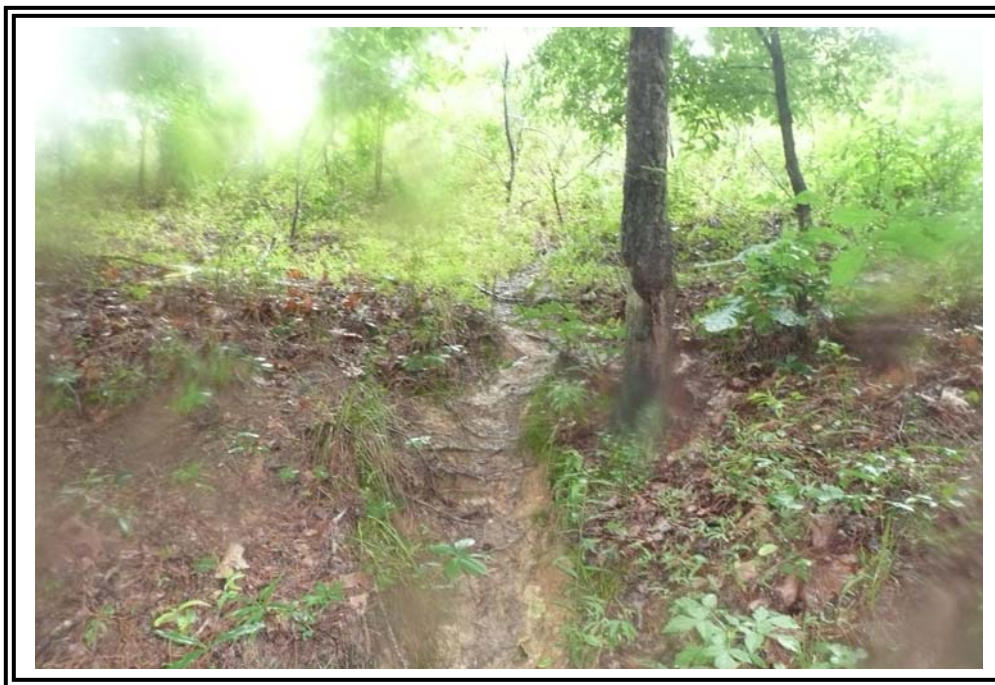
52

Animal slide (likely beaver or muskrat) on the downstream slope of the 1978 Ash Pond Dike.

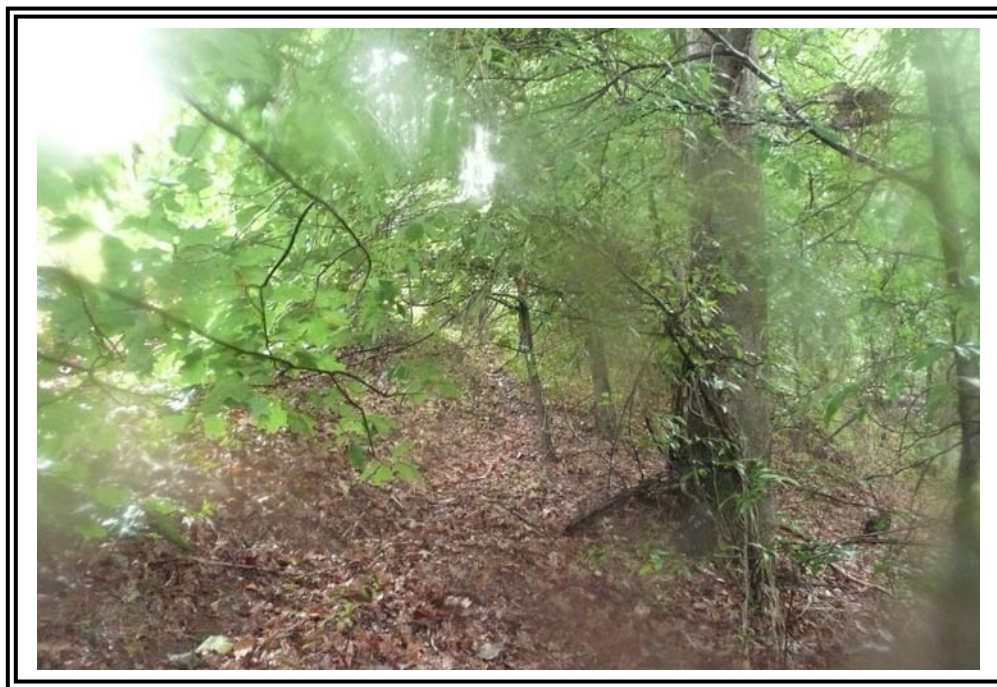
53

Generally wooded conditions along the east side of the 1978 Ash Pond Dike downstream slope.

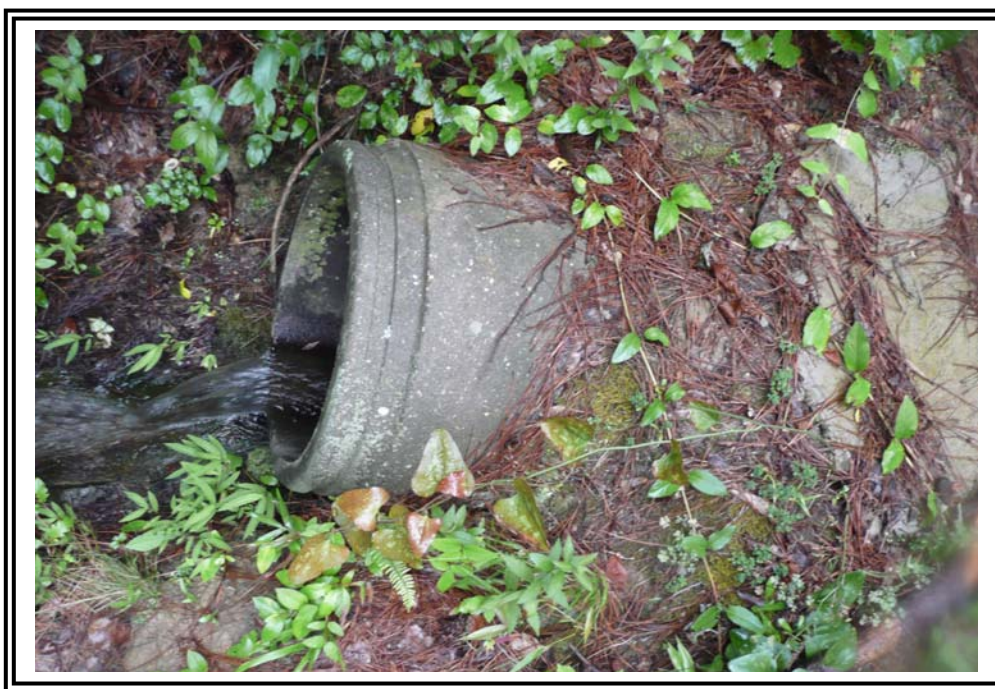
55

Discharge end of outlet pipe in the 1978 Ash Pond.

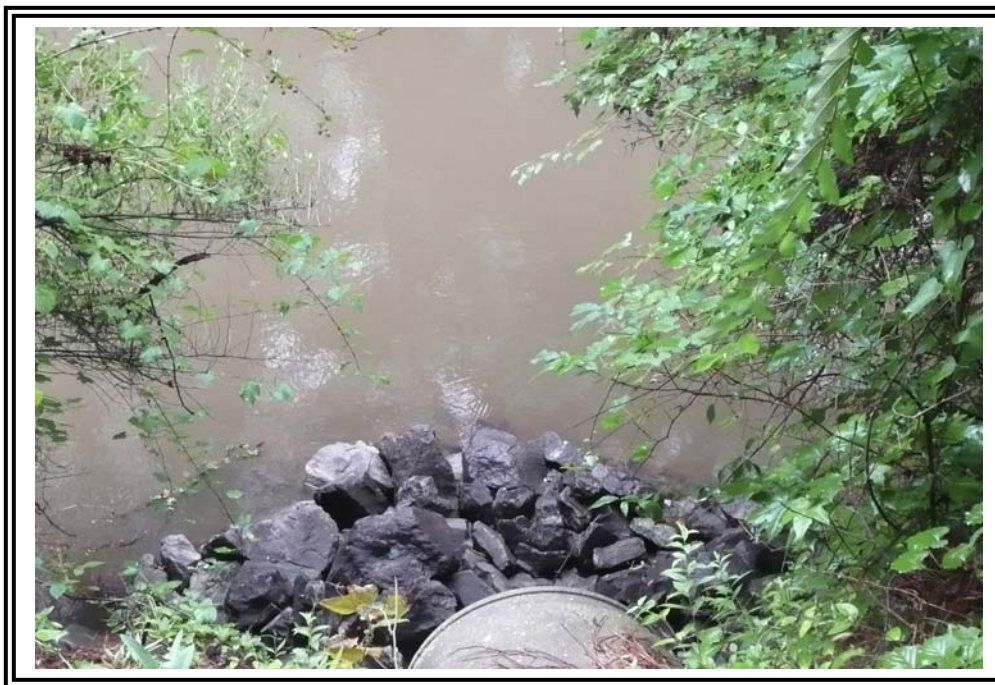
56

Discharge end of the outlet pipe in the 1978 Ash Pond.

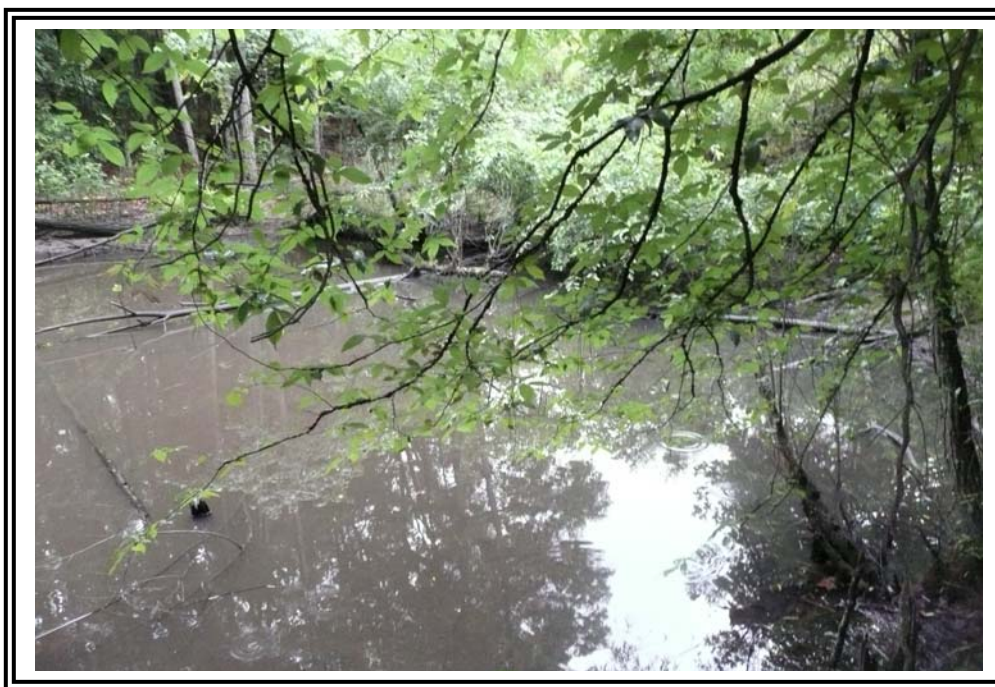
58

Ponded area south of the discharge pipe at the toe of the 1978 Ash Pond Dike.  
Reportedly excavated area from former adjacent property owner, who was a brick manufacturer.

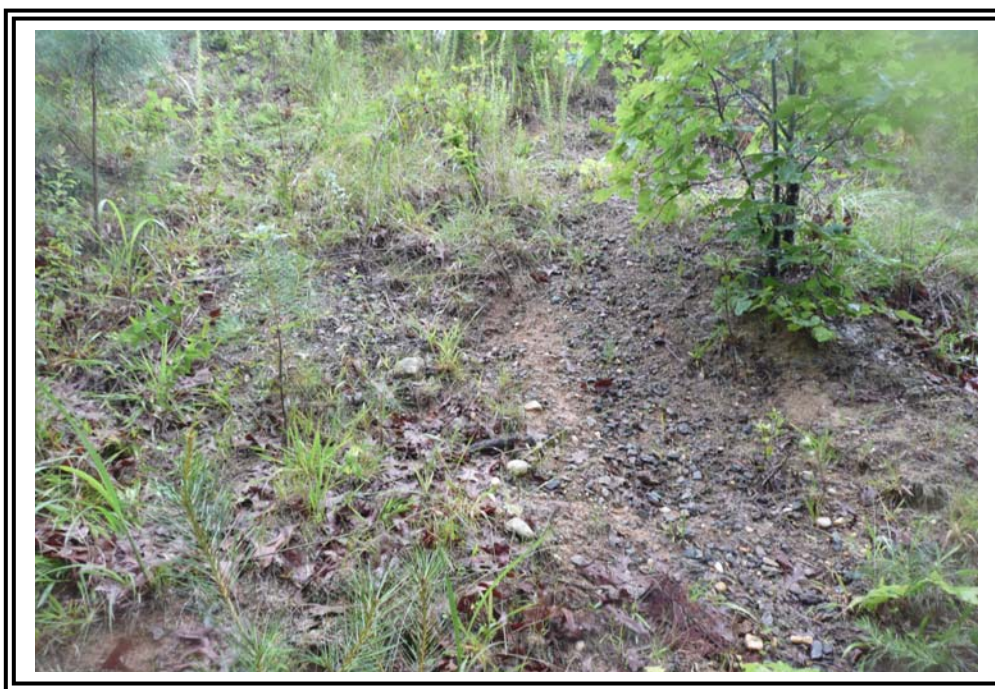
59

Surface erosion southeast of the downstream slope of the 1978 Ash Pond Dike.

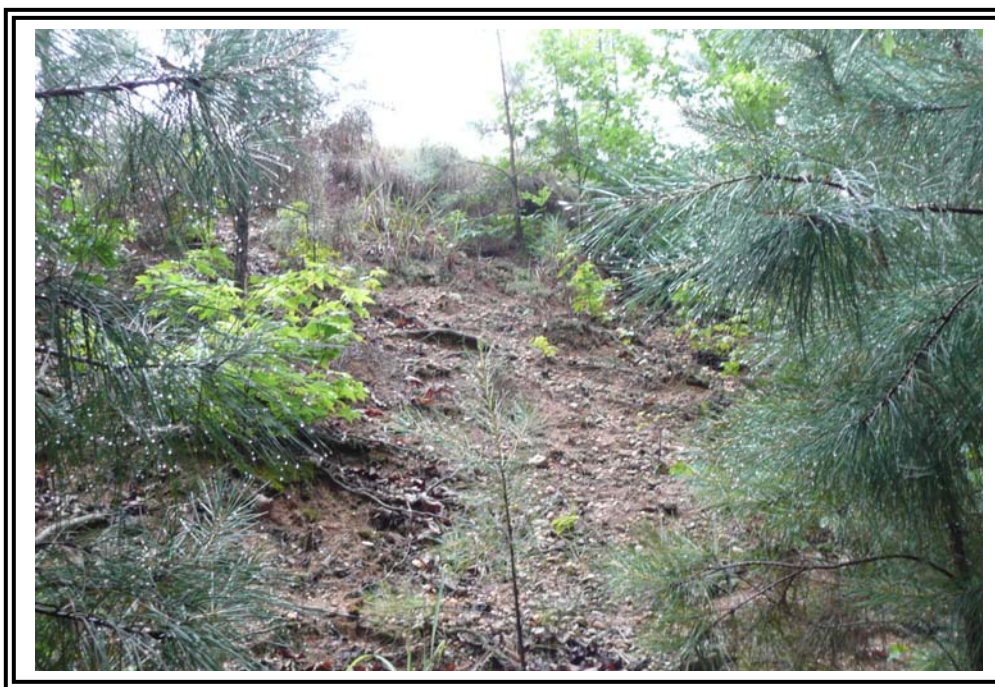
60

Surface erosion southeast of the downstream slope of the 1978 Ash Pond Dike.

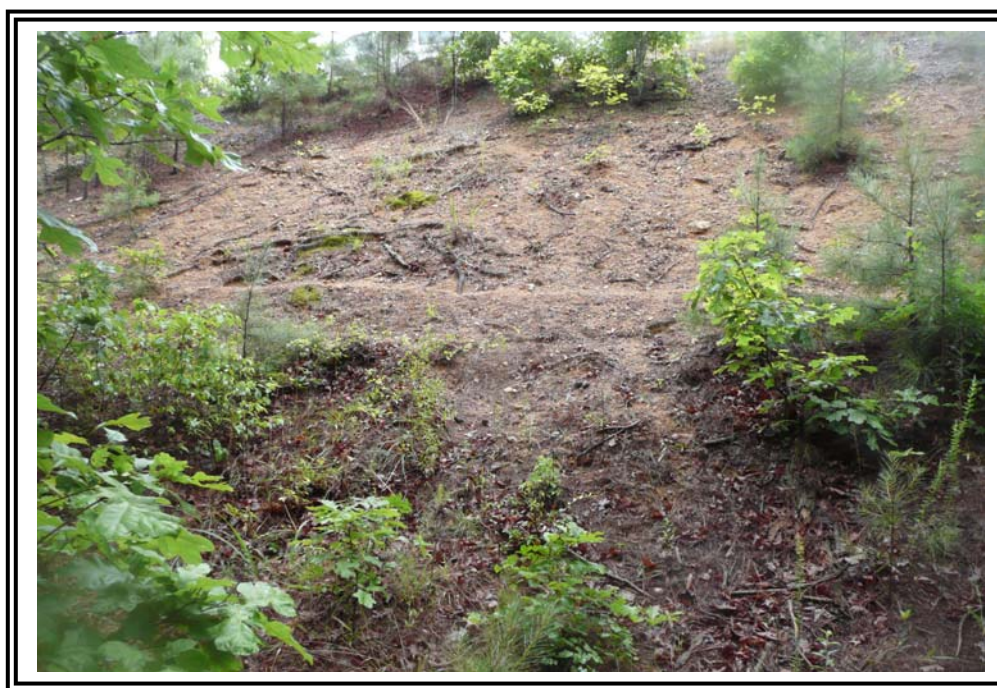
62

Downstream slope at the south end of the 1978 Ash Pond Dike is devoid of vegetation.

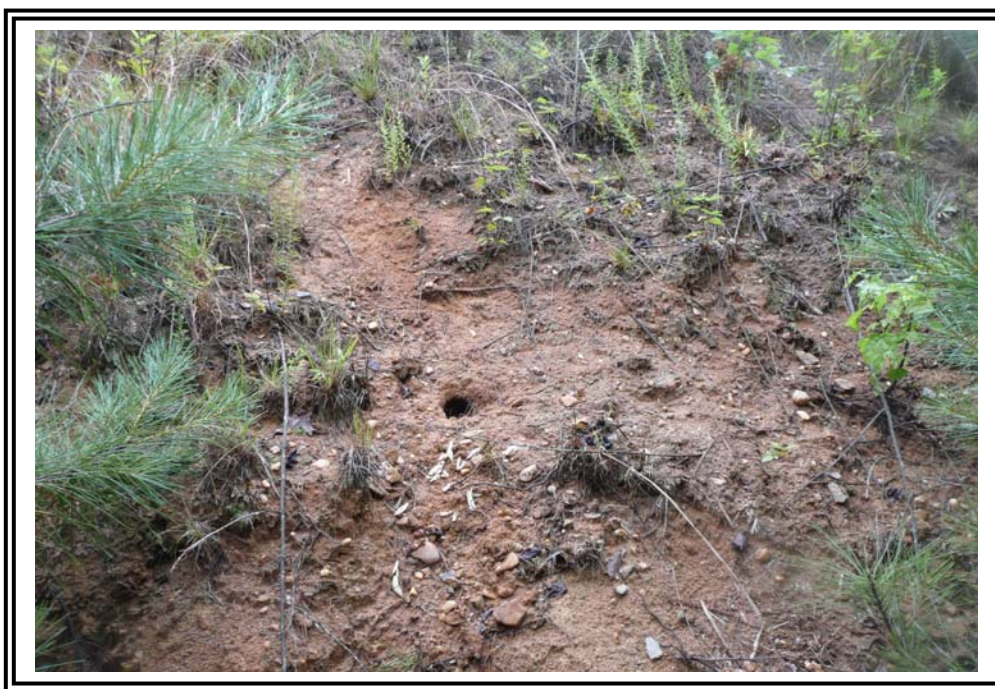
63

Evidence of animal burrow at the south end of the 1978 Ash Pond Dike.

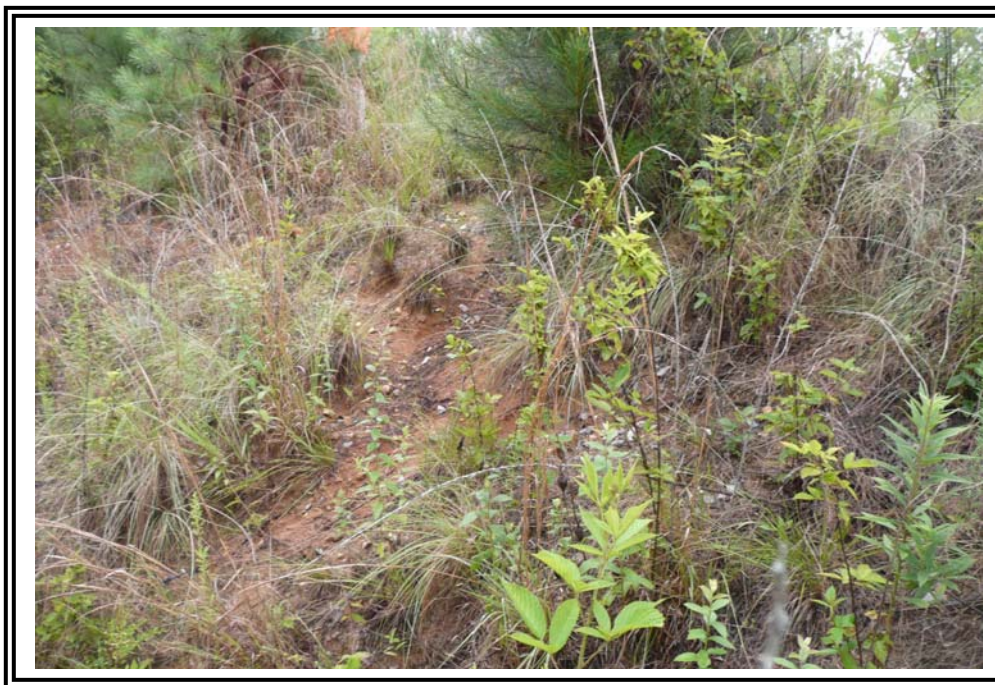
64

Example of erosion around sparse surface vegetation at the south end of the 1978 Pond.

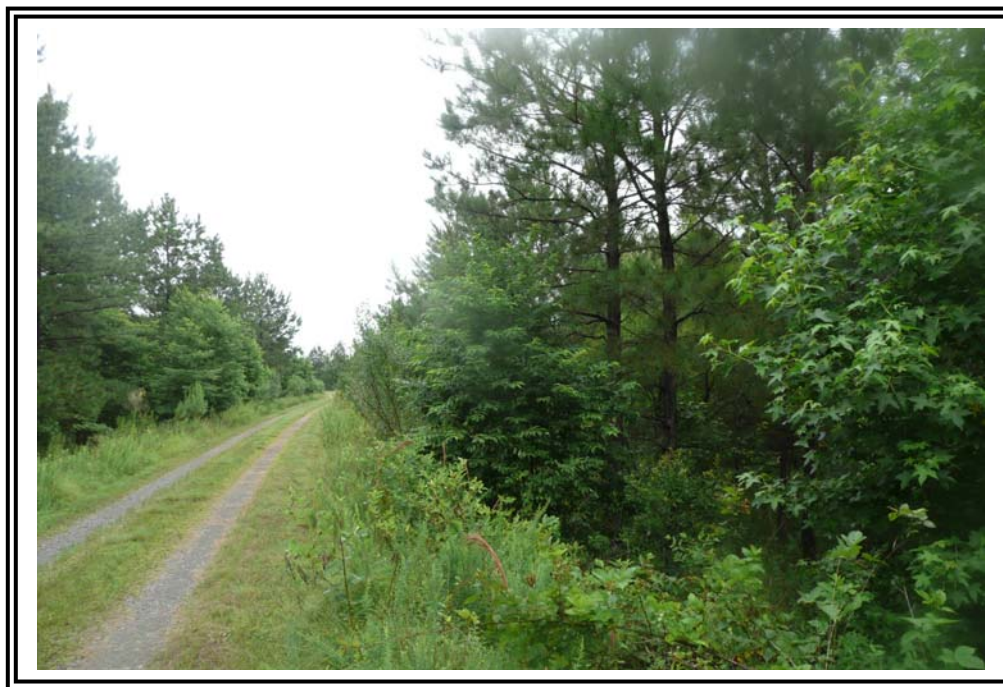
65

West Dike of 1978 Ash Pond shared with 1963/1970 Ash Ponds. Looking north, trees on either side are growing in deposited ash within the 1970 (left) and 1978 (right) ponds.

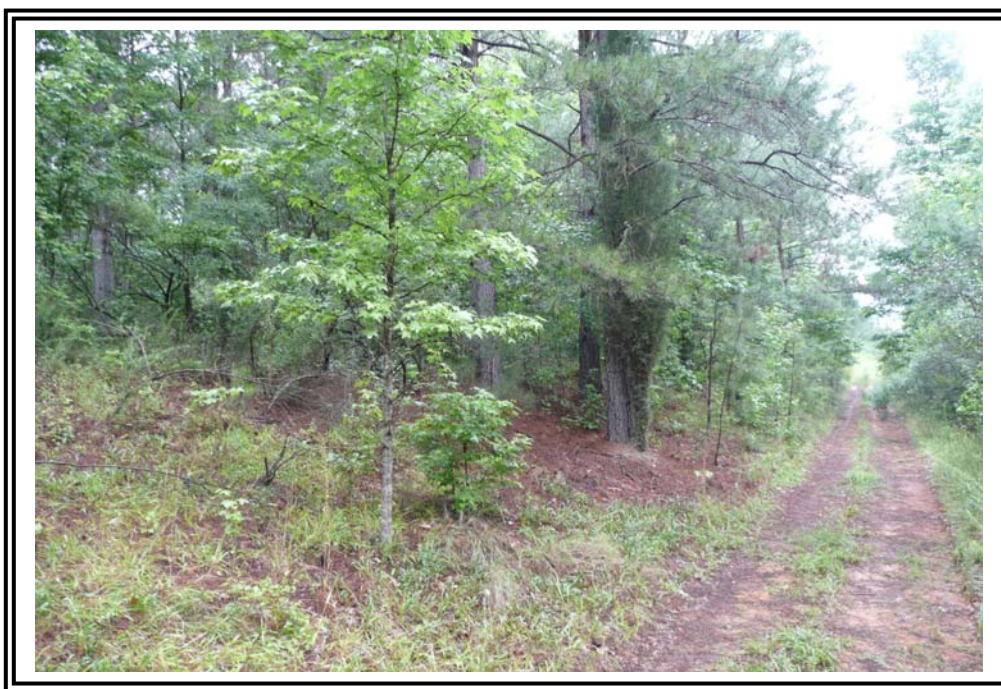
68

Toe of 1970 Ash Pond east dike, south end looking north. Road is at toe of dike.

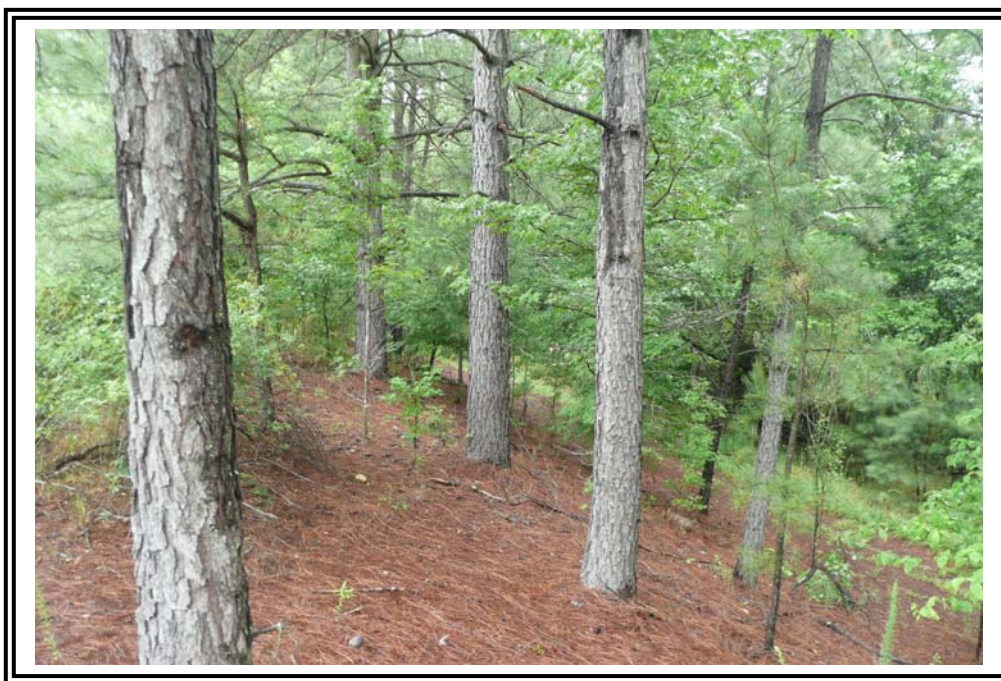
68A

Example of tree coverage on 1978 pond east dike.

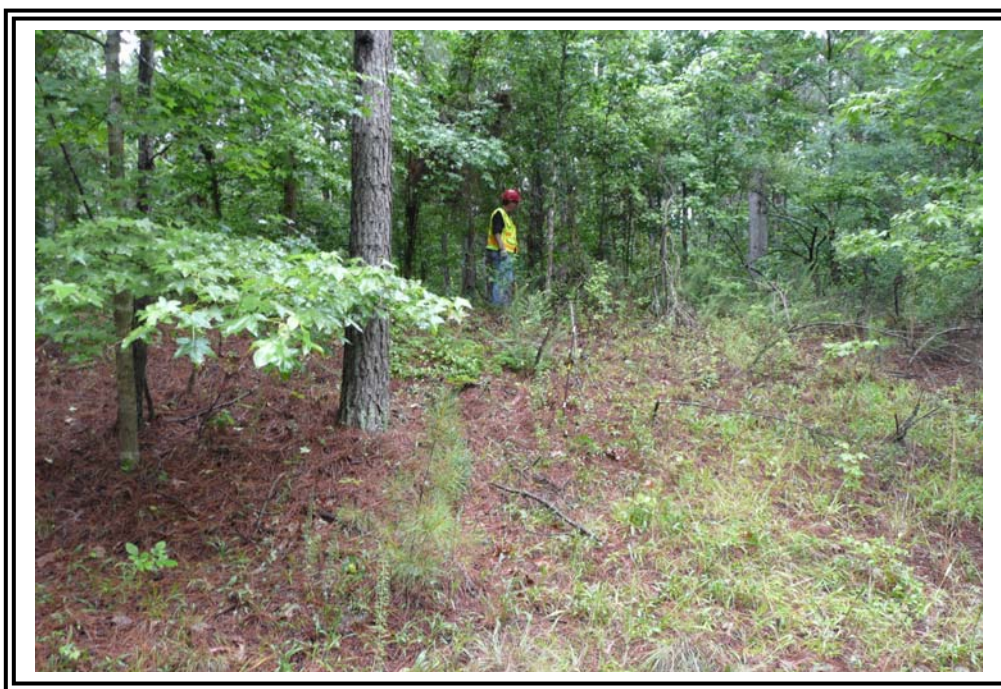
69

1970 Ash Pond east dike downstream slope. Note photographer is standing at the toe of the dike and the person in the photograph is standing at the crest.

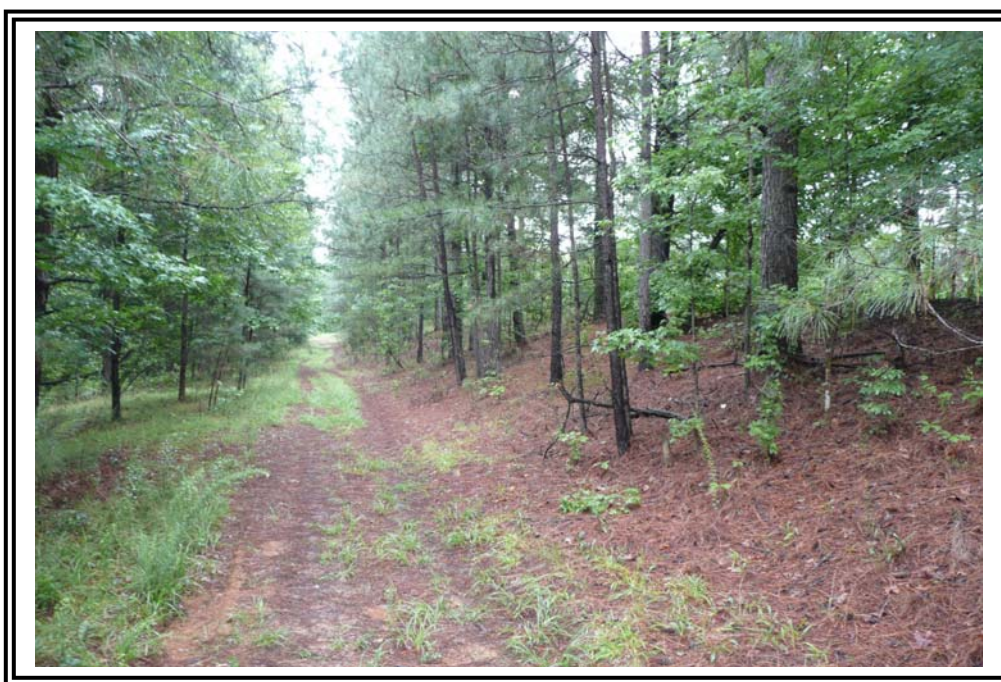
70

1970 Ash Pond east dike toe looking south. Note road runs along toe of dike in this area.

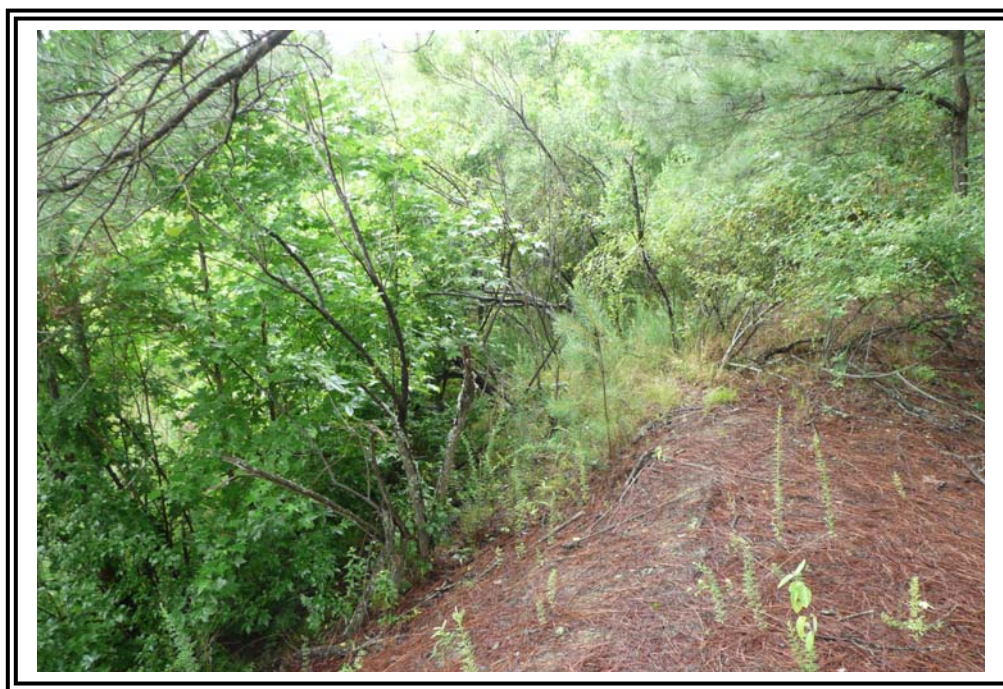
71

Upstream slope of 1970 Ash Pond east dike looking north.

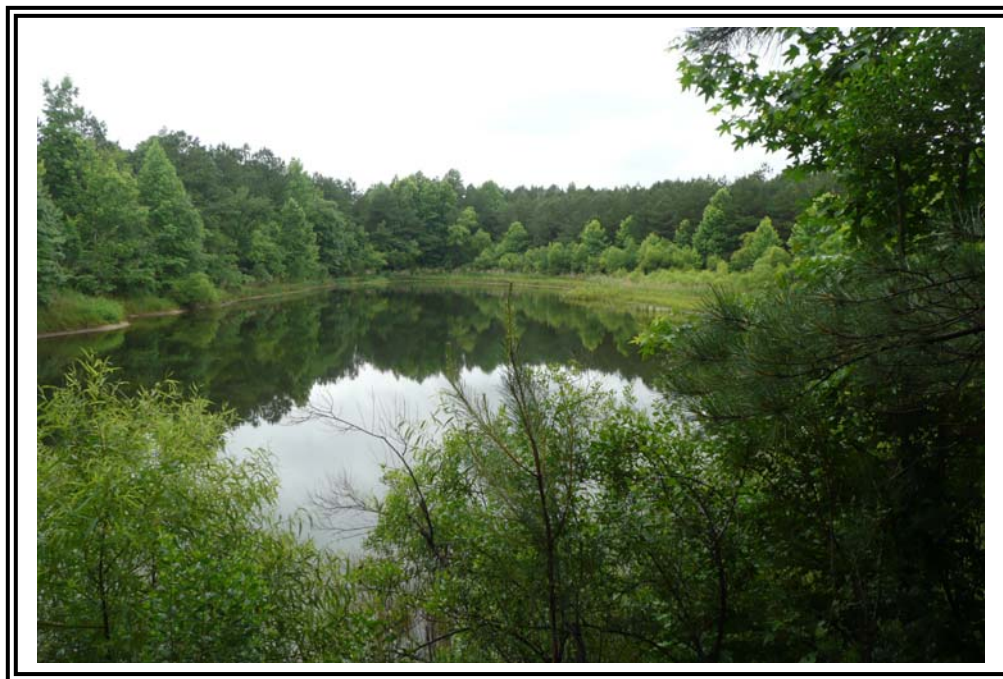
72

Southern portion of 1970 Ash Pond contains water. Looking west from east dike.

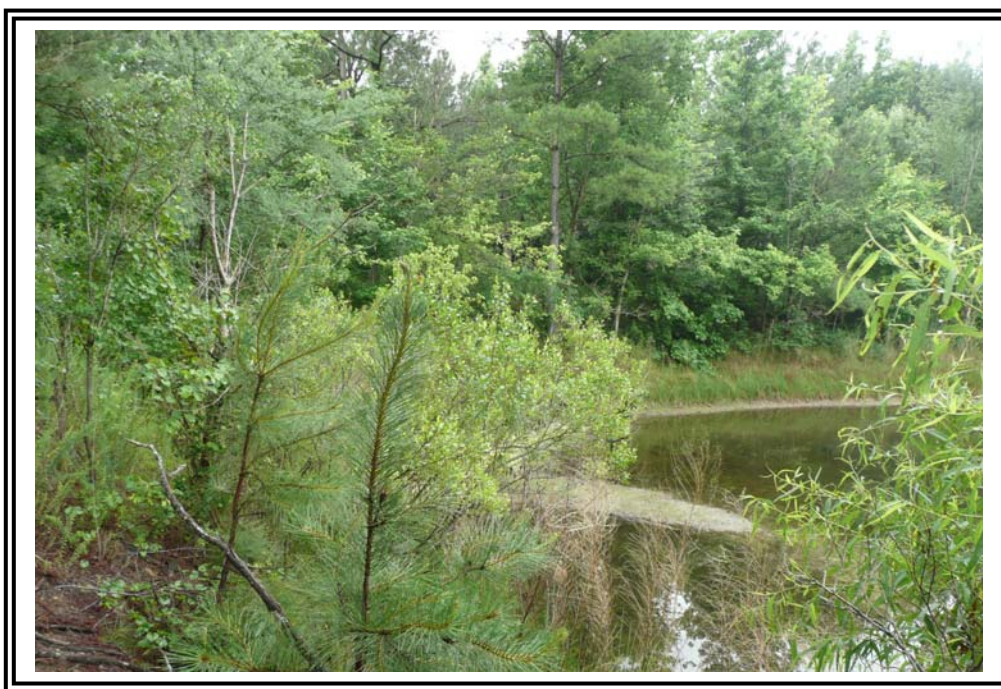
73

Upstream slope of south dike at 1970 Ash Pond looking southwest from east dike.

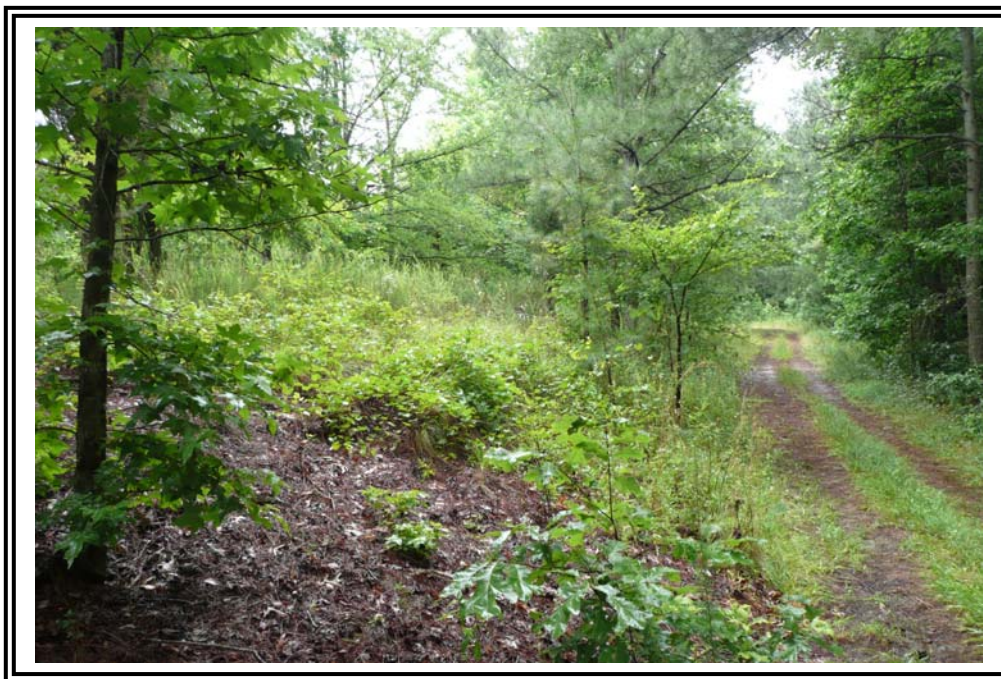
74

1970 Ash Pond south dike downstream slope looking east.

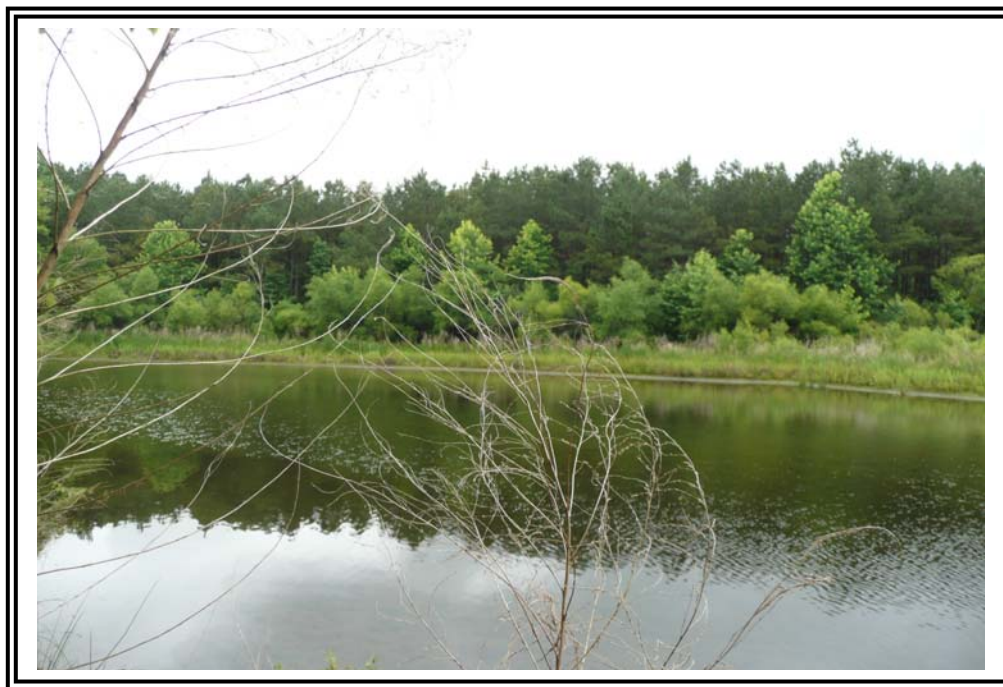
75

1970 Ash Pond looking north across the pond from the south dike.

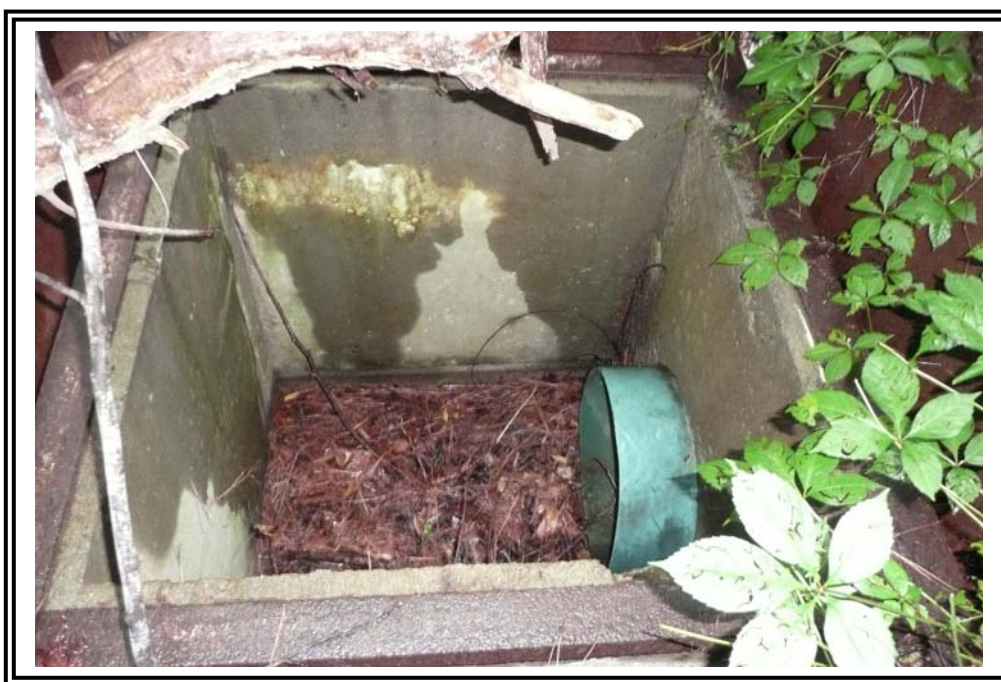
78

Close up of 1970 Ash Pond outlet control structure.

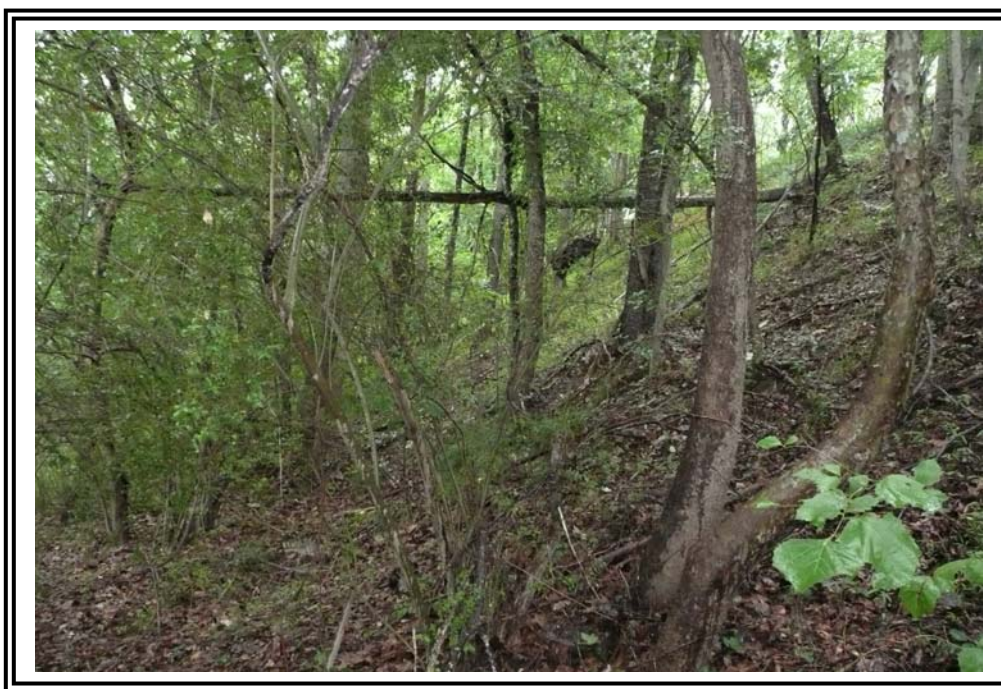
81

Typical condition of 1970 Ash Pond west dike downstream slope. (looking north)

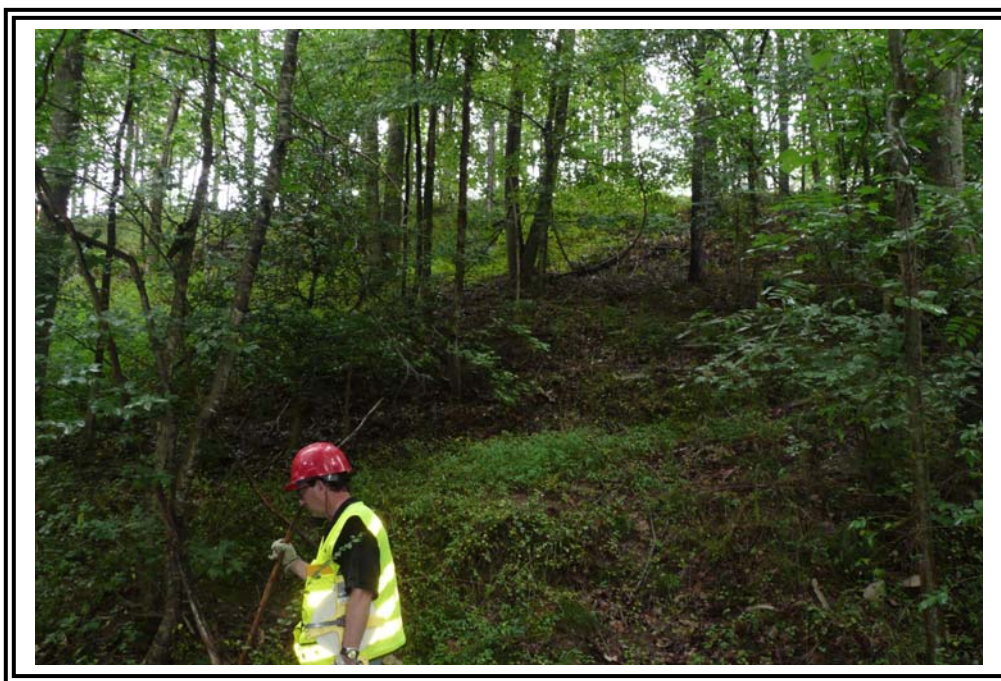
84

Surface erosion and sloughing on 1970 Ash Pond west dike downstream slope.

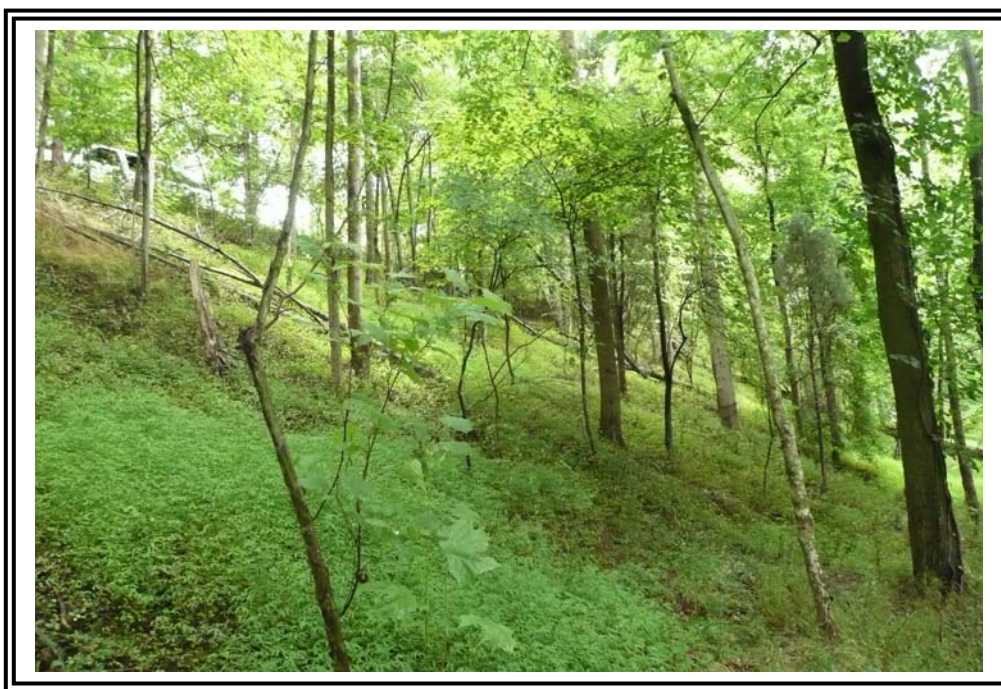
85

Downstream slope of 1963 Ash Pond west dike. Note suburban parked on crest for scale.

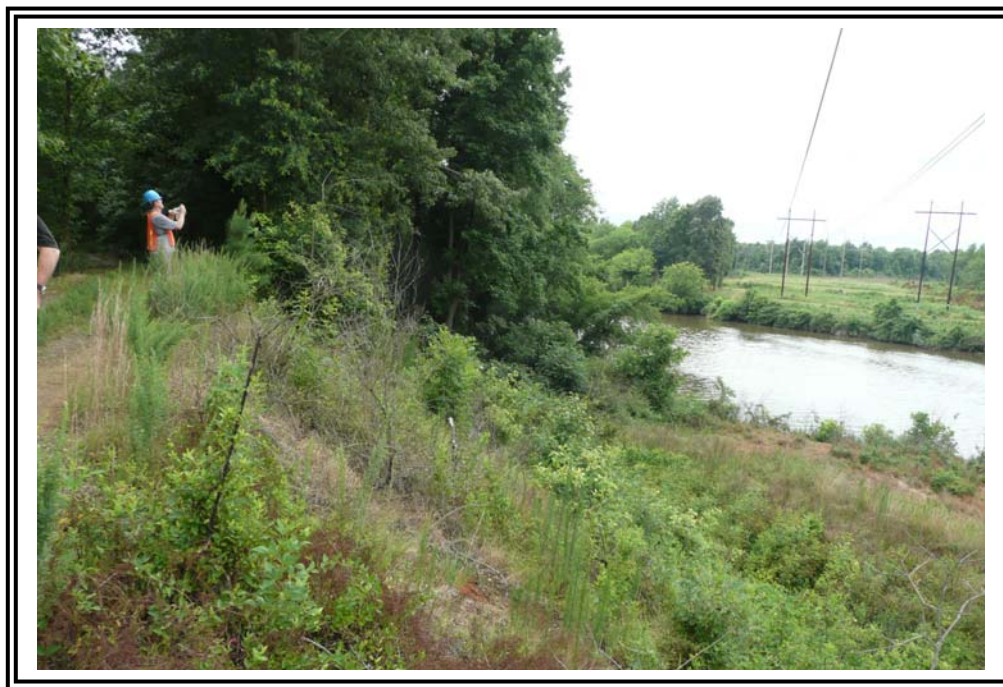
89

North end of 1963 Ash Pond west dike looking south. This is adjacent to the 1982 slide area. Water in background is the Cape Fear River.

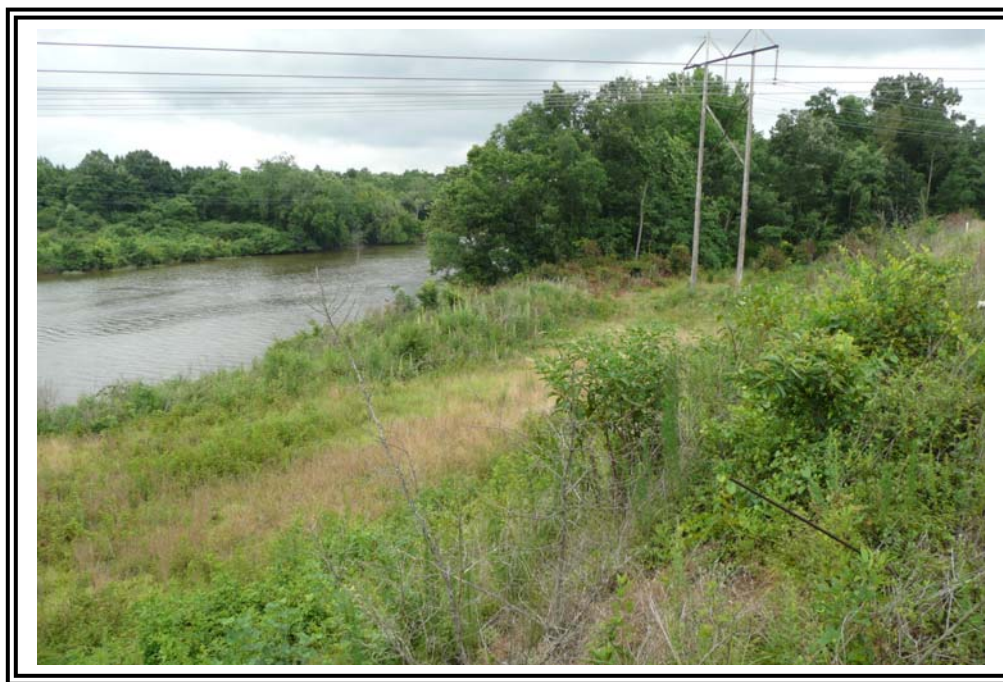
90

North end of 1963 Ash Pond west dike looking northeast. Water is Cape Fear River.

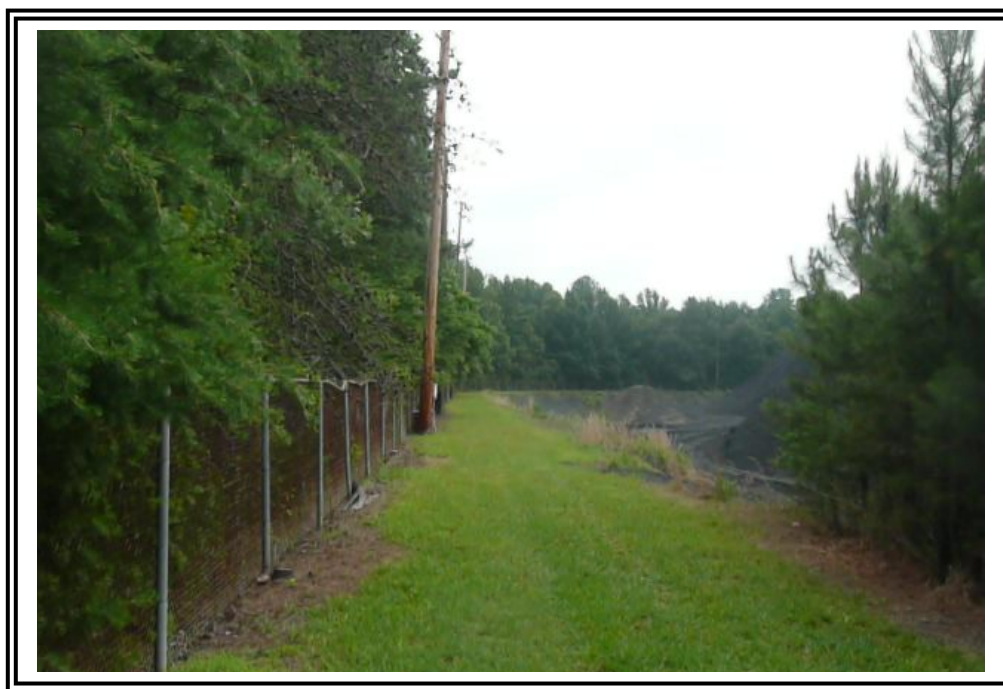
92

Flood control dike which contained the south side of the 1956 Ash Pond, looking northeast.

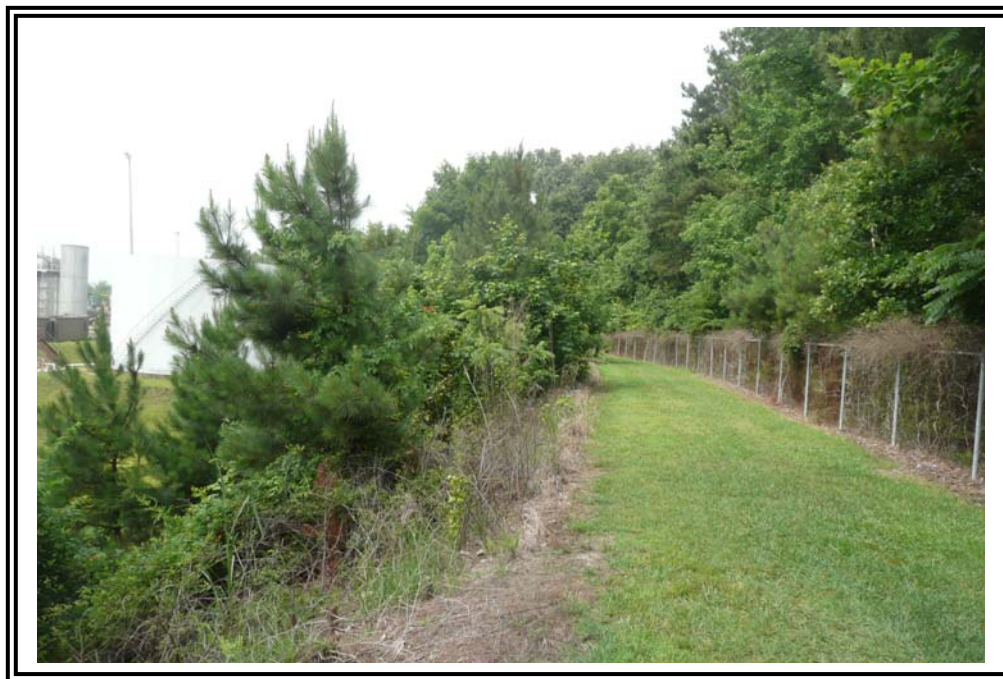
93

Flood control dike which contained the south side of the 1956 Ash Pond, looking southwest.

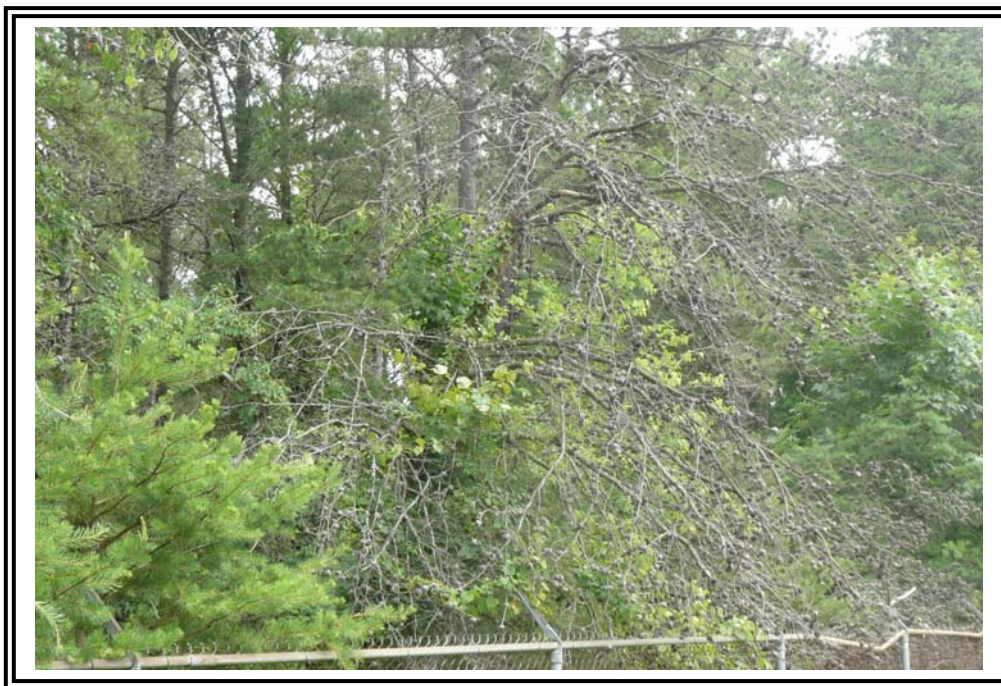
94

1956 Ash Pond from the south Dike, looking north.  
Note: This pond does not contain free water and is over grown with trees.
