# Assessment of Dam Safety Coal Combustion Surface Impoundments Draft Report

Progress Energy  
Carolinas  
Cape Fear Plant

Moncure, North Carolina

July 17, 2009

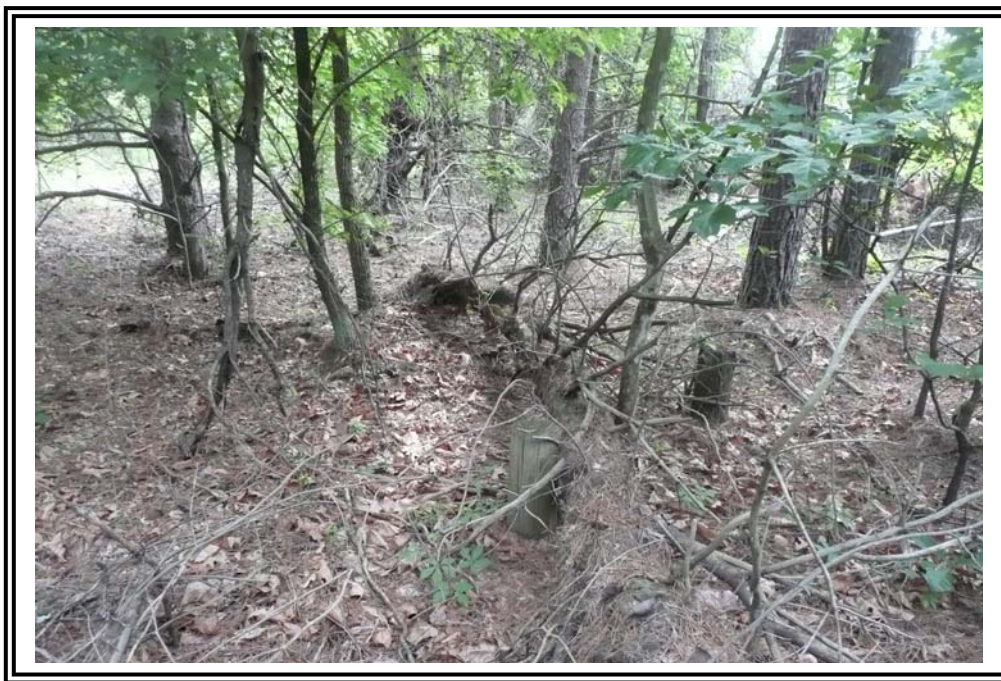
95

Remains of outlet structure at southwest corner of 1956 Ash Pond.

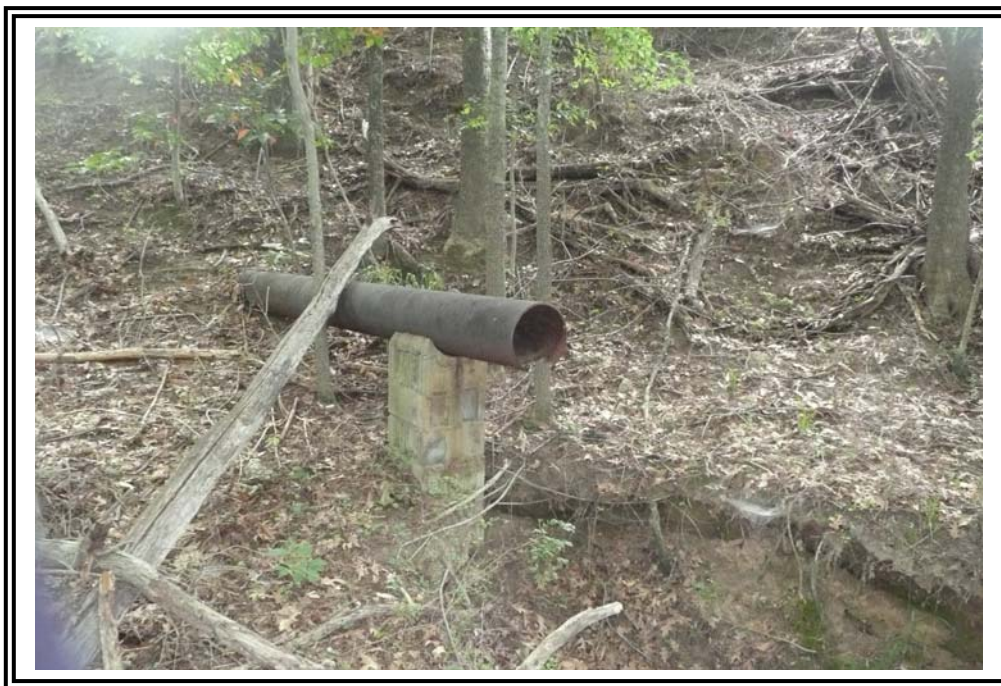
96

Former outlet pipe from 1956 Ash Pond. Pond no longer contains free water.

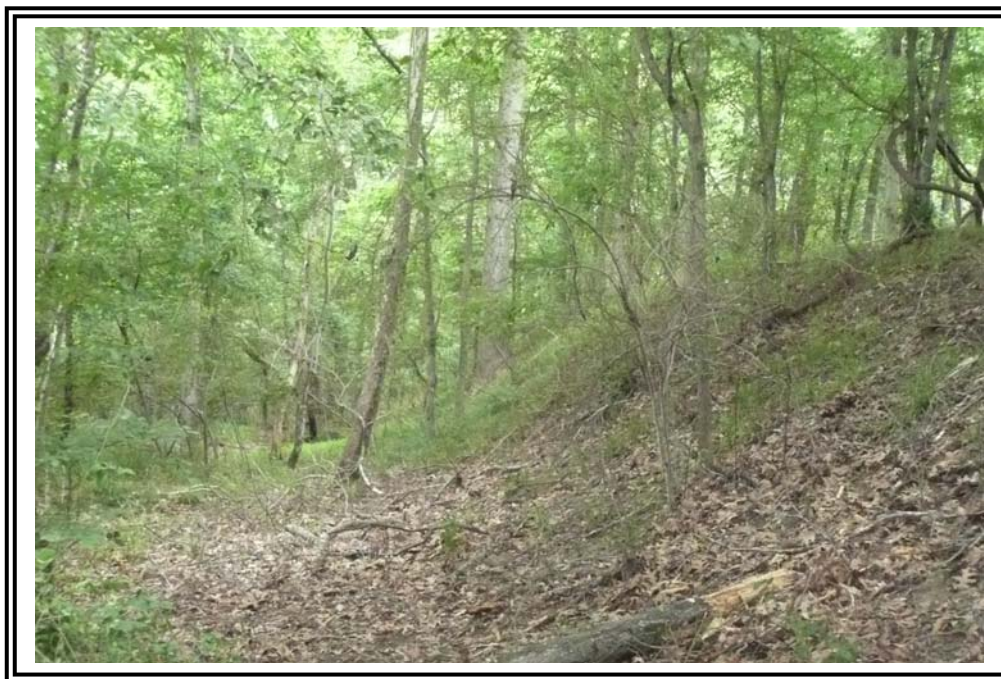
97

Downstream slope of the west Dike, looking north.

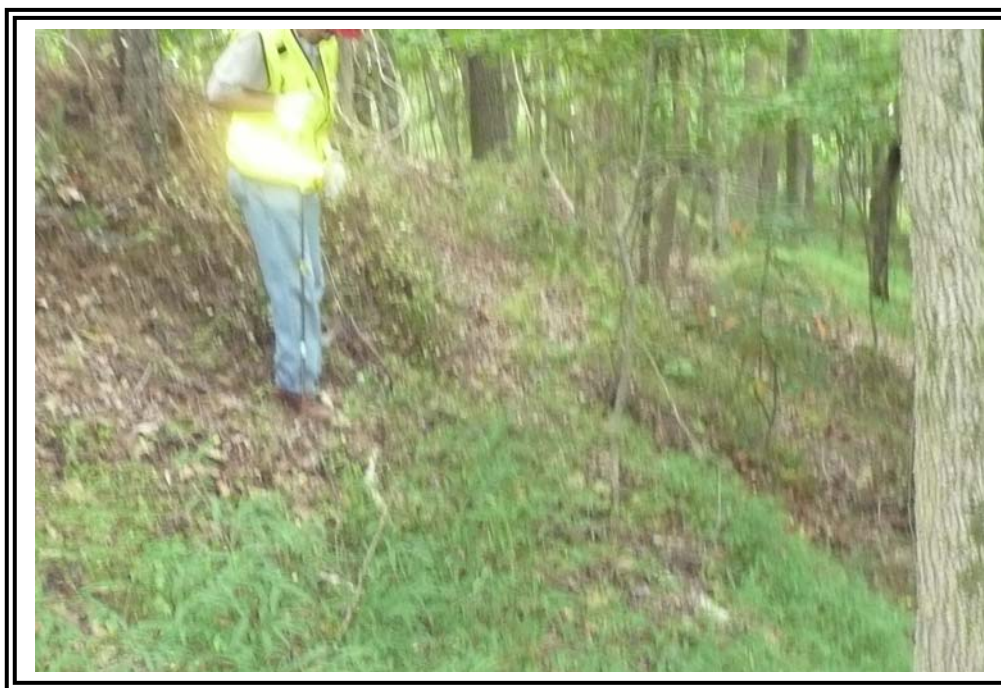
99

Same location as the previous photo with a person for scale.

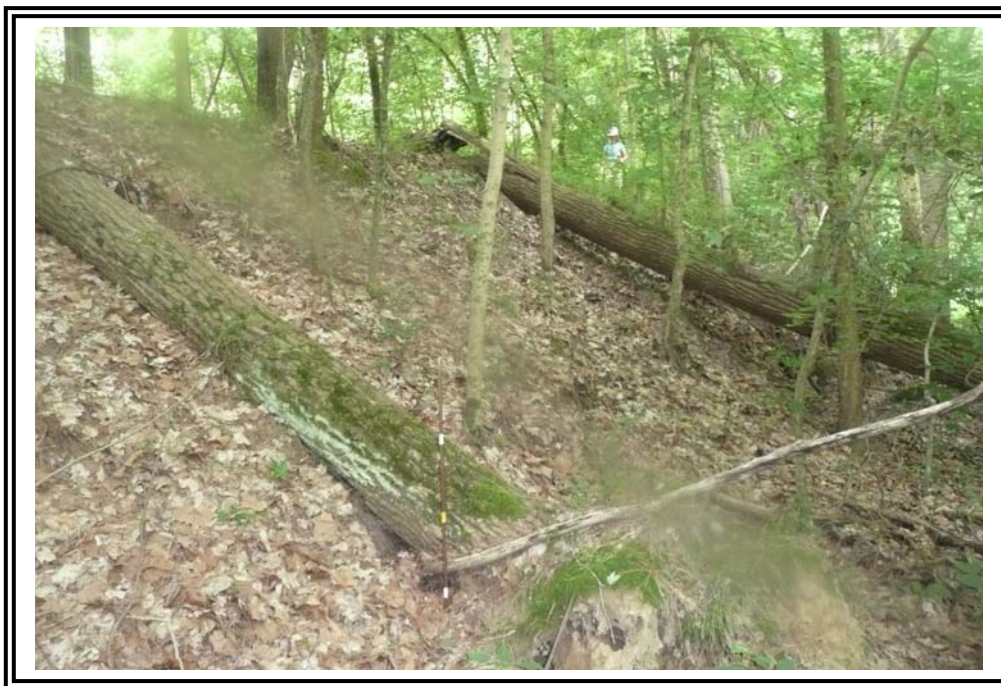
100

Typical size of fallen trees on the 1956 Ash Pond Dike slopes.

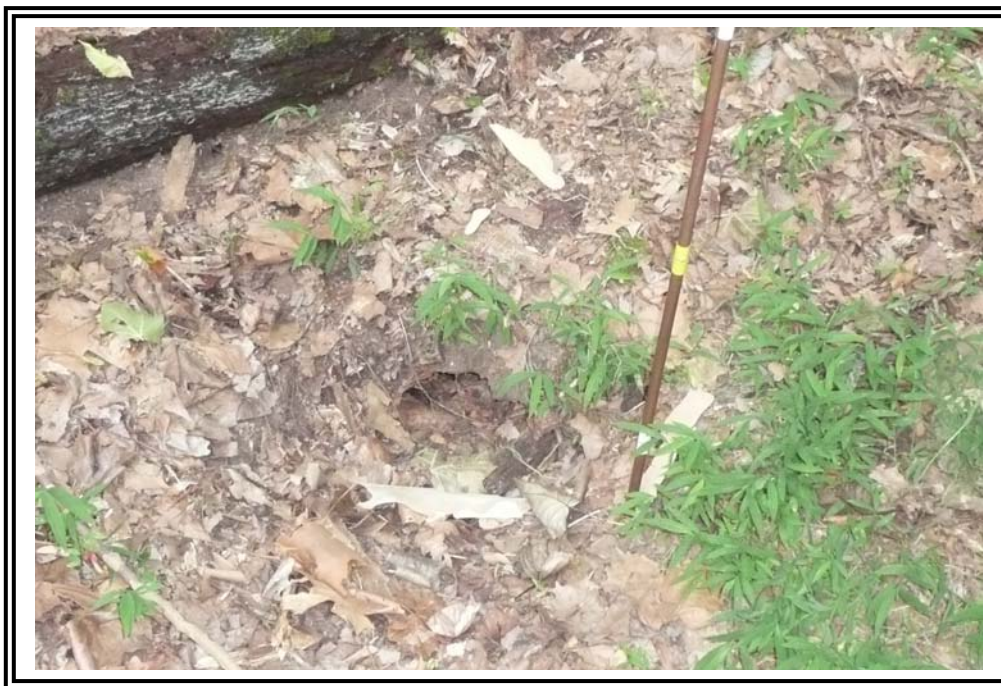
102

Top of probable stormwater outlet pipe on the 1956 Ash Pond Dike.

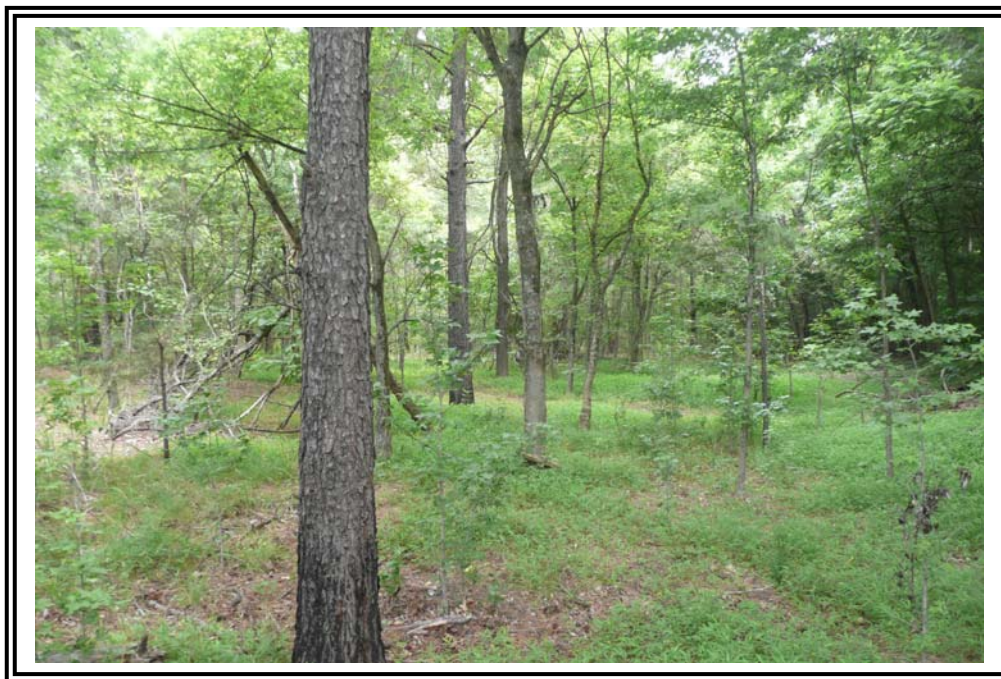
105

Typical forest cover on the 1956 Ash Pond.

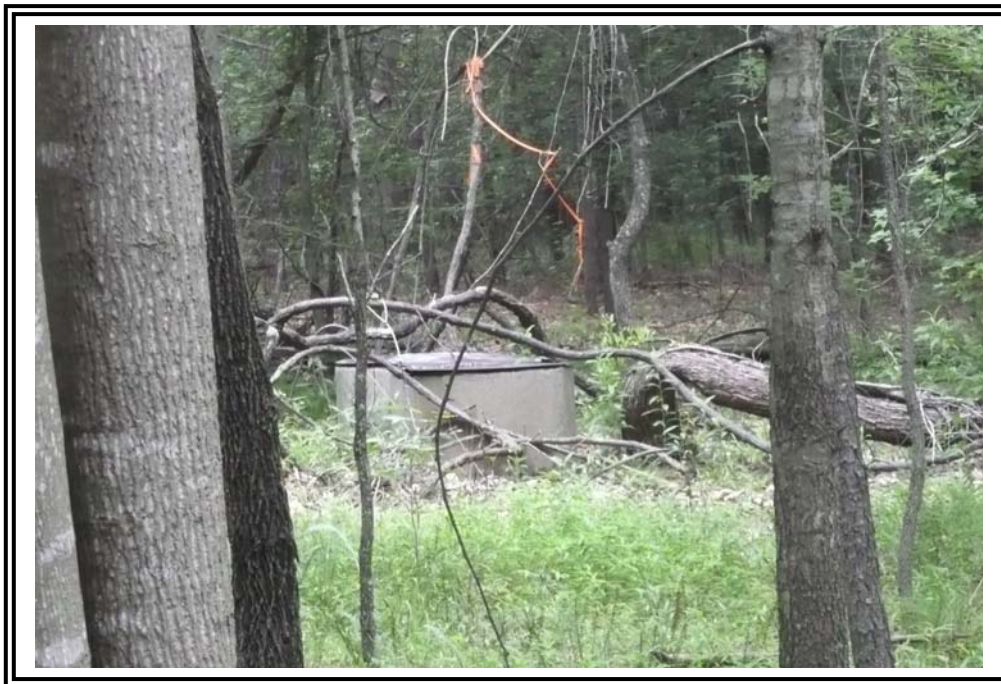
106

Storm water drainage structure at the northeast end of the 1956 Ash Pond.
