Coal Combustion Residue Impoundment

Round 9 - Dam Assessment Report

H.F. Lee Steam Electric Plant

*Active Ash Pond; Ash Pond 1; Ash Pond 2;
Ash Pond 3*

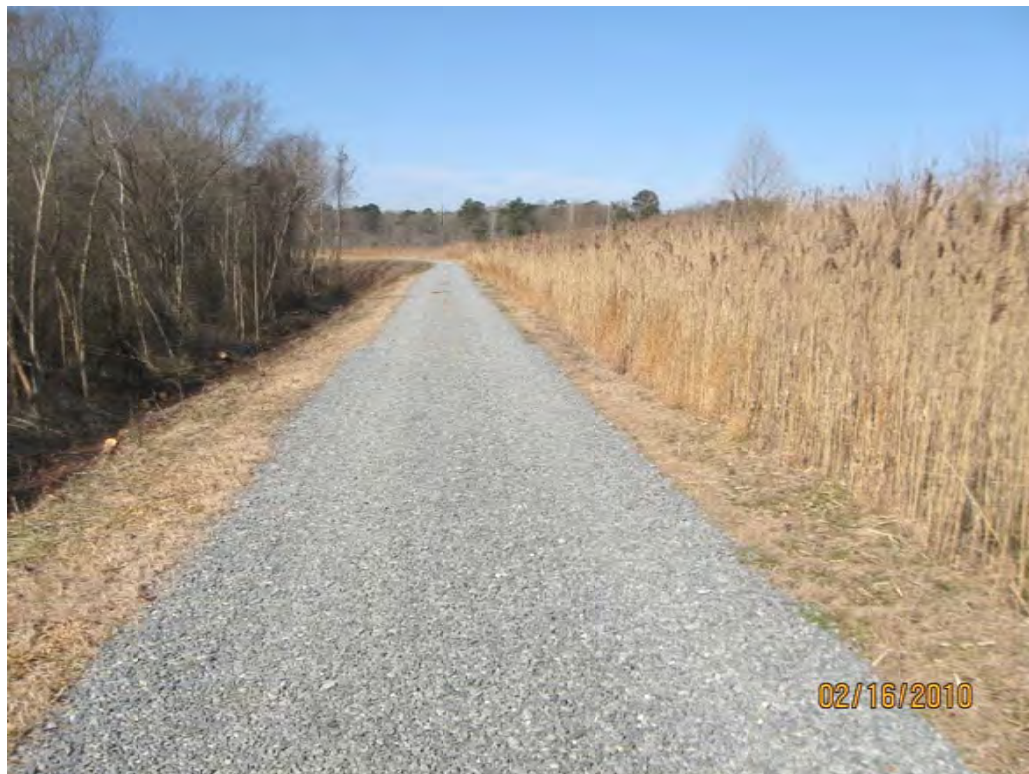
1. Ash Pond Dike – View of crest for south dike looking toward west.

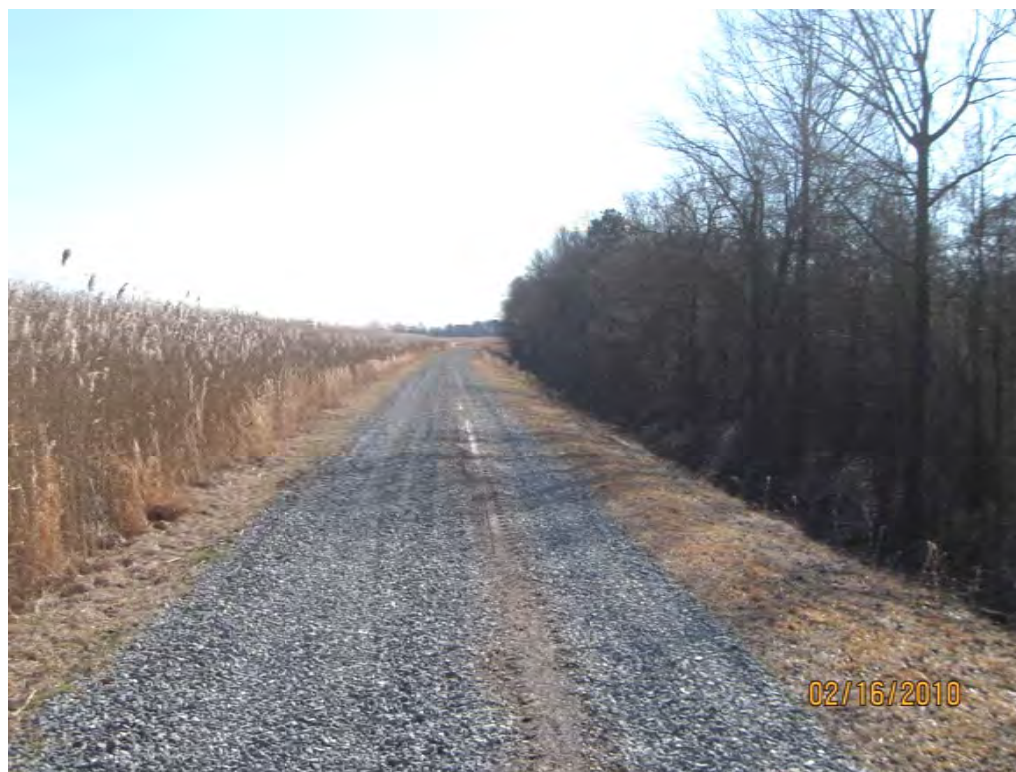
2. Ash Pond Dike – View of crest for south dike looking toward east.

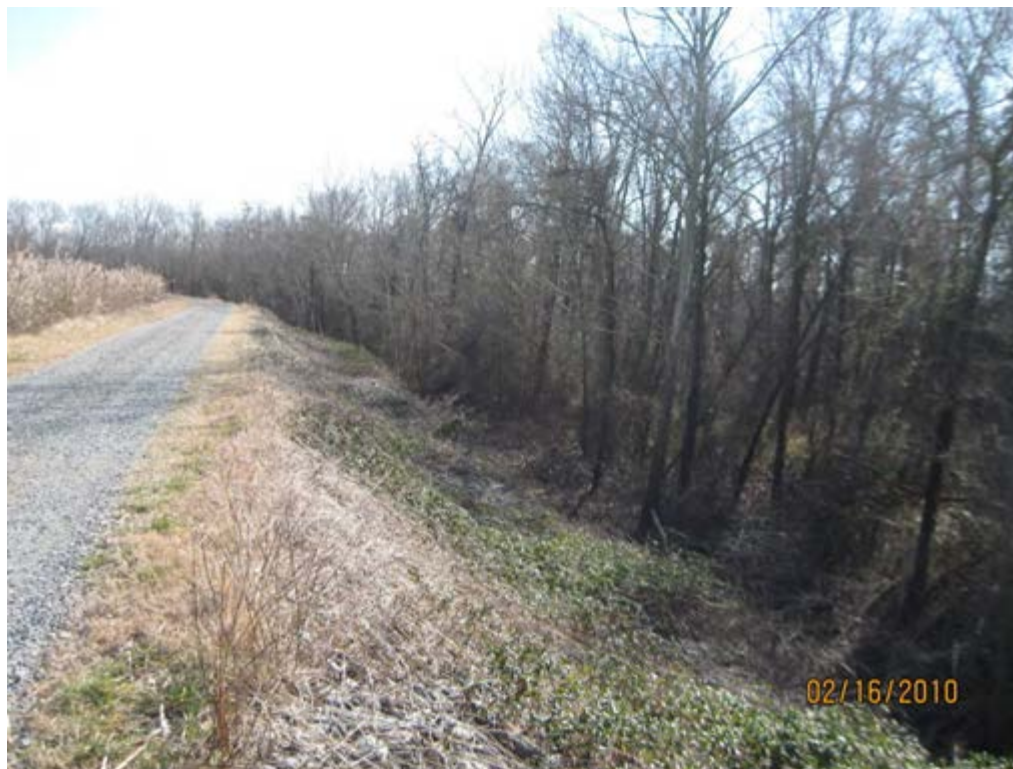
3. Ash Pond Dike – View of crest and outside slope on south dike.

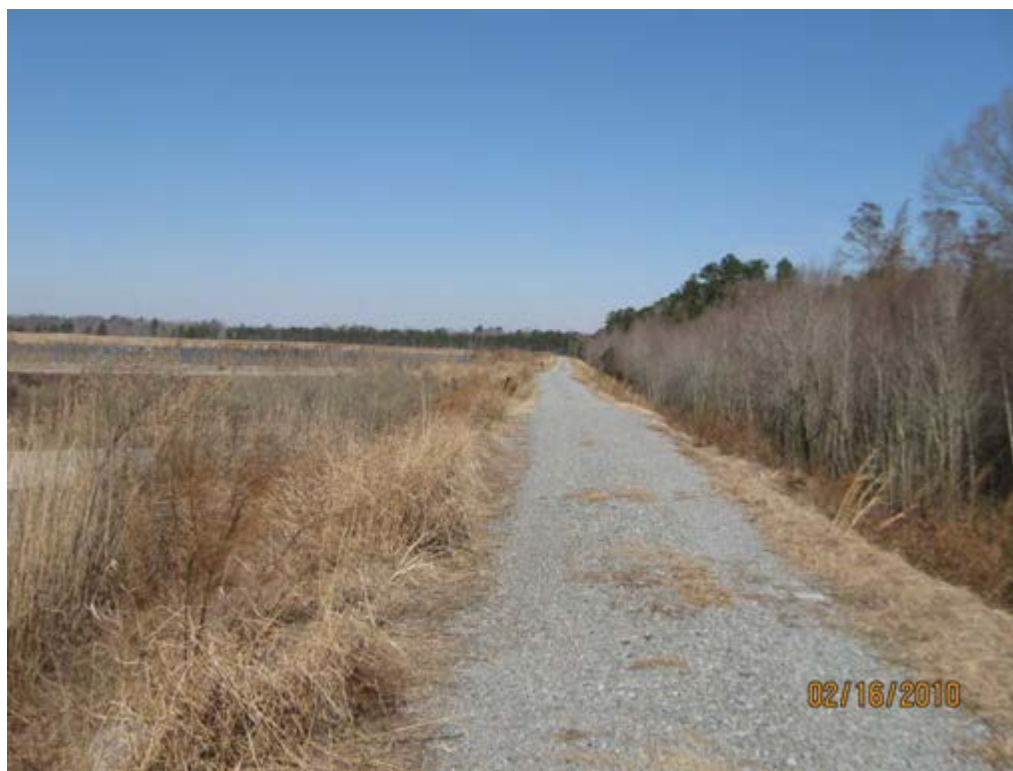
4. Ash Pond Dike – View of crest for east dike.

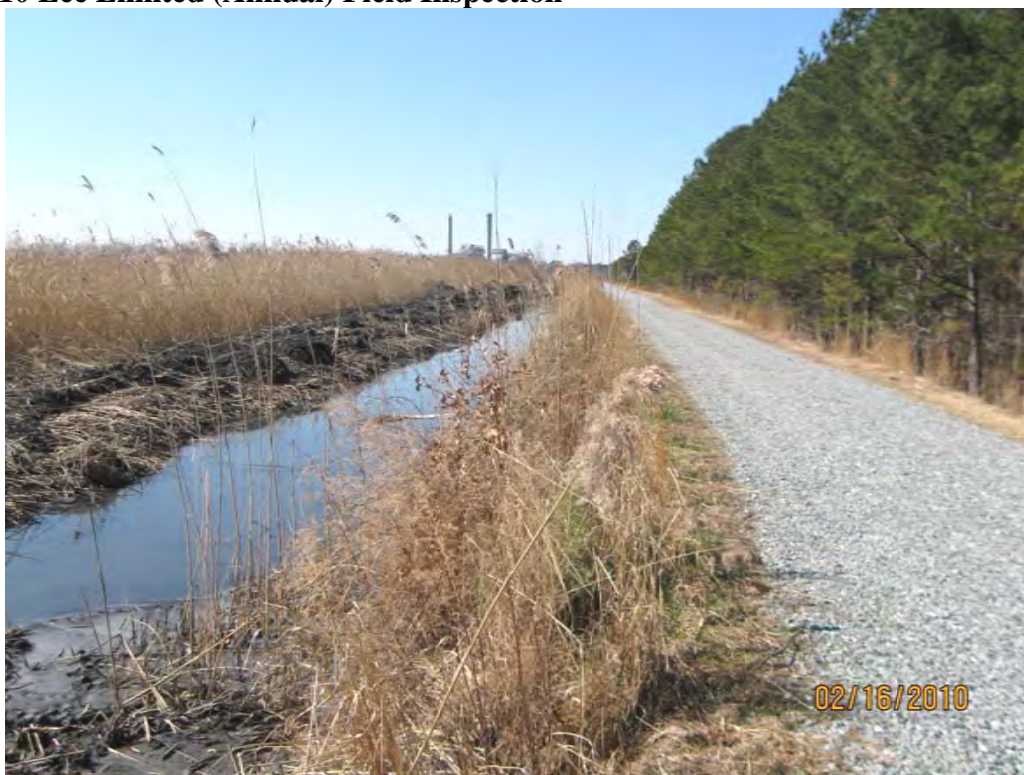
5. 5 Ash Pond Dike – View of crest for north dike.

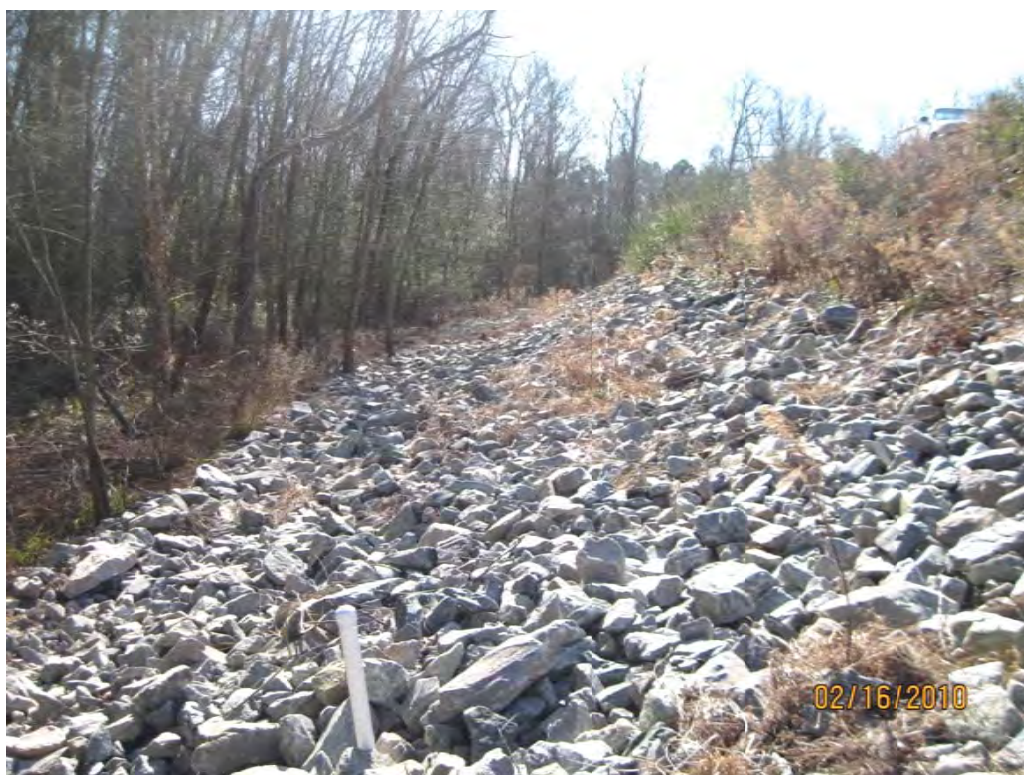
6. 6 Ash Pond Dike – View of riprap placed along toe of outside slope for secondary settling basin.

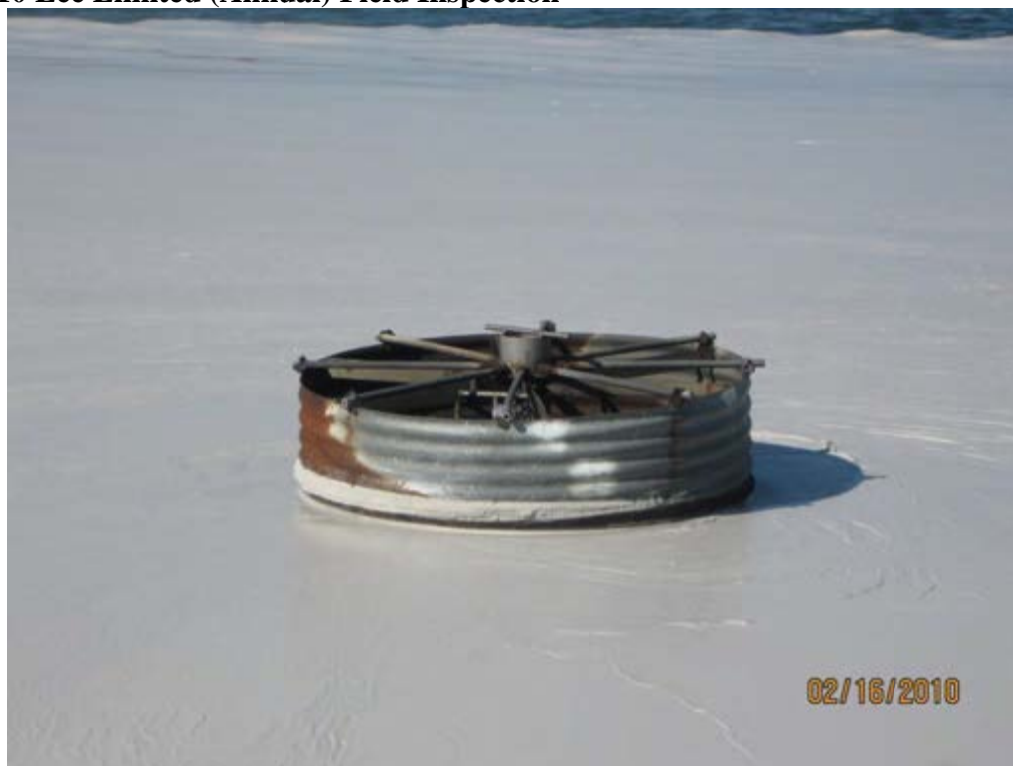
7. Ash Pond Dike – View of skimmer for ash pond discharge.

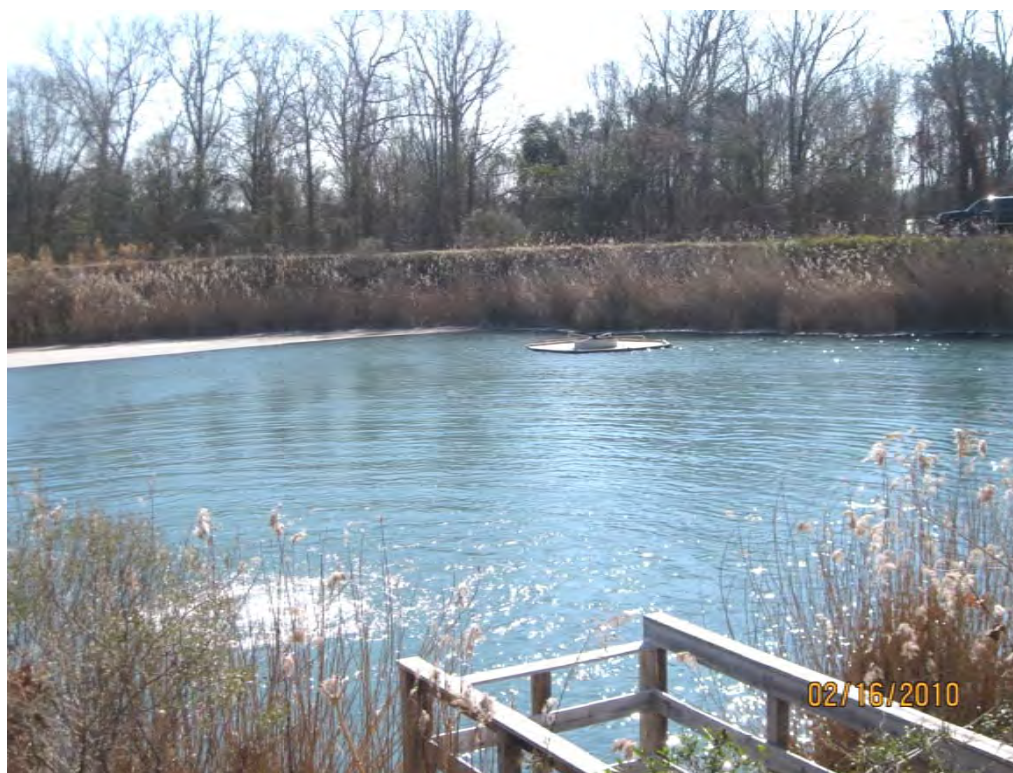
8. Ash Pond Dike – View of secondary settlement basin and skimmer for discharge riser. Turbulence is from ash pond discharge

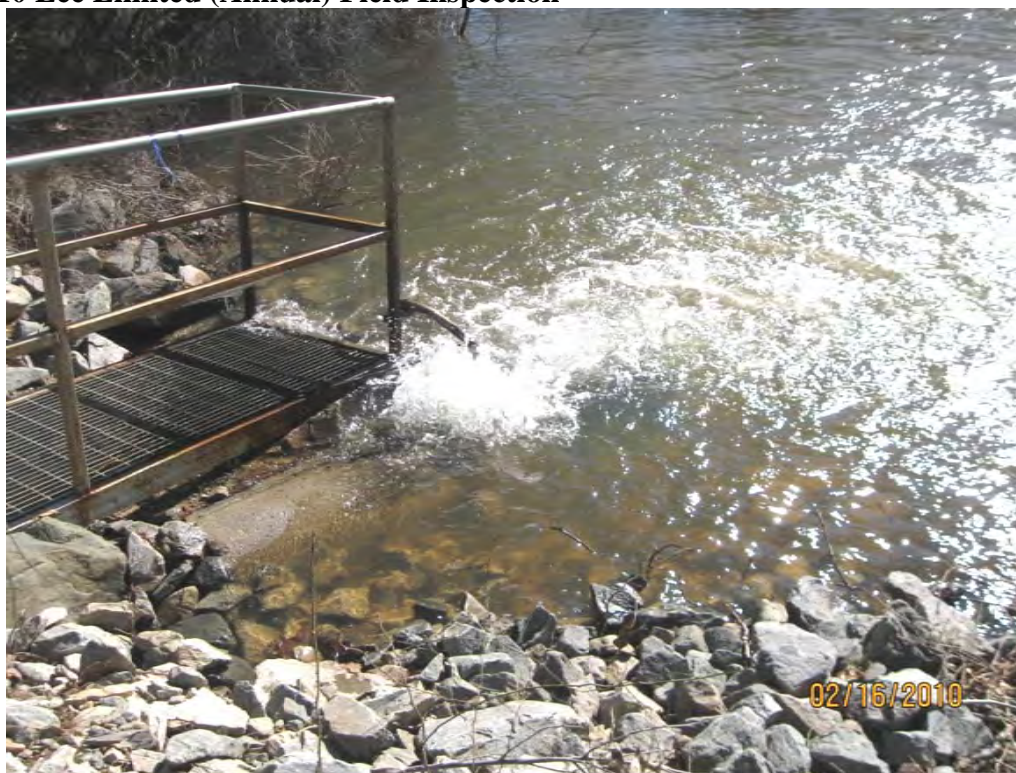
9. Ash Pond Dike – View of discharge from secondary settling basin at Neuse River.

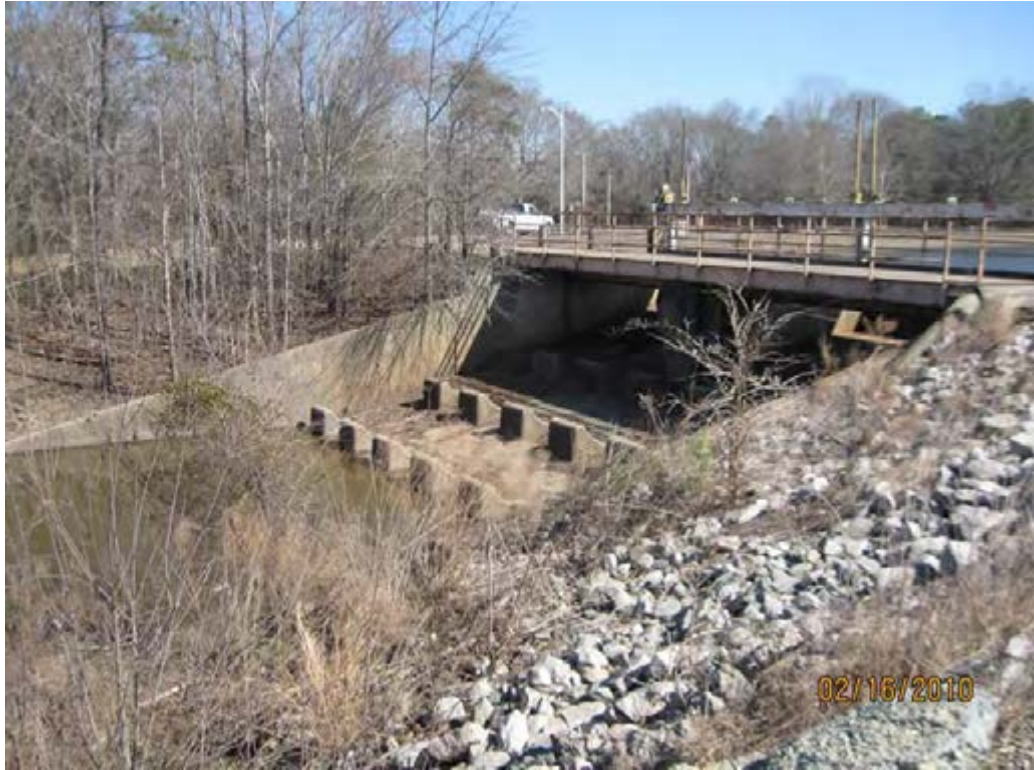
10. Cooling Lake Dike – View of spillway.

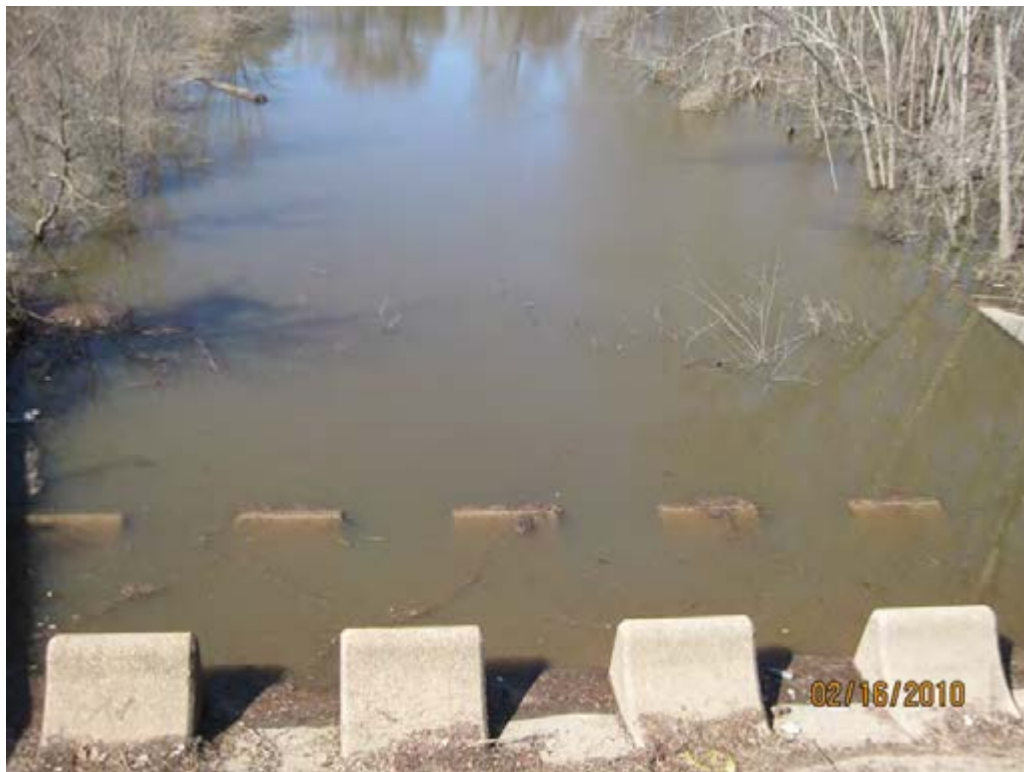
11. Cooling Lake Dike – View of energy dissipation blocks and downstream spillway channel with high tailwater conditions.

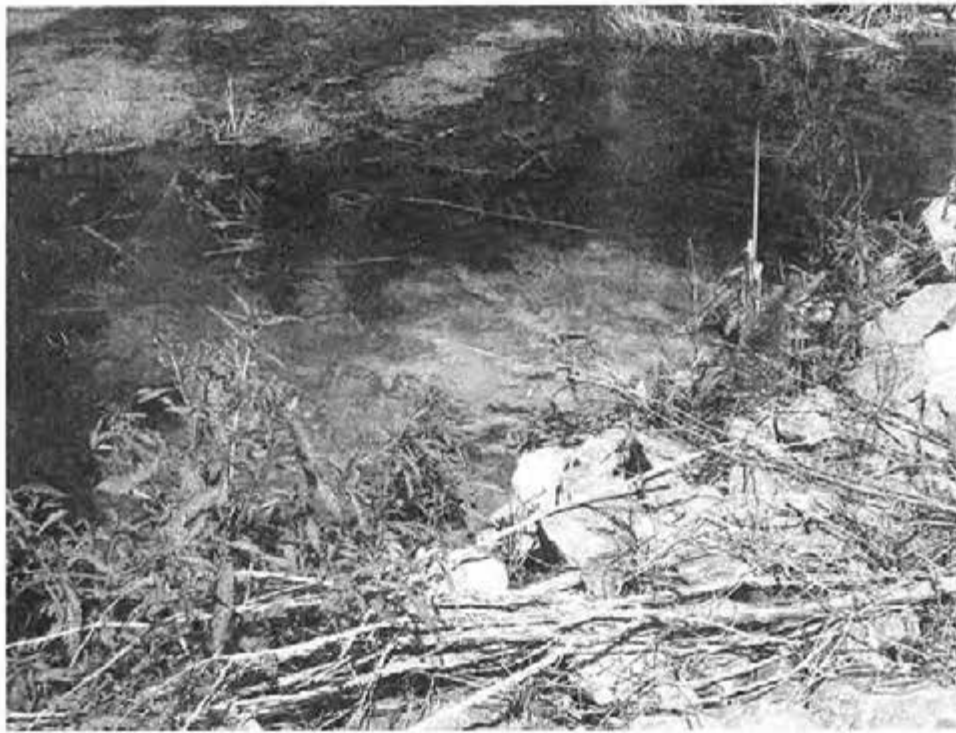
The water exit point is at the outer edge of the previously placed weighted filter and is approximately 50 feet west of piezometer P-6. Water was emerging from the underside of the filter. Water was also emerging from a small diameter boil located a few inches north of the filter edge. The boil had a slight roiling appearance and traces of silt or fine sand were observed in the flow. A small delta of fine sand was present at the boil. Photograph 1 shows the area. Photograph 2 shows the boil. Probing of the boil found an approximate 1-inch diameter opening 4 to 6 inches deep. The exit flow was estimated at less than 1 gallon per minute.

Photograph 1. Area of sediment deposit around small boil.

STEP 1 - PEEL BACK RIPRAP & NO. 57 STONE TO EXPOSE 12" OF FABRIC

PLACE NO. 57 STONE ON TOP OF RIPRAP LAYER TO
FILL VOIDS

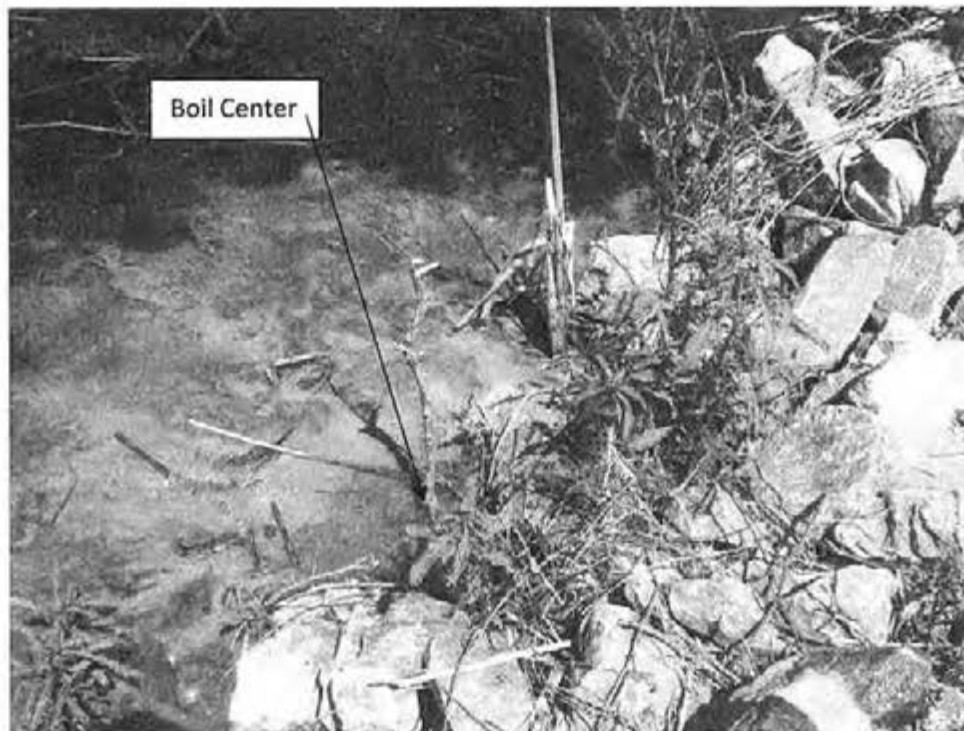
Photograph 2. Boil area (stick is in boil).

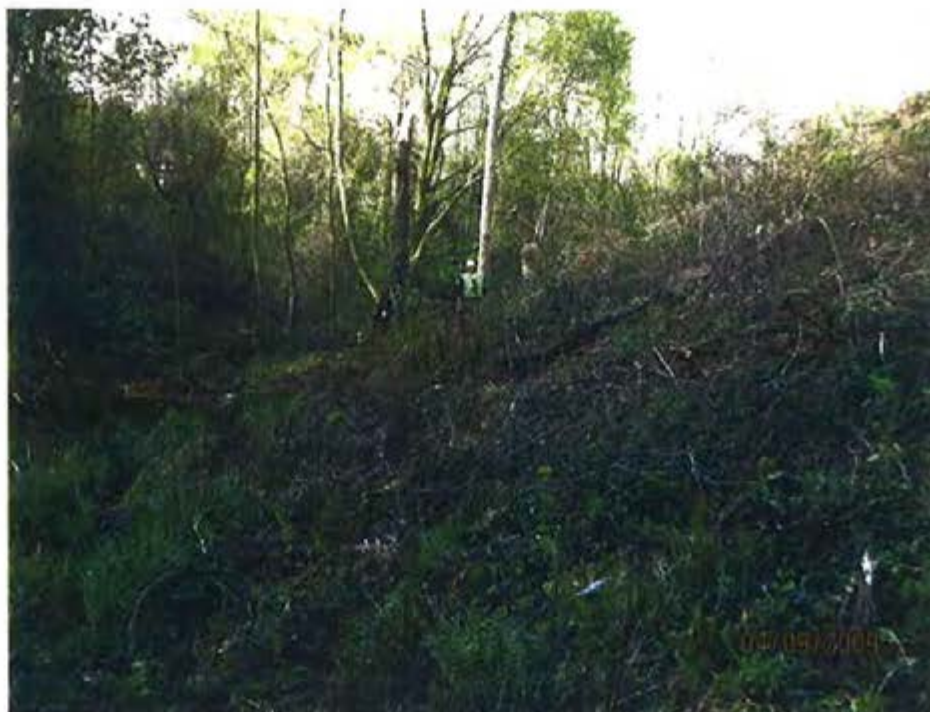
1. Initial slope clearing 4-9-09 – Not accepted; additional clearing done by TransAsh prior to geotextile installation and reviewed by MACTEC.

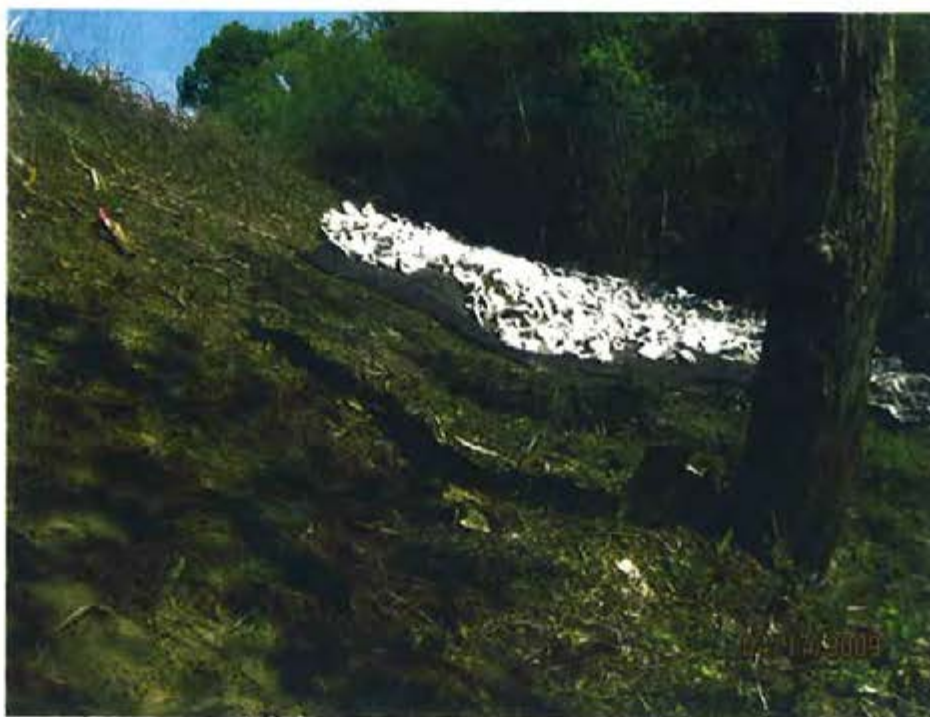
2. Final area for geotextile and riprap placement 4-17-09. Note satisfactory clearing.

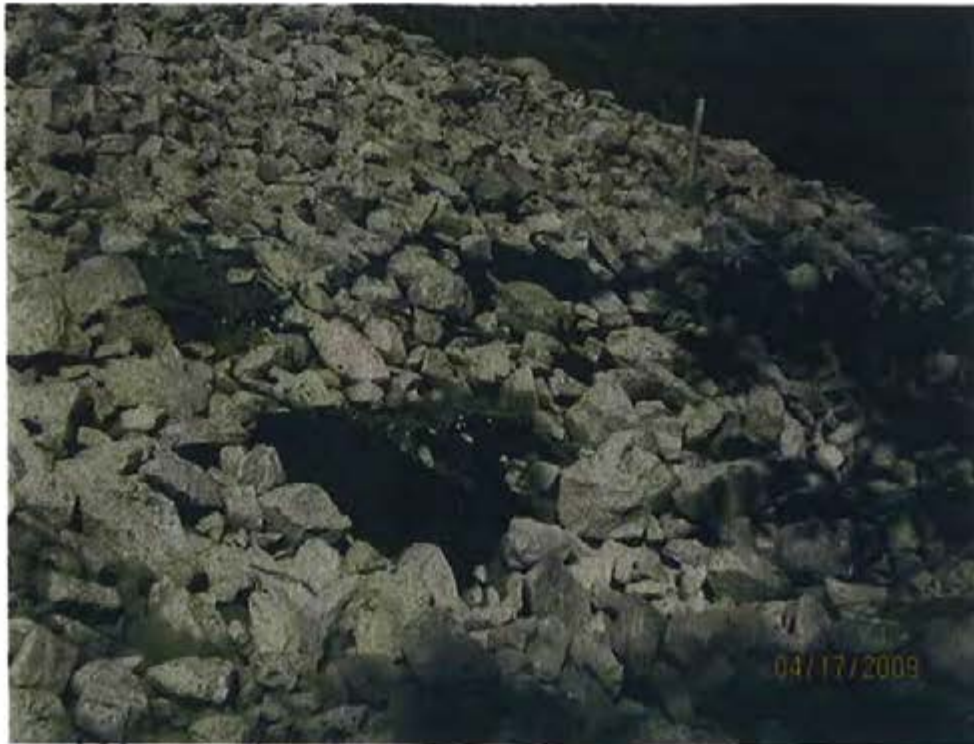
3. Areas within completed rip rap blanket where additional rip rap is needed 4-17-09.

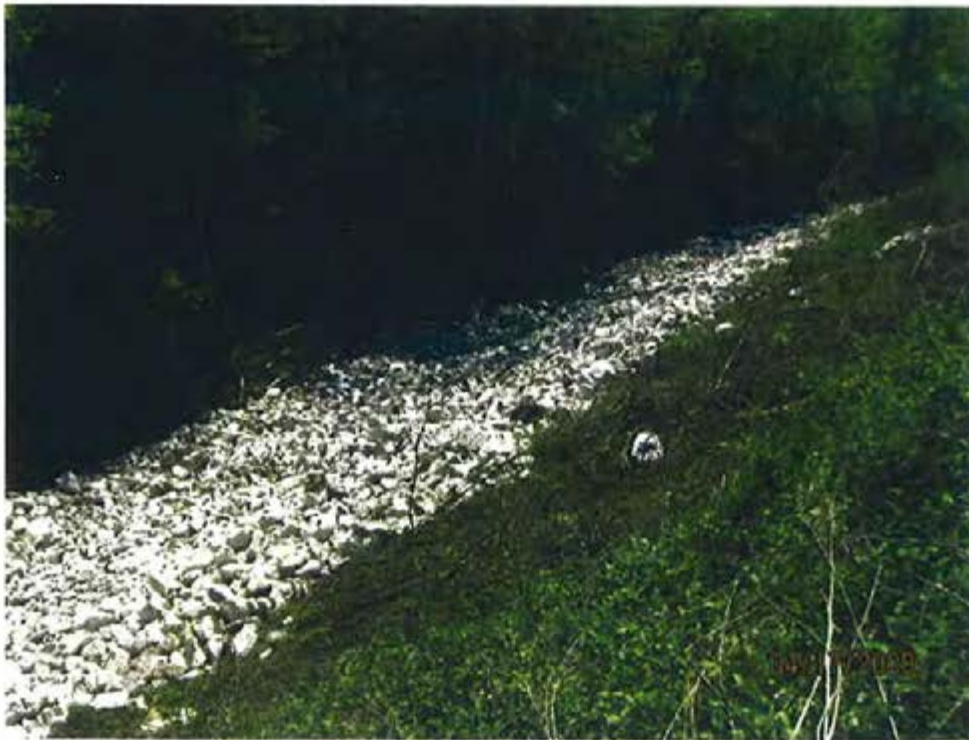
4. Overview of completed blanket 4-17-09.

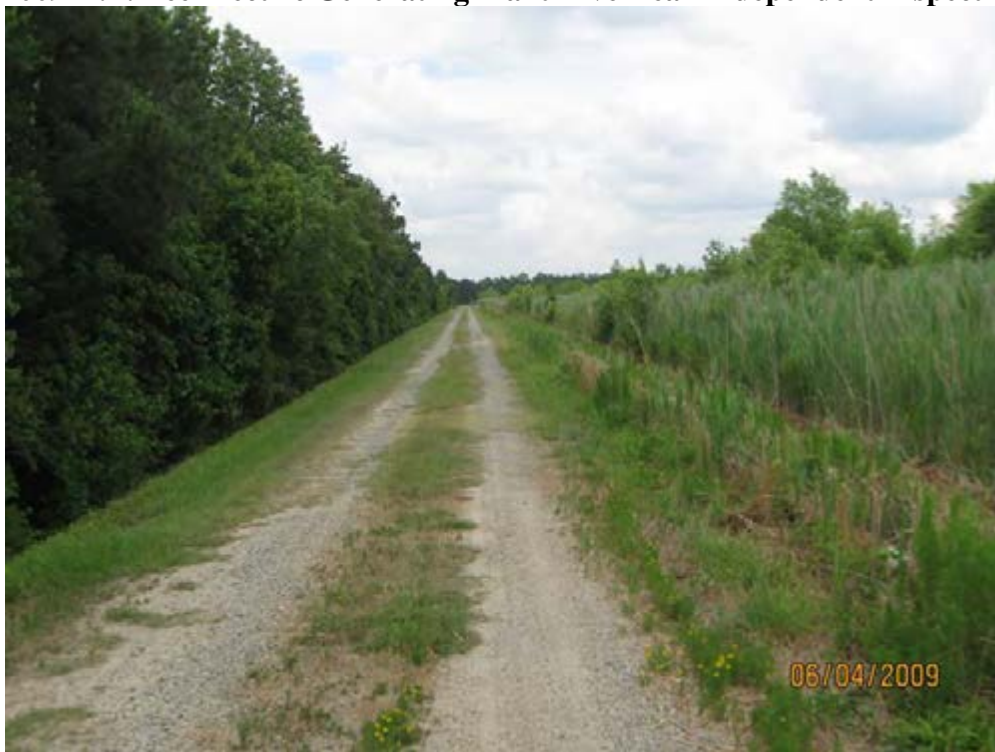
21. ASH POND- Crest of north dike.

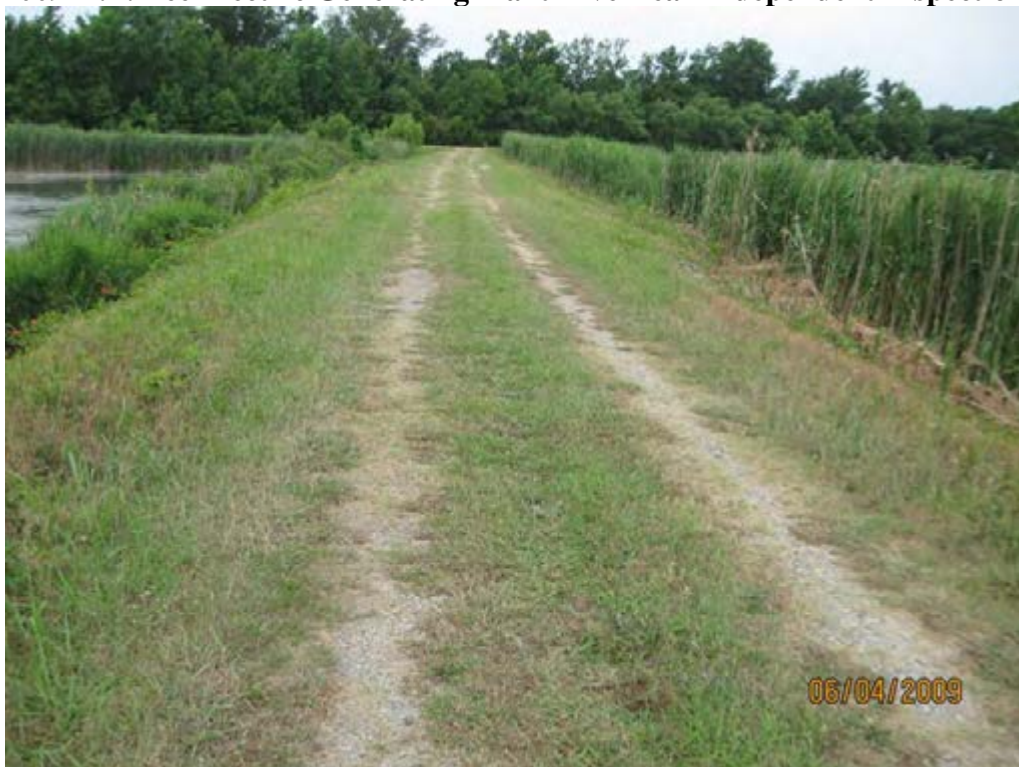
23. ASH POND- Crest of separator dike.

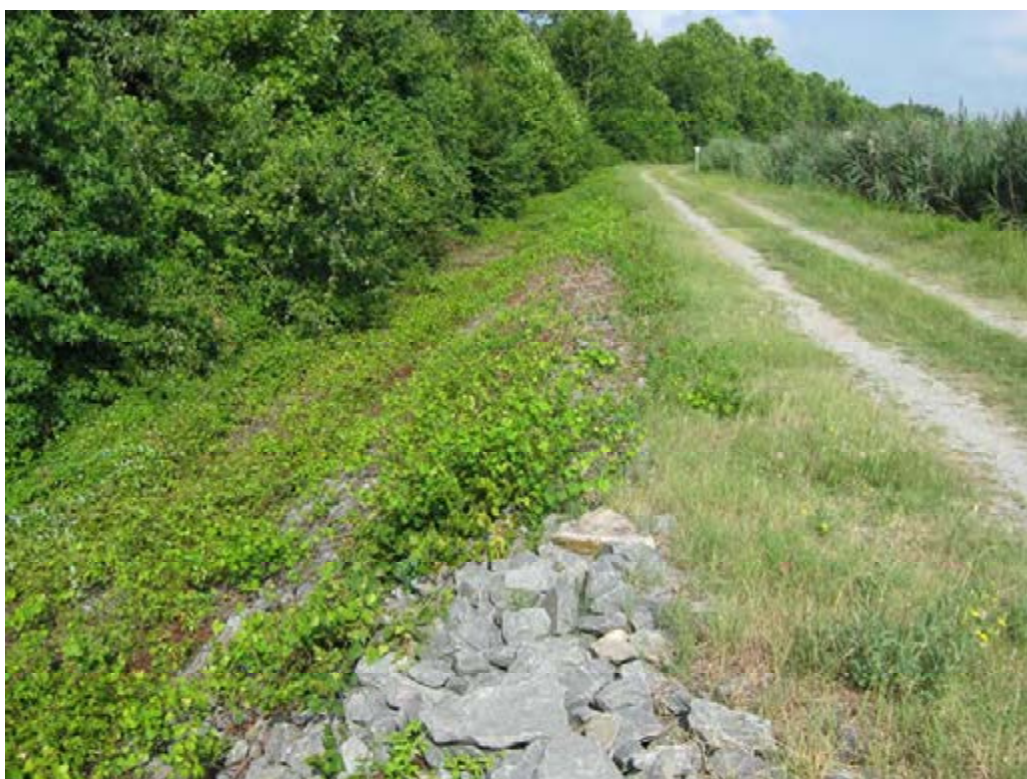
24. ASH POND- Crest and exterior slope of south dike.

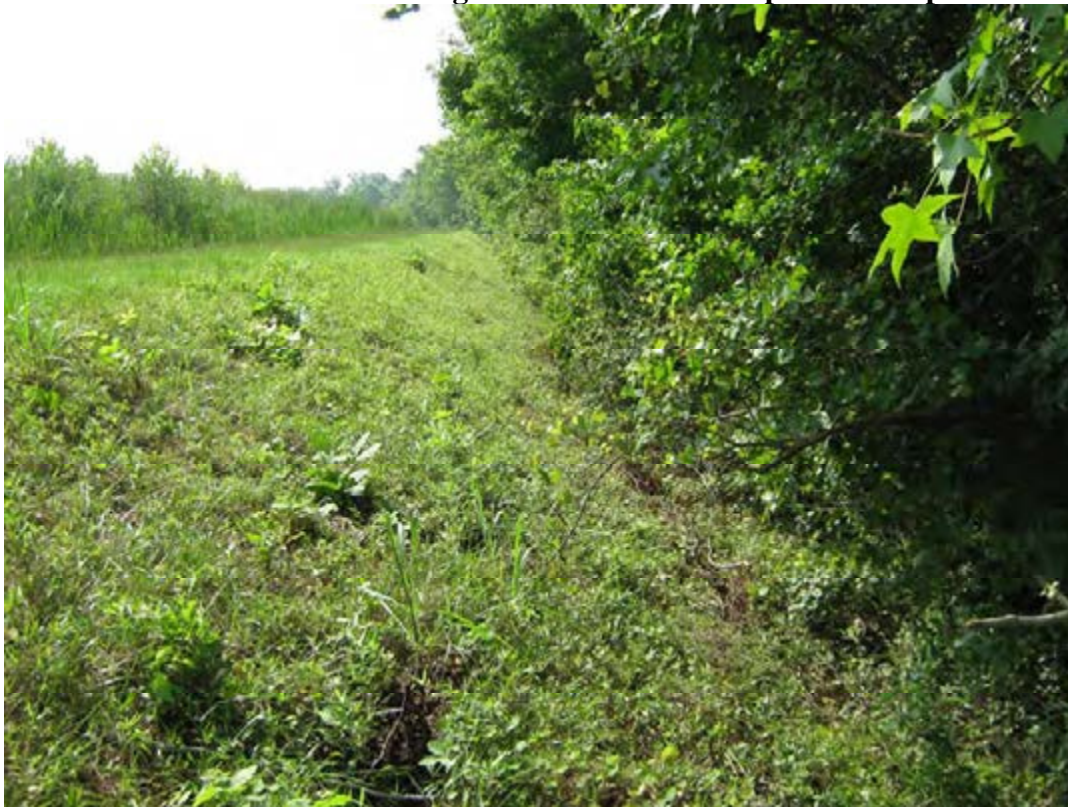
27. ASH POND- Exterior slope of south dike.

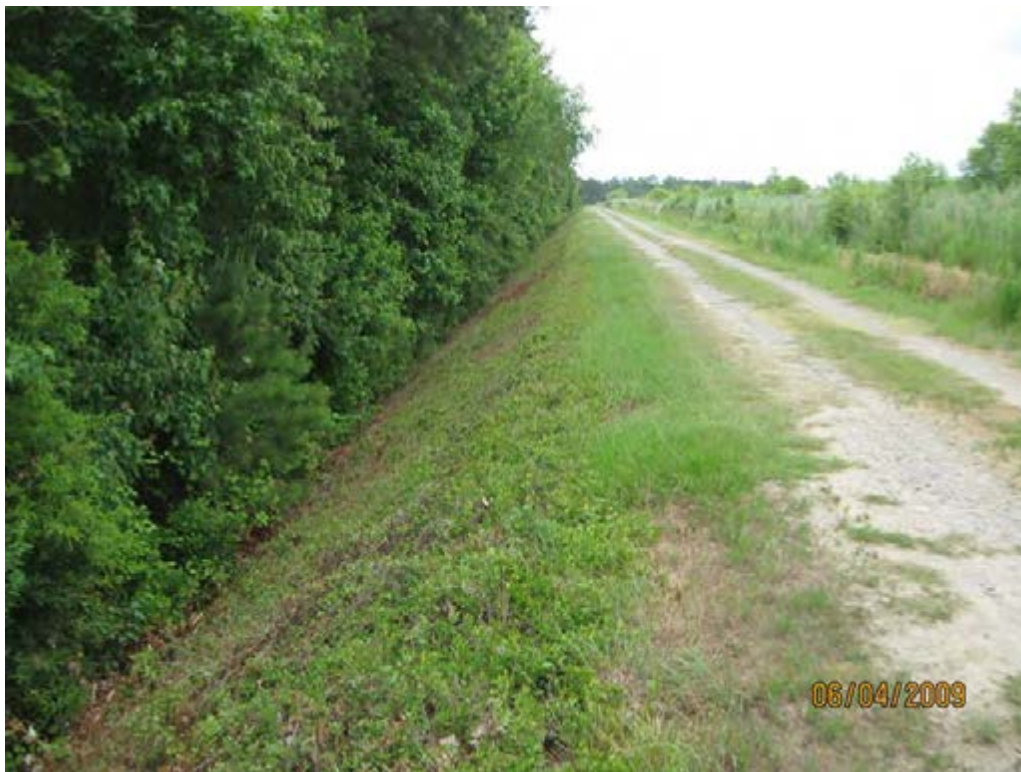
28. ASH POND- Exterior slope south dike.

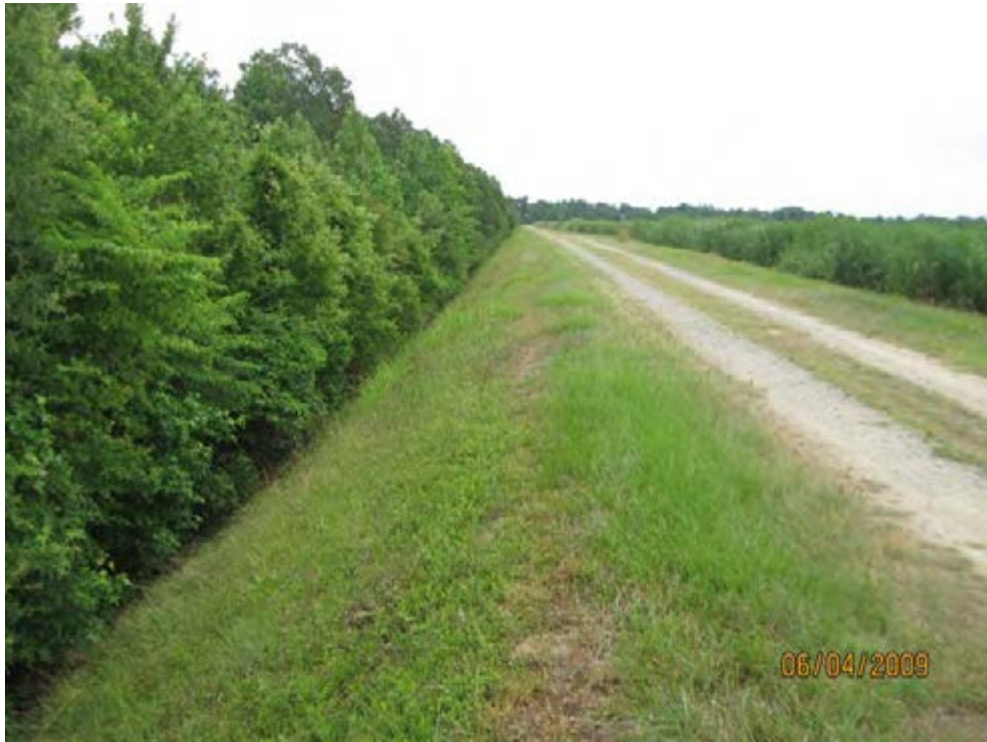
29. ASH POND- Crest and exterior slope-north dike.

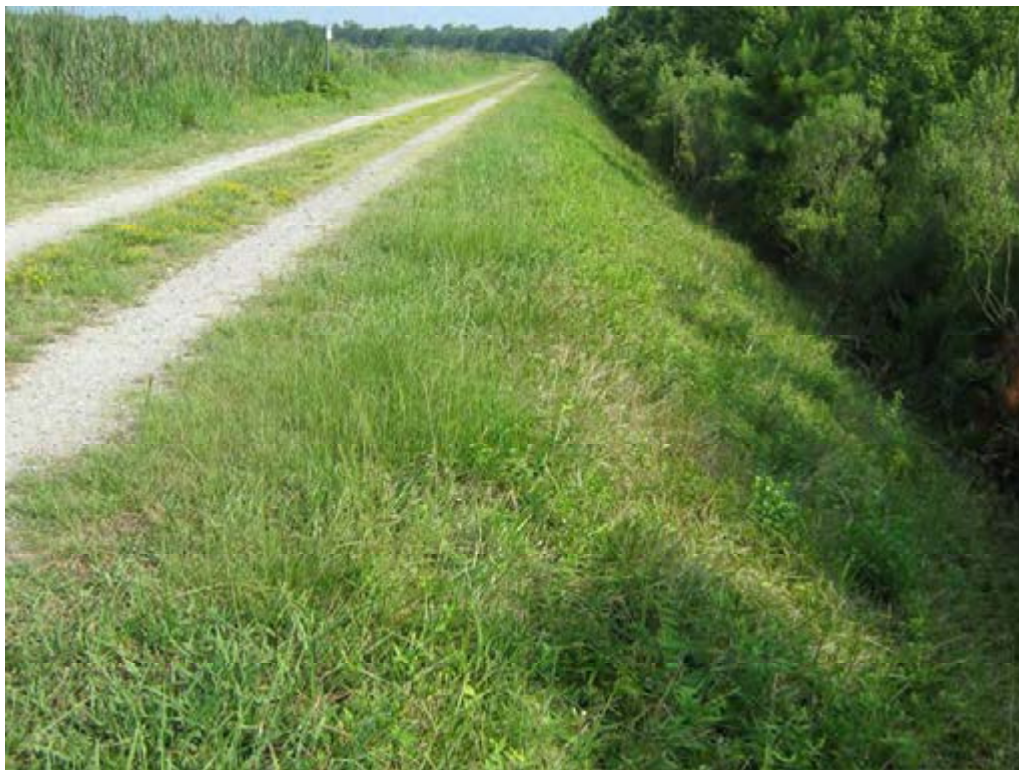
30. ASH POND- Exterior slope - east dike.

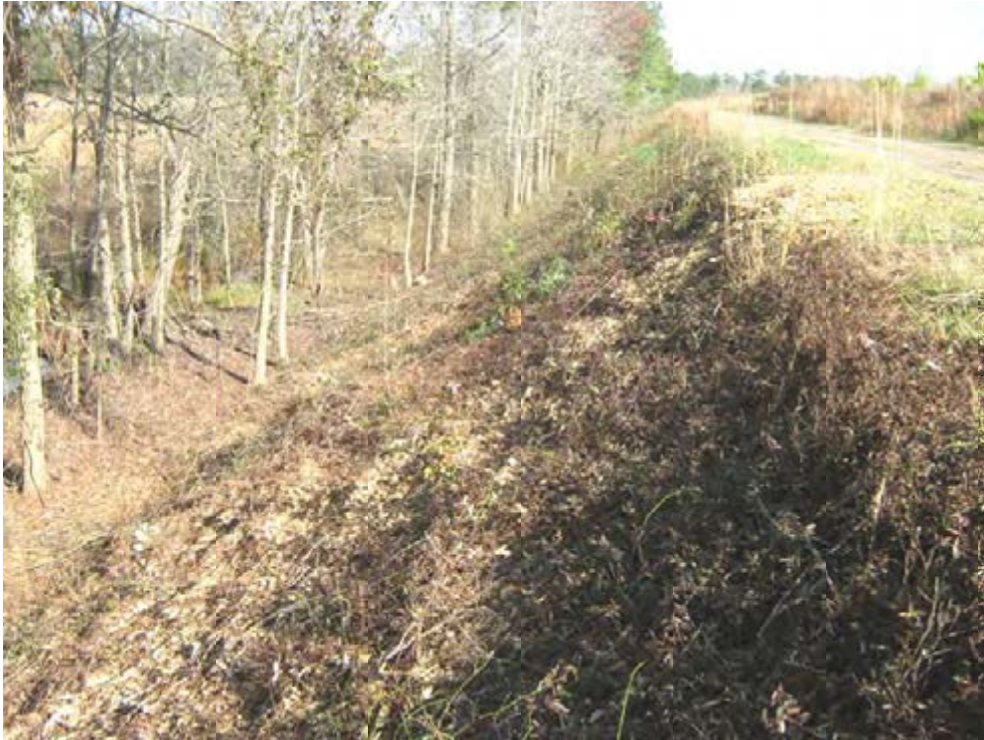
31. ASH POND-Cleared north dike exterior slope (12-3-09).

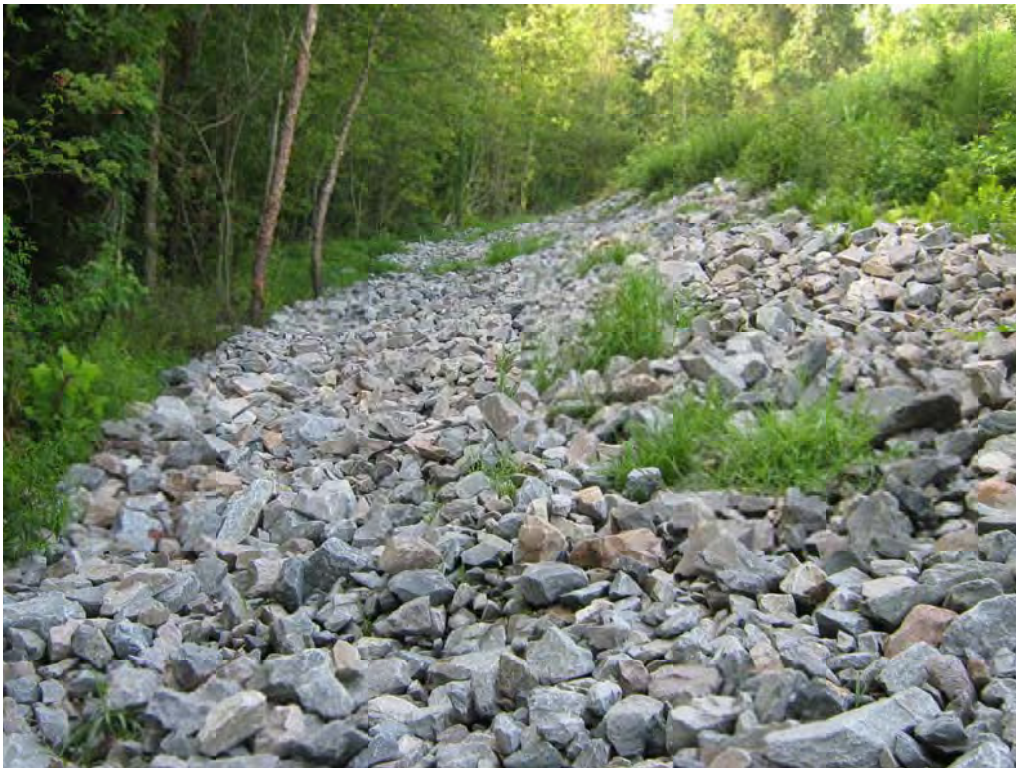
32. ASH POND- Drainage blanket at secondary settling pond-east slope

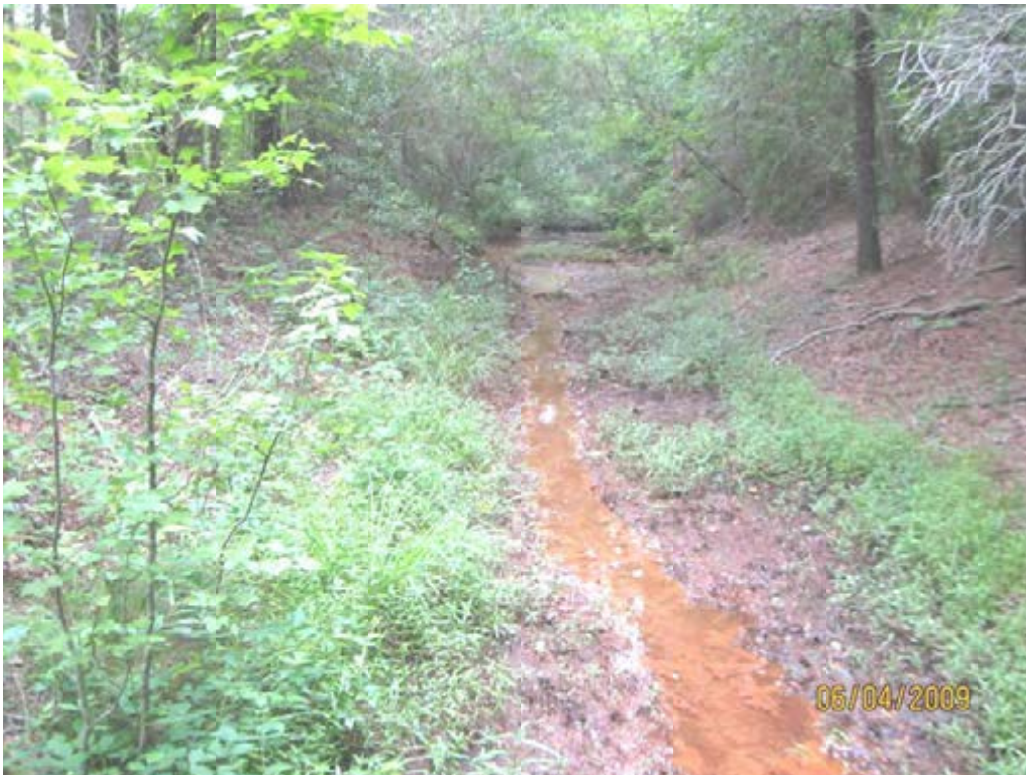
34. ASH POND-Small creek beside north dike.

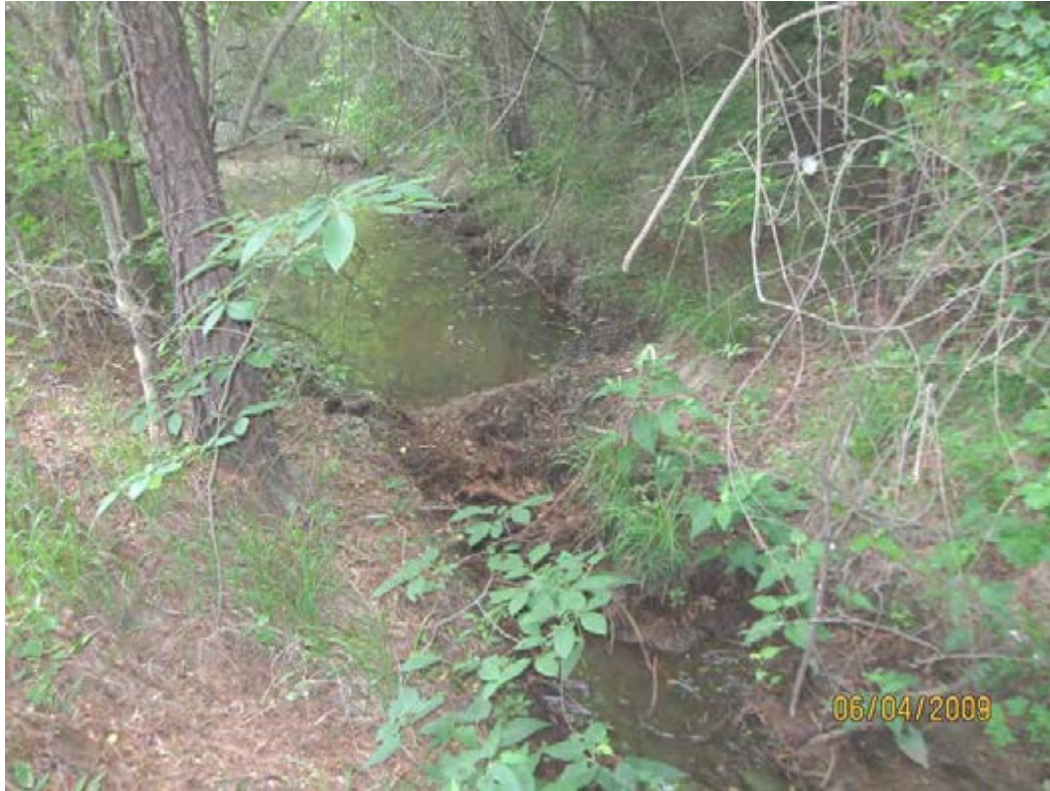
35. ASH POND-Small beaver dam on creek beside north dike.

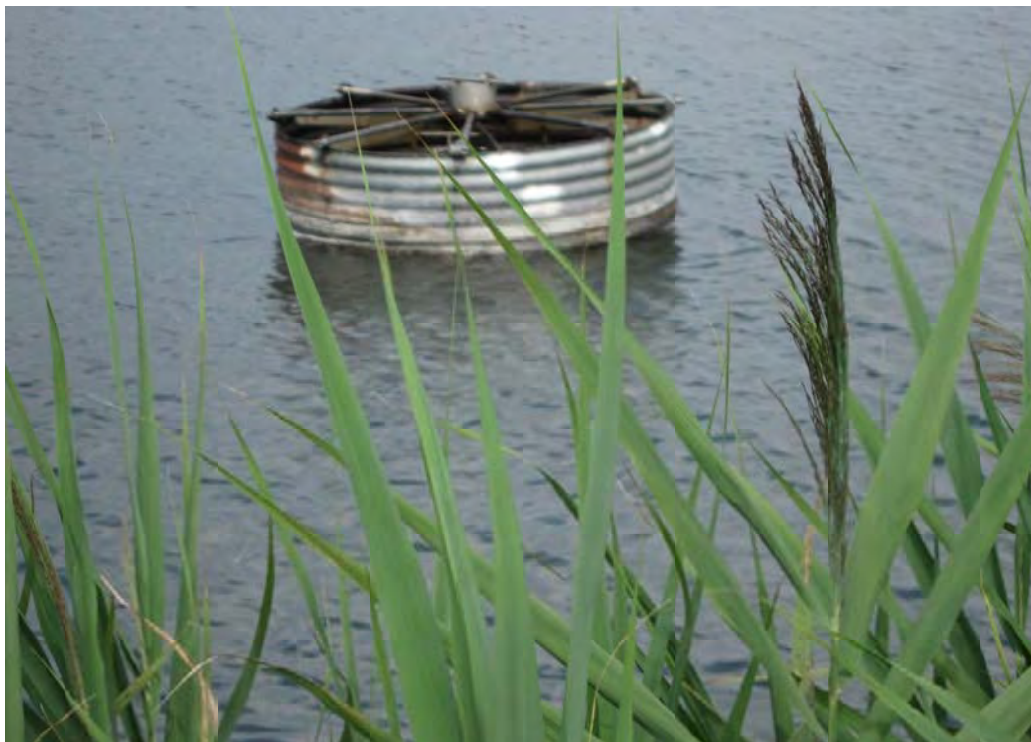
36. ASH POND-Skimmer structure on ash pond riser.
