Coal Combustion Residue Impoundment

Round 9 - Dam Assessment Report

H.F. Lee Steam Electric Plant

*Active Ash Pond; Ash Pond 1; Ash Pond 2;
Ash Pond 3*

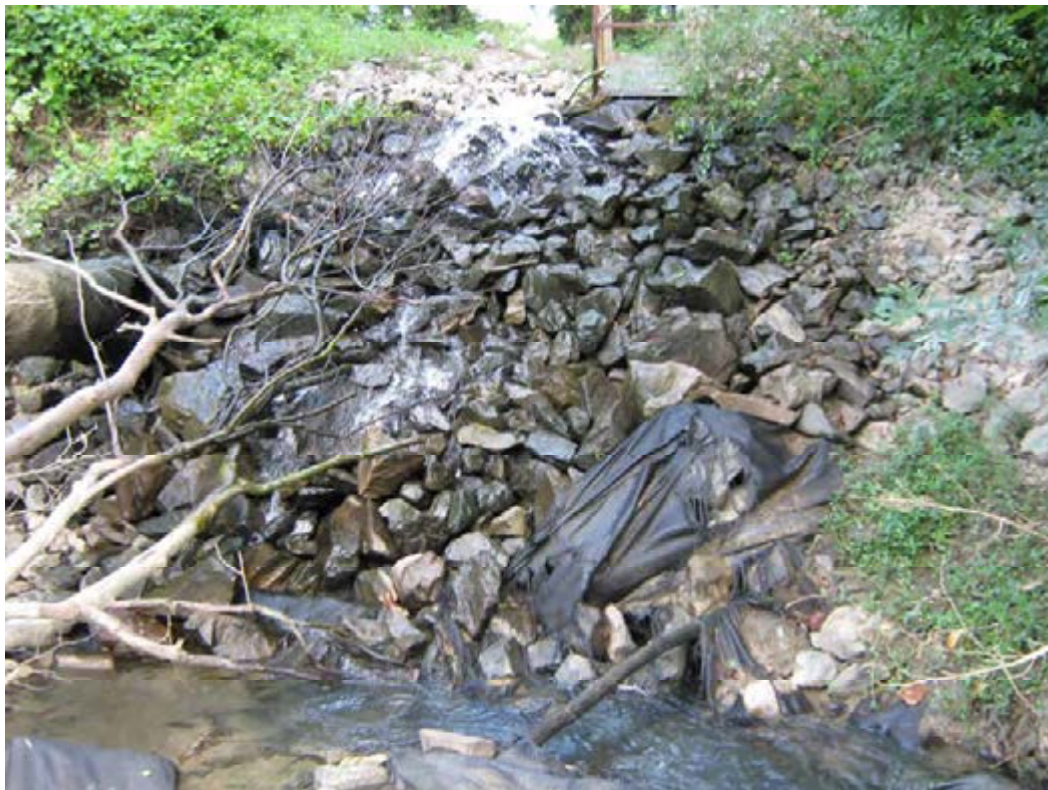
37. ASH POND-Discharge point for secondary settling pond outfall.
