**CAROLINA POWER & LIGHT  
MAYO ELECTRIC GENERATING PLANT**

**MAYO CREEK DAM  
ASH POND DAM  
PERSON COUNTY, NORTH CAROLINA**

**FIVE-YEAR INDEPENDENT CONSULTANT INSPECTION  
AS REQUIRED BY  
NORTH CAROLINA UTILITIES COMMISSION**

**December 22, 1999**

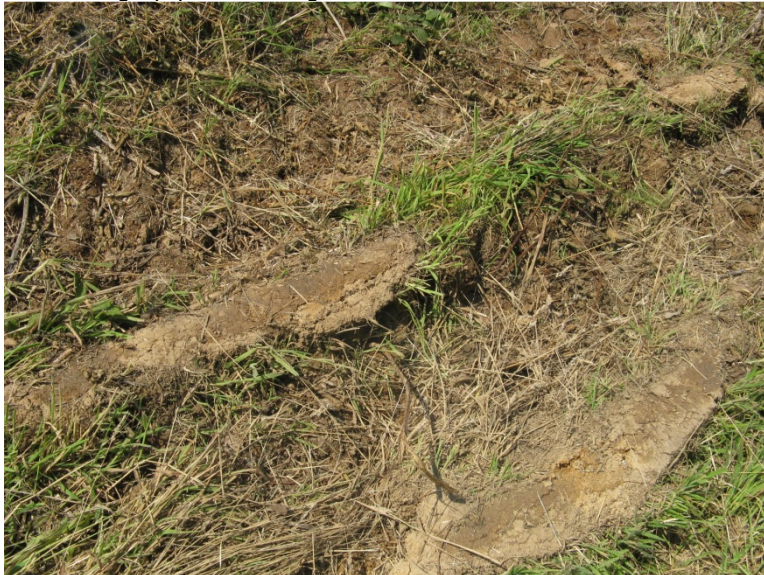
Photo 5: Embankment Looking to Right Abutment, Downstream Embankment, Photo: 036, 6/3/09  
(Note right and left are referenced from observer facing downstream)
