**Coal Combustion Residue Impoundment
Round 9 - Dam Assessment Report**

H. B. Robinson Power Station

***Progress Energy Carolinas
Hartsville, South Carolina***

Dewberry & Davis, LLC
Fairfax, Virginia

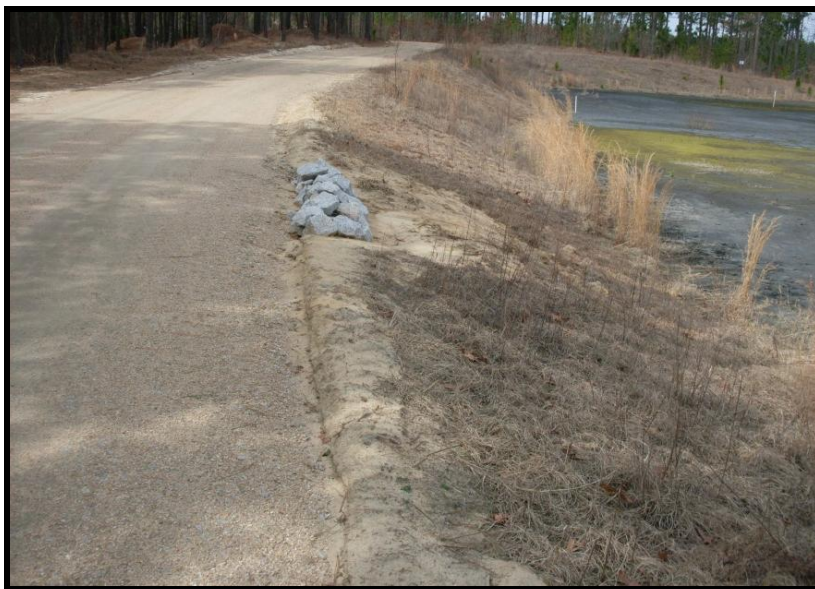
Photograph 5.2. Minor erosion at the upstream edge of crest at south side of embankment, looking west.

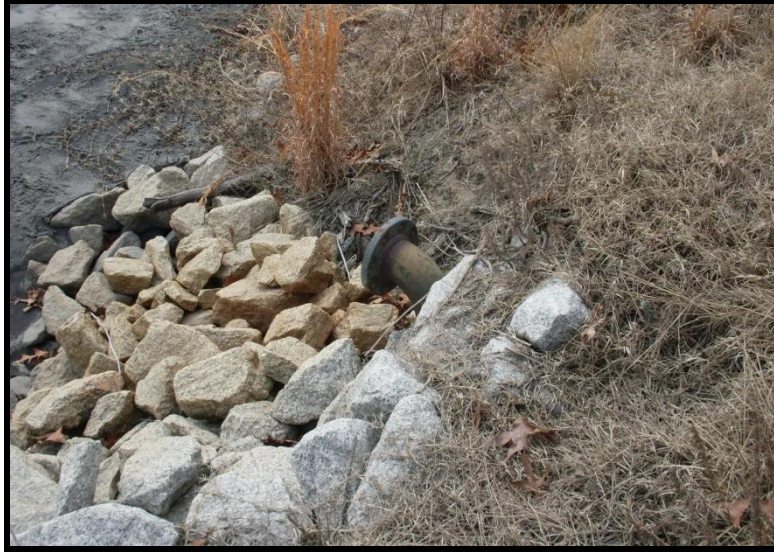
Photograph 5.3b. Discharge pipe from oil-water separator through north end of Ash Pond embankment.

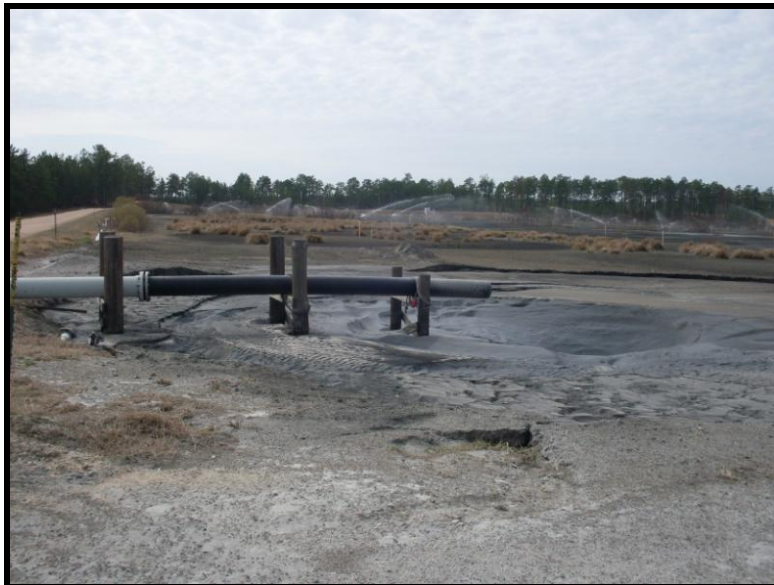
Photograph 5.3c. View of ash-sludge discharge line and ash-filled south portion of pond, looking south. (Note operation of sprinklers for dust control in south portion of pond).

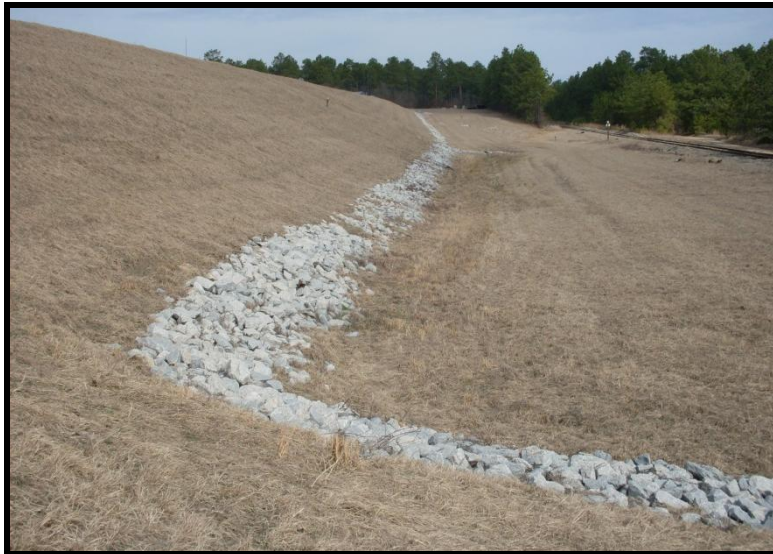
maintained, as shown in Photographs 5.4a, 5.4b, and 5.4c. Minor erosion from mowing equipment was observed on the slope. A portion of the buried sluice line along the downstream slope face was observed to be exposed due to erosion, and minor erosion was observed elsewhere along the soil-covered sluice line, as shown in Photograph 5.5. Progress Energy personnel indicated that the soil cover over the sluice line was not compacted. Local embankment soil material loss due to erosion into the riprap and minor depressions were observed at a number of locations on the downstream slope above the riprap; one of the worst of these is shown in Photograph 5.6a. It was noted that in a number of locations soil had eroded (or moved by creep) onto the surface of the riprap. Some areas of sparse grass growth on the outside slope were also observed (see Photograph 5.4a), but no major areas of erosion were noted. No slumps, slides, bulges, tension cracks, or other obvious signs of shear failure were observed on the downstream slope. No seepage or active animal holes were observed. Wet soils were observed in the shallow swale along the right (south) toe of the dike, but no seepage or flowing water appeared to be associated with this wet area, as shown in Photograph 5.6b. It appeared to be due to poor drainage. The catch basin at the low point of the toe (see Photograph 5.8) was observed to be surrounded with stone and a fine filter that apparently tends to easily clog with vegetation and grass clippings, which retards flow from the toe swale into the catch basin.

Photograph 5.4b. Downstream slope and toe of north portion of dike, looking north.

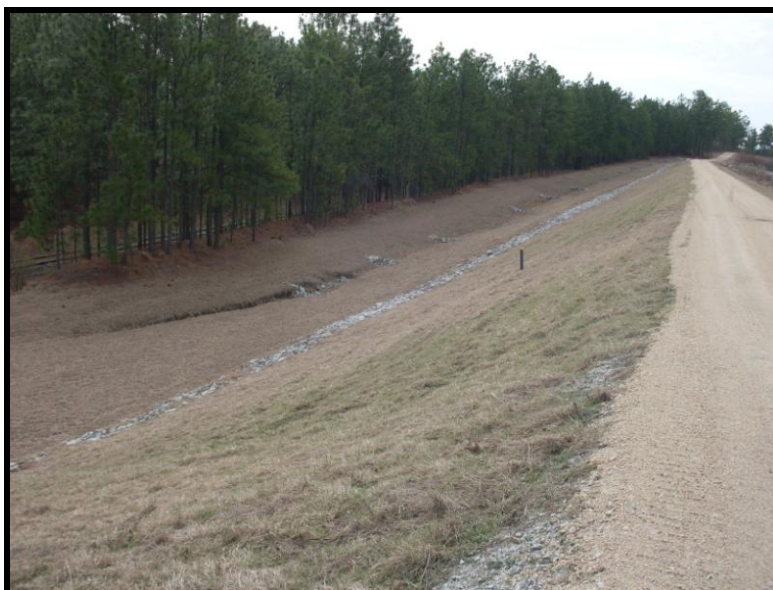
Photograph 5.4c. Downstream slope and toe of south portion of dike, and south abutment, looking south.

No erosion or displacements were observed where the finger dike intersects the embankment. No erosion, displacements, or noticeable seepage was observed where the embankment ties into high ground at the north and south ends. Previous erosion of the lower part of the right (south) abutment ditch located beyond the outside toe of the dike was observed. However, it was noted that rock check dams had been placed at intervals across the ditch to control the erosion. The abutment ditch with check dams is visible in Photograph 5.4c.

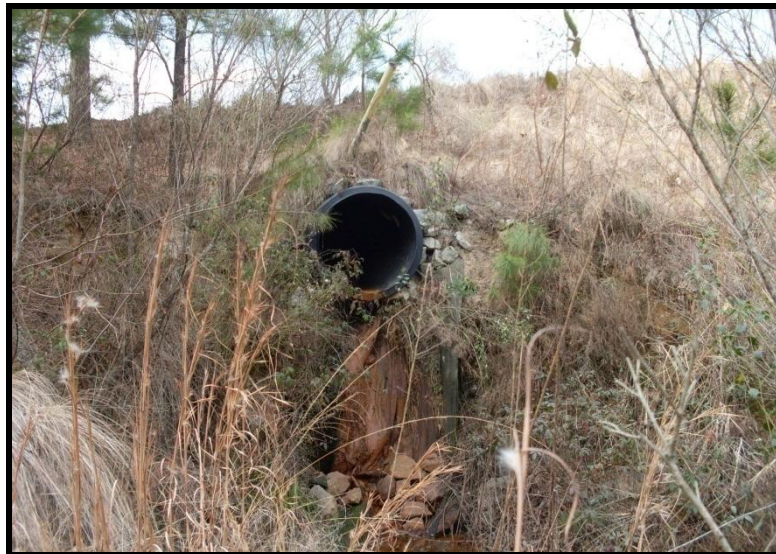
The overflow structure has bottom discharge into a 36-inch diameter RCP conduit to a manhole located on the downstream slope. The manhole is surrounded on three sides by a retaining wall, shown in Photograph 5.8, which was made necessary by the 2002 dike raise. The retaining wall appeared to be in good, sound condition. A 36-inch diameter HDPE conduit continues from the manhole to a covered catch basin at the downstream toe of the dike, as shown at the bottom of Photograph 5.8. A 24-inch diameter ADS storm drain pipe also discharges into the catch basin from the north side. None of the underground conduits and pipes could be viewed. The catch basin was observed to be in good condition, and the inside of the catch basin appeared to be dry, based on limited views through the open sides. A 36-inch diameter HDPE conduit continues from the catch basin 120 feet, passing under the railroad spur tracks and the toe access road, to the outfall channel. The end of the HDPE outfall pipe is shown in Photograph 5.9. The limited part of the HDPE pipe that could be observed at the outfall end appeared to be in good condition. A small amount of clear water was observed flowing from the end of the pipe. The source of this water is unknown, since no water was flowing into the overflow riser and the catch basin appeared to be dry. The invert of the black HDPE pipe was rust colored, apparently due to the presence of iron bacteria. The soil bank at the outfall was

observed to be very steep, and the small riprap that had been placed around the end of the outfall had eroded off its geotextile bedding.

Photograph 5.9. HDPE outlet into outfall channel downstream of junction box, looking west. (Note steep bank and eroded small riprap around end of pipe,)

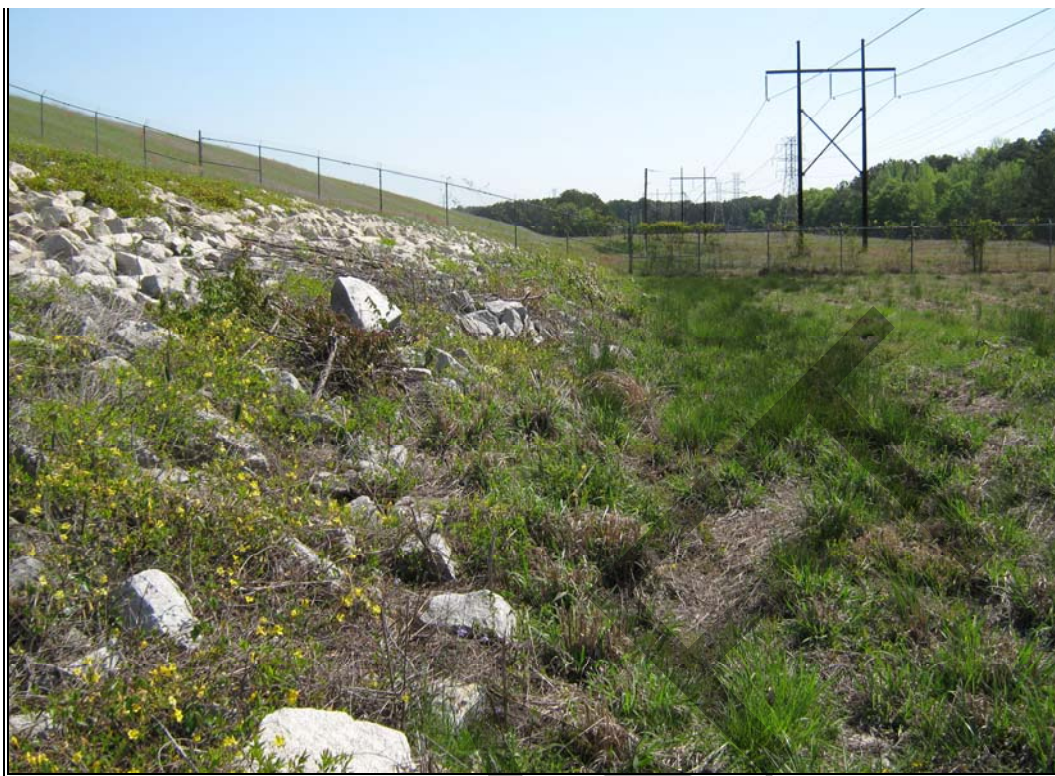
Photograph 7:

East of the spillway, the rip rap on the lower part of the dam is in good condition with some minor vegetation (Photograph 7). Progress Energy continues to cut and spray the vegetation in the rip rap to control growth. Some standing water was noted in the natural ground just beyond the toe of the dam in an area of low topography and ruts from mowing equipment (Photograph 8). The area is evident by color change in vegetation (Photograph 9). A walk along the toe of the dam did not find water emerging from the riprap. These areas have been observed during past inspections.

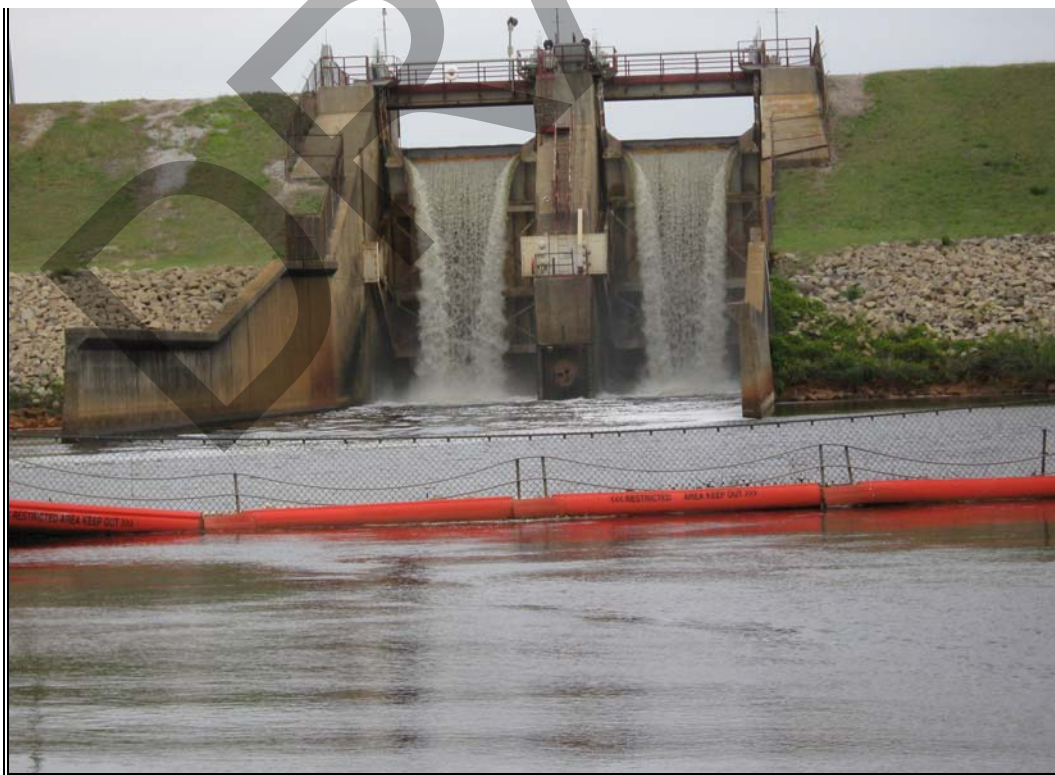
Photograph 10:

The spillway structure for the dam is in good condition (Photograph 10). The concrete entry walls do not show cracking (Photographs 11 and 12). Two areas of concrete scaling first noted in 1990 on the eastern bridge beam seats of the west spillway bridge were repaired in 2003 in general accordance with plans prepared by Progress Energy and shown in Exhibit 12. Photograph 13

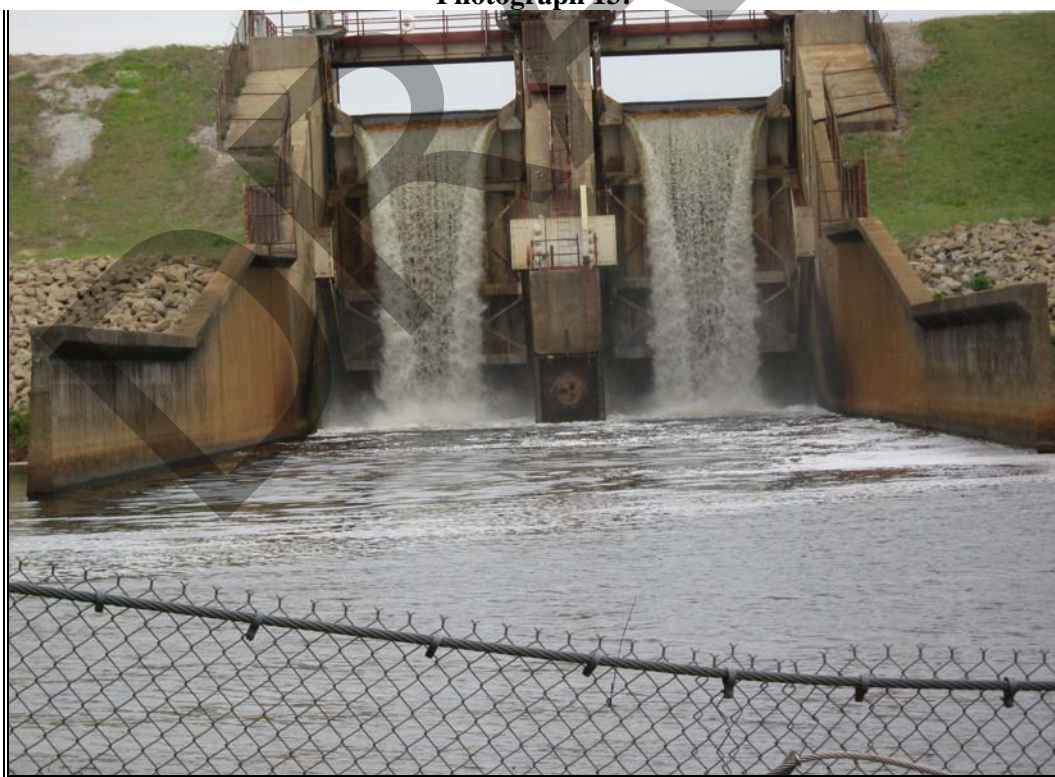
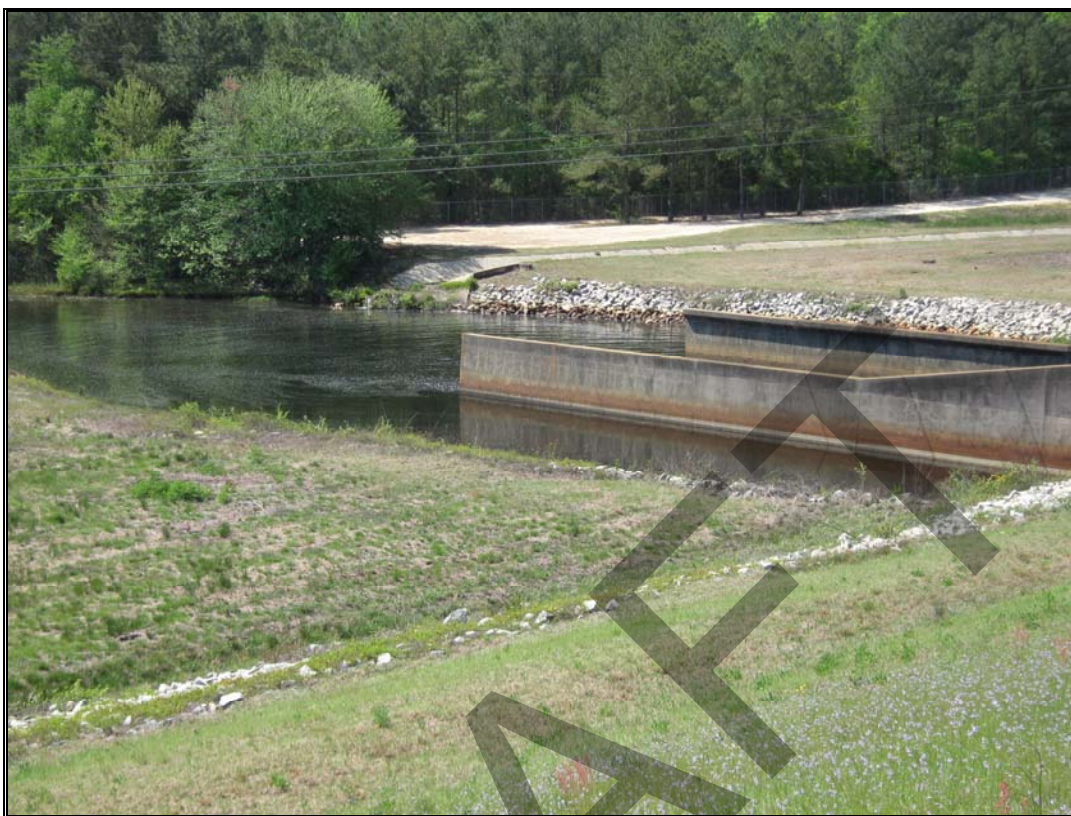
The spillway training/retaining walls are in good visual condition (Photographs 14, 15 and 16). The offsets in the spillway side retaining walls noted in previous inspections appeared to show no change. A crack movement gauge (now broken) was placed on the west wall offset in 1996 (Photograph 17). A similar monitor was placed on the east wall at the request of the State of South Carolina Department of Health and Environmental Control after their routine inspection conducted in 1999. Movements monitored since 1996 (west wall) and since 2000 (east wall) were erratic, but less than 1 millimeter in any direction. There are no signs of wall distress and the movements seen are not unusual for walls of their design and height. After review of the monitoring records in 2004 by MACTEC, a recommendation was made to discontinue monitoring based on the lack of change. The South Carolina Department of Health and Environmental Control agreed with the recommendation.

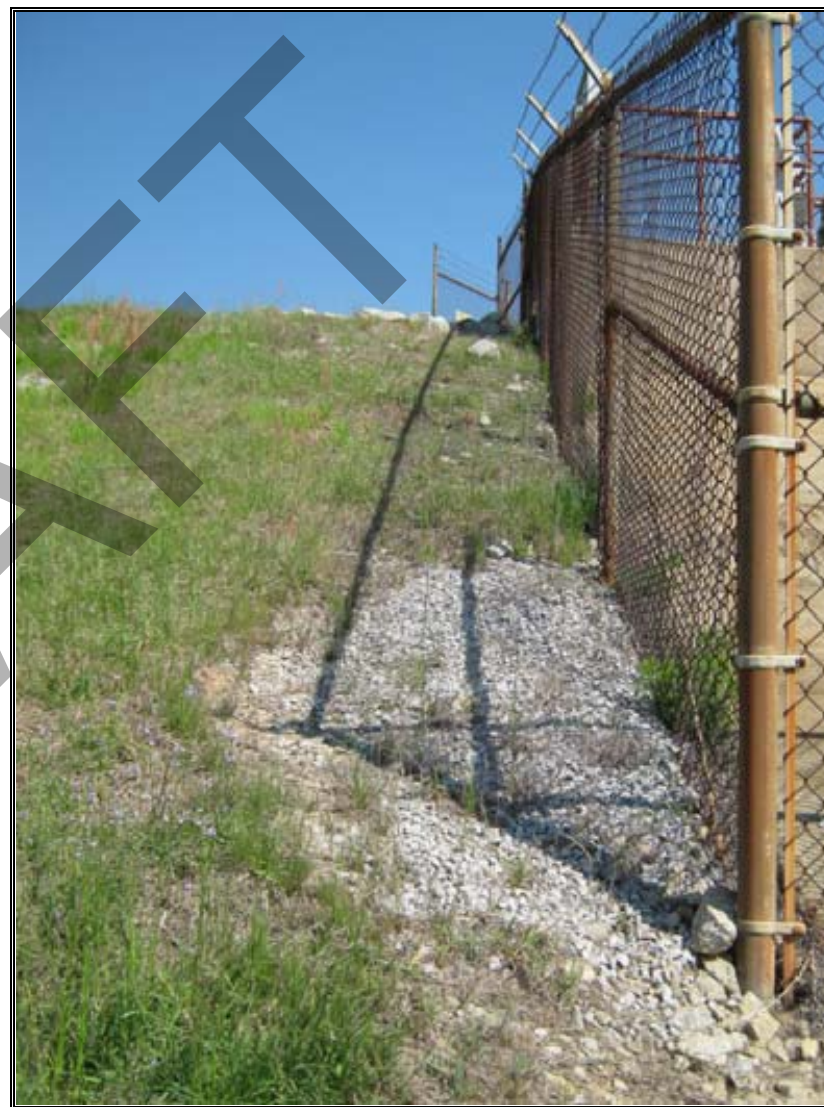
Photograph 18:

Along the junction of the west spillway wall and the downstream slope, the slight depressions noted in 2005 have been filled and show no indications of additional settlement (Photograph 18). Some loss of ground was noted around the post of the chain link security fence on the east side of the spillway adjacent to the retaining wall (Photograph 19). No indications of settlement adjacent to the retaining wall were seen (Photograph 20).

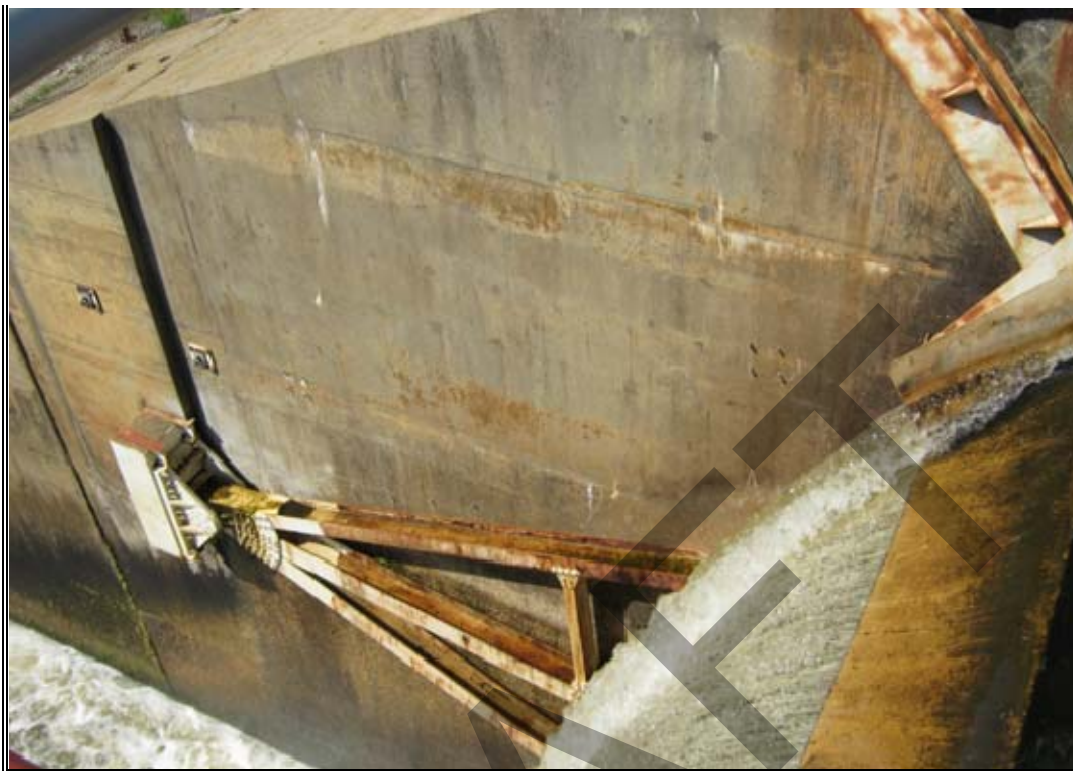
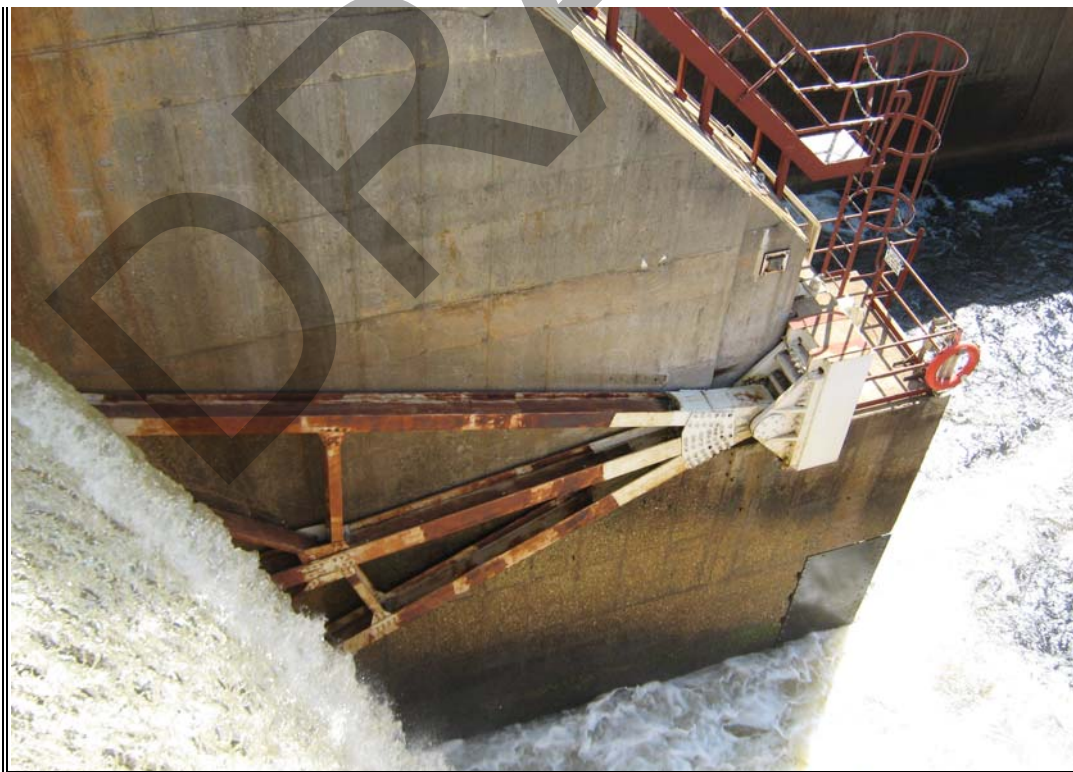
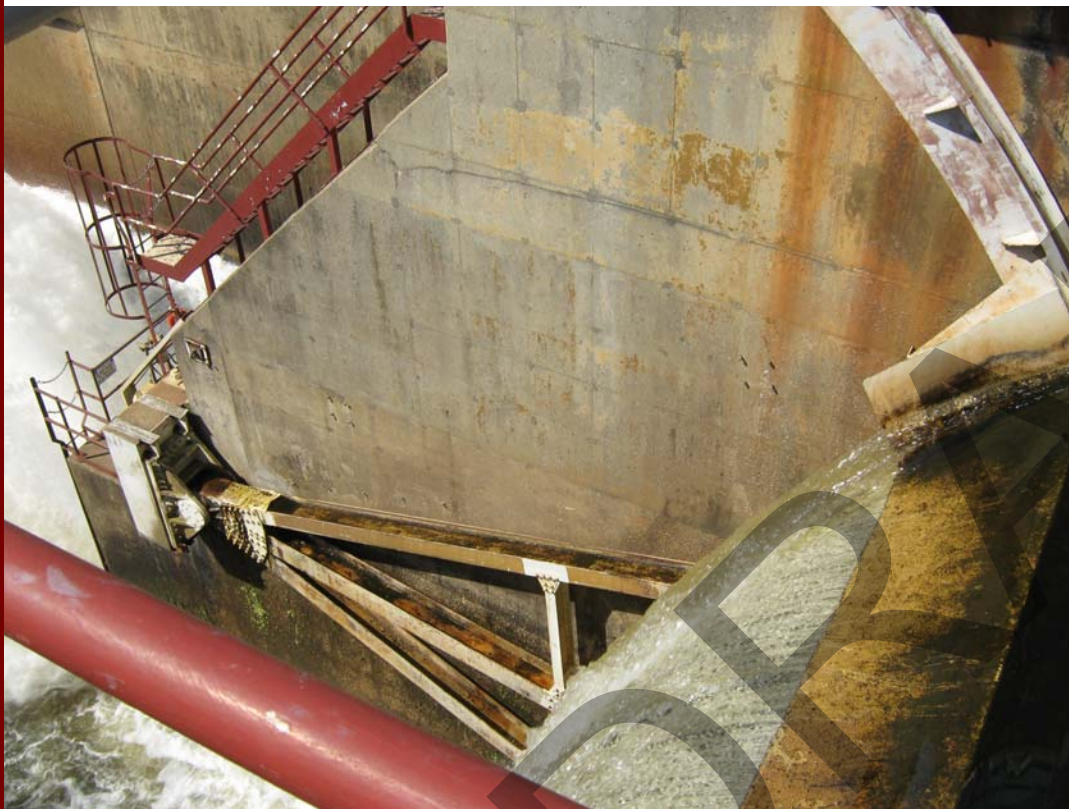
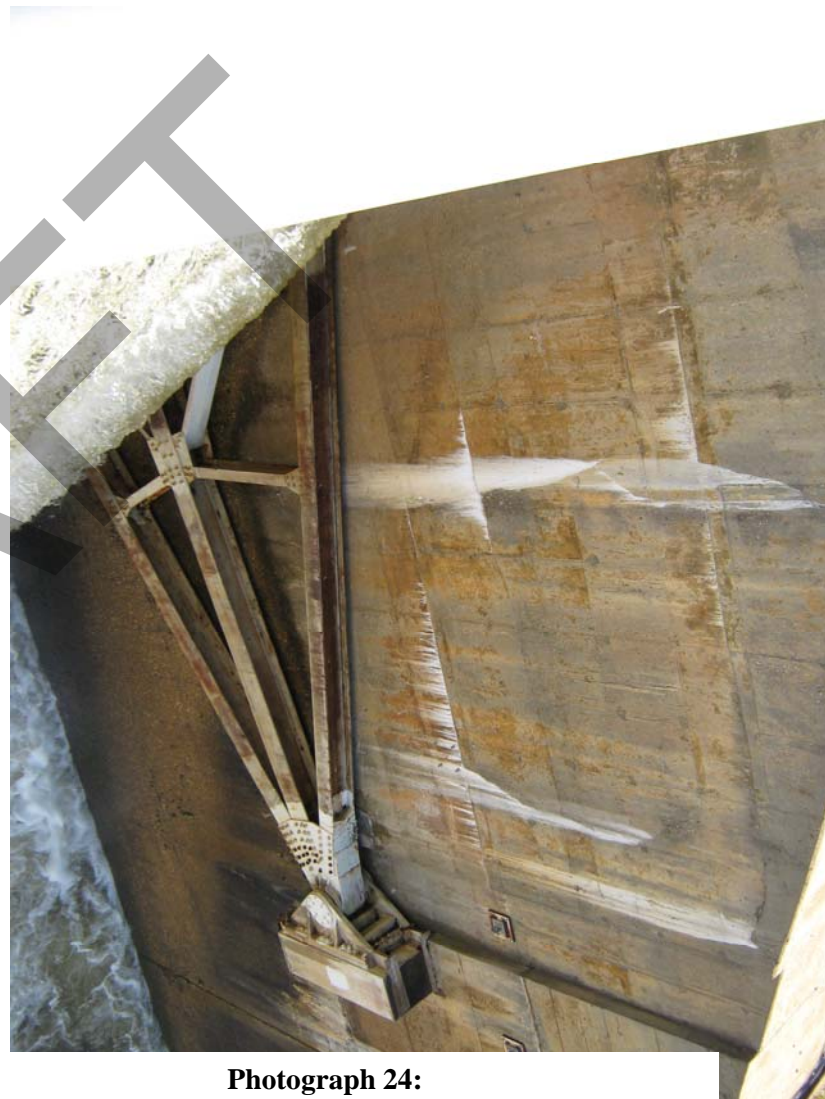
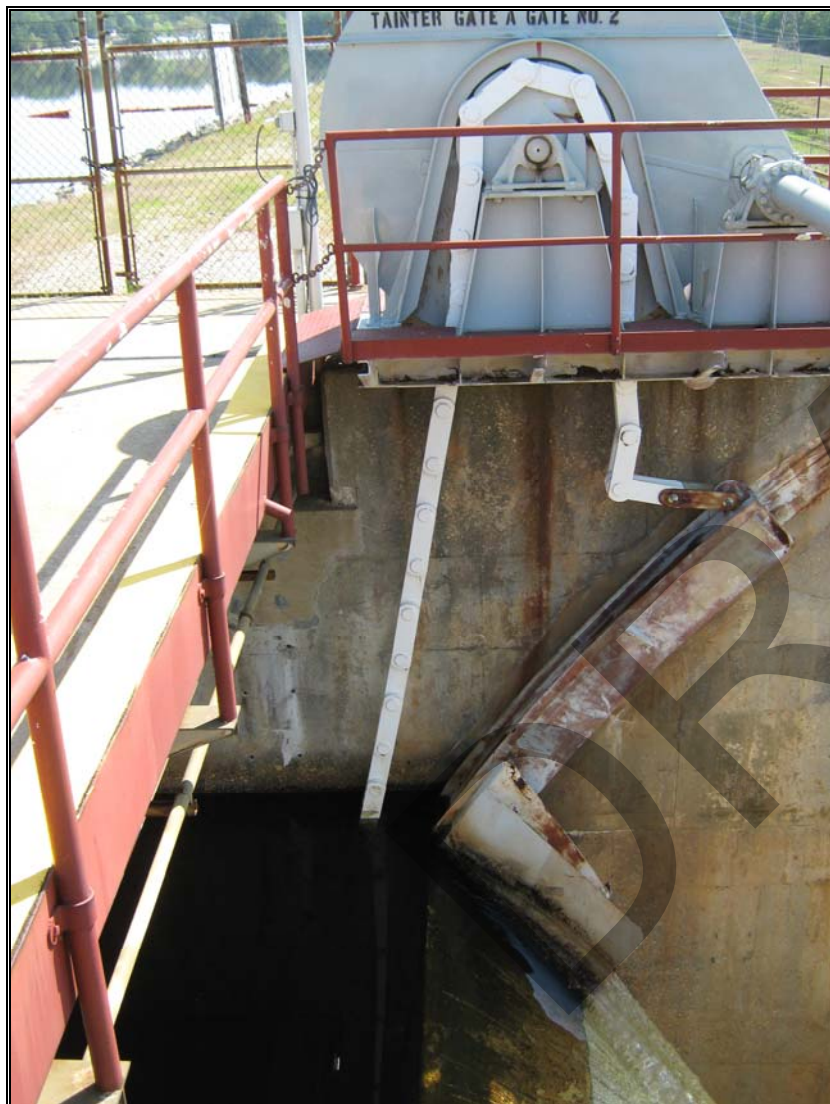
Lake water flows over the top of the closed Tainter gates during normal operations. The Howell-Bunger valves are used to control minor lake level changes and to provide low flow release. The water exits the spillway along a concrete lined channel. During the inspection, plant personnel were performing regular monthly operational checks⁸. The electric motor on the west gate was found to not operate; the backup propane-operated motor was used. Plant personnel reported the inoperative motor on their report. Both gates were operated by plant personnel, and normal water flow was observed. Photographs 21 through 28 show the conditions of the above-water portions of the Tainter gate arms and hoist chains.

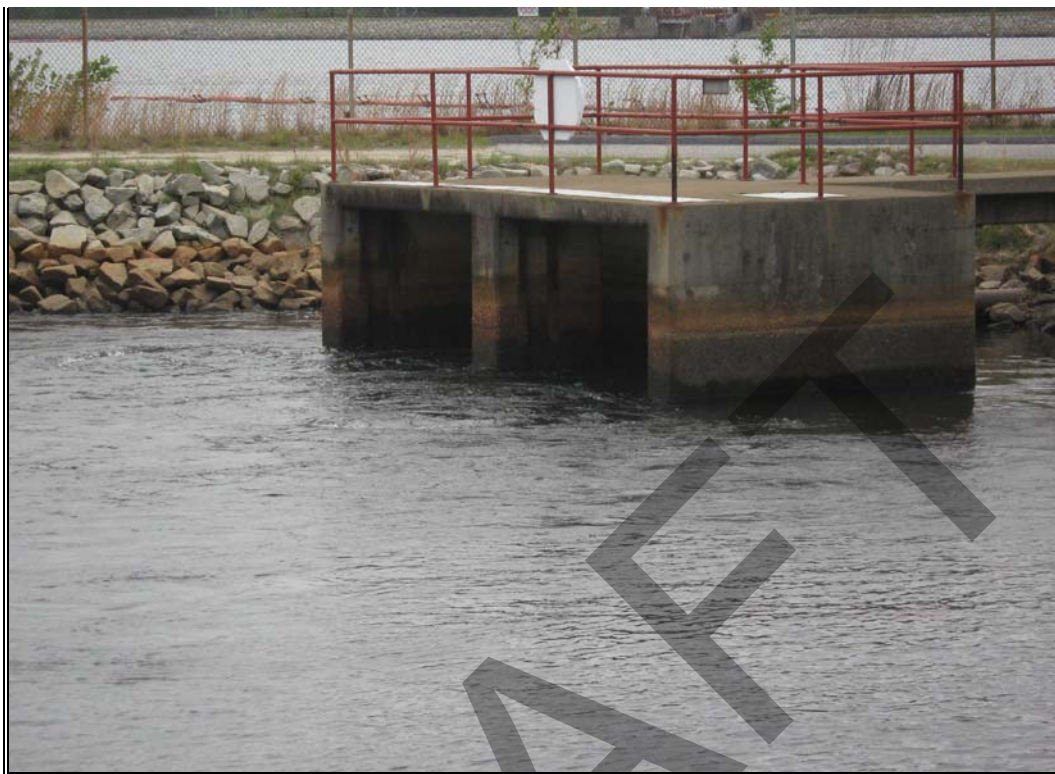
Photograph 31:

The circulating water withdrawn from the Cooling Lake exits through a concrete structure (Unit 1) and an underwater pipe (Unit 2) into a canal that directs the water back to the Cooling Lake. No active discharge from either unit was occurring at the time of our inspection. The Unit 1 concrete discharge structure did not show indications of distress (Photograph 31). An underwater inspection of the discharge structure was made in 1996 with no problems reported.

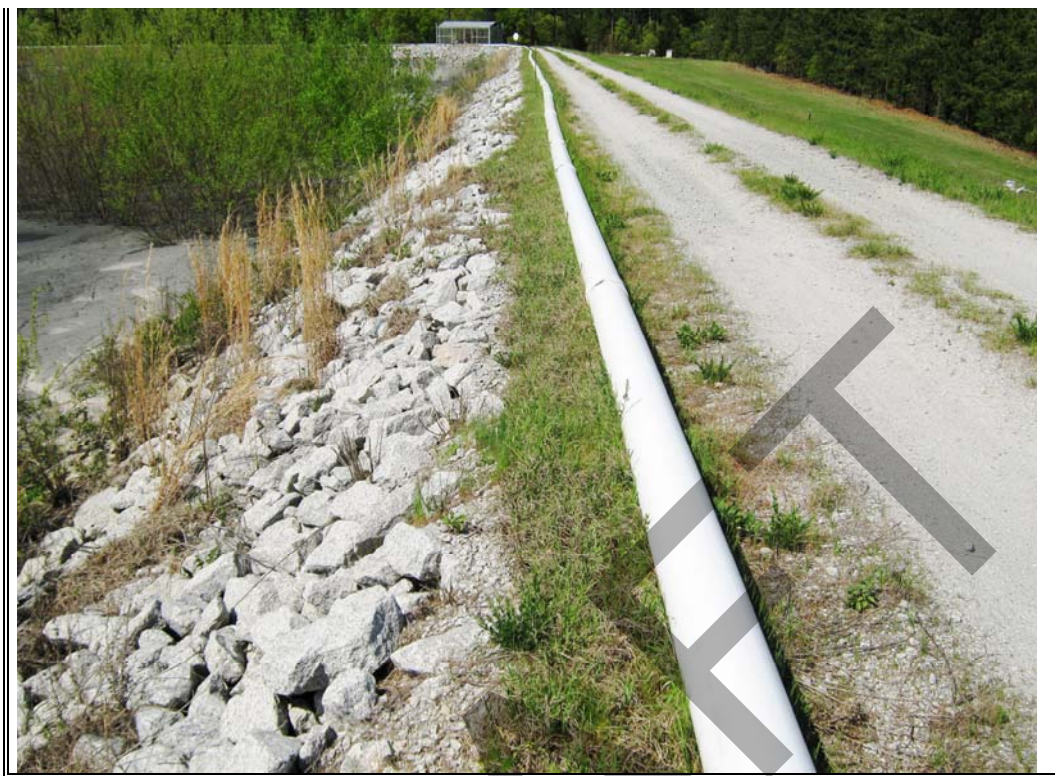
Photograph 41:

of distress were seen, and the weir end structures were in apparently good condition (Photograph 41).

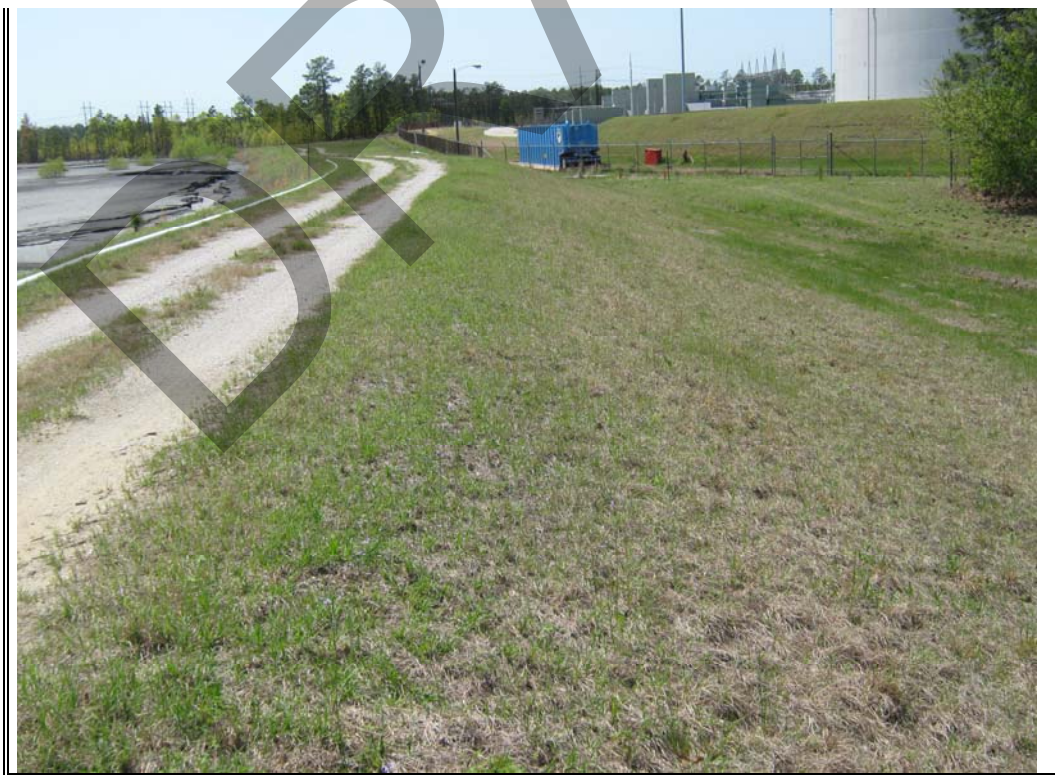
The crests of the northern and southern ash pond dike sections and the separator dike are in good visual condition with no significant visible dips or other evidence of distress (Photographs 42 through 45). A gravel road is present in the center of the dikes with sparse grass growth in the gravel and moderate grass growth where there is no gravel.

The interior slope of the north section is in good condition (Photographs 42 and 47). There is minor vegetative growth in the slope rip rap. Spraying is recommended to keep the vegetation under control. Sedimented ash has accumulated in the pond; the ash level is approximately 38 inches below the top of the riser pipe, or approximately elevation 266.3 feet. Some water is ponded in the north end of the pond and is against the dike. Progress Energy reported that the water level in the pond had risen to within about six to eight inches of the top of the riser during some extended rain events, but had not overtopped the riser.

Photograph 42: Crest and upstream slope of North Pond dike.

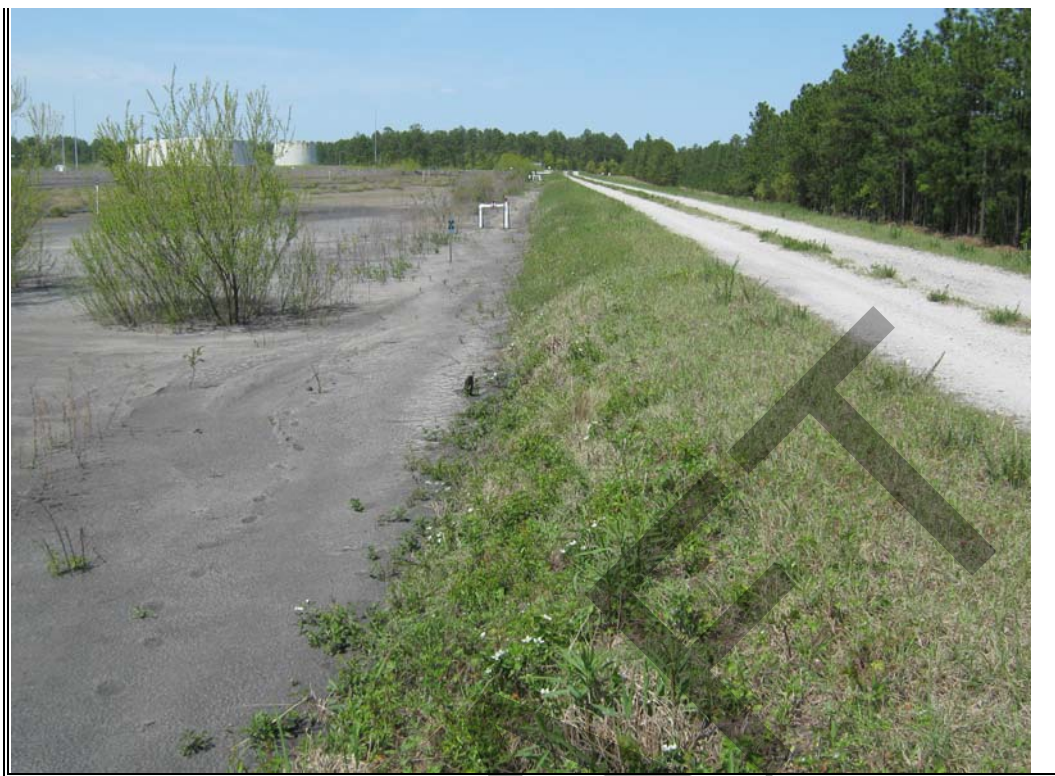
Photograph 43: Crest and exterior of northern extension dike at North Pond.

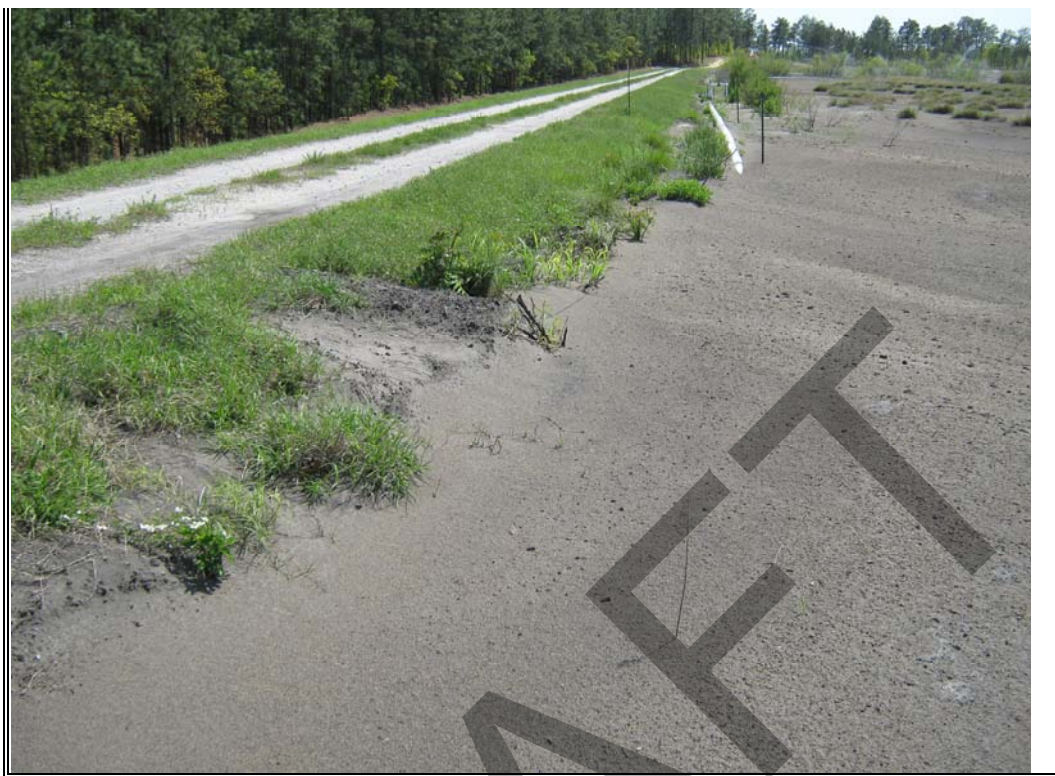
Photograph 45: Crest and south side of separating dike between North and South Ponds.

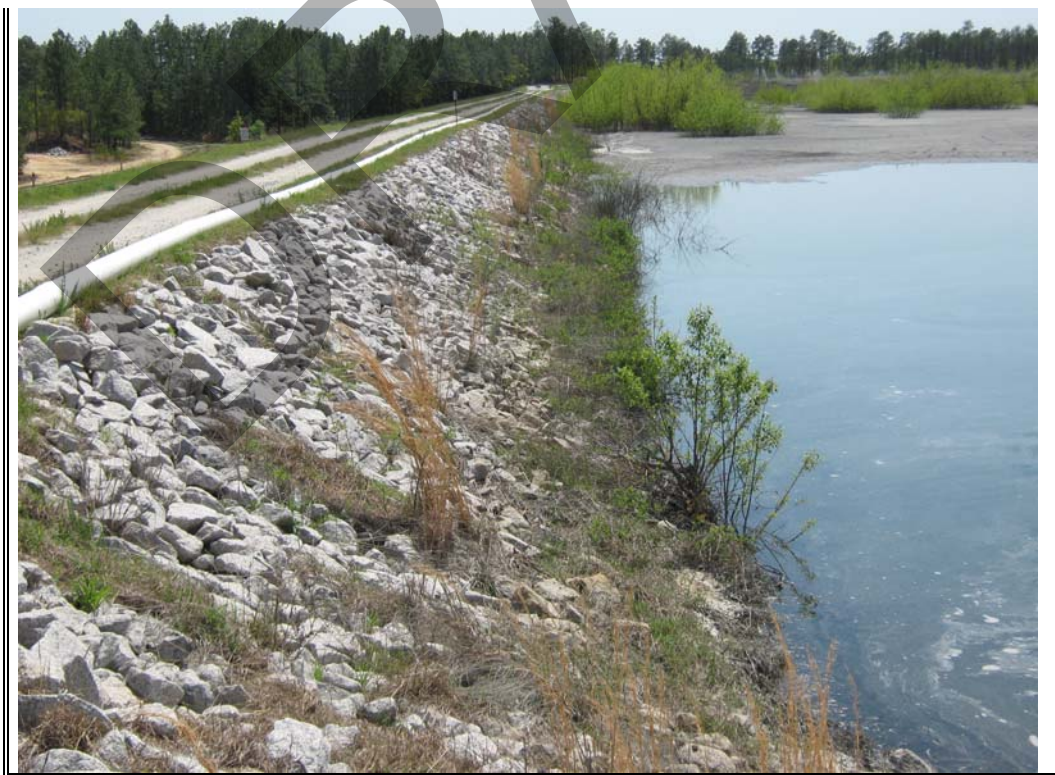
The sedimented ash has reduced the available freeboard for the south dike in an area near the ash discharge line (Photograph 46). In this area, the freeboard appears to be as little as 12 inches below the top of the dike. From the hydrologic studies made during the design of the dike raise in 2002, this is the minimum freeboard needed under the design storm (50-year, 24-hour). Further

Photograph 46: Limited freeboard of South Pond dike near ash line discharge.

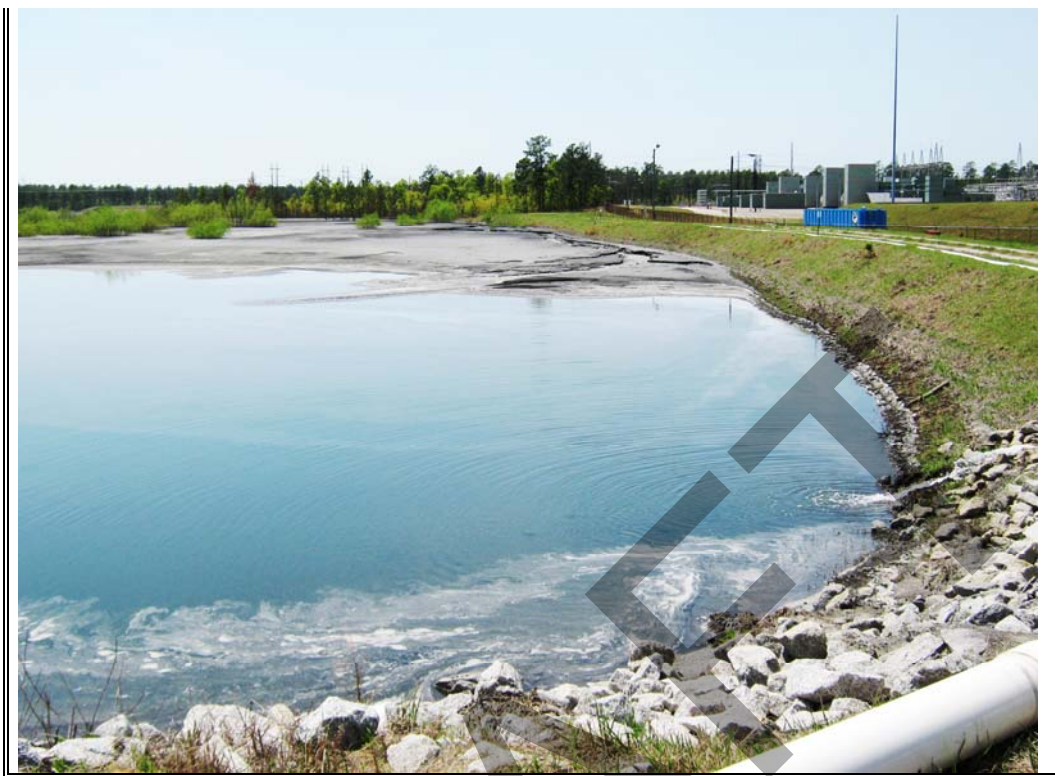
Photograph 47: Interior slope of North Pond dike. Note minor vegetation.

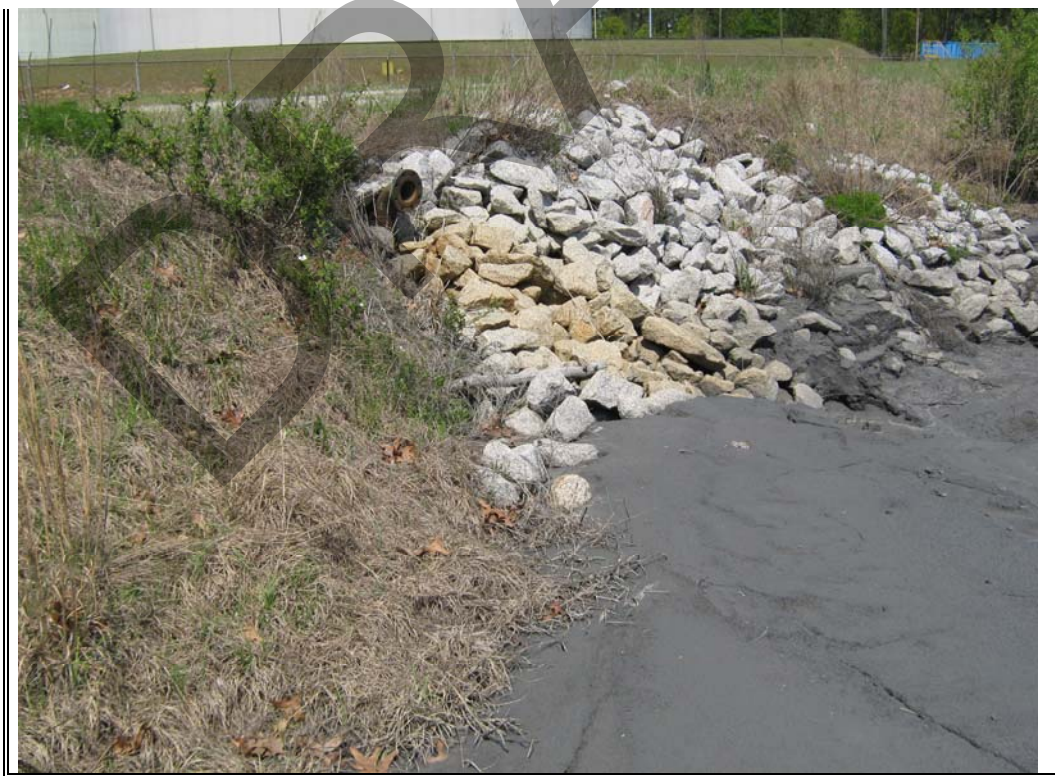
The dike raise in 2002 created a low height dike on the north end of the pond that continues west from the main dike. The crest, interior and exterior slopes of this dike are in good condition (Photograph 48). There has been a continuing minor erosion condition where a drain pipe from the Darlington oil-water separator penetrates the dike to discharge into the ash pond. The erosion has been stabilized reasonably well with rip rap (Photograph 49). The outflow from the Darlington pipe discharge has created an erosion channel in the ash adjacent to the dike that can be seen in photograph 48, but it does not pose a safety risk for the dike. At the intersection of the west extension with the north dike, the riprap placed in 2005 is in reasonably good condition (Photograph 50). Similar erosion at the intersection of the north dike and the separator dike that was also repaired with rip rap is in good condition.

Photograph 48: Interior slope of northern extension dike at North Pond.

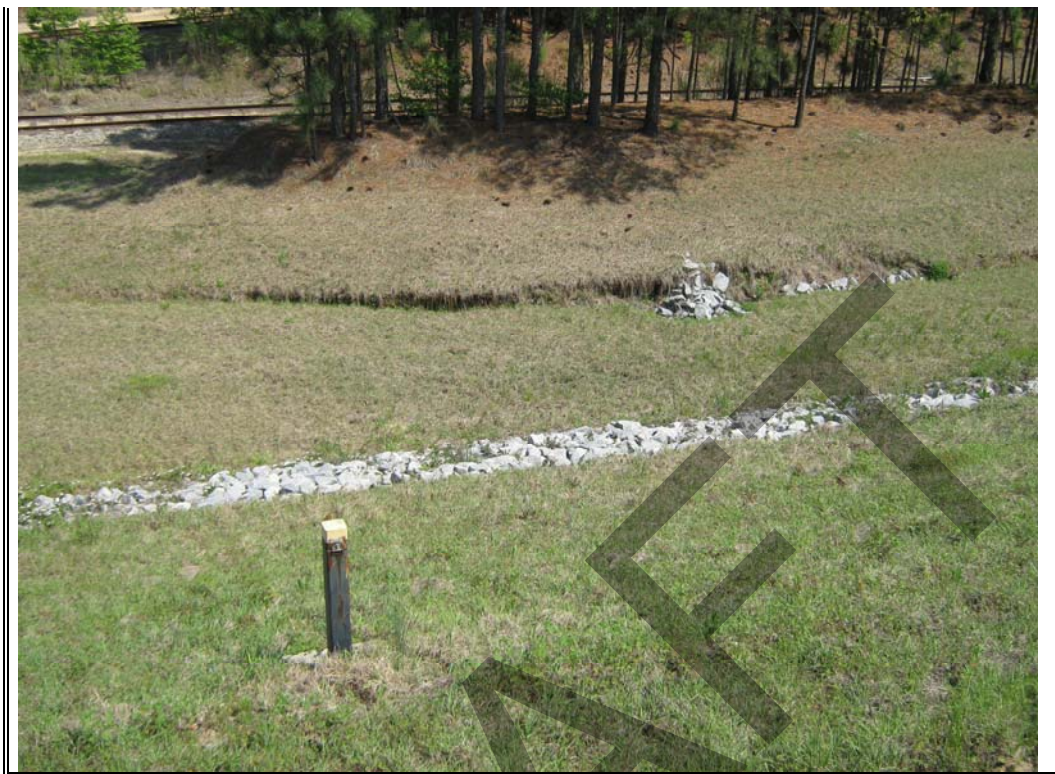
The exterior slope of the south dike is in good visual condition with a good grass cover (Photograph 51). No trees were noted. No indications of seepage, slumps or significant surface erosion were seen. A surface drainage ditch was constructed roughly parallel to the toe of the south dike and about 25 to 50 feet away. There has been erosion in the ditch resulting in deepening. Rock check dams were constructed in 2003. These are generally retarding the erosion and grass has taken root in the ditch and adjacent areas (Photograph 51). Some erosion is still present near the lower end of the ditch (Photograph 52). The ditch erosion is not impacting dam safety. If further erosion deepening or bypassing of rock check dams occurs, additional rock placement may be necessary.

Photograph 51: Exterior of South Pond dike. Note good vegetative cover of slope and drainage ditch adjacent to dike toe.

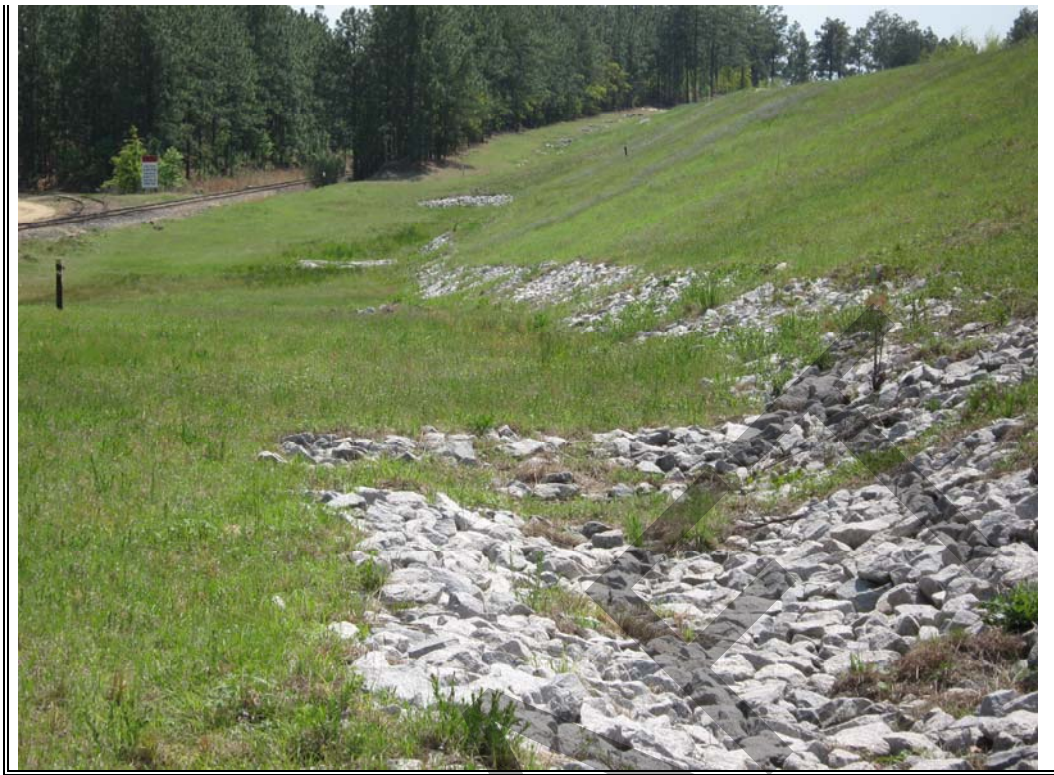
The exterior slope of the north dike is in good visual condition with a good grass cover (Photographs 53 and 54). Small spots where soil above the toe rip rap had eroded into the rip rap have been noted during some past site visits. These are routinely filled with gravel by Progress Energy. A few similar spots were noted in the area north of the catch basin (Photograph 55) and will be filled. A storm drain culvert passes under the north end of the north dike and outlets onto a rip rap apron. The apron was in good condition; grass has grown up in the rip rap, but the grass does not affect its function (Photograph 54). There was some ditching erosion adjacent to the downstream toe prior to a good vegetative cover being established. This ditching now has vegetation, and some rock check dams have been constructed (Photograph 56). The erosion appears inactive.

Photograph 53: Exterior slope and rock toe of North Pond dike.
