**Coal Combustion Residue Impoundment
Round 9 - Dam Assessment Report**

H. B. Robinson Power Station

***Progress Energy Carolinas
Hartsville, South Carolina***

Dewberry & Davis, LLC
Fairfax, Virginia

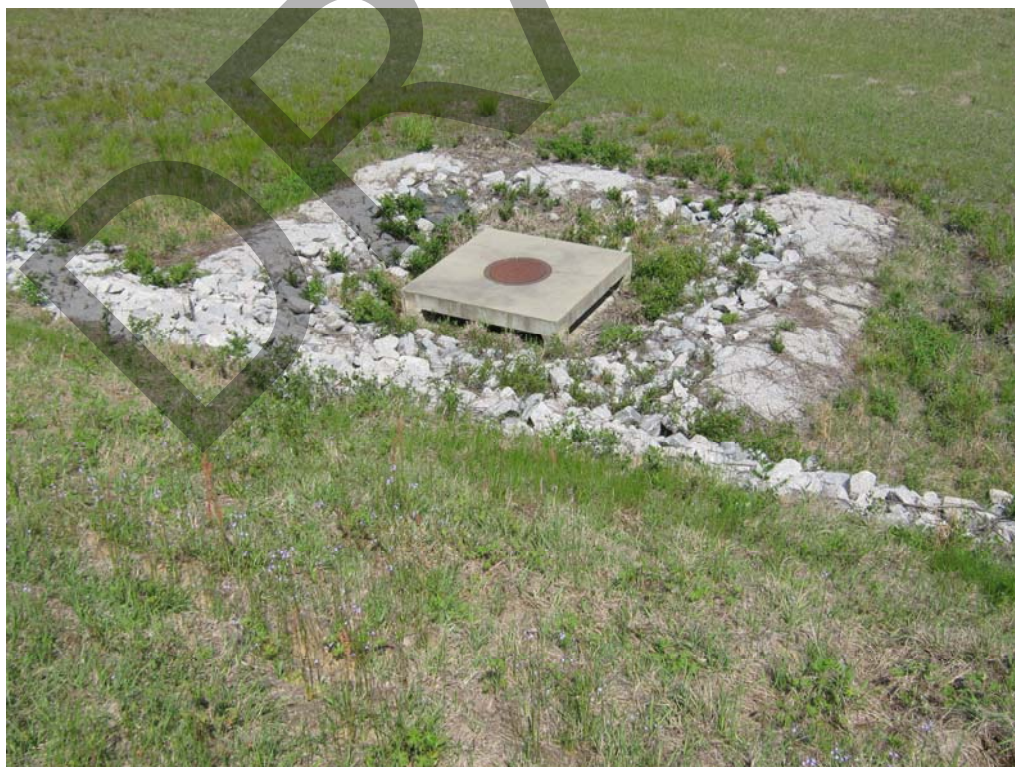
The exterior slope of the north dike is in good visual condition with a good grass cover (Photographs 53 and 54). Small spots where soil above the toe rip rap had eroded into the rip rap have been noted during some past site visits. These are routinely filled with gravel by Progress Energy. A few similar spots were noted in the area north of the catch basin (Photograph 55) and will be filled. A storm drain culvert passes under the north end of the north dike and outlets onto a rip rap apron. The apron was in good condition; grass has grown up in the rip rap, but the grass does not affect its function (Photograph 54). There was some ditching erosion adjacent to the downstream toe prior to a good vegetative cover being established. This ditching now has vegetation, and some rock check dams have been constructed (Photograph 56). The erosion appears inactive.

Photograph 56: Rock toe and rock check dams at toe of North Pond dike.

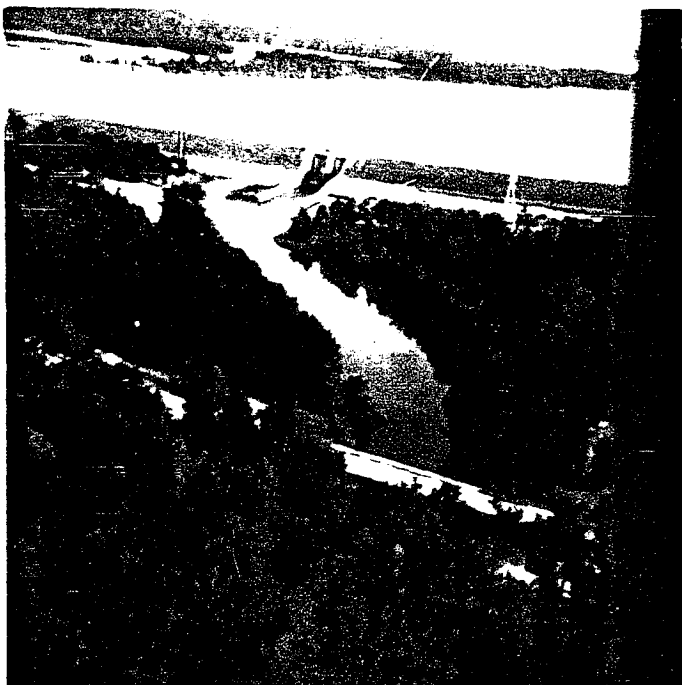
Photo No. 1

General View of Main Dam and Spillway.
Note Highway Bridge Downstream.

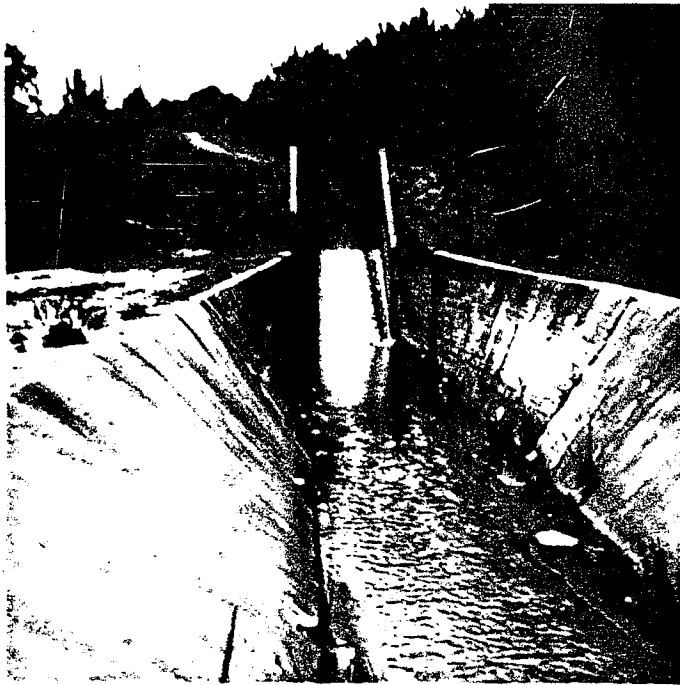
Photo No. 5

Station Drainage Outfall Structure.
Note weep holes in Invert.

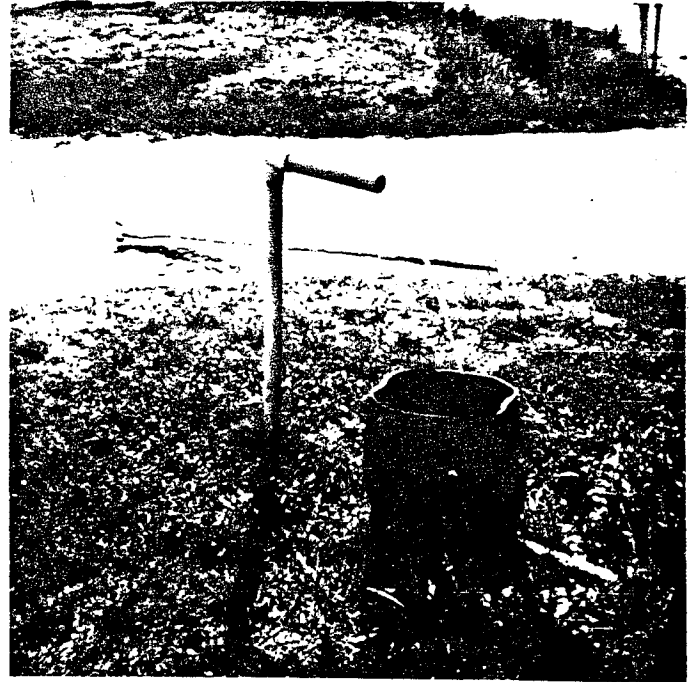
Photo No. 8

Artesian Well on State Highway
1623 Downstream of Dam.

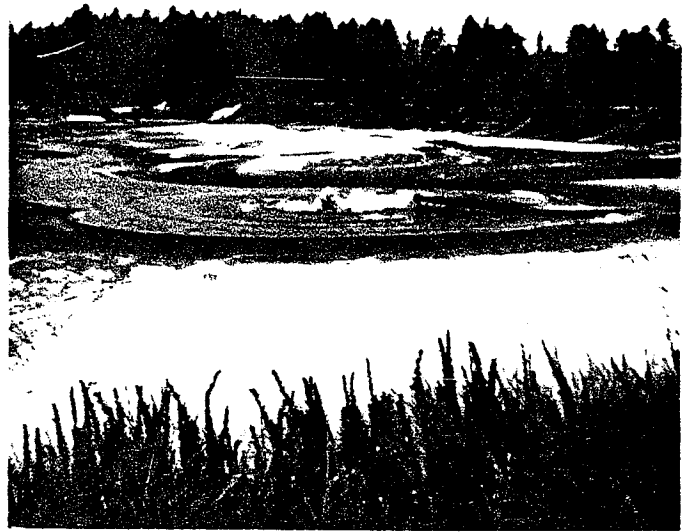
Photo No. 17

The Ash Pond Dam, Photo No. 17, was inspected by foot reconnaissance along the crest, downstream toe and from the baffle dike. The crest was true to grade with no dips or sags. The downstream slope had a well established vegetative cover and the downstream toe area was dry. There was no sign of slides, slumps, sinkholes or other evidence of distress.

Ash Pond Dam looking South.
Note Baffle Dike.

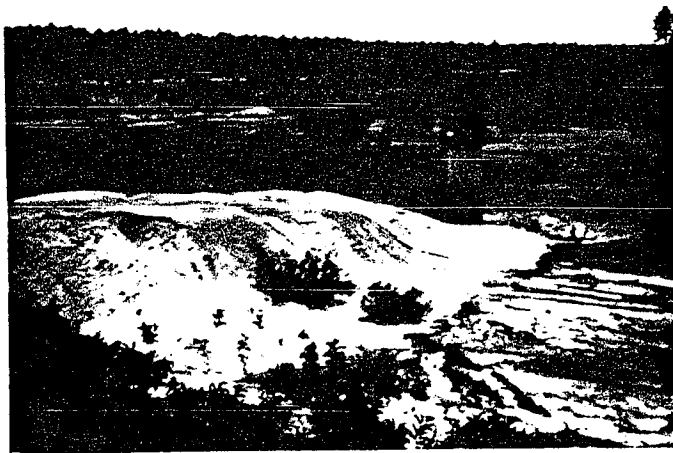
Photo No. 18

Ash Pond Dam and Ash Pipe
Outfall.

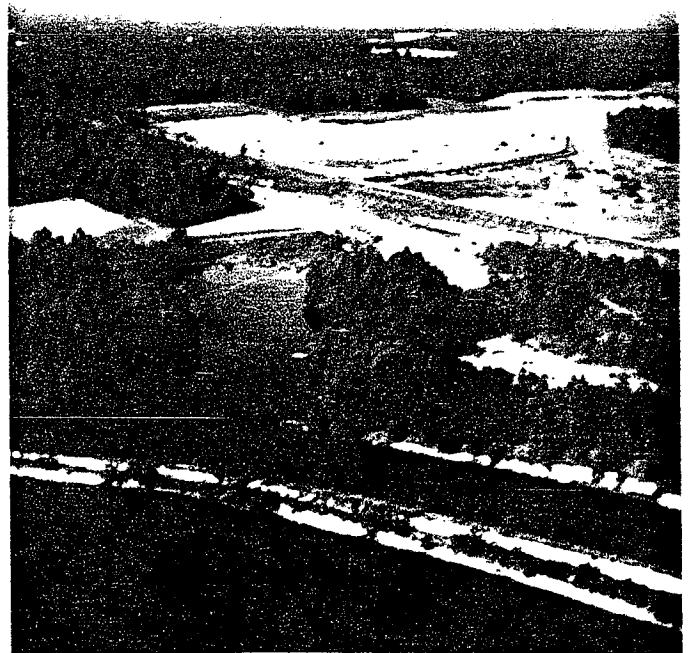
The baffle dike was true to grade with no evidence of significant settlement. The bypass channel which returns ash water to the drop inlet spillway structure was dry and in good condition. Photo No. 19 shows the drop inlet spillway structure with skimmer device and Photo No. 20 shows the

Ash Pond Dam Drop Inlet
Spillway with Skinner Device.

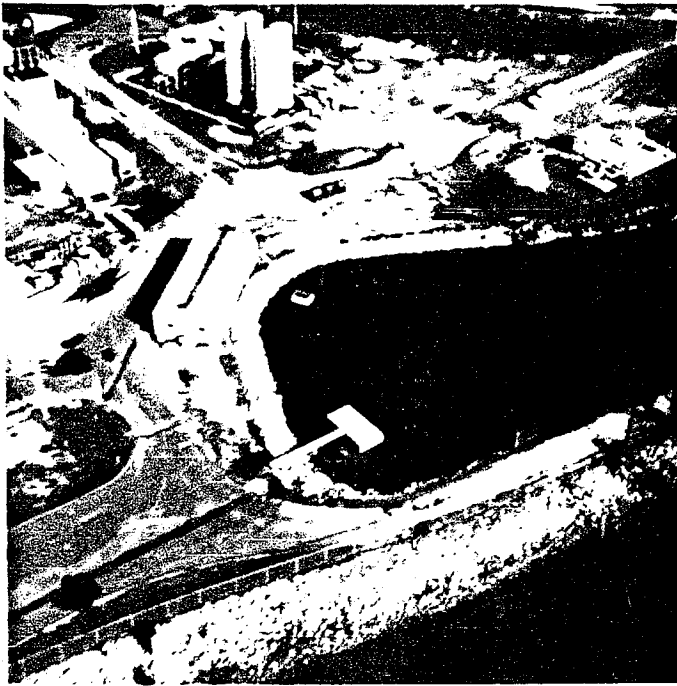
Photo No. 20

Ash Pond Dam Showing Downstream
Channel to Cooling Water
Discharge Canal.

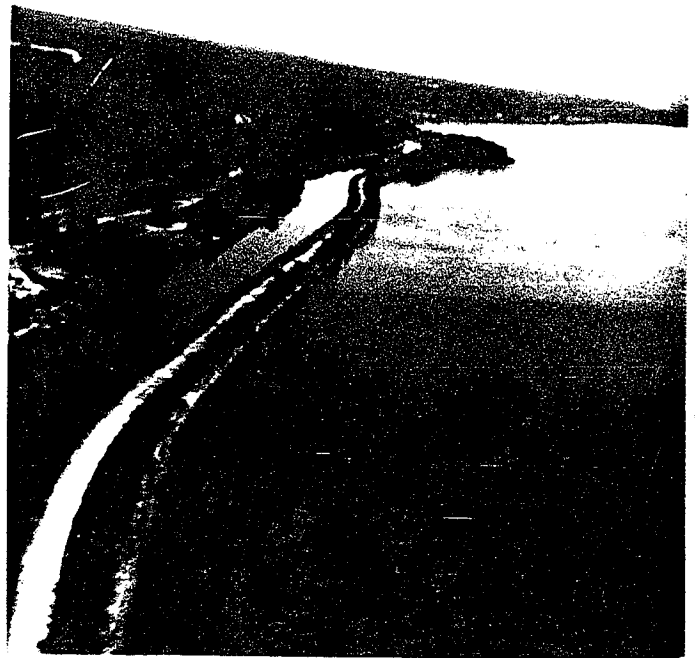
The cooling water canal runs approximately 4.2 miles along the west shoreline from the plant to the discharge weir. The canal is a cut/fill section with the reservoir side contained by a dike and natural ground. Photo No. 21 shows the plant cooling water discharge. Photo No. 22 shows the southern section of the canal, Photo No. 23 shows the canal opposite the Ash Pond Dam (Photo No. 20) and Photo No. 24 shows the discharge weir at the north end of the canal. The east dike section crest was inspected by car and the H. B. Robinson Lake shoreline side by boat. The dike and all riprapped faces were in excellent condition.

Cooling Water Canal at Plant End.

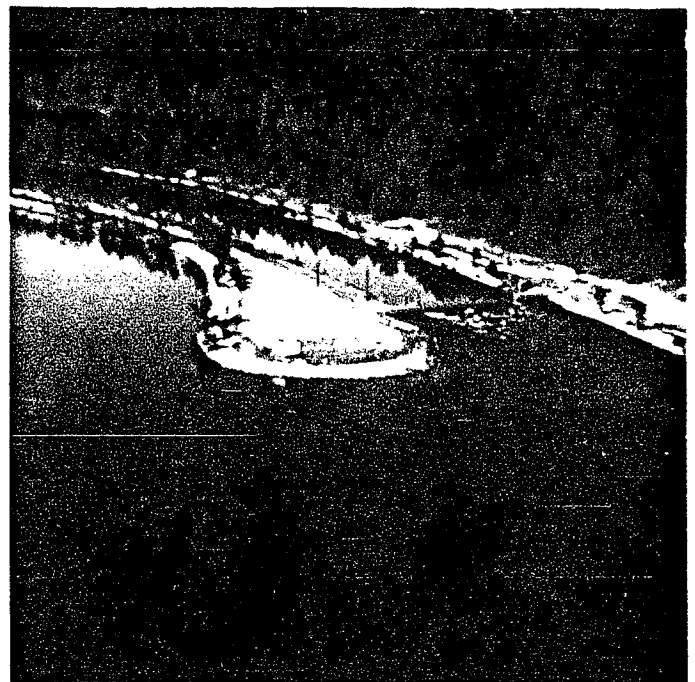
Photo No. 23

At the point opposite the Ash Pond Dam, Photo No. 23, the sluice structure formerly used to discharge cooling water was inspected, Plate No. 19. This structure was abandoned when Unit No. 2 was constructed at the plant and the cooling water canal extended. The structure is blocked by heavy sediment on the lake side but is otherwise in good condition.

Cooling Water Canal at Ash Pond Dam.
Note Sluice Structure in Dike
(center of photo).

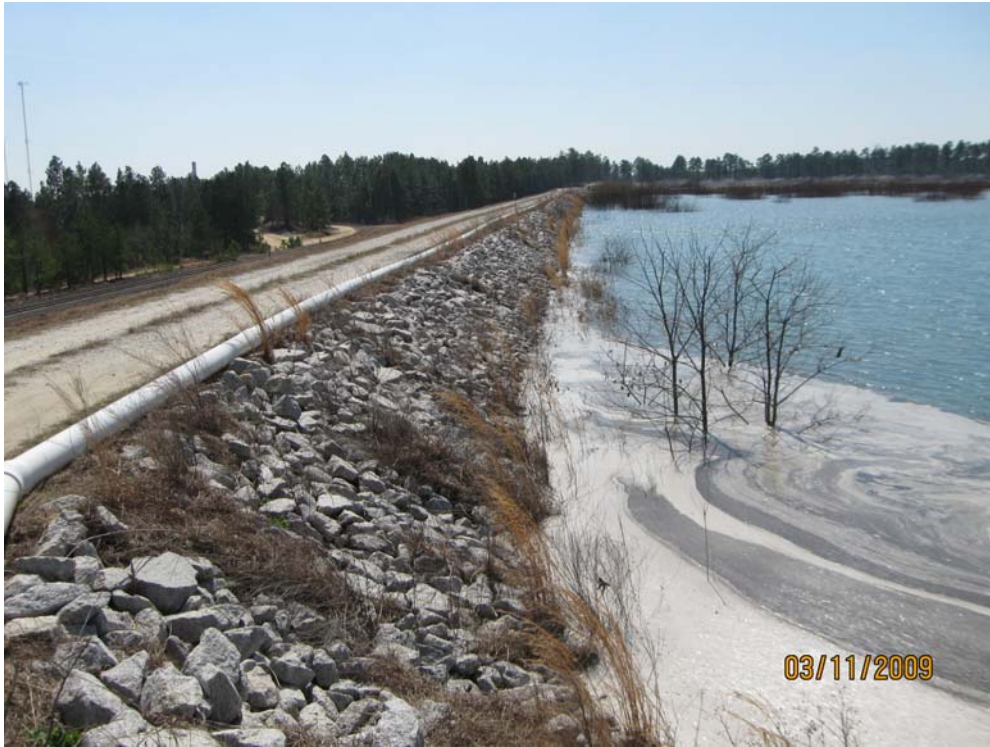
1. ASH POND - Crest and interior slope of north pond area looking south.

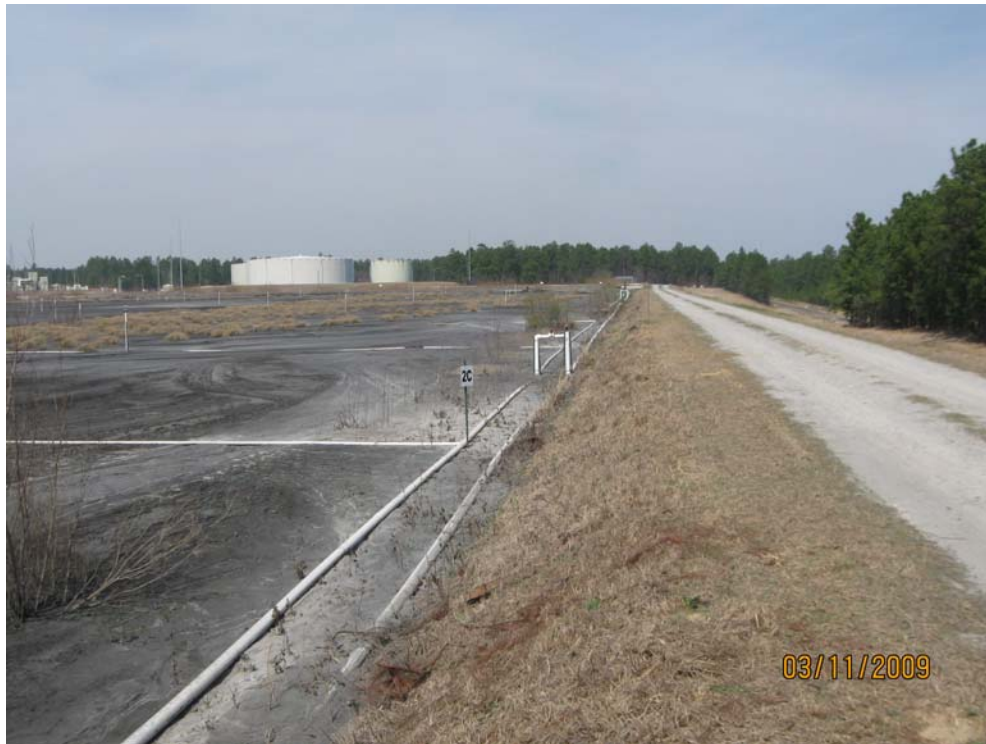
2. ASH POND – Crest and interior slope of south pond area looking north.

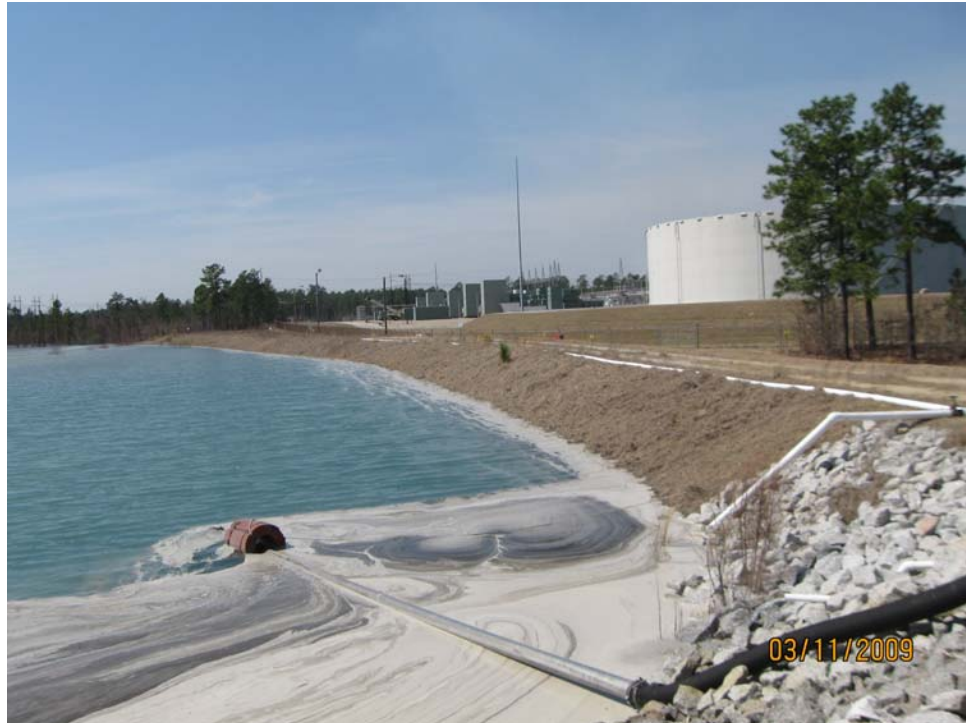
3. ASH POND – Crest and interior slope of north dike of north pond looking west.

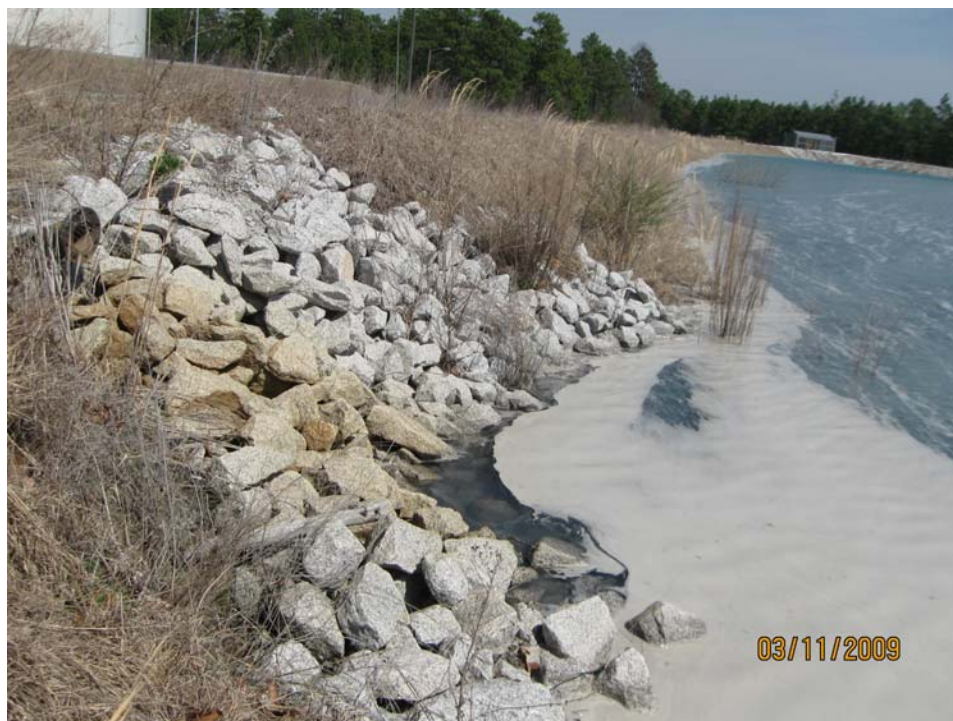
4. ASH POND – View of oil-water separator drain along the interior slope of north pond adjacent to Darlington County Plant.

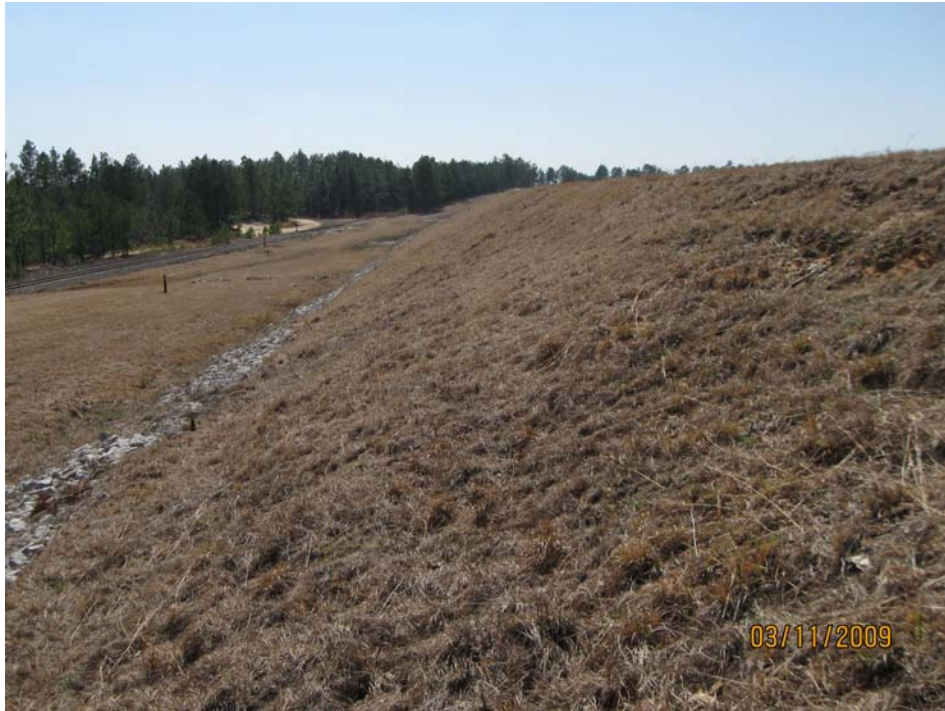
5. ASH POND – Toe of north pond area exterior slope looking south.

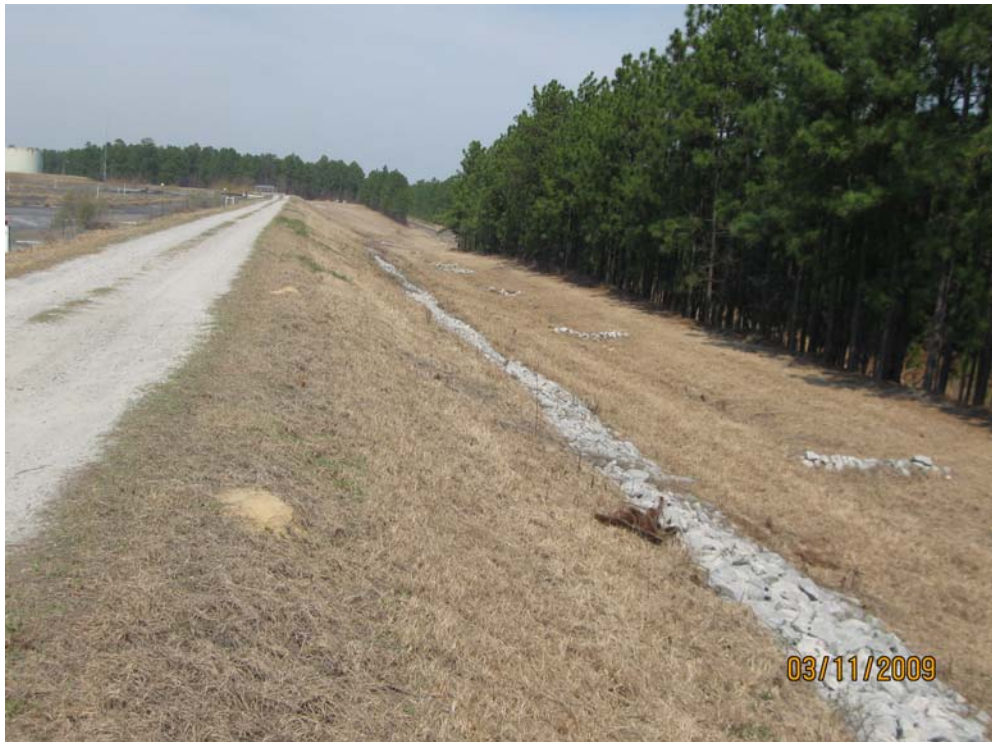
6. ASH POND – Exterior slope of South Pond looking north from southern end.

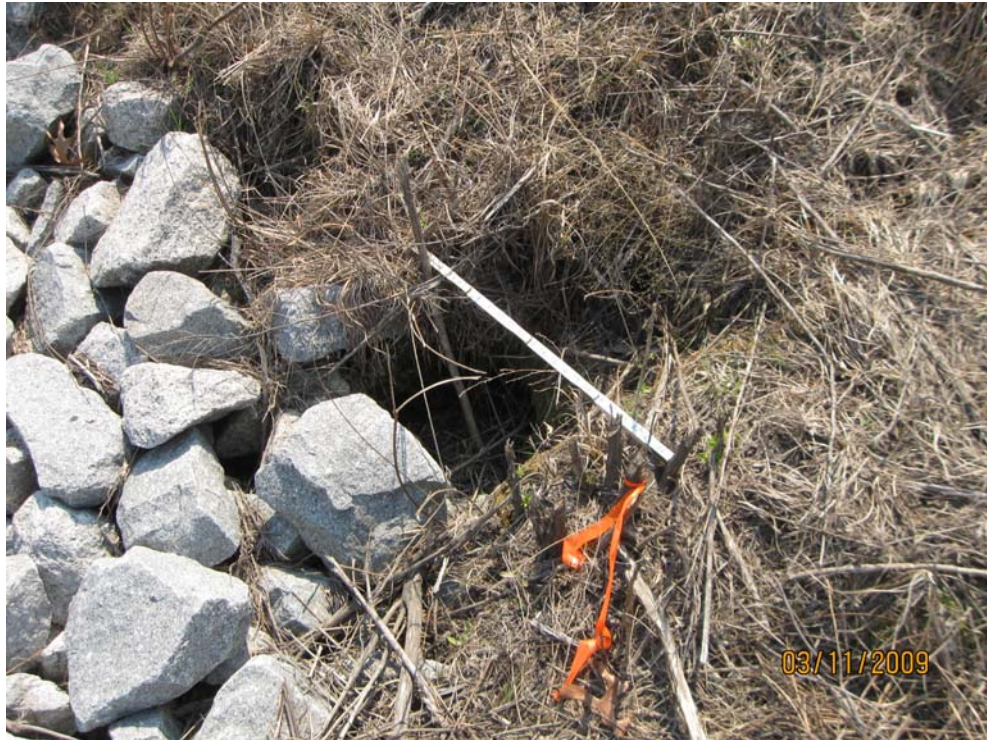
7. ASH POND – Typical local erosion hole at top of North Pond rock toe. Fill with gravel as a routine maintenance activity.

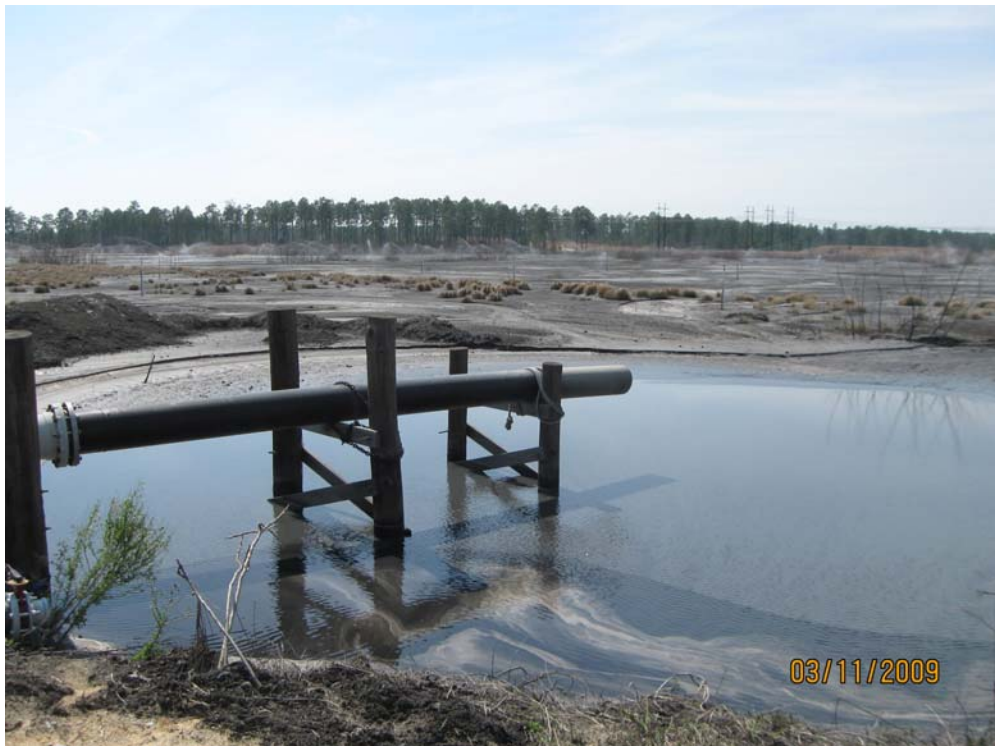
8. ASH POND – Ash discharge location in South Pond.

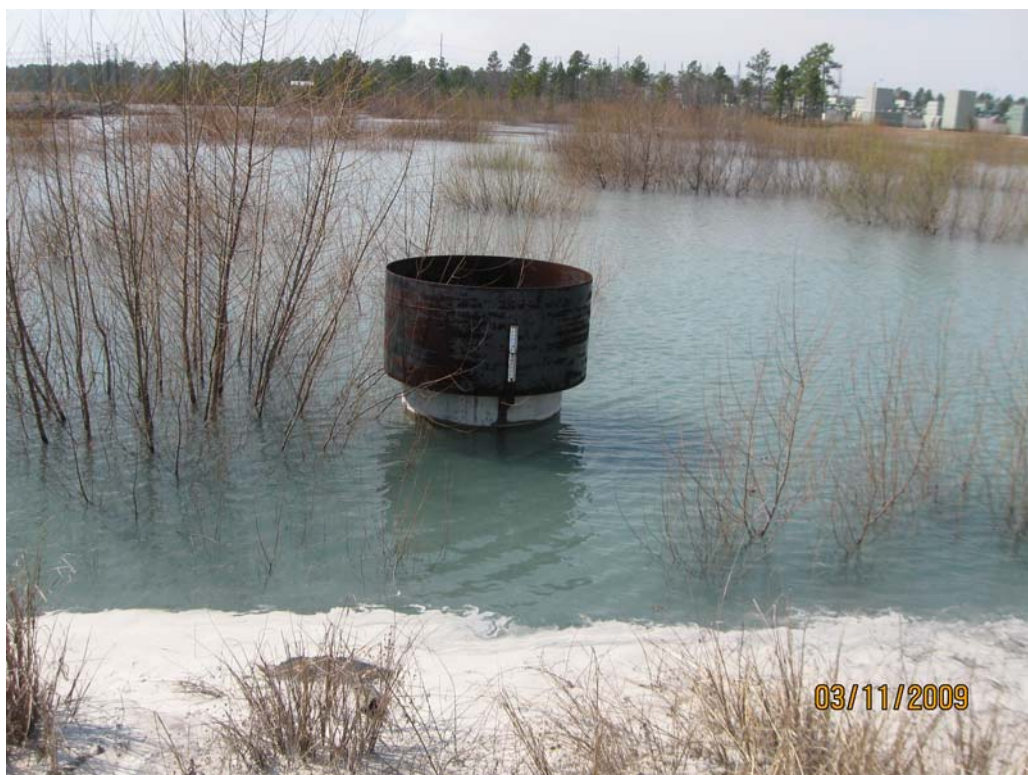
9. ASH POND – Vertical riser and trash guard at inlet point.

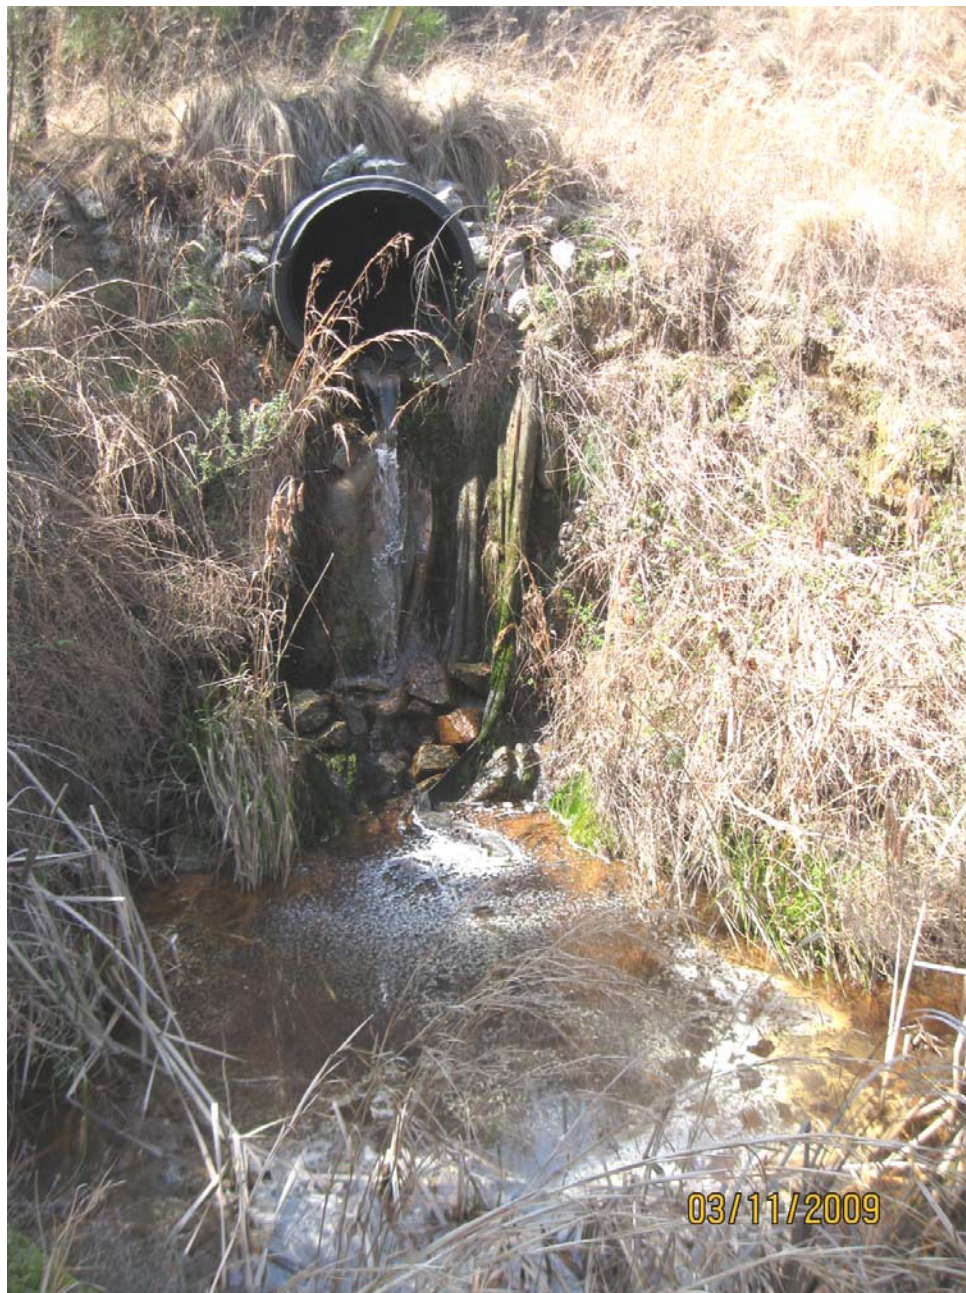
10. ASH POND – Outlet end of ash pond discharge pipe.
