**Coal Combustion Residue Impoundment
Round 9 - Dam Assessment Report**

L.V. Sutton Steam Electric Plant

Ash Ponds

***Progress Energy Carolinas, Inc.*
*Wilmington, North Carolina***

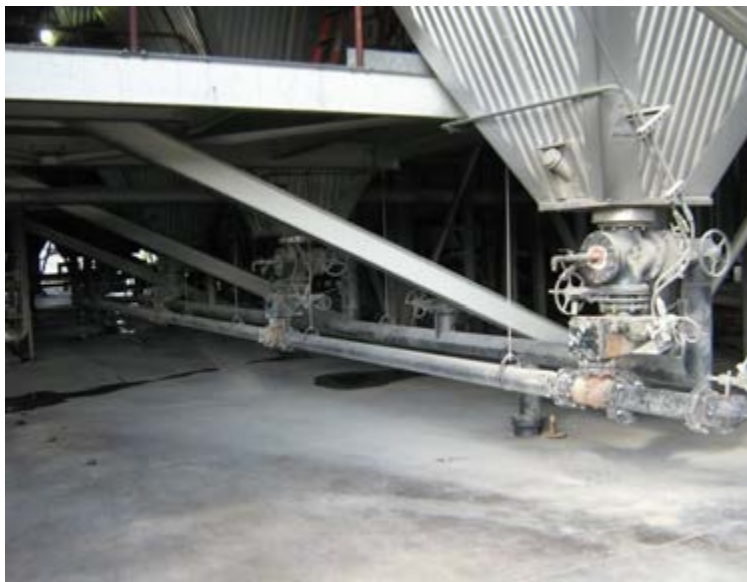
Hopper and fly ash sluice line

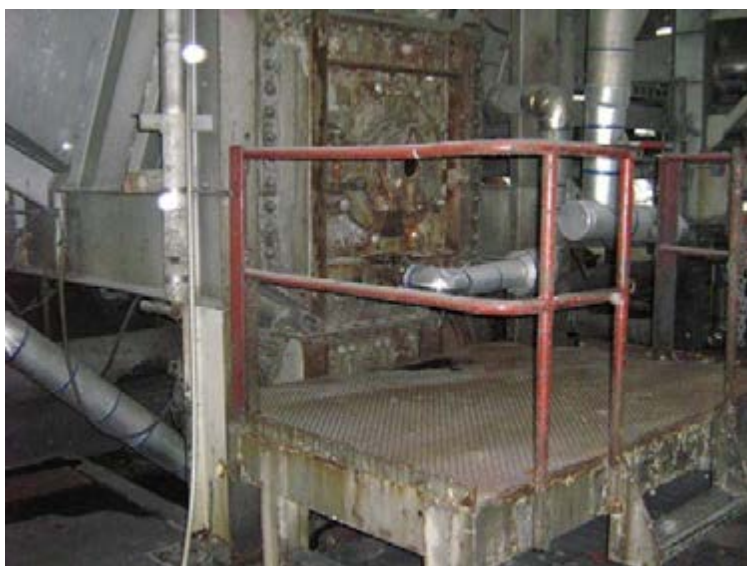
Location from where boiler slag is piped

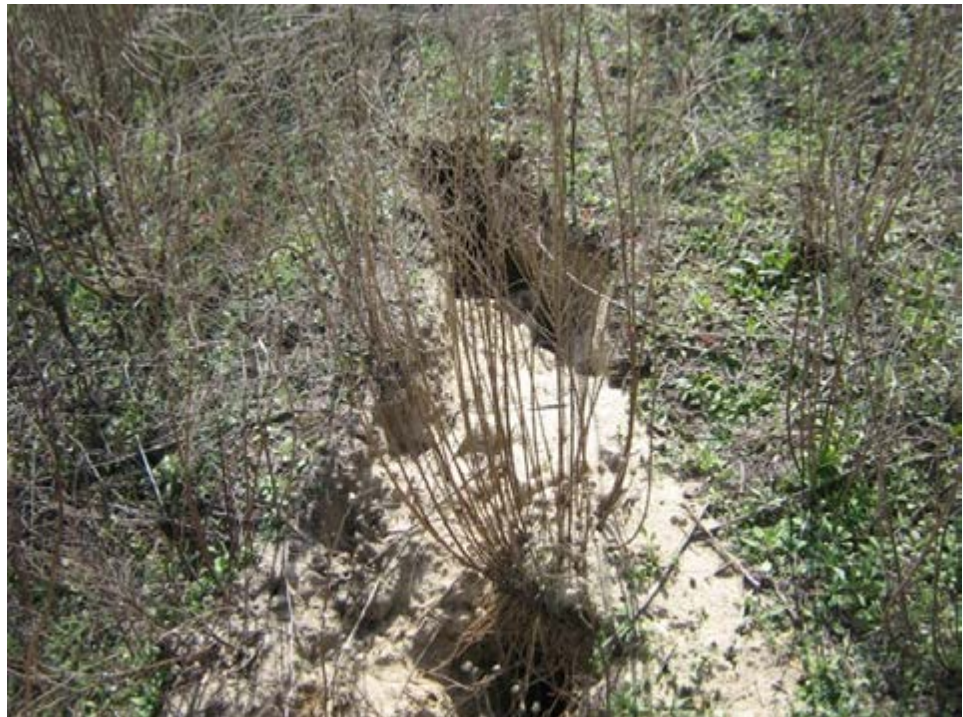
There were no signs of surficial sloughing along the downstream slope. Rill erosion and animals burrows were found in multiple places along the embankment. There were also areas that were bare and need to be seeded.

Animal burrows along downstream slope, 1984 Ash Pond

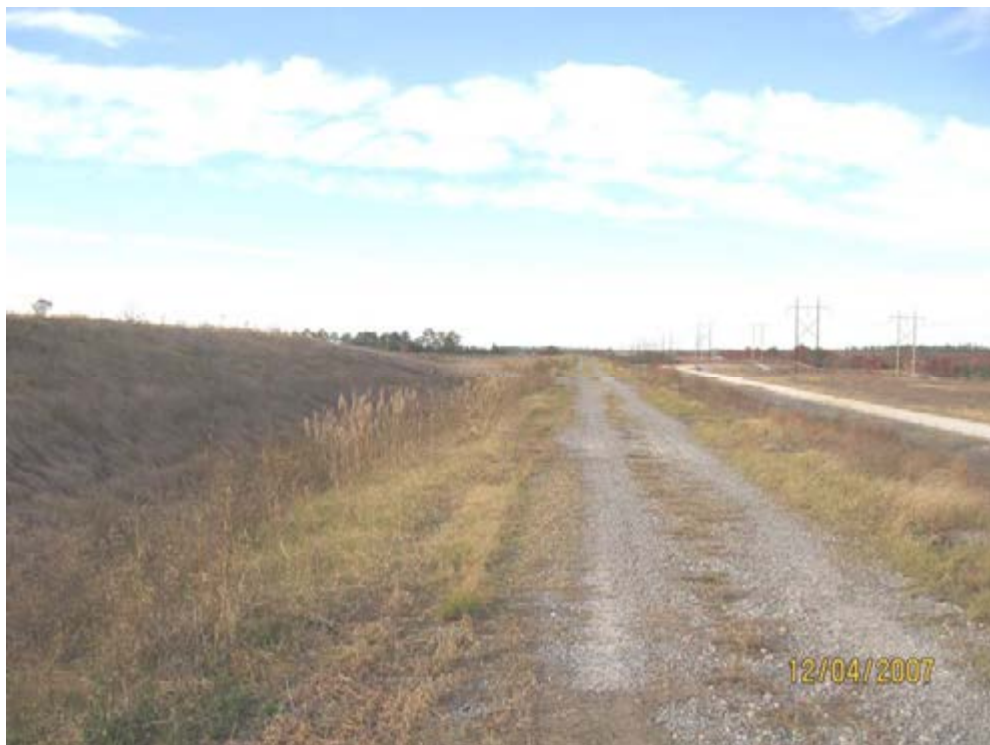
The exterior slope has exposed fly ash with sparse to good grass cover (Photographs 3 and 10). Erosion control netting is present on the slope. MACTEC observed several areas along the top of the stability berm on the north dike where circular depressions about one to four inches deep and about one to three feet in diameter were present (Photograph 11). Discussions with Mr. Alderman indicate these areas are the result of filling in erosion rills that developed in the fly ash slope. These areas are filled by Progress Energy as they are noted. We recommend such areas be checked during each monthly inspection and their positions marked with flags so they can continue to be filled. We interpret these depressions as due to infiltration of surface water and not due to subsurface piping. Also, along the toe of the stability berm slope in the general vicinity of the discharge structure, several local slumps with minor seepage or wet areas were observed (Photograph 12). Due to the width of the stability berm and the gentle slope, these local slumps do not represent an immediate concern. They should be marked and observed during monthly inspections for signs of increasing size or seepage flow.

Photo 3. 1984 Ash Pond – Crest of 1984 dike and exterior slope of 2006 dike.

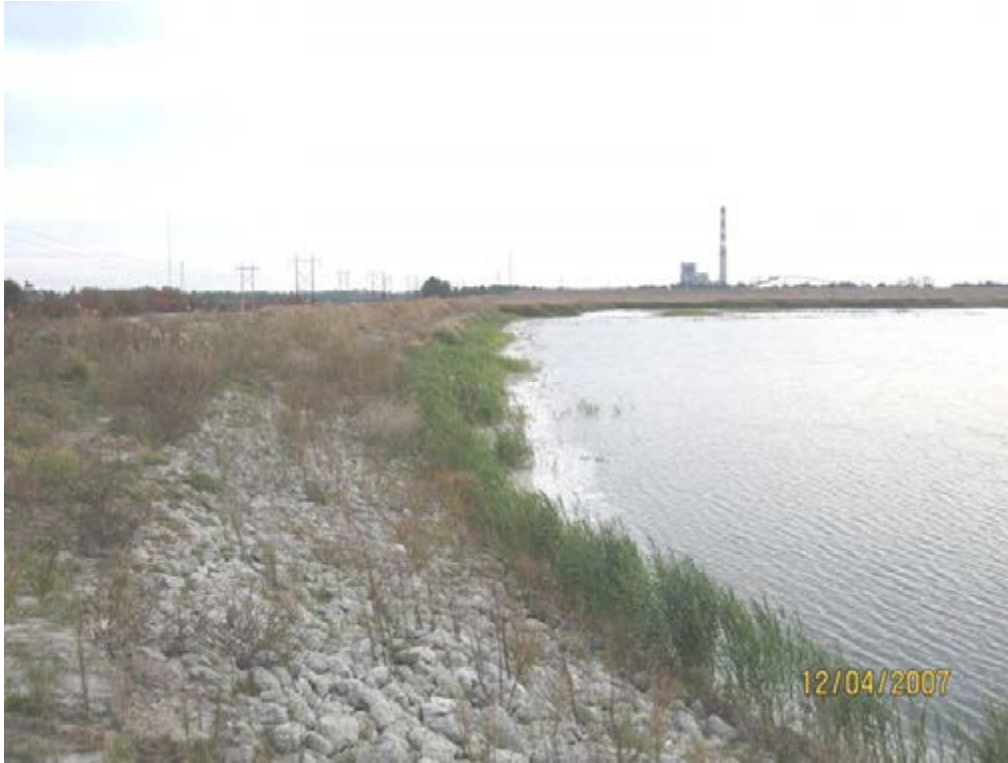
Photo 5. 1984 Ash Pond – Typical interior slope looking south. Note minor grass growth.

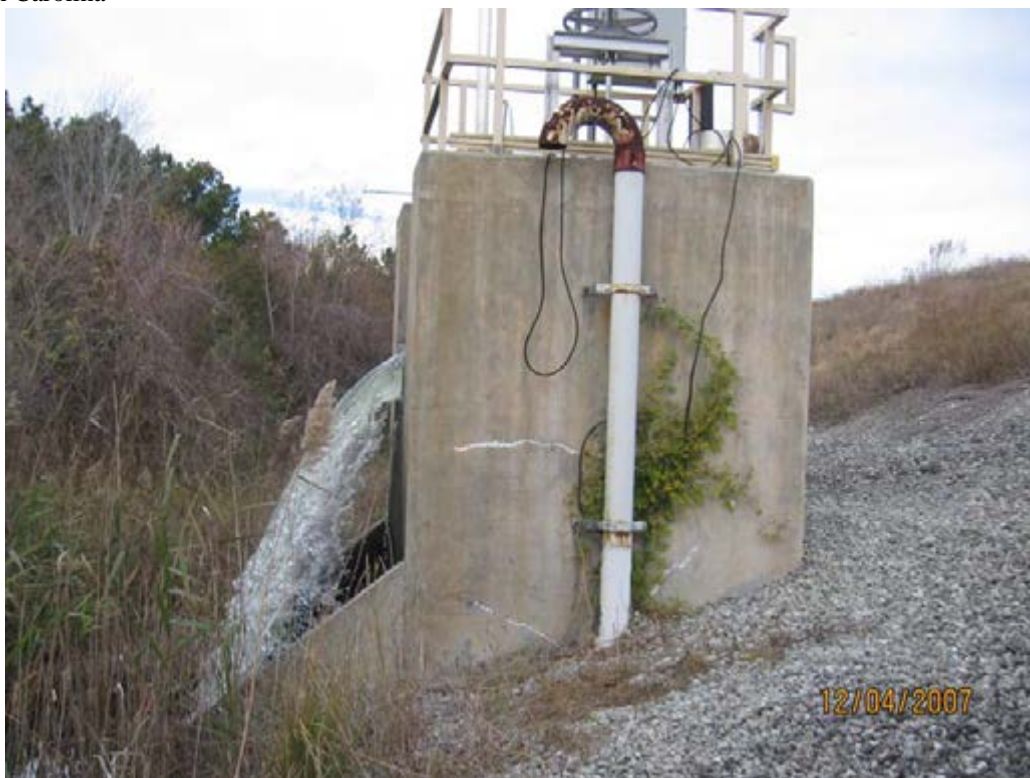
cracks were seen on the west side of this structure, near the base, with minor efflorescence (Photograph 7). These have been observed previously, are not unusual and pose no concern.

Photo 7. Ash Pond – Outlet drainage Structure looking northwest.

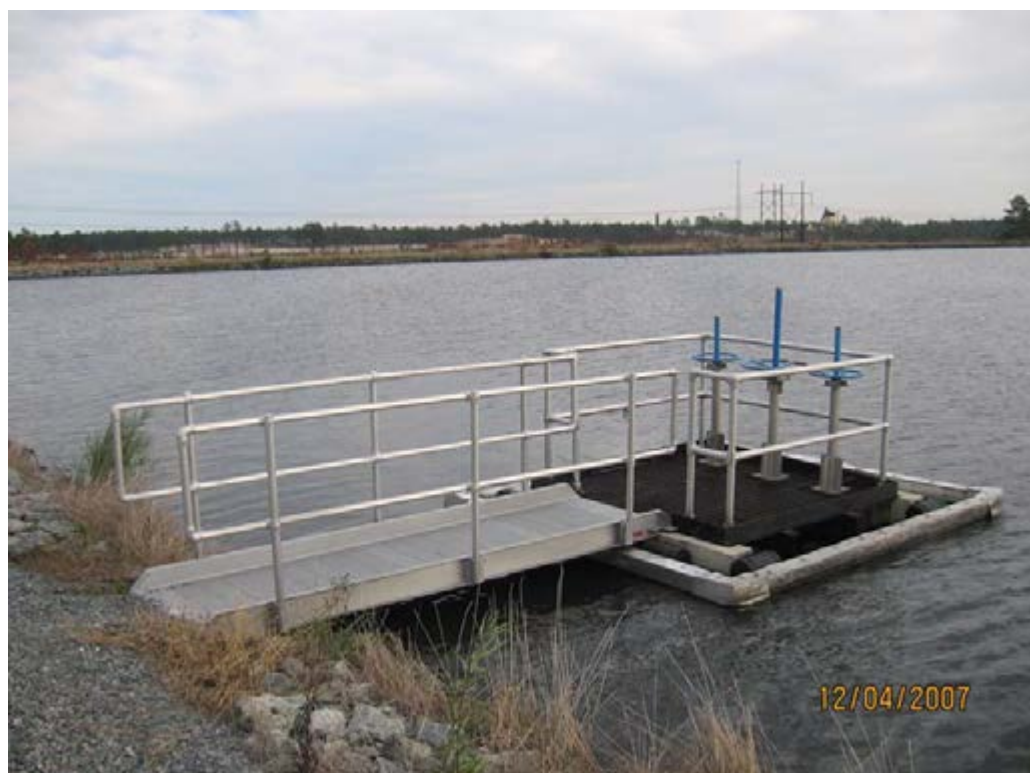
At the time of our inspections, the water level in the interior storage area was slightly above elevation 40.0 feet MSL, and was flowing over the top of the riser (Photograph 8) and out into the 1984 ash pond (Photograph 9). A slight discharge of seepage water from the seepage drain pipe alongside the discharge pipe was observed on the west side of the pipe.

Photo 8. 2006 Interior Ash Pond Inlet looking east.

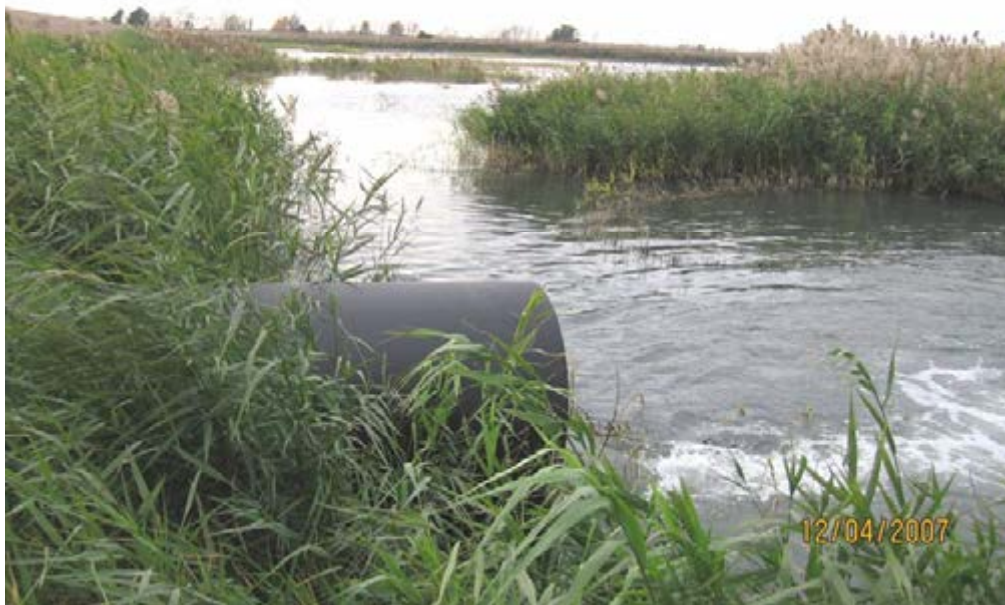
Photo 9. 2006 Outlet Pipe draining into 1984 pond.

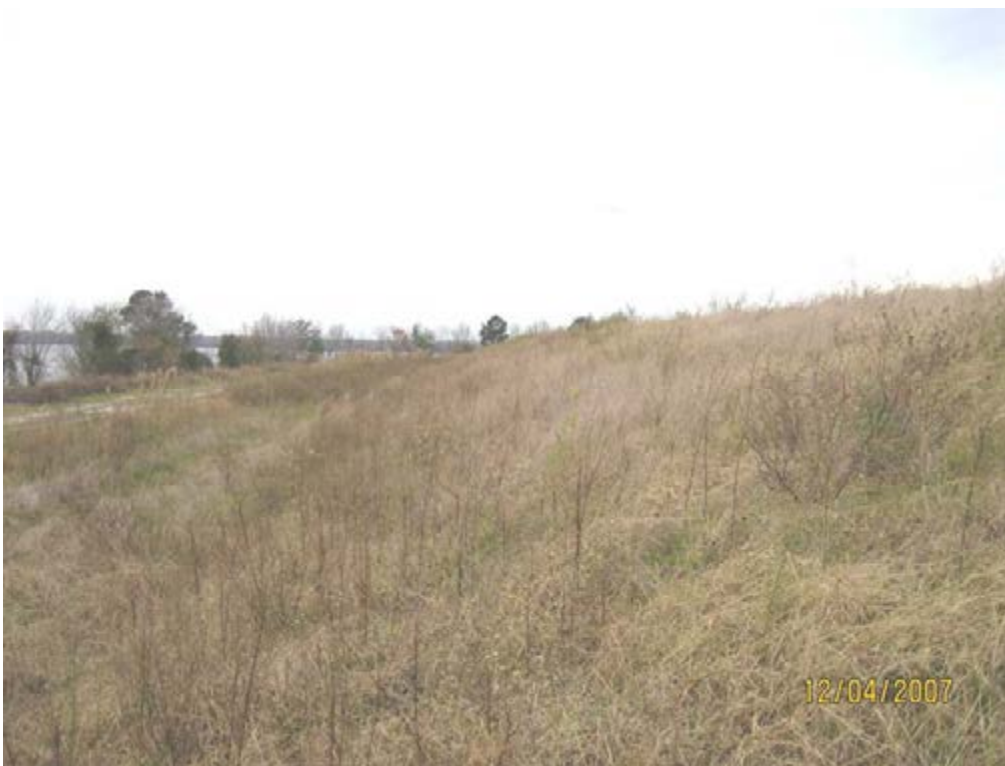
Photo 10. Ash Pond –Typical exterior slopes of 2006 dike.

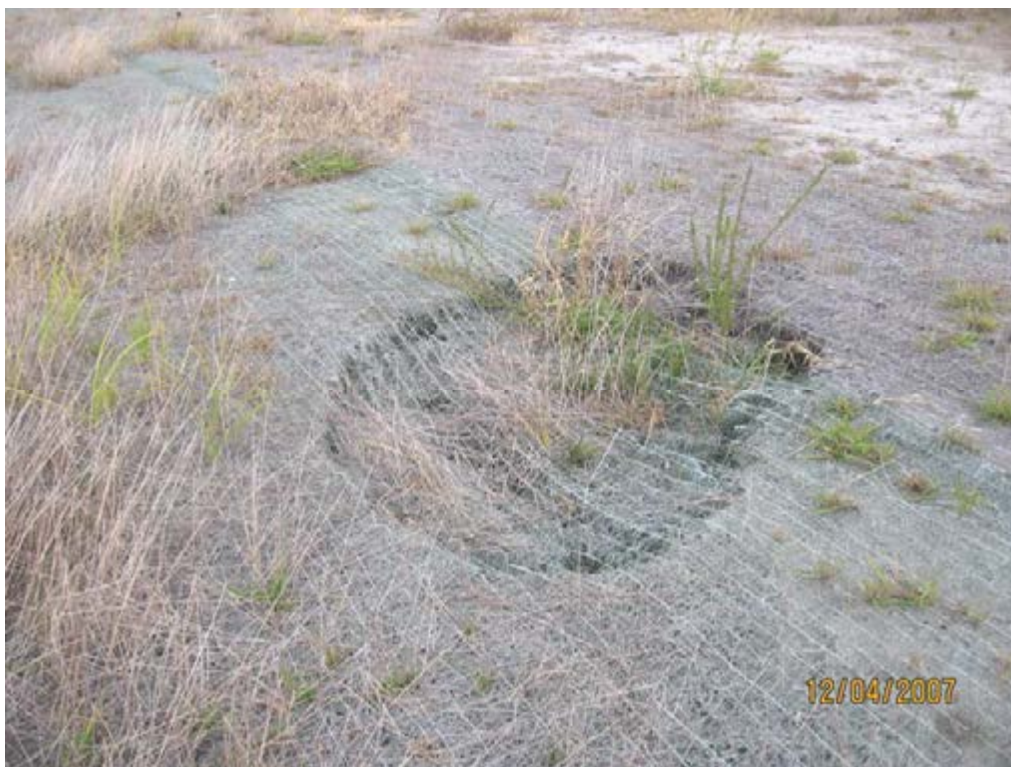
Photo 11. 2006 interior Ash Dike –Exterior Slope looking a sink hole.

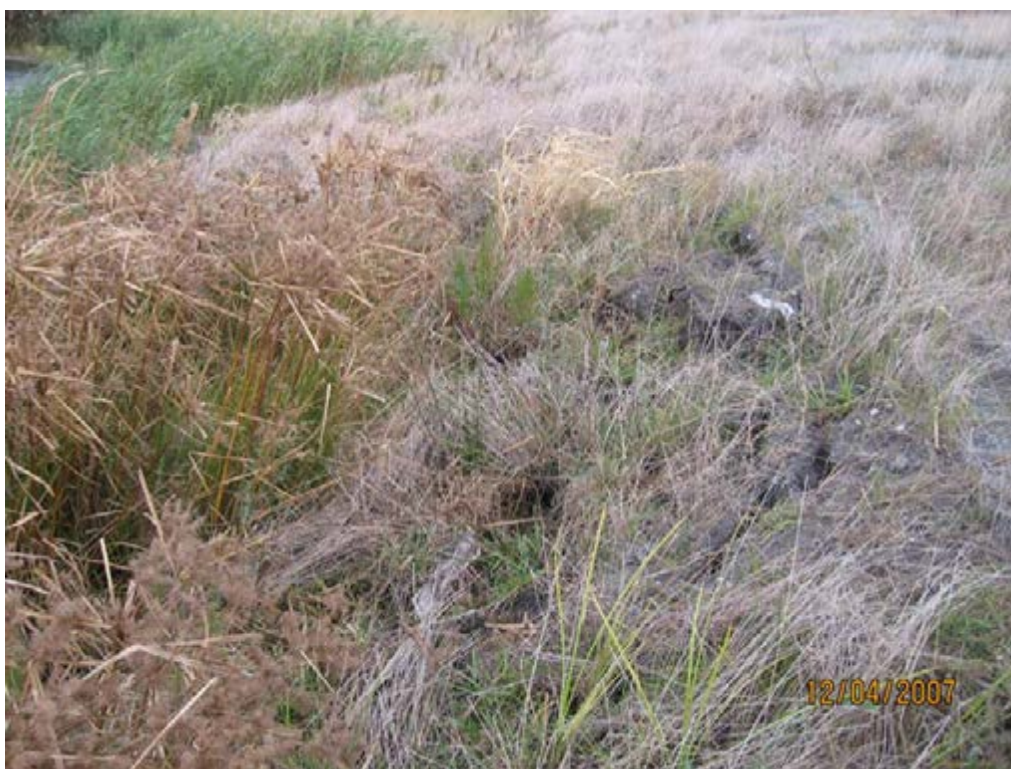
Photo 12. 2006 interior Ash Dike – Area of erosion of ash along exterior slope of dike.

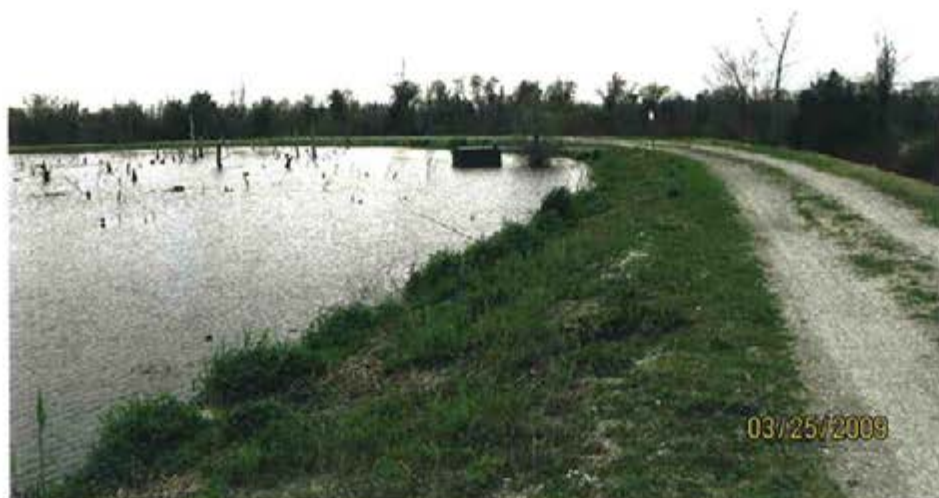
1. 1983 Ash Pond – View of interior slope, outlet riser and standing water near riser.

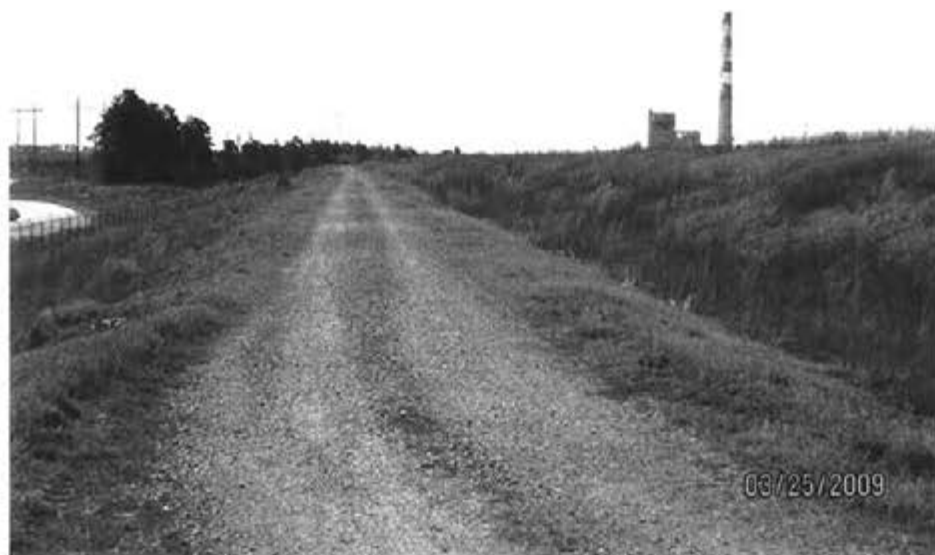
6. 1984 Ash Pond -- View of dike crest and exterior slope on east side of pond

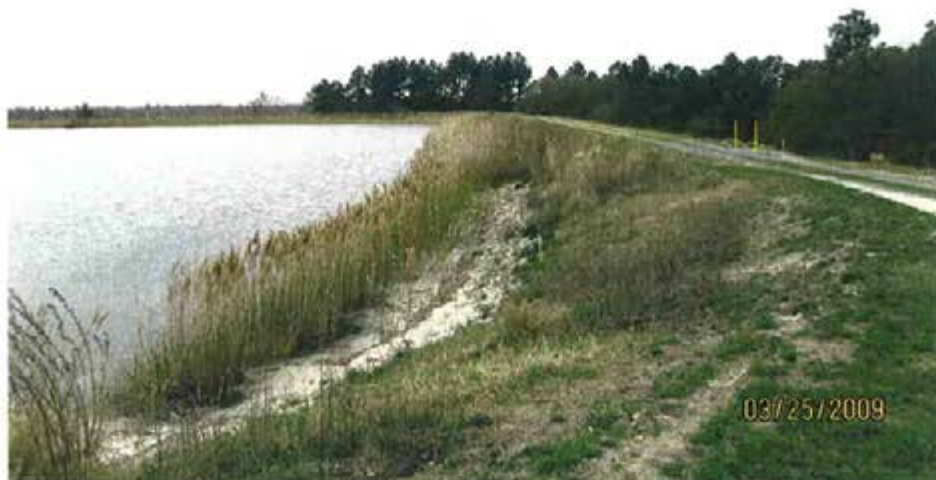
7. 1984 Ash Pond - View of riprap placed for interior slope on north side of pond.

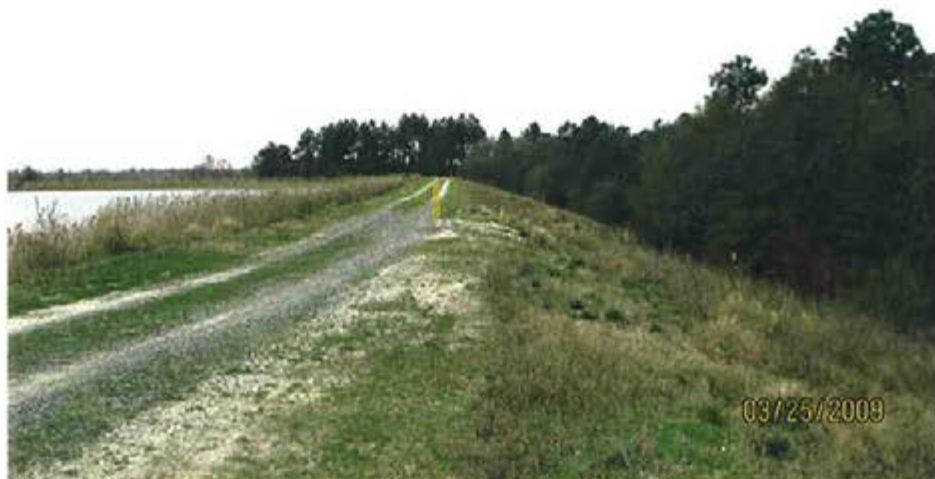
8. 1984 Ash Pond – View of exterior slope on north side of pond.

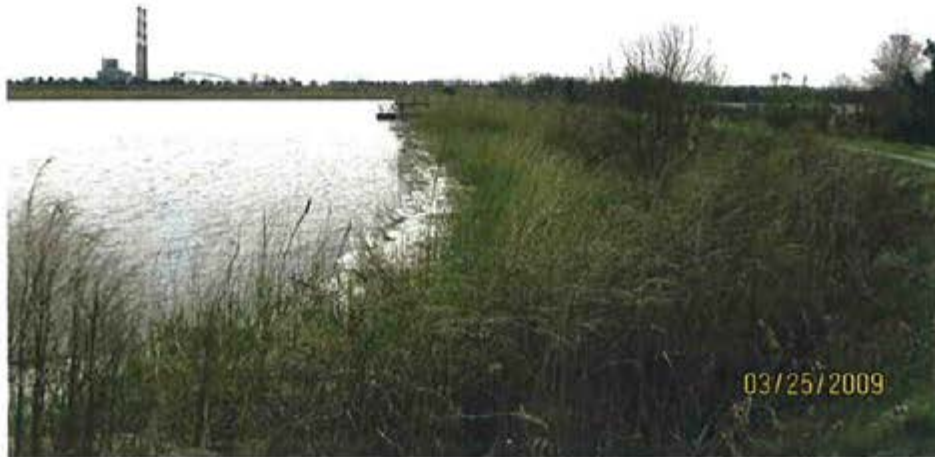
9. 1984 Ash Pond – View of interior slope of dike on west side of pond looking toward discharge riser.

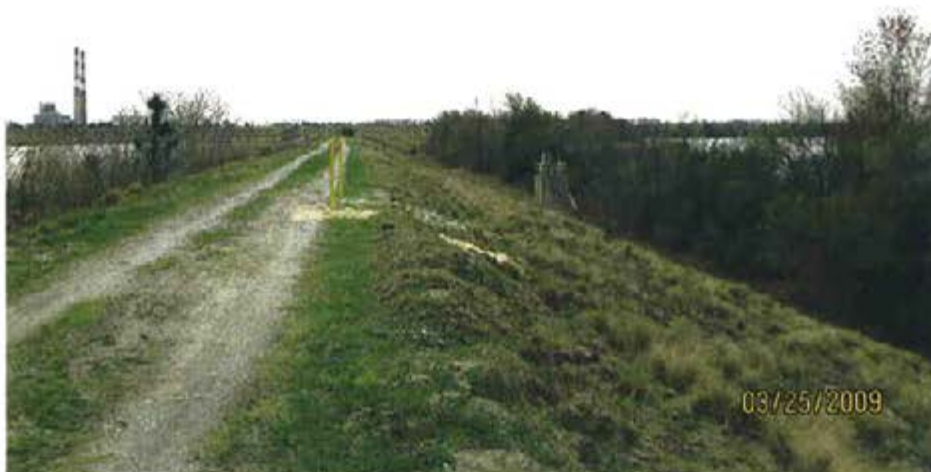
10. 1984 Ash Pond – View of exterior slope of dike on west side of pond looking toward outlet structure.

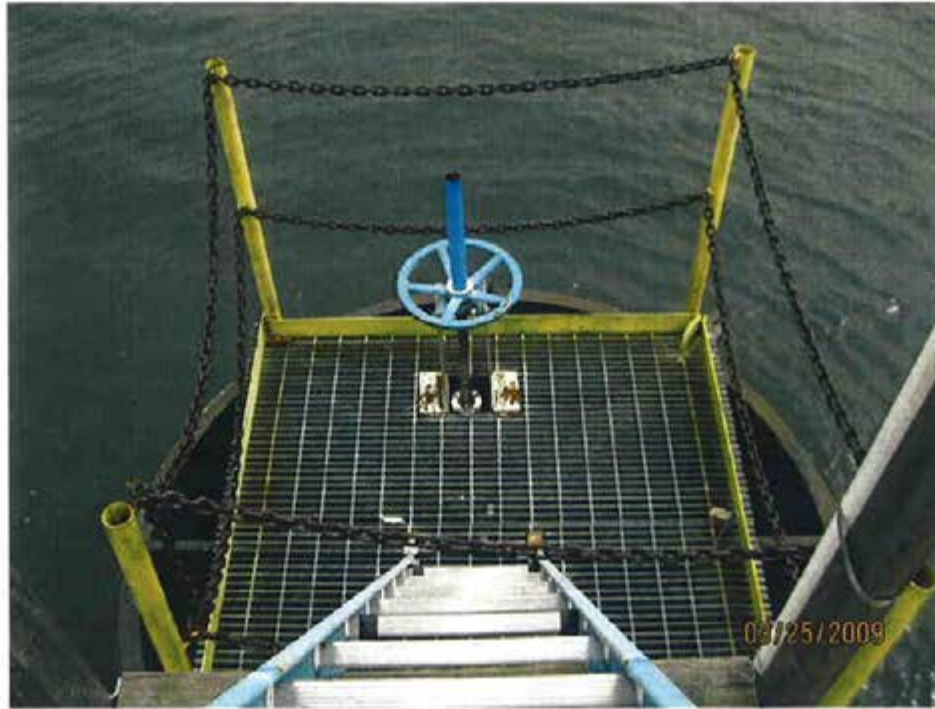
11. 1984 Ash Pond – View of top for discharge riser.

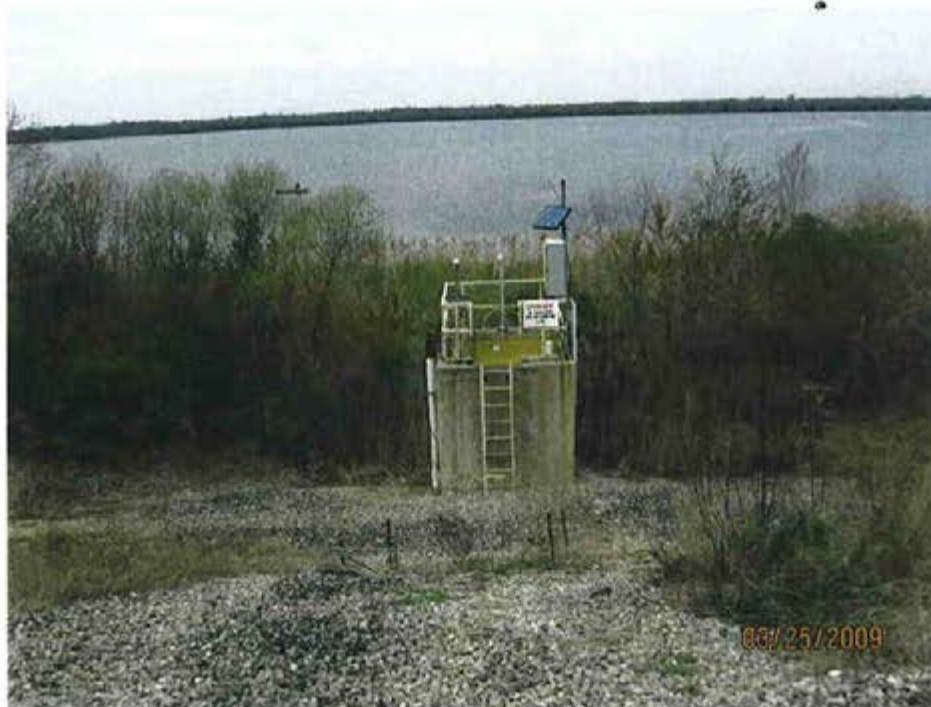
12. 1984 Ash Pond – View of top for discharge structure looking toward cooling pond.

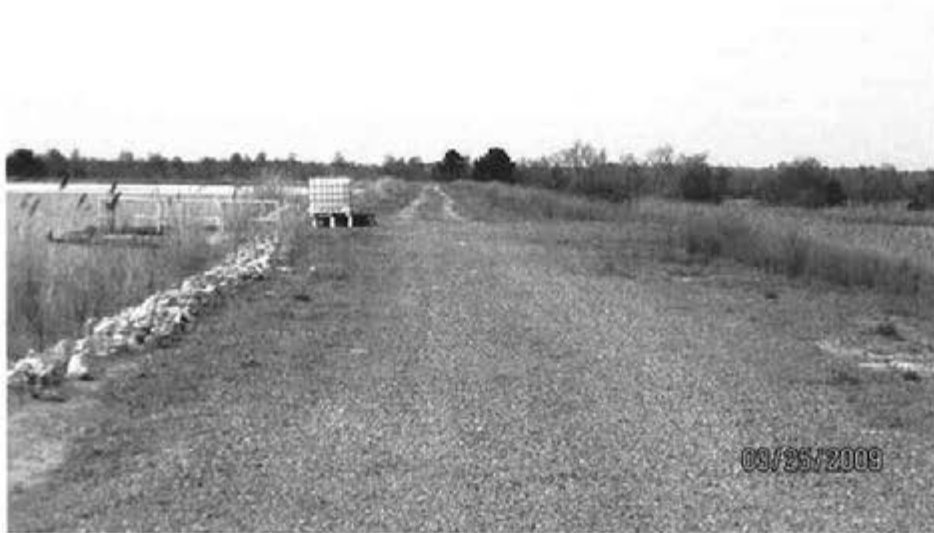
13. 1984 Ash Pond (Interior Storage Area) – View of dike crest looking toward discharge structure on north side of pond.

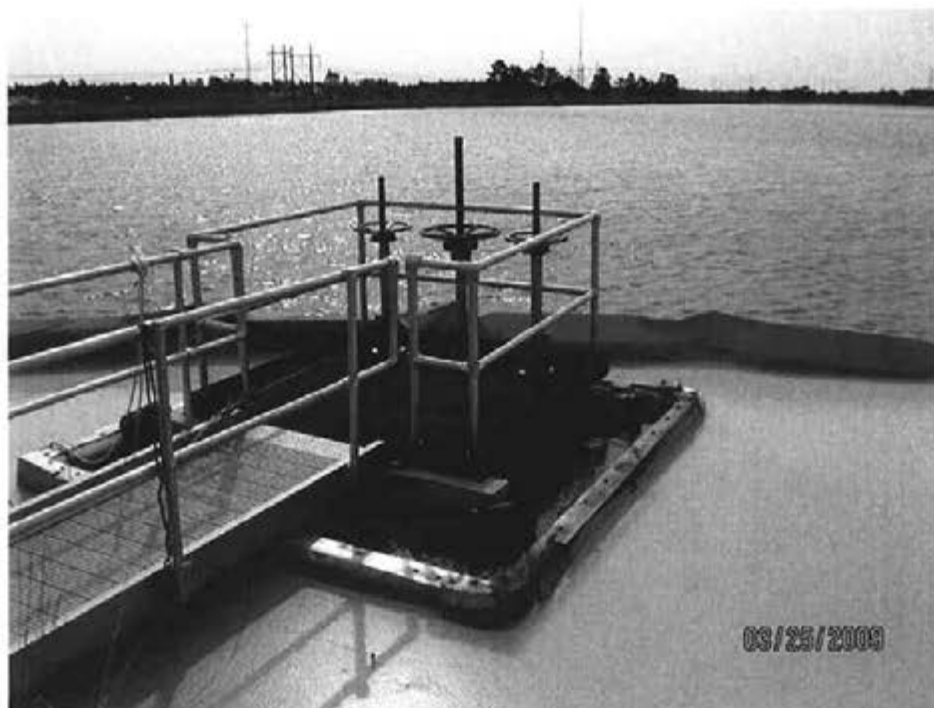
14. 1984 Ash Pond (Interior Storage Area) – View of discharge structure.

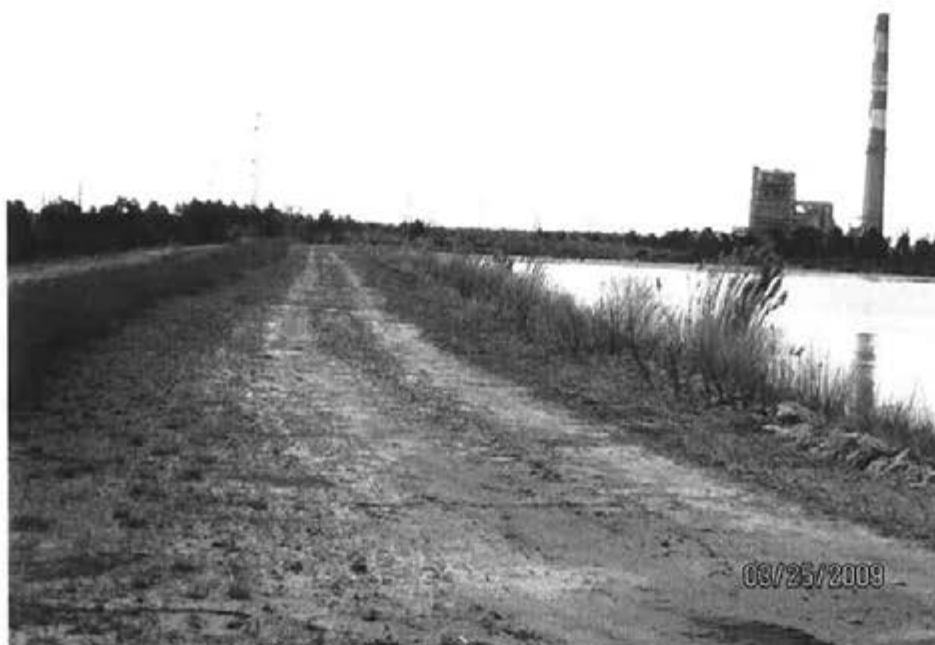
15. 1984 Ash Pond (Interior Storage Area) – View of crest of dike and interior slope along east side of pond.

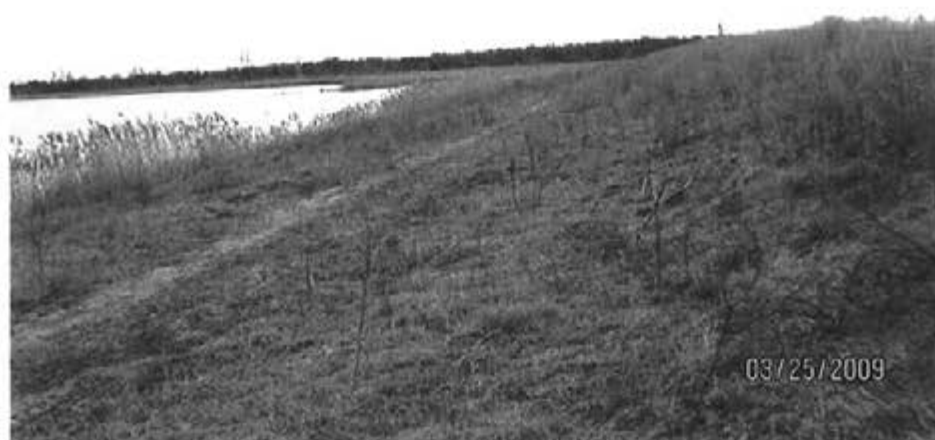
16. 1984 Ash Pond (Interior Storage Area) – View of along toe of north dike.

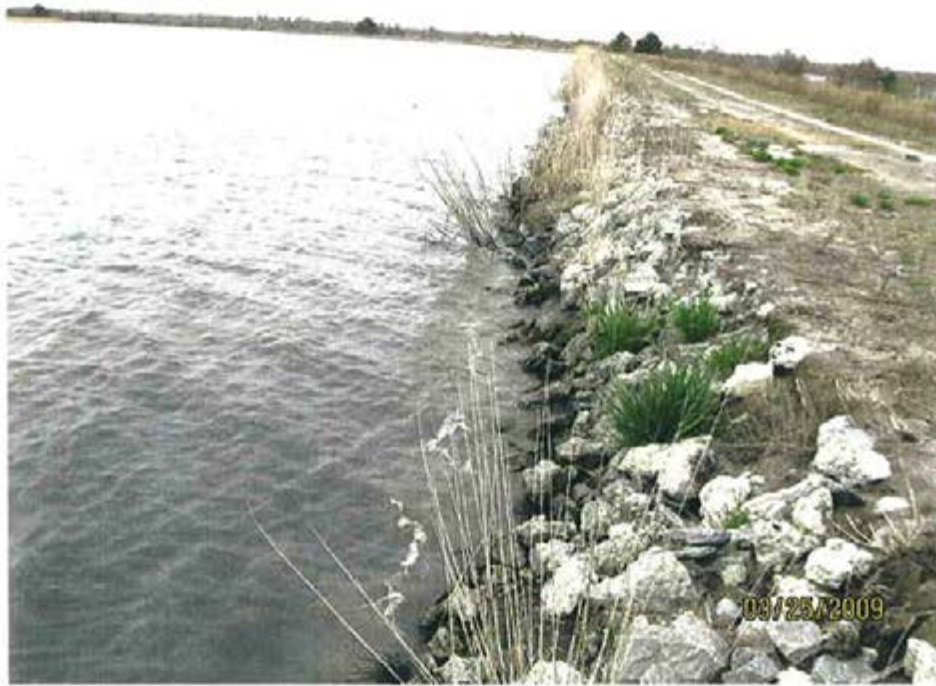
17. 1984 Ash Pond (Interior Storage Area) – View of riprap along interior slope on north side of pond.

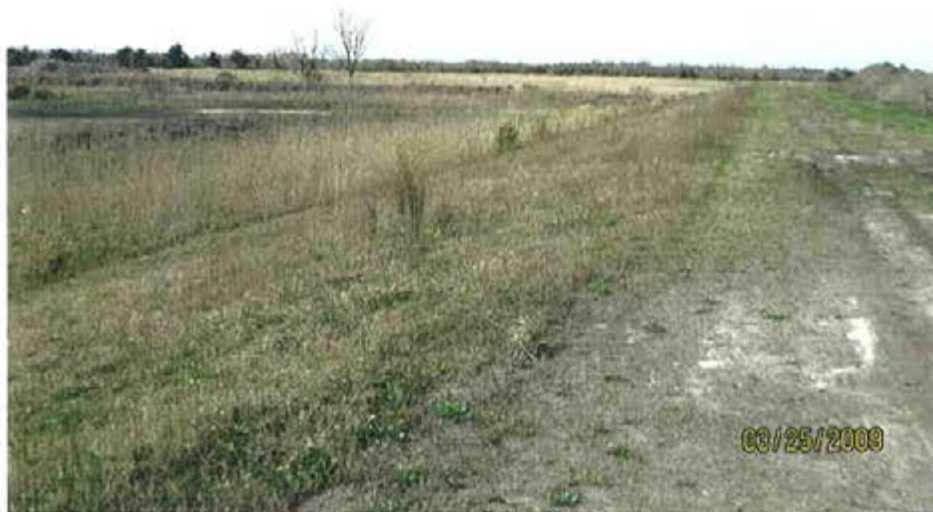
18. 1984 Ash Pond (Interior Storage Area) – View of exterior slope on south side of pond.

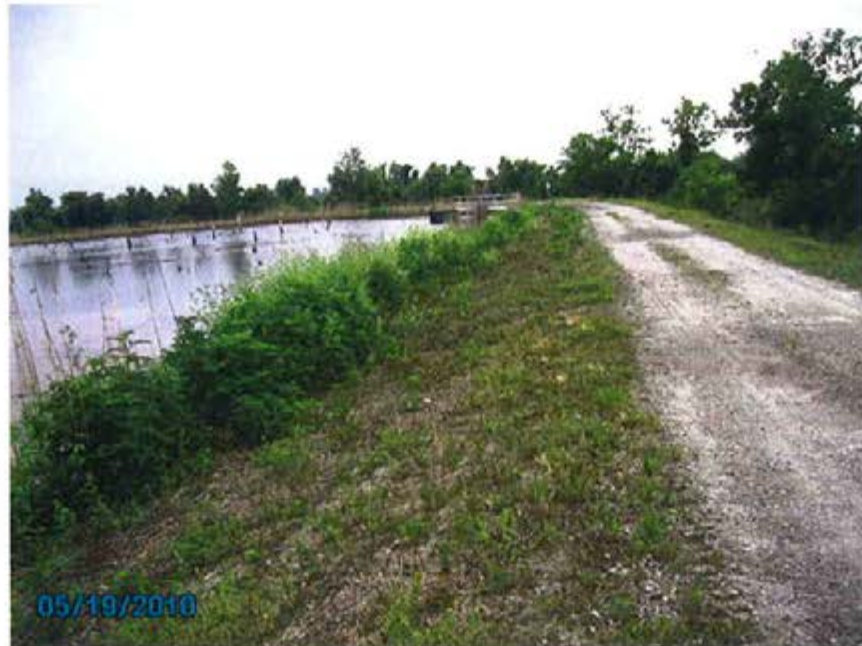
1. 1983/1971 Ash Pond – View of interior slope for west dike looking toward discharge structure.

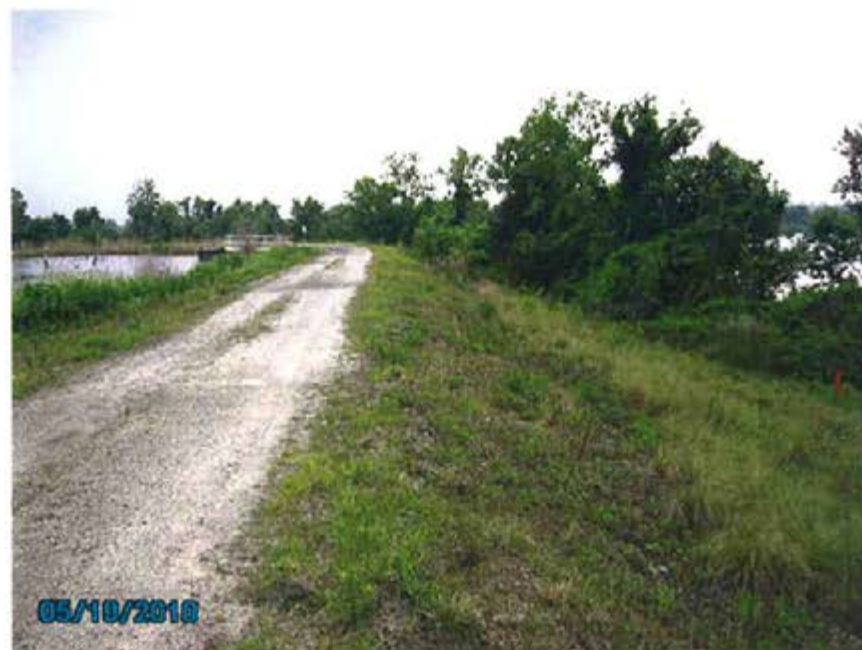
2. 1983/1971 Ash Pond – View of exterior slope for west dike looking toward discharge structure.

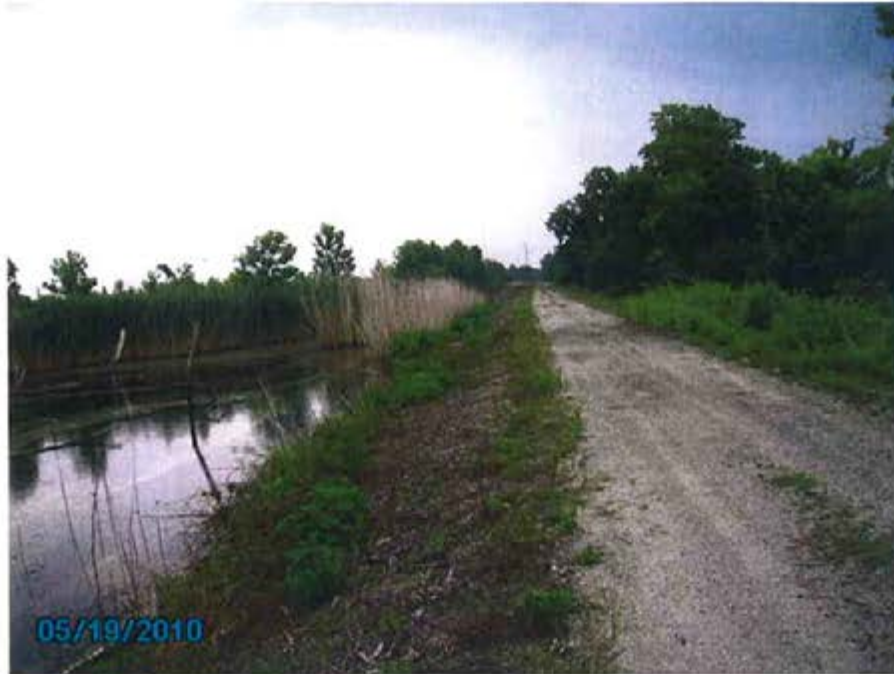
3. 1983/1971 Ash Pond – View of interior slope for south dike.

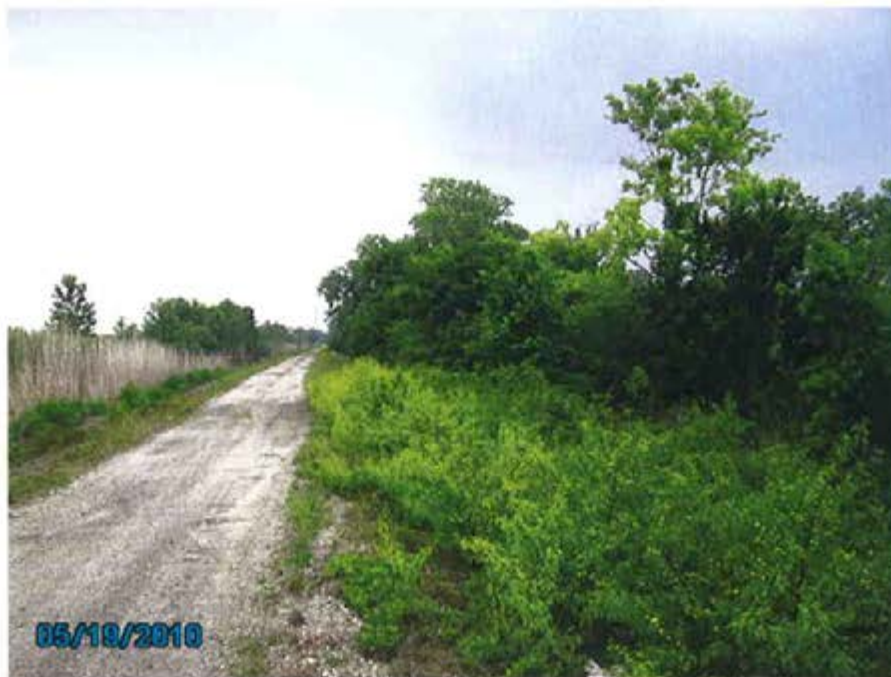
4. 1983/1971 Ash Pond – View of exterior slope for south dike.

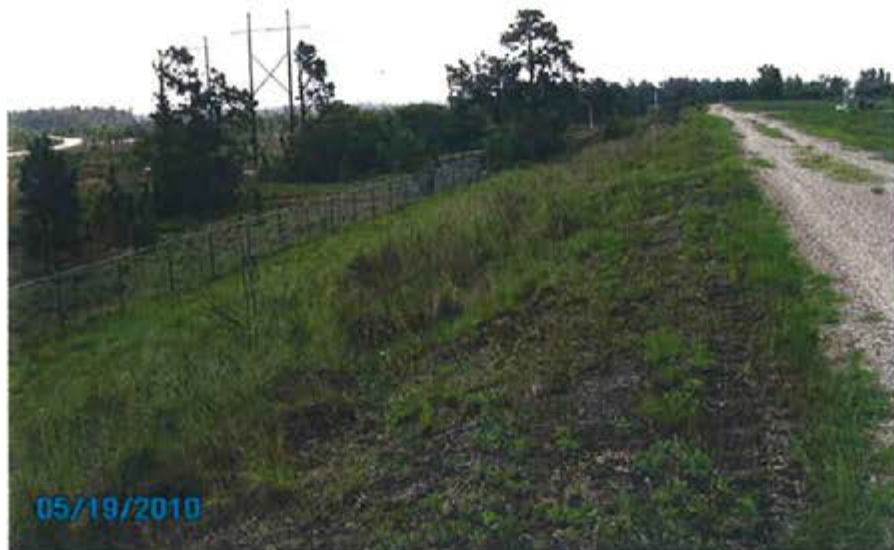
5. 1984 Ash Pond – View of exterior slope for east dike looking south.

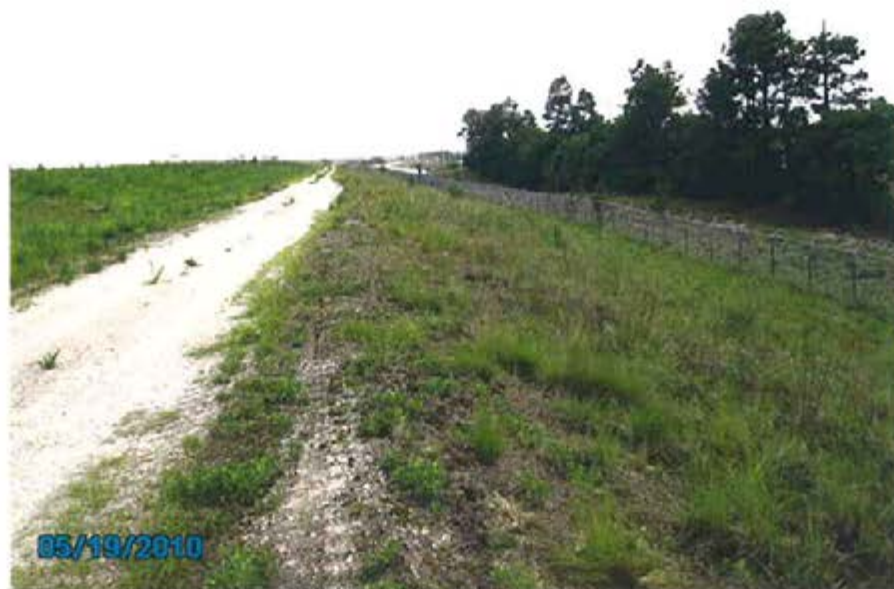
6. 1984 Ash Pond – View of exterior slope for east dike looking north.

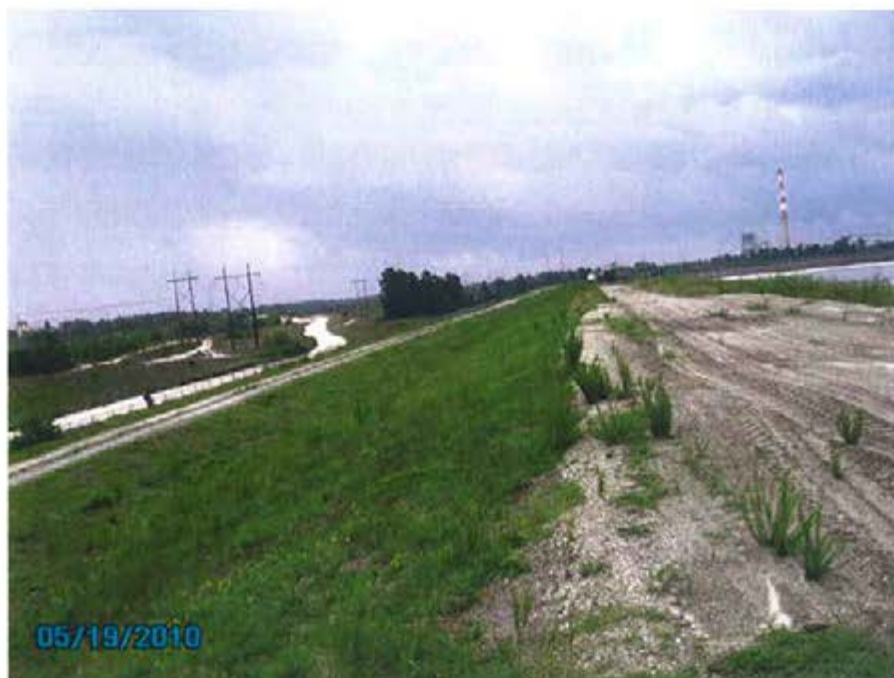
7. 1984 Ash Pond – View of exterior slope for east dike looking south (at northeast corner).

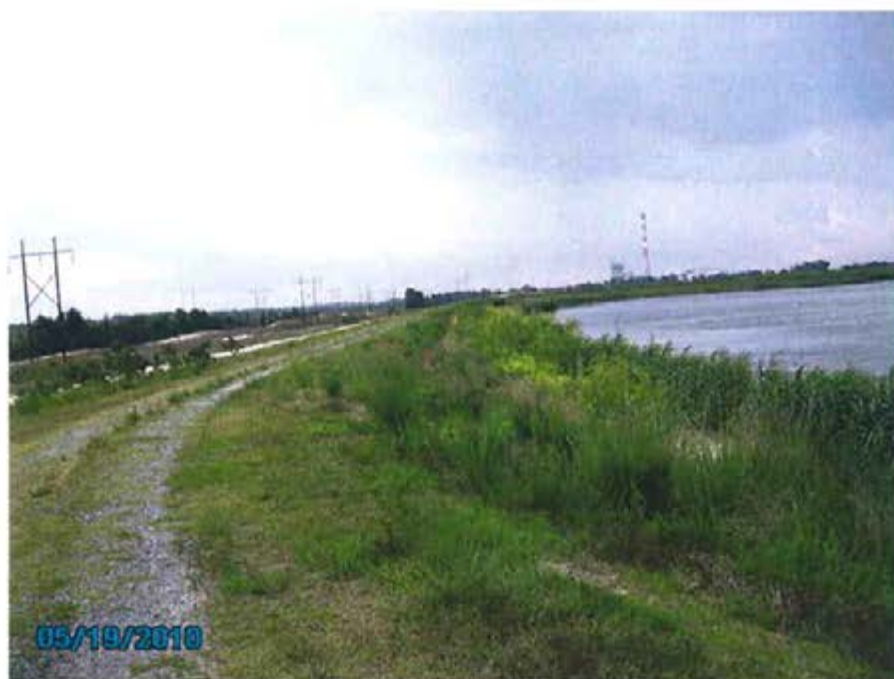
8. 1984 Ash Pond – View of interior slope for east dike looking south (at northeast corner).

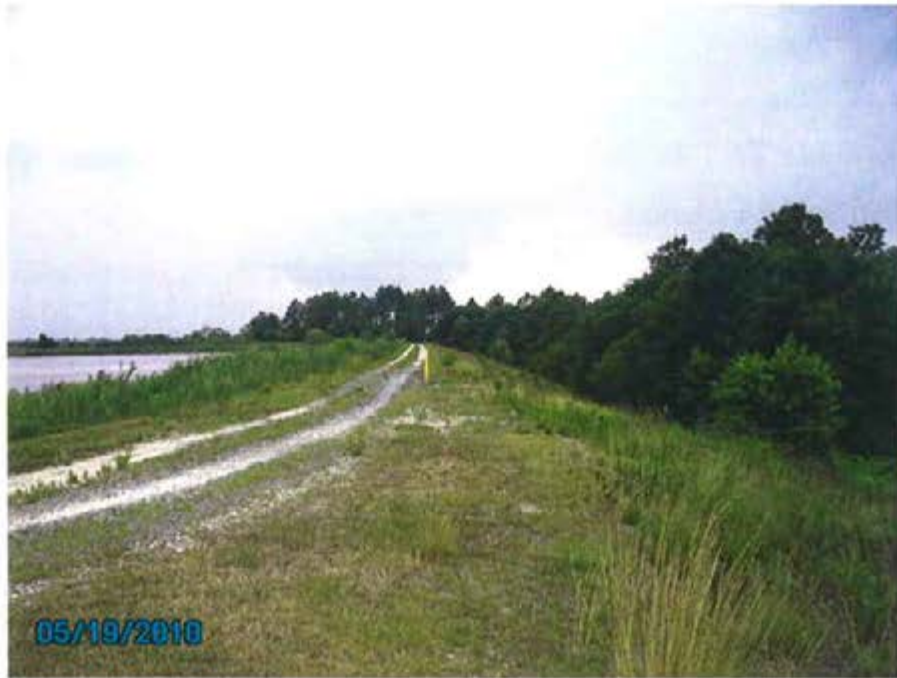
9. 1984 Ash Pond – View of exterior slope for south dike looking west (at northeast corner).

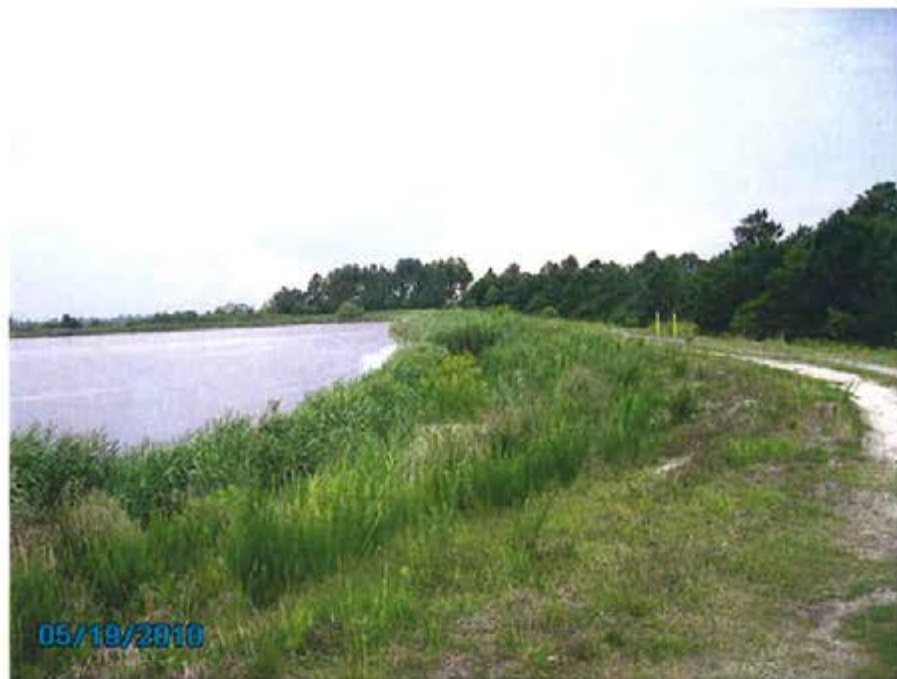
10. 1984 Ash Pond – View of interior slope for south dike looking west (at northeast corner).

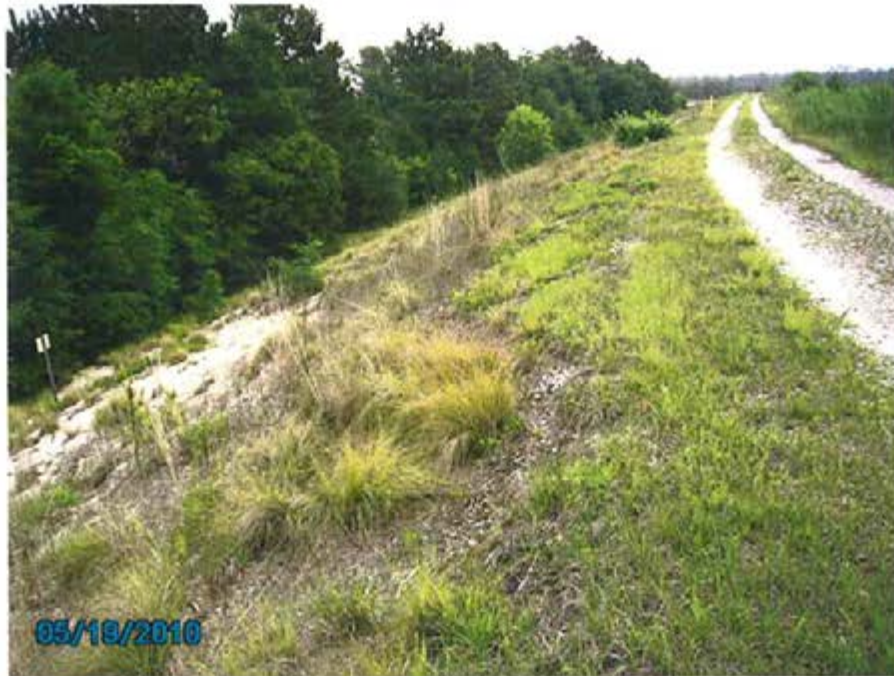
11. 1984 Ash Pond – View of exterior slope for south dike looking toward east (at northwest corner).

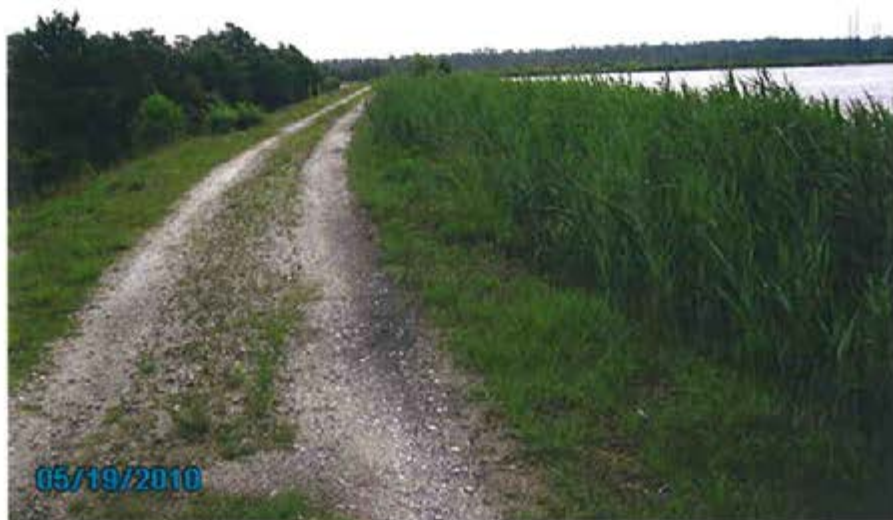
12. 1984 Ash Pond – View of exterior slope for south dike looking east (at northwest corner).
