**Coal Combustion Residue Impoundment
Round 9 - Dam Assessment Report**

L.V. Sutton Steam Electric Plant

Ash Ponds

***Progress Energy Carolinas, Inc.*
*Wilmington, North Carolina***

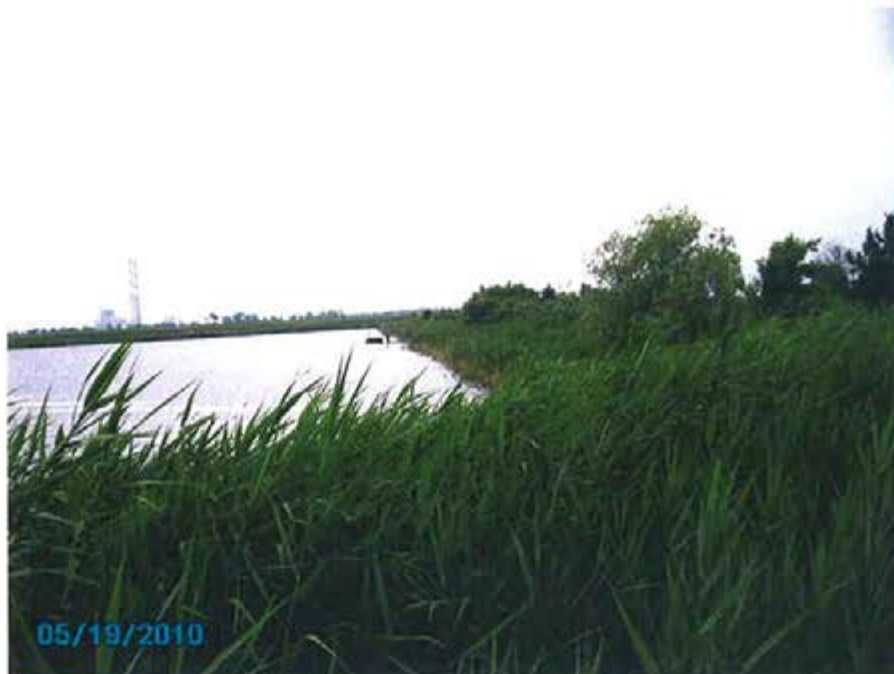
13. 1984 Ash Pond – View of interior slope for west dike looking toward discharge structure.

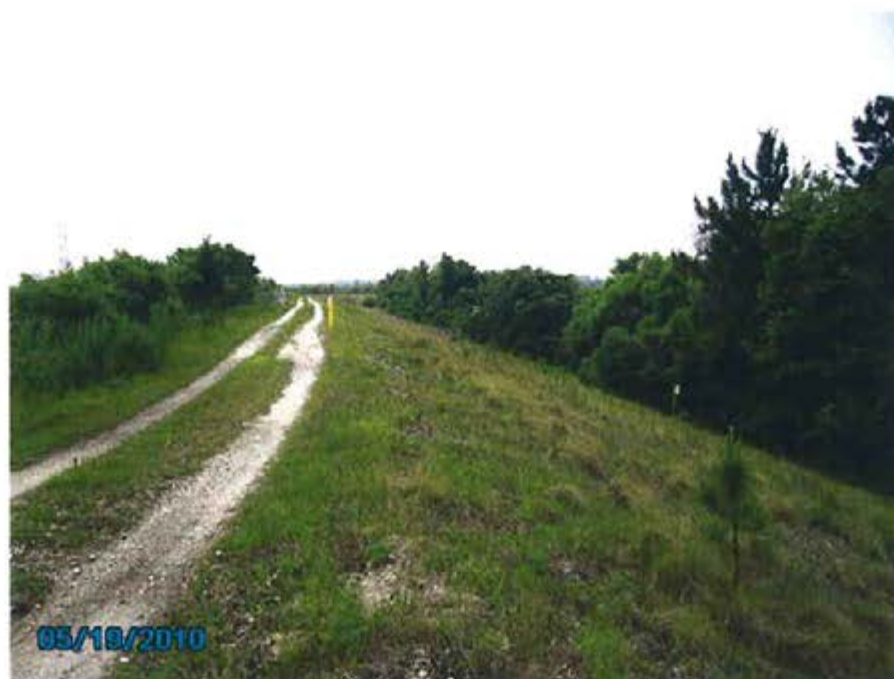
14. 1984 Ash Pond – View of exterior slope for west dike looking toward discharge structure.

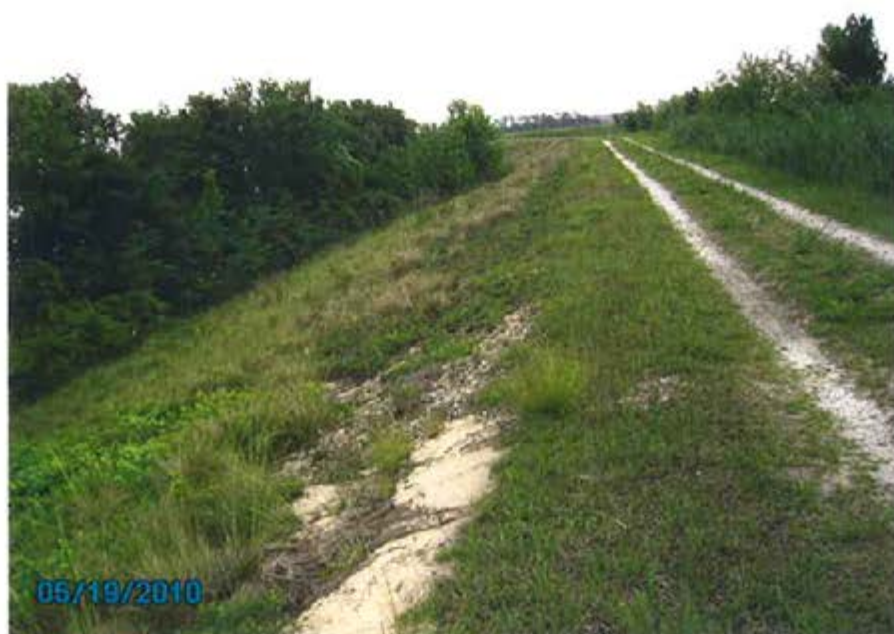
15. 1984 Ash Pond – View of exterior slope for west dike looking north.

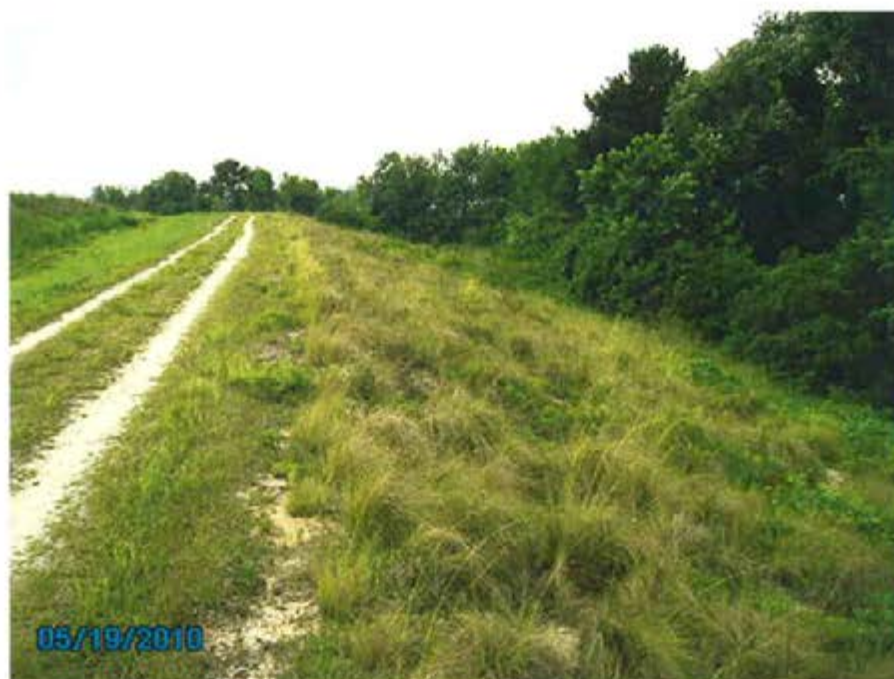
16. 1984 Ash Pond – View of exterior slope for west dike looking south.

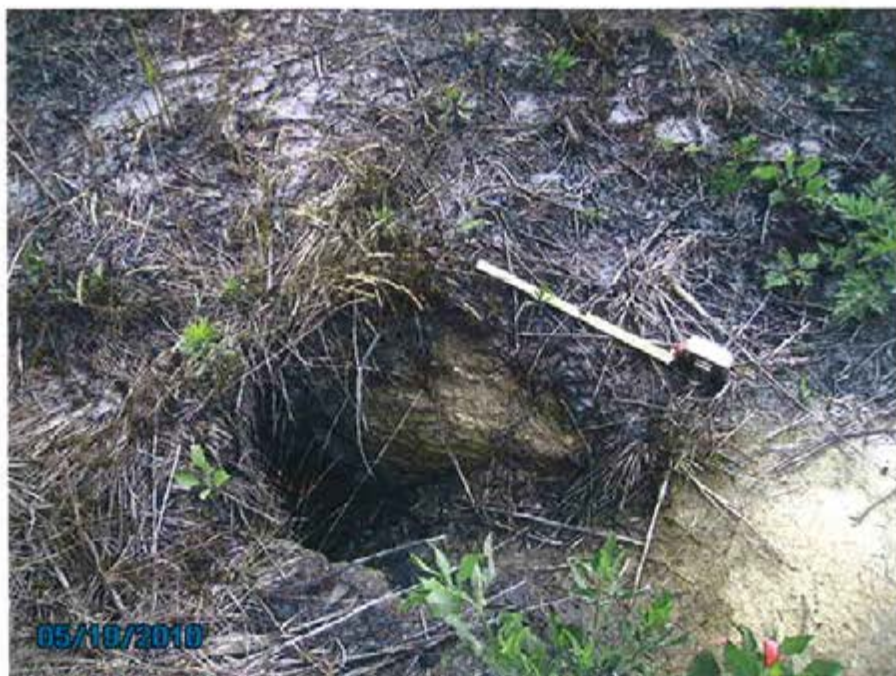
17. 1984 Ash Pond – View of animal burrow on the exterior slope for east dike (12 inch tape extension shown for scale).

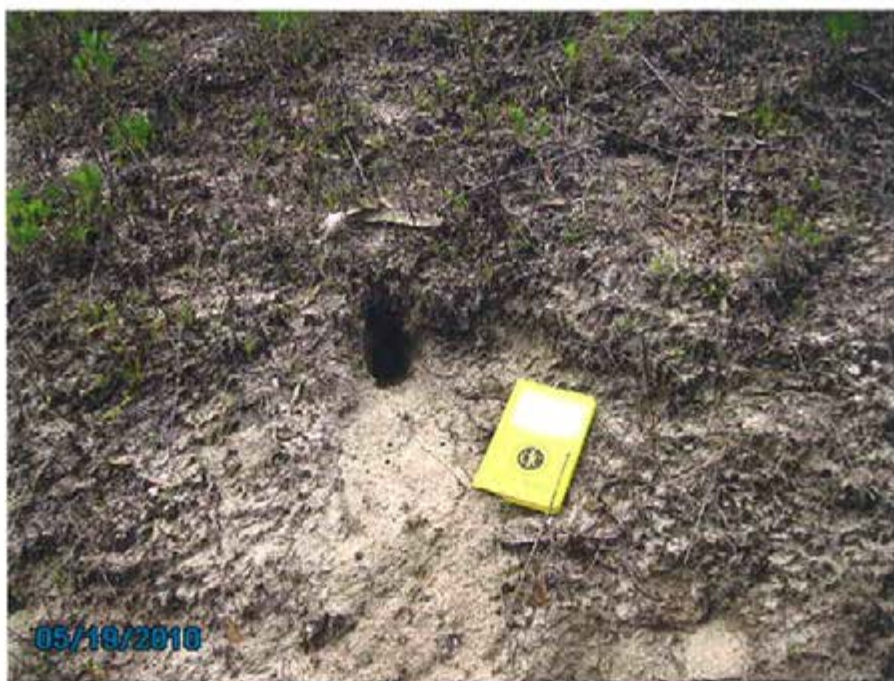
18. 1984 Ash Pond – View of animal burrow on the exterior slope for north dike (4" x 7" field book shown for scale).

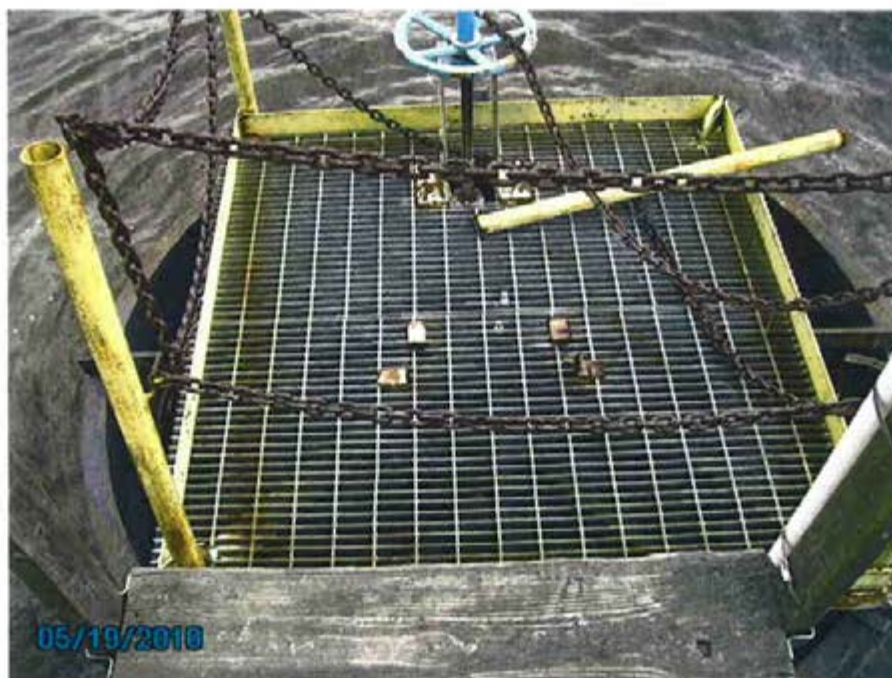
19. 1984 Ash Pond – View at top of platform mounted on skimmer for discharge structure.

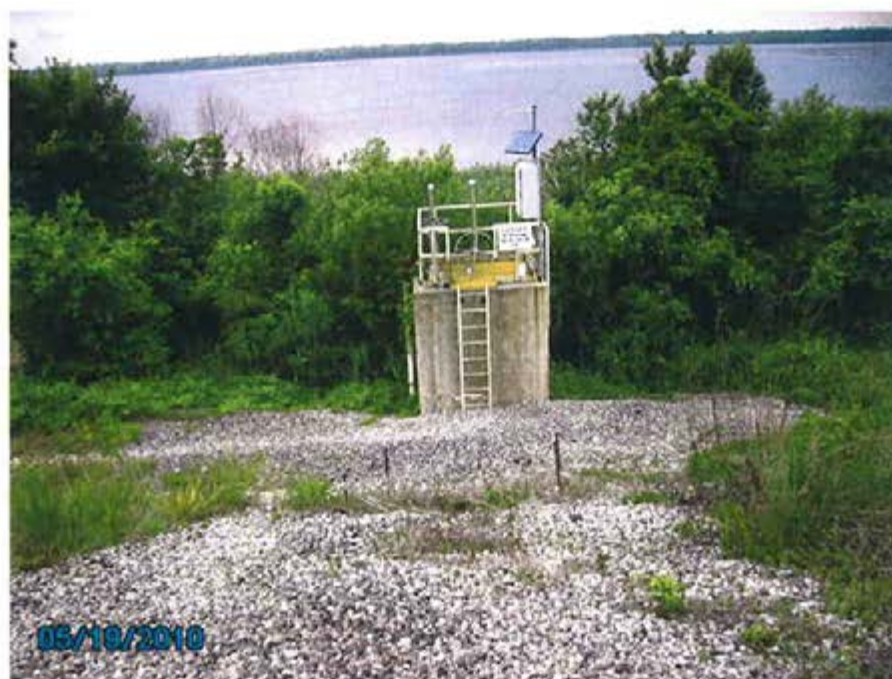
20. 1984 Ash Pond – View of discharge diversion structure at toe of west dike.

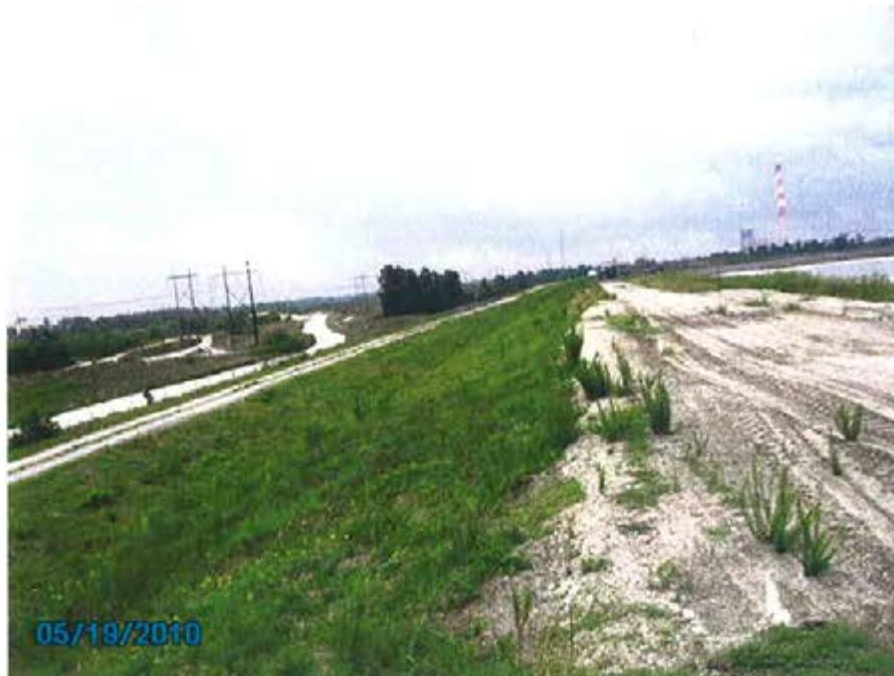
21. 1984 Ash Pond/Interior Storage – View of exterior slope for containment dike looking south.

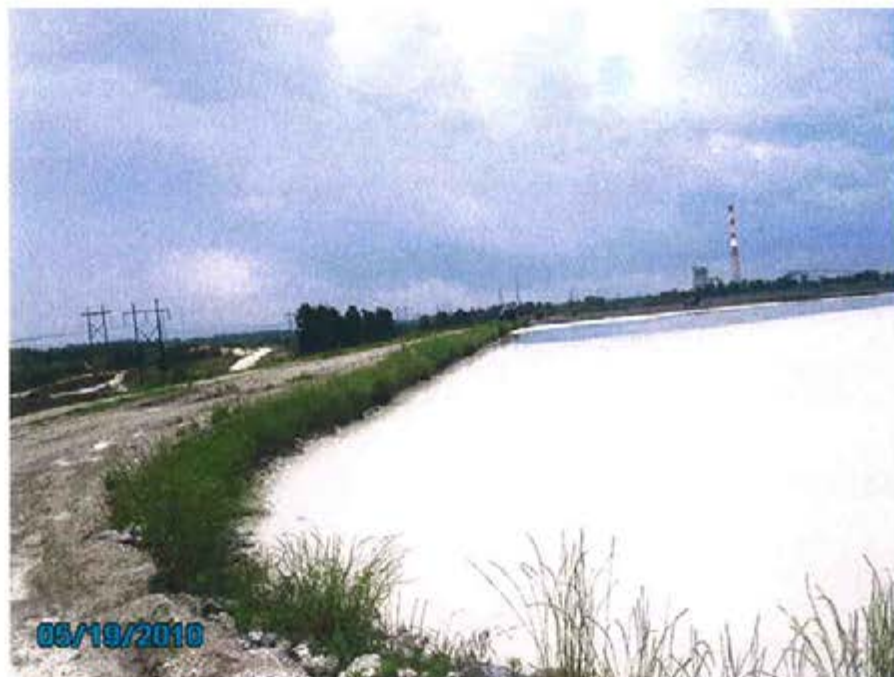
22. 1984 Ash Pond/Interior Storage – View of interior slope for containment dike looking south.

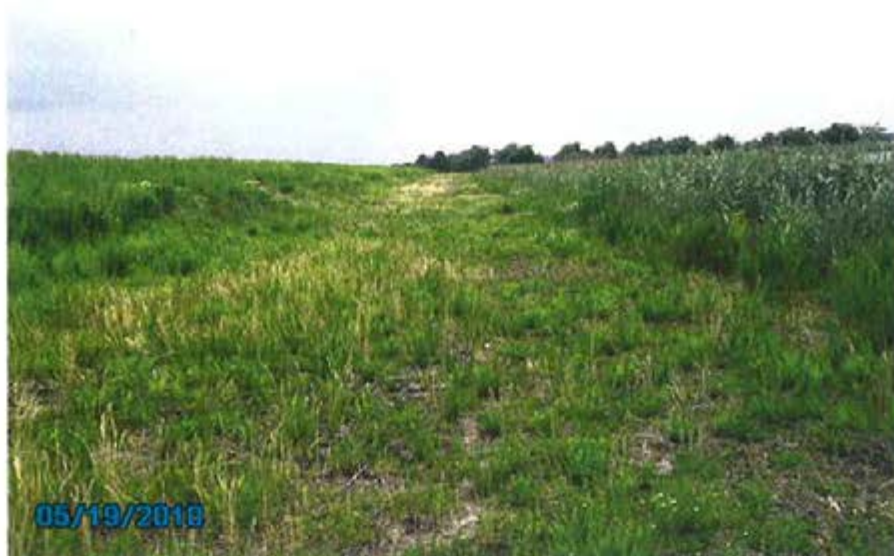
23. 1984 Ash Pond/Interior Storage – View of stability berm for containment dike looking west.

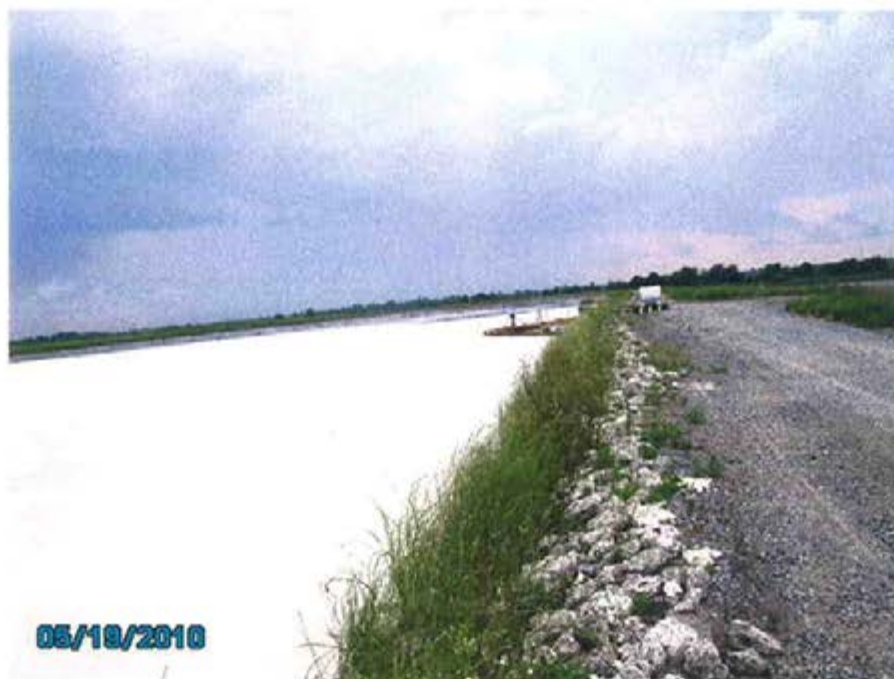
24. 1984 Ash Pond/Interior Storage – View of interior slope for containment dike and discharge structure looking west.

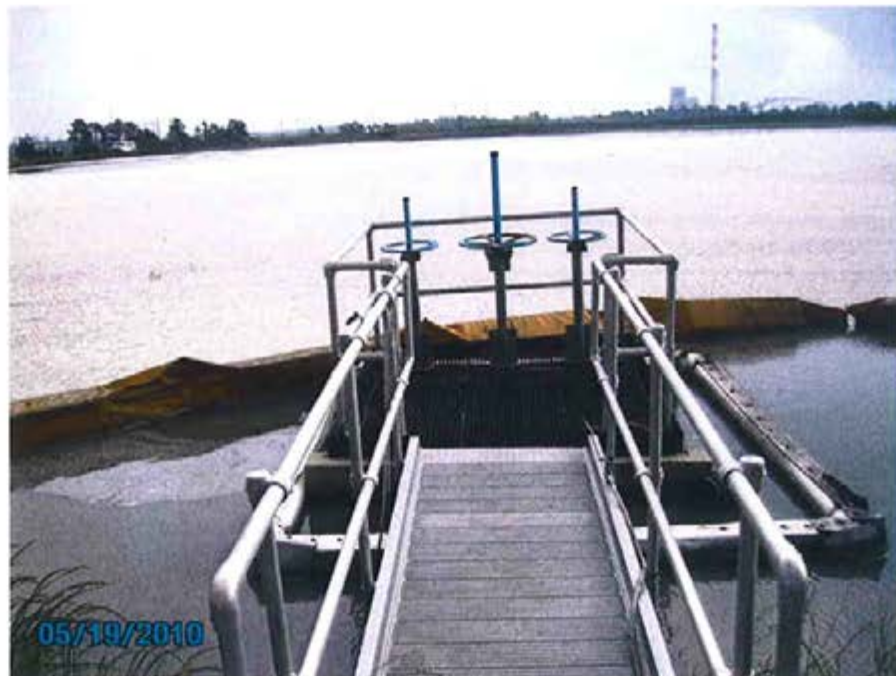
25. 1984 Ash Pond/Interior Storage – View of discharge structure from access platform.

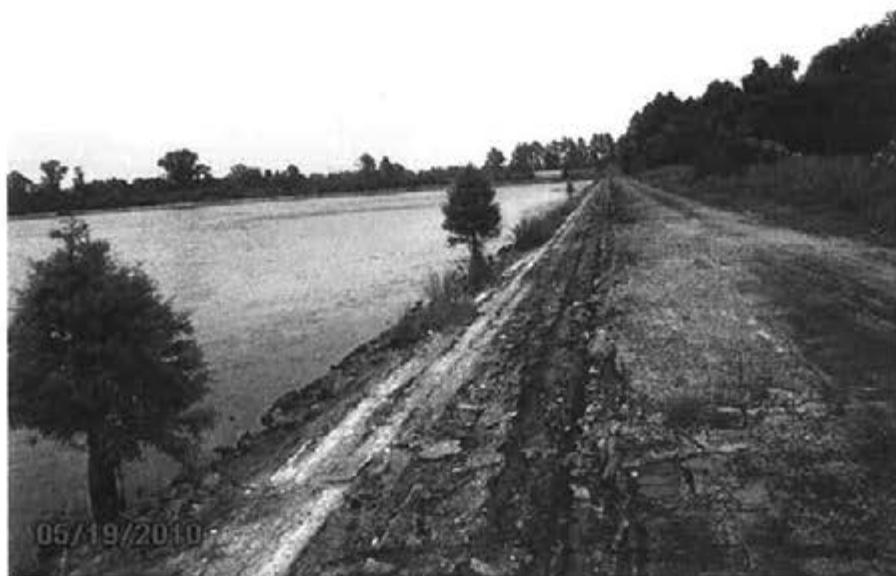
26. Cooling Pond – (Bay #1) View of crest and interior slope showing small trees growing at toe.

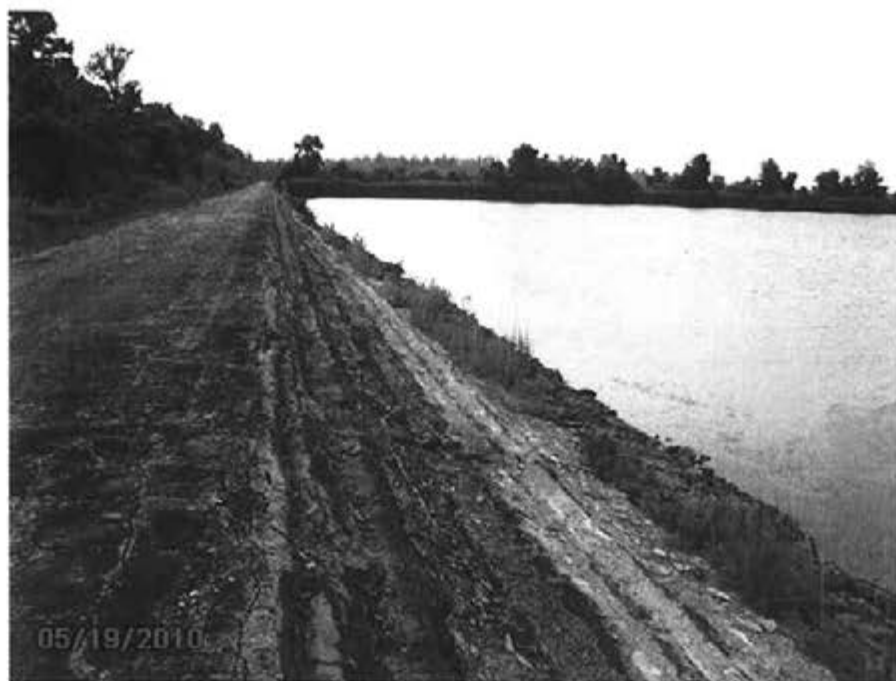
27. Cooling Pond – (Bay #1) View of crest and interior slope looking west.

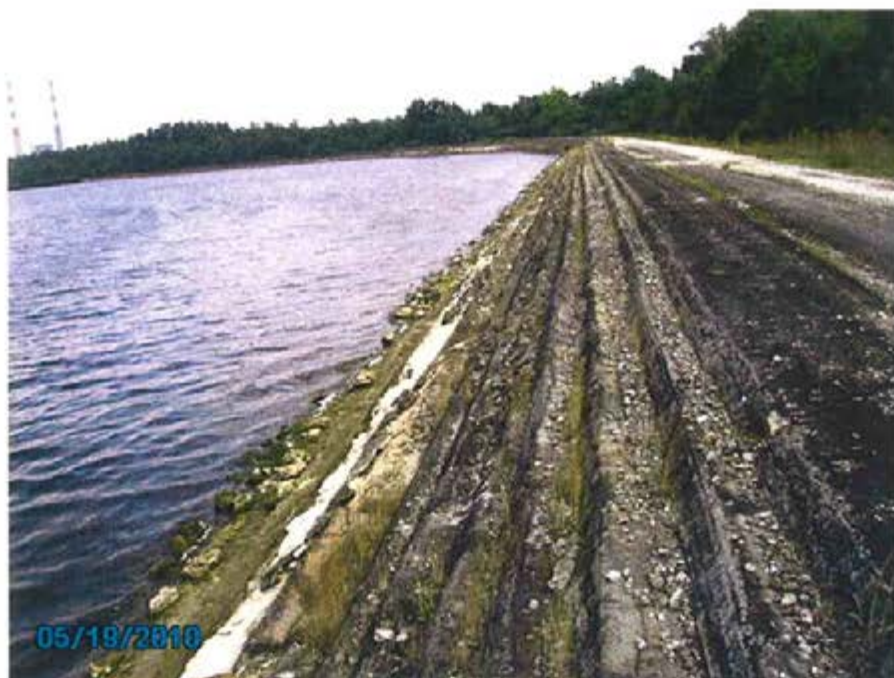
28. Cooling Pond – (Bay #2) View of crest and interior slope looking south.

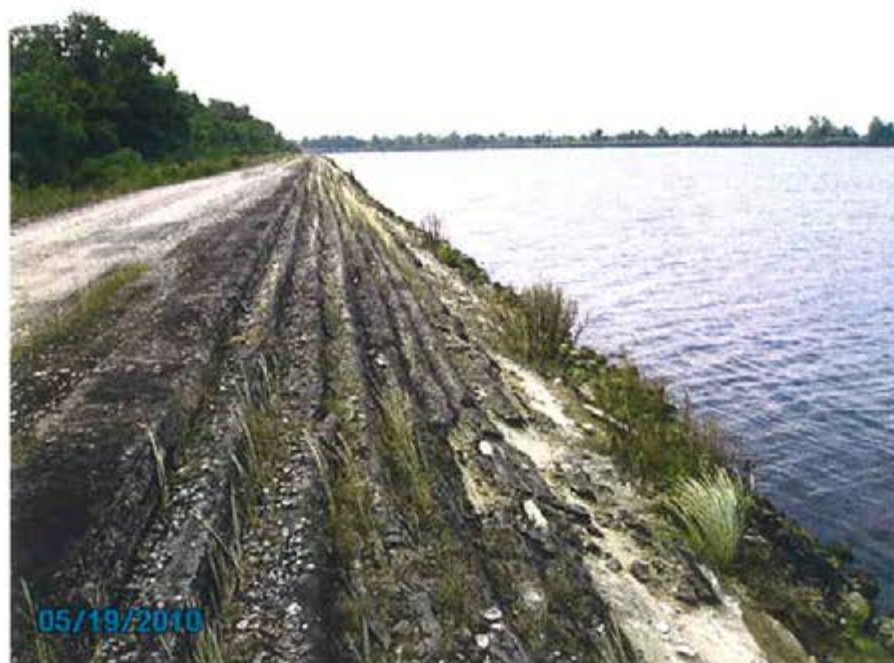
29. Cooling Pond – (Bay #2) View of crest and interior slope looking north.

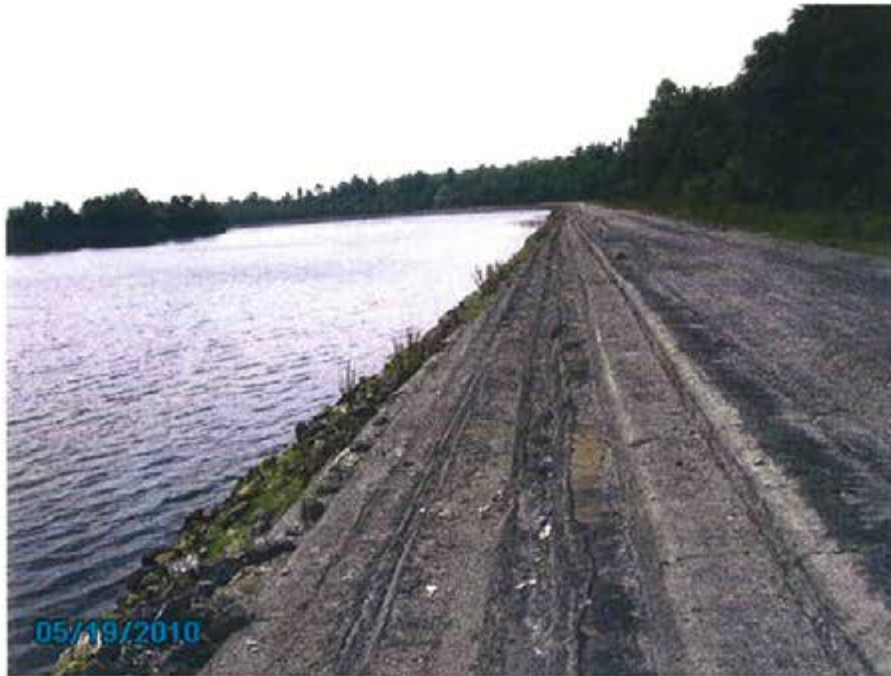
30. Cooling Pond – (Bay #3) View of crest and interior slope looking south.

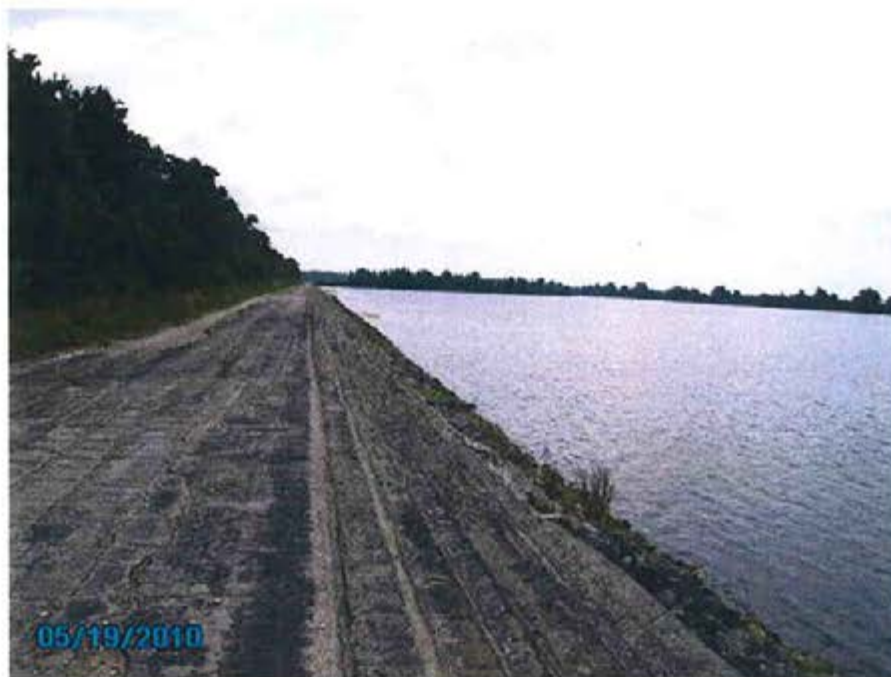
31. Cooling Pond – (Bay #3) View of crest and interior slope looking north.

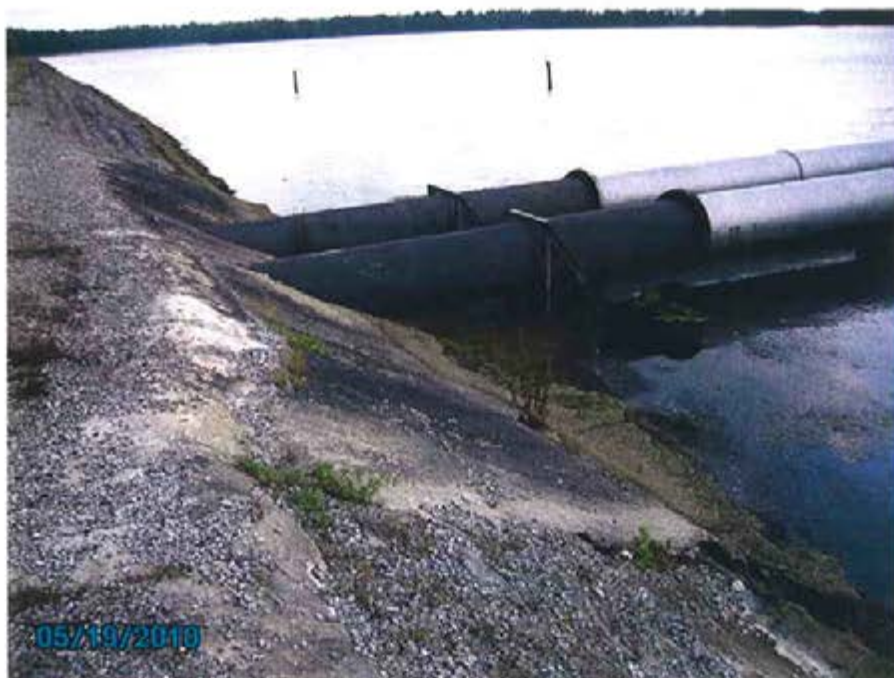
32. Cooling Pond – (Bay #4) View of makeup discharge pipes on upstream side of dike.

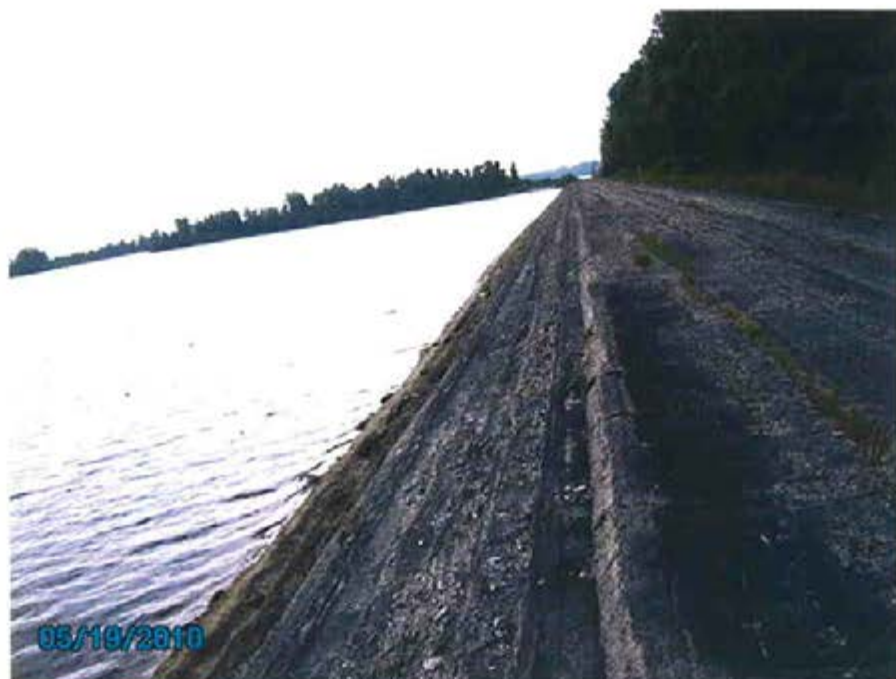
33. Cooling Pond – (Bay #4) View of crest and interior slope looking south.

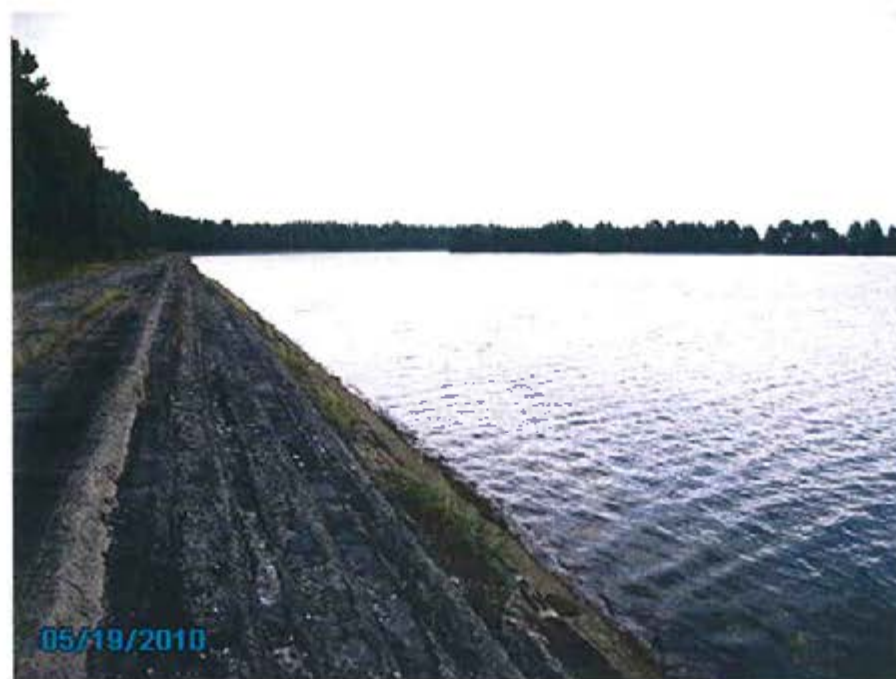
34. Cooling Pond – (Bay #4) View of crest and interior slope looking north.

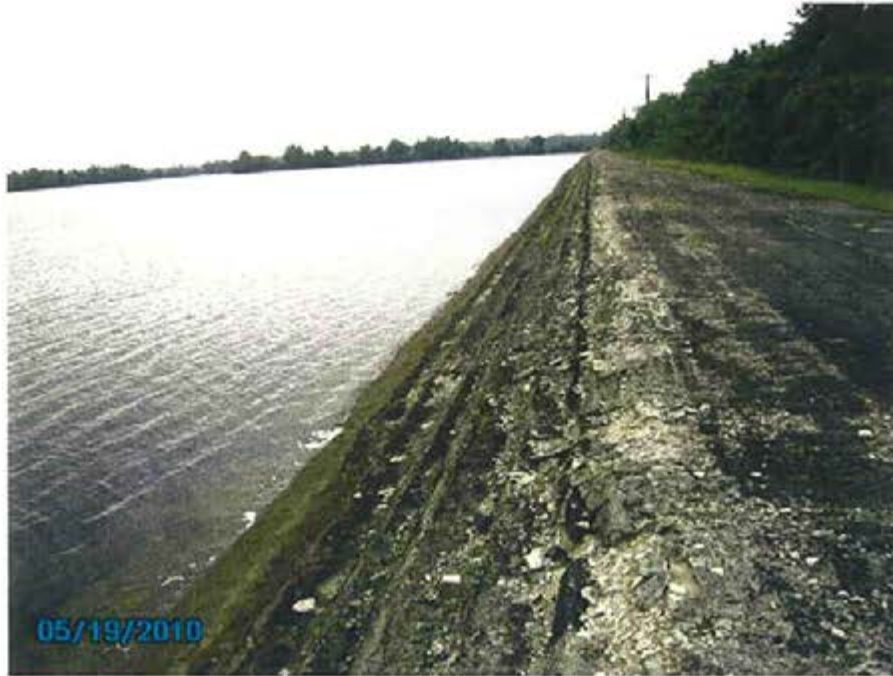
35. Cooling Pond – (Bay #5) View of crest and interior slope looking east.

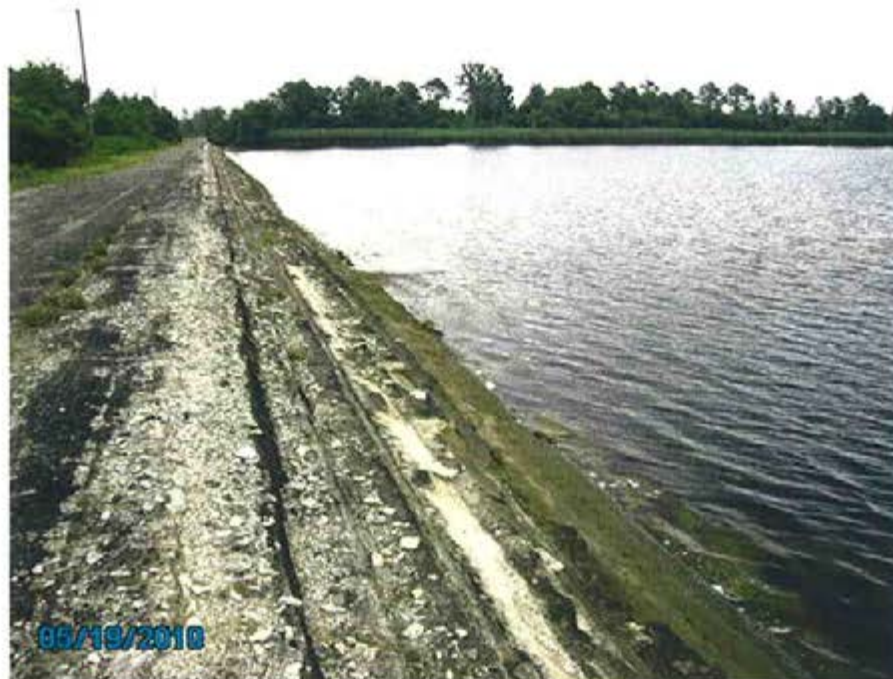
36. Cooling Pond – (Bay #5) View of crest and interior slope looking west.

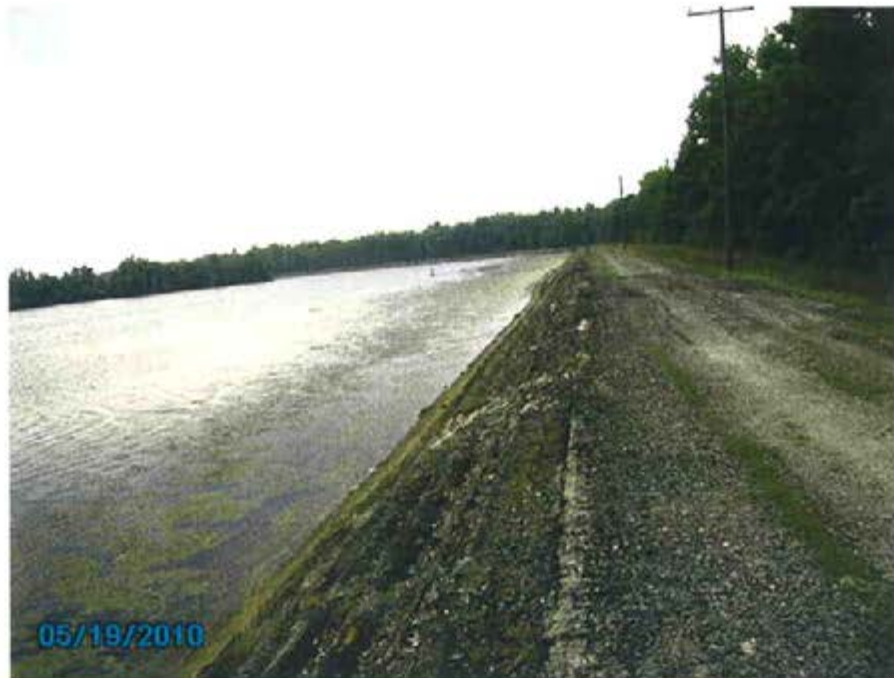
37. Cooling Pond – (Bay #6) View of crest and interior slope looking east.

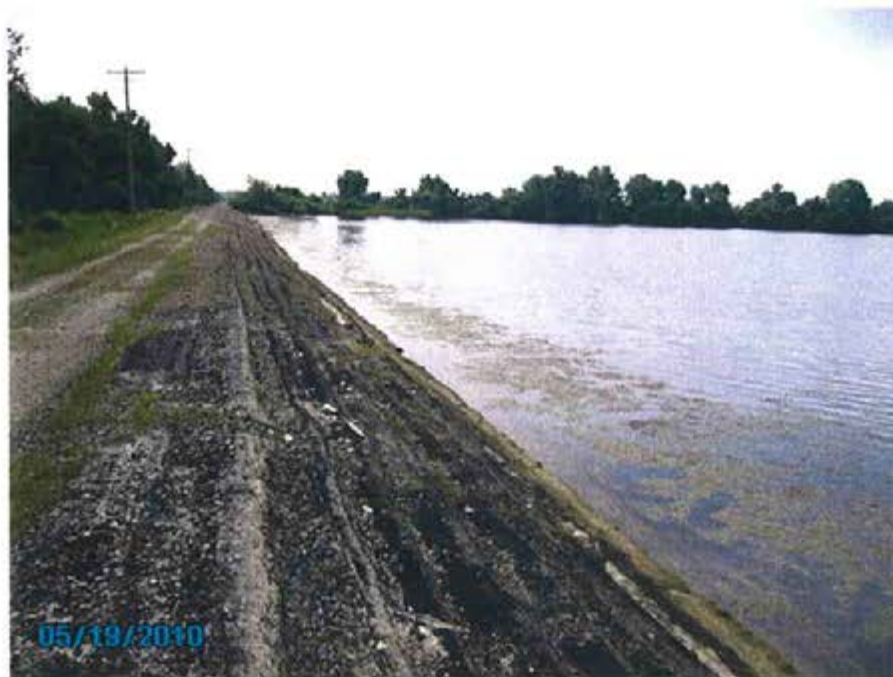
38. Cooling Pond – (Bay #6) View of crest and interior slope looking west.

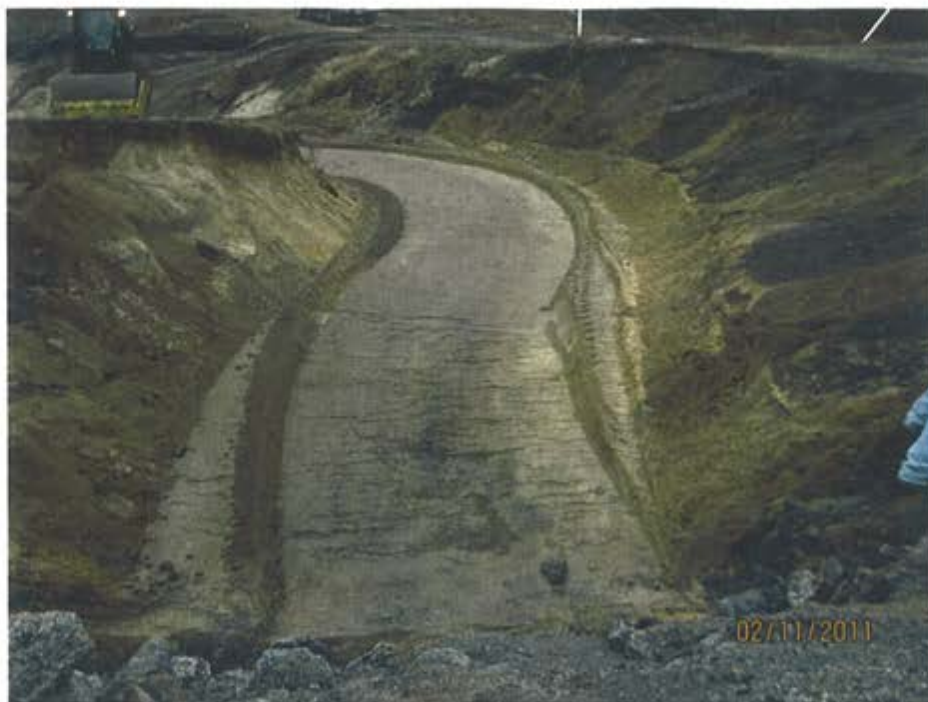
MACTEC Engineering and Consulting, Inc. (MACTEC) has provided engineering observation and construction testing services related to implementation of repairs to the small breach area in the 1985 Ash Pond Dike at the Sutton Plant. Emergency repairs in the breach area were made immediately after the breach, in September, 2010. Plans for a permanent repair were prepared by MACTEC under the engineering supervision of J. Allan Tice, P. E. and approved by the North Carolina Department of Environment and Natural Resources, Division of Land Resources (DLR) by letter dated January 21, 2011. This Completion Report summarizes construction activities and MACTEC's observations and testing results. Appendices contain results of laboratory and field tests. Two sets of Record Drawings and a Certificate of Completion are attached. This Completion Report and its attachments is to be submitted to DLR by Progress Energy.

Photo 1. Breach bottom area after initial preparation.

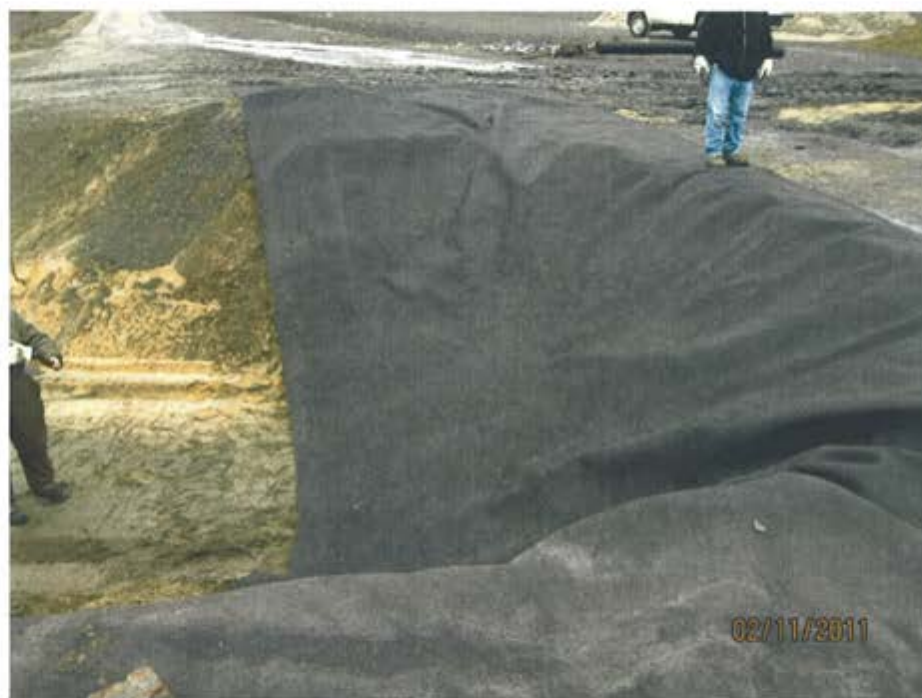
Photo 2. Placing geotextile across riprap face of emergency plug.

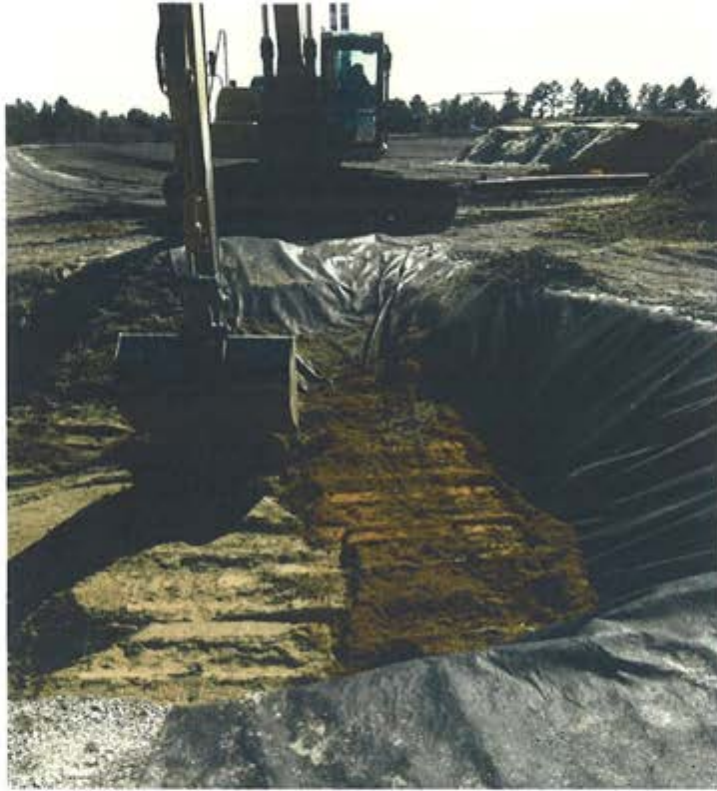
Photo 3. Sand and clay fill nearing top of repair zone.

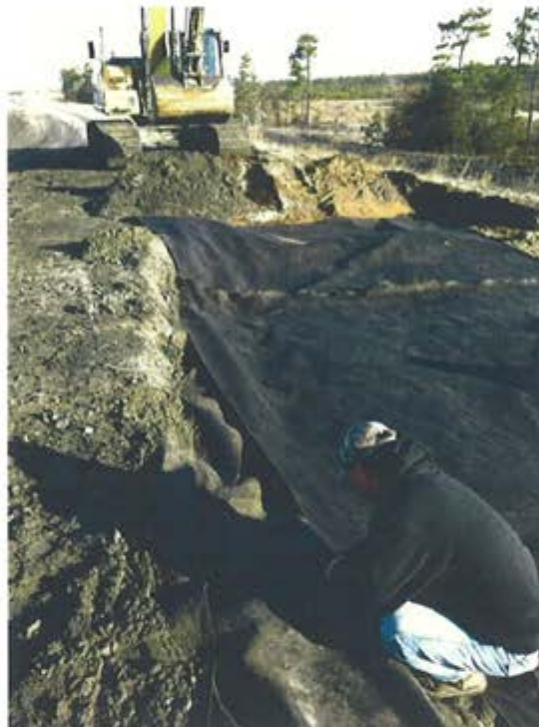
Photo 4. Placing geotextile in preparation for crest gravel.

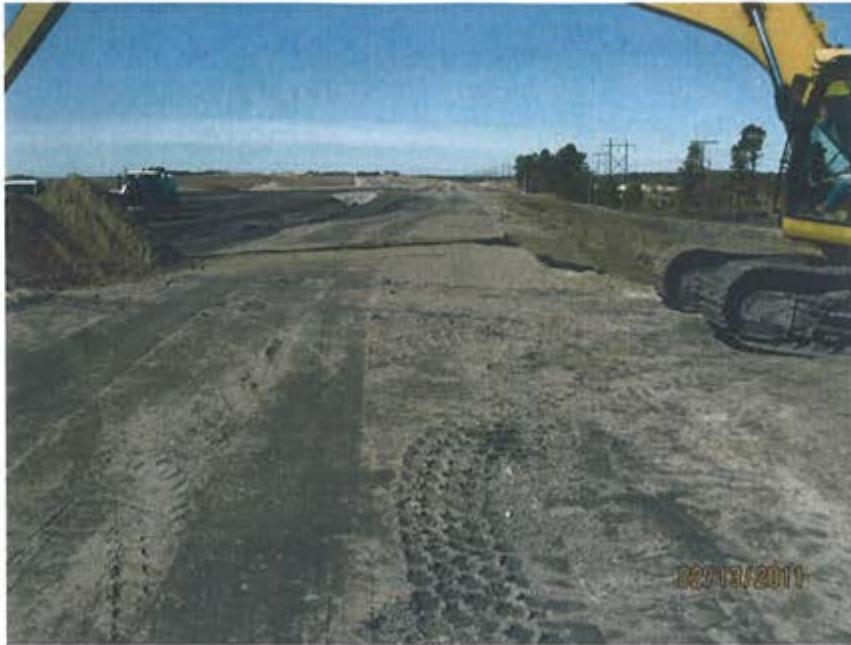
Photo 5. Crest at final grade.
