Assessment of Dam Safety of Coal Combustion Surface Impoundments

Cleco Corporation

Brame Energy Center

March 14, 2011

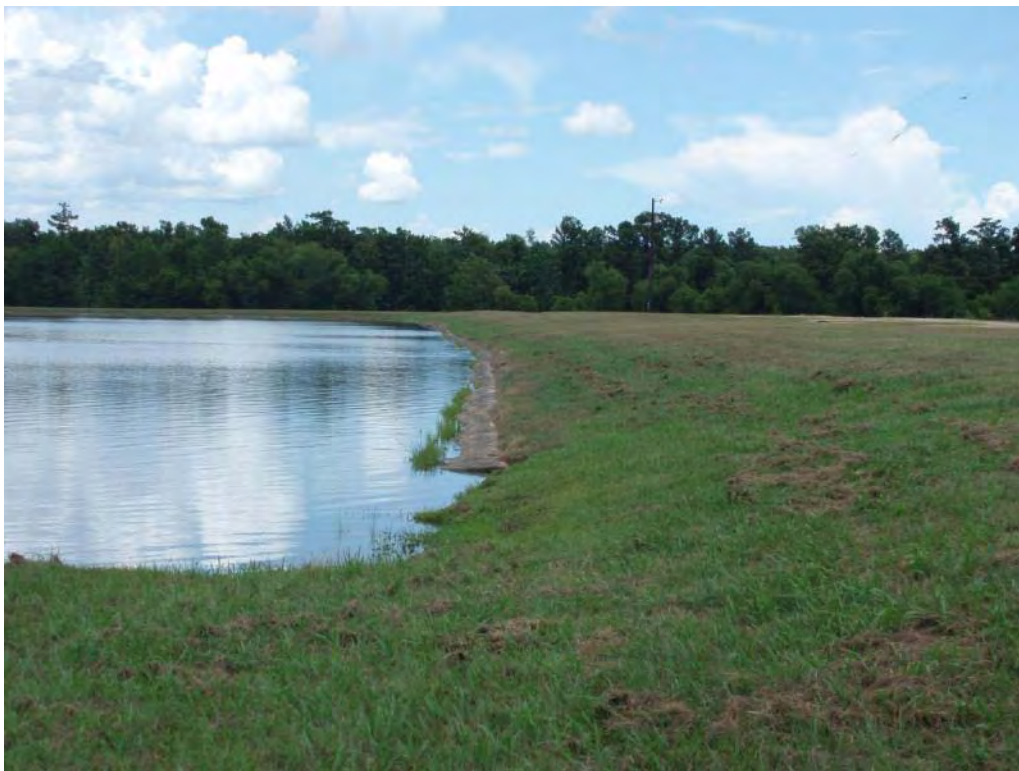
Photo No. 1: Bottom Ash Pond – East embankment interior slope from southeast corner, looking northeast.

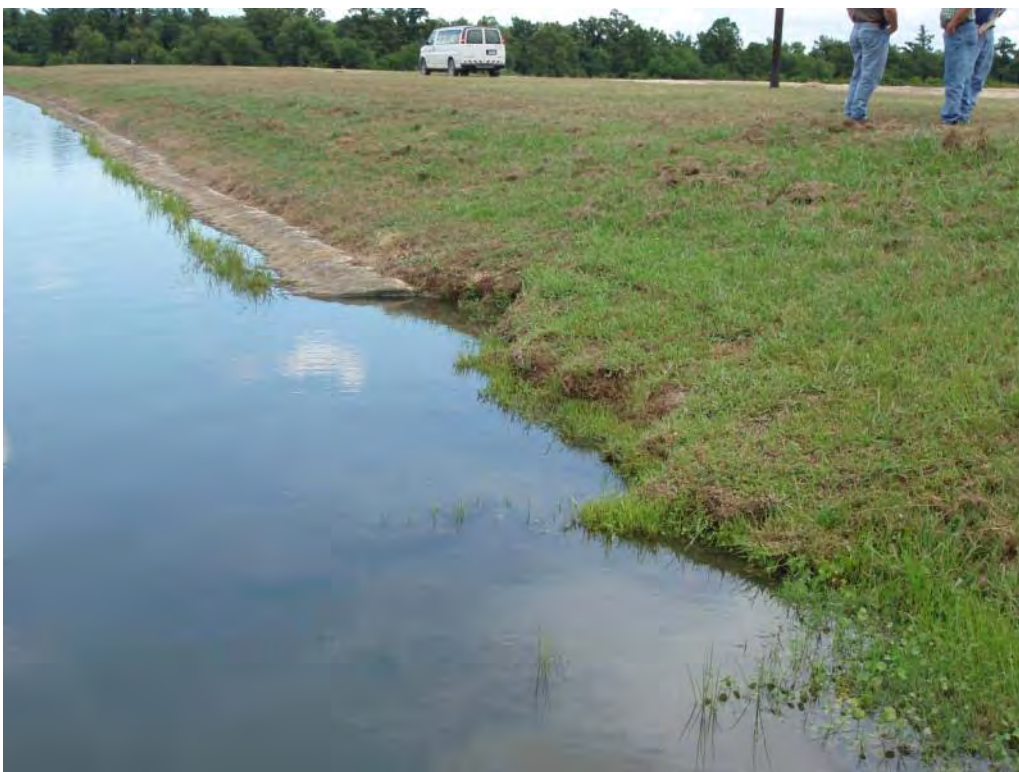
Photo No. 2: Bottom Ash Pond – East embankment interior slope from southeast corner, looking northeast.

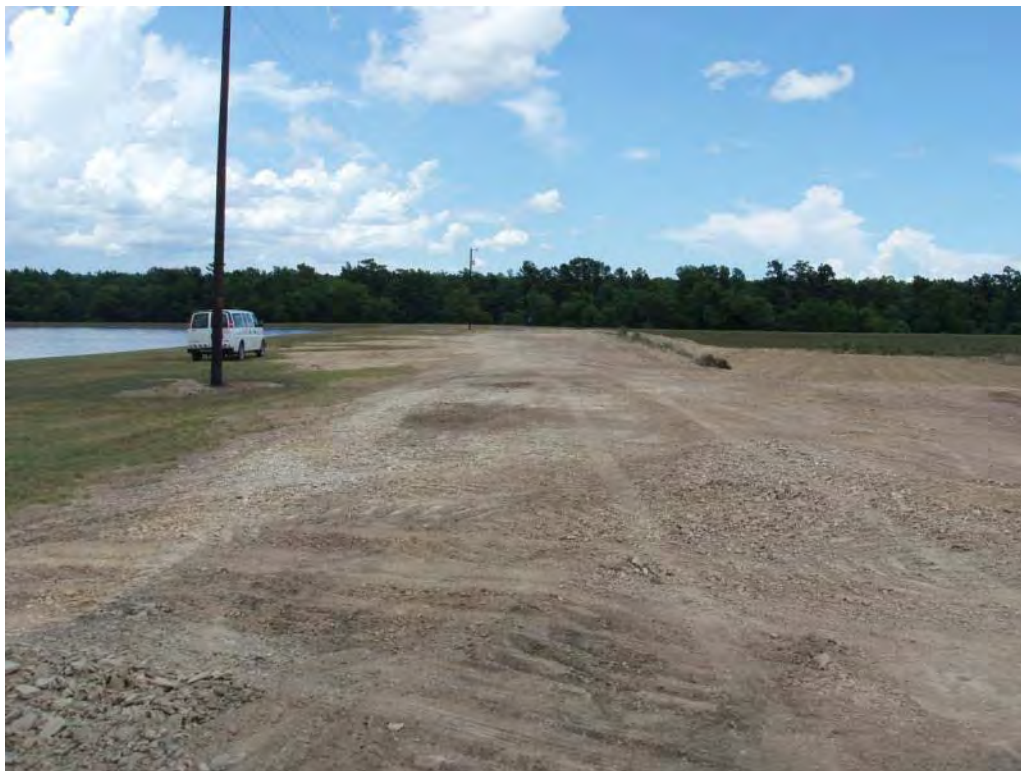
Photo No. 3: Fly Ash Pond - West embankment interior slope, looking northeast. Fill material covering slope.

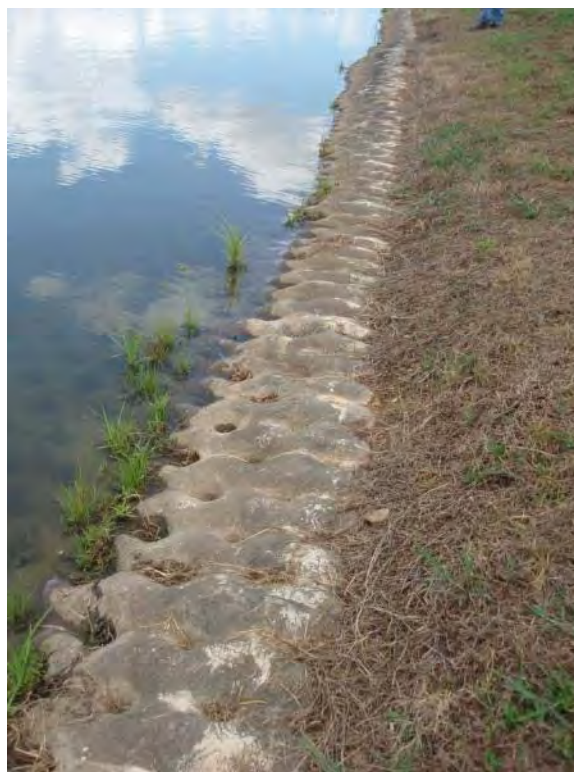
Photo No. 4: Bottom Ash Pond - East embankment interior slope, looking at typical concrete armor.

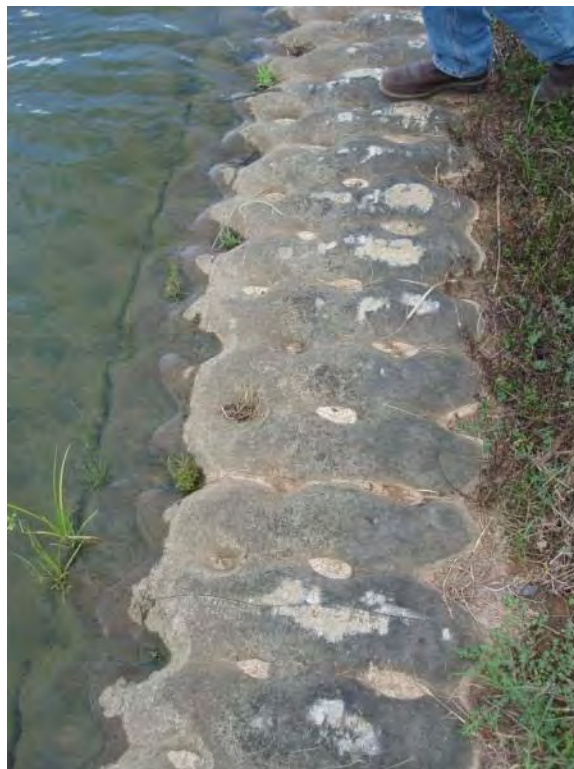
Photo No. 7: Bottom Ash Pond - East embankment interior slope, concrete armor.

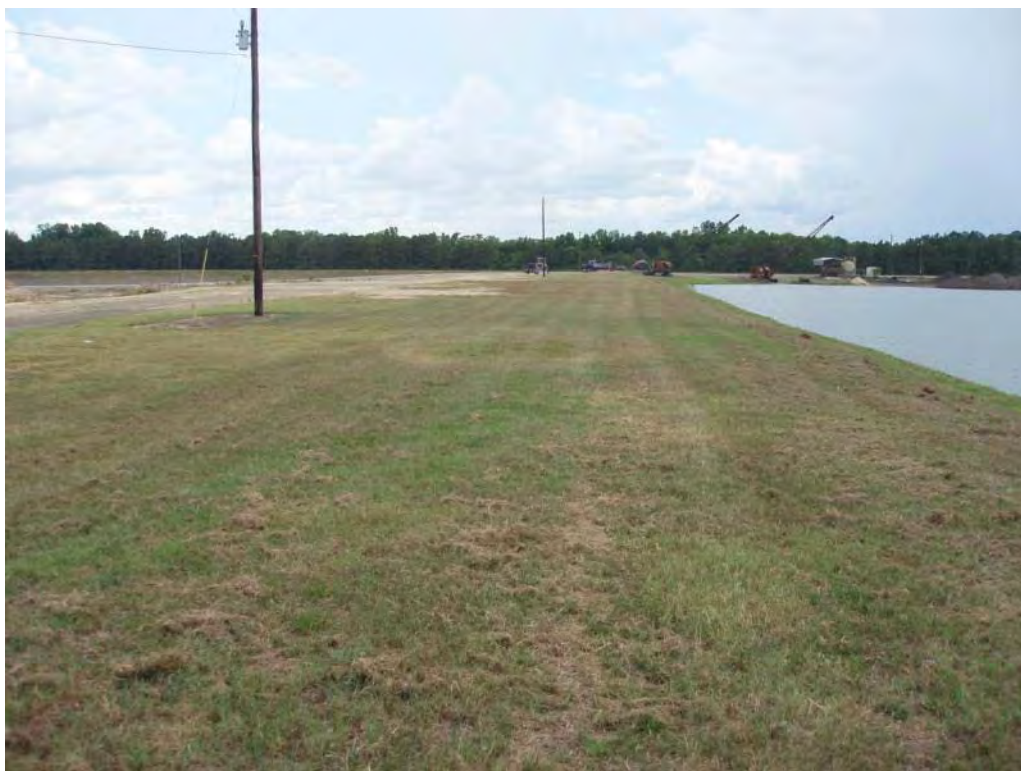
The east (divider) embankment exterior slope was covered with ash product and could not be observed (Photographs 9, 10 and 73). The south (divider) embankment exterior slope was backfilled with ash product hauled by trucks and deposited in the fly ash storage and could not be observed (Photograph 66).

Photo No. 9: Bottom Ash Pond - East embankment crest, looking southwest.

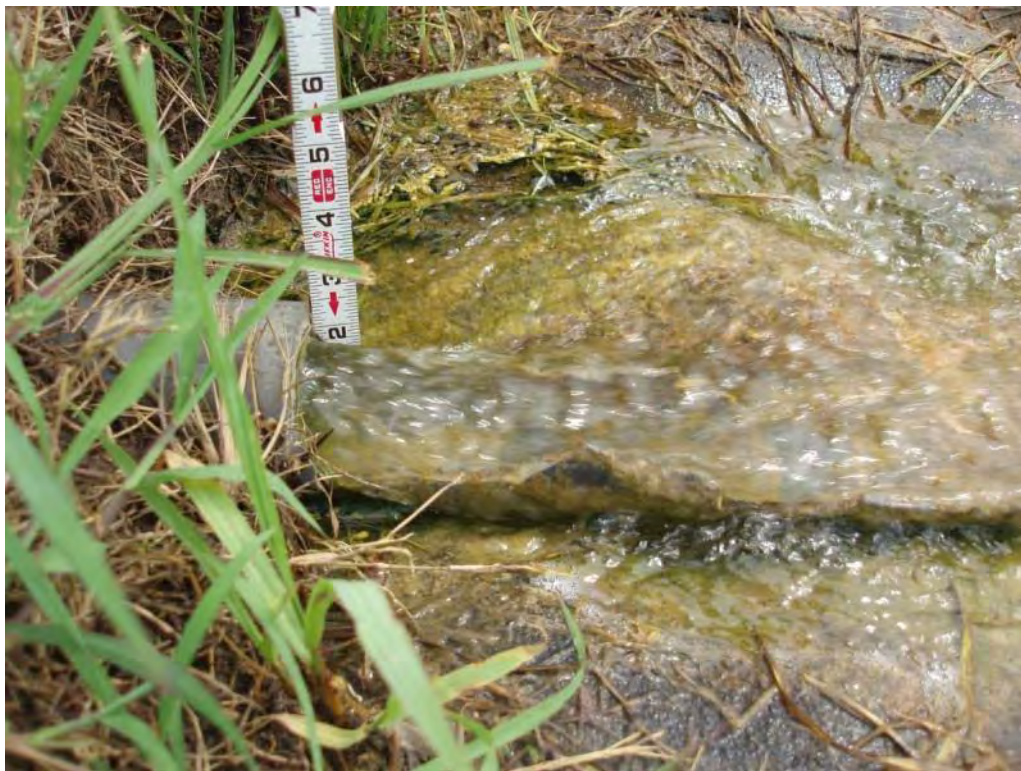
The outlet pipe in the Fly Ash Pond appears to be in good condition. Water is pumped from the Fly Ash Pond through a 4-inch-diameter HDPE pipe into the Bottom Ash Pond (Photographs 11, 73 and 131). The intake and outlet are free of debris.

Photo No. 11: Bottom Ash Pond - Inlet pipe from Fly Ash Pond on west embankment.

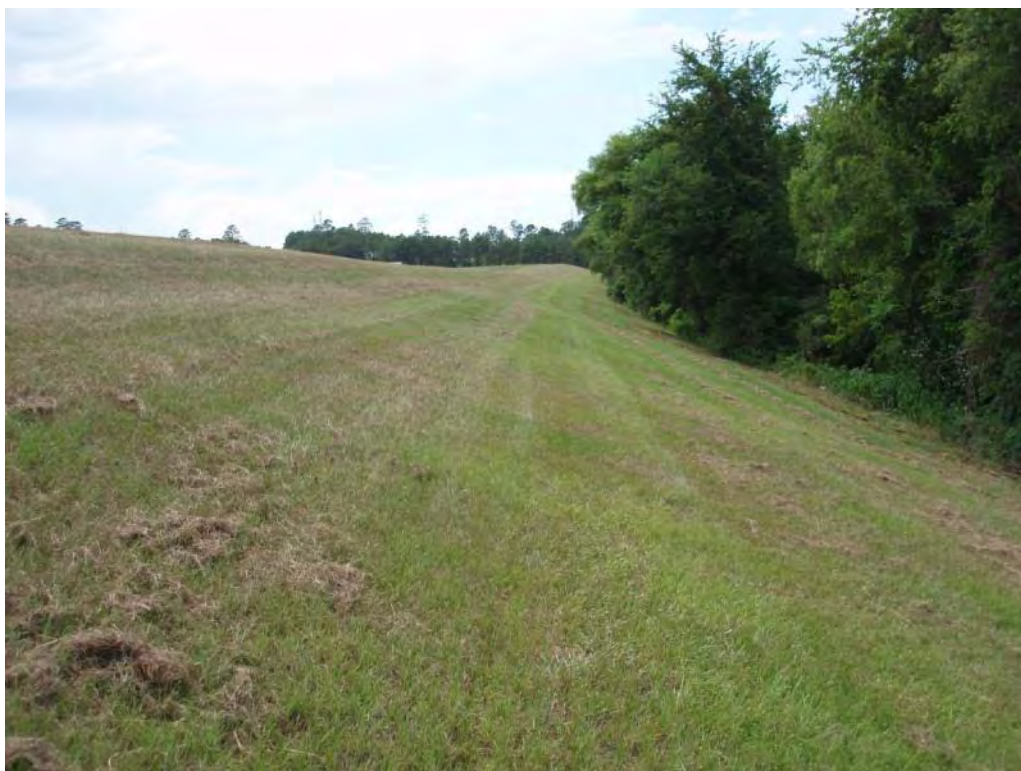
Photo No. 13: Bottom Ash Pond – North embankment exterior slope, looking northwest.

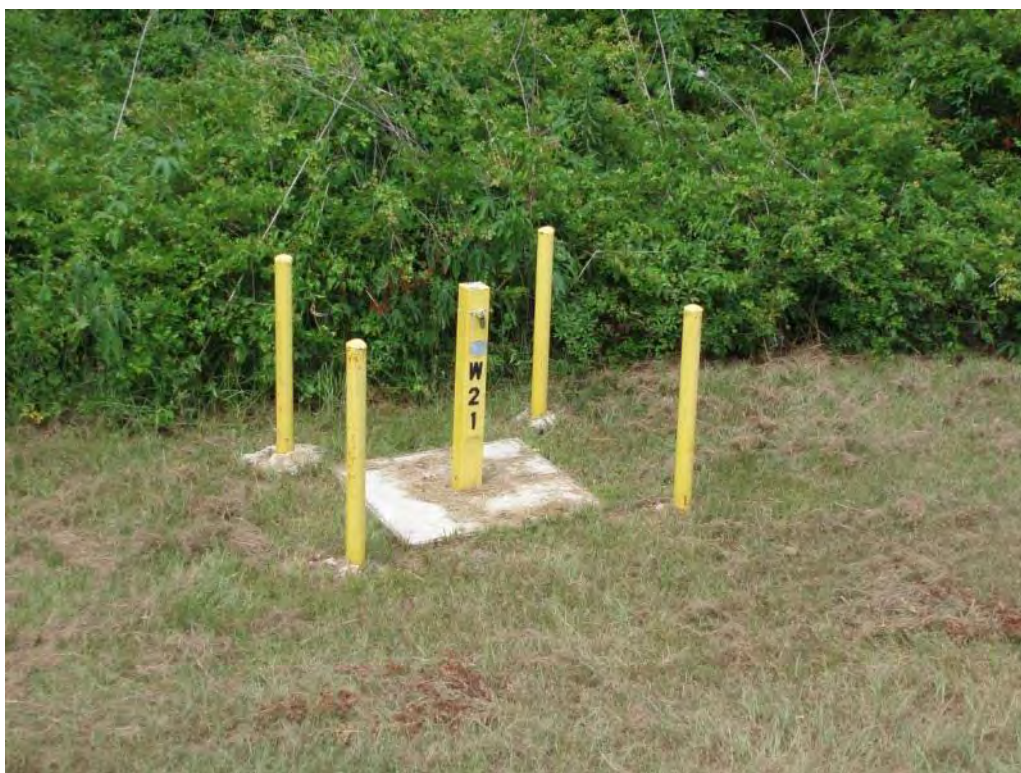
Photo No. 14: Monitoring Well W-21, located near Bottom Ash Pond northeast corner exterior toe.

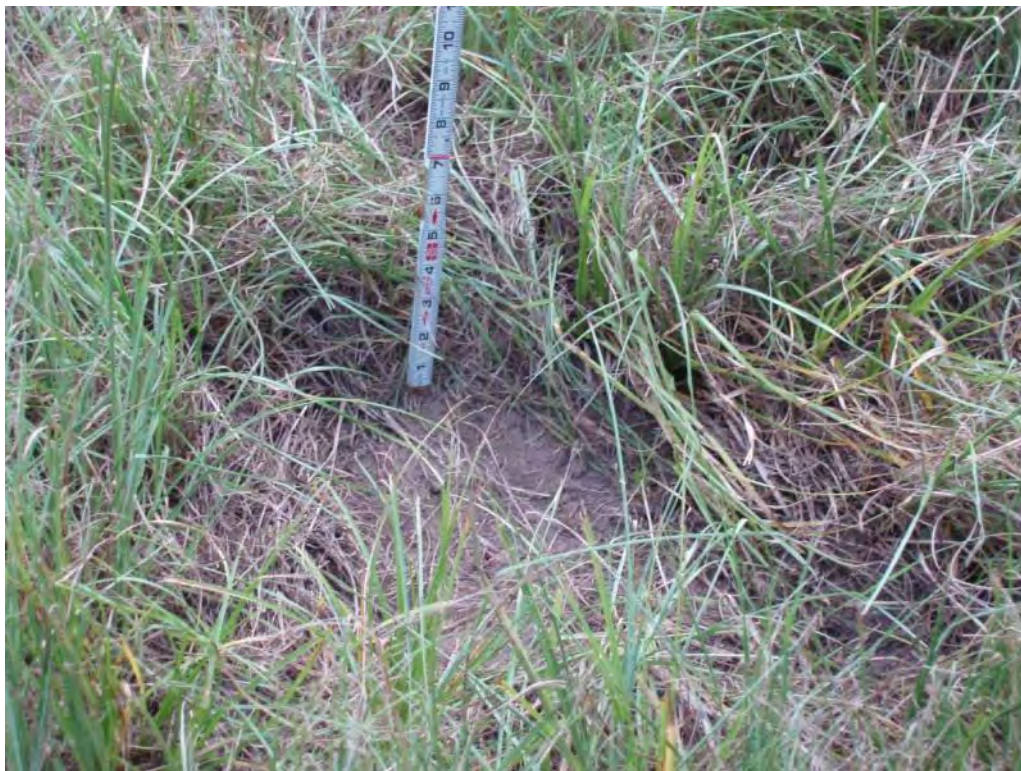
The embankment exterior slopes of the Bottom Ash Pond appeared to be in fair condition. The exterior slopes were approximately 4H:1V. The upper two-thirds of the north embankment exterior slope was generally covered with grass approximately 4 inches in height (Photographs 13, 14 and 35). The lower third of the north embankment slope, extending to the toe, was heavily vegetated with shrubs, brush and trees up to 18 inches in diameter (Photographs 20, 22, 25 and 42). Several rodent burrows were observed along the edge of the heavily vegetated area of the north embankment slope (Photographs 21 and 34). In addition, numerous holes up to 16 inches in depth and 4 inches in diameter were observed on the north embankment exterior slope, which Cleco personnel speculated was evidence of wild boar rooting (Photographs 15, 16, 23, 24, 34 and 37).

Photo No. 15: Bottom Ash Pond - North embankment exterior slope. 6"x6" area of bare soil.

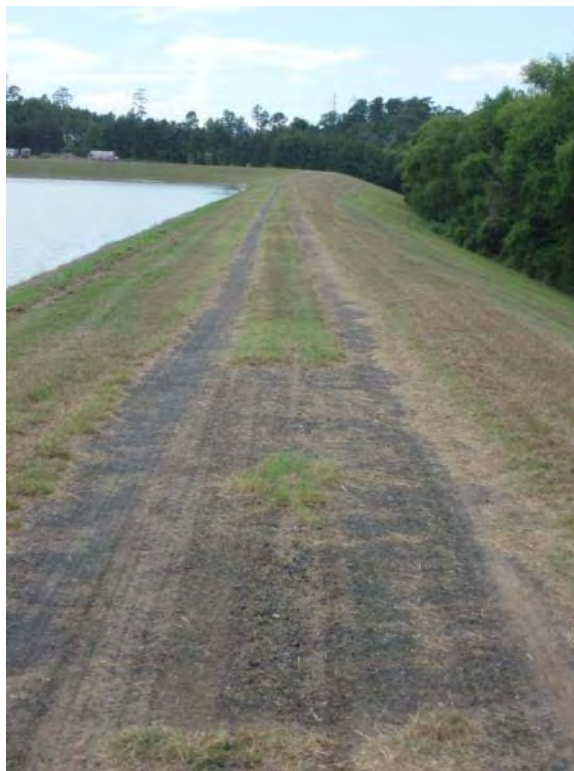
Photo No. 17: Bottom Ash Pond - North embankment crest, looking northwest.

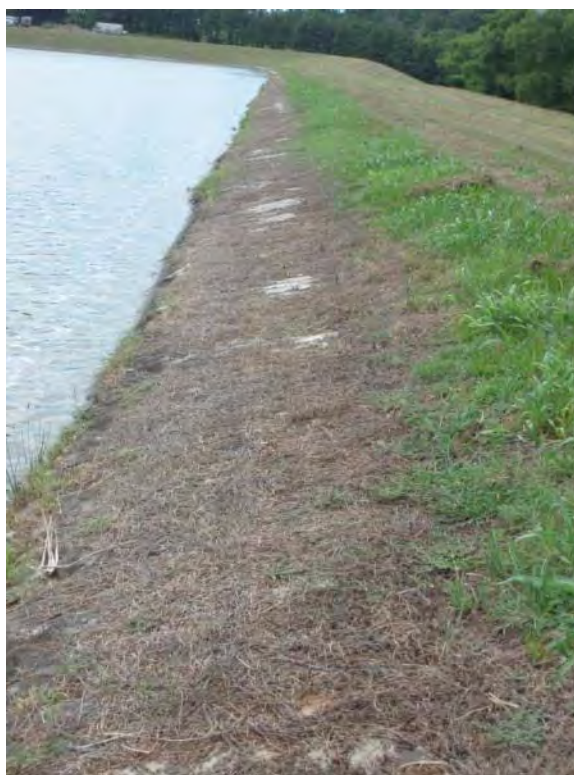
Photo No. 18: Bottom Ash Pond - North embankment interior slope, looking northwest.

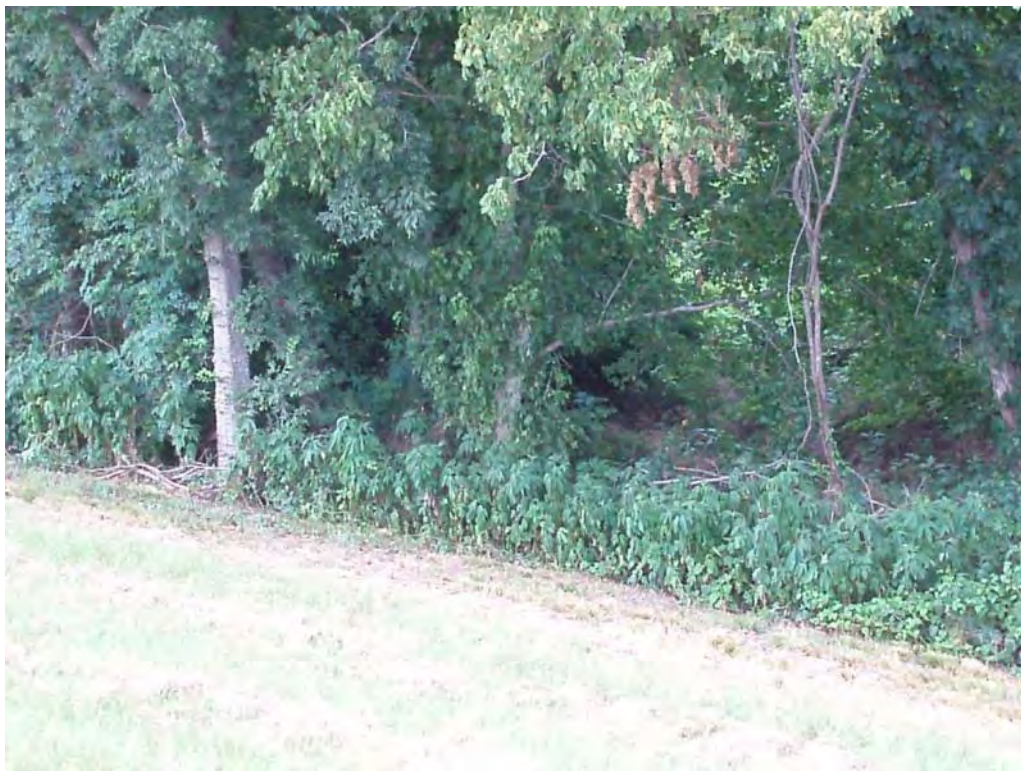
Photo No. 19: Bottom Ash Pond - North embankment exterior slope, looking north. Note vegetation growing on bottom of slope.

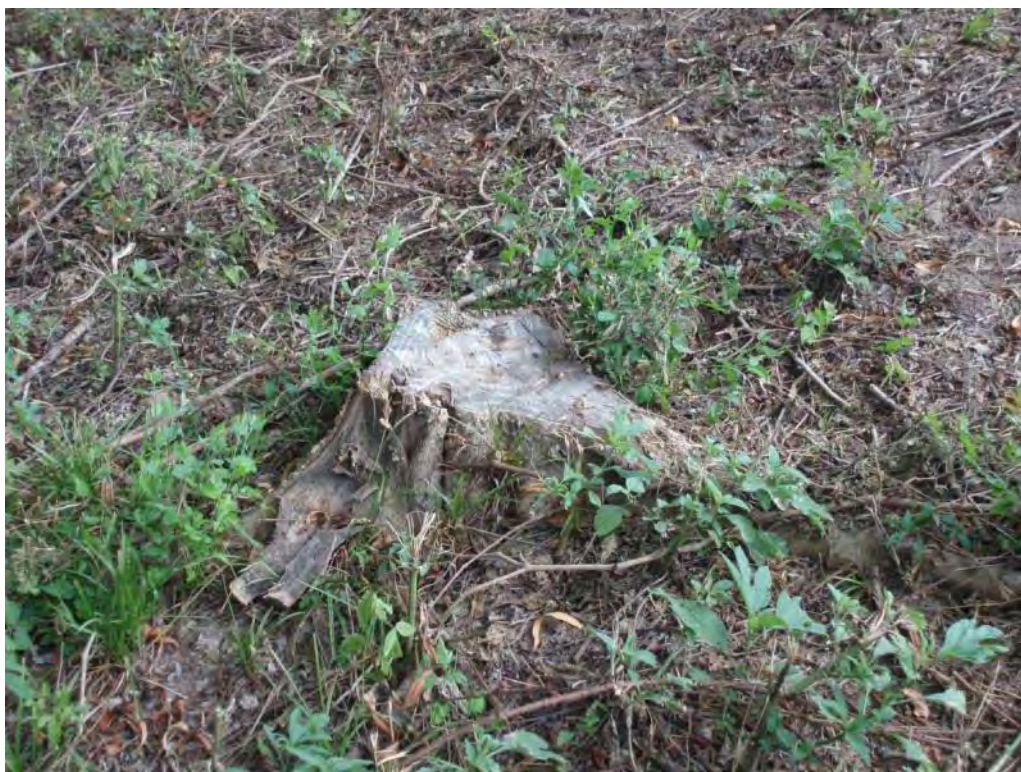
Photo No. 20: Bottom Ash Pond - North embankment exterior slope. Tree stump located on slope.

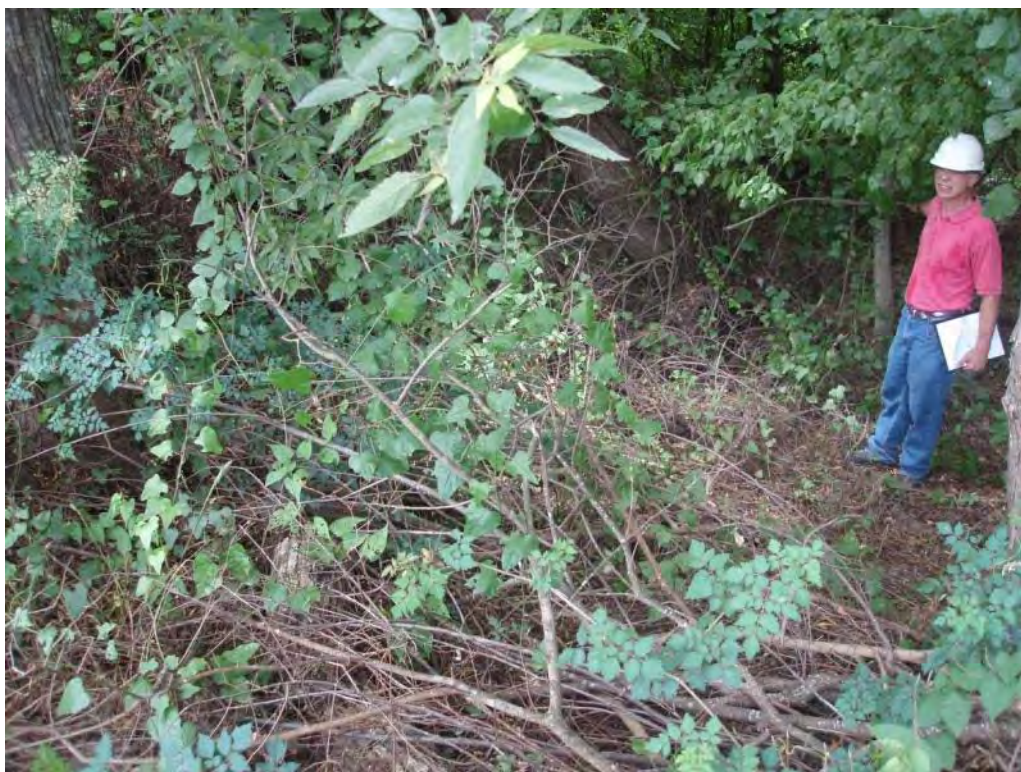
Photo No. 22: Bottom Ash Pond - North embankment exterior slope. Vegetation growing on bottom of slope.

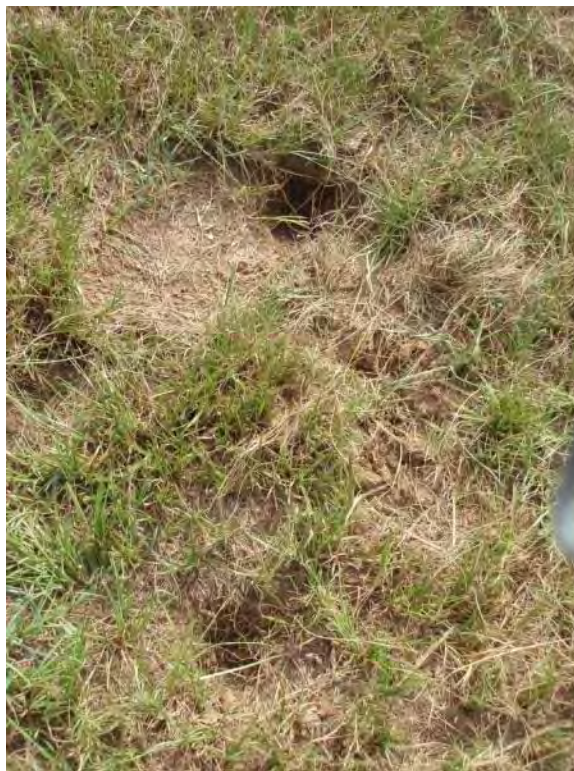
Photo No. 23: Bottom Ash Pond - North embankment exterior slope. Looking at two areas of animal burrowing/rooting.

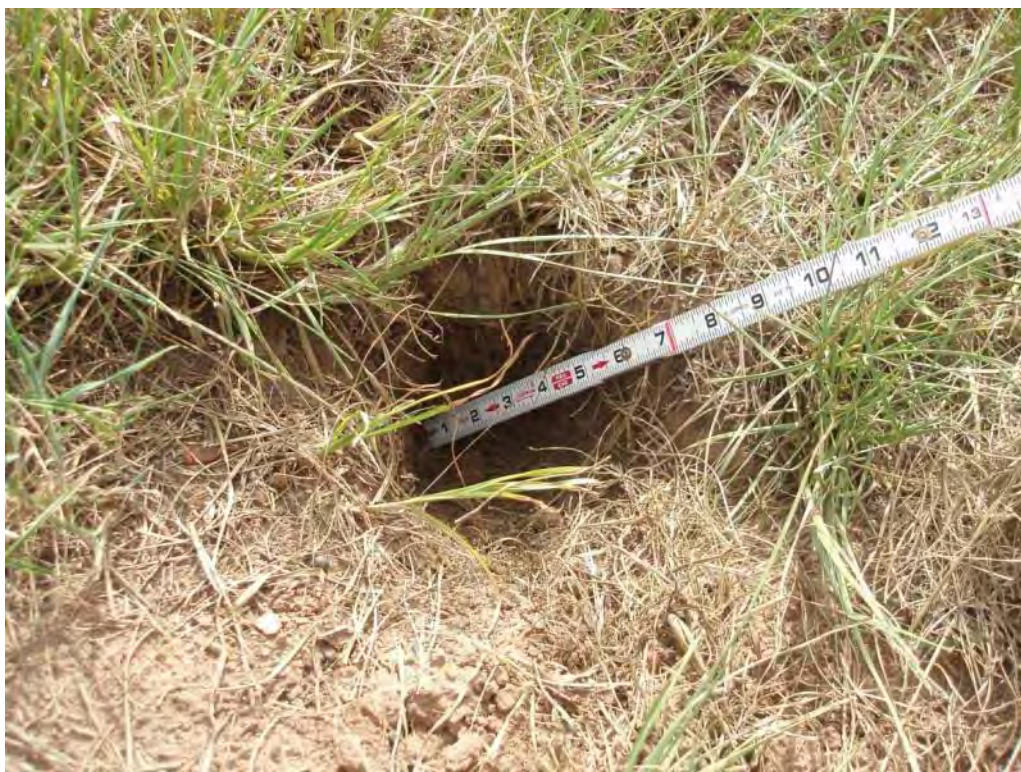
Photo No. 24: Bottom Ash Pond - North embankment exterior slope. Looking at 3-inch-diameter, 6-inch-deep animal burrow hole.

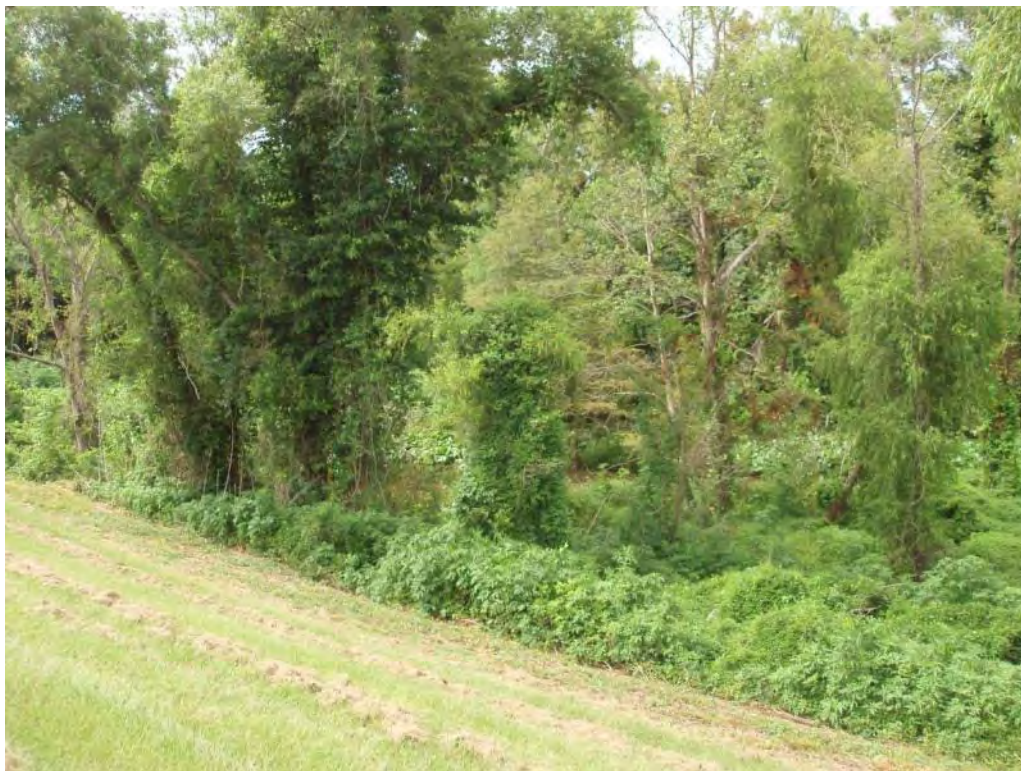
Photo No. 25: Bottom Ash Pond - North embankment exterior slope, looking north. Standing water near toe.

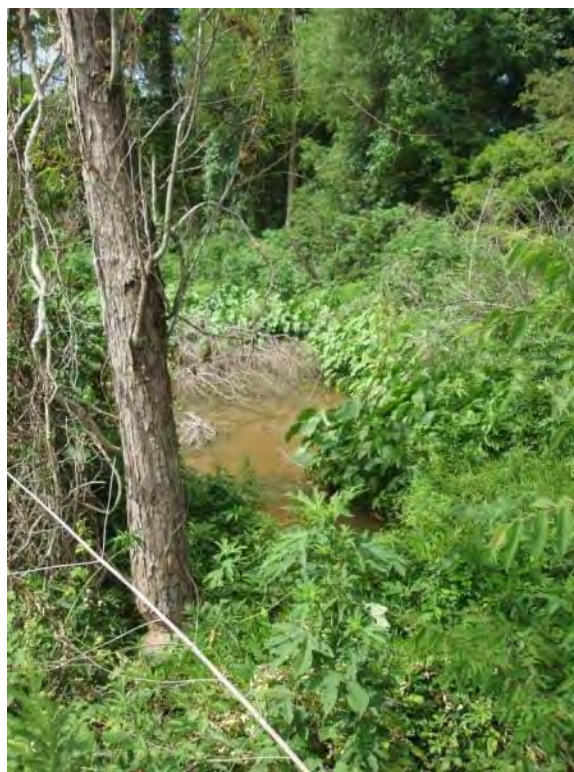
Evidence of beavers was observed along the base of the north embankment exterior slope, including numerous tree cuttings (Photographs 26, 27 and 28). An area of ponded water was observed which extended more than 300 feet along the toe of the exterior slope of the north embankment (Photographs 28, 30 and 31). Although not observed due to the depth of the water and the dense vegetation, it was presumed that beavers had constructed a dam on a small stream that runs parallel to the embankment. The presence of heavy vegetation precluded observation of erosion features, additional animal burrows, or seepage on the lower third of the exterior slope of the north embankment.

Photo No. 26: Bottom Ash Pond - North embankment exterior toe, looking north. Standing water at toe. Note beaver activity on tree in foreground.

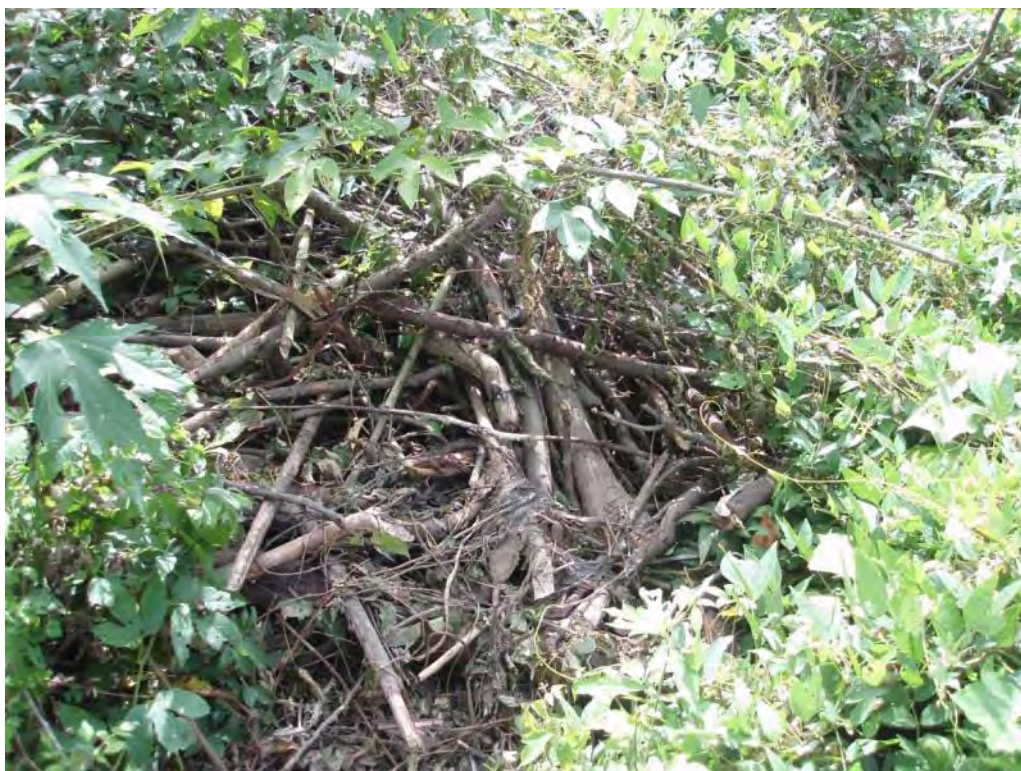
Photo No. 27: Bottom Ash Pond – North embankment exterior toe, looking southwest.
Possible beaver dam activity.

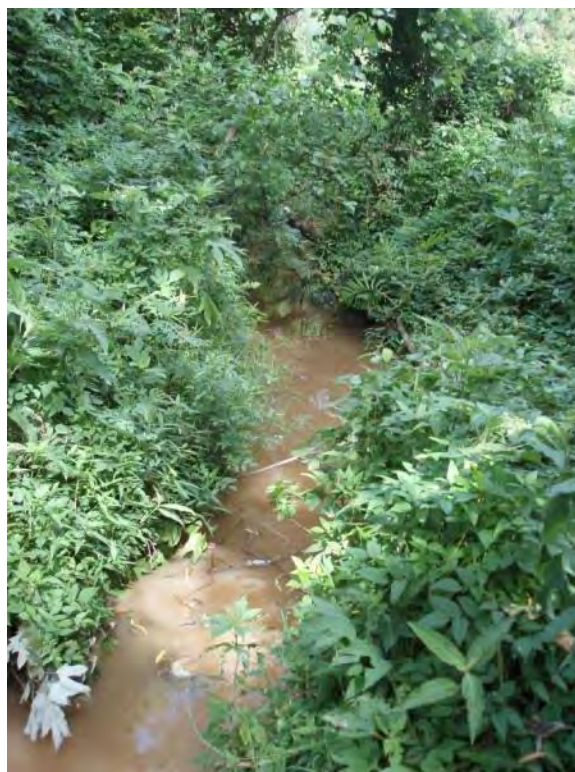
Photo No. 30: Bottom Ash Pond - North of north embankment toe, looking southeast.
Looking at standing water or drainage ditch.

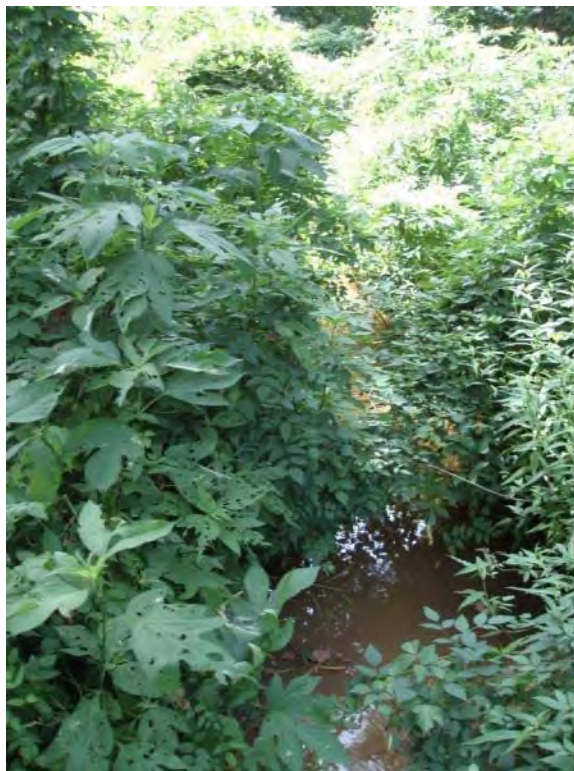
Photo No. 31: Bottom Ash Pond - North of north embankment toe, looking northwest.
Looking at standing water or drainage ditch.

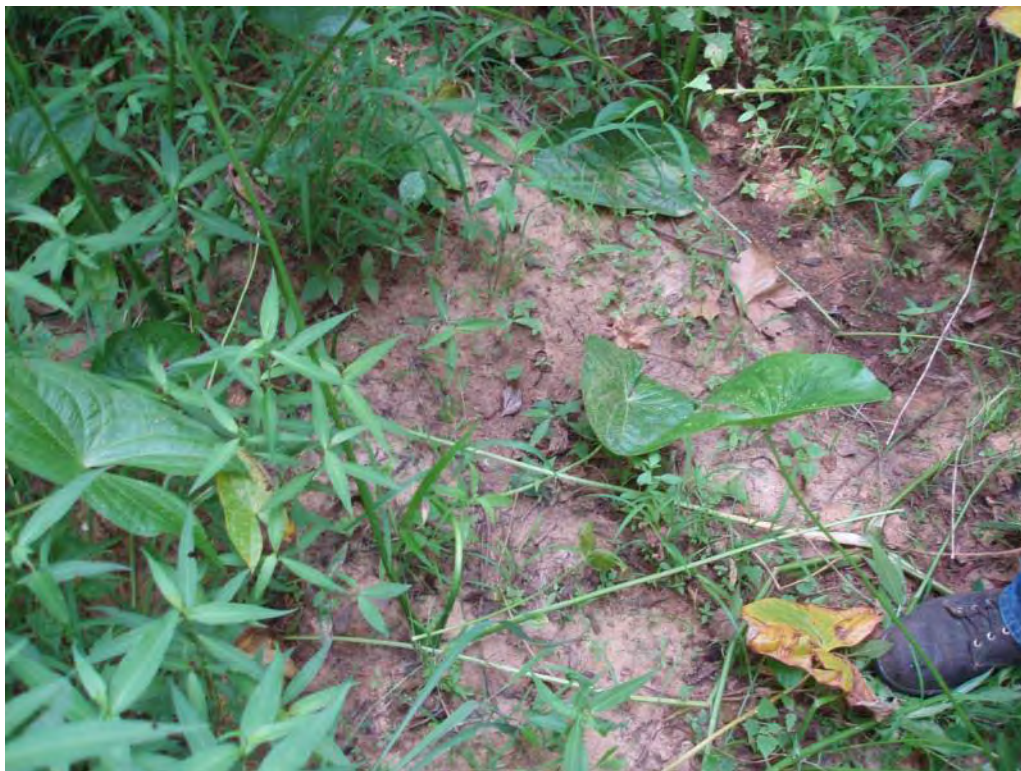
Photo No. 33: Bottom Ash Pond – North of north embankment toe, looking at damp area of soil approximately 4'x3'.

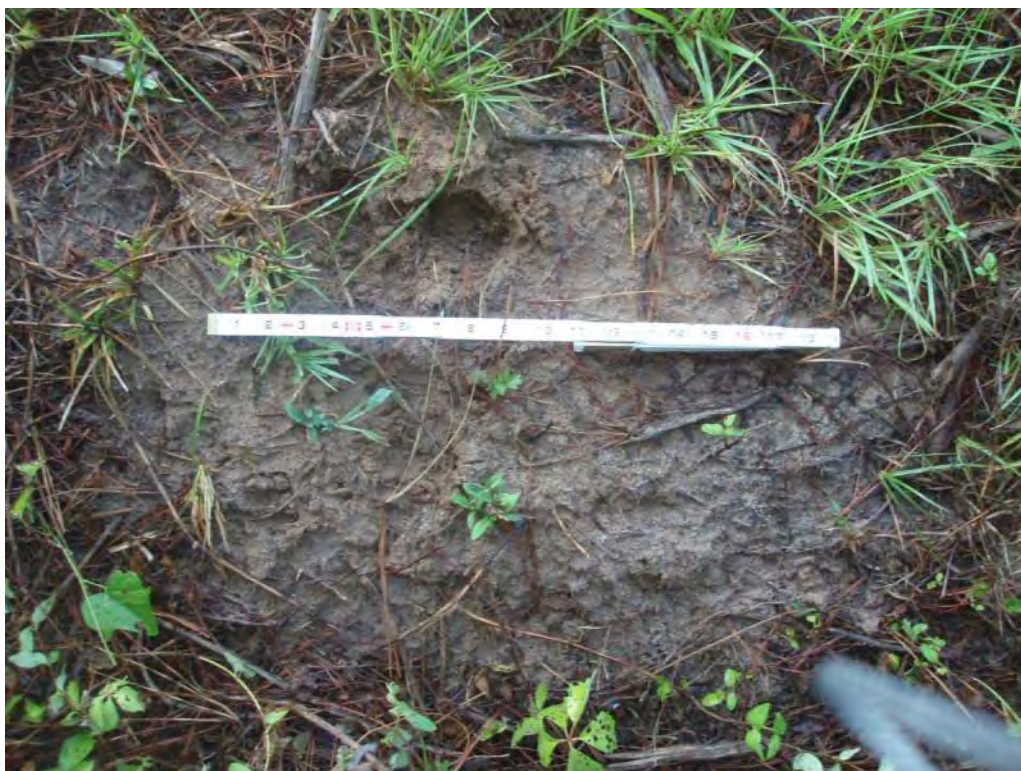
Photo No. 37: Bottom Ash Pond – North embankment exterior slope. Looking at 2'x1.5' area of damp, bare soil excavated from animal rooting/burrowing.

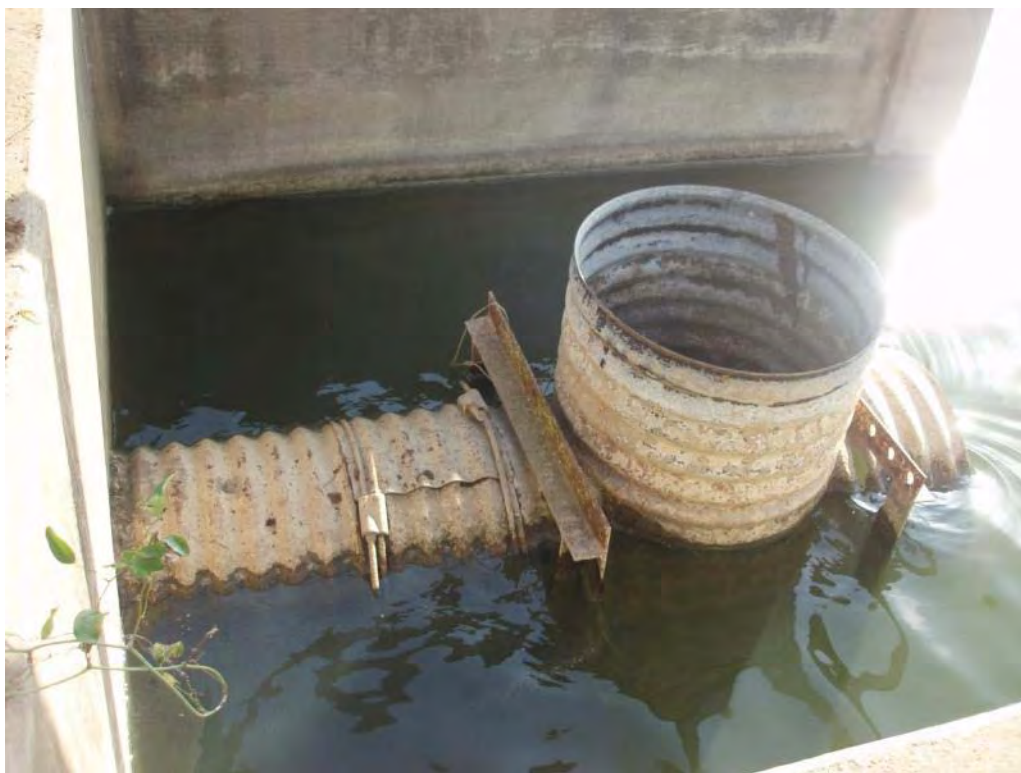
The outlet, a 24-inch-diameter CMP with an invert elevation of 102.6, appeared to be in fair condition (Photographs 43, 45 and 46). The inlet was free of debris and water was flowing freely through the pipe.

Photo No. 45: Bottom Ash Pond – 24-inch-diameter corrugated metal pipe outlet on west embankment. Outlet discharges to channel on exterior slope of west embankment.

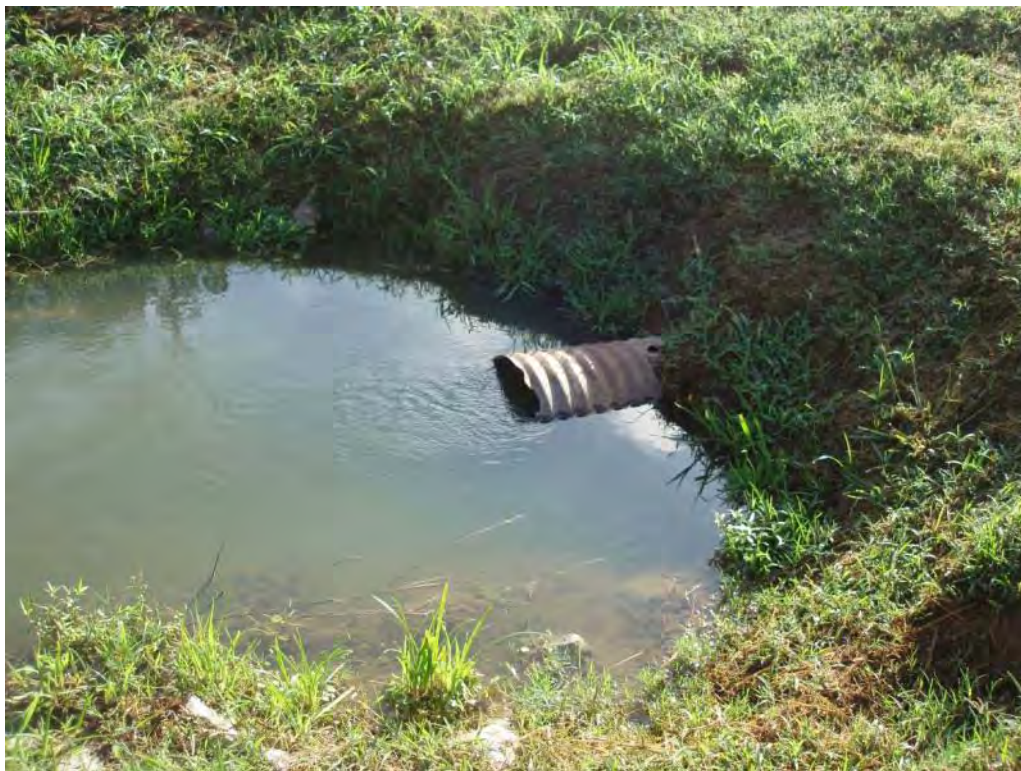
The west embankment exterior slope was well vegetated with various species of grasses, ranging in height from 3 to 12 inches (Photograph 41). Surface erosion was observed at the 24-inch-diameter CMP discharge (Photograph 47). At a separate location, riprap had formerly been downstream of a stormwater drainage discharge outlet on the west embankment exterior slope. Bank erosion, with a maximum depth of approximately 40 inches and a maximum width of approximately five feet, was observed at the outer edge of the riprap, apparently created by historic discharges from these pipes (Photographs 48 and 49).

Photo No. 47: Discharge channel located at west embankment exterior toe. Water discharged into channel from Bottom Ash Pond.

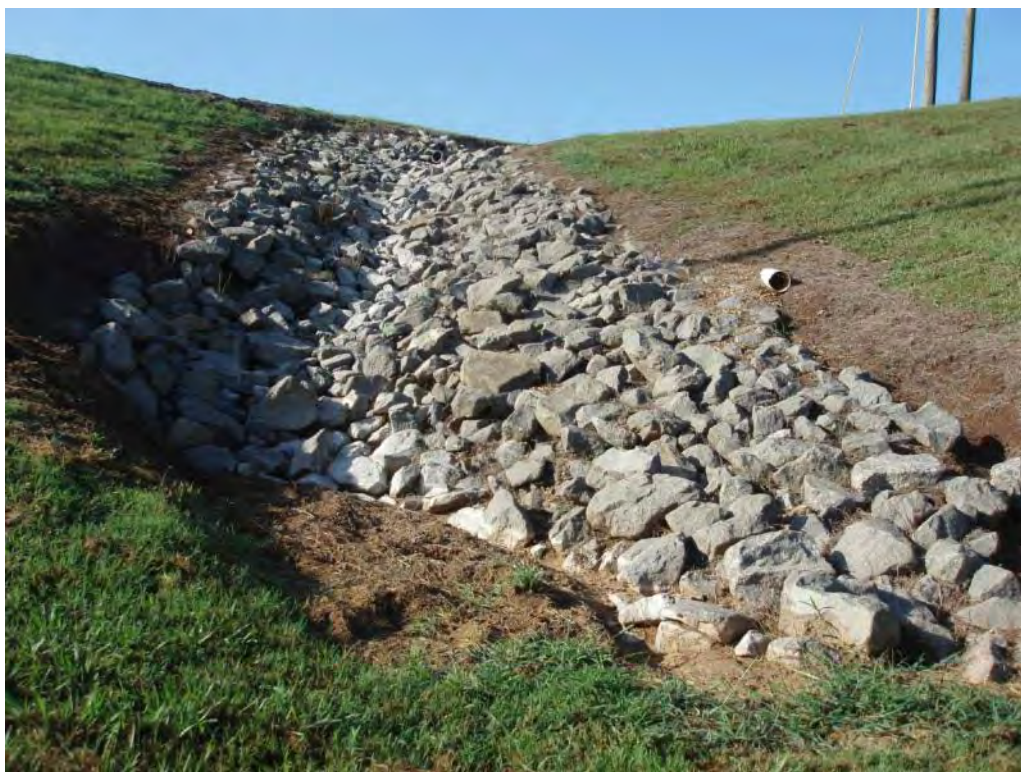
Photo No. 48: Bottom Ash Pond - West embankment exterior slope, looking at riprap protection and outlet pipes discharging into channel.

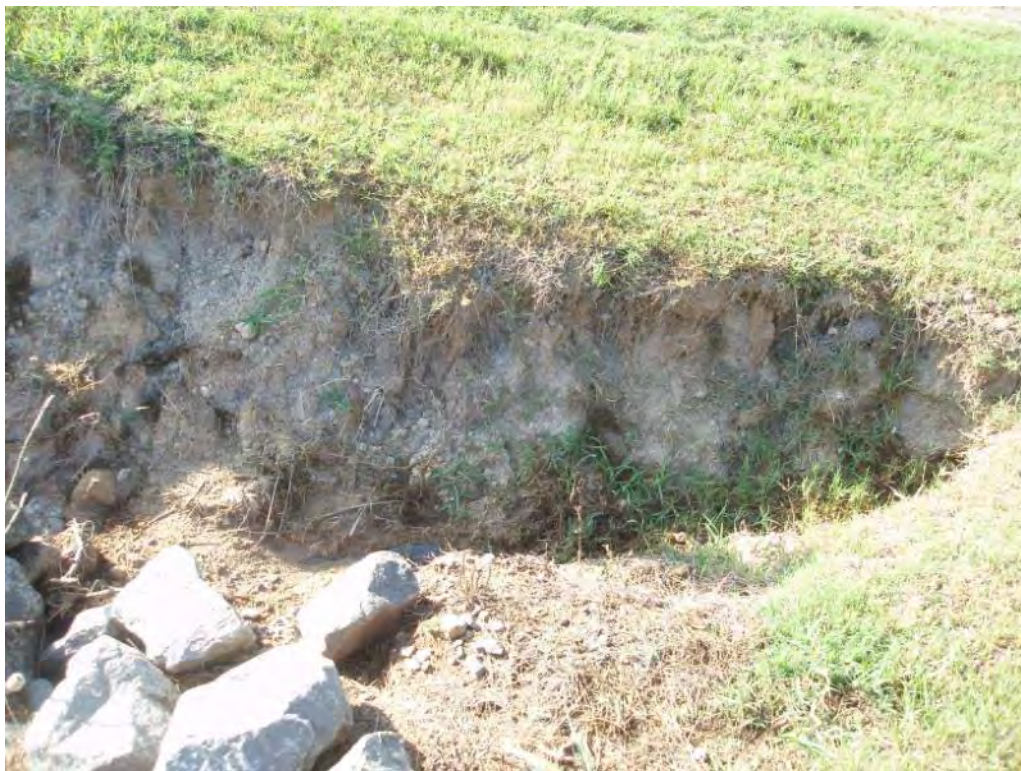
Photo No. 49: Bottom Ash Pond - West embankment exterior slope. Looking at erosion around edges of riprap.

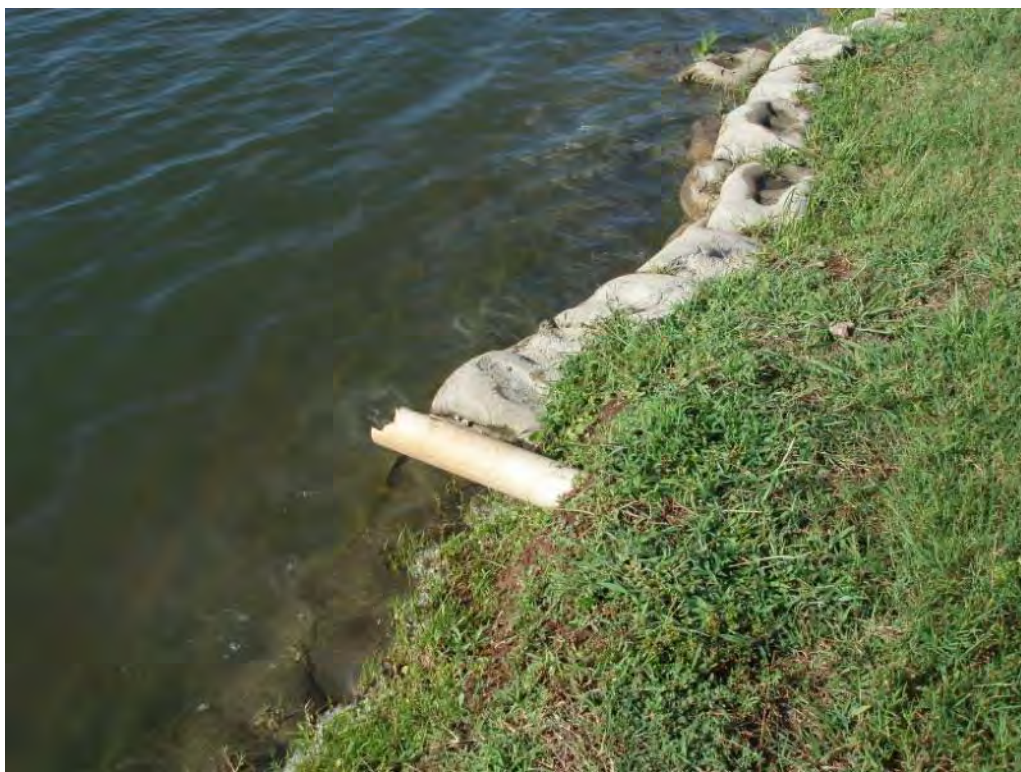
Photo No. 50: Bottom Ash Pond - West embankment interior slope. Looking at discharge pipe (unknown origin) and discontinuation of concrete armor.

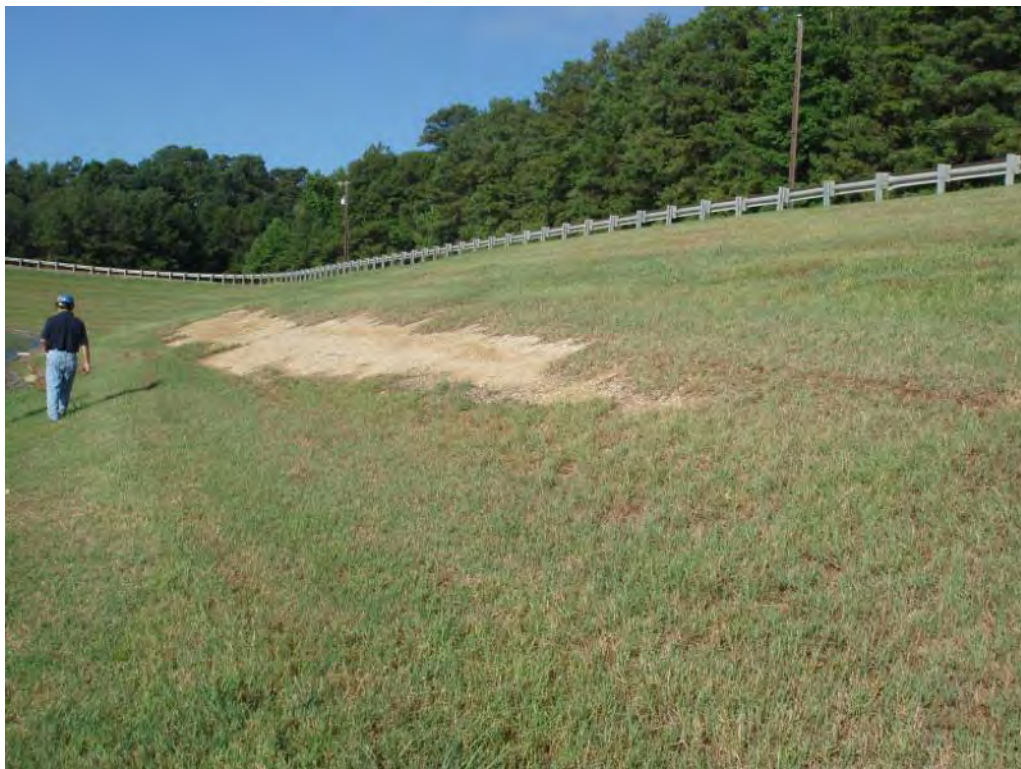
The embankment interior slopes appear to be in good condition. The interior slope was approximately 3H:1V, with cast-in-place concrete armoring (Photographs 4, 7, 8, 39 and 58) in place except at the southeast corner. Cleco representatives indicated the armoring stopped in this corner to accommodate dredging operations for the removal of bottom ash. Areas of the concrete armoring were observed to be undercut and cracked longitudinally, apparently due to wave action (Photographs 6, 7, and 52). A section, approximately 50 feet long, of the west embankment interior slope was observed where armoring had been undermined and was displaced into the pond (Photograph 52). The embankment interior slopes were generally well vegetated with grass, typically less than 6 inches in height (Photographs 1, 2, 12 and 64). Several areas were observed where grass is sparse or missing and rutting has occurred from mowing operations (Photographs 5, 12, 18, 51 and 69).

Photo No. 51: Bottom Ash Pond - West embankment interior slope, looking southwest.
Looking at patch of bare soils.
