Assessment of Dam Safety of Coal Combustion Surface Impoundments

Cleco Corporation

Brame Energy Center

March 14, 2011

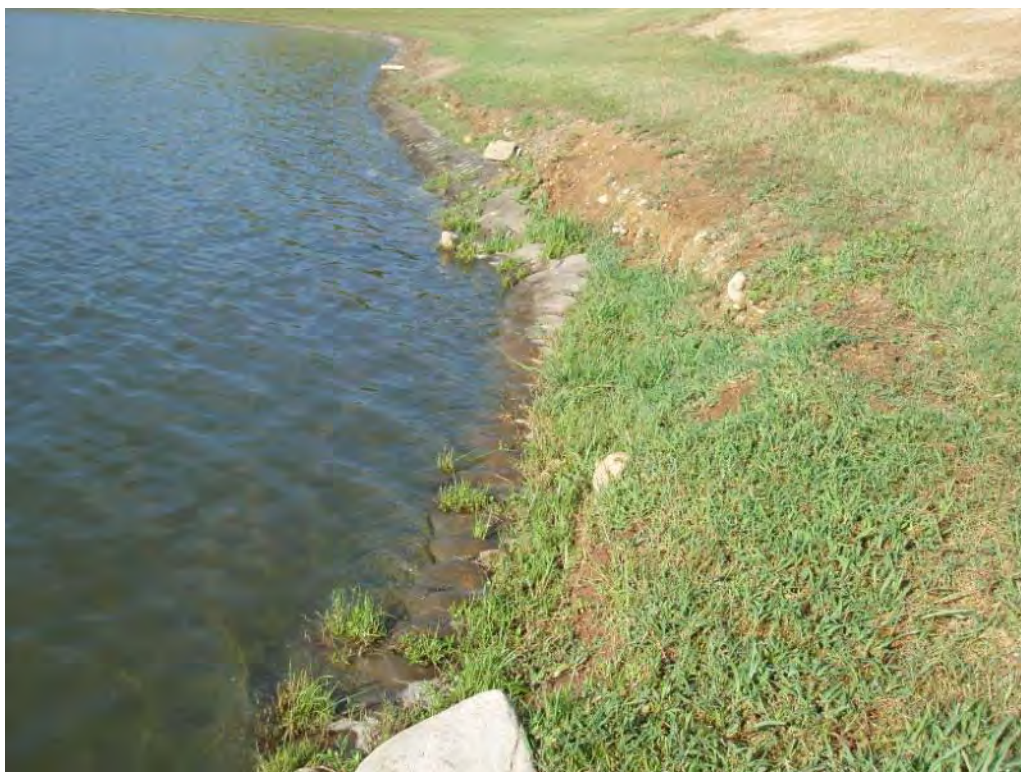
Photo No. 52: Bottom Ash Pond - West embankment interior slope, looking southwest.
Looking at surface erosion above concrete armor.

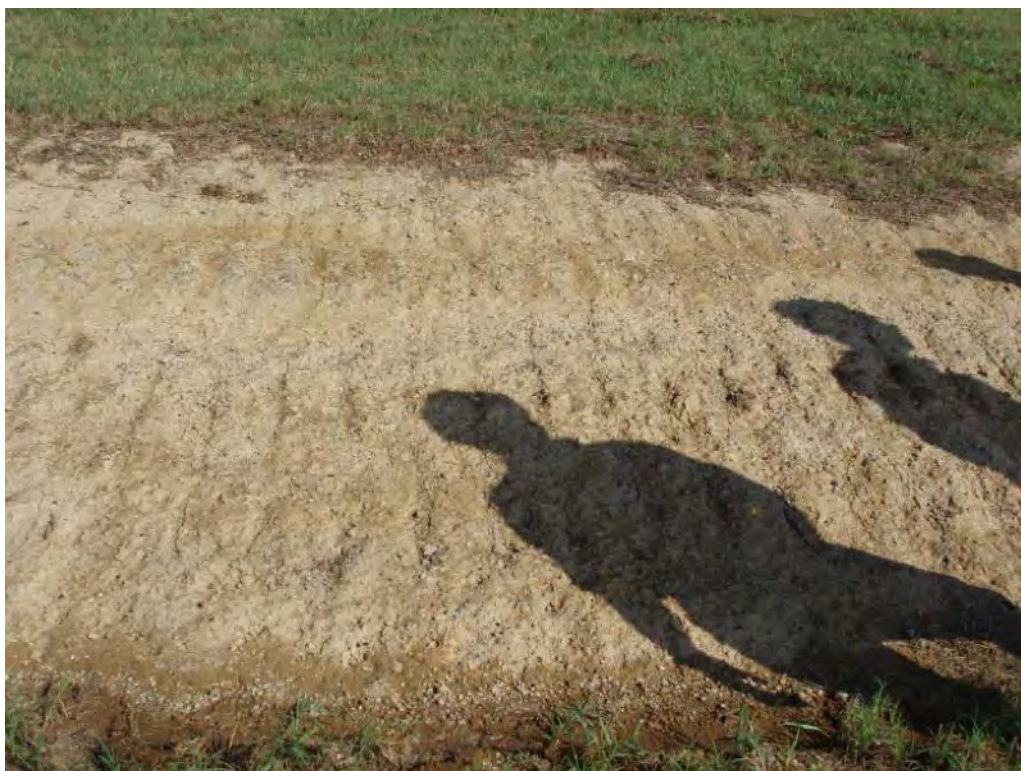
Photo No. 53: Bottom Ash Pond – West embankment interior slope. Looking at close-up of bare patch of soils (also shown in Photo No. 51)

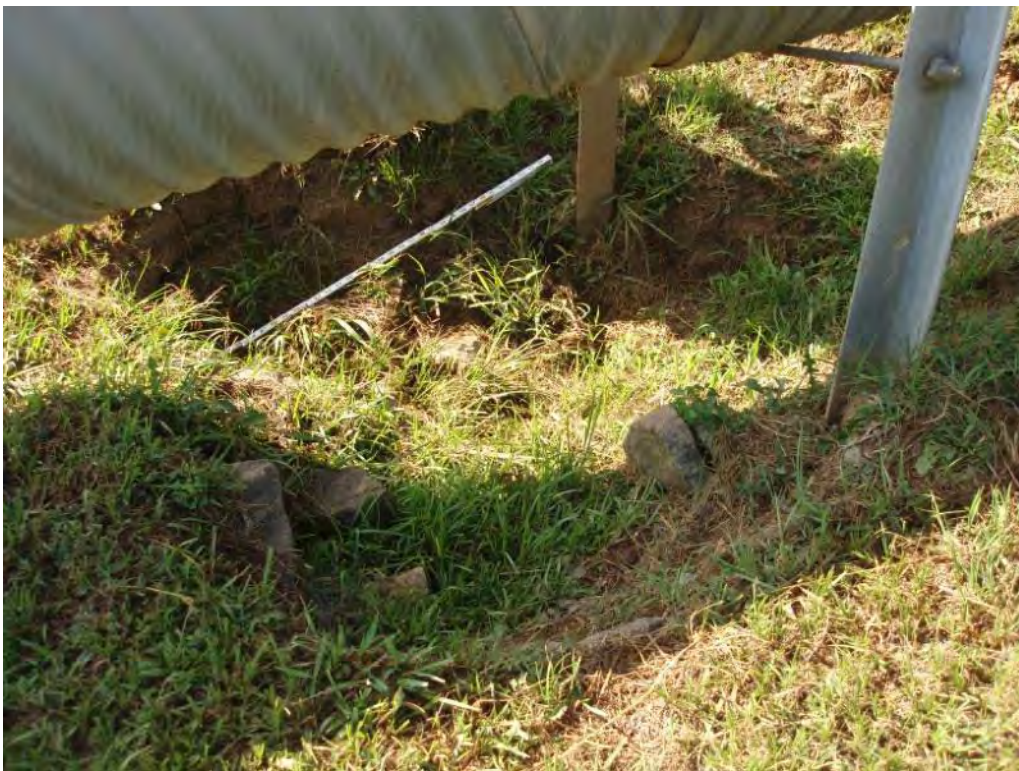
Several minor erosion features were observed on the south embankment interior slope. An erosion rill, approximately 20 inches wide by 10 inches deep, was observed on the south embankment interior slope at the point where sluice lines from Unit 2 passed under the haul road (Photograph 63). Minor surface erosion was observed below a (leaking) joint in piping used for drawing water from the Bottom Ash Pond to fill tank trucks used in dust control on plant haul roads (Photograph 68). A depression, approximately 3 feet wide by 2 feet deep, was observed beneath an elevated 30-inch-diameter CMP stormwater discharge pipe. The depression was

located near a steel pipe support and an observed pipe joint and is likely the result of leakage through the joint (Photograph 57).

Photo No. 57: Bottom Ash Pond – South embankment interior slope. Looking at depression (approximately 3 feet wide and 2 feet deep) beneath pipe supports.

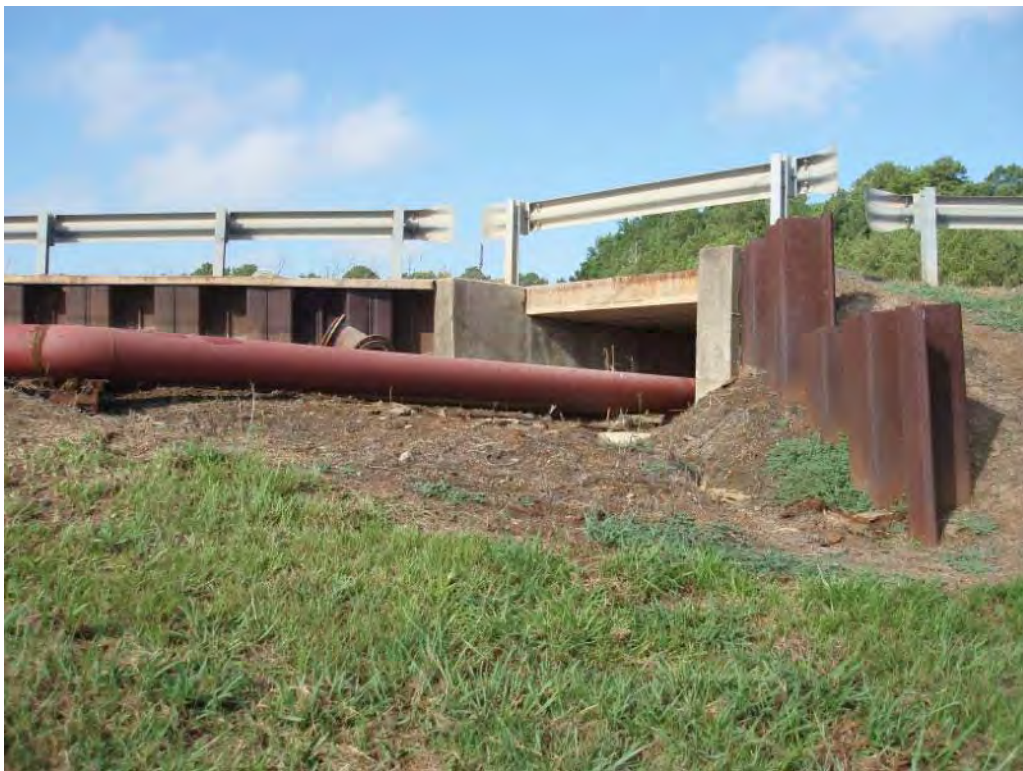
Photo No. 59: Bottom Ash Pond - South embankment interior slope, looking southwest.
Looking at surface erosion near sluice piping.

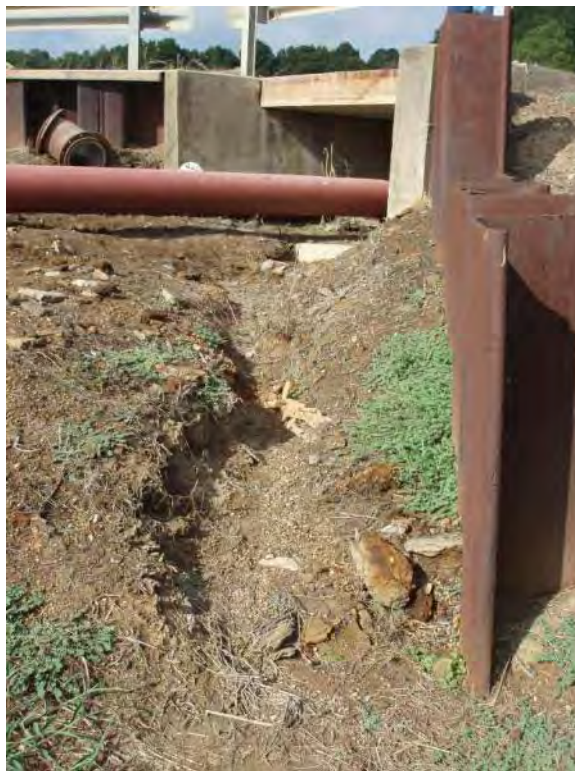
Photo No. 63: Bottom Ash Pond – South embankment interior slope. Looking at erosion rill (approximately 20 inches wide and 10 inches deep) near sluice lines.

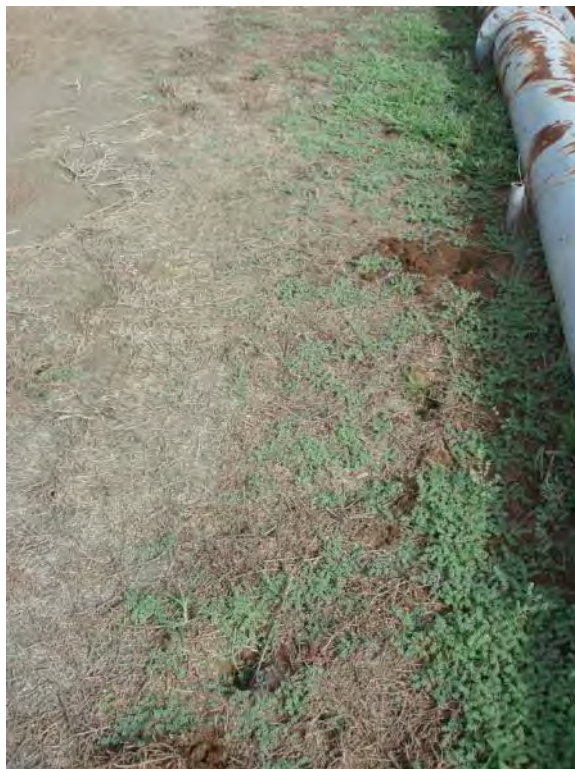
Photo No. 65: Bottom Ash Pond - South embankment interior slope. Looking at surface erosion near sluice lines.

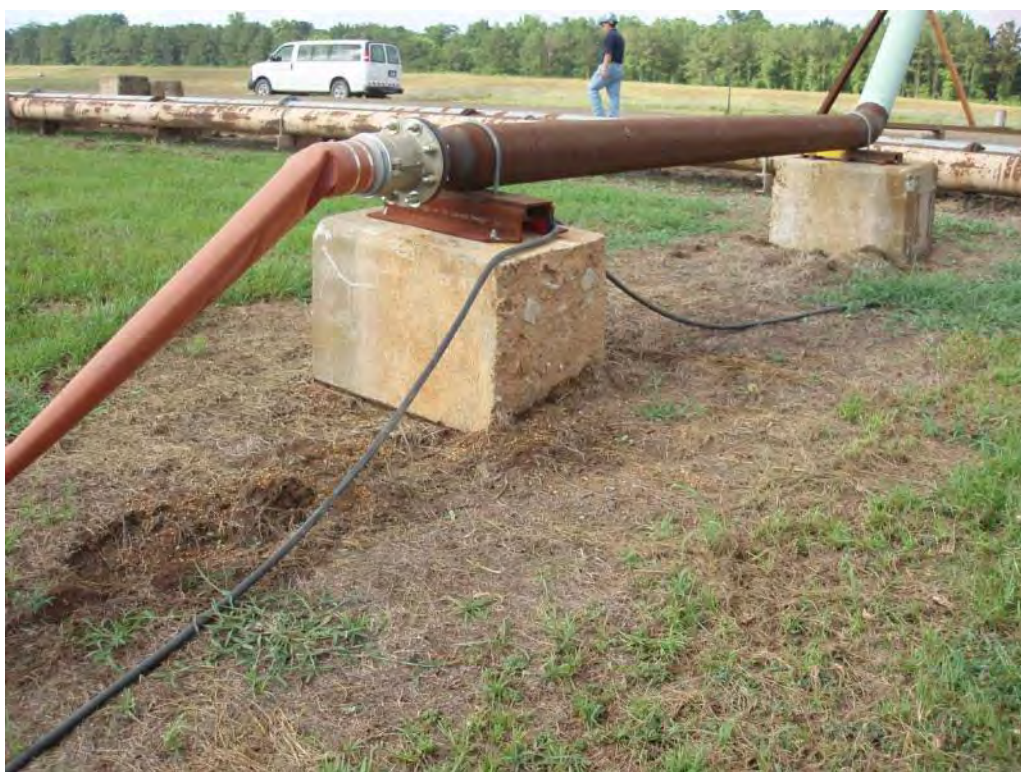
Photo No. 68: Bottom Ash Pond - South embankment interior slope, looking at minor surface erosion at piping for water truck filling.

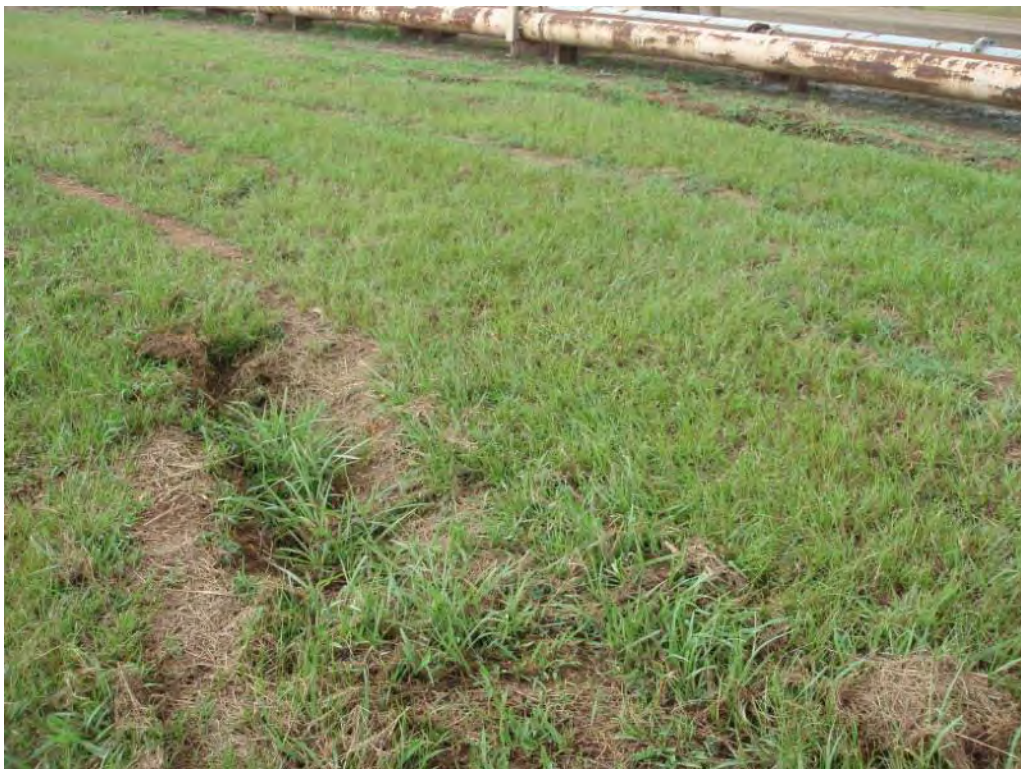
The embankment interior slopes appear to be in good condition. The interior slope was approximately 3H:1V, with cast-in-place concrete armoring (Photographs 4, 7, 8, 39 and 58) in place except at the southeast corner. Cleco representatives indicated the armoring stopped in this corner to accommodate dredging operations for the removal of bottom ash. Areas of the concrete armoring were observed to be undercut and cracked longitudinally, apparently due to wave action (Photographs 6, 7, and 52). A section, approximately 50 feet long, of the west embankment interior slope was observed where armoring had been undermined and was displaced into the pond (Photograph 52). The embankment interior slopes were generally well vegetated with grass, typically less than 6 inches in height (Photographs 1, 2, 12 and 64). Several areas were observed where grass is sparse or missing and rutting has occurred from mowing operations (Photographs 5, 12, 18, 51 and 69).

Photo No. 69: Bottom Ash Pond – South embankment interior slope. Looking at rut on slope.

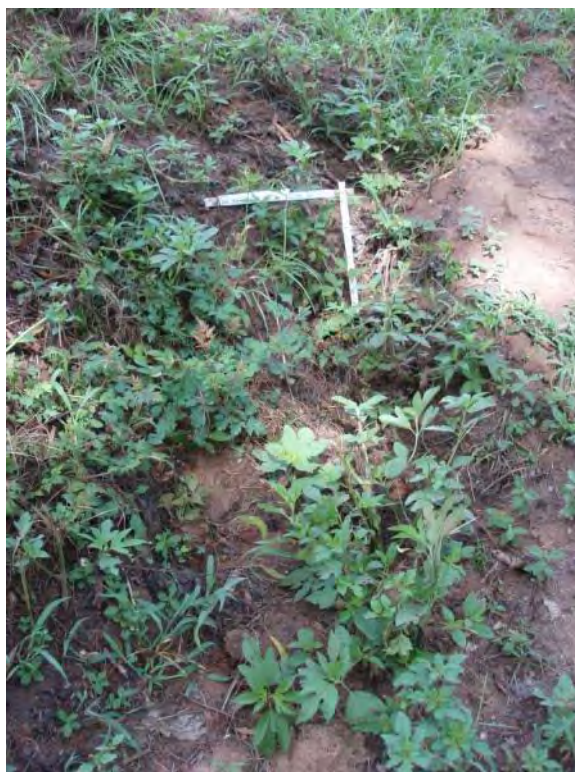
Photo No. 74: Fly Ash Pond – North embankment exterior slope. Looking at erosion rill.

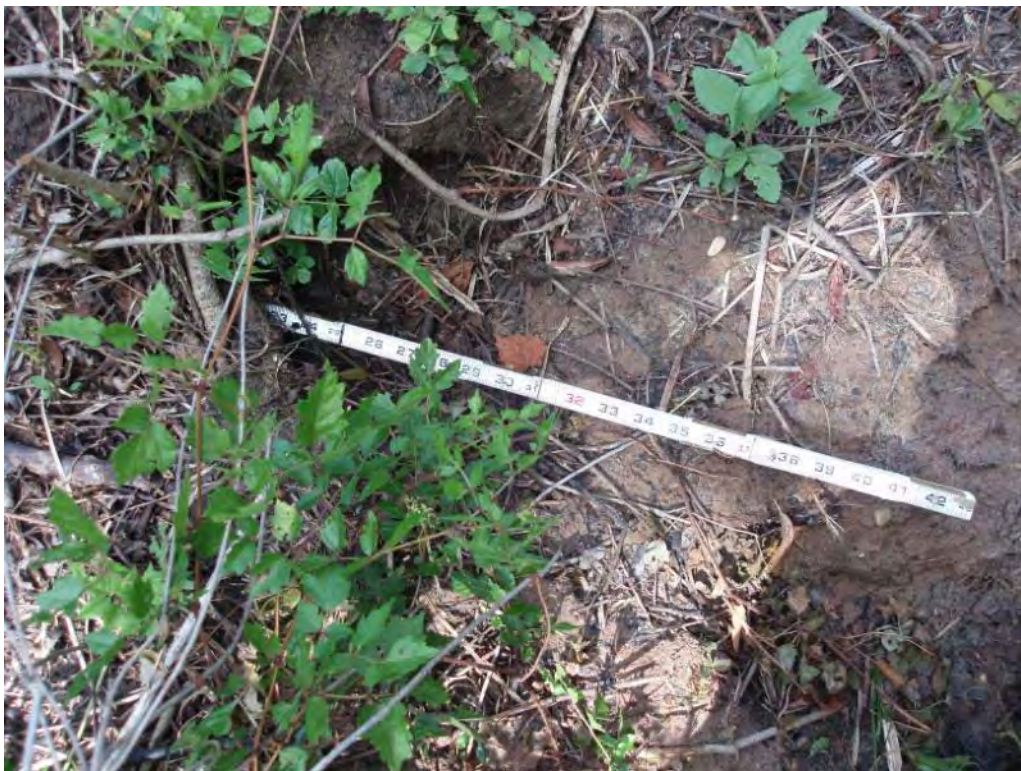
A rodent burrow was observed along the edge of the heavily vegetated area of the north embankment exterior slope (Photograph 75). A downed tree was observed near the exterior toe of the north embankment. Active erosion and possible animal burrowing were observed near the base of the tree (Photograph 100). An erosion rill, approximately 10 inches deep by 12 inches wide, was observed on the north embankment exterior slope (Photograph 74). An erosion rill just outside the north embankment exterior slope, approximately 5 feet wide and 3 feet deep, was observed (Photograph 94). The rill is not impacting the embankment slope at this time. Isolated areas of rutting and loss of grass cover, apparently due to mowing operations were observed on the north and south embankment exterior slopes (Photographs 79 and 121). The presence of heavy vegetation precluded observation of any additional erosion features, animal burrows, or potential seepage on the lower portions of the exterior slope of the north and east embankments. The south embankment exterior slope had been re-seeded recently and grass had not yet been reestablished. Turf

Photo No. 75: Fly Ash Pond – North embankment exterior slope. Rodent burrow (approximately 4 inches in diameter and 24 inches deep).

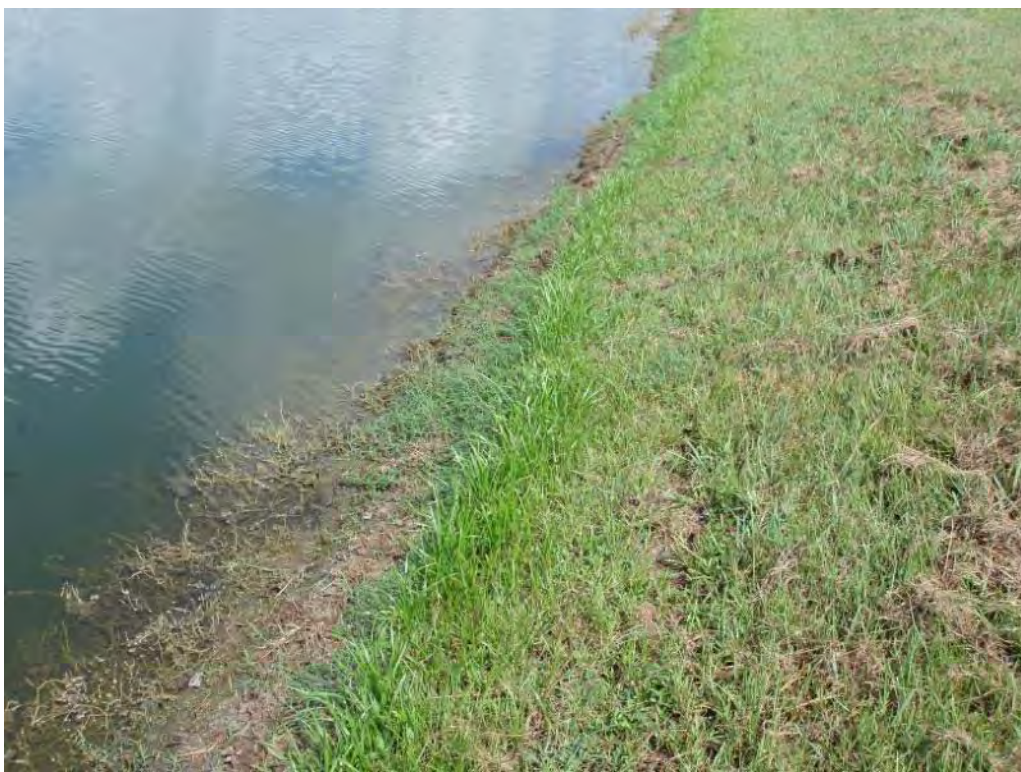
The interior embankment did not have erosion protection or armoring along the waterline (Photographs 76, 90, 114, 116 and 117). Erosion of the unprotected north and south embankment interior slope was observed (Photographs 76, 111, and 117). Numerous longitudinal cracks, approximately 1 to 2 inches wide and extending approximately 15 inches below grade, were observed on the north and east embankment interior slopes (Photographs 92, 93, 96, 97 and 101). The cracks appeared to be located in fill material placed over the original embankment cross section.

Photo No. 76: Fly Ash Pond – North embankment interior slope, looking northwest.

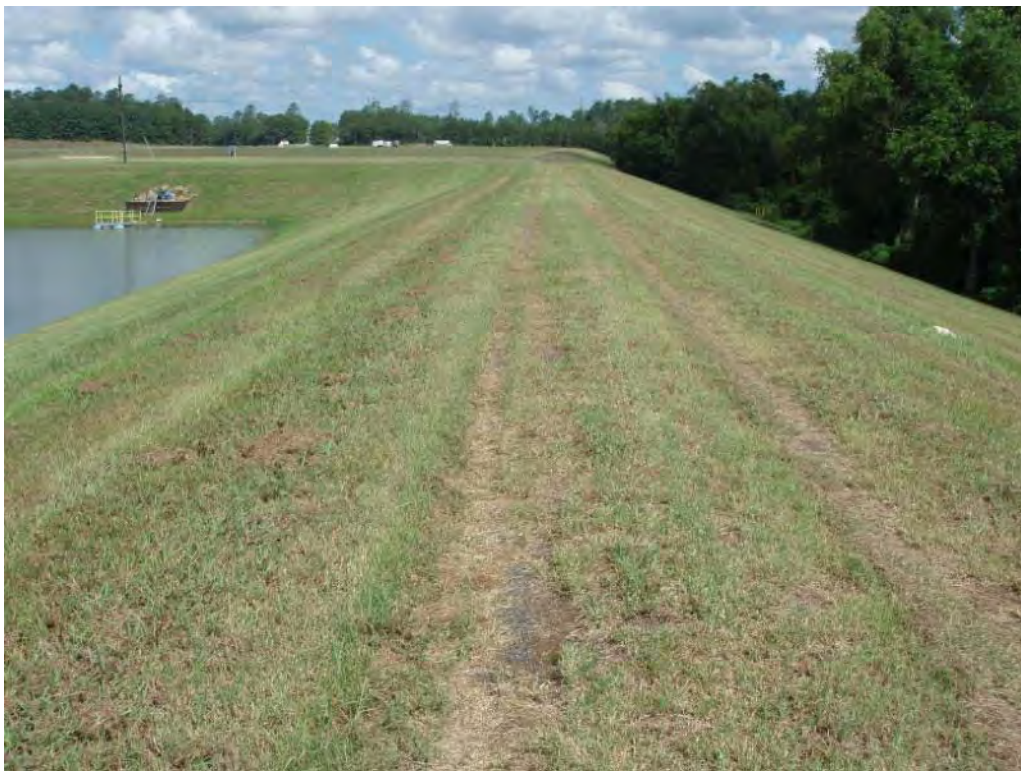
The crest of the Fly Ash pond embankments appeared to be in good condition (Photographs 82, 103 and 107). The north and south embankment crests are approximately 20 feet wide and the east embankment crest is approximately 30 feet wide. As shown in Figure 5, drawings prepared by Sargent & Lundy, last revised in April 1981, show the west (divider) embankment crest 20 feet wide. Fill material has been placed along portions of the west embankment's interior slope and graded to the top of crest, effectively increasing the width of the crests to nearly 100 feet (Photograph 128). The crest's surface, where used as a haul road on the south and west embankments, consists of compacted granular material (Photographs 107 and 122). The balance of the crest is well vegetated with grass generally less than 4 inches in height (Photographs 77, 82 and 103).

Photo No. 77: Fly Ash Pond - North embankment crest, looking northwest.

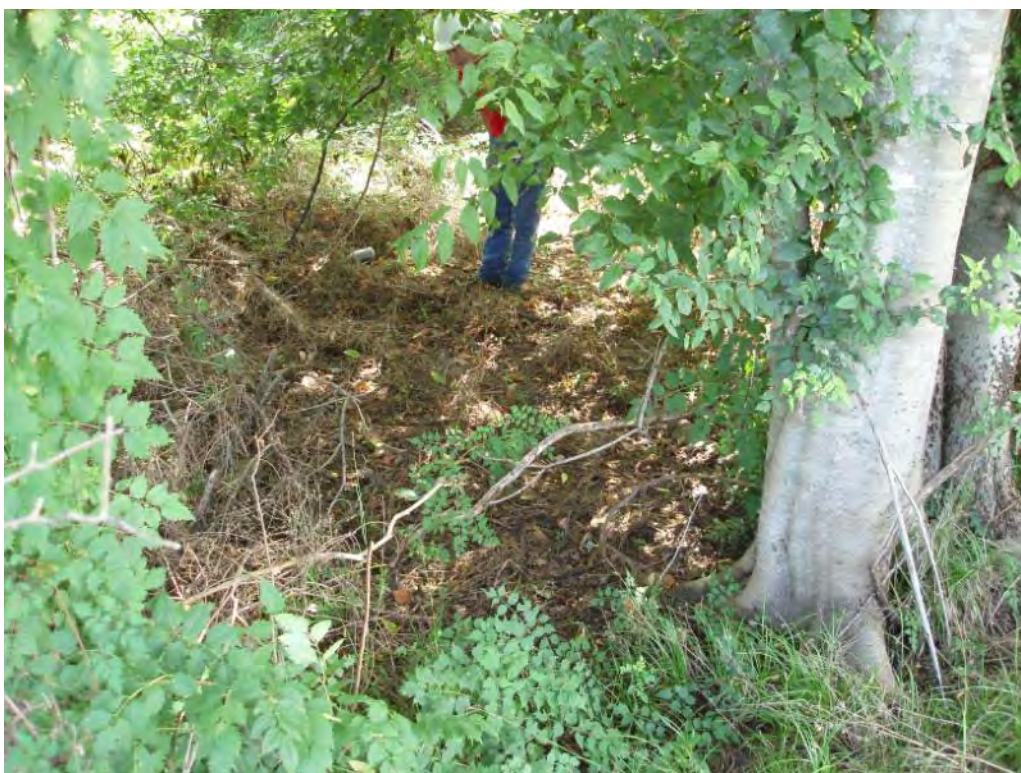
Photo No. 78: Fly Ash Pond - North embankment exterior slope. Vegetation located on bottom third of slope.

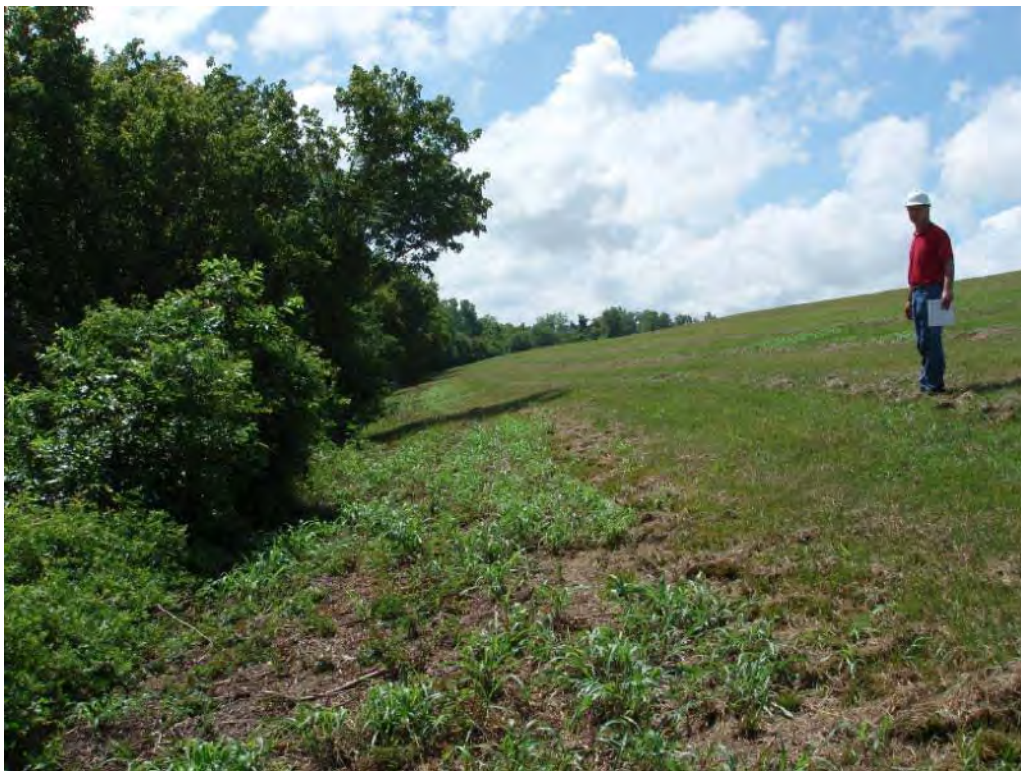
The embankment exterior slopes appear to be in fair condition. The embankment exterior slopes of the Fly Ash Pond are approximately 4H:1V. The upper two-thirds of the north embankment exterior slope were generally covered with grass approximately 4 inches in height (Photographs 79 and 103). The lower third of the north embankment slope, extending to the toe, was heavily vegetated with shrubs, brush and trees up to 18 inches in diameter (Photographs 78, 80, 81, 84 and 88). The toe of the east embankment exterior slope was heavily vegetated with dense brush and trees (Photographs 102 and 103). A drainage ditch, running along the north embankment was observed (Photograph 81).

Photo No. 79: Fly Ash Pond - North embankment exterior slope, looking southeast. Note vegetation growing on bottom third of slope.

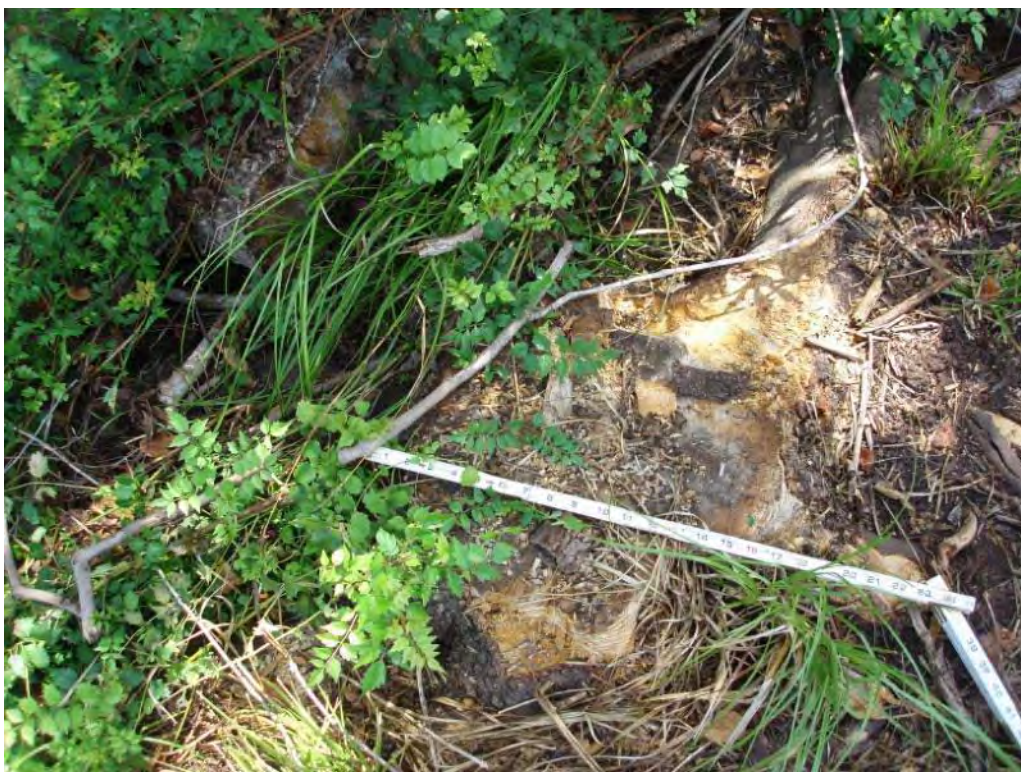
Photo No. 80: Fly Ash Pond - North embankment exterior slope. Tree stump (approximately 18 inches in diameter).

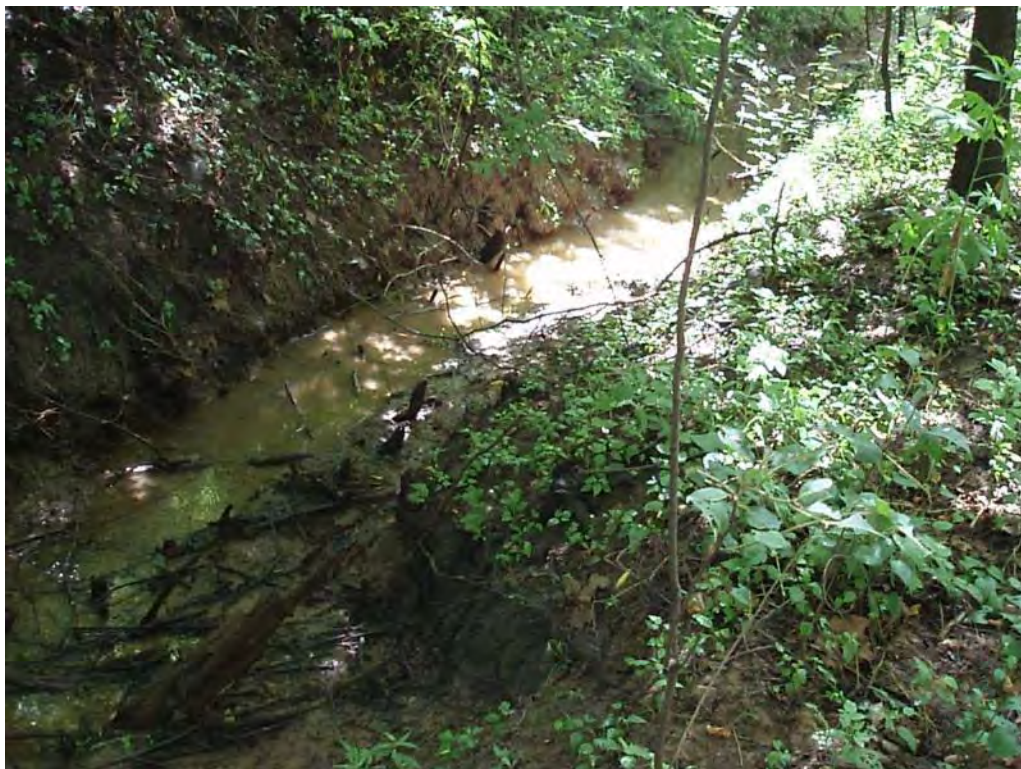
Photo No. 81: Fly Ash Pond - Outside toe of north embankment. Looking at drainage ditch running parallel to the north embankment.

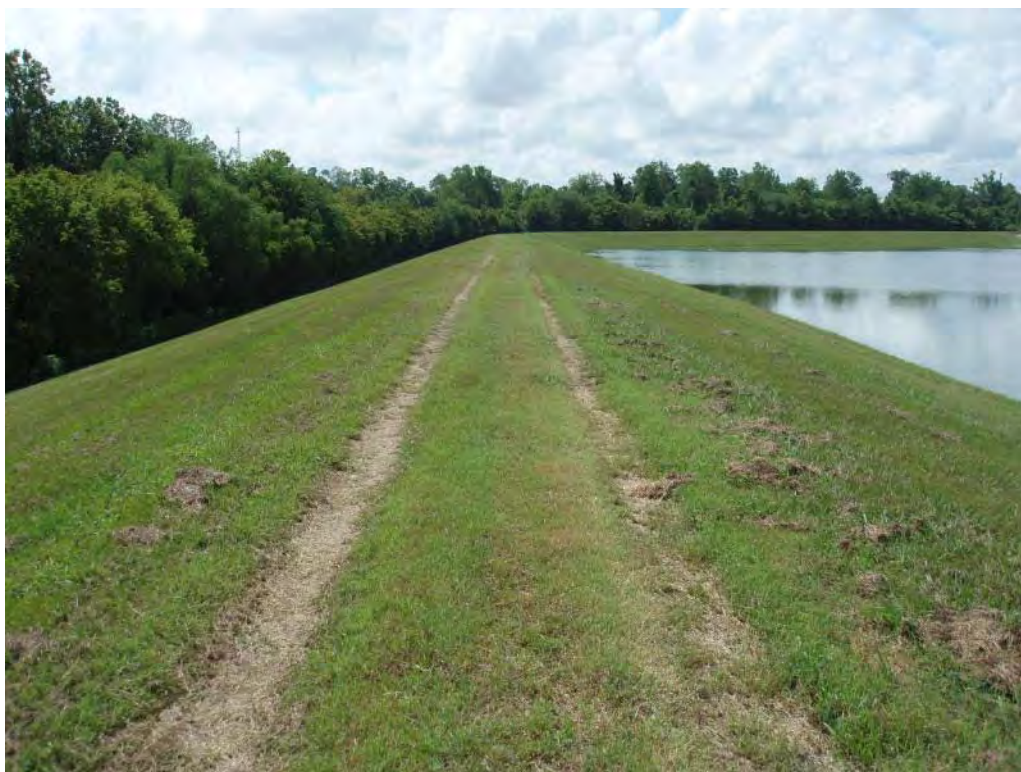
Photo No. 82: Fly Ash Pond - North embankment crest, looking southeast.

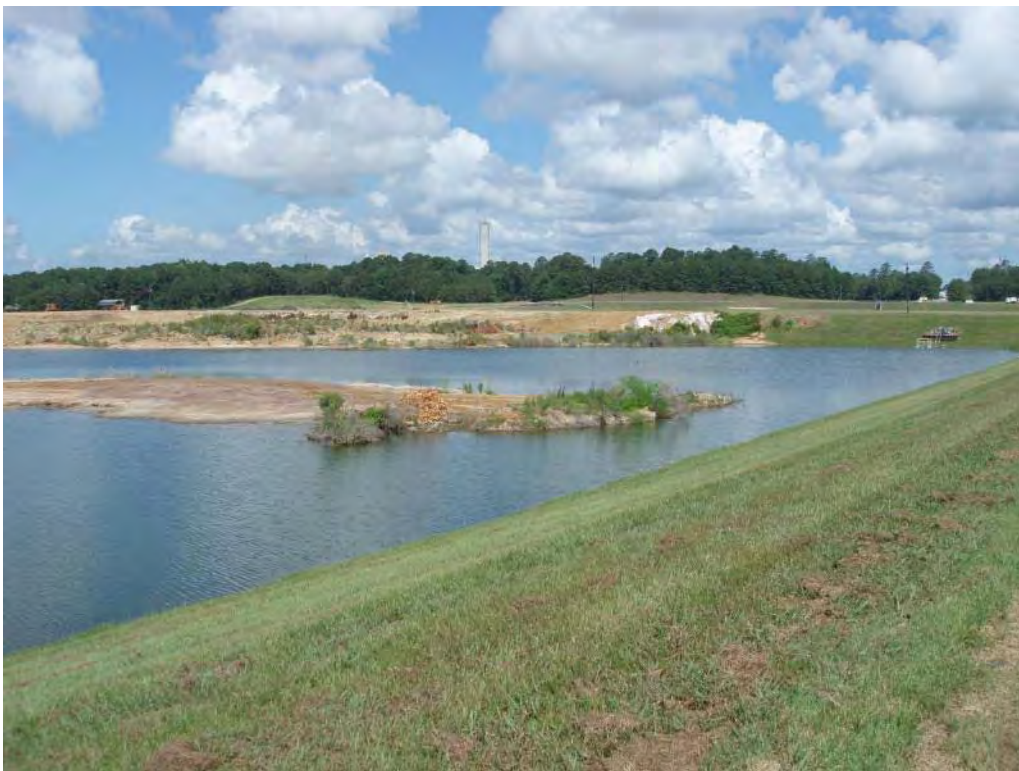
Photo No. 83: Fly Ash Pond – North embankment interior slope. West embankment interior slope in distance.

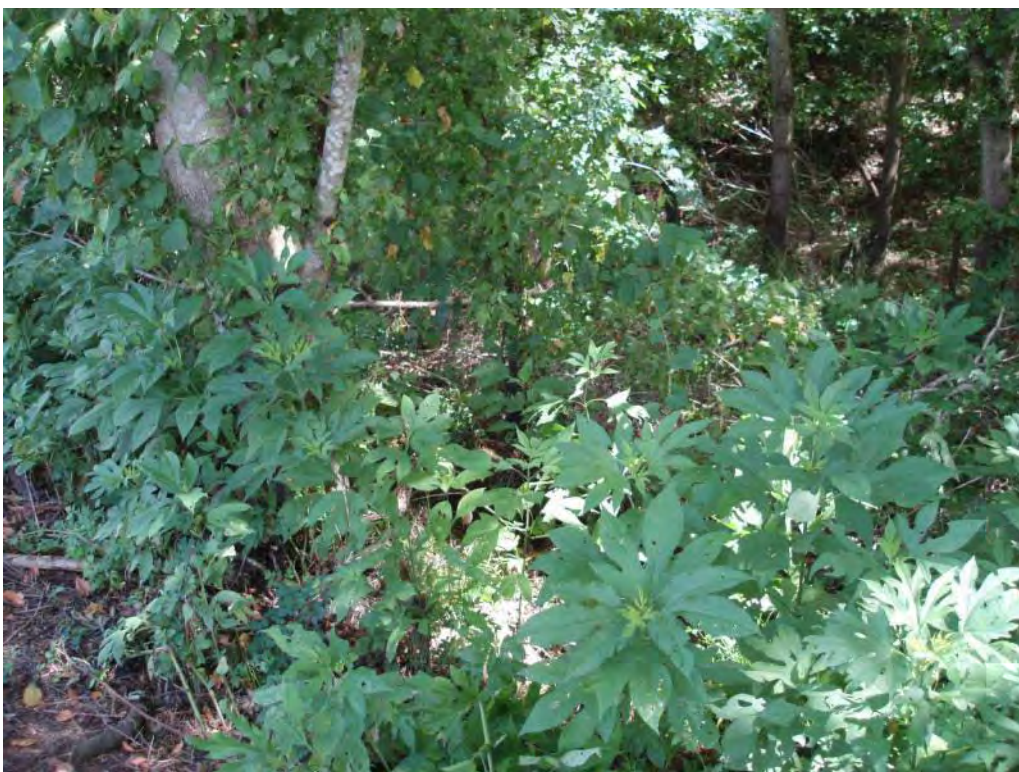
Photo No. 84: Fly Ash Pond – North embankment exterior slope. Looking at vegetation on bottom third of slope.

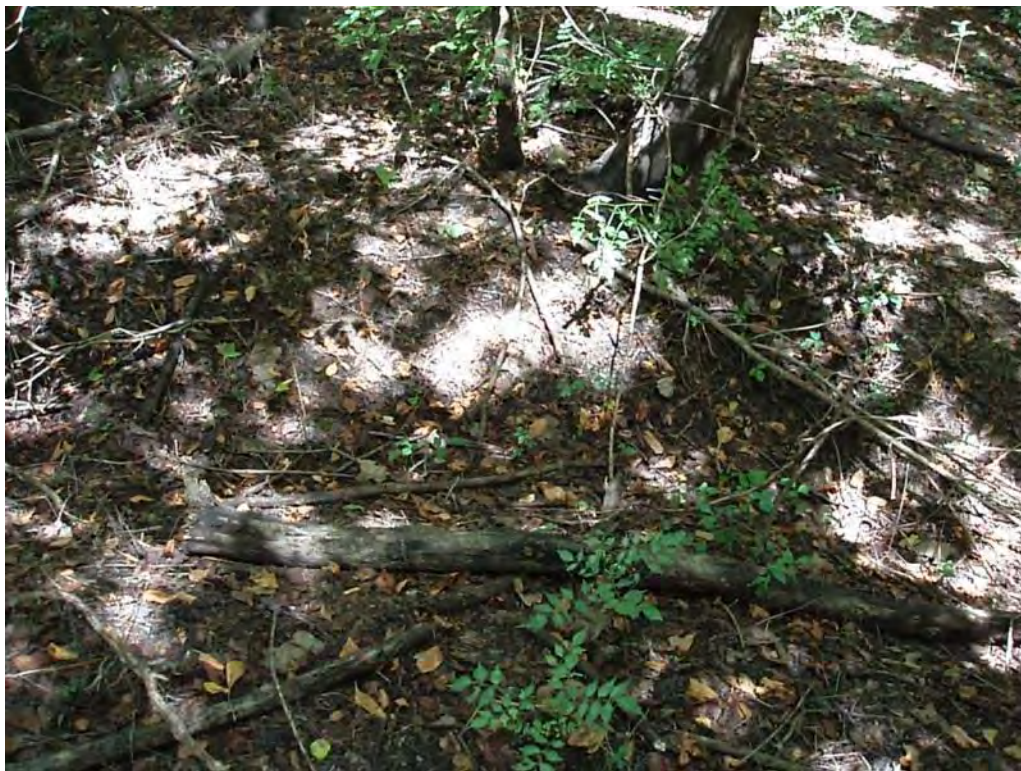
Photo No. 85: Fly Ash Pond - North embankment exterior toe. Looking at area with change in vegetation near toe.

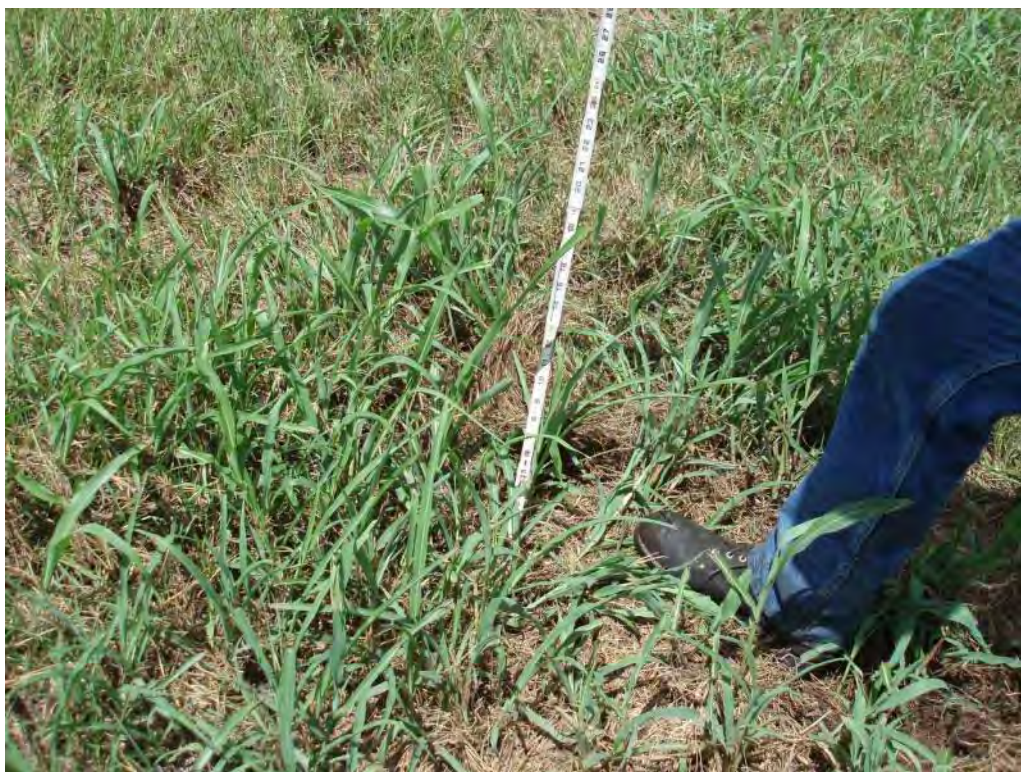
Photo No. 86: Fly Ash Pond - North embankment interior slope. Looking at area of animal rooting/burrowing.

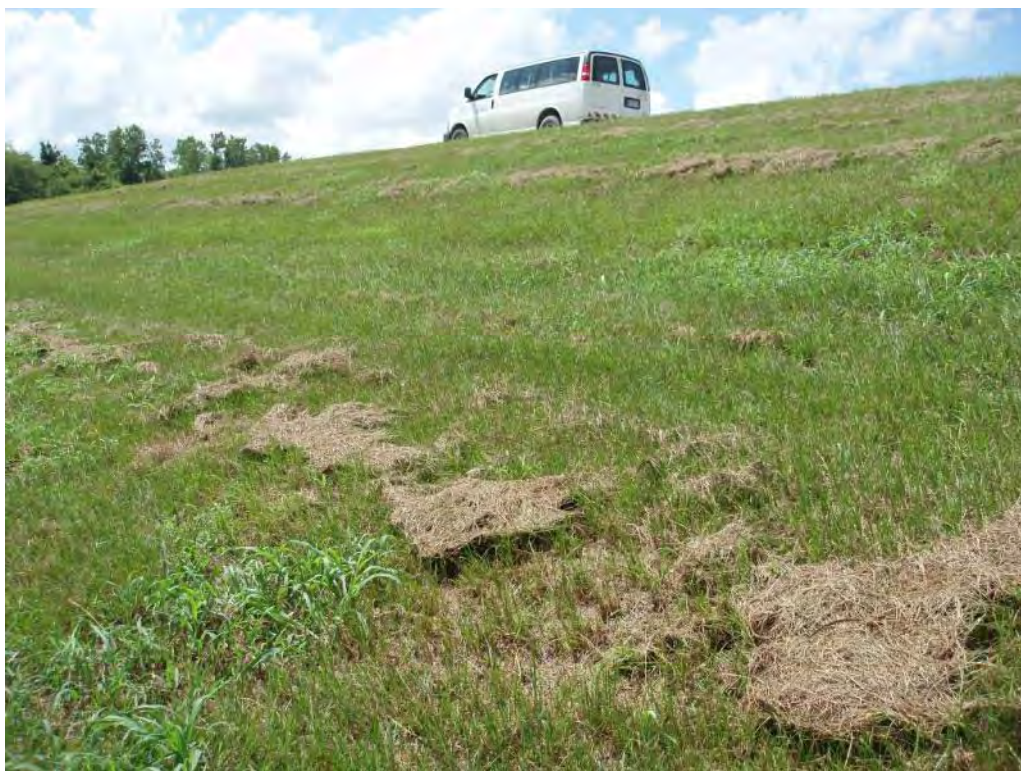
Photo No. 87: Fly Ash Pond - North embankment exterior slope, looking southeast.

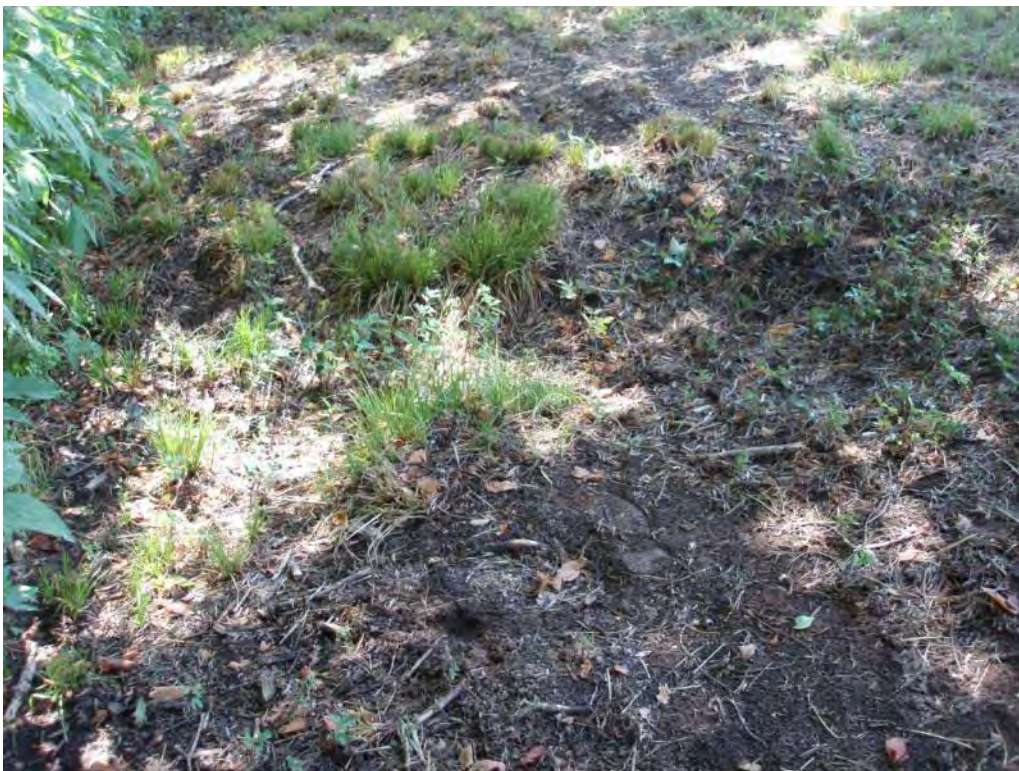
An area of possible seepage was observed near the toe of the north embankment exterior slope. The area was poorly vegetated, and the soil surface was spongy and wet (Photograph 89).

Photo No. 89: Fly Ash Pond - North embankment exterior slope. Looking at small depression in area of spongy, damp soils.

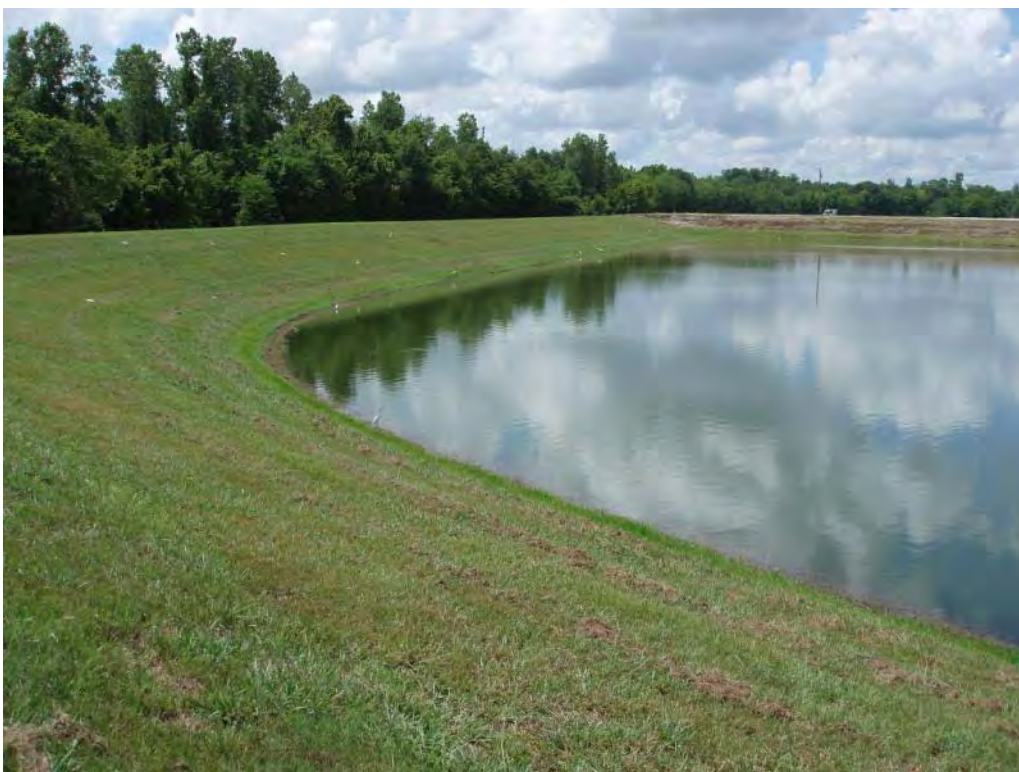
The interior slopes appear to be in fair condition. The embankment interior slopes range from approximately 4H:1V to 5H:1V. In general, the embankment's north and east interior slopes are well vegetated with various species of grass, typically 3 to 5 inches in height (Photographs 73, 77, and 90). The eastern 700 feet of the south embankment interior slope had been re-seeded recently and grass had not yet been reestablished. TRM placed on the exposed soil for erosion protection appeared to be effective (Photographs 103, 105, 106, 112 and 115).

Photo No. 90: Fly Ash Pond - Northeast corner interior slope, looking south.

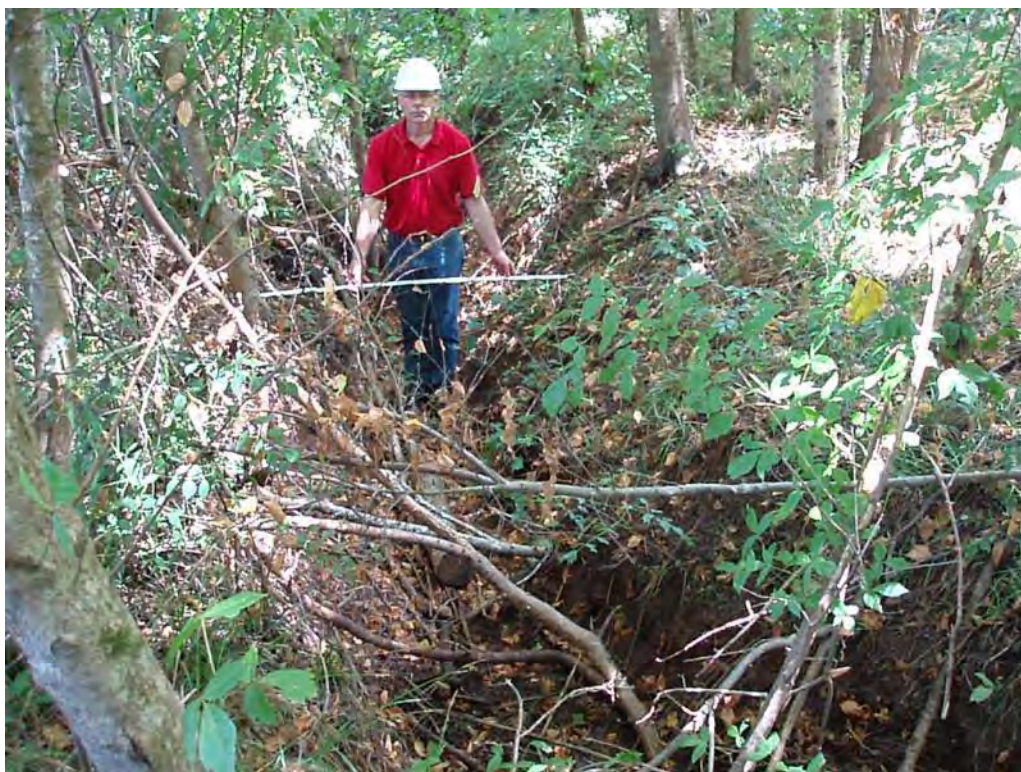
Photo No. 94: Fly Ash Pond - Drainage ditch north of the north embankment exterior toe.

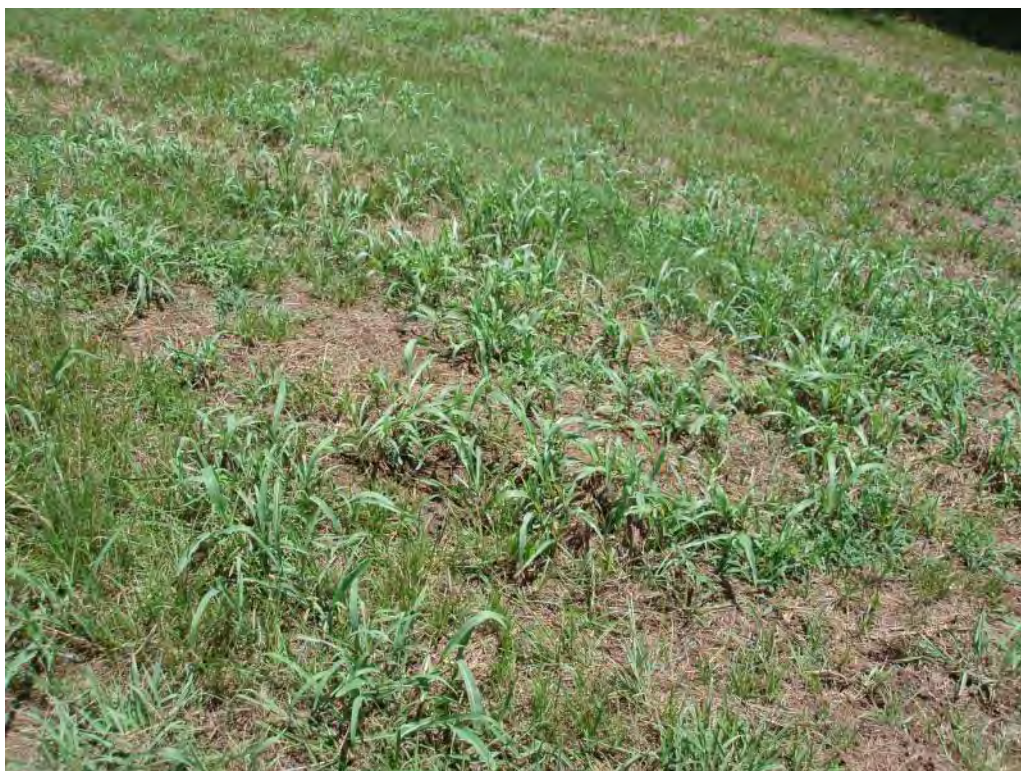
Photo No. 95: Fly Ash Pond - North embankment exterior slope, looking north.
