Assessment of Dam Safety of Coal Combustion Surface Impoundments

Cleco Corporation

Brame Energy Center

March 14, 2011

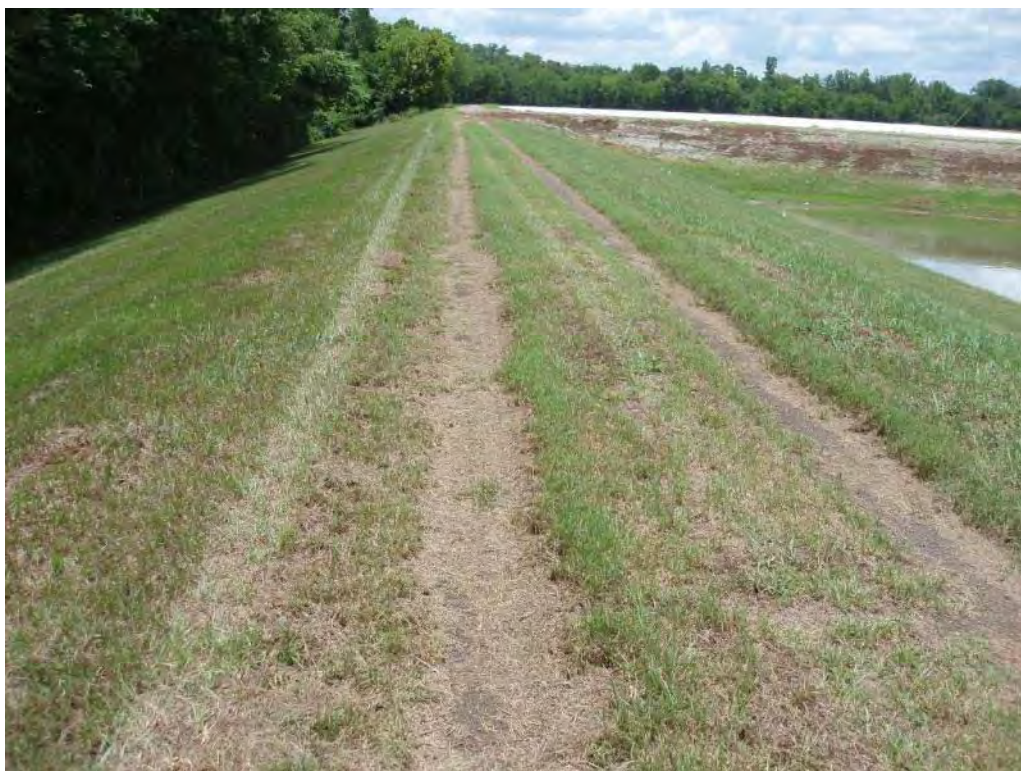
The embankment exterior slopes appear to be in fair condition. The embankment exterior slopes of the Fly Ash Pond are approximately 4H:1V. The upper two-thirds of the north embankment exterior slope were generally covered with grass approximately 4 inches in height (Photographs 79 and 103). The lower third of the north embankment slope, extending to the toe, was heavily vegetated with shrubs, brush and trees up to 18 inches in diameter (Photographs 78, 80, 81, 84 and 88). The toe of the east embankment exterior slope was heavily vegetated with dense brush and trees (Photographs 102 and 103). A drainage ditch, running along the north embankment was observed (Photograph 81).

The crest of the Fly Ash pond embankments appeared to be in good condition (Photographs 82, 103 and 107). The north and south embankment crests are approximately 20 feet wide and the east embankment crest is approximately 30 feet wide. As shown in Figure 5, drawings prepared by Sargent & Lundy, last revised in April 1981, show the west (divider) embankment crest 20 feet wide. Fill material has been placed along portions of the west embankment's interior slope and graded to the top of crest, effectively increasing the width of the crests to nearly 100 feet (Photograph 128). The crest's surface, where used as a haul road on the south and west embankments, consists of compacted granular material (Photographs 107 and 122). The balance of the crest is well vegetated with grass generally less than 4 inches in height (Photographs 77, 82 and 103).

The interior slopes appear to be in fair condition. The embankment interior slopes range from approximately 4H:1V to 5H:1V. In general, the embankment's north and east interior slopes are well vegetated with various species of grass, typically 3 to 5 inches in height (Photographs 73, 77, and 90). The eastern 700 feet of the south embankment interior slope had been re-seeded recently and grass had not yet been reestablished. TRM placed on the exposed soil for erosion protection appeared to be effective (Photographs 103, 105, 106, 112 and 115).

Photo No. 103: Fly Ash Pond – East embankment crest, looking south.

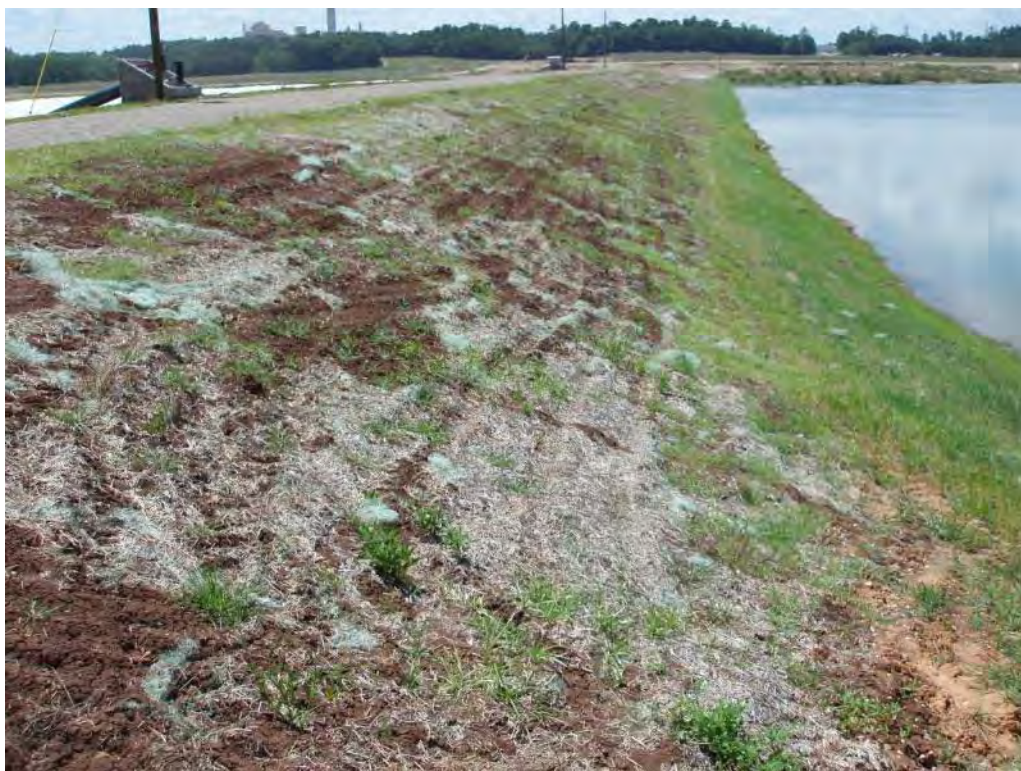
The embankment exterior slopes appear to be in poor condition. The embankment exterior slopes of the Leachate Pond are approximately 3H:1V. The exterior slope of the north (divider) embankment was covered in grass up to 3 inches tall (Photograph 105). Several minor erosion features were observed on the north embankment exterior slope, such as bare soils, and erosion near the toe (Photograph 111). The north (divider) embankment exterior slope had been re-seeded recently and grass had not yet been reestablished. TRM placed on the exposed soil for erosion protection appeared to be effective (Photograph 112). Heavy vegetation with trees up to 16 inches in diameter covers the exterior slope of the east and south embankments (Photographs 132, 133, 135, and 138). The presence of heavy vegetation precluded observation of any erosion features, animal burrows, or potential seepage on the exterior slope of the east and south embankments. The west embankment exterior slope was covered with a woven geotextile fabric (Photograph 141). An area of localized dampness was observed about mid-length of the east embankment slope, near the toe of the slope. Due to recent rainfall, it was not clear if the observed dampness is due to seepage or precipitation.

Photo No. 105: Fly Ash Pond - South embankment interior slope, looking northwest.
Looking at TRM at location recently re-seeded.

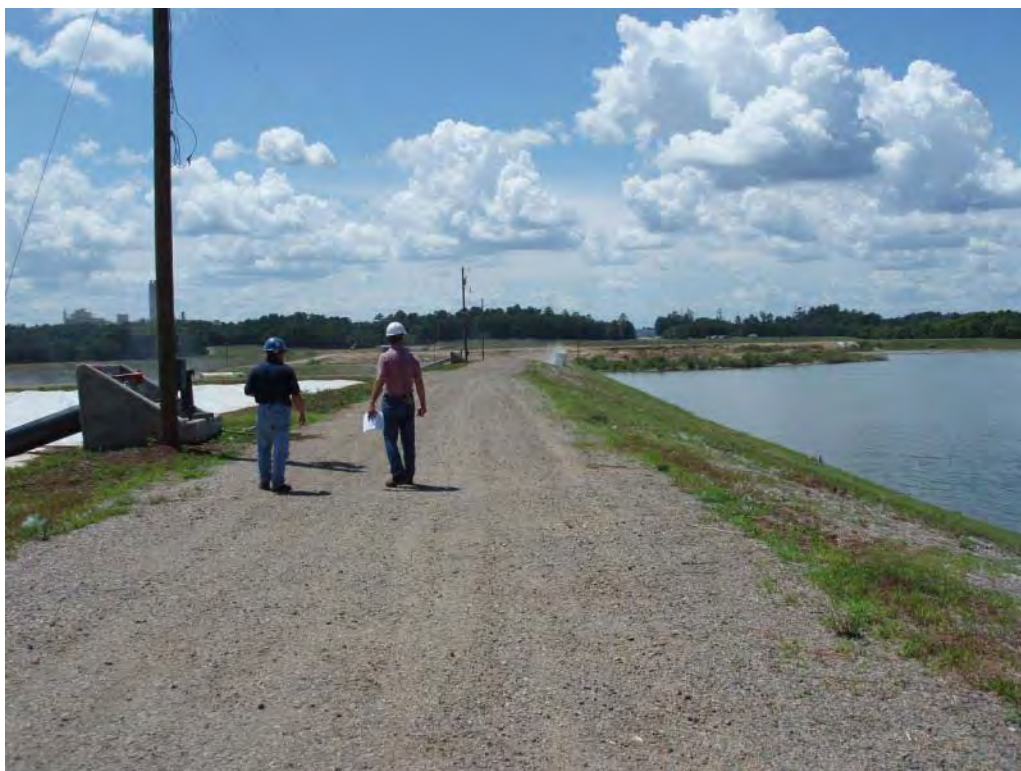
Photo No. 107: Fly Ash Pond - South embankment crest, looking northwest.

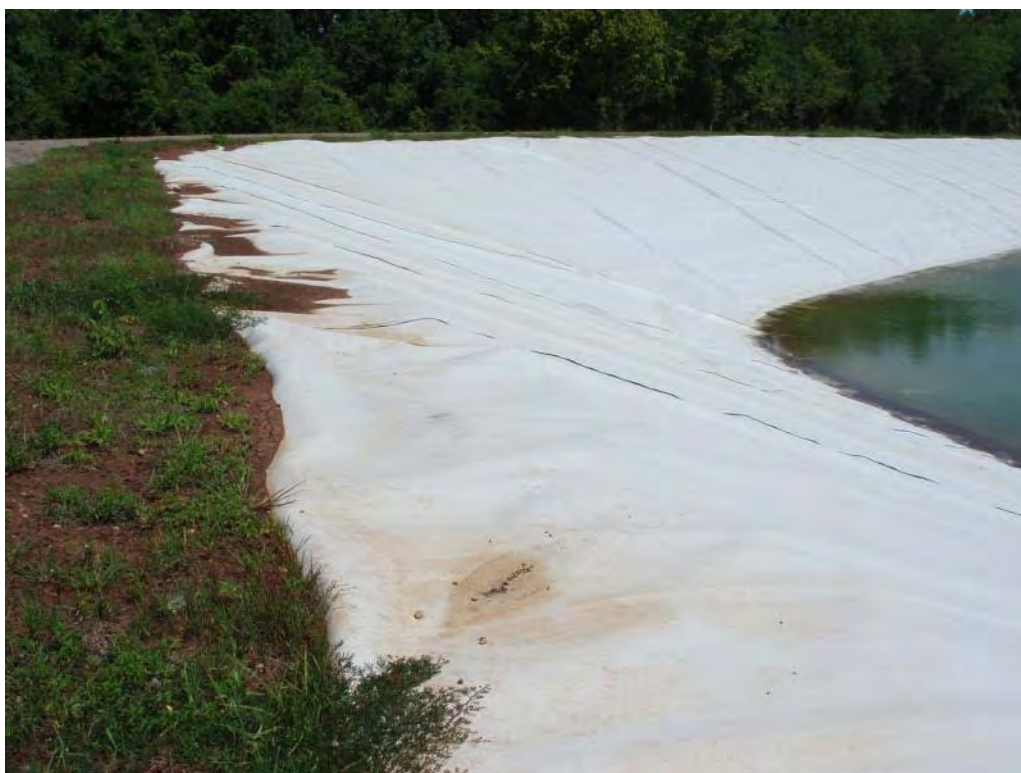
Photo No. 108: Fly Ash Pond - South (divider) embankment exterior slope. Leachate Pond lined with 60-mil-thick HDPE liner.

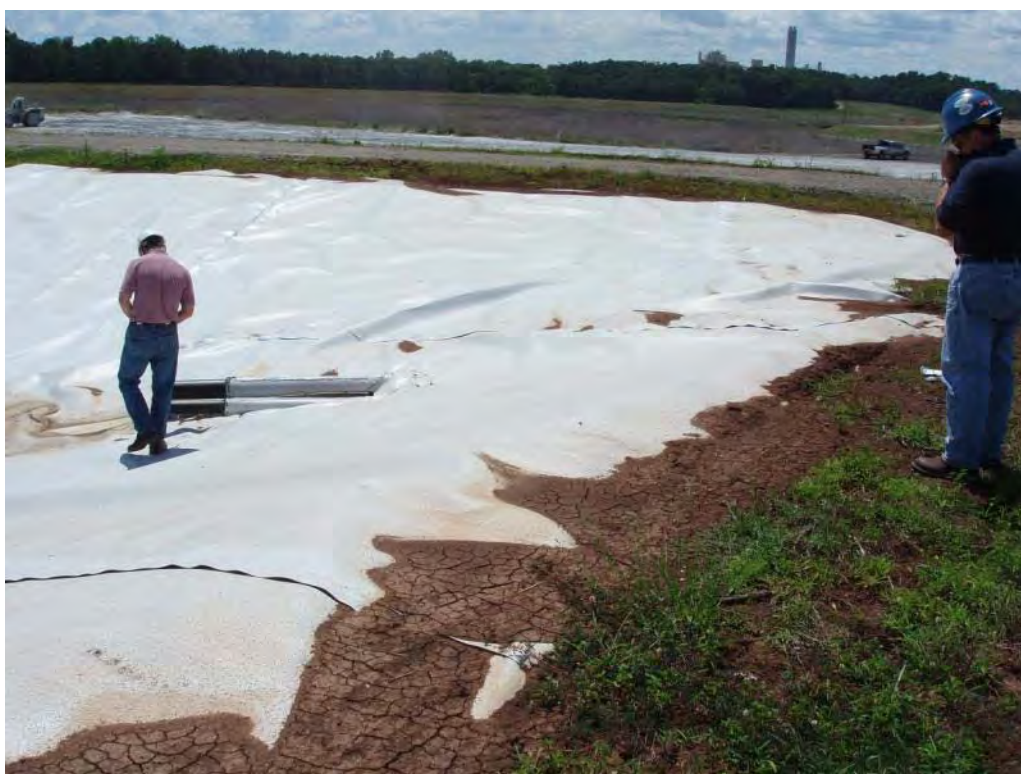
Photo No. 110: Fly Ash Pond – South (divider) embankment exterior slope, looking at northwest corner of Leachate Pond. Inlet pipes into Leachate Pond.

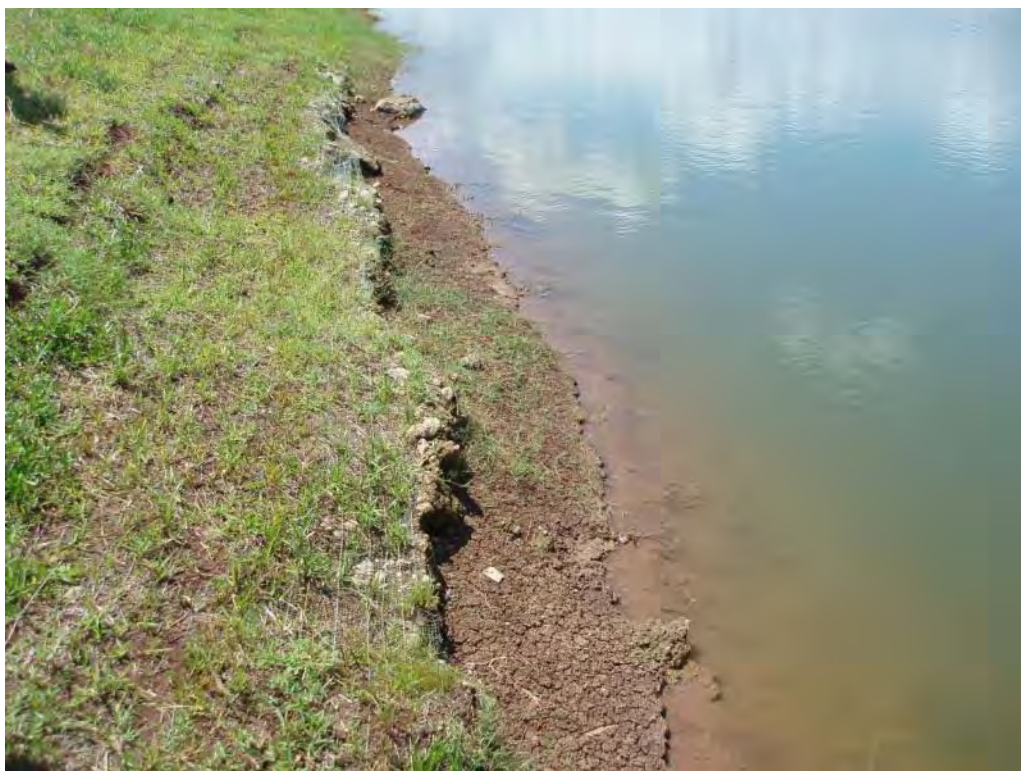
The interior embankment did not have erosion protection or armoring along the waterline (Photographs 76, 90, 114, 116 and 117). Erosion of the unprotected north and south embankment interior slope was observed (Photographs 76, 111, and 117). Numerous longitudinal cracks, approximately 1 to 2 inches wide and extending approximately 15 inches below grade, were observed on the north and east embankment interior slopes (Photographs 92, 93, 96, 97 and 101). The cracks appeared to be located in fill material placed over the original embankment cross section.

Photo No. 111: Fly Ash Pond - South embankment interior slope. Looking at erosion near water line. Note TRM on slope where recently re-seeded.

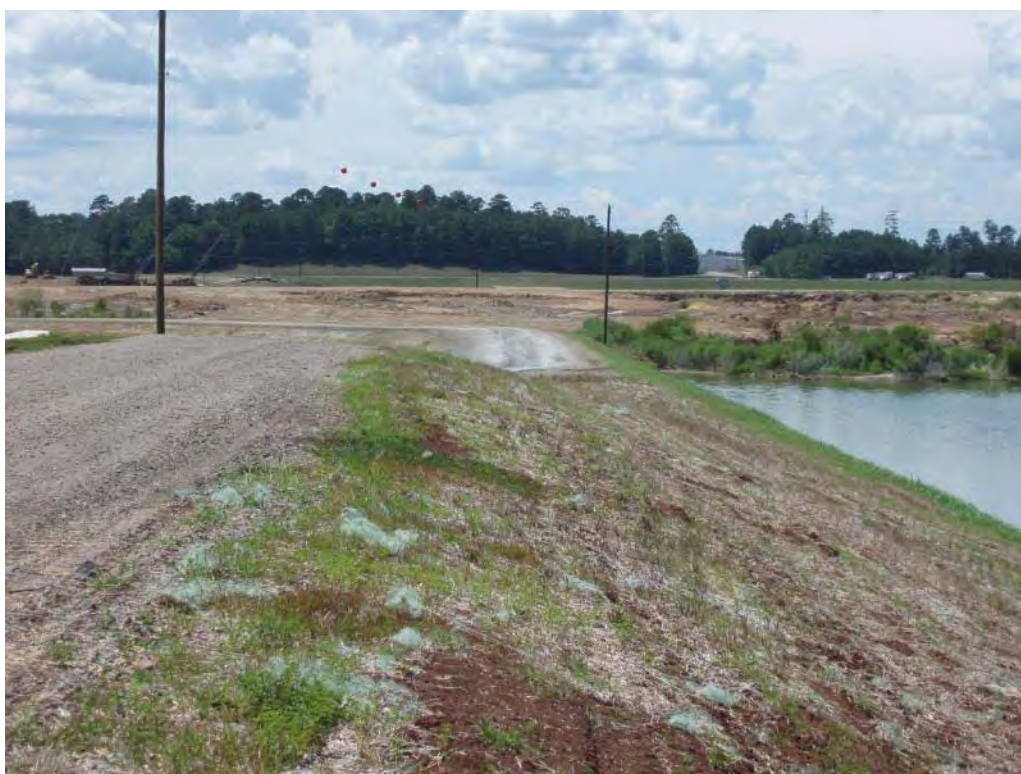
Photo No. 112: Fly Ash Pond - South embankment interior slope, looking northwest.

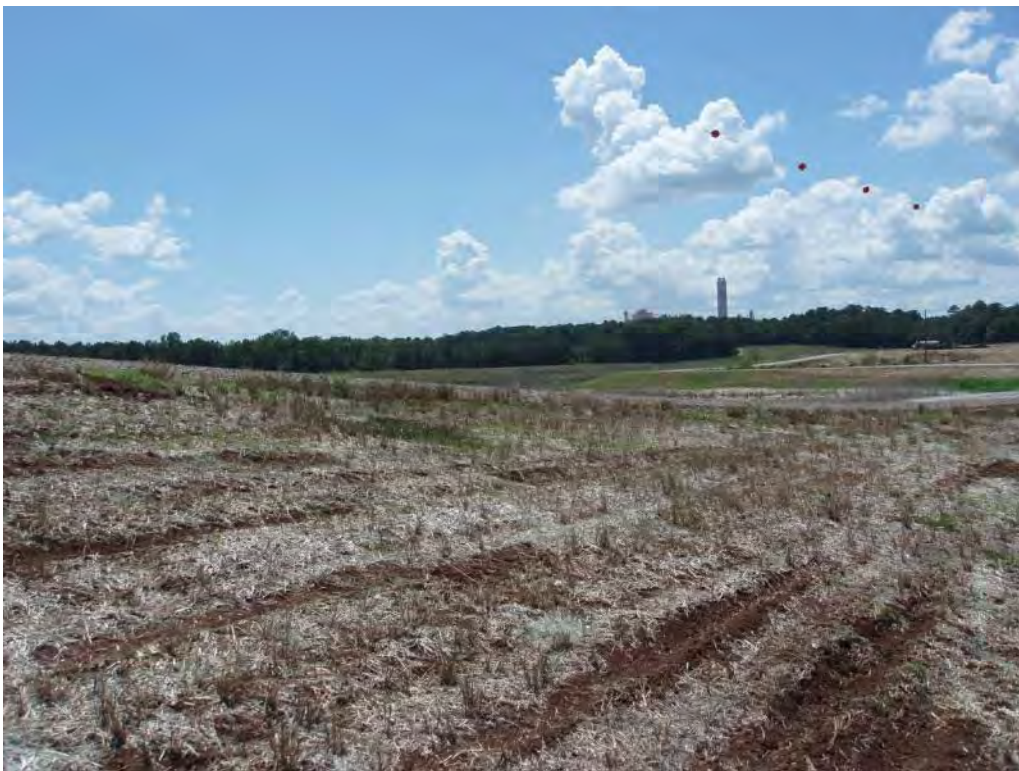
Photo No. 115: Fly Ash Pond - South embankment interior slope, looking northwest. Note area recently re-seeded and covered with TRM.

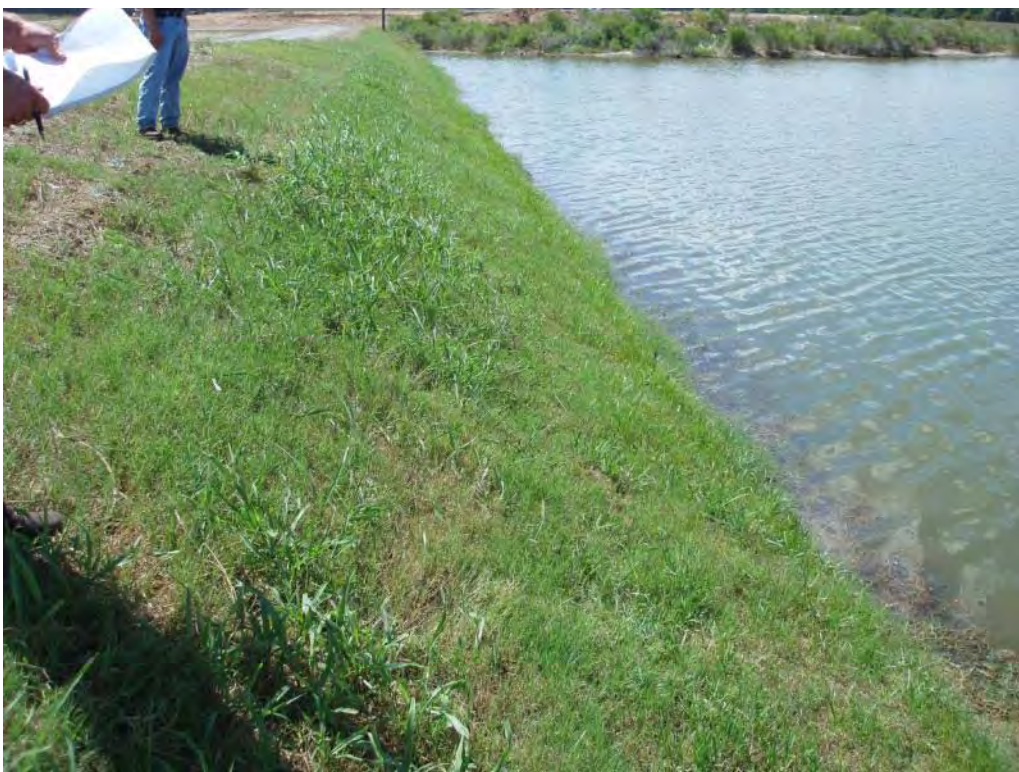
Photo No. 116: Fly Ash Pond - South embankment interior slope, looking northwest.

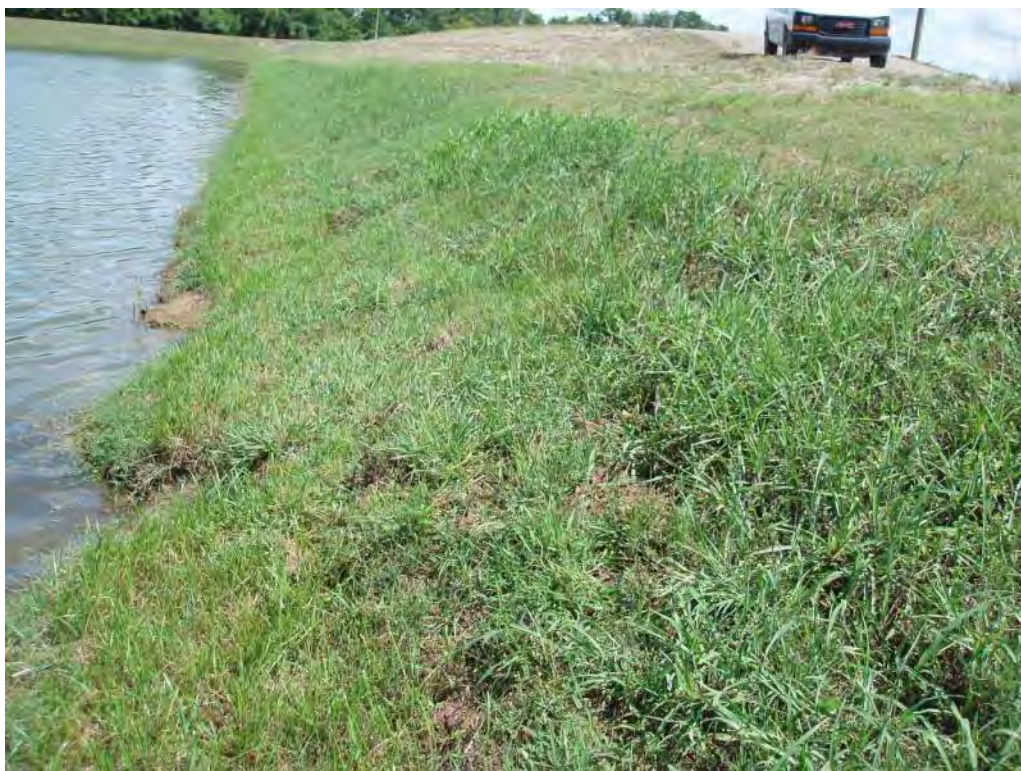
Photo No. 117: Fly Ash Pond - South embankment interior slope, looking southeast. Note erosion near water line.

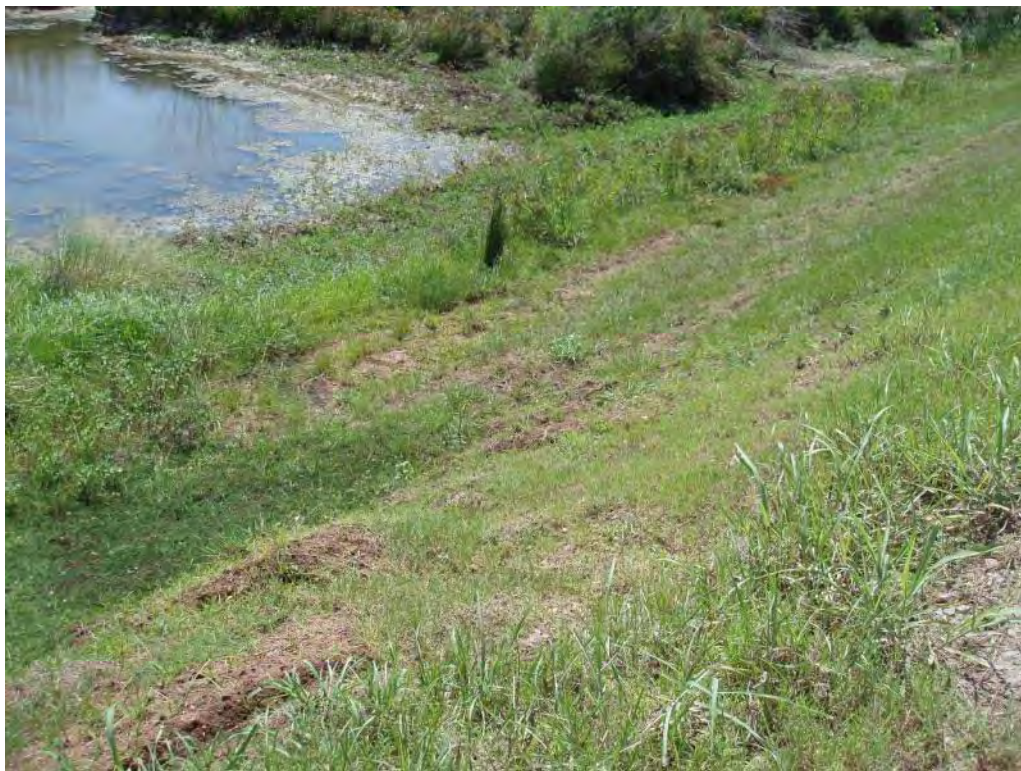
Photo No. 123: Fly Ash Pond - South embankment exterior slope, looking west. Note area of standing water within ash storage area.

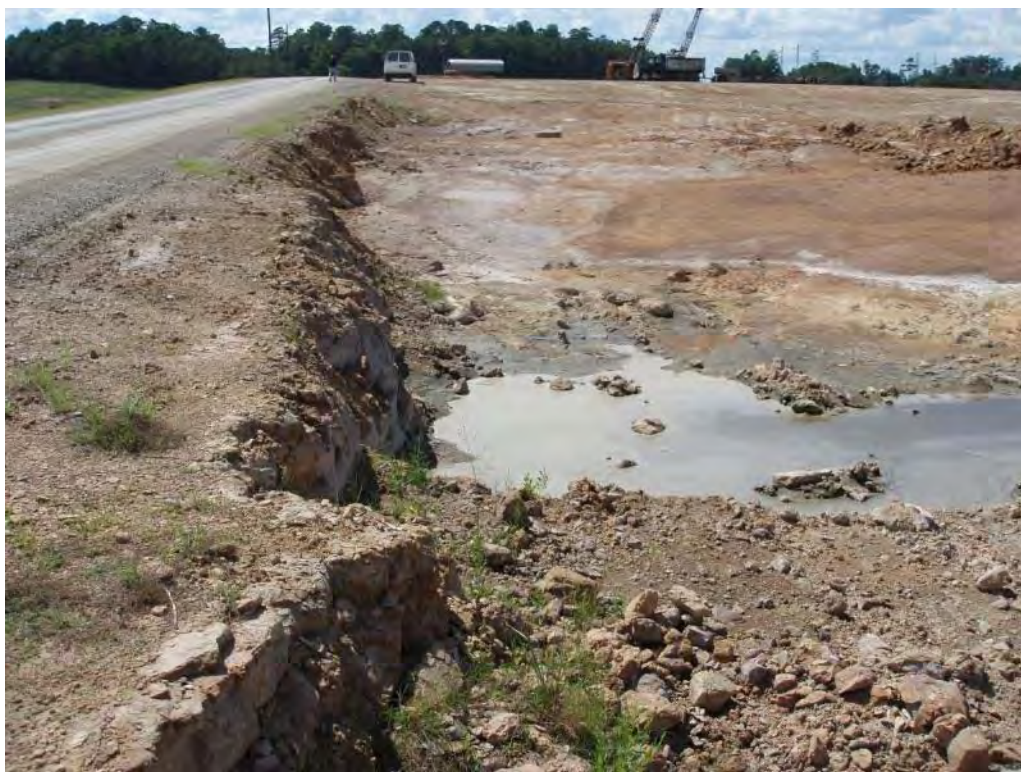
Ash product has been placed along the west (divider) embankment's interior slope and graded to top of crest, effectively increasing the width of the crests to nearly 100 feet (Photographs 127 and 128). Ash product has also been placed along approximately half of the south embankment's interior slope (Photograph 120 and 122). In this area, over-excavation of dry ash product near the west end of the south

embankment appeared to have infringed on the south embankment interior slope, over a distance of approximately 60 feet (Photograph 124).

Photo No. 124: Fly Ash Pond - South embankment interior slope, looking northwest. Note slope has been excavated into during removal of ash material.

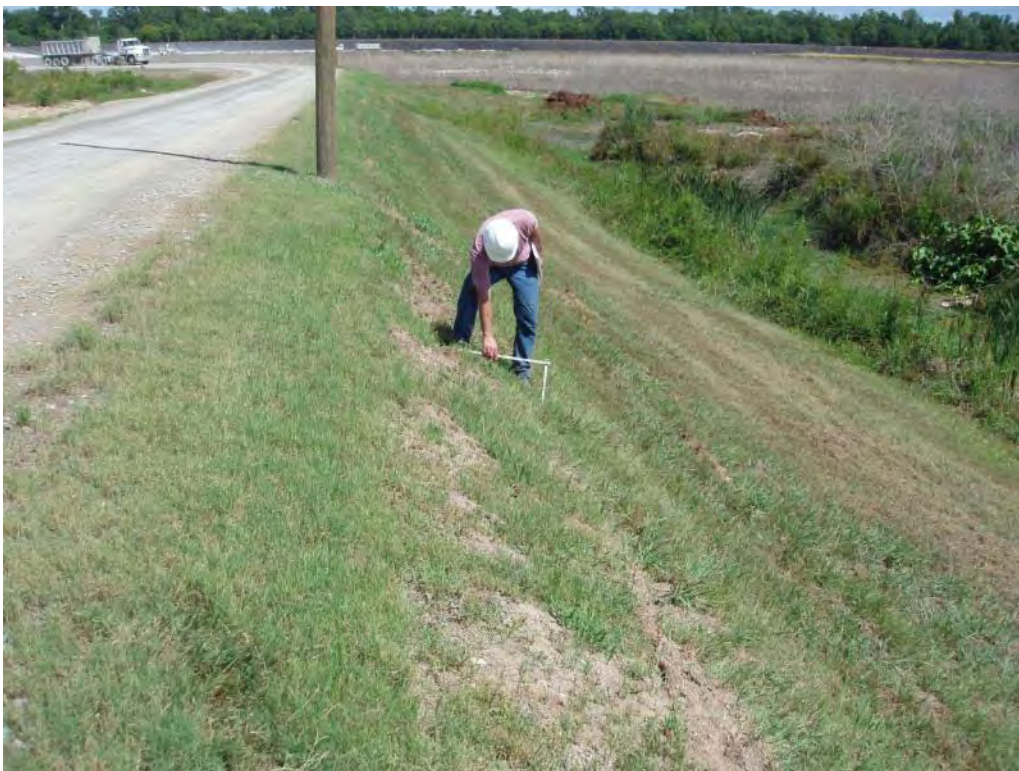
Photo No. 125: Fly Ash Pond – South embankment exterior slope, looking southeast.

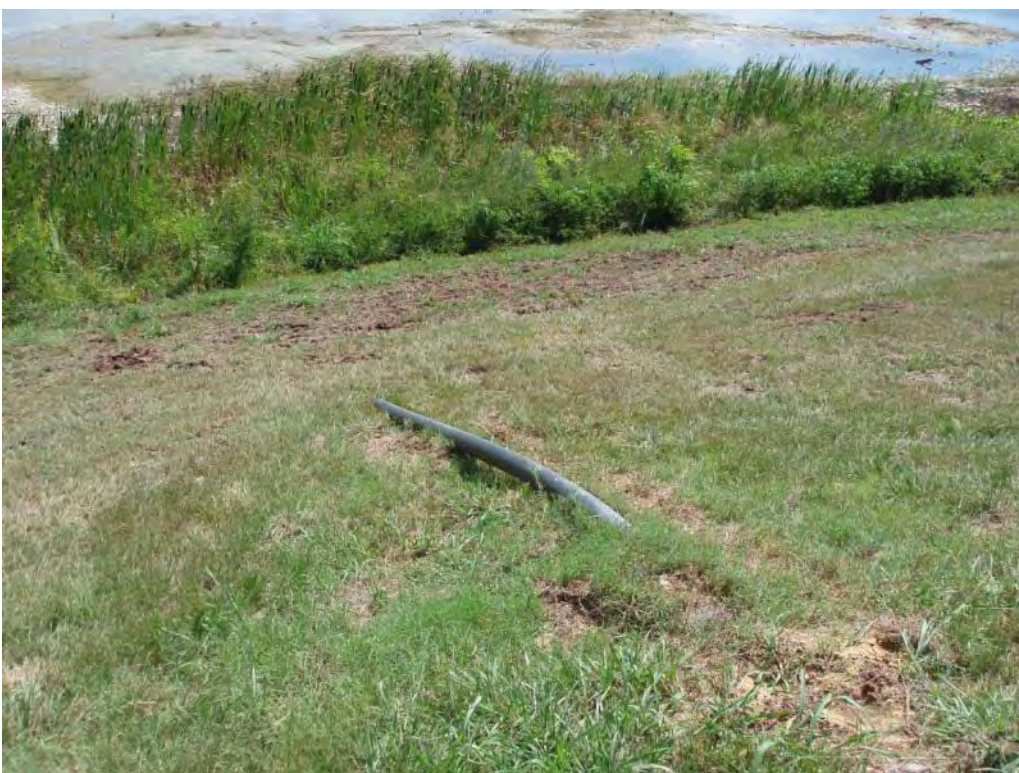
Photo No. 126: Fly Ash Pond – South embankment exterior slope, looking south. Unknown pipe discharging into ash storage area.

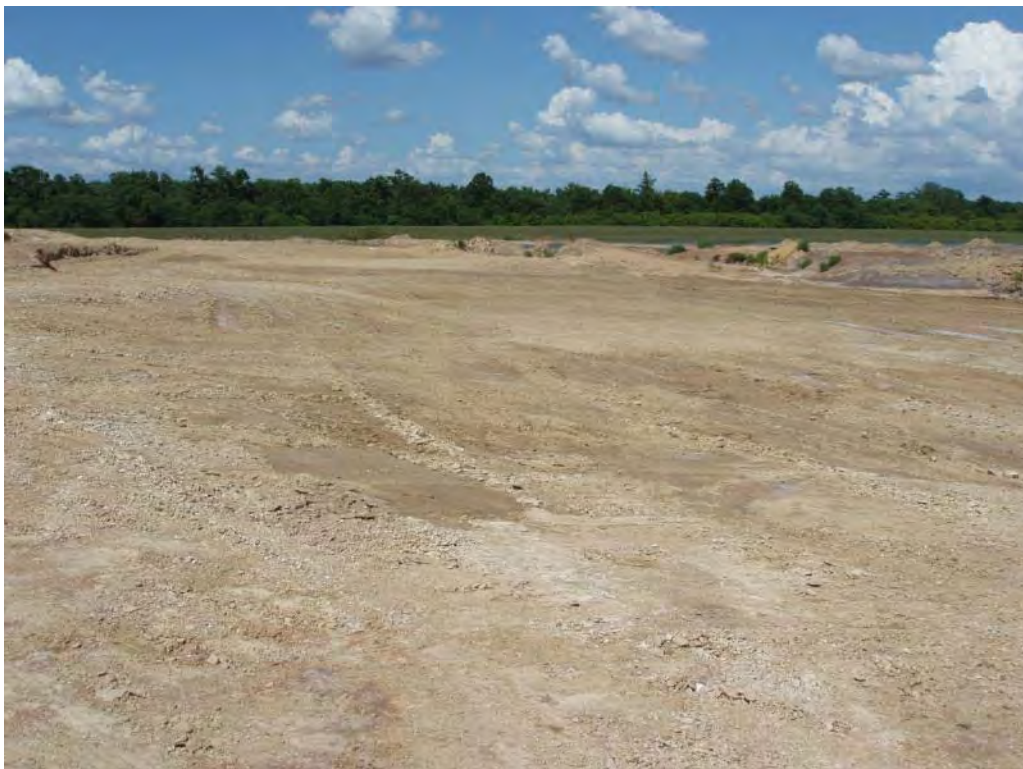
Photo No. 127: Fly Ash Pond - Near southwest corner of pond. Note ash material has been placed up to the crest elevation.

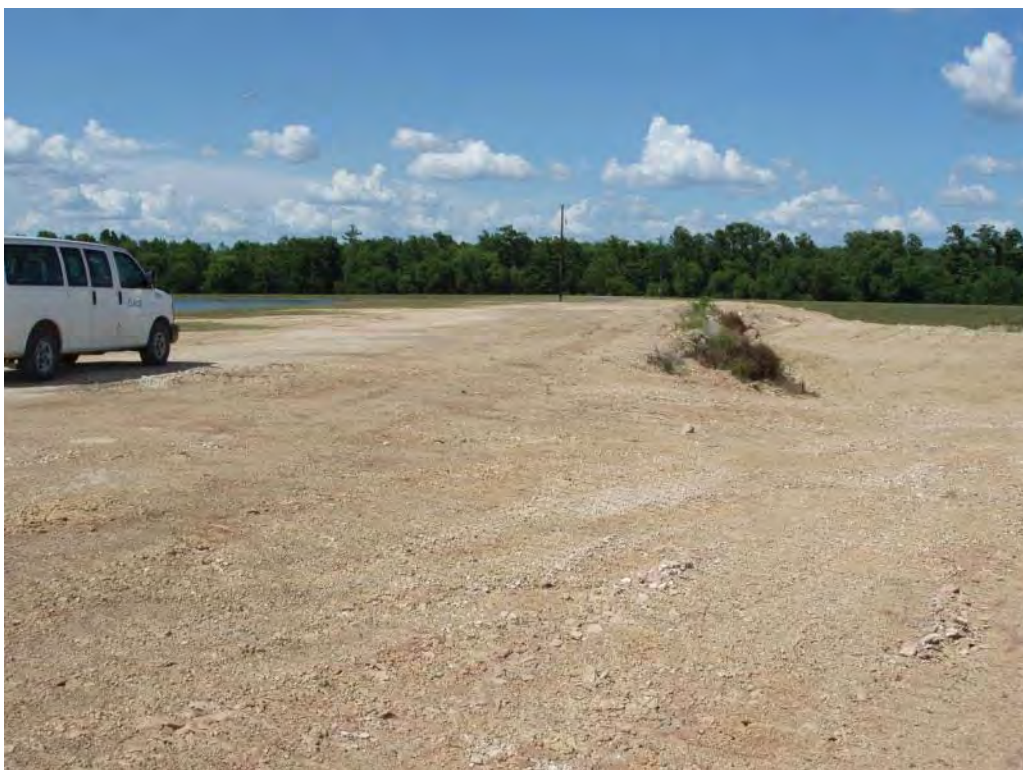
Photo No. 128: Fly Ash Pond - Near southwest corner of pond. Note ash material has been placed up to the crest elevation.

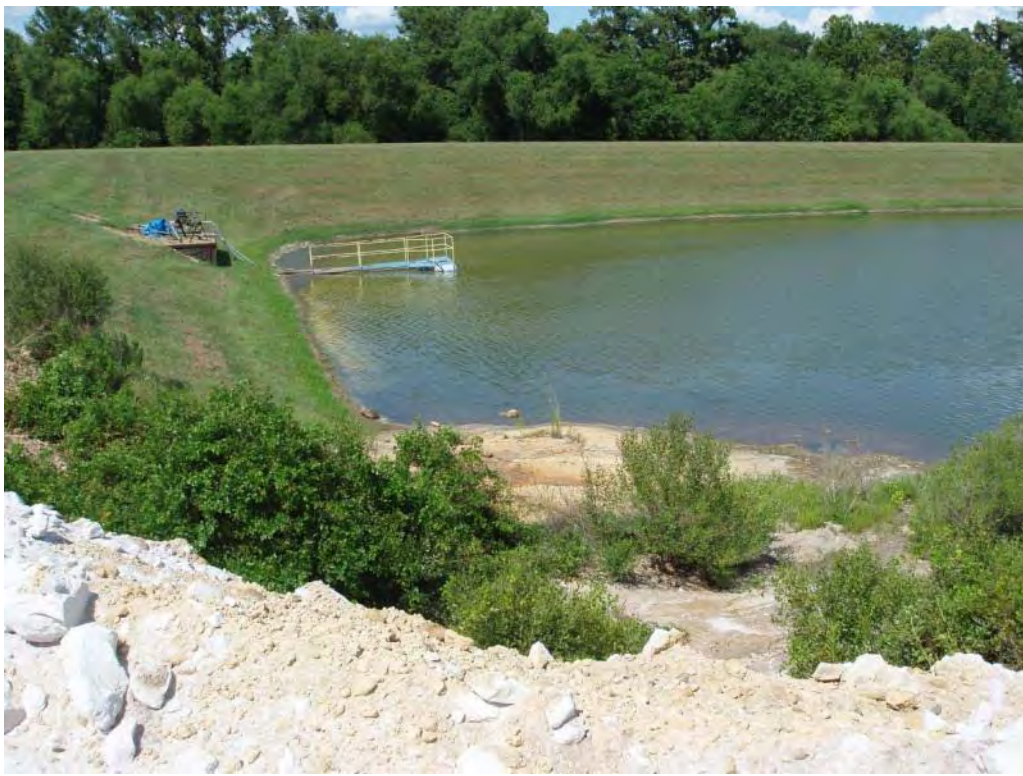
Photo No. 129: Fly Ash Pond - West embankment interior slope, looking northeast. Outlet pump and piping in distance.

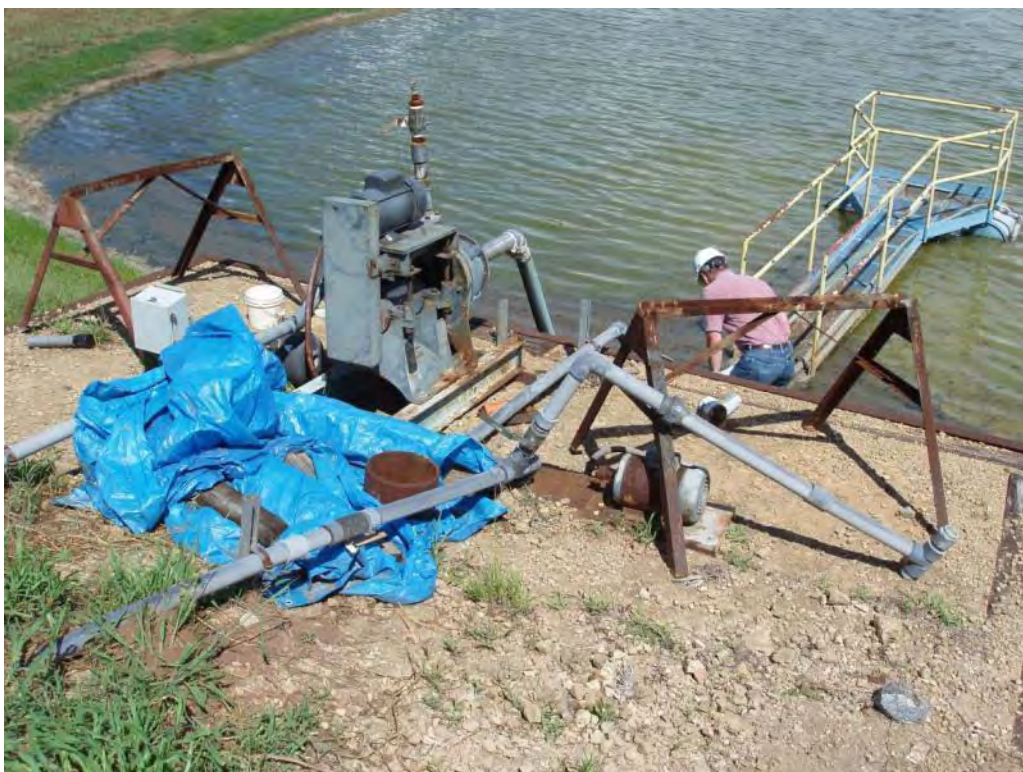
Photo No. 130: Fly Ash Pond - West embankment interior slope, looking east. Outlet pump and piping.

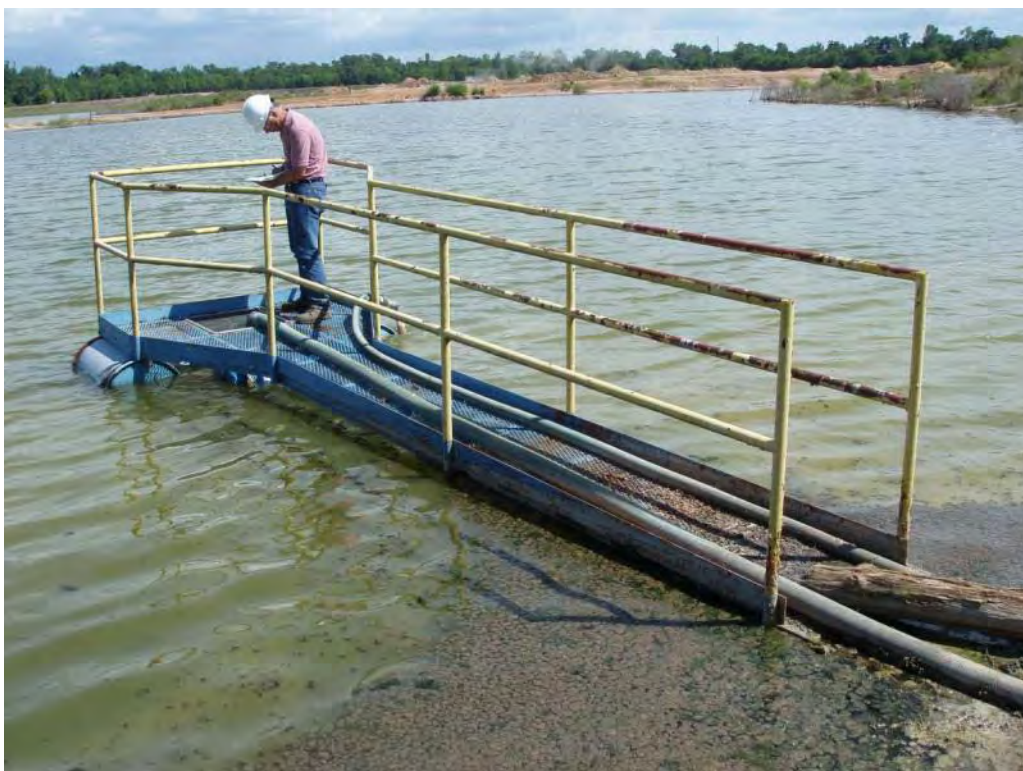
Photo No. 131: Fly Ash Pond – Outlet piping near northwest corner.

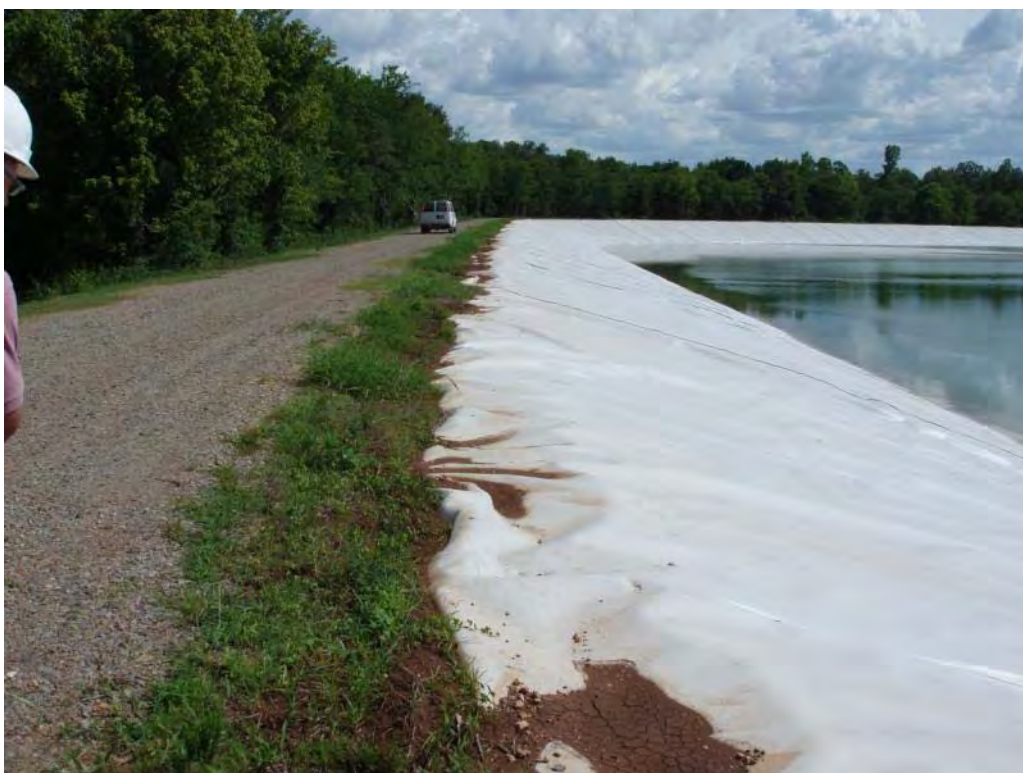
The embankment crest appeared to be in good condition (Photographs 132, 136, 138 and 143). The embankment crest is approximately 30 feet wide, and serves as an access road around the entire perimeter of the impoundment. The crest's surface consists of compacted granular material. Sparse vegetation was observed on the outer edges of the crest, consisting primarily of grasses less than 3 inches in height (Photograph 140). Significant longitudinal cracking, approximately 1 to 2 inches wide

Photo No. 132: Leachate Pond – East embankment interior slope and crest.

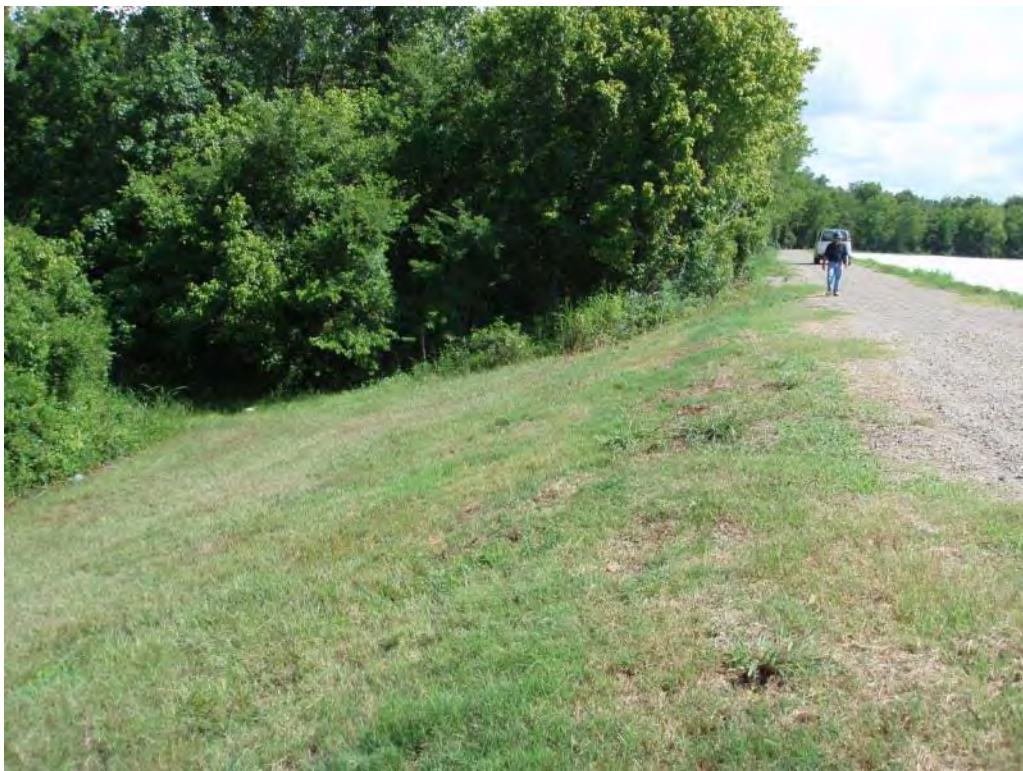
Photo No. 133: Leachate Pond - East embankment exterior slope, looking southeast. Note dense vegetation covering slope.

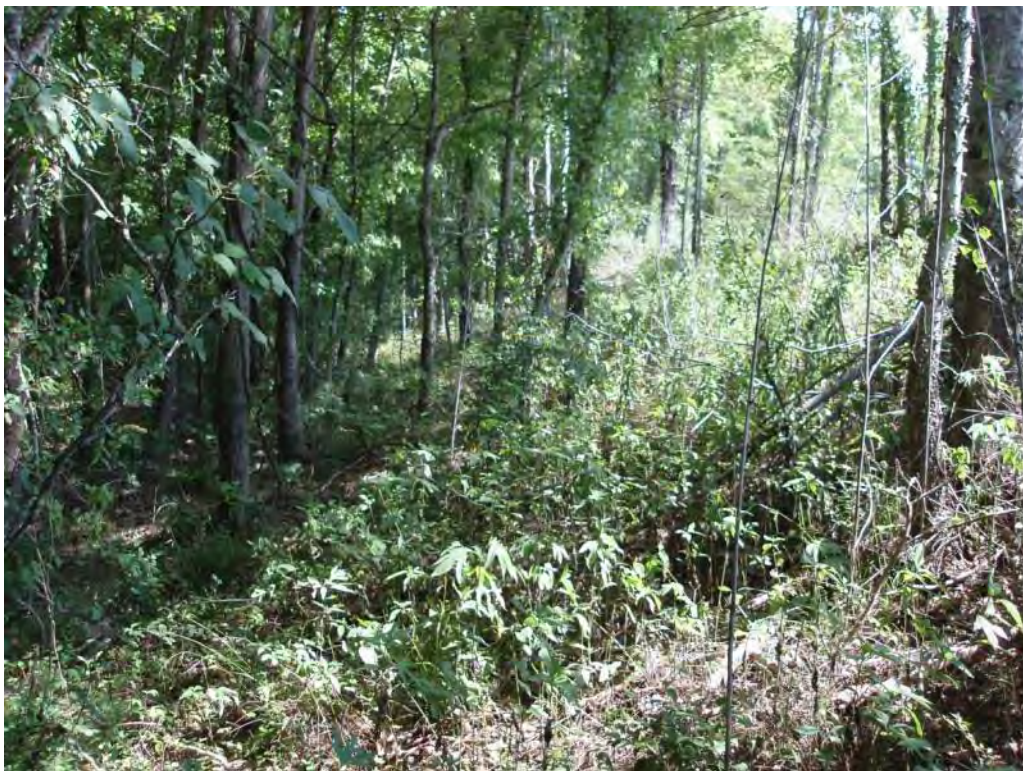
Photo No. 135: Leachate Pond - East embankment exterior slope. Looking at dense vegetation covering slope.

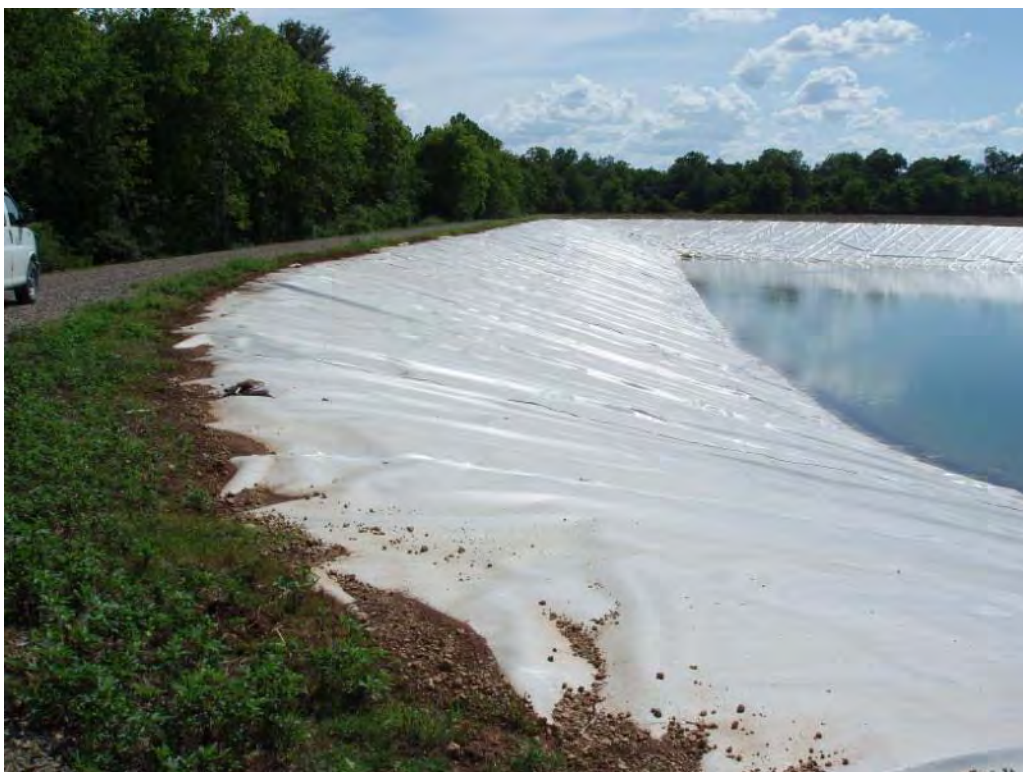
Photo No. 136: Leachate Pond - South embankment interior slope, looking southwest.

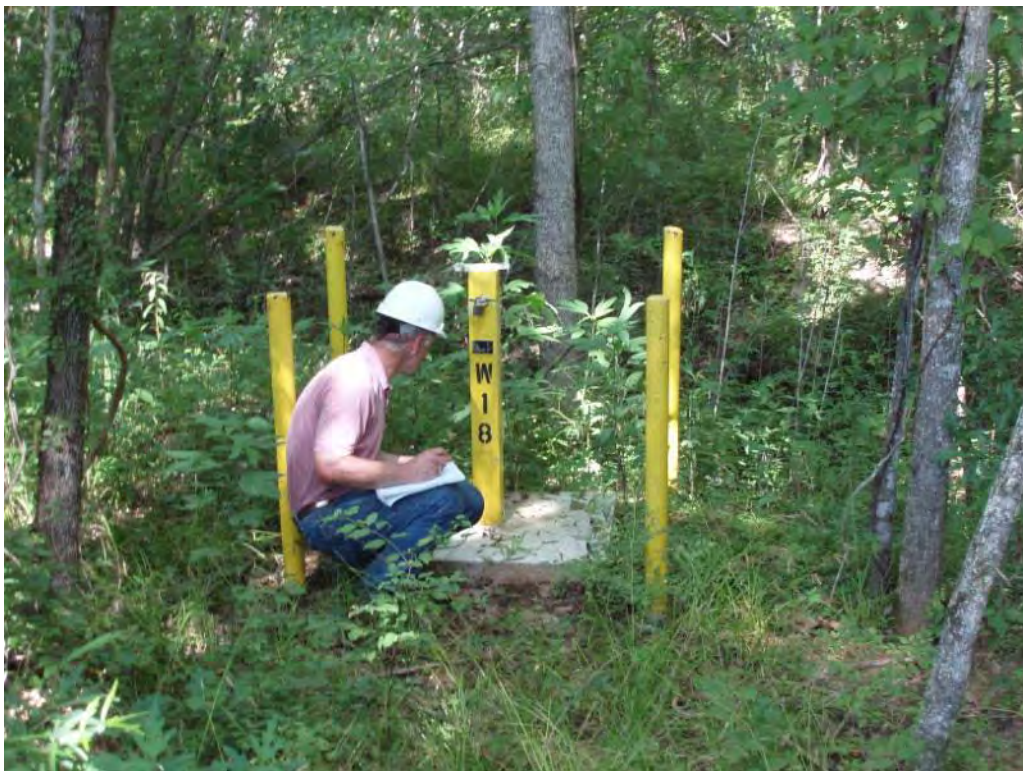
Photo No. 137: Groundwater Monitoring Well W-18, located near the southeast corner of the Leachate Pond.

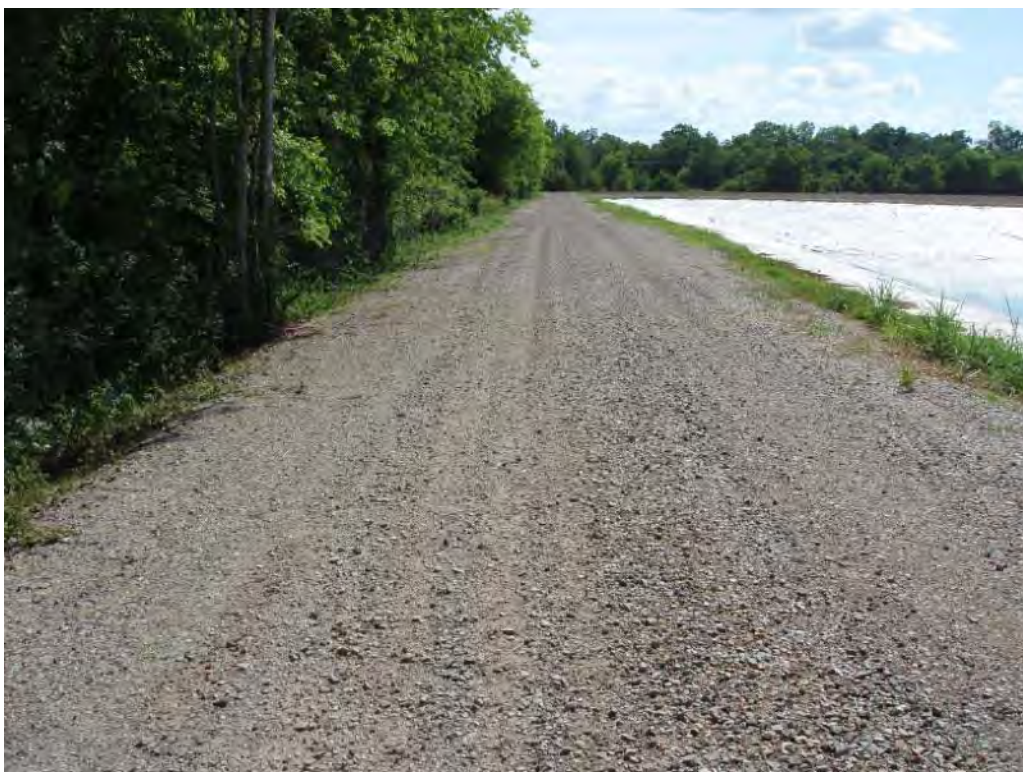
Photo No. 138: Leachate Pond - South embankment crest, looking southeast.

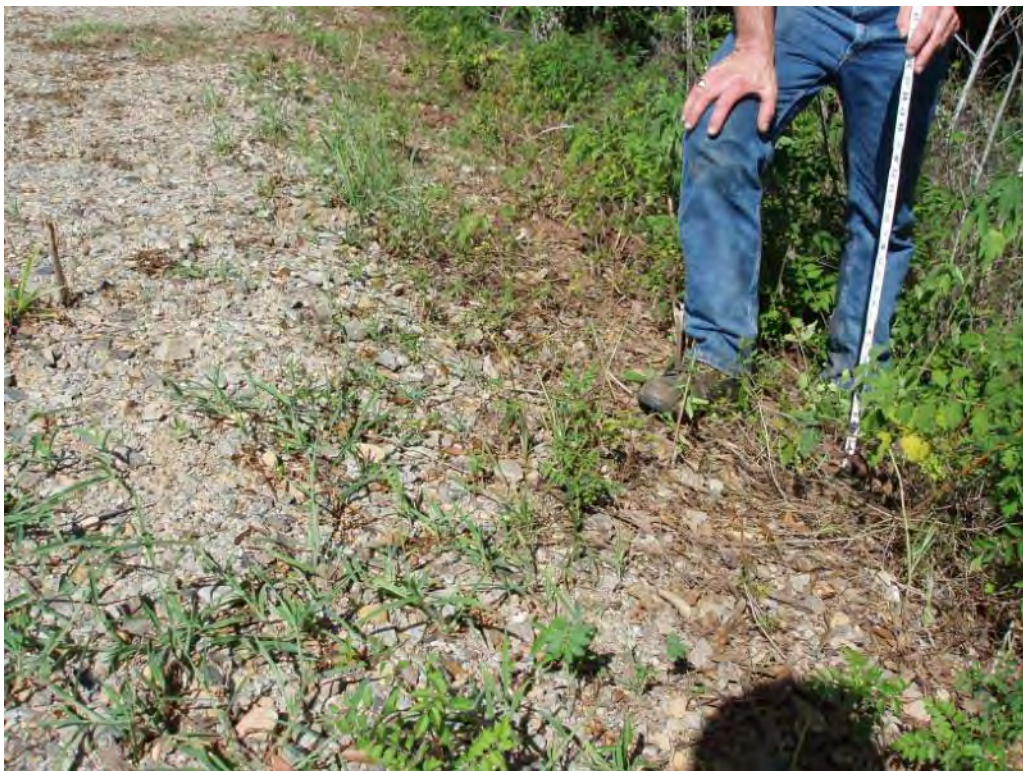
Photo No. 139: Leachate Pond – South embankment exterior slope. Looking at extent of granular surfacing on crest.
