Assessment of Dam Safety of Coal Combustion Surface Impoundments

Cleco Corporation

Brame Energy Center

March 14, 2011

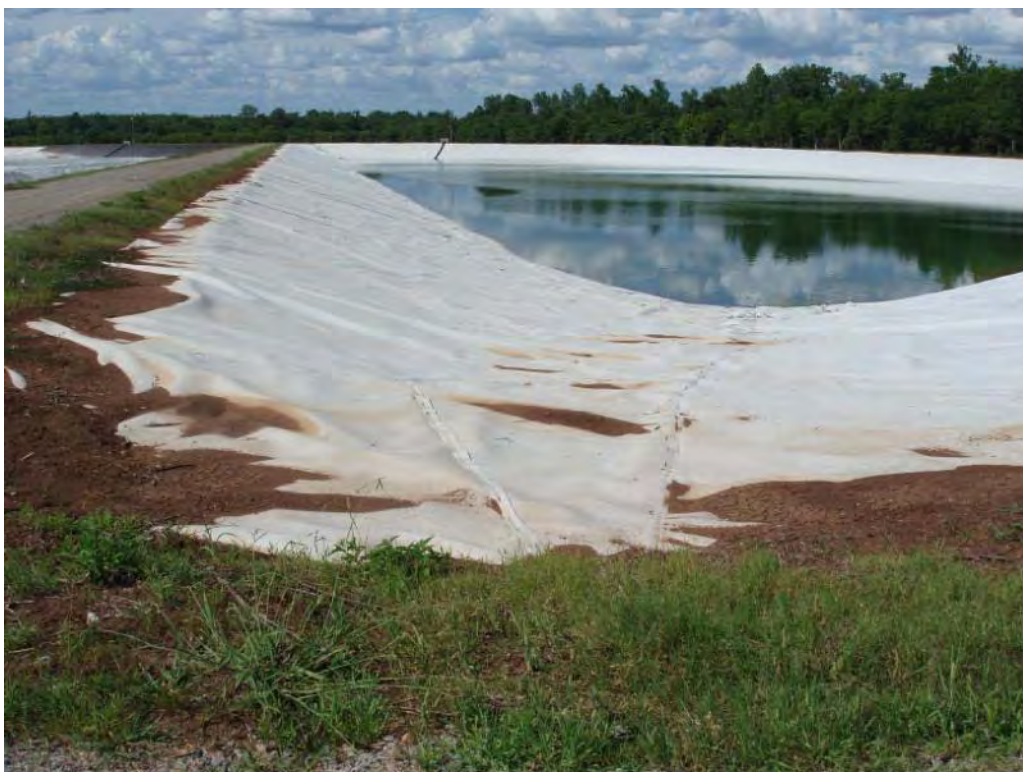
The embankment crest appeared to be in good condition (Photographs 132, 136, 138 and 143). The embankment crest is approximately 30 feet wide, and serves as an access road around the entire perimeter of the impoundment. The crest's surface consists of compacted granular material. Sparse vegetation was observed on the outer edges of the crest, consisting primarily of grasses less than 3 inches in height (Photograph 140). Significant longitudinal cracking, approximately 1 to 2 inches wide

Photo No. 140: Leachate Pond – Southwest corner of pond, looking northeast.

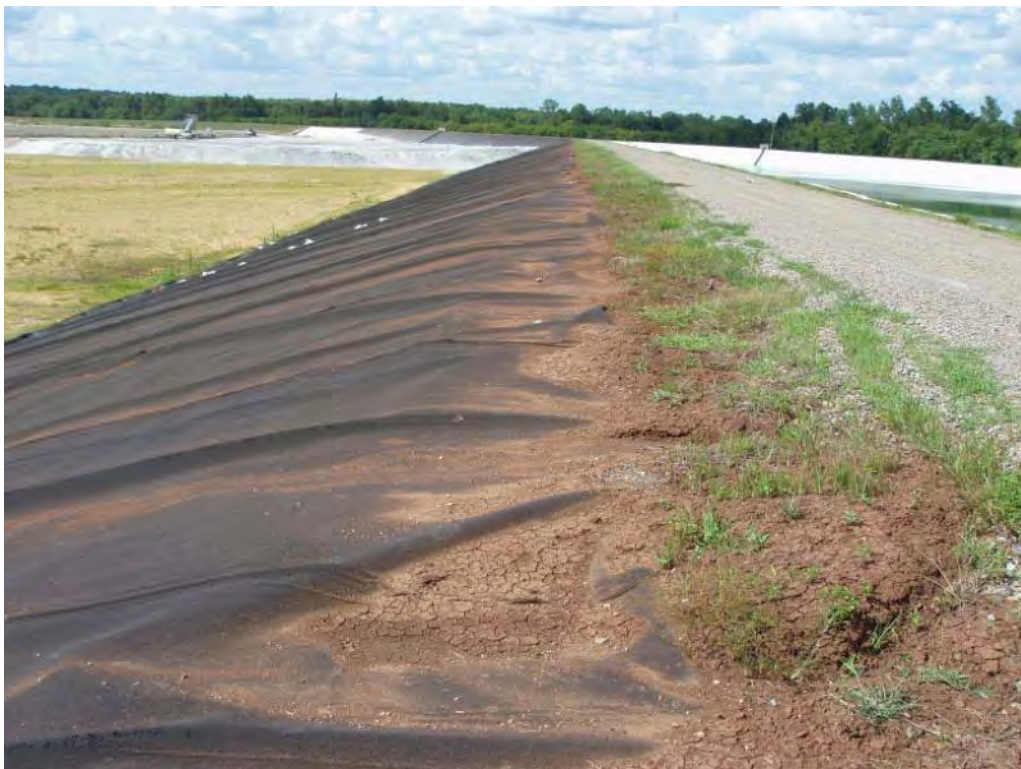
Photo No. 141: Leachate Pond - West embankment exterior slope, looking north. Divider embankment with coal ash landfill covered with geotextile fabric.

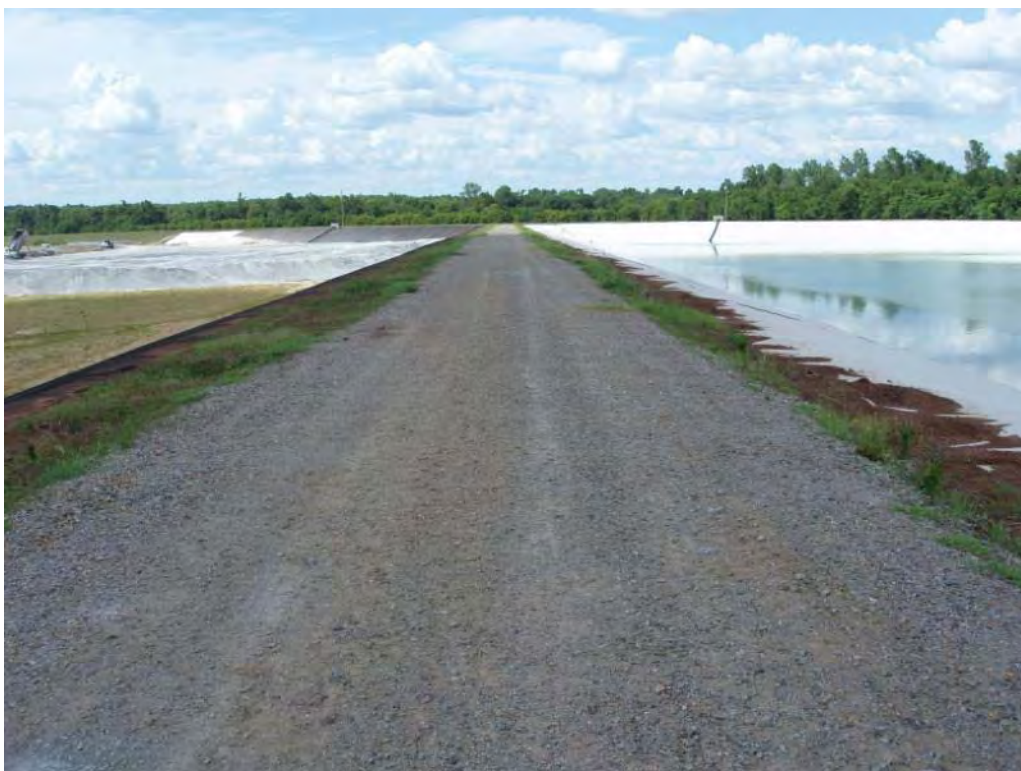
Photo No. 143: Leachate Pond – West embankment crest, looking north.

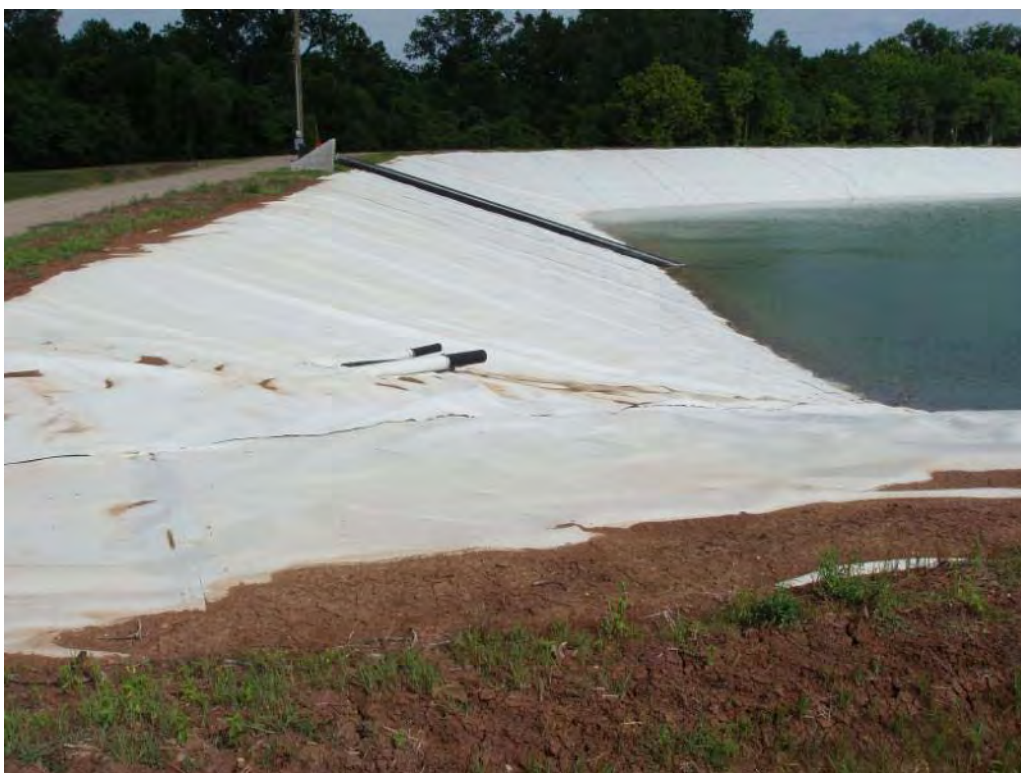
The outlet pipe in the Leachate Pond appears to be in good condition (Photograph 144). Outflow from the Leachate Pond is through the pump station located on the north embankment of the pond. Water pumped from the Leachate pond is either discharged into Lake Rodemacher in accordance with the Power Station's LPDES Permit, reused in the ash hydration process, or used for on-site dust control.

Photo No. 144: Leachate Pond – Northwest corner, looking east. Two discharge pipes into pond. Outlet pump and piping in background.
