# ASSESSMENT OF DAM SAFETY OF COAL COMBUSTION SURFACE IMPOUNDMENTS – DRAFT REPORT

**San Miguel Electric  
Cooperative, Inc.  
San Miguel Electric Plant  
Christine, Texas**

Prepared for  
*U.S. Environmental  
Protection Agency  
Washington, D.C.*

November 2012  
Revision 2, December 2013

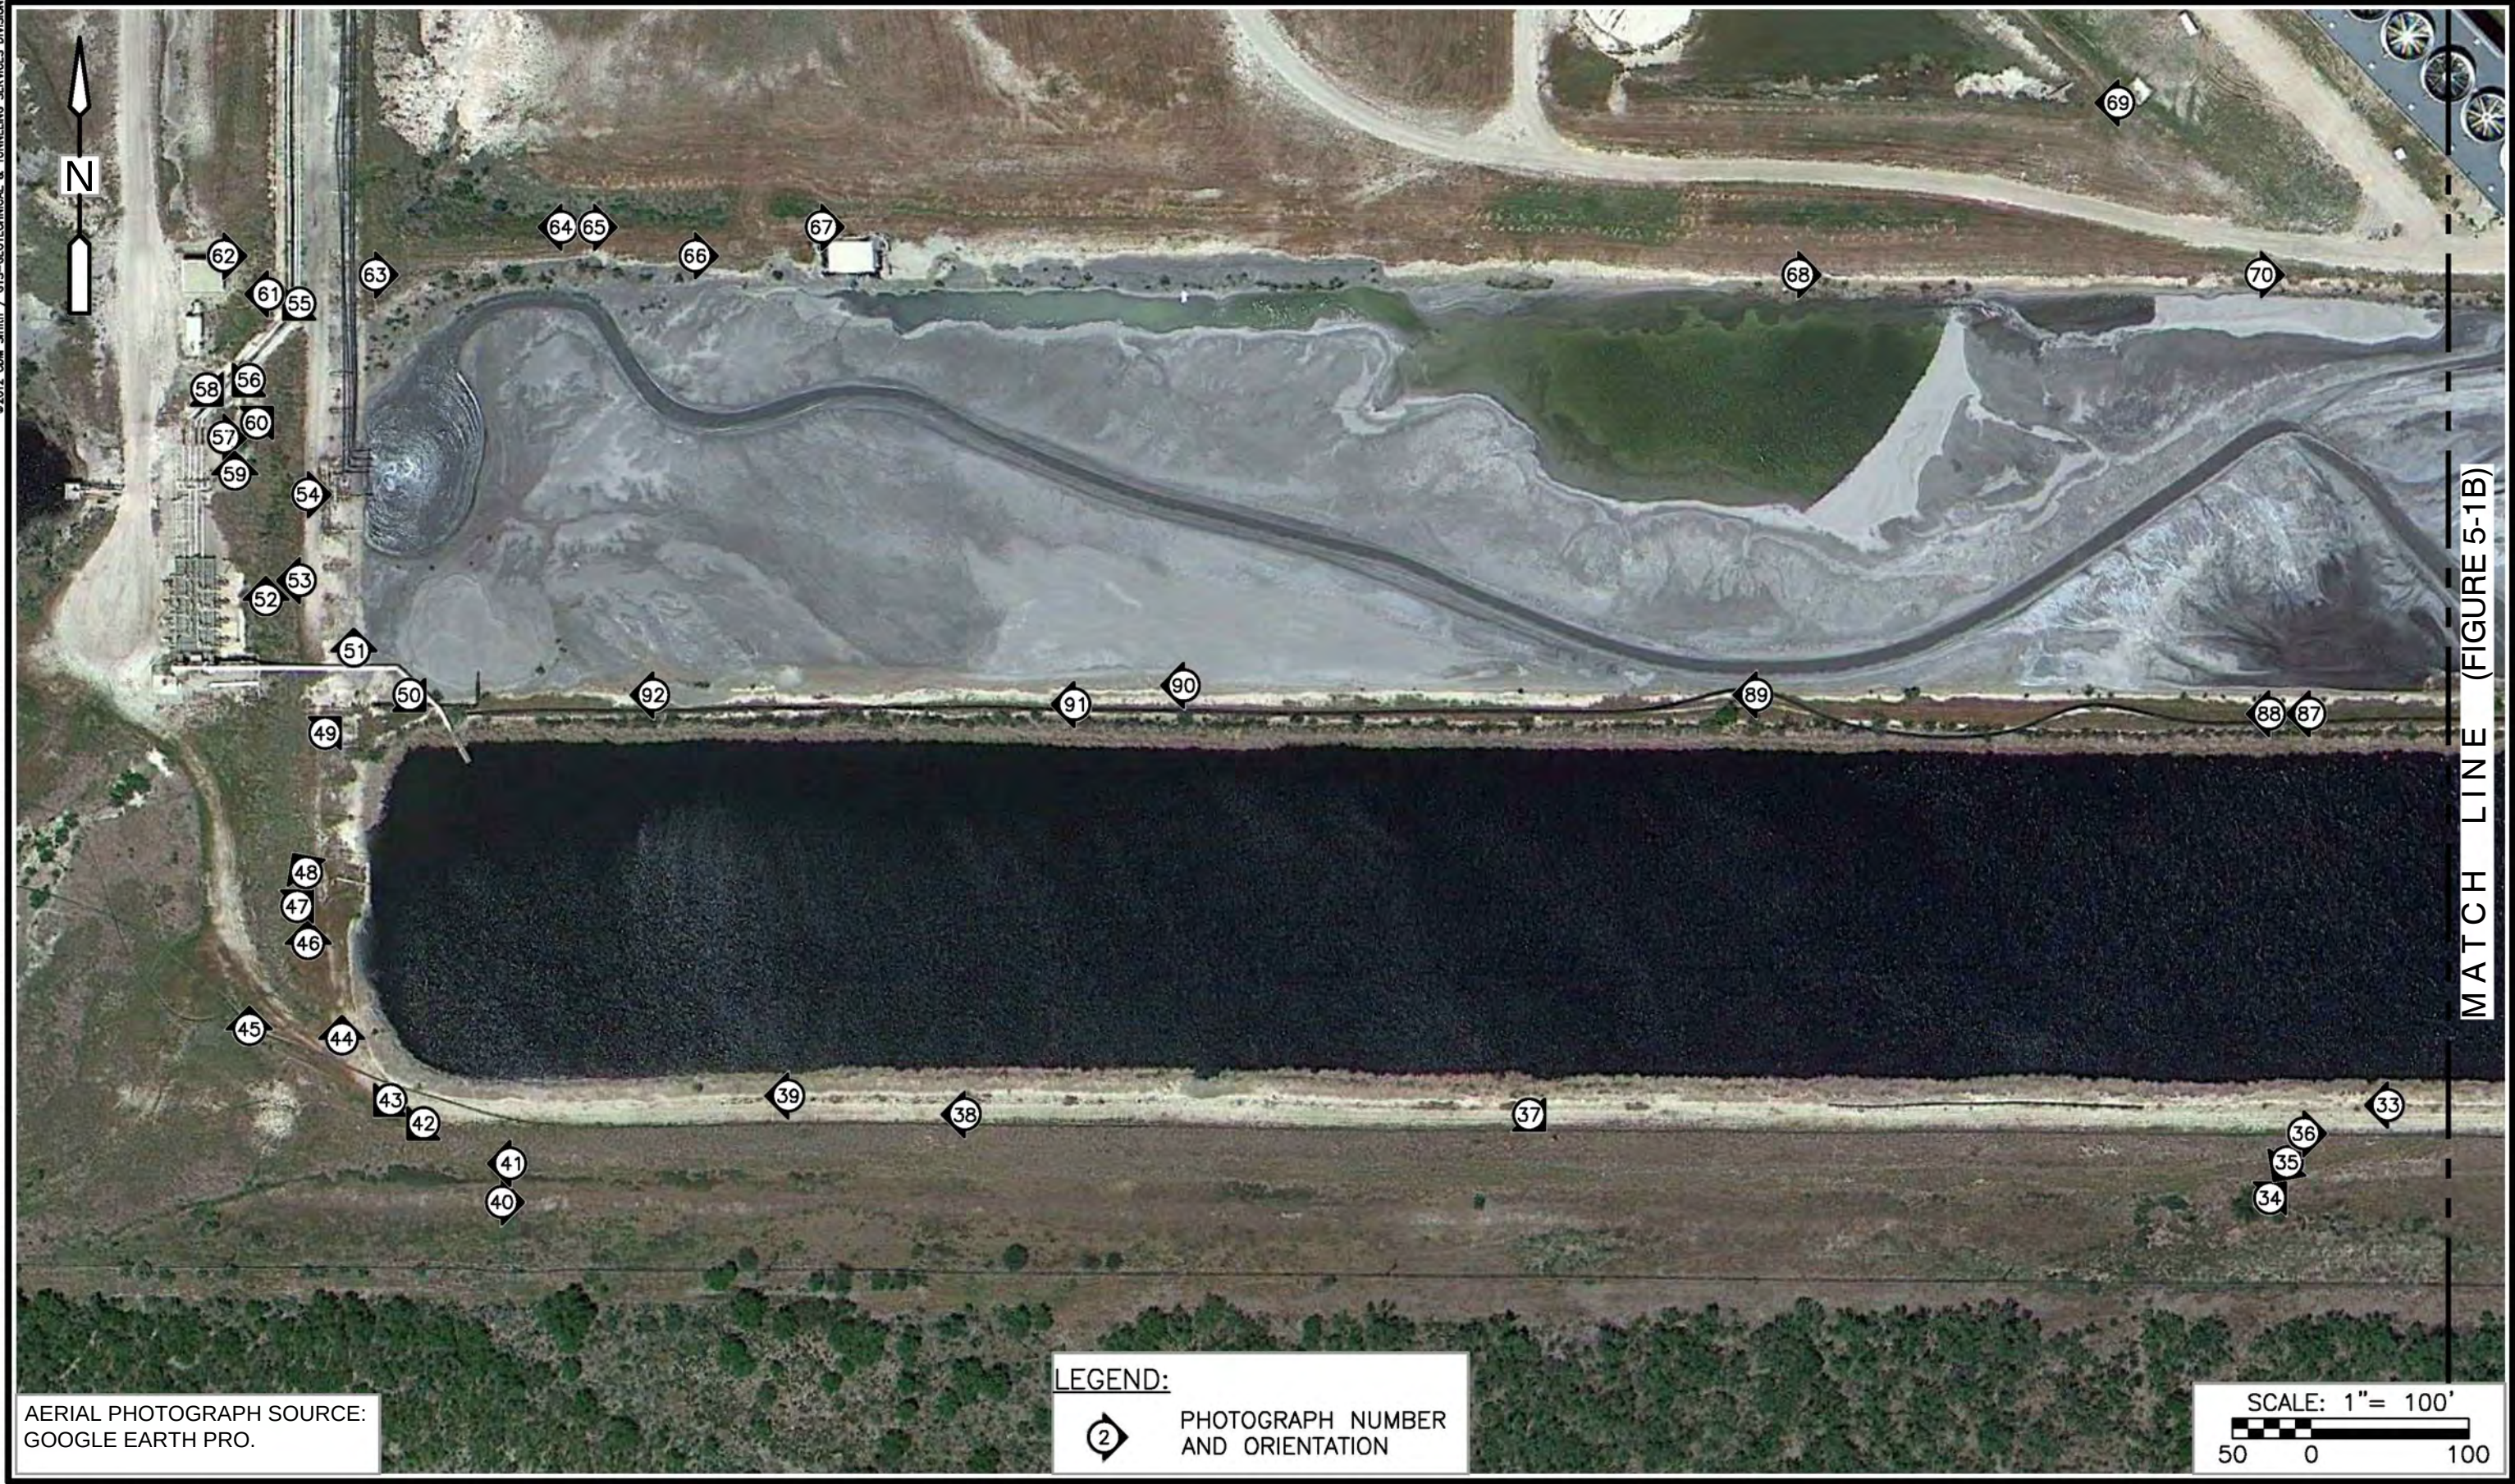
SAN MIGUEL POWER PLANT  
CHRISTINE, TEXAS  
ASH WATER TRANSPORT POND PHOTOGRAPH LOCATION PLAN  
FIGURE 5-1A

At the time of the assessment, the Ash Pond contained ash and liquids with approximately 0.5 feet of freeboard. An overview of the photographs taken at the Ash Pond during the CDM Smith site assessment is included in **Figure 5-1A** and **5-1B**.

The crest of the Ash Pond appeared to be in satisfactory condition (Photographs 1, 21, 46, 72 and 82). The center embankment separating the Ash Pond into north and south sections included a metal gate structure that is kept open during normal operating conditions (Photographs 7, 9, and 78). Areas showing signs of tension or desiccation cracks were observed on the crest near the southeast and southwest corners of the impoundment (Photograph 13). Animal burrows were observed on the crest near the southwest corner (Photograph 42). The 15 to 35-foot-wide crest of the embankment consists of compacted granular soils and gravel and is exposed to minimal vehicle traffic. Support poles for overhead powerlines were located on the crest of the south embankment (Photograph 27). No depressions or evidence of settlement were observed on the crest.

Due to the water level in the Ash Pond during the assessment, only the upper 0.5 to 1 foot of the interior slopes was visible (Photographs 2, 22, 51, 66, and 86). Based on drawings, the interior slopes are 2.5H:1V. An area of erosion into the interior slope approximately 5 feet wide was observed on the east embankment (Photograph 15). Reportedly, this erosion was a result of leakage from a water well pipe traversing the Ash Pond embankment. The water well pipe had been repaired at the time of the site assessment. Minor slope erosion was observed on the east embankment interior slope (Photograph 3). Minor erosion rills were observed on the south embankment interior slopes (Photographs 23 through 26). Grass, approximately 18 inches in height, covered some portions of the interior slopes that were visible (Photographs 2, 33, 63, and 84). Visible portions of interior slopes did not include riprap or other armoring.

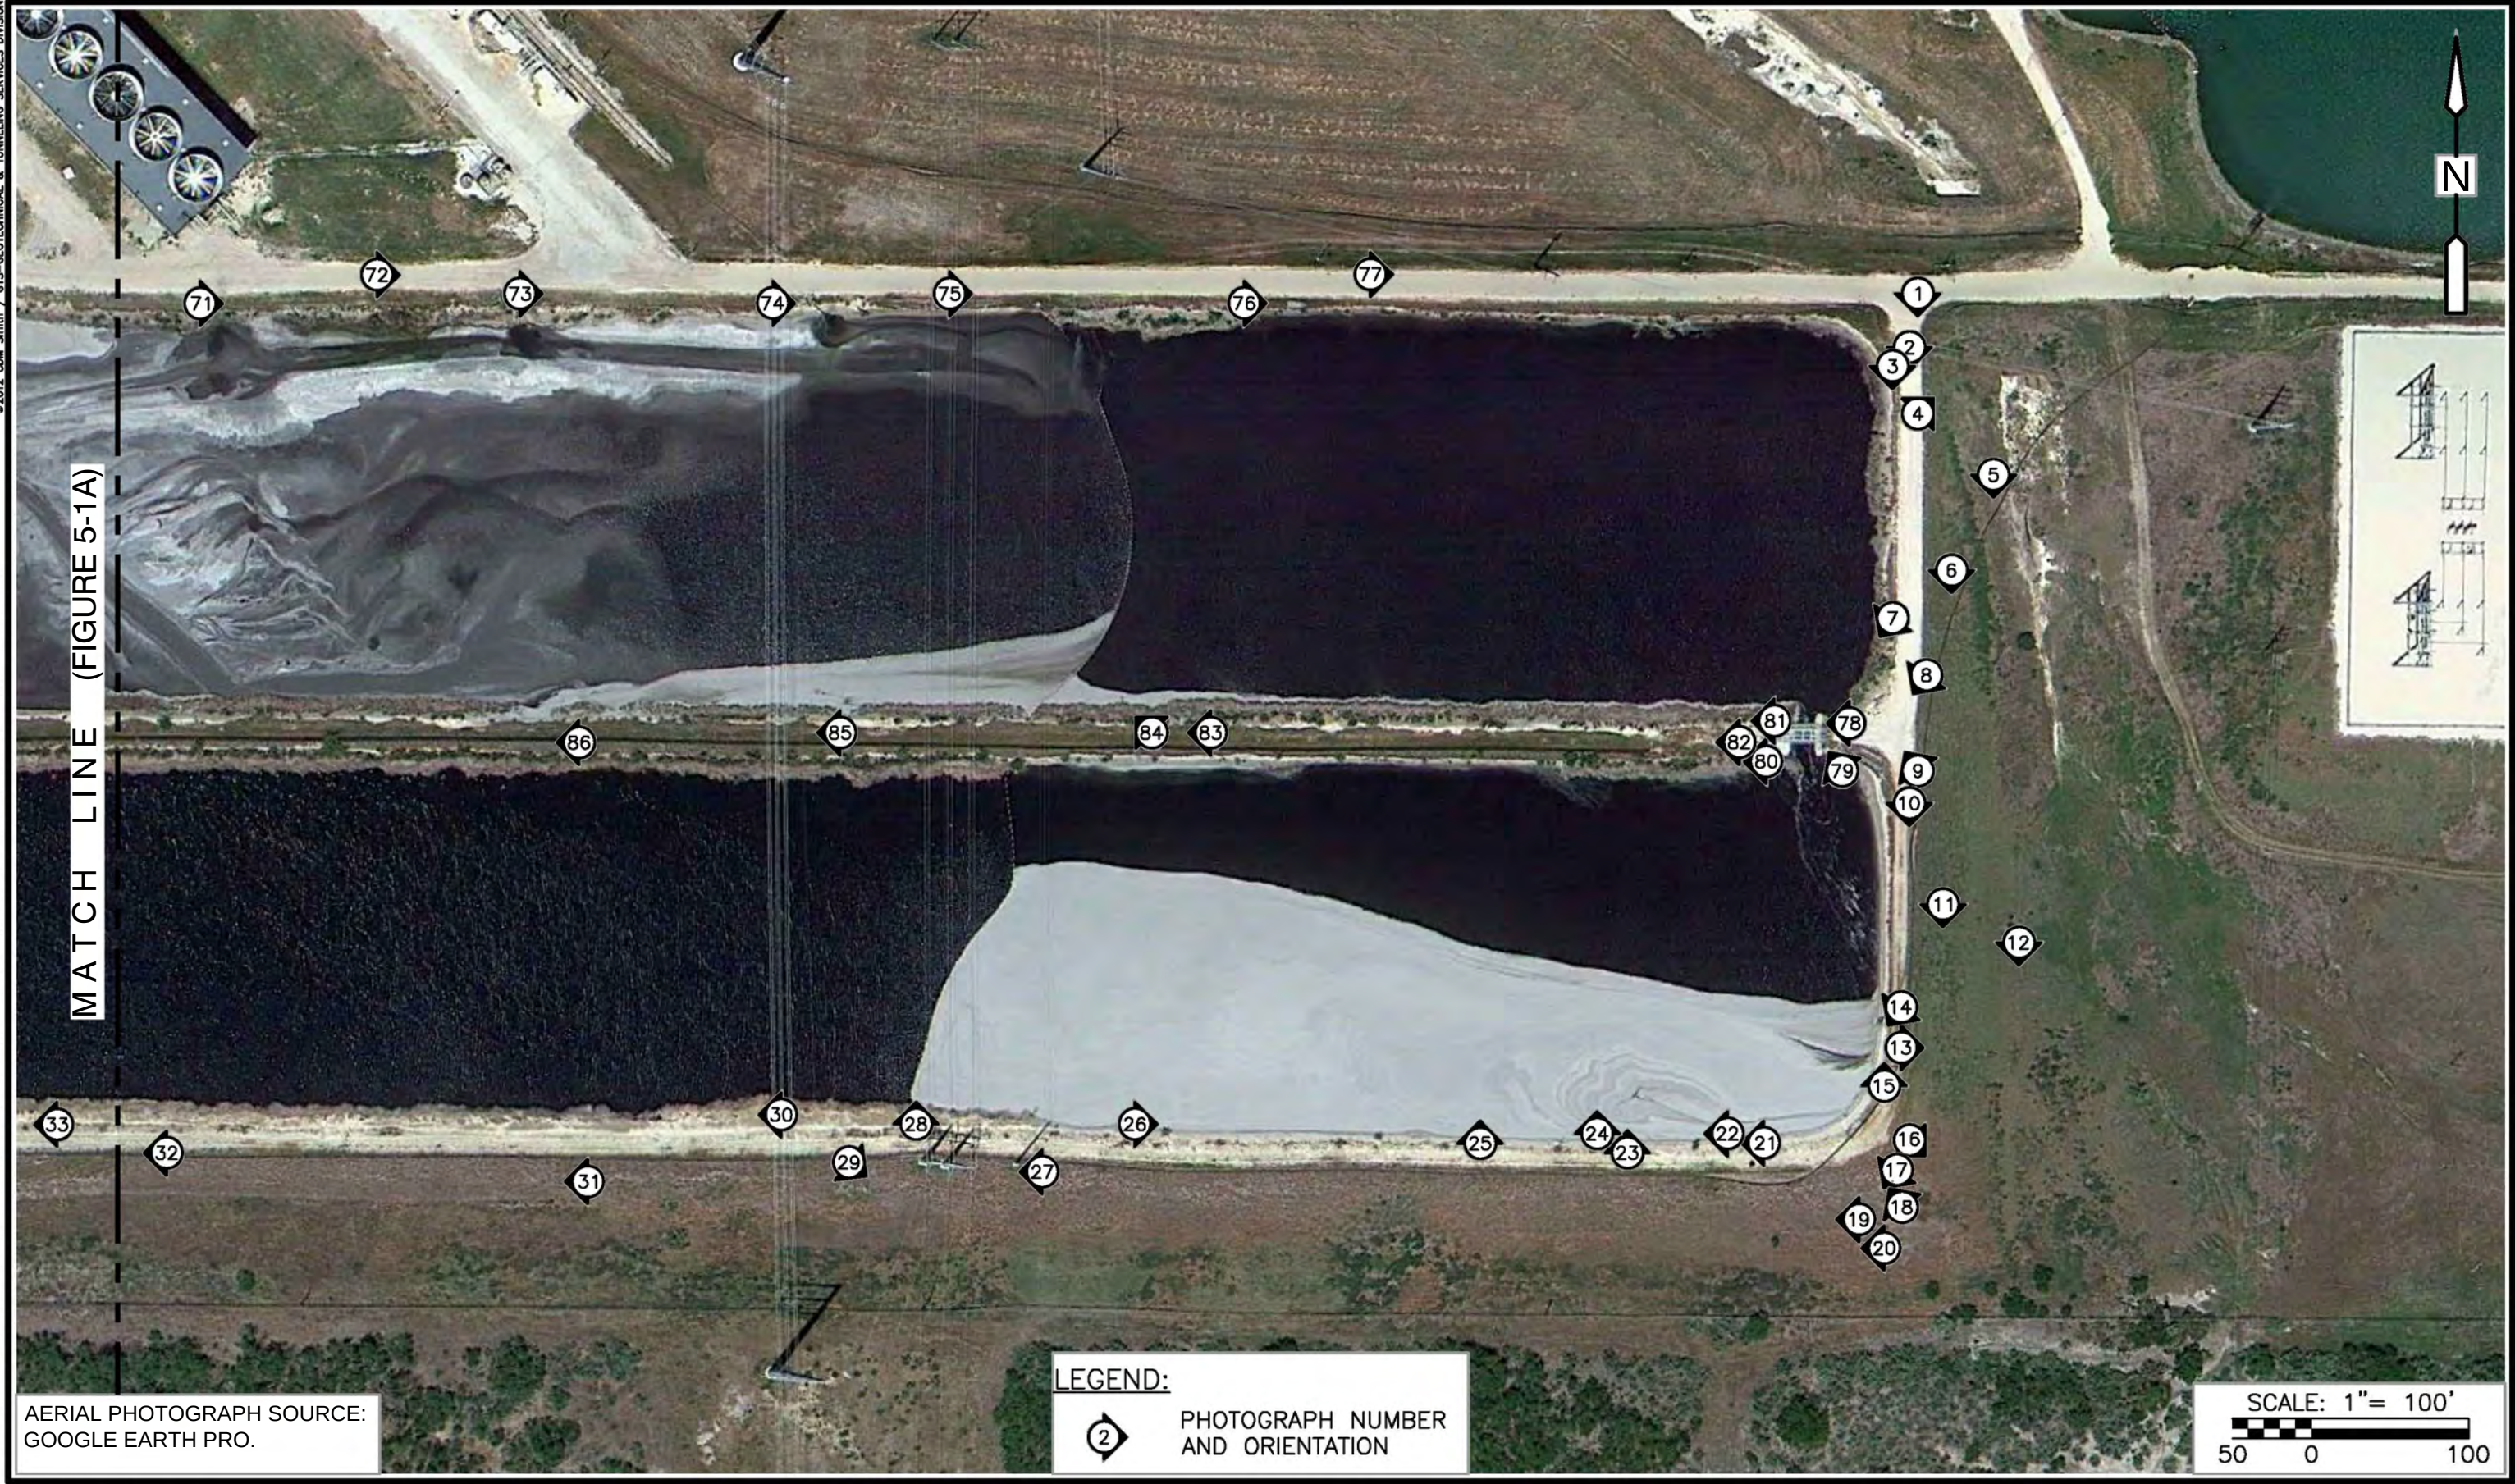
SAN MIGUEL POWER PLANT  
CHRISTINE, TEXAS  
ASH WATER TRANSPORT POND PHOTOGRAPH LOCATION PLAN  
FIGURE 5-1B

(Photograph 16) and on the west embankment near the potential seepage area (Photograph 58). The exterior slopes are approximately 2.5H:1V and covered in grassy vegetation approximately 2 feet tall (Photographs 5, 19, and 52). The coal pile runoff pond is approximately 100 feet west of the west embankment exterior toe (Photograph 48).

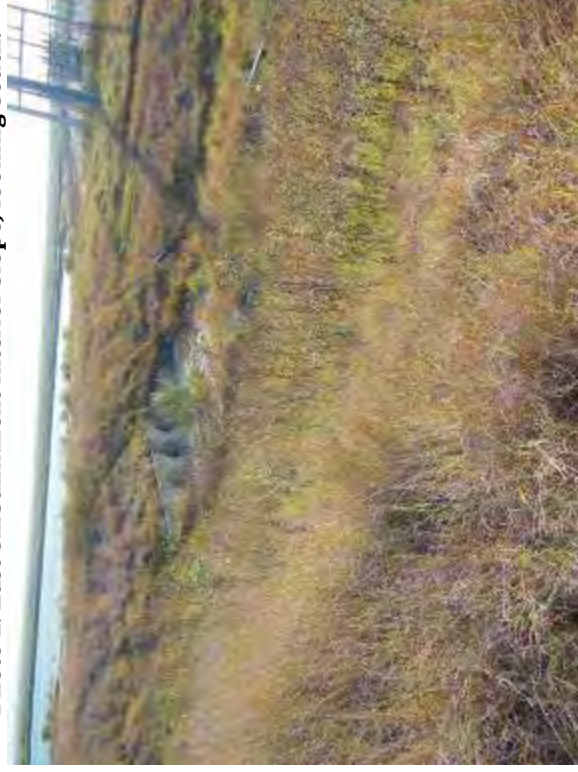
Photo 4: East embankment exterior slope, looking northeast. Note culvert at northeast corner toe.

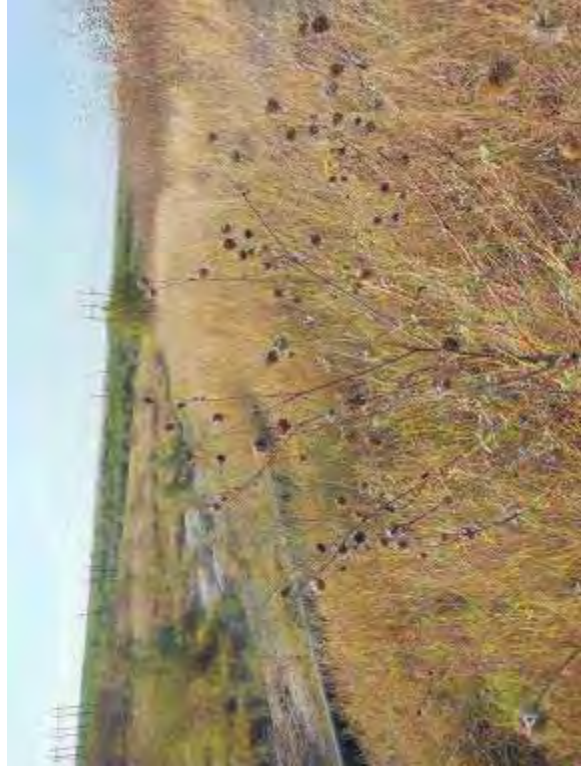
Photo 5: East embankment exterior slope, looking south. Piping from water well to water pond to the left.

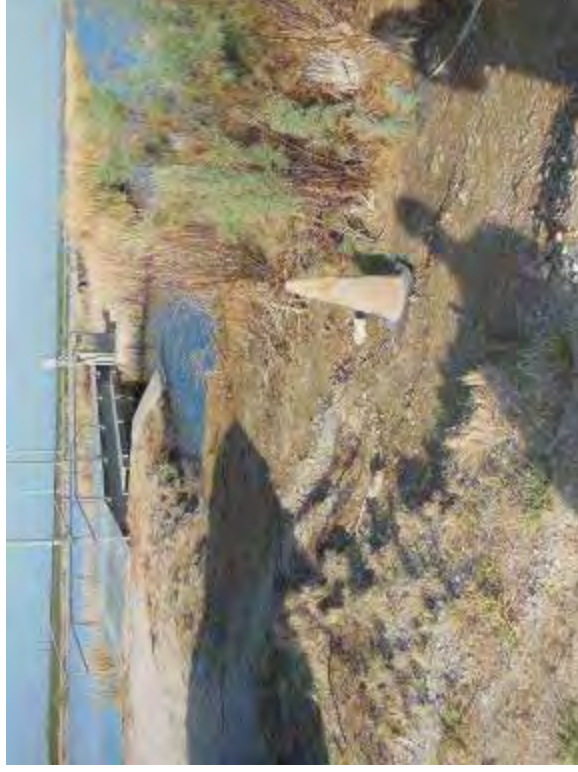
Photo 8: Gate structure between north and south sections of Ash Pond, looking west.

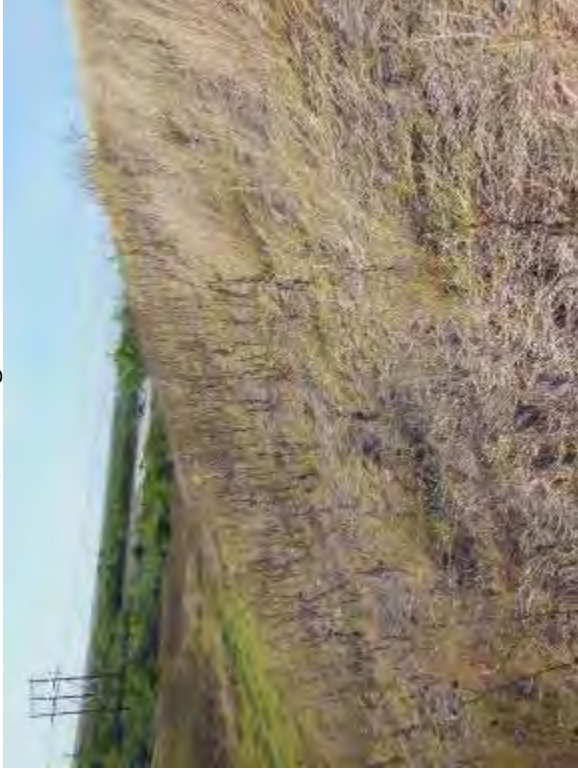
The Ash Pond includes exterior slopes on the west, south, and east embankments. The north side of the Ash Pond is incised (Photograph 67). The exterior slopes appear to be in fair condition (Photographs 11, 31, and 48). An area of potential seepage approximately 20 feet by 10 feet was located on the west embankment exterior slope (Photographs 56 through 60). The area included cattails and other vegetation varying from the surrounding vegetation, and the ground was damp. According to documentation provided by San Miguel, this area of potential seepage is in the vicinity of a location of documented seepage in the 1980's. A berm approximately 10 feet wide adjacent to and about halfway up the south embankment exterior slope was observed (Photographs 40 and 41). Plant staff suggested this may have been constructed as a road embankment to access the pond during reconstruction of the clay liner in the 1980s or from cleanout operations. An animal burrow was observed on the east embankment exterior slope (Photograph 17). A few small trees and bushes with diameters less than 3 inches in diameter were observed on the exterior slopes at the southeast corner

Photo 11: East embankment exterior slope, looking south.

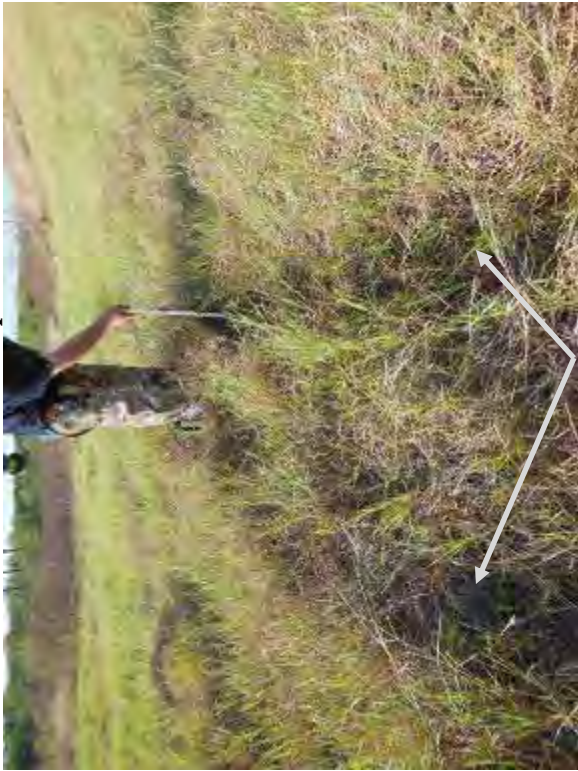
Photo 12: Stormwater runoff drainage feature at east embankment exterior toe, looking south.

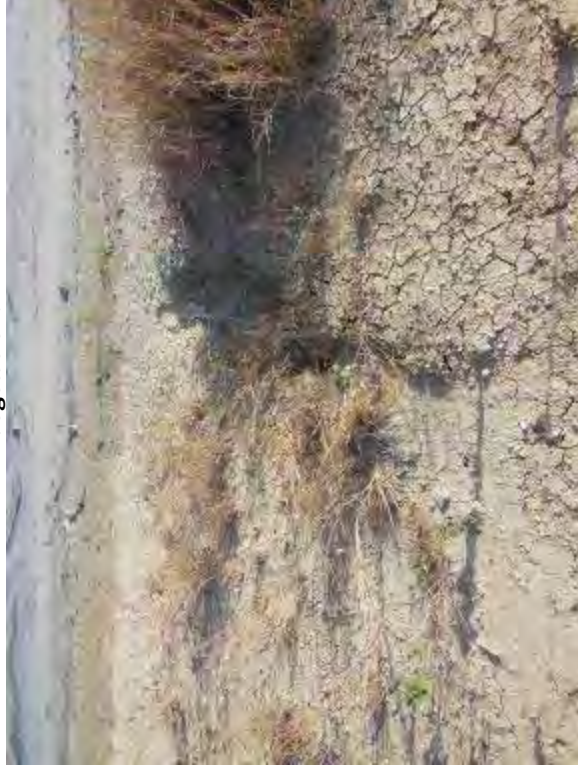
Photo 24: Erosion rills at south embankment interior slope.

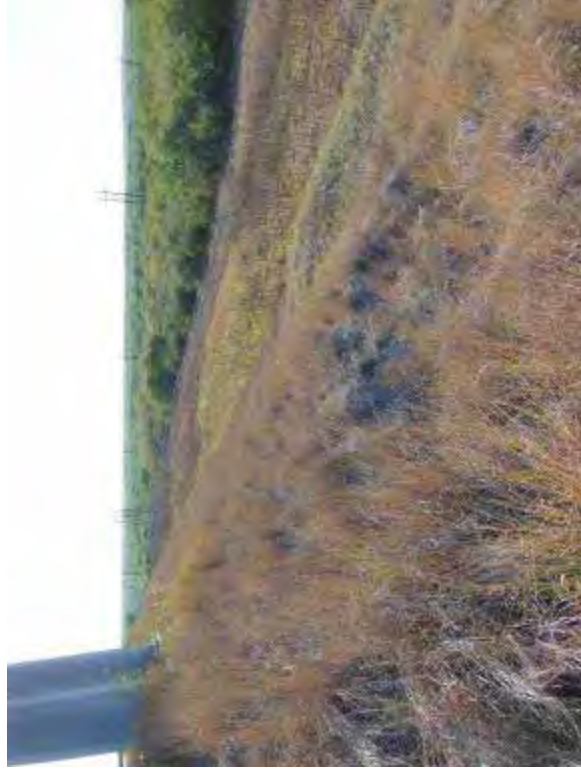
Photo 29: South embankment exterior slope, looking southeast.  
Power line support poles to the left.

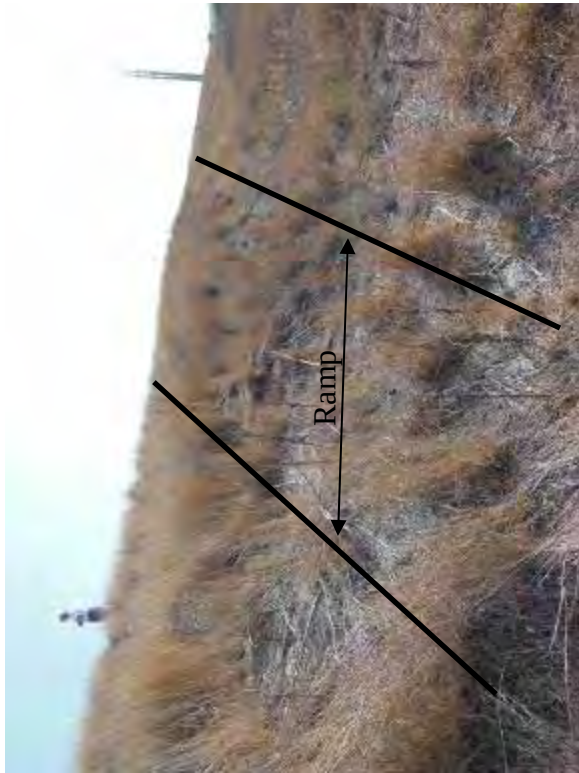
Photo 34: South embankment exterior slope, looking northeast. Note remnants of roadway ramp from Ash Pond cleanout in 1987.

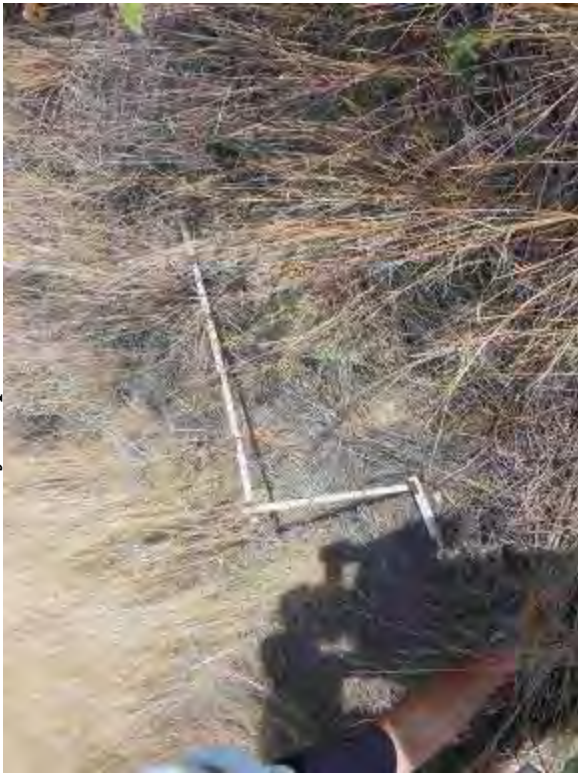
Photo 36: South embankment exterior slope approximately 2.5H:1V.

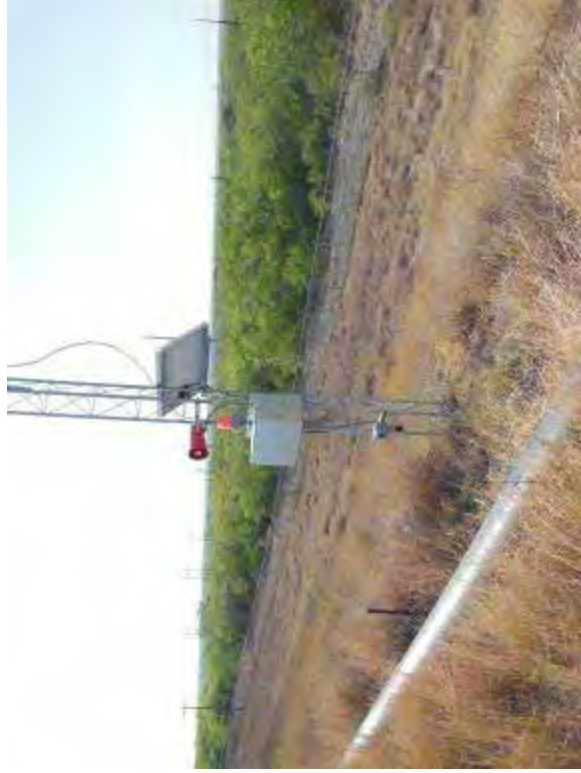
Photo 37: Hydrogen sulfide warning siren at south embankment exterior slope, looking southeast.

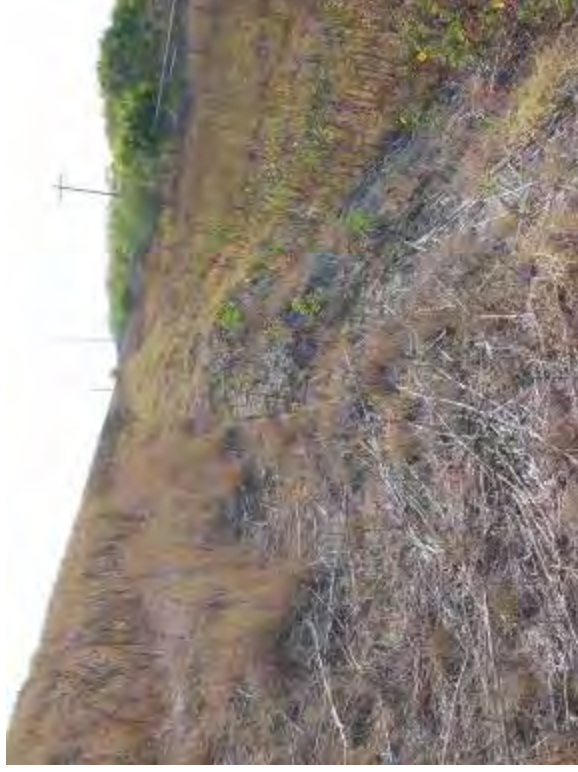
Photo 40: Berm at south embankment exterior toe, looking east.

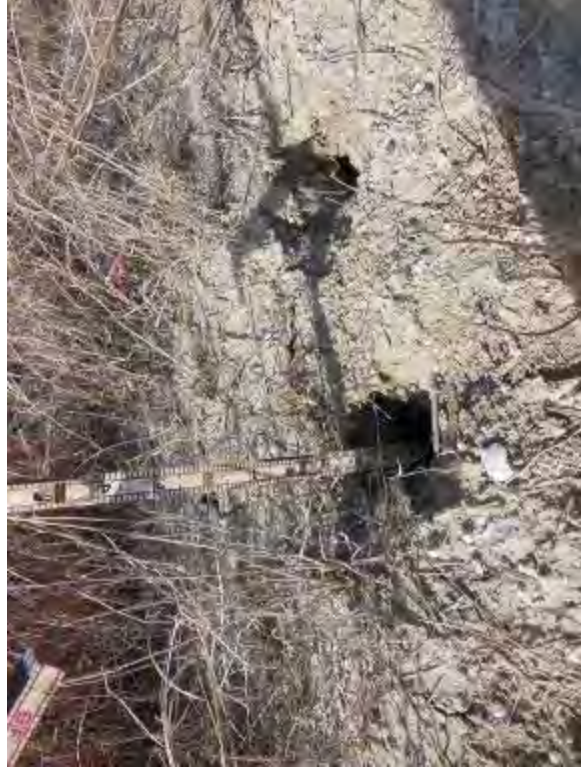
Photo 42: Approximately 6-inch-deep animal burrows on crest near south west corner.

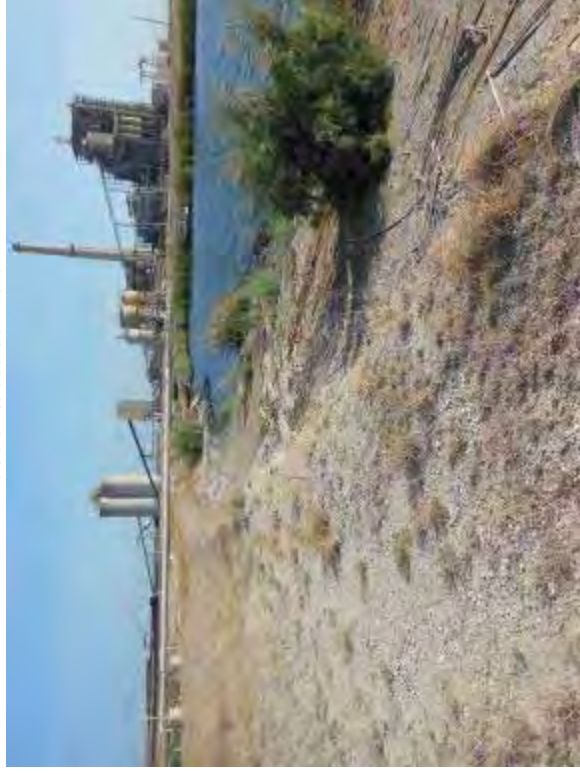
Photo 44: West embankment interior slope, looking north.

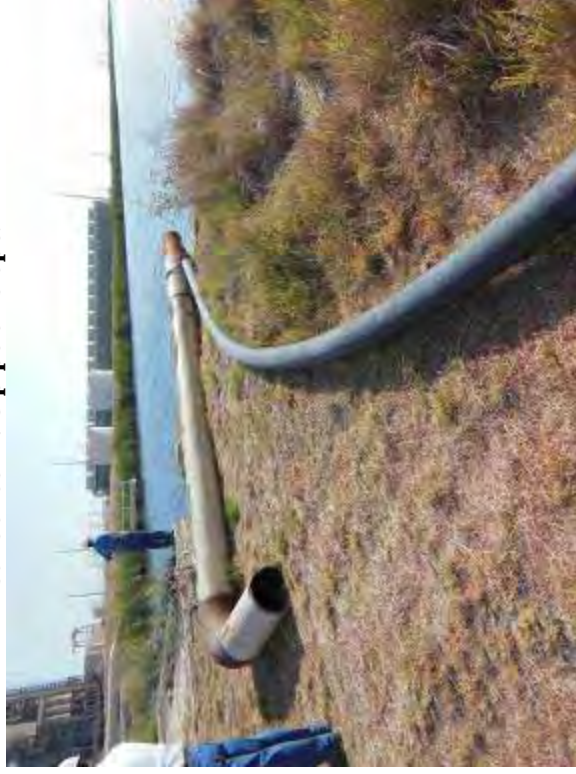
Photo 47: West embankment crest, looking northeast. Note  
abandoned steel and PVC pipe.

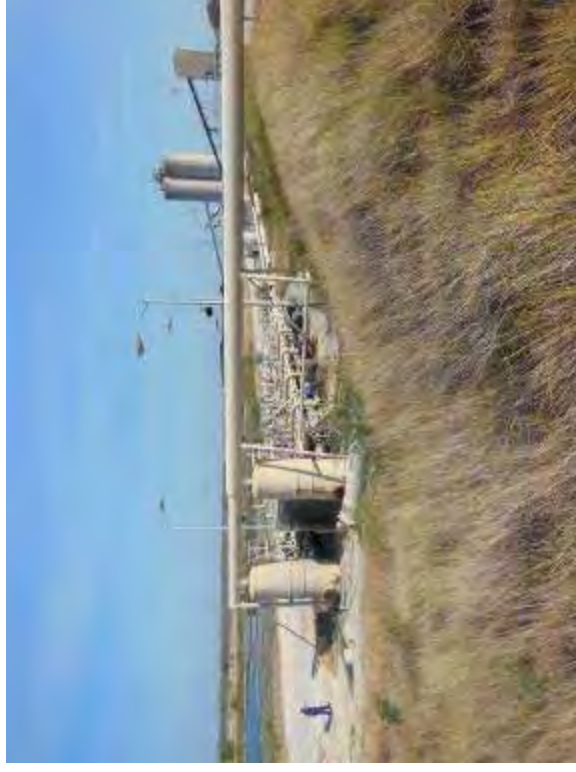
Photo 48: Pumps at west embankment exterior toe, looking north. Note  
coal pile runoff pond to the left.

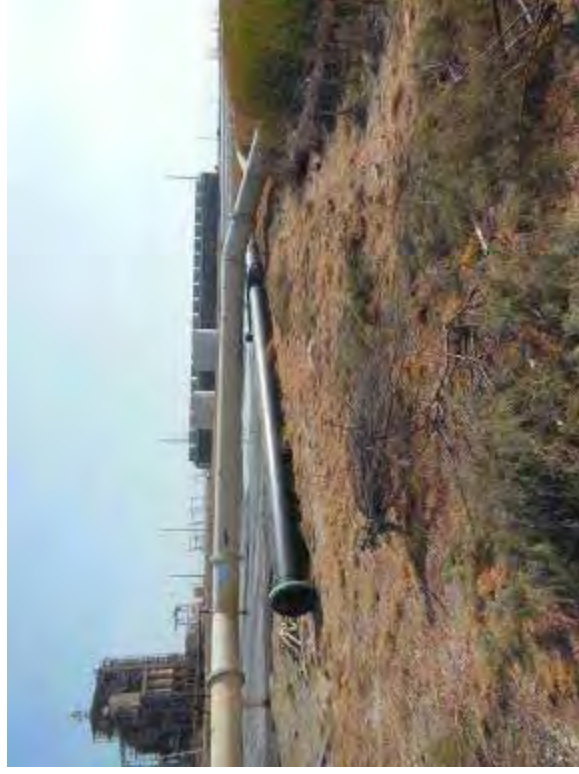
The outlet structure consists of a 24-inch-diameter steel siphon pipe on the west embankment interior slope (Photographs 49 and 50). The steel pipe transports liquids to the pumps at the west embankment exterior toe, and the liquids are then pumped to the Plant for reuse in plant processes.

Photo 49: 24-inch-diameter steel outlet pipe at west embankment interior slope. PVC pipe along center embankment.

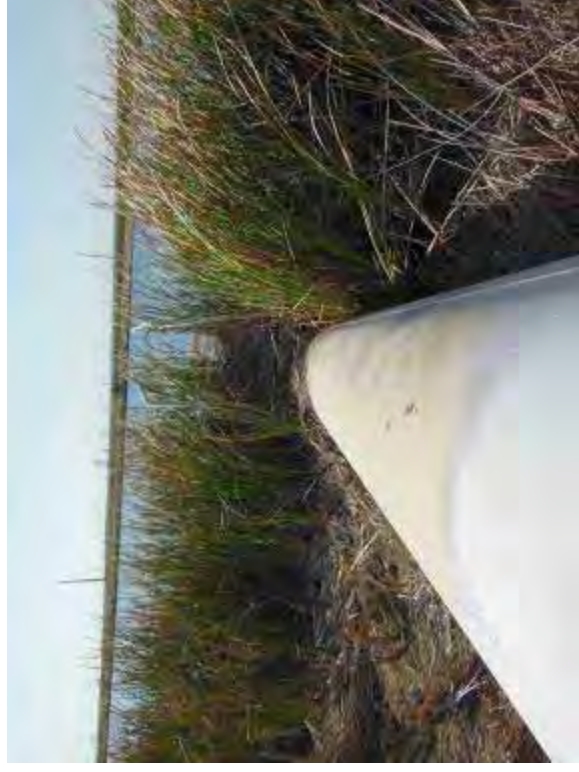
Six inlet pipes are located on the interior slope of the west embankment: two 12-inch PVC, two 16-inch-diameter PVC, one 12-inch-diameter steel, and one 6-inch-diameter PVC pipe (Photograph 54). Two inlet pipes are located on the interior slope of the north embankment: a 6-inch-diameter metal and 6-inch-diameter high-density polyethylene (HDPE) pipe (Photographs 71 and 74). The outlet pipe is located on the west embankment interior slope (Photograph 50).

Photo 50: 24-inch-diameter steel outlet pipe at west embankment interior slope.

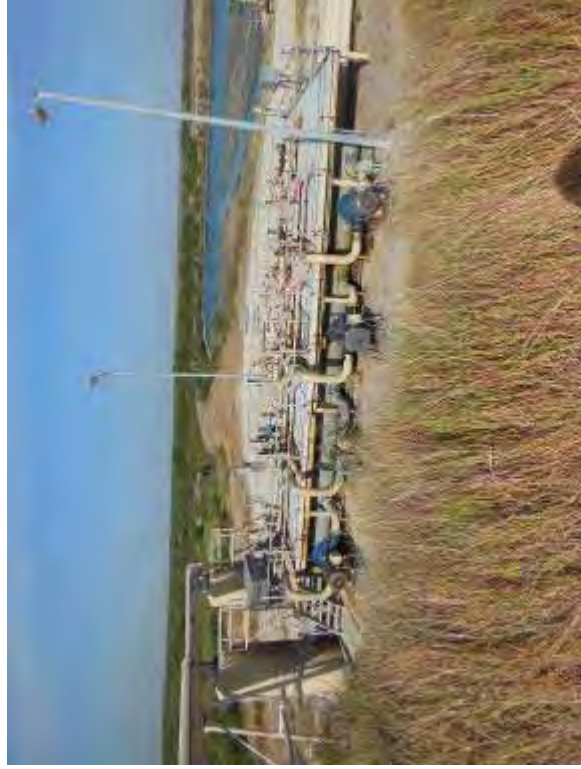
Photo 53: Pumps at west embankment exterior toe, looking west.

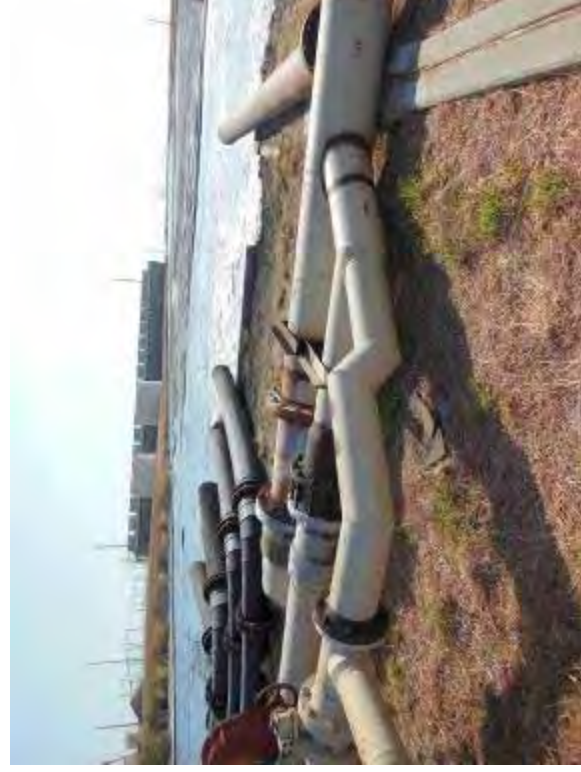
Photo 54: Inlet pipes at west embankment interior slope, looking east.

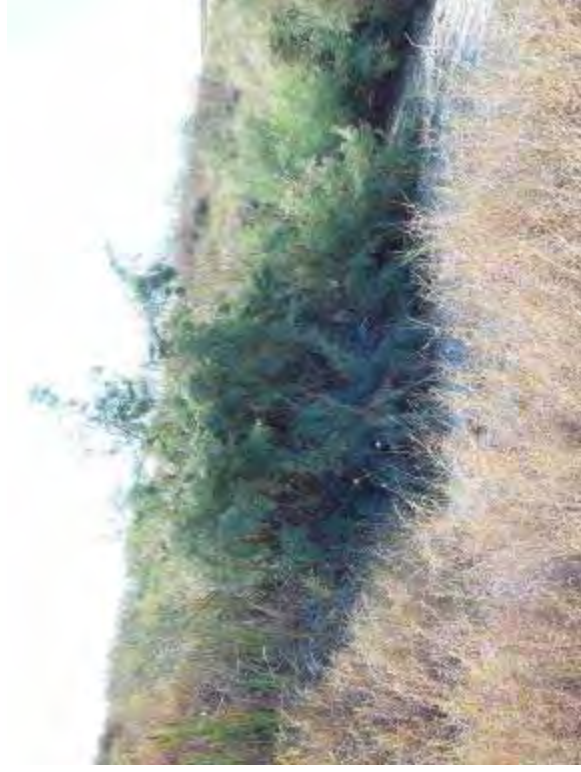
Photo 58: Cattails and vegetation growing near wet area at west embankment exterior slope.

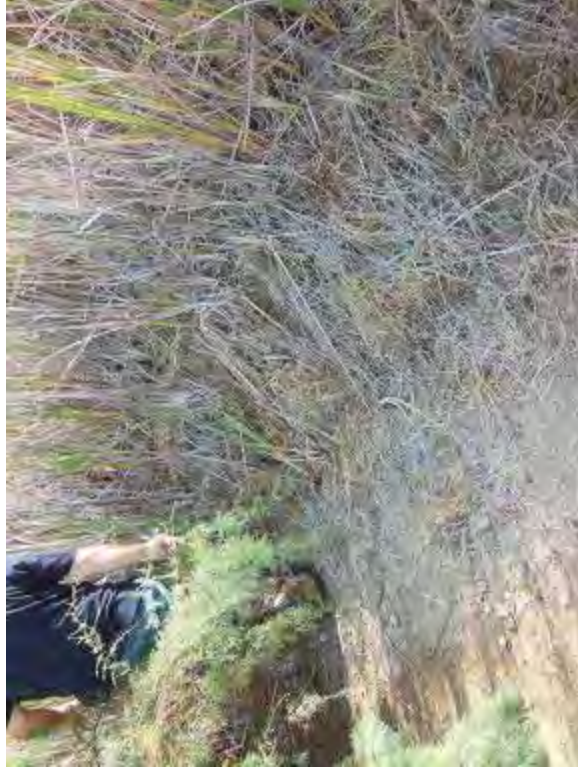
Photo 59: Minor erosion near wet area at west embankment exterior slope.

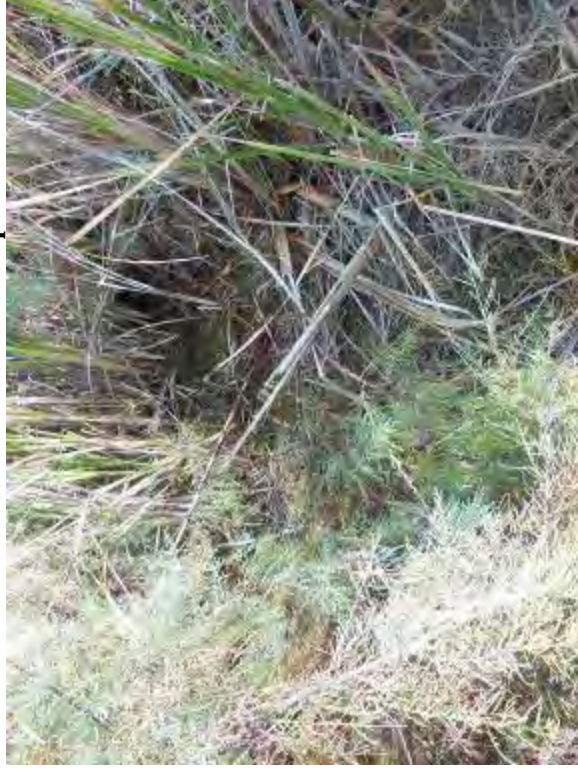
Photo 60: Wet area at west embankment exterior slope.

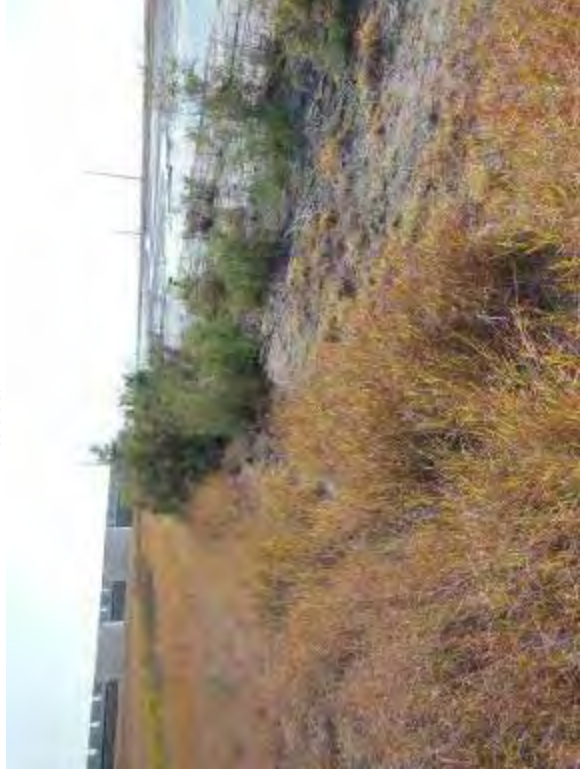
Photo 63: North embankment interior slope, looking east. Note vegetation growing on slope.

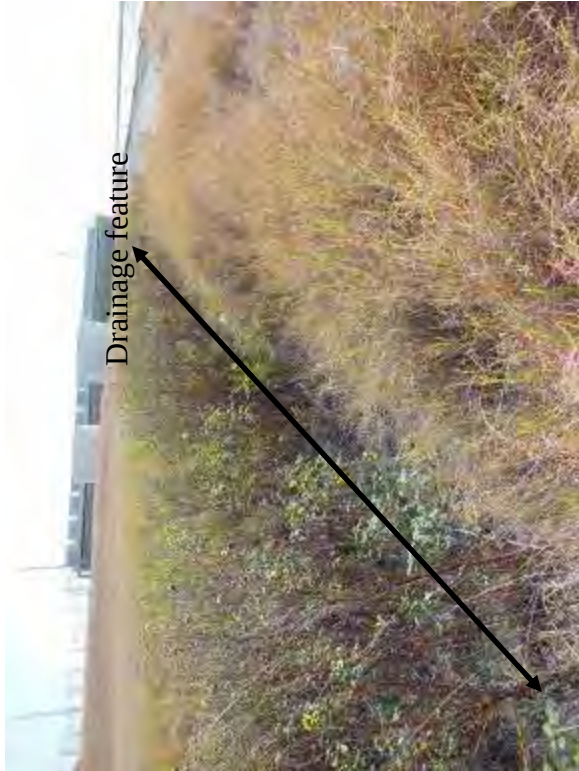
Photo 65: Drainage feature at north embankment exterior slope, looking east.

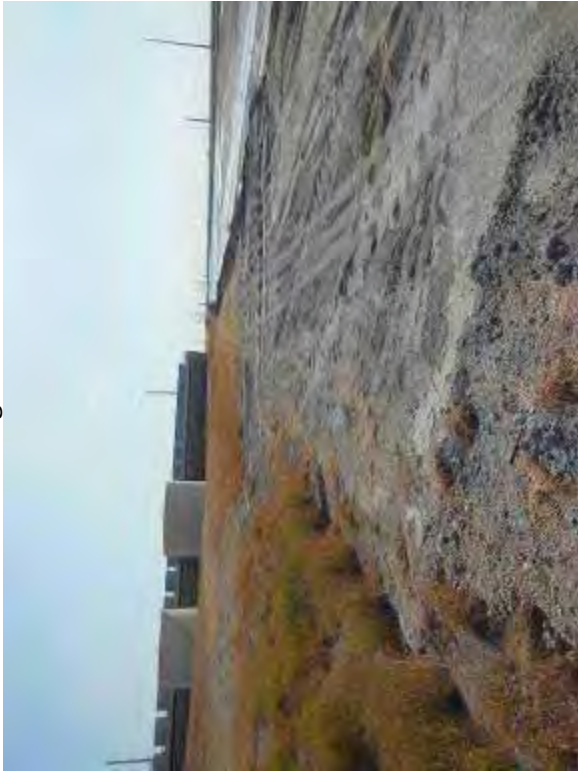
Photo 67: North embankment crest, looking east.

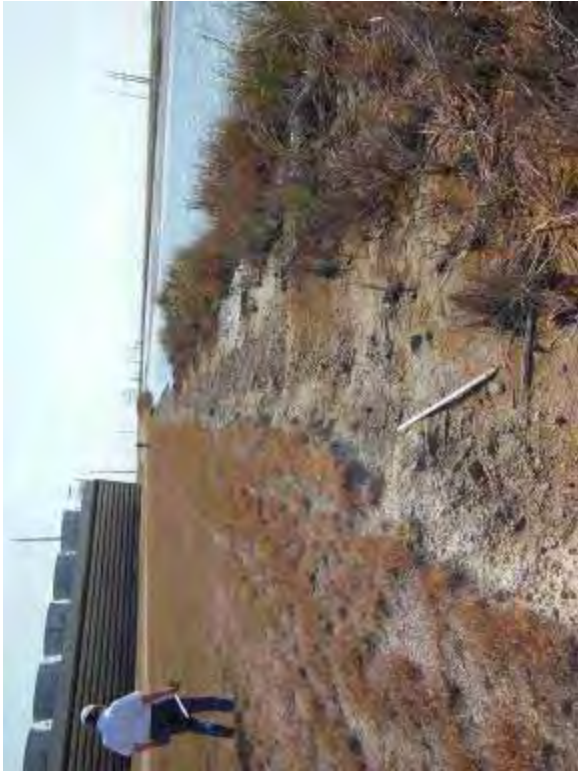
Photo 68: North embankment interior slope, looking east. Note vegetation growing on interior slope.

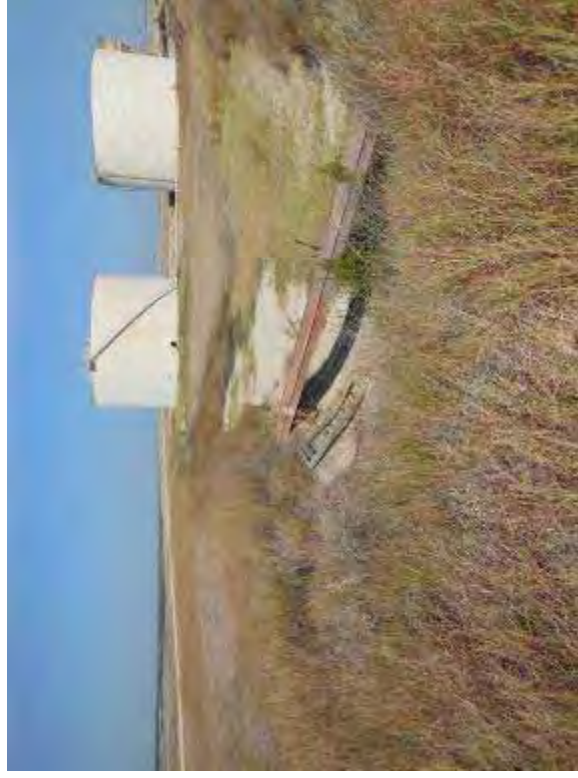
Photo 69: Tank retention area at north embankment exterior slope, looking west.

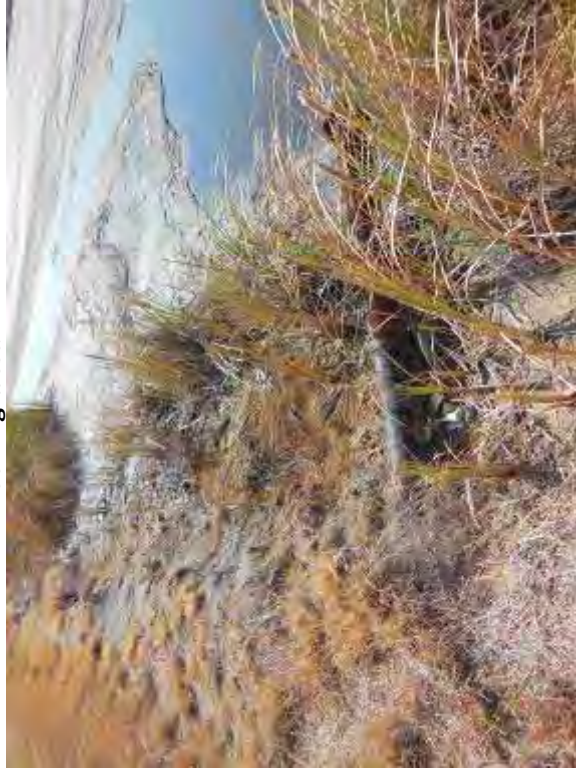
Photo 71: 6-inch-diameter pipe inlet from cooling tower at north embankment interior slope.

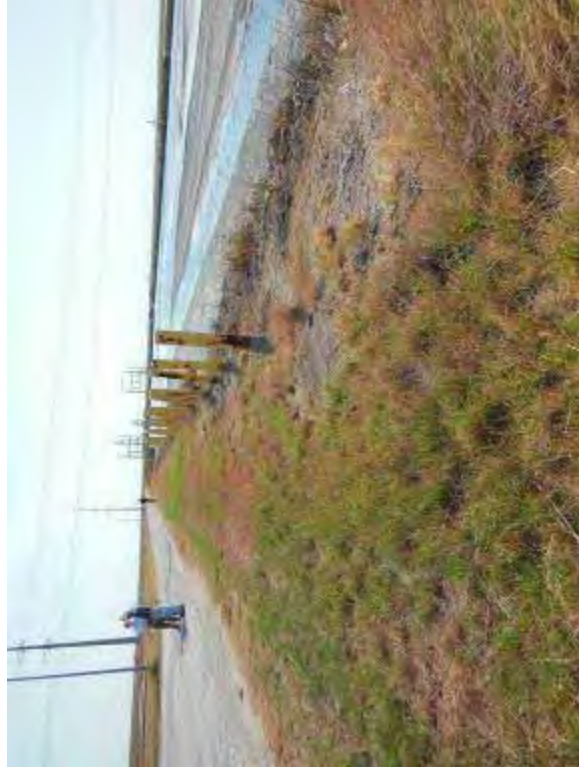
Photo 73: North embankment interior slope, looking east. Note bollards in embankment at the end of roadway.

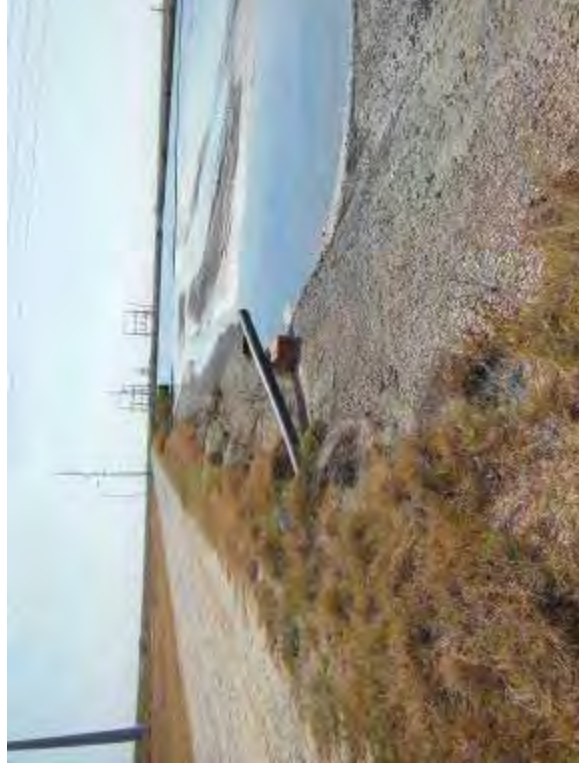
Photo 74: 6-inch-diameter inlet pipe from waste treatment sump at north embankment interior slope.
