# ASSESSMENT OF DAM SAFETY OF COAL COMBUSTION SURFACE IMPOUNDMENTS – DRAFT REPORT

**San Miguel Electric  
Cooperative, Inc.  
San Miguel Electric Plant  
Christine, Texas**

Prepared for  
*U.S. Environmental  
Protection Agency  
Washington, D.C.*

November 2012  
Revision 2, December 2013

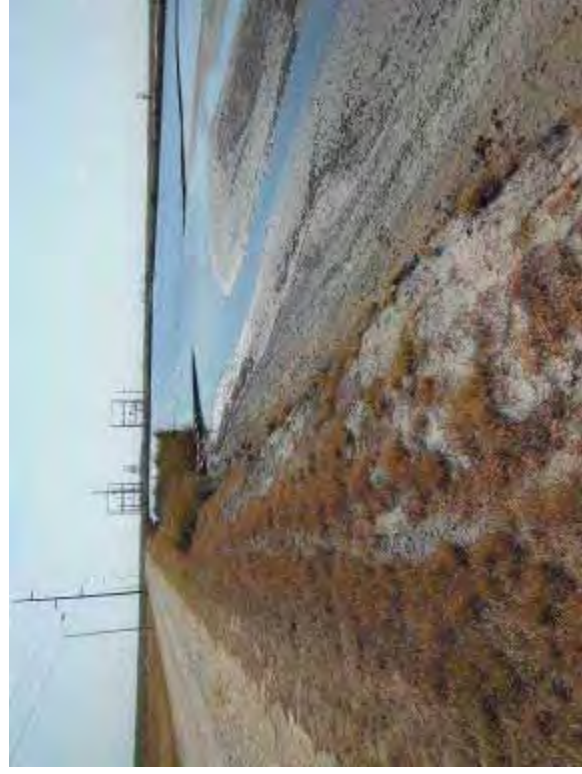
Photo 75: North embankment interior slope, looking east. Note floating skimmers in north section of Ash Pond.

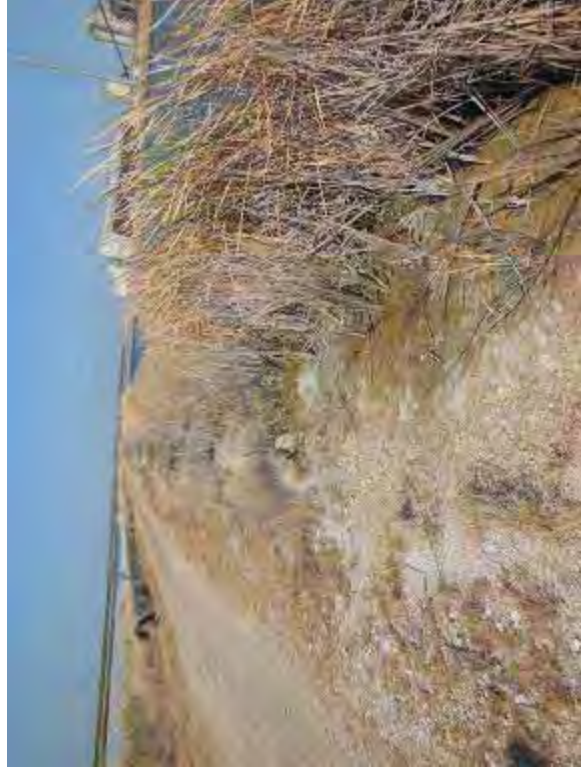
Photo 81: Center embankment north slope, looking west. Note vegetation on slope.

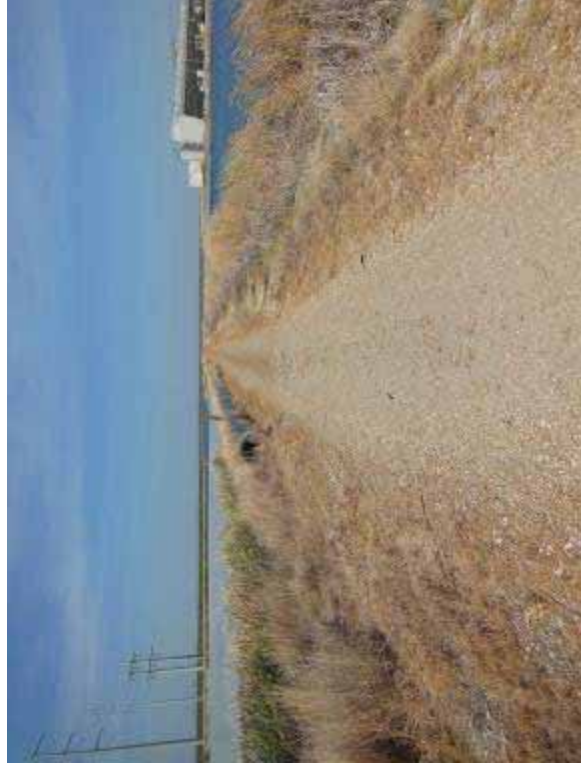
Photo 82: Center embankment crest, looking west. Note end of PVC pipe running along center embankment.

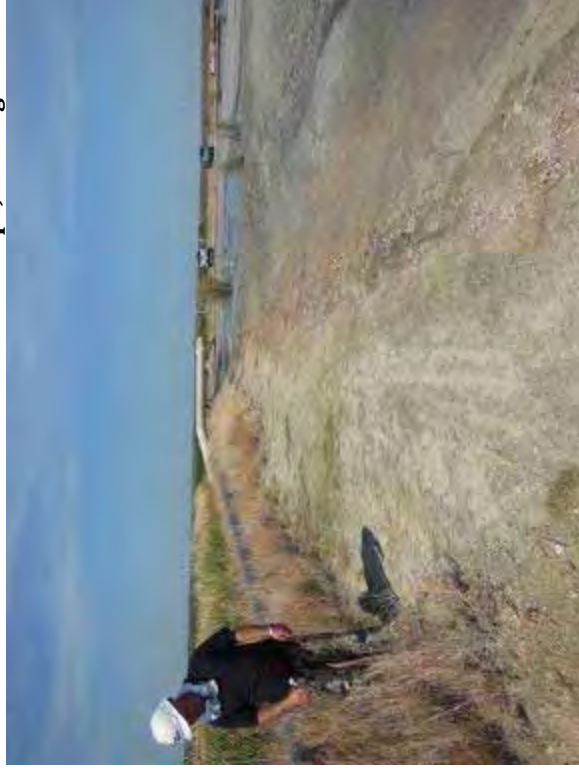
Photo 92: Center embankment north slope, looking west. Note 24-inch-diameter steel outlet pipe in distance.

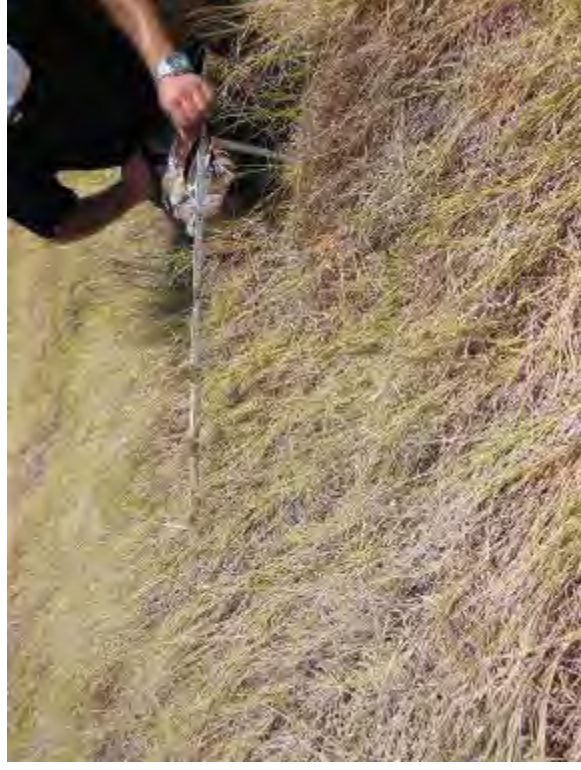
Interior slopes appeared to be in fair condition (Photographs 97, 128, 138, and 147). Erosion rills were observed on the west embankment interior slope (Photographs 99 and 100). An area of either erosion or settling of fill material was observed below the headwall for the stormwater inlet on the west embankment interior slope (Photograph 102). An area of erosion was observed near the outlet structure on the west embankment interior slope (Photograph 151). Based on construction drawings, the interior slopes are 3H:1V for all embankments, though slopes measured in the field ranged from 2H:1V to 3H:1V. Grassy vegetation and small trees up to 3 inches in diameter were observed on the upper portion of the west, north, and east interior slopes (Photographs 103, 108, 117, and 138). Riprap in good condition, but with vegetation growing within was observed on the upper portion of the south embankment interior slope (Photograph 147).

Photo 99: Erosion rill at west embankment interior slope.

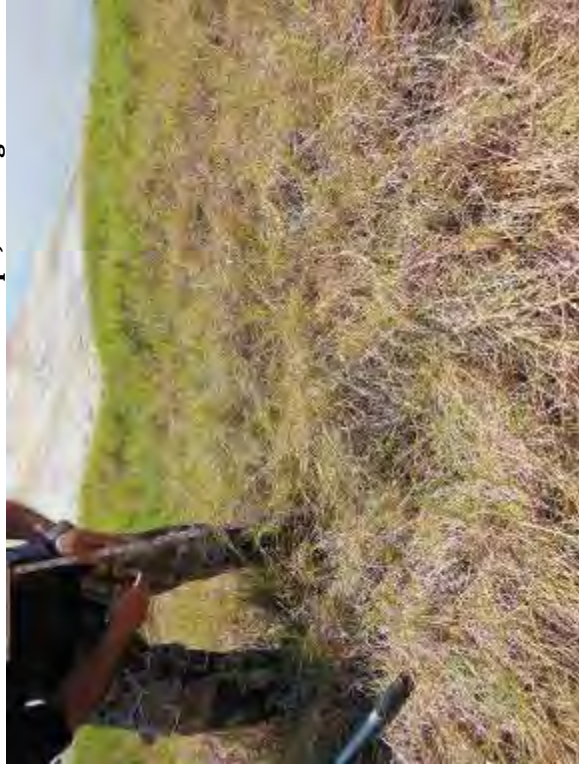
Photo 100: Approximately 14-inch-deep erosion rill at west embankment interior slope.

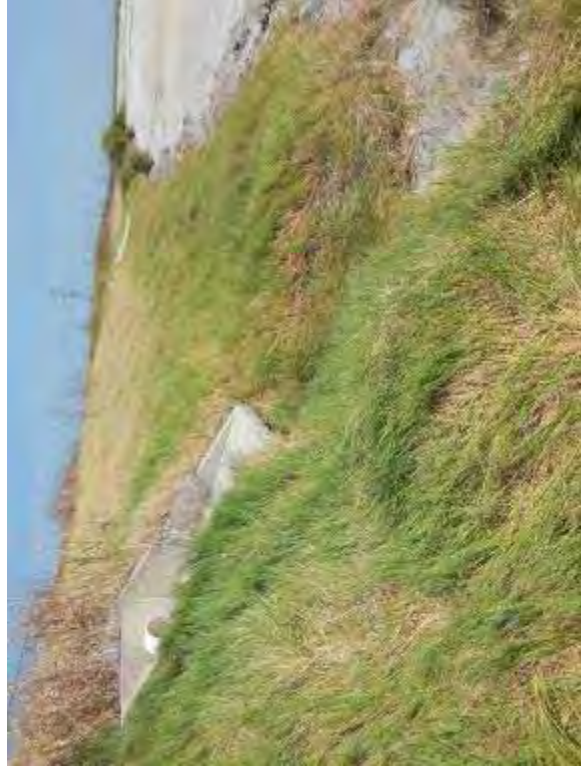
Photo 102: Approximately 3-ft-high area of erosion or settlement under stormwater inlet.

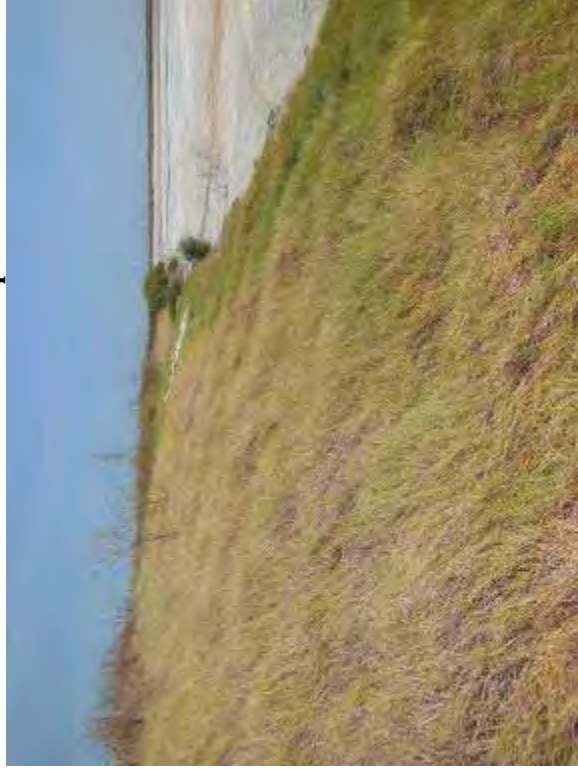
A 12-inch-diameter HDPE inlet pipe (Photographs 101 and 102), a 12-inch-diameter steel inlet pipe (Photograph 104), and an 8-inch-diameter HDPE inlet pipe (Photograph 109) were located on the west embankment interior slope. Reportedly, additional 6- and 8-inch-diameter inlet pipes discharge from the west embankment interior slope, though those inlets were not visible during the site assessment due to vegetation. Outlets were located on the west embankment interior slope (Photograph 93) and south embankment interior slope (Photograph 145).

Photo 104: 12-inch-diameter plant stormwater inlet pipe at west embankment interior slope.

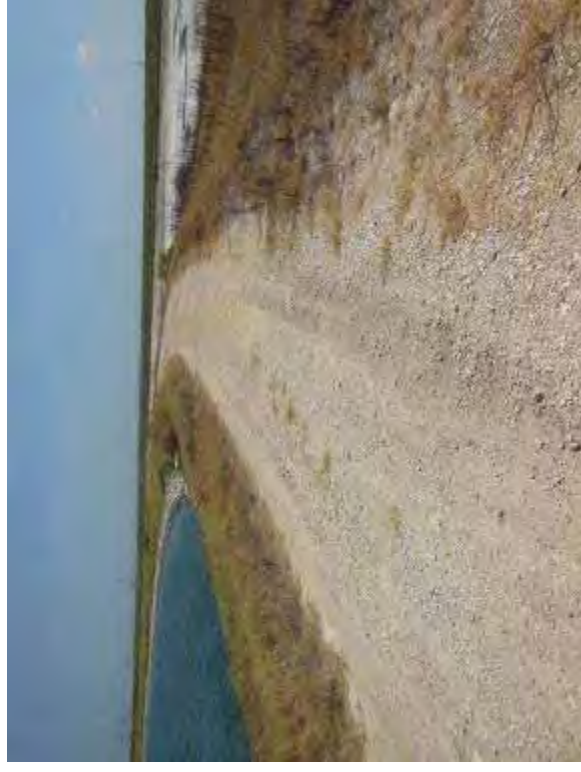
Photo 106: West embankment crest, looking northeast. Water well pond located to left.

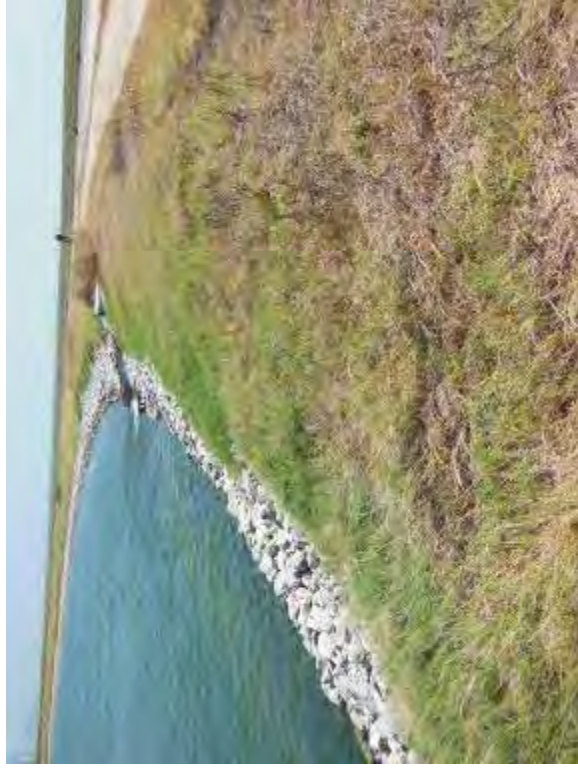
The exterior slopes appear to be in good condition and are covered with grassy vegetation approximately 2 feet high (Photographs 107, 122, 133, and 146). An animal burrow was observed on the south embankment exterior slope (Photograph 143). Based on construction drawings, the exterior slopes are 3H:1V for all embankments, though slopes measured in the field ranged from 3H:1V to 3.5H:1V. The water well storage pond is located at the west embankment exterior slope (Photographs

Photo 107: West embankment exterior slope, looking northeast.  
Common embankment with water well pond.

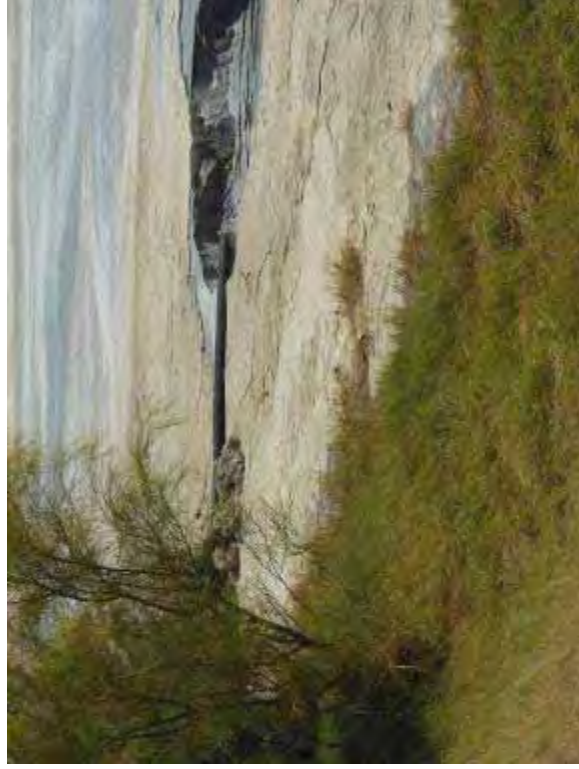
Photo 109: 8-inch-diameter inlet pipe from acid storage area at west embankment interior slope.

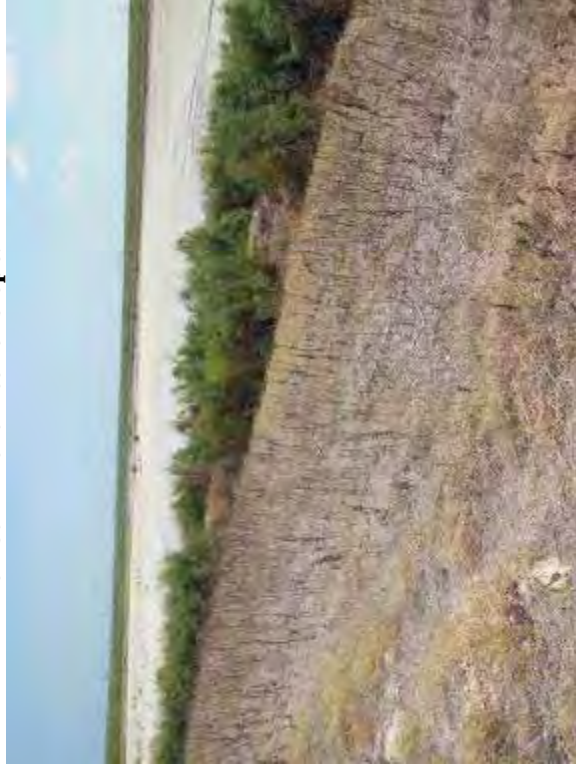
Photo 111: West embankment interior slope, looking east.  
Note vegetation on slope.

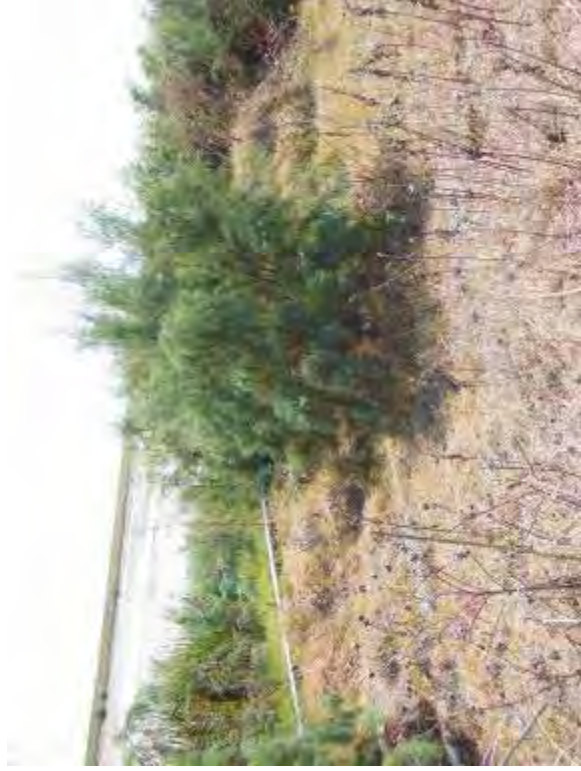
Photo 113: Pipe on mounded earth at west embankment interior slope.

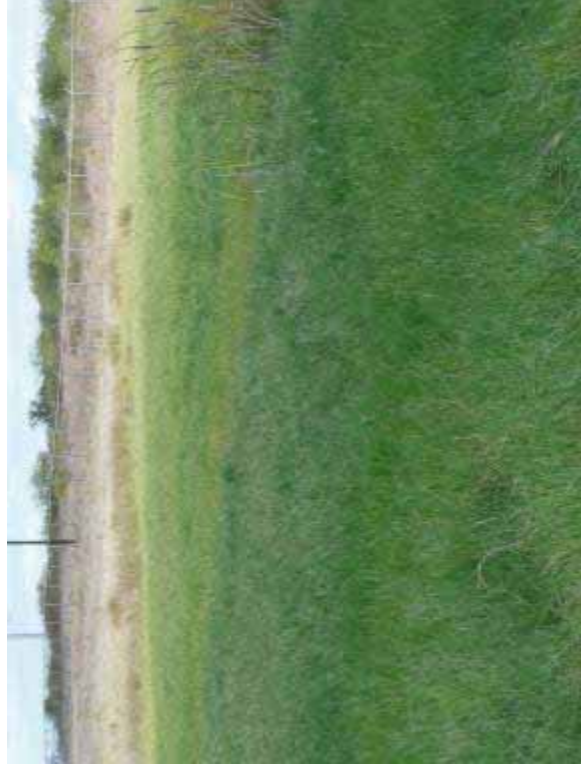
Photo 125: Cattails and vegetation along drainage feature at north embankment exterior toe, looking west.

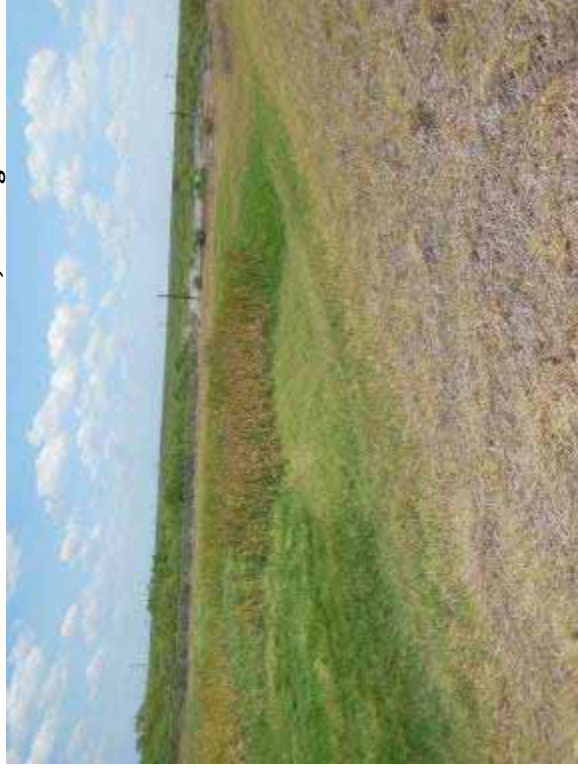
Photo 127: Cattails and vegetation at north embankment exterior toe, looking northeast.

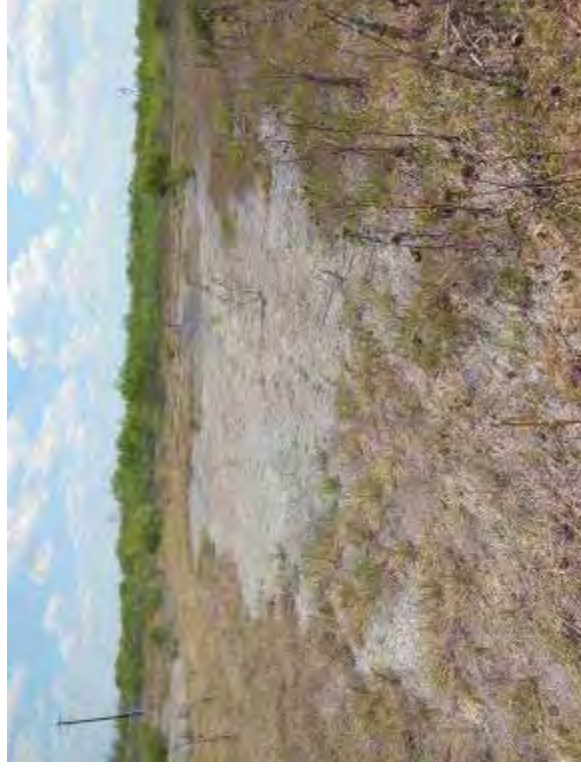
Photo 130: Barren area at northeast corner toe, looking east.

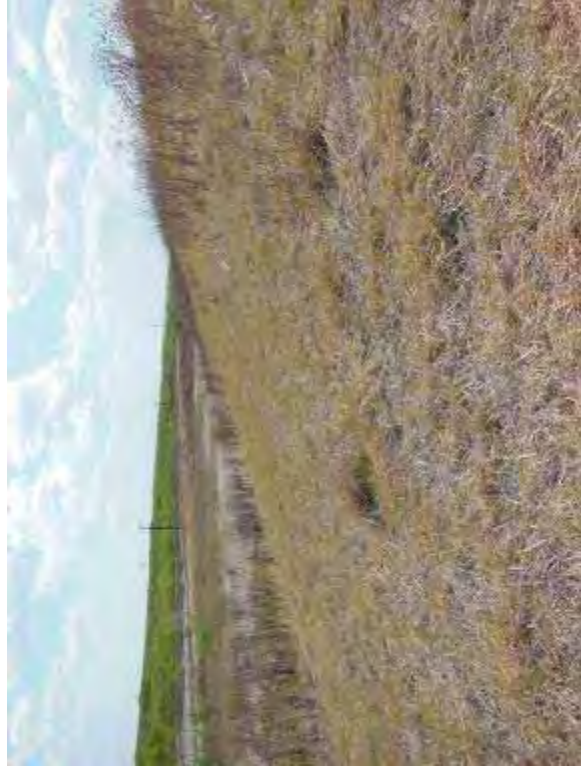
Photo 133: East embankment exterior slope, looking south.

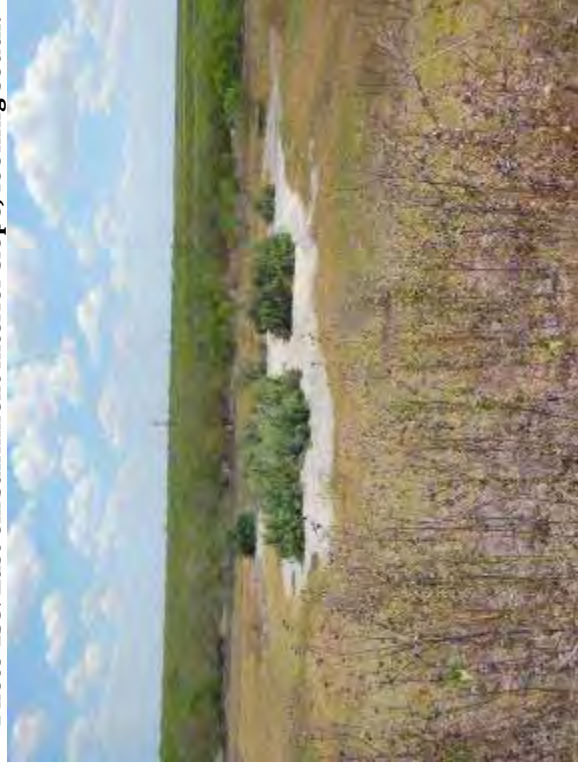
Photo 140: Trees at east embankment exterior toe, looking south.

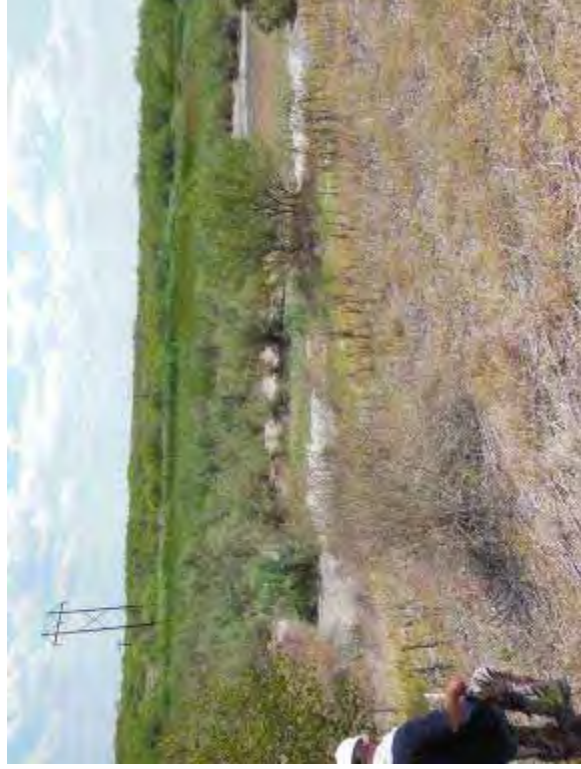
Photo 141: Cattails and vegetation at southeast corner exterior toe, looking south.

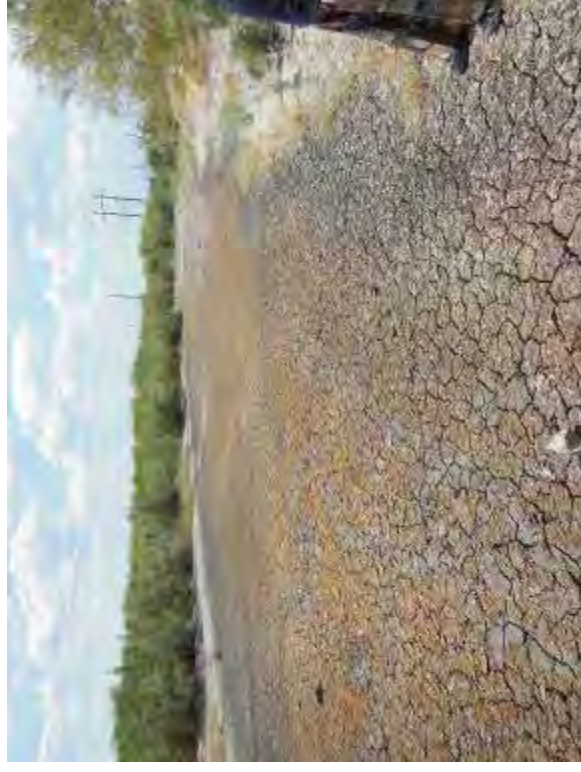
Photo 142: Barren area at southeast corner exterior toe, looking west.

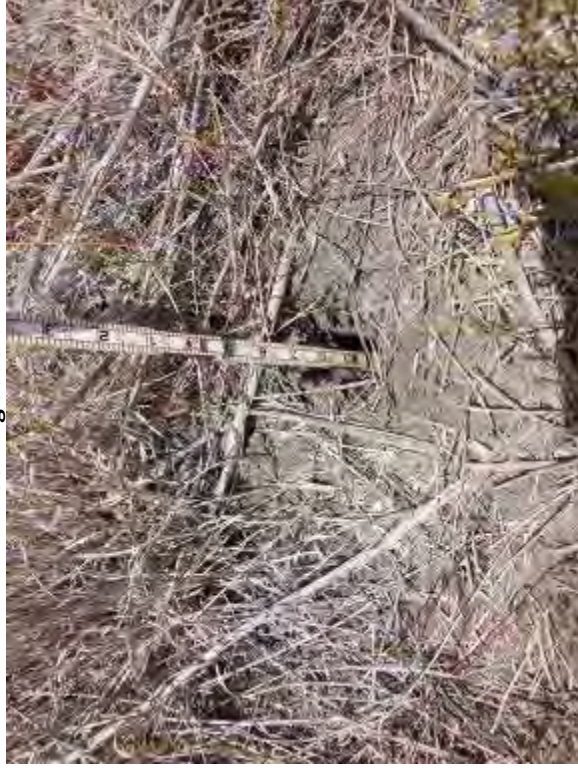
Photo 143: Approximately 3-foot-deep animal burrow at south embankment exterior slope.

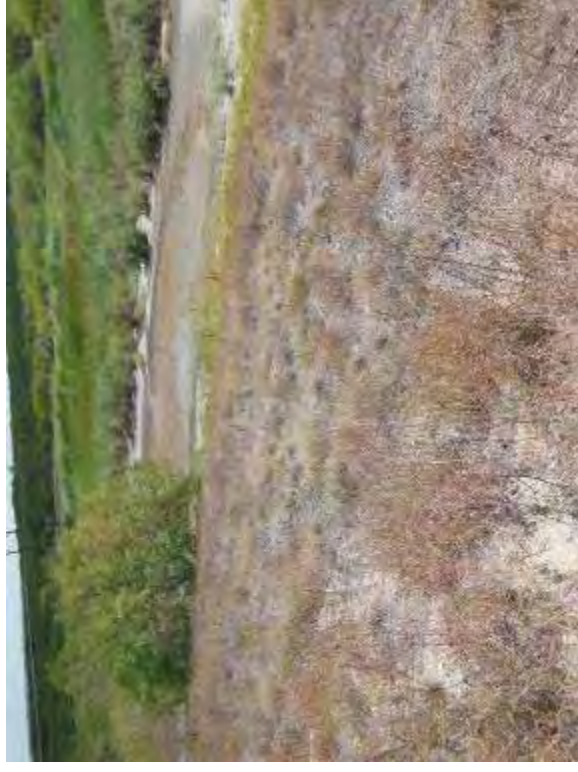
Photo 144: Barren area at southeast corner exterior toe, looking southeast.

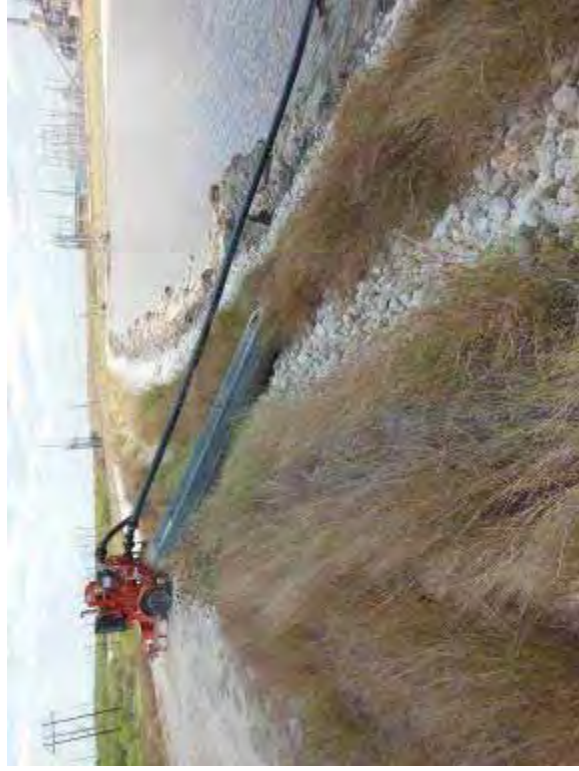
Photo 145: 6-inch-diameter outlet pipe and pump at south embankment interior slope, looking west.

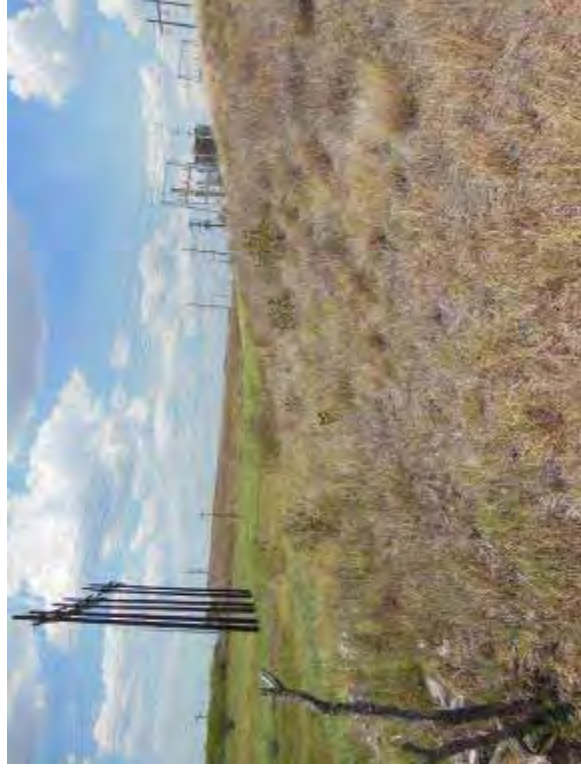
Photo 149: South embankment exterior slope, looking northwest.  
Note overhead powerlines and substation in distance.

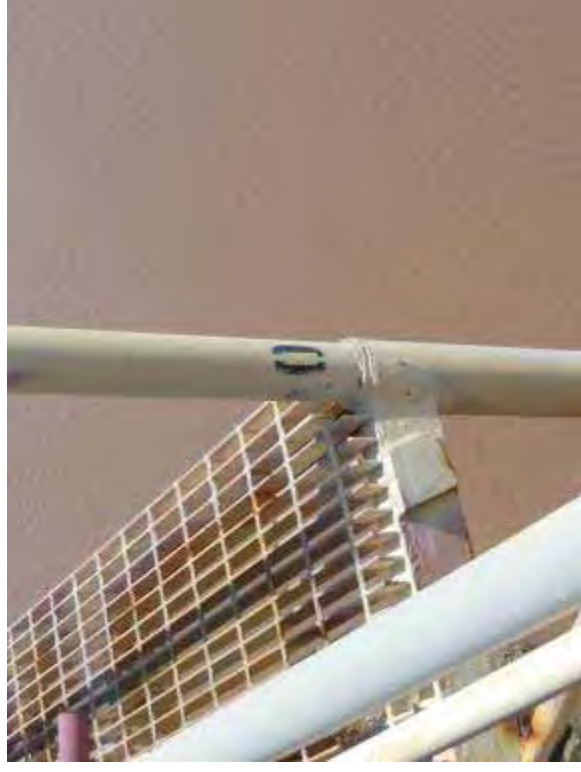
Photo 150: Reference mark for measuring water level in Sludge Basin.  
Zero corresponds to 18 inches of freeboard.

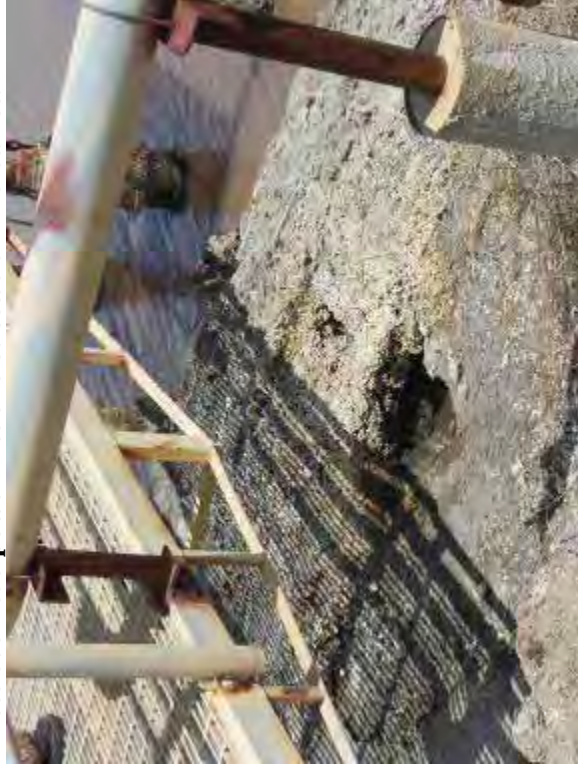
Photo 151: Erosion under submersible pump outlet structure at west  
embankment exterior slope.
