# ASSESSMENT OF DAM SAFETY OF COAL COMBUSTION SURFACE IMPOUNDMENTS FINAL REPORT

**San Miguel Electric  
Cooperative, Inc.  
San Miguel Electric Plant  
Christine, Texas**

Prepared for  
*U.S. Environmental  
Protection Agency  
Washington, D.C.*

March 2014  
Revision 1, April 2014

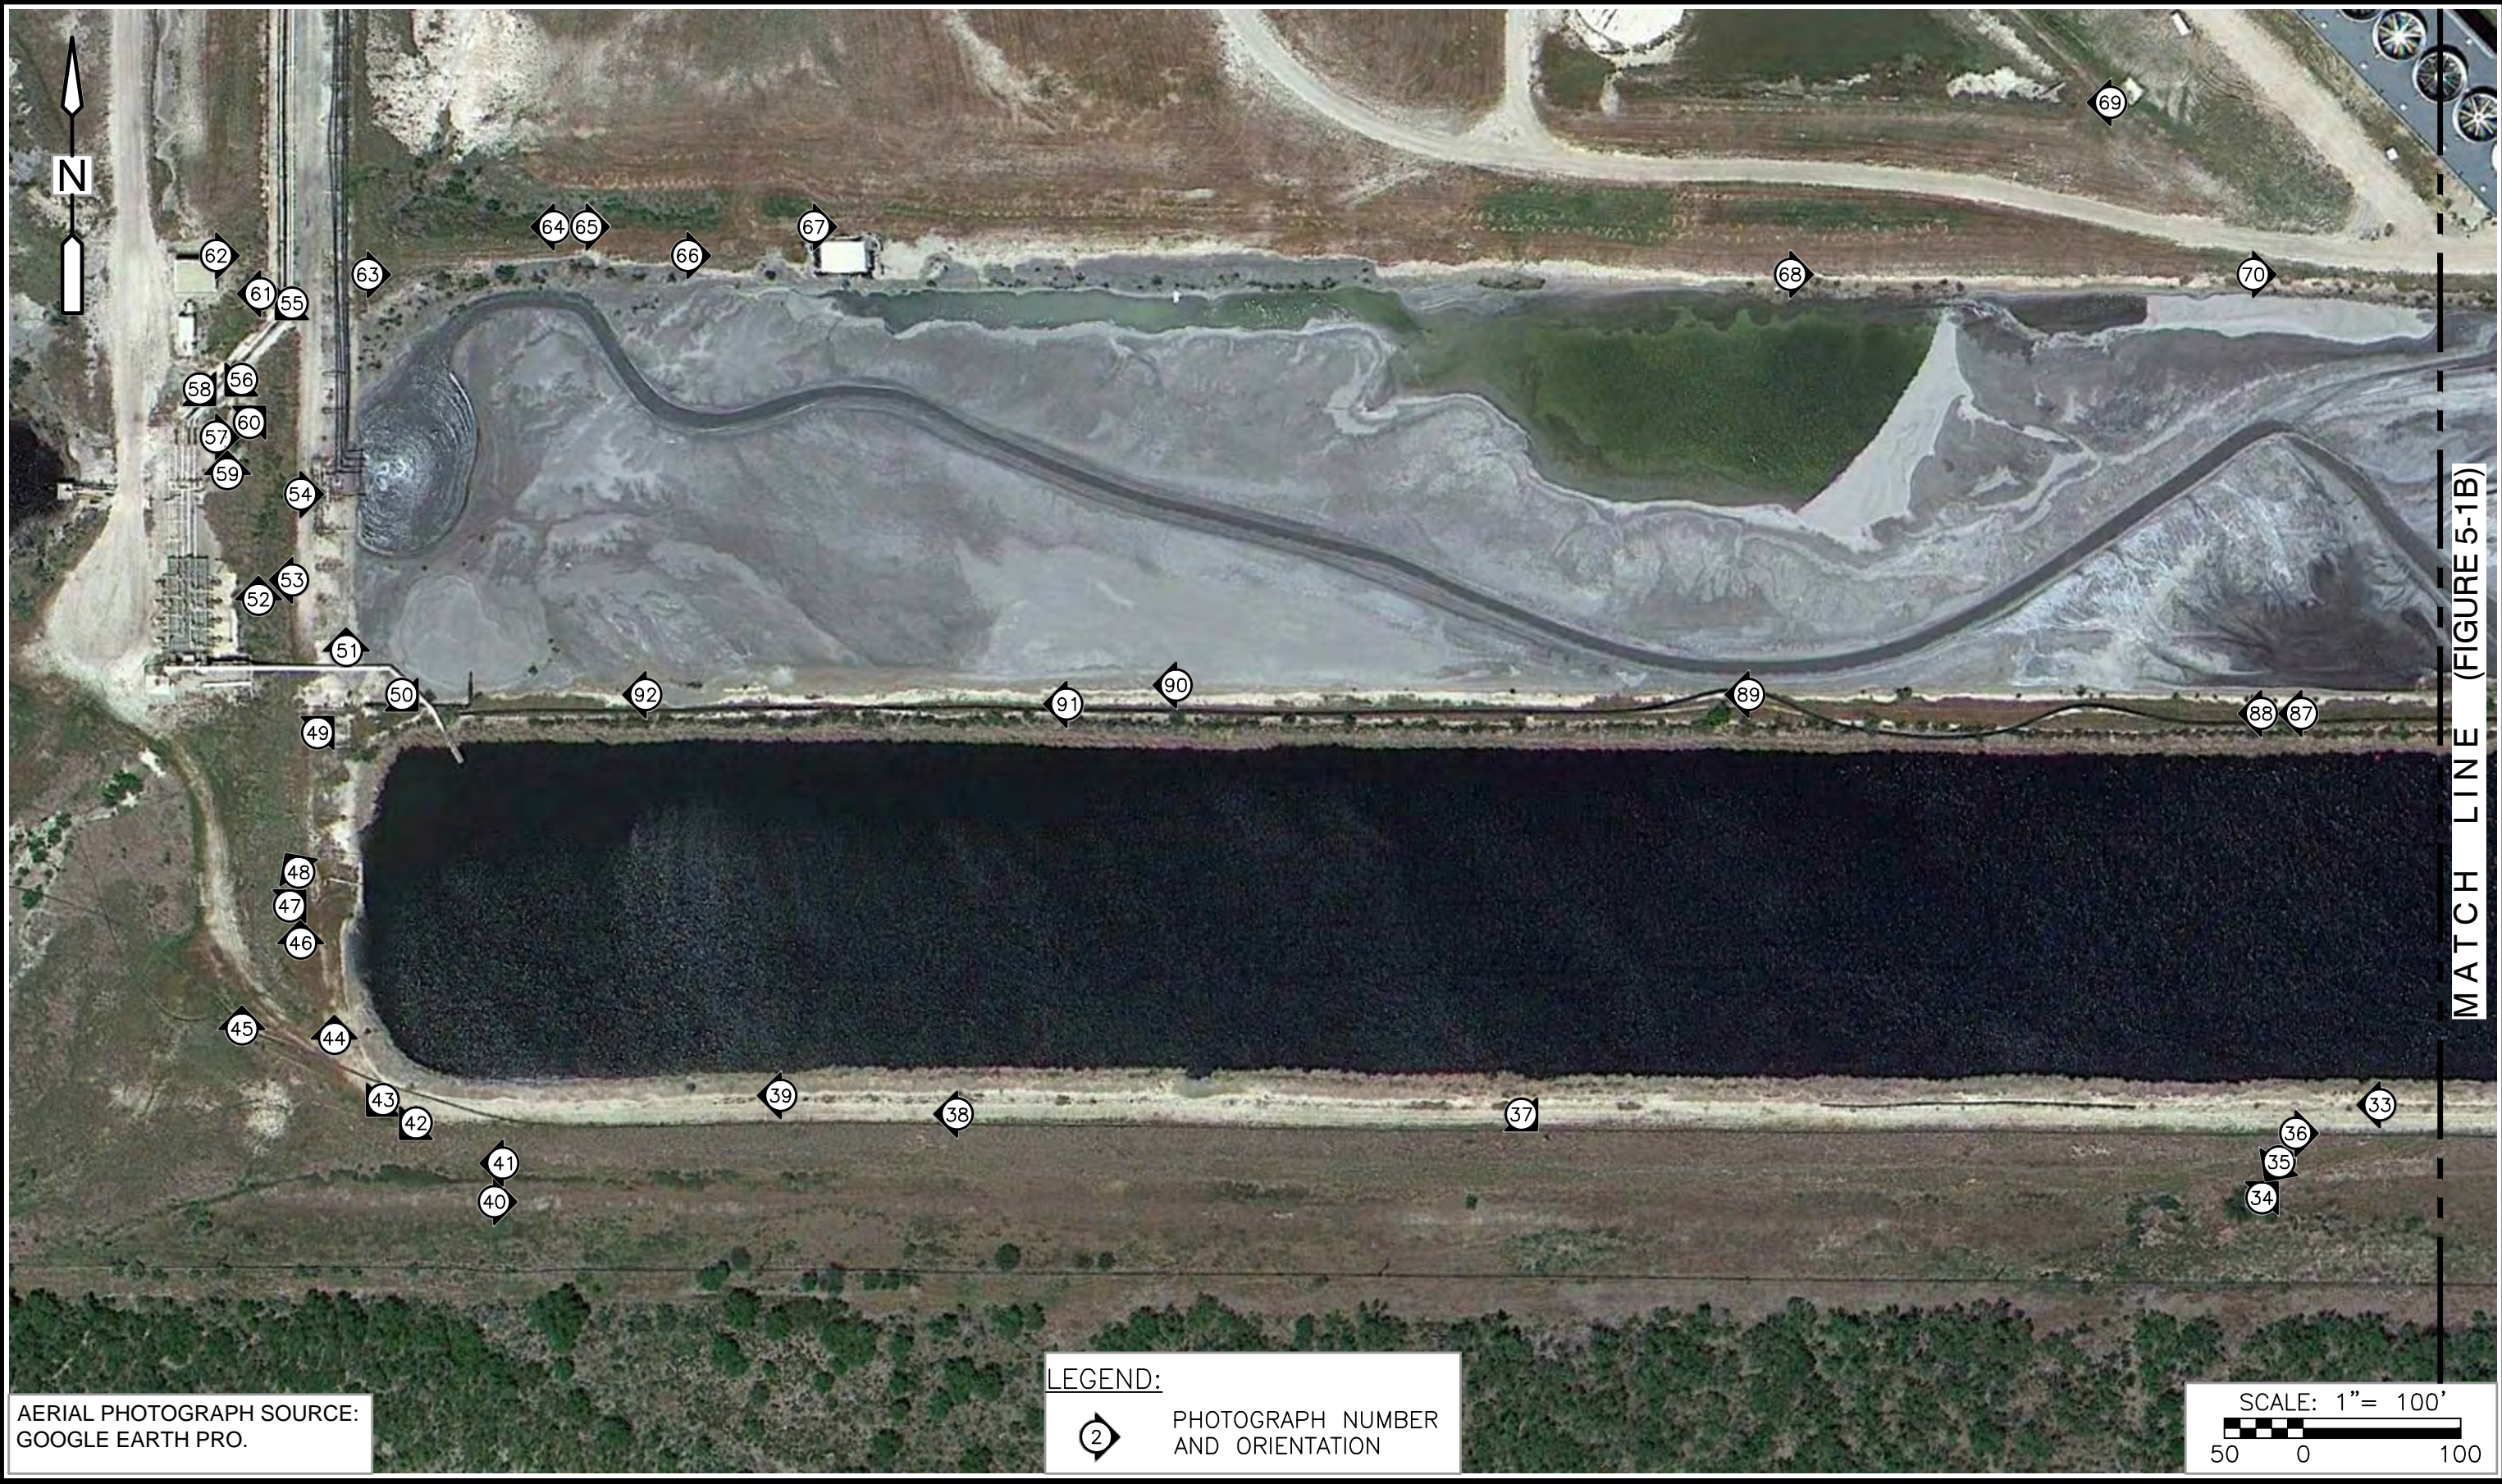
SAN MIGUEL POWER PLANT  
CHRISTINE, TEXAS  
ASH WATER TRANSPORT POND PHOTOGRAPH LOCATION PLAN  
FIGURE 5-1A

At the time of the assessment, the Ash Pond contained ash and liquids with approximately 20 inches of freeboard. An overview of the photographs taken at the Ash Pond during the CDM Smith site assessment is included in **Figure 5-1A** and **5-1B**.

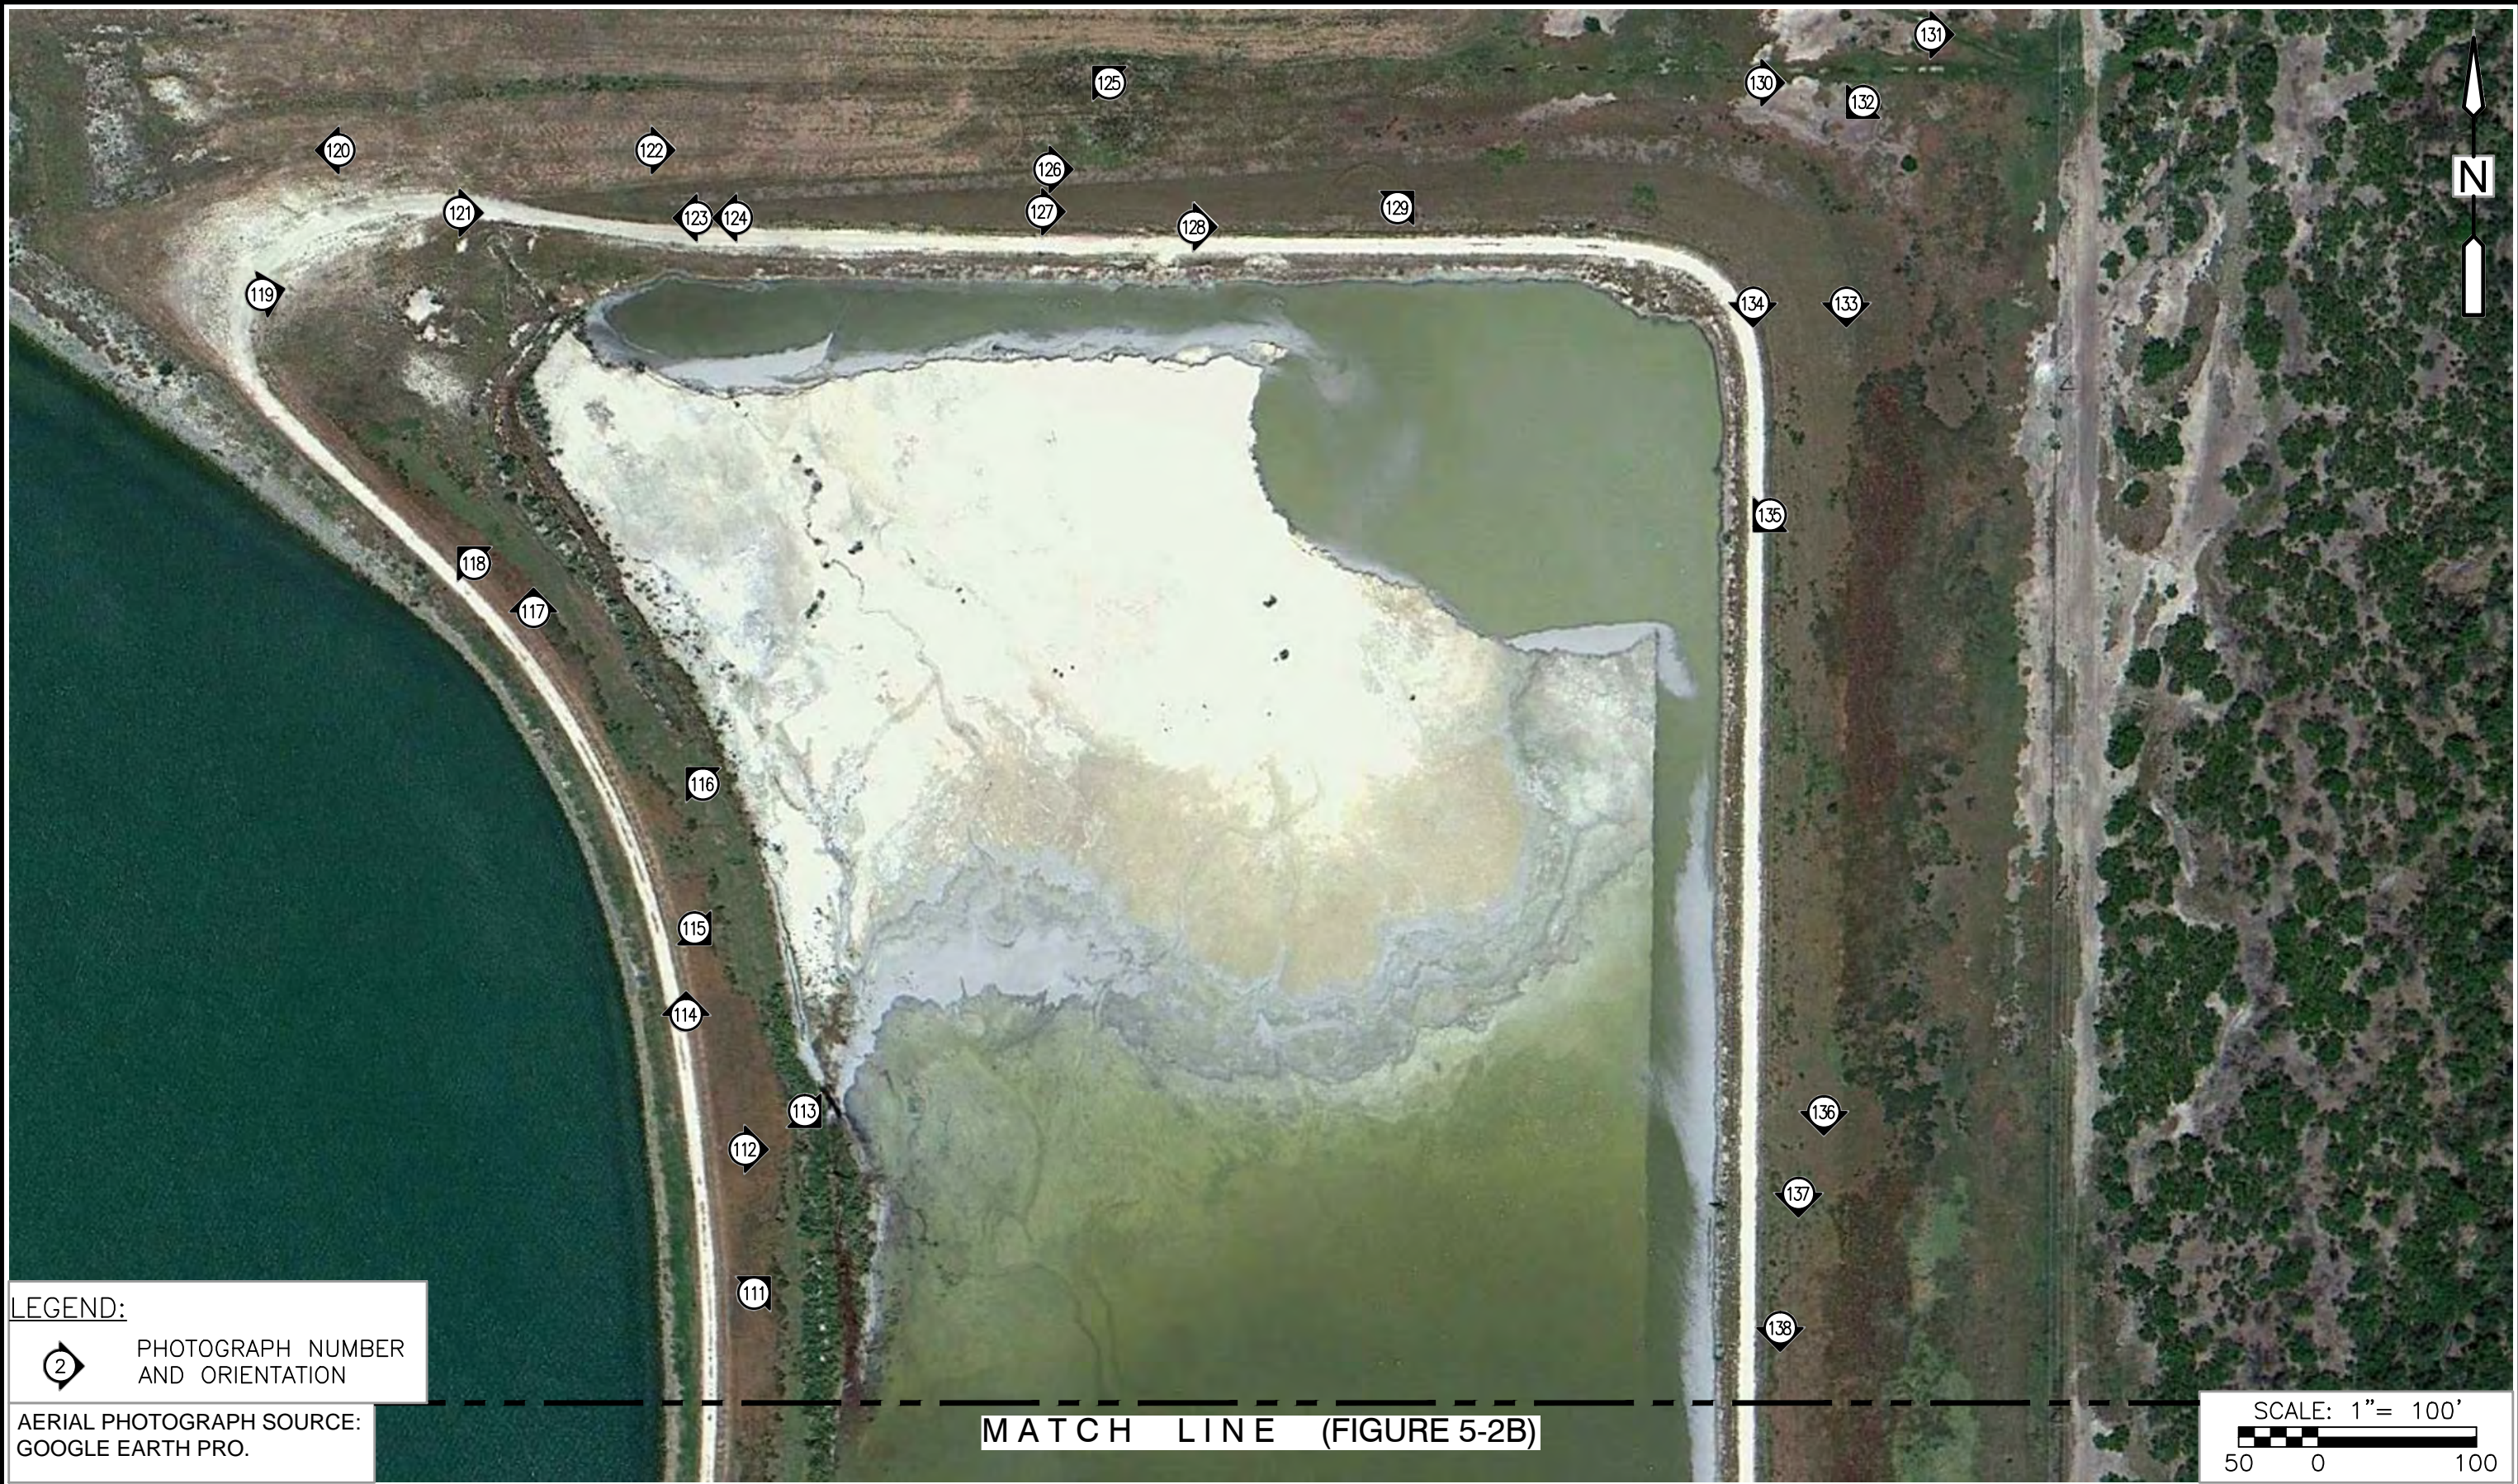
SAN MIGUEL POWER PLANT  
CHRISTINE, TEXAS  
SLUDGE DISPOSAL BASIN PHOTOGRAPH LOCATION PLAN  
FIGURE 5-2A

At the time of the assessment, the Sludge Basin contained sludge and liquids with approximately 8 feet of freeboard. An overview of the photographs taken at the Sludge Basin during the CDM Smith site assessment is included in **Figure 5-2A** and **5-2B**.

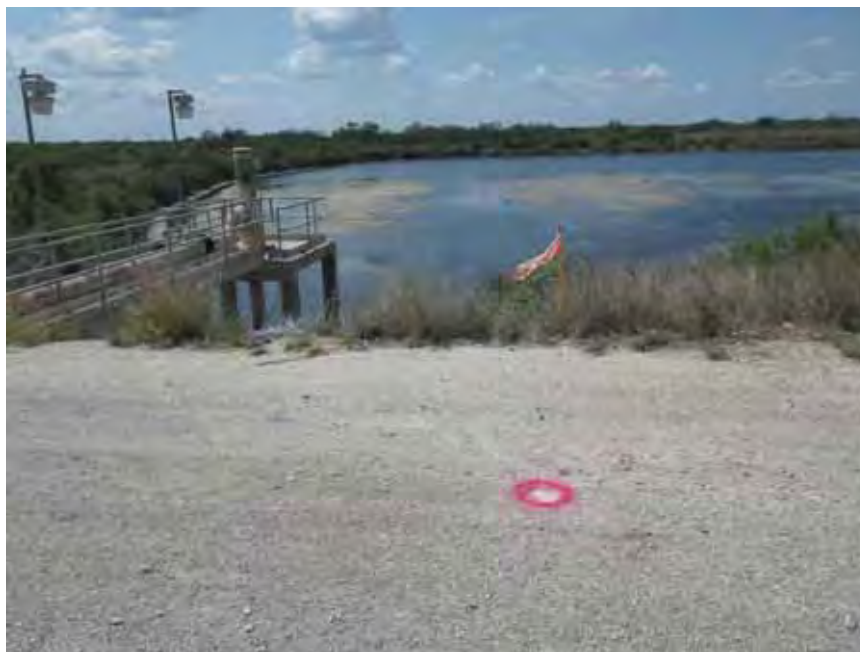
Photo 1 – View looking west at Boring B-2 and the Yard Drainage Retention Pond.

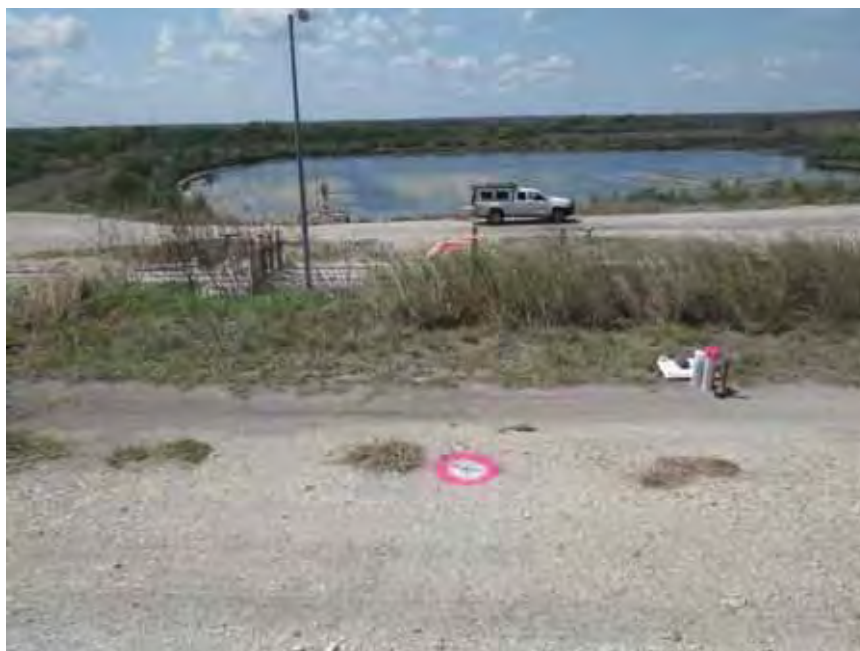
Photo 2 – View looking west from Ash Disposal Pond at Boring B-1, with Boring B-2 in the distance.

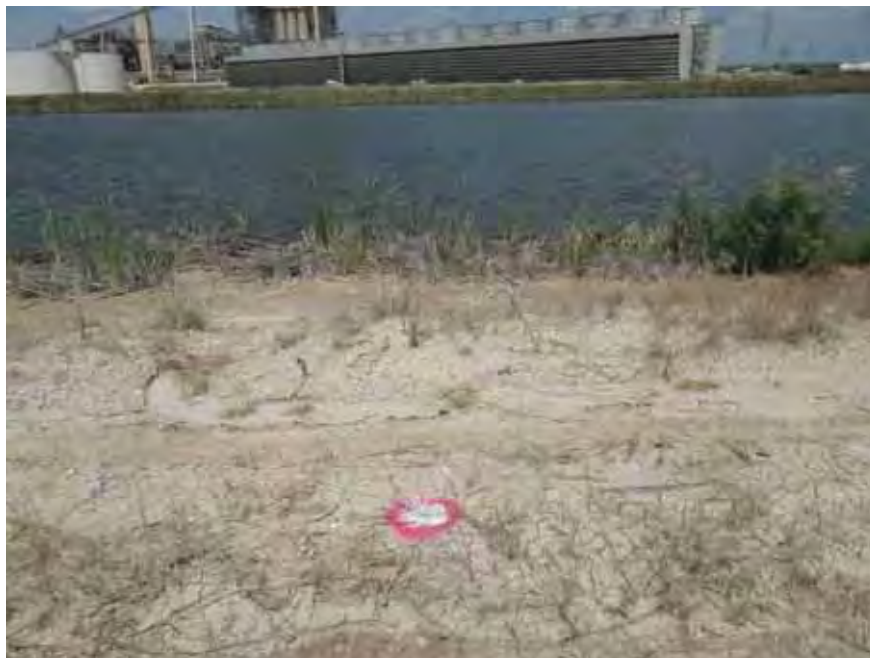
Photo 3 – View looking north at Ash Disposal Pond from Boring B-5.

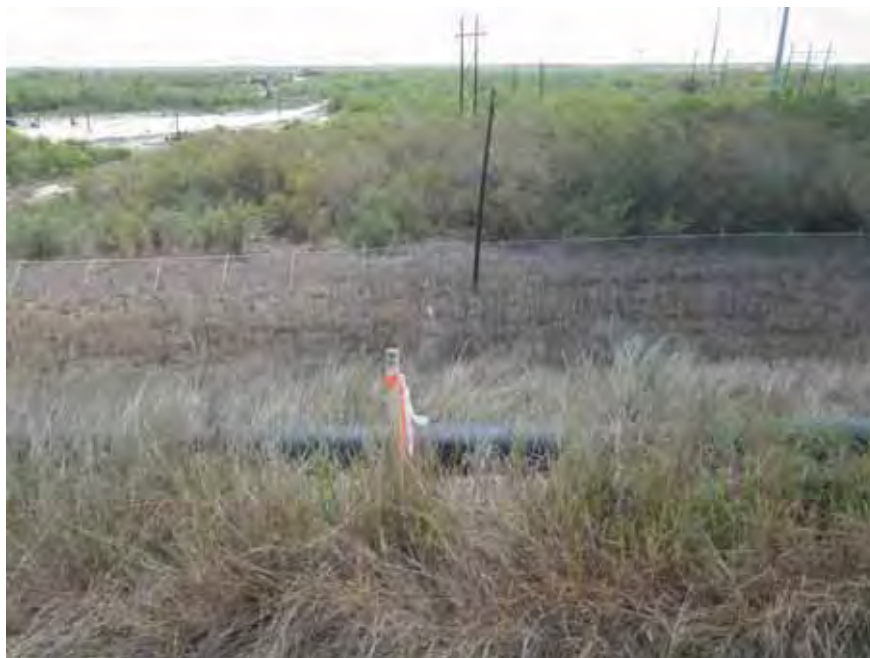
Photo 4 – View looking south from Boring B-6 towards Boring B-7 near the fence.

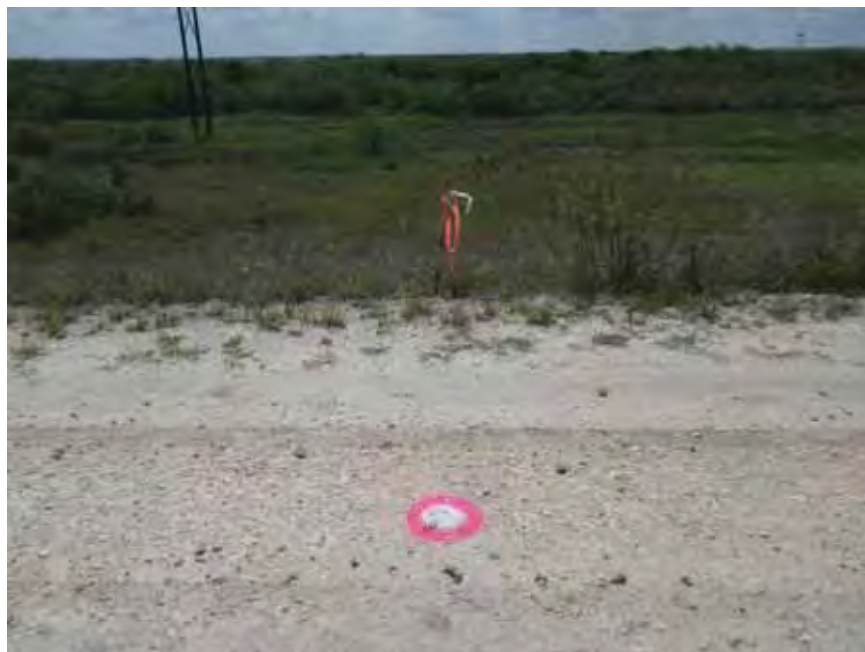
Photo 5 – View looking south from Sludge Disposal Basin at Boring B-8, with Boring B-9 in the distance.

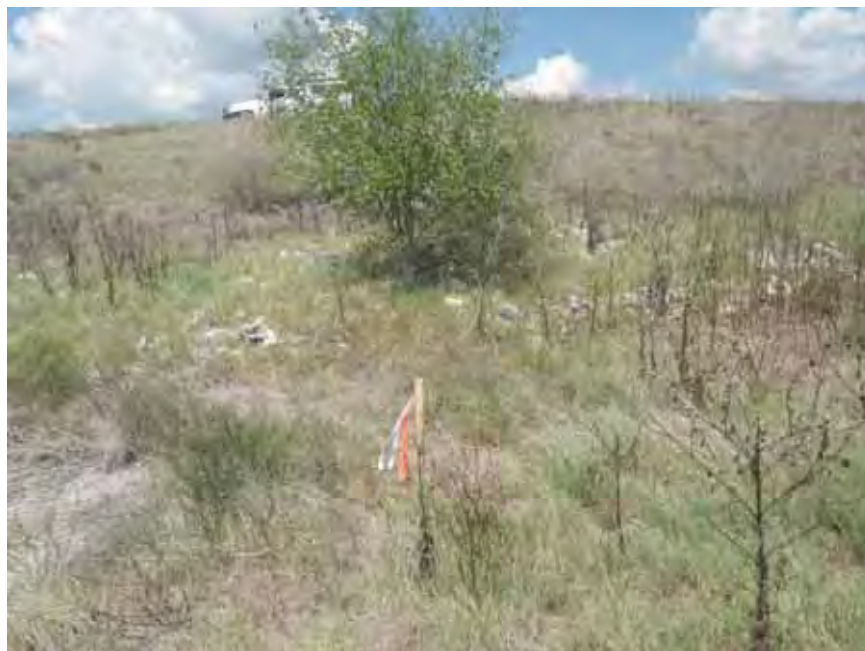
Photo 6 – View looking to the northwest at Boring B-11, with Boring B-10 at top near the truck.

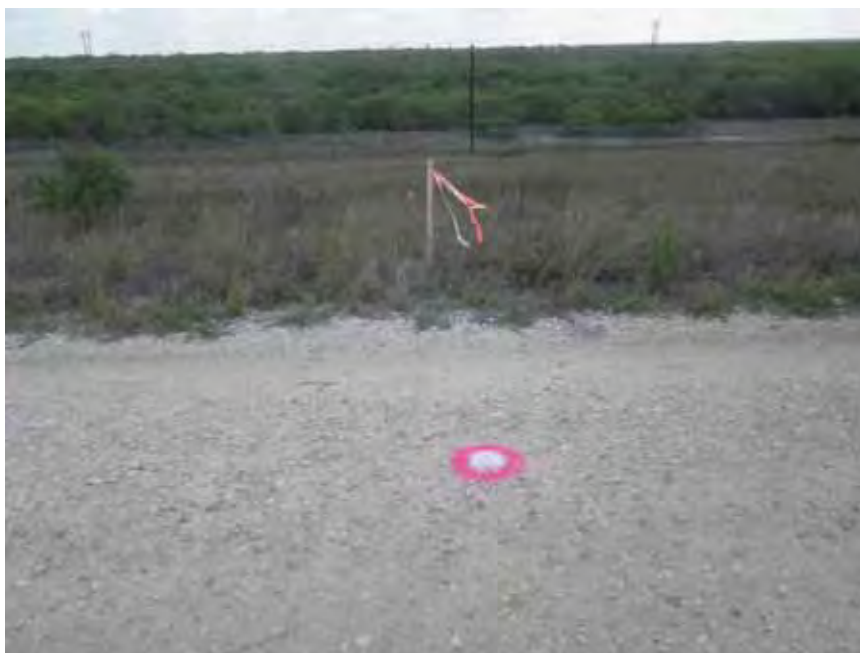
Photo 7 – View looking east from Sludge Disposal Basin at Boring B-13, with Boring B-14 in the distance.

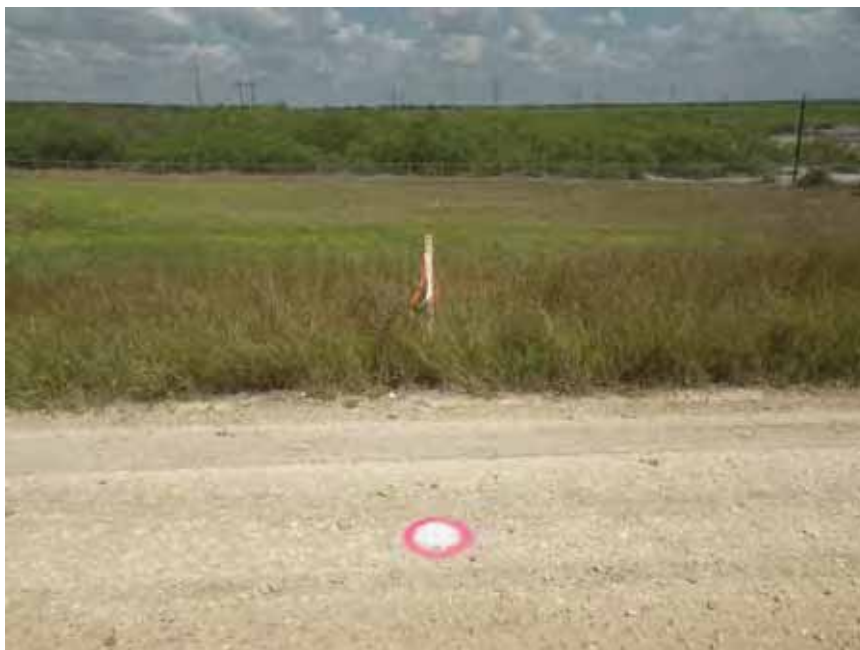
Photo 8 – View looking north from Sludge Disposal Basin at Boring B-16, with Boring B-17 in the distance.

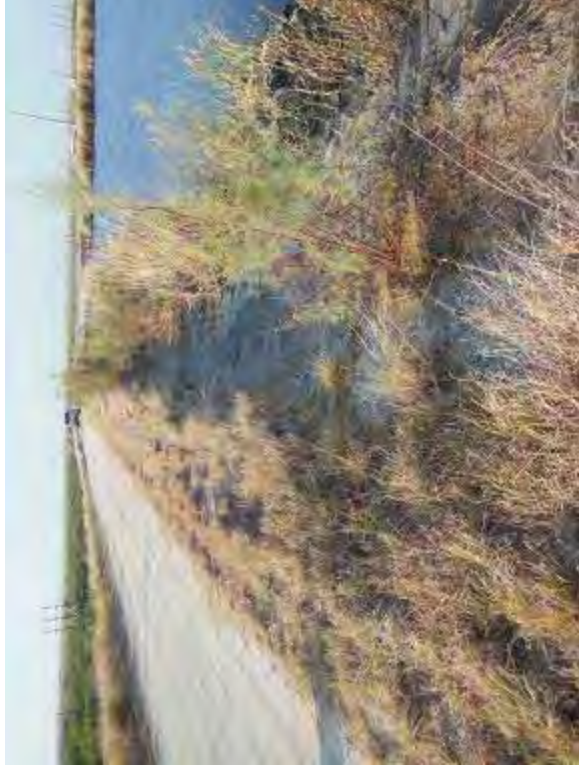
Due to the water level in the Ash Pond during the assessment, only the upper 1.5 to 2 feet of the interior slopes was visible (Photographs 2, 22, 51, 66, and 86). Based on drawings, the interior slopes are 2.5H:1V. An area of erosion into the interior slope approximately 5 feet wide was observed on the east embankment (Photograph 15). Reportedly, this erosion was a result of leakage from a water well pipe traversing the Ash Pond embankment. The water well pipe had been repaired at the time of the site assessment. Minor slope erosion was observed on the east embankment interior slope (Photograph 3). Minor erosion rills were observed on the south embankment interior slopes (Photographs 23 through 26). Grass, approximately 18 inches in height, covered some portions of the interior slopes that were visible (Photographs 2, 33, 63, and 84). Visible portions of interior slopes did not include riprap or other armoring.

Photo 2: East embankment interior slope, looking south.

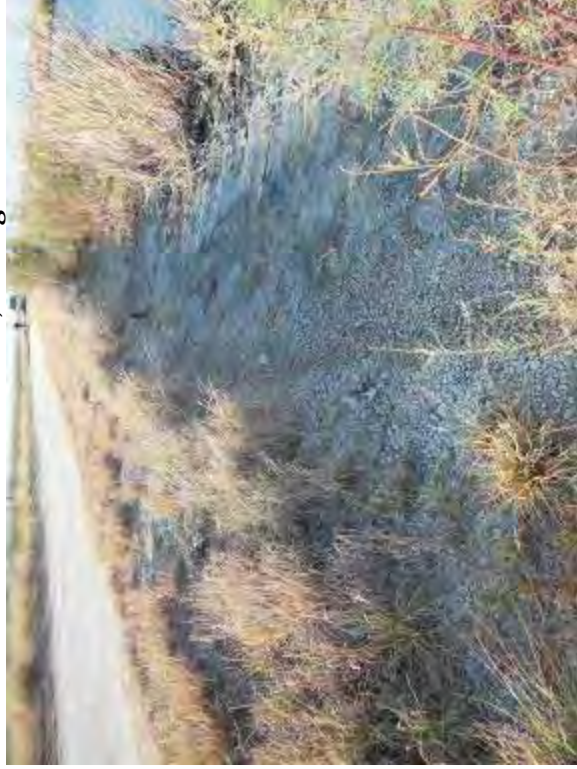
Photo 3: East embankment exterior slope, looking south. Note slope erosion.

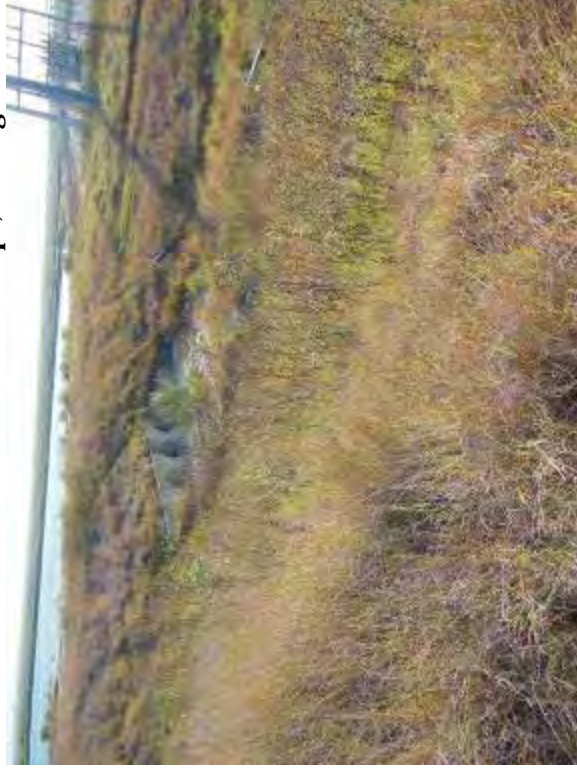
Photo 4: East embankment exterior slope, looking northeast. Note culvert at northeast corner toe.

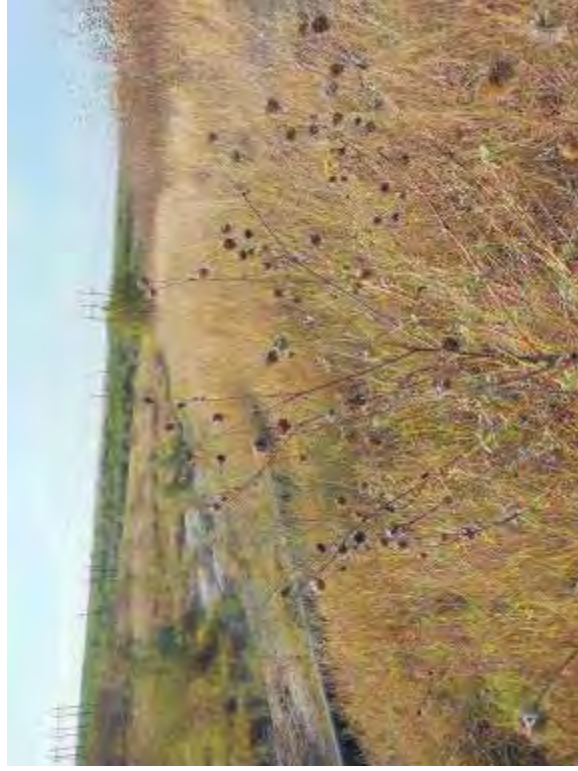
(Photograph 16) and on the west embankment near the potential seepage area (Photograph 58). The exterior slopes are approximately 2.5H:1V and covered in grassy vegetation approximately 2 feet tall (Photographs 5, 19, and 52). The coal pile runoff pond is approximately 100 feet west of the west embankment exterior toe (Photograph 48).

Photo 5: East embankment exterior slope, looking south. Piping from water well to water well pond to the left.

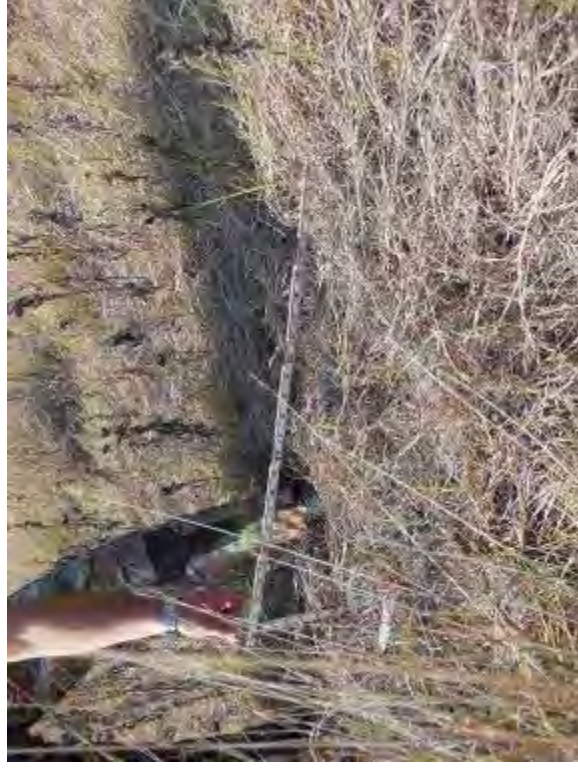
Photo 6: East embankment exterior slope approximately 2.5H:1V.

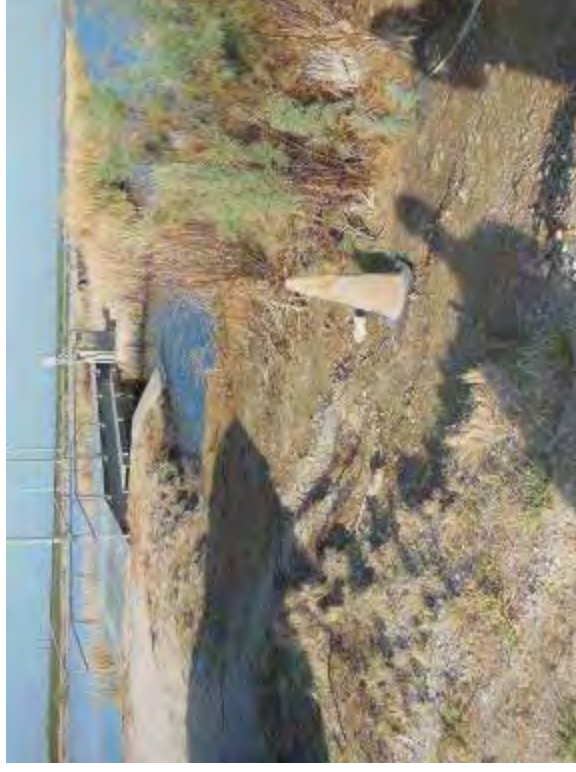
Photo 8: Gate structure between north and south sections of Ash Pond, looking west.

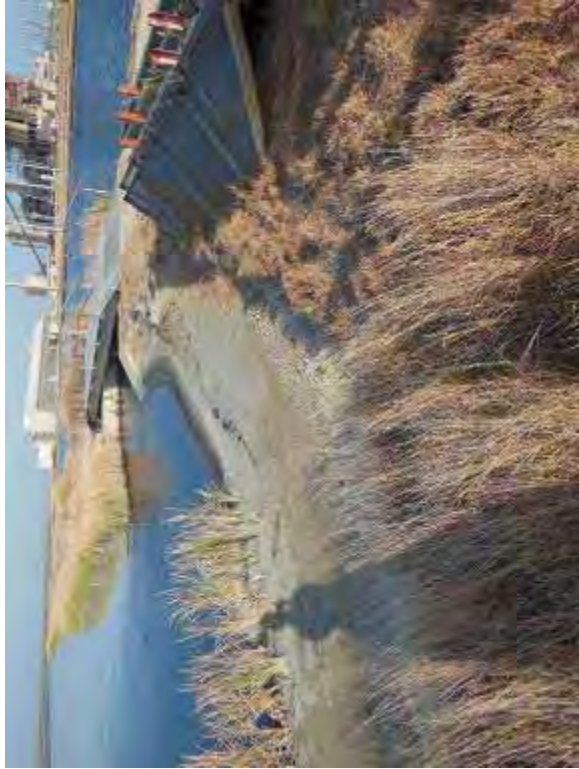
The crest of the Ash Pond appeared to be in satisfactory condition (Photographs 1, 21, 46, 72 and 82). The center embankment separating the Ash Pond into north and south sections included a metal gate structure that is kept open during normal operating conditions (Photographs 7, 9, and 78). Areas showing signs of tension or desiccation cracks were observed on the crest near the southeast and southwest corners of the impoundment (Photograph 13). Animal burrows were observed on the crest near the southwest corner (Photograph 42). The 15 to 35-foot-wide crest of the embankment consists of compacted granular soils and gravel and is exposed to minimal vehicle traffic. Support poles for overhead power lines were located on the crest of the south embankment (Photograph 27). No depressions or evidence of settlement were observed on the crest.

Photo 9: Gate structure between north and south sections of Ash Pond, looking west.

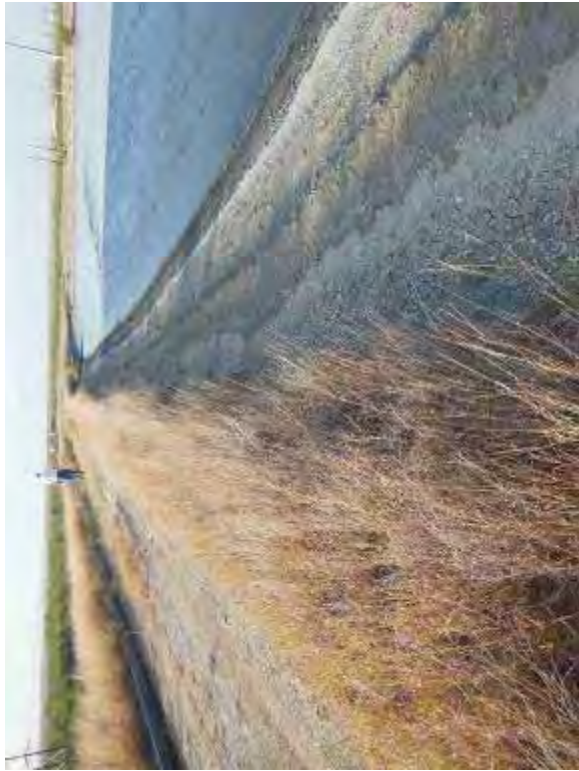
Photo 10: East embankment interior slope, looking south. Piping from water well to water well pond to the left.

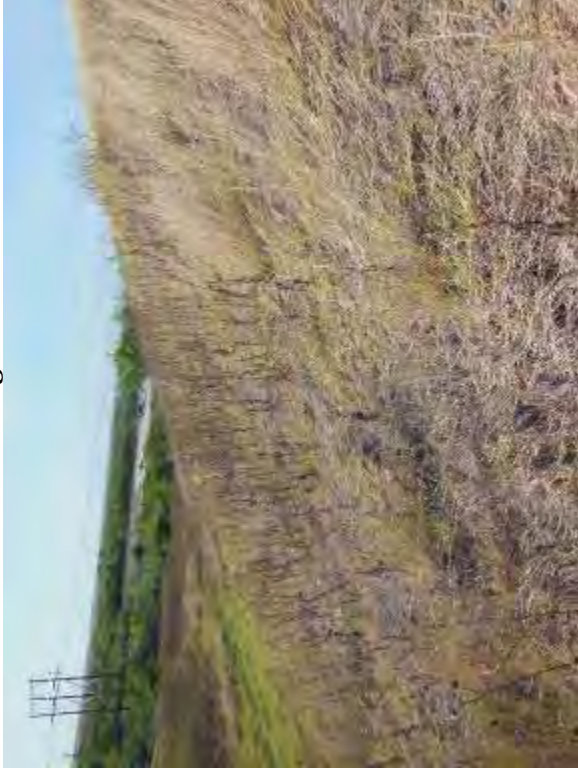
The Ash Pond includes exterior slopes on the west, south, and east embankments. The north side of the Ash Pond is incised (Photograph 67). The exterior slopes appear to be in fair condition (Photographs 11, 31, and 48). An area of potential seepage approximately 20 feet by 10 feet was located on the west embankment exterior slope (Photographs 56 through 60). The area included cattails and other vegetation varying from the surrounding vegetation, and the ground was damp. According to documentation provided by San Miguel, this area of potential seepage is in the vicinity of a location of documented seepage in the 1980's. A berm approximately 10 feet wide adjacent to and about halfway up the south embankment exterior slope was observed (Photographs 40 and 41). Plant staff suggested this may have been constructed as a road embankment to access the pond during reconstruction of the clay liner in the 1980s or from cleanout operations. An animal burrow was observed on the east embankment exterior slope (Photograph 17). A few small trees and bushes with diameters less than 3 inches in diameter were observed on the exterior slopes at the southeast corner

Photo 11: East embankment exterior slope, looking south.

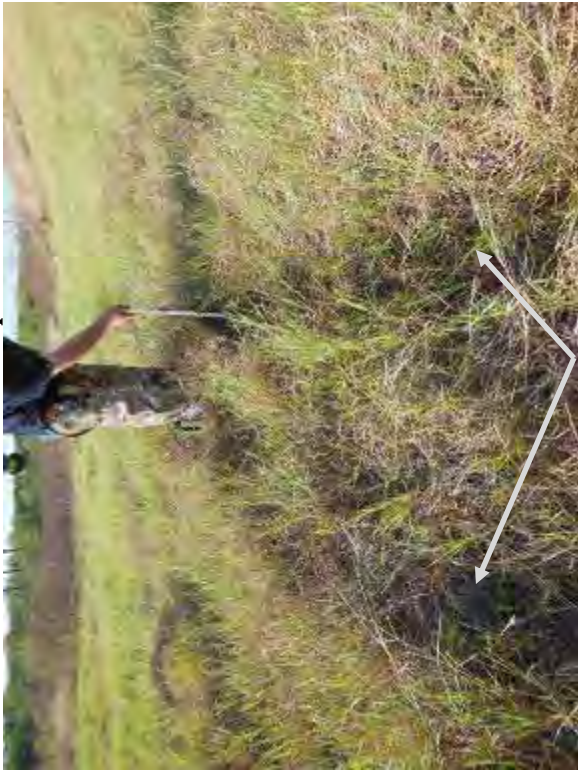
Photo 12: Stormwater runoff drainage feature at east embankment exterior toe, looking south.

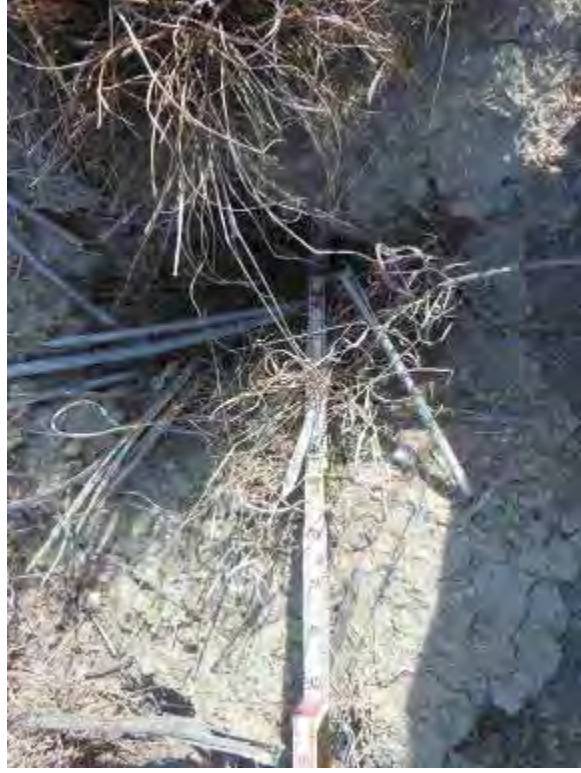
Photo 17: Approximately 12-inch-deep animal burrow hole at west embankment exterior slope.

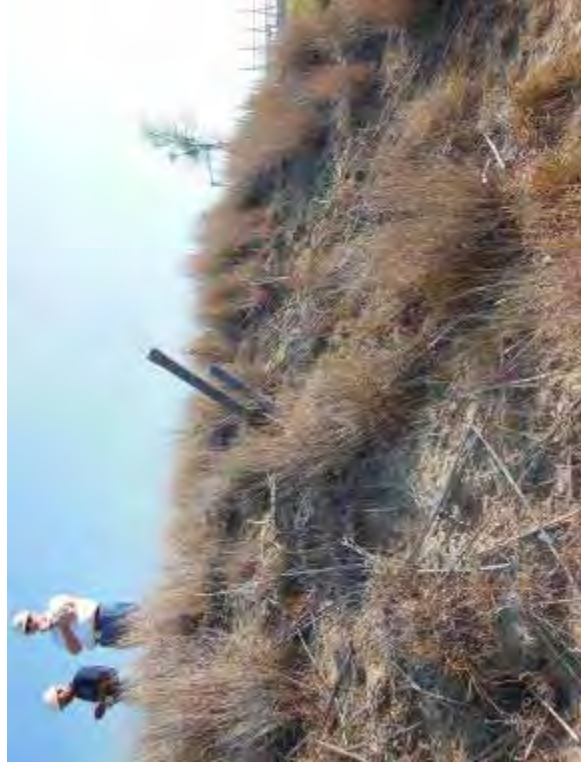
Photo 18: Unknown steel pipes near southeast corner exterior slope.

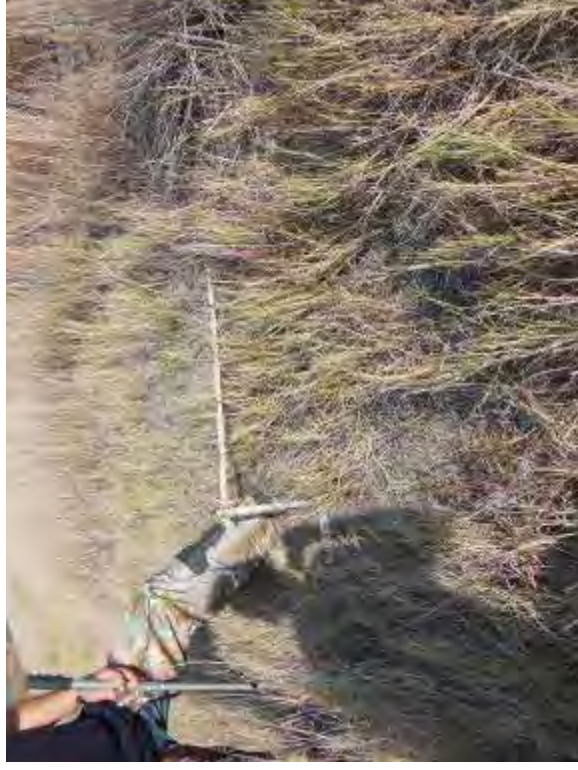
Photo 20: South embankment exterior slope approximately 2.5H:1V.

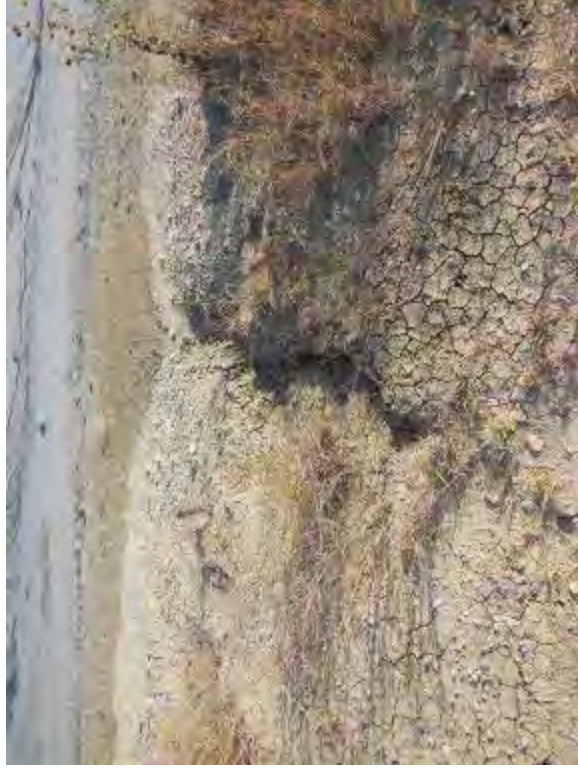
Photo 23: Erosion rills at south embankment interior slope.

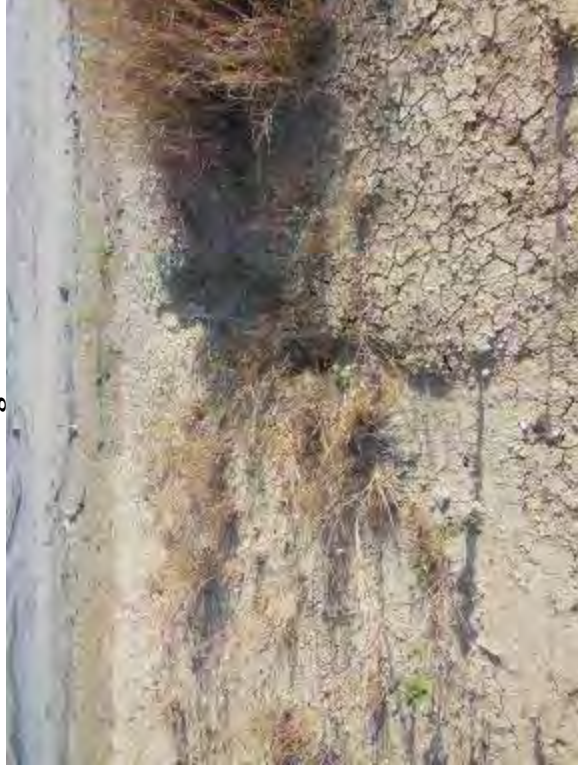
Photo 24: Erosion rills at south embankment interior slope.

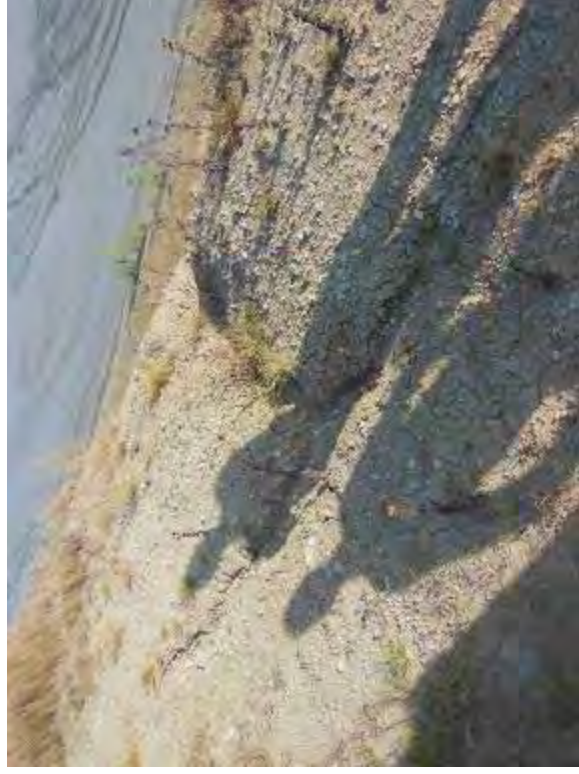
Photo 25: Erosion rills at south embankment interior slope.

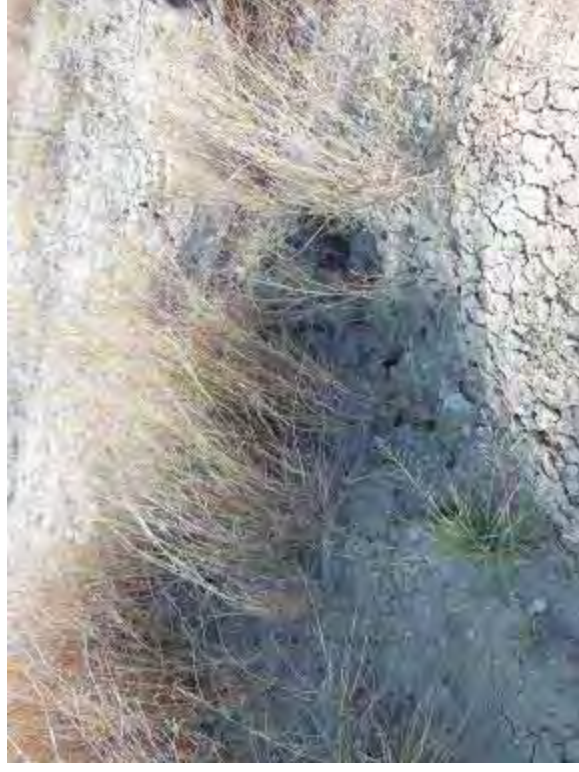
Photo 26: Erosion rills at south embankment interior slope.

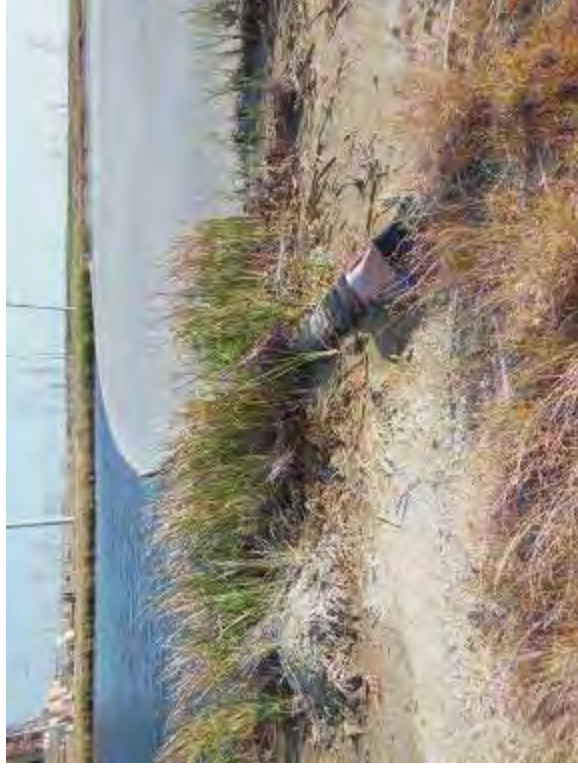
Photo 28: Skimmer floats in south section of Ash Pond, looking north.

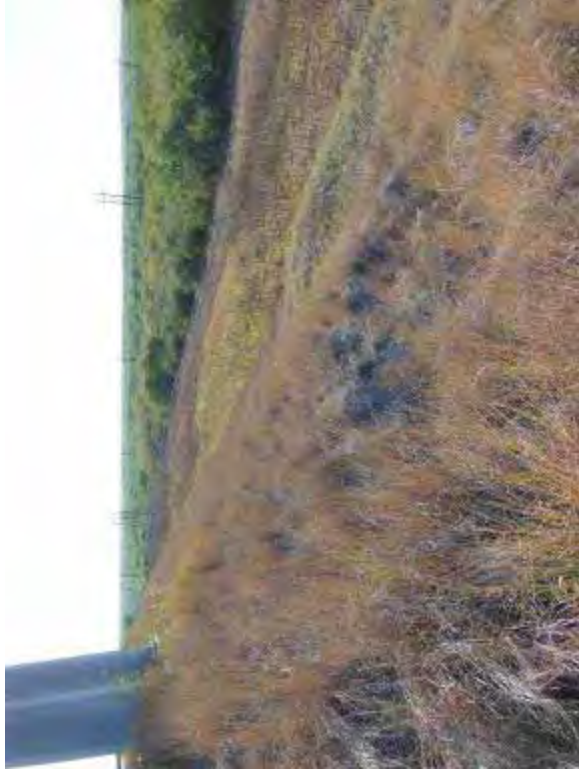
Photo 29: South embankment exterior slope, looking southeast.  
Power line support poles to the left.

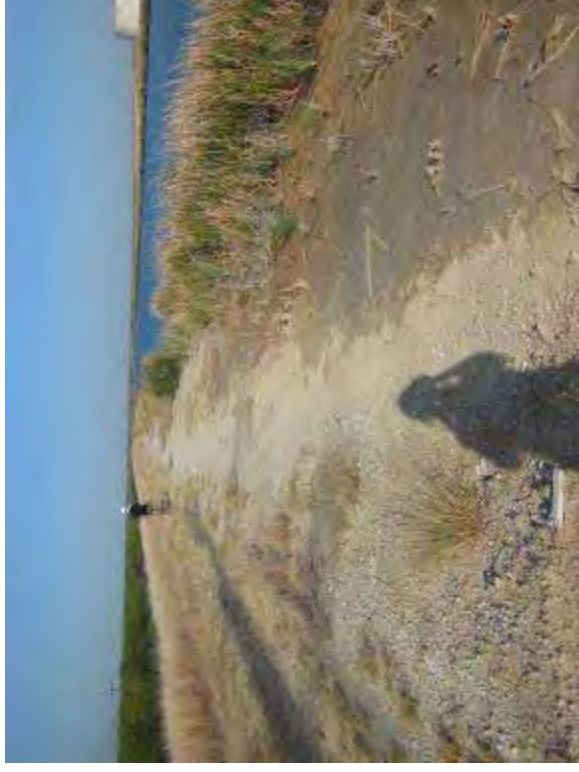
Photo 30: South embankment interior slope, looking west.

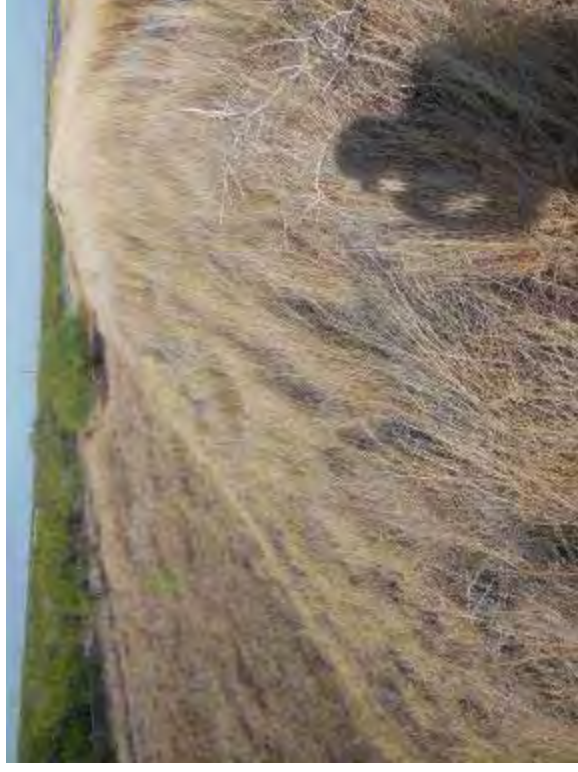
Photo 32: South embankment exterior slope, looking west.
