# ASSESSMENT OF DAM SAFETY OF COAL COMBUSTION SURFACE IMPOUNDMENTS FINAL REPORT

**San Miguel Electric  
Cooperative, Inc.  
San Miguel Electric Plant  
Christine, Texas**

Prepared for  
*U.S. Environmental  
Protection Agency  
Washington, D.C.*

March 2014  
Revision 1, April 2014

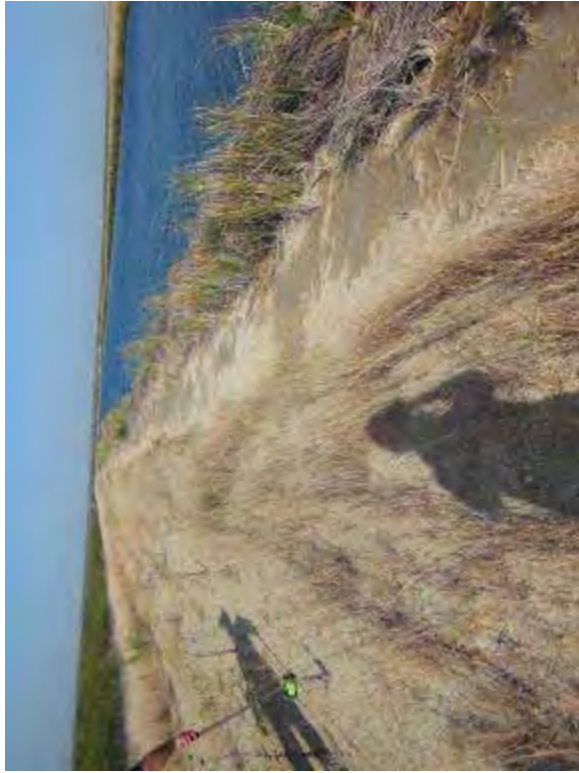
Due to the water level in the Ash Pond during the assessment, only the upper 1.5 to 2 feet of the interior slopes was visible (Photographs 2, 22, 51, 66, and 86). Based on drawings, the interior slopes are 2.5H:1V. An area of erosion into the interior slope approximately 5 feet wide was observed on the east embankment (Photograph 15). Reportedly, this erosion was a result of leakage from a water well pipe traversing the Ash Pond embankment. The water well pipe had been repaired at the time of the site assessment. Minor slope erosion was observed on the east embankment interior slope (Photograph 3). Minor erosion rills were observed on the south embankment interior slopes (Photographs 23 through 26). Grass, approximately 18 inches in height, covered some portions of the interior slopes that were visible (Photographs 2, 33, 63, and 84). Visible portions of interior slopes did not include riprap or other armoring.

Photo 33: South embankment interior slope, looking west.

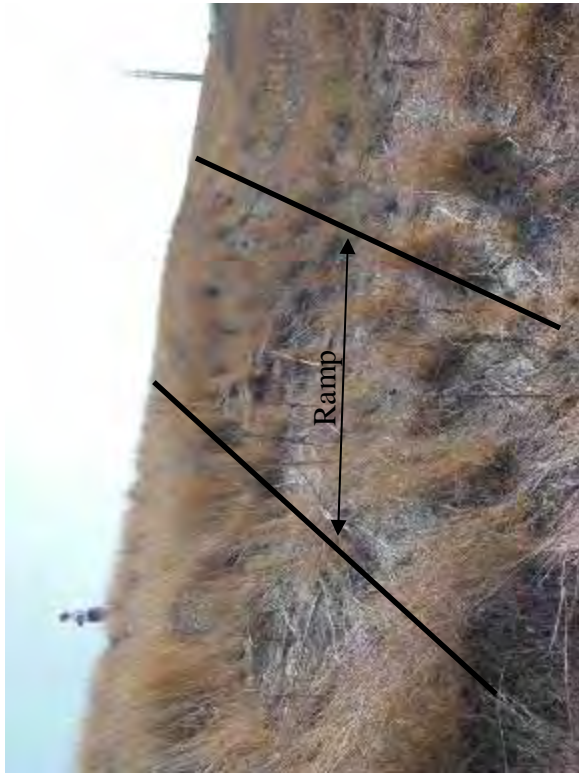
Photo 34: South embankment exterior slope, looking northeast. Note remnants of roadway ramp from Ash Pond cleanout in 1987.

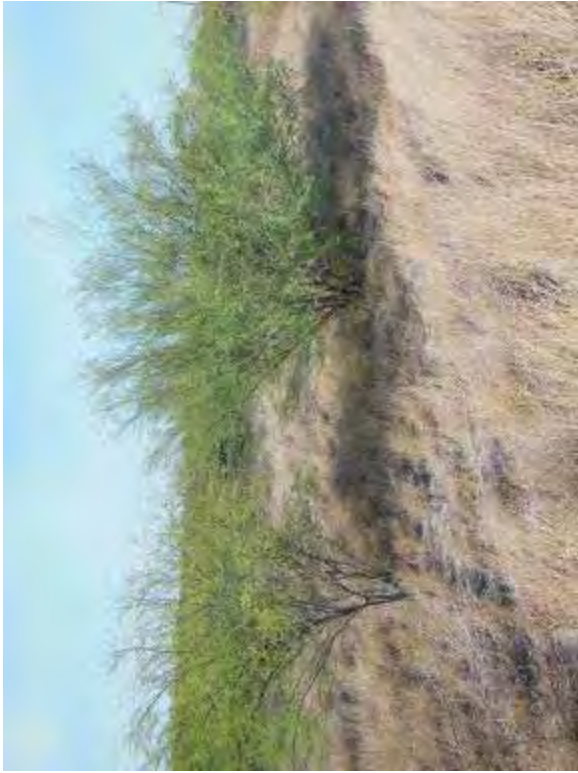
Photo 35: Trees at south embankment exterior toe, looking south.

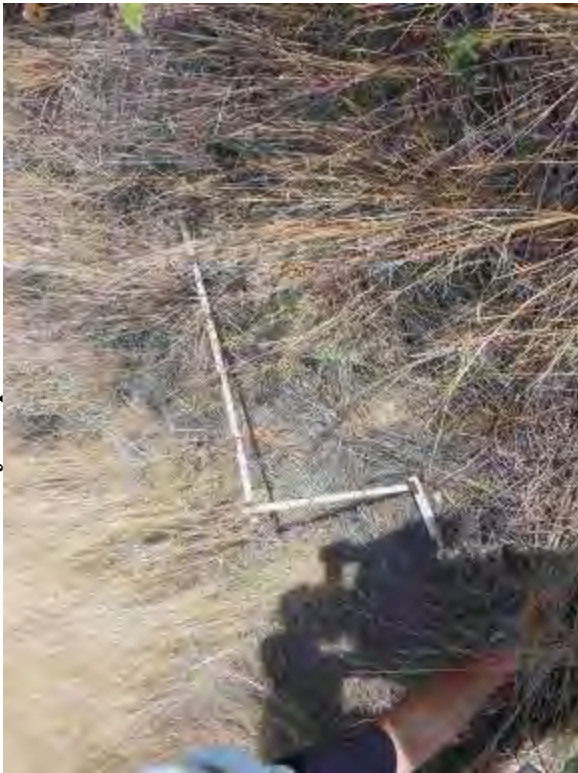
Photo 36: South embankment exterior slope approximately 2.5H:1V.

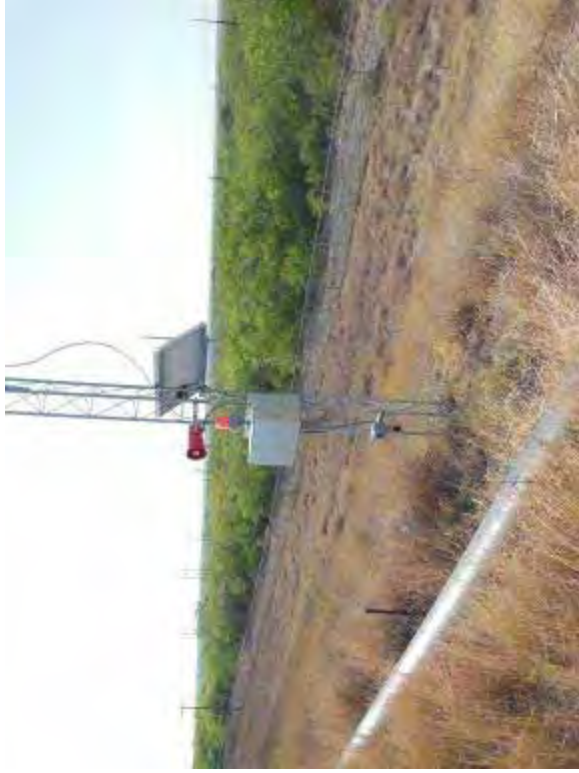
Photo 37: Hydrogen sulfide warning siren at south embankment exterior slope, looking southeast.

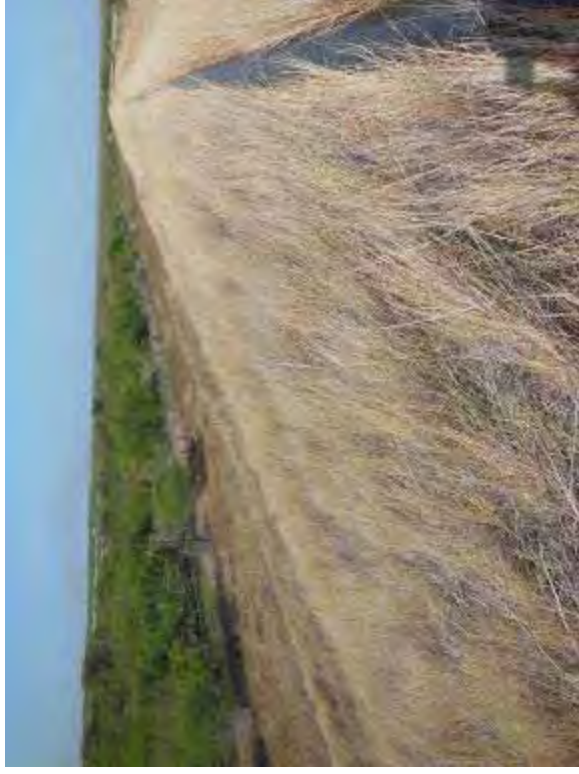
Photo 38: South embankment exterior slope, looking west.

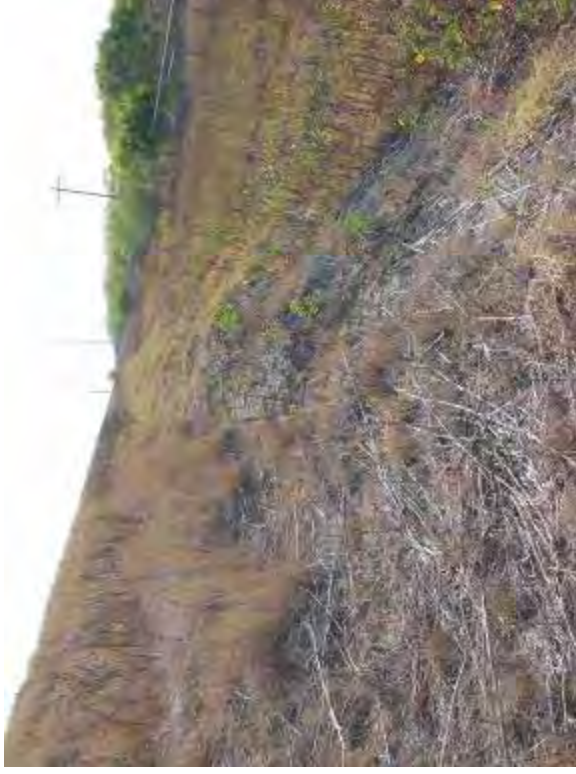
Photo 40: Berm at south embankment exterior toe, looking east.

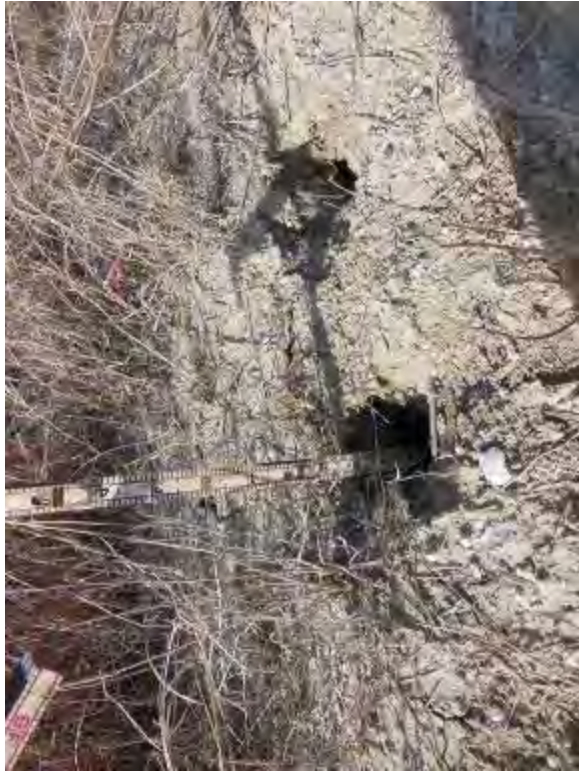
Photo 42: Approximately 6-inch-deep animal burrows on crest near southwest corner.

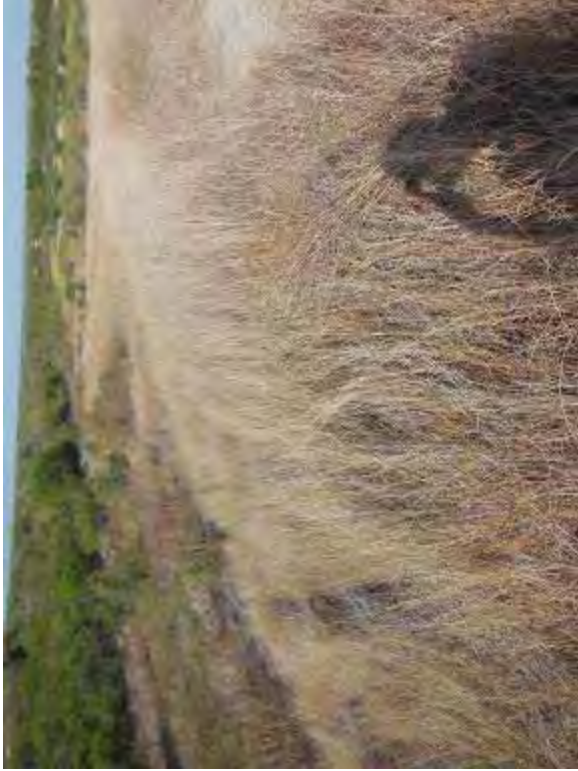
Photo 43: Southwest corner exterior slope, looking west.

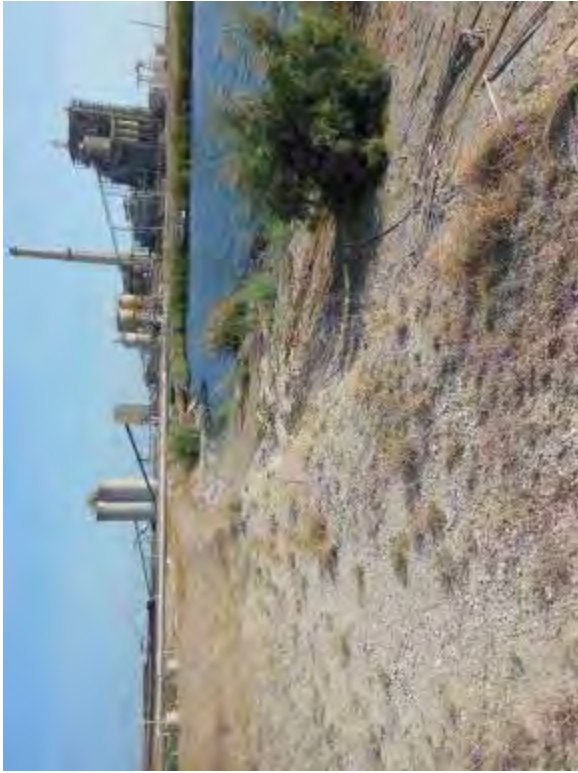
Photo 44: West embankment interior slope, looking north.

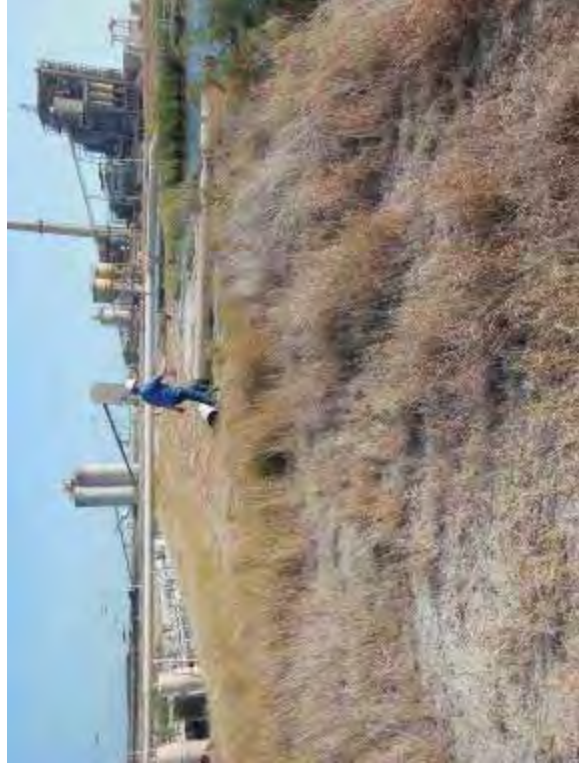
The crest of the Ash Pond appeared to be in satisfactory condition (Photographs 1, 21, 46, 72 and 82). The center embankment separating the Ash Pond into north and south sections included a metal gate structure that is kept open during normal operating conditions (Photographs 7, 9, and 78). Areas showing signs of tension or desiccation cracks were observed on the crest near the southeast and southwest corners of the impoundment (Photograph 13). Animal burrows were observed on the crest near the southwest corner (Photograph 42). The 15 to 35-foot-wide crest of the embankment consists of compacted granular soils and gravel and is exposed to minimal vehicle traffic. Support poles for overhead power lines were located on the crest of the south embankment (Photograph 27). No depressions or evidence of settlement were observed on the crest.

Photo 46: West embankment crest, looking north.

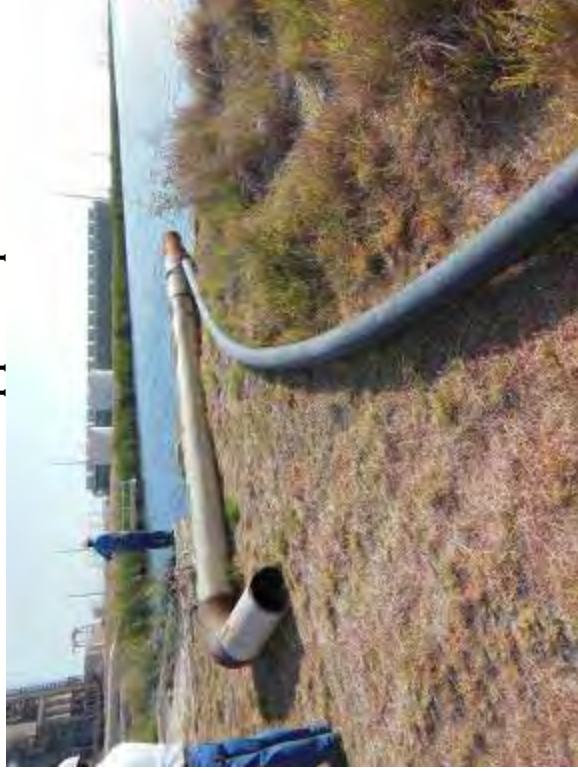
Photo 47: West embankment crest, looking northeast. Note  
abandoned steel and PVC pipe.

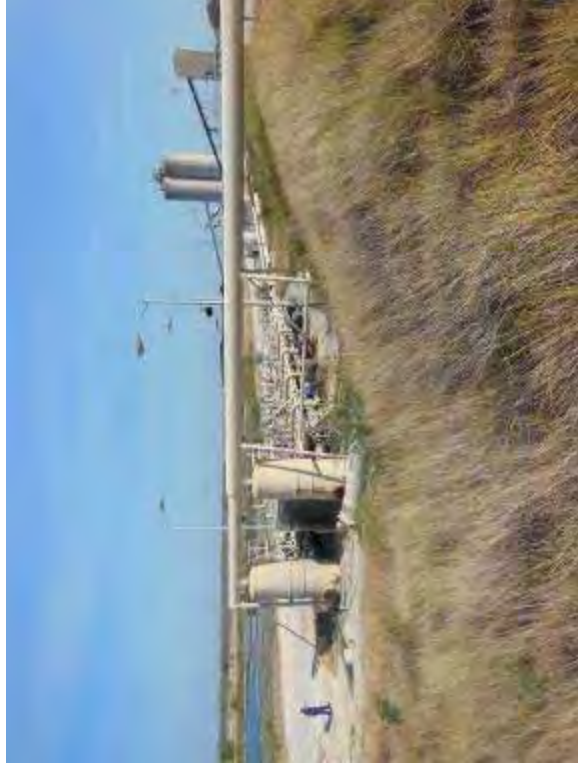
The Ash Pond includes exterior slopes on the west, south, and east embankments. The north side of the Ash Pond is incised (Photograph 67). The exterior slopes appear to be in fair condition (Photographs 11, 31, and 48). An area of potential seepage approximately 20 feet by 10 feet was located on the west embankment exterior slope (Photographs 56 through 60). The area included cattails and other vegetation varying from the surrounding vegetation, and the ground was damp. According to documentation provided by San Miguel, this area of potential seepage is in the vicinity of a location of documented seepage in the 1980's. A berm approximately 10 feet wide adjacent to and about halfway up the south embankment exterior slope was observed (Photographs 40 and 41). Plant staff suggested this may have been constructed as a road embankment to access the pond during reconstruction of the clay liner in the 1980s or from cleanout operations. An animal burrow was observed on the east embankment exterior slope (Photograph 17). A few small trees and bushes with diameters less than 3 inches in diameter were observed on the exterior slopes at the southeast corner

(Photograph 16) and on the west embankment near the potential seepage area (Photograph 58). The exterior slopes are approximately 2.5H:1V and covered in grassy vegetation approximately 2 feet tall (Photographs 5, 19, and 52). The coal pile runoff pond is approximately 100 feet west of the west embankment exterior toe (Photograph 48).

Photo 48: Pumps at west embankment exterior toe, looking north. Note  
coal pile runoff pond to the left.

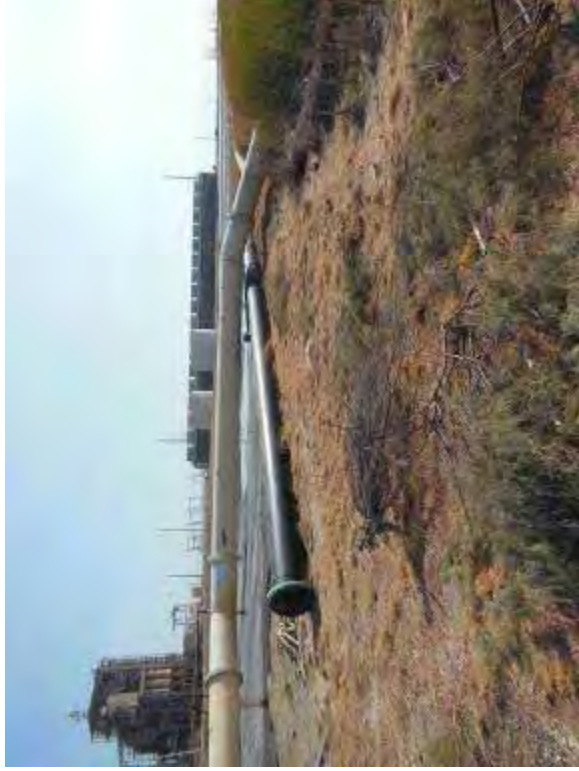
The outlet structure consists of a 24-inch-diameter steel siphon pipe on the west embankment interior slope (Photographs 49 and 50). The steel pipe transports liquids to the pumps at the west embankment exterior toe, and the liquids are then pumped to the Plant for reuse in plant processes.

Photo 49: 24-inch-diameter steel outlet pipe at west embankment interior slope. PVC pipe along center embankment.

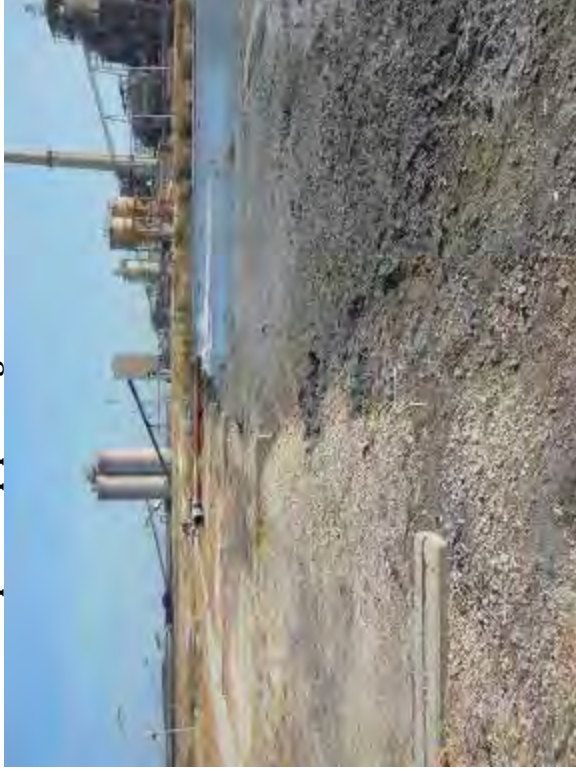
Photo 51: West embankment interior slope, looking north. Note inlet pipes in distance.

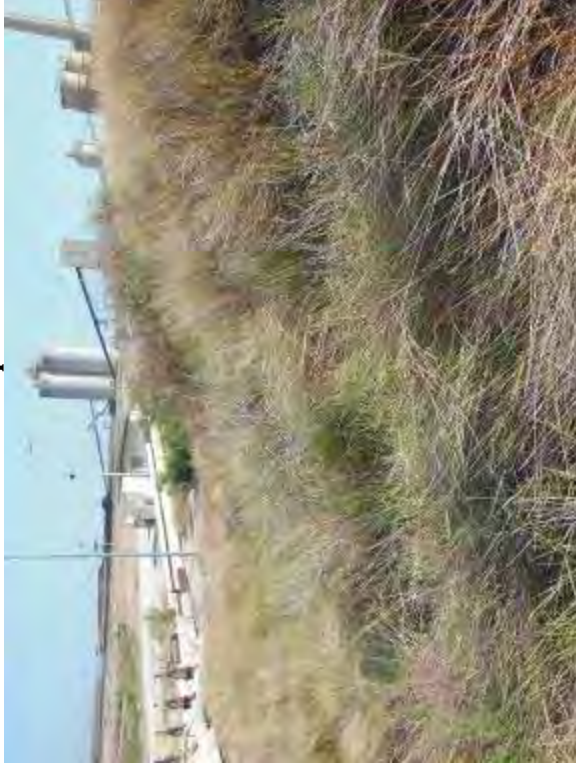
Photo 52: West embankment exterior slope, looking north.

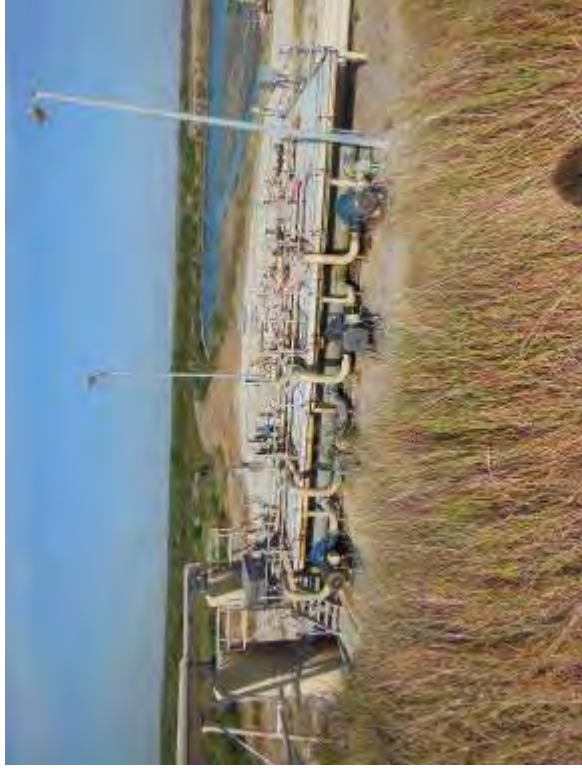
Photo 53: Pumps at west embankment exterior toe, looking west.

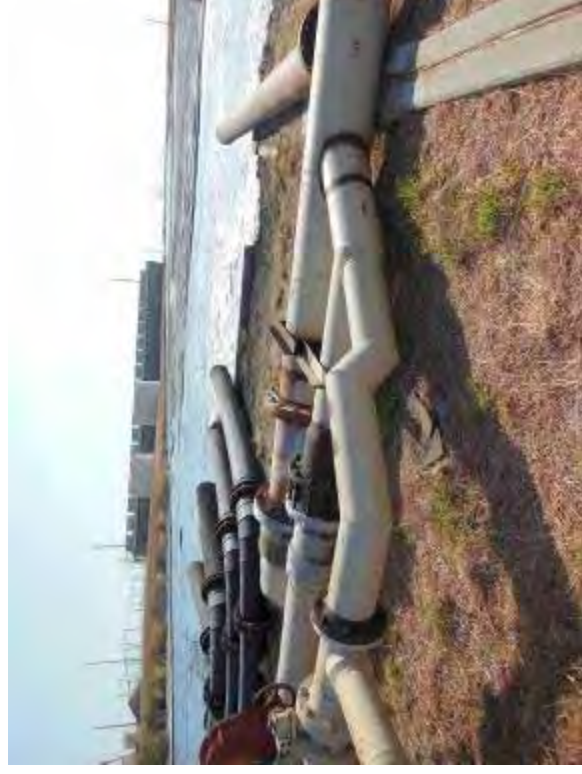
Six inlet pipes are located on the interior slope of the west embankment: two 12-inch PVC, two 16-inch-diameter PVC, one 12-inch-diameter steel, and one 6-inch-diameter PVC pipe (Photograph 54). Two inlet pipes are located on the interior slope of the north embankment: a 6-inch-diameter metal and 6-inch-diameter high-density polyethylene (HDPE) pipe (Photographs 71 and 74). The outlet pipe is located on the west embankment interior slope (Photograph 50).

Photo 54: Inlet pipes at west embankment interior slope, looking east.

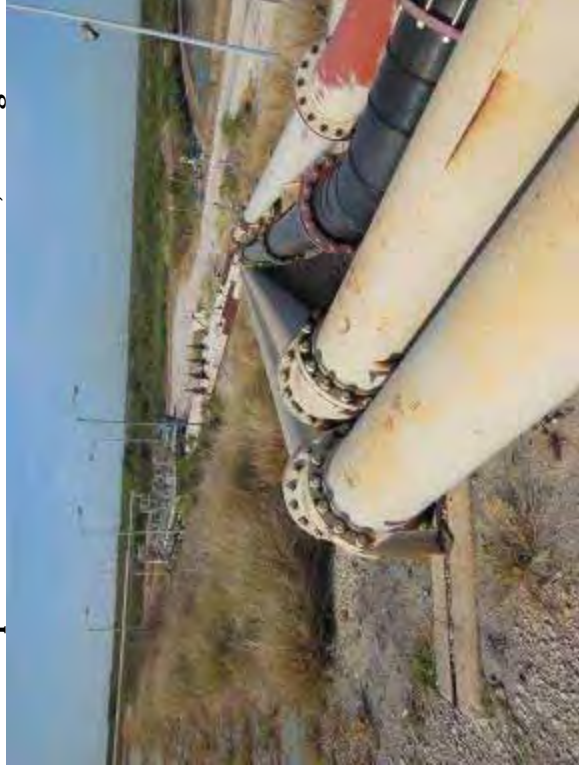
Photo 55: Piping from Plant to pumps at west embankment exterior slope, looking southwest.

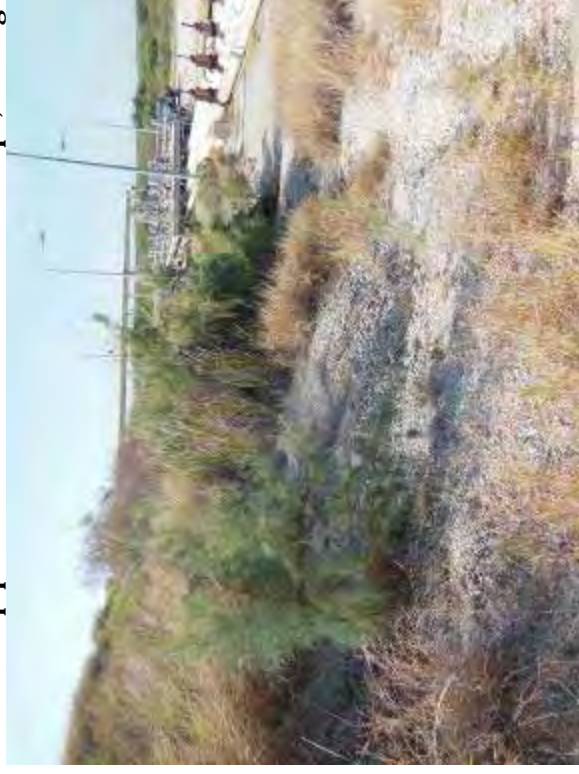
Photo 56: West embankment exterior slope, looking south. Note cattails and other vegetation growing near toe.

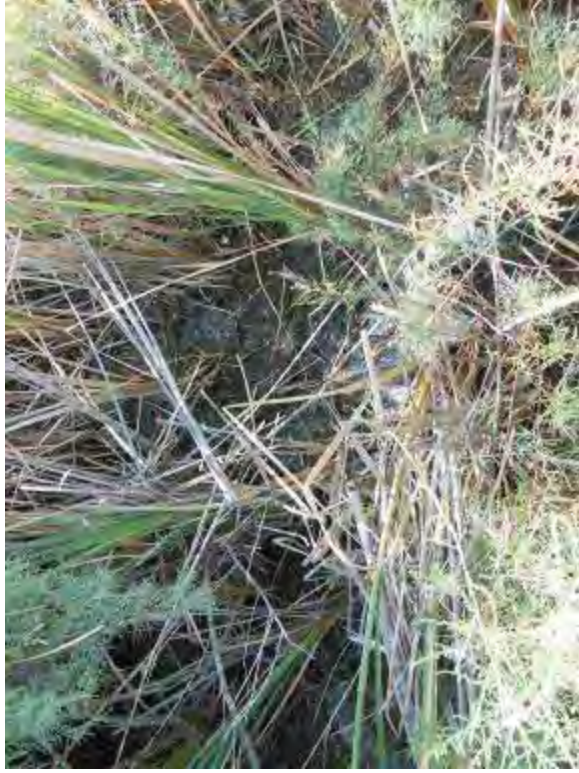
Photo 57: Wet area at west embankment exterior slope.

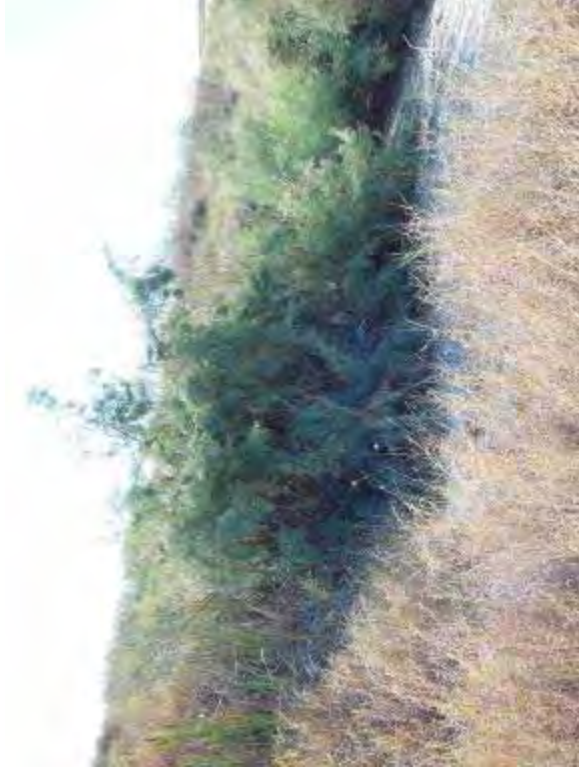
Photo 58: Cattails and vegetation growing near wet area at west embankment exterior slope.

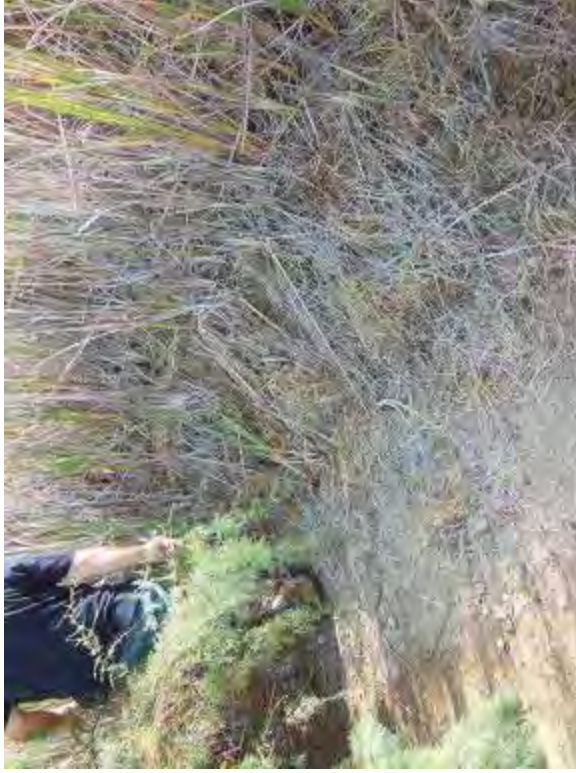
Photo 59: Minor erosion near wet area at west embankment exterior slope.

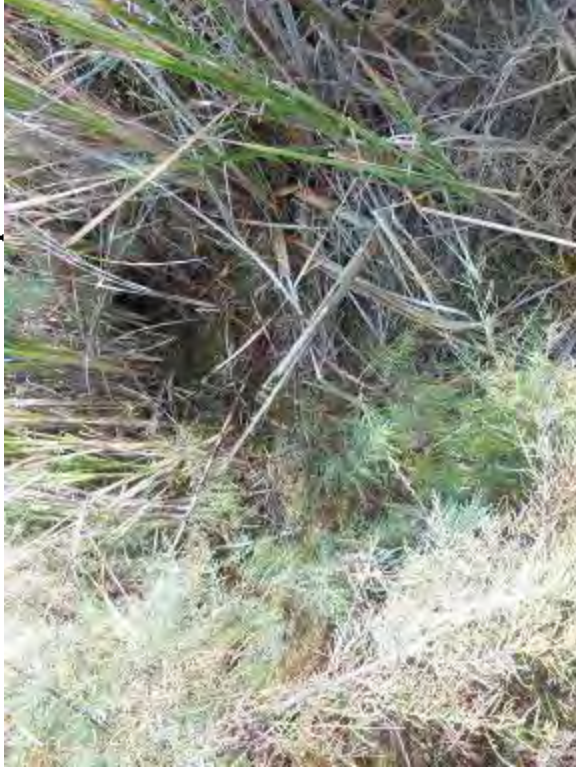
Photo 60: Wet area at west embankment exterior slope.

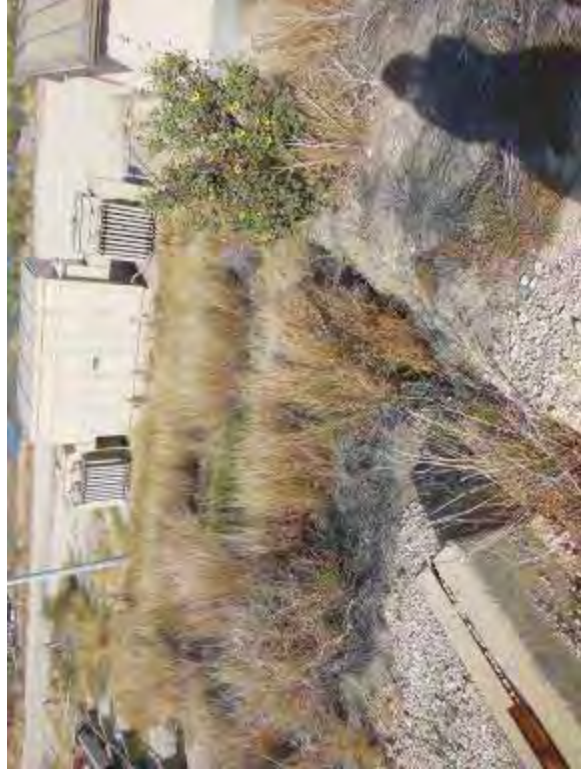
Photo 61: Erosion rill at west embankment exterior slope, looking west.

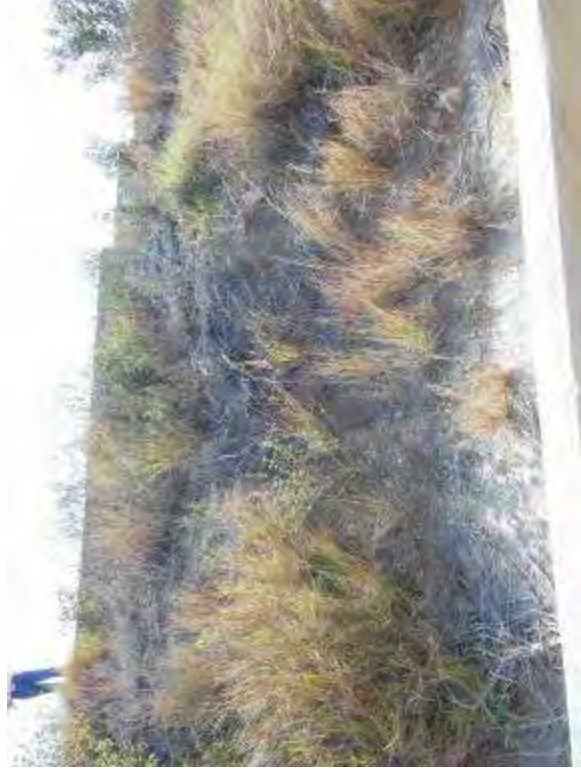
Photo 62: Erosion rill at west embankment exterior slope, looking east.

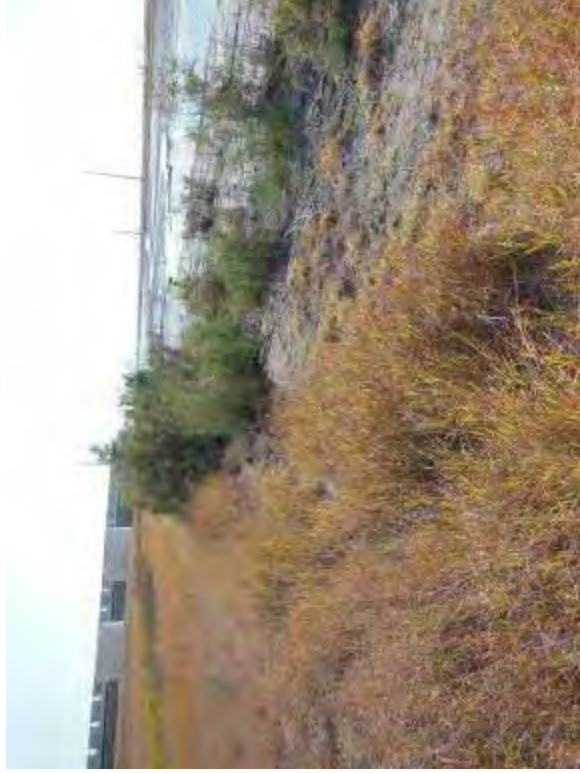
Photo 63: North embankment interior slope, looking east. Note vegetation growing on slope.

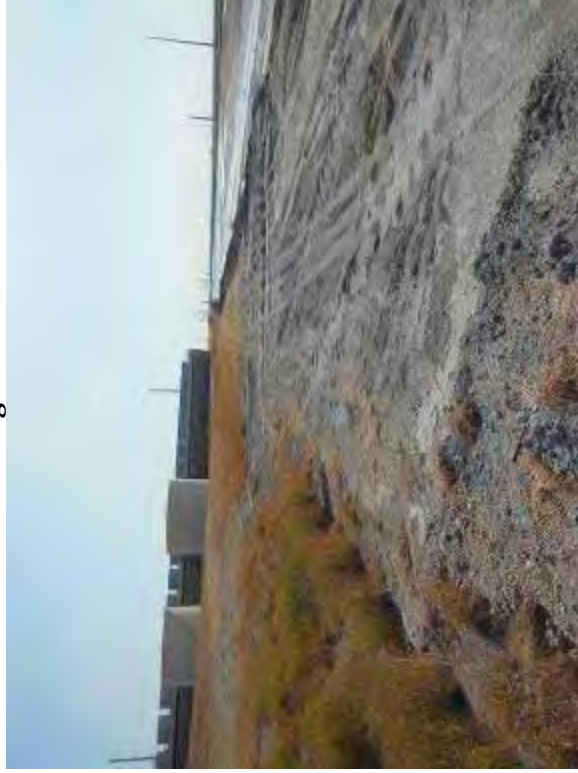
Photo 67: North embankment crest, looking east.

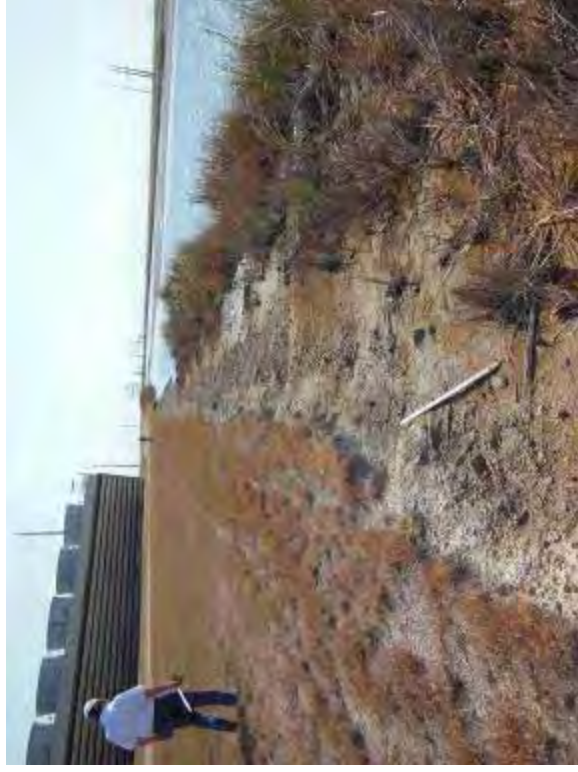
Photo 68: North embankment interior slope, looking east. Note vegetation growing on interior slope.

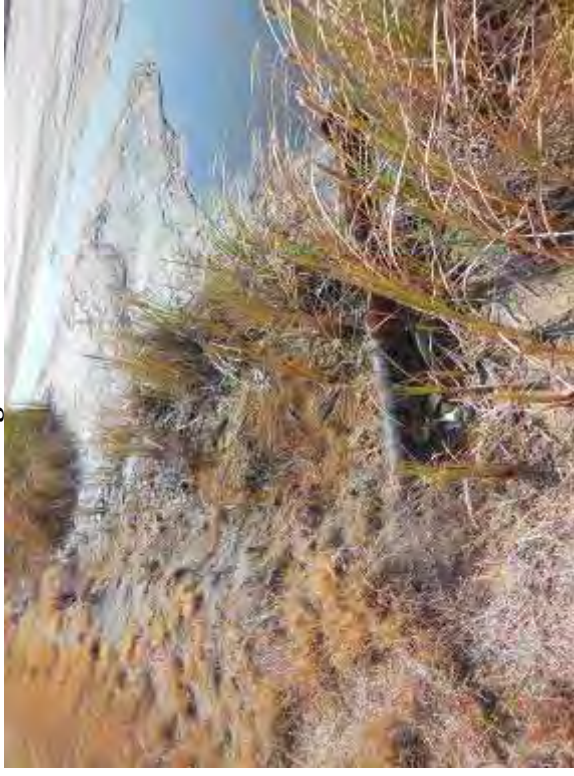
Photo 71: 6-inch-diameter pipe inlet from cooling tower at north embankment interior slope.

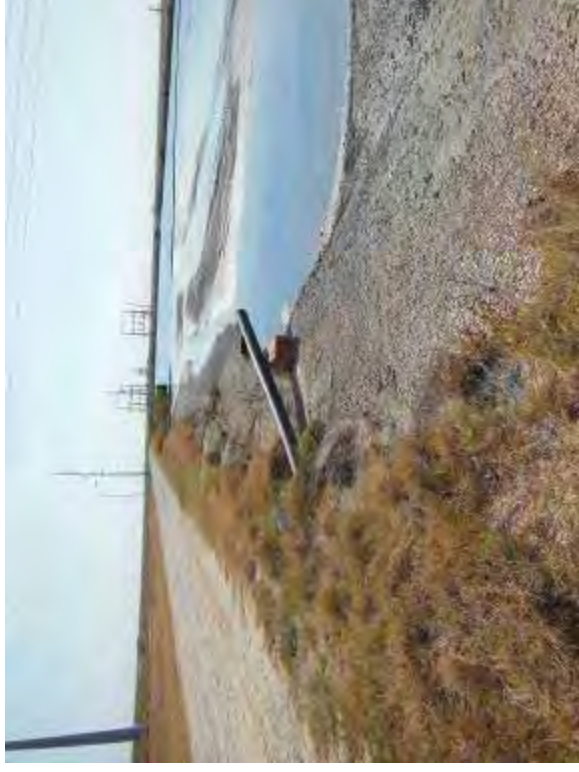
Photo 74: 6-inch-diameter inlet pipe from waste treatment sump at north embankment interior slope.

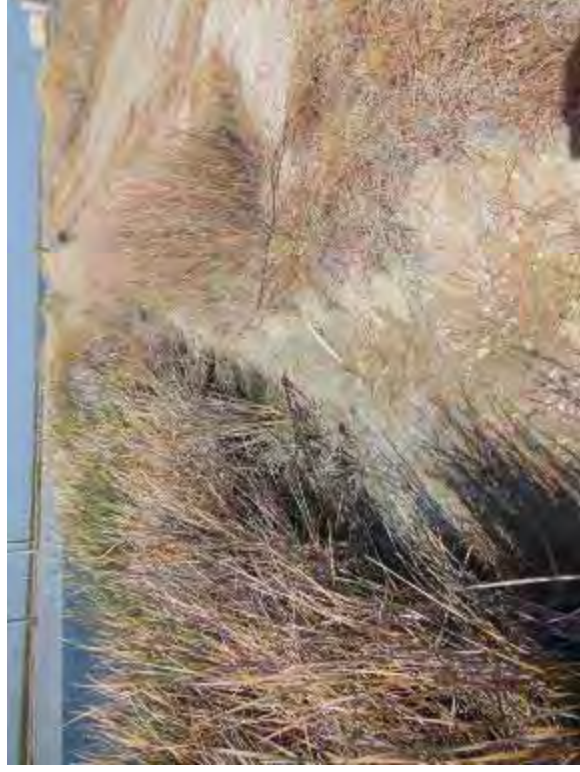
Photo 80: Center embankment south slope, looking west. Note vegetation on slope.

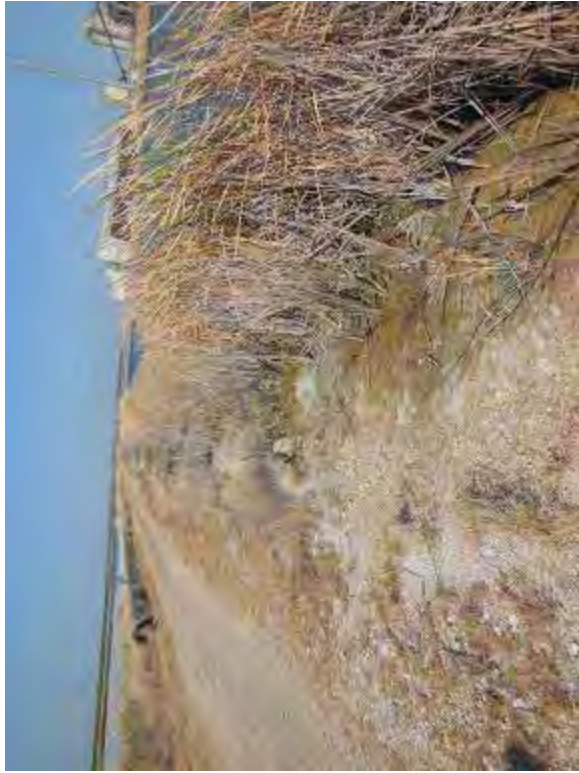
Photo 81: Center embankment north slope, looking west. Note vegetation on slope.

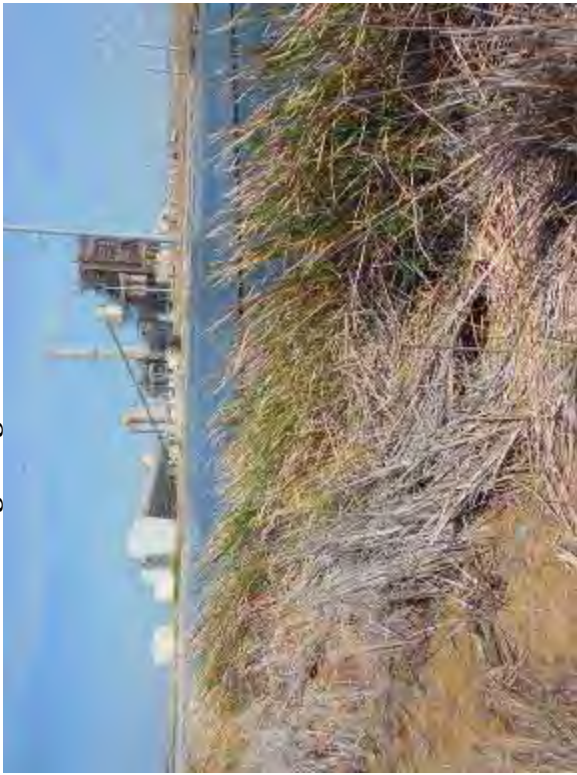
Photo 84: Center embankment north slope, looking northwest. Note vegetation on slope.

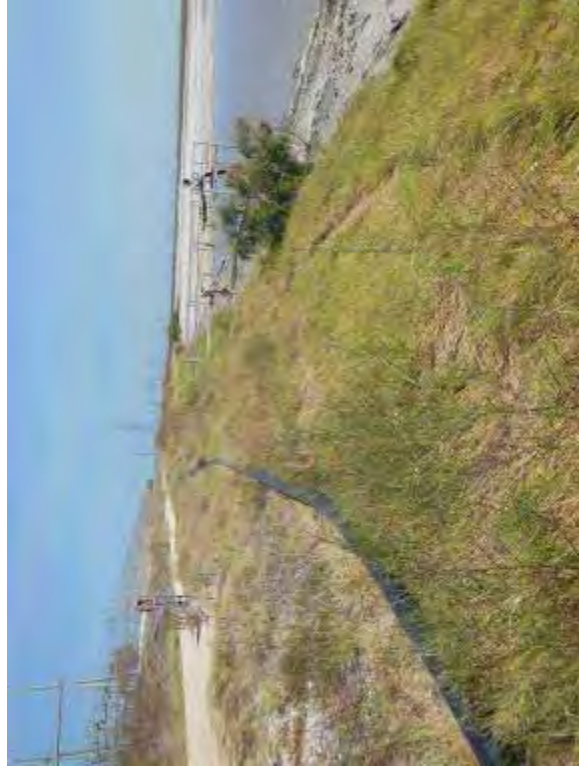
A 12-inch-diameter HDPE inlet pipe (Photographs 101 and 102), a 12-inch-diameter steel inlet pipe (Photograph 104), and an 8-inch-diameter HDPE inlet pipe (Photograph 109) were located on the west embankment interior slope. Reportedly, additional 6- and 8-inch-diameter inlet pipes discharge from the west embankment interior slope, though those inlets were not visible during the site assessment due to vegetation. Outlets were located on the west embankment interior slope (Photograph 93) and south embankment interior slope (Photograph 145).

Two outlets were observed at the Sludge Basin, one of which was not in service during the site assessment. A catwalk structure to a 6-inch-diameter HDPE outlet pipe and submersible pump that was not in service during the site assessment is located on the west embankment interior slope (Photograph 93). A 6-inch-diameter HDPE outlet pipe was located on the south embankment interior slope (Photograph (145). Liquids are pumped from the Sludge Basin, via the two outlet pipes, to the Ash Water Transport Pond for recycling of the water.

Photo 93: West embankment interior slope, looking north.  
Submersible pump structure in top right.

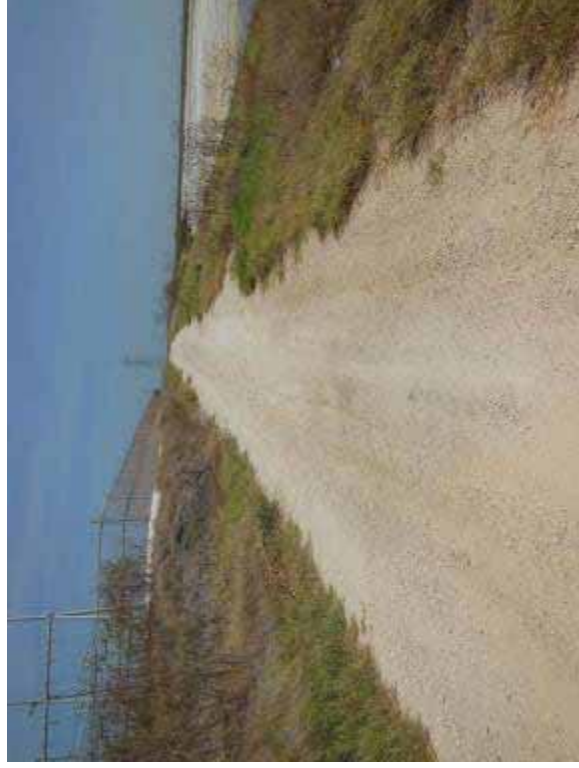
The embankment crest of the Sludge Basin appeared to be in satisfactory condition (Photographs 94, 106, 121, 137 and 145). The crest ranged from 15 to 20 feet wide. The crest of the embankment consists of a compacted gravel drive and grass. The surface is exposed to minimal vehicle traffic. No depressions or evidence of settlement were observed on the crest.

Photo 94: West embankment crest, looking north.

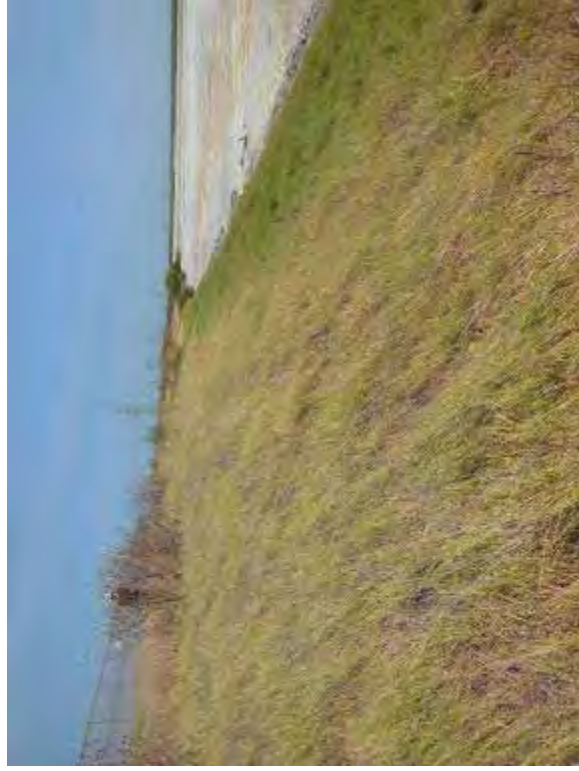
Interior slopes appeared to be in fair condition (Photographs 97, 128, 138, and 147). Erosion rills were observed on the west embankment interior slope (Photographs 99 and 100). An area of either erosion or settling of fill material was observed below the headwall for the stormwater inlet on the west embankment interior slope (Photograph 102). An area of erosion was observed near the outlet structure on the west embankment interior slope (Photograph 151). Based on construction drawings, the interior slopes are 3H:1V for all embankments, though slopes measured in the field ranged from 2H:1V to 3H:1V. Grassy vegetation and small trees up to 3 inches in diameter were observed on the upper portion of the west, north, and east interior slopes (Photographs 103, 108, 117, and 138). Riprap in good condition, but with vegetation growing within was observed on the upper portion of the south embankment interior slope (Photograph 147).

Photo 97: West embankment interior slope, looking north.

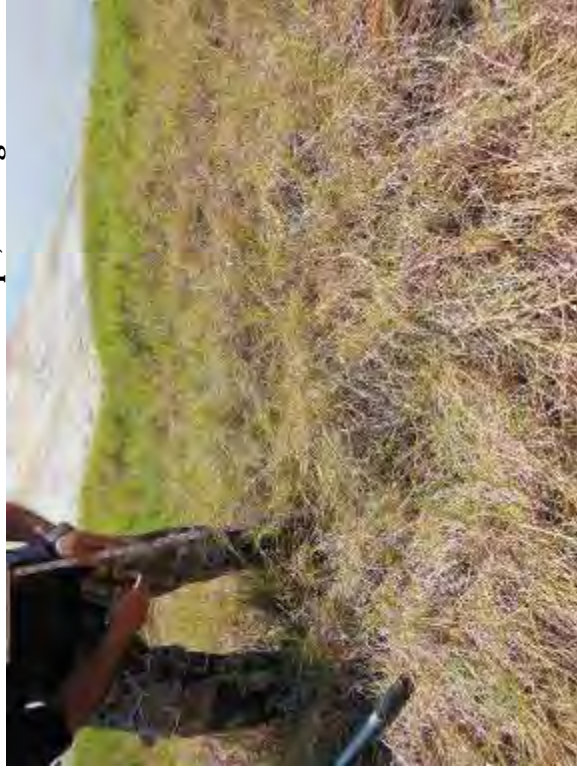
Photo 99: Erosion rill at west embankment interior slope.

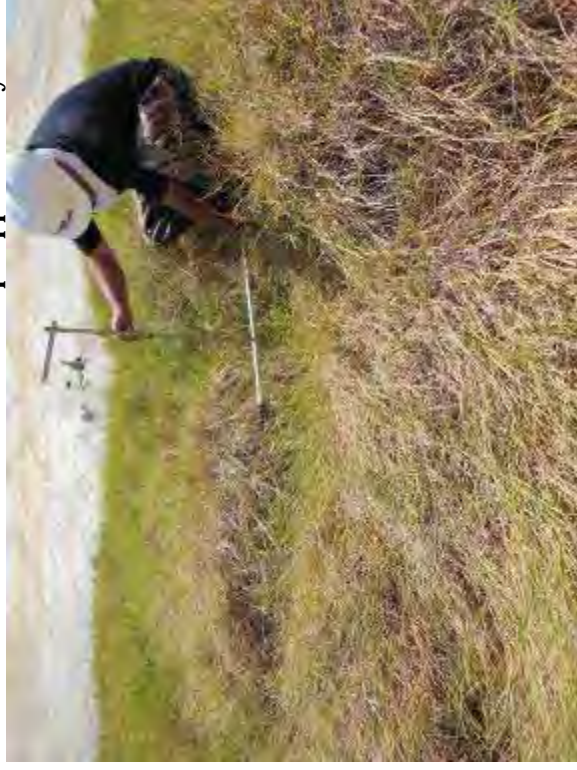
Photo 100: Approximately 14-inch-deep erosion rill at west embankment interior slope.

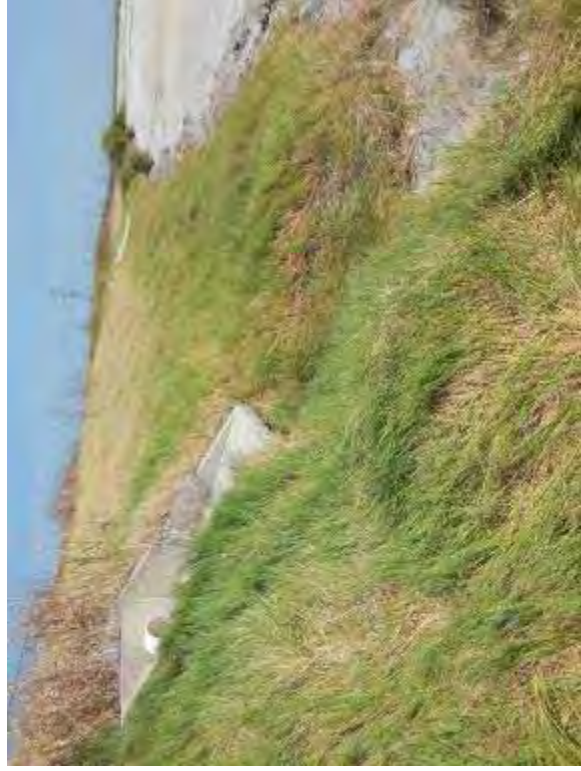
Photo 101: 12-inch-diameter substation stormwater drain inlet at west embankment interior slope.

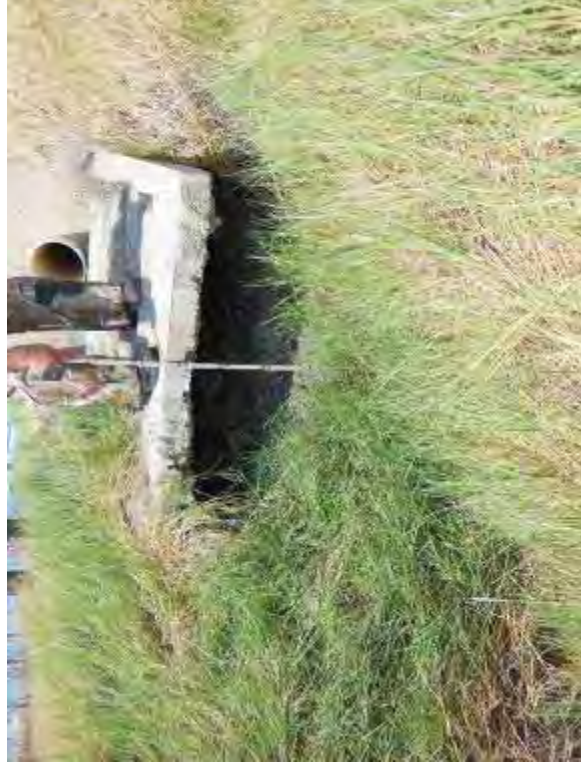
Photo 102: Approximately 3-ft-high area of erosion or settlement under stormwater inlet.

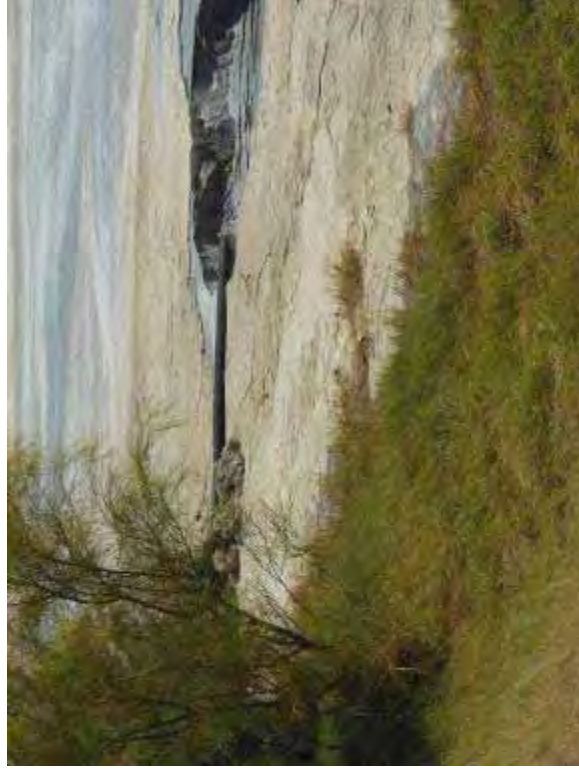
Photo 109: 8-inch-diameter inlet pipe from acid storage area at west embankment interior slope.

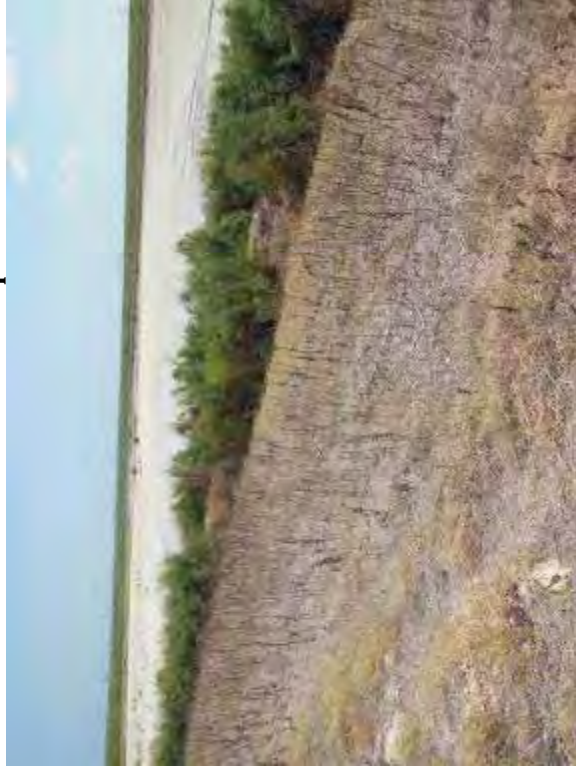
Photo 111: West embankment interior slope, looking east.  
Note vegetation on slope.

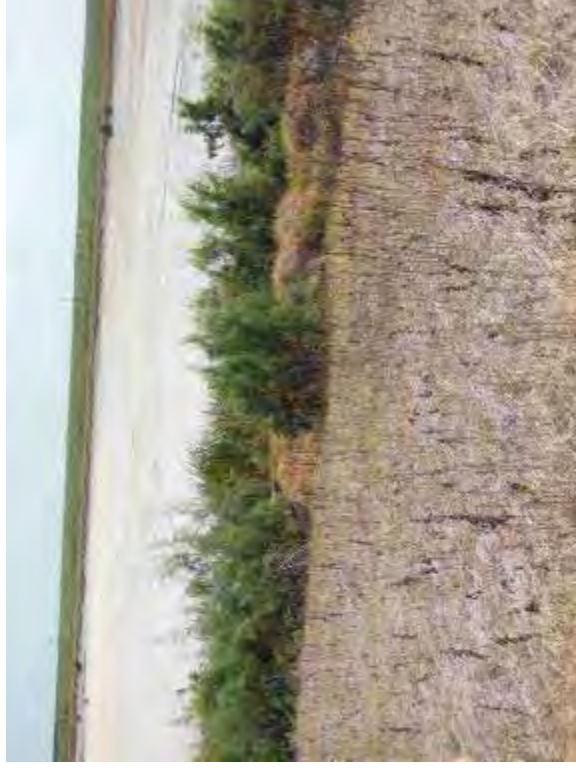
Photo 112: Mounded earth at west embankment interior slope, looking east. Note vegetation on slope.

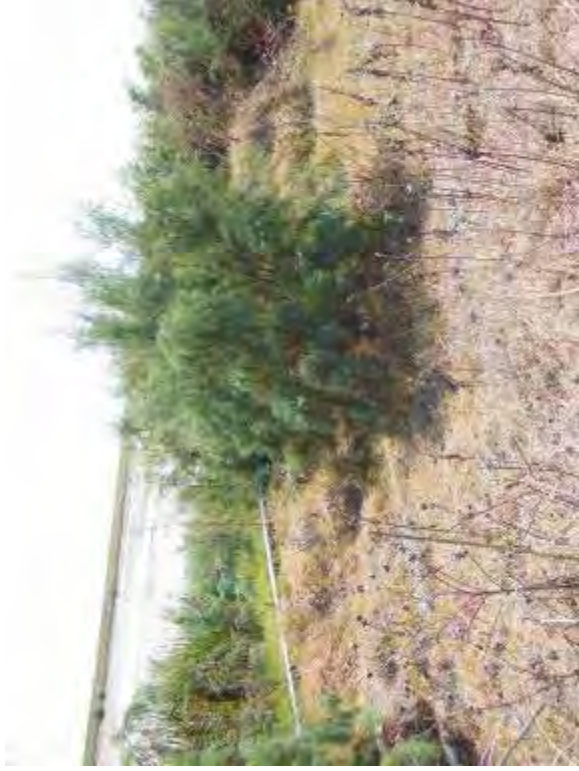
Photo 113: Pipe on mounded earth at west embankment interior slope.
