# ASSESSMENT OF DAM SAFETY OF COAL COMBUSTION SURFACE IMPOUNDMENTS FINAL REPORT

**San Miguel Electric  
Cooperative, Inc.  
San Miguel Electric Plant  
Christine, Texas**

Prepared for  
*U.S. Environmental  
Protection Agency  
Washington, D.C.*

March 2014  
Revision 1, April 2014

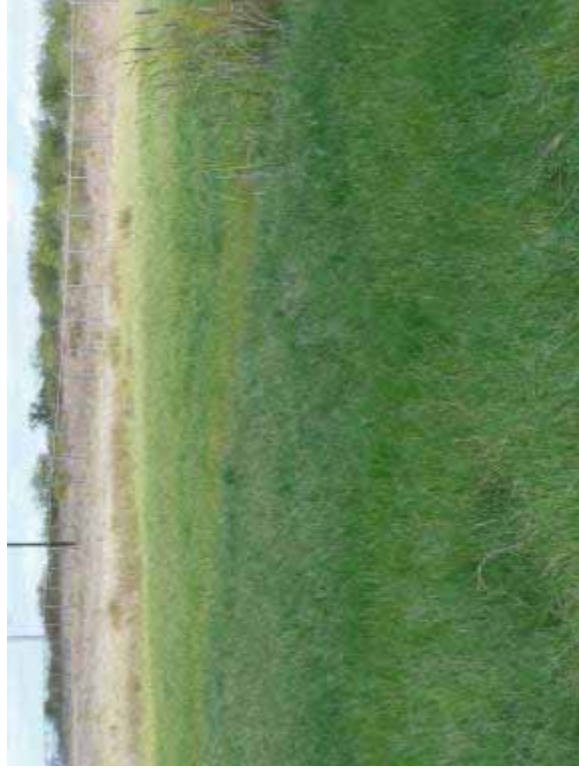
Photo 125: Cattails and vegetation along drainage feature at north embankment exterior toe, looking west.

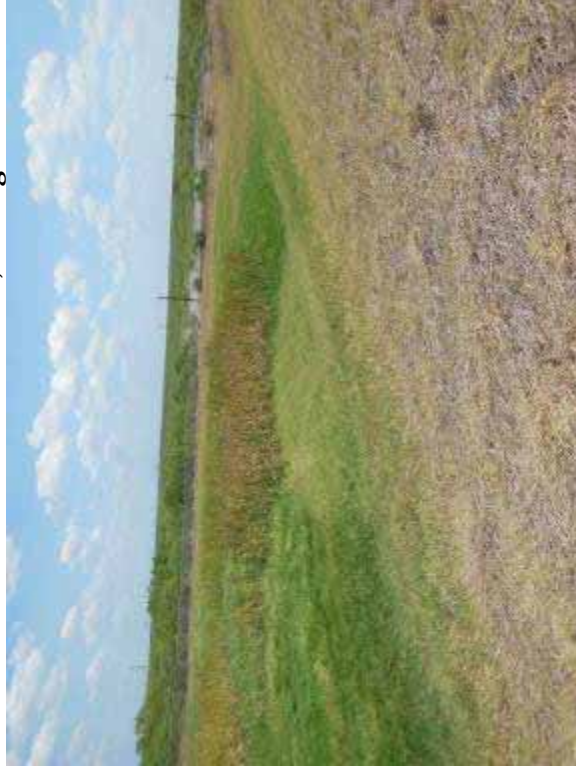
Photo 127: Cattails and vegetation at north embankment exterior toe, looking northeast.

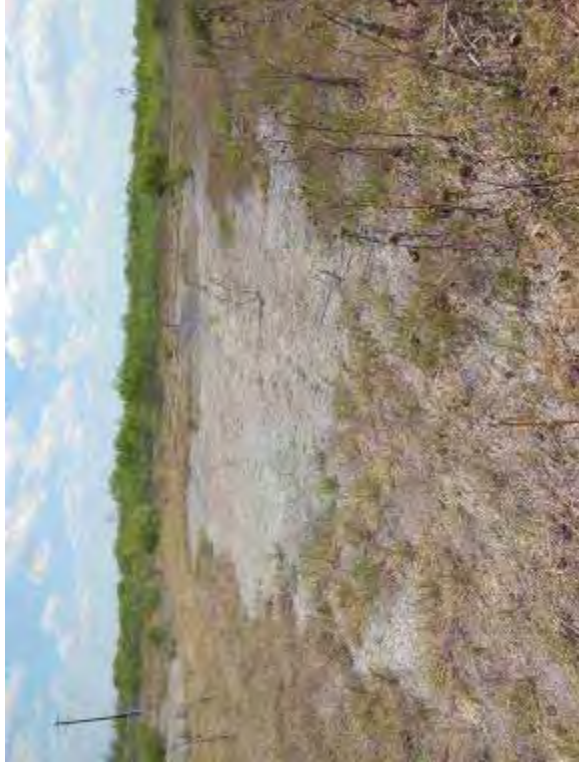
Photo 130: Barren area at northeast corner toe, looking east.

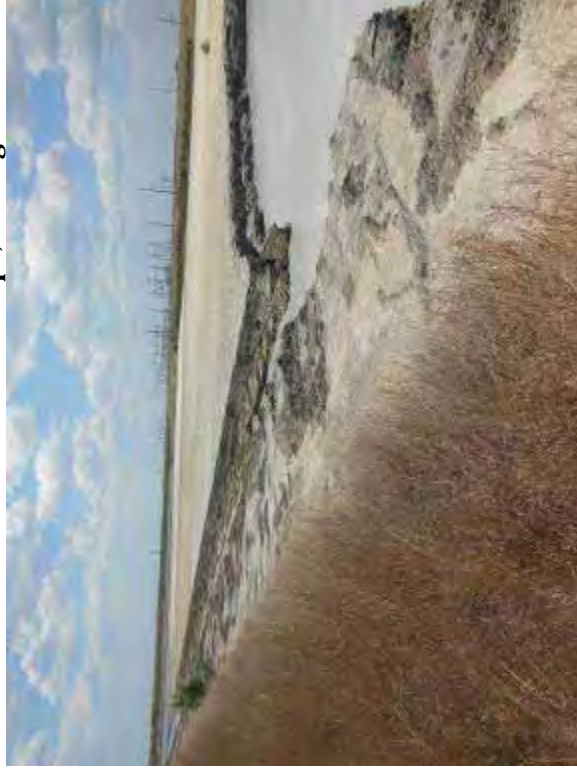
Photo 135: Sludge deposits near northeast corner of Sludge Basin, looking southwest.

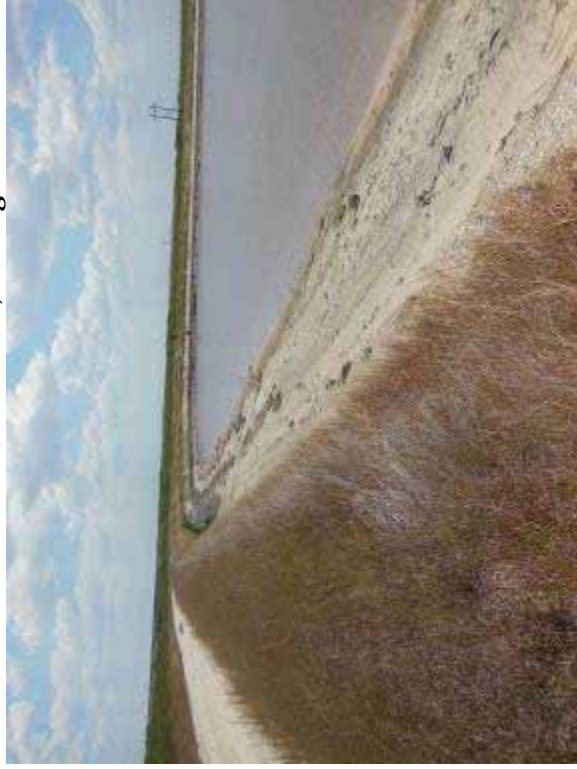
Photo 139: East embankment interior slope, looking south.

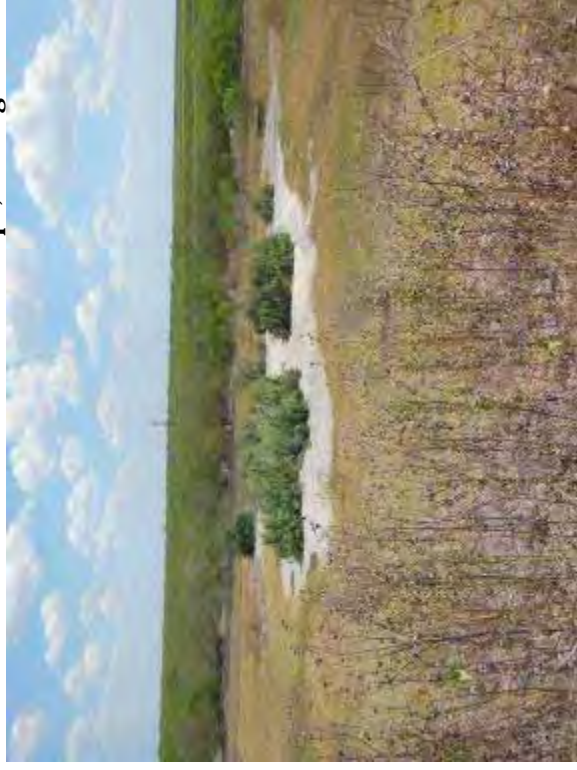
Photo 140: Trees at east embankment exterior toe, looking south.

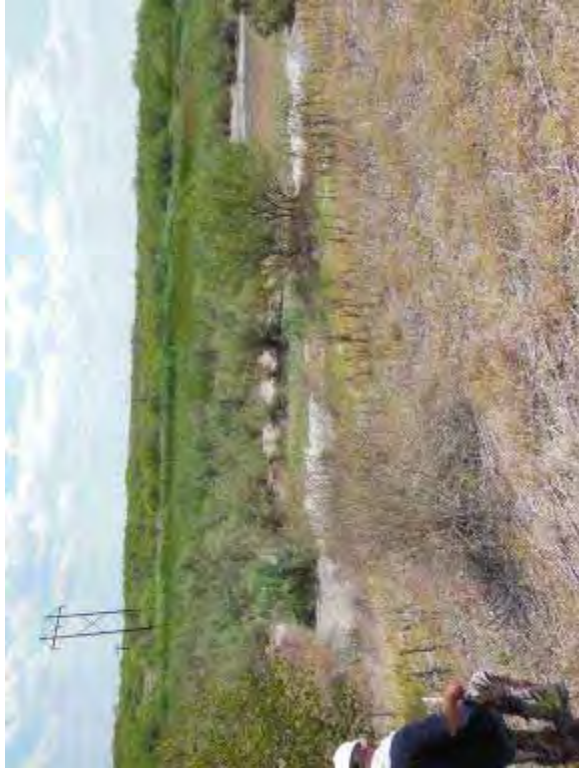
Photo 141: Cattails and vegetation at southeast corner exterior toe, looking south.

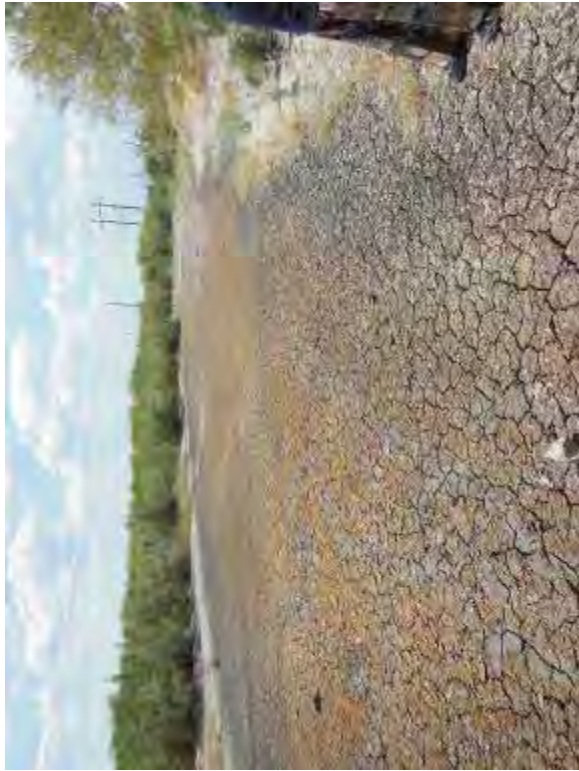
Photo 142: Barren area at southeast corner exterior toe, looking west.

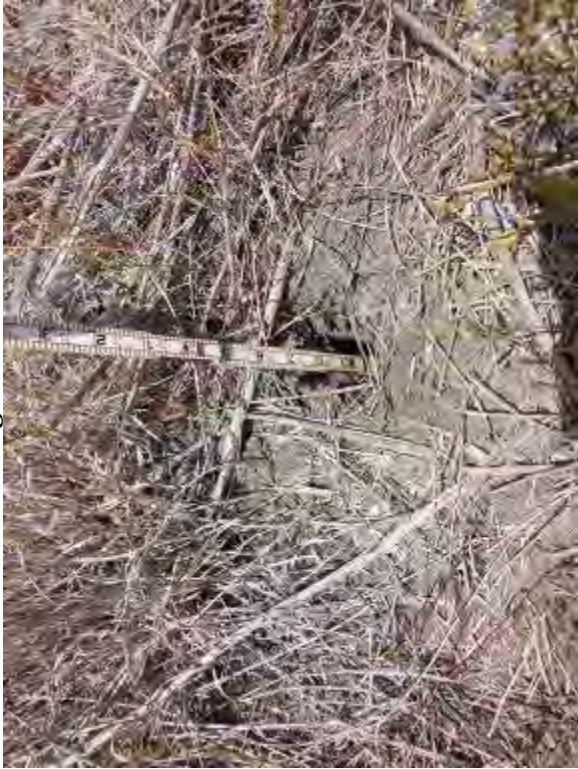
The exterior slopes appear to be in good condition and are covered with grassy vegetation approximately 2 feet high (Photographs 107, 122, 133, and 146). An animal burrow was observed on the south embankment exterior slope (Photograph 143). Based on construction drawings, the exterior slopes are 3H:1V for all embankments, though slopes measured in the field ranged from 3H:1V to 3.5H:1V. The water well storage pond is located at the west embankment exterior slope (Photographs

Photo 143: Approximately 3-foot-deep animal burrow at south embankment exterior slope.

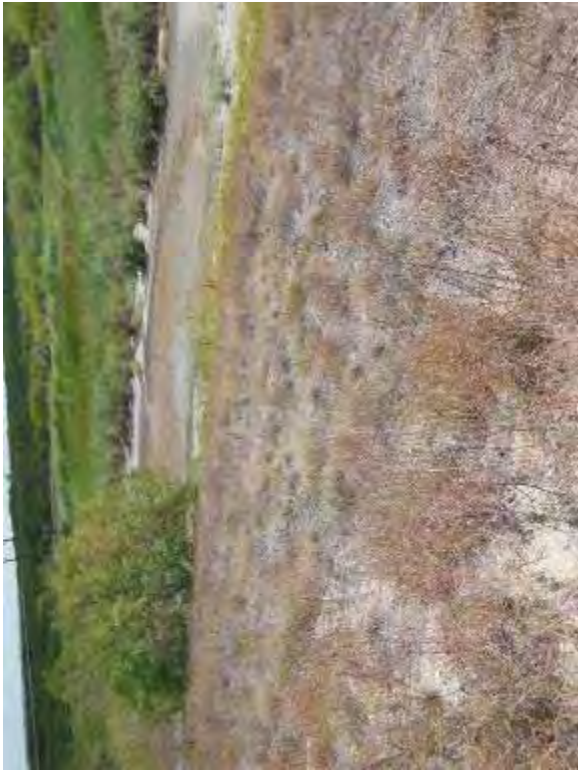
Photo 144: Barren area at southeast corner exterior toe, looking southeast.

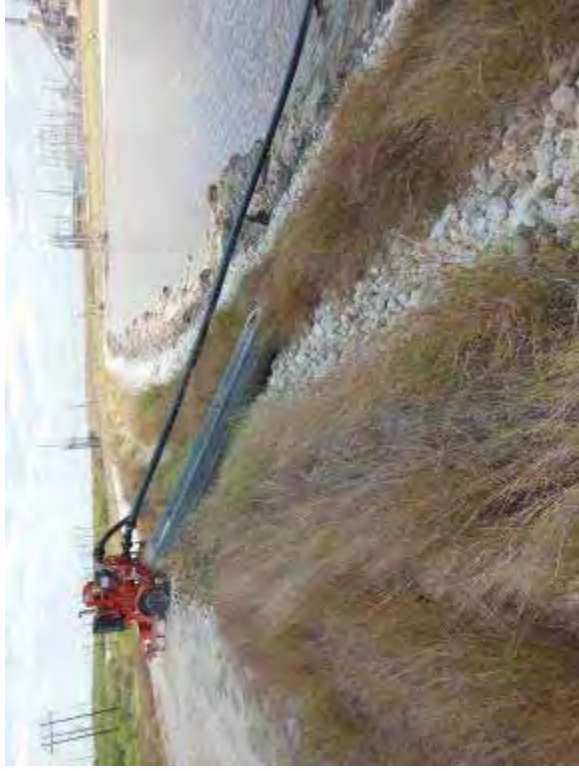
A 12-inch-diameter HDPE inlet pipe (Photographs 101 and 102), a 12-inch-diameter steel inlet pipe (Photograph 104), and an 8-inch-diameter HDPE inlet pipe (Photograph 109) were located on the west embankment interior slope. Reportedly, additional 6- and 8-inch-diameter inlet pipes discharge from the west embankment interior slope, though those inlets were not visible during the site assessment due to vegetation. Outlets were located on the west embankment interior slope (Photograph 93) and south embankment interior slope (Photograph 145).

Photo 145: 6-inch-diameter outlet pipe and pump at south embankment interior slope, looking west.

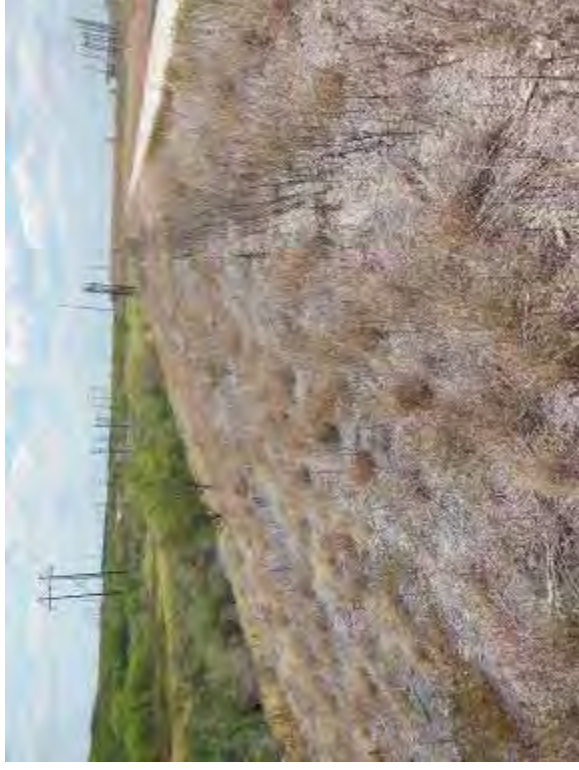
Photo 146: South embankment exterior slope, looking west.

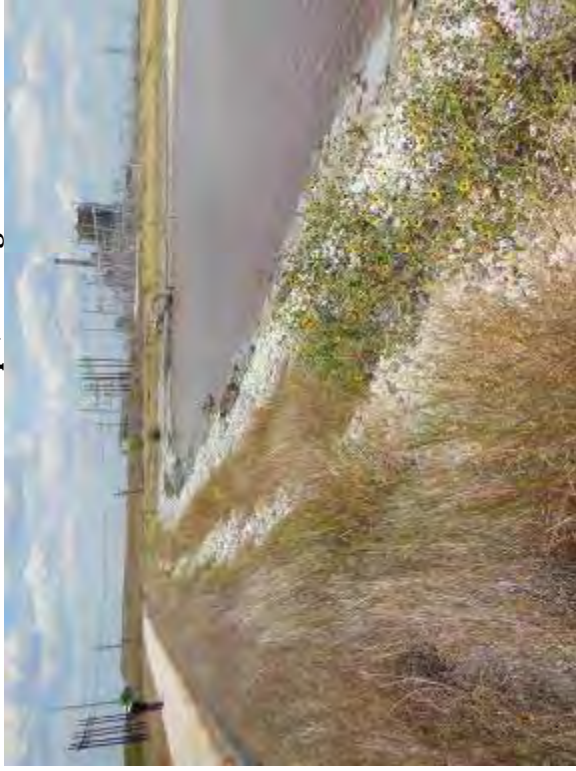
Interior slopes appeared to be in fair condition (Photographs 97, 128, 138, and 147). Erosion rills were observed on the west embankment interior slope (Photographs 99 and 100). An area of either erosion or settling of fill material was observed below the headwall for the stormwater inlet on the west embankment interior slope (Photograph 102). An area of erosion was observed near the outlet structure on the west embankment interior slope (Photograph 151). Based on construction drawings, the interior slopes are 3H:1V for all embankments, though slopes measured in the field ranged from 2H:1V to 3H:1V. Grassy vegetation and small trees up to 3 inches in diameter were observed on the upper portion of the west, north, and east interior slopes (Photographs 103, 108, 117, and 138). Riprap in good condition, but with vegetation growing within was observed on the upper portion of the south embankment interior slope (Photograph 147).

Photo 147: South embankment interior slope, looking west.

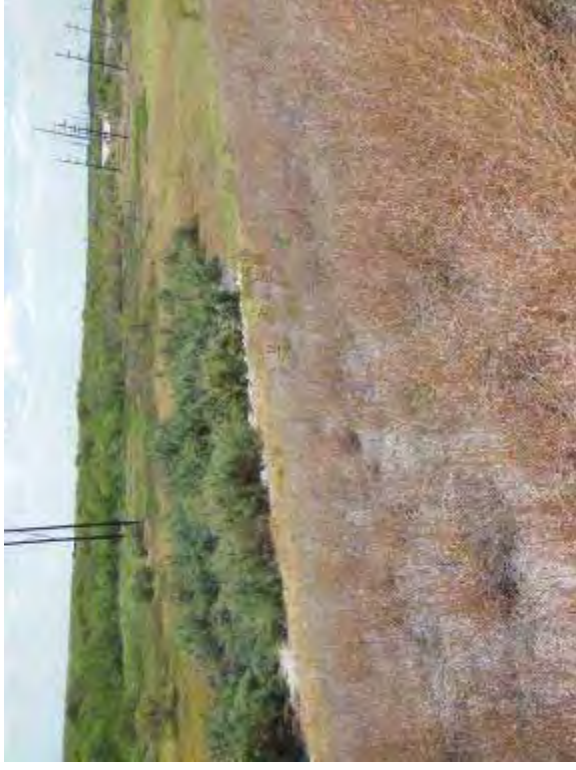
Photo 148: South embankment exterior slope, looking southwest.

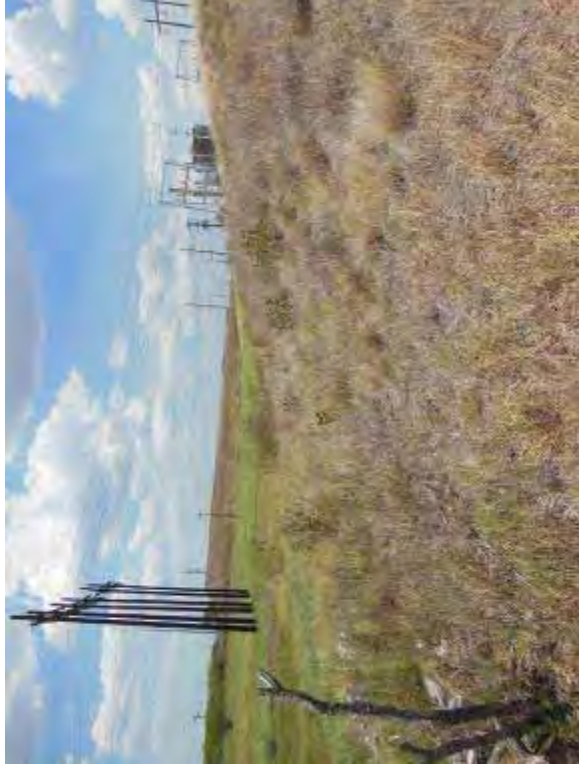
Photo 149: South embankment exterior slope, looking northwest.  
Note overhead powerlines and substation in distance.

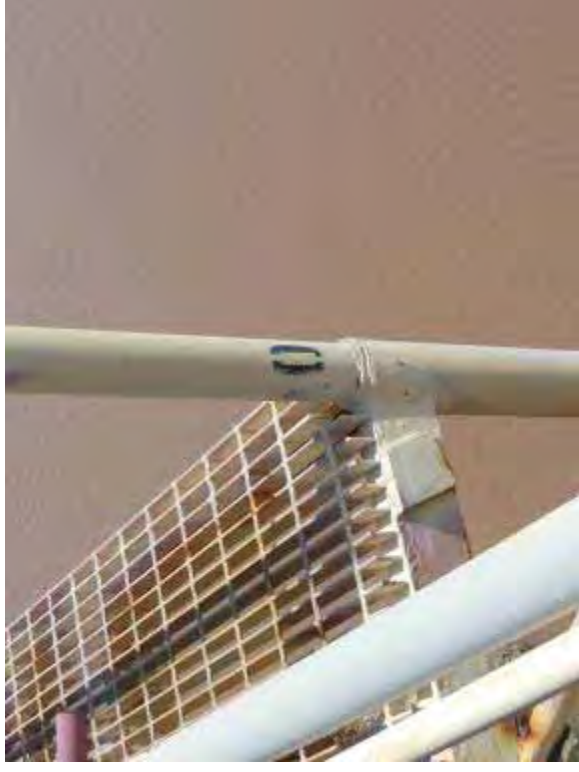
Photo 150: Reference mark for measuring water level in Sludge Basin.  
Zero corresponds to 18 inches of freeboard.

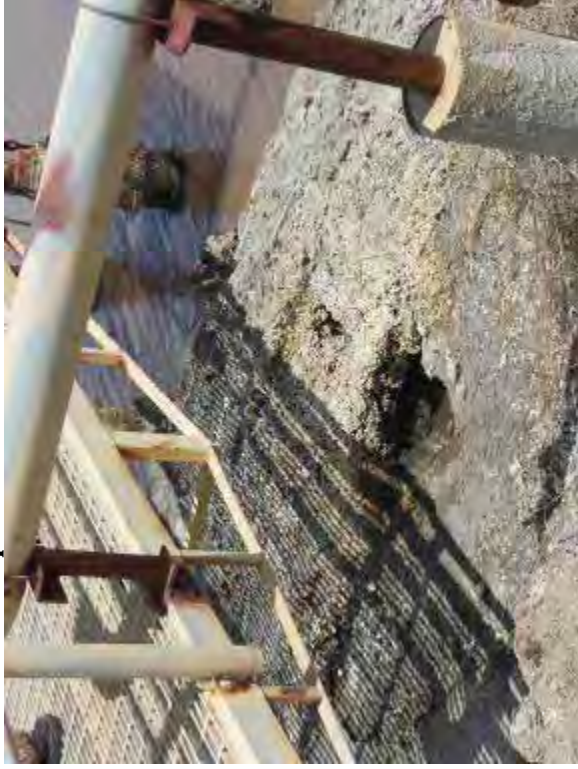
Photo 151: Erosion under submersible pump outlet structure at west embankment exterior slope.
