**Coal Combustion Residue Impoundment  
Round 9 - Dam Assessment Report**

*Canadys Steam Power Station  
Ash Pond Embankments  
South Carolina Electric & Gas  
Canadys, South Carolina*

Dewberry & Davis, LLC  
Fairfax, Virginia

Under Contract Number: EP-09W001727  
**May 2011**

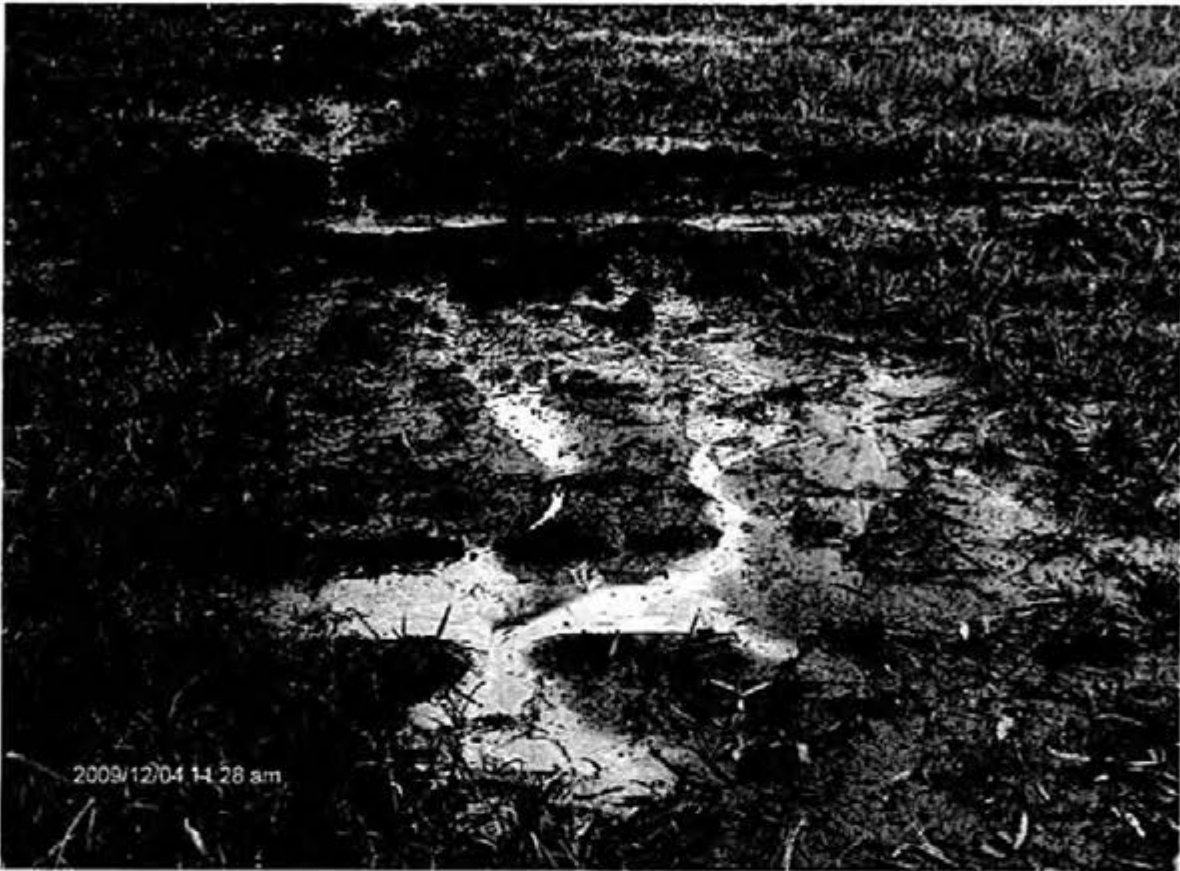
**Figure 1: Perched Water Wet Area (Typical)**

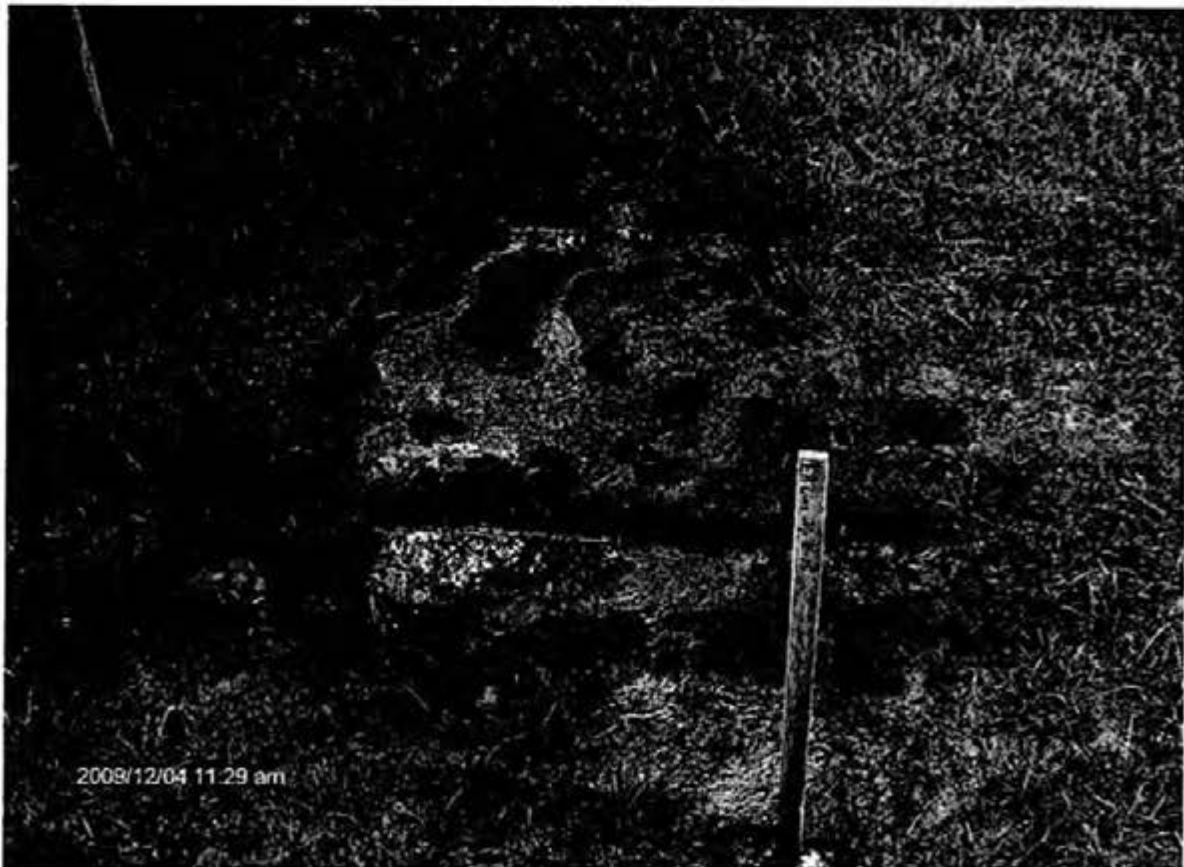
**Figure 2: WA-2 at Time of Annual Inspection**

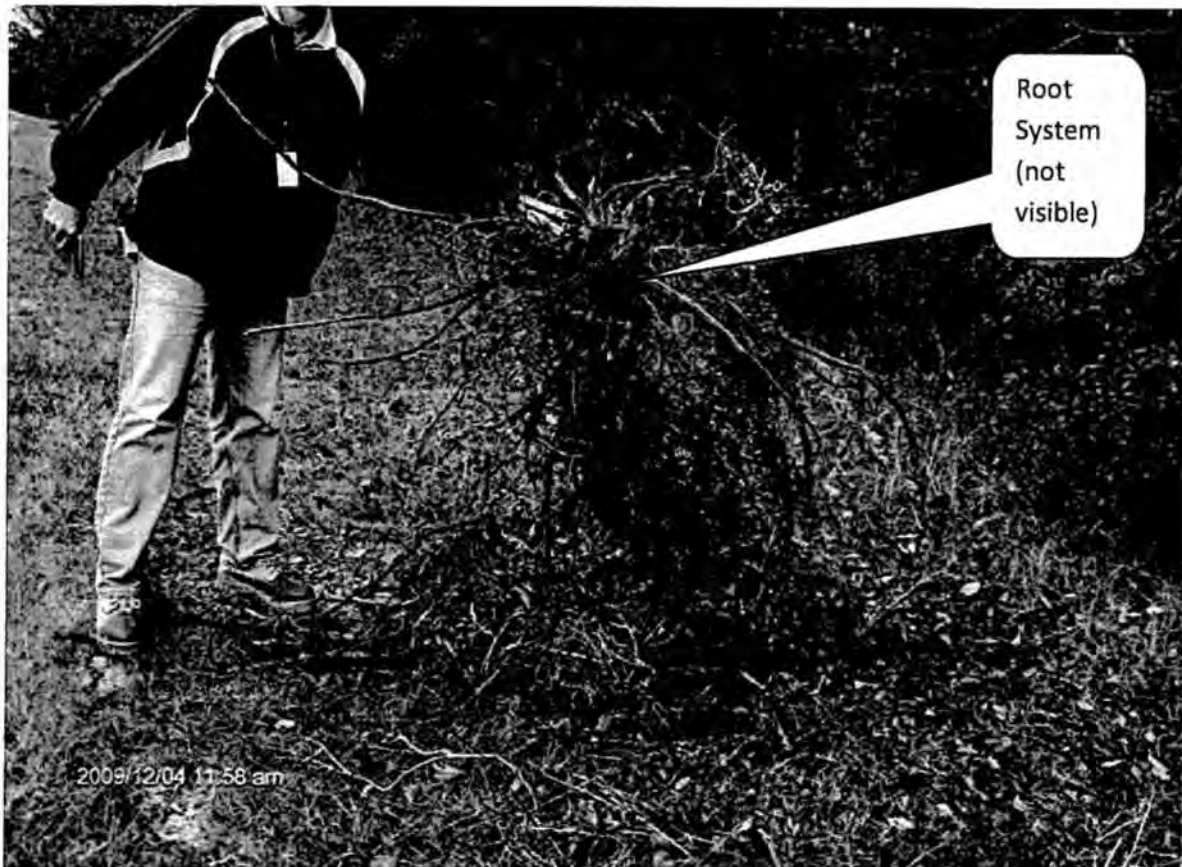
**Figure 12: Example of Woody Vegetation Growing on Downstream Side of Berm**
