**Coal Combustion Residue Impoundment  
Round 9 - Dam Assessment Report**

***Canadys Steam Power Station  
Ash Pond Embankments  
South Carolina Electric & Gas  
Canadys, South Carolina***

**December 2011**

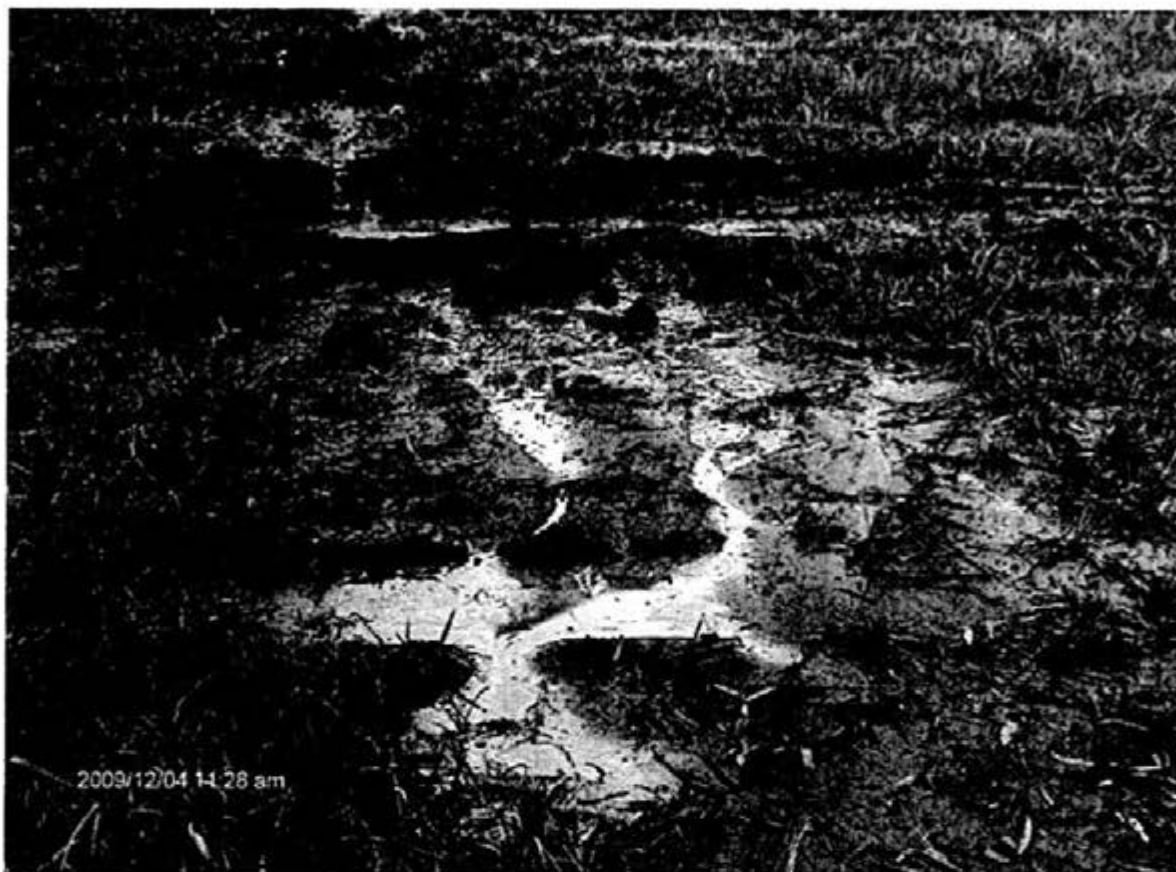
**Figure 1: Perched Water Wet Area (Typical)**

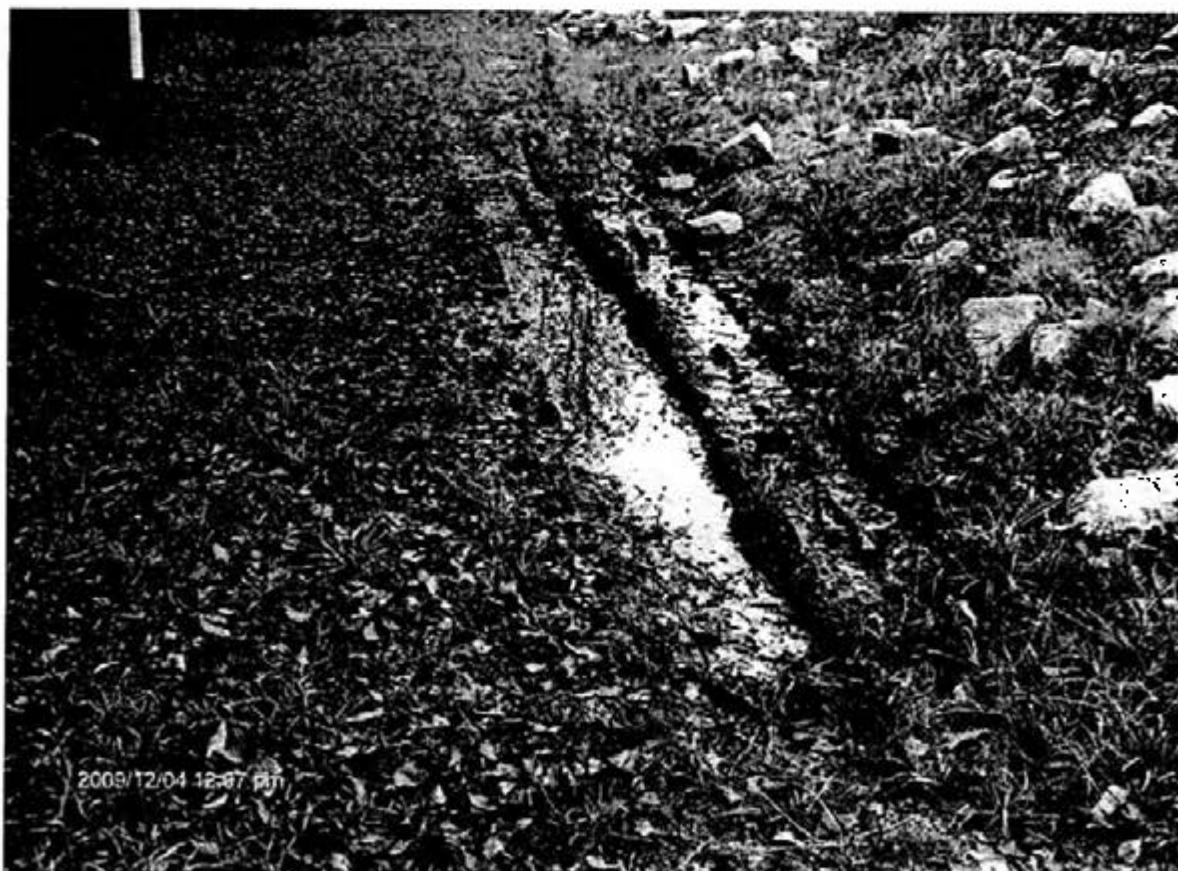
**Figure 8: Example of Area of Standing Water Along Toe of Active Pond West Berm**

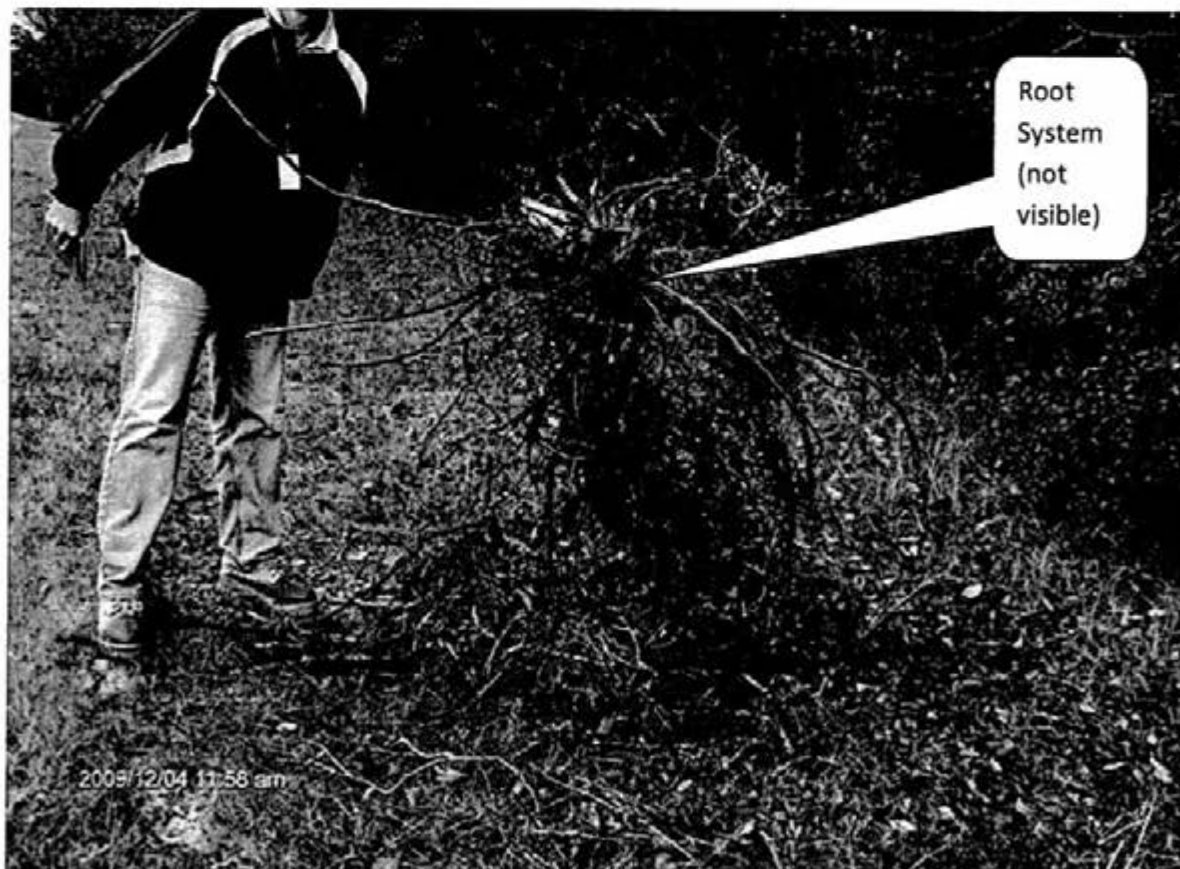
**Figure 12: Example of Woody Vegetation Growing on Downstream Side of Berm**

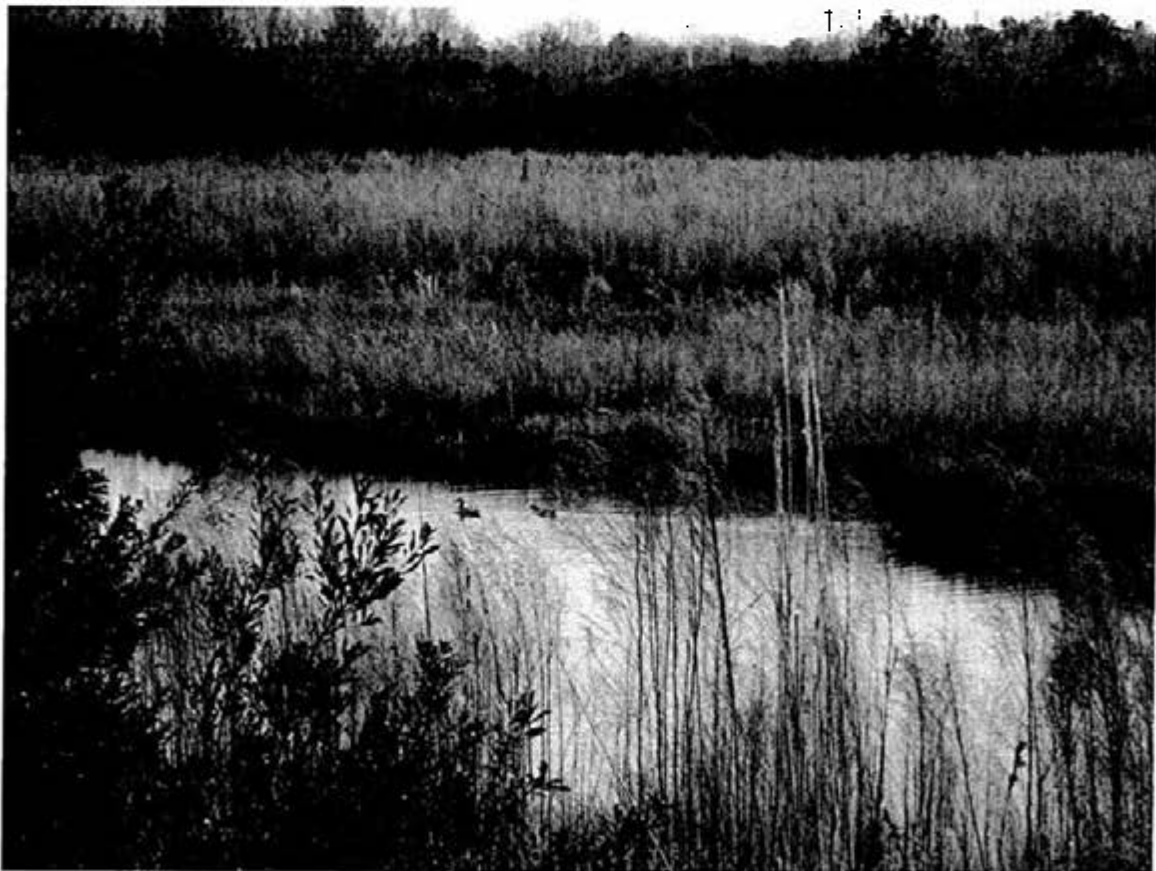
- Surficial erosion was observed; it was noted that the areas were small and should “be easily repaired”;
- Thick vegetation has established along the interior bank;
- Tall grass was noted inside the active ash pond where little or no water was apparent.
- The observer noticed “medium, large, and very large trees” flourishing within the ash of both ponds.
- Waterfowl were noticed in the impounded water within the inactive pond.

**Figure 16: Ducks Swimming in Impounded Water within Inactive Pond**
