Coal Combustion Residue Impoundment

Round 9 - Dam Assessment Report

Urquhart Generating Station

Ash Ponds

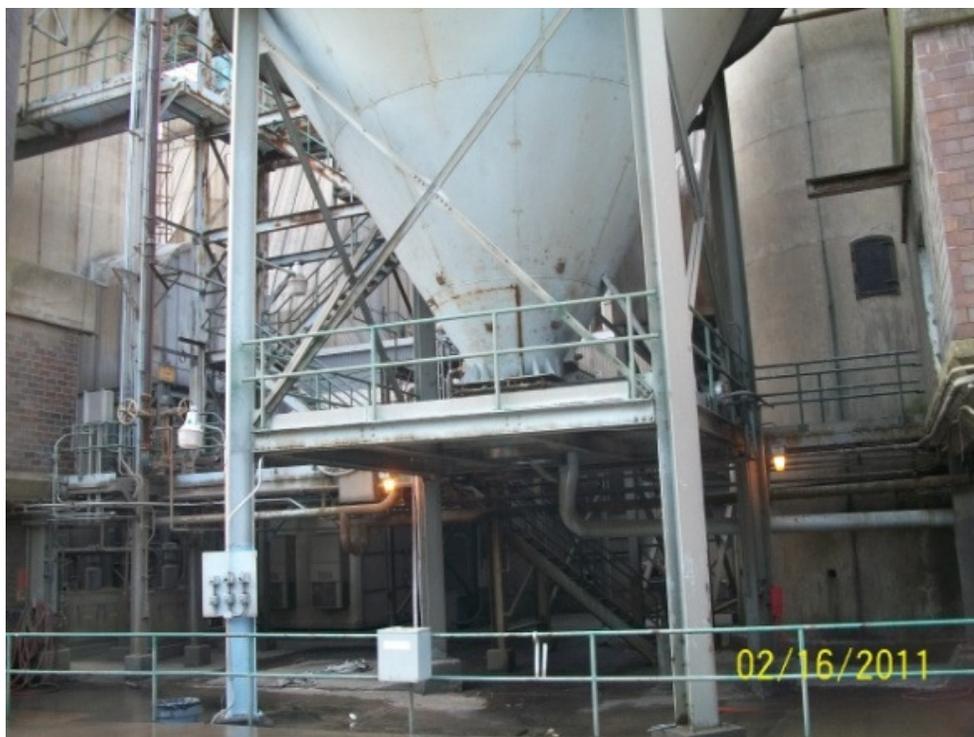
Hopper discharge where trucks can load ash material
