**Coal Combustion Waste Impoundment
Round 7- Dike Assessment Report**

Lawrence Energy Center

Ash Impoundment Dike

Westar Energy

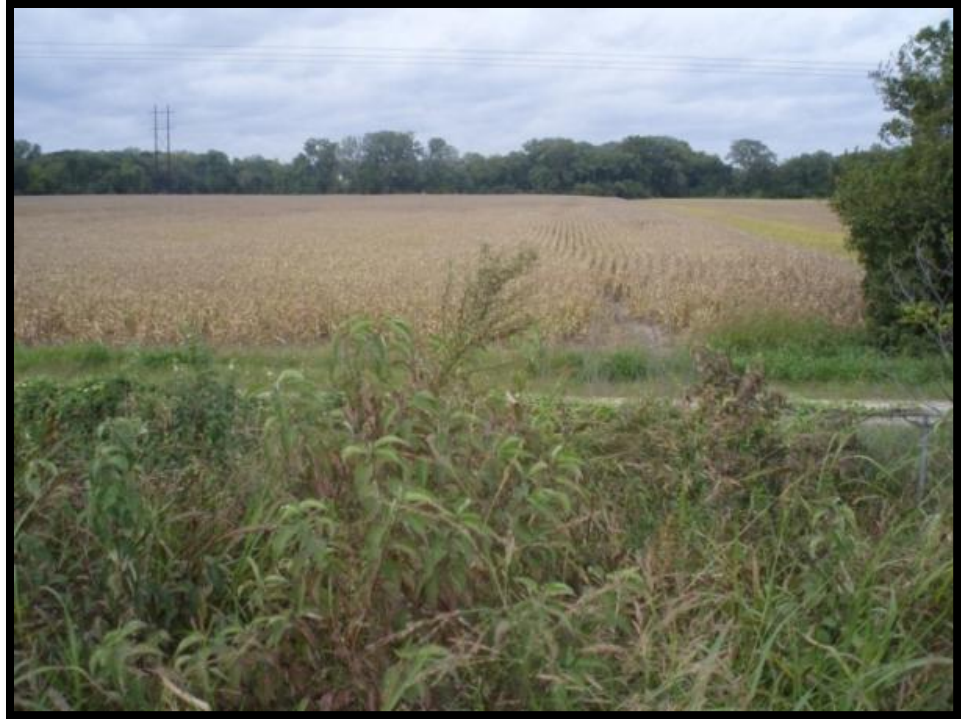
Figure 5.3.3-2: Agricultural Land to West of the Ash Ponds.

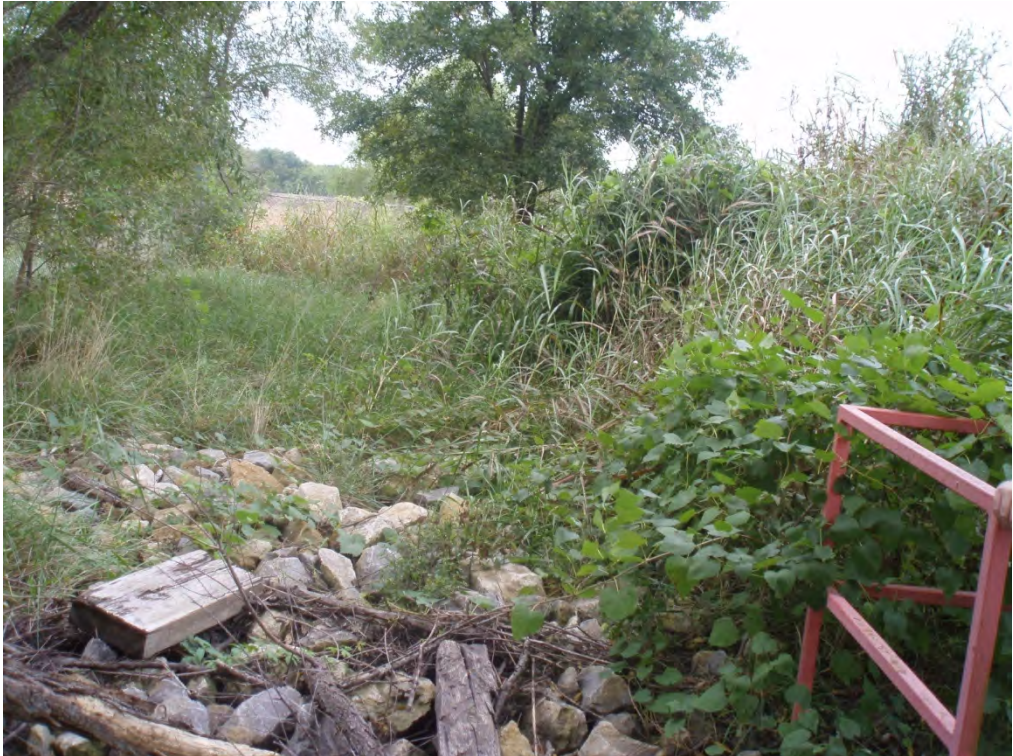
26. SOUTH SIDE OF STORM WATERPOND (AREA 3).

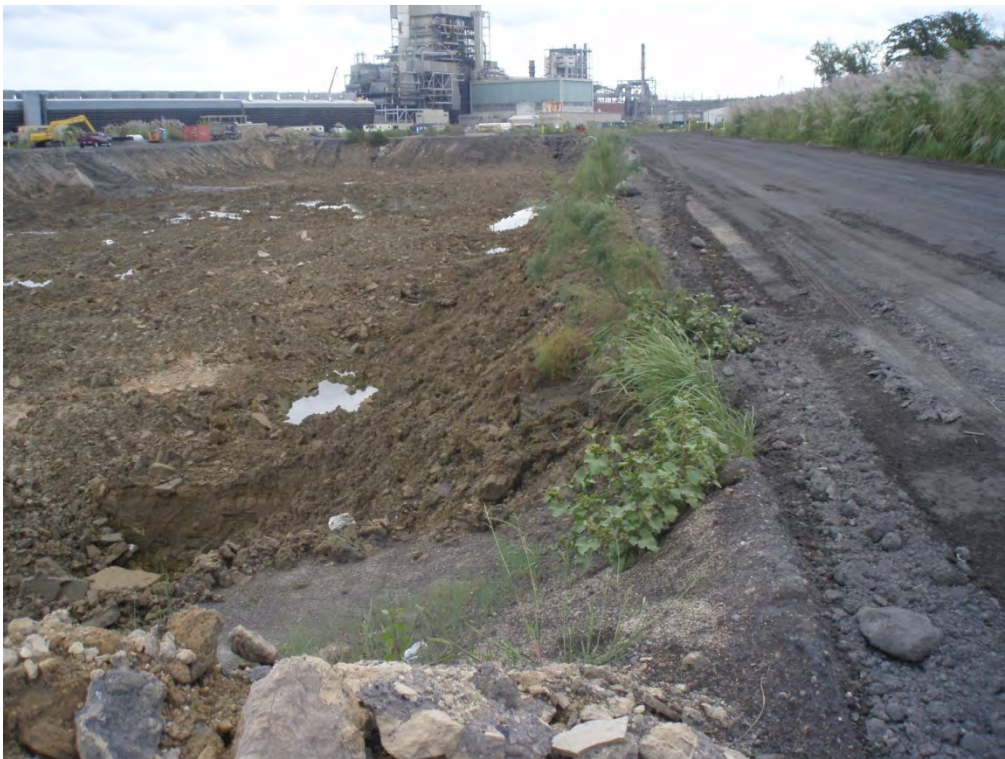
29. AREA 2/MIDDLE CELL - TAKEN FROM WEST END LOOKING EAST.

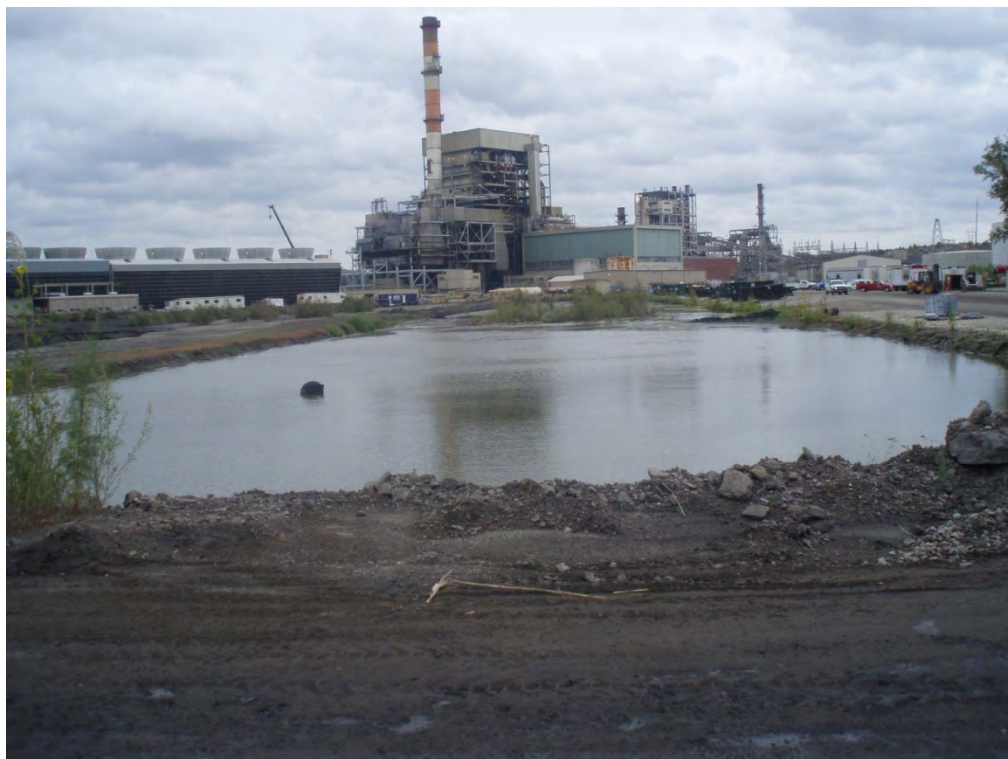
31. AREA 2/SOUTH CELL - TAKEN FROM SOUTHWEST CORNER LOOKING NORTHEAST.
