**Coal Combustion Waste Impoundment
Round 7 - Dam Assessment Report**

Black Dog Power Station

Surface Impoundments

April 2011

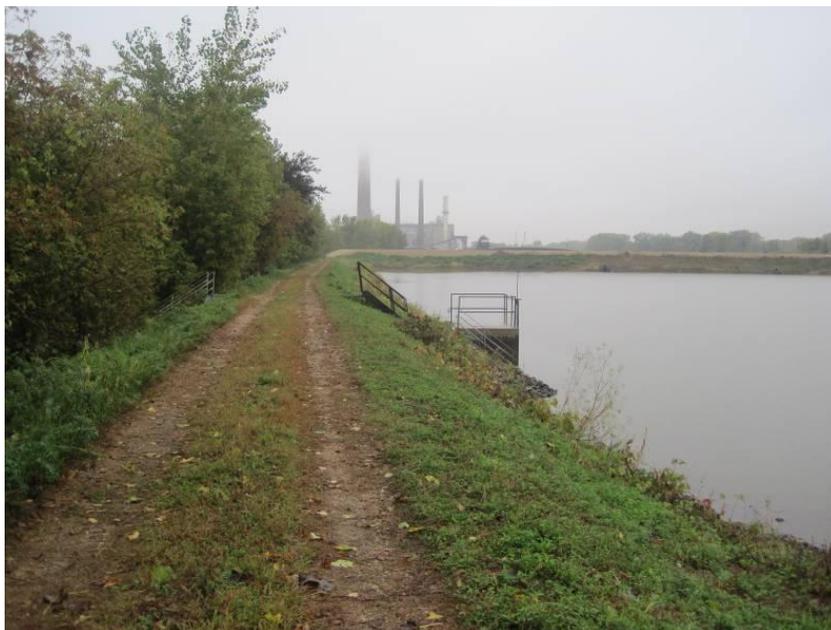
The crest of the embankment had no signs of significant depressions, tension cracks or other indications of settlement or shear failure. Figure 5.2.1-1 and Figure 5.2.1-2 show the typical crest condition of the embankment along Pond 3 and Pond 4, respectively.

Figure 5.2.1-2: Crest of embankment looking west; Pond 4 is to the right and Black Dog Lake is to the left; Crest does not serve as the flood control berm; Note the flood control berm wrapping to the right in the distance around Ponds 3, 2, and 1, which are not shown in the photo

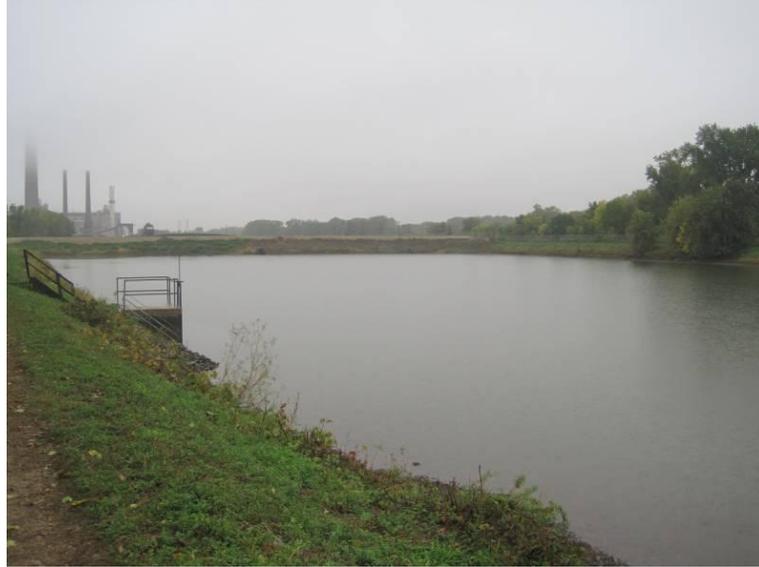
The inside slope of the embankment, including all groins, had a coverage of mixed grasses/weeds and gravel adjacent to Pond 3, and mixed grasses/weeds adjacent to Pond 4. There were no observed scarps, sloughs, bulging, cracks, depressions or other indications of slope instability. Figures 5.2.2-1 and 5.2.2-2 show a representative section of the embankment looking east and west from Pond 3 and Pond 4, respectively.

Figure 5.2.2-2: Inside slope of embankment looking west; Pond 4 is located to the immediate right

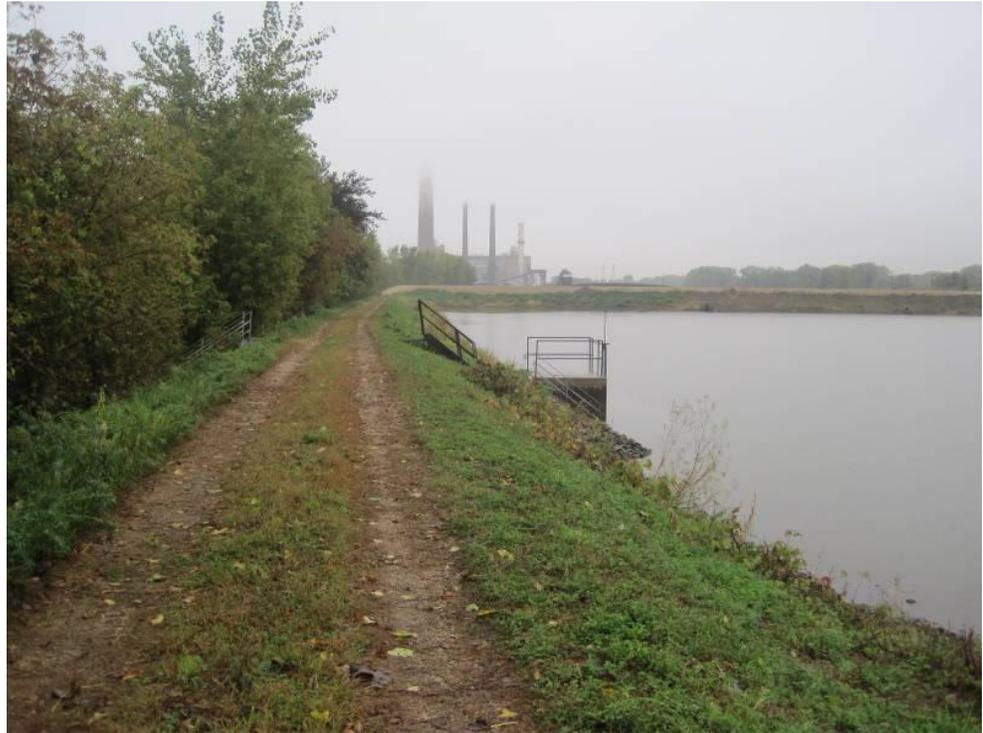
The outside slope of the embankment is vegetated with various species of tall grasses and weeds. The toe of the embankment follows the shoreline of Black Dog Lake where there are trees also growing. Heavy overgrowth along the outside slope of the embankment and toe made close observation of the embankment difficult. Based on what could be observed there were no scarps, sloughs, bulging, cracks, depressions or other indications of slope instability. Figures 5.2.3-1 and 5.2.3-2 show a representative section of the embankment looking west from Pond 3 and Pond 4.

Figure 5.2.3-2: Outside slope of embankment to the left looking west; Pond 4 is located to the immediate right

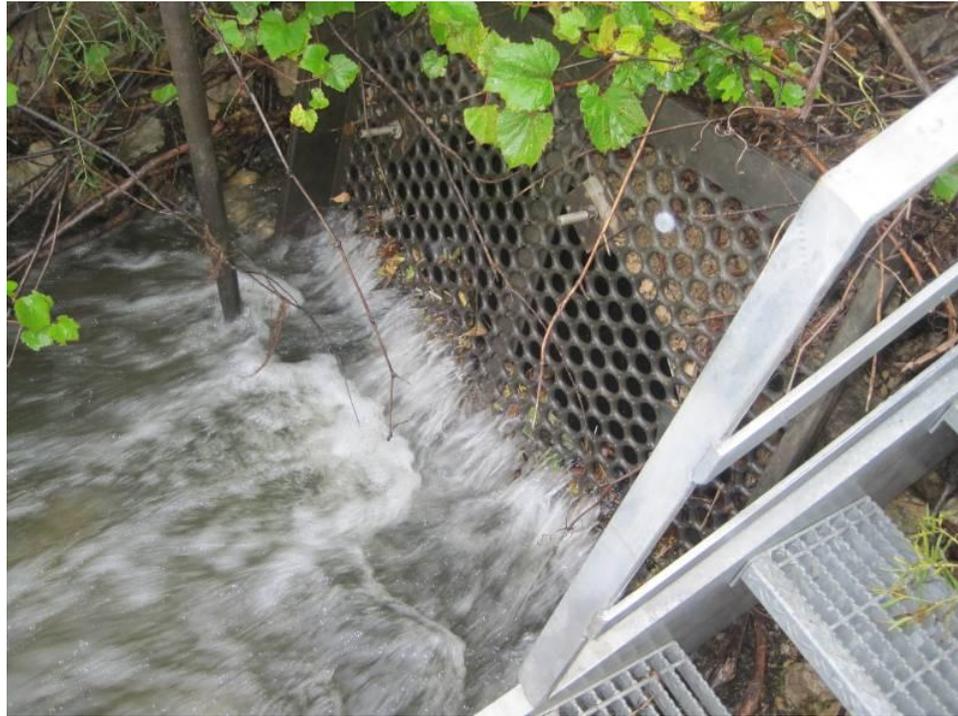
The outlet conduit consists of a 42-inch pipe with a trash rack on its downstream outfall at Black Dog Lake. The conduit appeared to be in good shape with no visible signs of clogging and the water exiting the outlet was flowing clear. Figure 5.3.2-1 shows the outfall of the outlet conduit.

Figure 5.3.2-1: Outfall of outlet conduit in operation

A separate emergency spillway was not observed. It is unclear, based on the documentation provided, if the overflow spillway also serves as the emergency spillway for the impoundment (i.e. a combined drop-inlet principle/emergency spillway). After NSP-M reviewed the draft version of this report, NSP-M confirmed that the only outlet from pond 4 is the outfall shown in Figure 5.3.2-1.

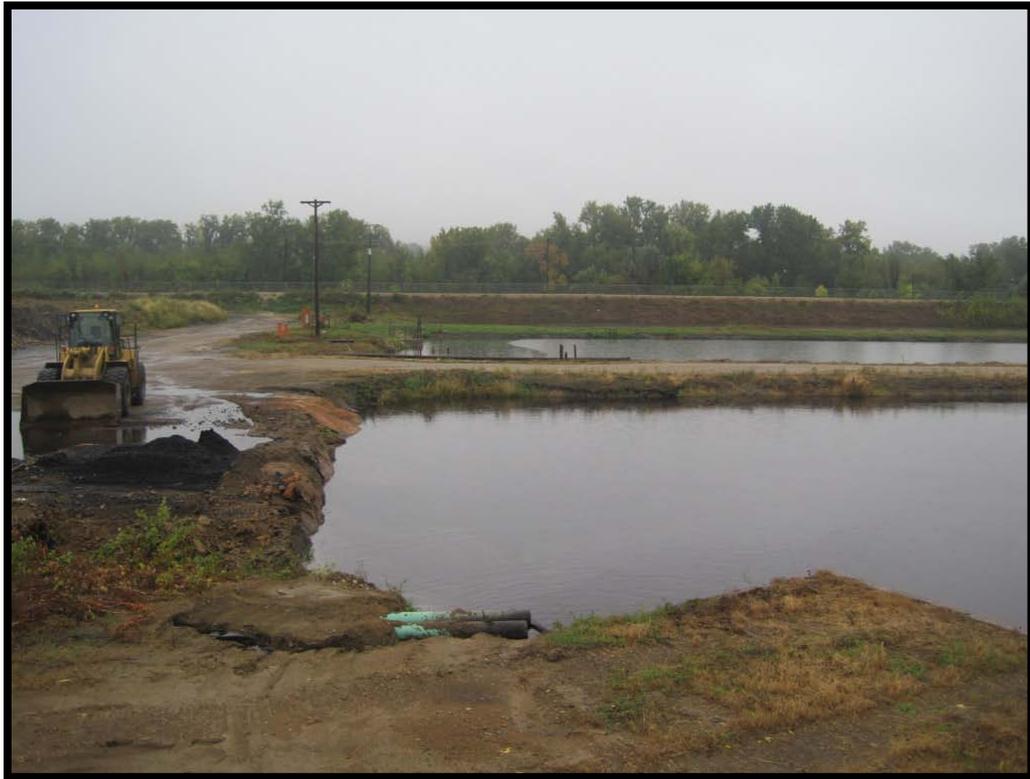
Figure 1: Ash Water and Bilge Line Outlet to Process Water Settling Pond # 3

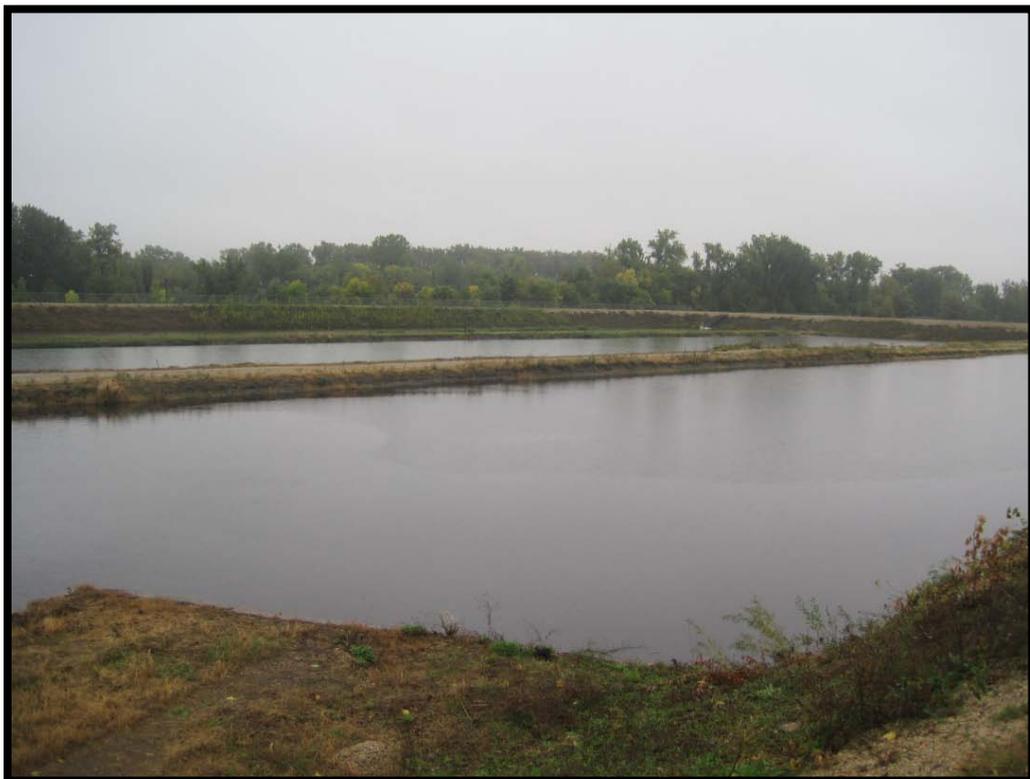
Figure 2: Process Water Settling Pond # 3, Northeast

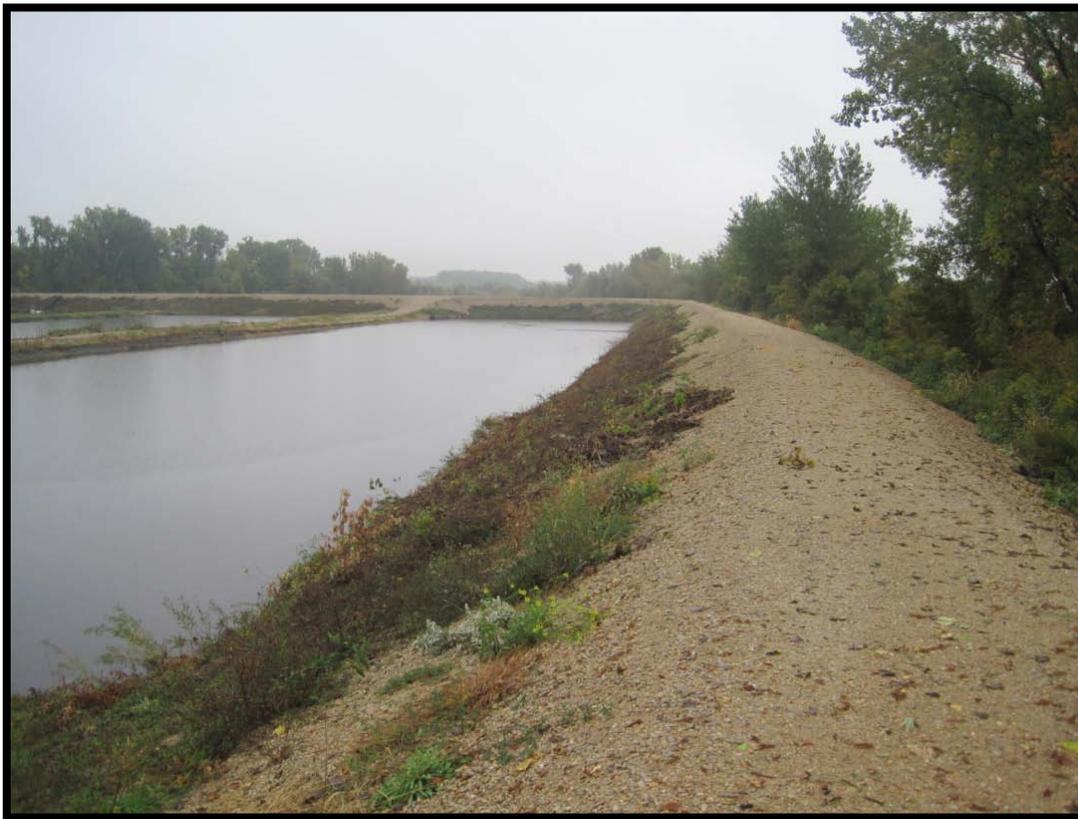
Figure 3: Process Water Settling Pond # 3, East

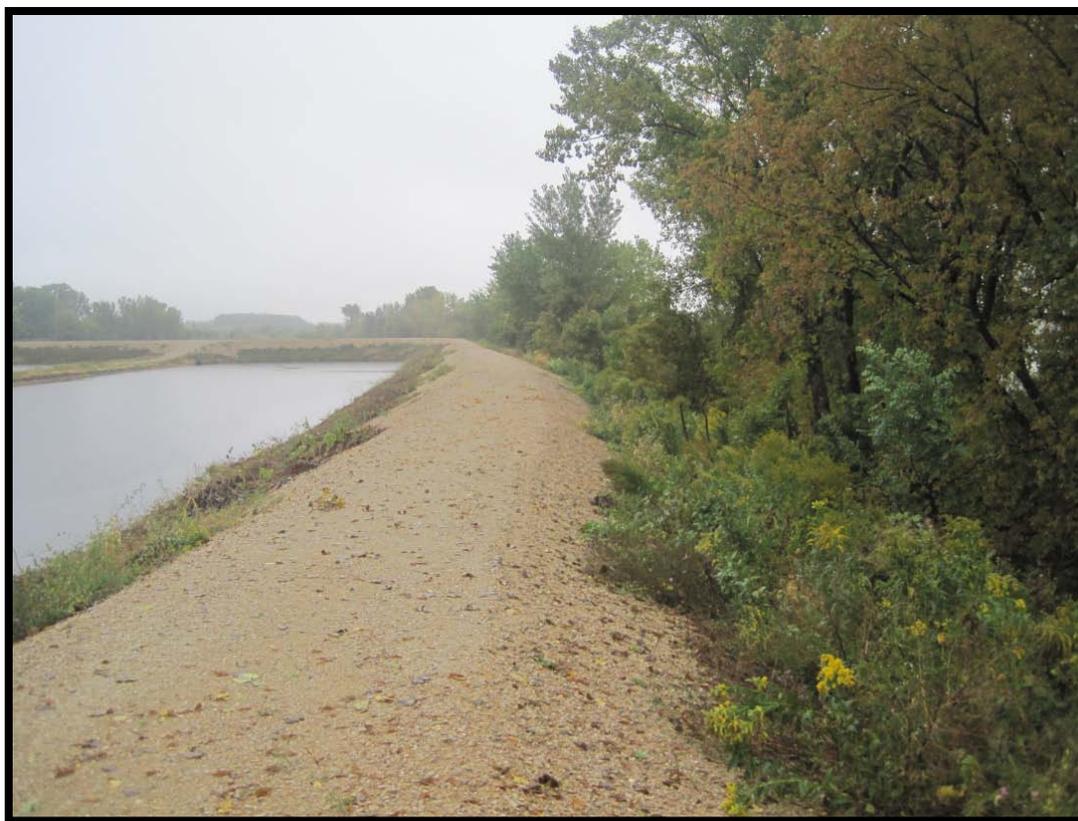
Figure 4: Process Water Settling Pond # 3, East

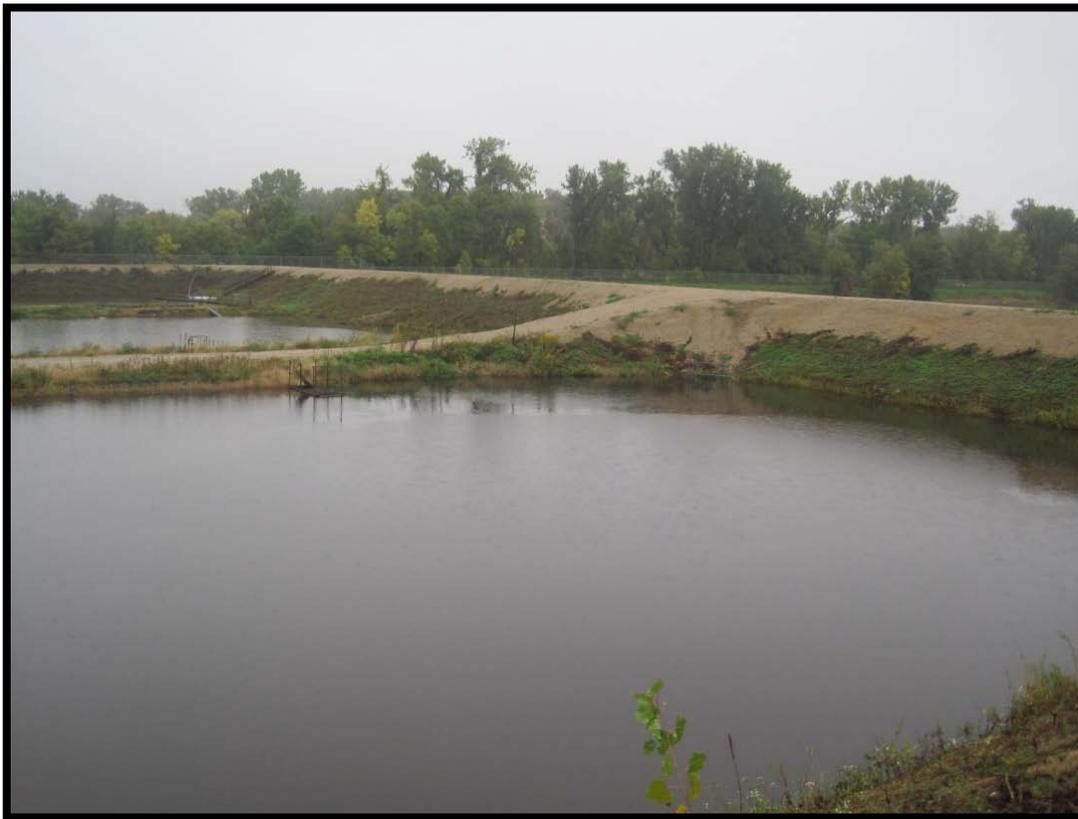
Figure 5: Process Water Settling Pond # 3, North

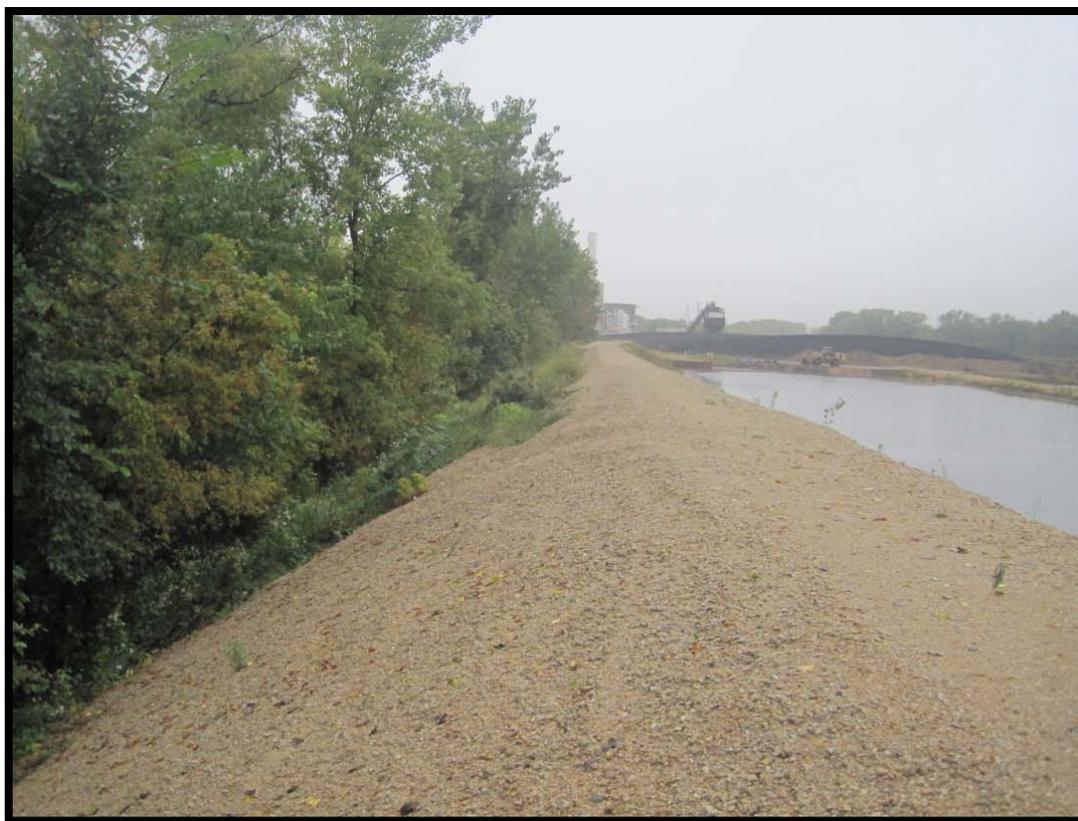
Figure 6: Process Water Settling Pond # 3, West

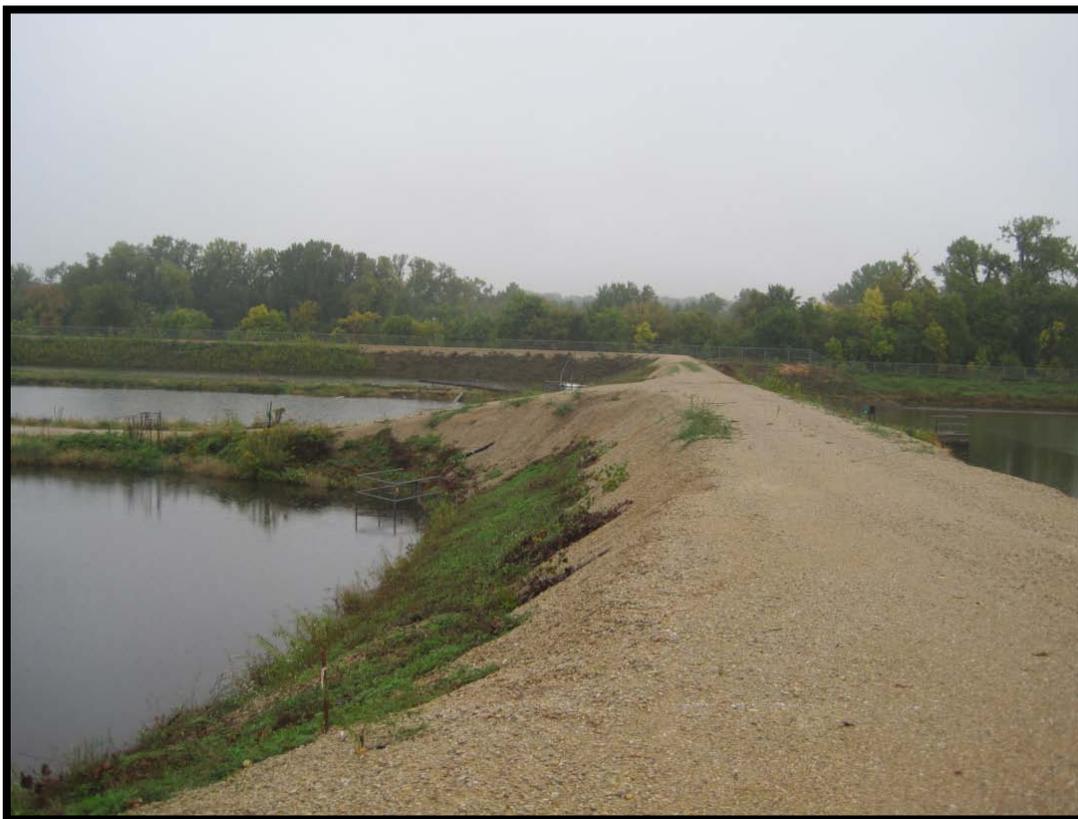
Figure 7: Process Water Settling Pond Divide for Ponds #1-#3 and #4, Northwest

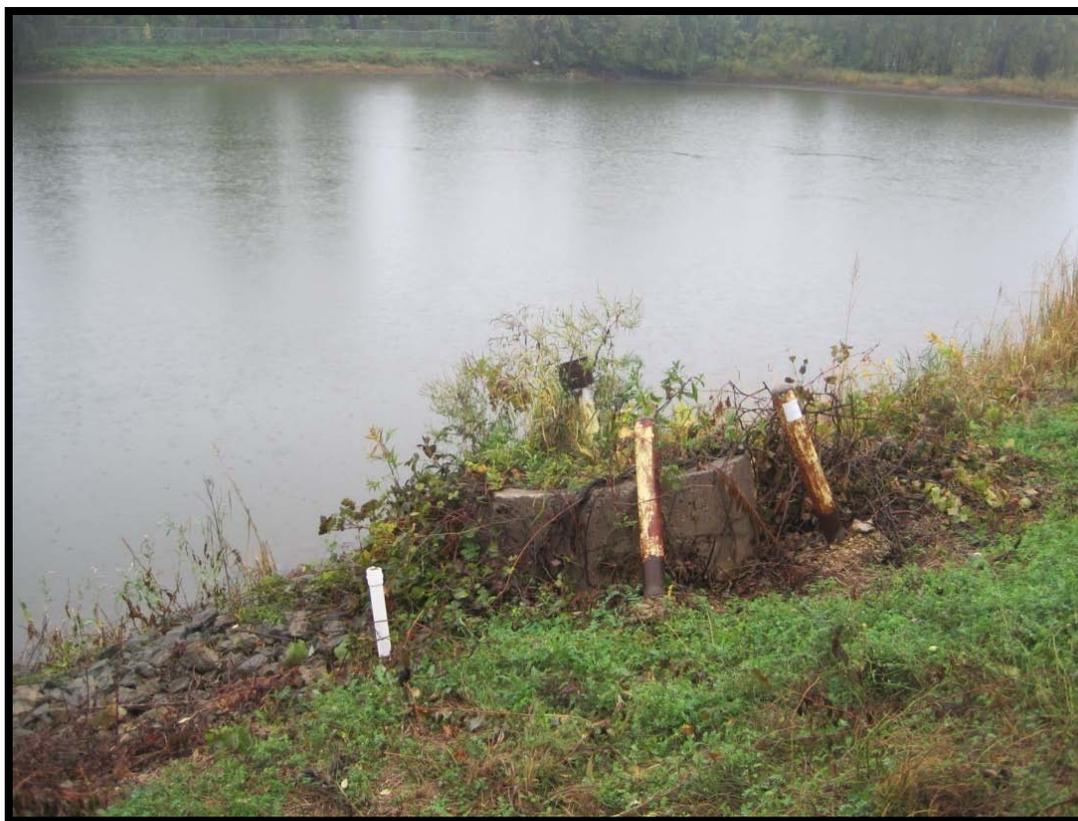
Figure 8: Process Water Settling Pond # 4, North

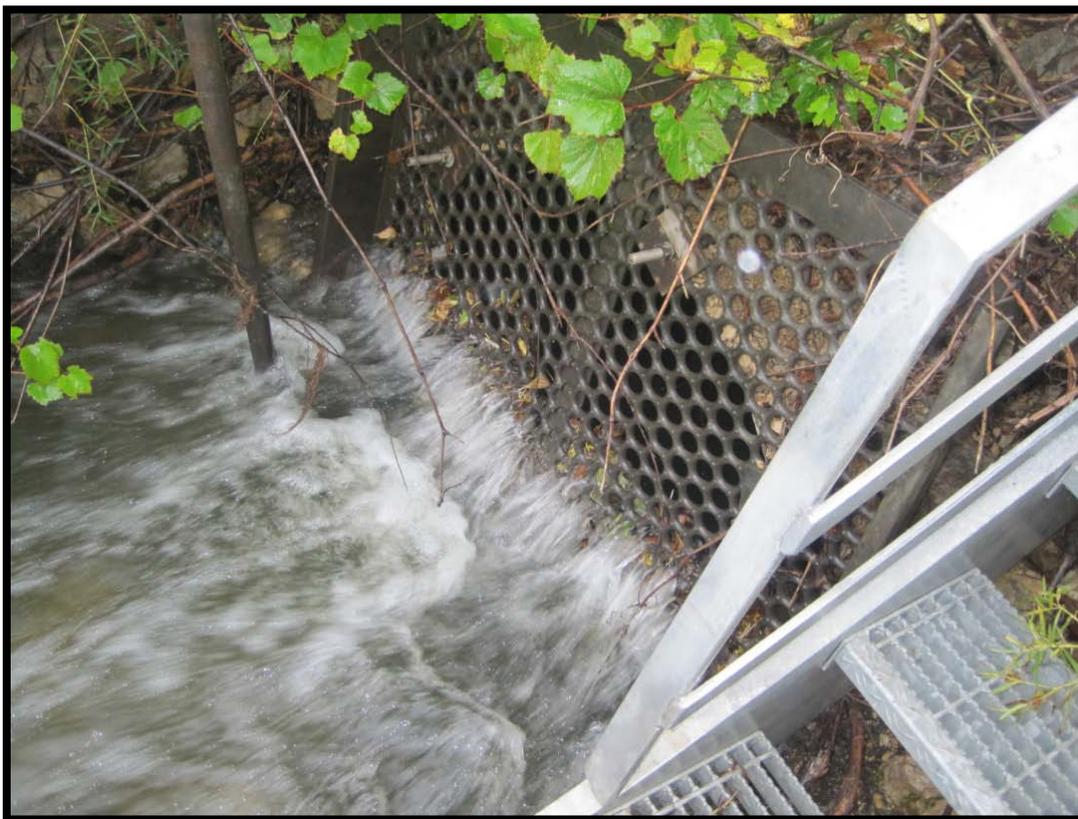
Figure 9: Process Water Settling Pond # 4 Outlet to Black Dog Lake

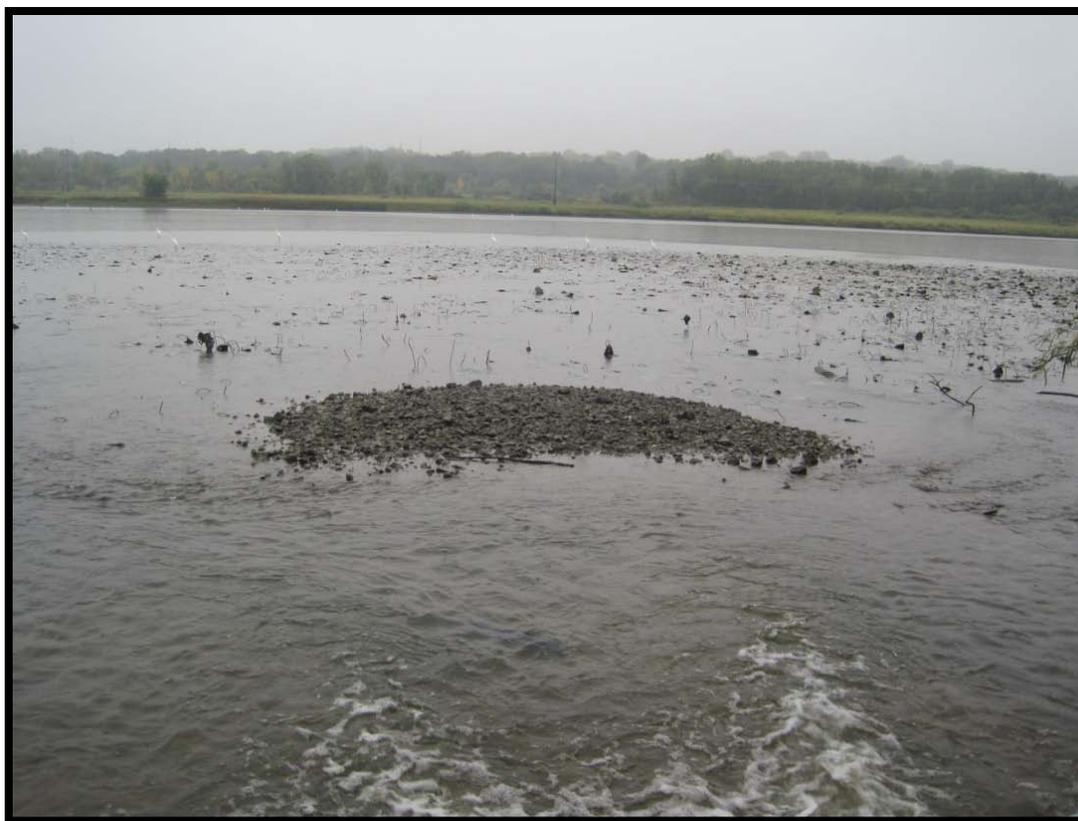
Figure 10: Black Dog Lake at Process Water Settling Pond # 4 Outlet

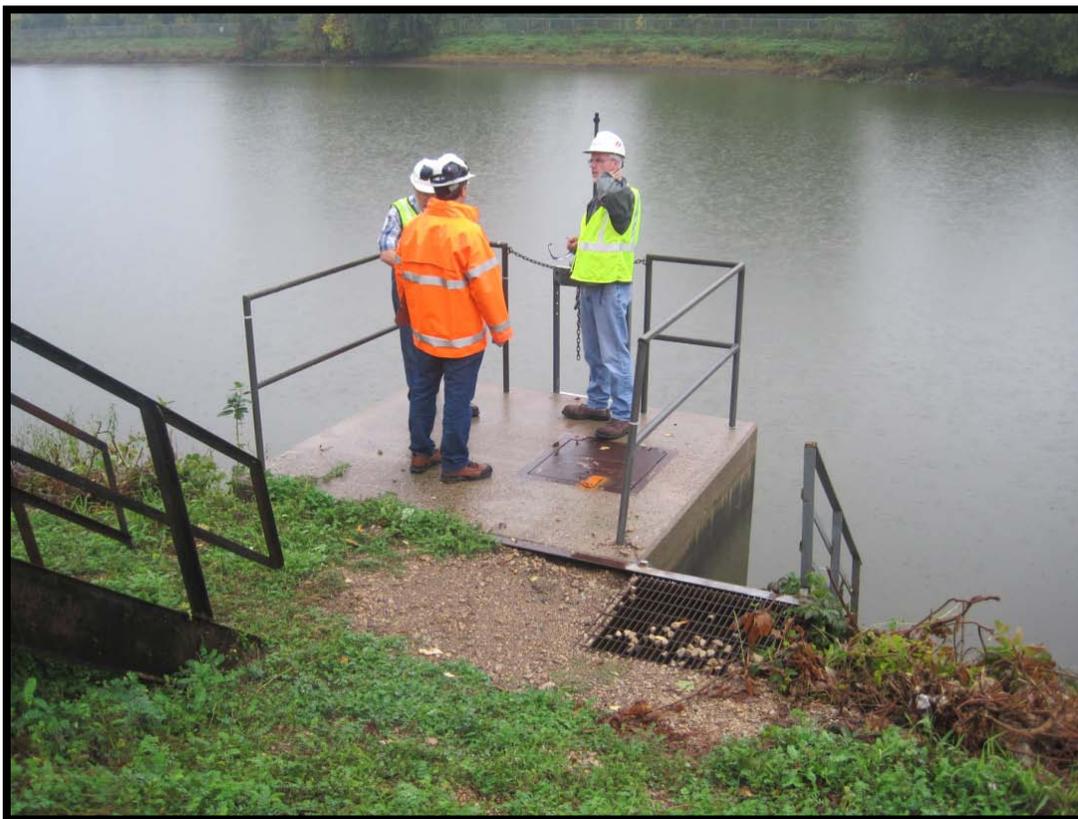
Figure 11: Process Water Settling Pond # 4 Inlet to Black Dog Lake

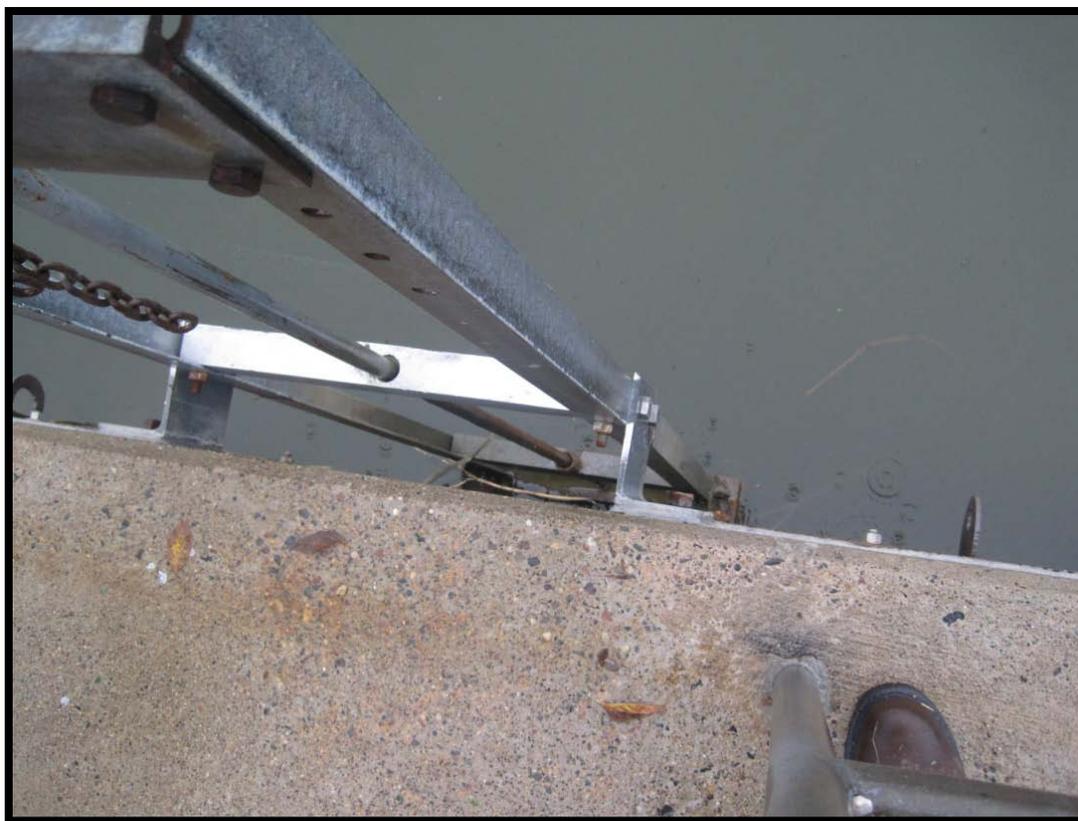
Figure 12: Process Water Settling Pond # 4 Access Ladder for Inlet to Black Dog Lake

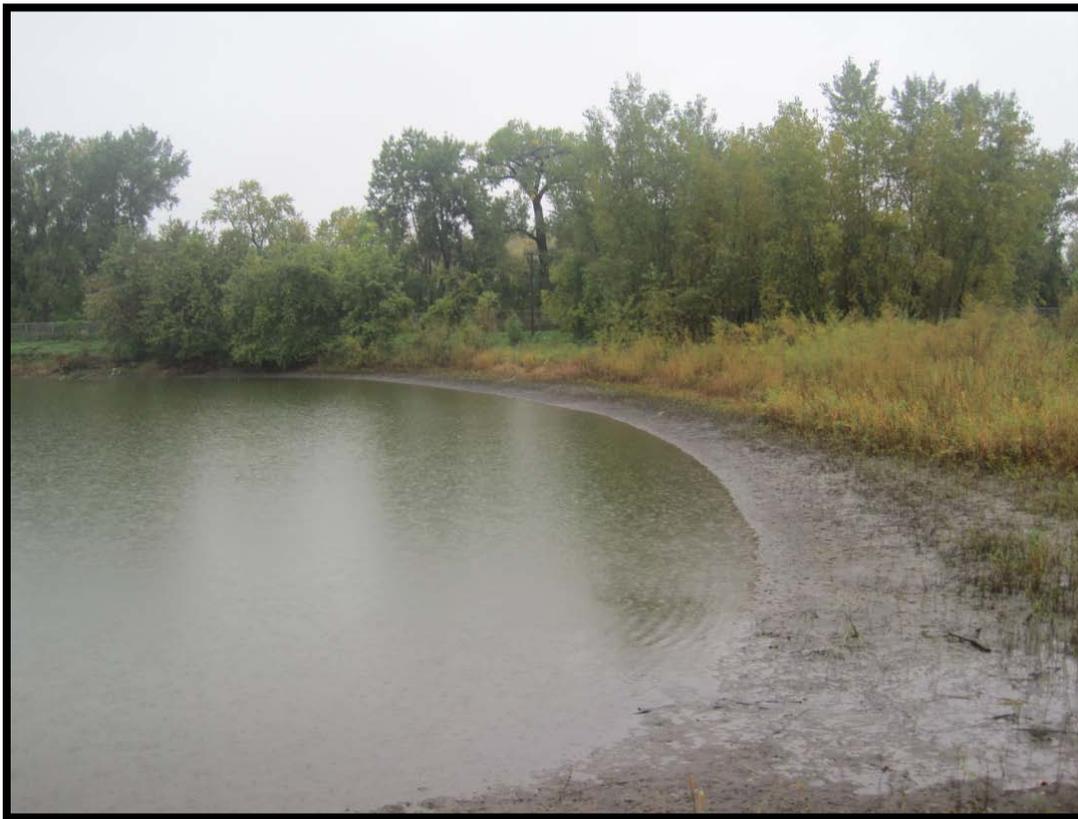
Figure 13: Process Water Settling Pond # 4, North

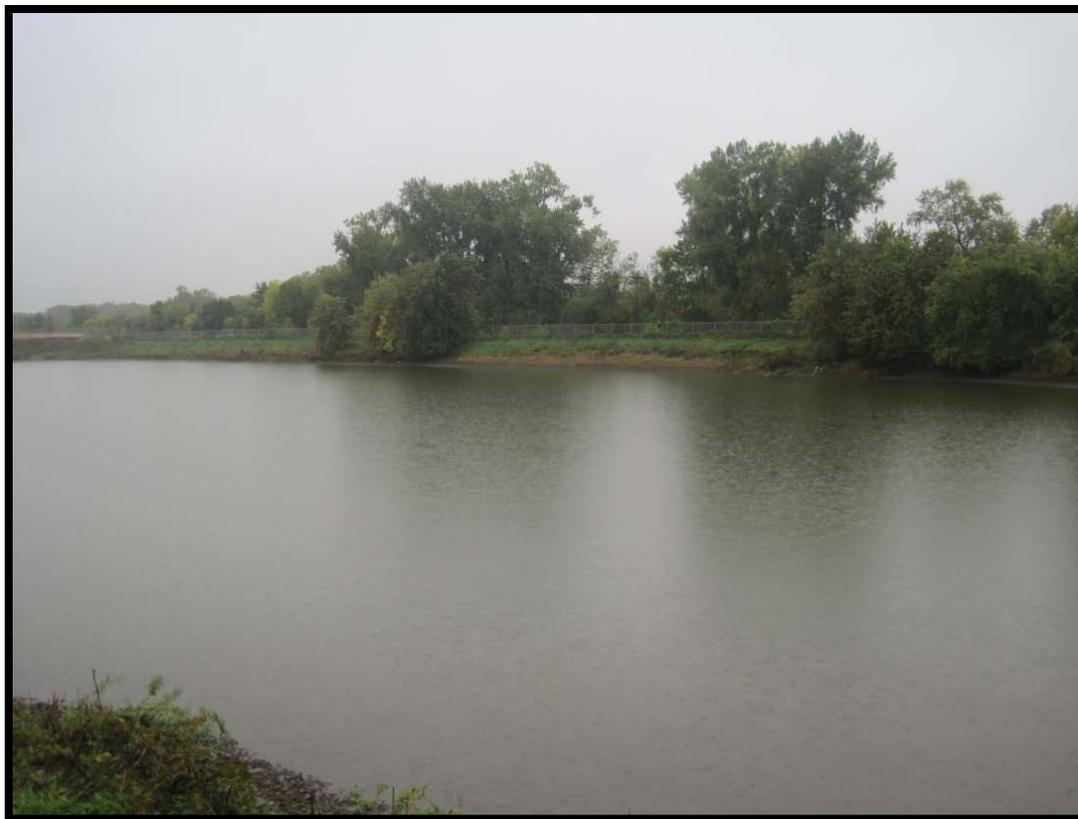
Figure 14: Process Water Settling Pond # 4, Northwest

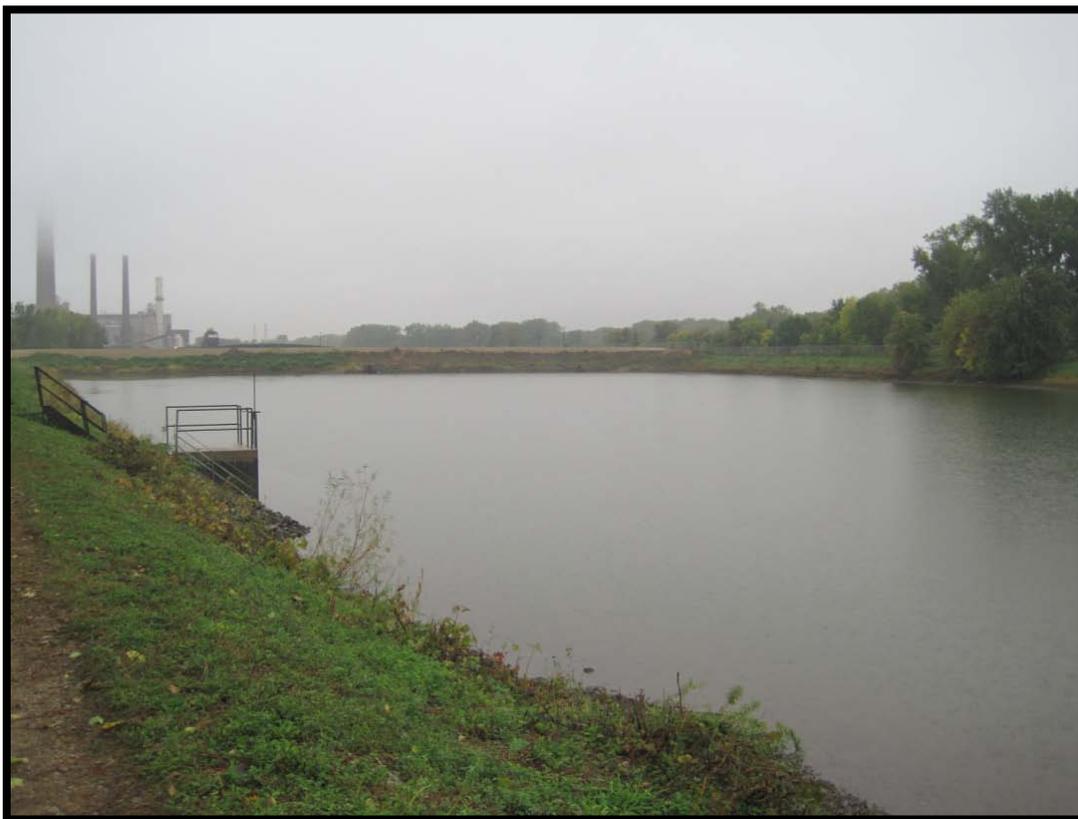
Figure 15: Process Water Settling Pond # 4, West

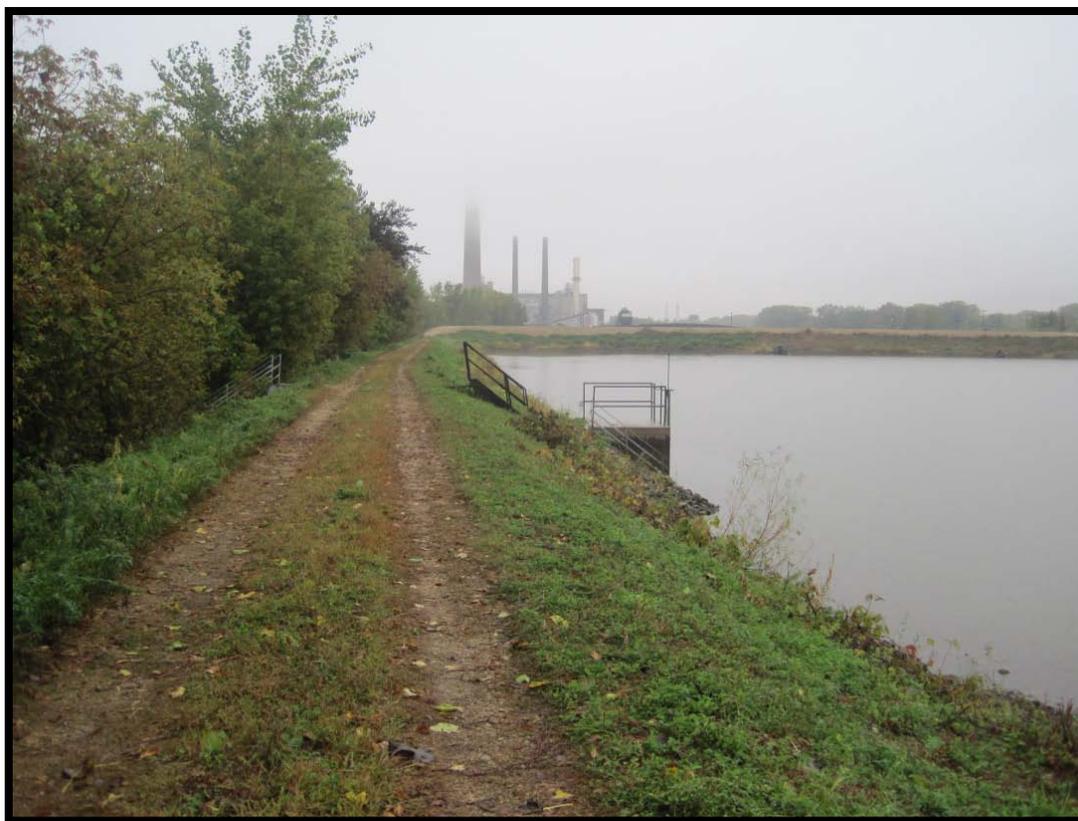
Figure 16: Process Water Settling Pond # 4, Southwest

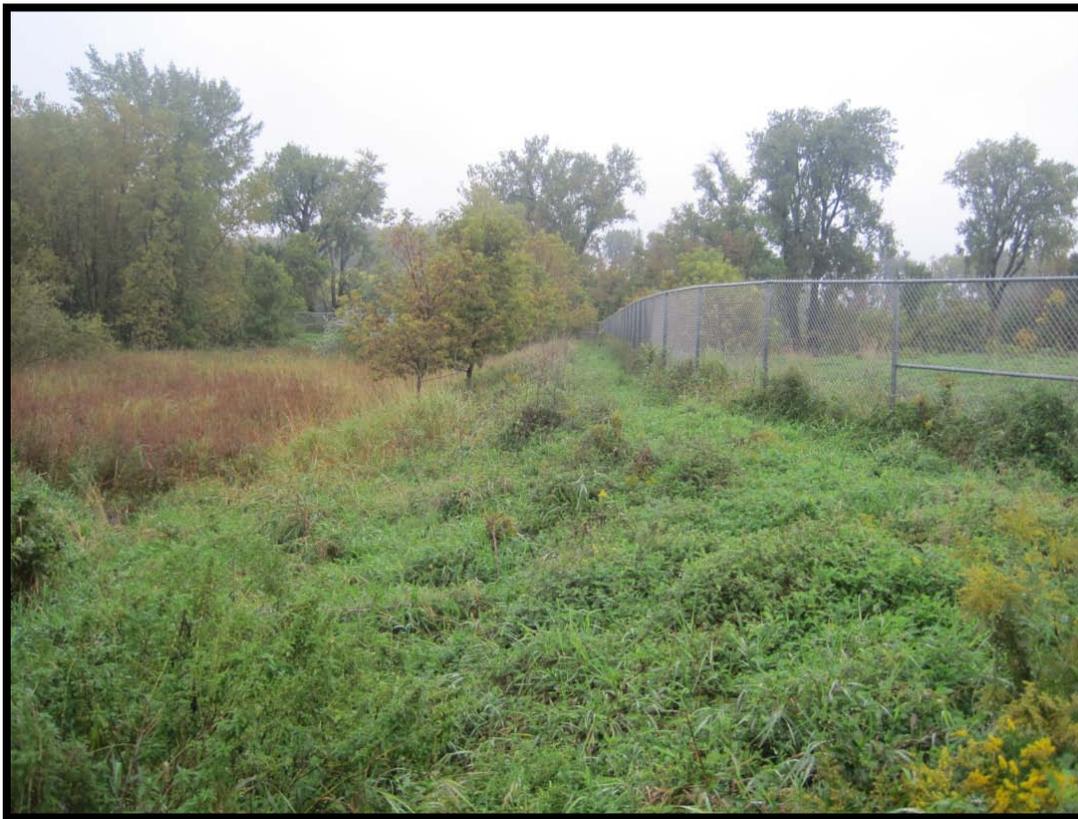
Figure 17: Southeast Corner of Process Water Settling Pond # 2, Northwest

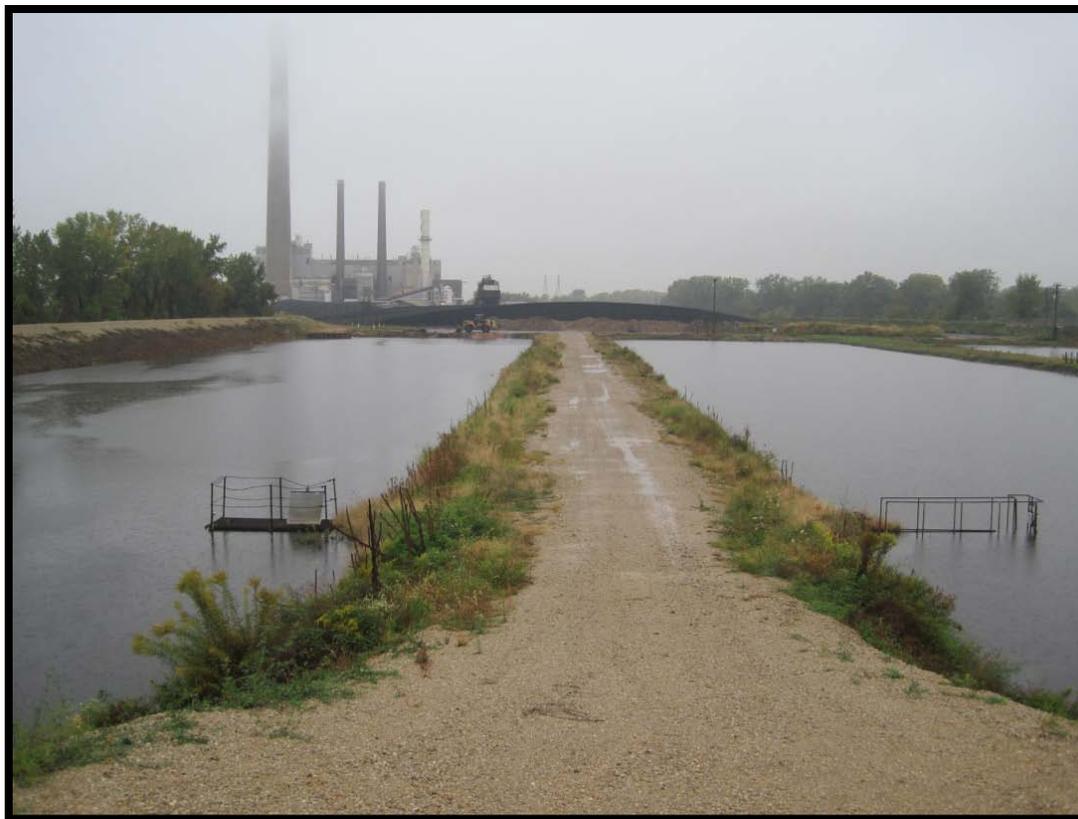
Figure 18: Process Water Settling Pond # 3 and Pond # 2, West
