Appendix A
Storm Water Management Plan: Comments from NDEP and Co-Permittee Response

**Appendix B
Clark County**

**Appendix B.1
Documentation of Findings**

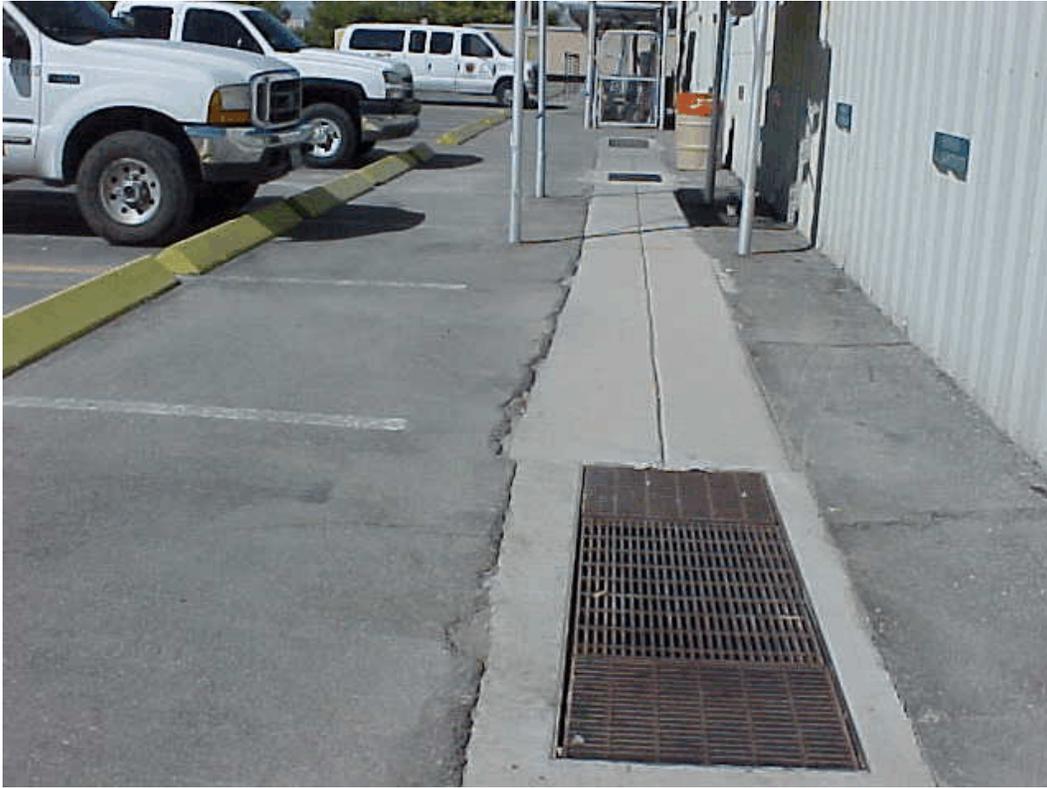
Photo 1. Fleet (primary) facility: Unprotected storm water inlets at north edge of parking area.

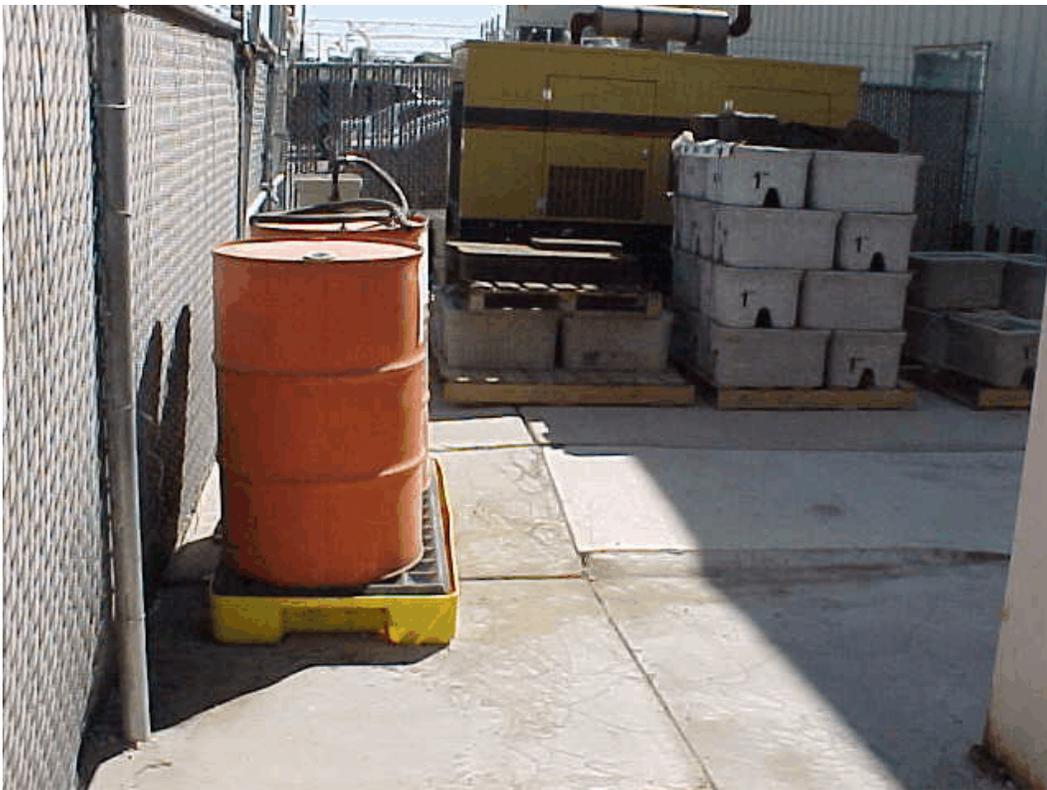
Photo 2. Fleet (primary) facility: Two uncovered 55-gallon drums of solvent.

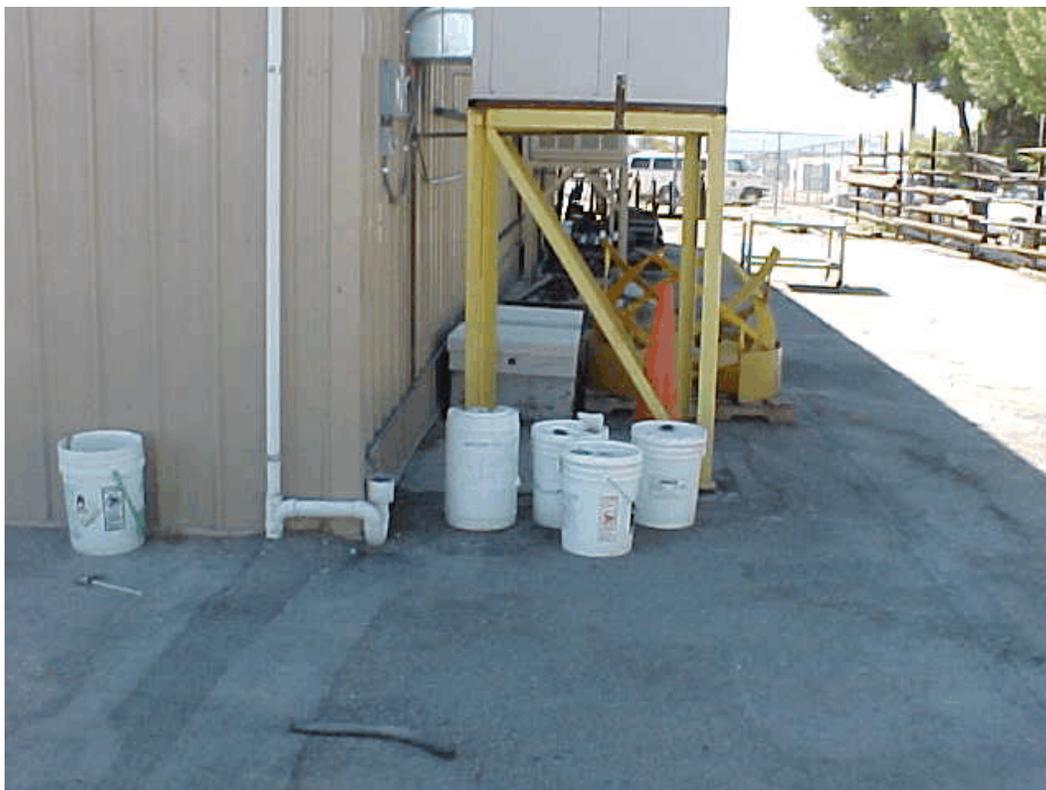
Photo 3. Fleet (primary) facility: Four uncovered and uncontained 5-gallon pails of truck wash chemical.

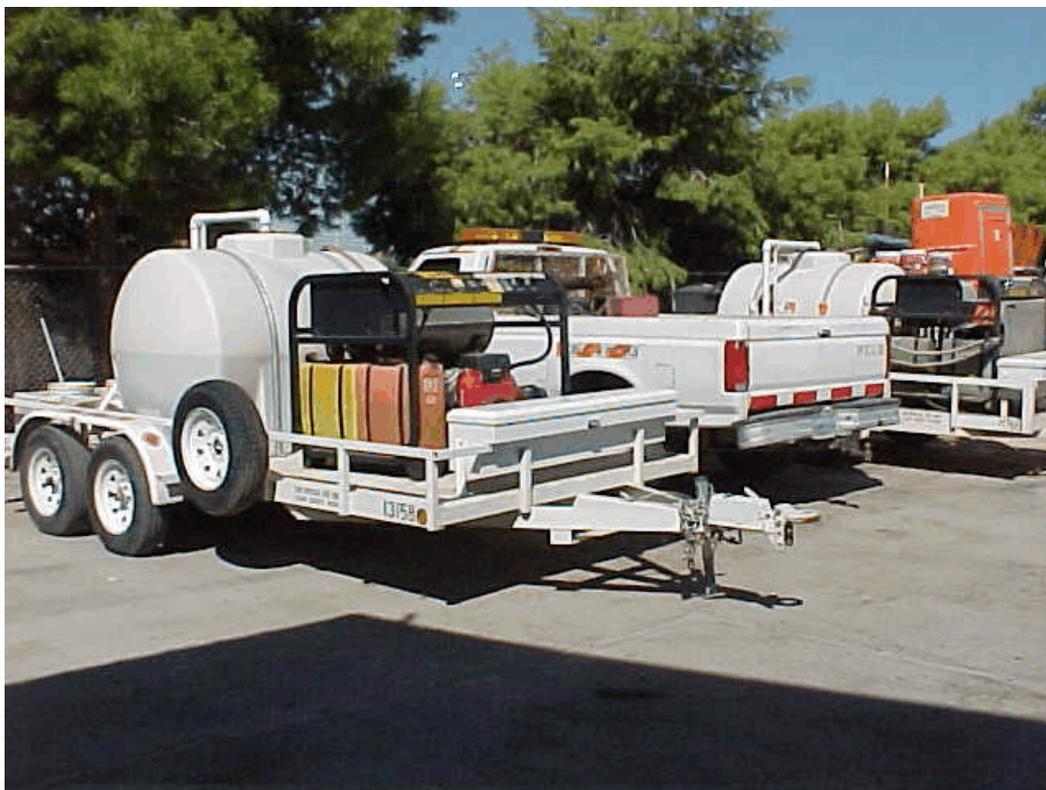
Photo 4. Fleet (primary) facility: Power washer for trucks.

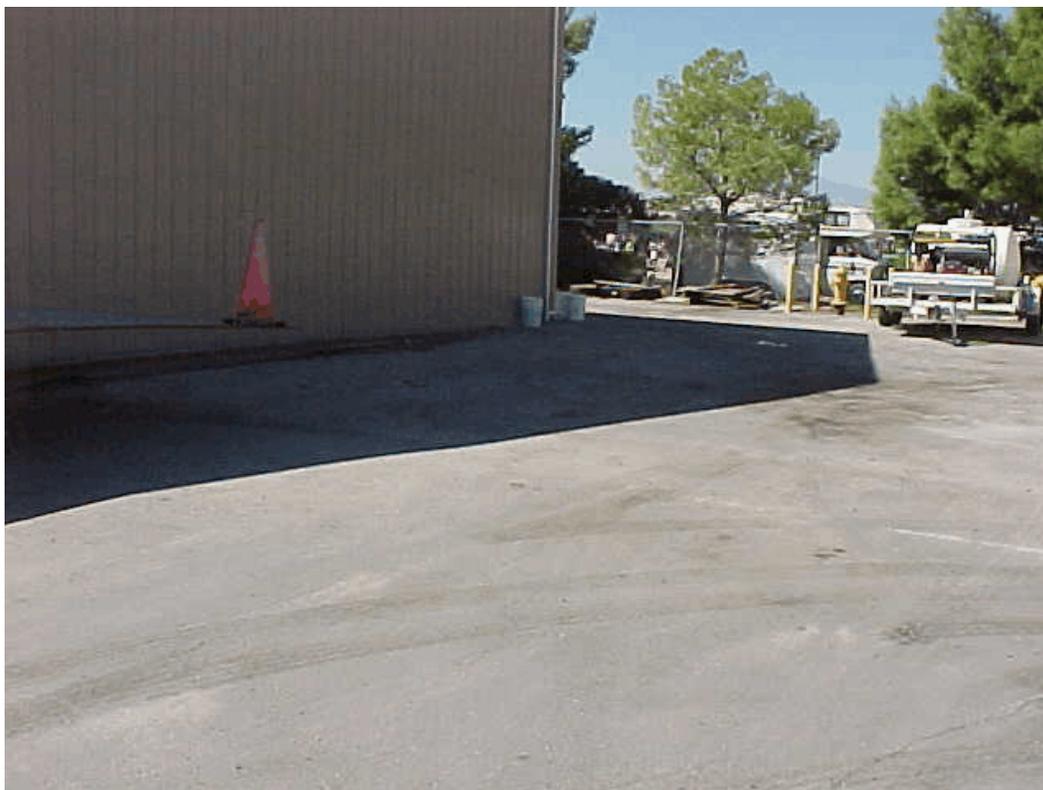
Photo 5. Fleet (primary) facility: Truck wash area is outside, uncontained, uncovered.

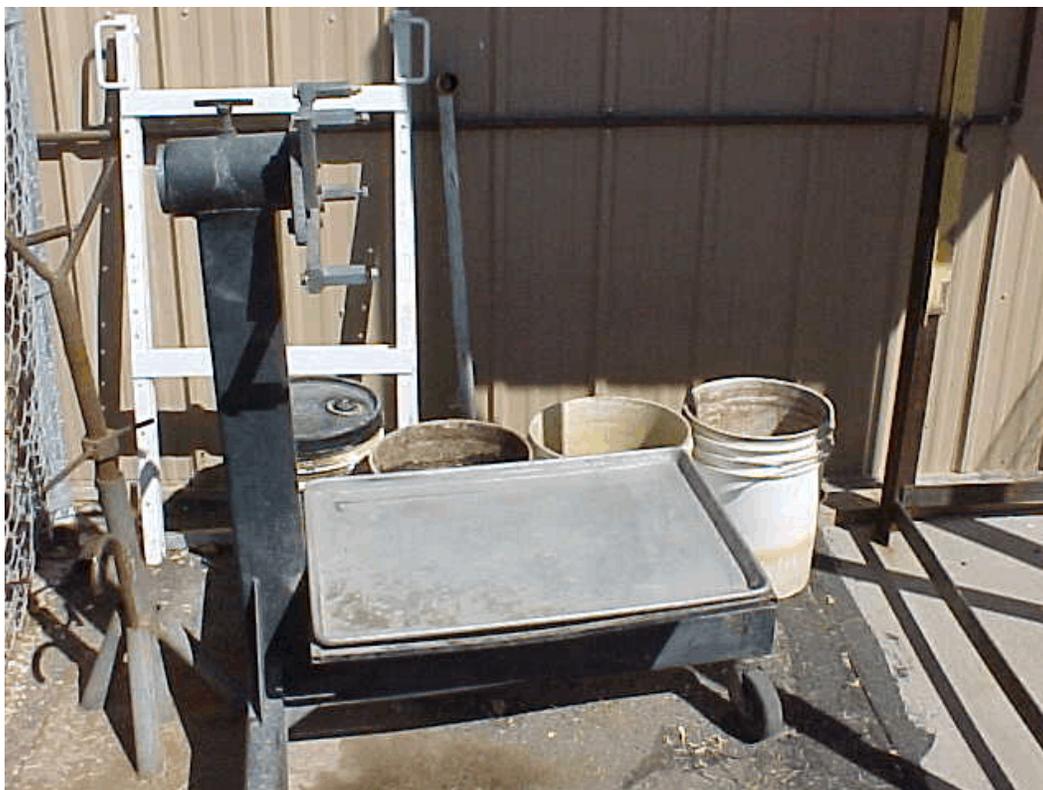
Photo 6. Fleet (primary) facility: Four 5-gallon pails stored outside. One, without a lid, is 50% full of used petroleum product.

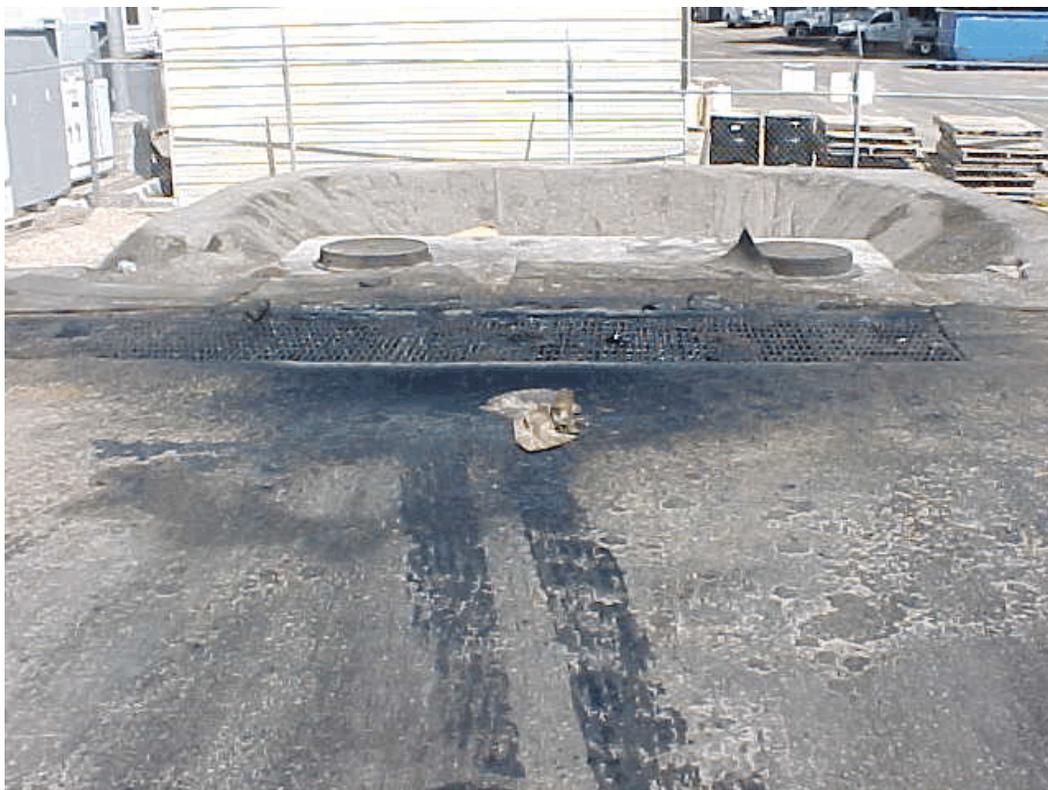
Photo 16. Fleet (secondary) facility: Abandoned asphalt washout area.

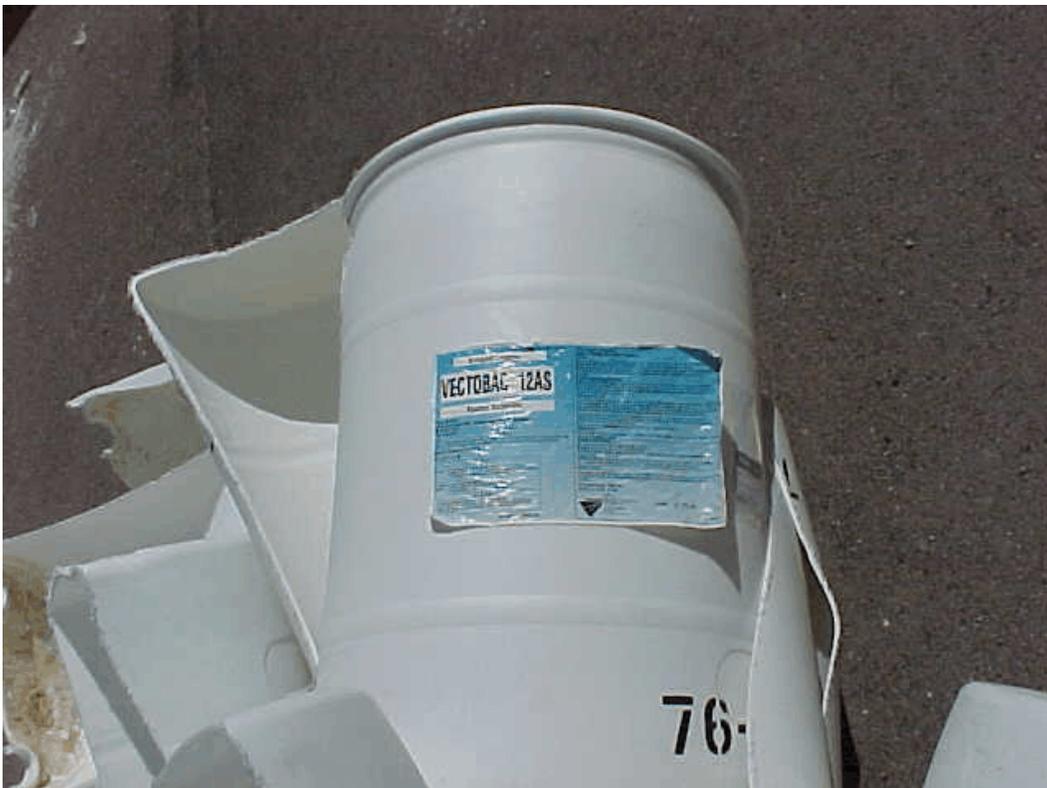
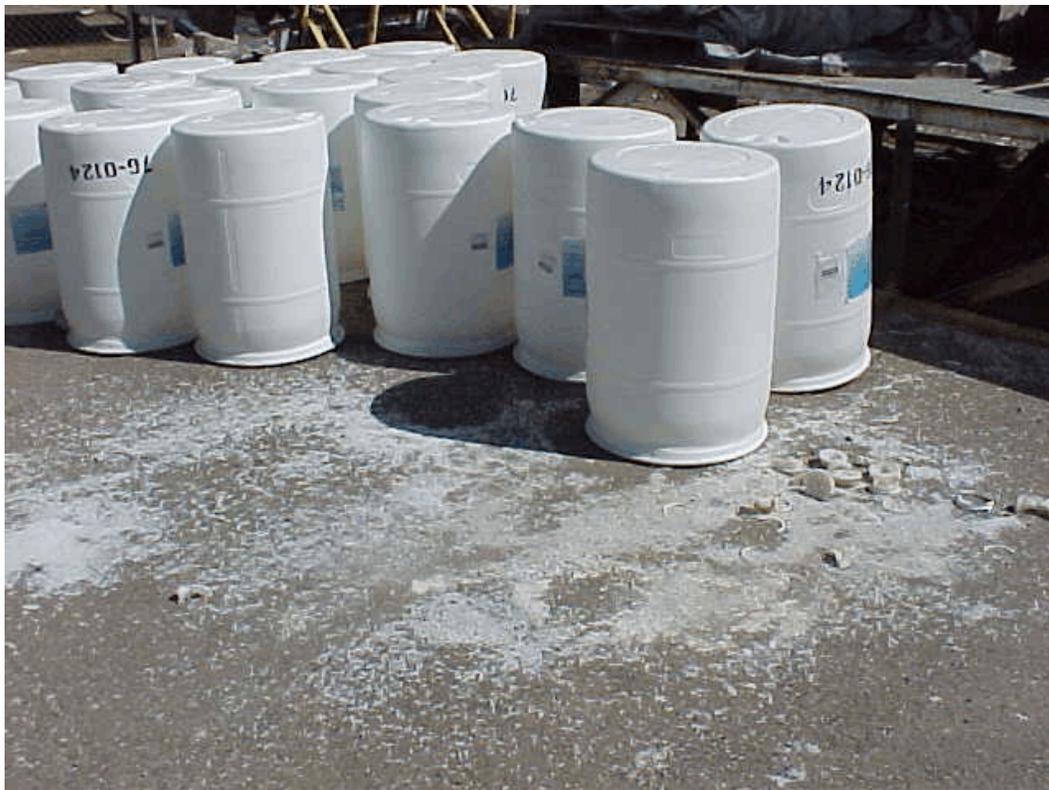
6. The spilled residue biological larvicide was in a uncontained, uncovered area of pavement at the Vector Control facility. Storm water runoff would potentially carry the larvicide off site.

Photo 17. Vector Control facility: Empty drums of larvicide had been cut open in an uncontained location and residue spilled to the pavement.

Photo 18. Vector Control facility: Empty drums of larvicide had been cut open in an uncontained location and residue spilled to the pavement.

Photo 19. Vector Control facility: Empty drums of larvicide had been cut open in an uncontained location and residue spilled to the pavement.

Photo 20. Vector Control facility: Empty drums of larvicide had been cut open in an uncontained location and residue spilled to the pavement.

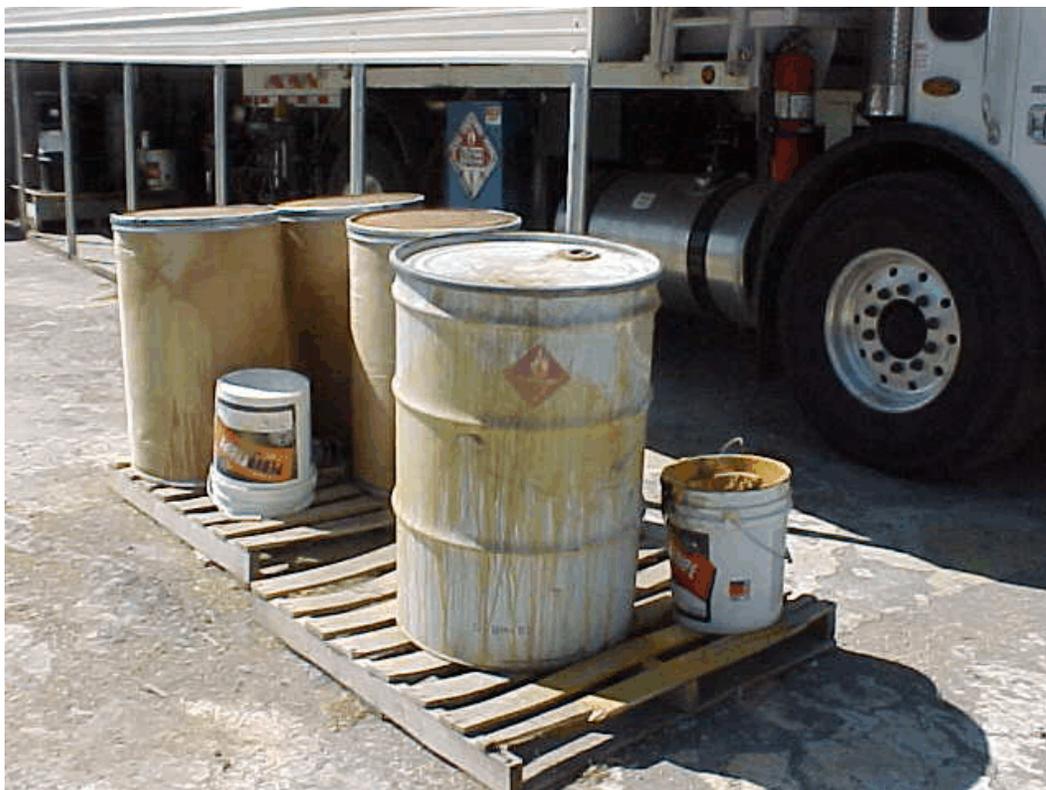
7. The Traffic facility had chemical containers that were uncontained and exposed to rain and rupture from vehicle accident. Storm water would carry any spillage that might occur.

Photo 21. Traffic facility: One 55-gallon drum of flammable contents and three fiber drums of unknown contents were uncovered and uncontained.

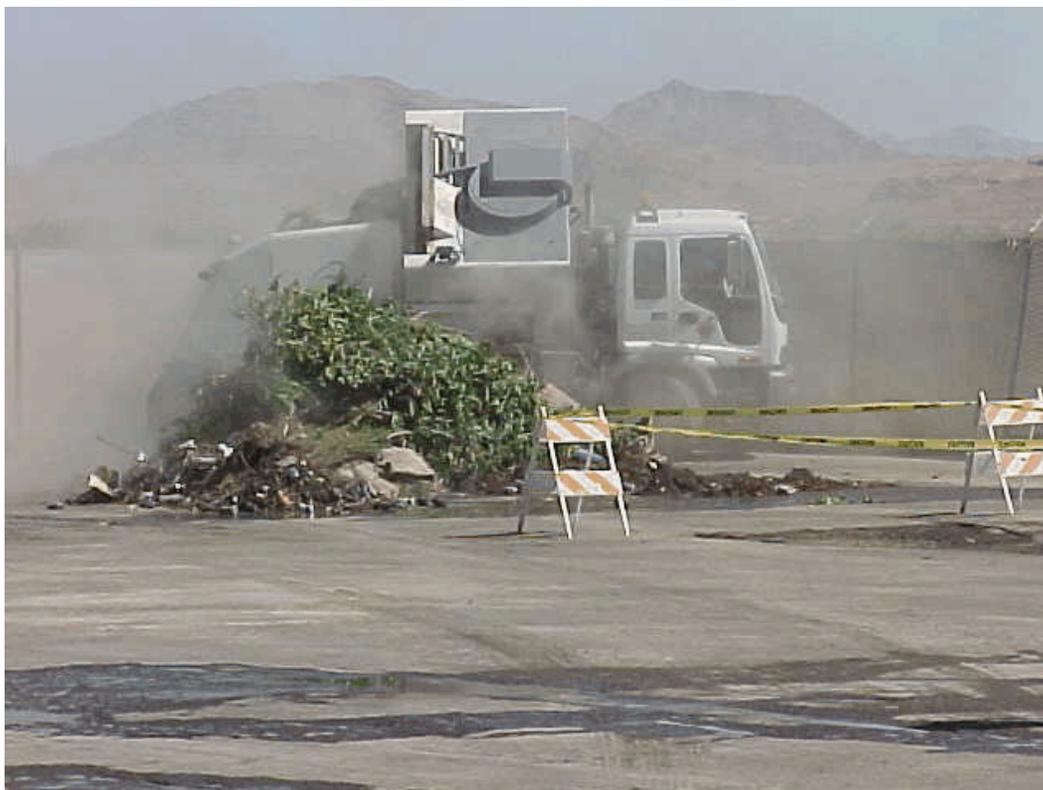
Photo 1. Street sweeper unloading and sweeping facility area.

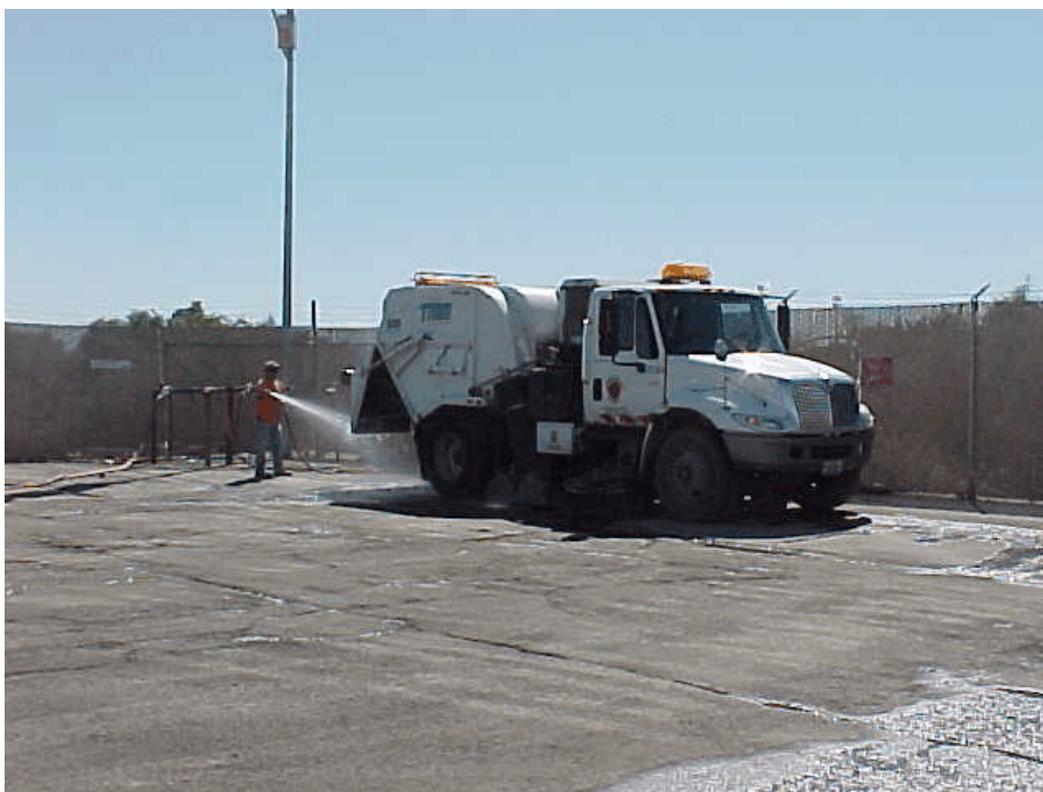
Photo 2. Street sweeper being washed out.

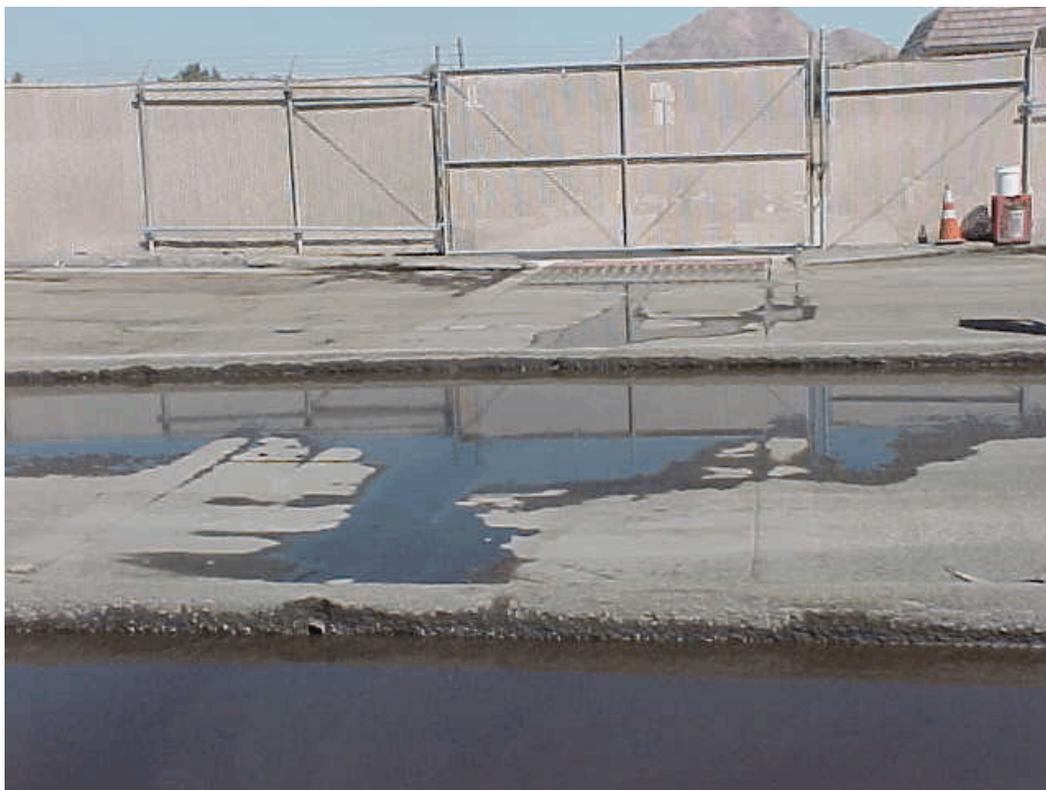
Photo 3. Sediment traps to collect soil and debris from street sweeper unloading.

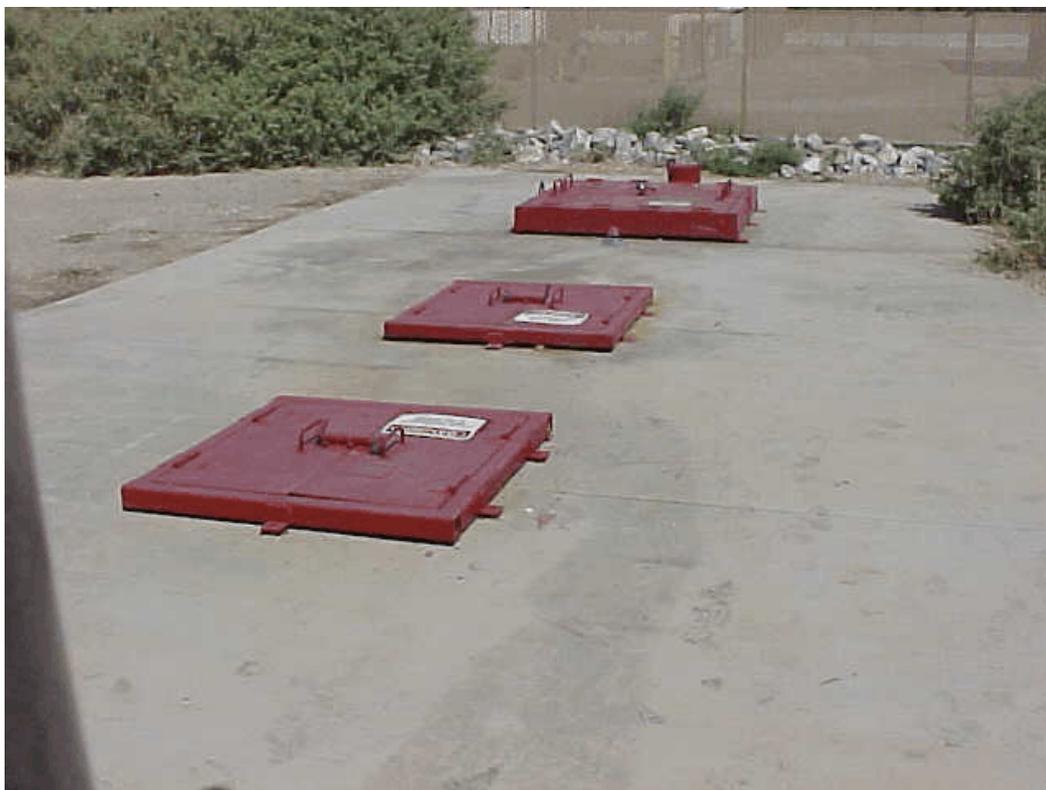
Photo 4. Treatment basin for materials escaping the sediment traps.

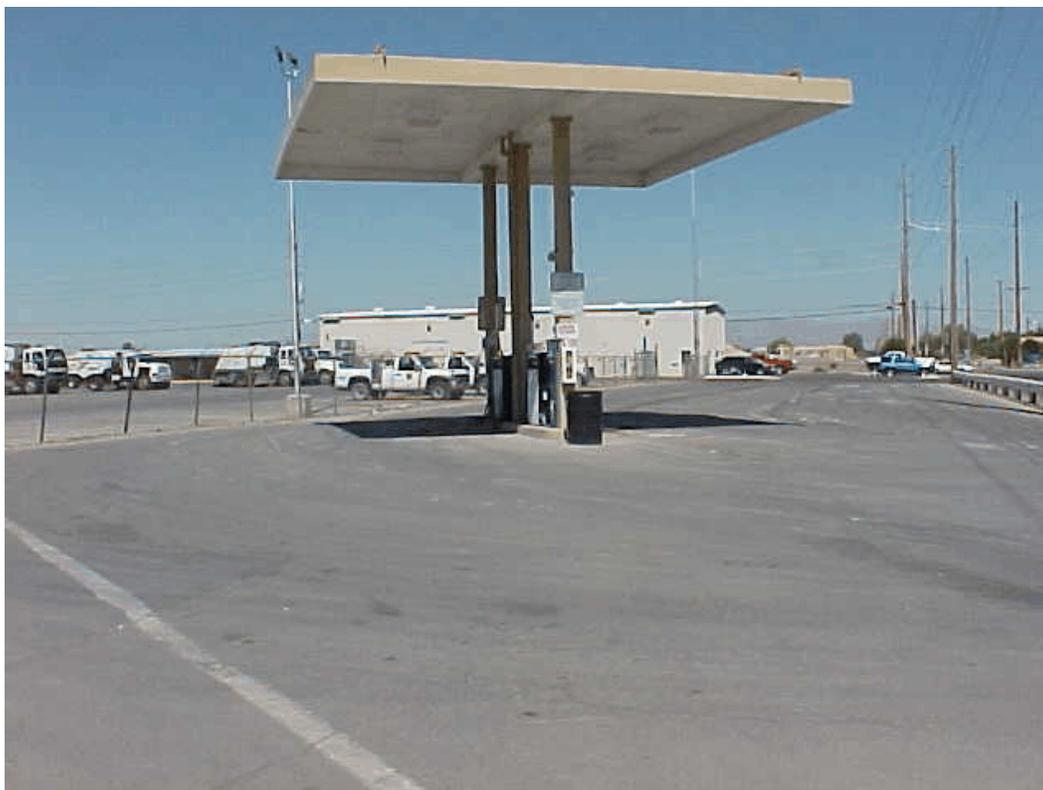
Photo 5. View of fuel island.

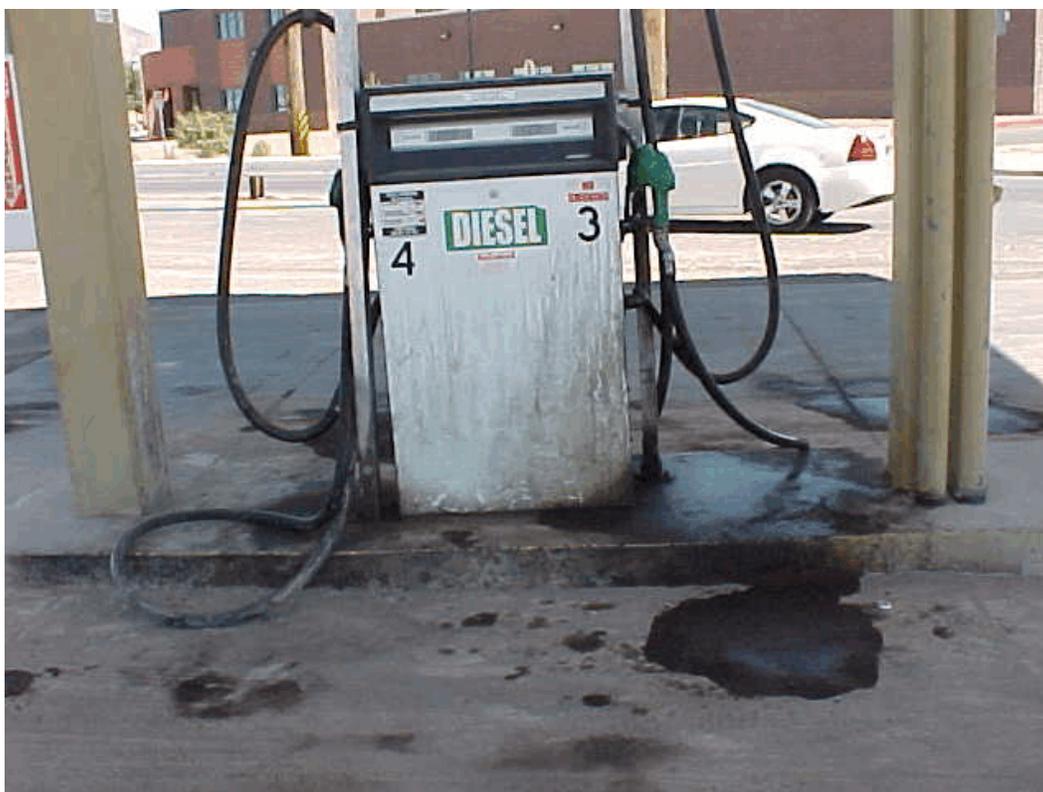
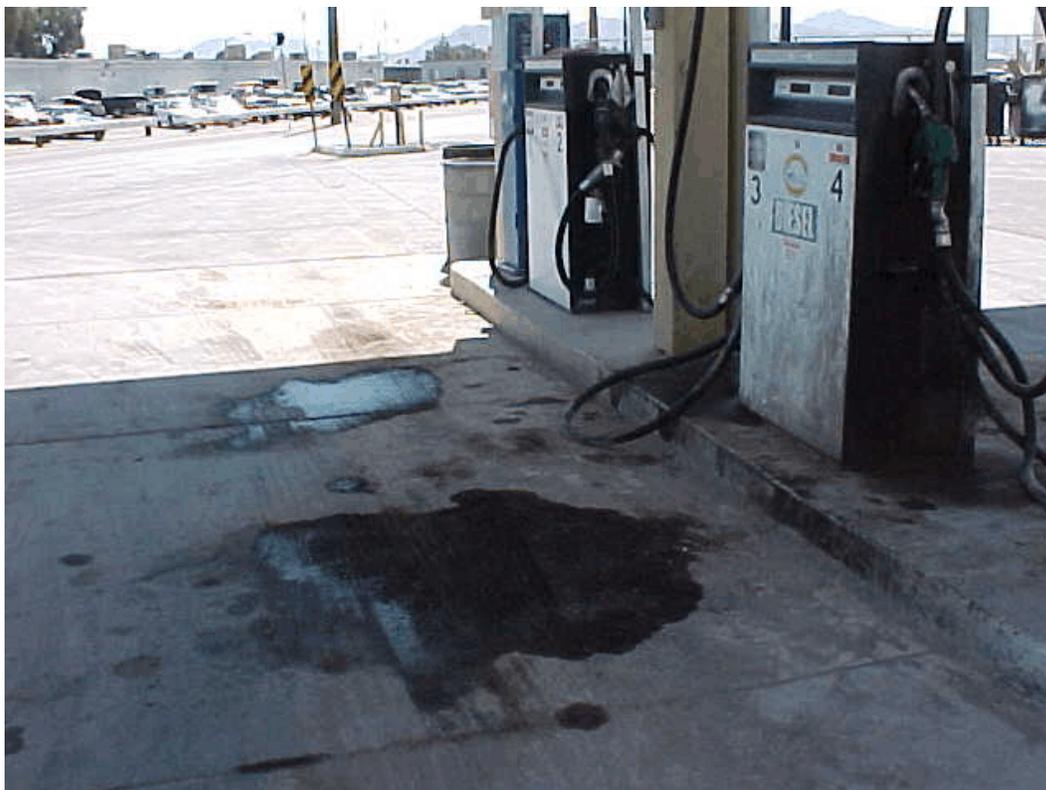
1. Exposed and uncontained used batteries at the Automotive Repair facility had the potential to lose acid to storm water runoff.
2. The spillage at the Fuel Point area was under the canopy, but had the potential to be tracked out of the canopy area and be carried to the adjacent street by storm water.

Photo 6. Spillage at fuel island.

Photo 7. Spillage at fuel island.

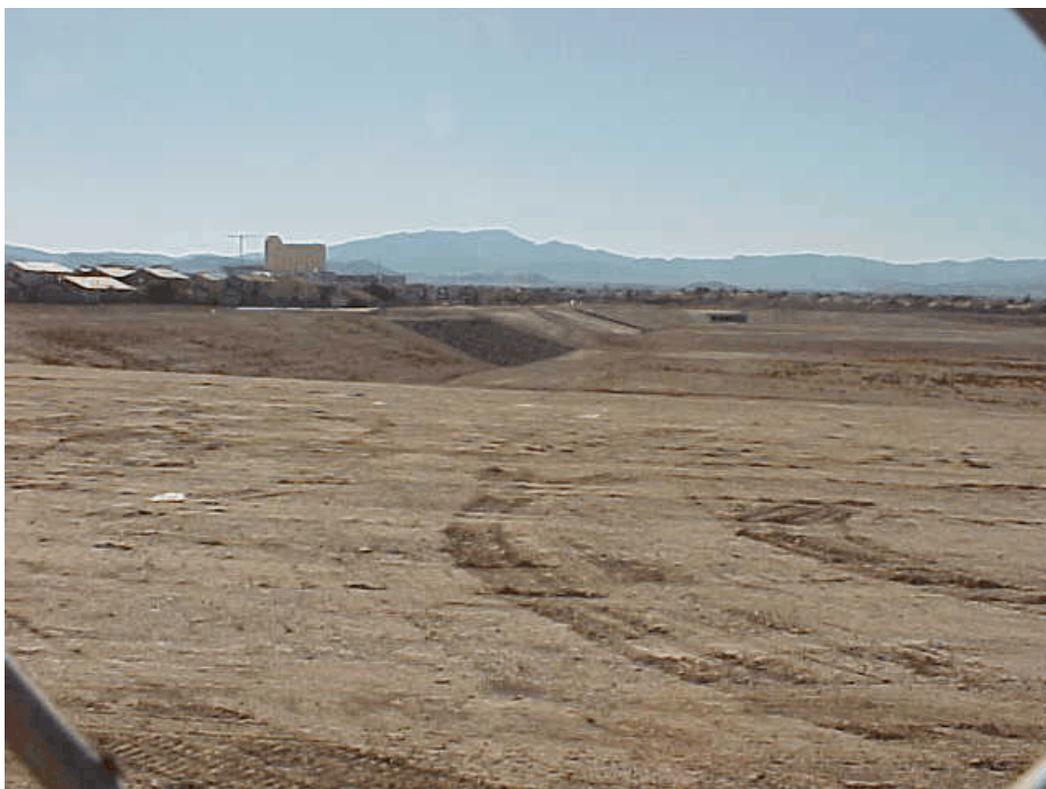
Photo 2. Southwest view of the detention basin from the east fence.

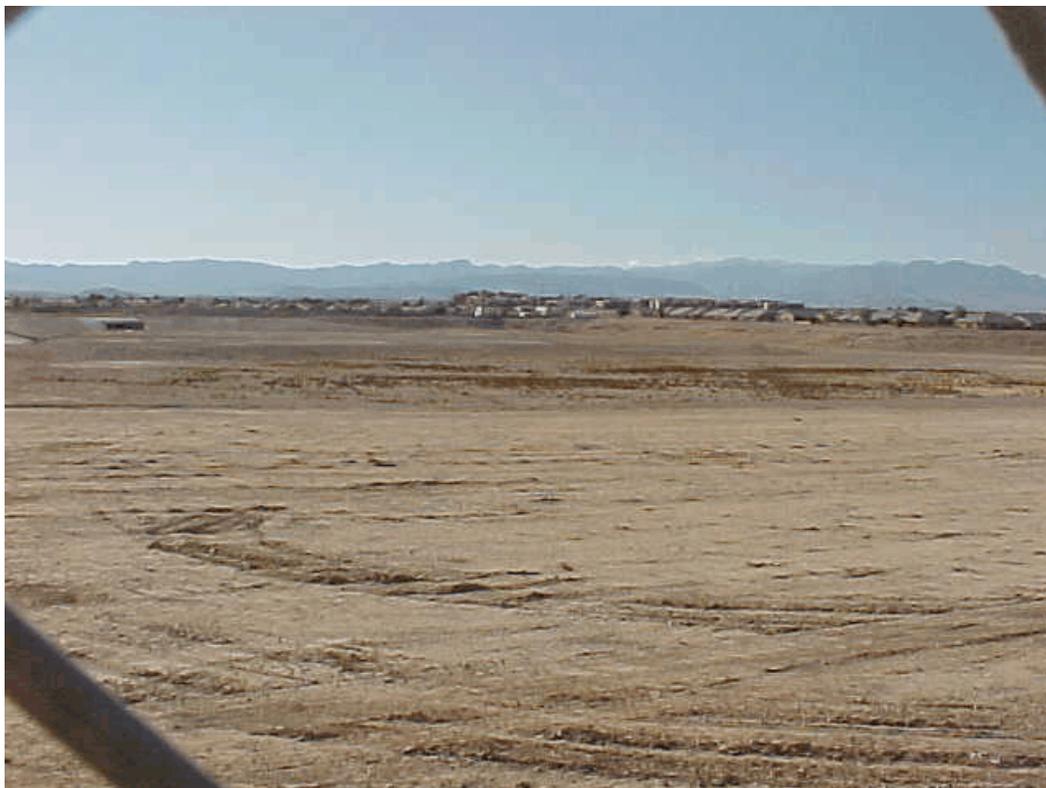
Photo 3. West view of the detention basin from the east fence.

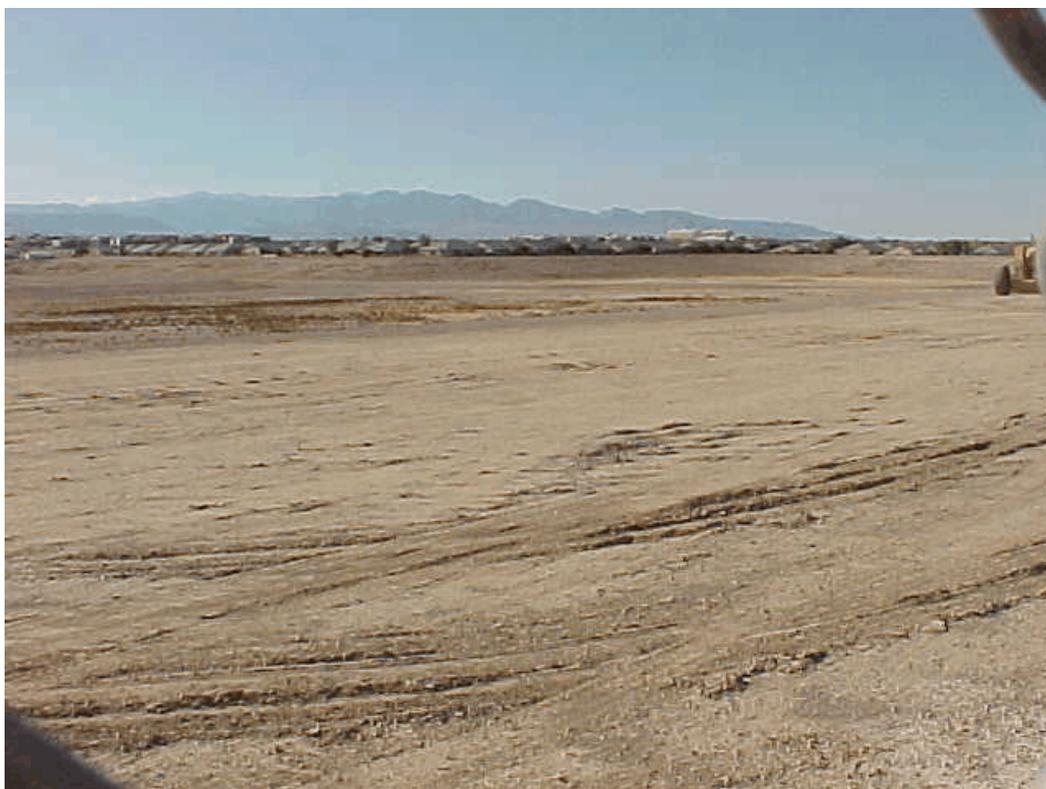
Photo 4. Northwest view of the detention basin from the east fence.

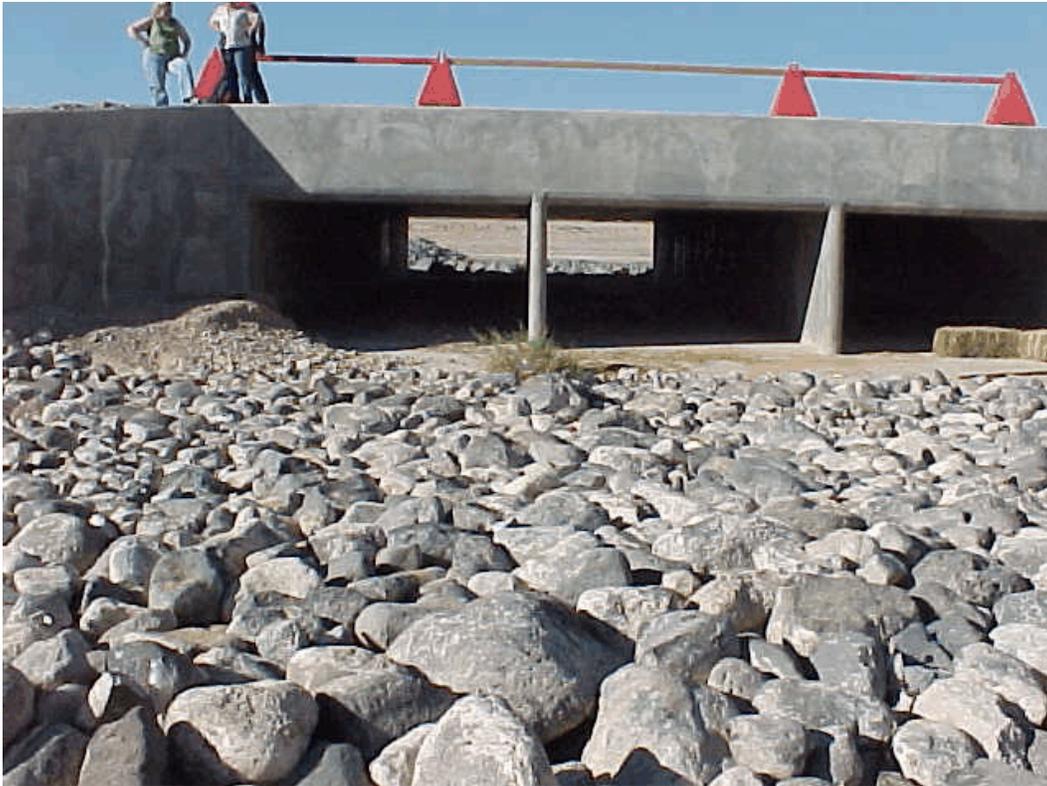
Photo 5. View of the wash passing under the street to the detention basin.

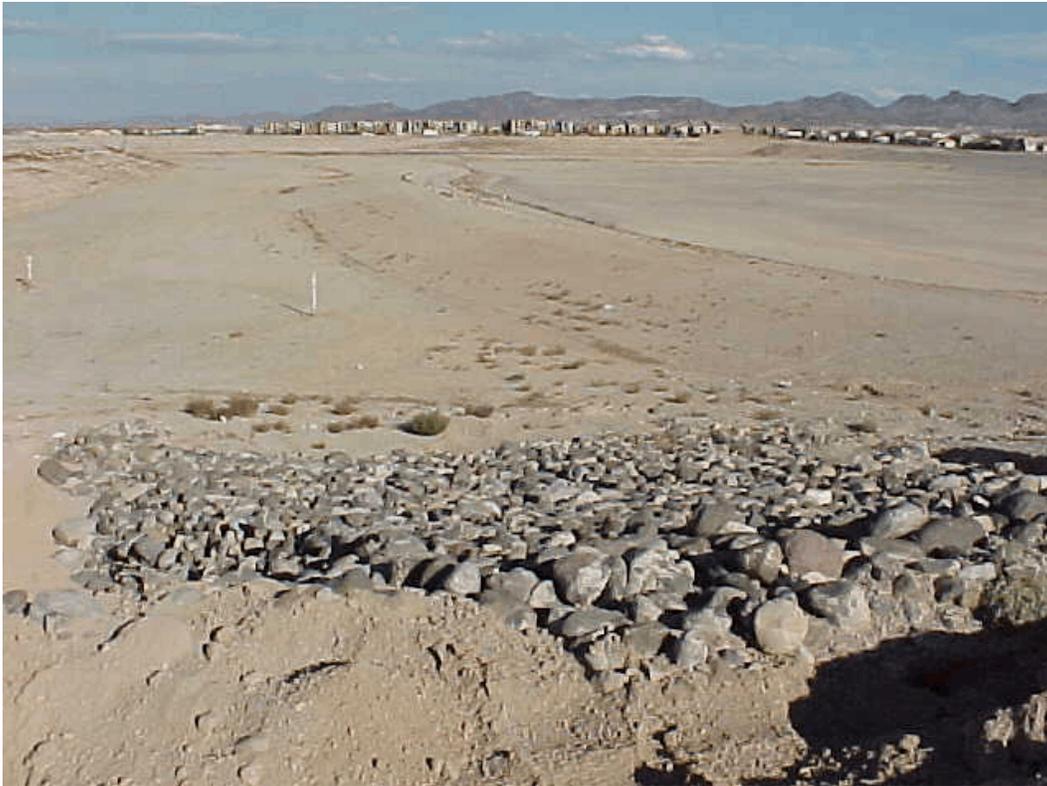
Photo 7. East view of detention basin.

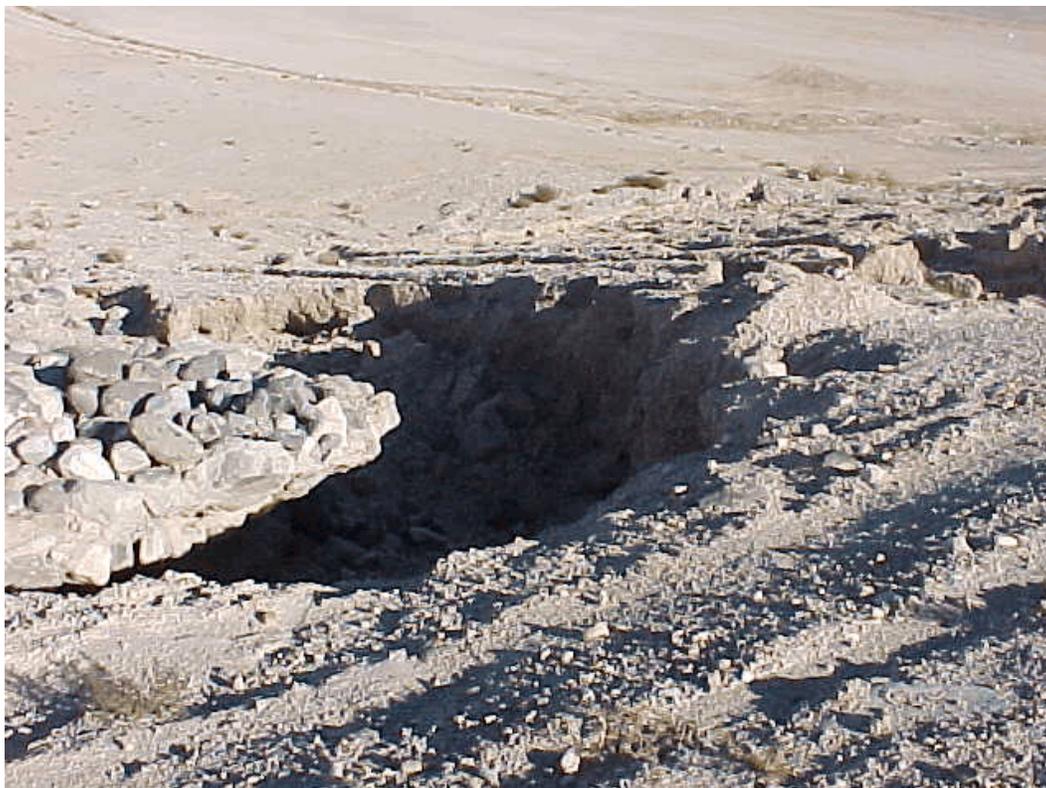
1. Erosion into the detention basin was observed at several locations. Some erosion channels in the west wall of the detention basin were at least four feet deep and six feet wide. Mr. Suckow stated that the erosion in the west wall had occurred several months ago.
2. Utility work was ongoing outside the east fence of the detention basin. The heavy equipment was parked inside a locked gate to the detention basin area. Mr. Suckow was unaware of the ongoing work.
3. An approximately 36-inch pipe for storm water discharge to the detention basin had recently been installed at the northwest corner of the detention basin. The pipe appeared to have been installed by the developer of an adjacent subdivision. Mr. Suckow was unaware of the installation.

1. Clark County is not actively repairing erosion into the detention basin and has not implemented Best Management Practices (BMPs) such as stabilization and/or riprap of the basin walls. Loose soils eroded into the basin will potentially be carried by storm water to the Duck Creek Channel when a rain event occurs.

Photo 8. Erosion on west wall of detention basin.

Photo 9. Erosion on west wall of detention basin.

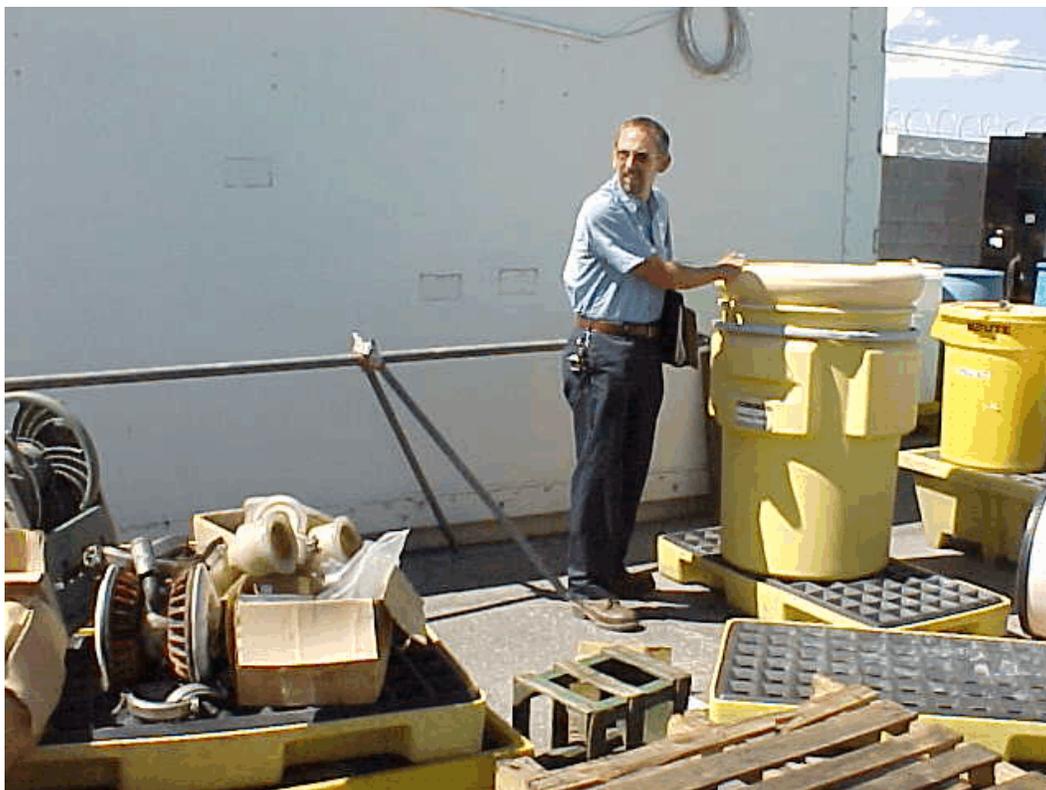
Photo 1. Mr. Palsgrove inspecting containers located on containment in the used equipment storage area.

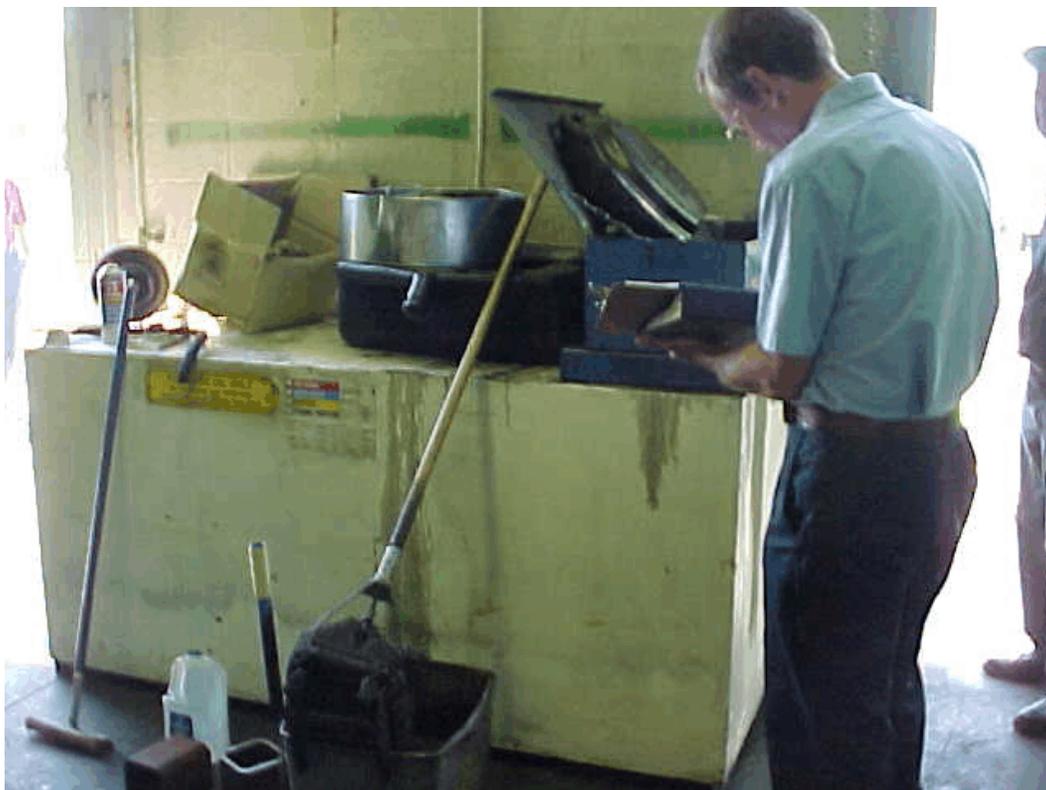
Photo 2. Mr. Palsgrove inspecting used oil containment tank.

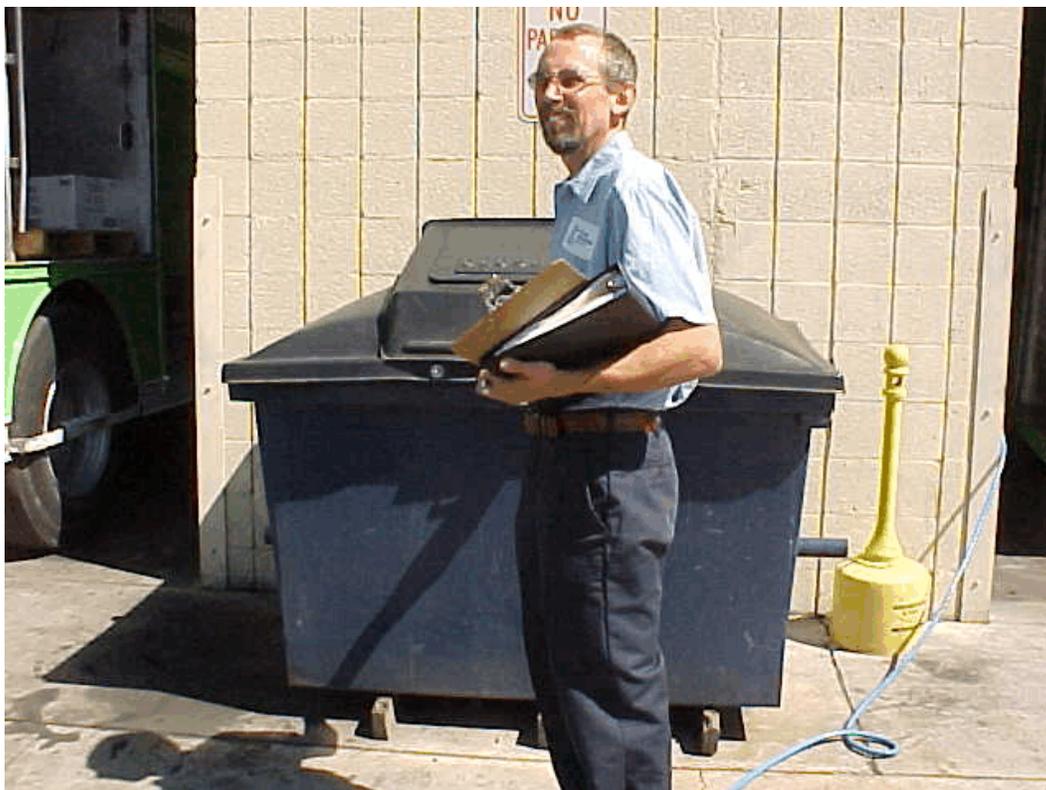
Photo 3. Mr. Palsgrove inspecting used oil filter disposal.
