Appendix A
Storm Water Management Plan: Comments from NDEP and Co-Permittee Response

**Appendix B
Clark County**

**Appendix B.1
Documentation of Findings**

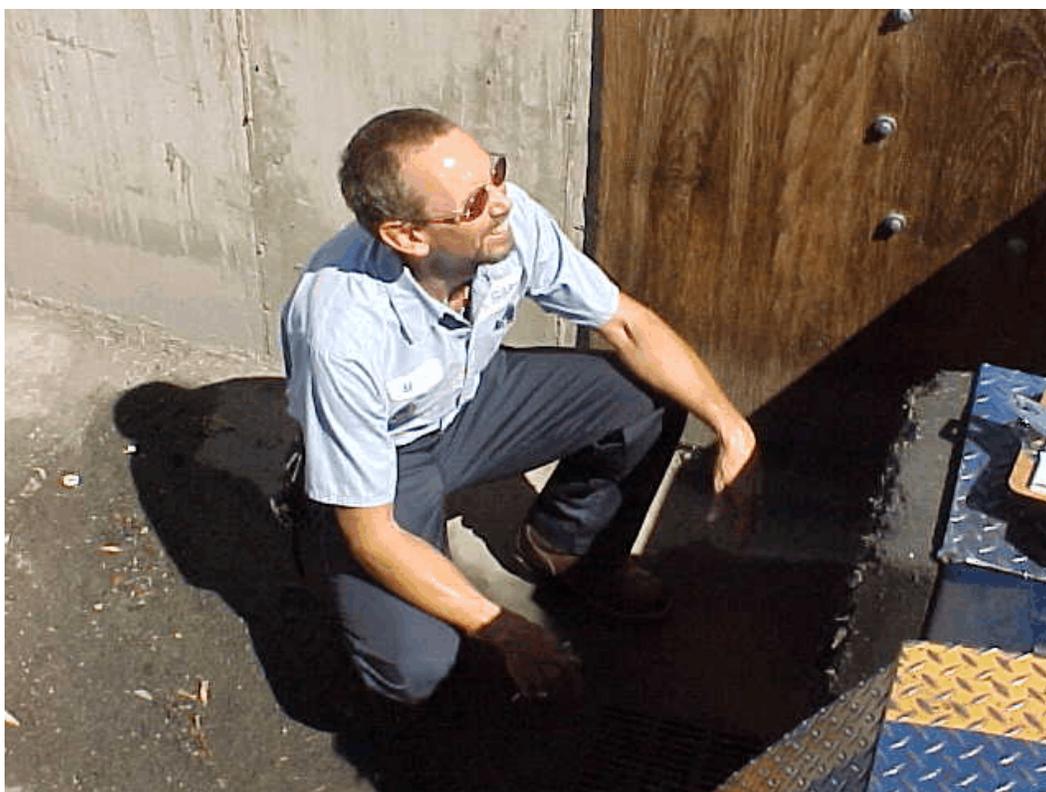
Photo 4. Mr. Palsgrove inspecting loading dock and dead sump for collection of storm water.

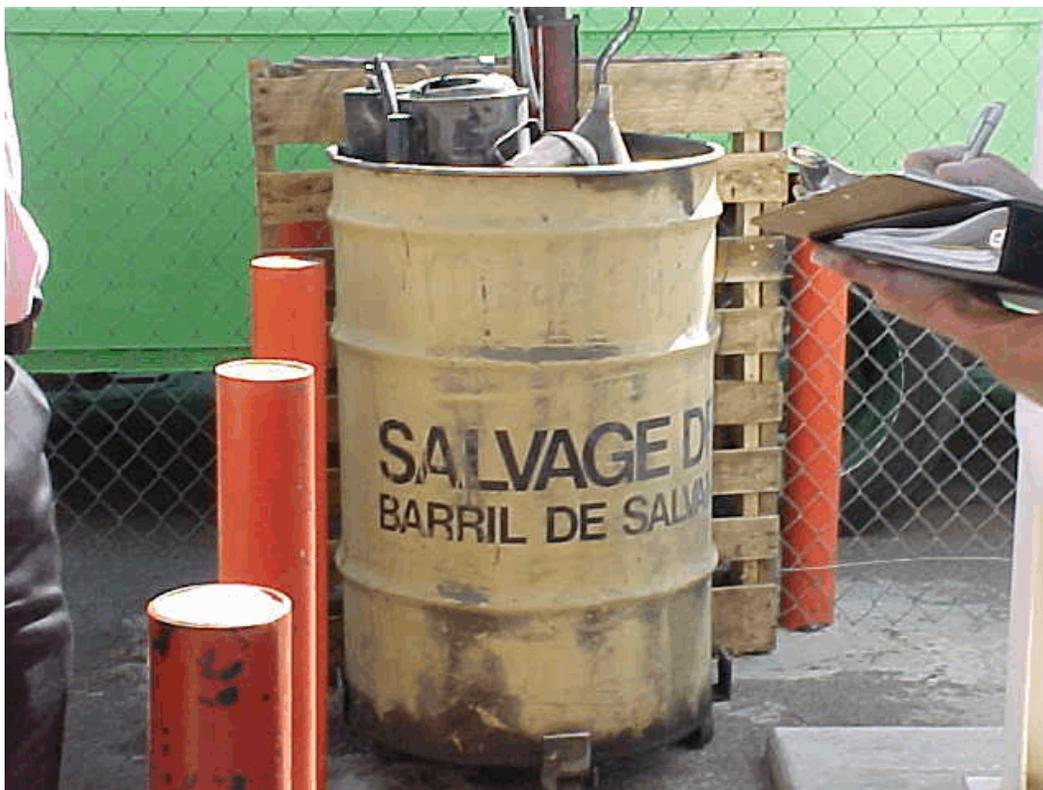
Photo 5. Salvage material drum at propane fueling point.

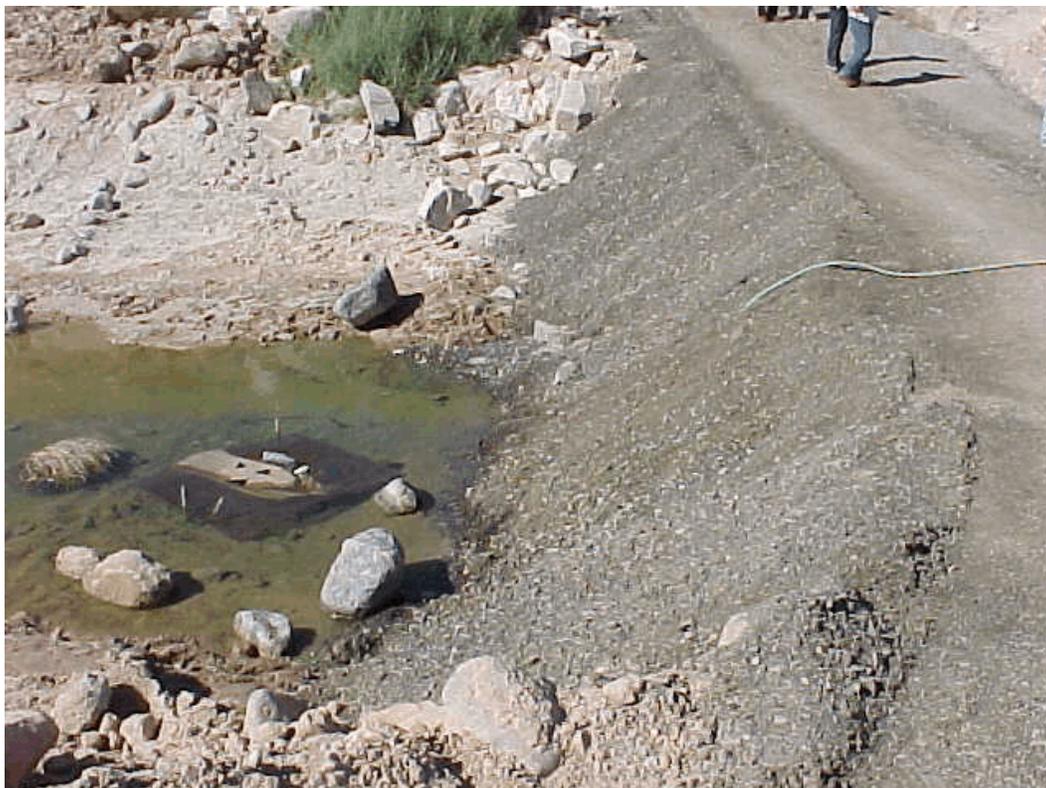
Photo 1. Diversion inlet (photo left) and earthen dam.

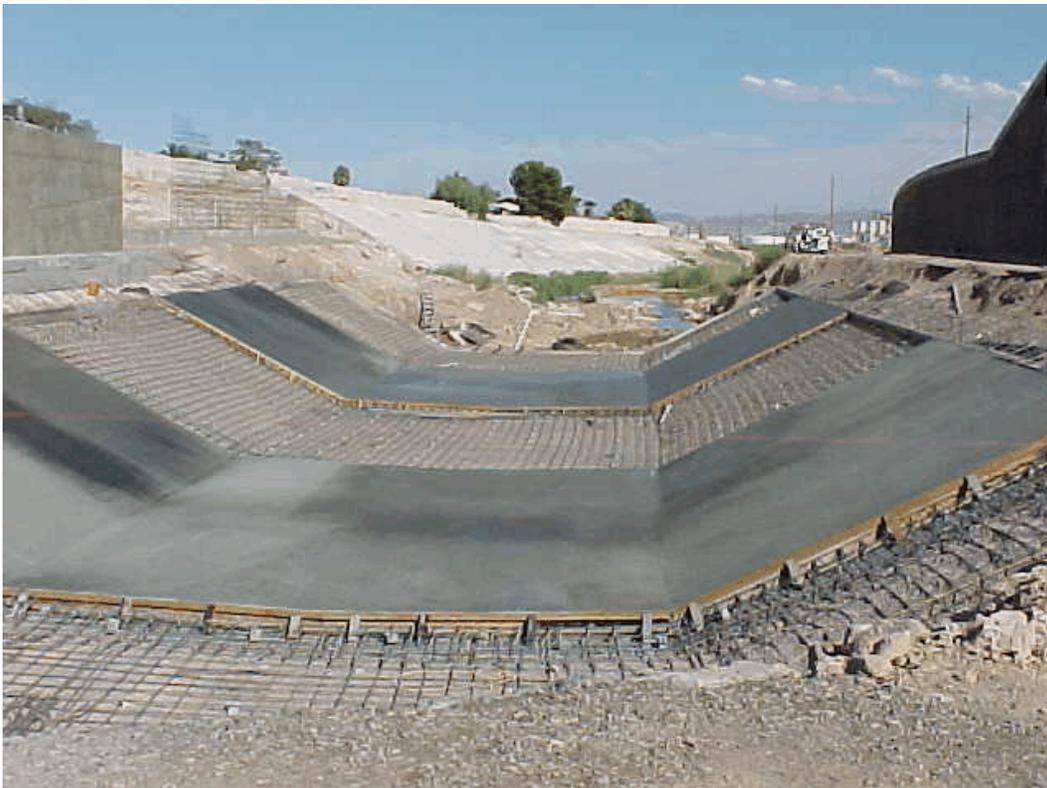
Photo 4. View downstream from earthen dam of Duck Creek Channel (photo center) and retaining walls (photo left and right).

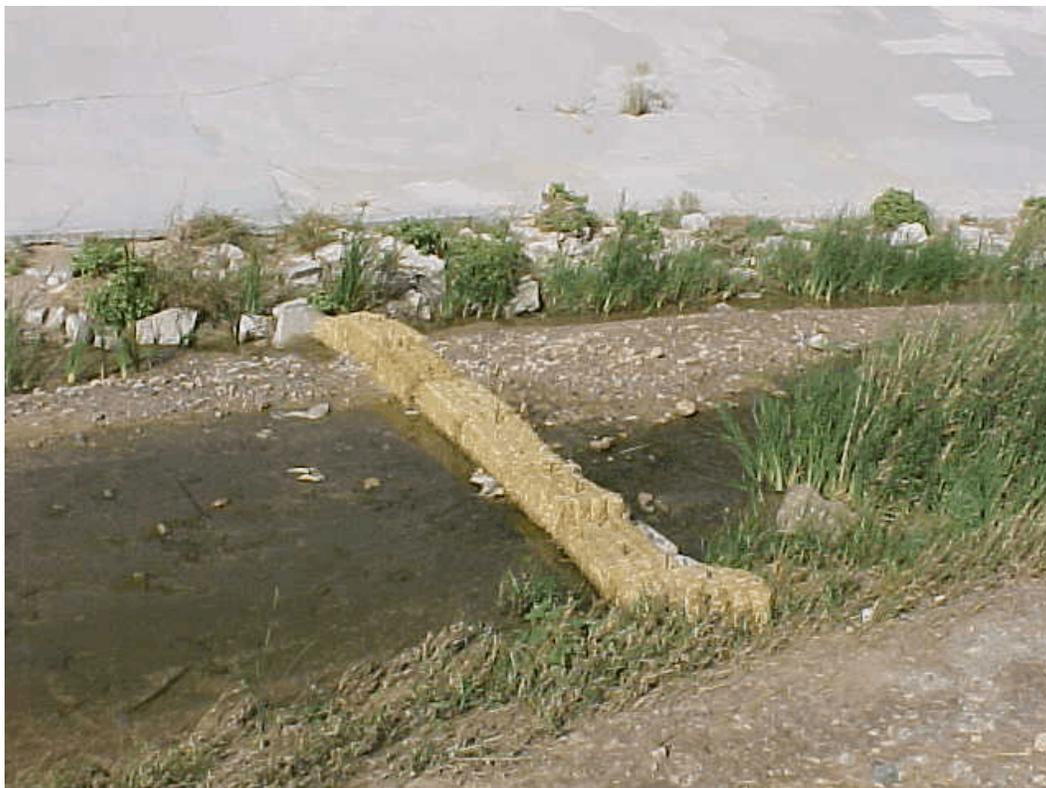
Photo 5. View of straw bale filter in Duck Creek Channel downstream from the construction area.

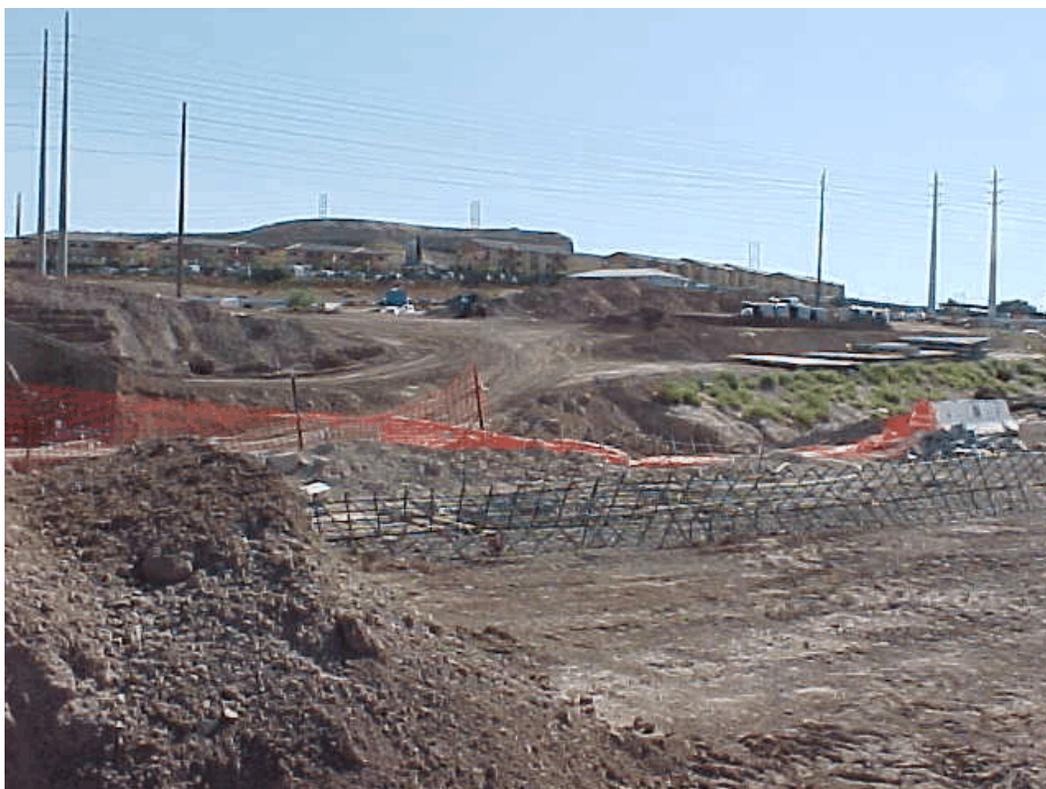
Photo 6. Staging area. Note the soil disturbance and no BMPs.

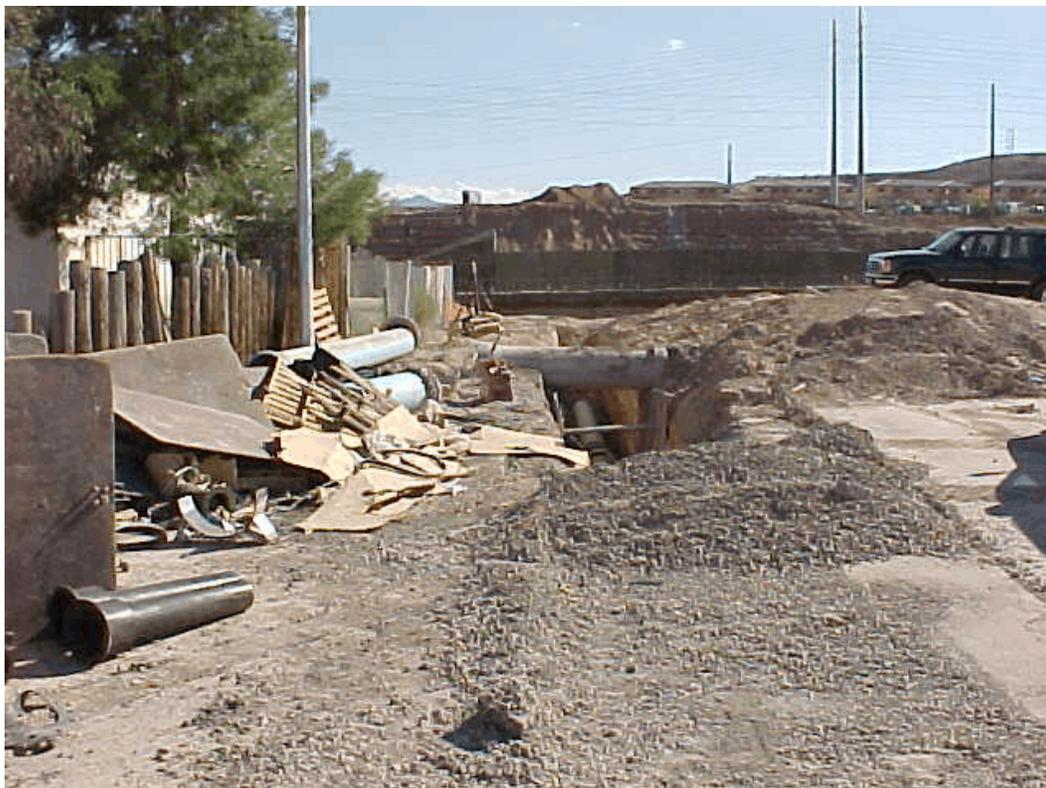
Photo 7. Additional staging area. Note uncontained five-gallon gas can (photo center).

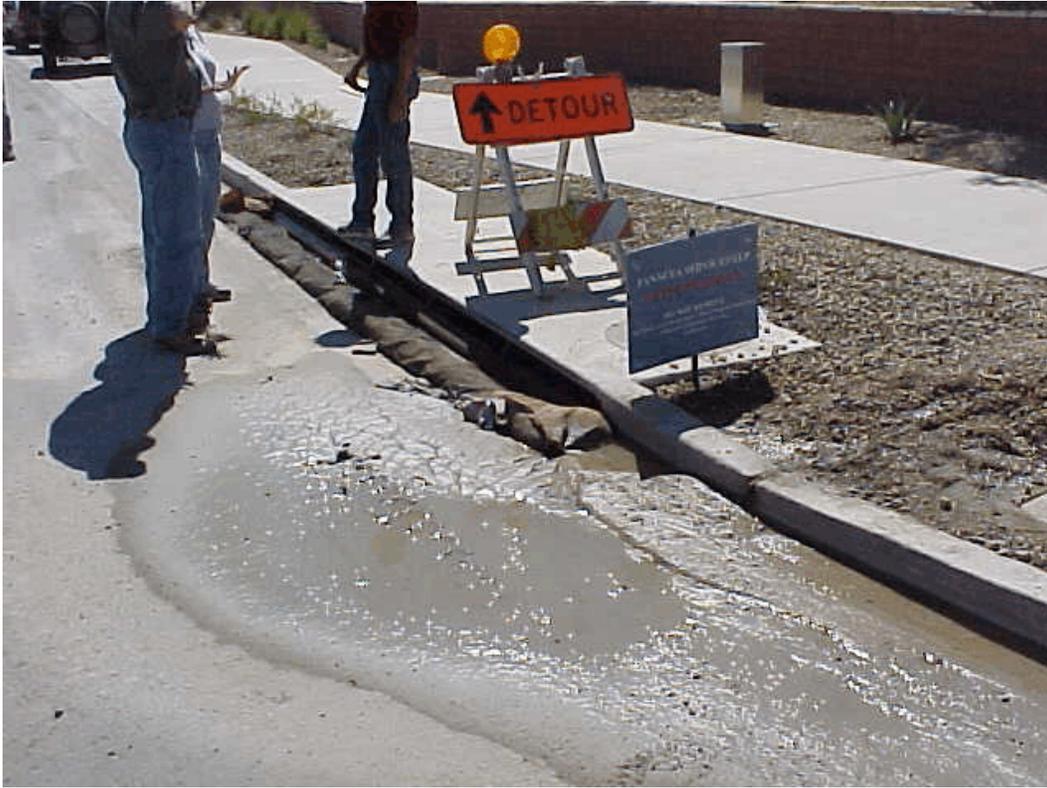
Photo 1. Street inlet protection that is poorly maintained by Landtec LLC.

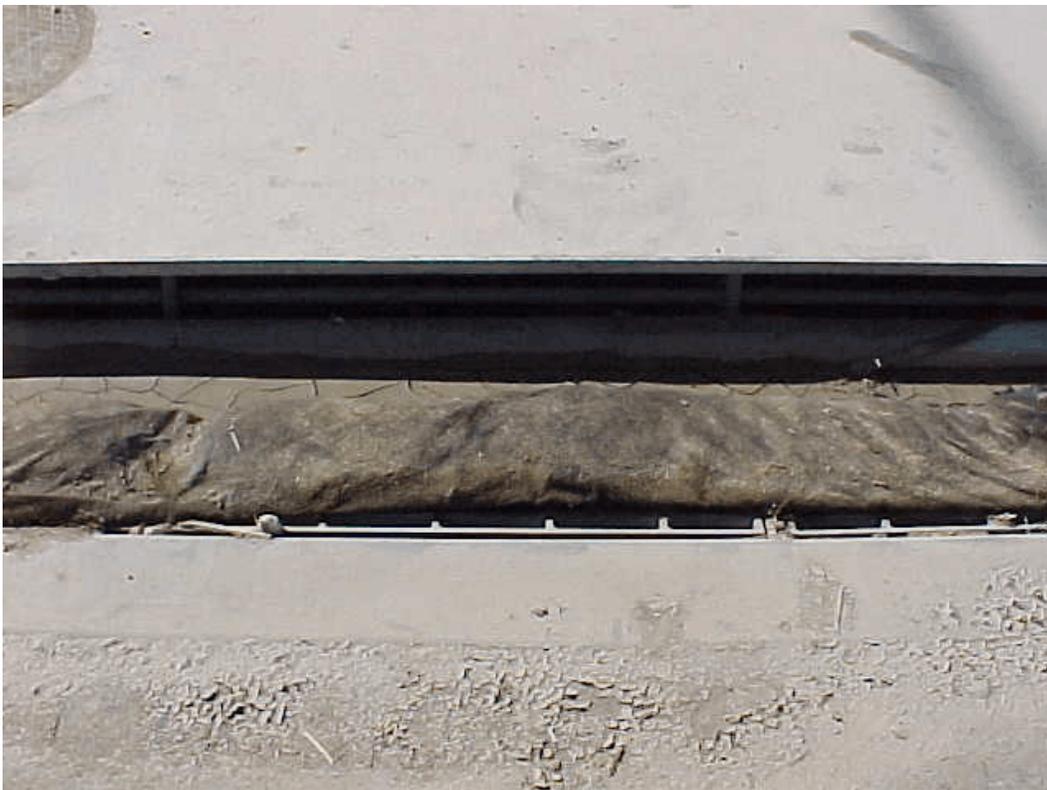
Photo 2. Street inlet protection that is poorly maintained by Landtec LLC.

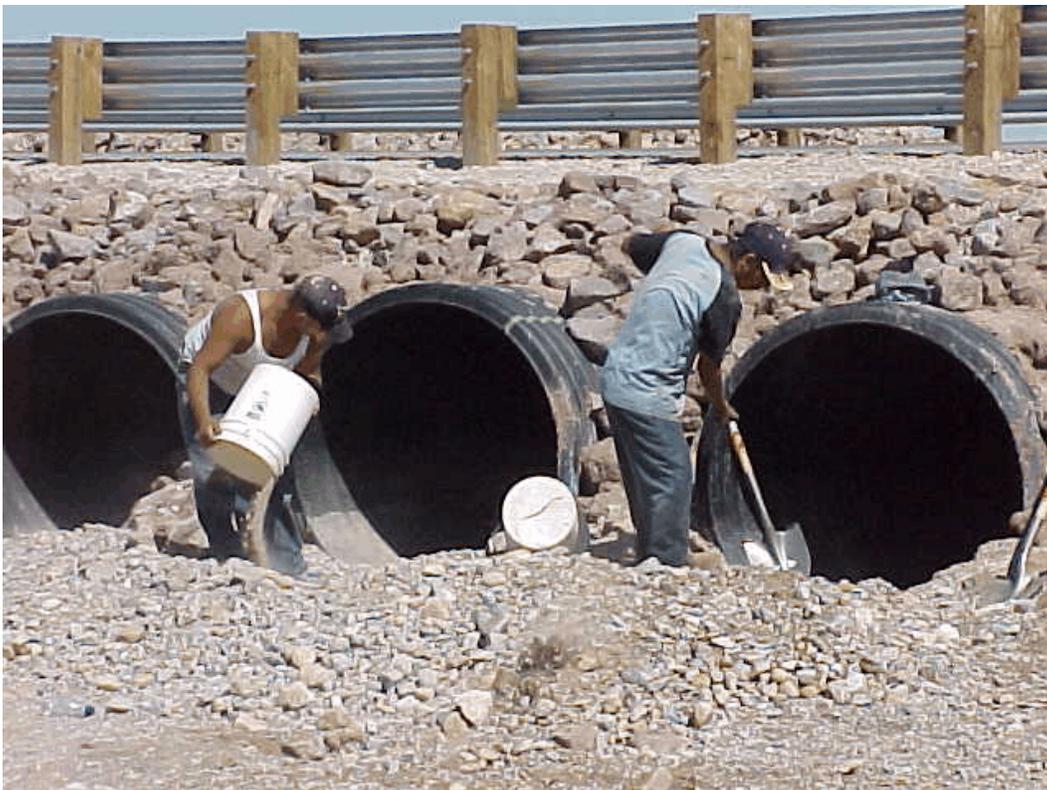
Photo 4. KB Home hand cleaning of culverts in wash.

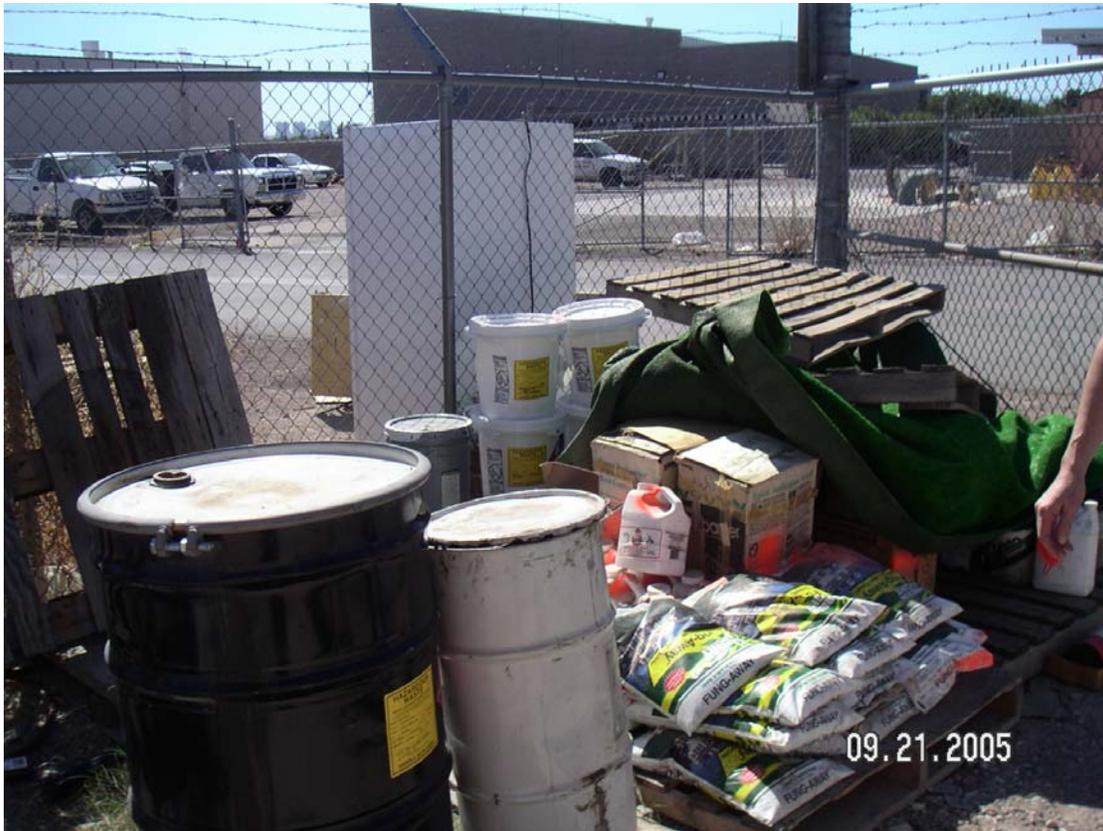
Photo 3. Waste materials abandoned by Parks Department.

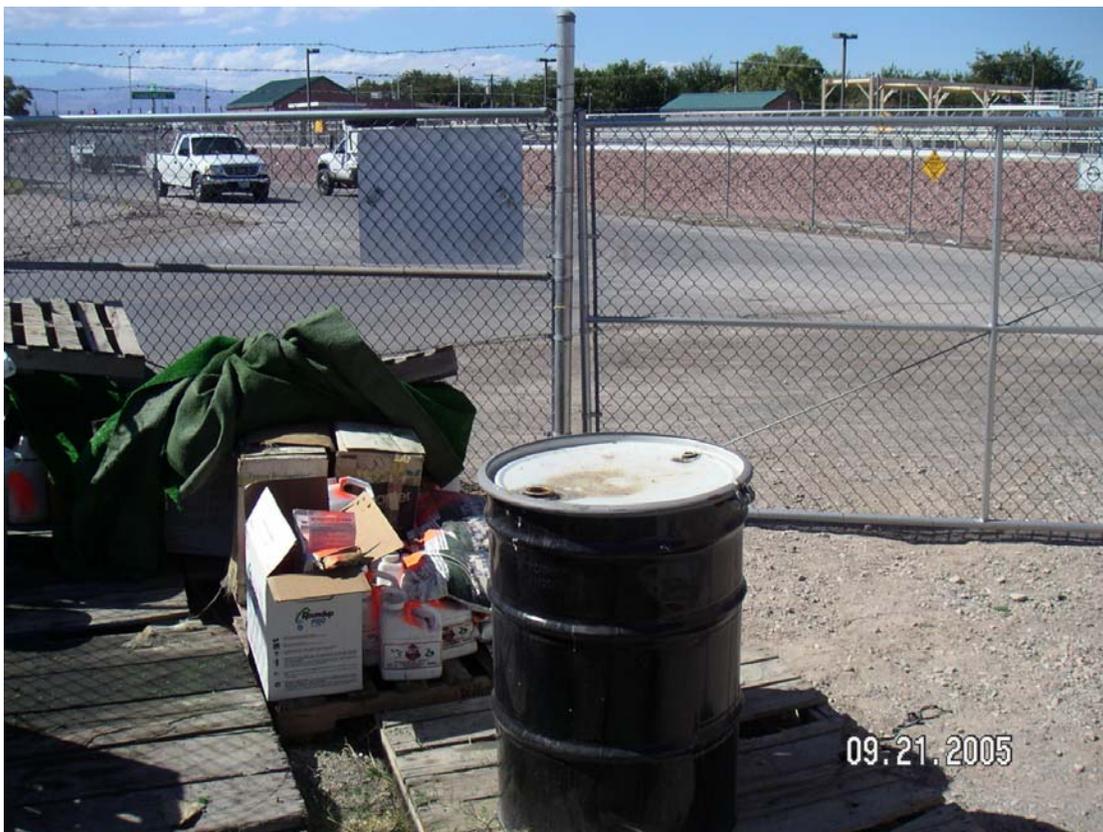
Photo 4. Waste materials abandoned by Parks Department.

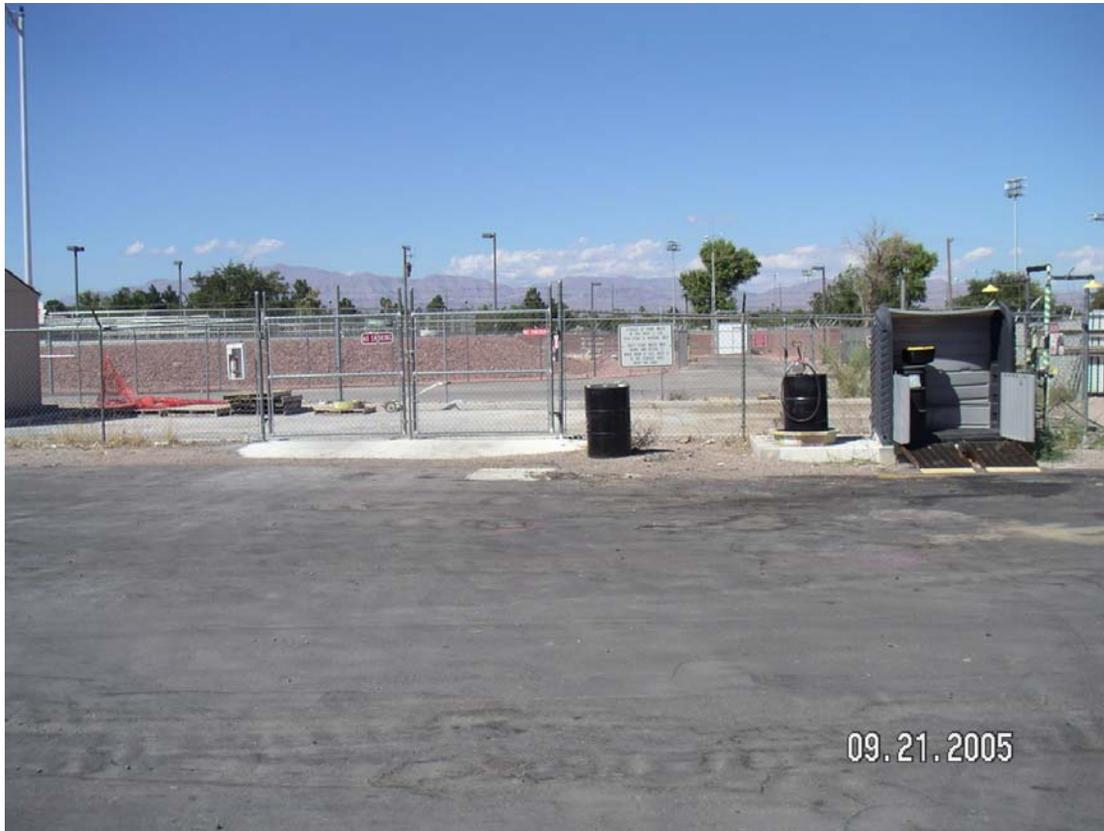
1. The filter fabric over the storm drain grate should be checked more often than twice per year. There are piles of sand, gravel, and soil nearby, and the filter fabric is the only barrier to storm water that could contain these materials.
2. The gate of the satellite accumulation area was not locked.
3. Acid appeared to have leaked from exposed and uncontained used batteries onto the concrete surface and thence to the MS4.
4. During rain events, oil, grease, and metals could leach from equipment stored in the open.
5. An NOI should be submitted under the current MS4 permit.

Photo 5. Satellite accumulation area.

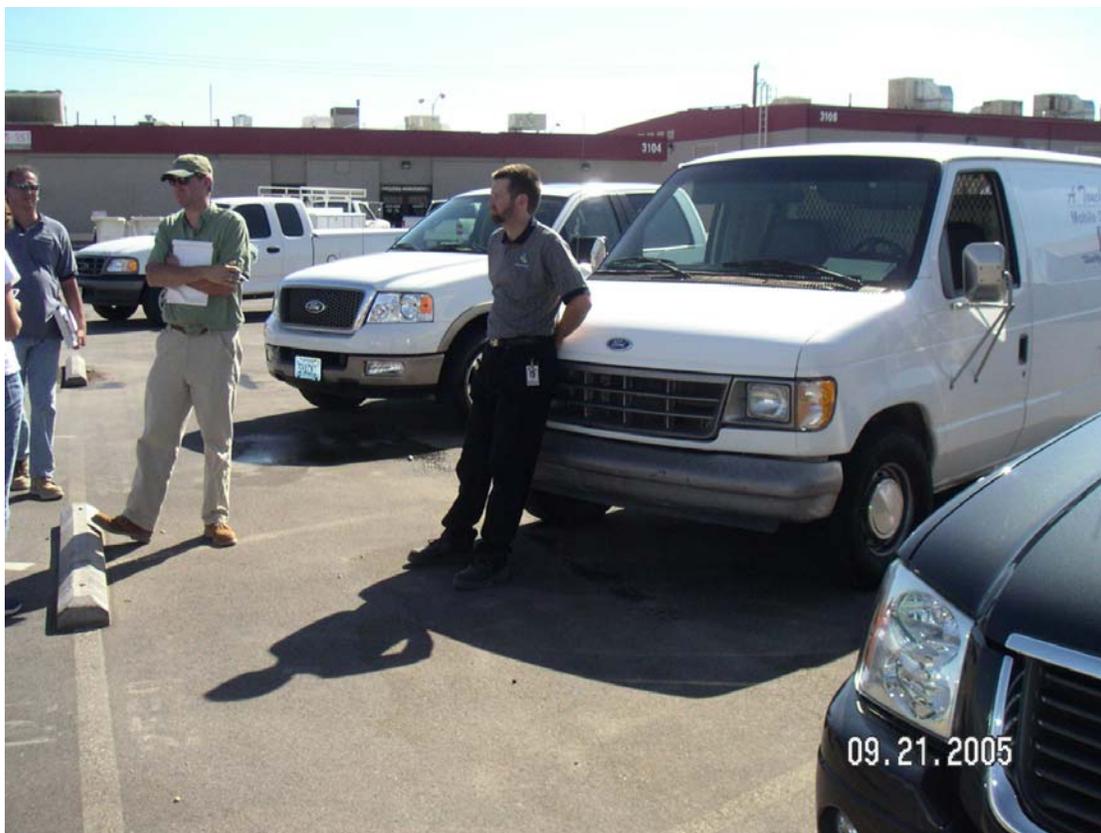
Photo 9. Mobile car wash in parking lot of East Yard.

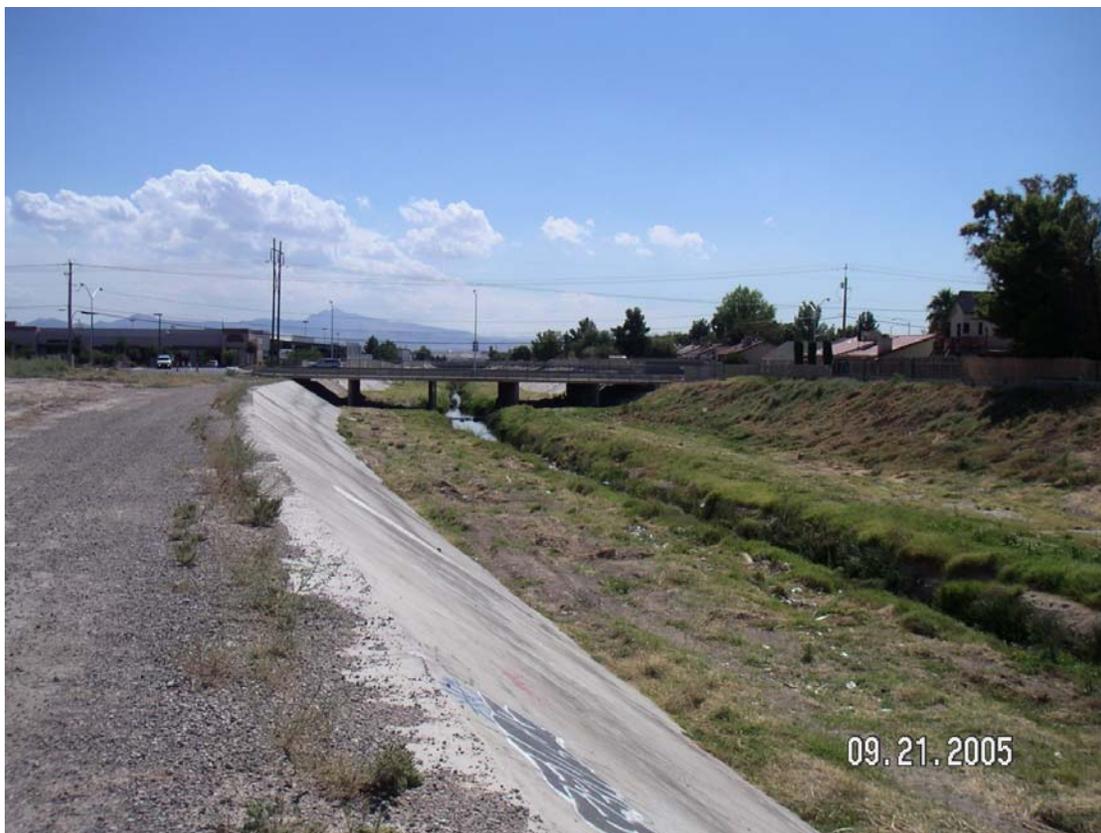
Photo 3. View of Las Vegas Wash near intersection of Stewart Avenue and Nellis Boulevard.

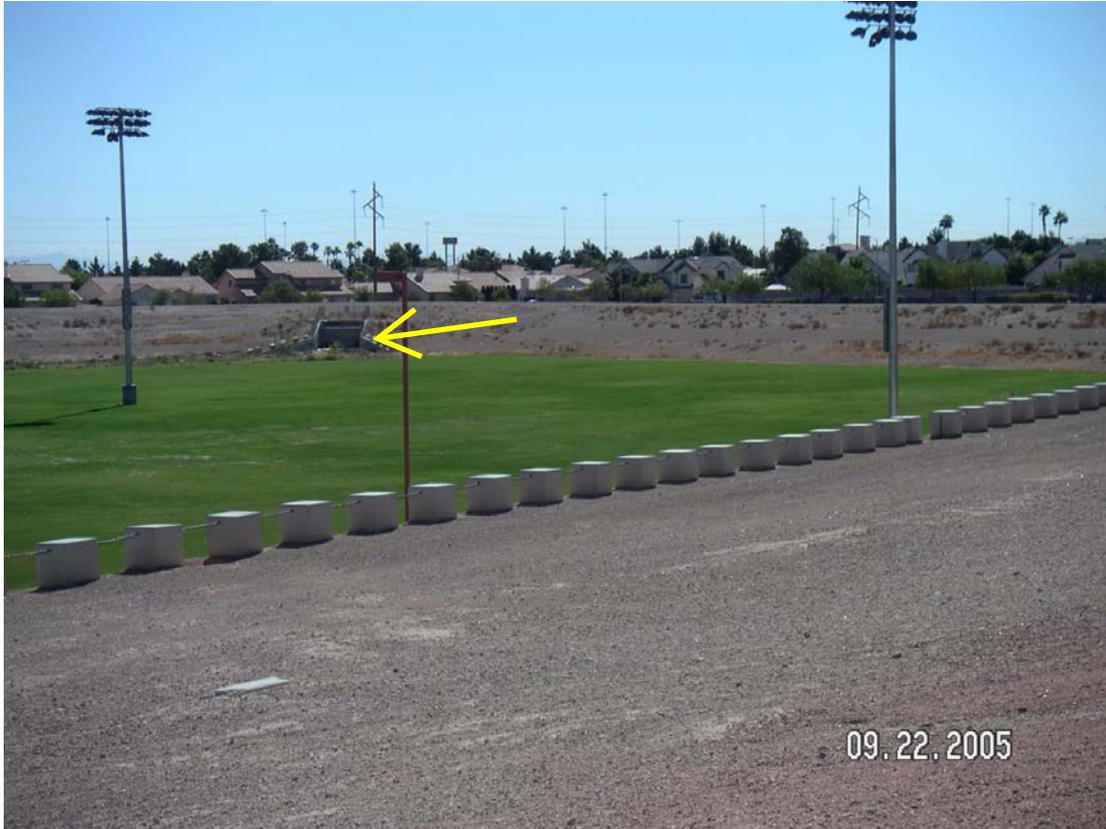
Trash cans left in Gowan Detention Basin could contribute to the pollutants leaving the MS4. Fertilizers applied to the field could also contaminate storm water.

Photo 1. Gowan Detention Basin - inlet.

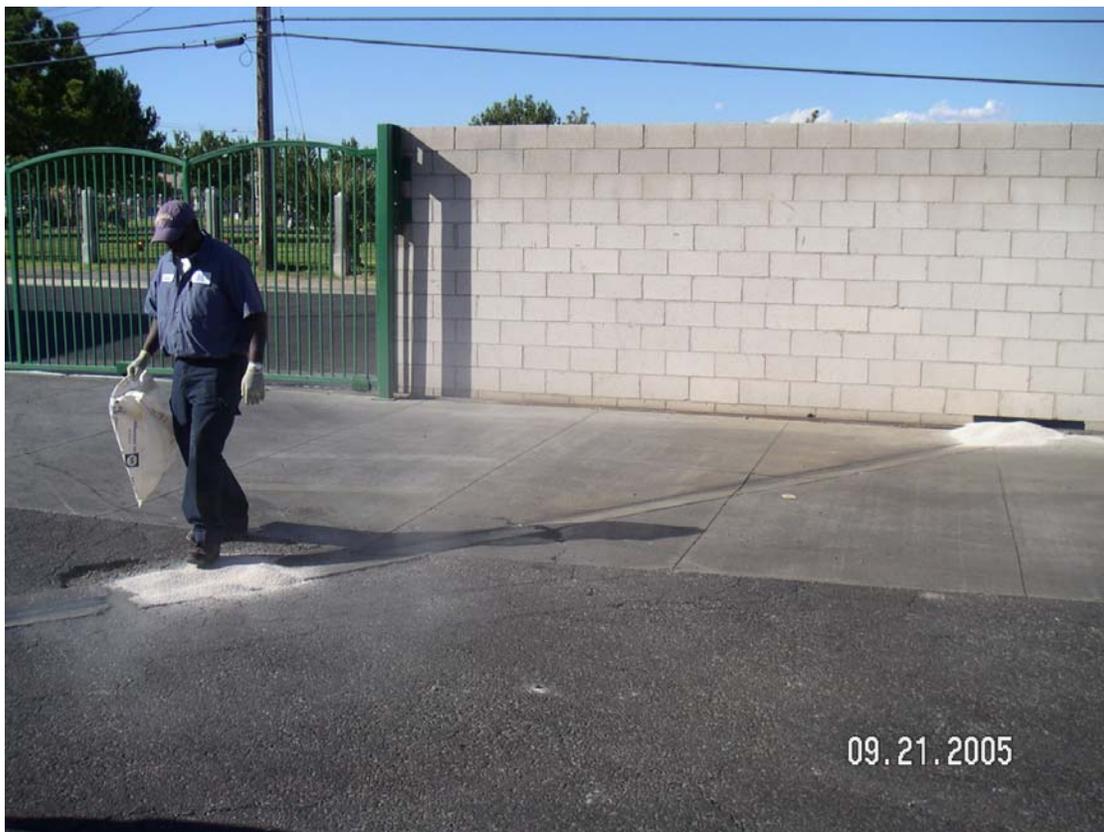
Photo 4. Worker spreading absorbent material.

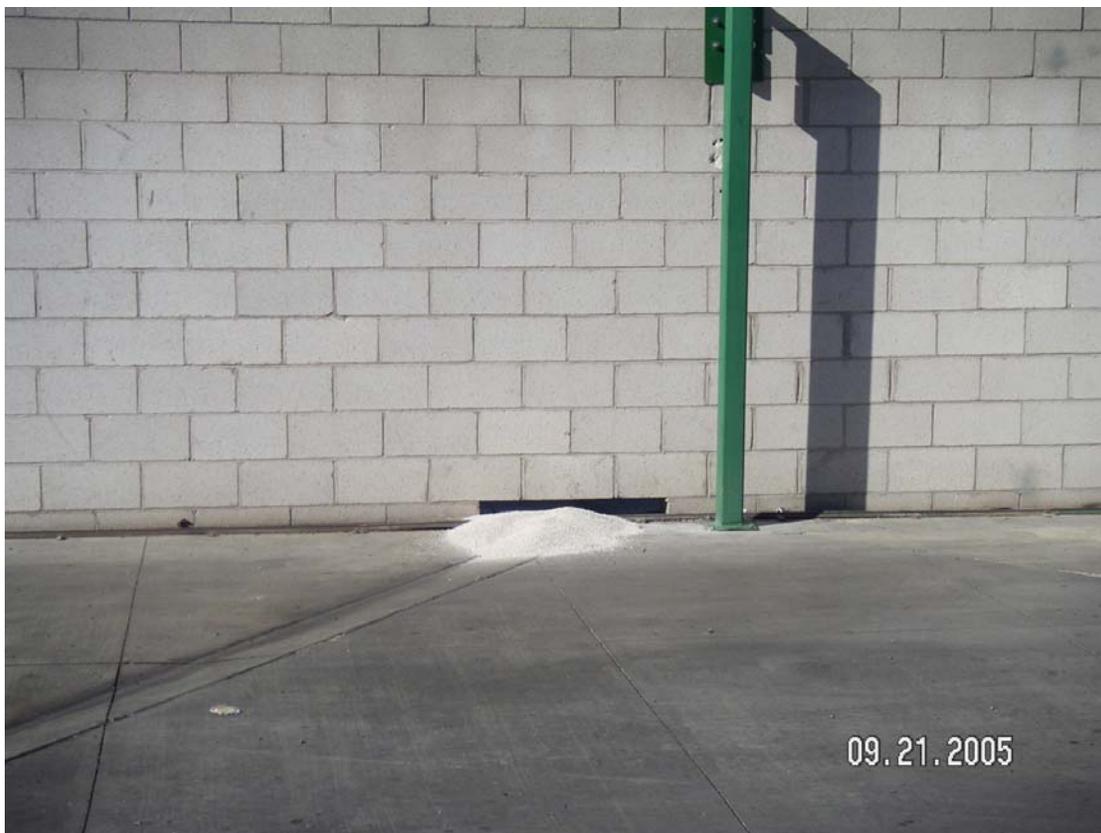
Photo 5. Absorbent material at point of outflow from yard.

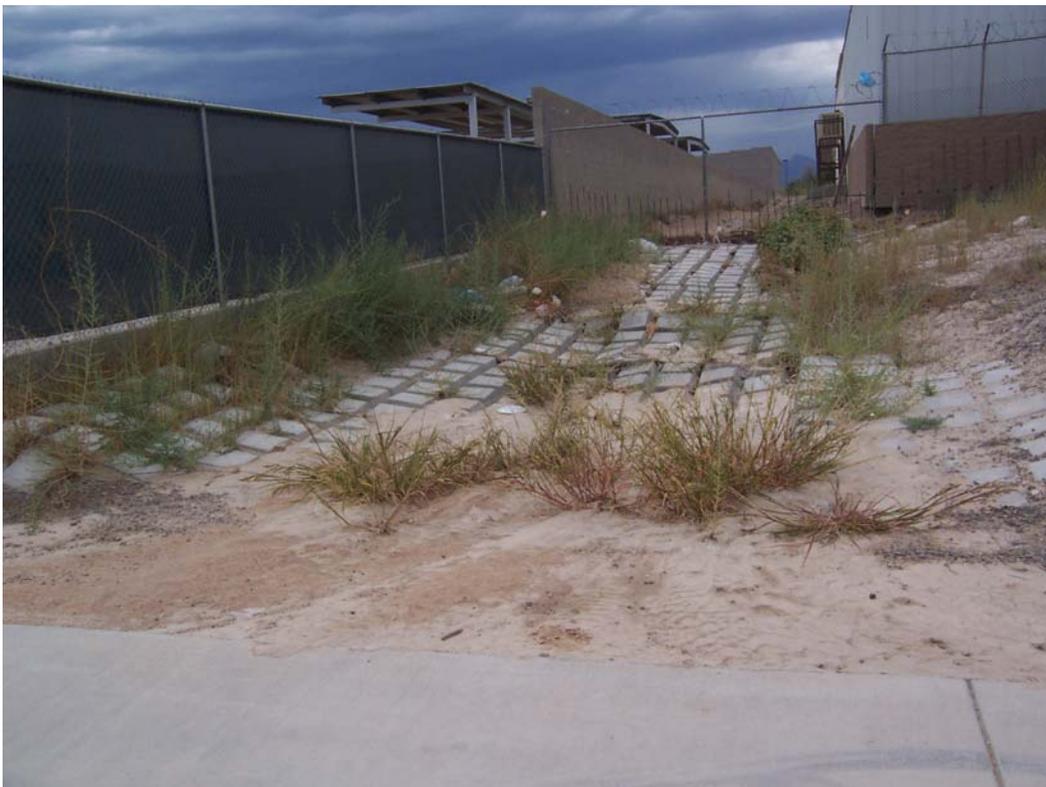
Photo 4. Riprap channel between commercial properties. Note lower end of channel appears to be clogged with sediment.

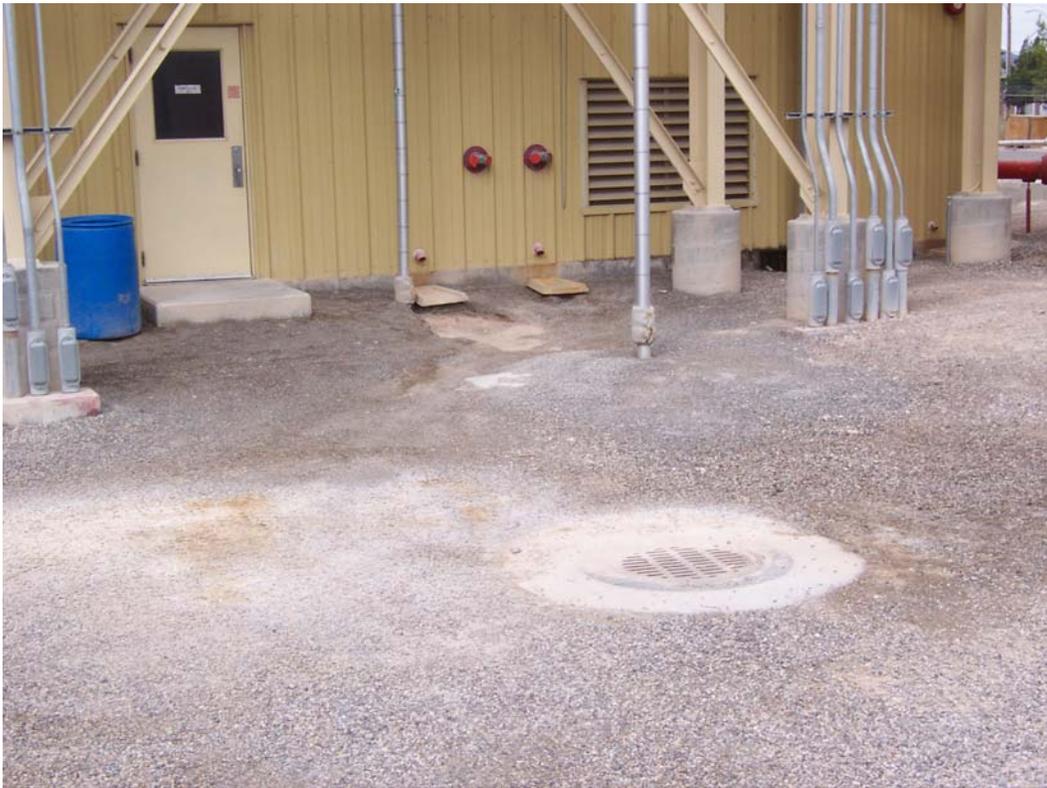
1. Mr. Rura did not note an area next to a building where a roof downspout was causing soil erosion that appeared to be going directly to a yard drain.

Photo 1. Inspector did not note evidence of soil erosion at roof drain discharge (to the right of the doorway) that appeared to be going directly to the area storm inlet.

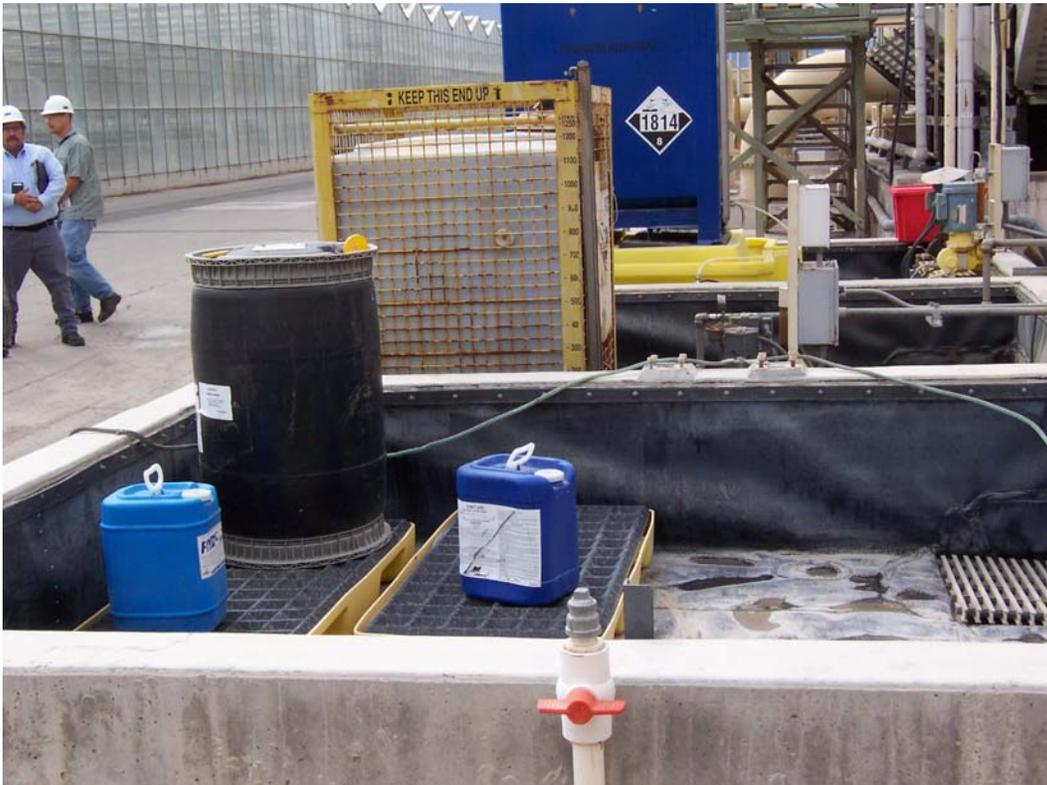
Photo 2. The inspector did note that all containers five gallons or larger have been provided with secondary containment as required by local ordinance.

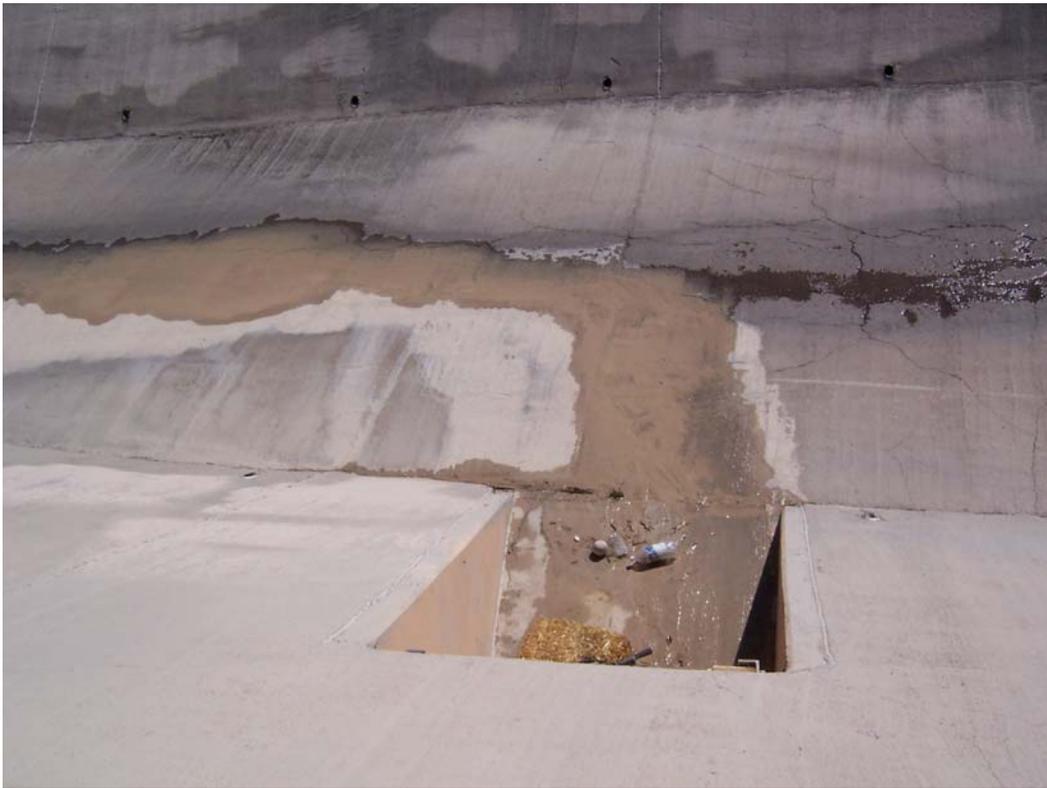
Photo 1. Water and sediment from the construction site entering the wash.

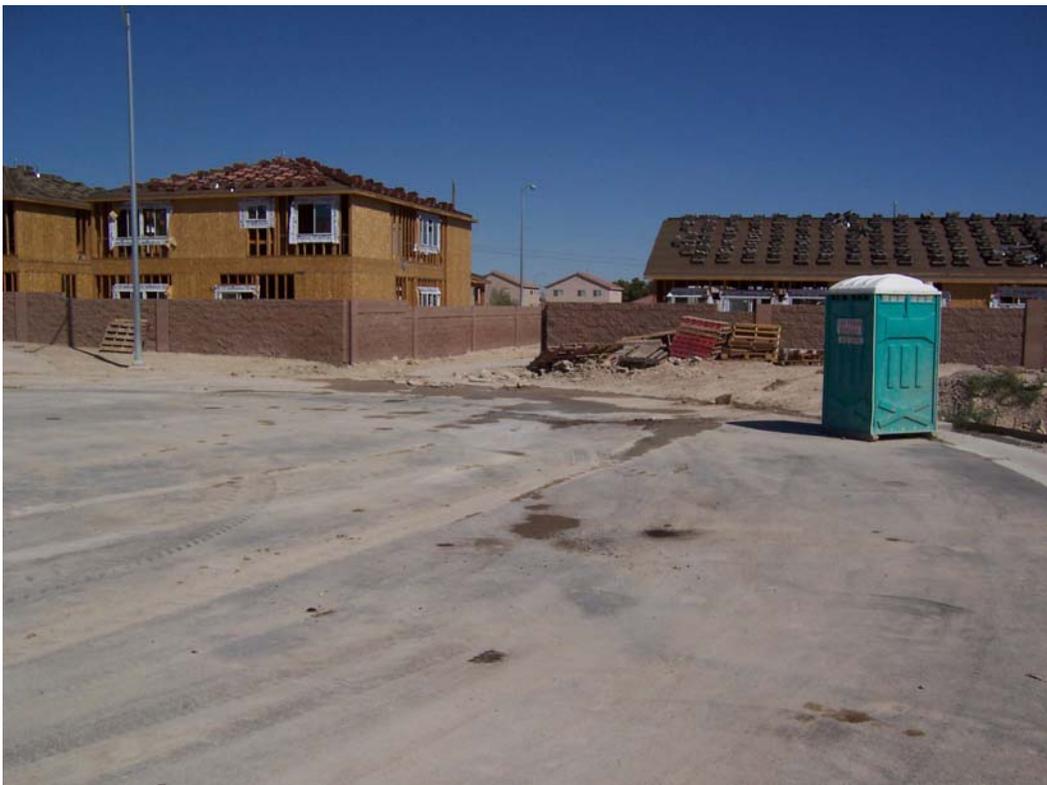
Photo 4. Portable toilet placed where spillage would go directly to storm inlet. Storm inlet is left center photo, at the end of the sidewalk to the cul-de-sac.

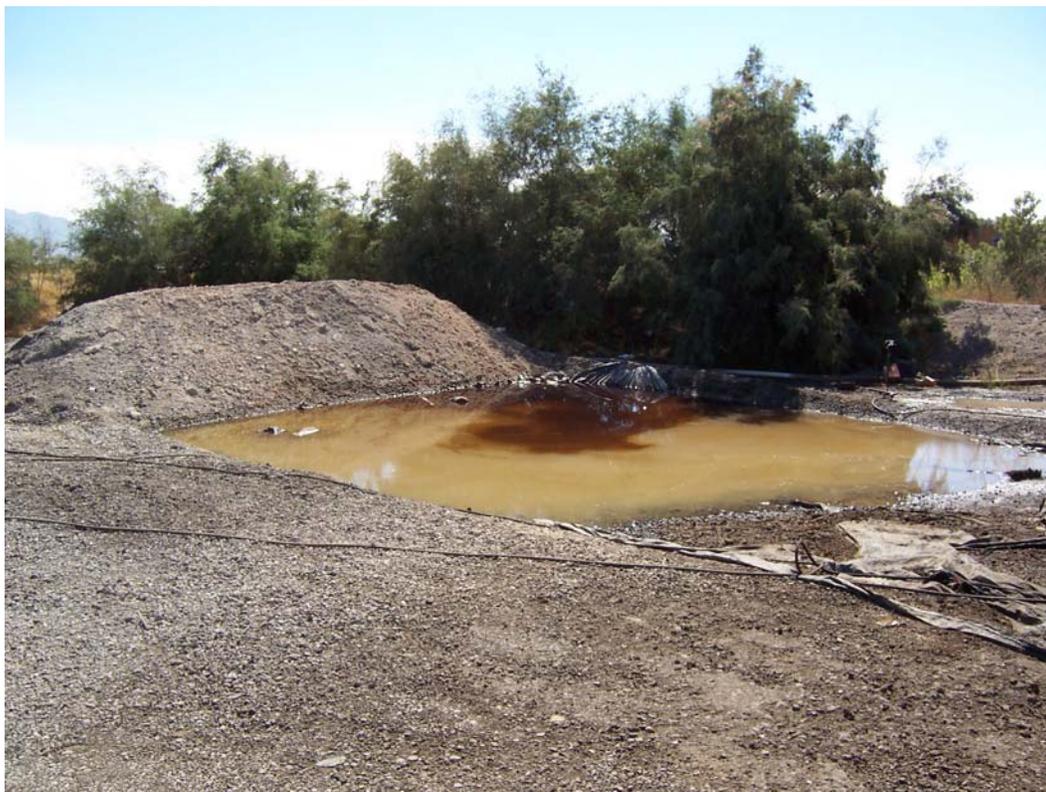
Photo 3. Temporary pit dug to contain wash water from equipment cleaning operation. Note floating oil on the surface of the water.

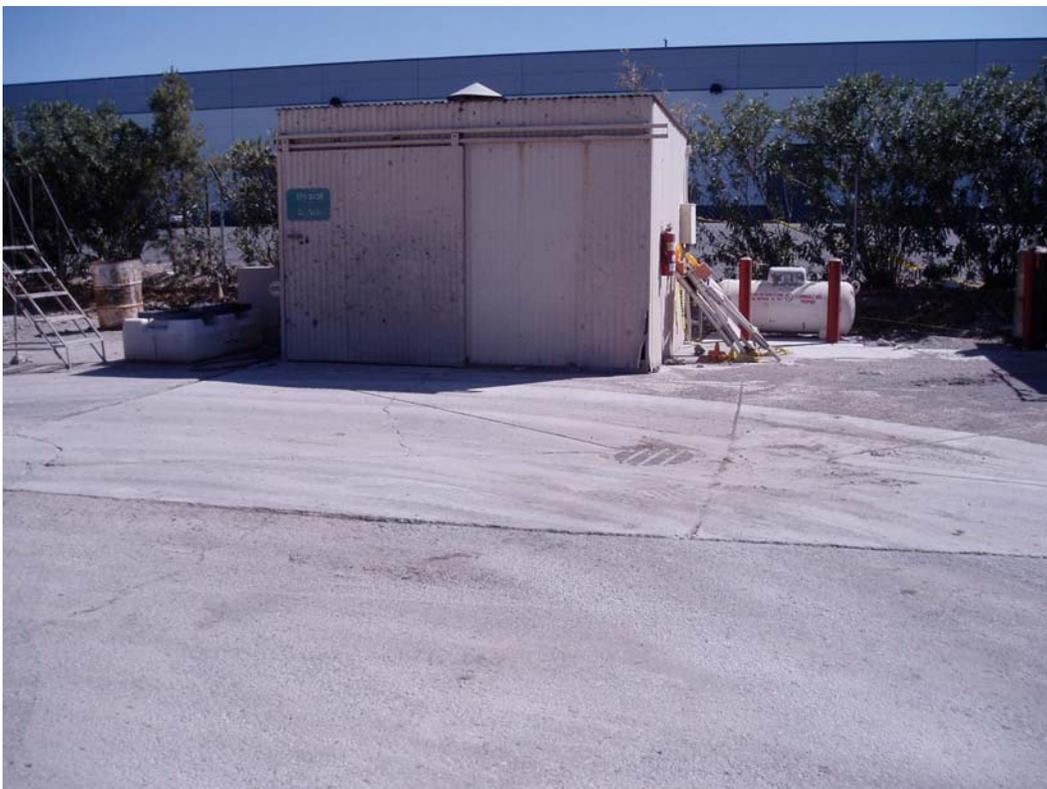
Photo 2. Car wash area. Drain flows to sanitary sewer.

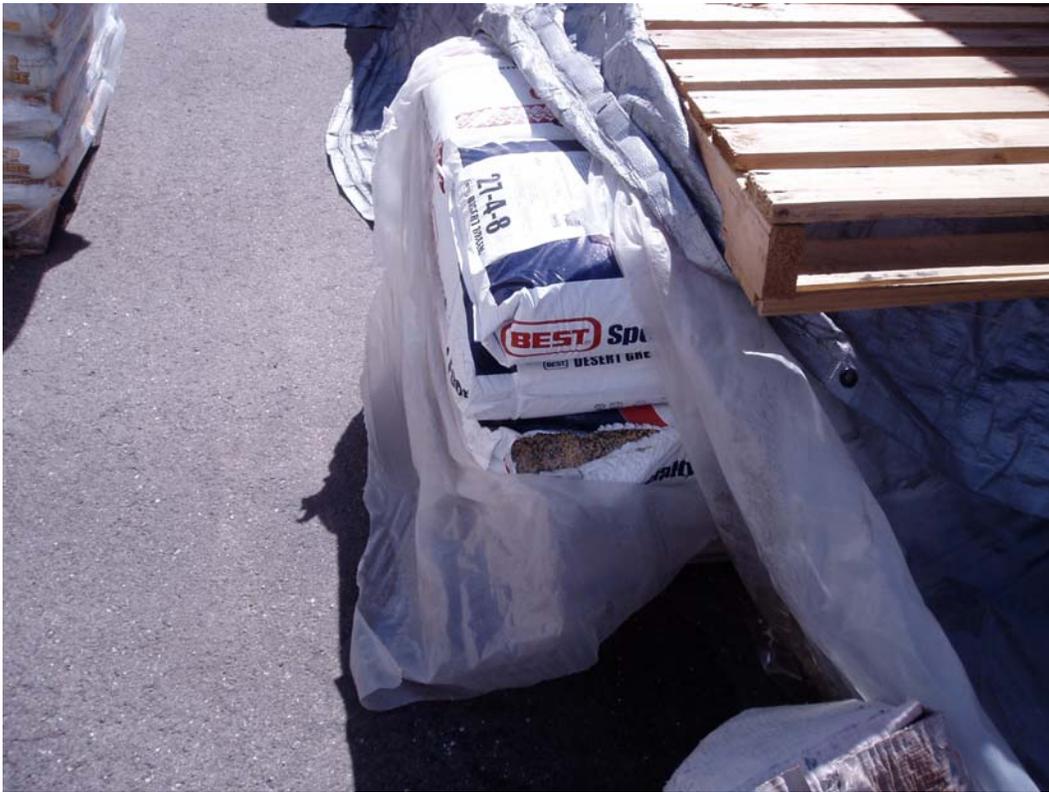
Photo 1. Fertilizer, note tear in package.
