Appendix A
Storm Water Management Plan: Comments from NDEP and Co-Permittee Response

**Appendix B
Clark County**

**Appendix B.1
Documentation of Findings**

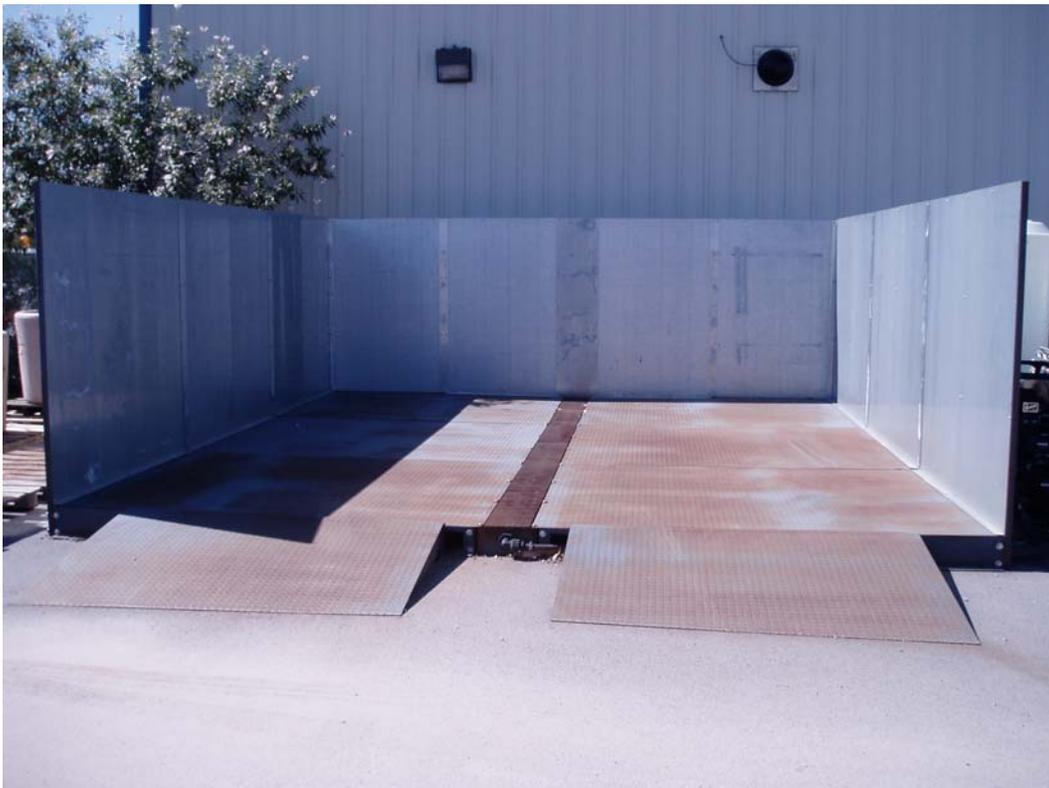
Photo 2. Equipment wash area with water recycling unit.

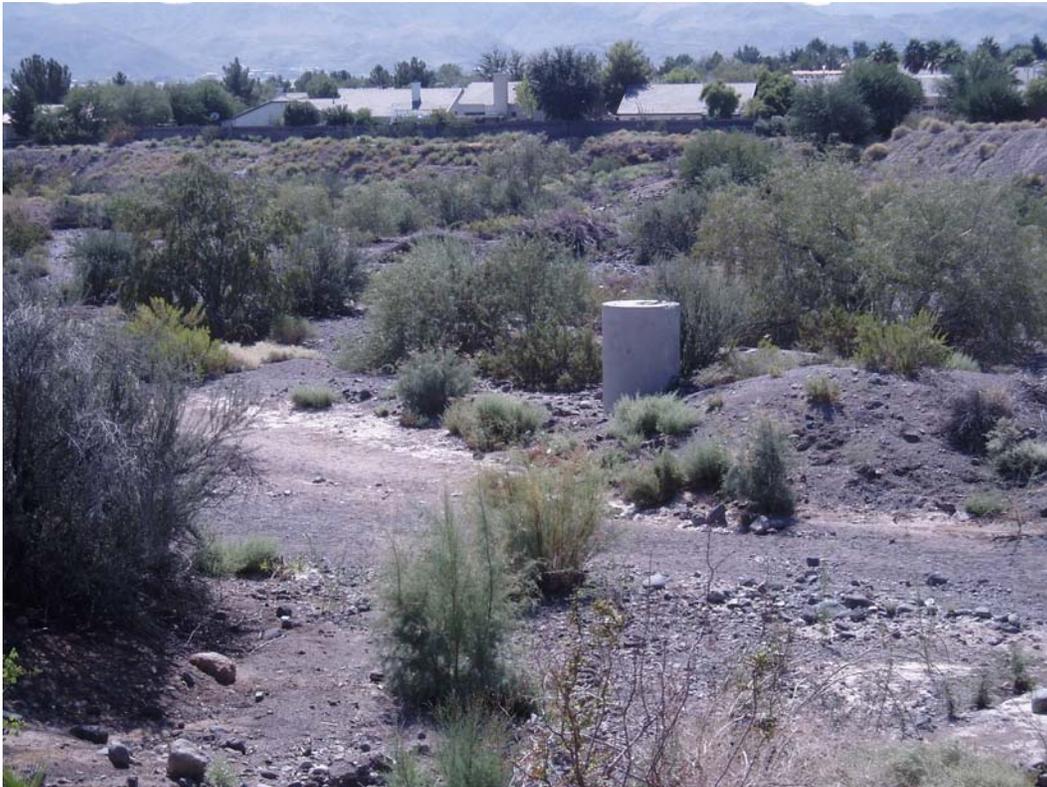
Photo 3. Project Green, elevated manhole in photo center.

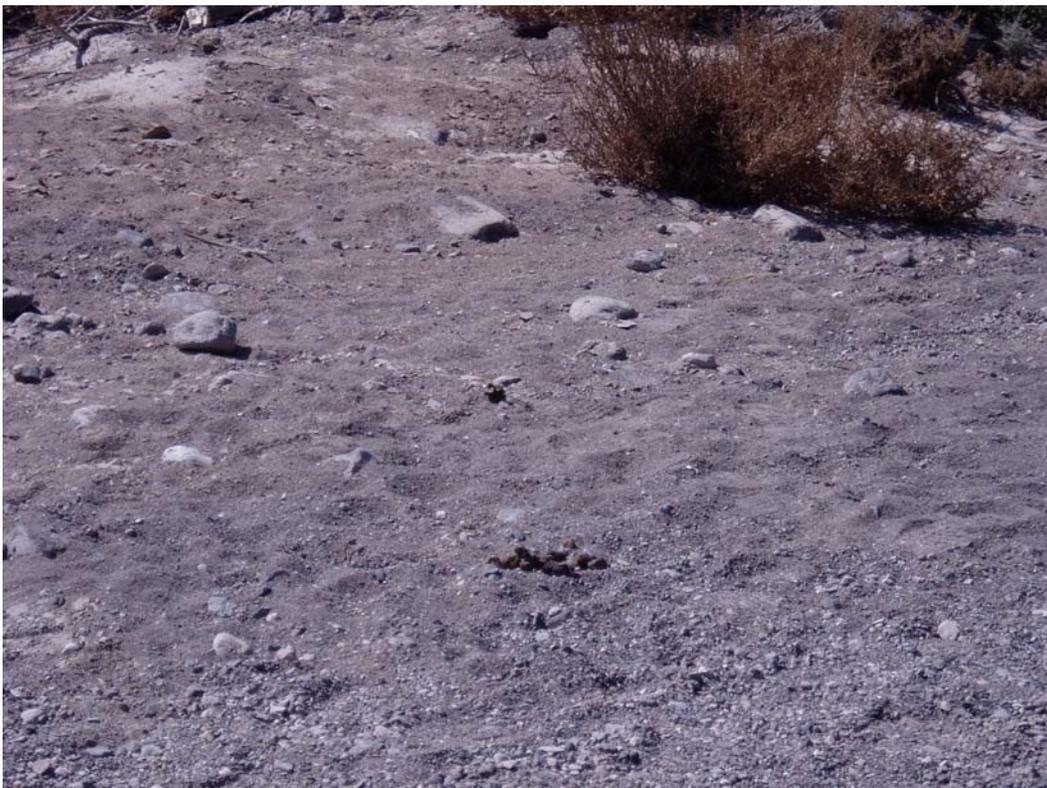
Photo 6. Pet waste (photo center towards the bottom) in Project Green area of Pittman Wash.

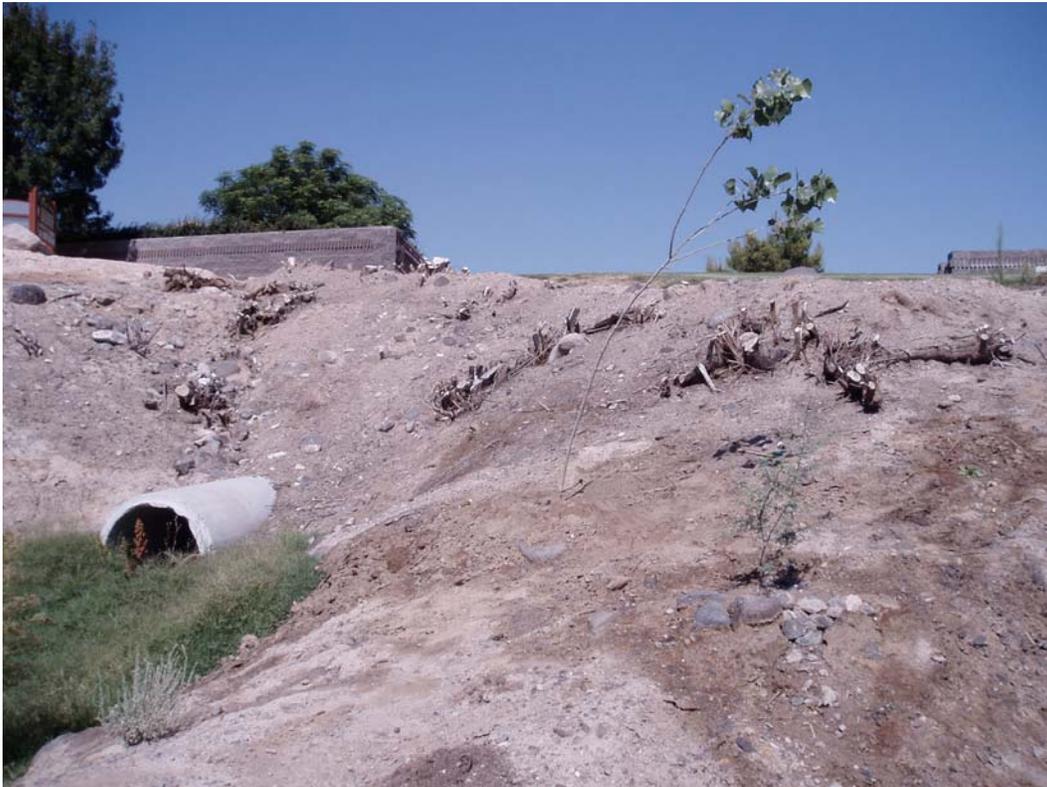
Photo 7. Cottonwood and mesquite trees with tamarisk stumps (photo right); outfall to wash (photo left).

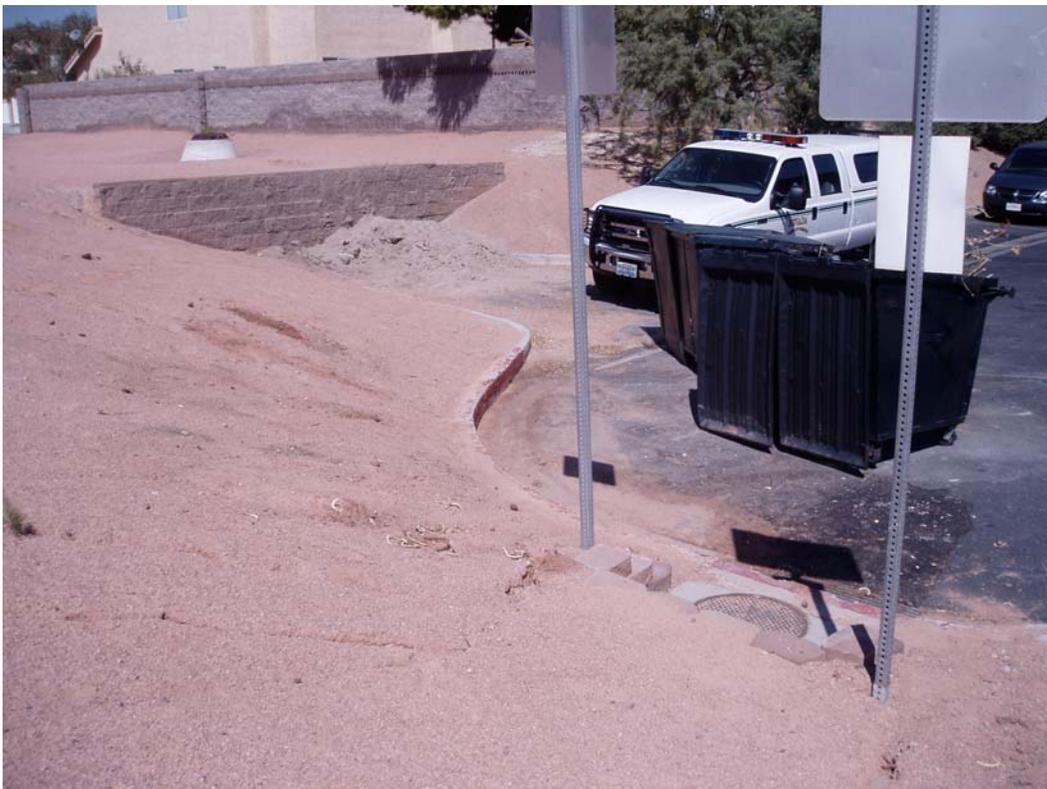
Photo 8. Parks and Recreation Department dirt storage. Trackout visible to inlet, which flows to outfall in Photo 7.

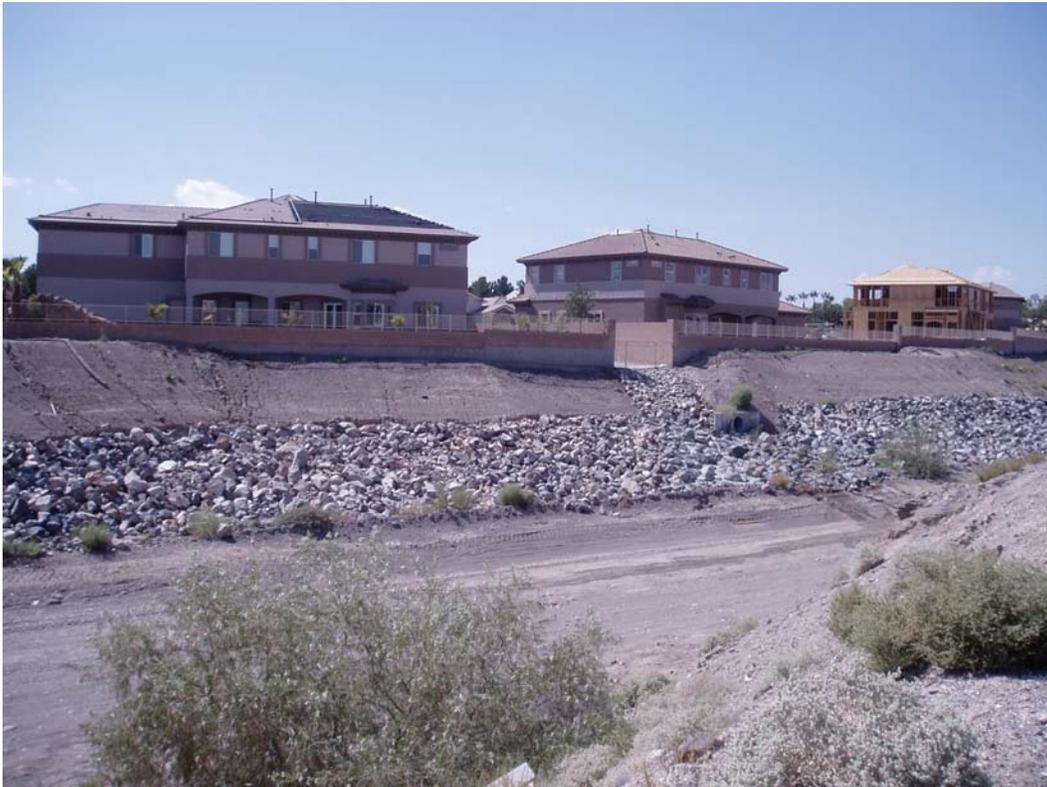
Photo 9. Upper Pittman Wash downstream of Project Green (flows left). Minor flow was visible from the outfall (right, center).

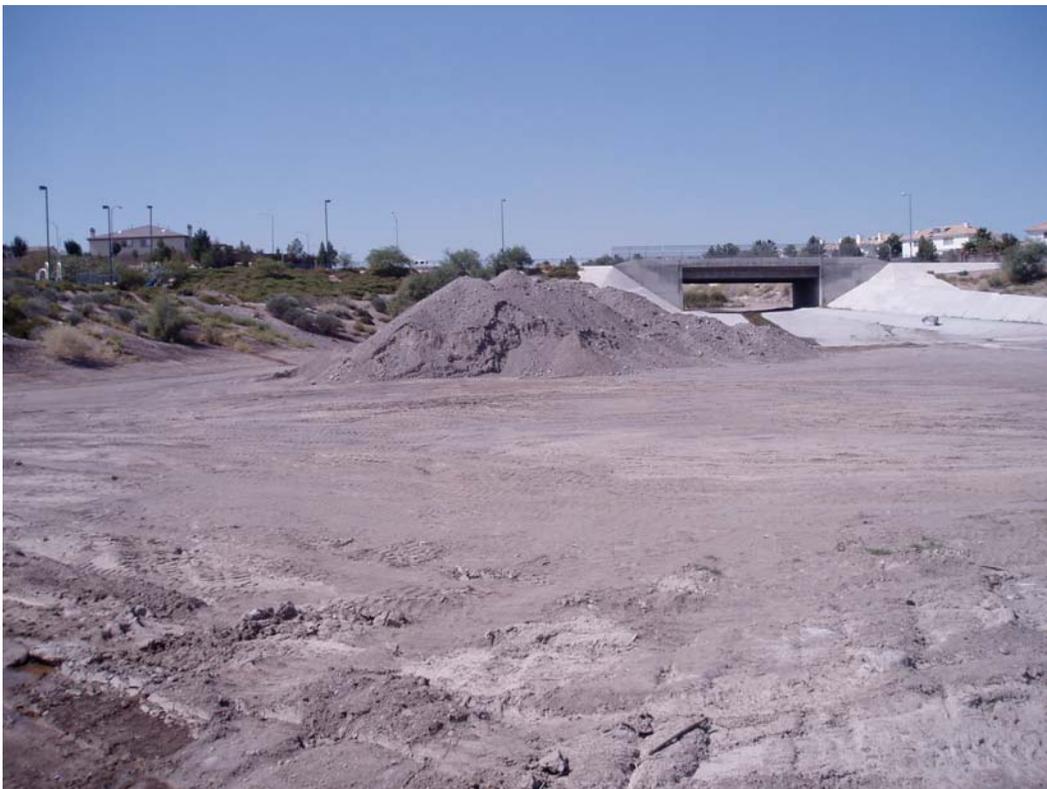
Photo 14. Sediment pile in Pittman Wash.

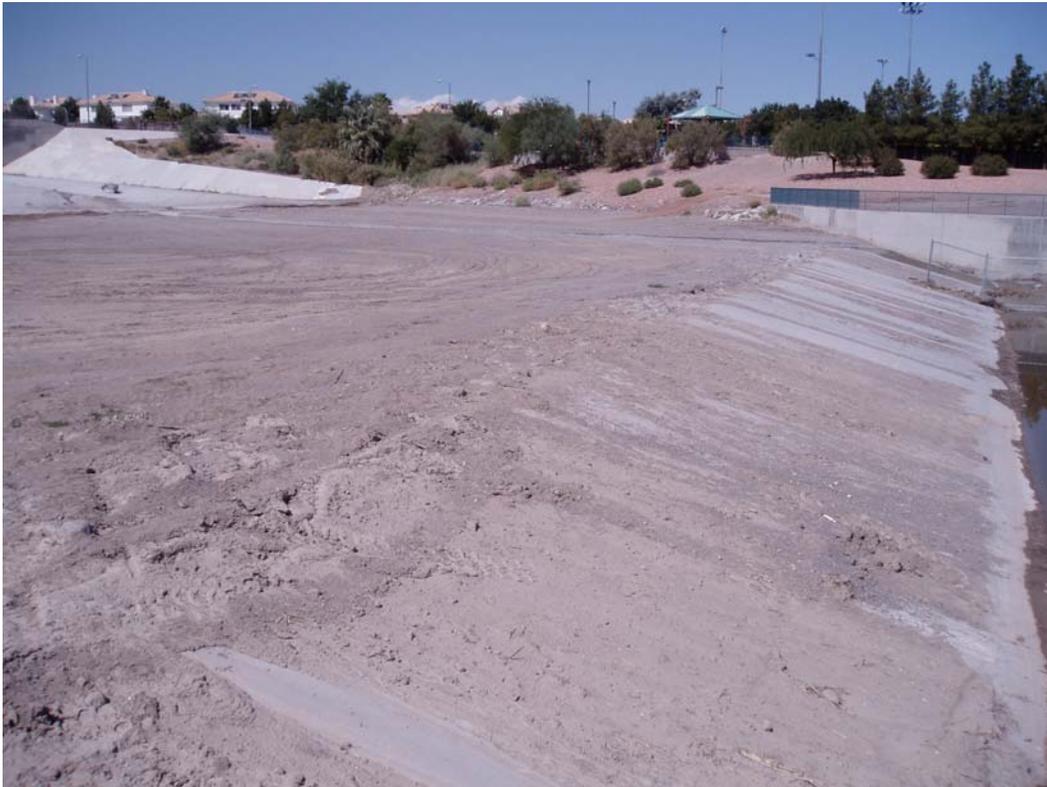
Photo 15. Location of first sediment deposit.

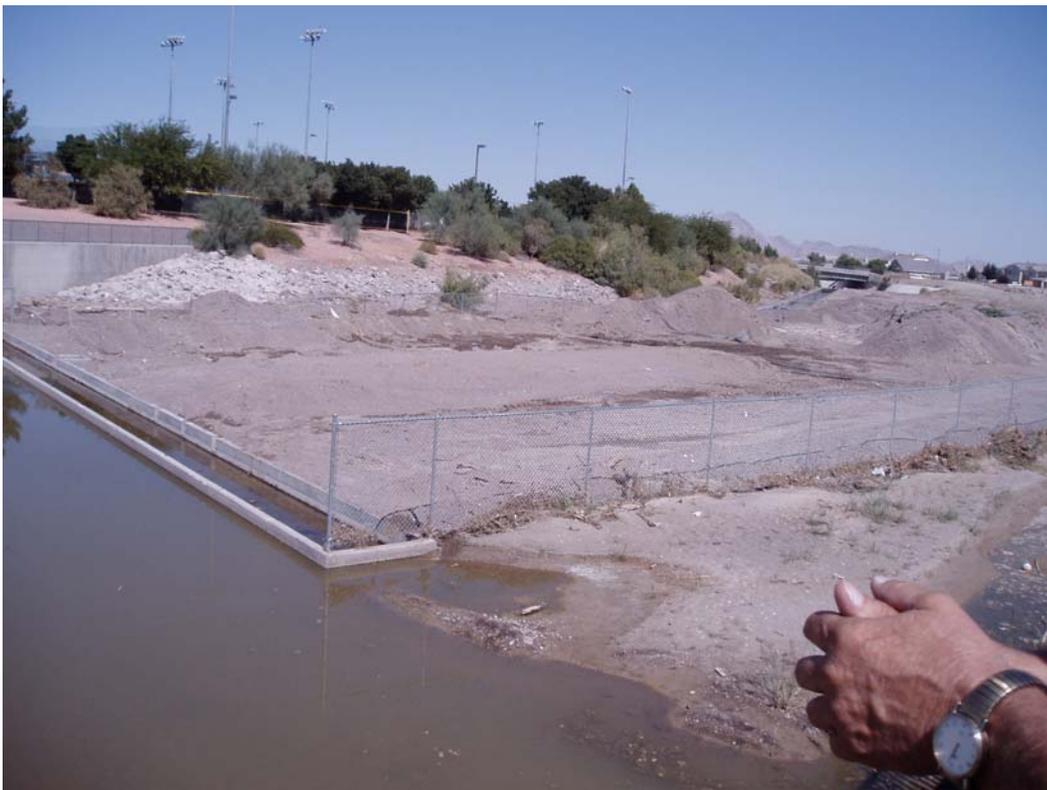
Photo 16. Location of second sediment deposit.

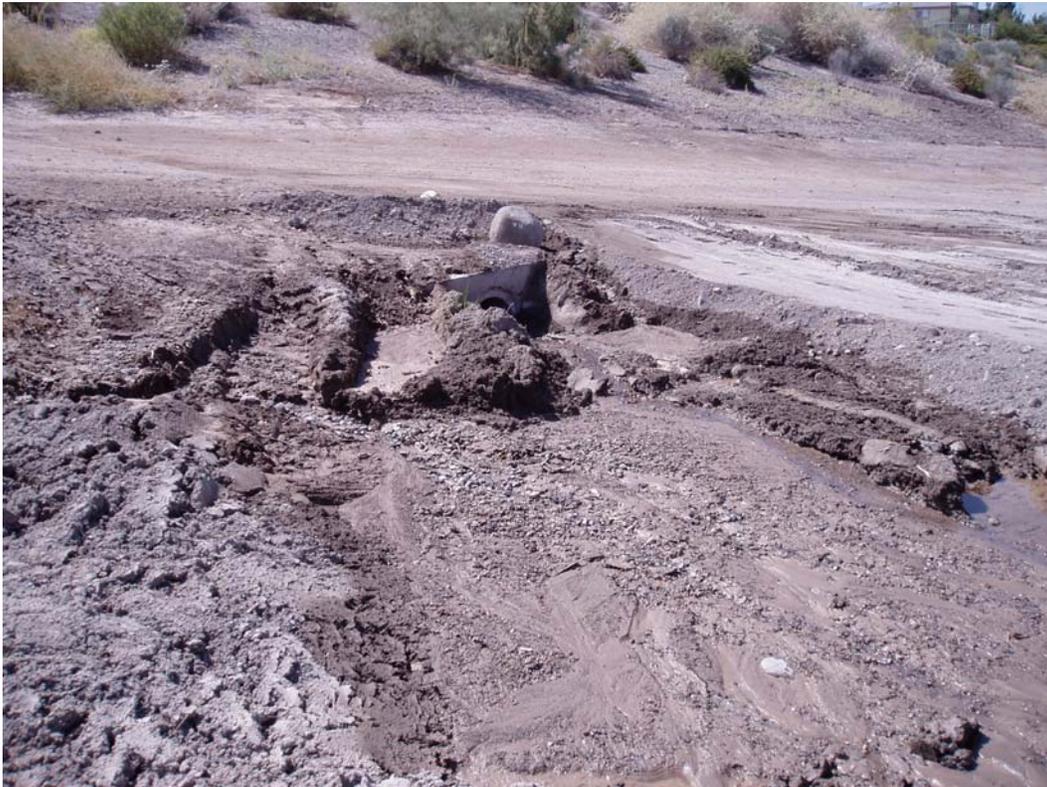
Photo 17. Outfall that discharges groundwater.

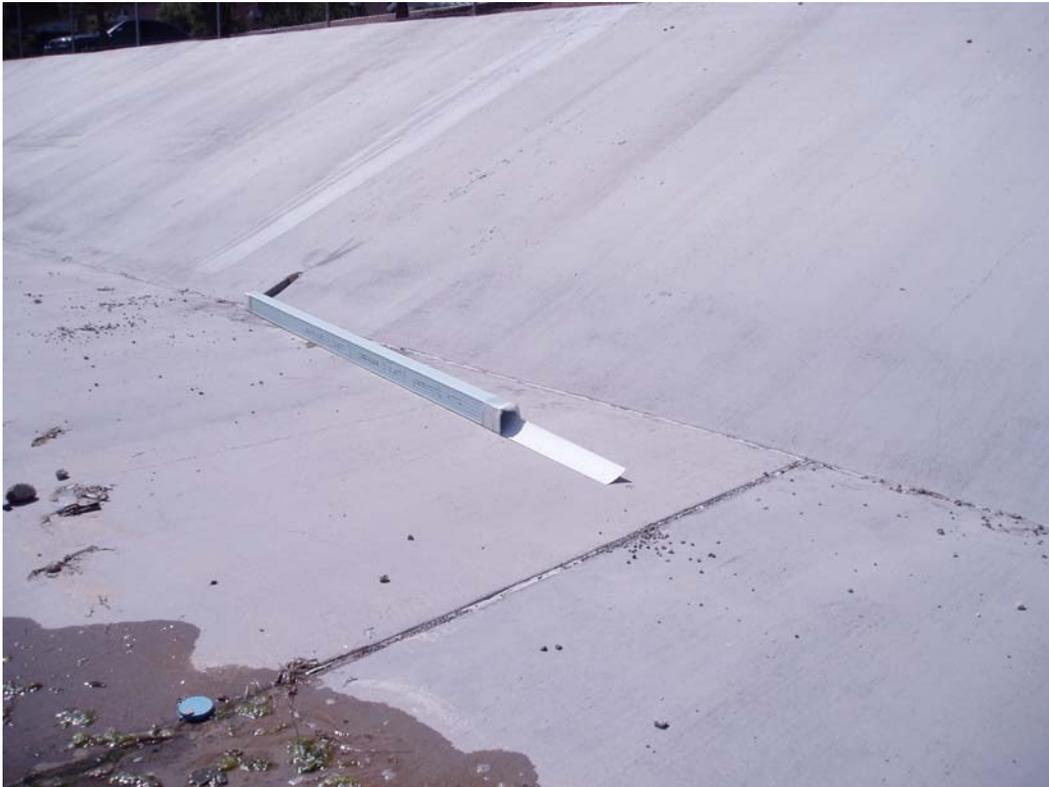
Photo 21. Empty box dumped in channel.

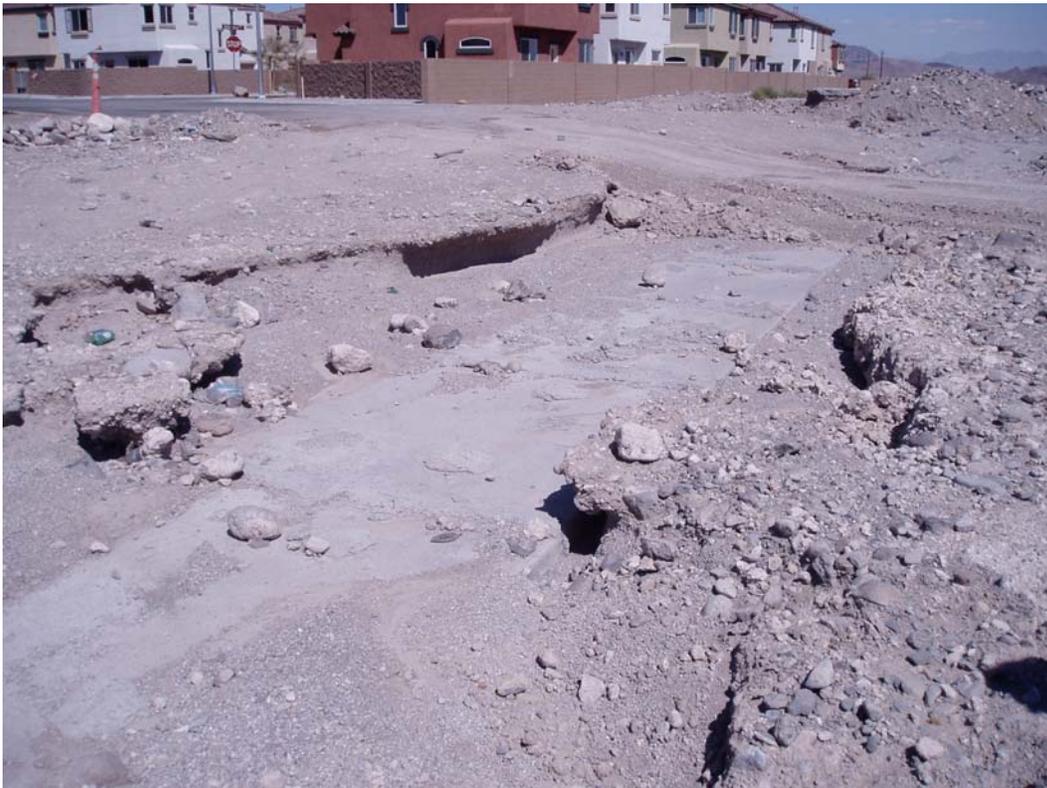
Photo 24. Exposed box.

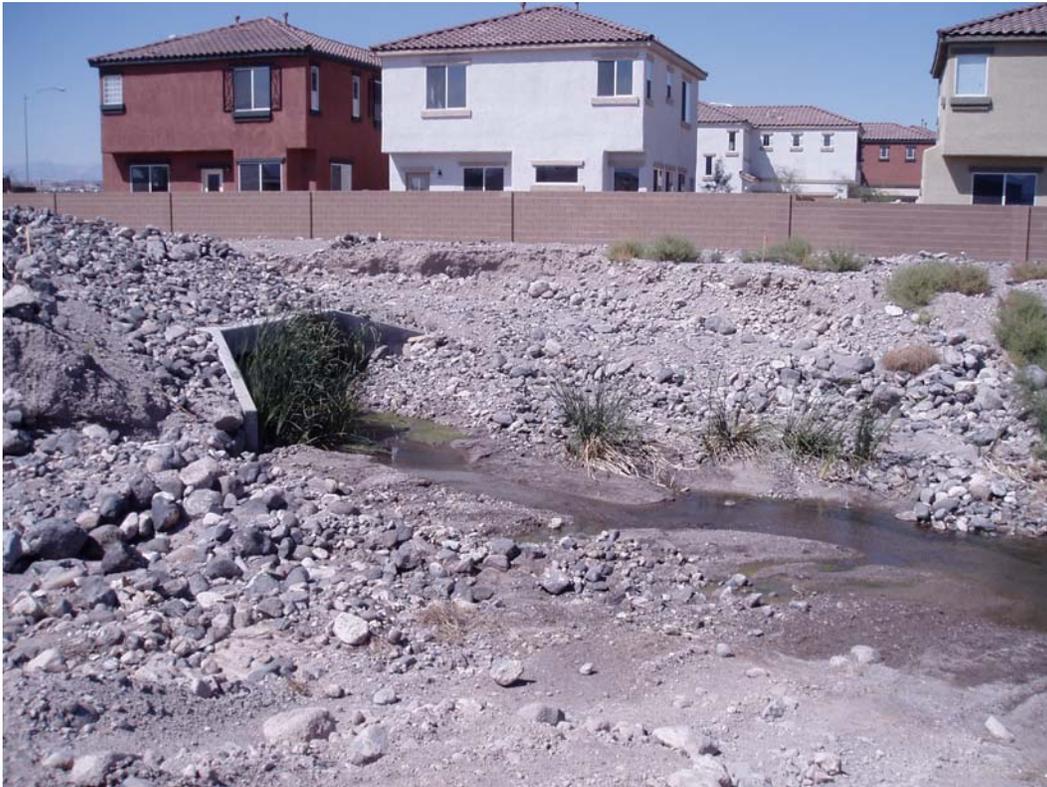
Photo 25. Outfall with flow.

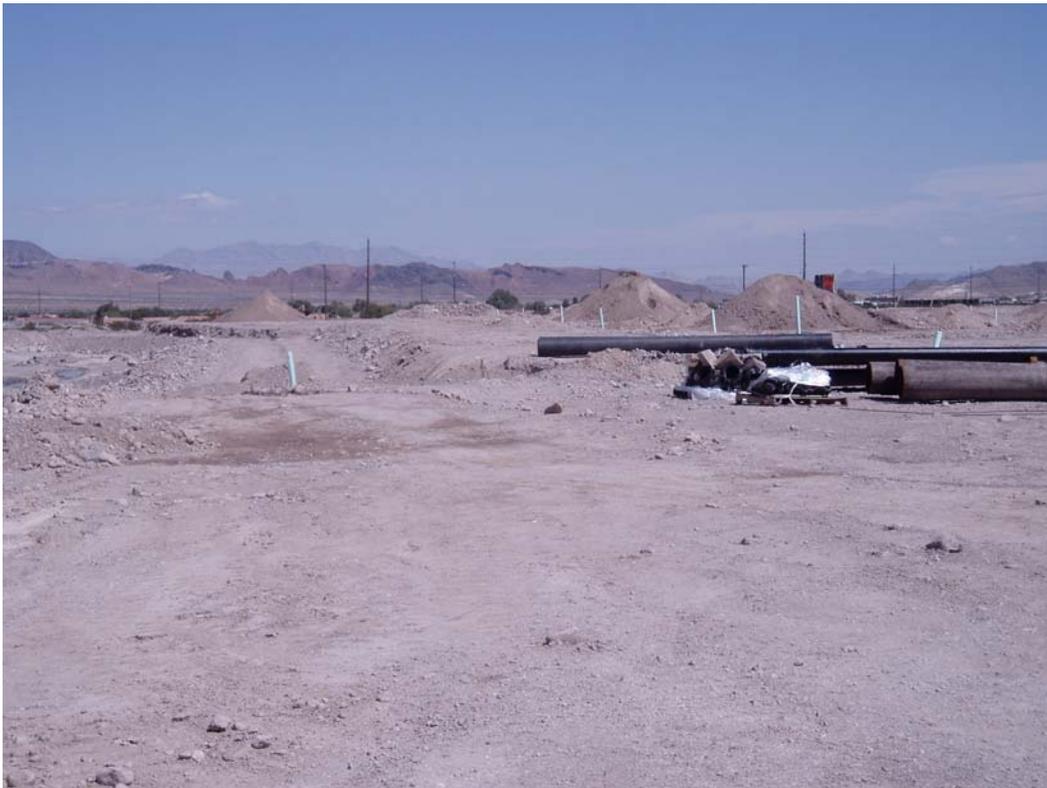
Photo 26. Construction and sediment piles (photo right) adjacent to Gibson Channel (photo left).

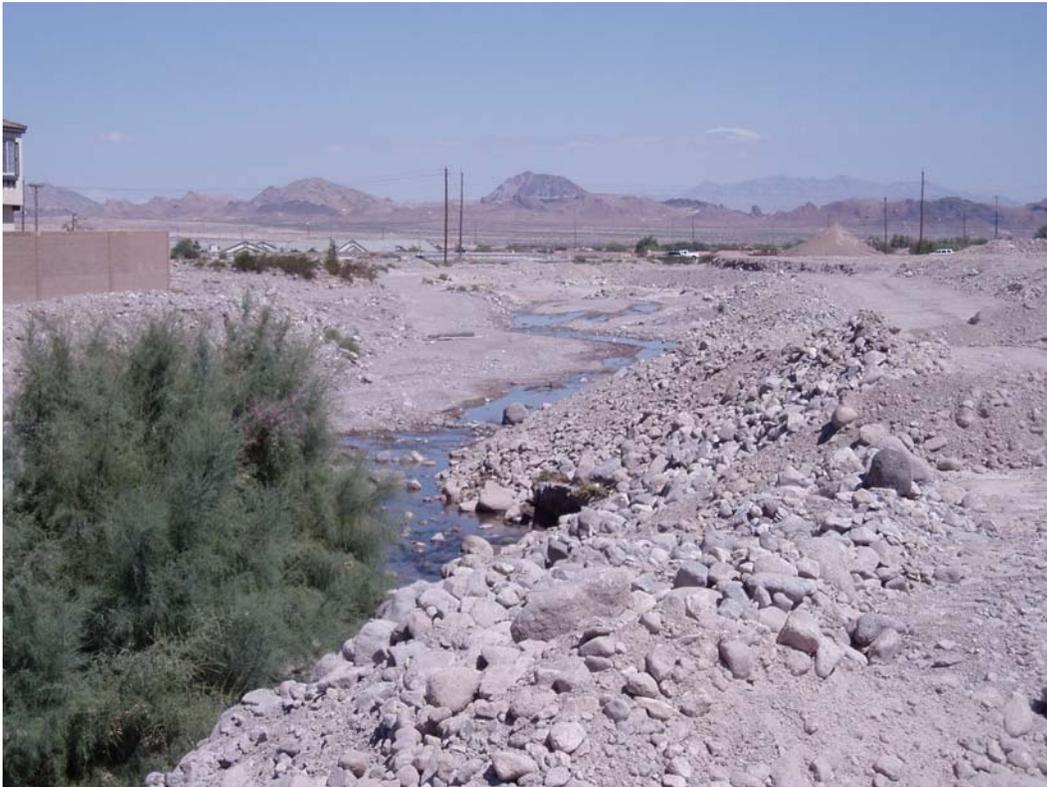
Photo 27. Flow from outfall in Photo 25.

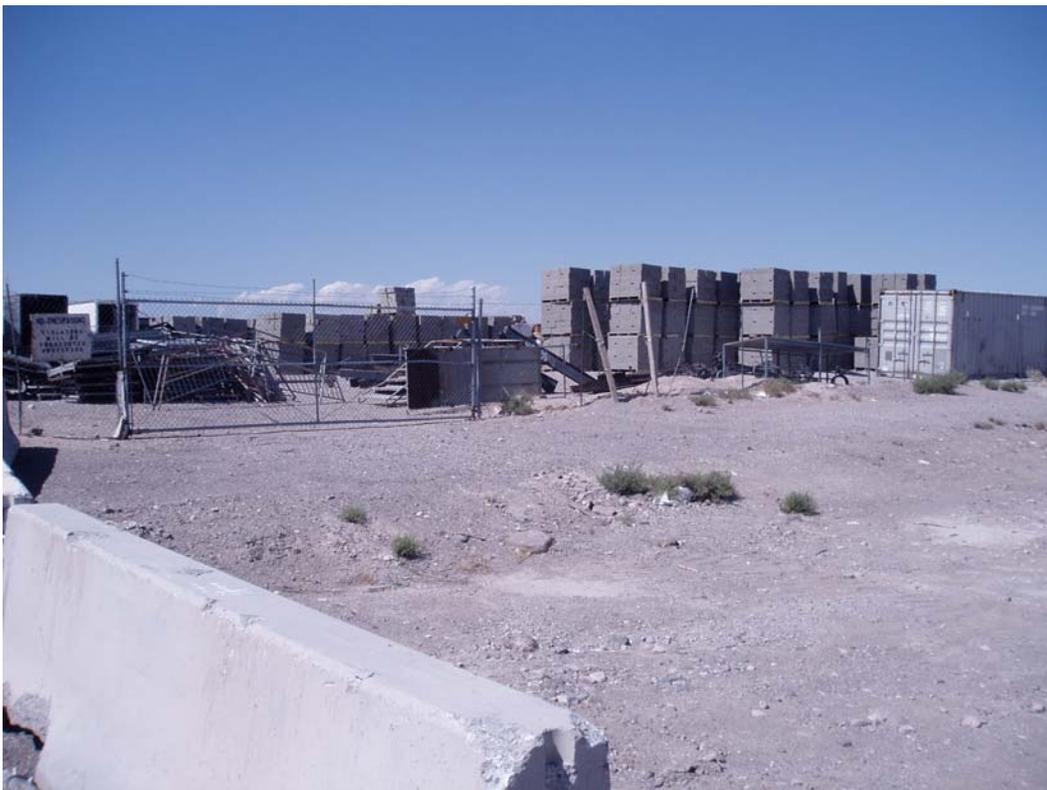
Photo 28. Storage along Gibson Channel.

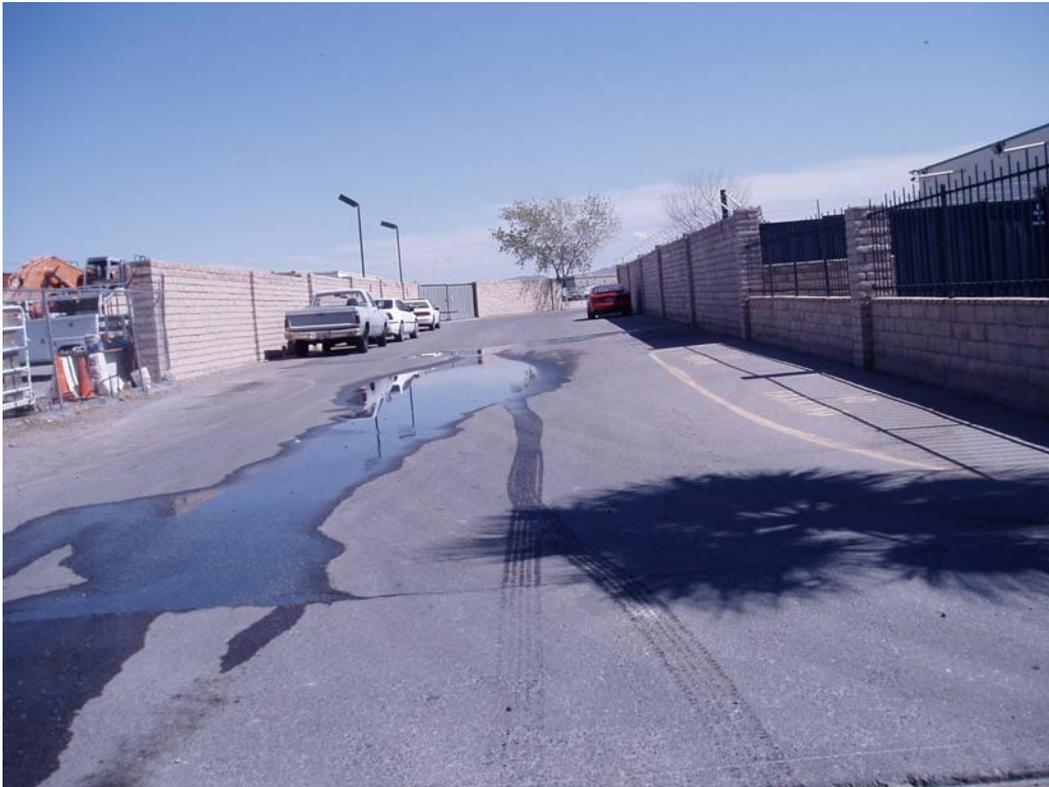
Photo 29. Discharge coming from B.Witt parking lot.

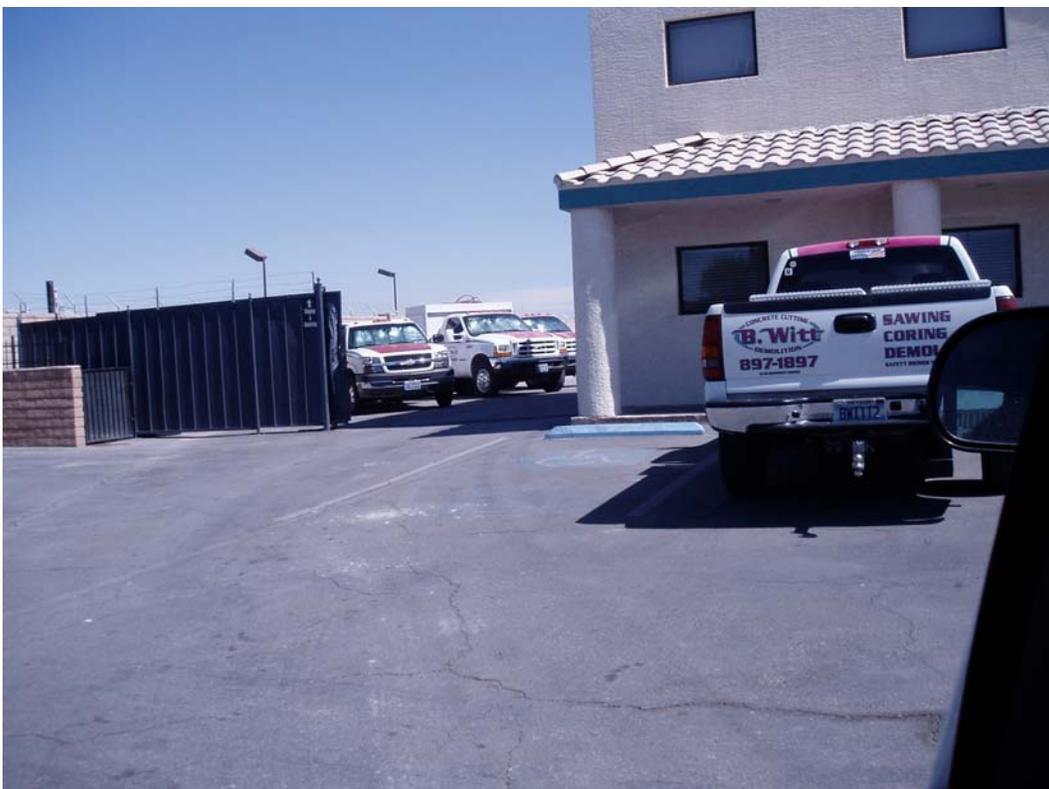
Photo 30. Parking lot source of discharge in Photo 29.

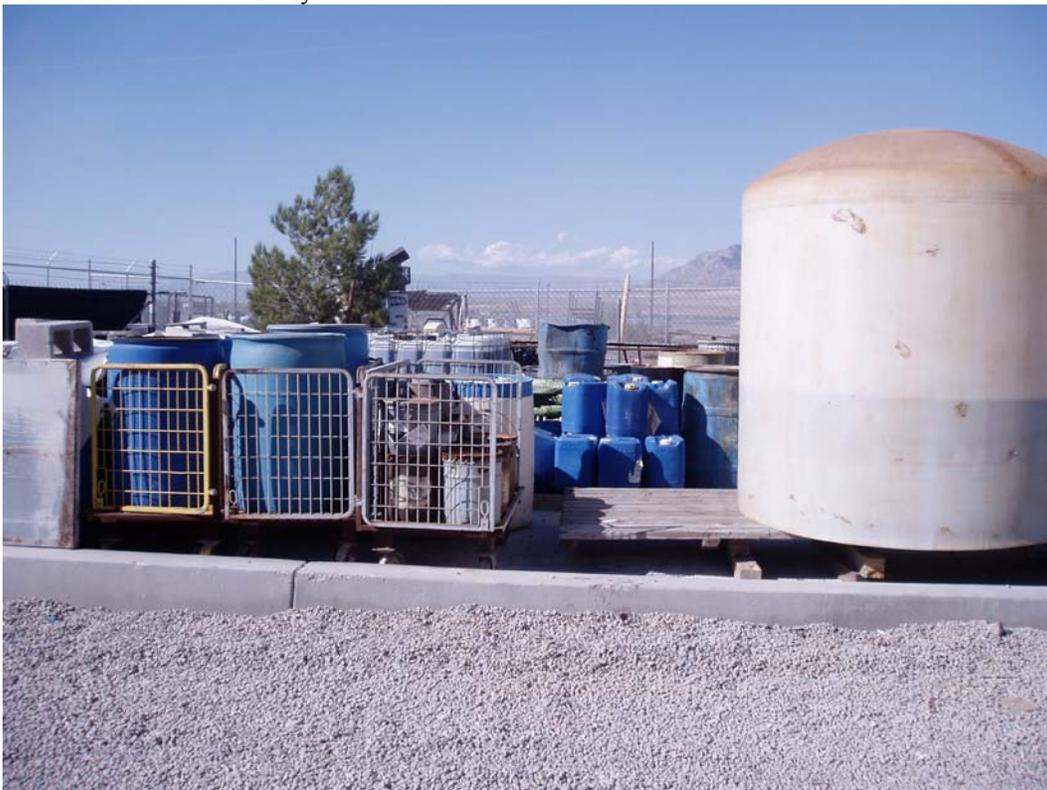
Photo 2. Bermed area for chemical storage.
