Restoration of Tidally Restricted Salt Marshes Rumney Marsh in Massachusetts:

Balancing Flood Protection with Marsh
Restoration by use of Self-Regulating Tidegates

Edward Reiner - EPA New England

New England Association of
Environmental Biologists
March 17, 2010
Newport, RI

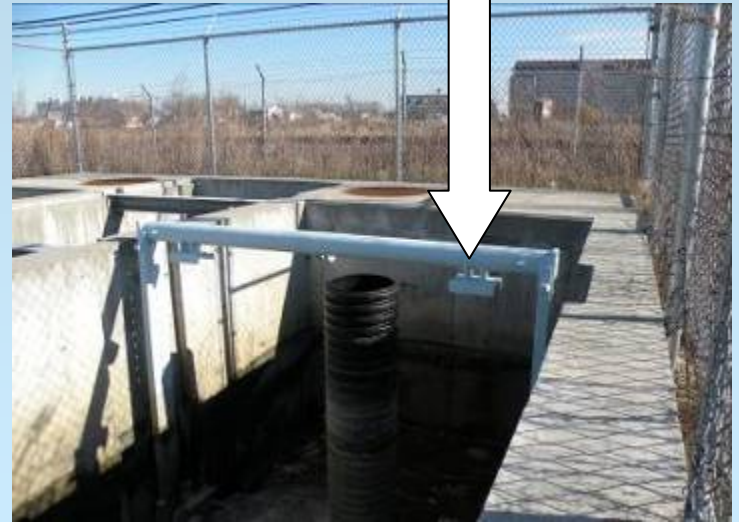
Aluminum Grates
and Parts Stolen

Rocks Thrown at SRT

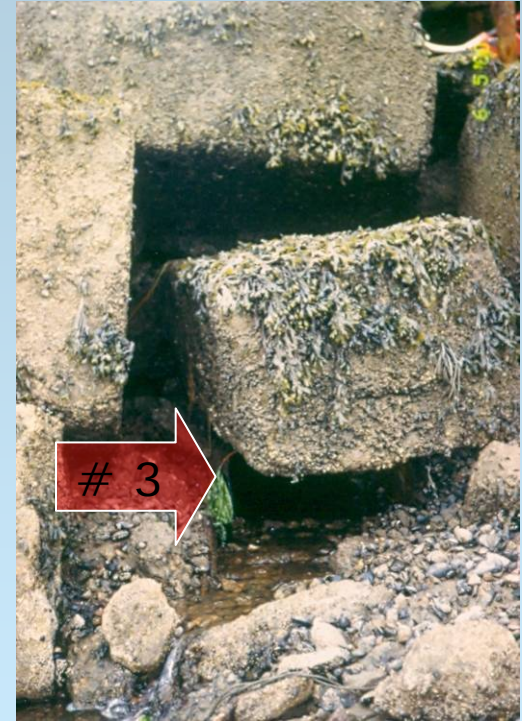
Culvert Outlet
Blocked

- Check engineering design
- Clear permit conditions & plans
- Operation and Maintenance plans
 - Monitor and make adjustments
 - Periodic inspection/maintenance
- Repair or replace culverts
- Avoid small size riprap

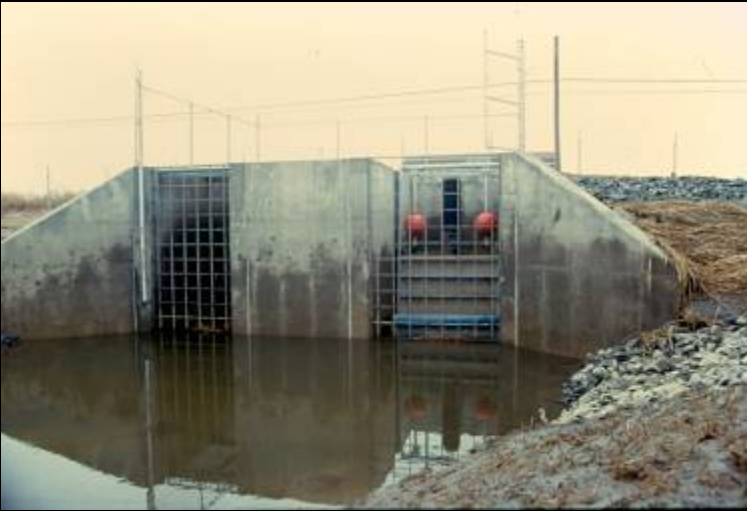
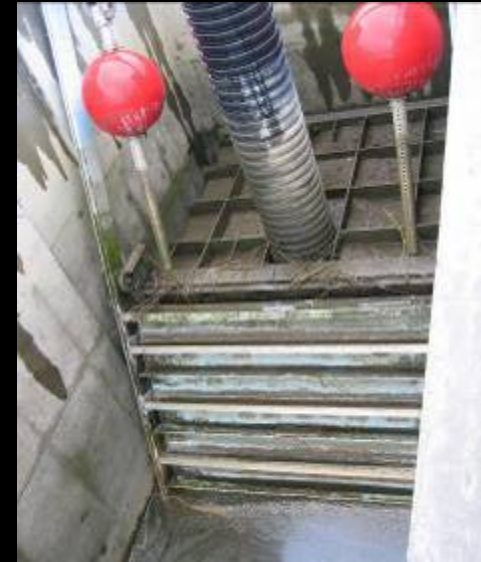
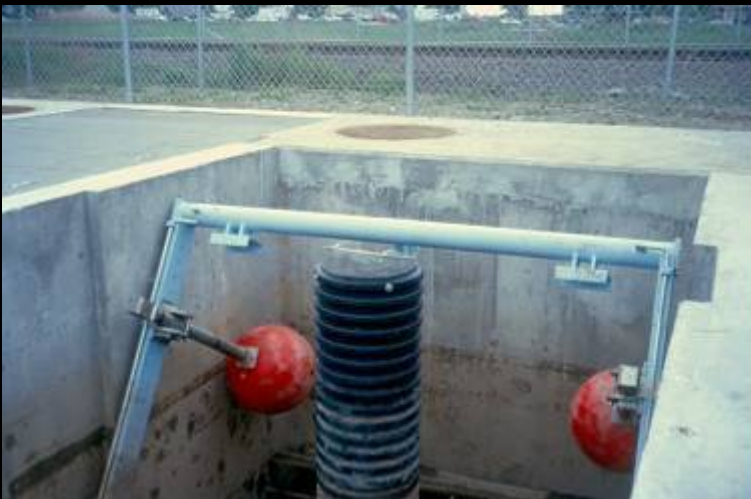
Engineering Error

The concrete vault was too narrow to allow correct SRT adjustment

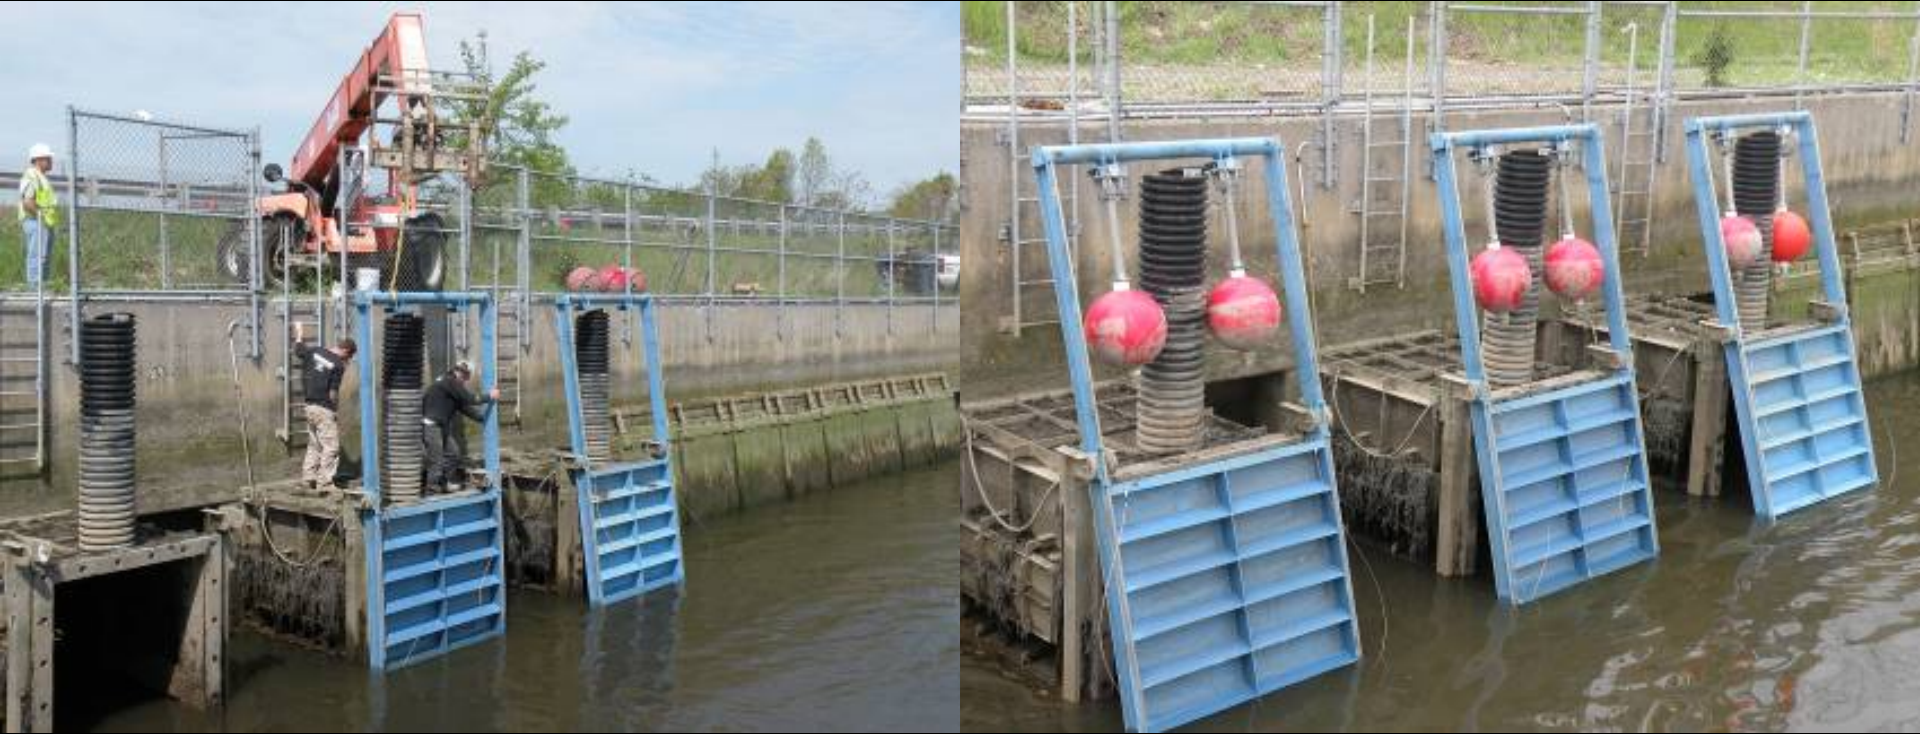
Replacement Gates

Installed in 2009

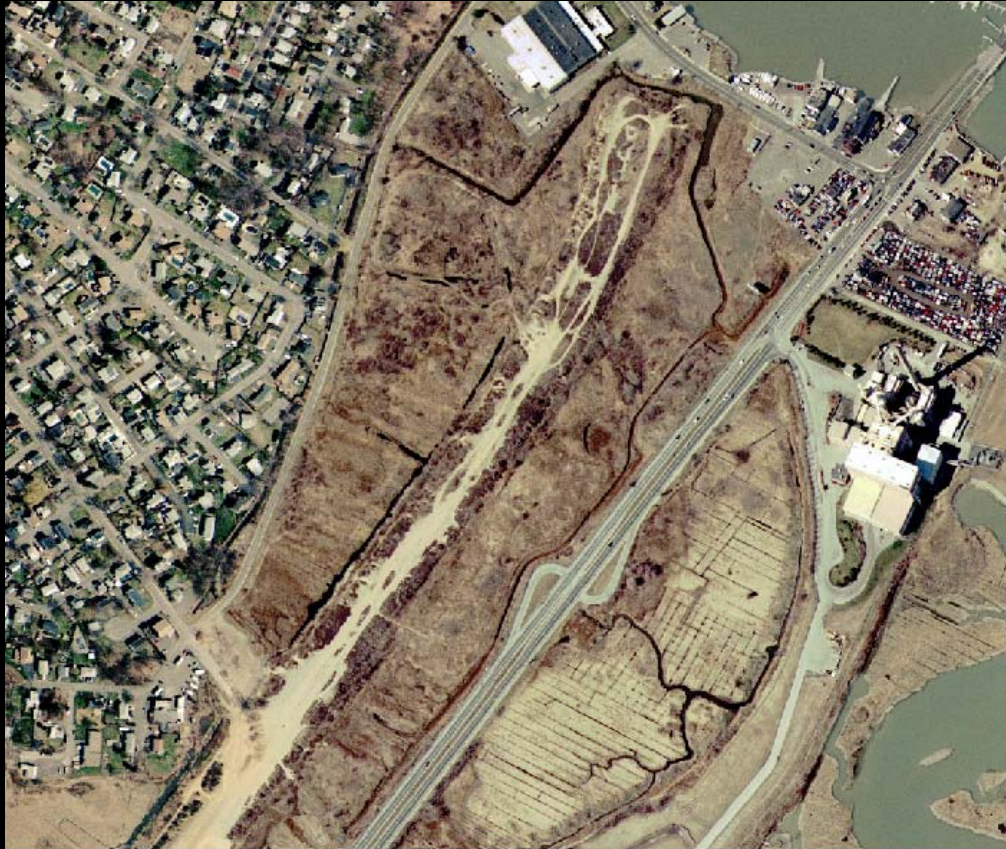
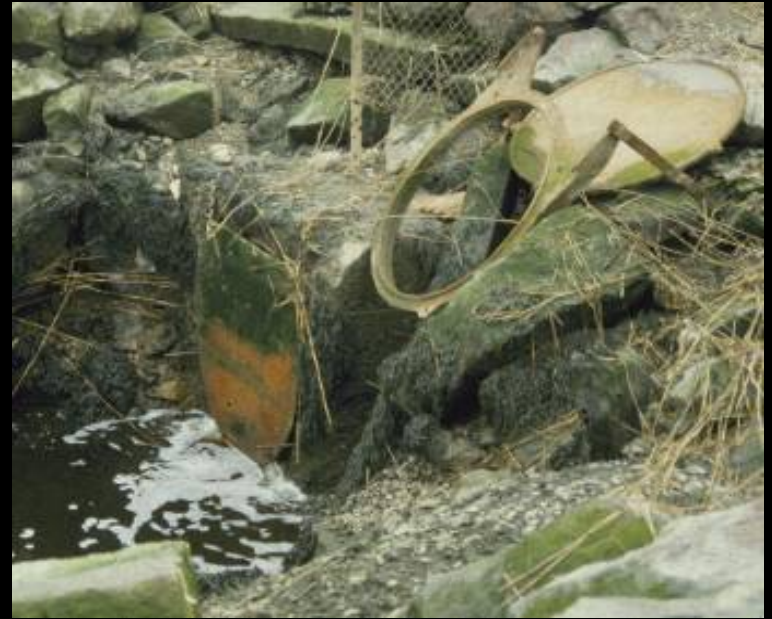
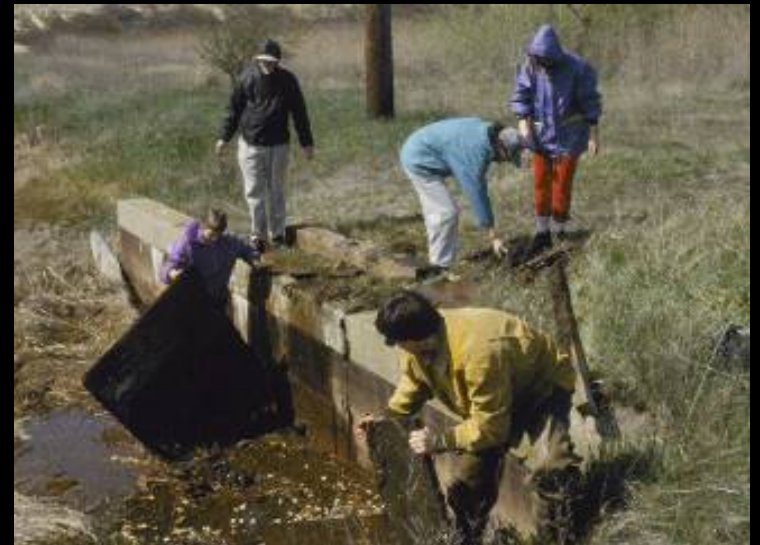
Ballard Street Salt Marsh

23 Acres Damaged
